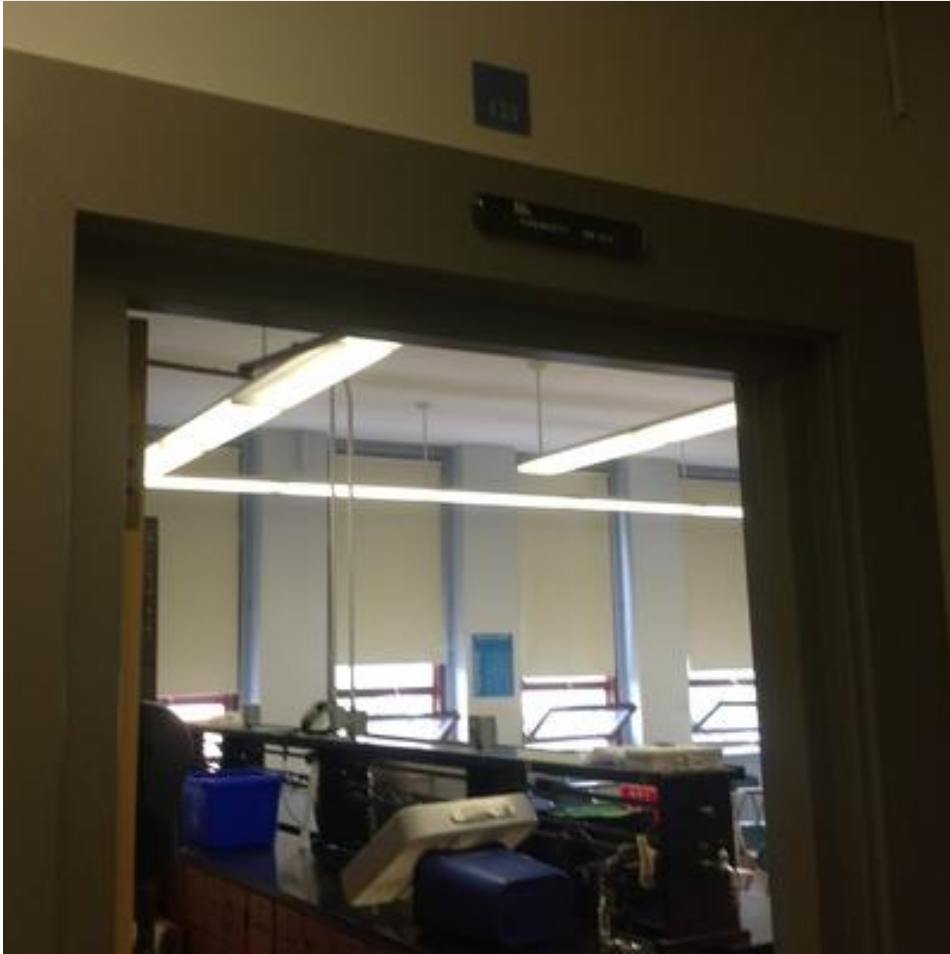
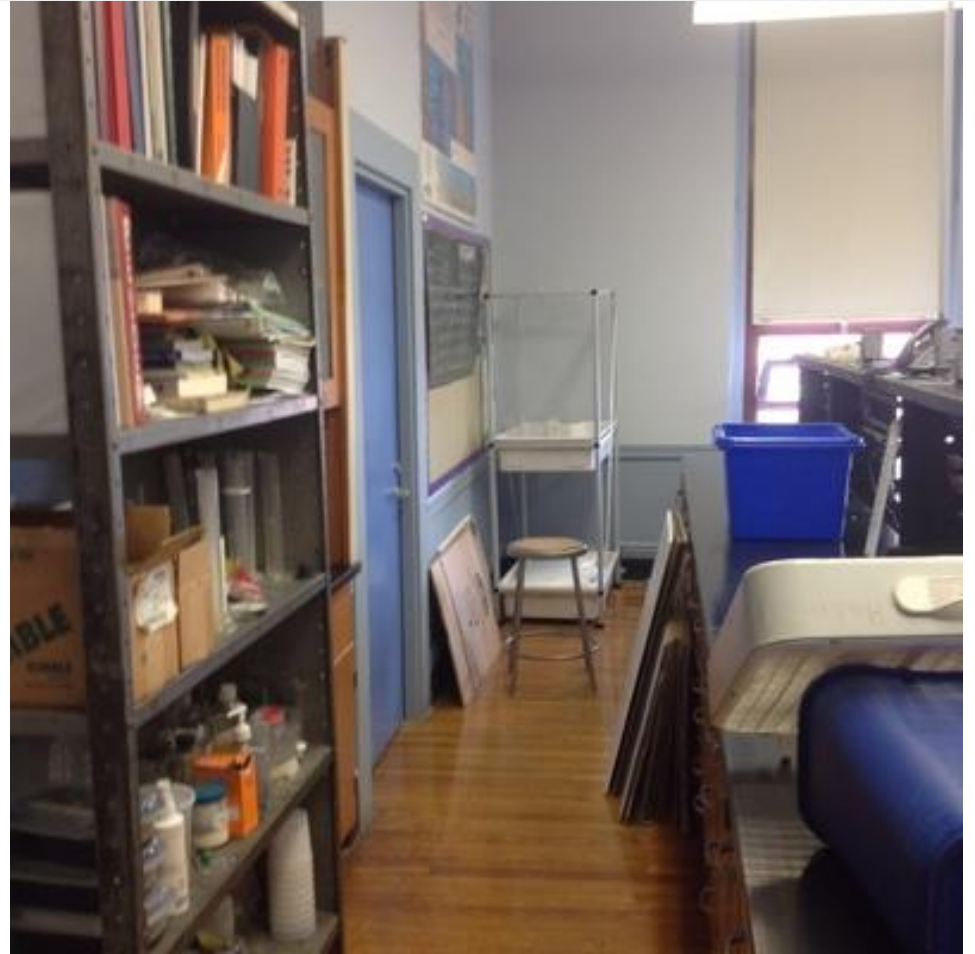
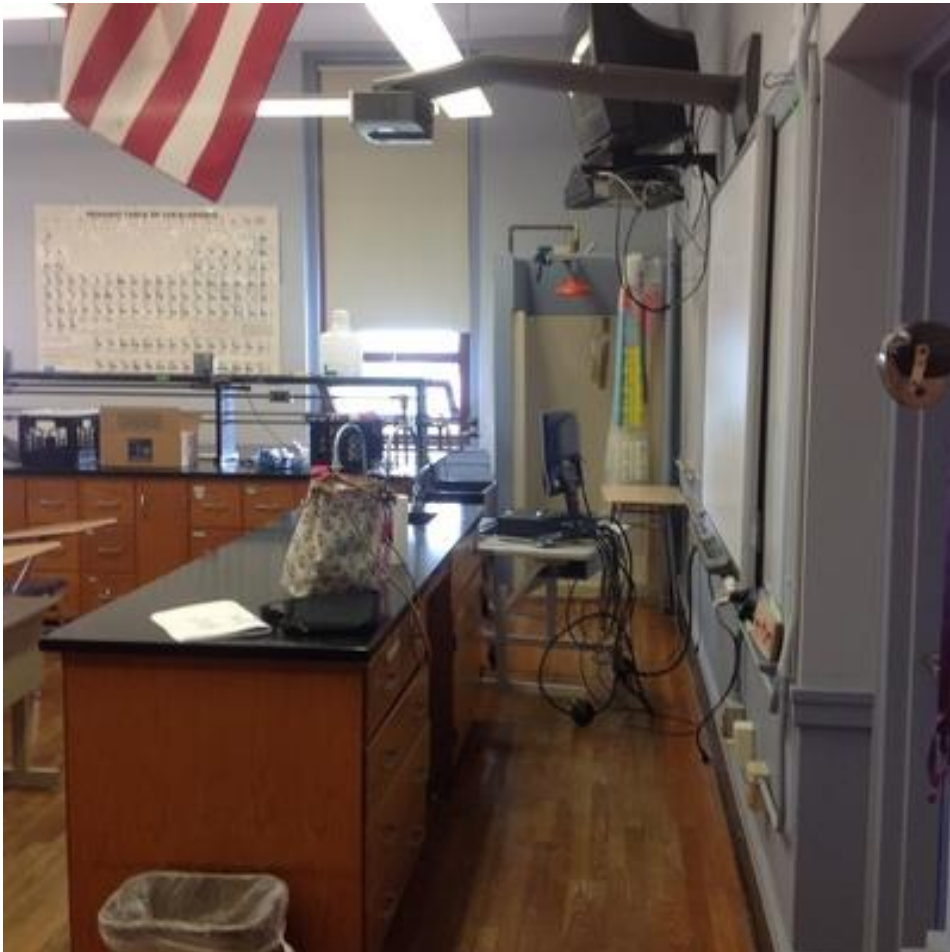
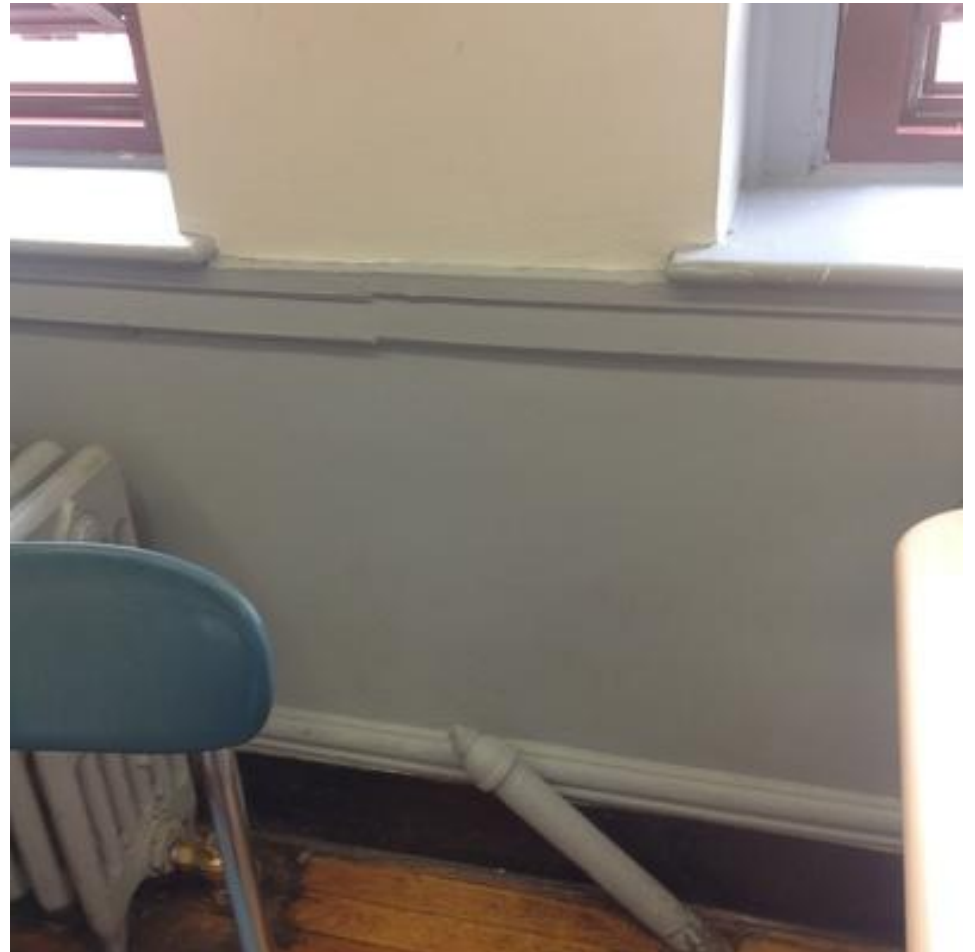
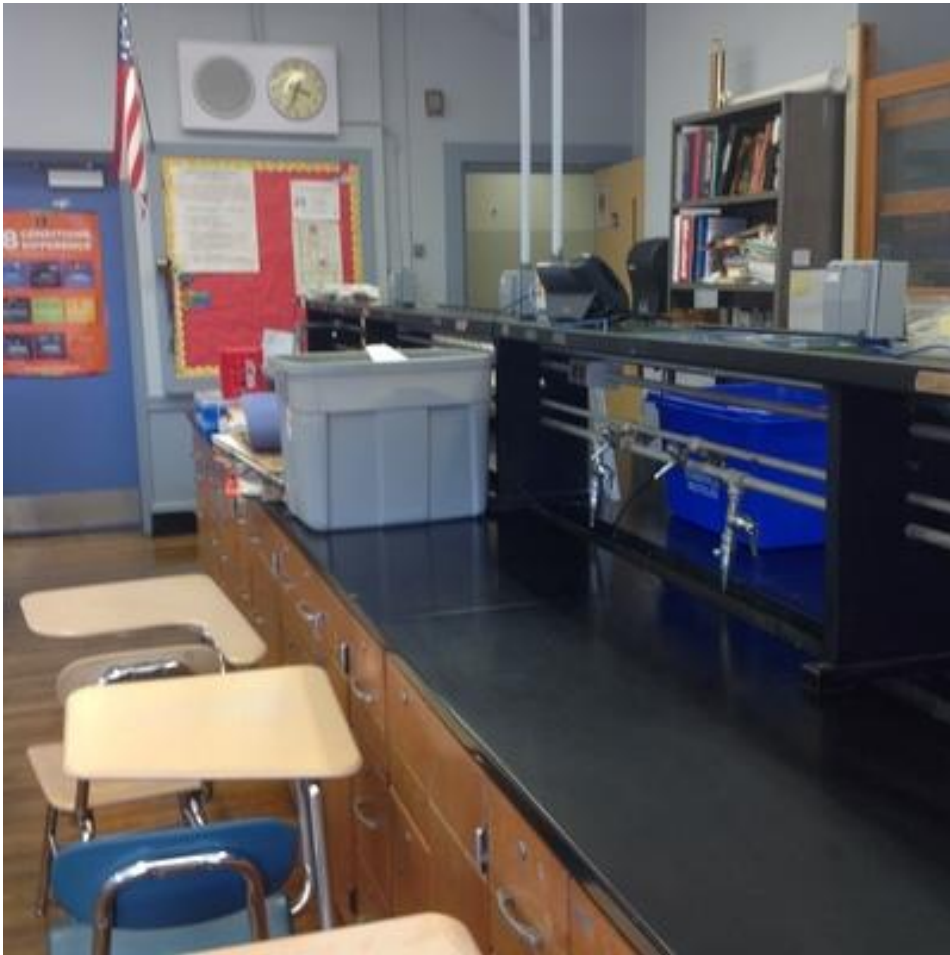
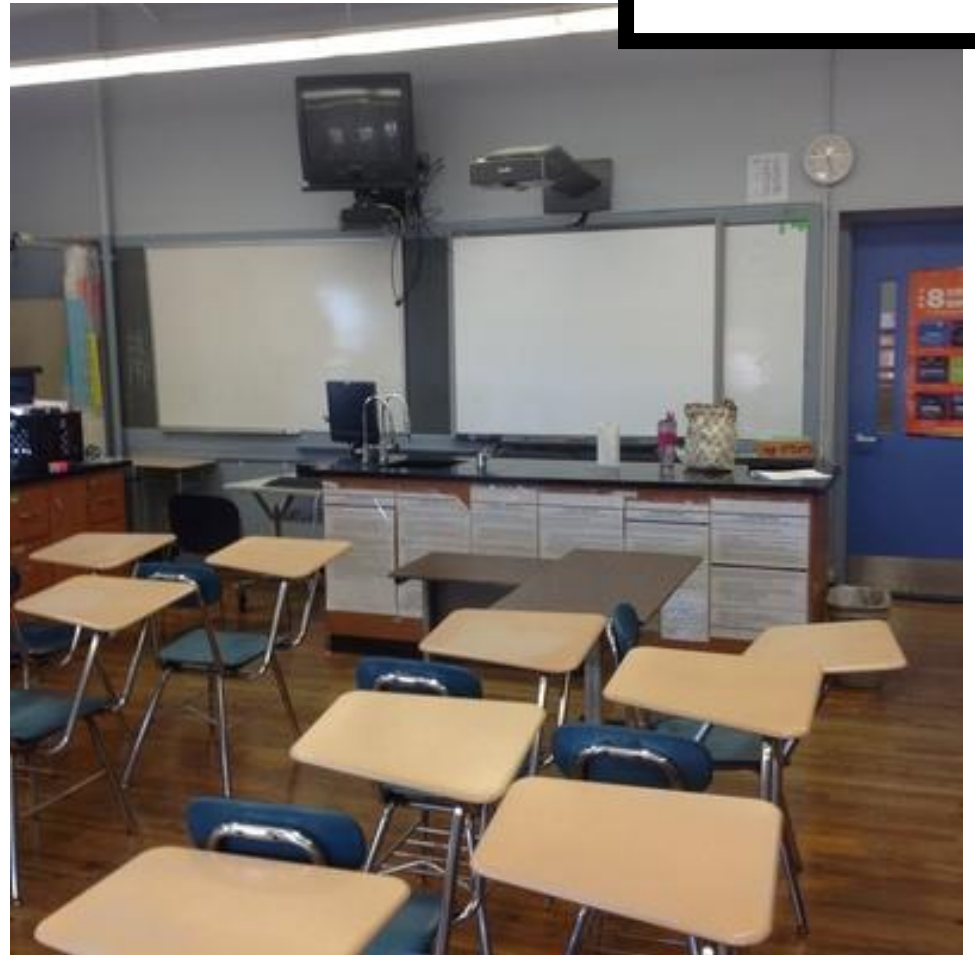
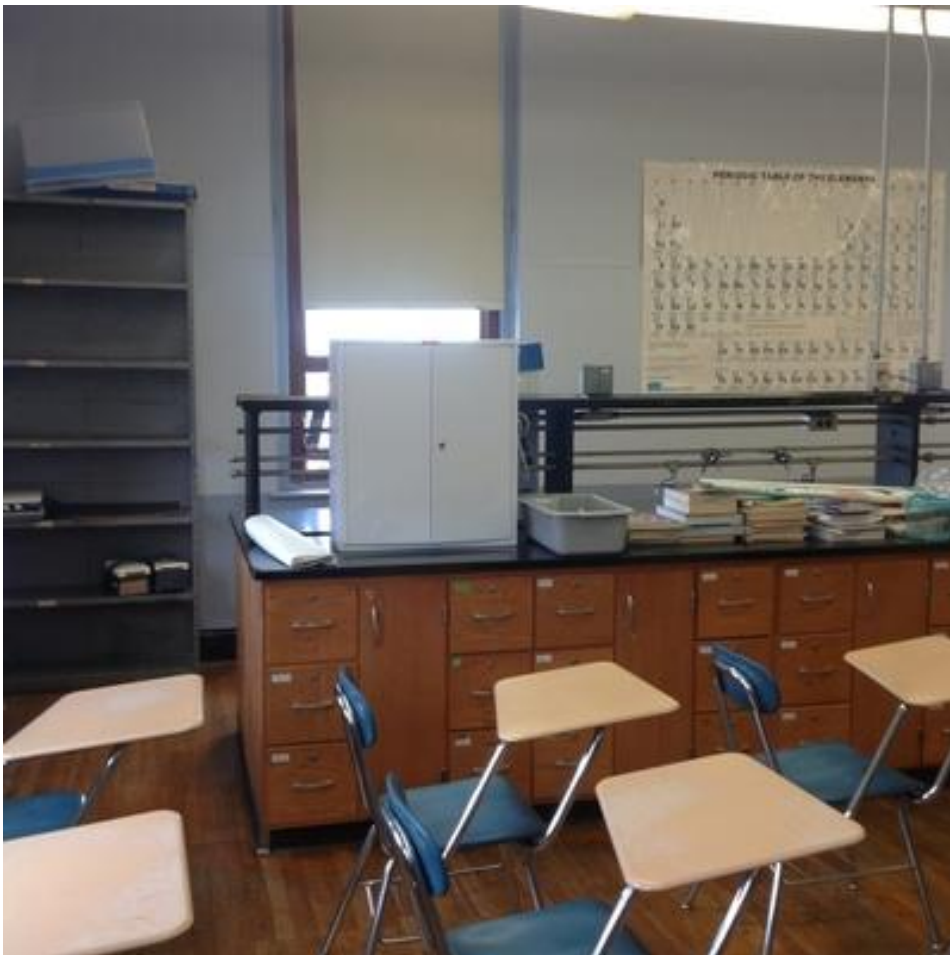
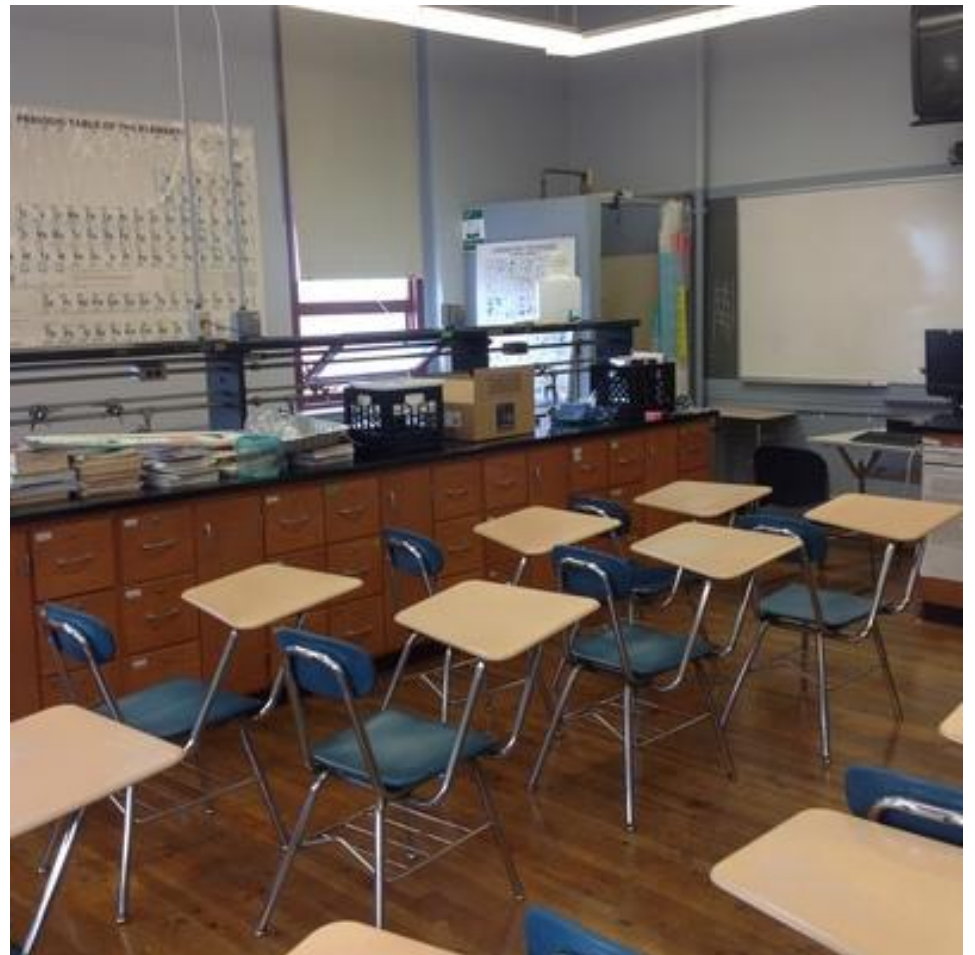
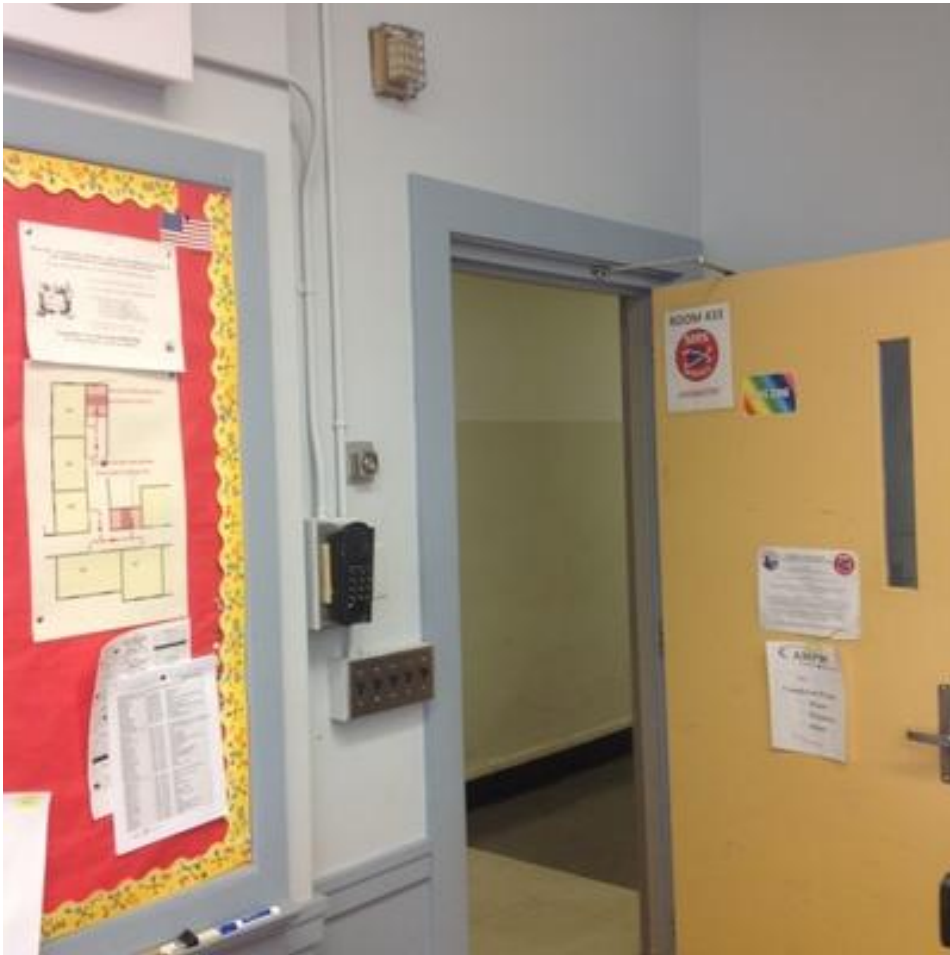
Attached Images for ID KJ-00035

Description
Wood flooring in good condition but creaky. Paint is chipping on walls and ceiling. Light fixtures missing covers in some locations. 10'x20' area of 12"x12" VCT on ceiling. Surface mounted equipment and wiring is haphazard. Shades are in poor condition. Millwork in poor condition. Unit heater in poor condition. Some windows have lost their seal. Classroom has smartboard. Chemistry millwork limits functional space within classroom.

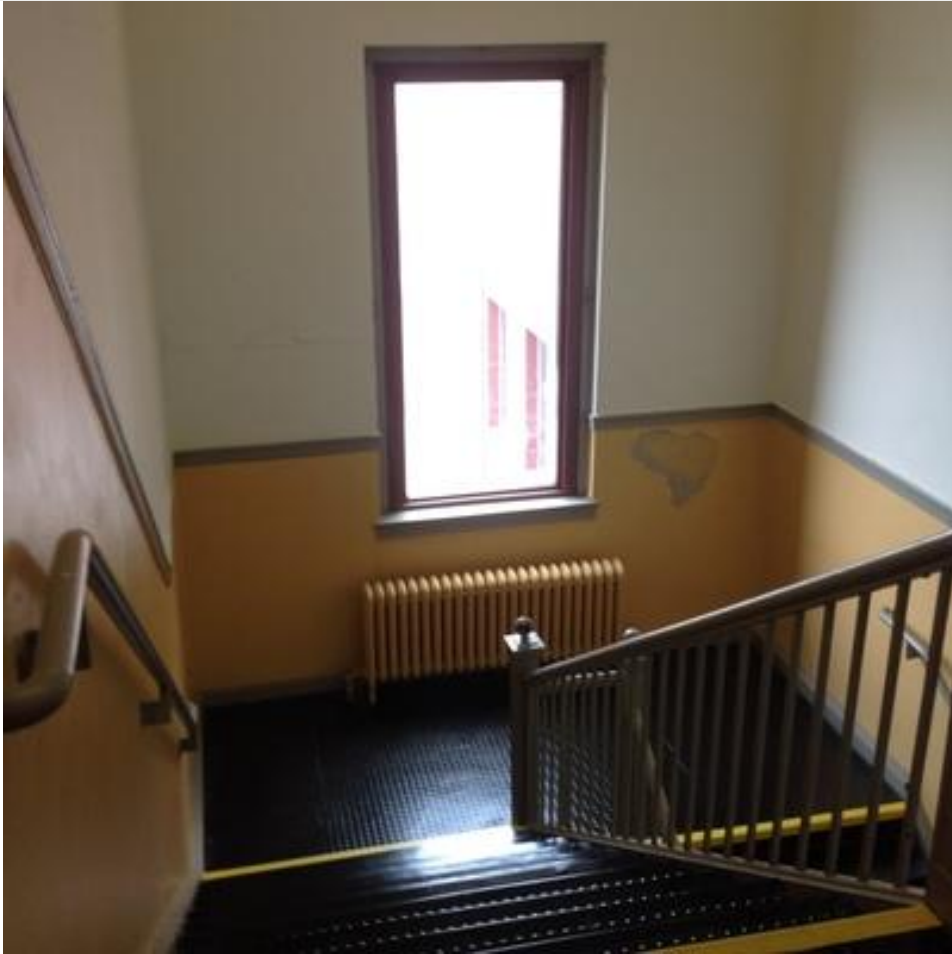
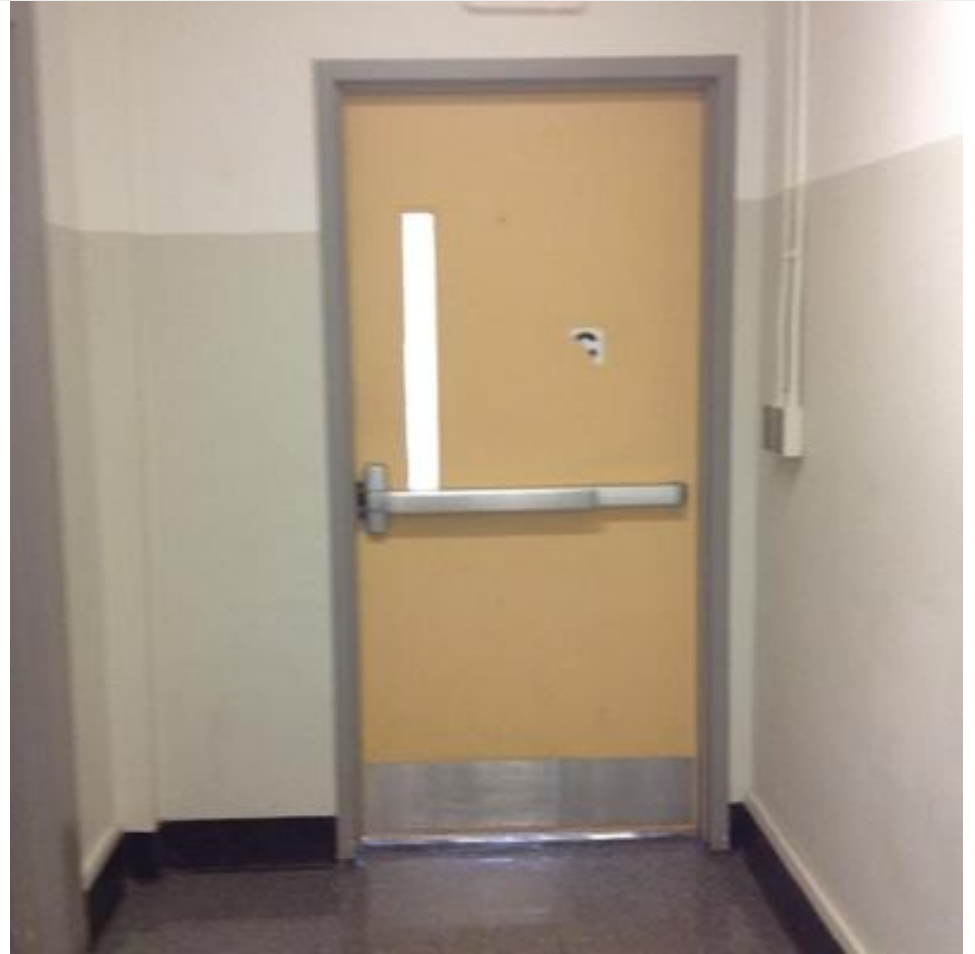
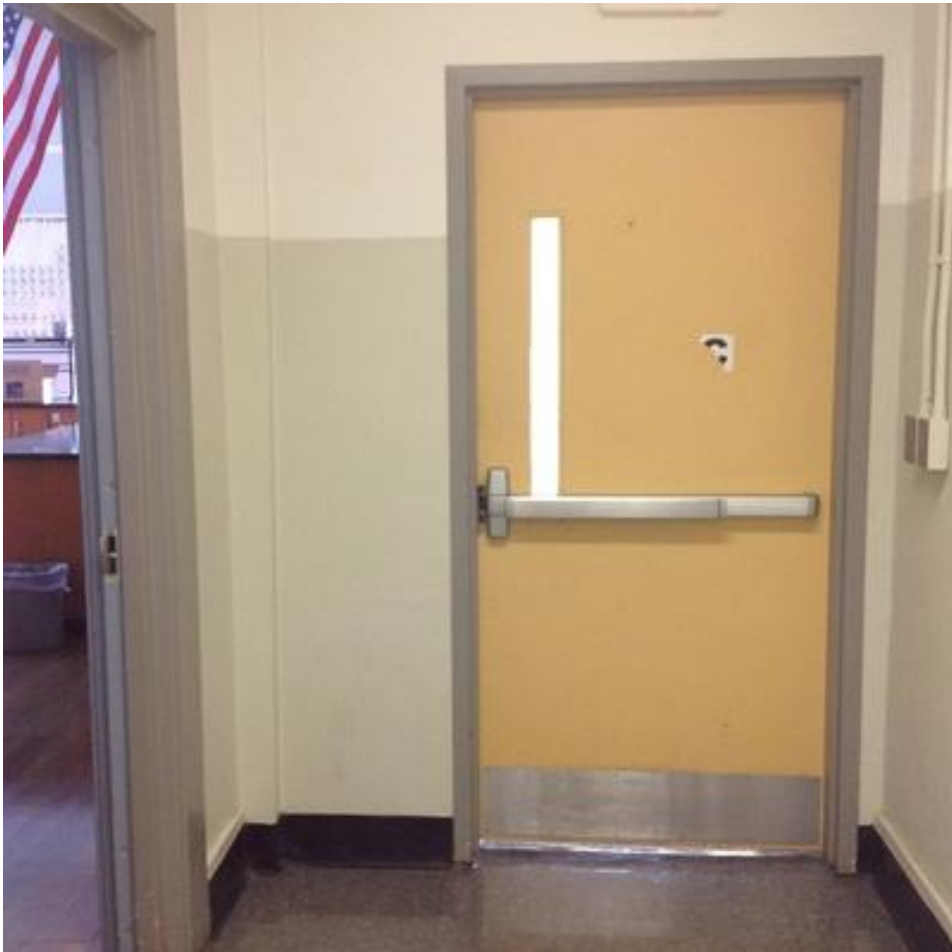
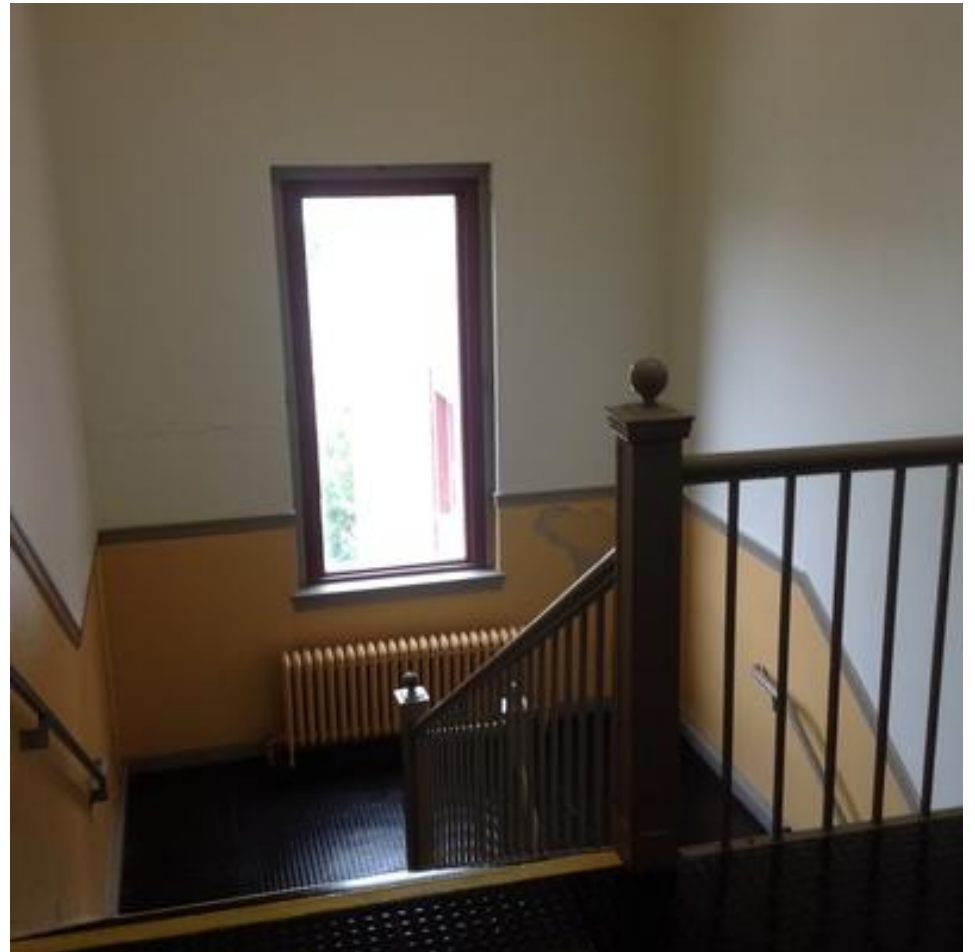
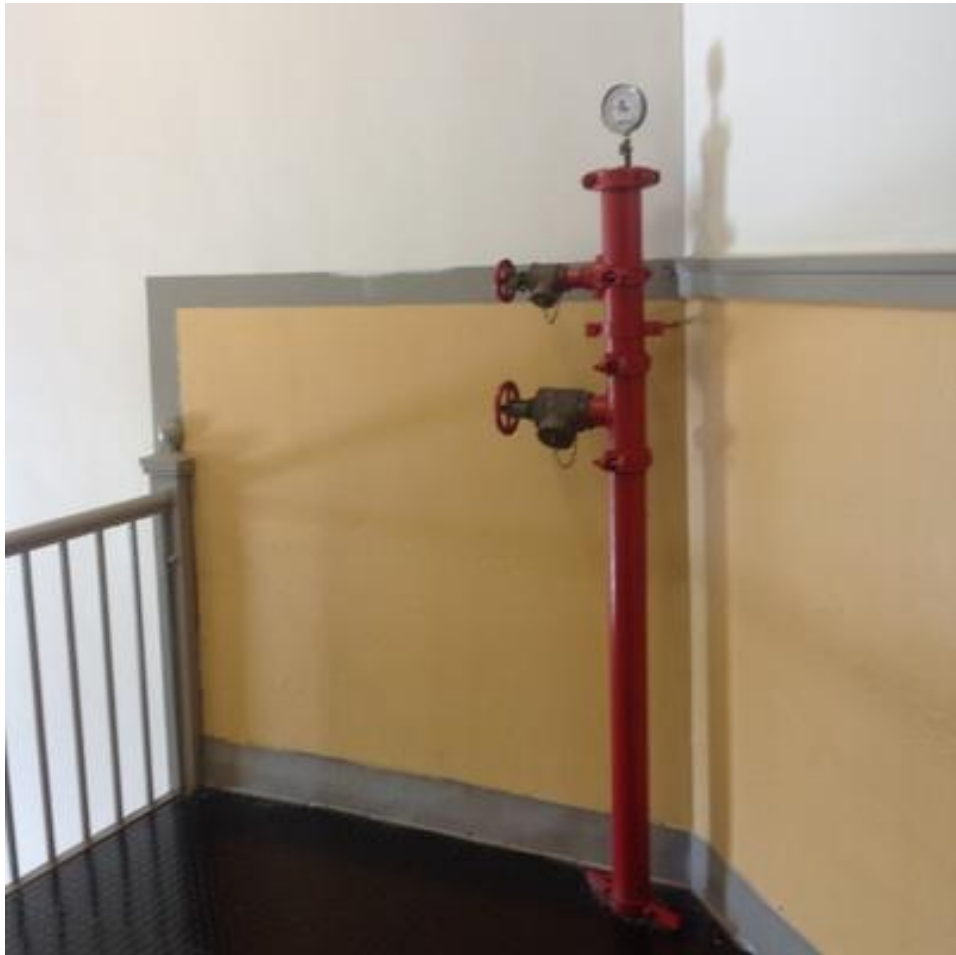
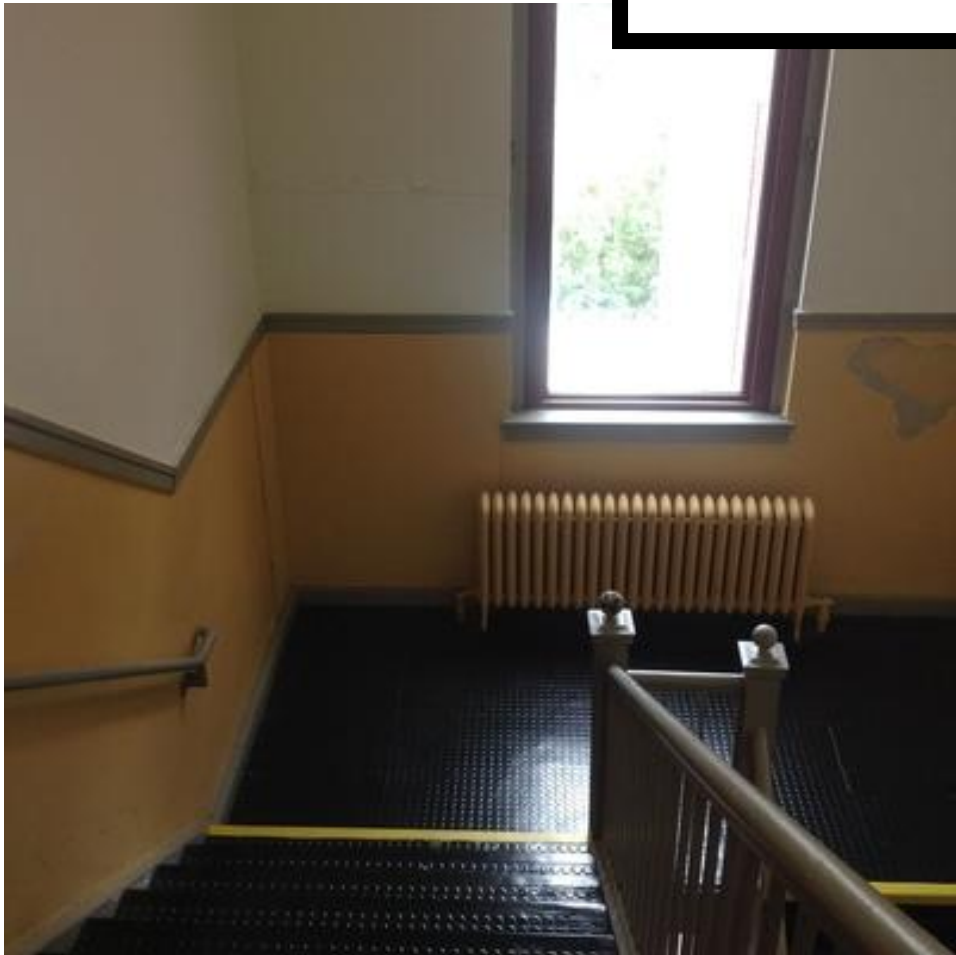
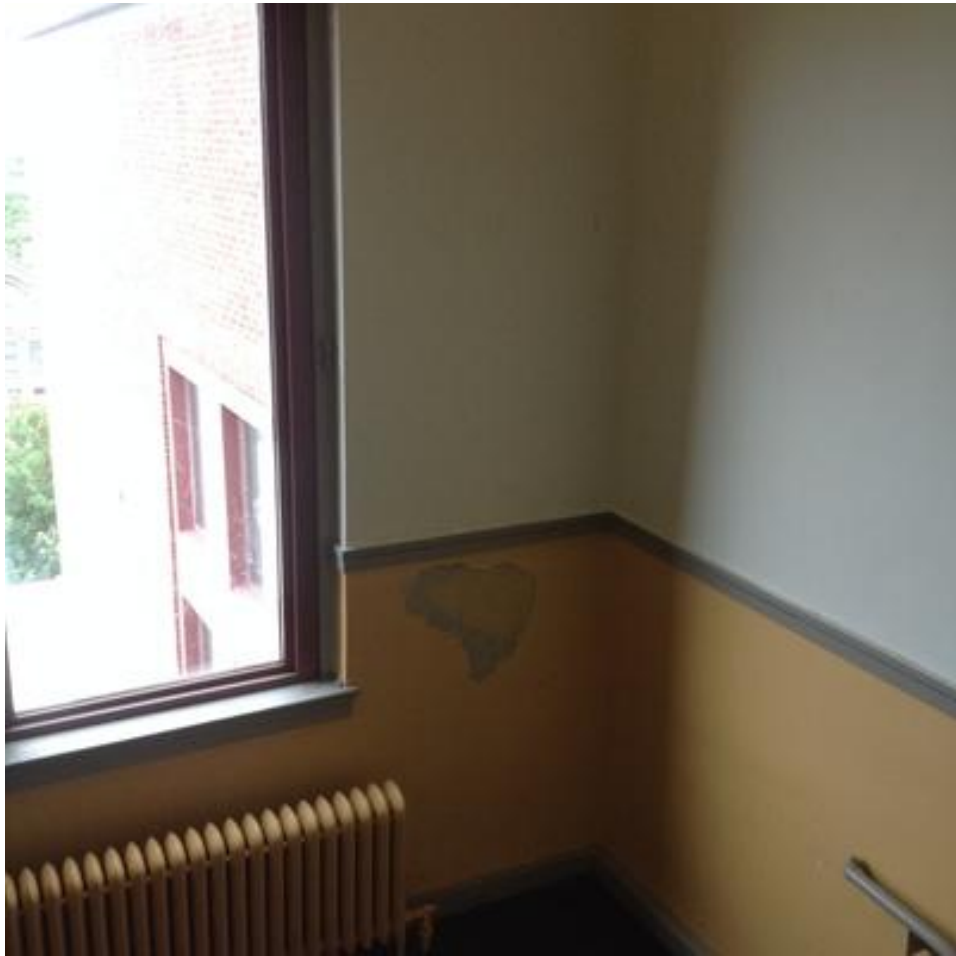
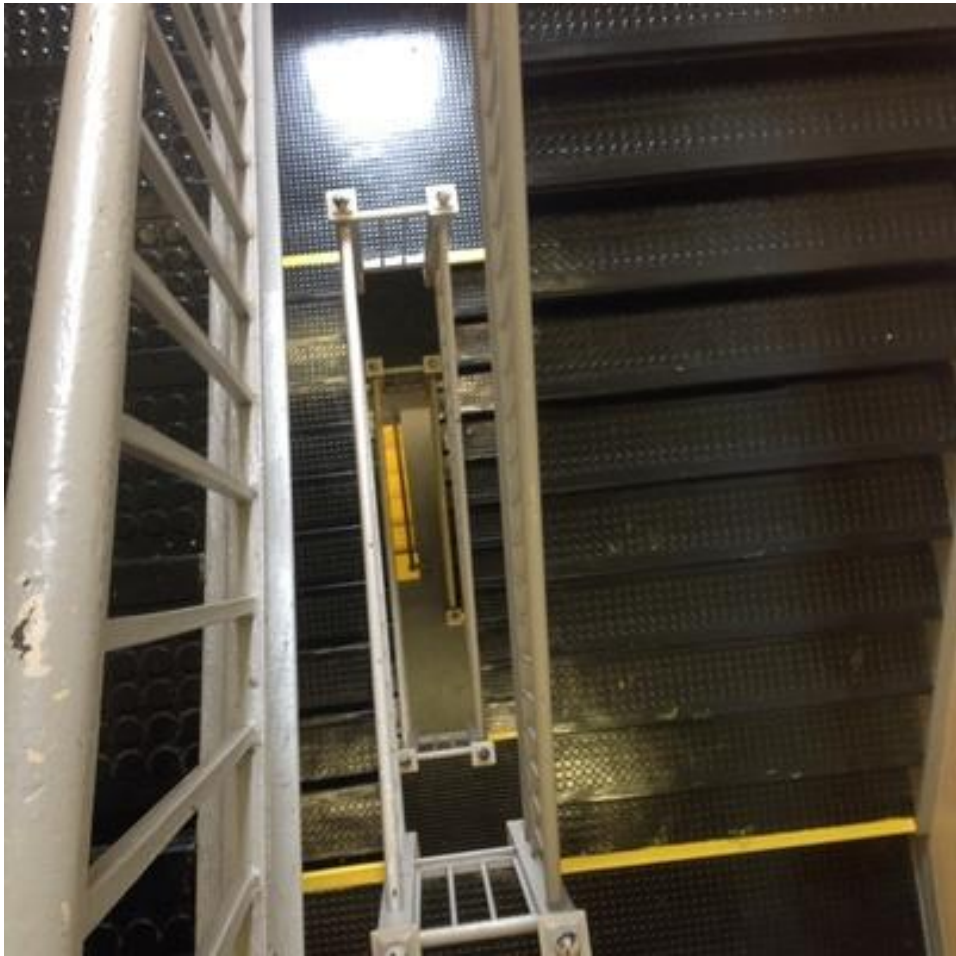
Attached Images for ID KJ-00036

| Description Stair 4C in fair condition. Guard/hand rails do not comply with current code. | | | |

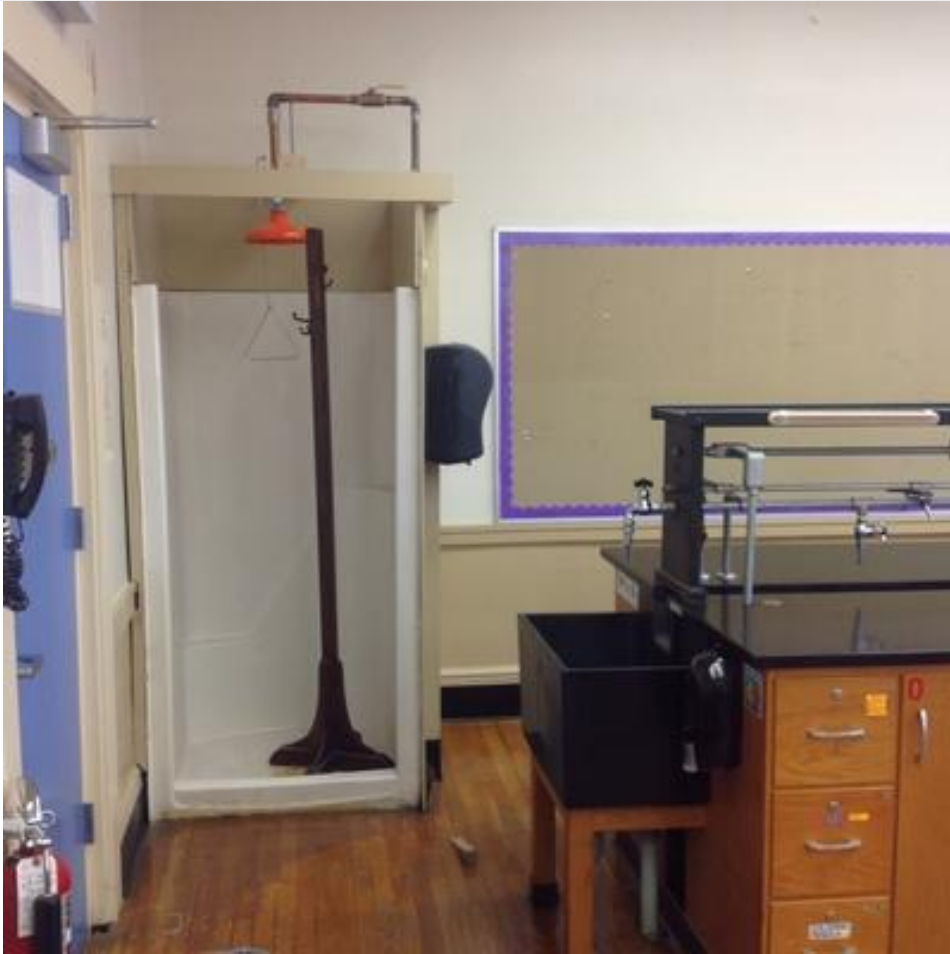
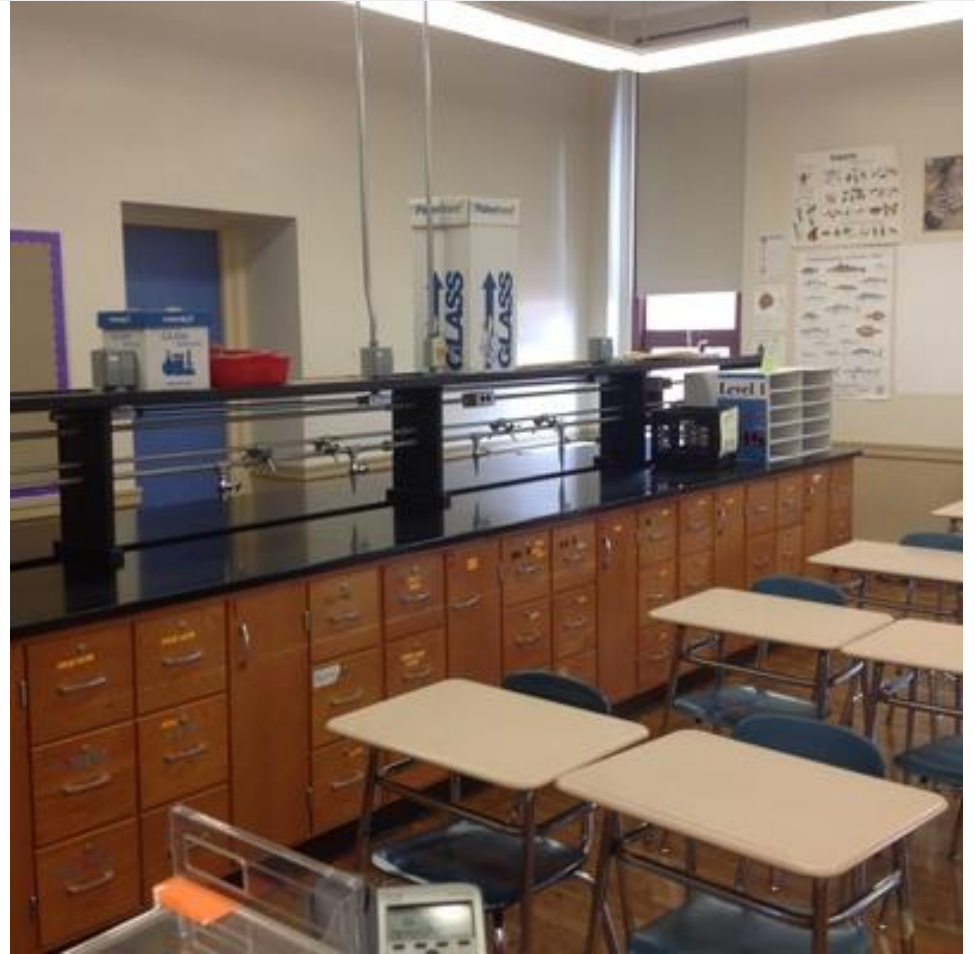
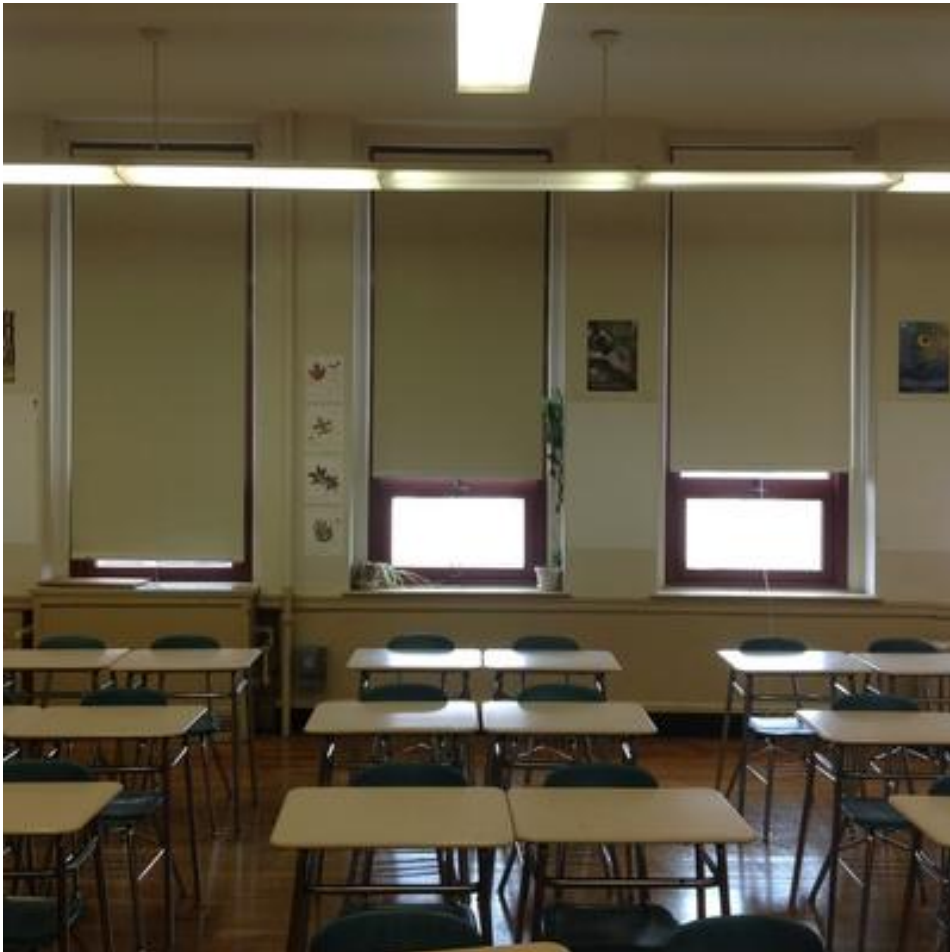
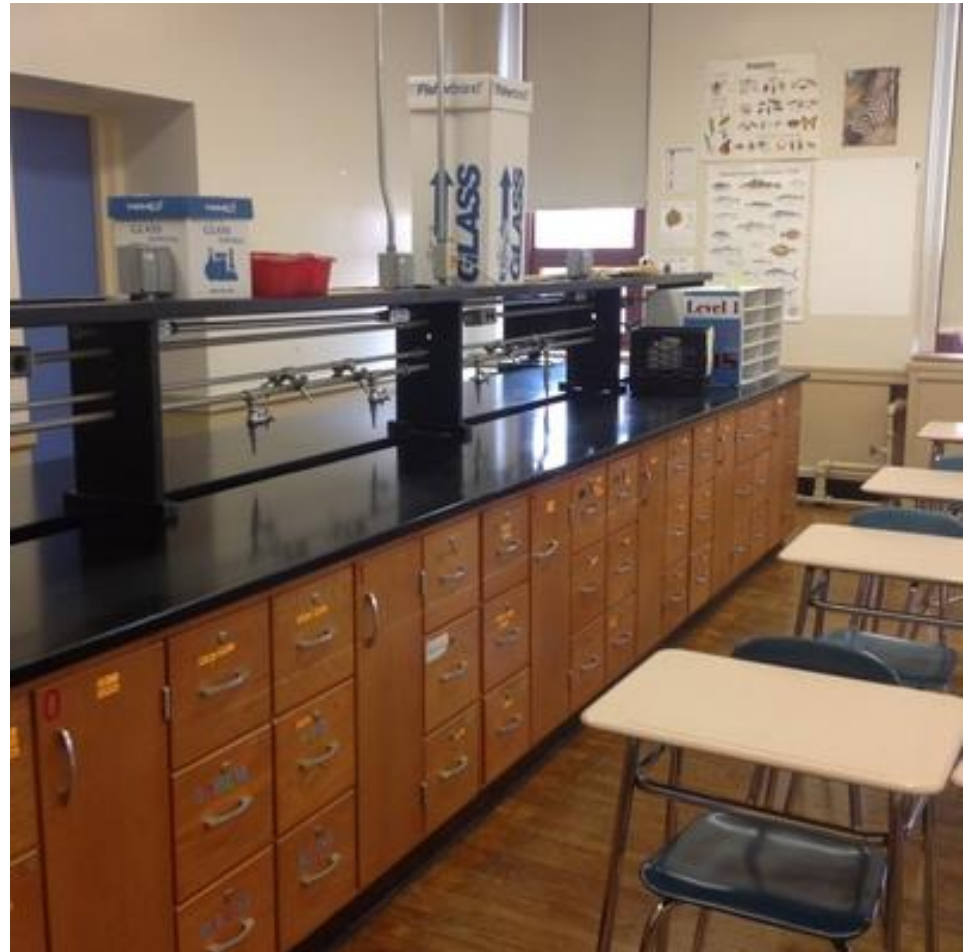
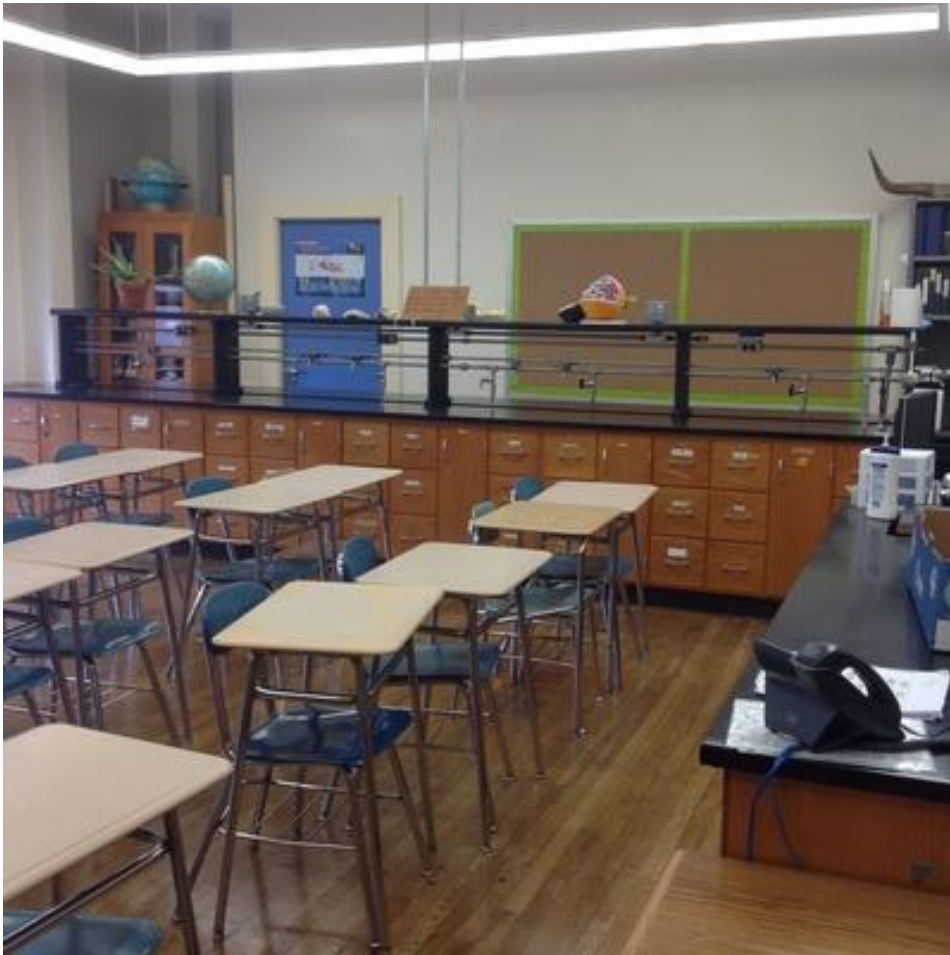
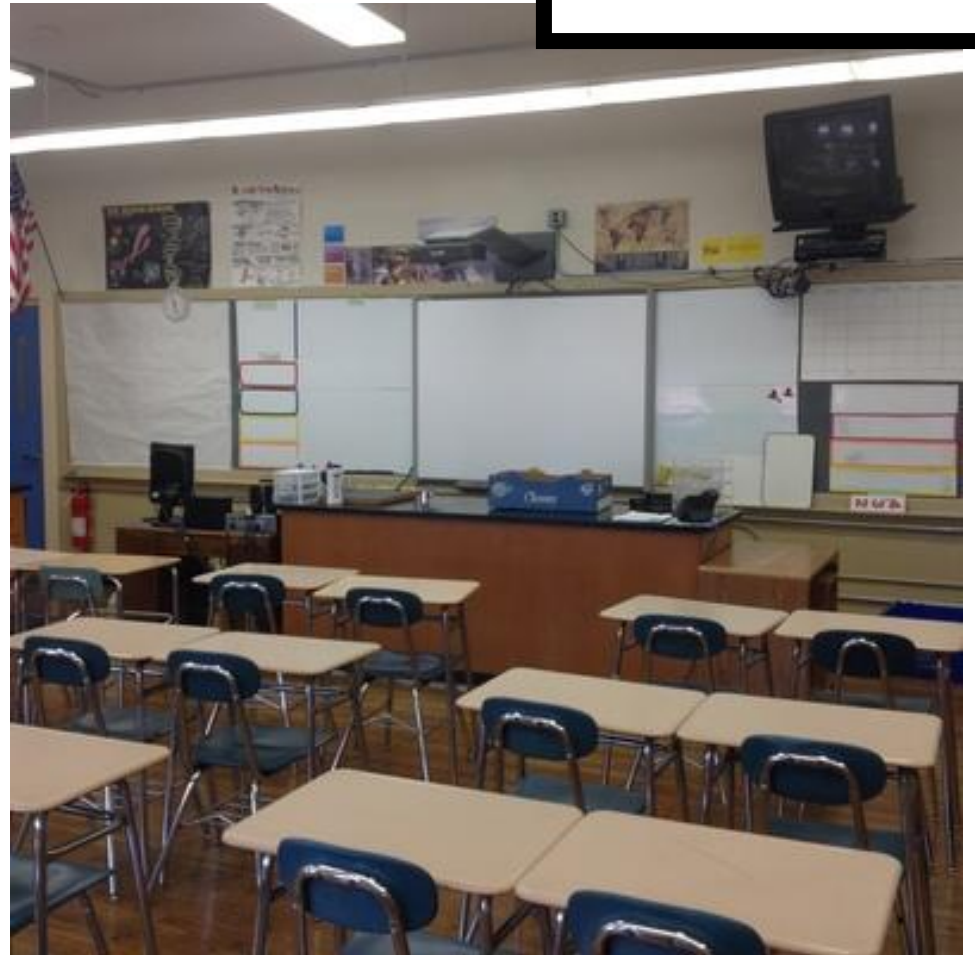
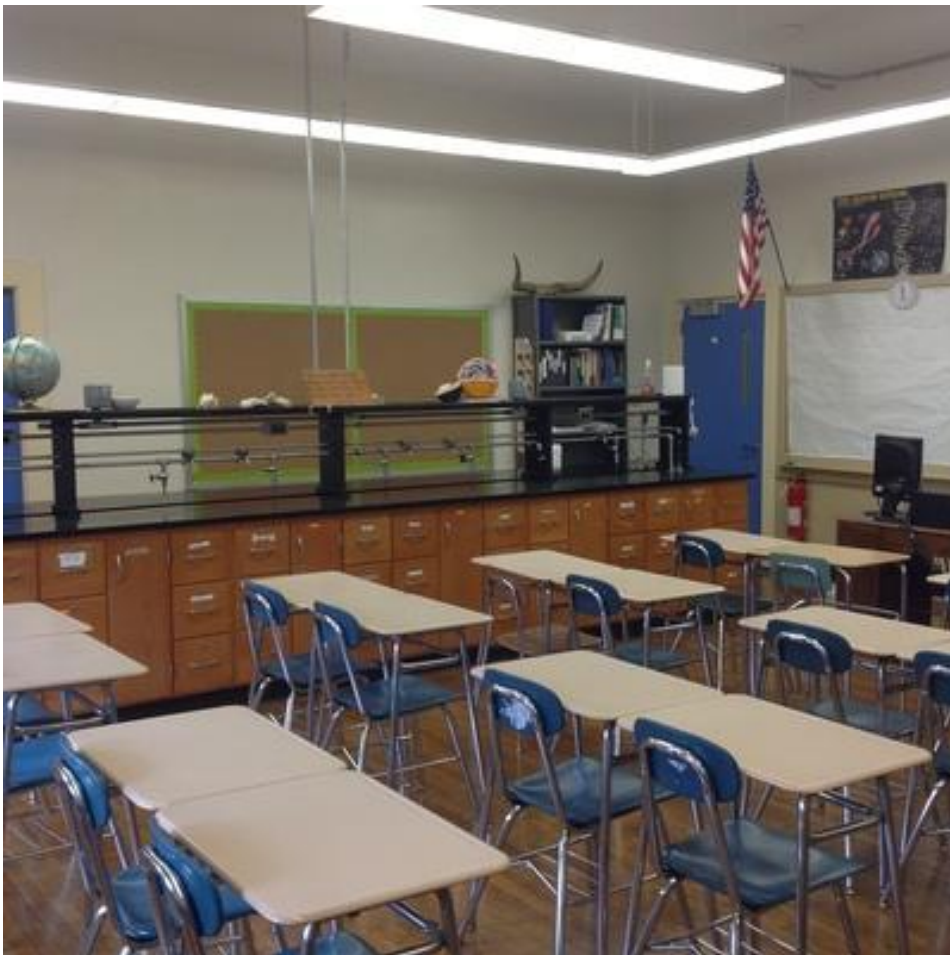
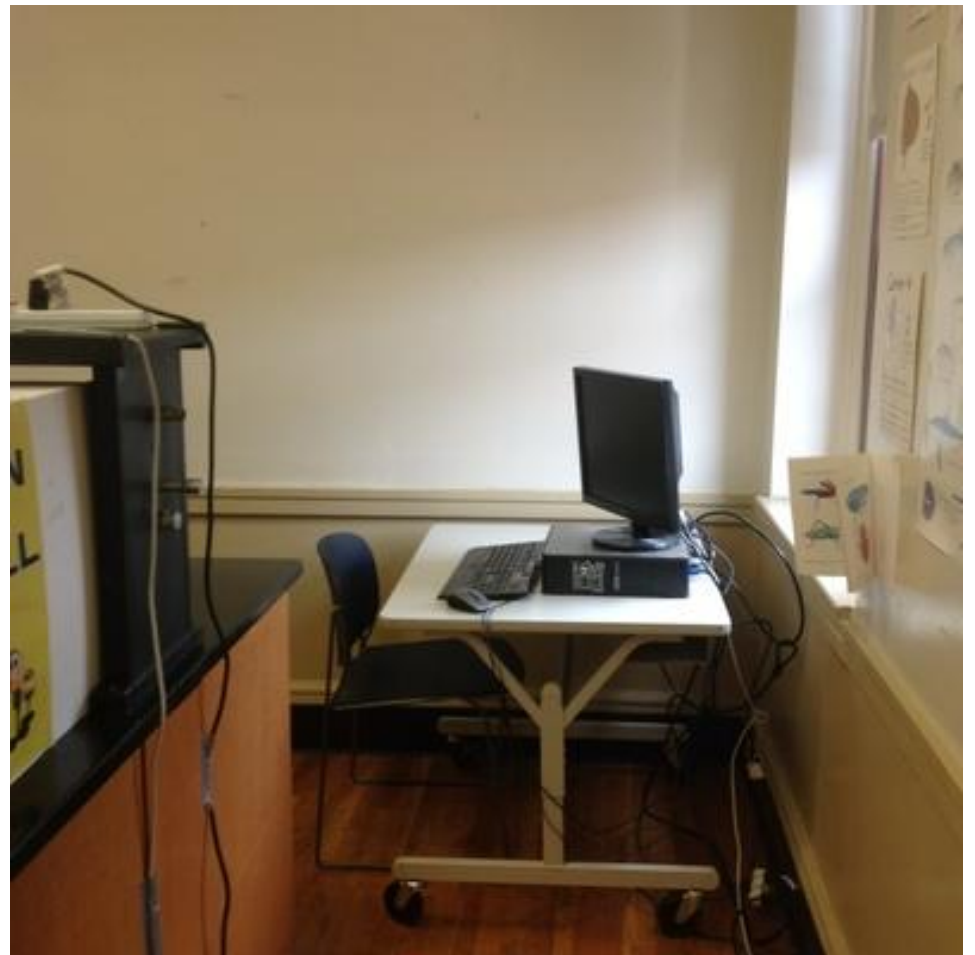
Attached Images for ID KJ-00037

Wood flooring in good condition but creaky. Paint is chipping on walls and ceiling. Light fixtures missing covers in some locations. Surface mounted equipment and wiring is haphazard. Shades are in poor condition. Millwork in poor condition. Chemistry millwork limits functionality of classroom. Unit heater in poor condition. Some windows have lost their seal. Classroom has smartboard.
