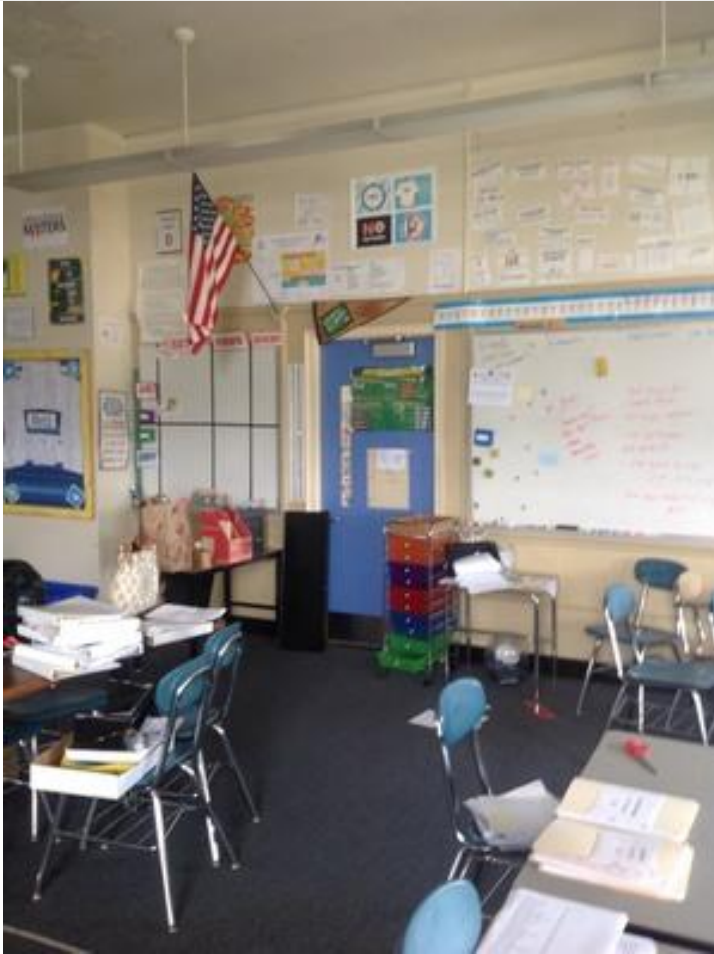
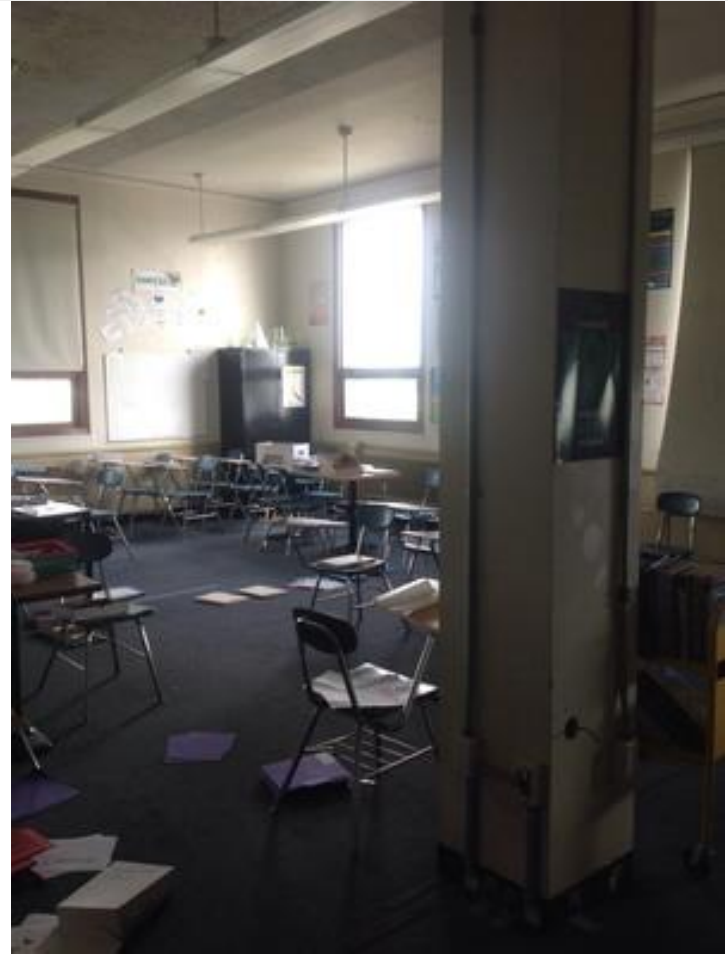
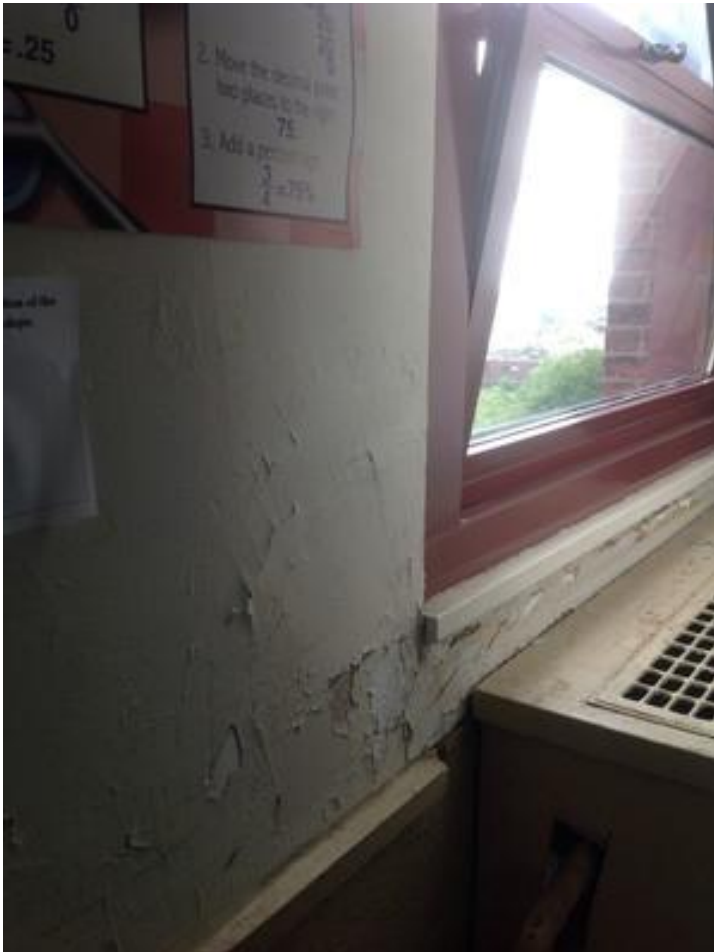
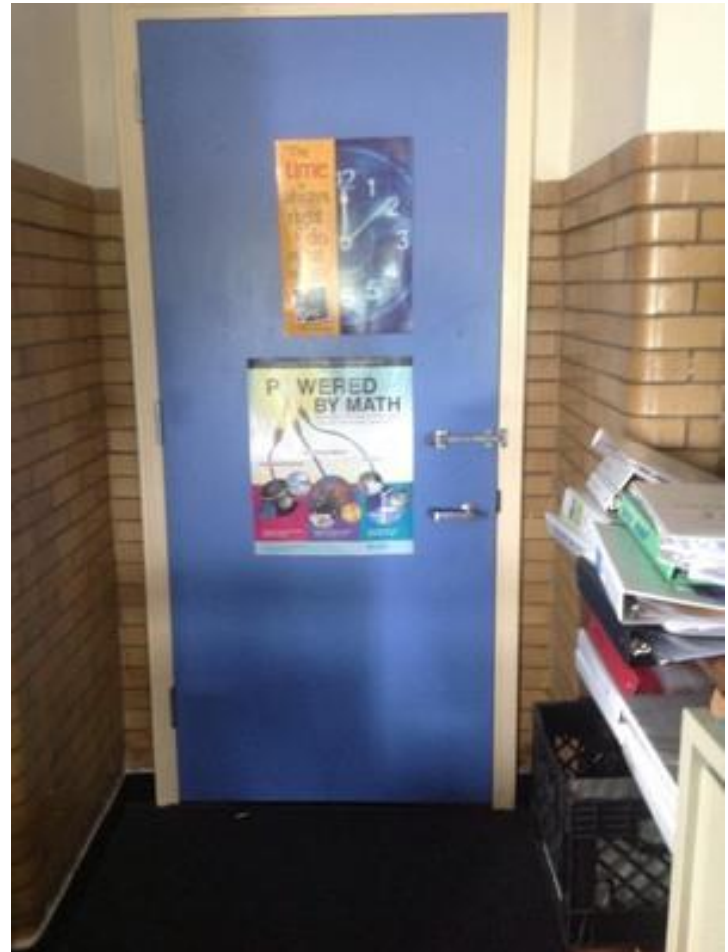
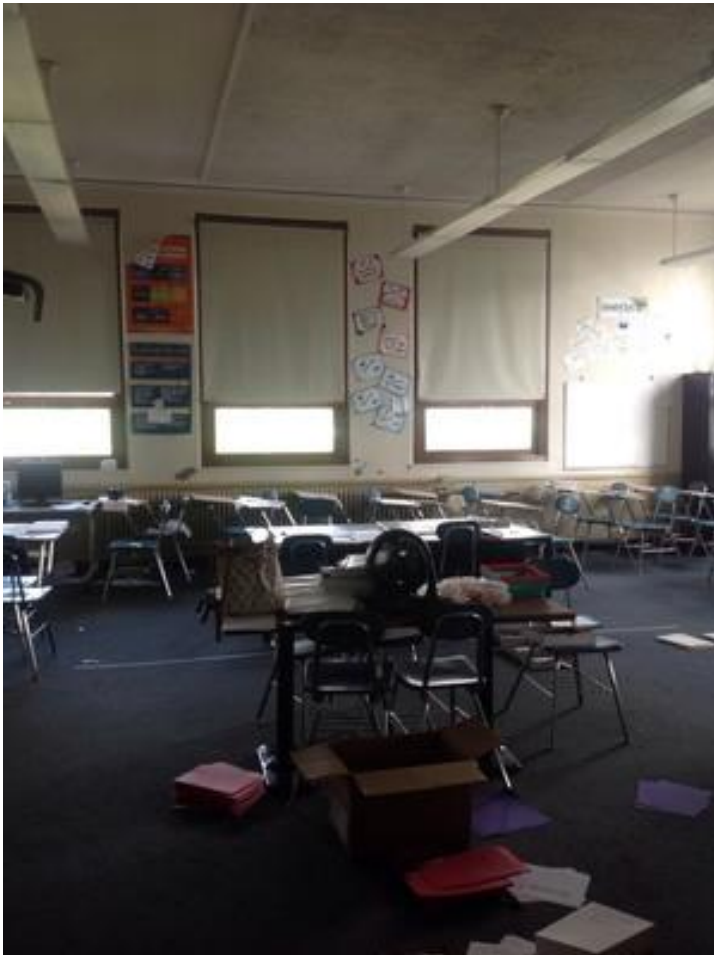
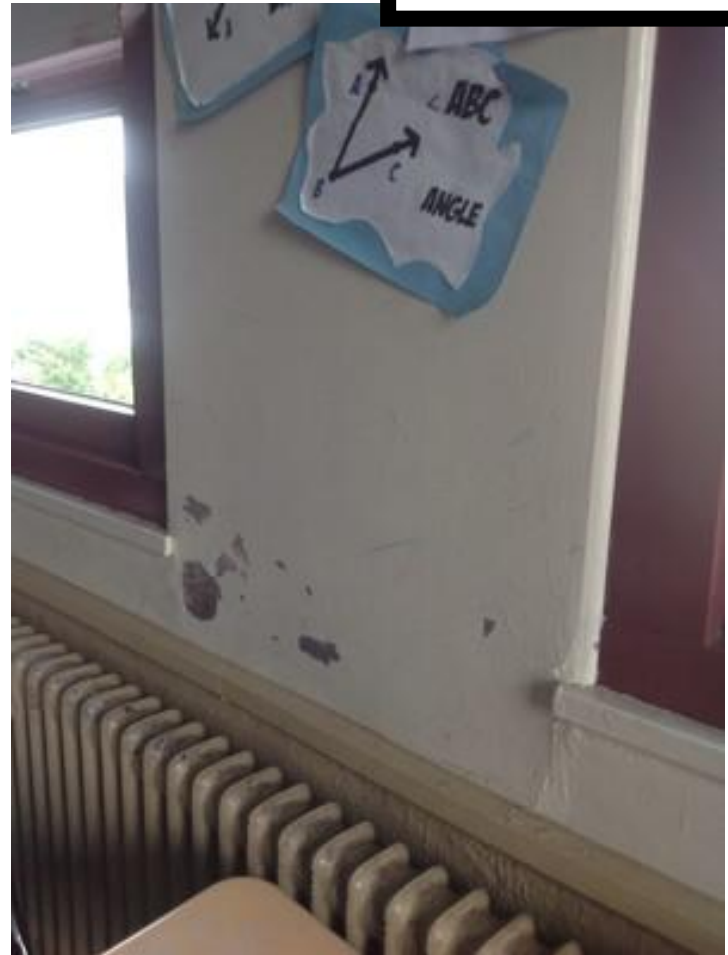
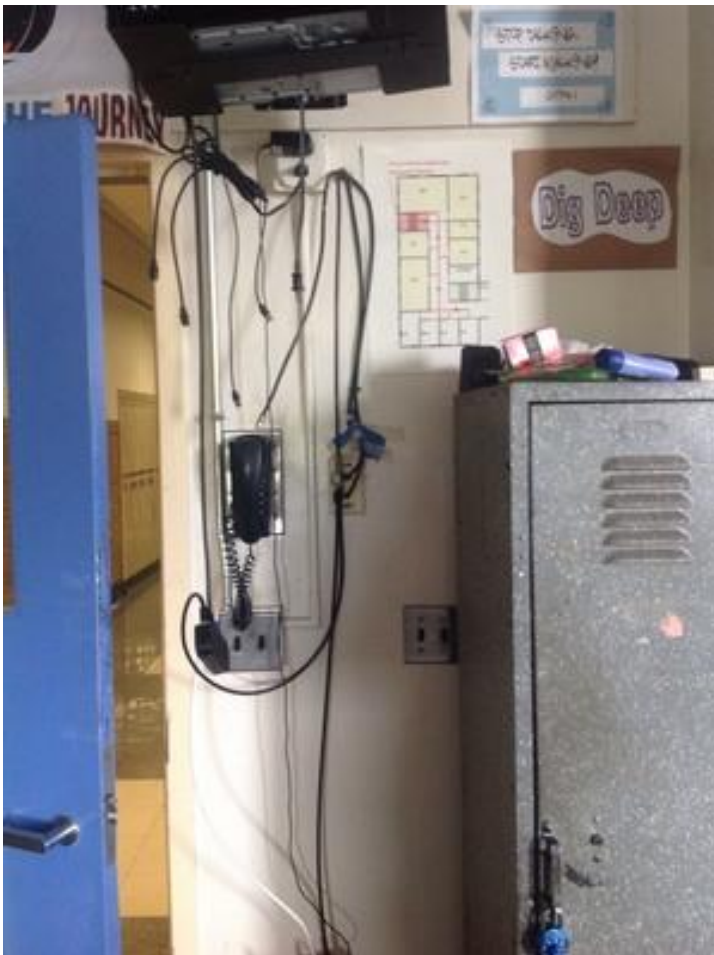
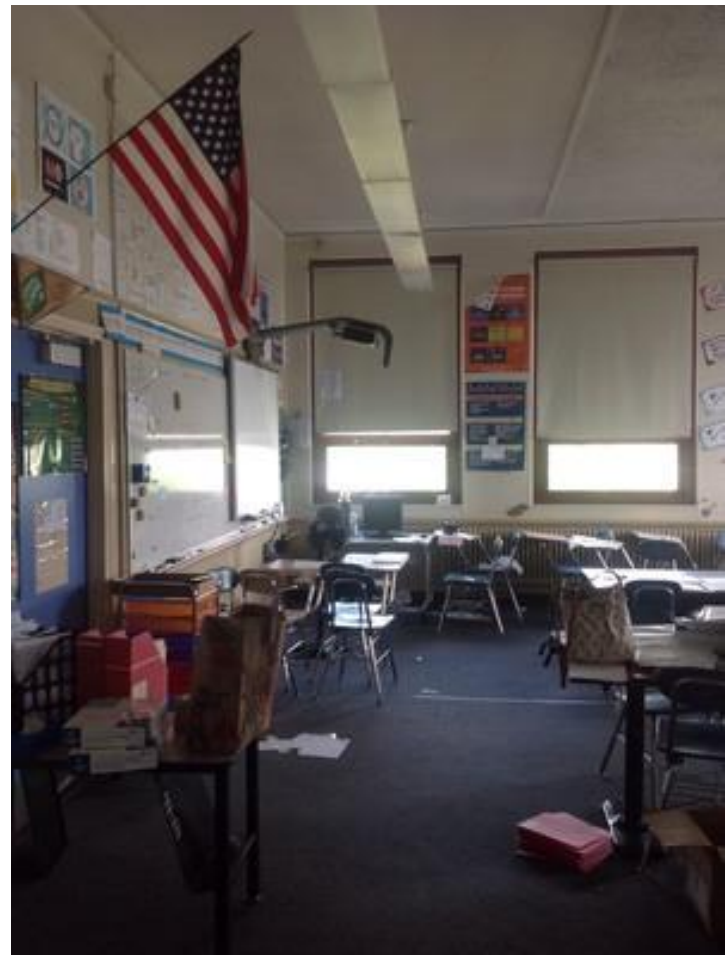
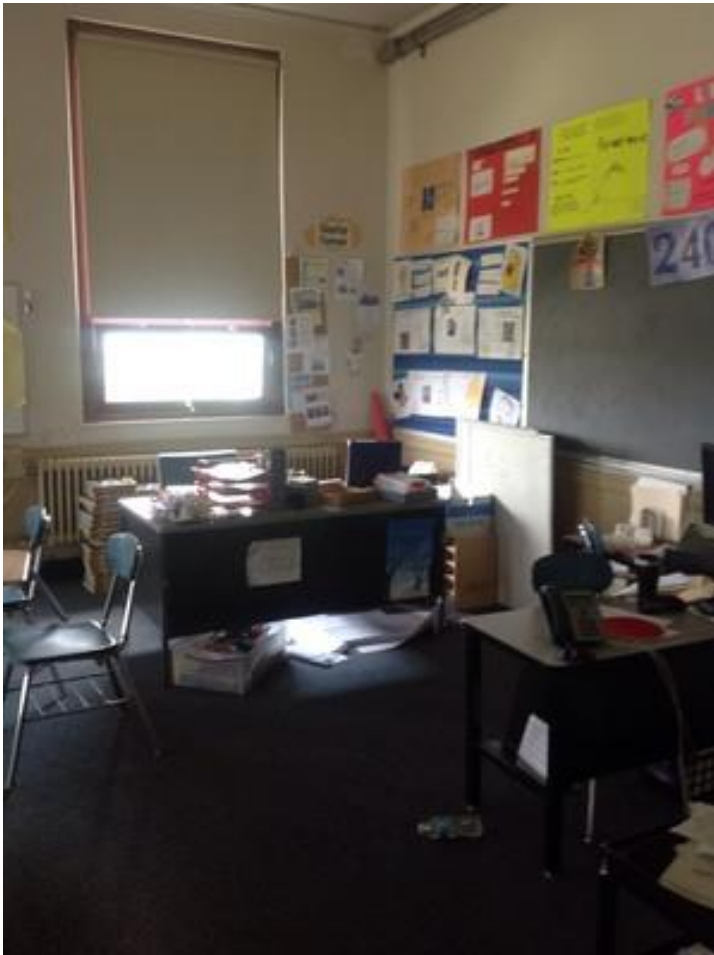
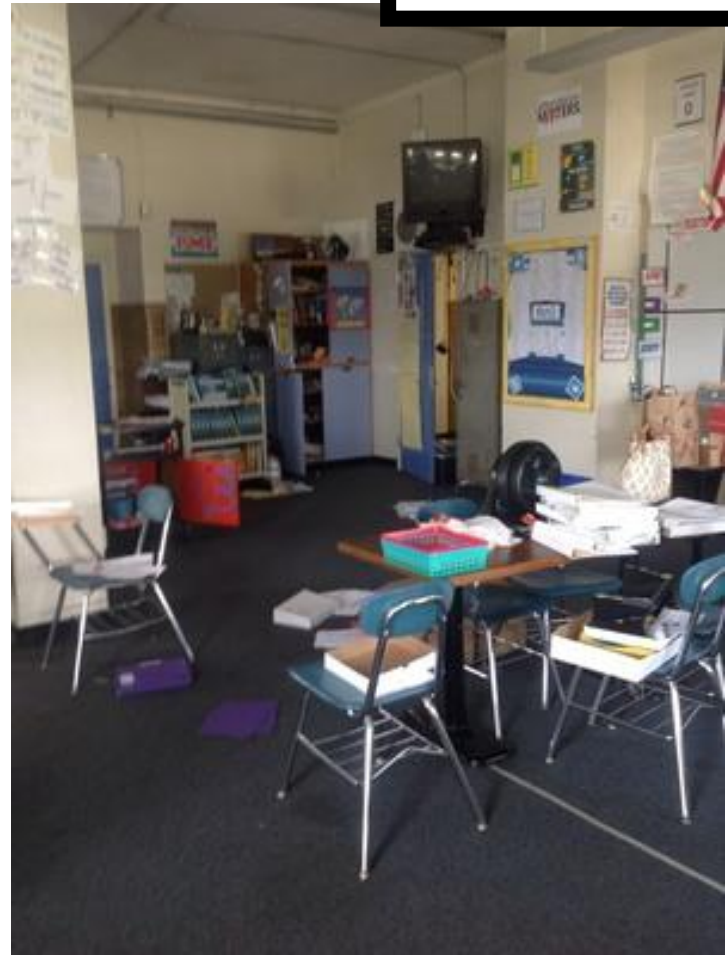
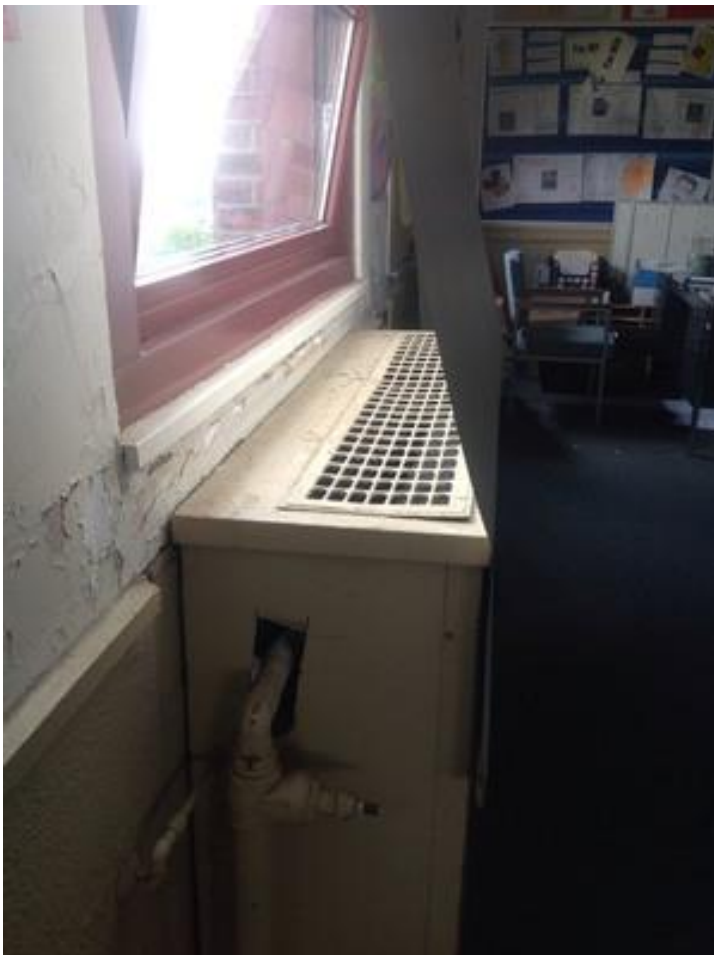
Attached Images for ID KJ-00013

Description
Paint is chipping on walls, ceiling, and moulding. Lighting is poor and covers are missing from fixtures. Partial area of acoustic ceiling but less than half of space. Smart board in corner of room. Wiring is haphazardly placed.

| Condition | Poor | | |

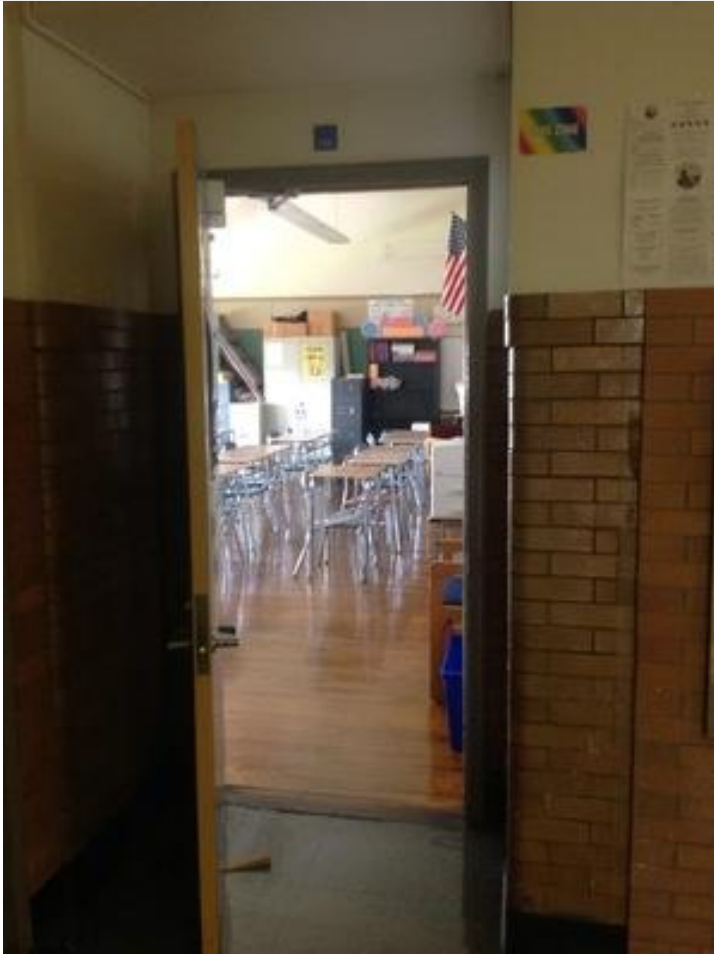
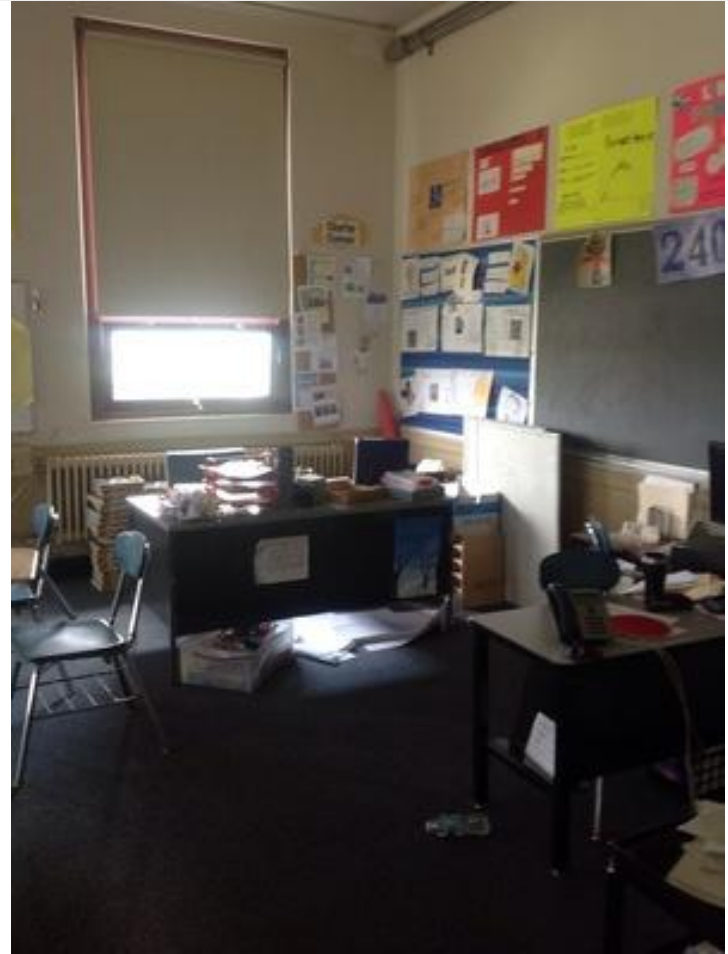
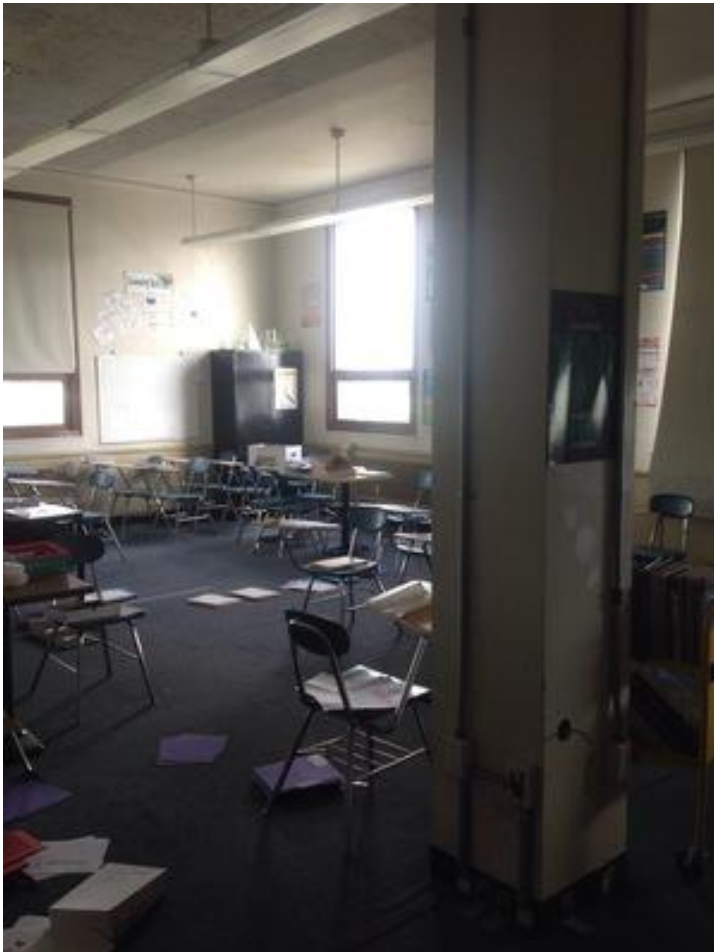
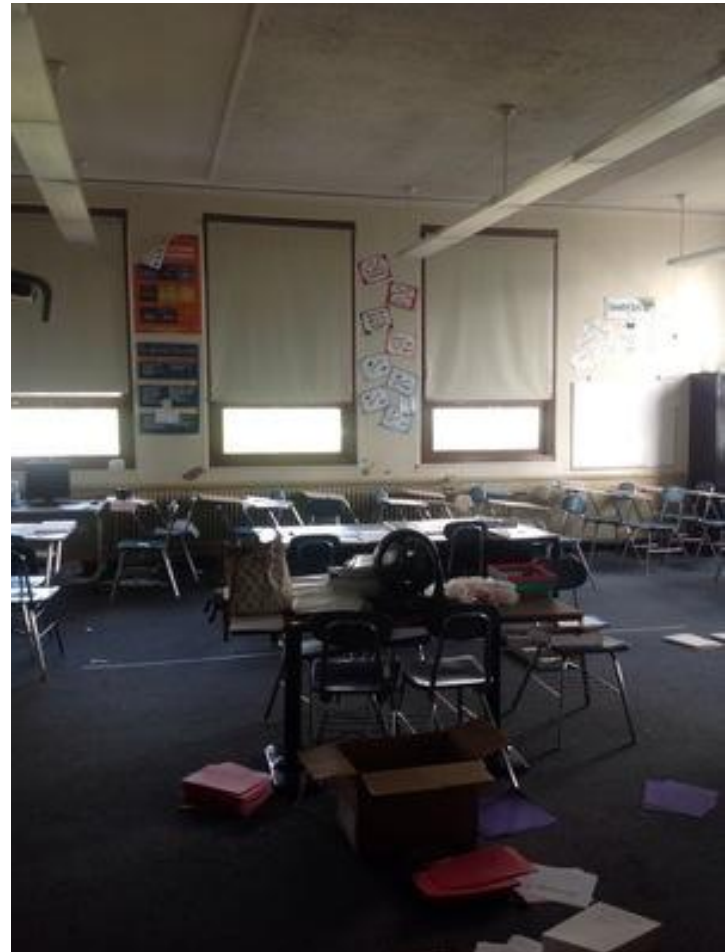
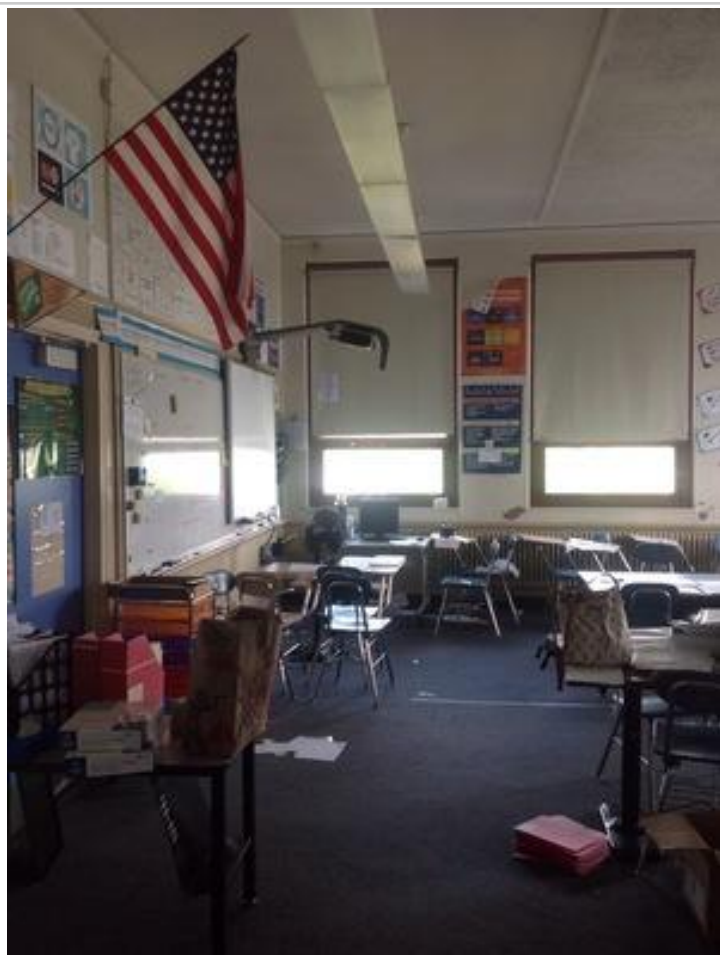
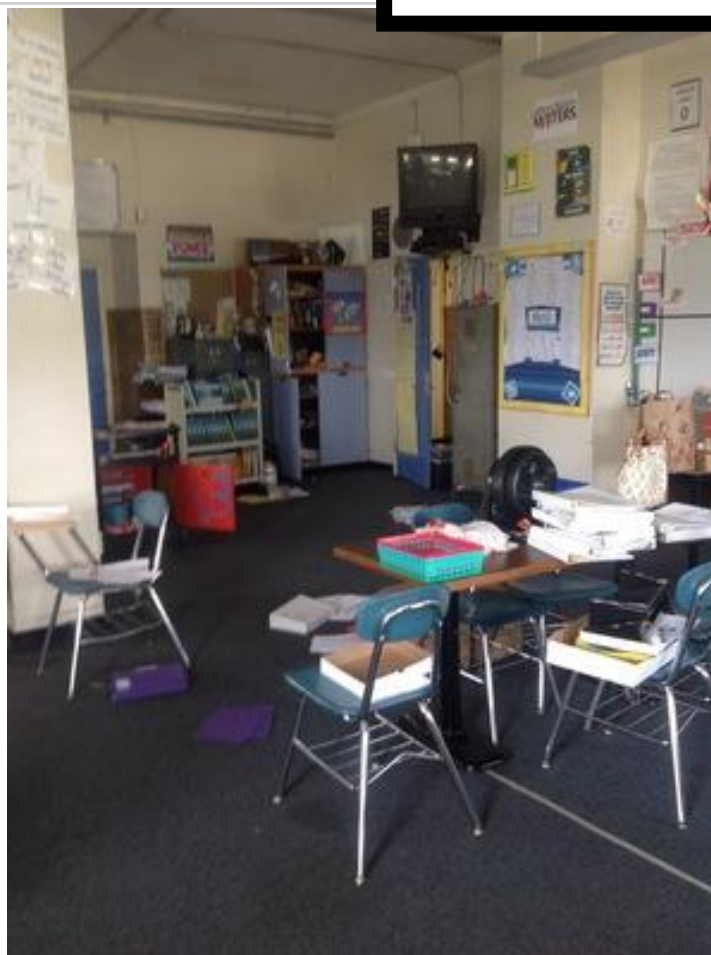
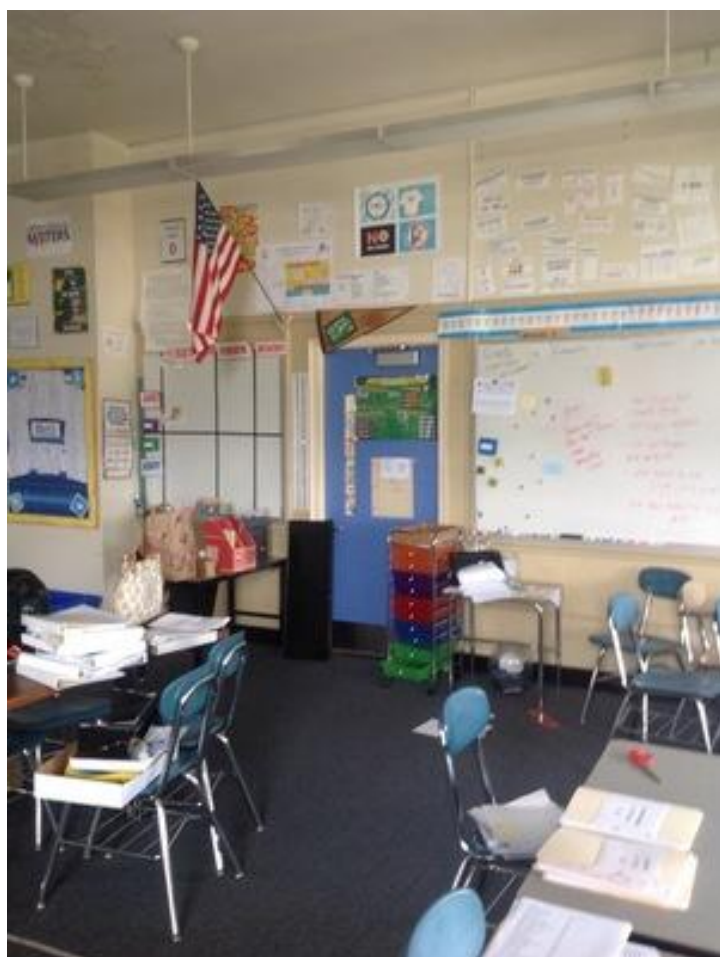
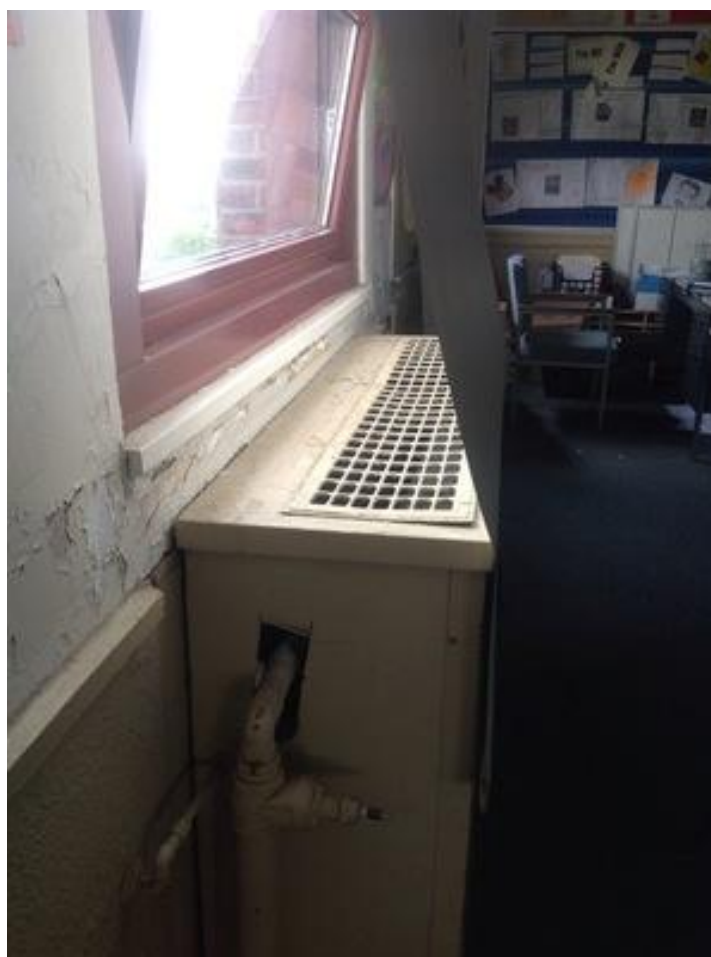
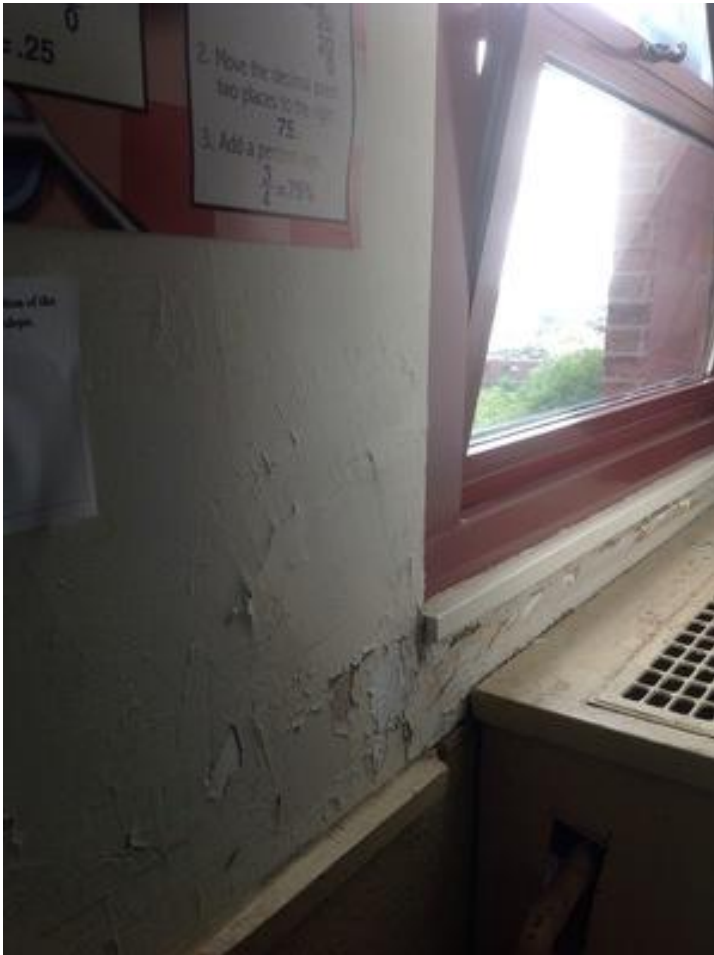
Attached Images for ID KJ-00023

Carpet is in poor condition. Paint is chipping on walls and ceiling. Light fixtures missing covers in some locations. 10'x20' area of 12"x12" VCT on ceiling. Surface mounted equipment and wiring is haphazard. Shades are in poor condition. Millwork in poor condition. Unit heater in poor condition. Classroom has smartboard.

| Condition | Poor | | |

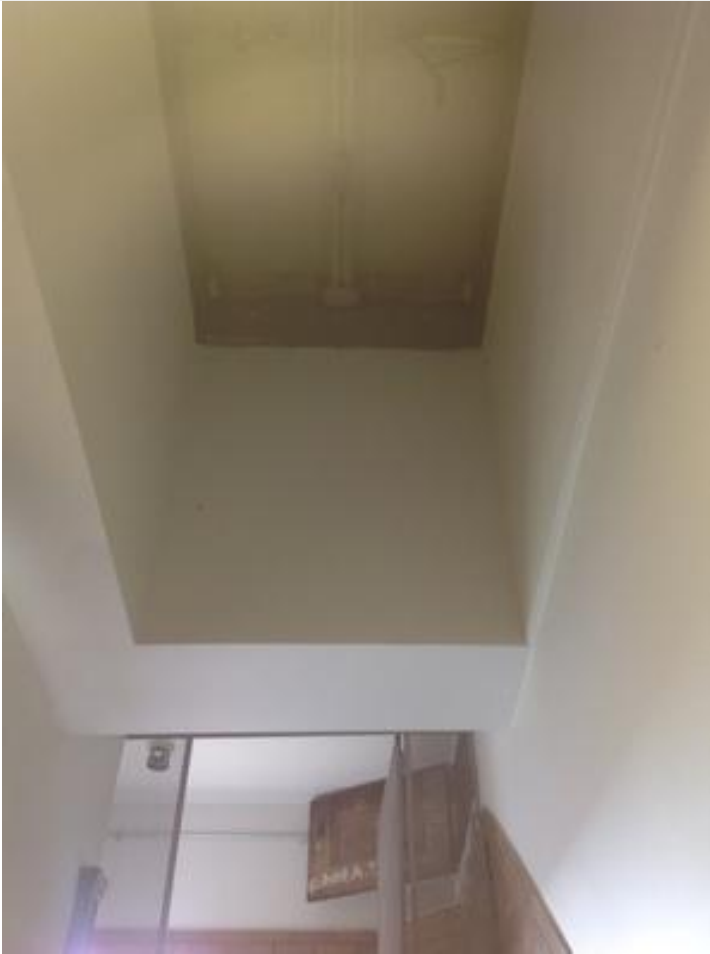
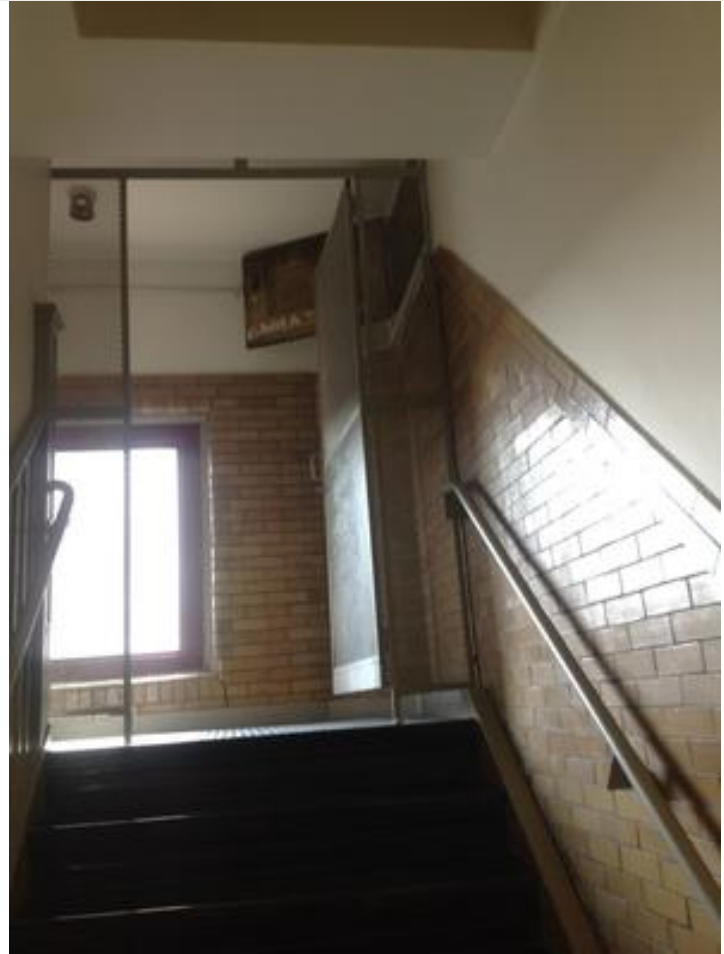
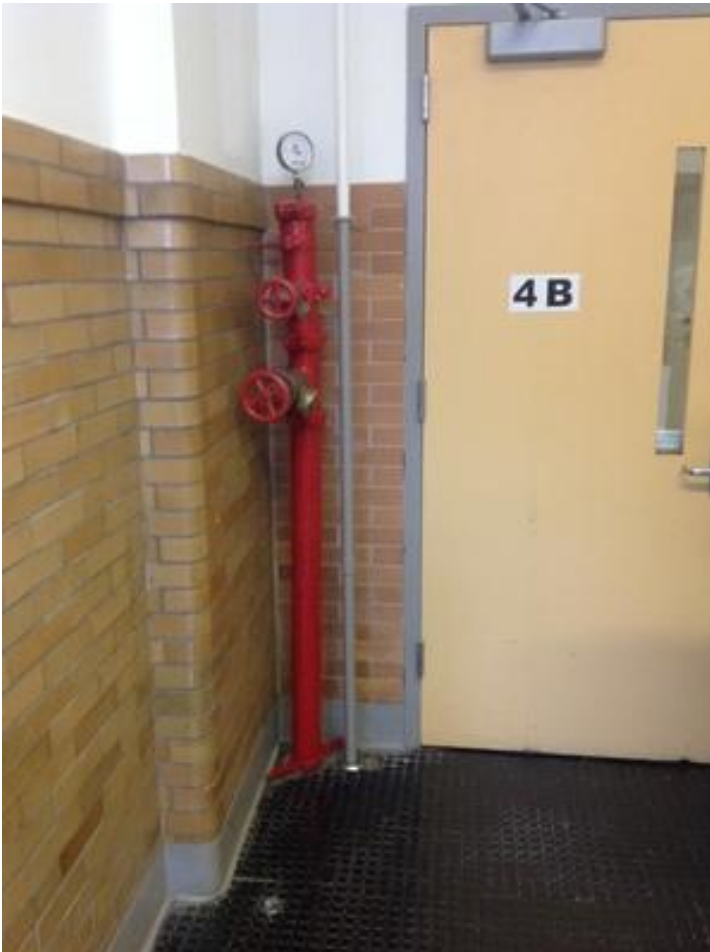
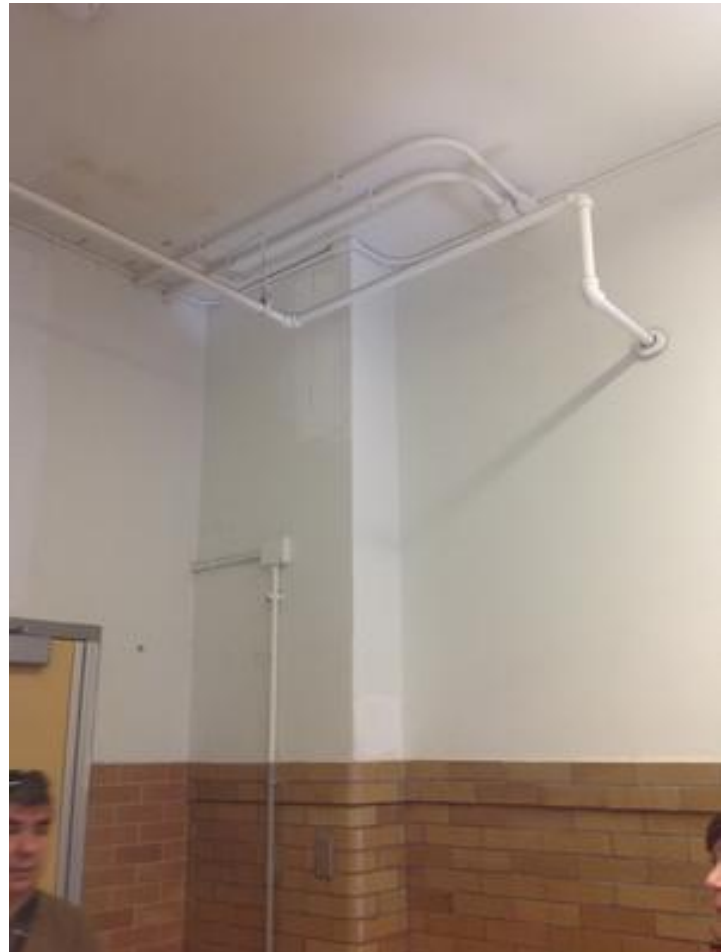
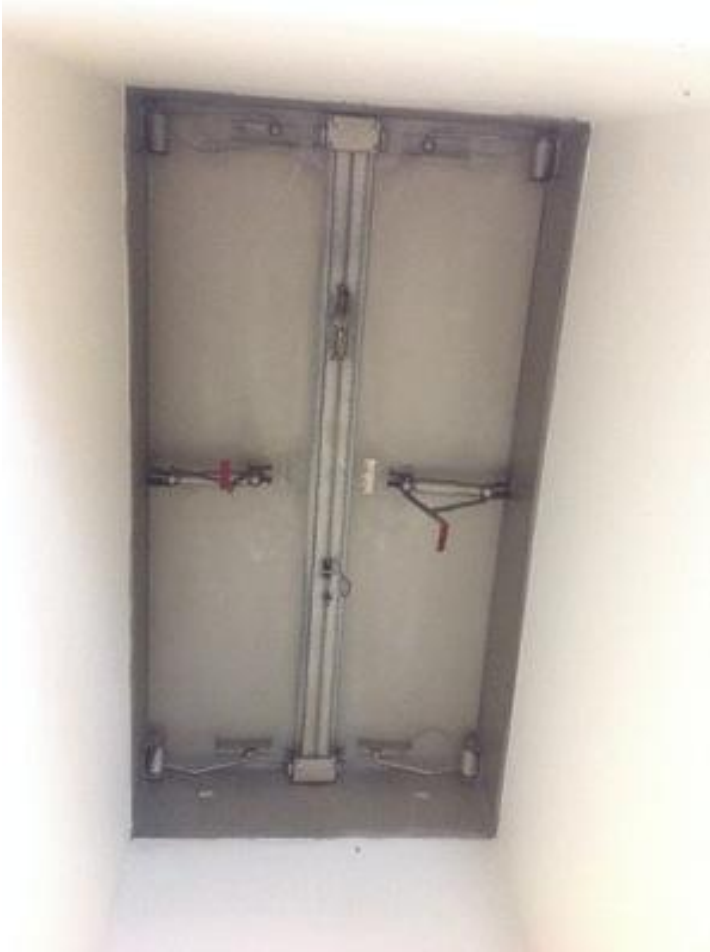
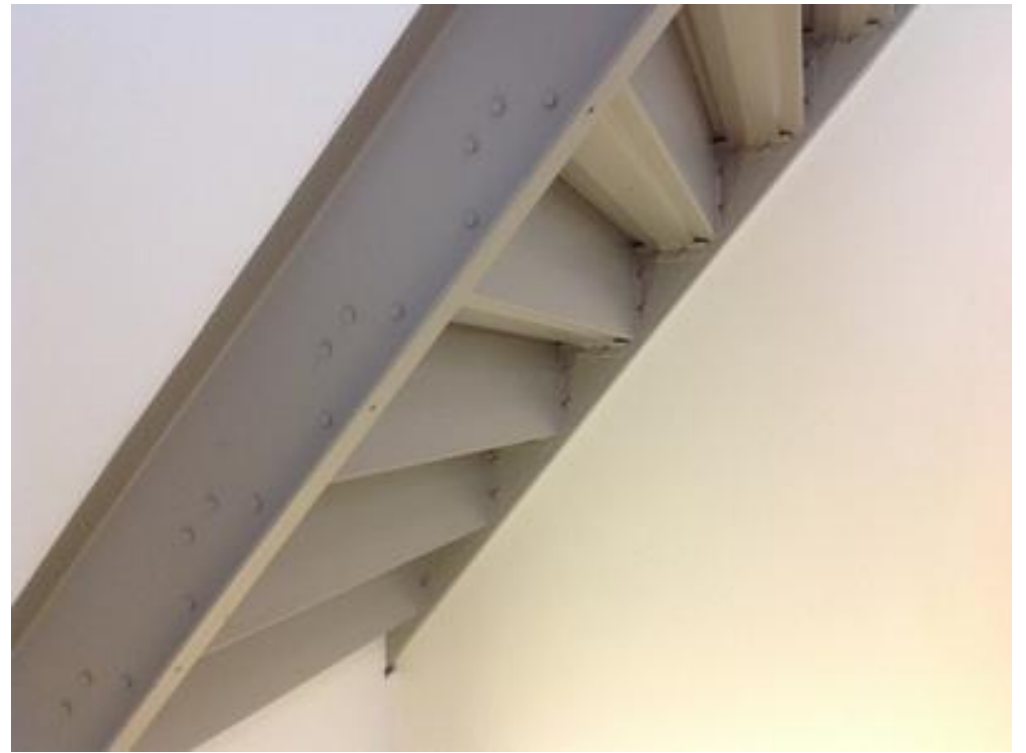
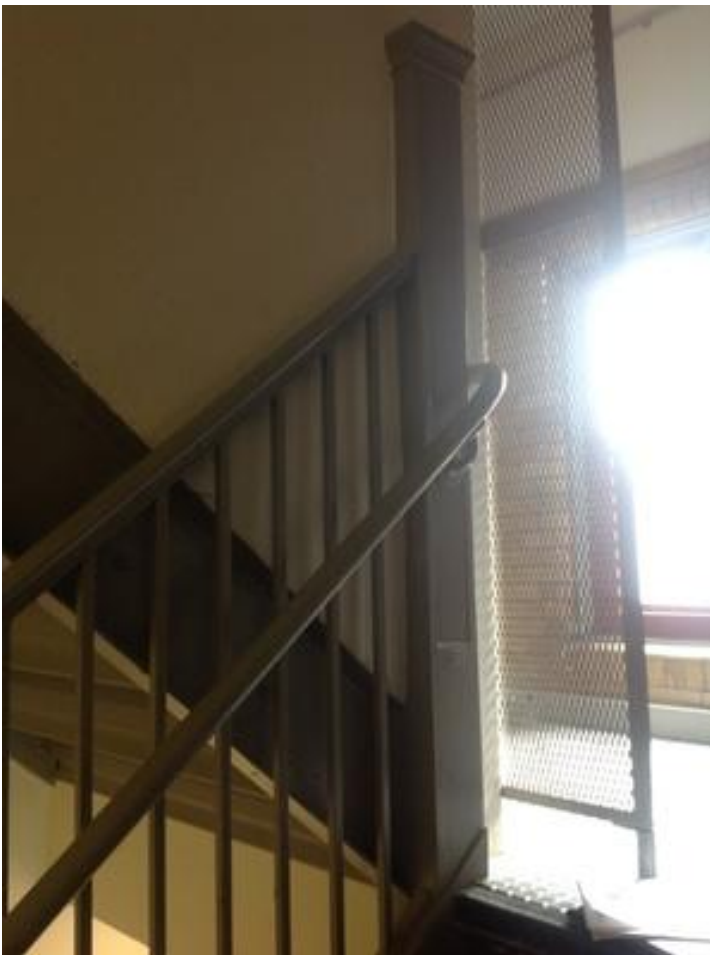
Attached Images for ID KJ-00021

Smoke hatch in Stair in fair condition. Paint is chipping on walls and ceiling. Gate to roof in good condition. Access panel shows wood roof structure.
