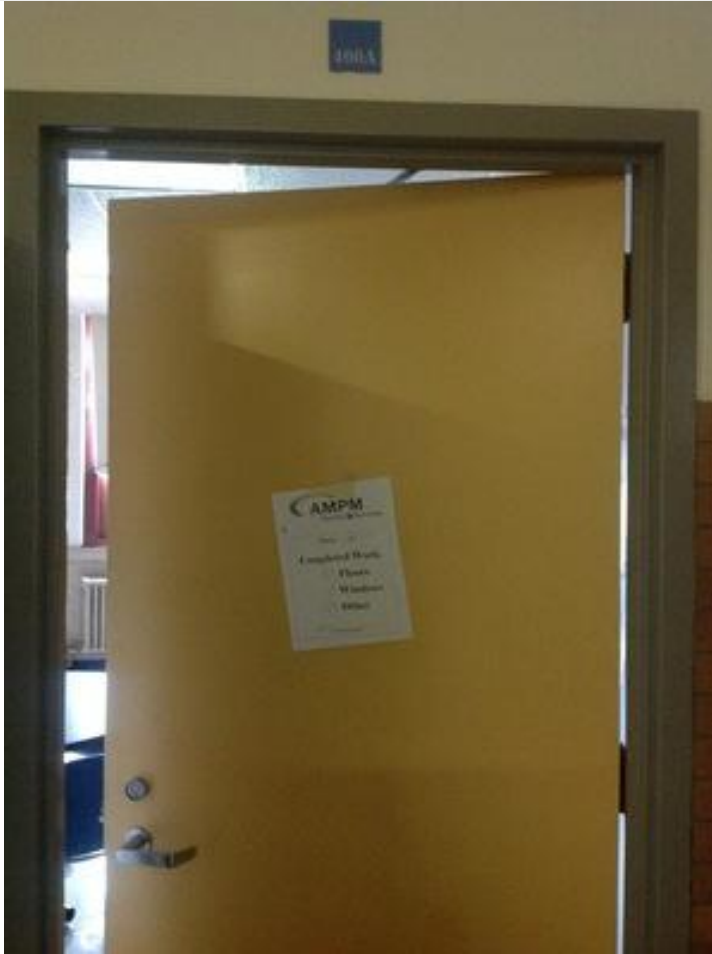
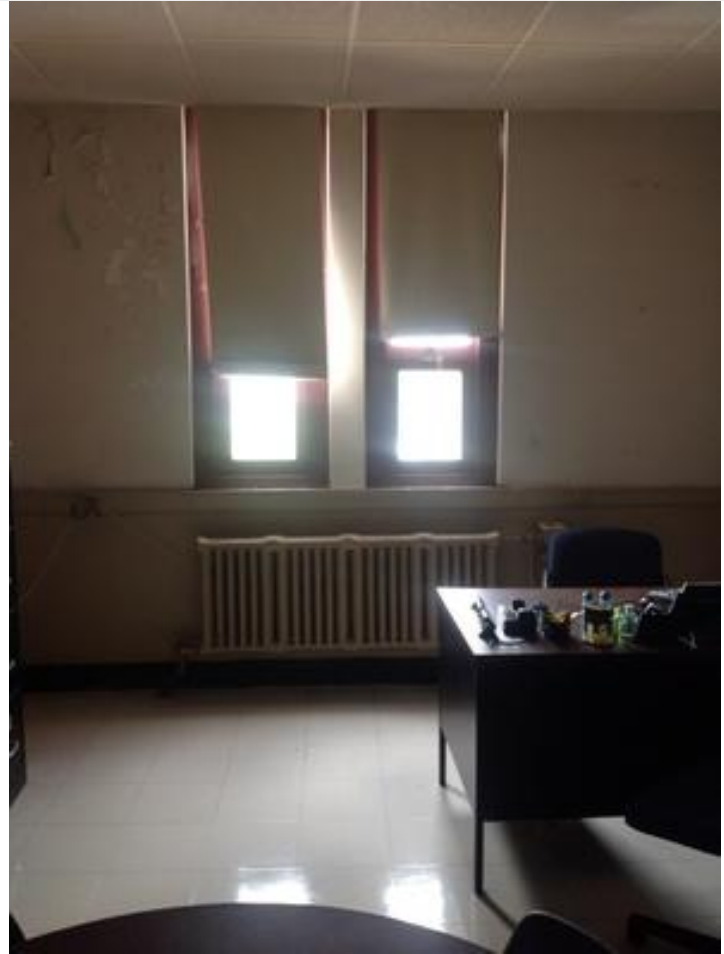
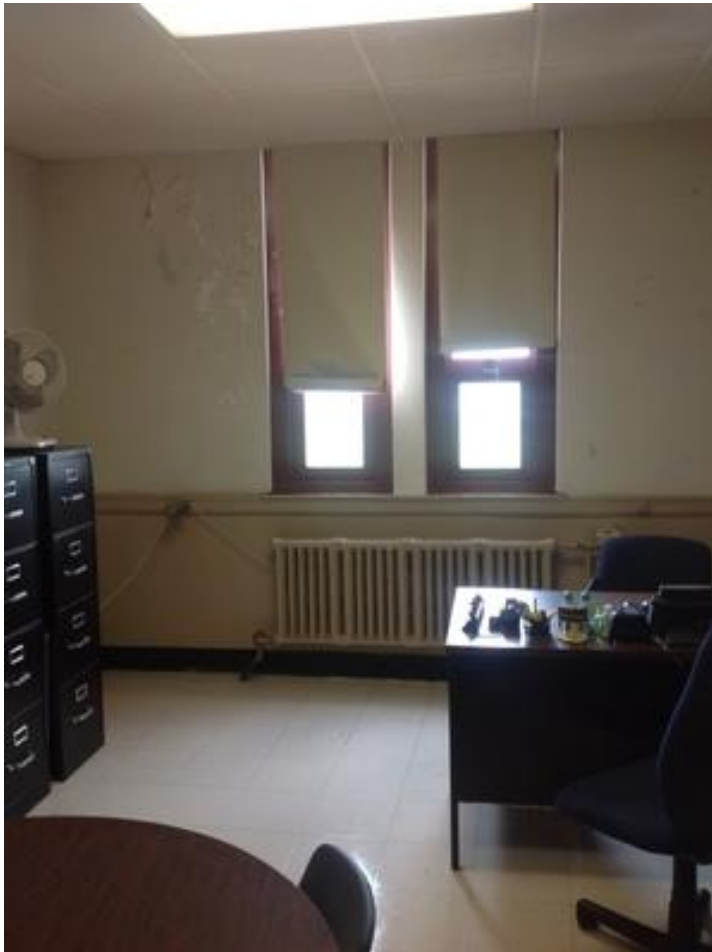
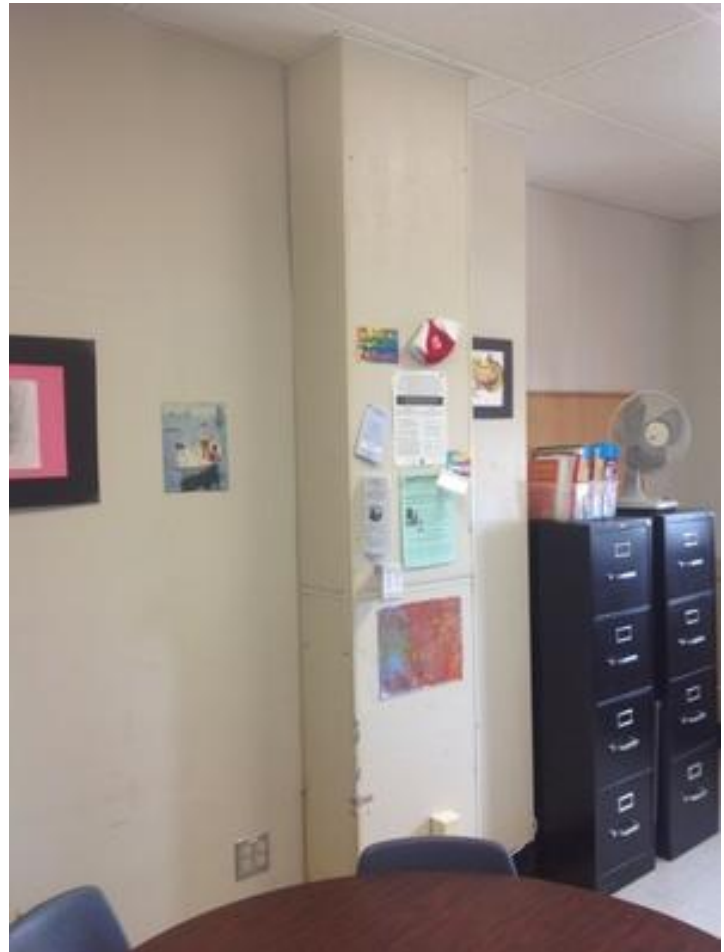
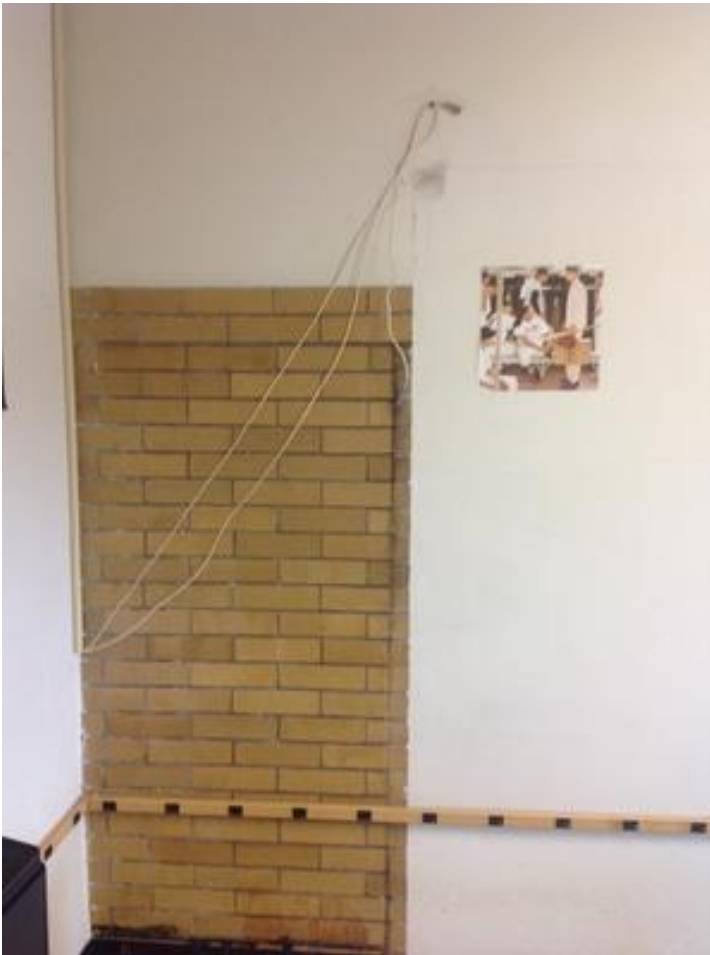
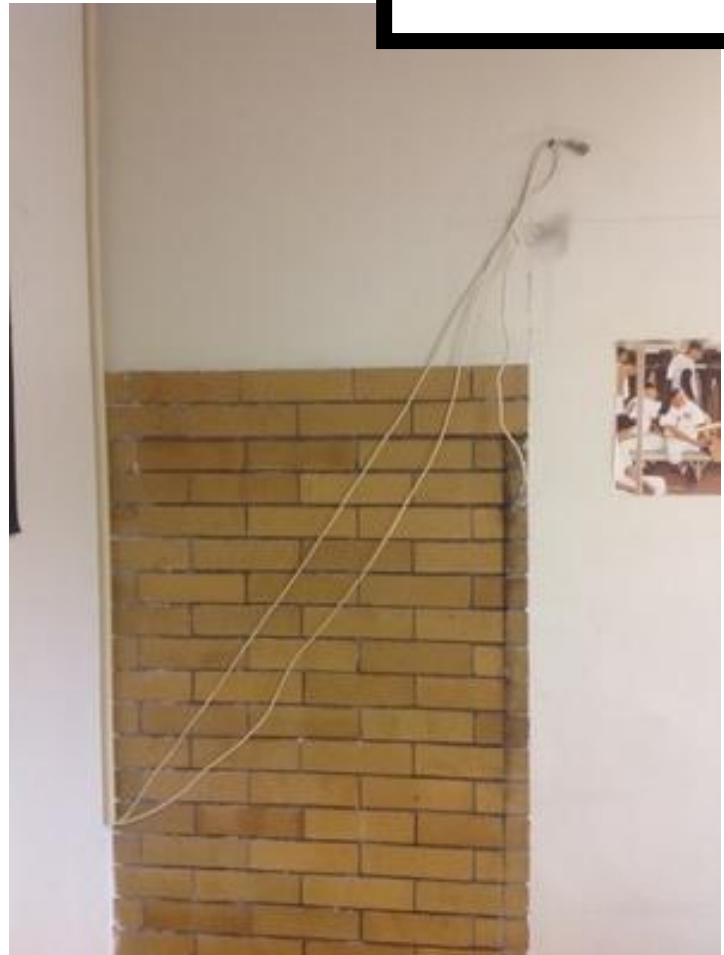
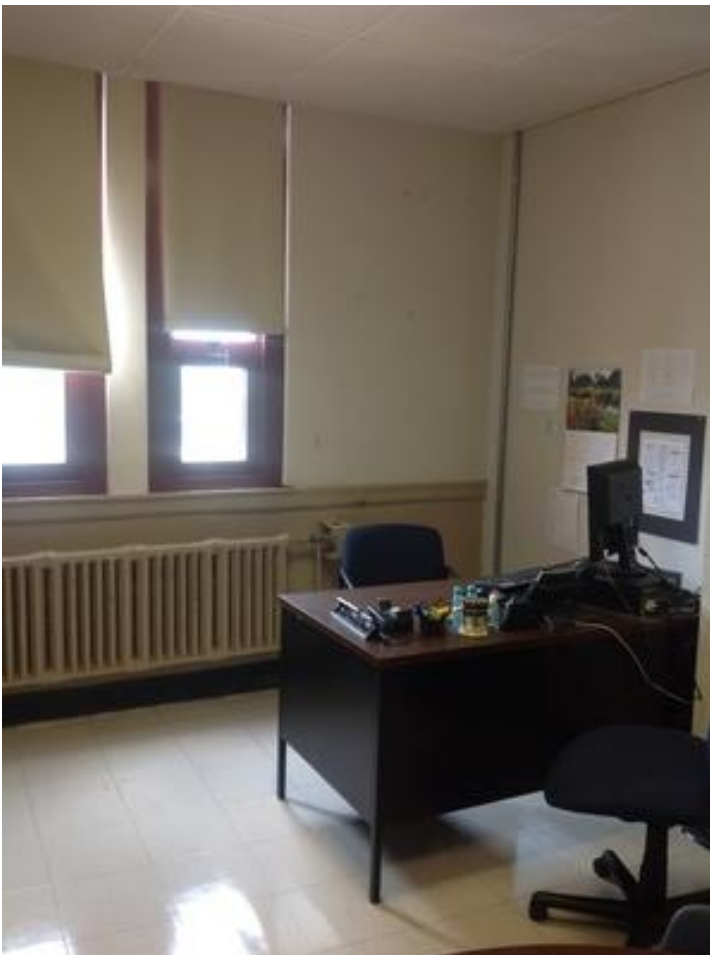
Attached Images for ID KJ-00028

VCT flooring in fair condition. ACT ceiling in fair condition. Walls and ceiling have chipping paint. Shades are in poor condition. Heating unit in poor condition. FRP column cover in poor condition. Wires are haphazardly placed.

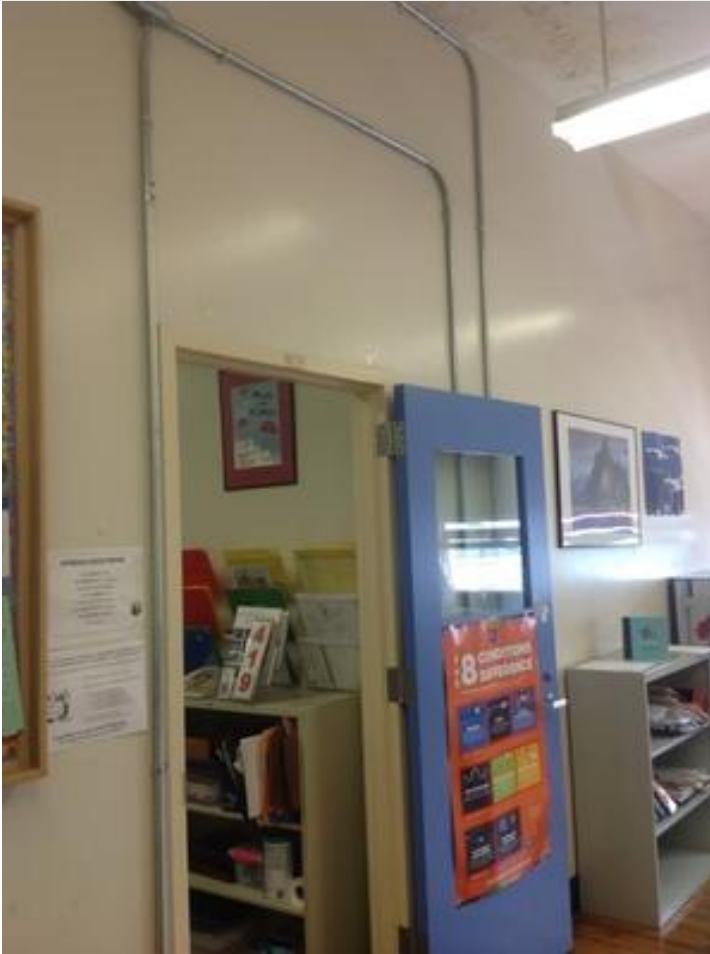
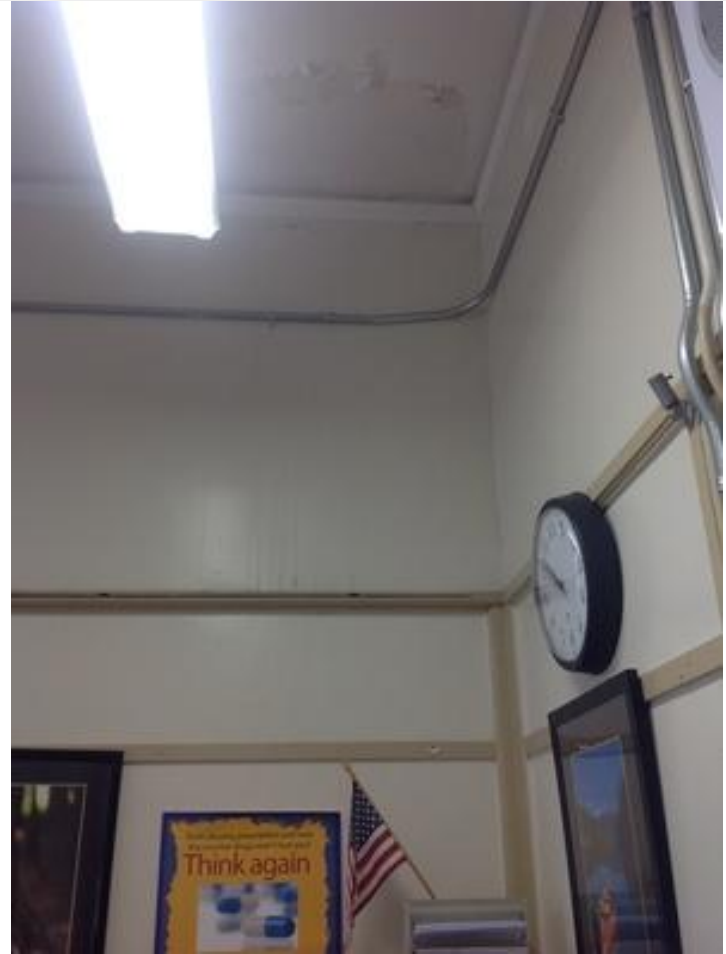
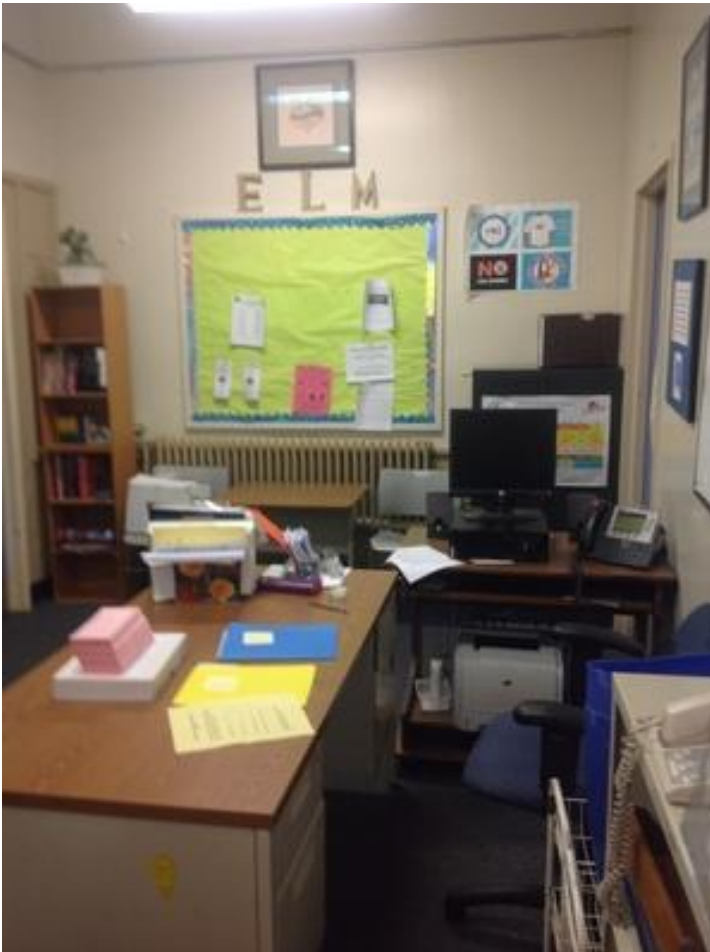
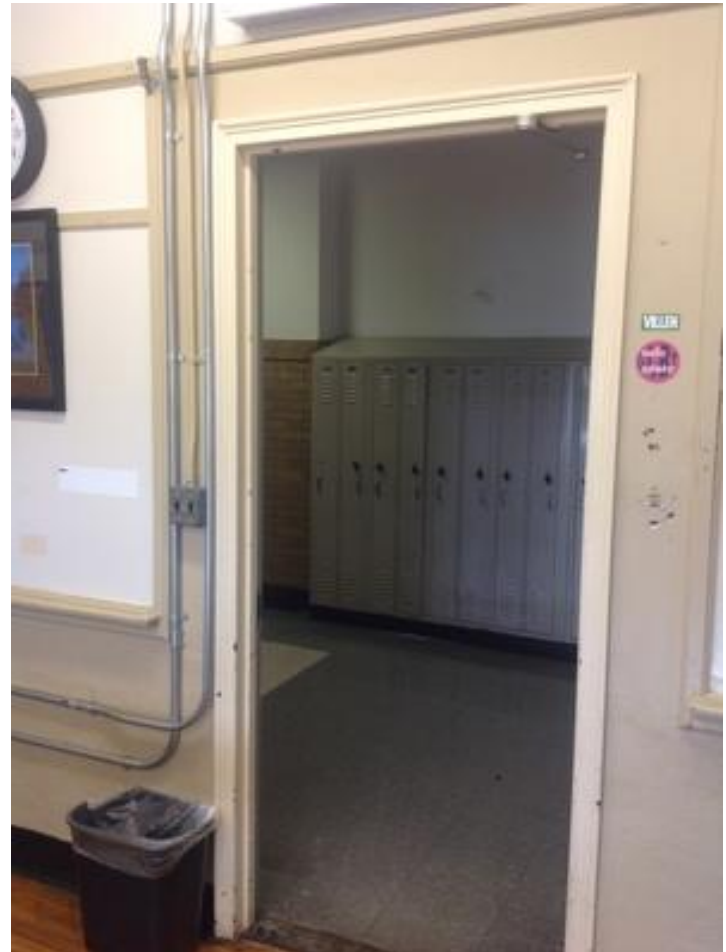
Attached Images for ID KJ-00030

| Description Carpet is in poor condition. Paint is chipping on walls and ceiling. Water damage on ceiling. | | | |

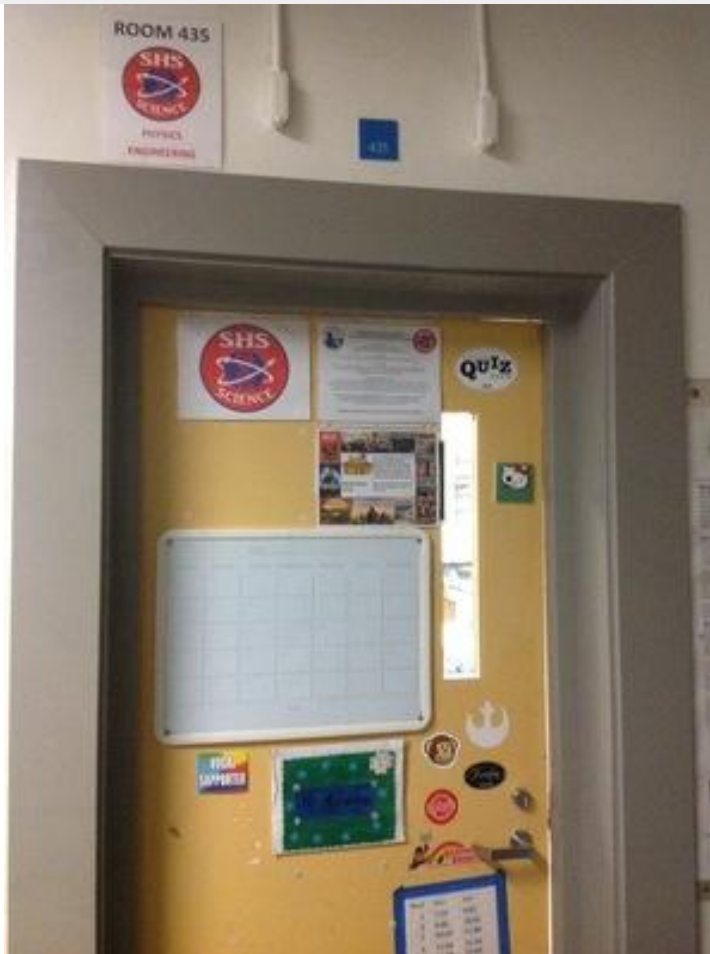
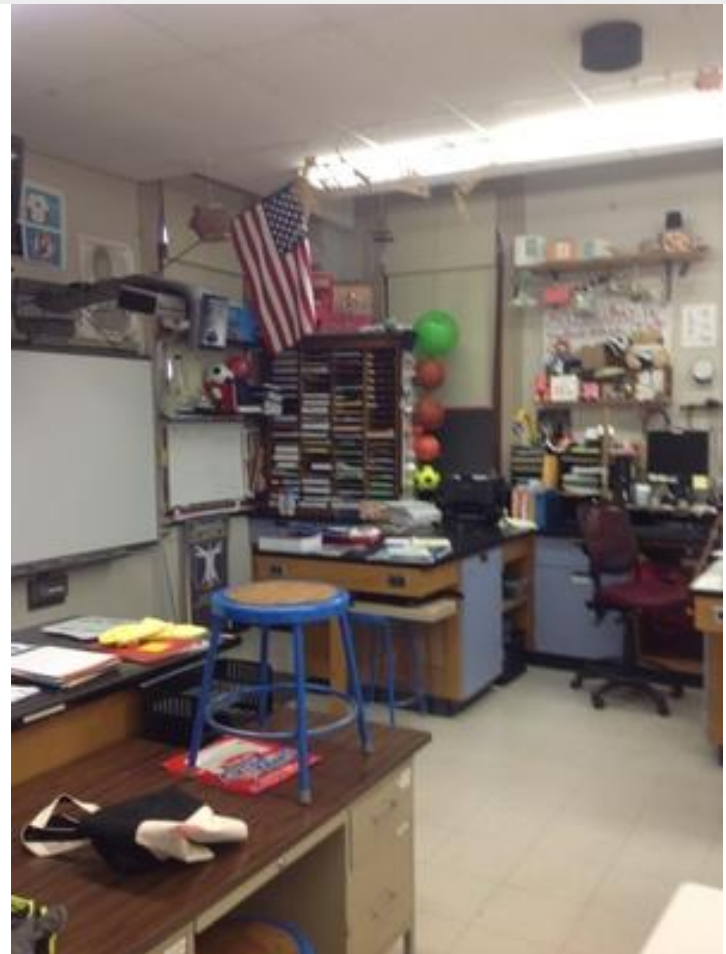
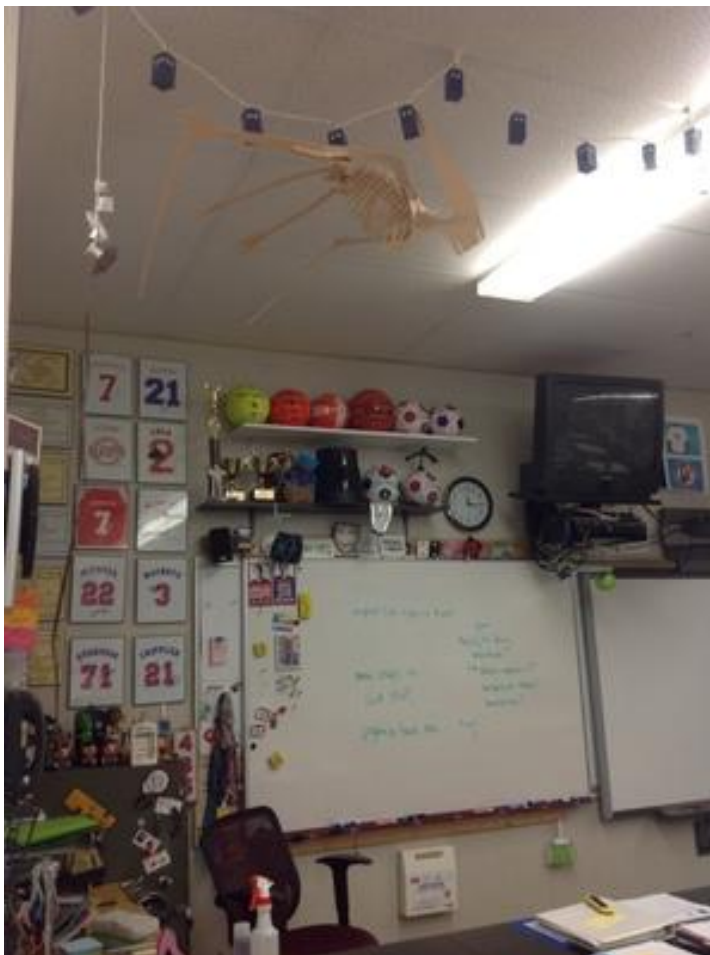
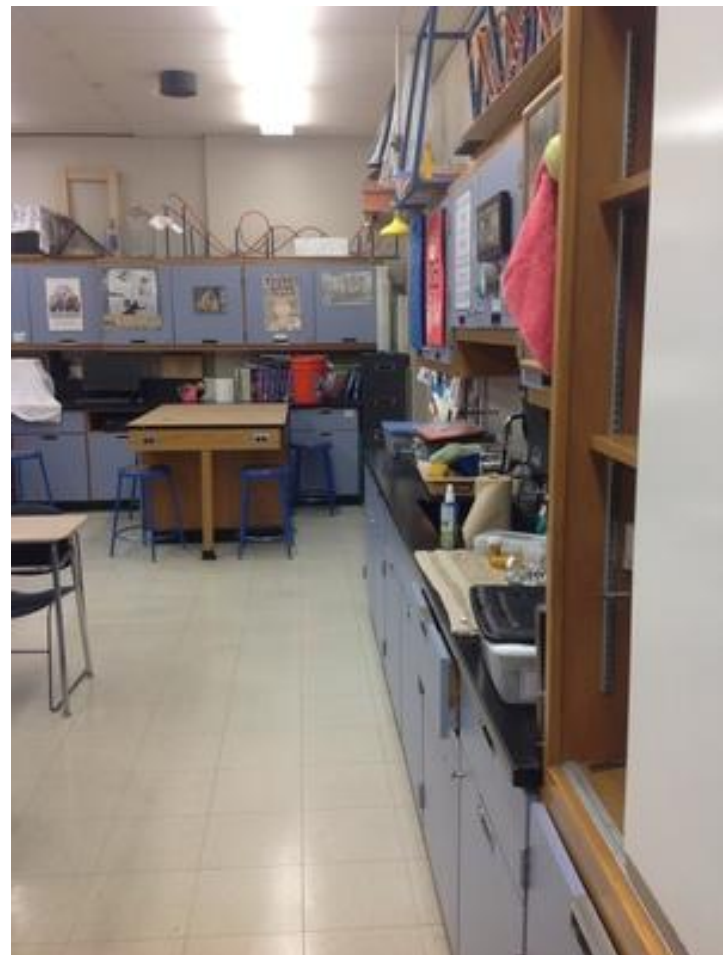
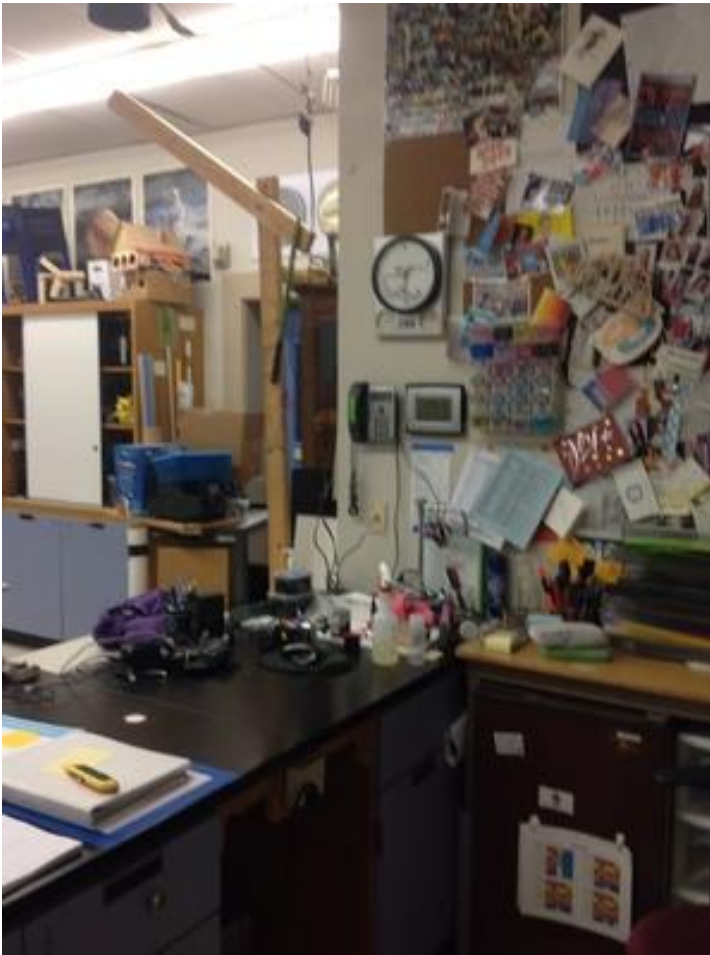
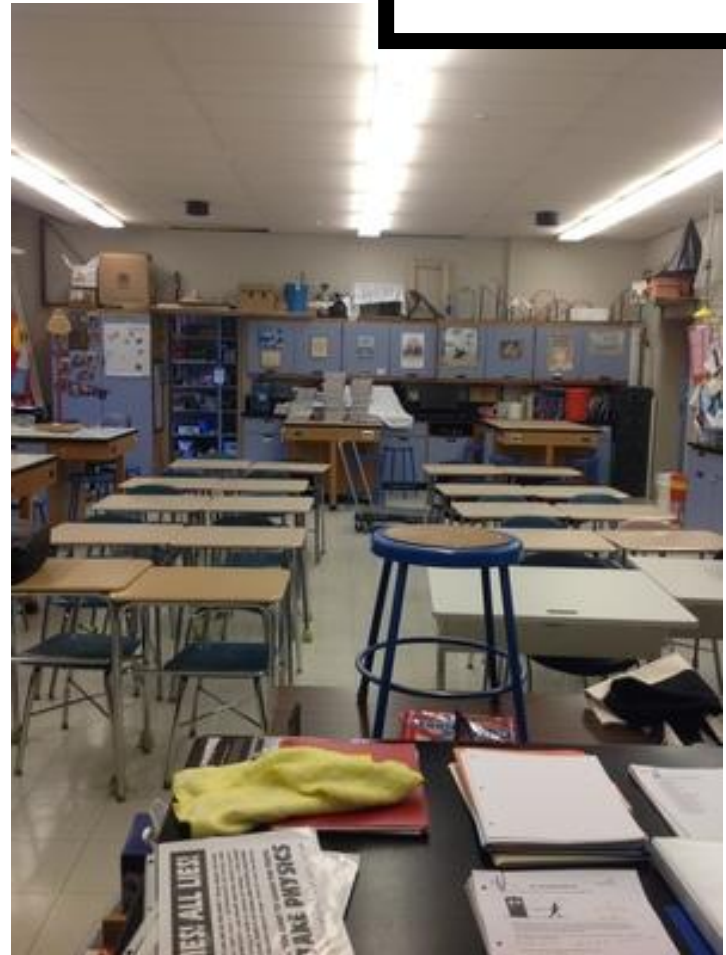
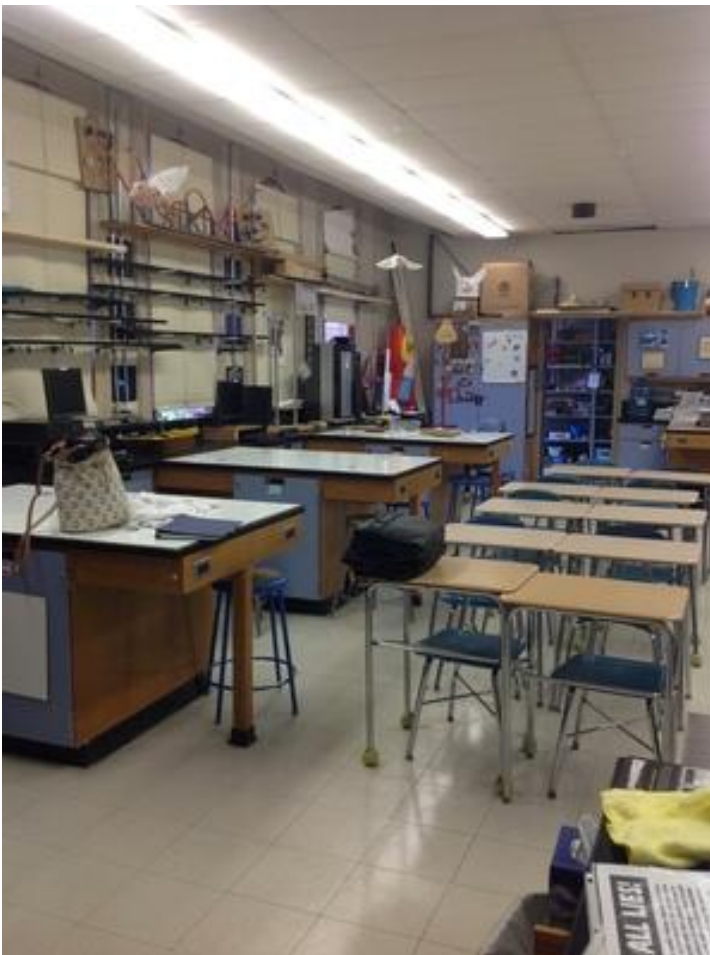
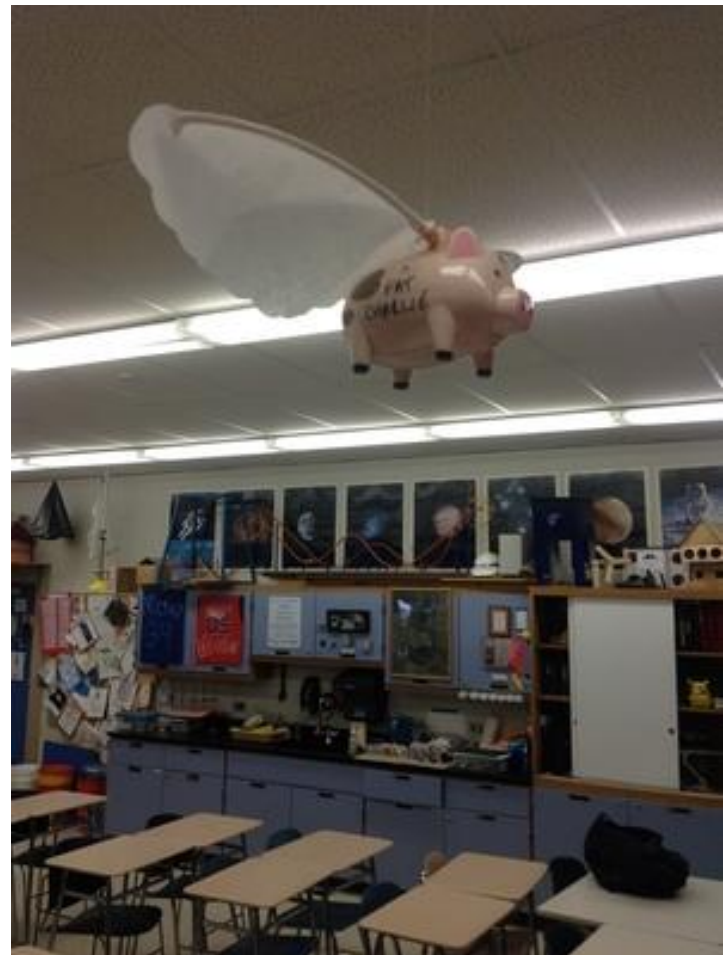
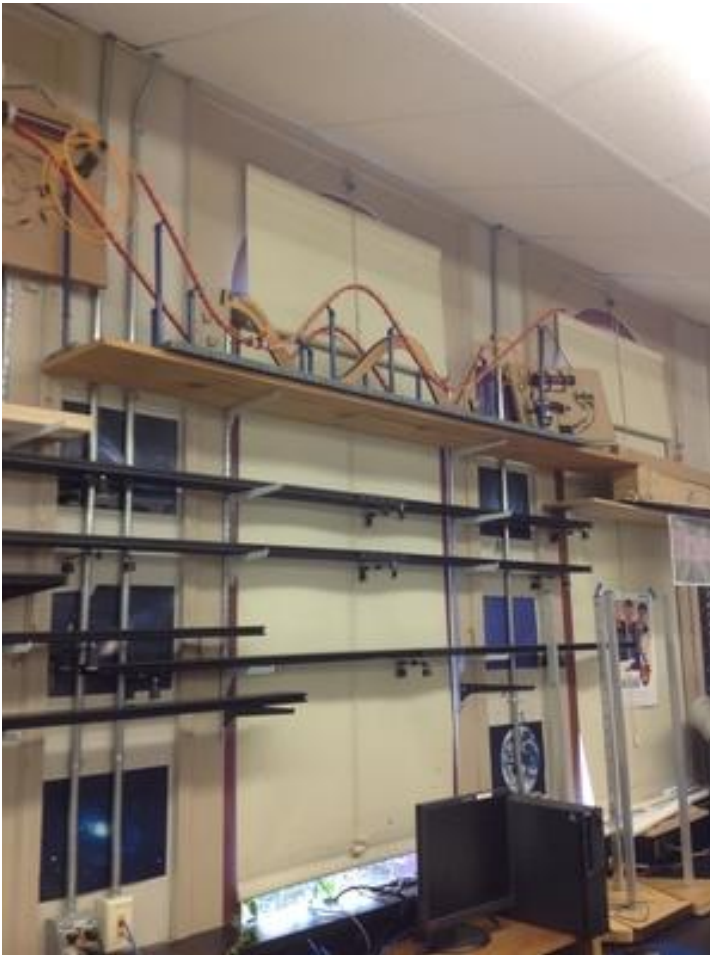
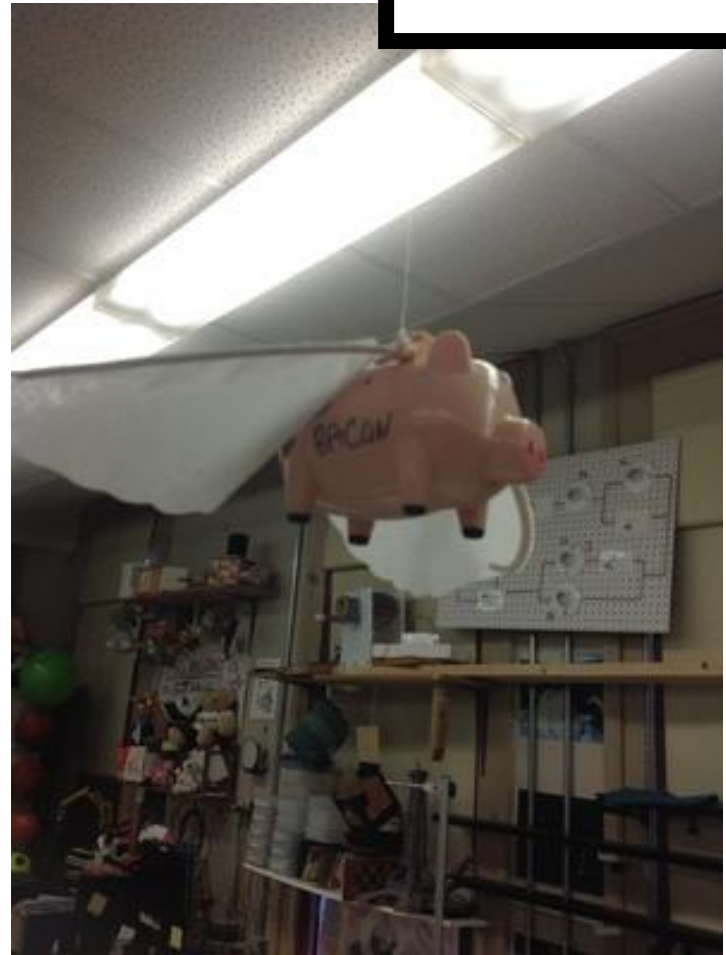
Attached Images for ID KJ-00043

Description
VCT is in fair condition Paint is chipping on walls in some locations.. 2x4 ACT in fair condition. Surface mounted equipment and wiring is haphazard. Shades are in poor condition. Some windows have lost seal. Millwork in poor condition. Unit heater in poor condition. Some windows have lost their seal. Classroom has smartboard.

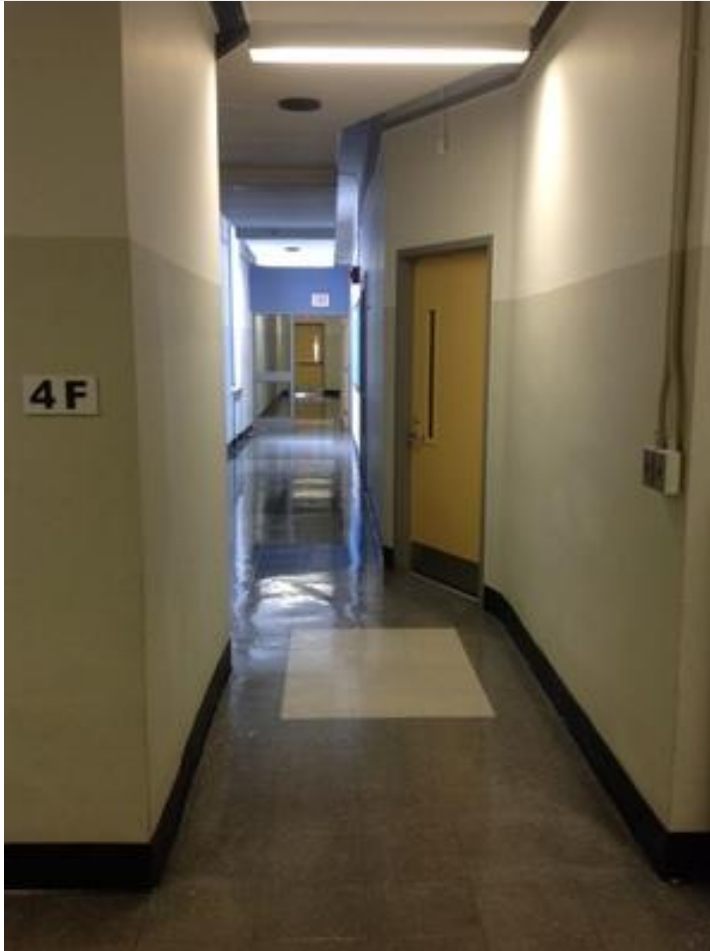
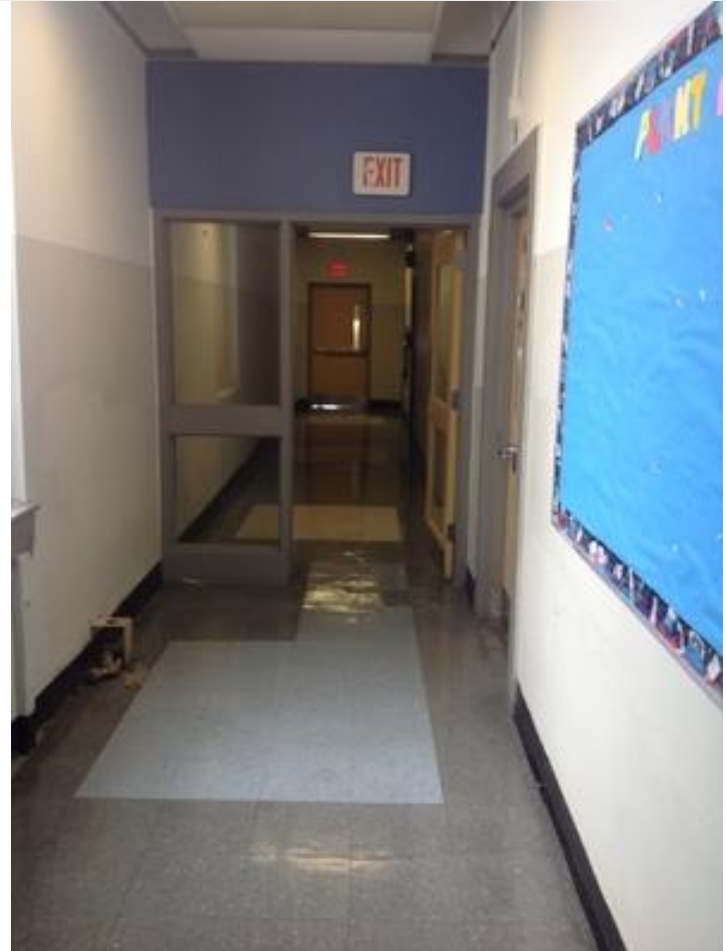
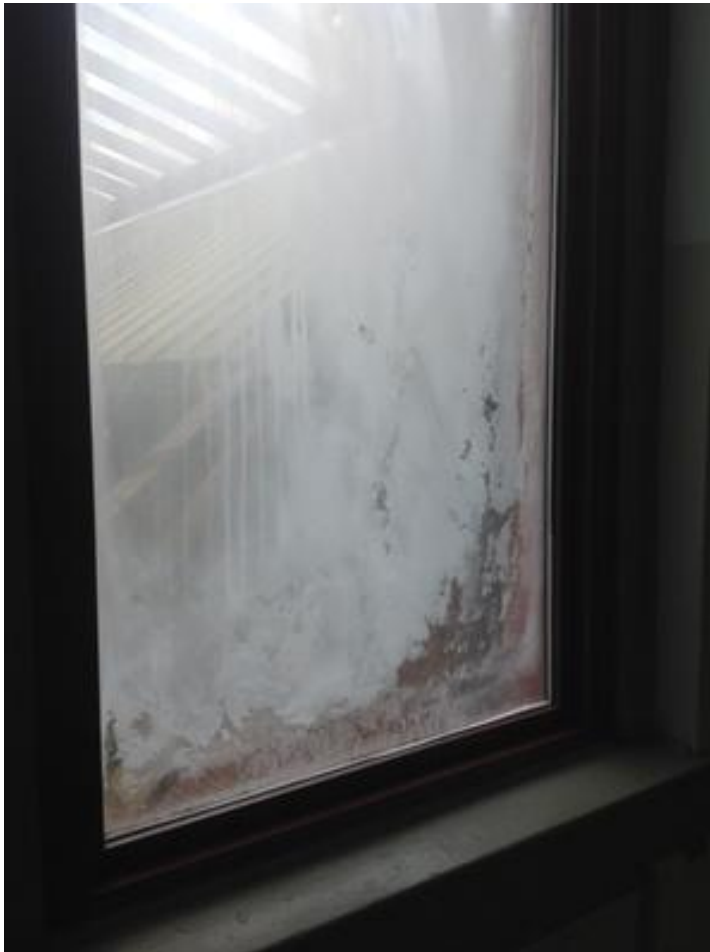
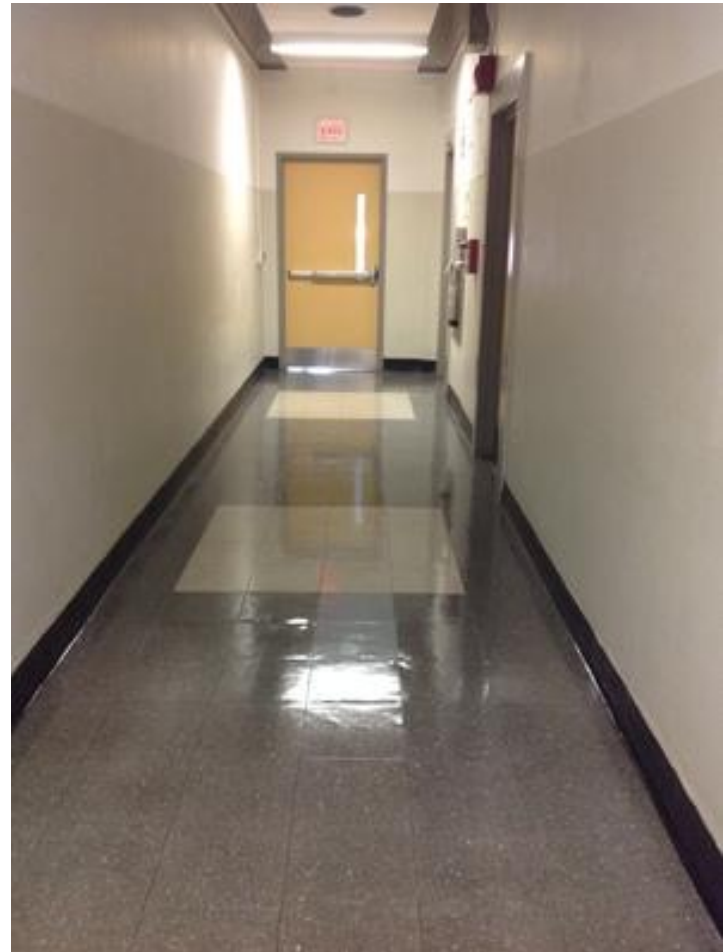
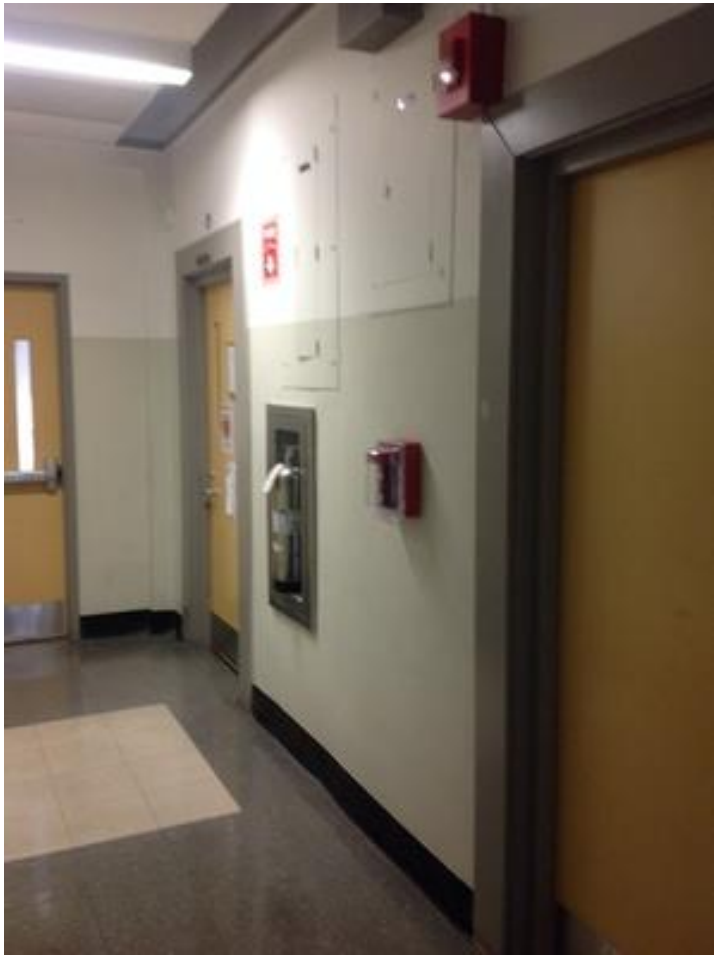
Attached Images for ID KJ-00047

Description
VCT flooring is bumpy and uneven. Partial 2x4 ACT ceiling and grid centered in corridor open to plaster ceiling above. Piping/ductwork exposed around ACT ceiling. Surface mounted ceiling fixtures. Wall base in fair condition. Heating units in poor condition. Some windows have lost seal. Narrow corridor would create difficulty in passing time.

| Condition | Fair | | |

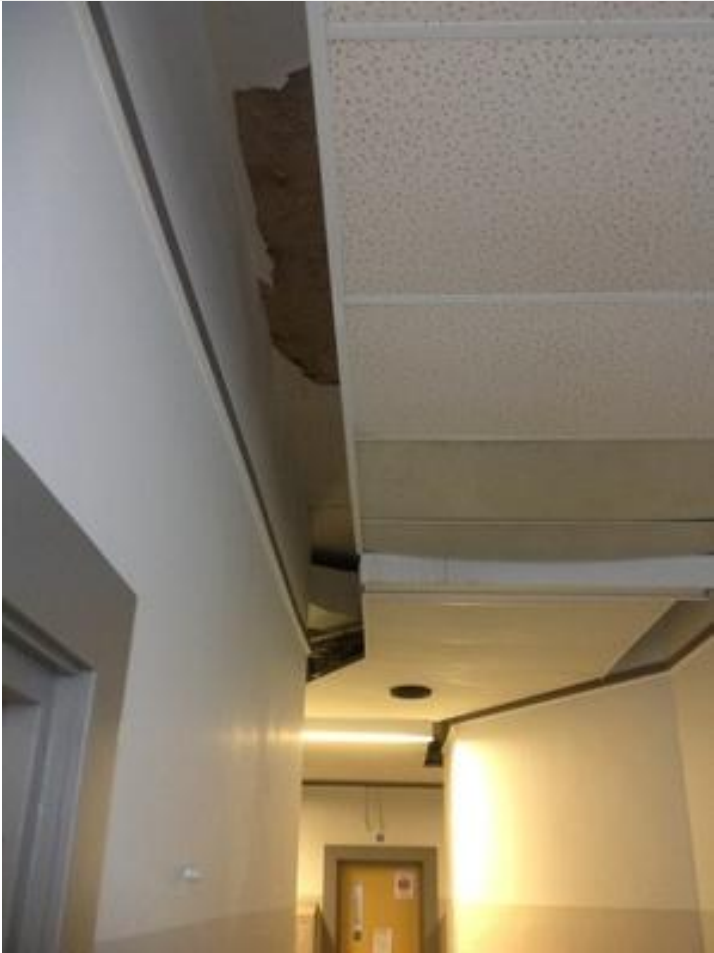
Attached Images for ID KJ-00050

| Description Corridor ceiling damage visible. Flooring is warped. | | | |

| Condition | Poor | | |
