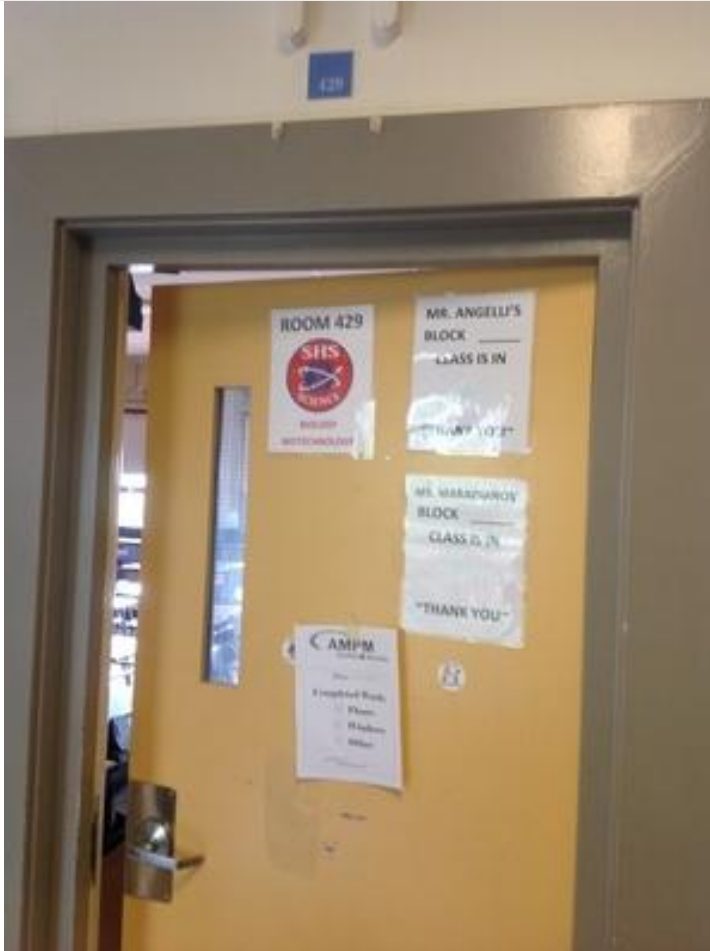
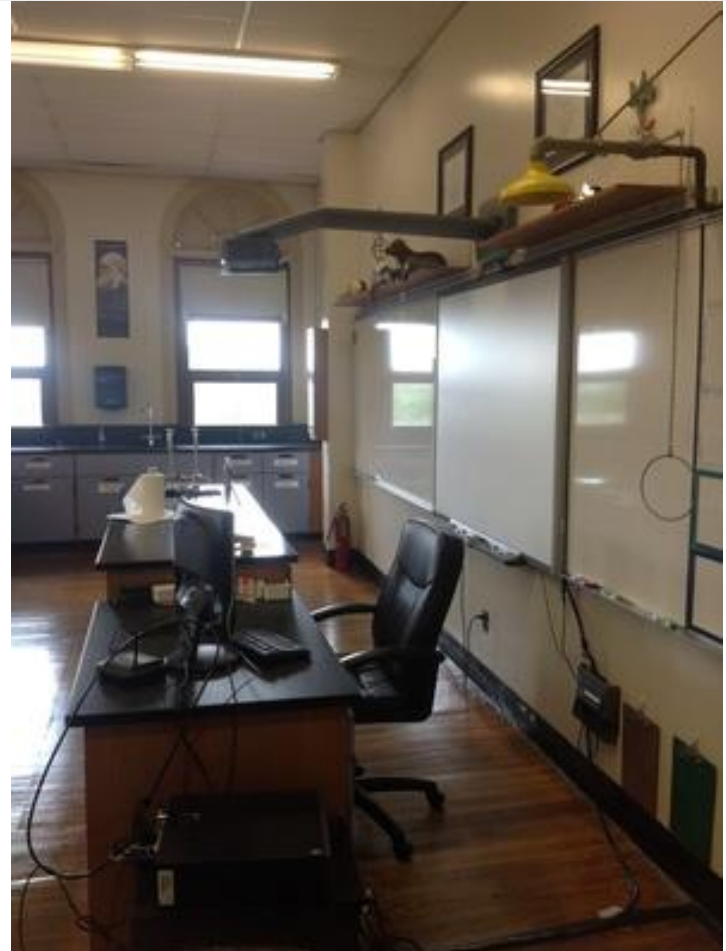
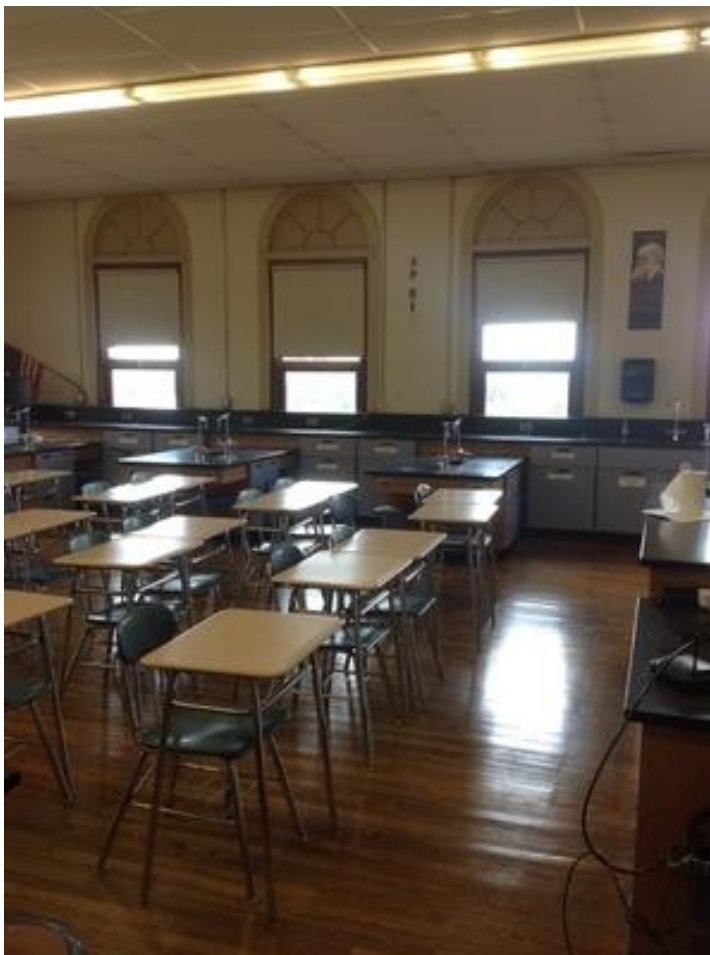
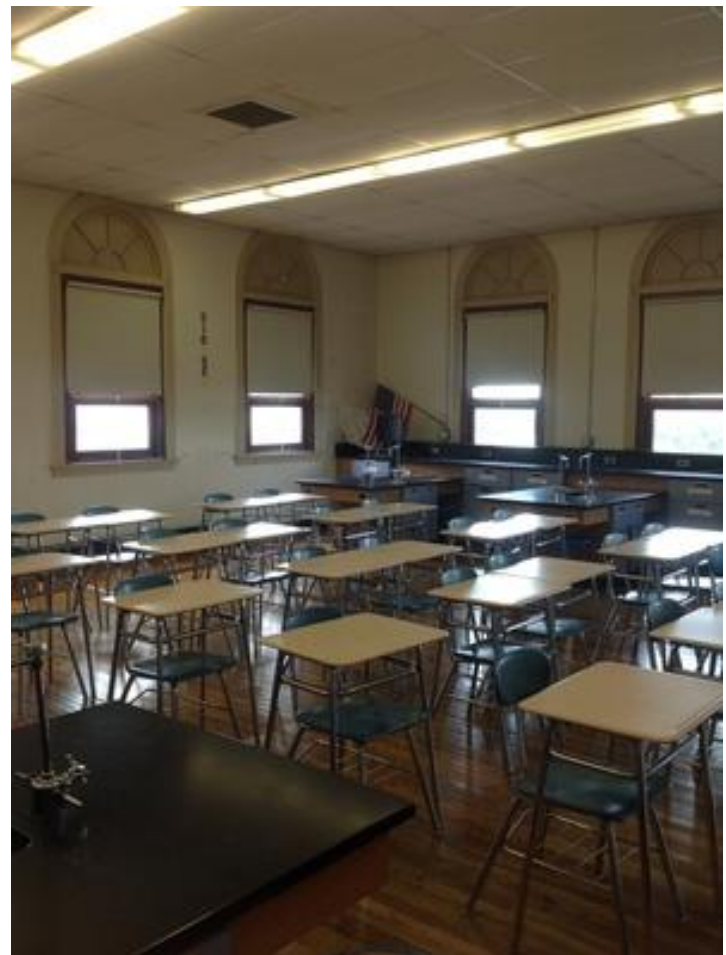
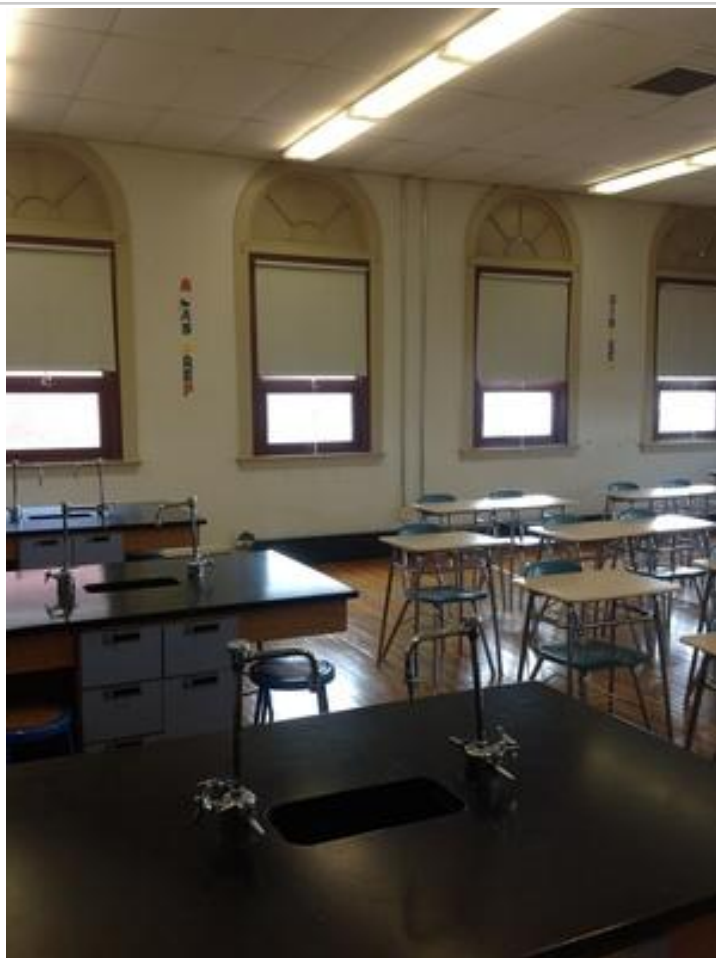
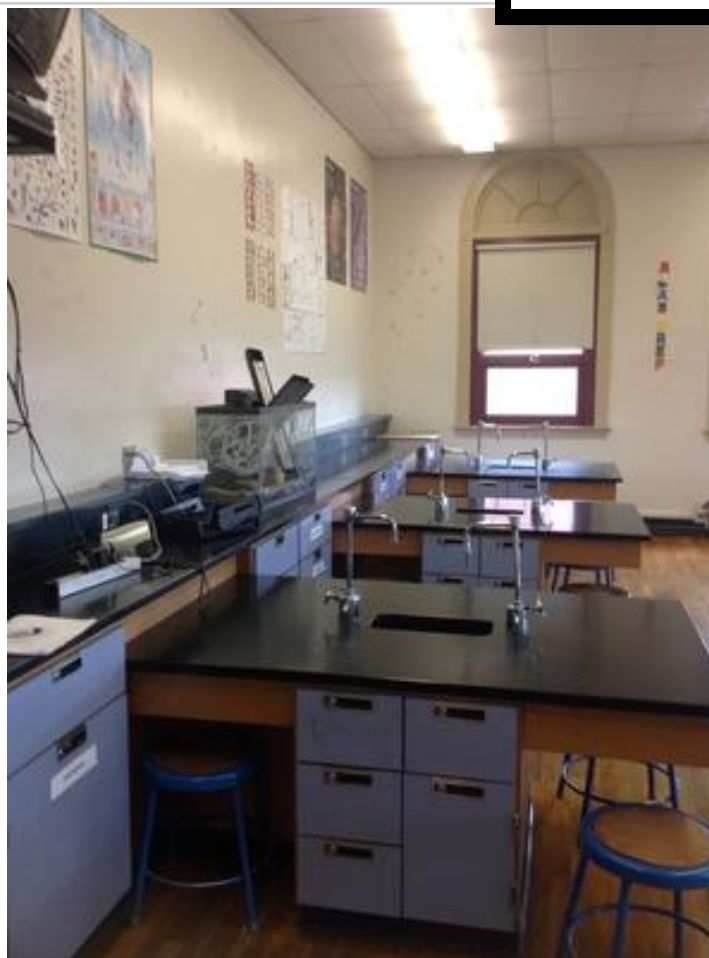
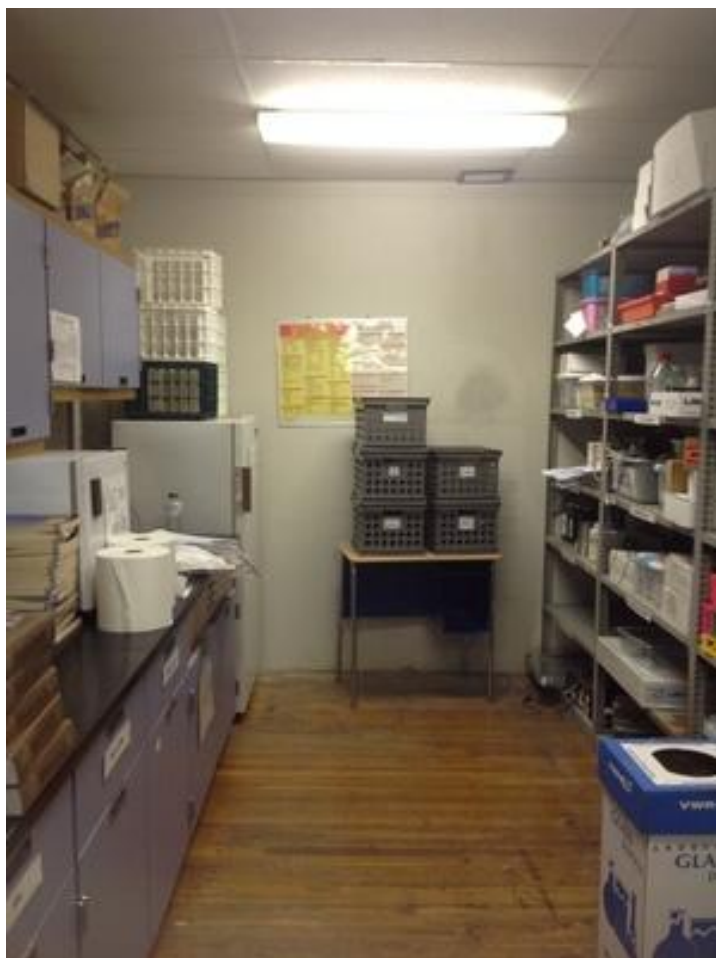
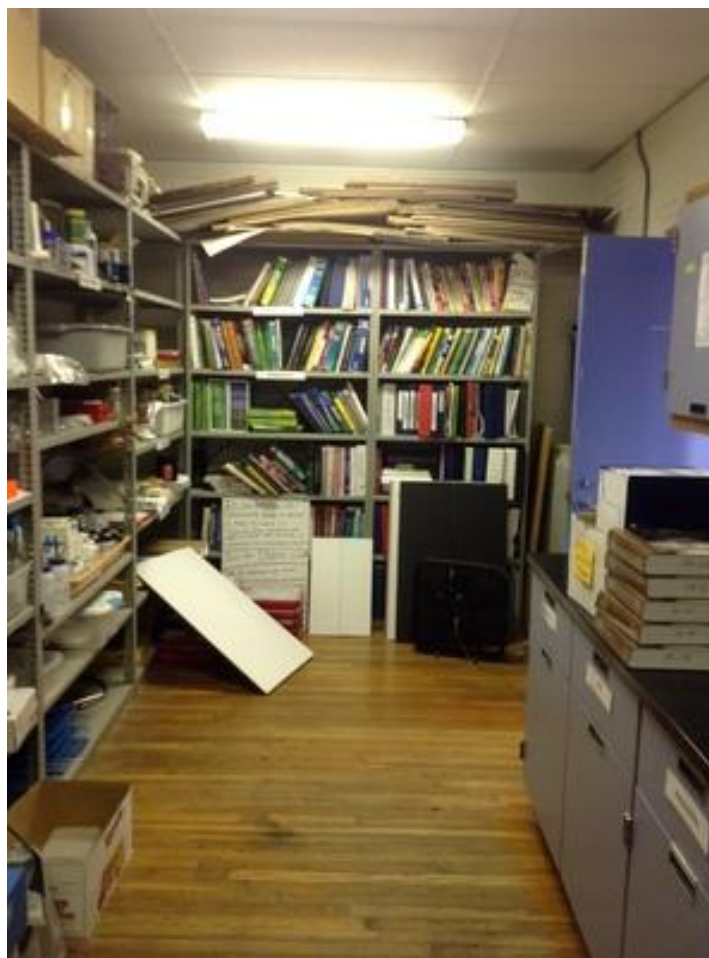
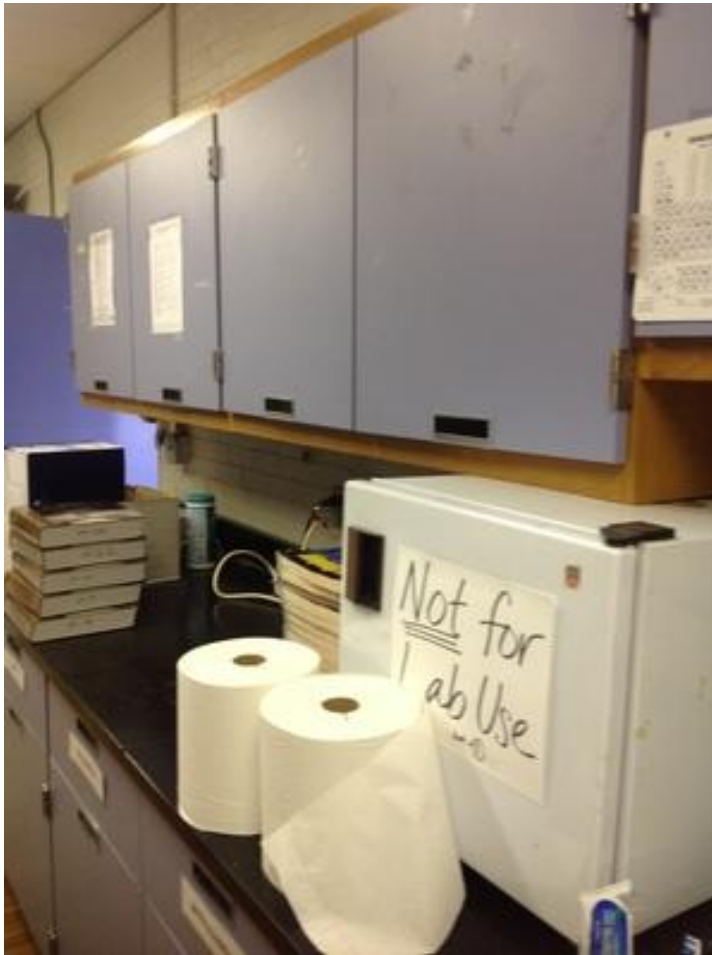
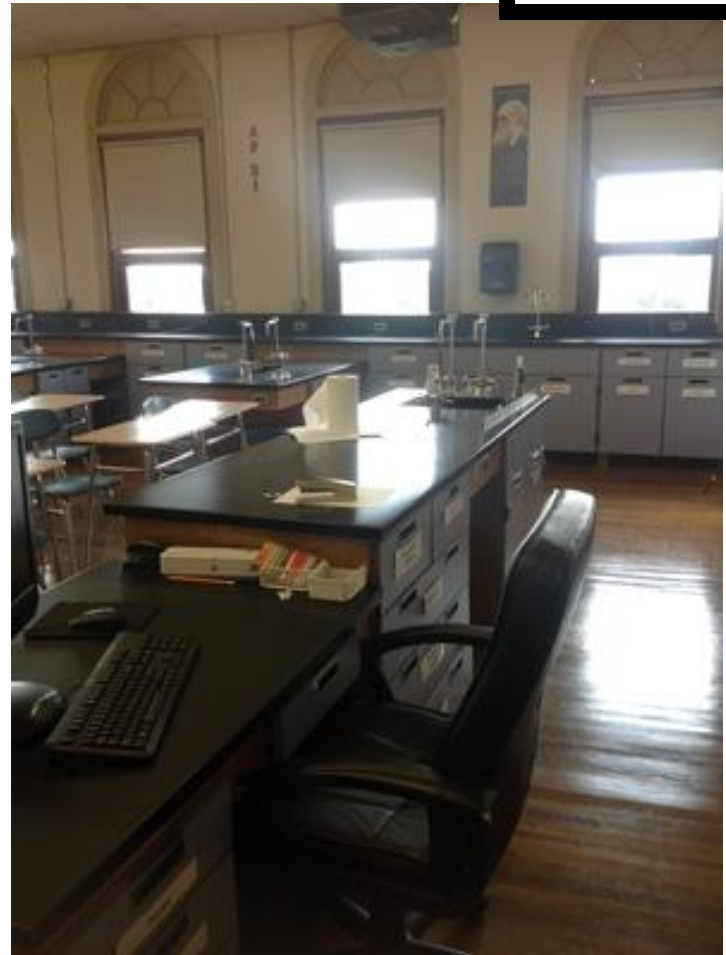
Attached Images for ID KJ-00051

Description
Wood flooring in good condition but creaky. Paint is chipping on walls 2x4 on ceiling in fair condition. Surface mounted equipment and wiring is haphazard. Shades are in poor condition. Millwork in poor condition. Unit heater in poor condition. Some windows have lost their seal. Transom window panes painted. Classroom has smartboard.

| Condition | Fair | | |

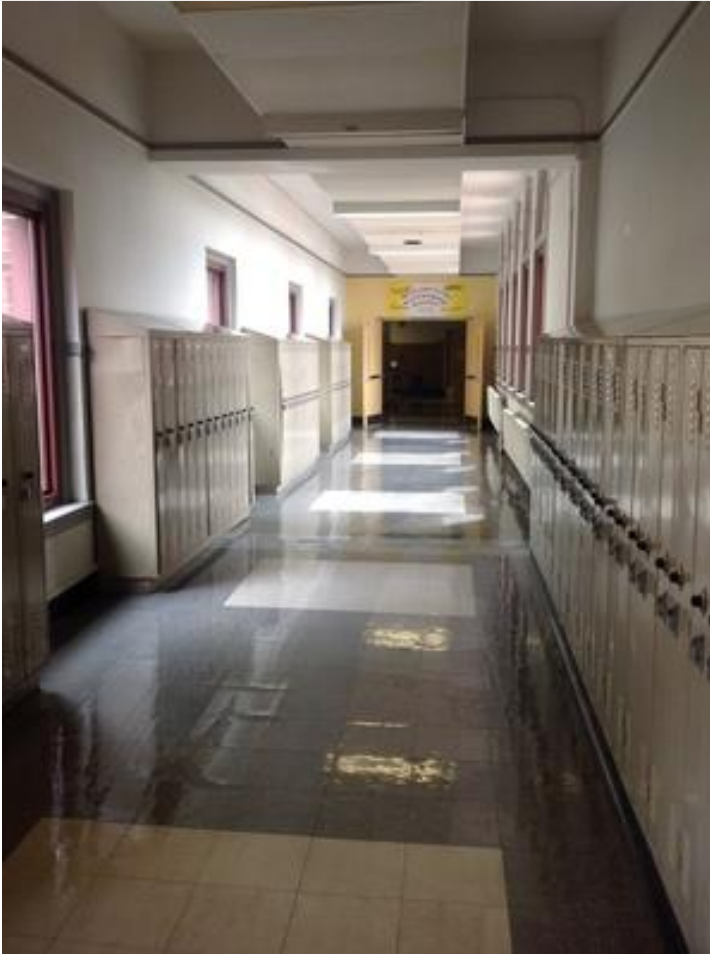
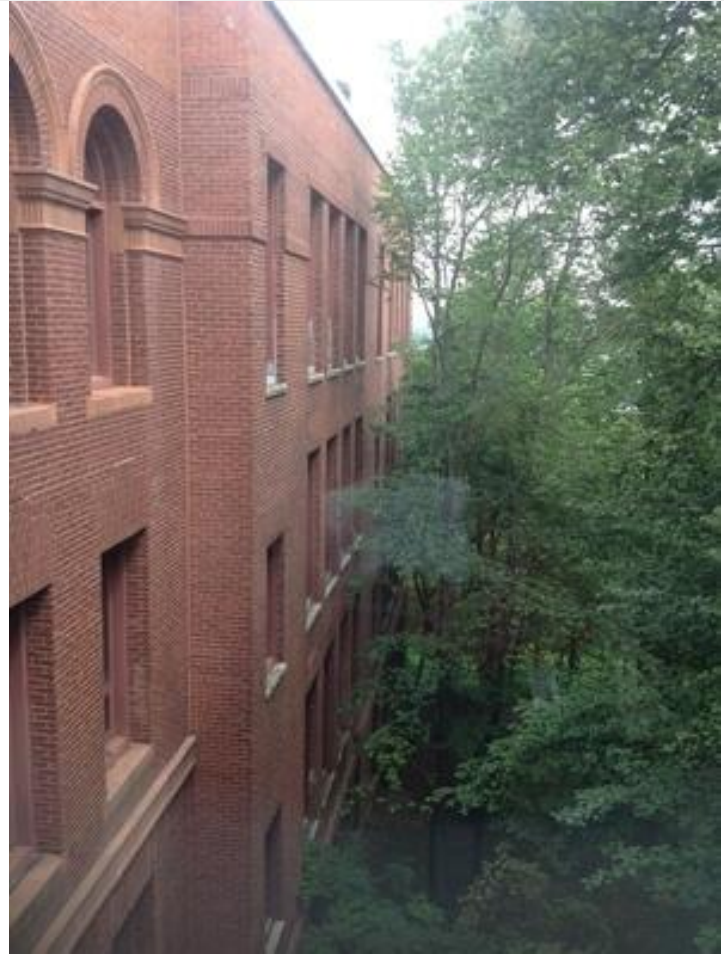
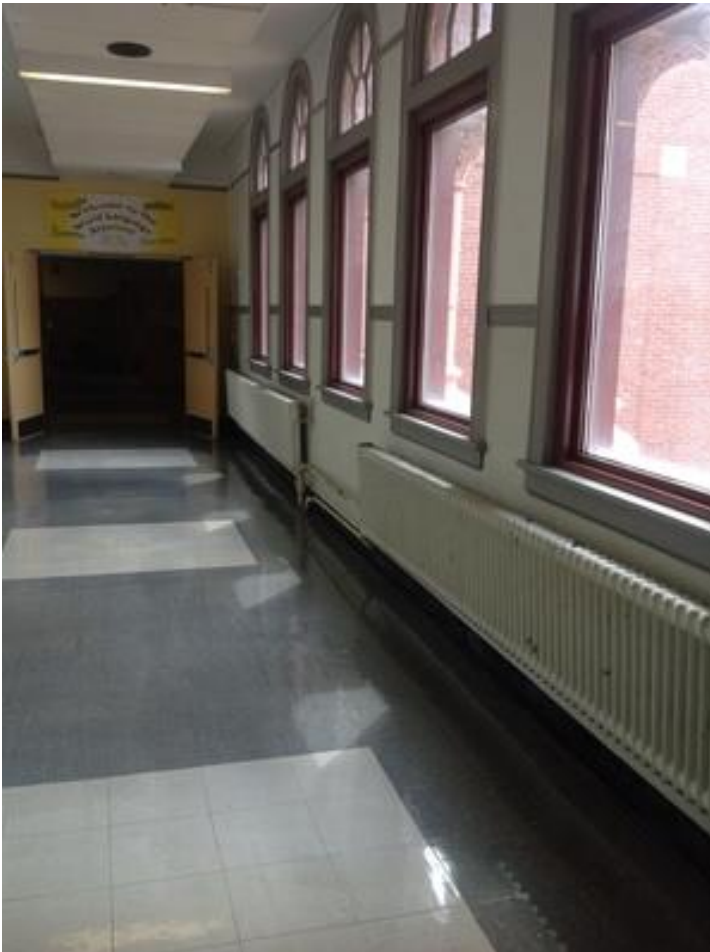
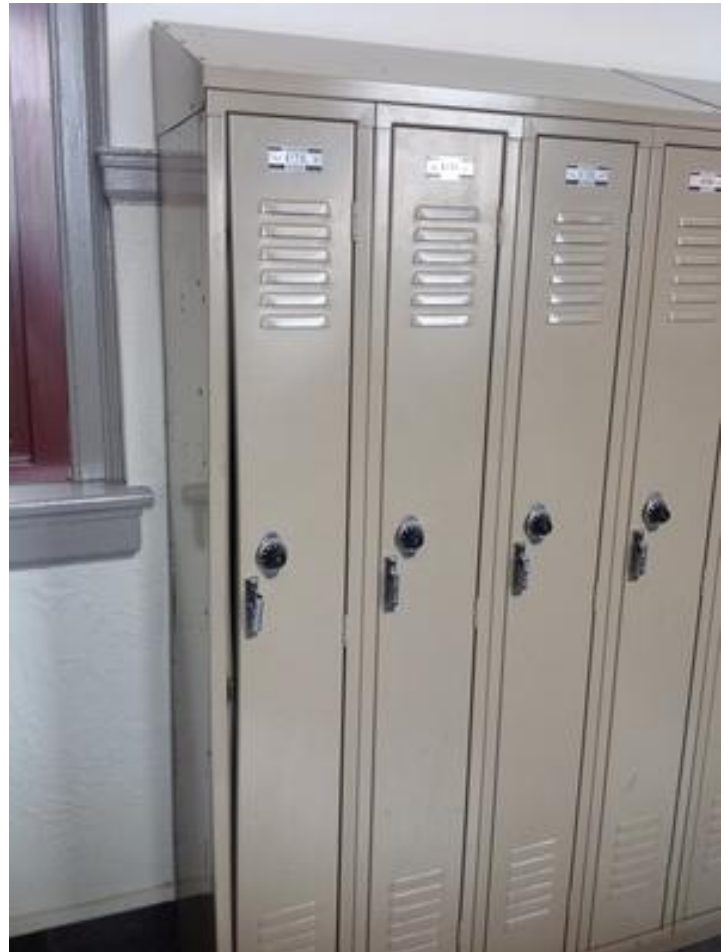
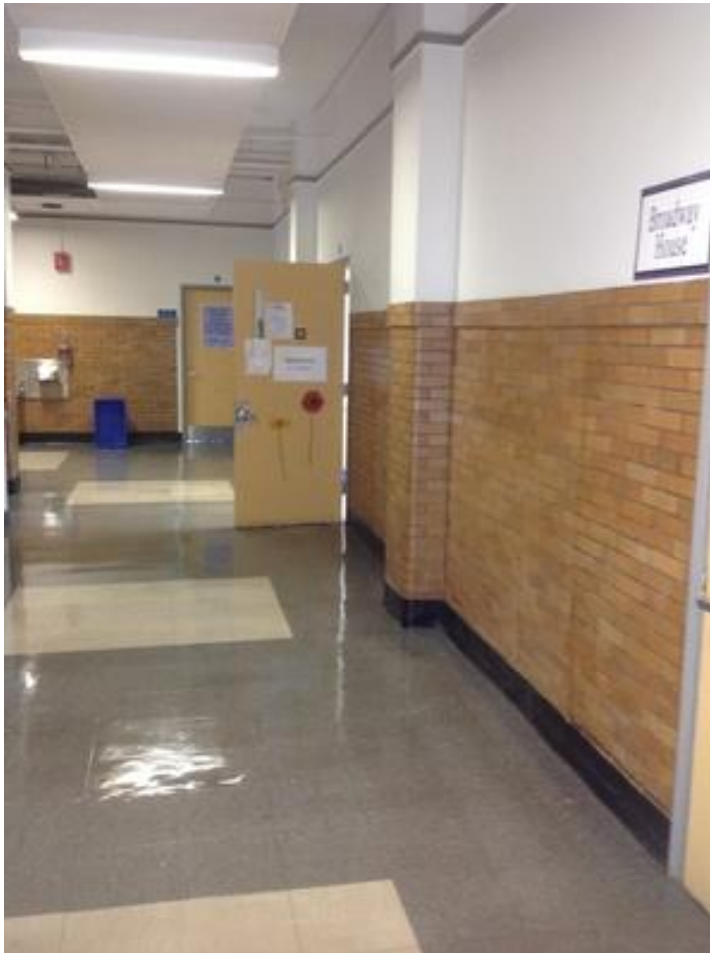
Attached Images for ID KJ-00052

Description
Double loaded corridor with recessed lockers. Plaster in fair condition. Partial 2x4 ACT ceiling and grid centered in corridor open to plaster ceiling above. Piping/ductwork exposed around ACT ceiling. Surface mounted ceiling fixtures. Wall base in fair condition. Some windows have lost seal.

| Condition | Fair | | |

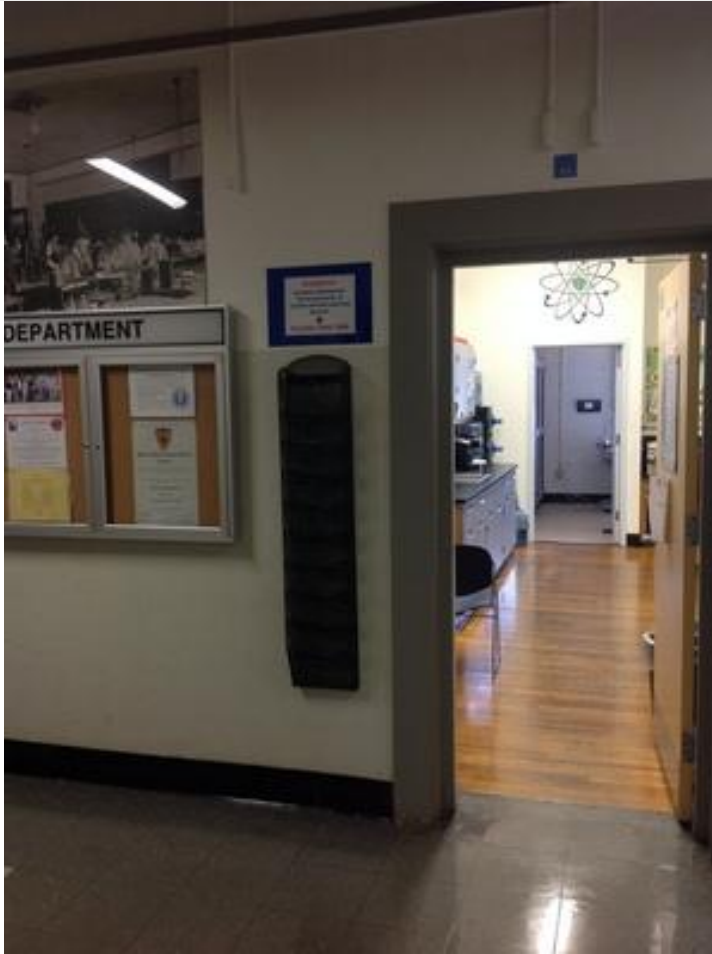
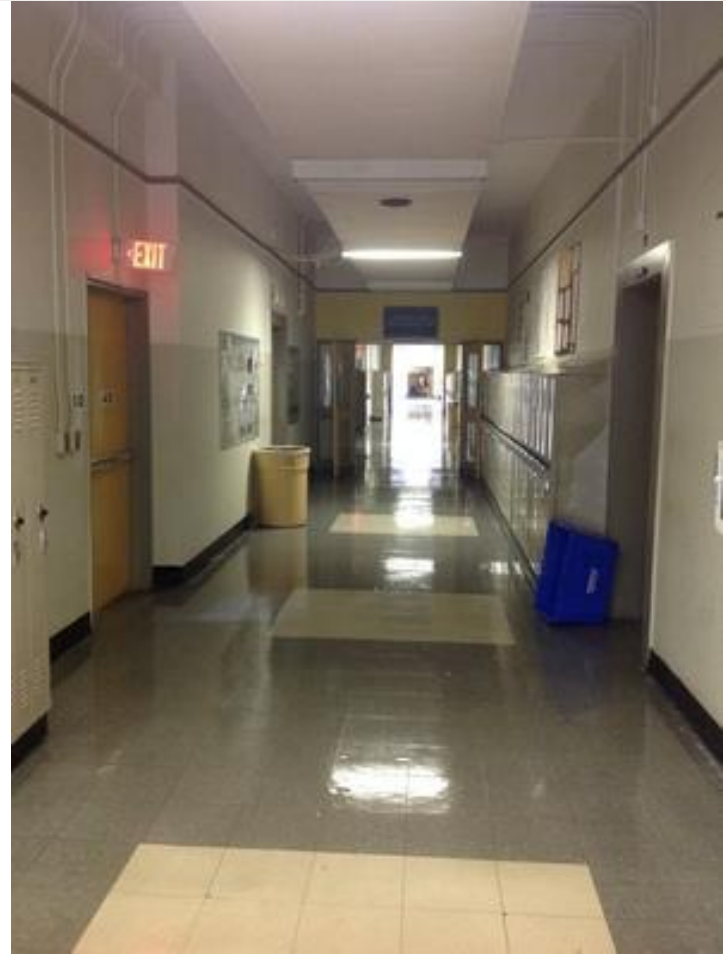
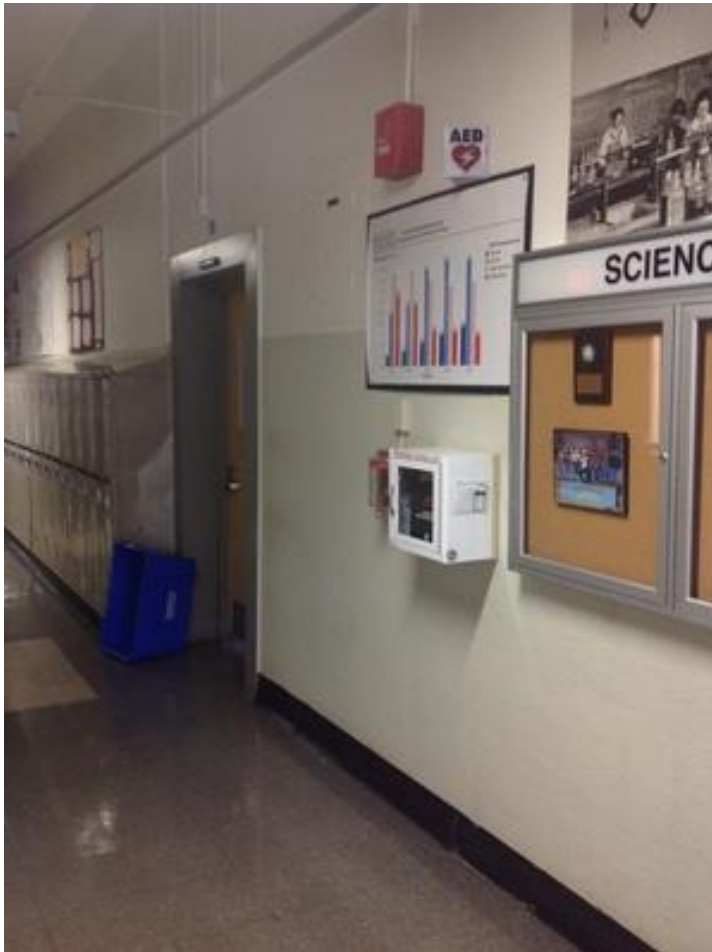
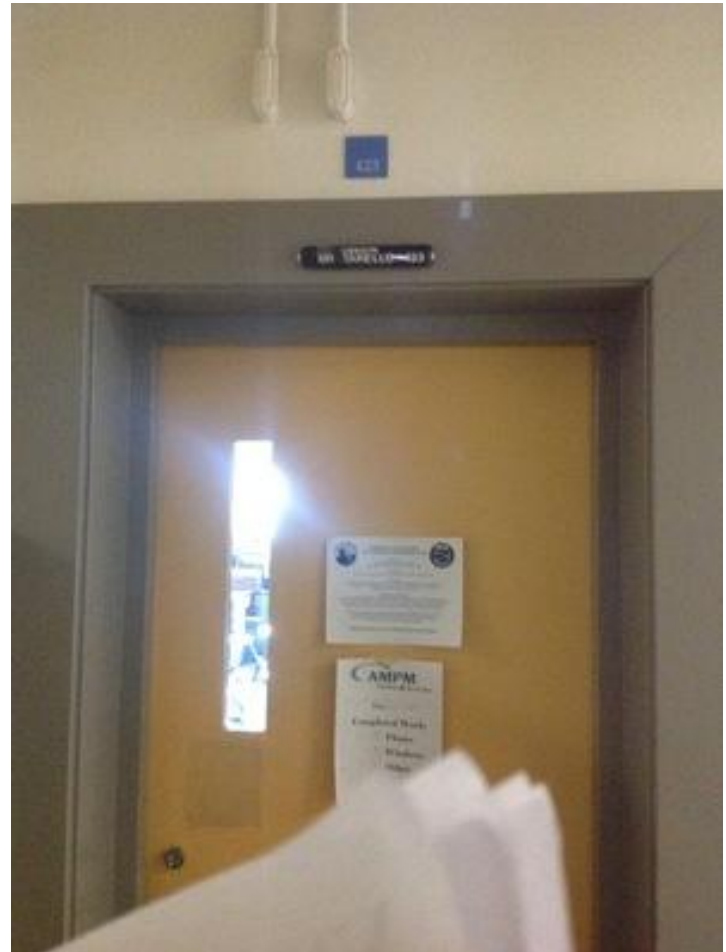
Attached Images for ID KJ-00039

Description
VCT flooring is bumpy and uneven. Partial 2x4 ACT ceiling and grid centered in corridor open to plaster ceiling above. Piping/ductwork exposed around ACT ceiling. Surface mounted ceiling fixtures. Wall base in fair condition. Heating units in poor condition.

| Condition | Fair | | |

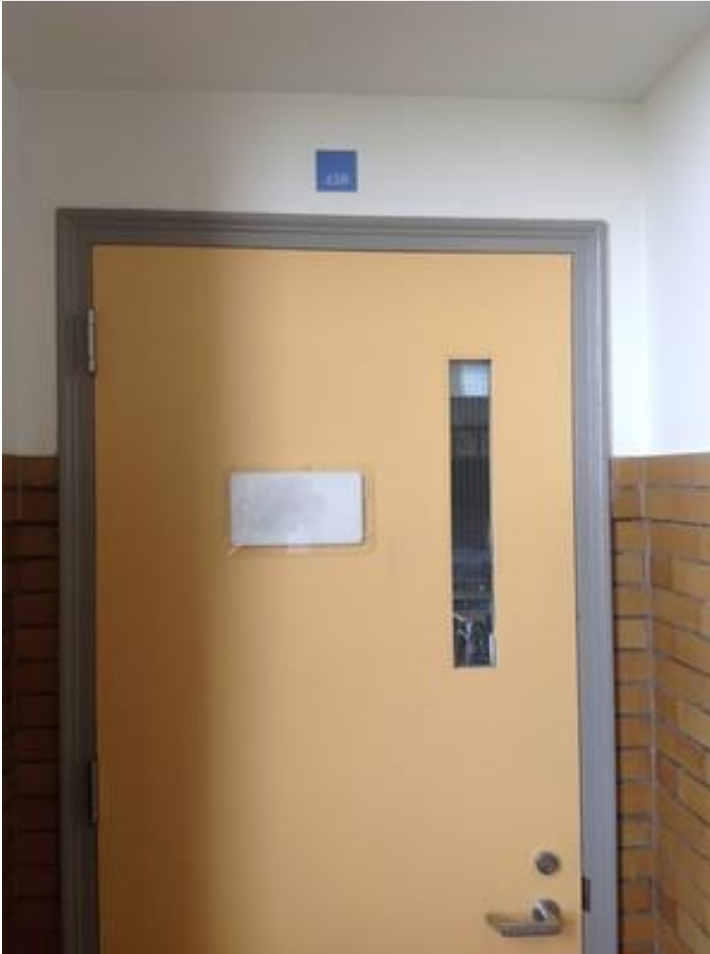
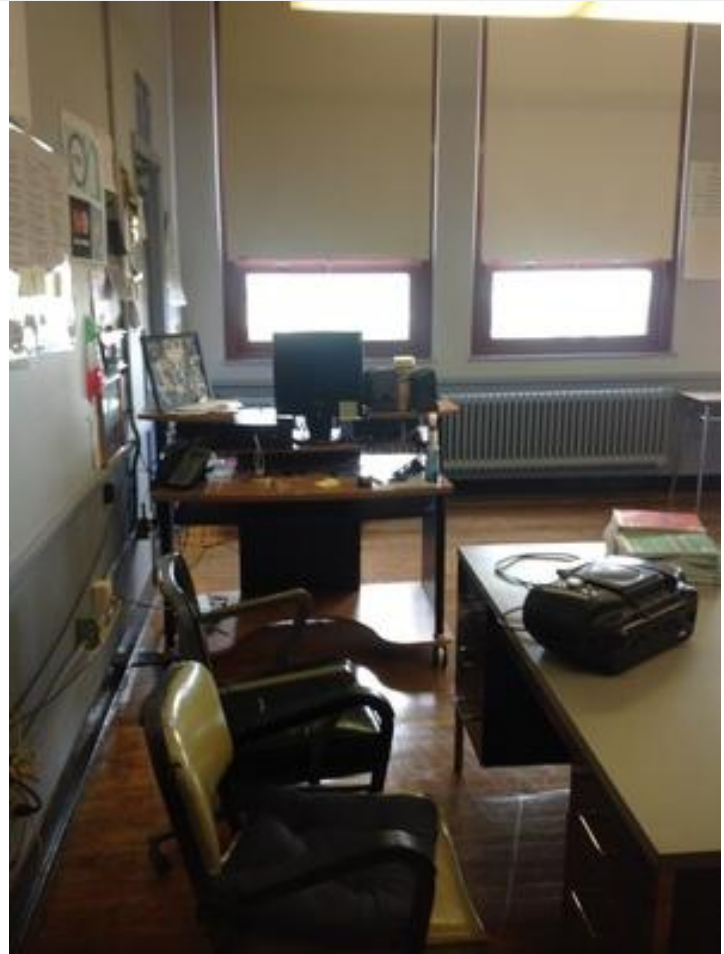
Attached Images for ID KJ-00058

Description
Wood flooring in good condition but creaky. Paint is chipping on walls and ceiling. Light fixtures missing covers in some locations. 10'x20' area of 12"x12" VCT on ceiling. Surface mounted equipment and wiring is haphazard. Shades are in poor condition. Millwork in poor condition. Unit heater in poor condition. Some windows have lost their seal. Classroom has smartboard.

| Condition | Fair | | |

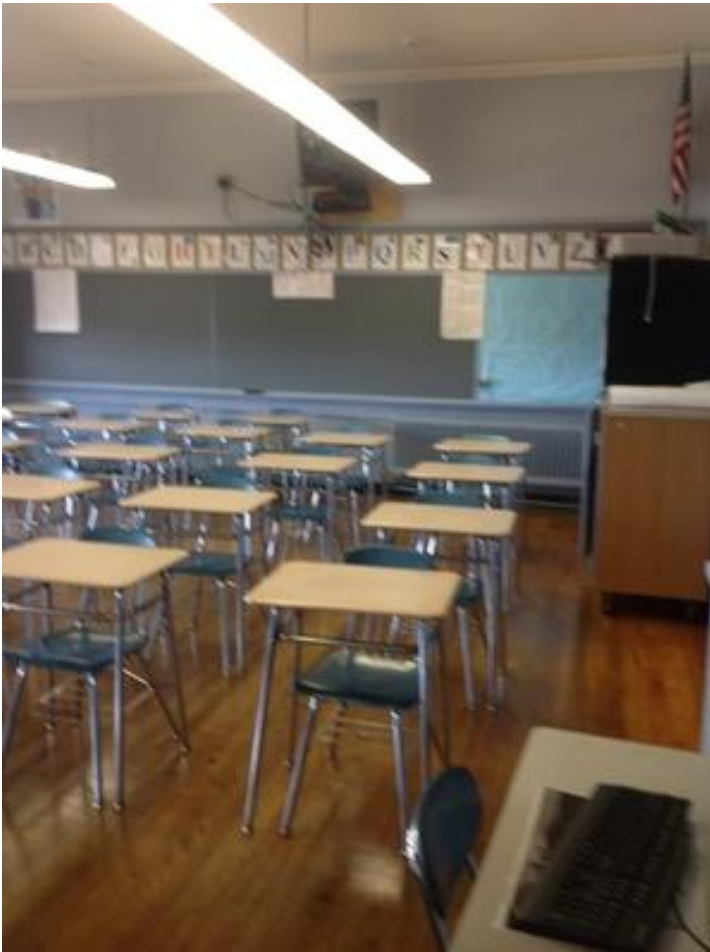
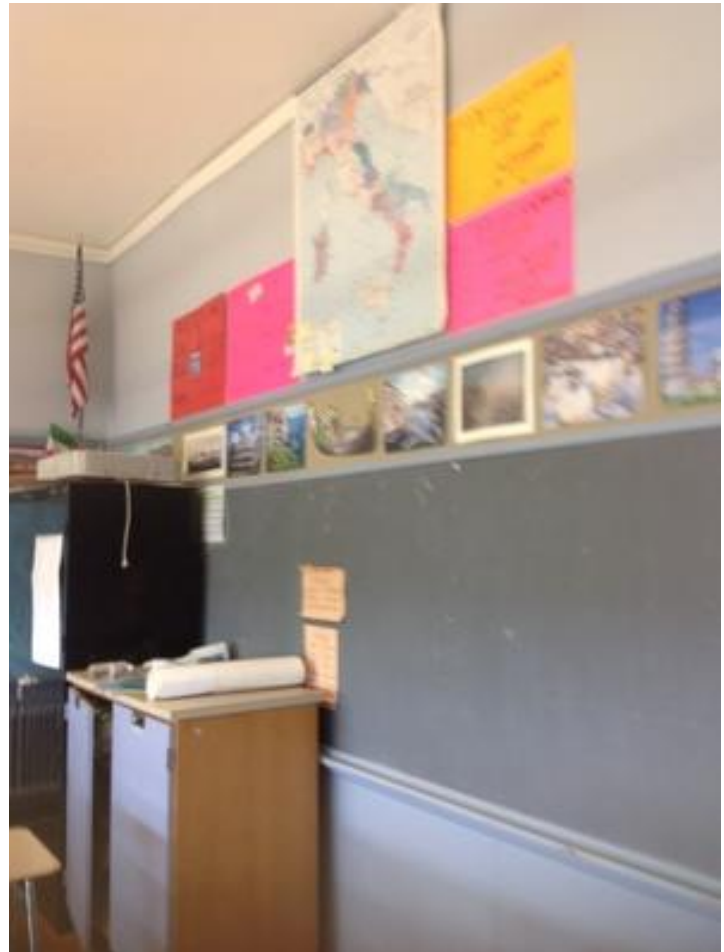
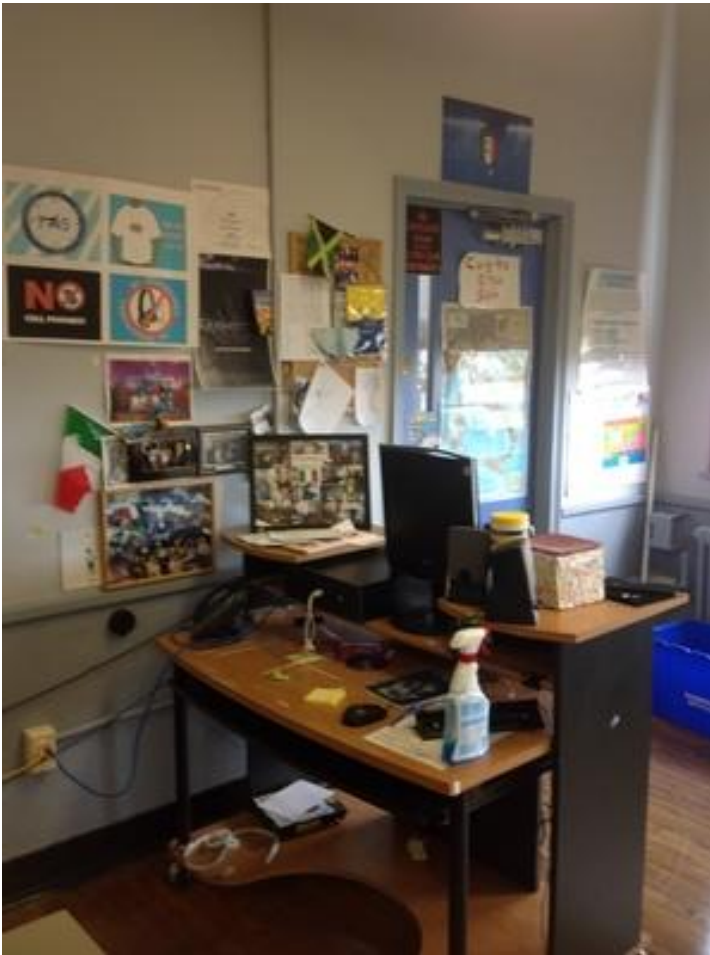
| Description Wood flooring in good condition but creaky. Paint is chipping on walls and ceiling. Light fixtures missing covers in some locations. 10'x20' area of 12"x12" VCT on ceiling. Surface mounted equipment and wiring is haphazard. Shades are in poor condition. Millwork in poor condition. Unit heater in poor condition. Some windows have lost their seal. Classroom has smartboard. | |

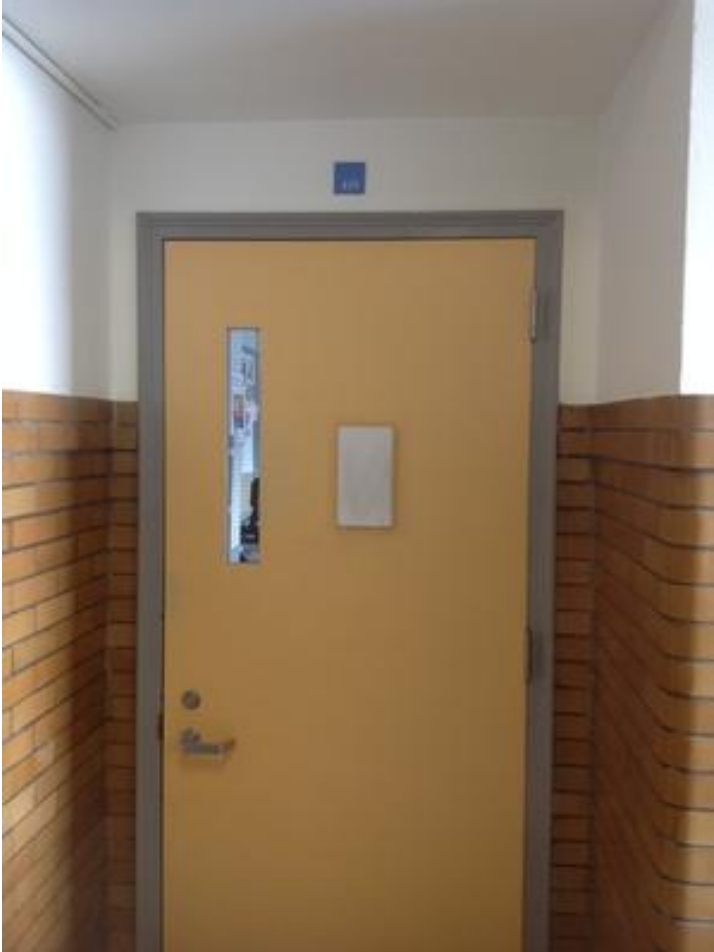
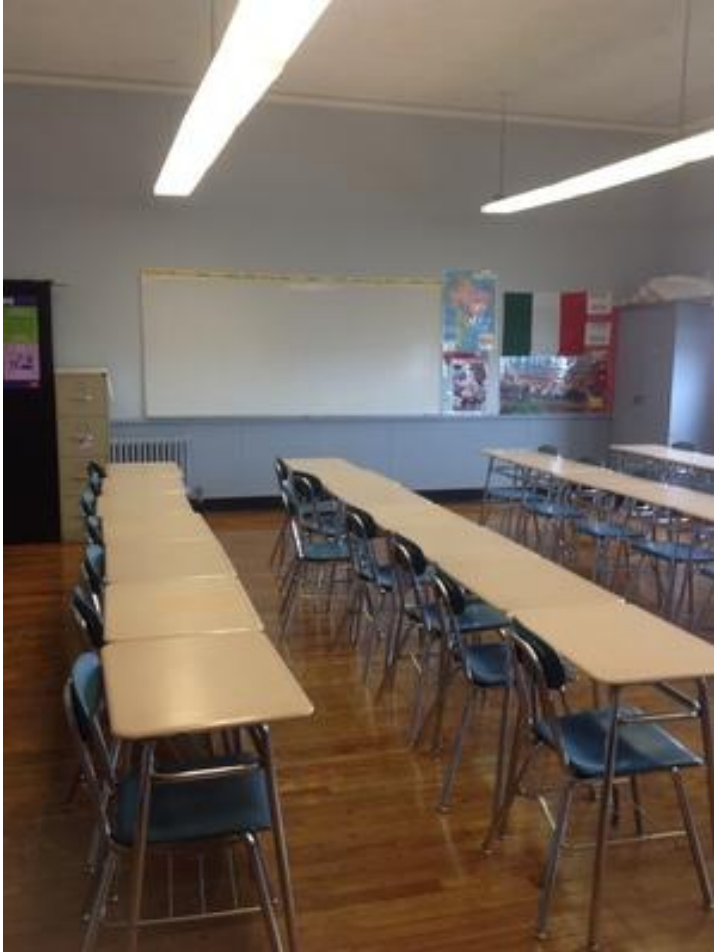
Attached Images for ID KJ-00059

Description
Wood flooring in good condition but creaky. Paint is chipping on walls and ceiling. Light fixtures missing covers in some locations. 10'x20' area of 12"x12" VCT on ceiling. Surface mounted equipment and wiring is haphazard. Shades are in poor condition. Millwork in poor condition. Unit heater in poor condition. Some windows have lost their seal. Classroom has smartboard.

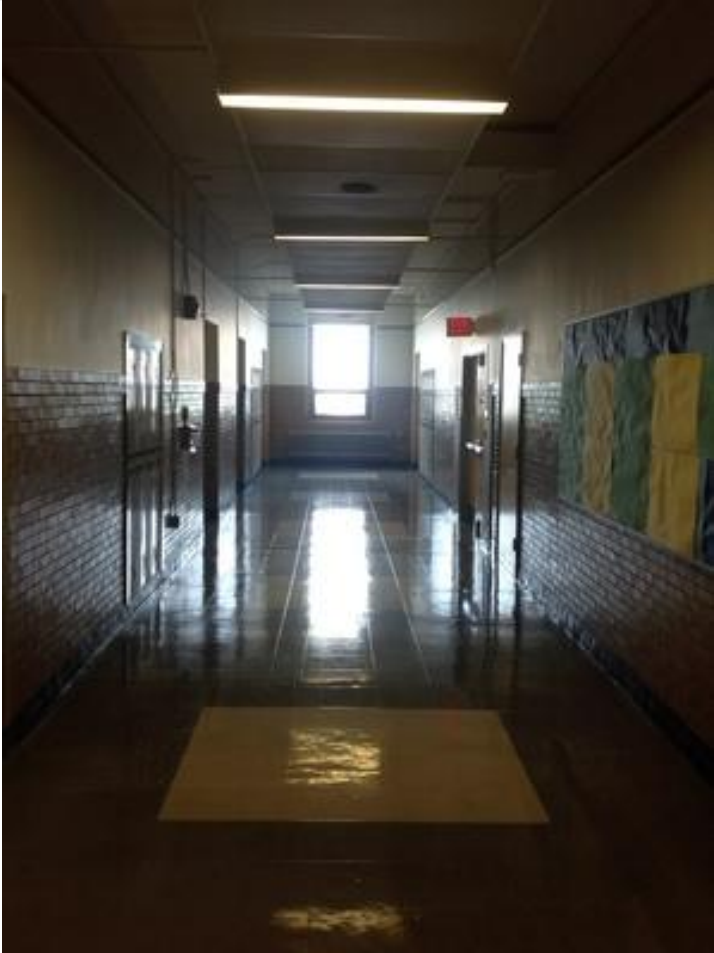
Attached Images for ID KJ-00062

Double loaded corridor with recessed lockers. Glazed and unglazed brick with plaster above in fair condition. Partial 2x4 ACT ceiling and grid centered in corridor open to plaster ceiling above. Piping/ductwork exposed around ACT ceiling. Surface mounted ceiling fixtures. Wall base in fair condition.

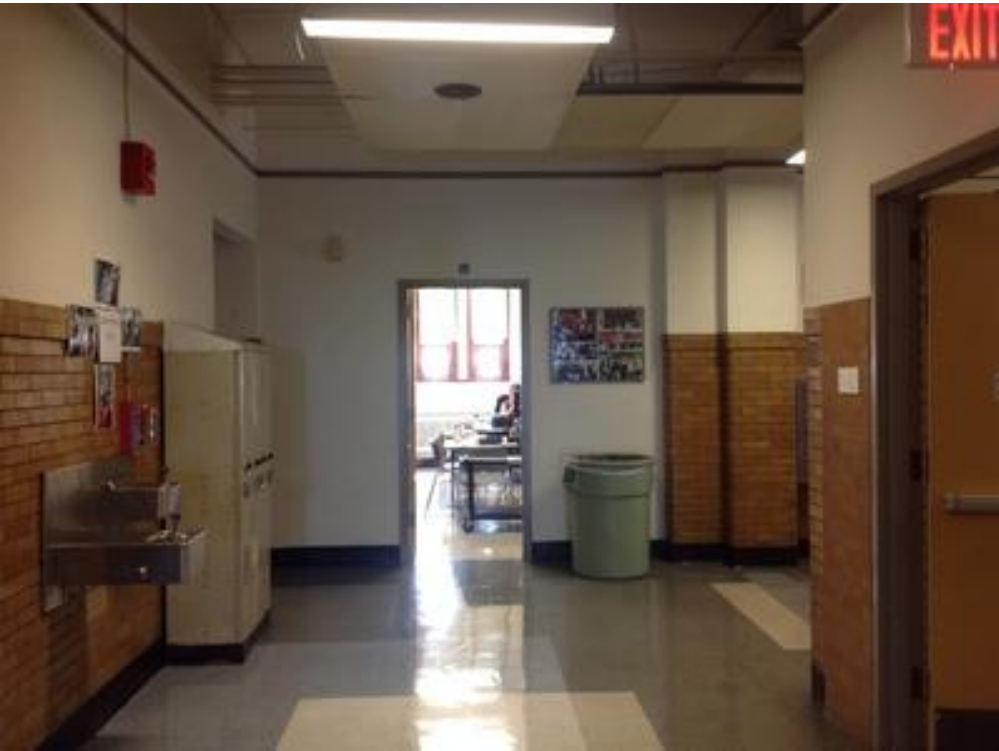
| Attached Images for ID KJ-00070 | | | |

| Description Double loaded corridor with recessed lockers. Glazed and unglazed brick with plaster above in fair condition. Partial 2x4 ACT ceiling and grid centered in corridor open to plaster ceiling above. Piping/ductwork exposed around ACT ceiling. Surface mounted ceiling fixtures. Wall base in fair condition. | | | |

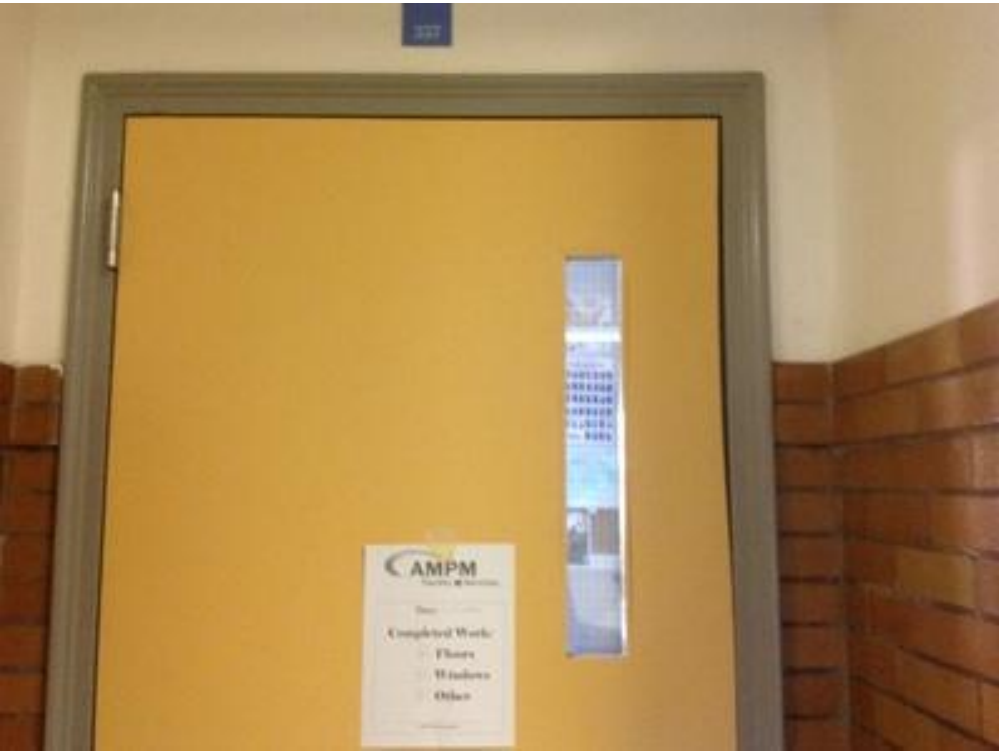
| Attached Images for ID KJ-00071 | | | |

| Description Wood flooring in good condition but creaky. Paint is chipping on walls and ceiling. 10'x20' area of 12"x12" VCT on ceiling. Surface mounted equipment and wiring is haphazard. Shades are in poor condition. Millwork in poor condition. Unit heater in poor condition. Some windows have lost their seal. Classroom has smartboard. | | | |

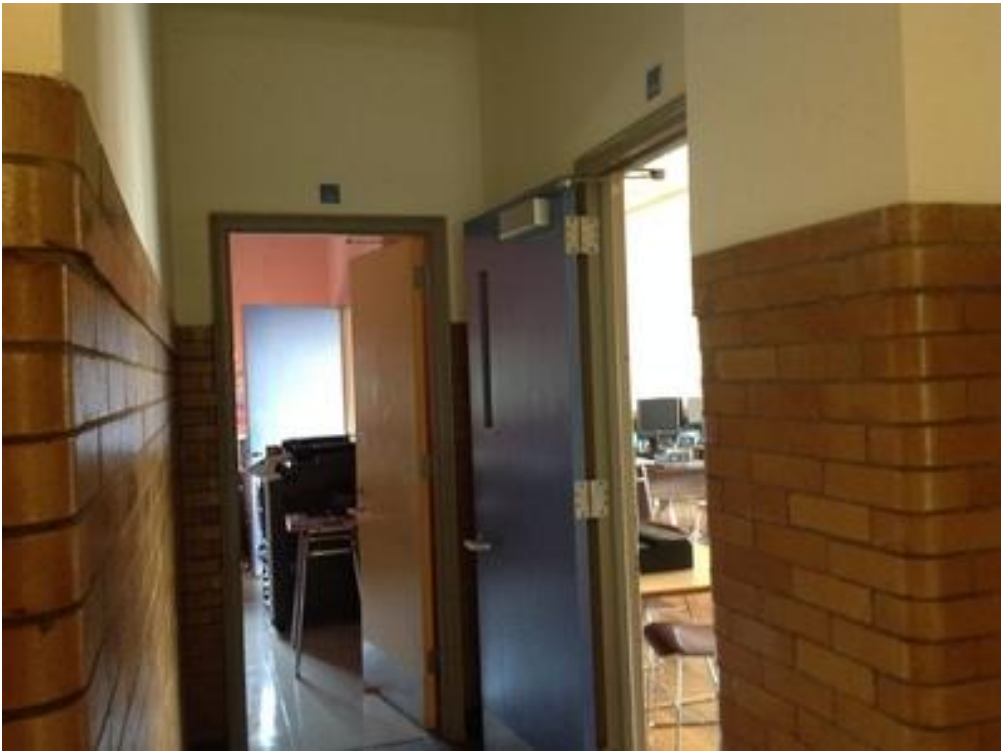
| Attached Images for ID KJ-00072 | | | |

| Description VCT flooring in fair condition. Paint has chipping and cracking. Teacher workroom in fair condition. Entry to space is not accessible. | | | |
