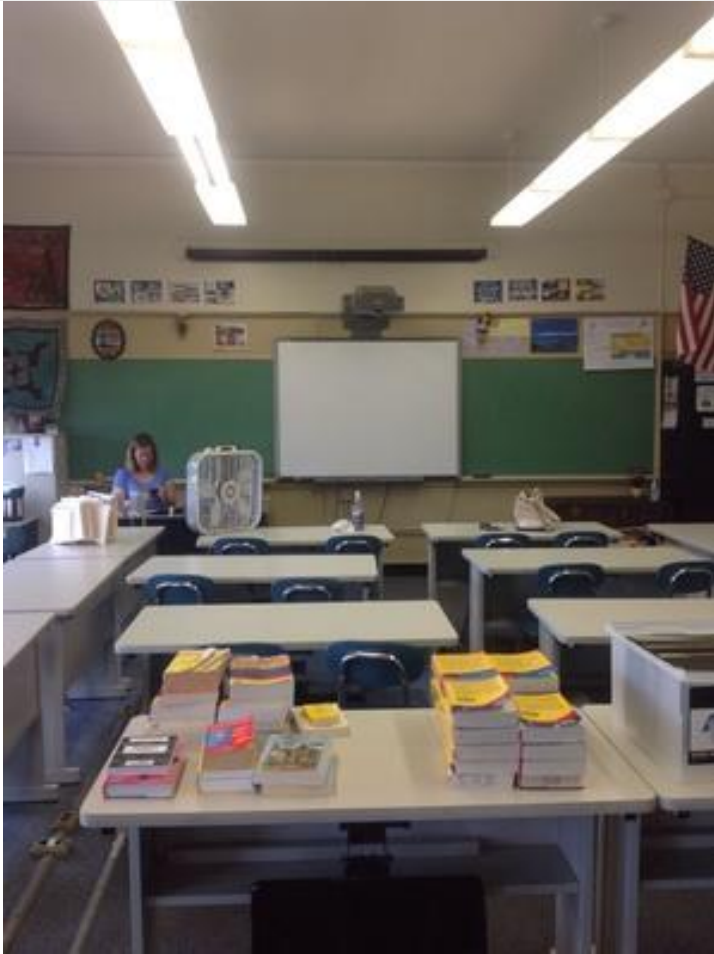
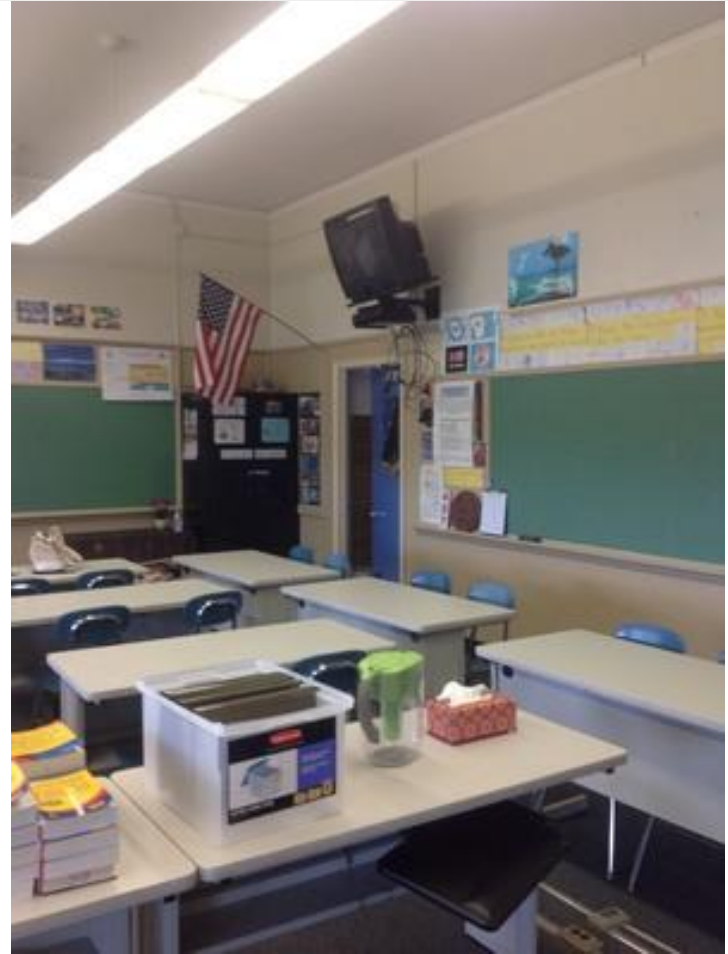
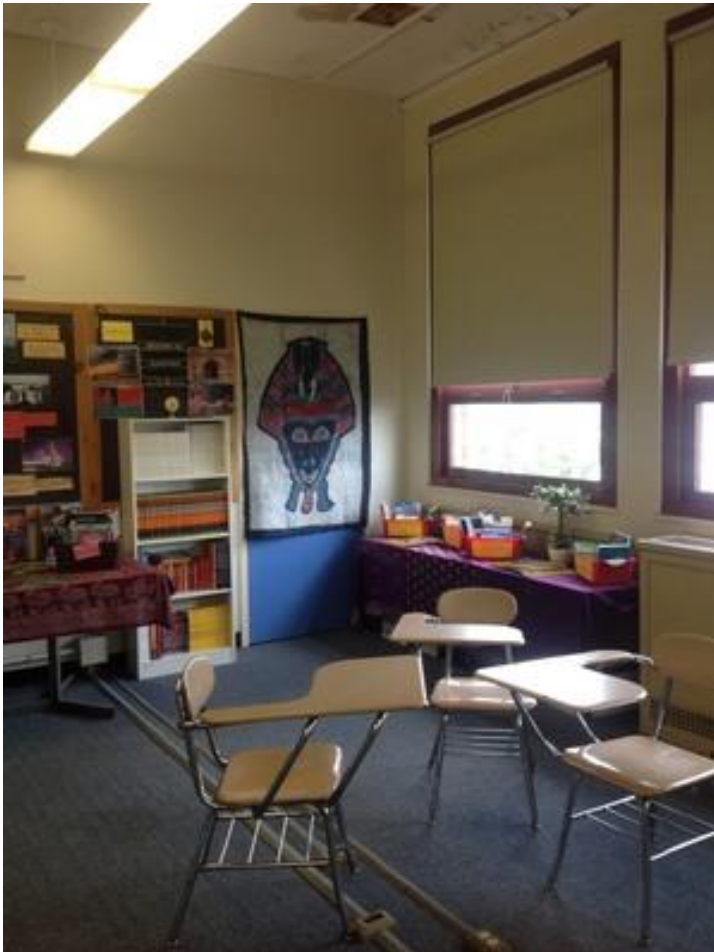
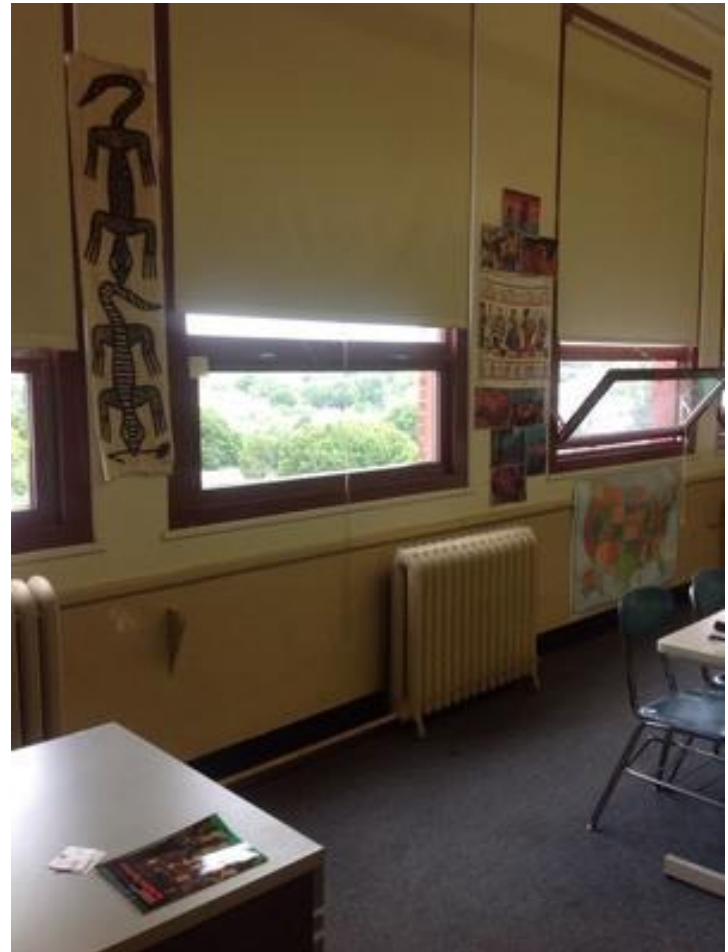
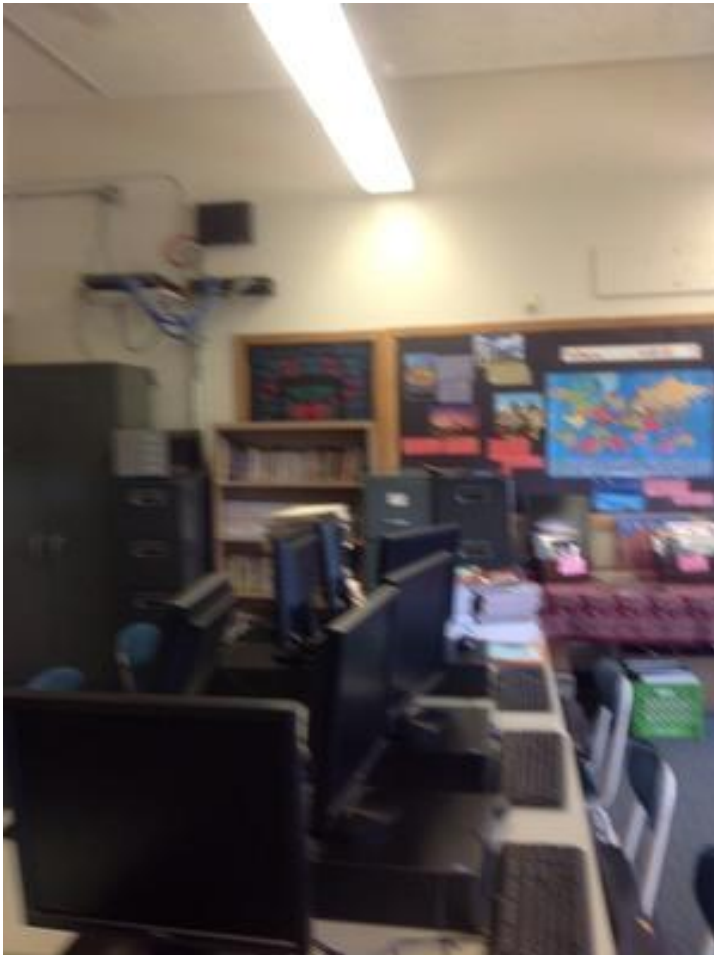
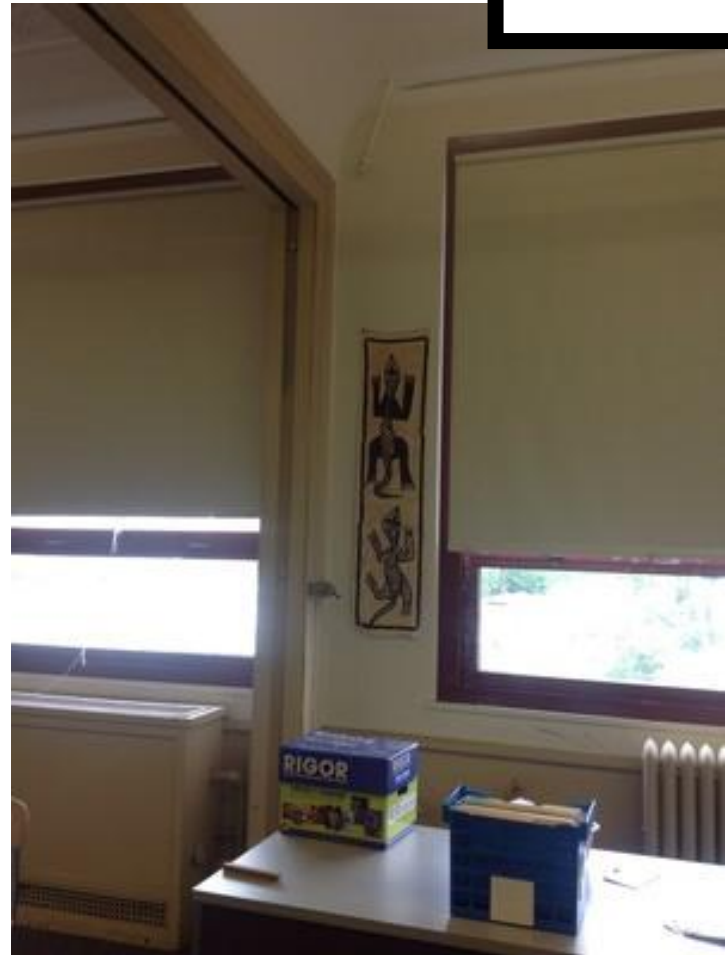
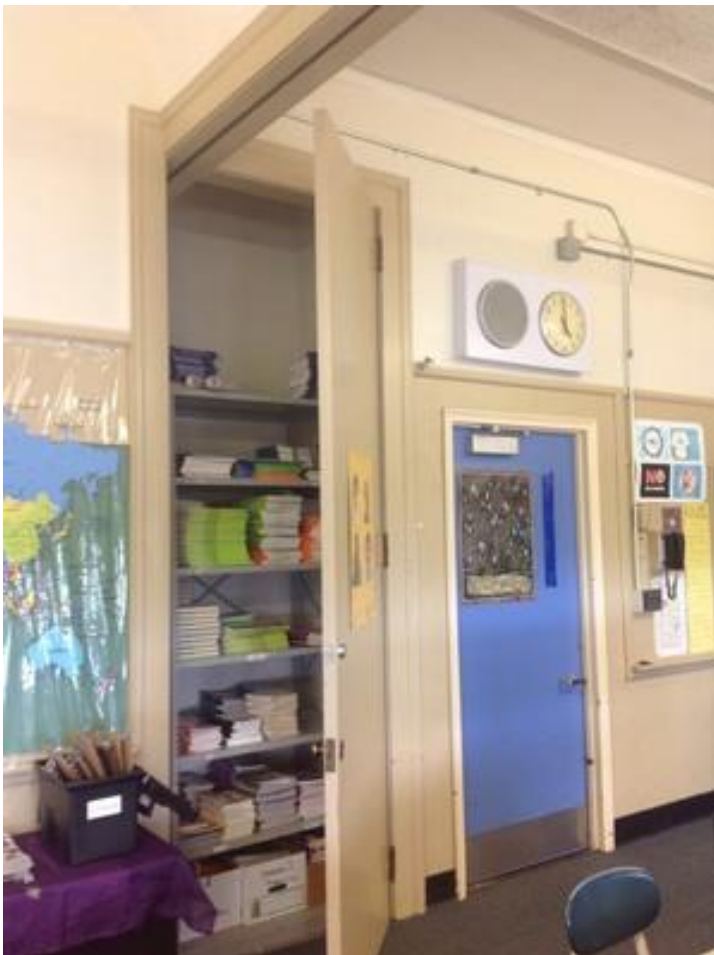
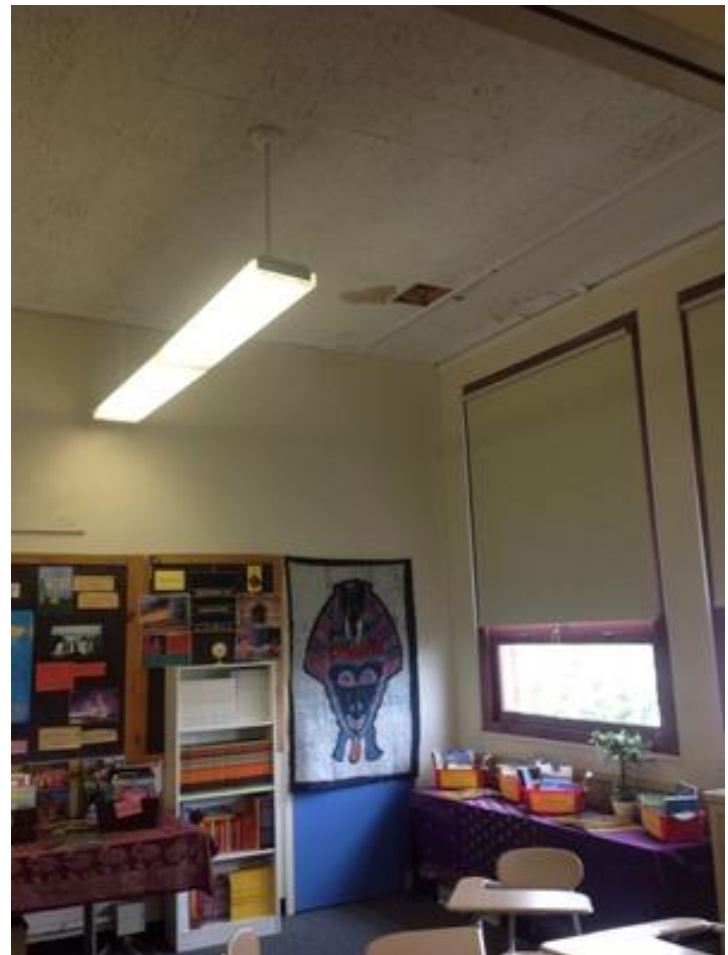
Attached Images for ID KJ-00015

Description
Paint is chipping on walls, ceiling, and moulding. Lighting is poor and covers are missing from fixtures. Partial area of acoustic ceiling but less than half of space. Smart board in corner of room. Wiring is haphazardly placed. Floor boxes against code. Room divider track remains. Broken window.

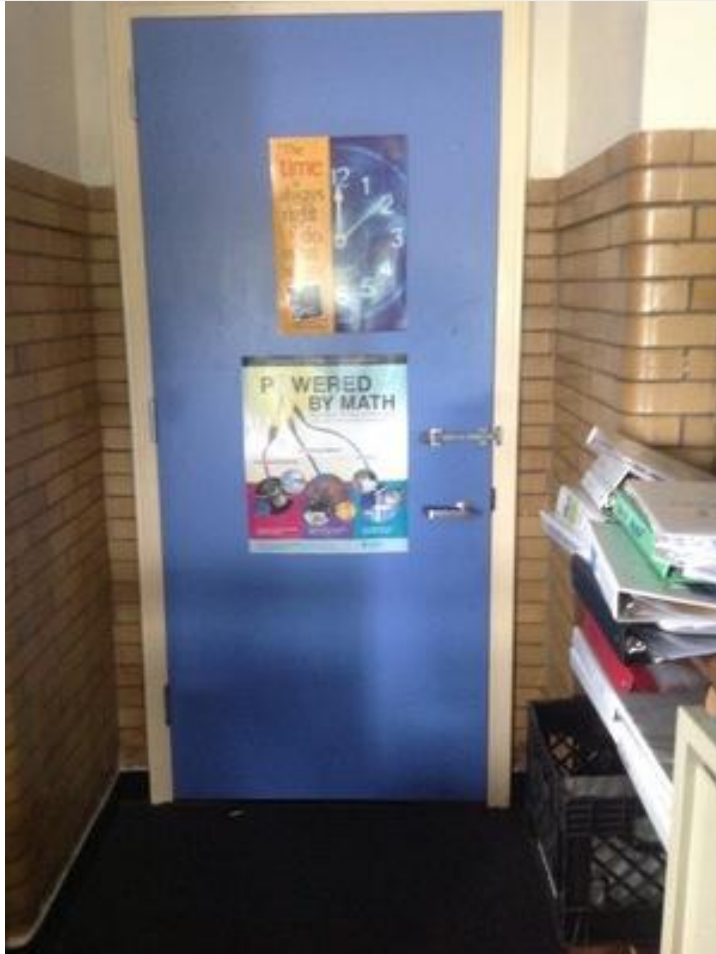
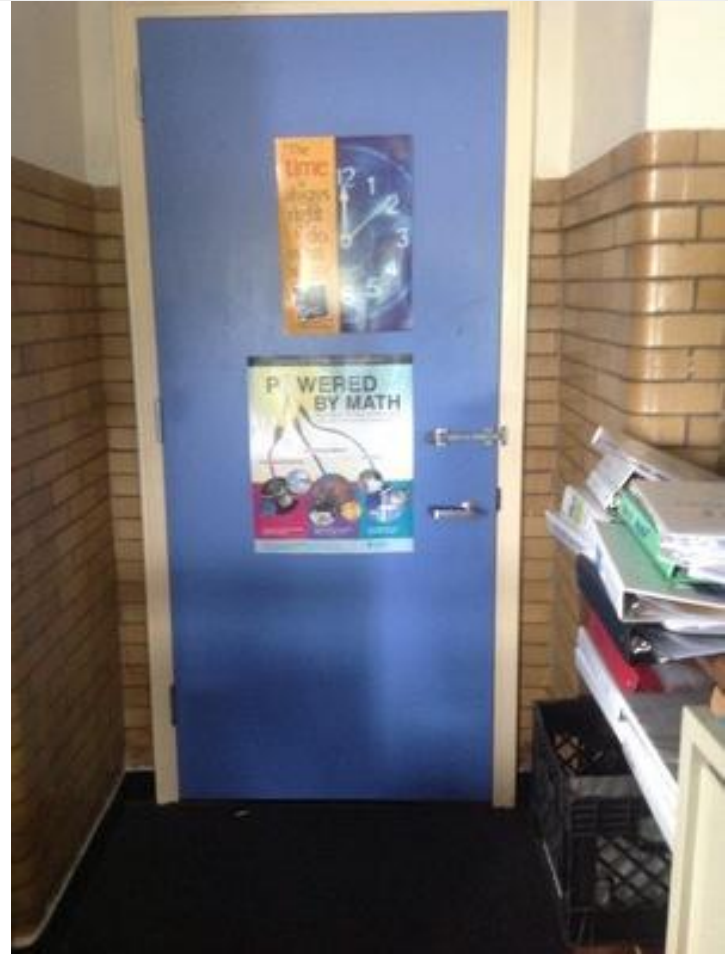
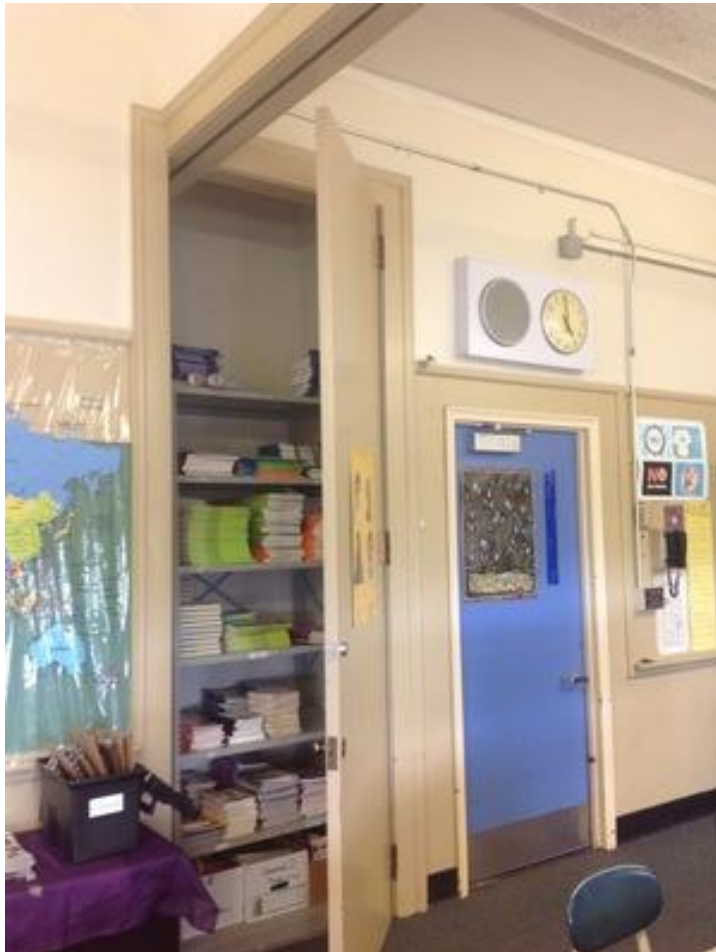
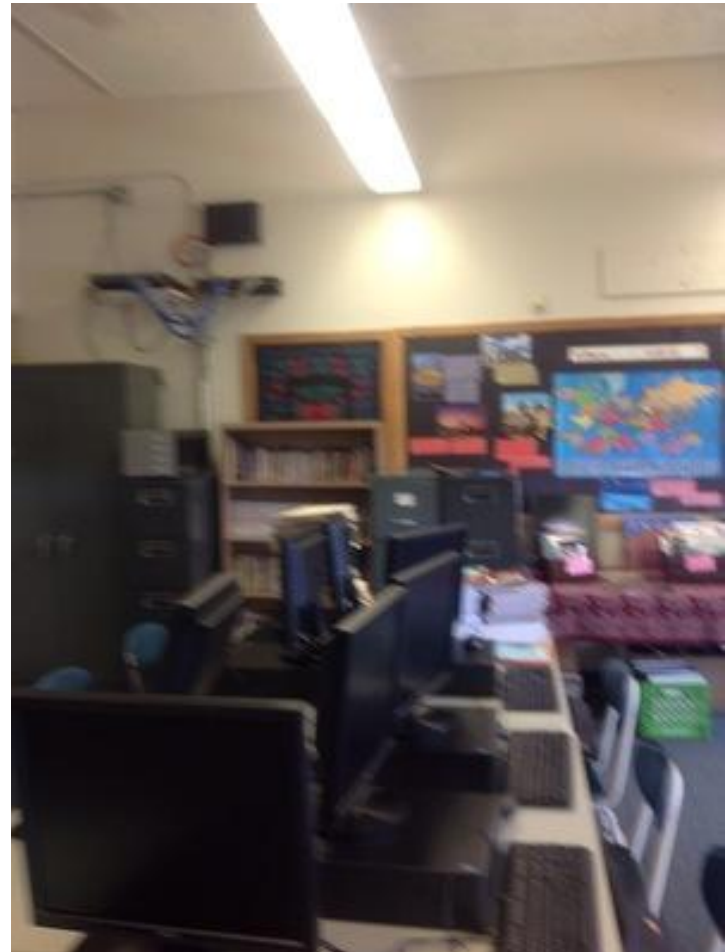
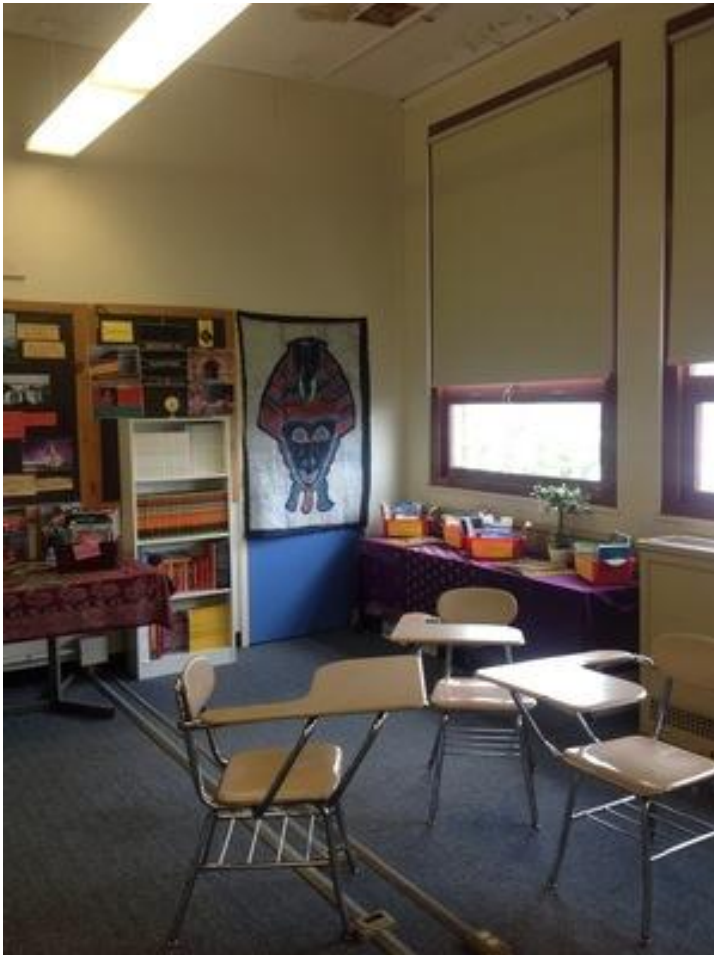
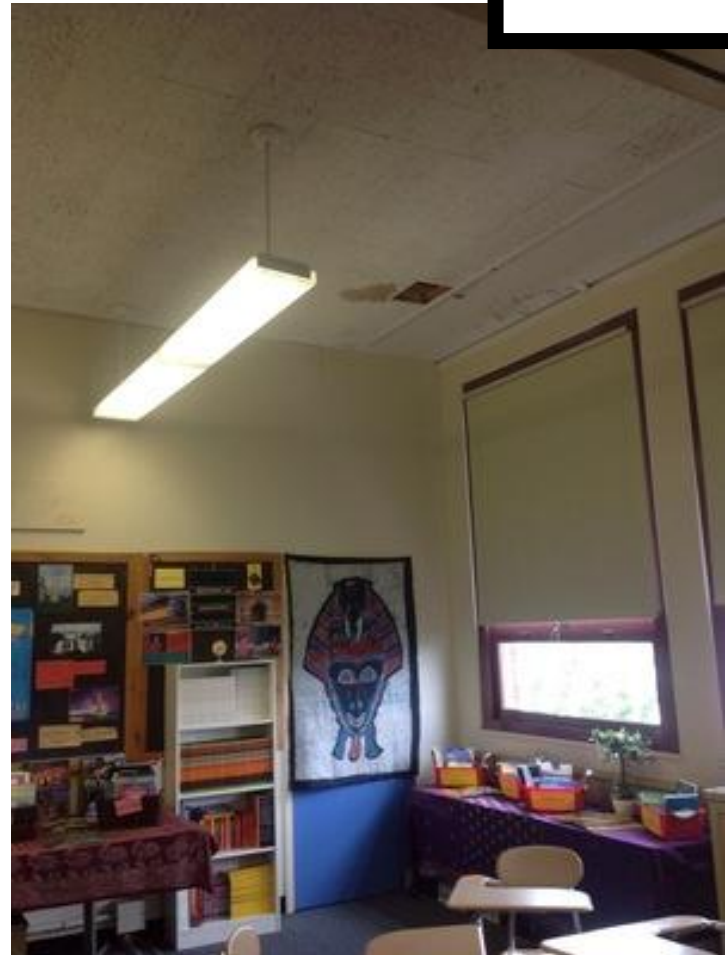
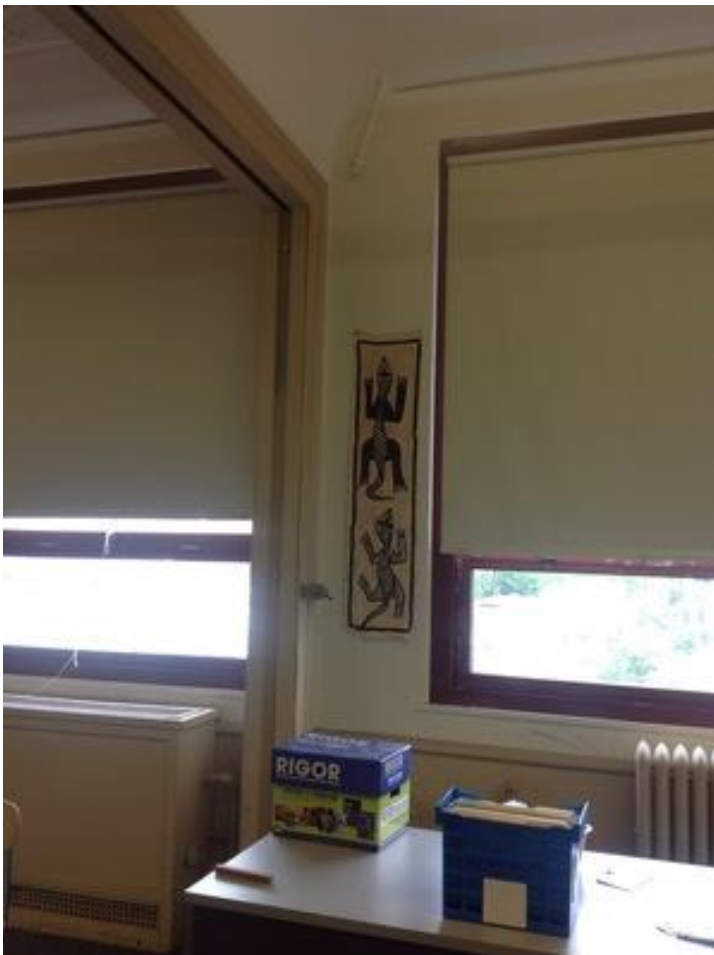
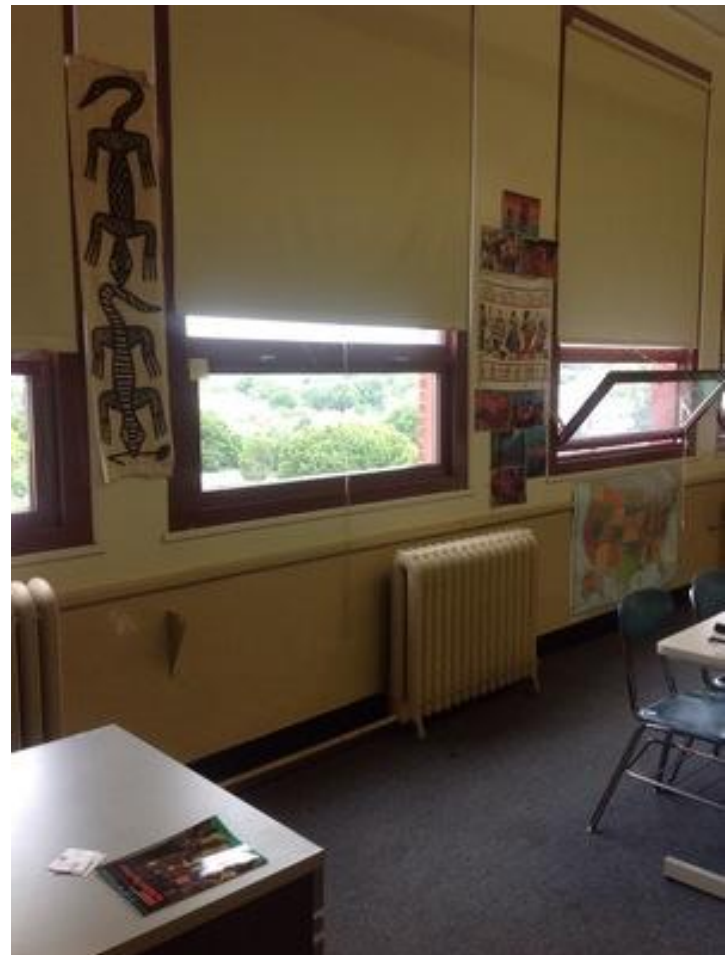
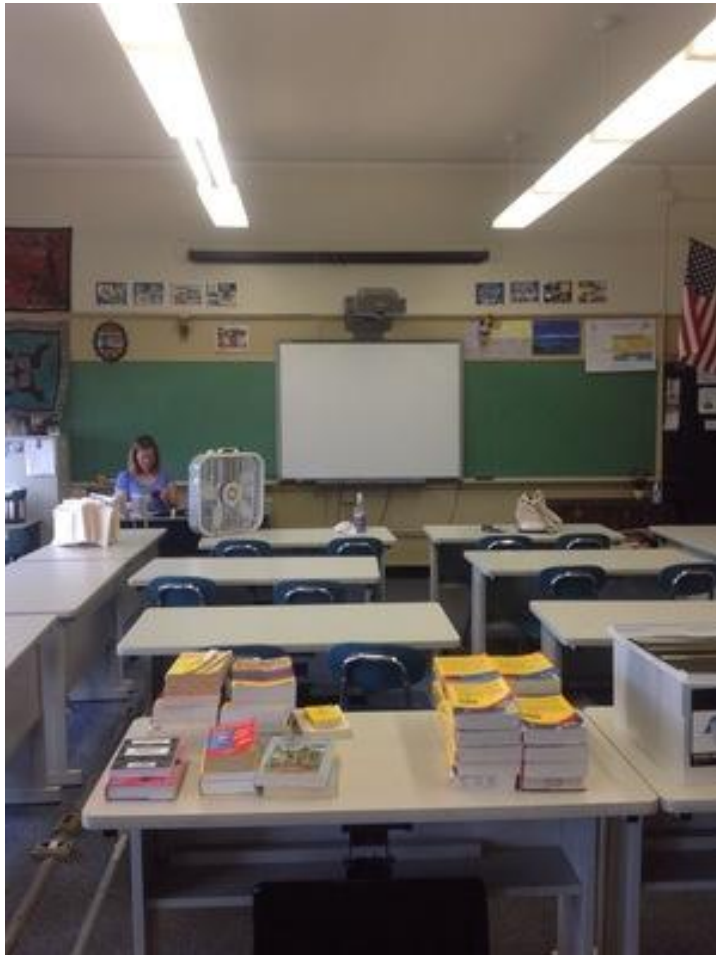
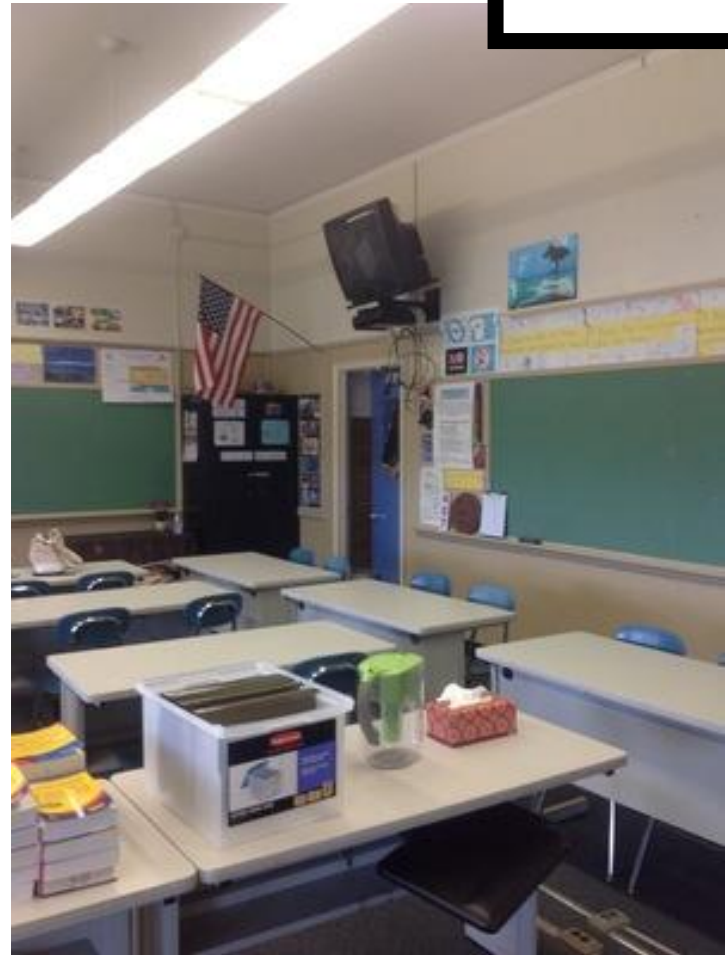
Attached Images for ID KJ-00024

Description
Carpet is in poor condition. Paint is chipping on walls and ceiling. Light fixtures missing covers in some locations. 10'x20' area of 12"x12" VCT on ceiling. Surface mounted equipment and wiring is haphazard. Shades are in poor condition. Millwork in poor condition. Unit heater in poor condition. Classroom has smartboard. Floor boxes are a tripping hazard and not ADA compliant.

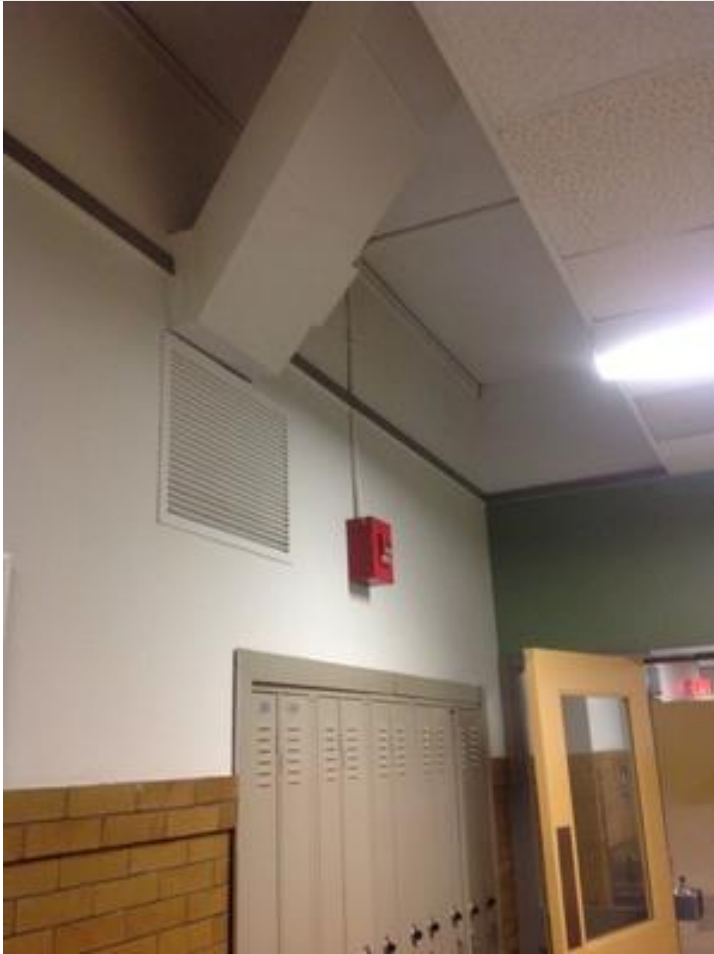
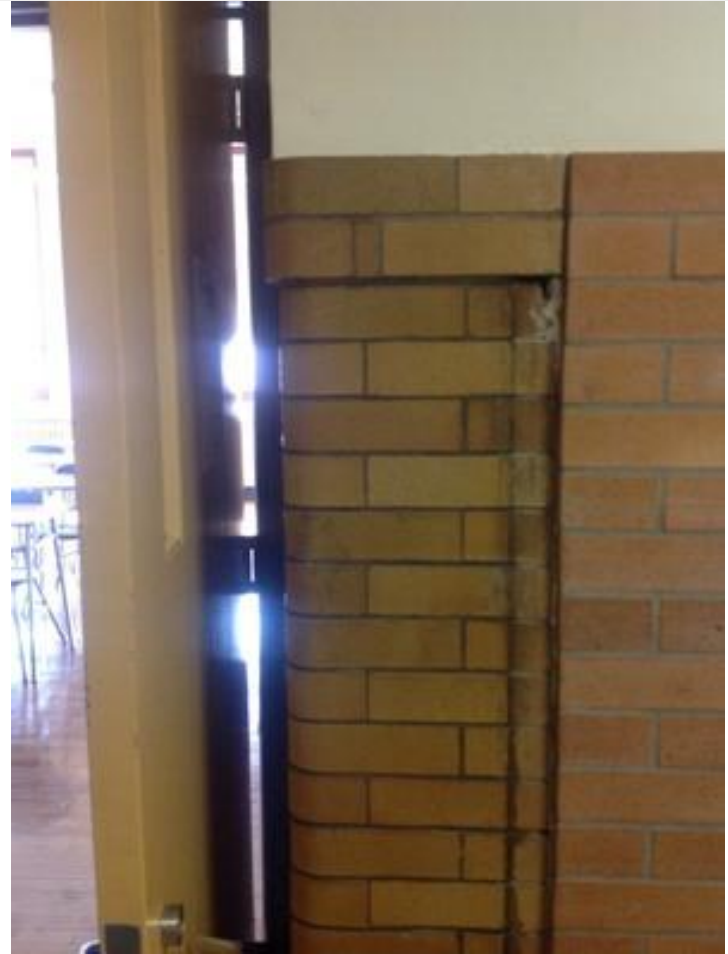
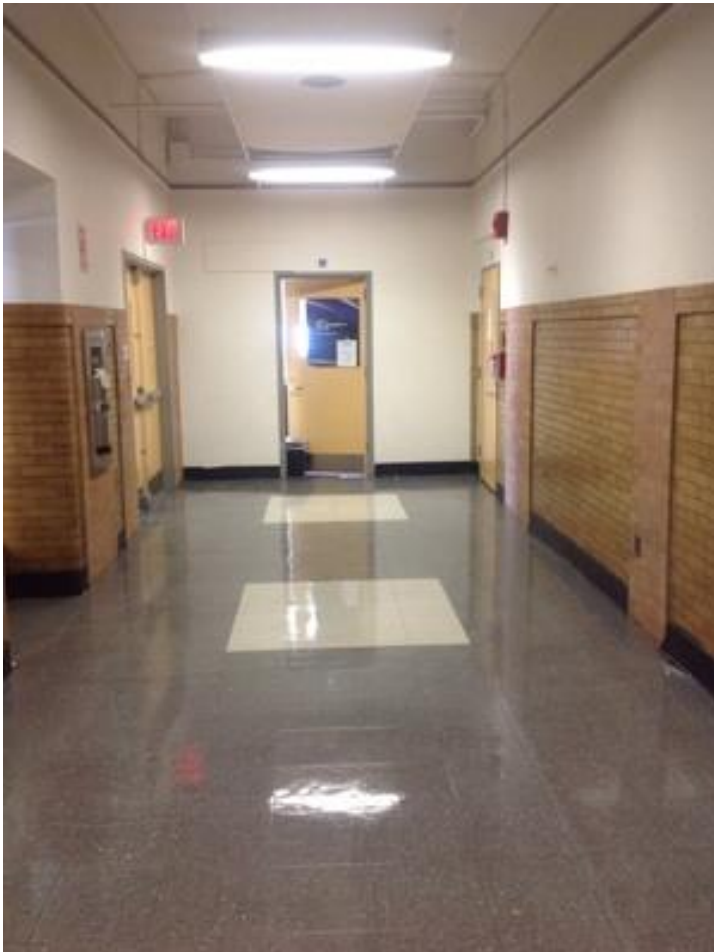
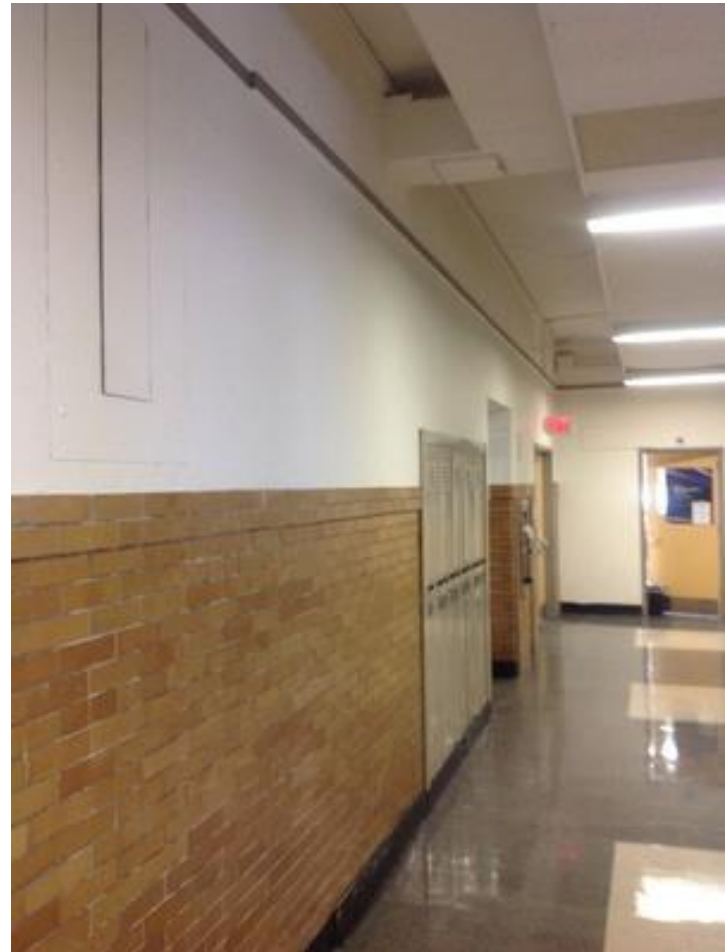
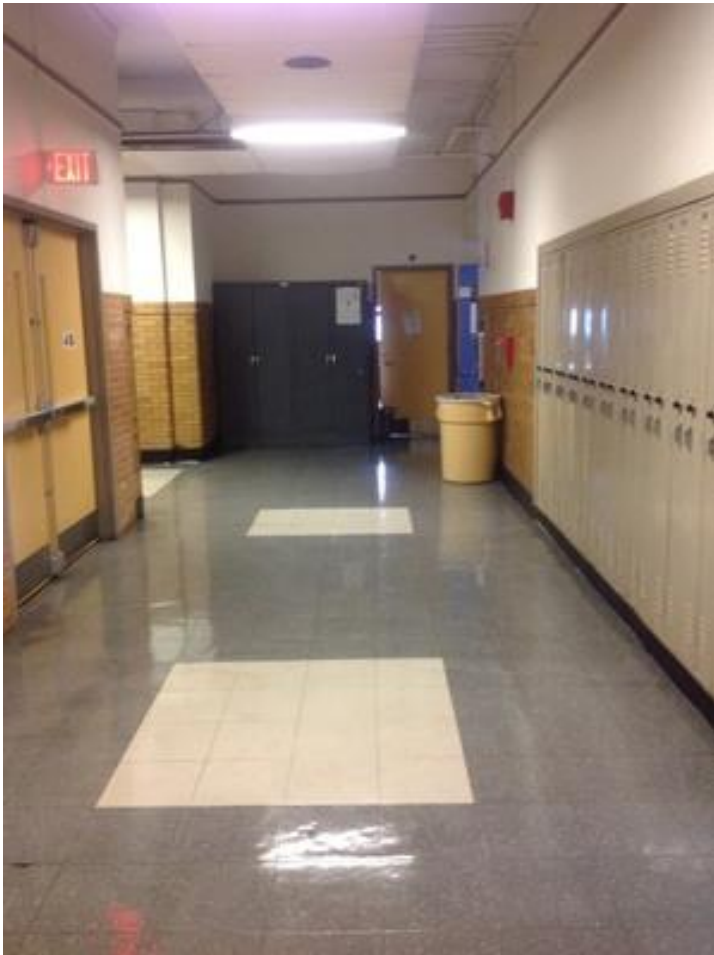
Attached Images for ID KJ-00017

Corridor has exposed piping and ductwork. 2x4 act in poor condition. Wiring is surface mounted. Doors not all accessible and some enter into corridor. Flooring in fair condition. Glazed tile. Wall base has some damage.

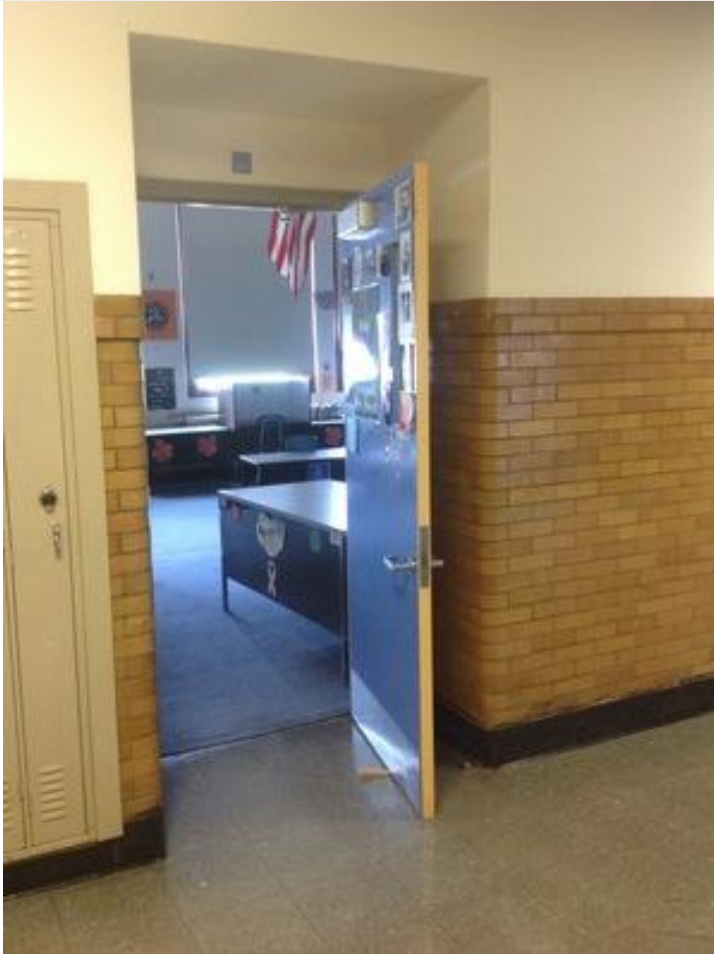
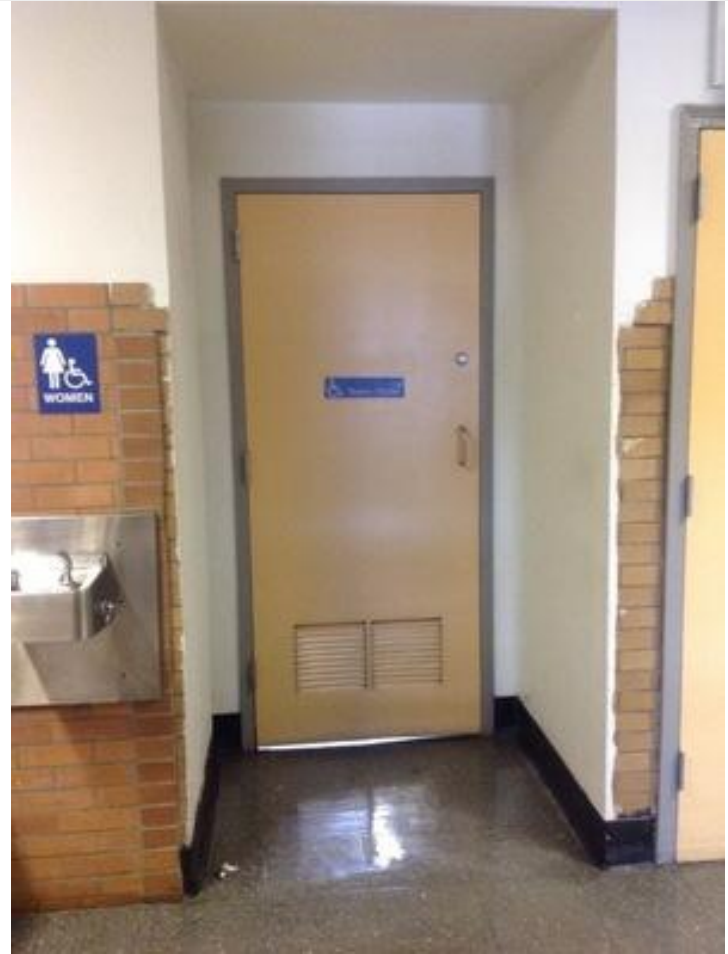
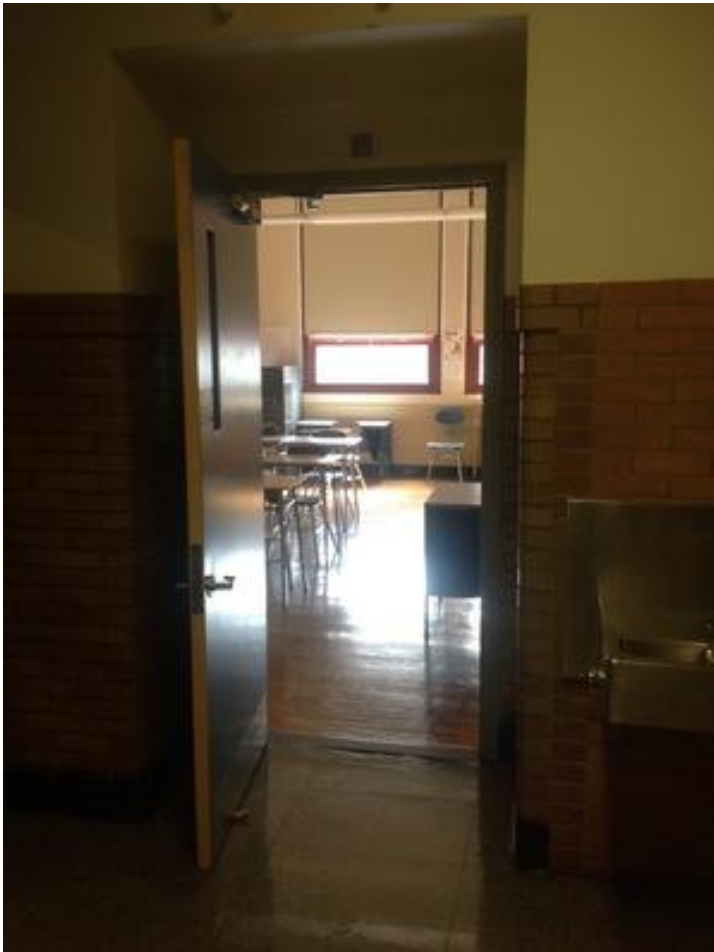
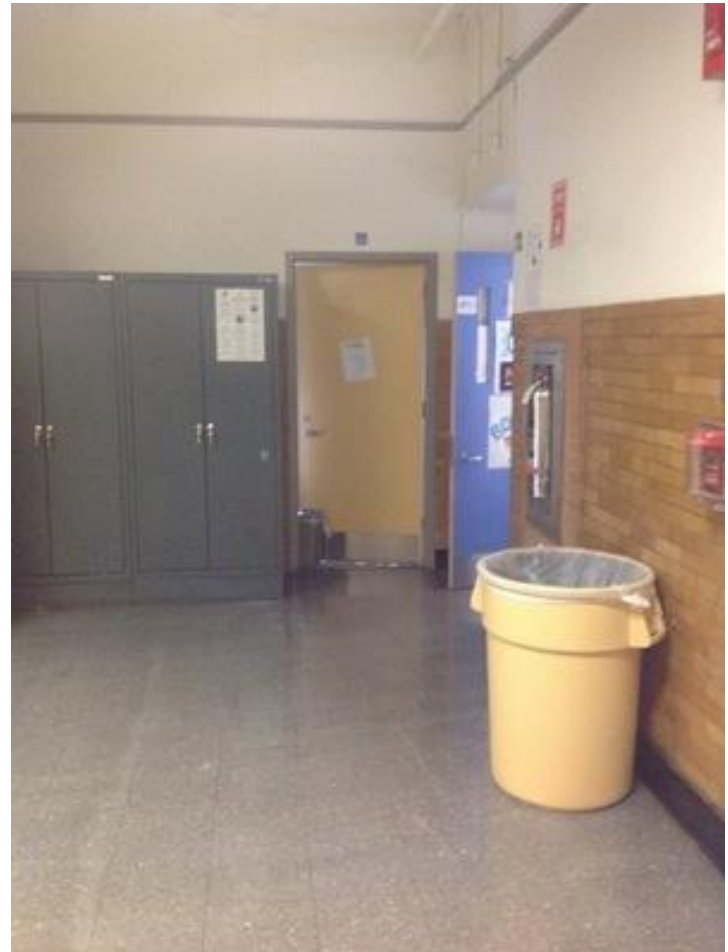
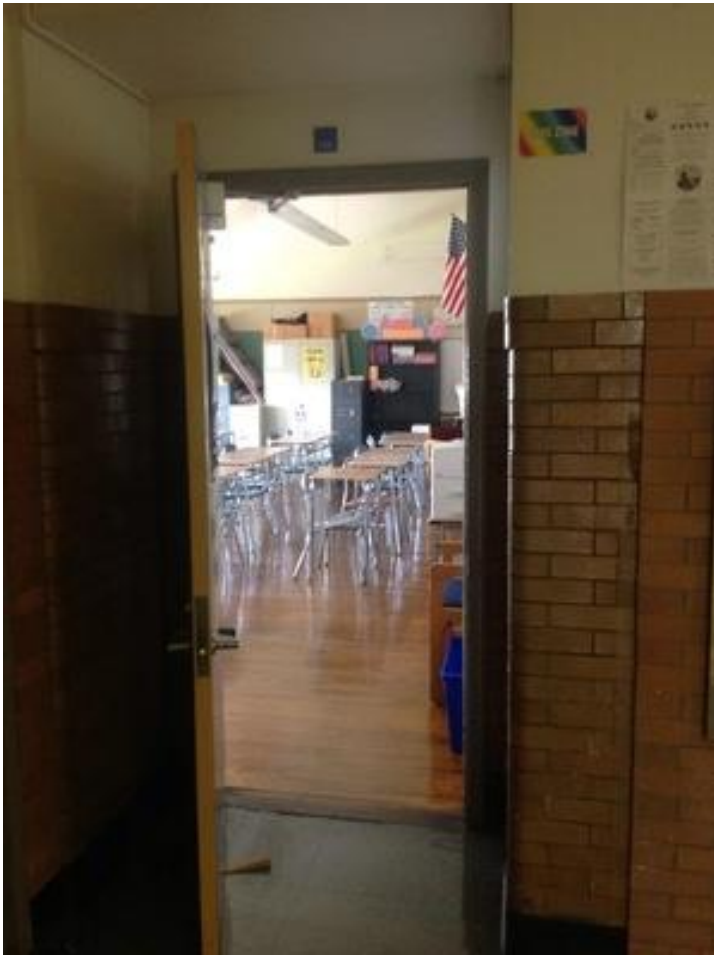
Attached Images for ID KJ-00022

Doors do not have proper push/pull for ADA compliance. Corridor is glazed and unglazed brick in fair condition.
