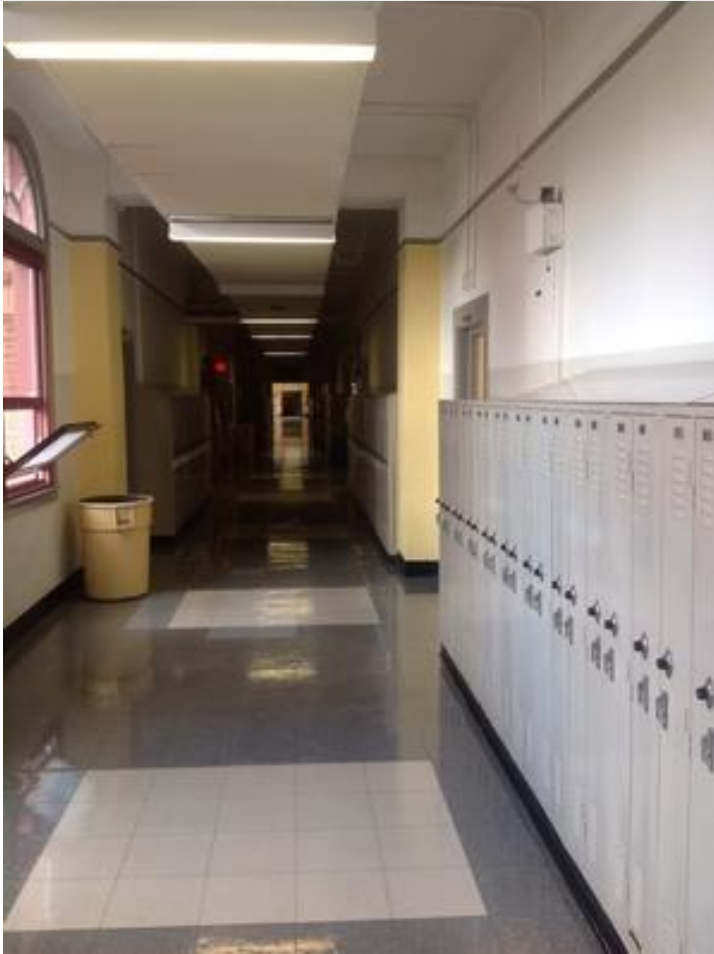
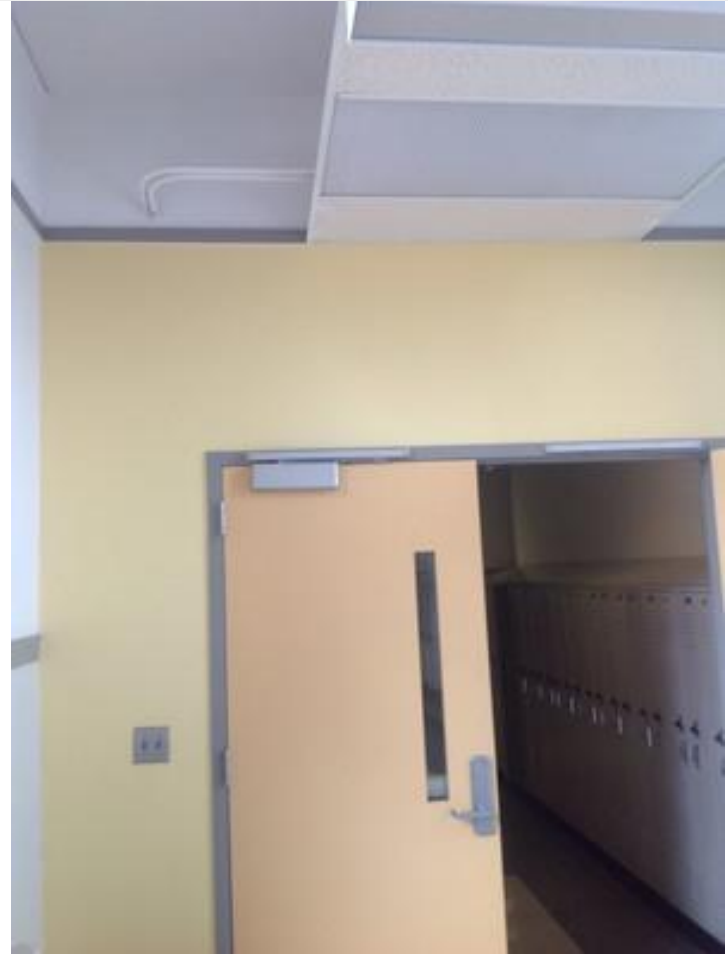
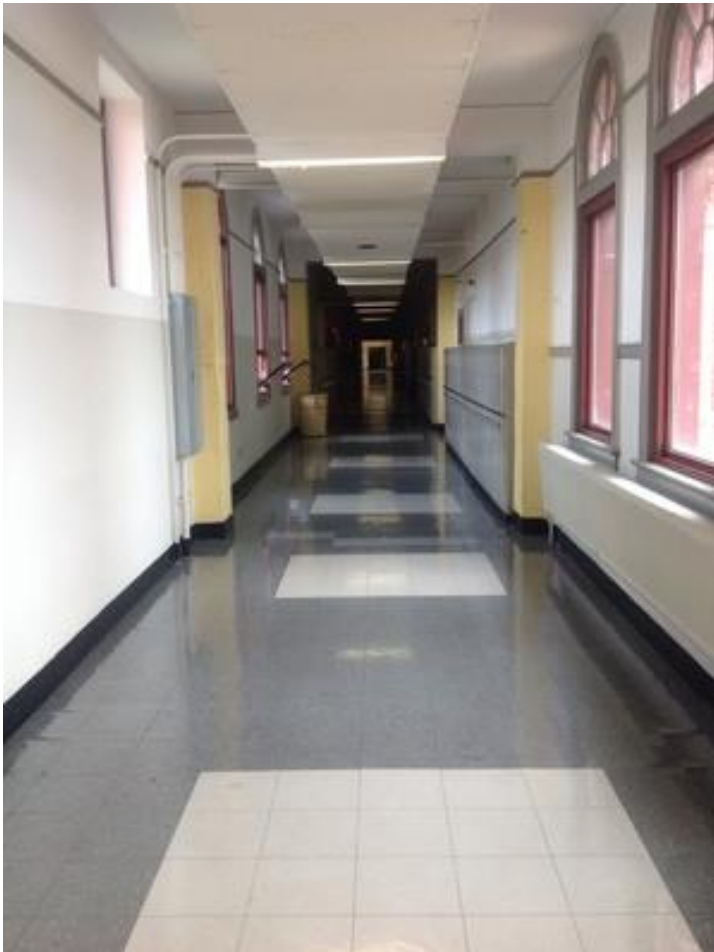
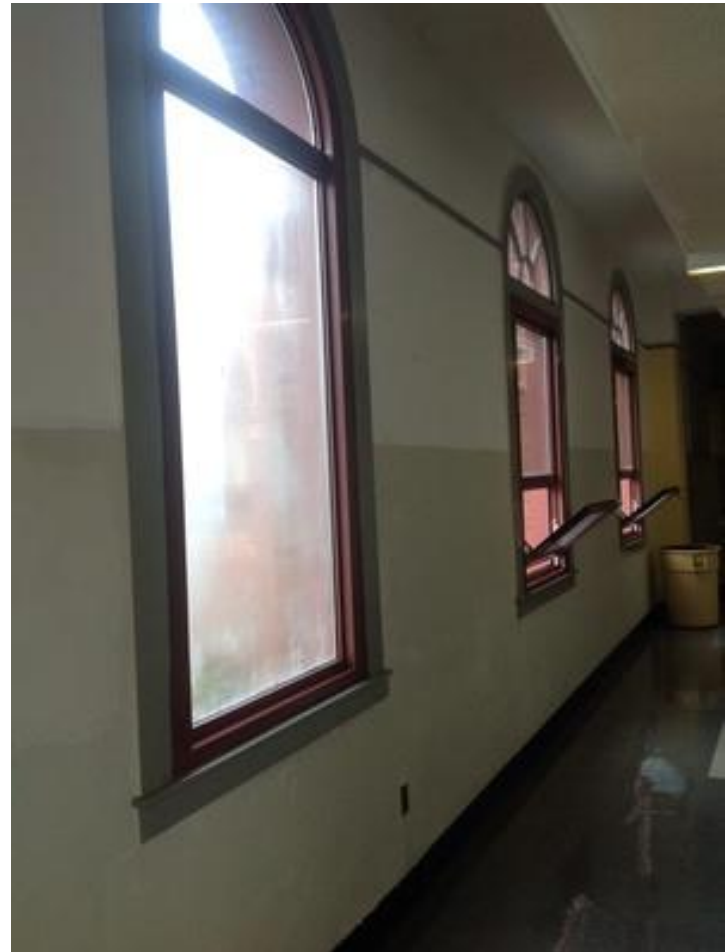
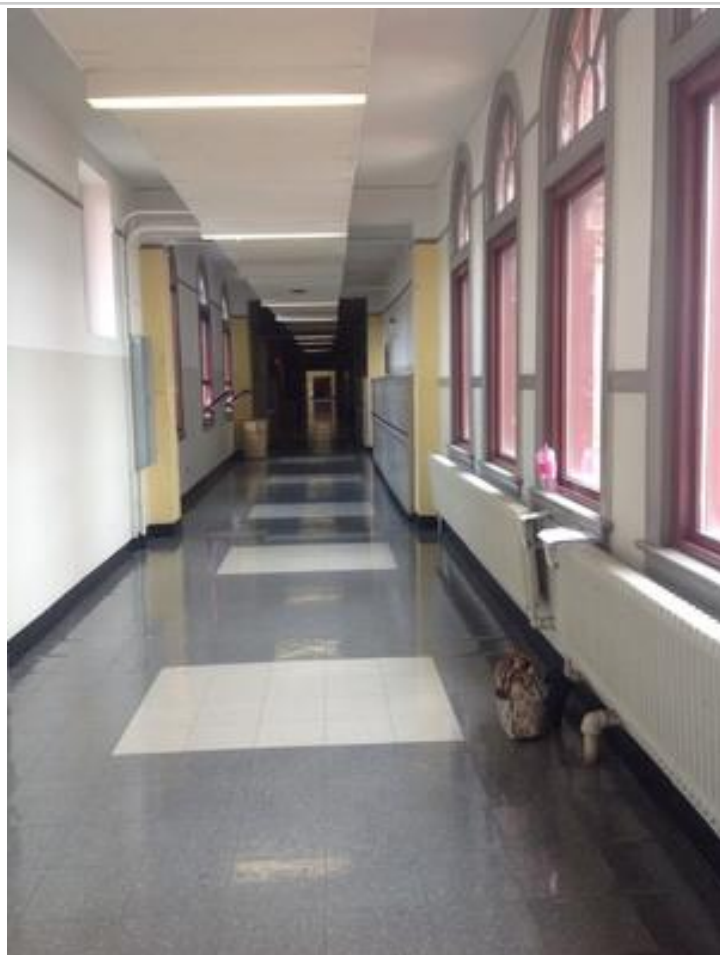
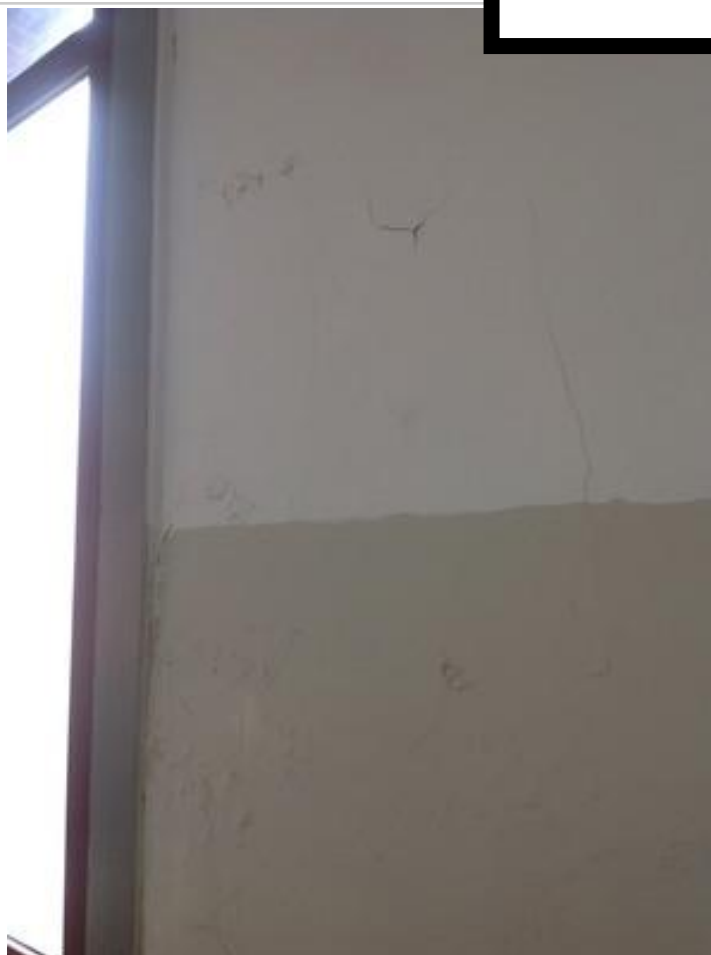
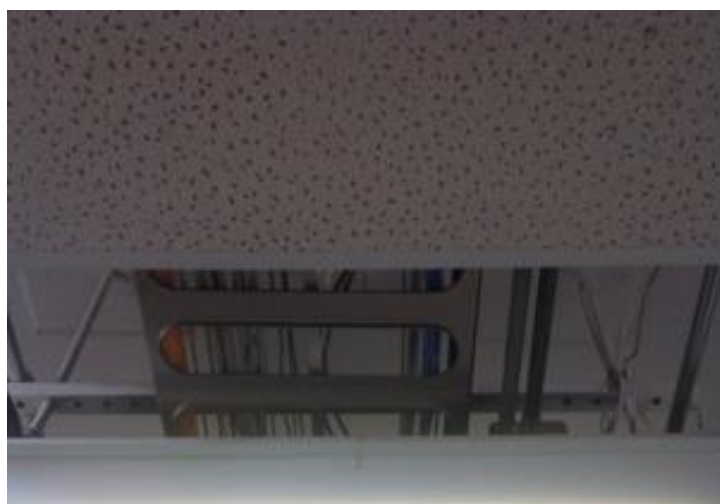
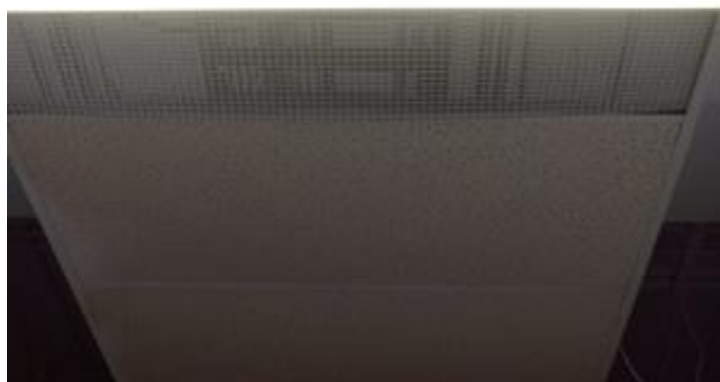
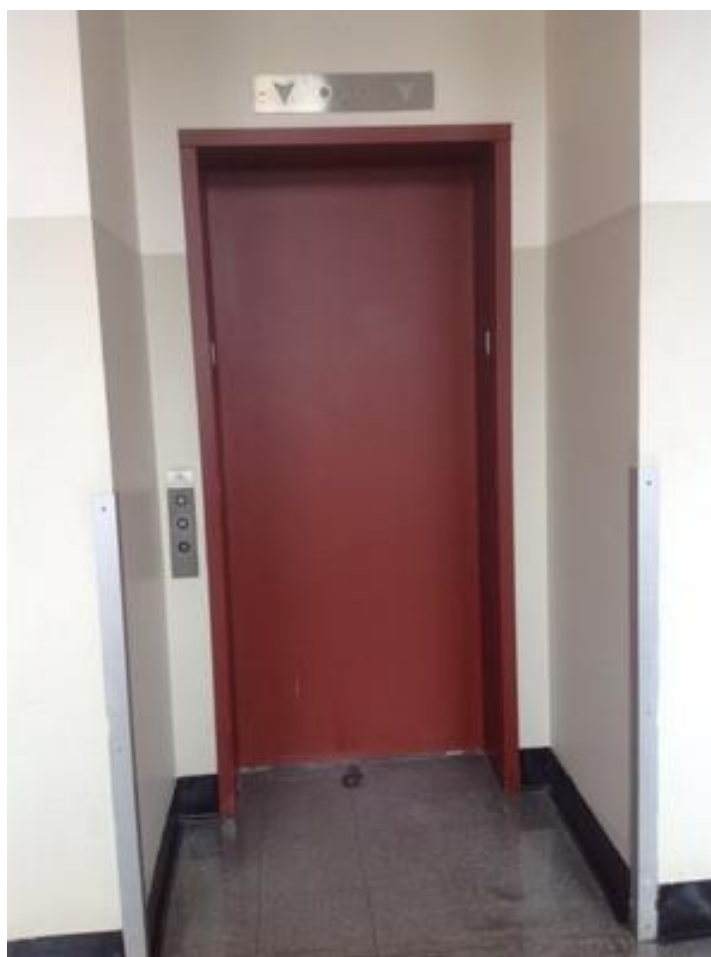
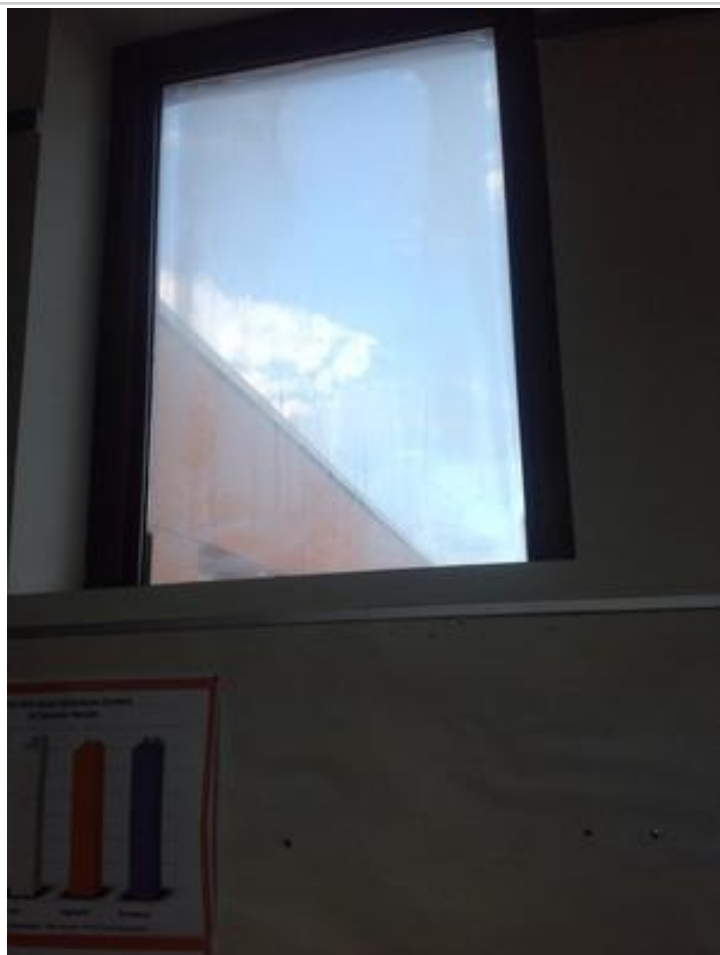
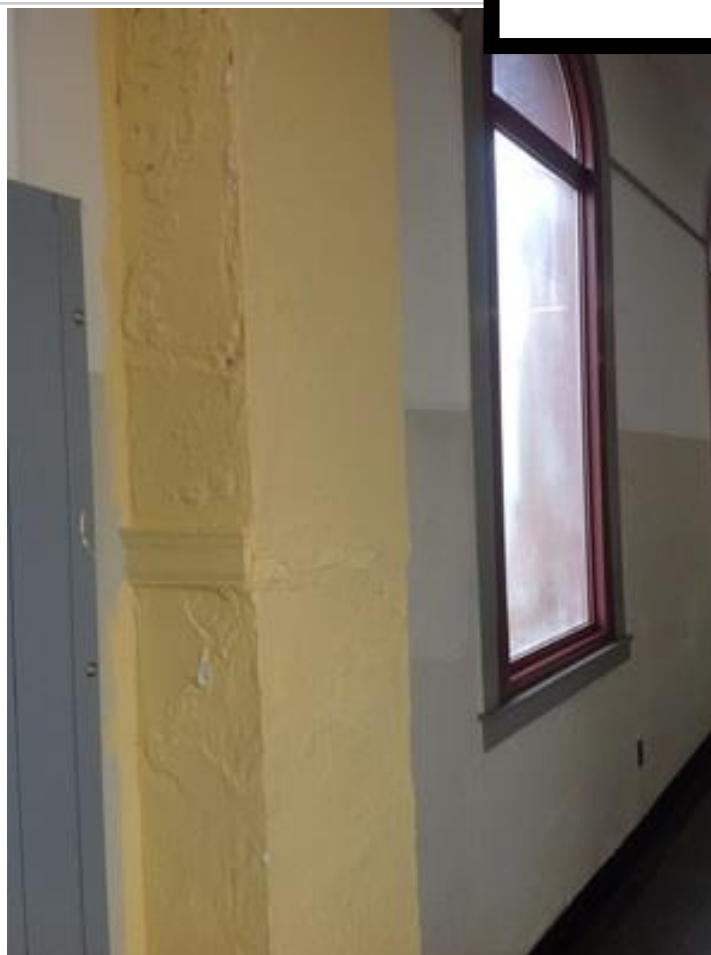
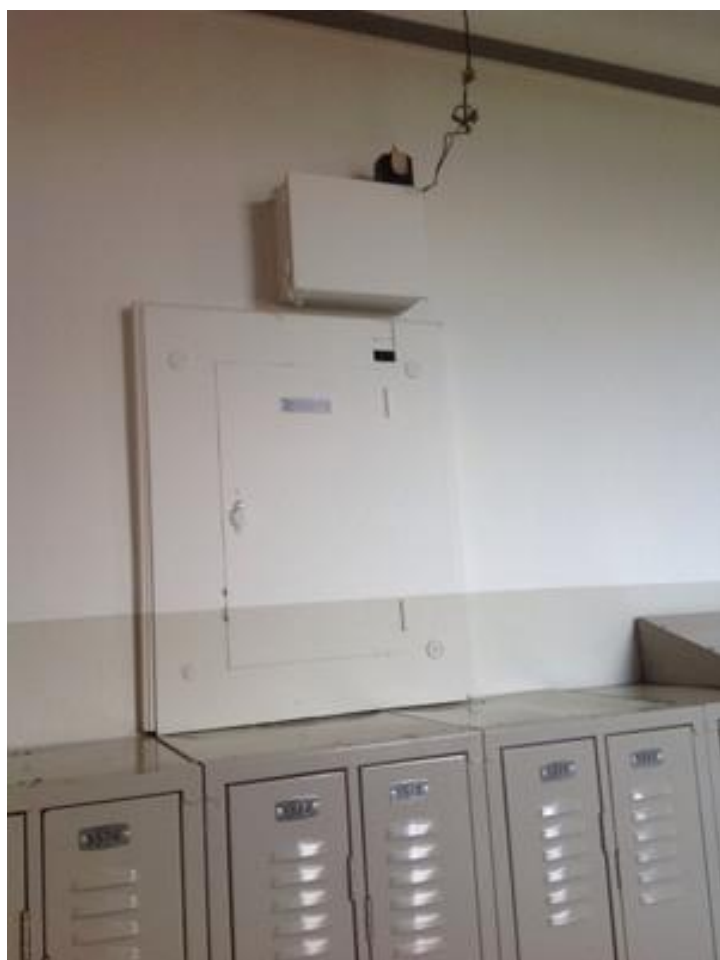
Attached Images for ID KJ-00018

Plaster walls poor. 2x4 ceiling poor. Windows show broken seals. Flooring in fair condition. Base shows damage.

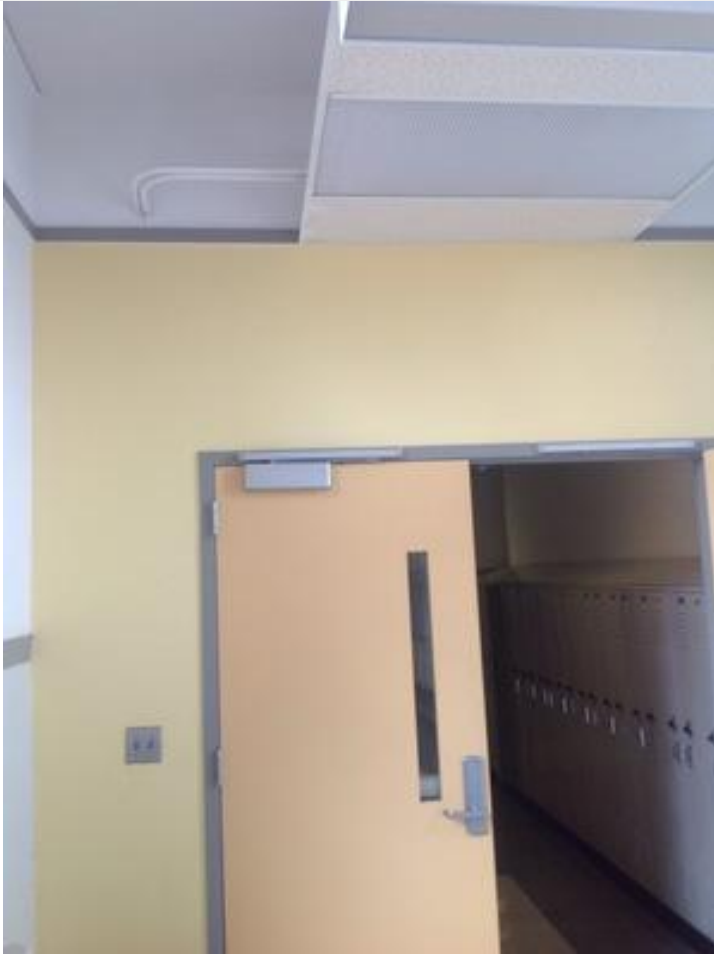
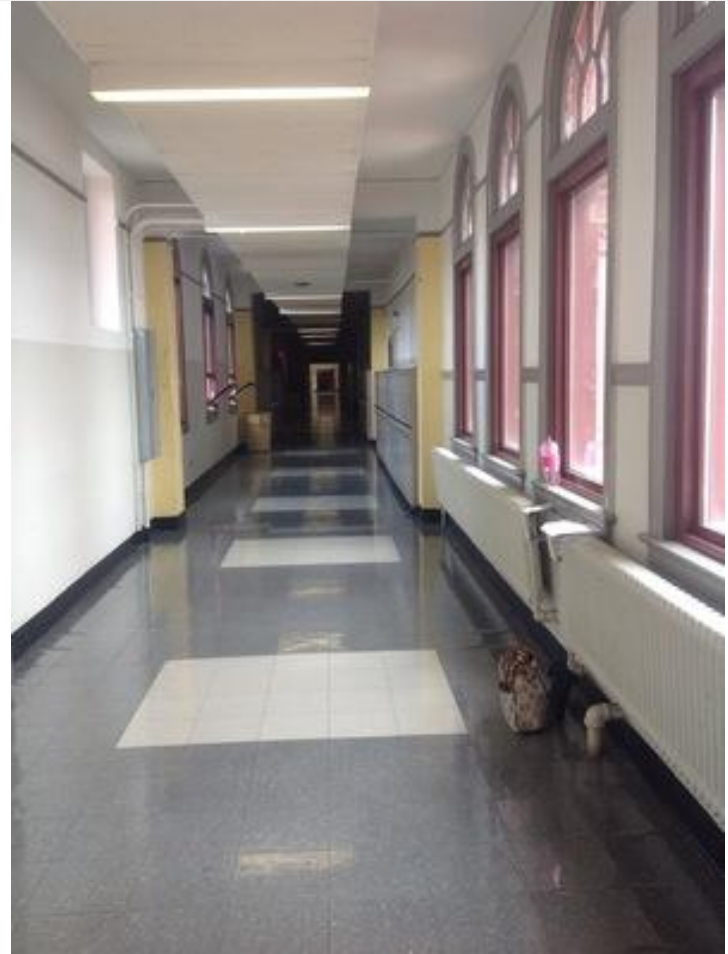
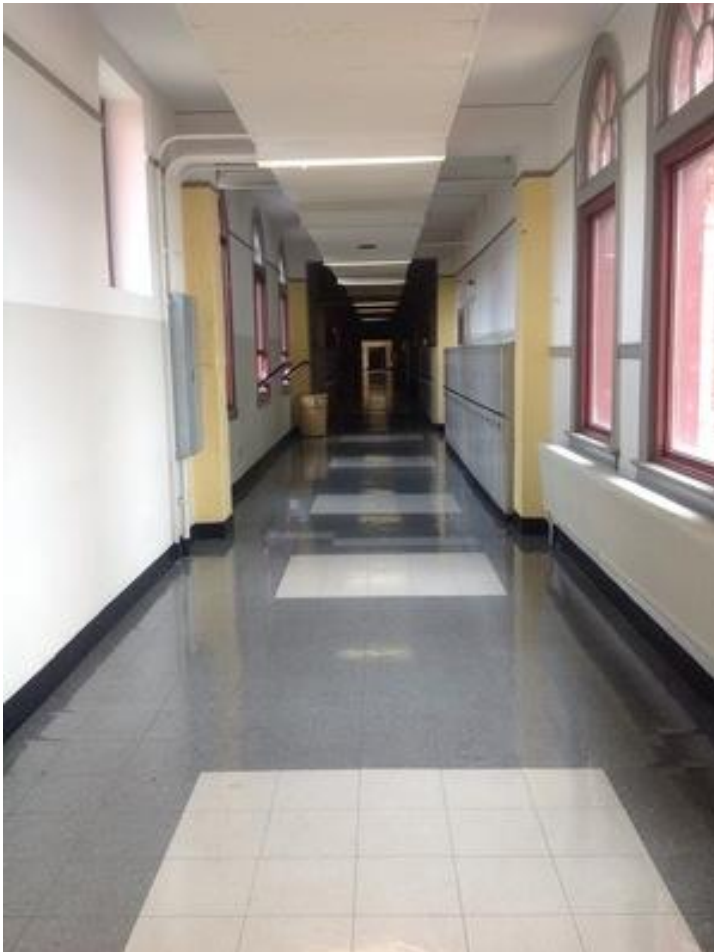
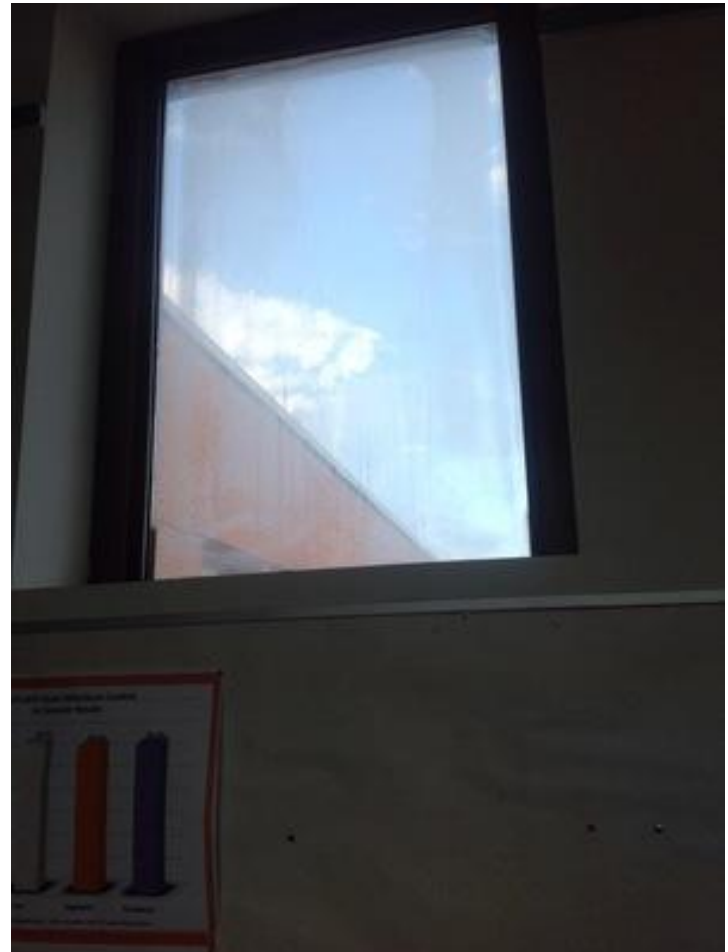
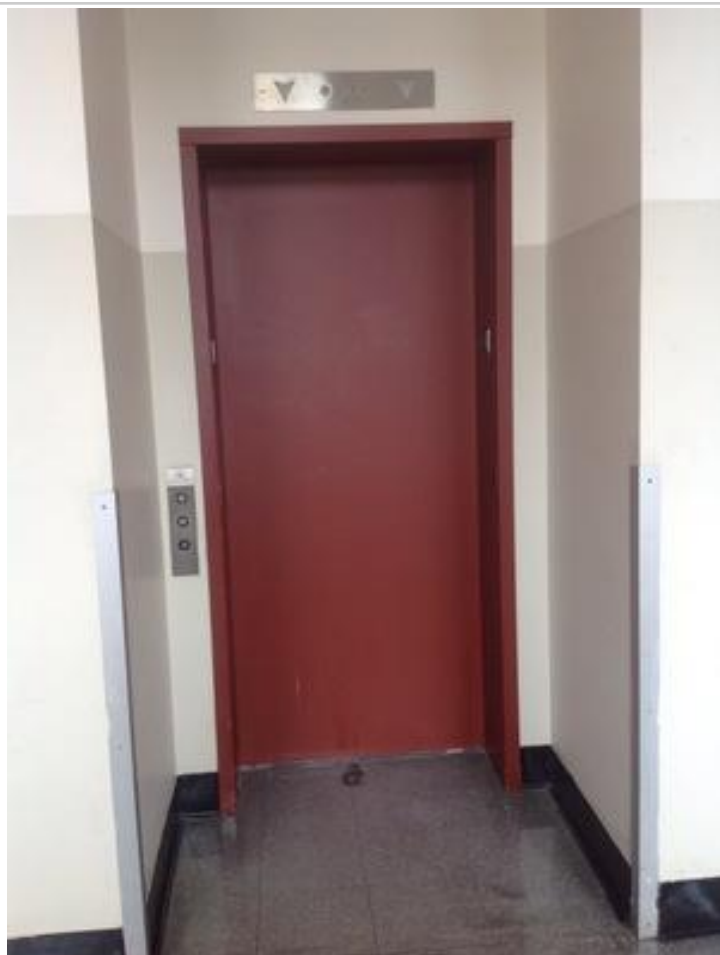
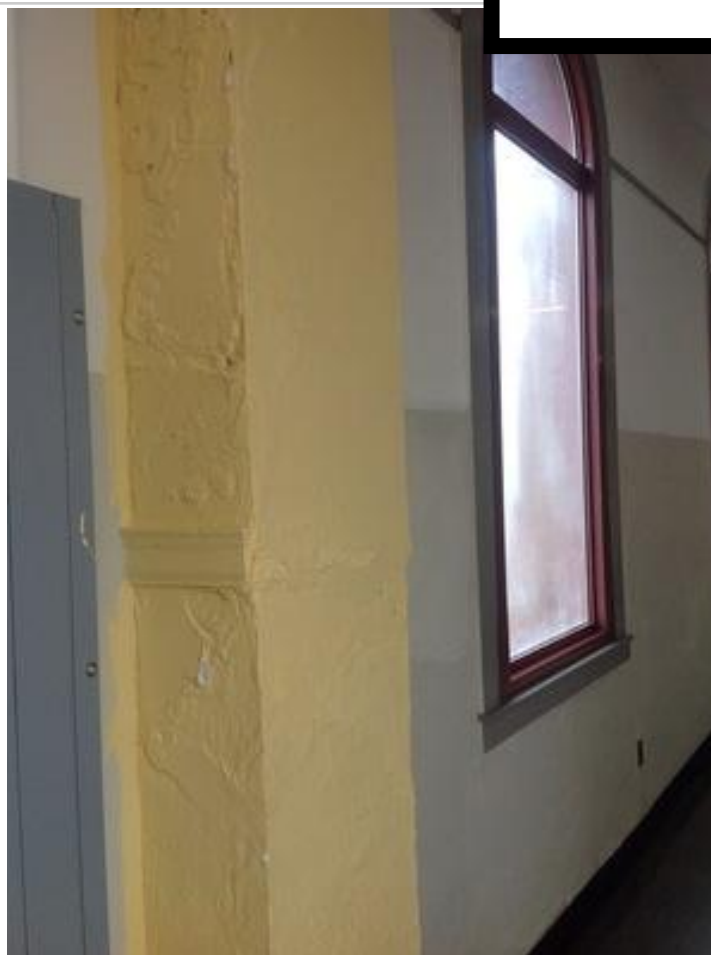
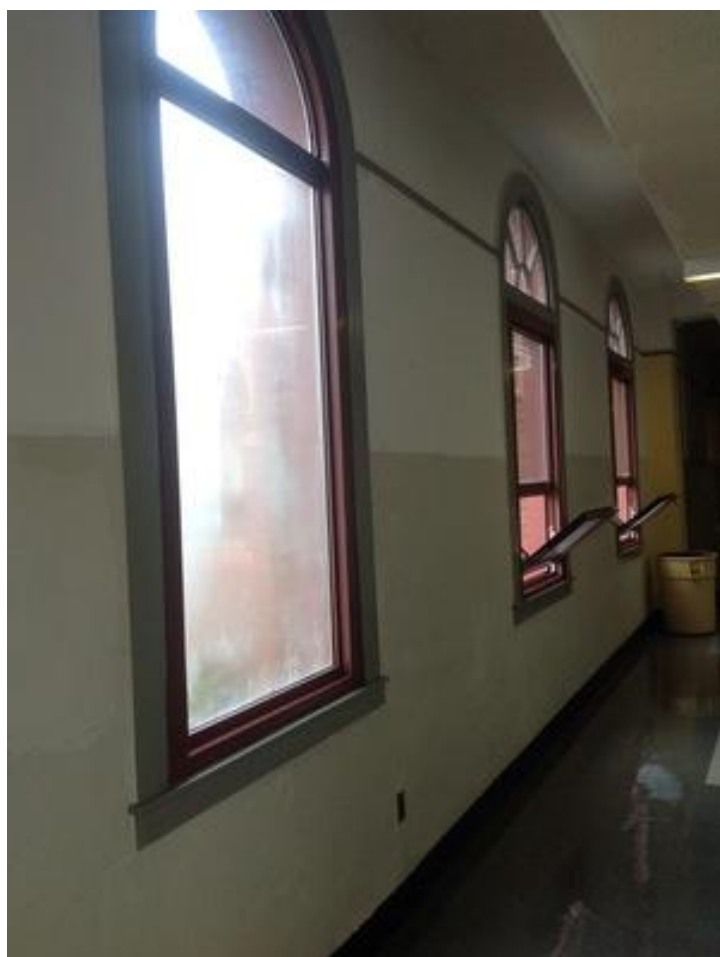
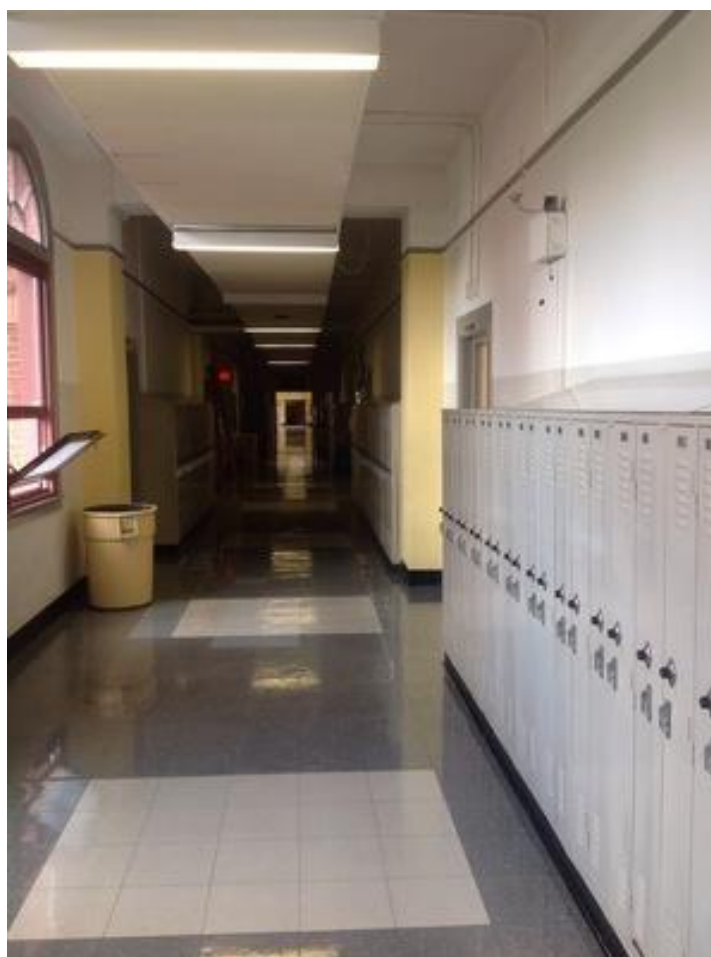
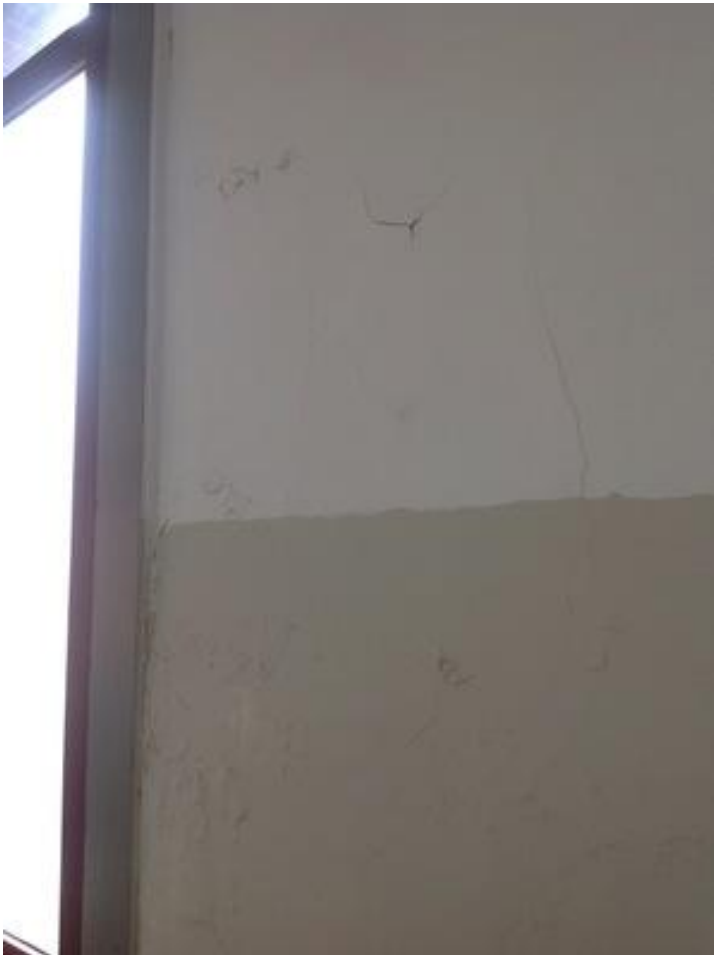
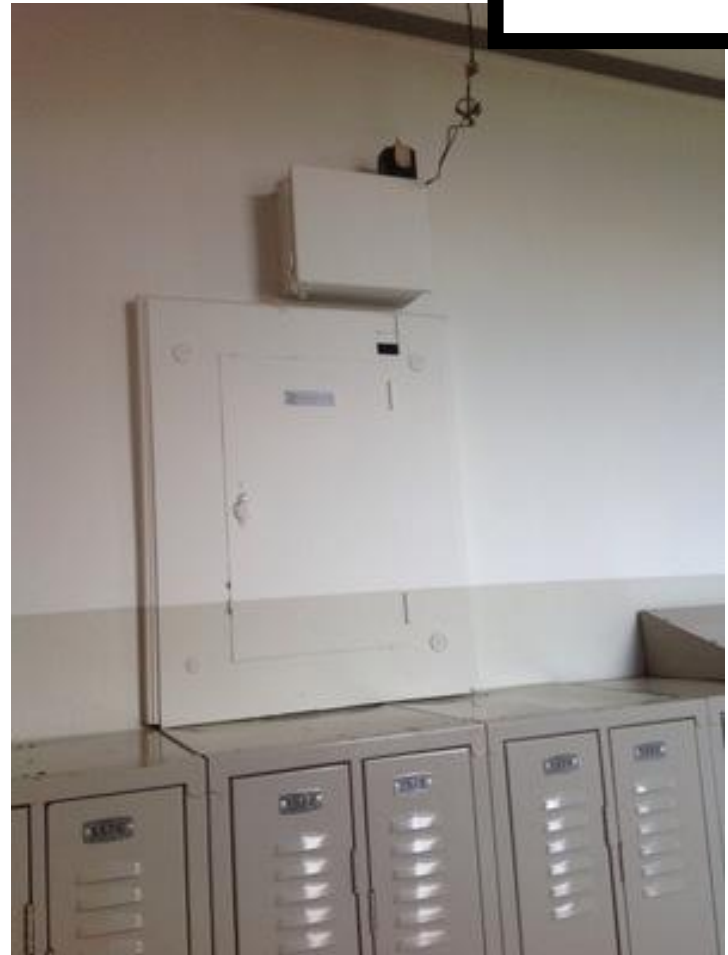
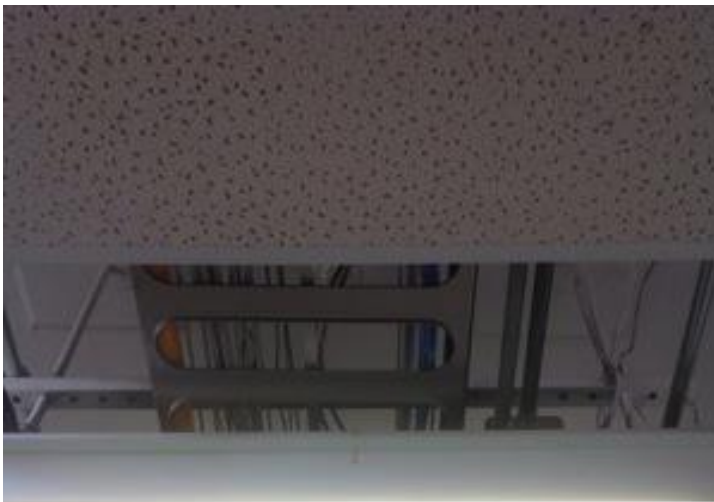
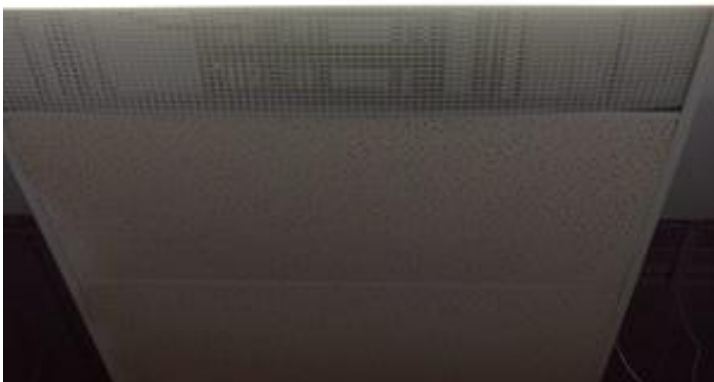
Attached Images for ID KJ-00031

Double loaded corridor with recessed lockers. Paint is chipping on walls and ceiling plaster. Partial 2x4 ACT ceiling and grid centered in corridor open to plaster ceiling above. Piping/ductwork exposed around ACT ceiling. Surface mounted ceiling fixtures. Wall base in fair condition. Some windows have lost seals and moisture is evident between panes. Elevator could not be accessed.

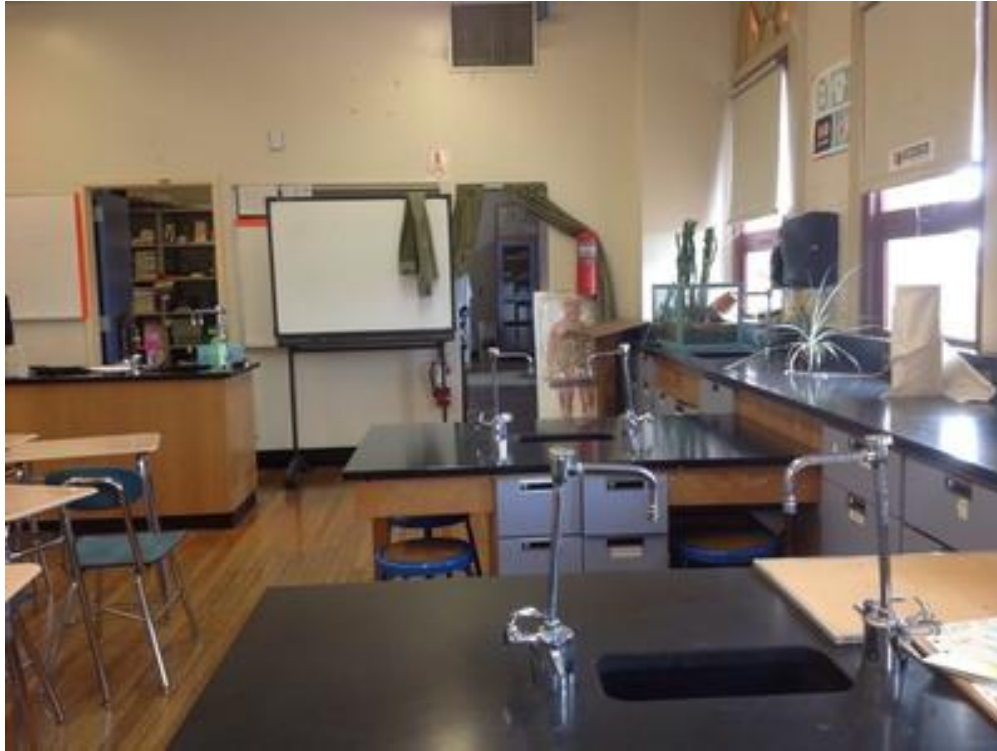
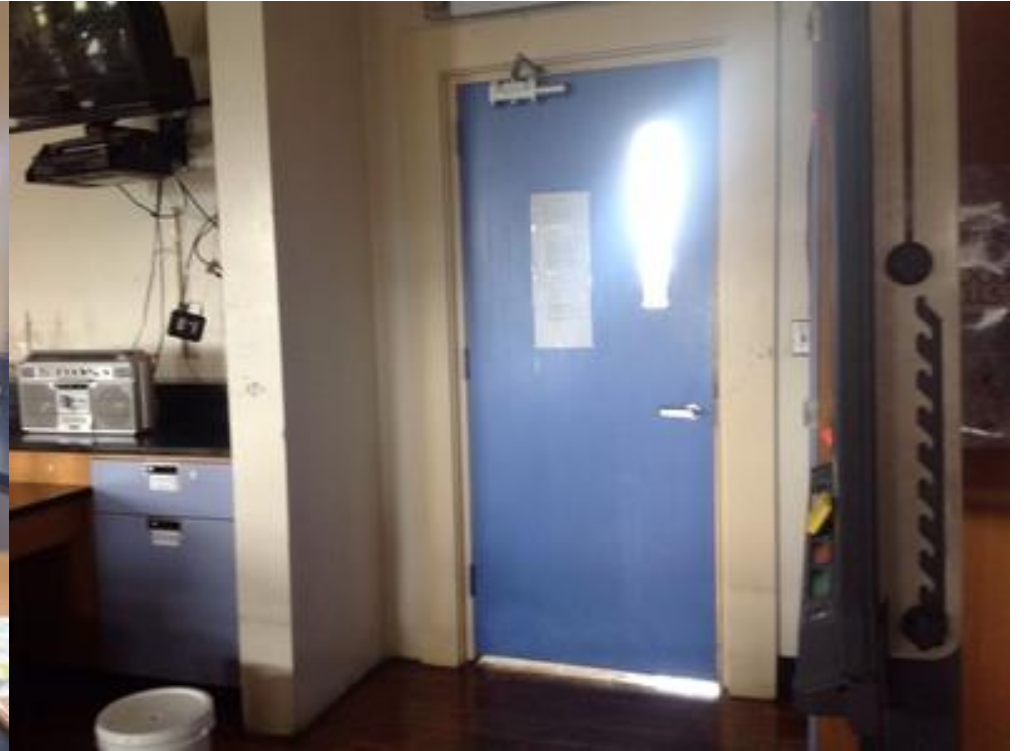
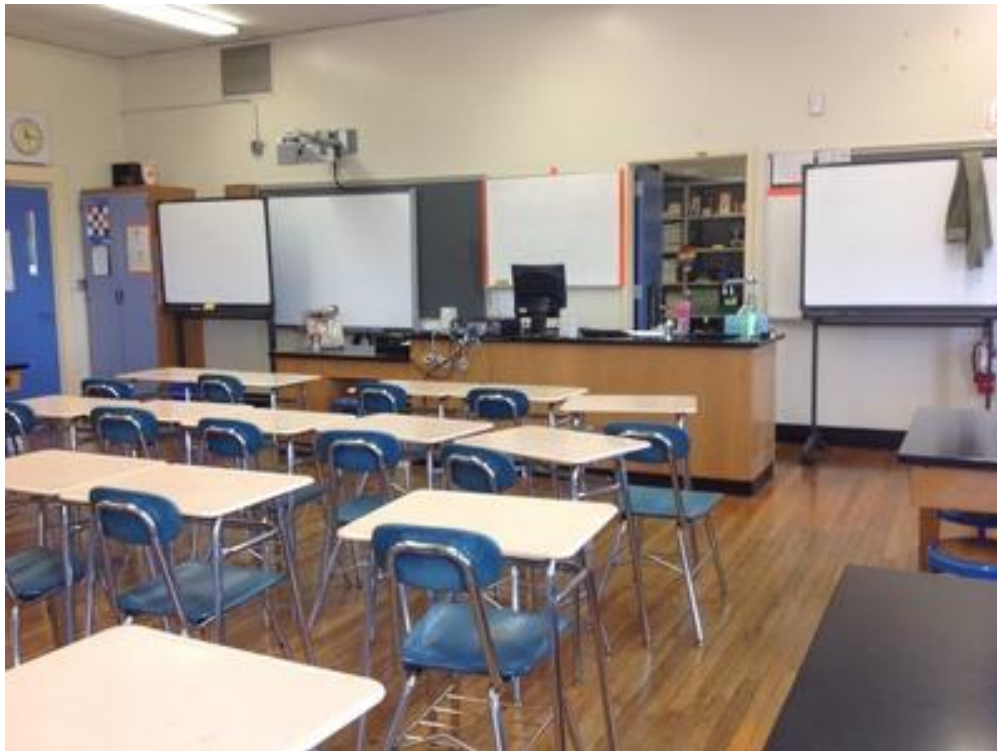
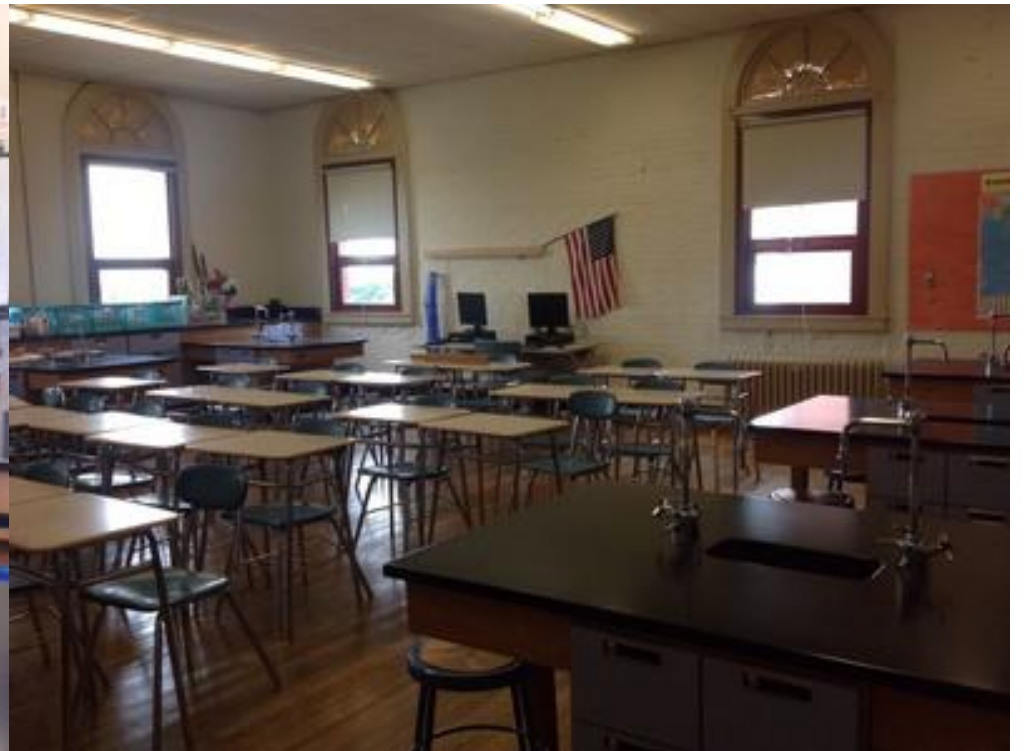
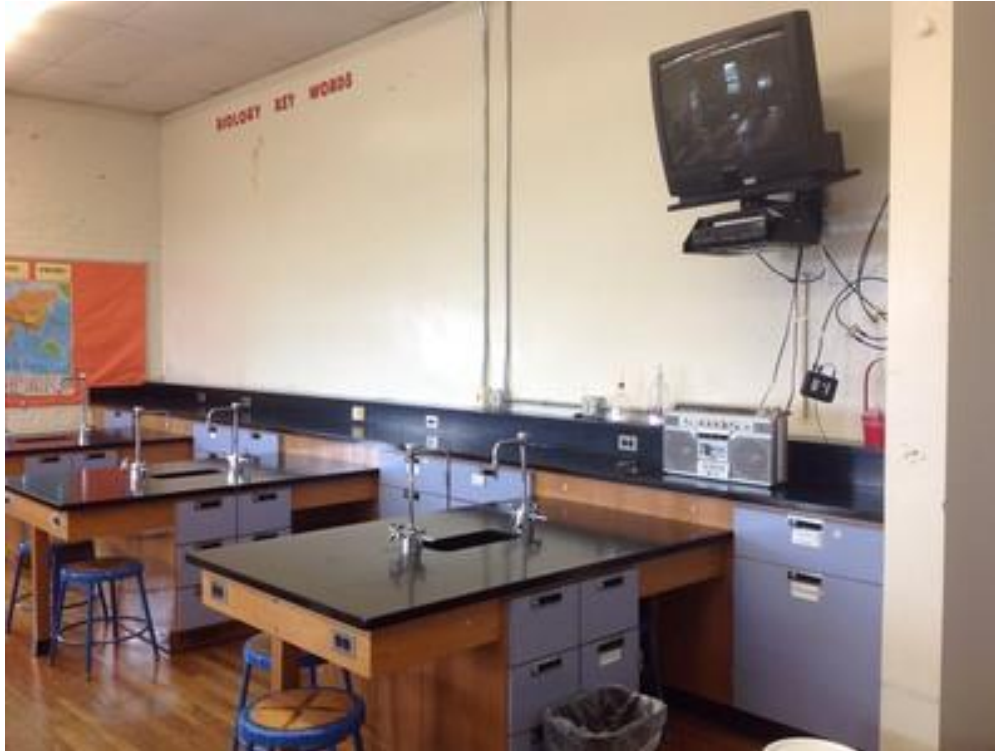
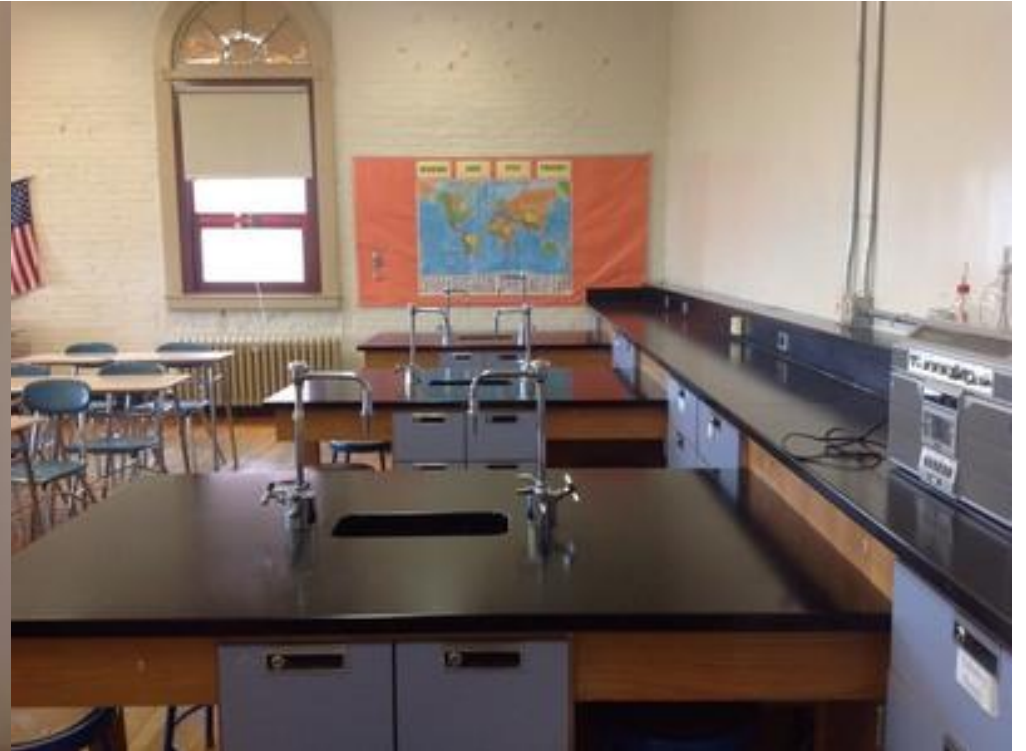
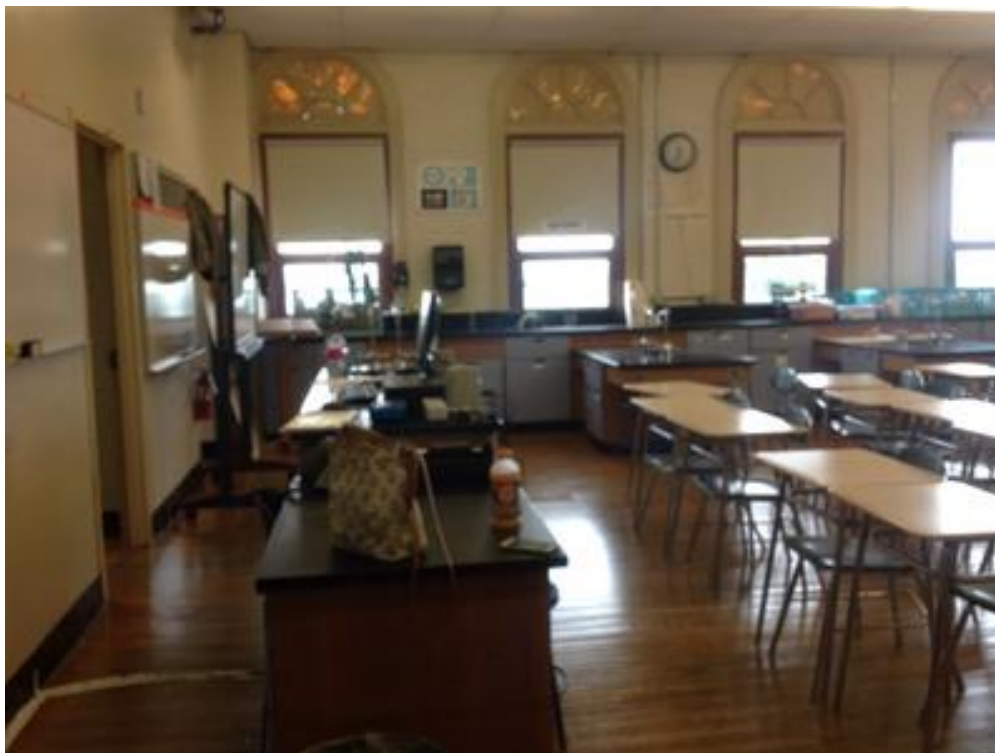
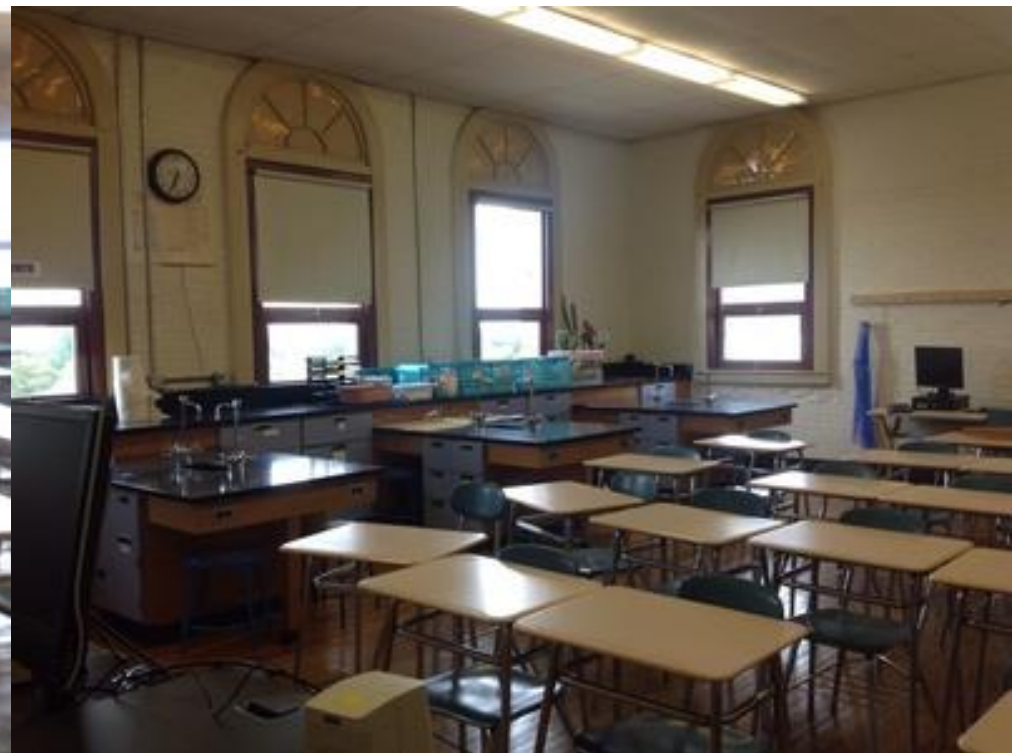
Description
Plaster walls poor. 2x4 ceiling poor. Windows show broken seals. Flooring in fair condition. Base shows damage. Painted brick for 2 Walls. Millwork in poor condition. Window transom so have been painted. Wood flooring is creaky. Window shades in poor condition. Strip lighting is old and some fixtures are missing covers. Science stations at perimeter of classroom.

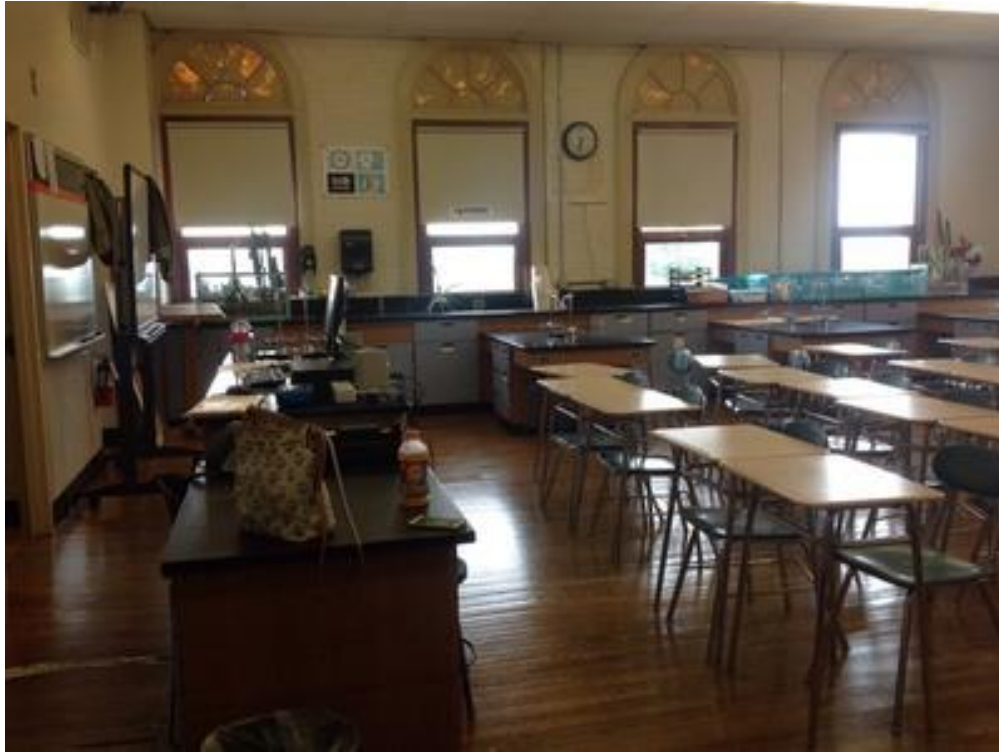
IMG_f332286b-90b7-492b-964b-1c079bcfca1a.jpg

Description
Wood flooring in good condition but creaky. Paint is chipping on walls and ceiling. Light fixtures missing covers in some locations. 10'x20' area of 12"x12" VCT on ceiling. Surface mounted equipment and wiring is haphazard. Shades are in poor condition. Millwork in poor condition. Unit heater in poor condition. Window transoms painted over and paint is chipping. 2 walls are painted exposed brick. Classroom has smartboard.
