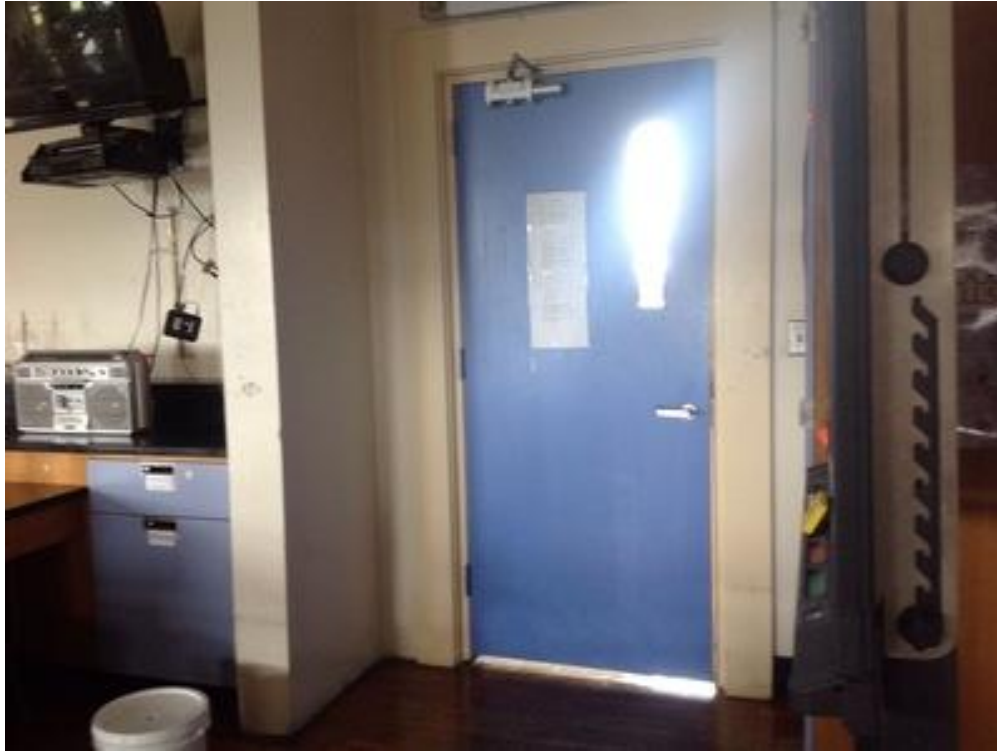
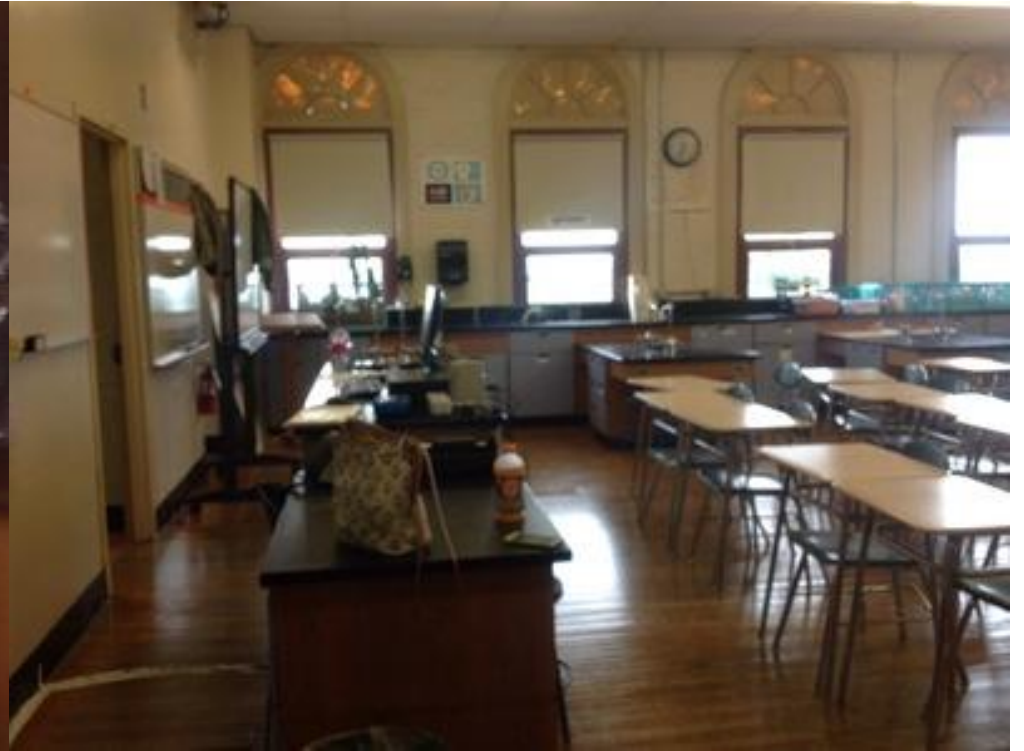
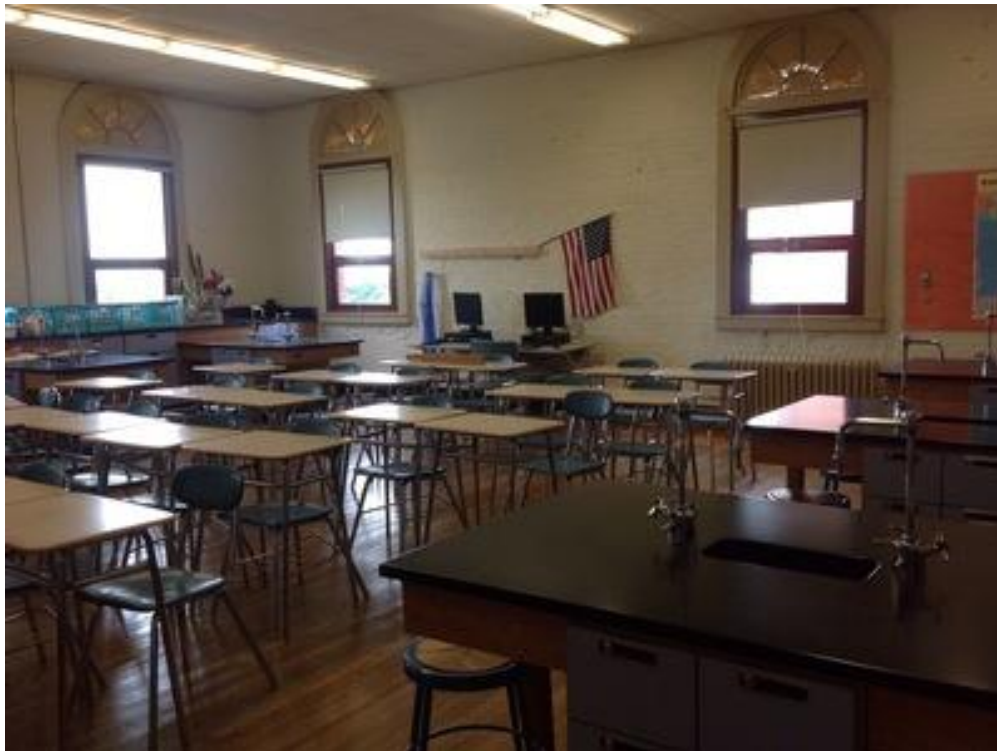
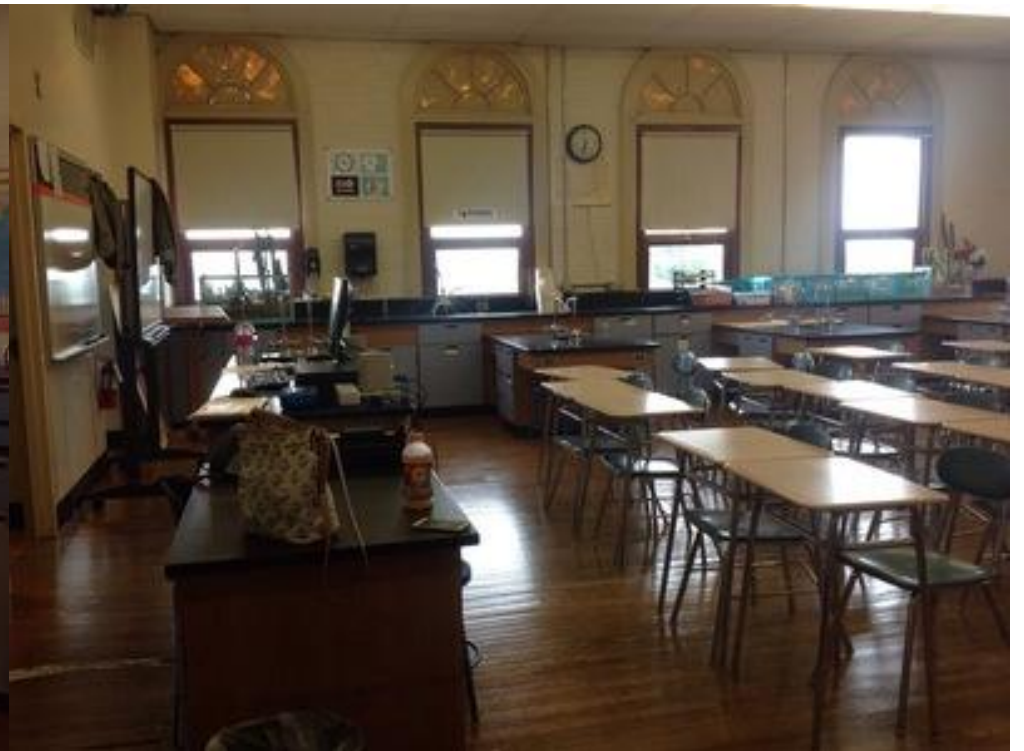
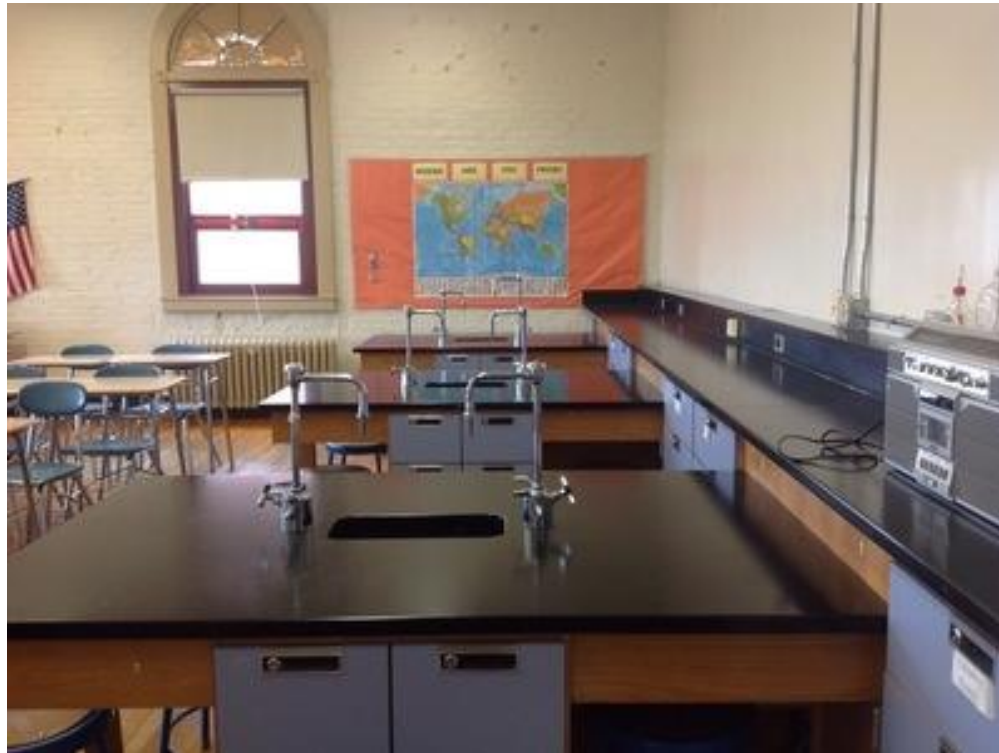
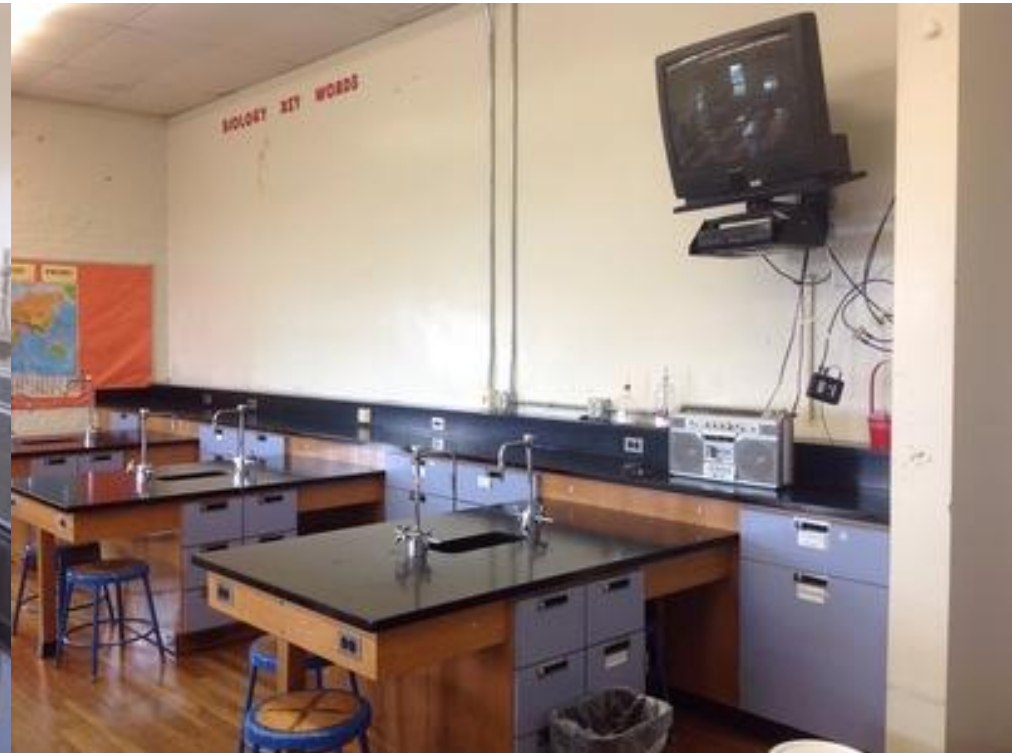
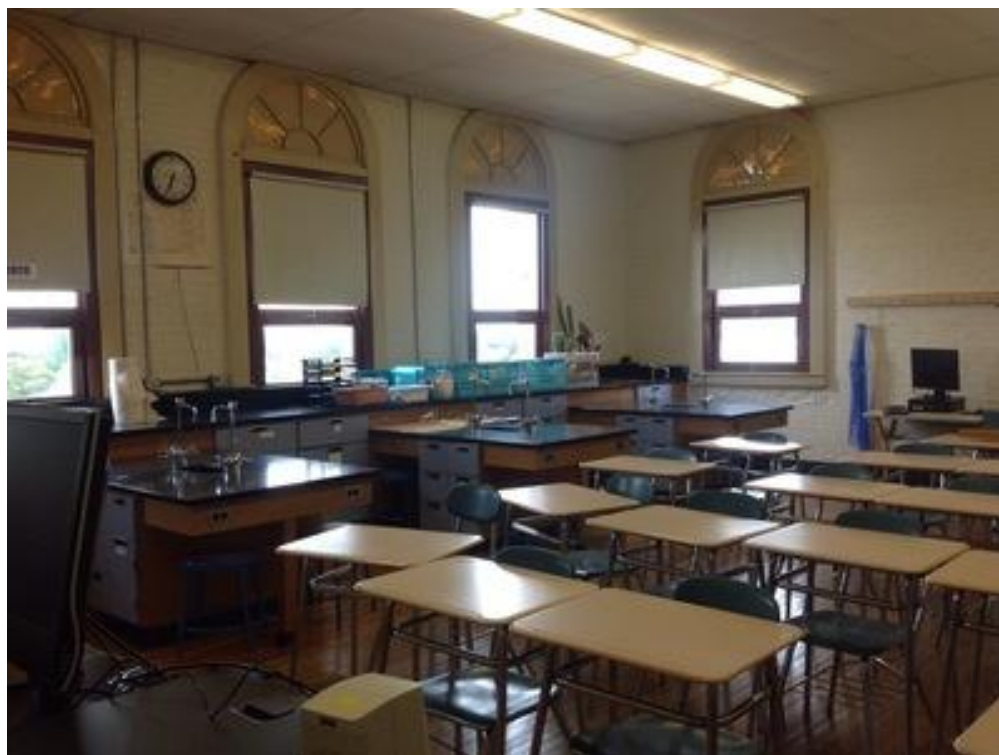
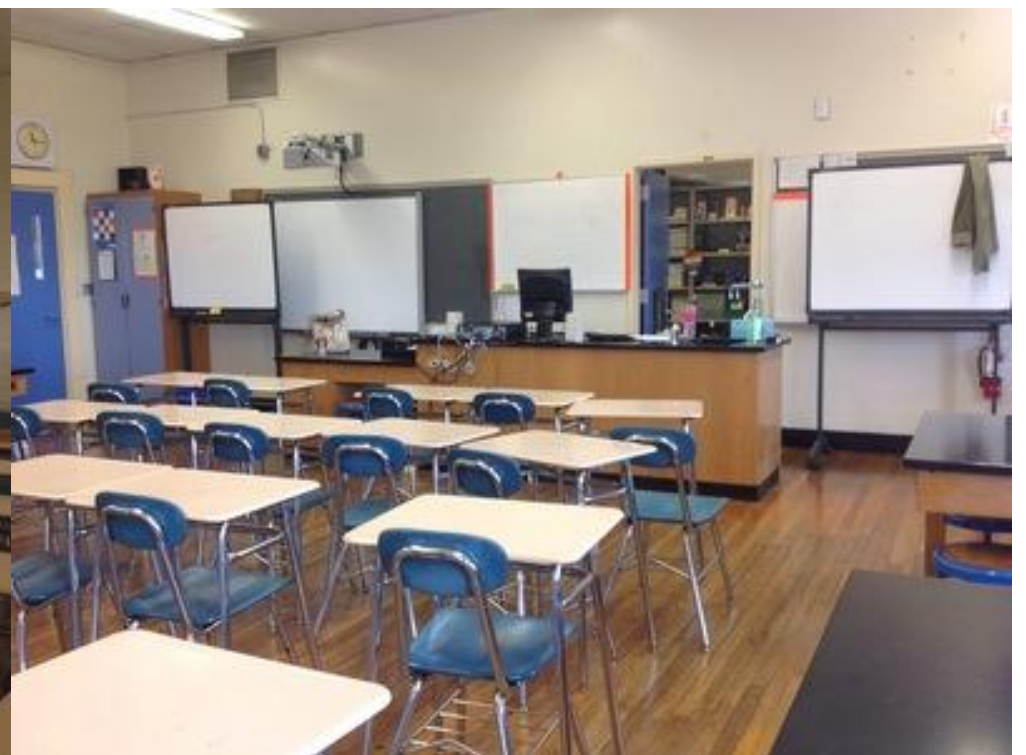
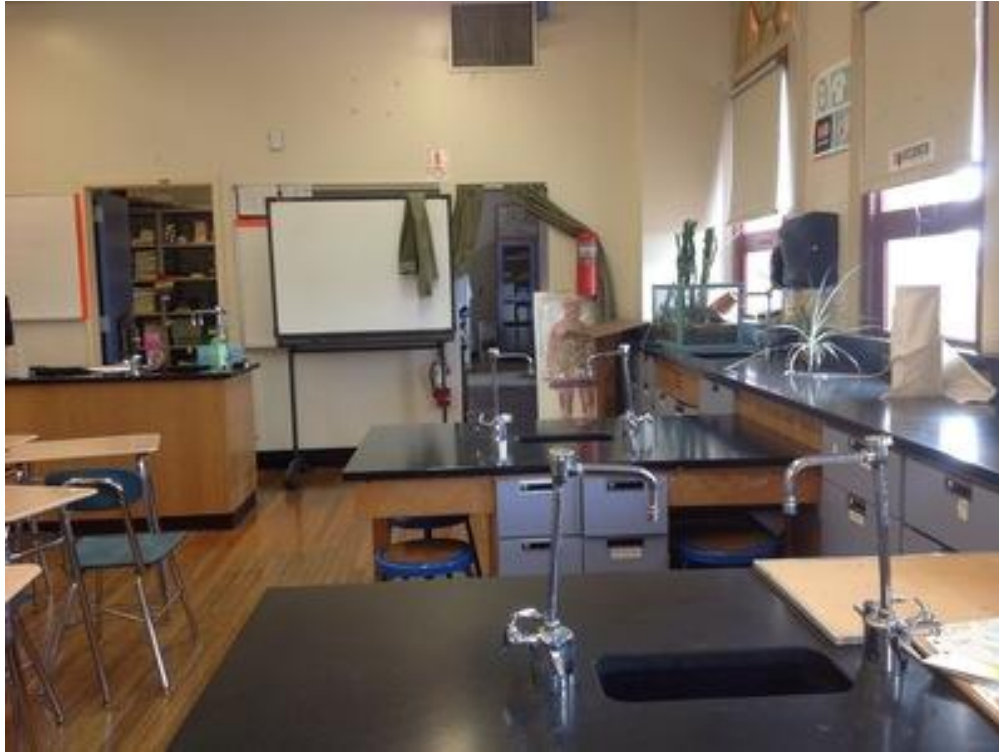
Description
Wood flooring in good condition but creaky. Paint is chipping on walls and ceiling. Light fixtures missing covers in some locations. 10'x20' area of 12"x12" VCT on ceiling. Surface mounted equipment and wiring is haphazard. Shades are in poor condition. Millwork in poor condition. Unit heater in poor condition. Classroom has smartboard.

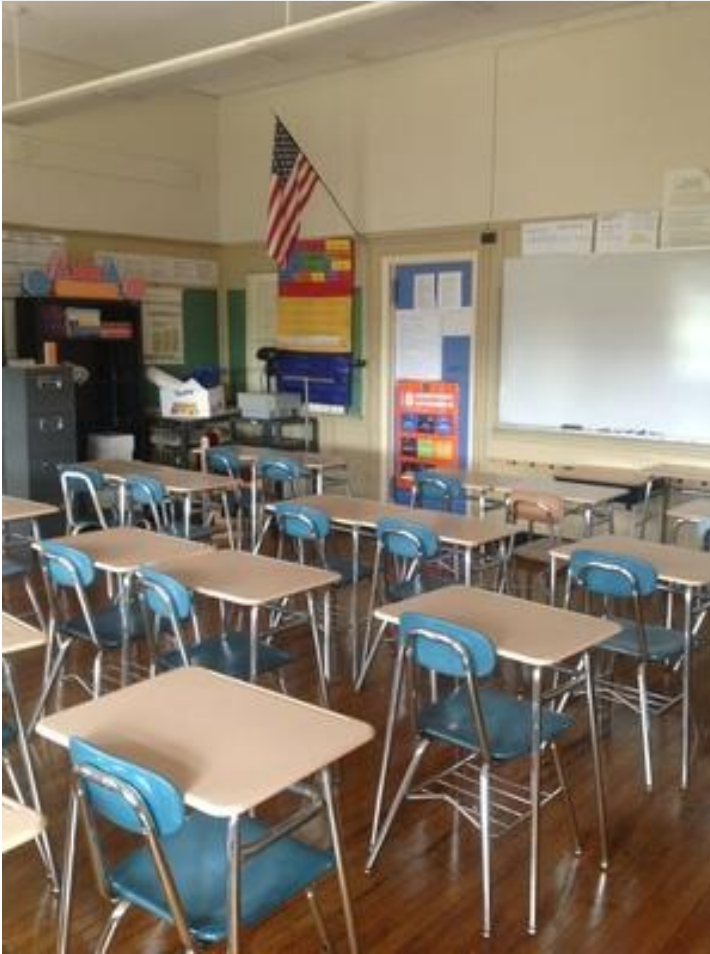
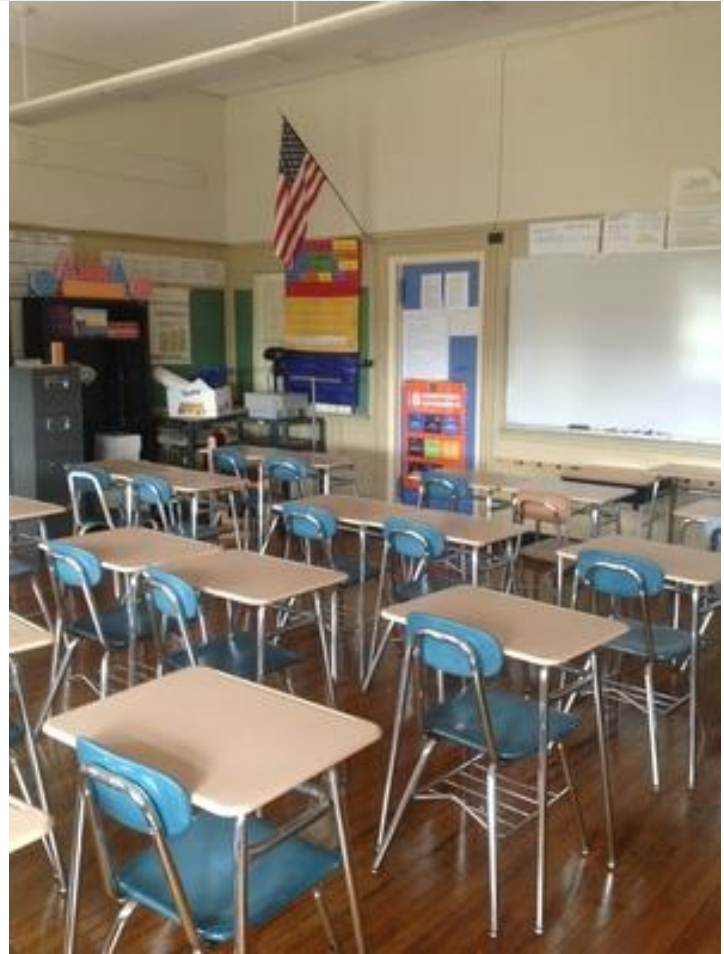
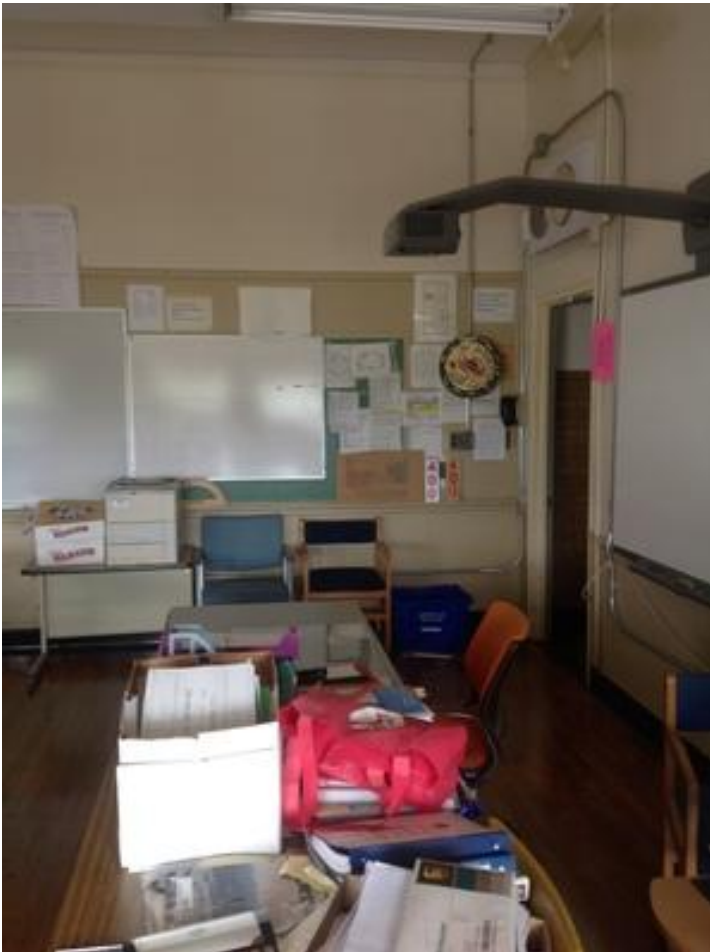
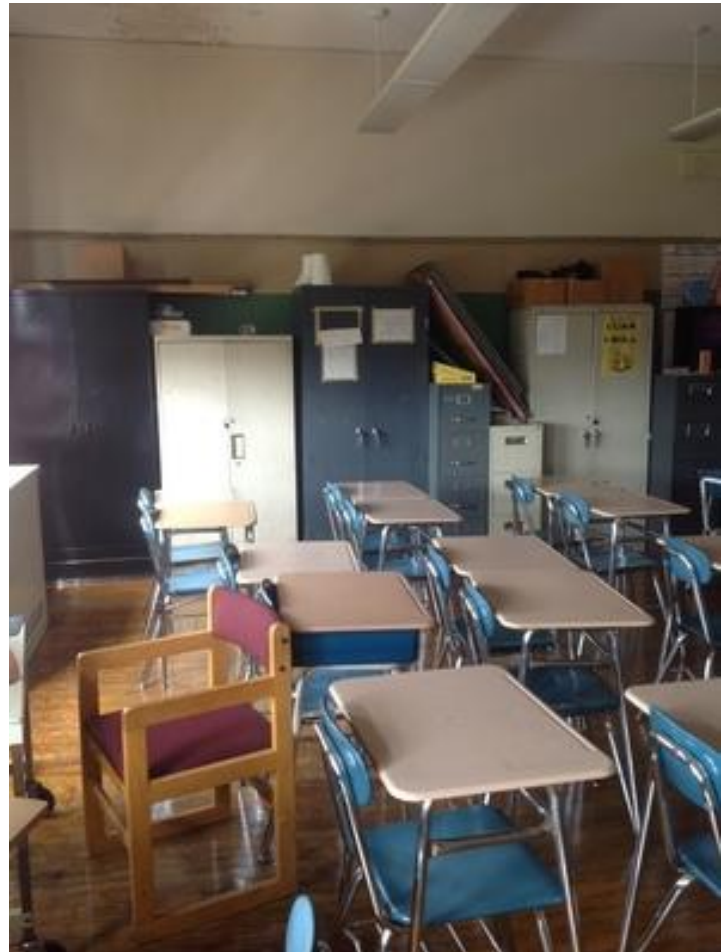
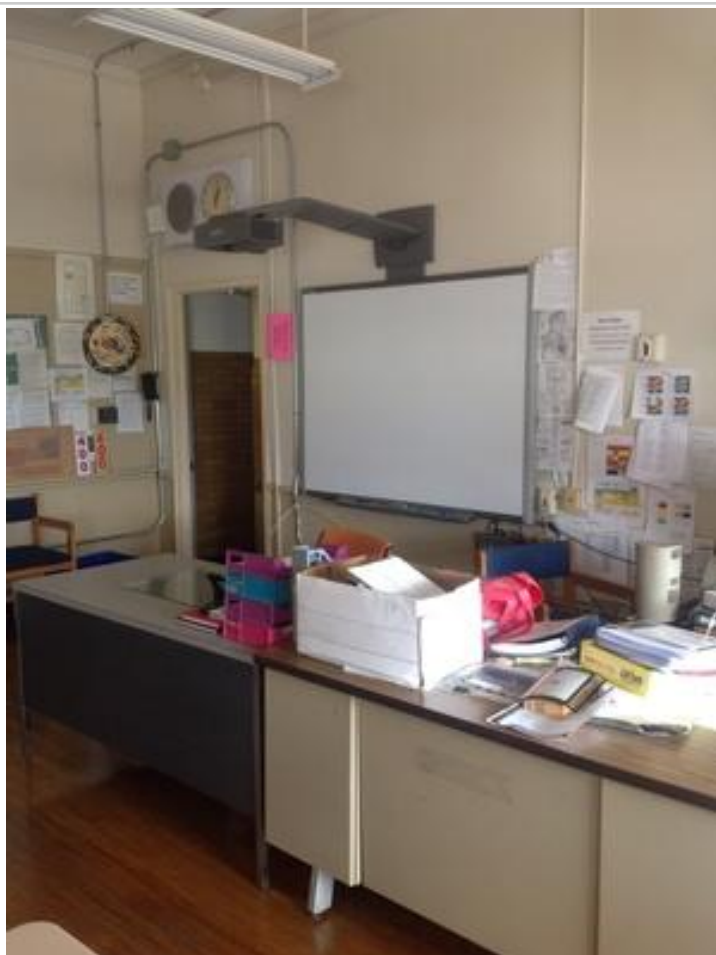
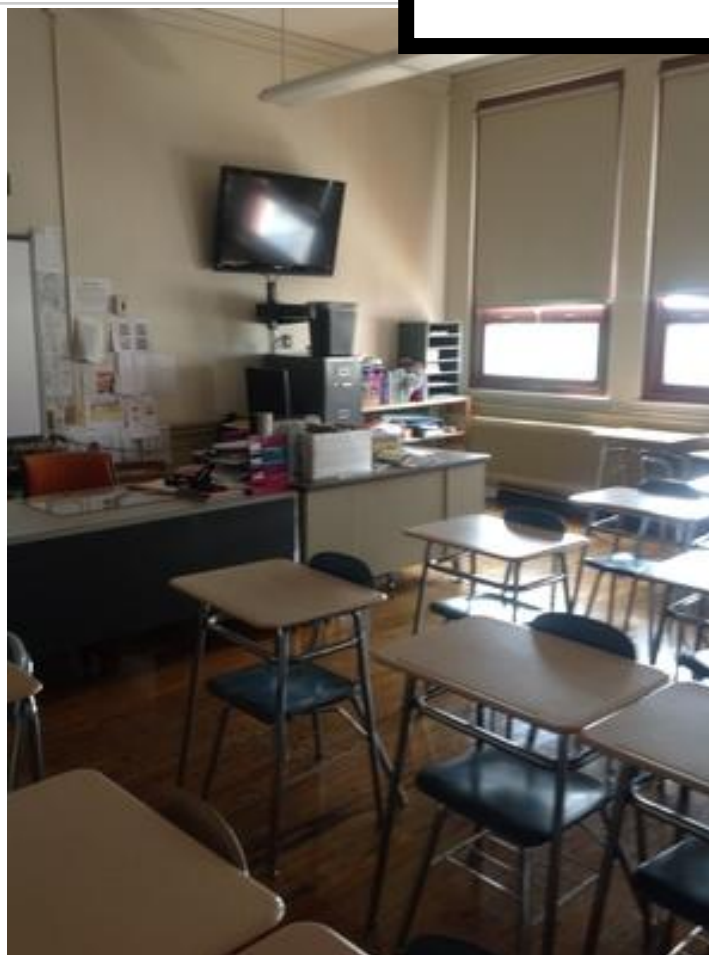
Attached Images for ID KJ-00027

Plaster walls poor. 2x4 ceiling poor. Windows show broken seals. Flooring in poor condition. Base shows damage. Painted brick for 1 Wall. Millwork in poor condition. Window transom so have been painted. Wood flooring is creaky. Window shades in poor condition. Strip lighting is old and some fixtures are missing covers.

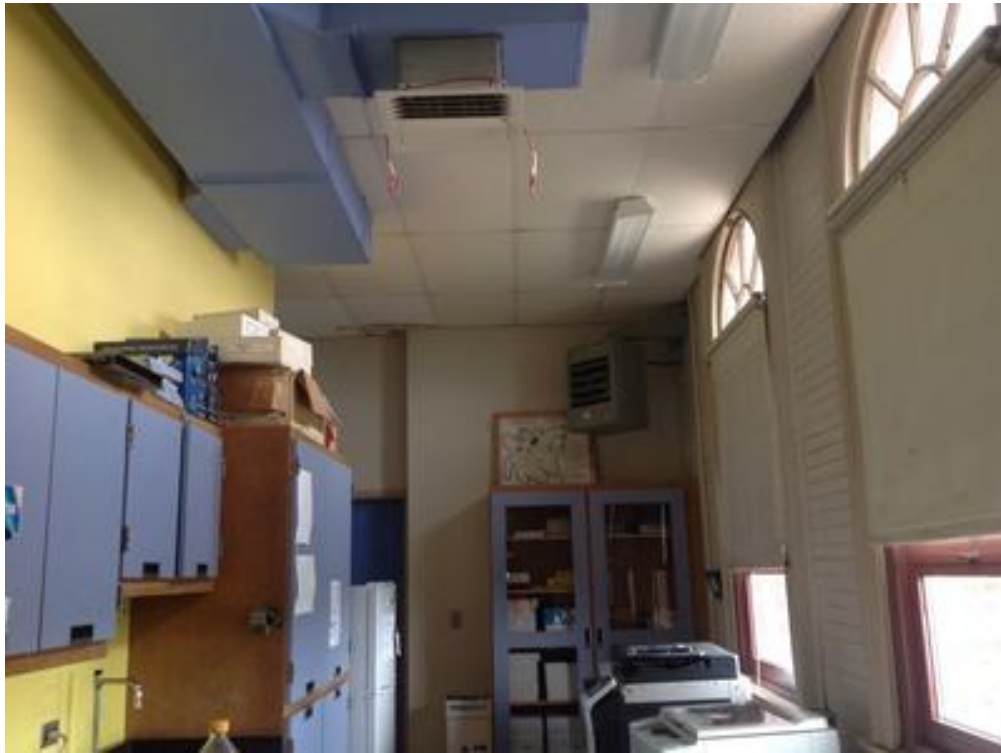
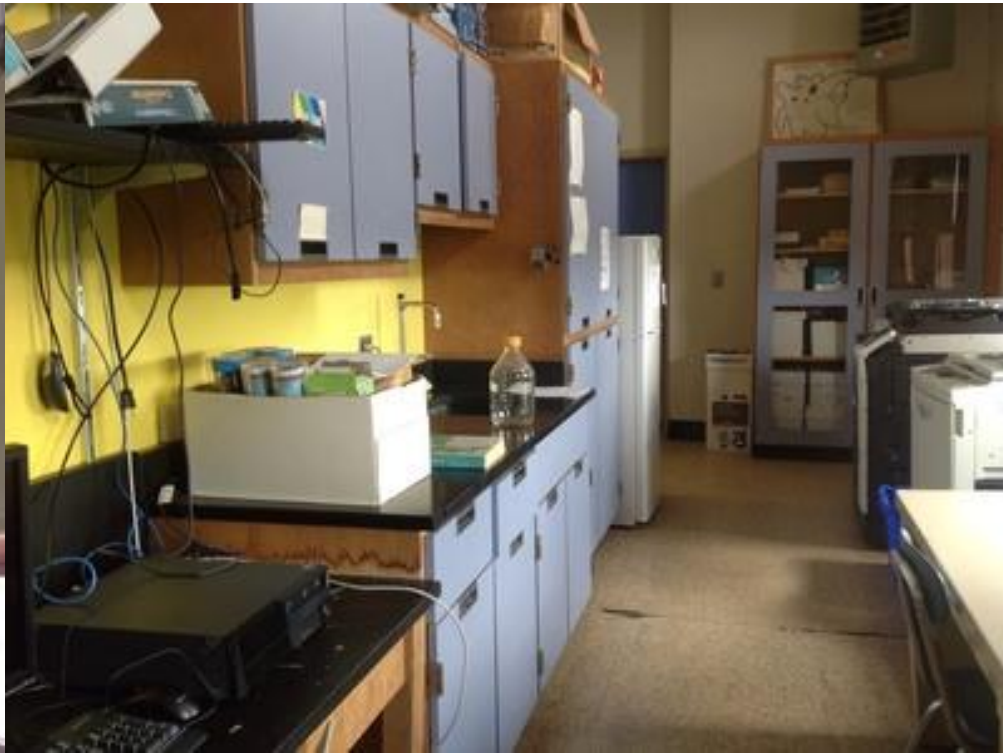
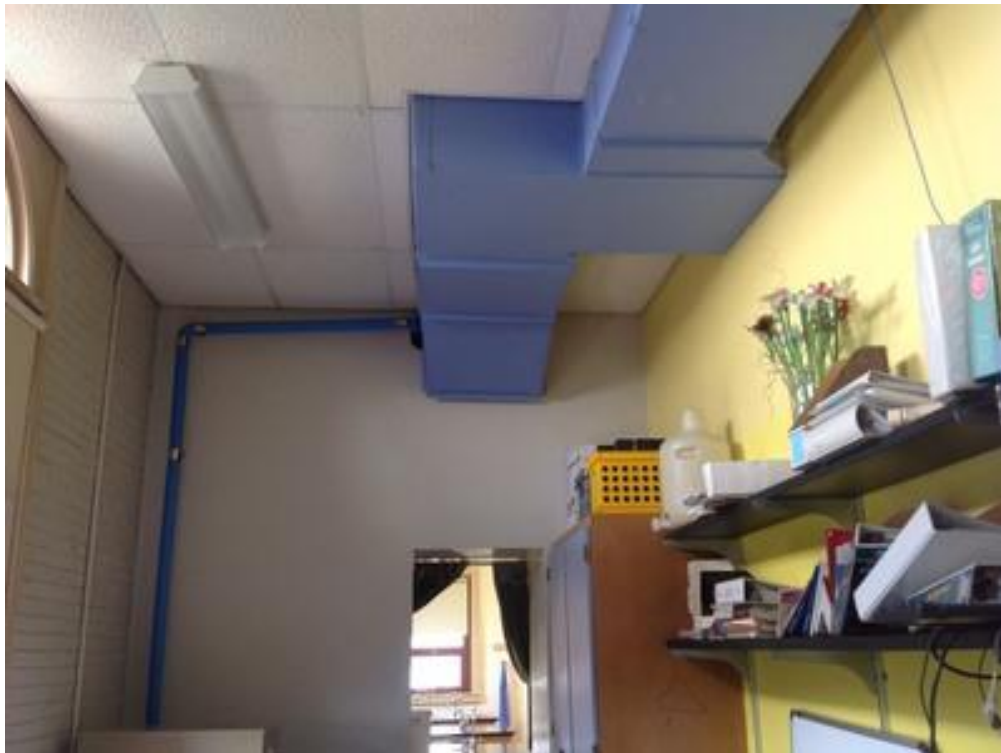
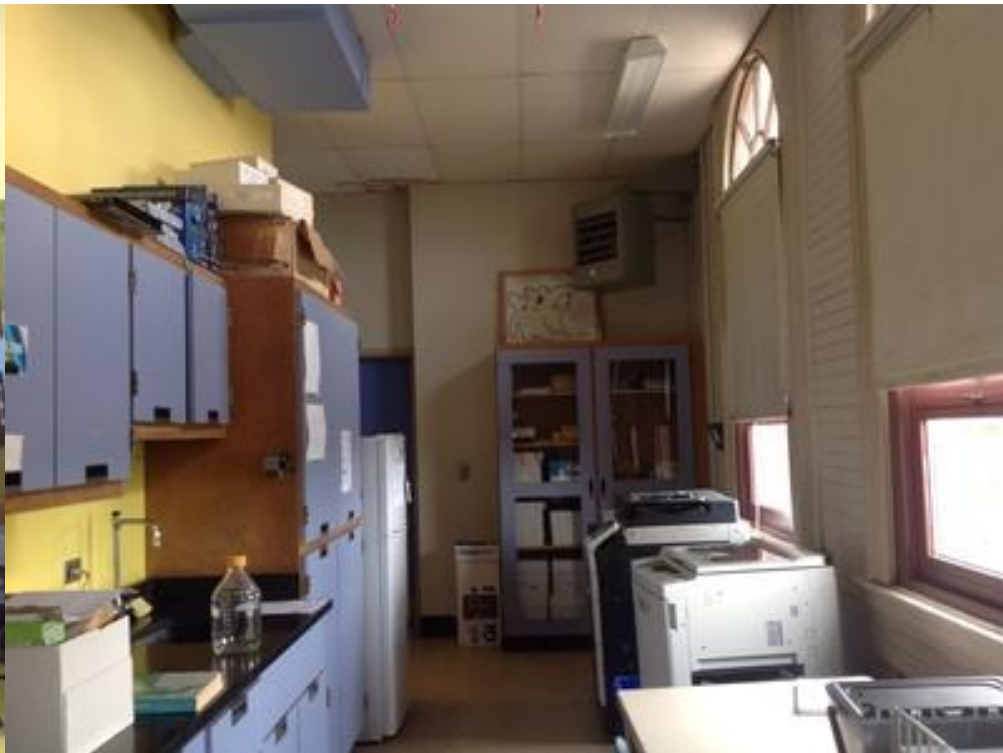
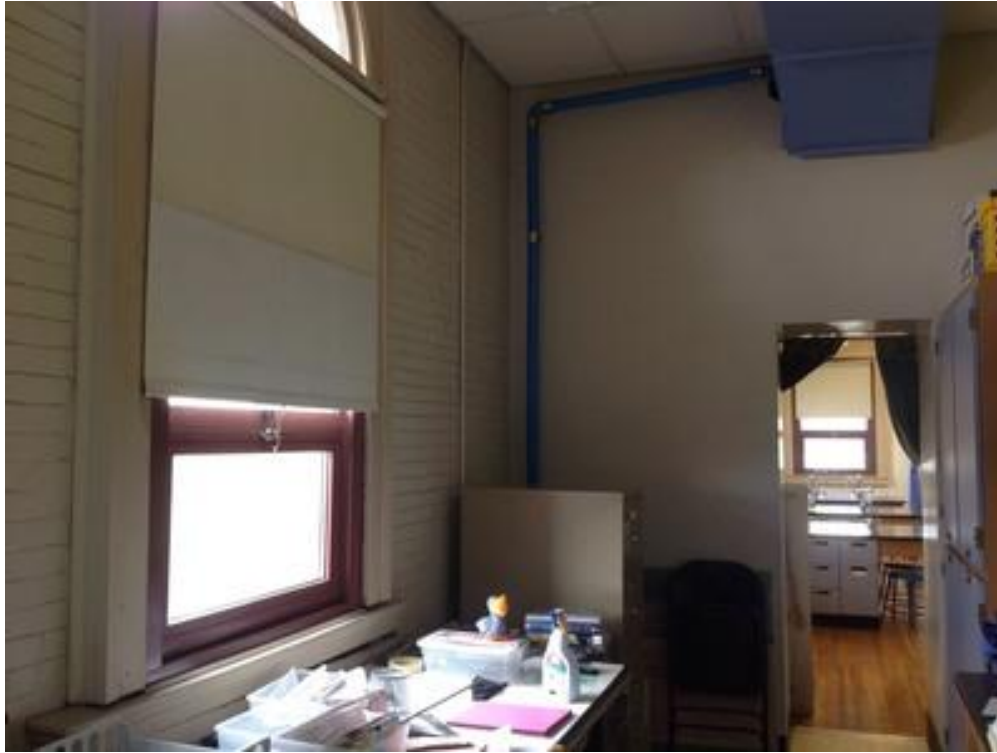
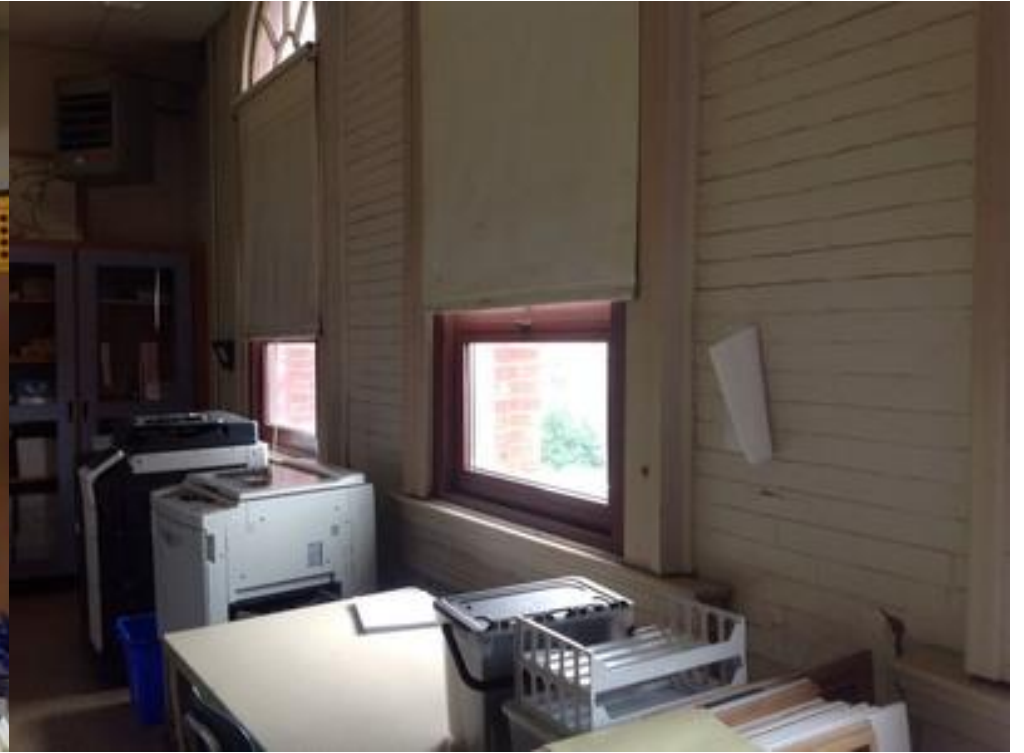
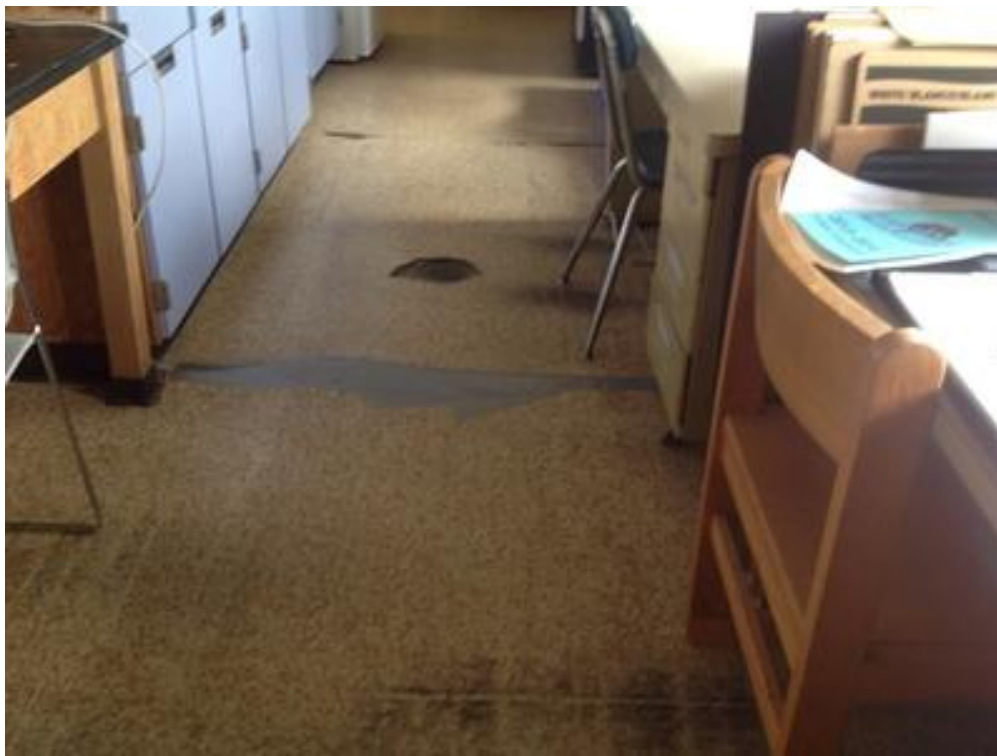
Description
Flooringin poor condition but many holes partularly around floor drain. Paint is chipping on walls, brick, and ceiling. 2x4 ACT in poor condition. Surface mounted equipment and wiring is haphazard.

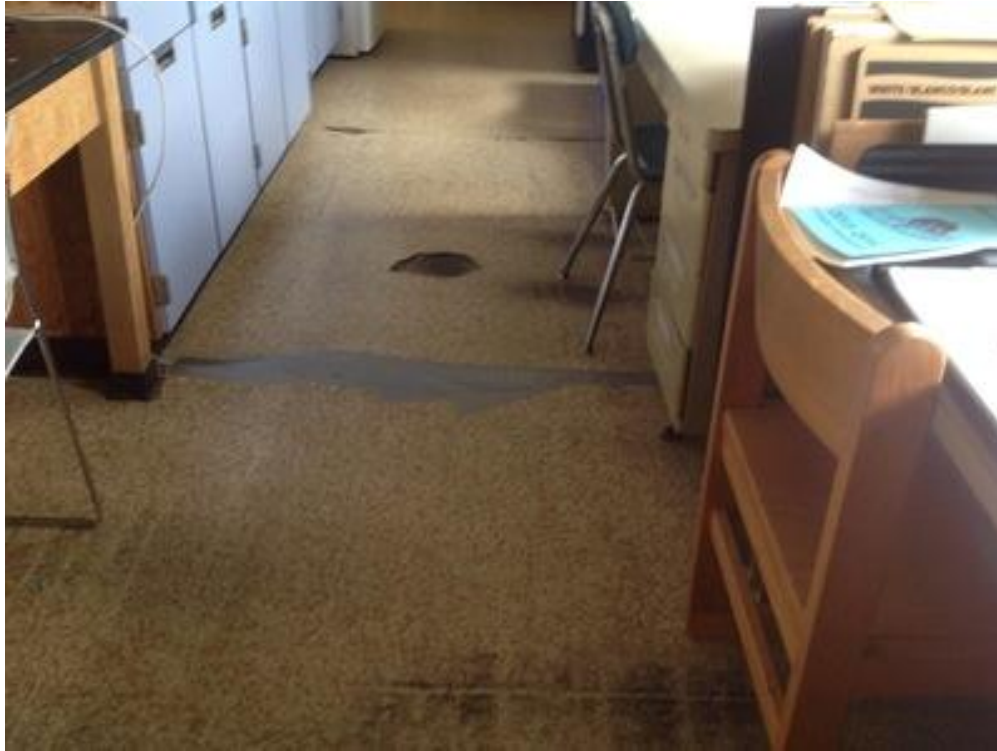
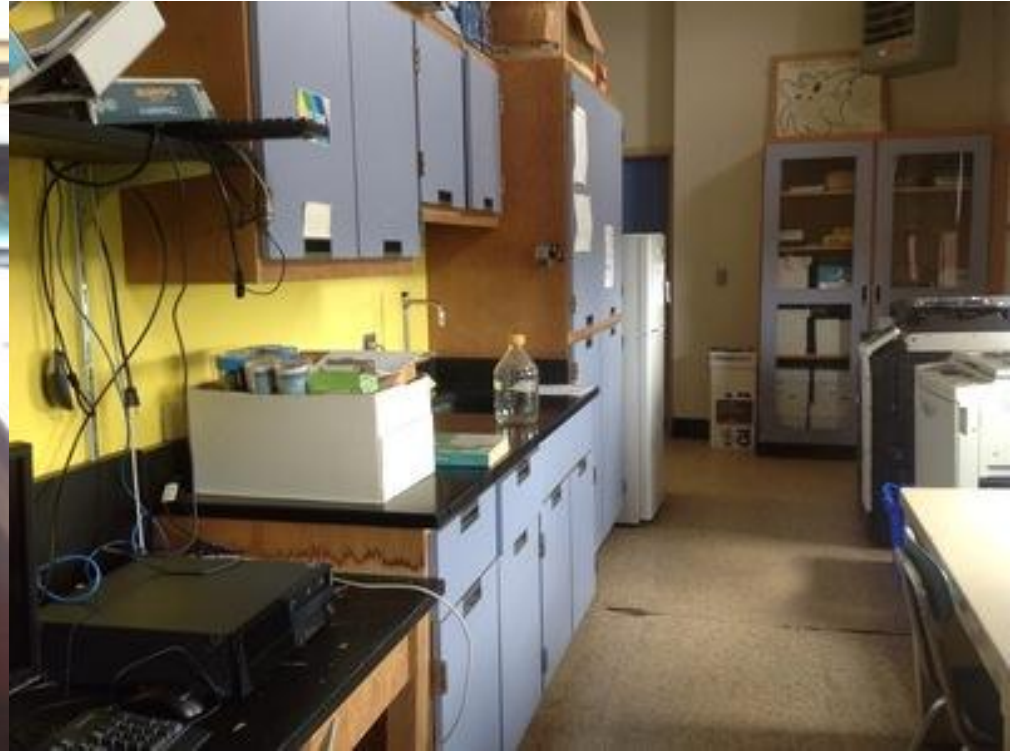
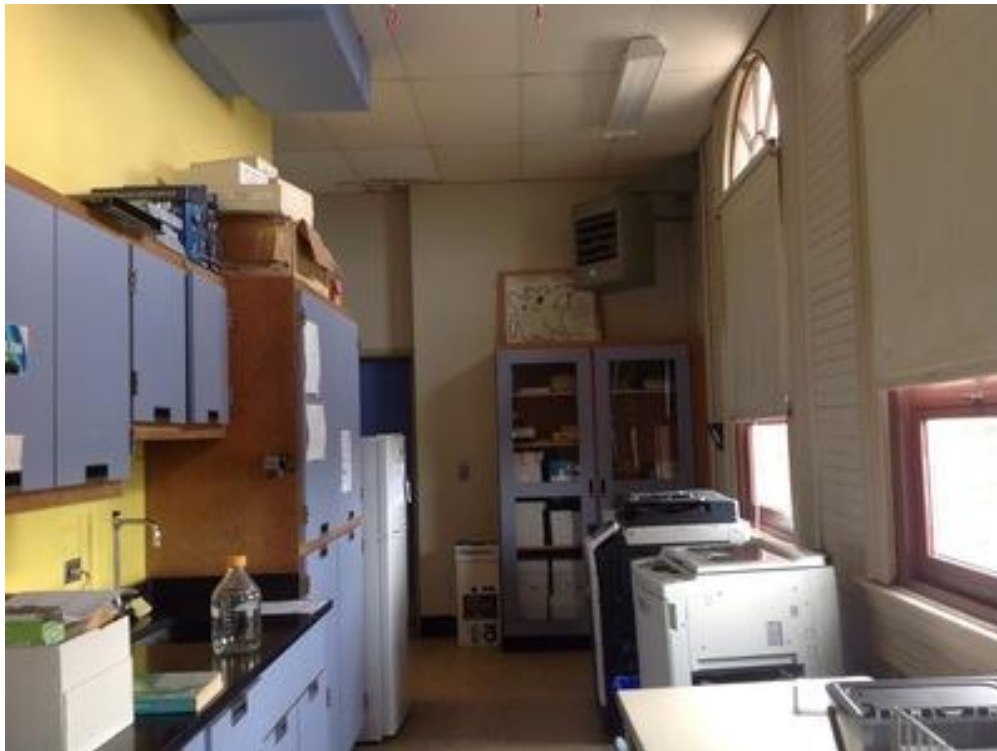
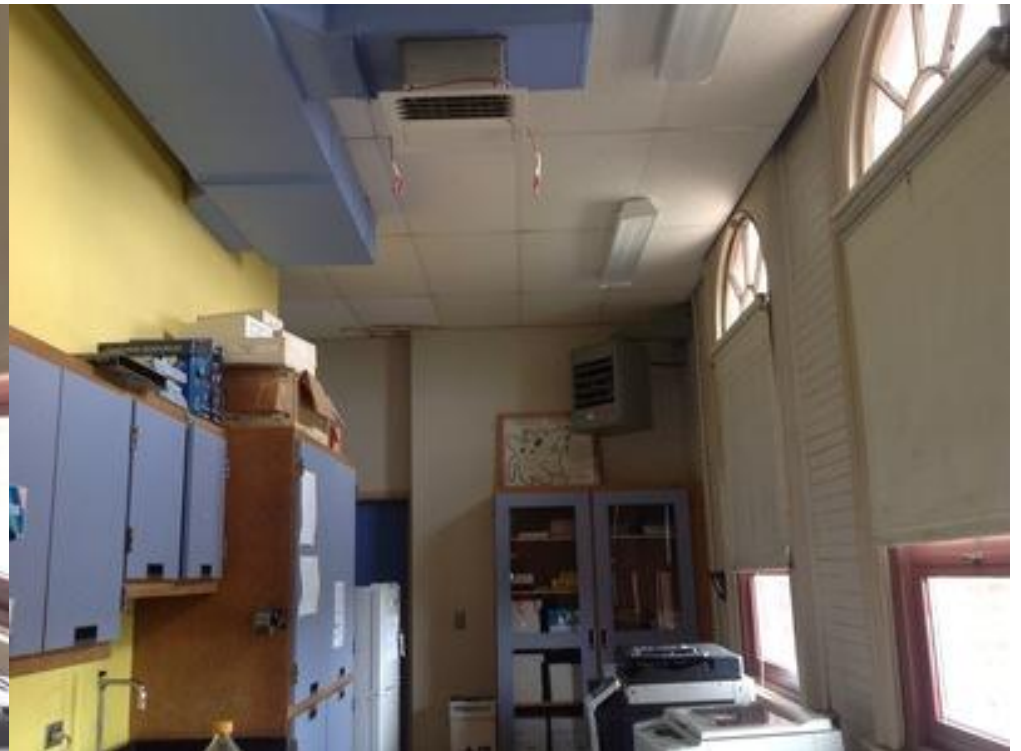
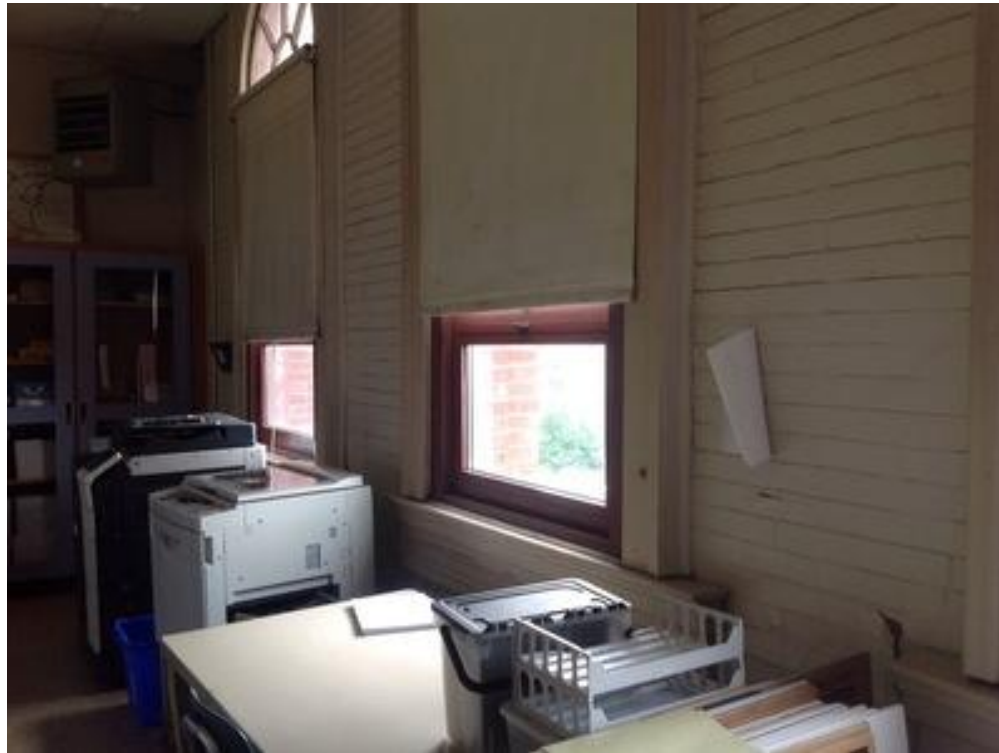
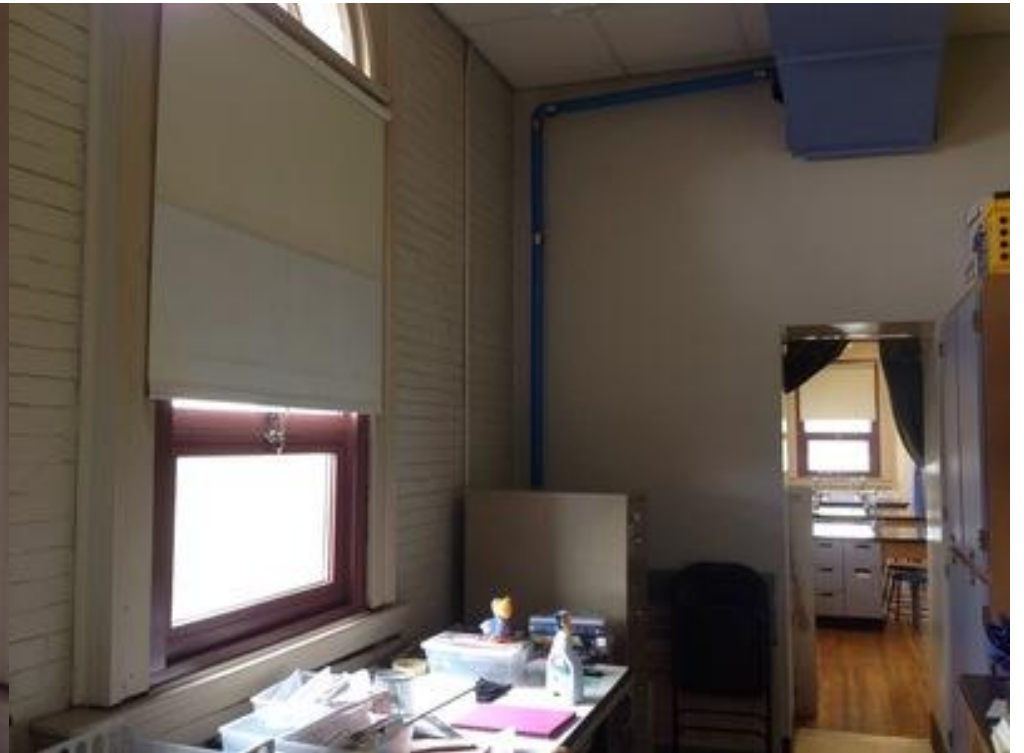
Description
Wood flooring in good condition but creaky. Paint is chipping on walls and ceiling. Light fixtures missing covers in some locations. 2x4 ceiling is in fair condition but tiles are sagging. Surface mounted equipment and wiring is haphazard. Millwork in poor condition.
