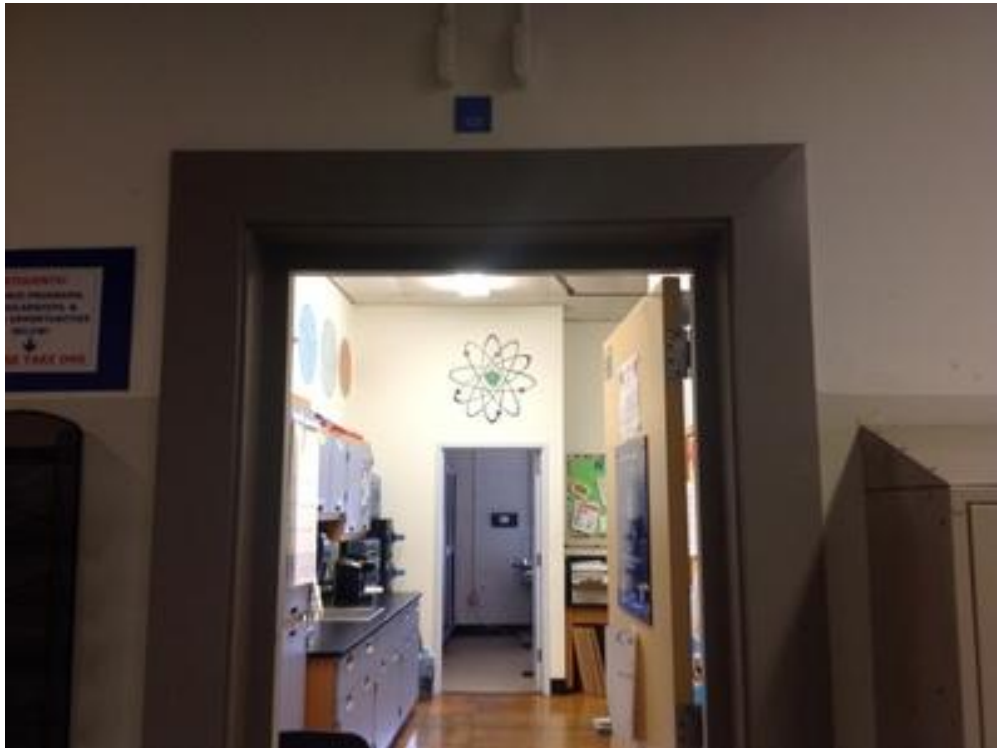
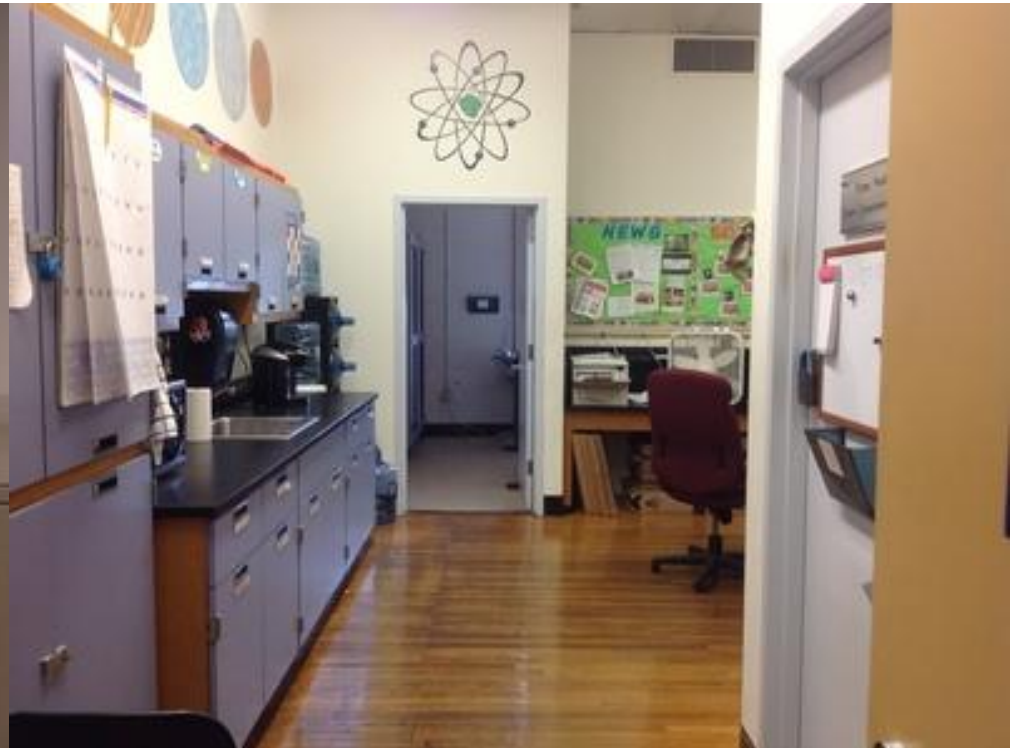
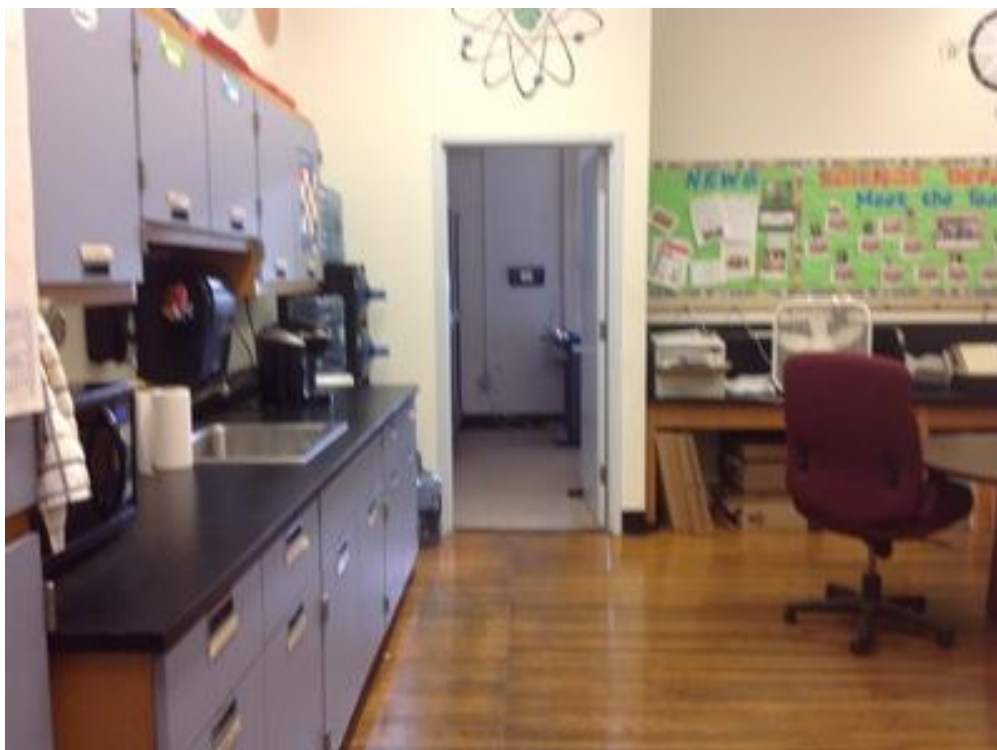
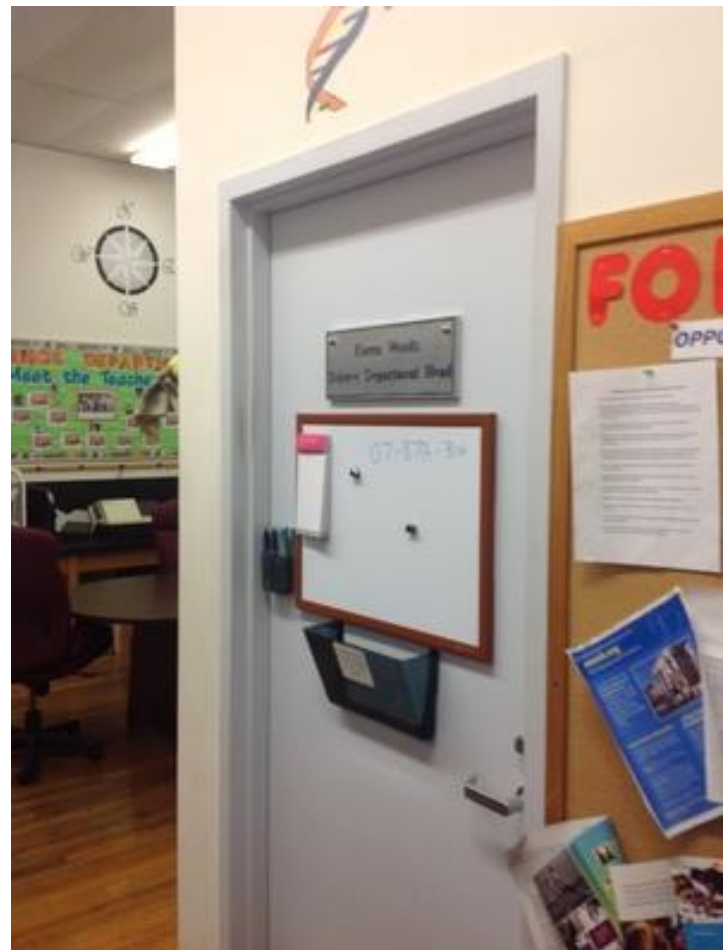
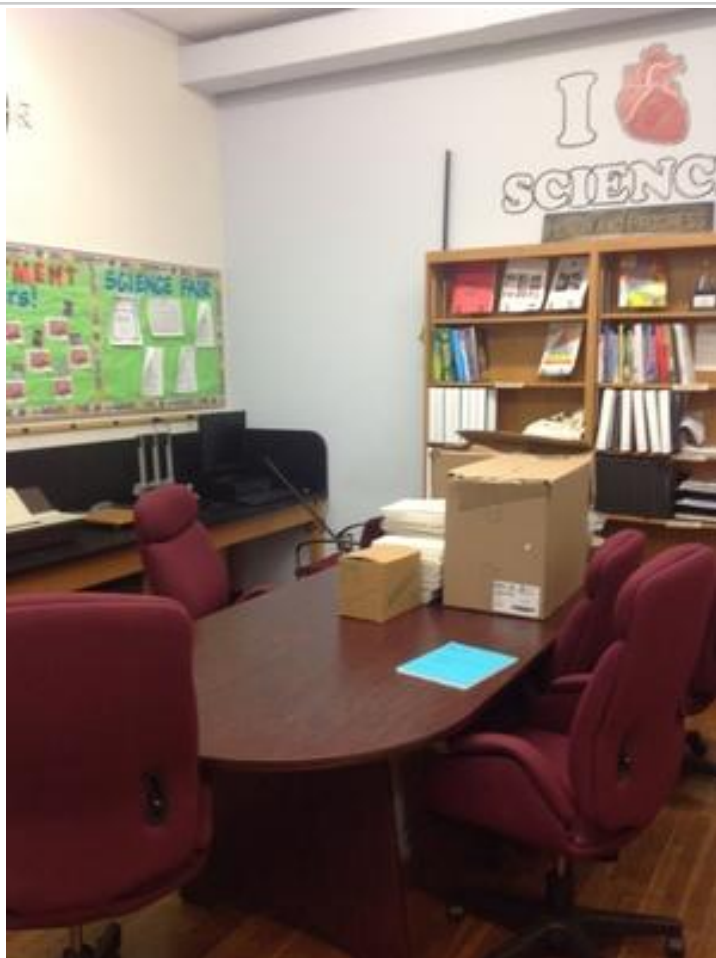
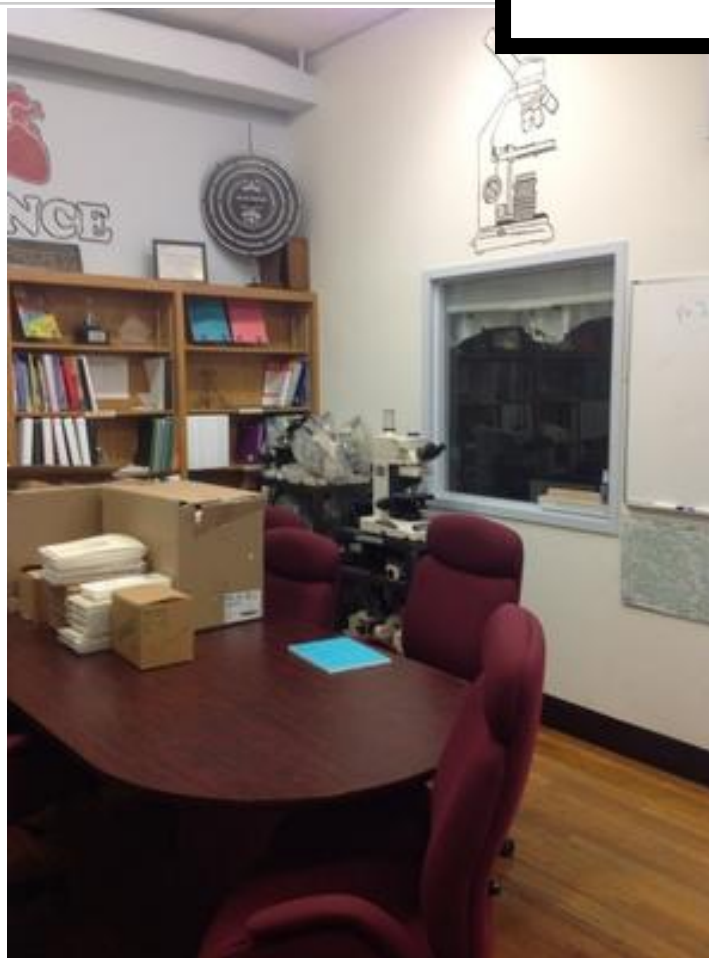
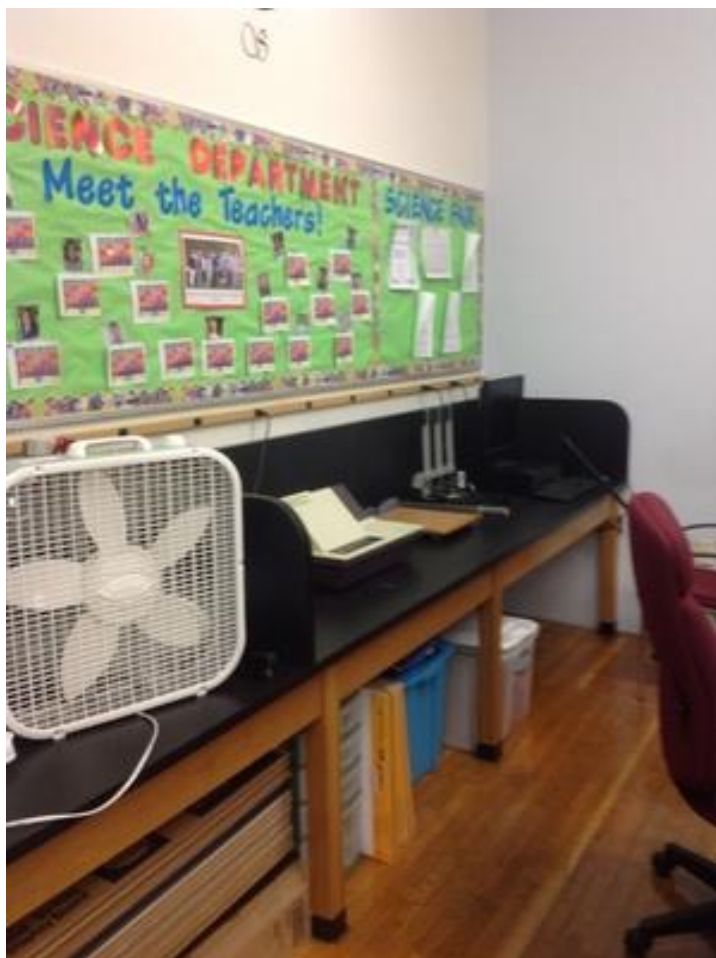
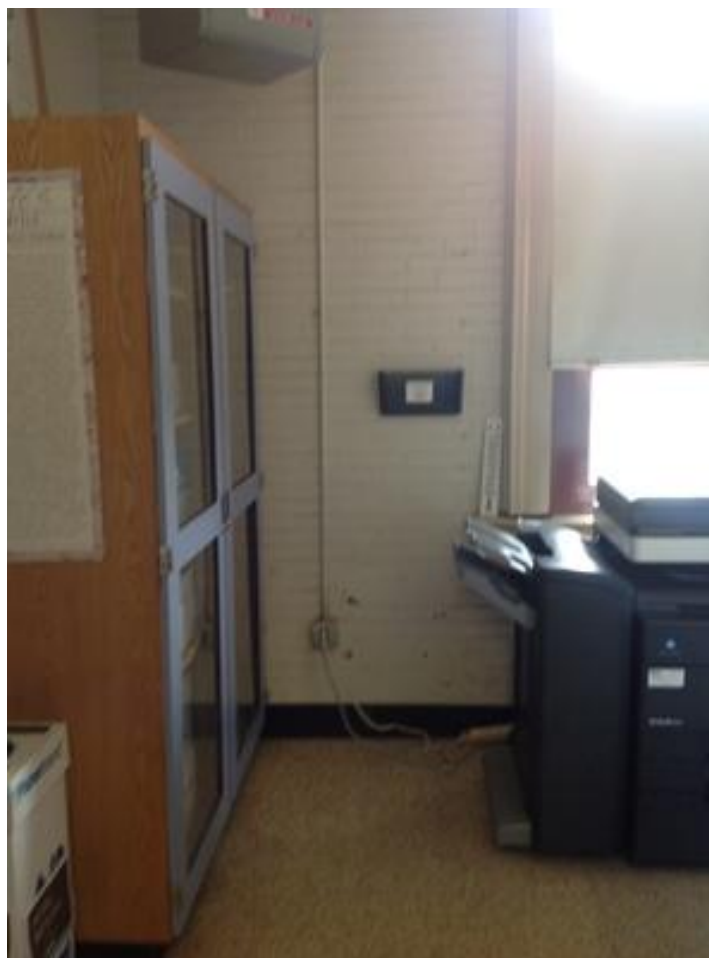
Description
Wood flooring in good condition but creaky. Paint is chipping on walls and ceiling. Light fixtures missing covers in some locations. 2x4 ceiling is in fair condition but tiles are sagging. Surface mounted equipment and wiring is haphazard. Millwork in poor condition.

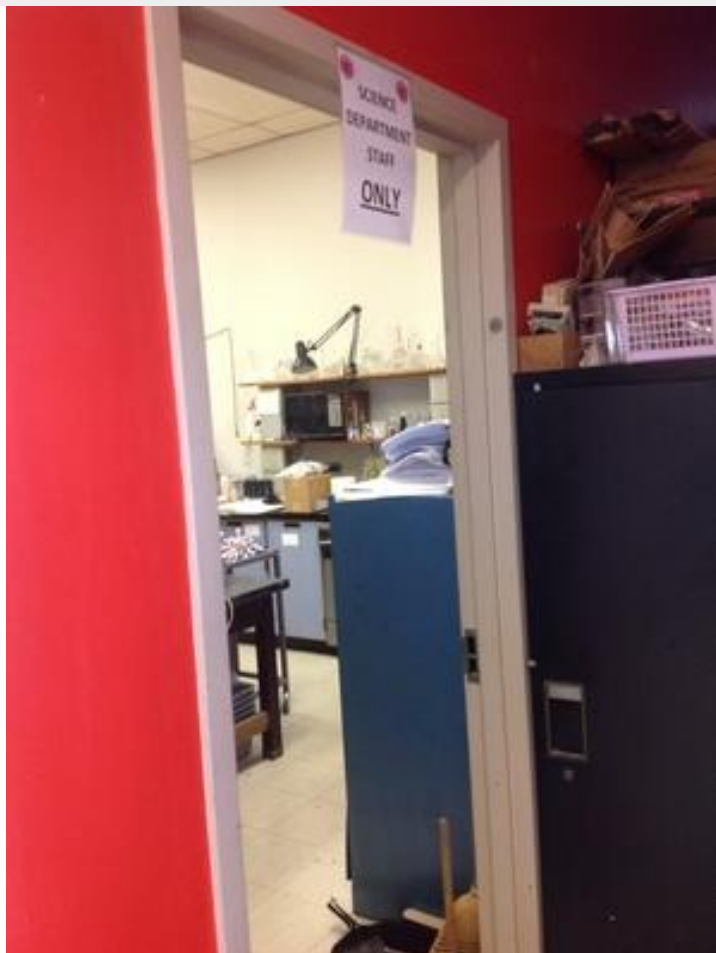
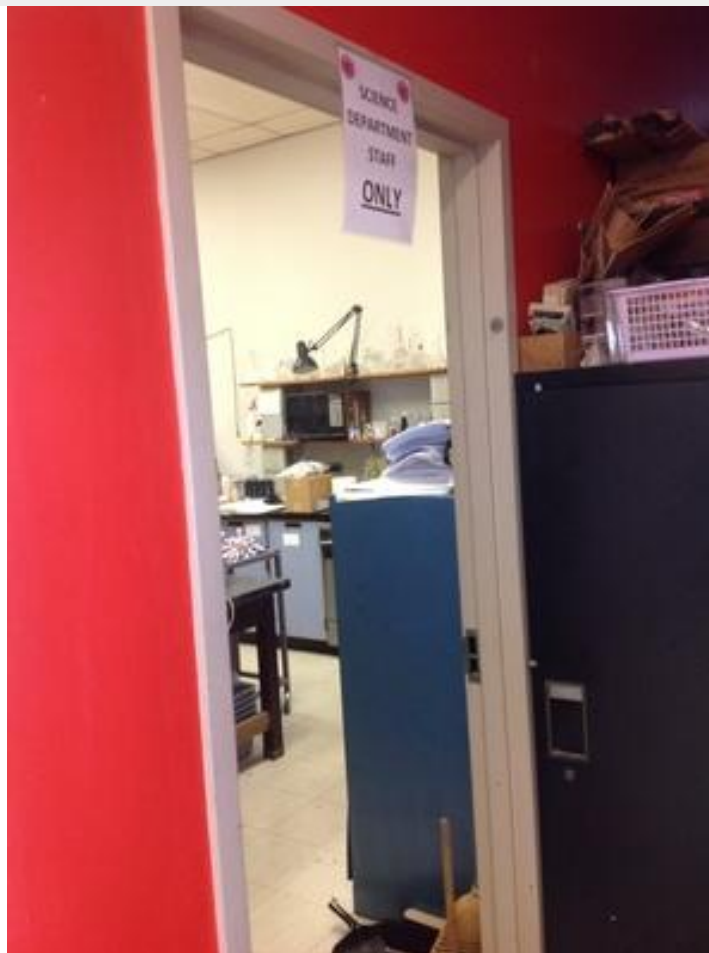
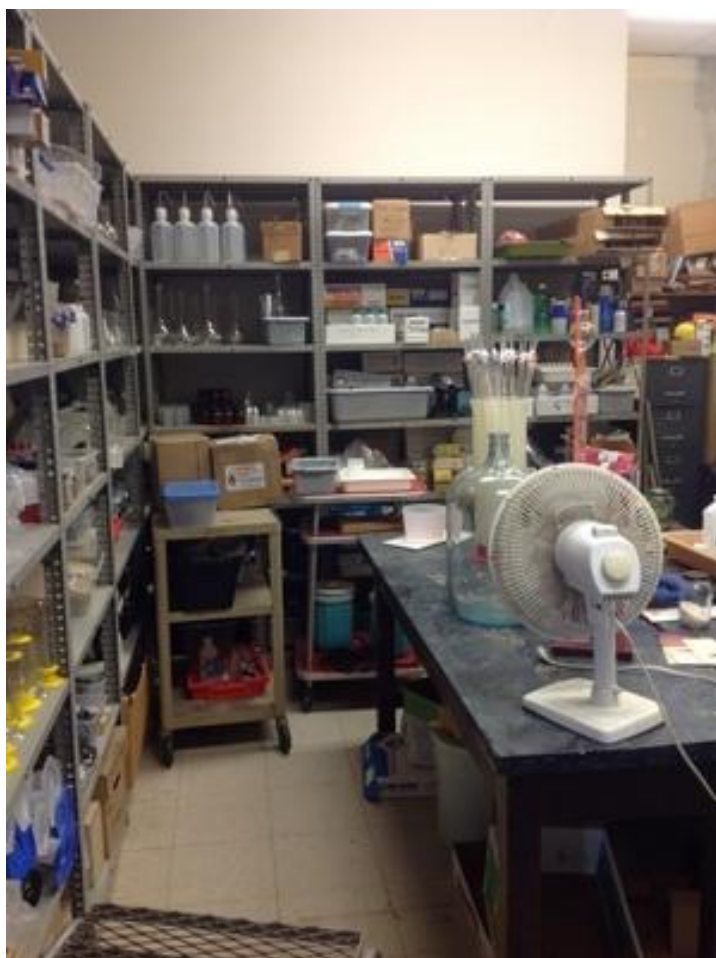
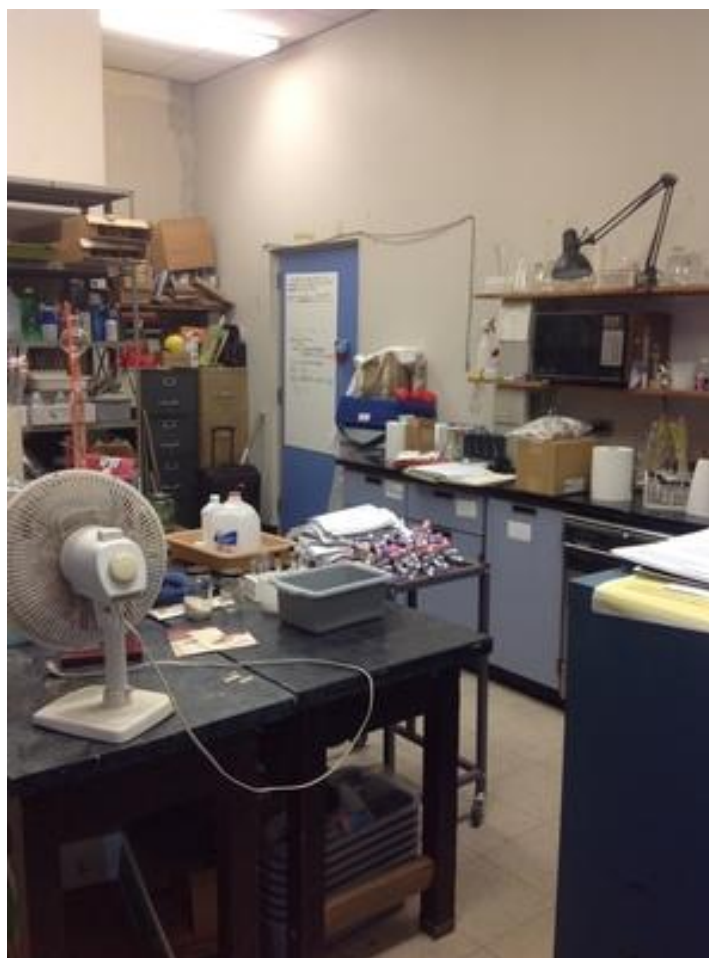
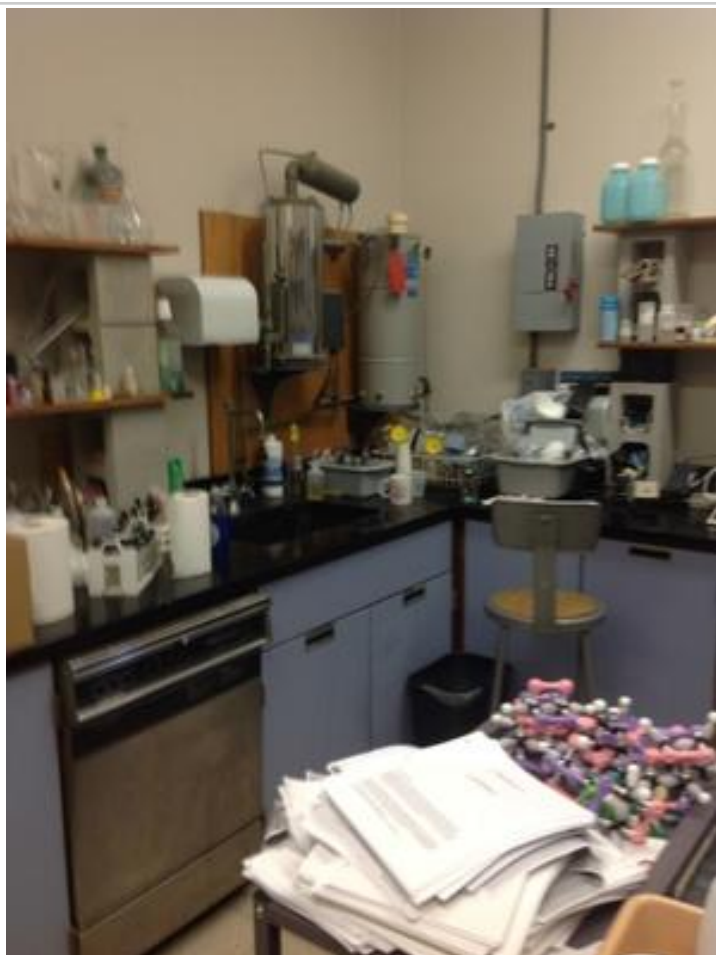
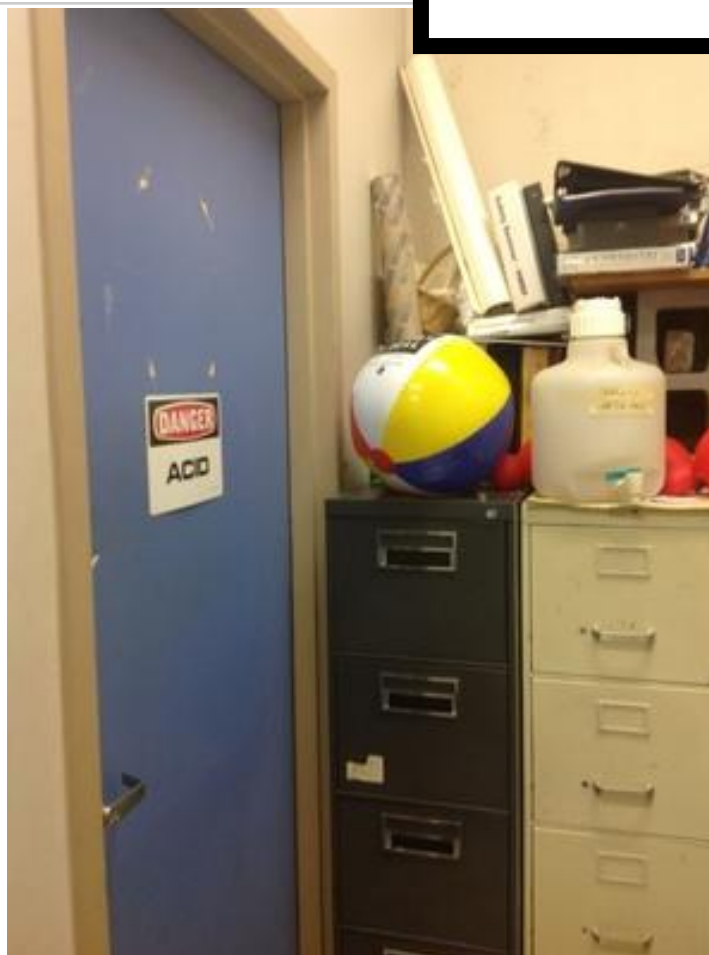
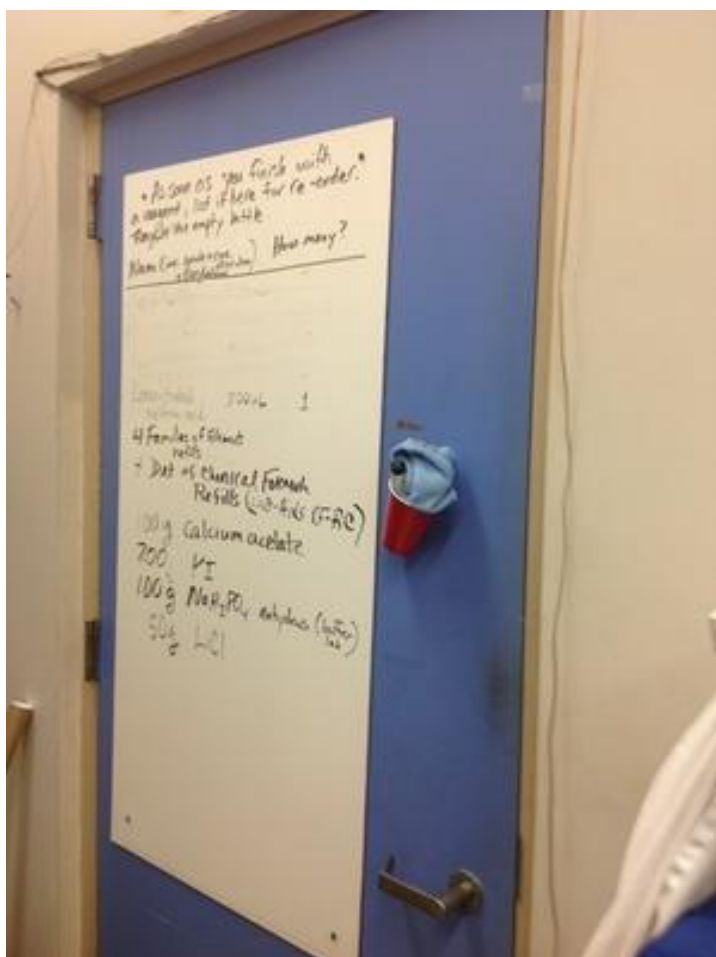
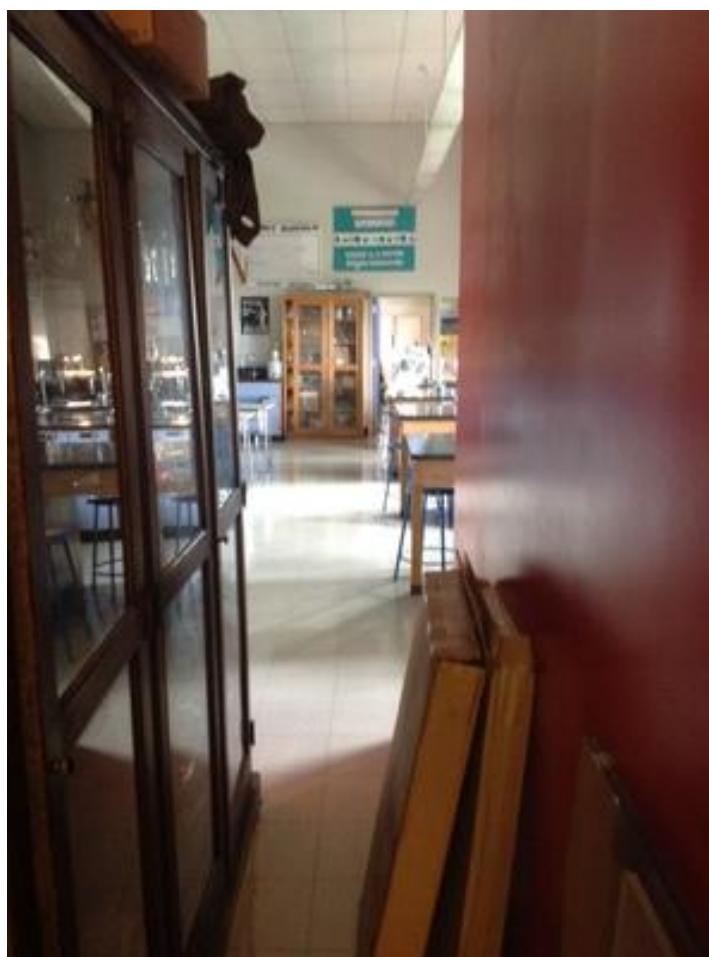
Attached Images for ID KJ-00041

VCT flooring in fair condition. Corridor does not provide adequate space for accessibility. Paint is chipping on walls. Ceiling 2x4 ACT in fair condition.

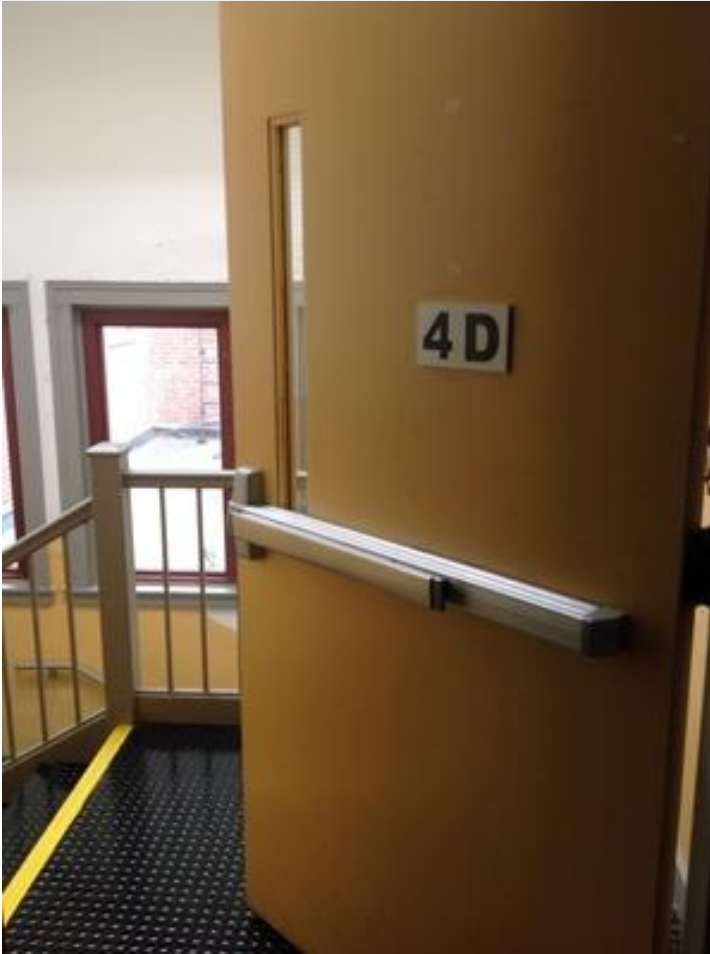
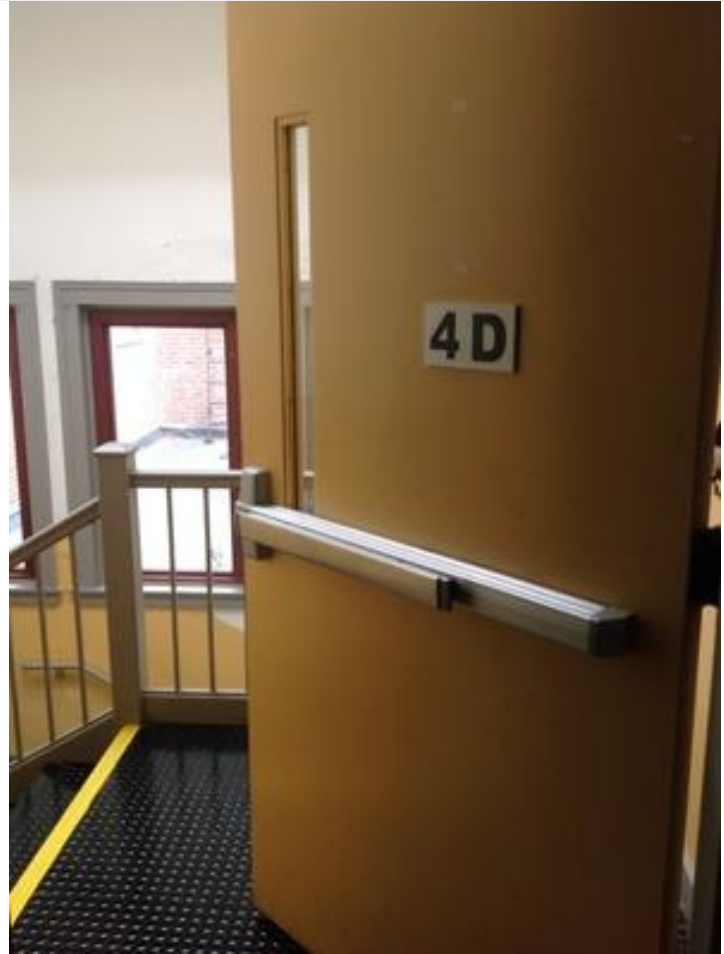
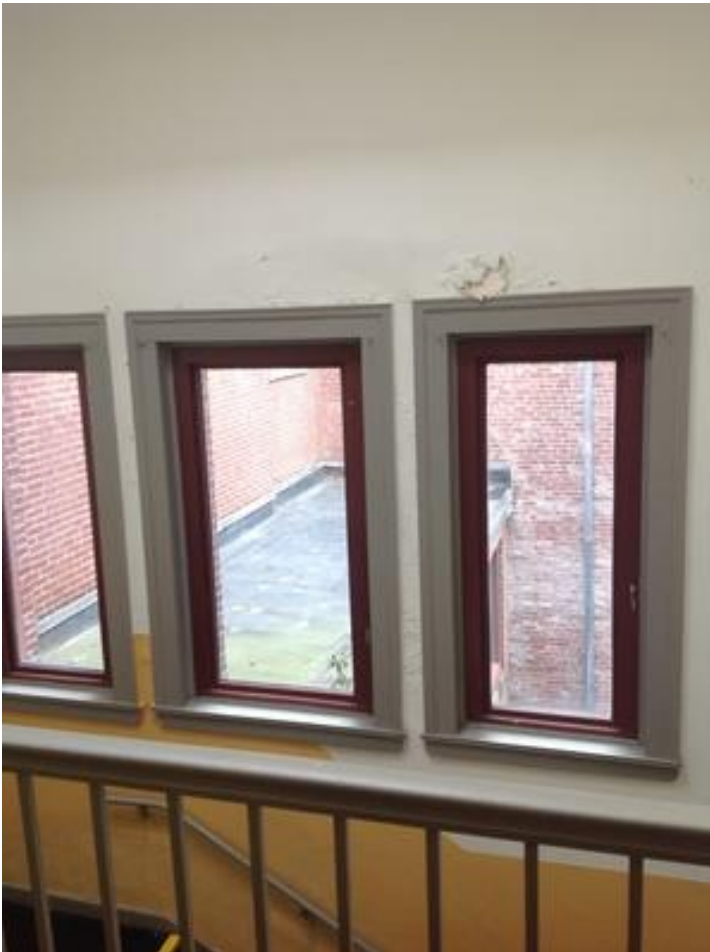
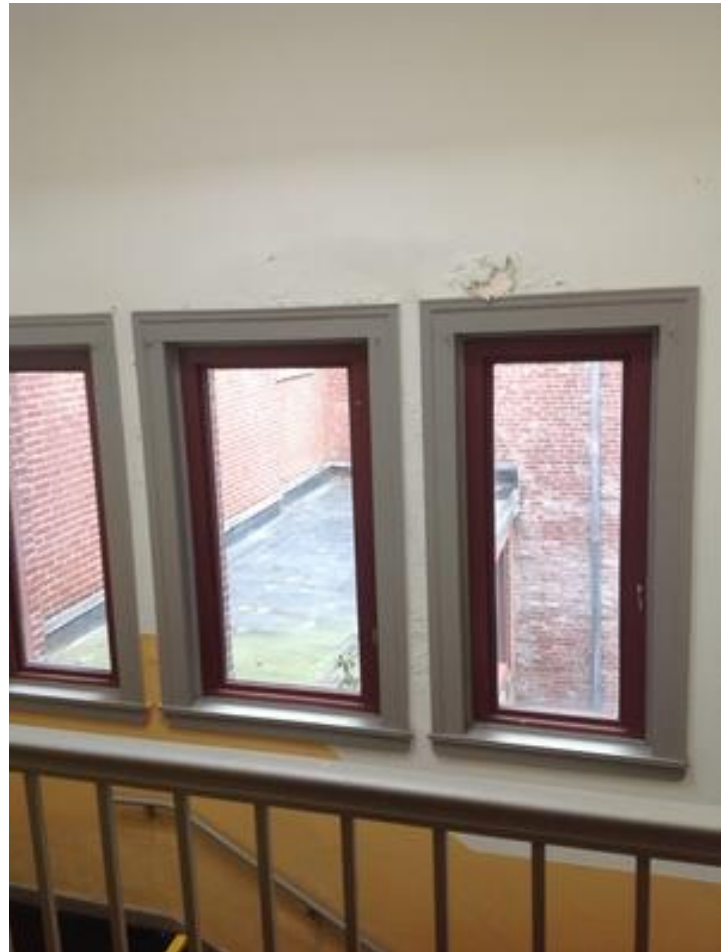
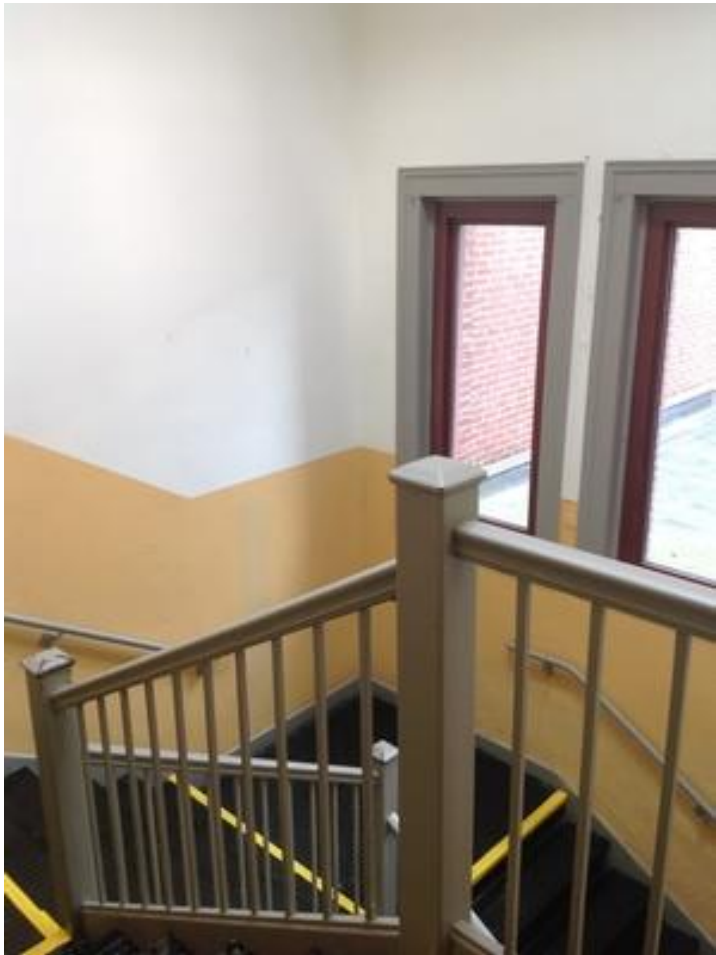
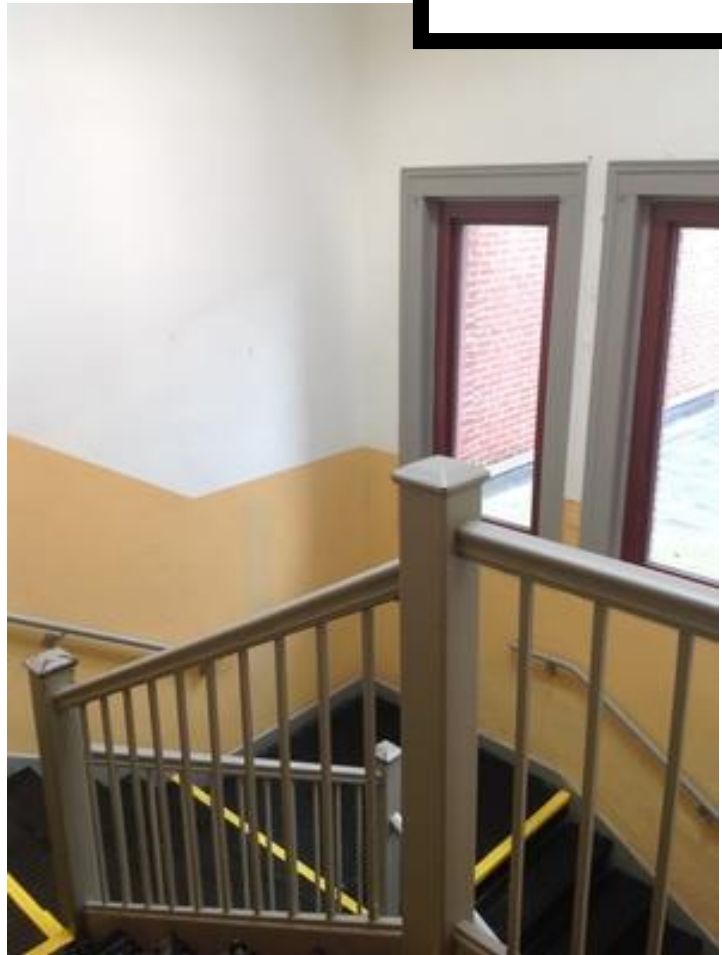
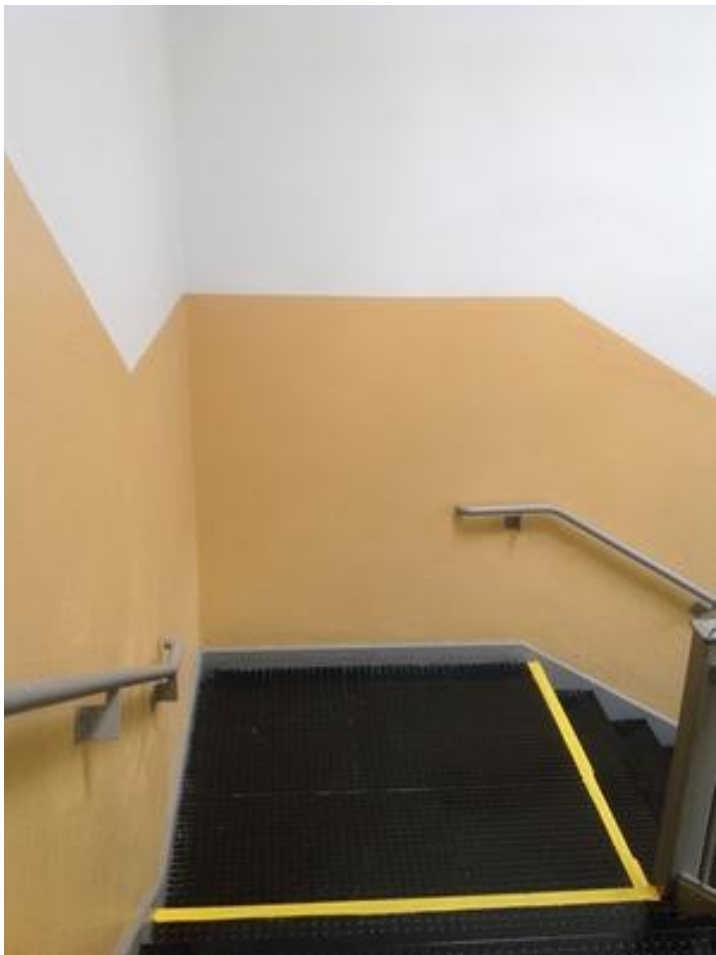
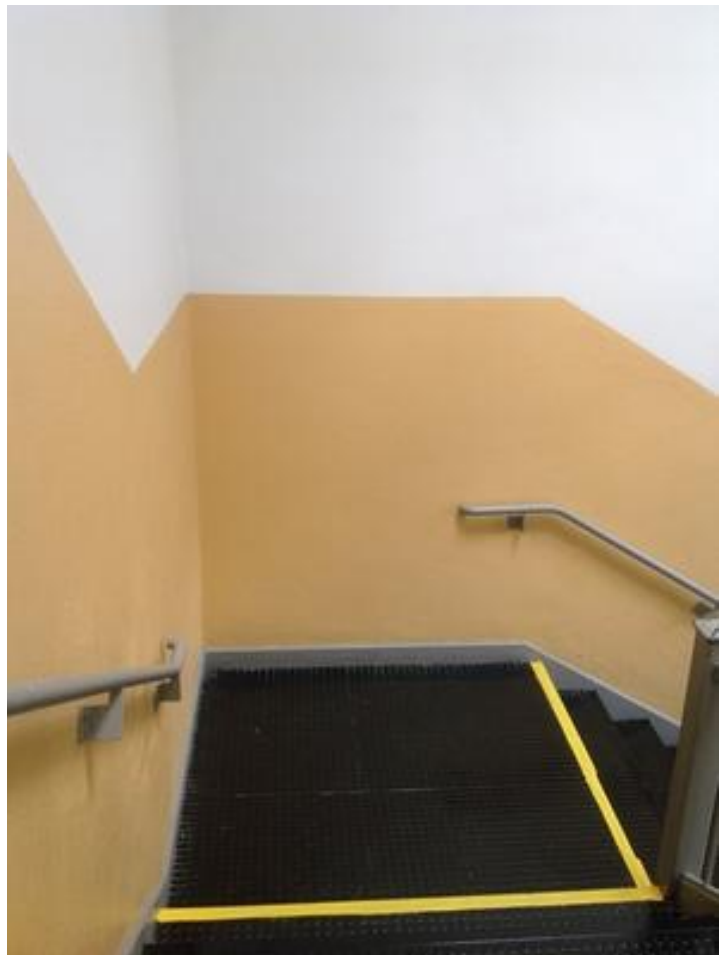
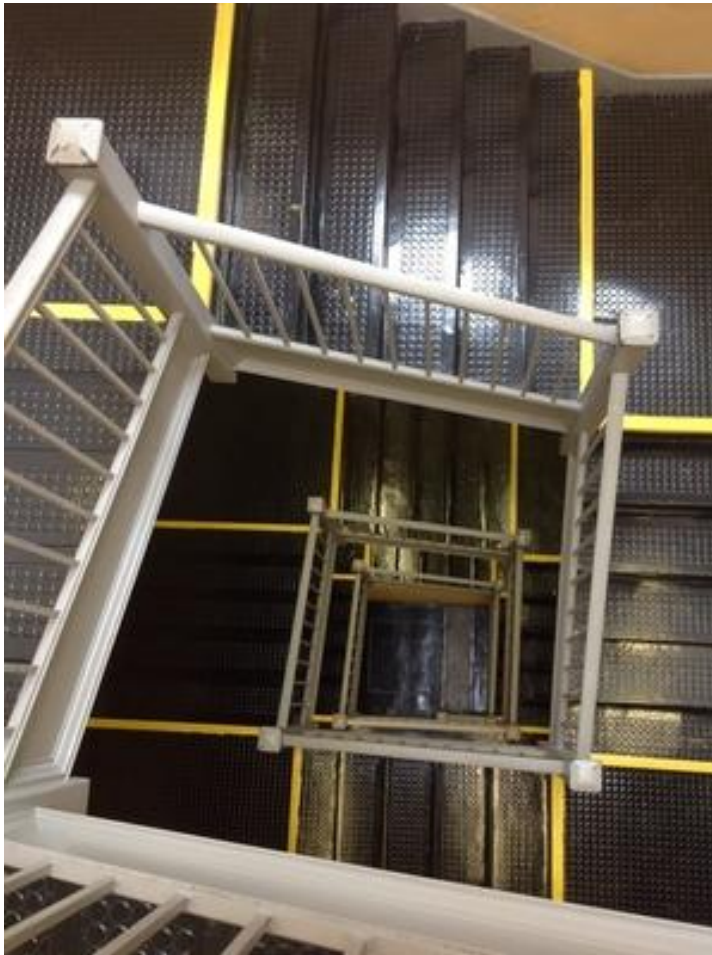
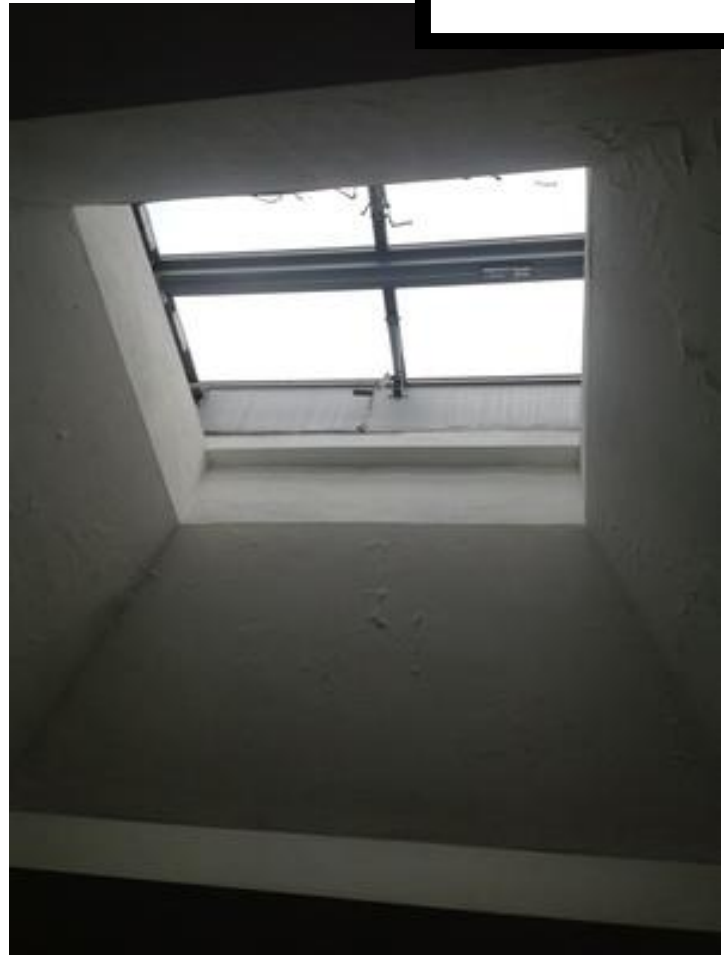
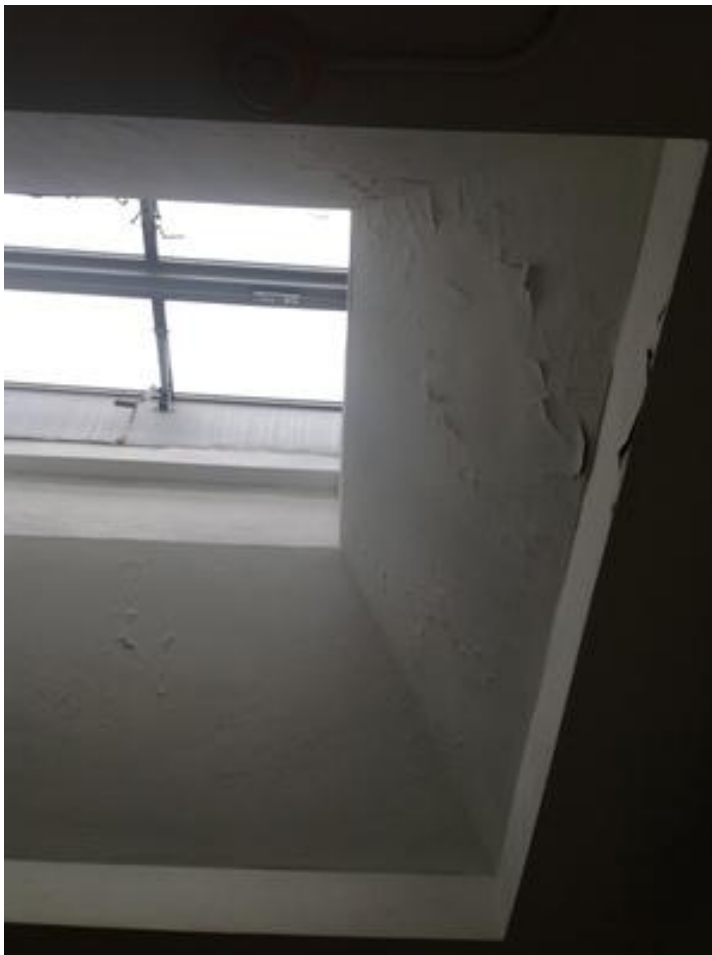
Attached Images for ID KJ-00042

Stair 4D in fiar condition. Gaurd/hand rails to not meet current code. Ceiling at smoke hatch has considerable paint chipping and evidence of water infiltration
