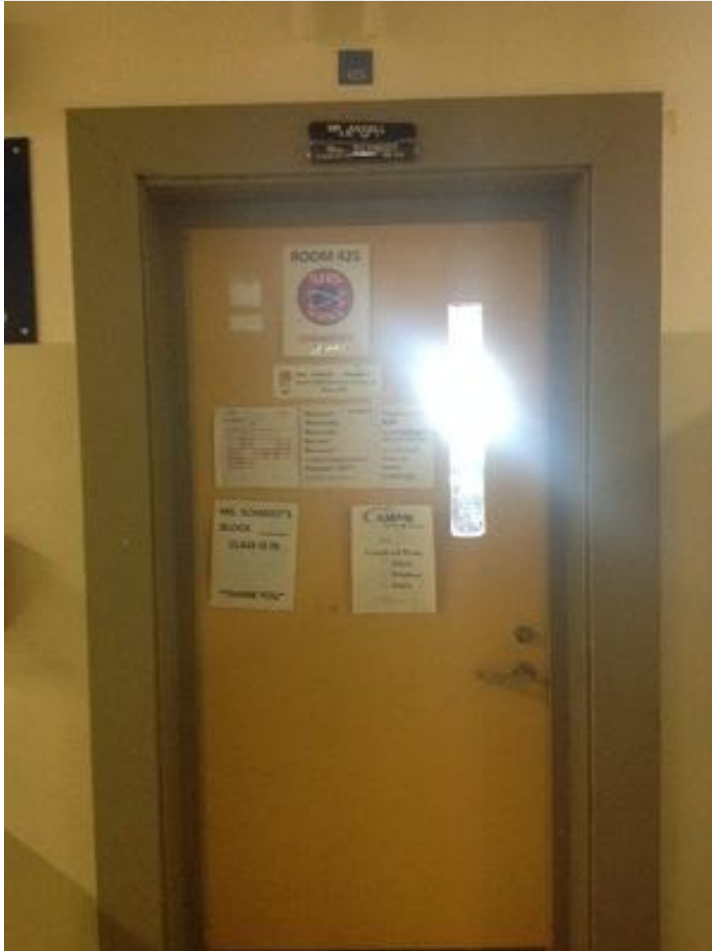
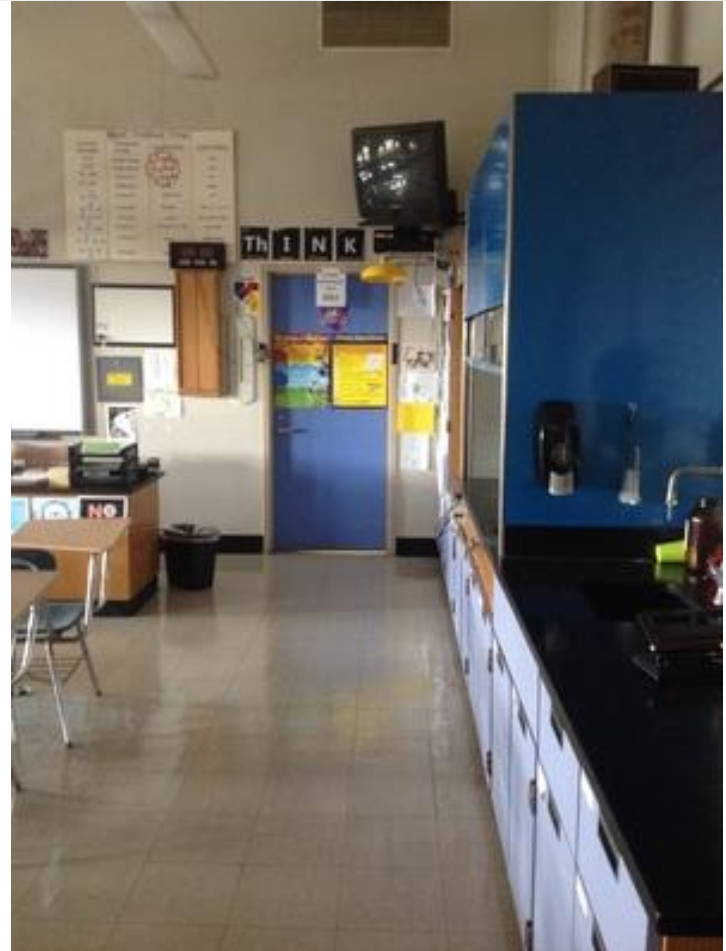
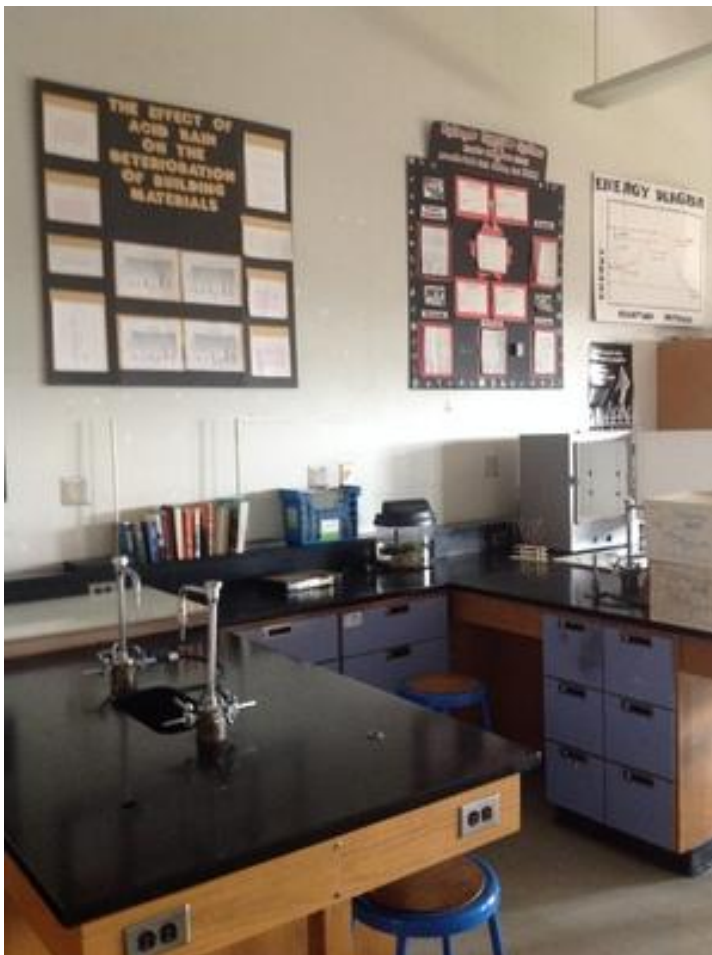
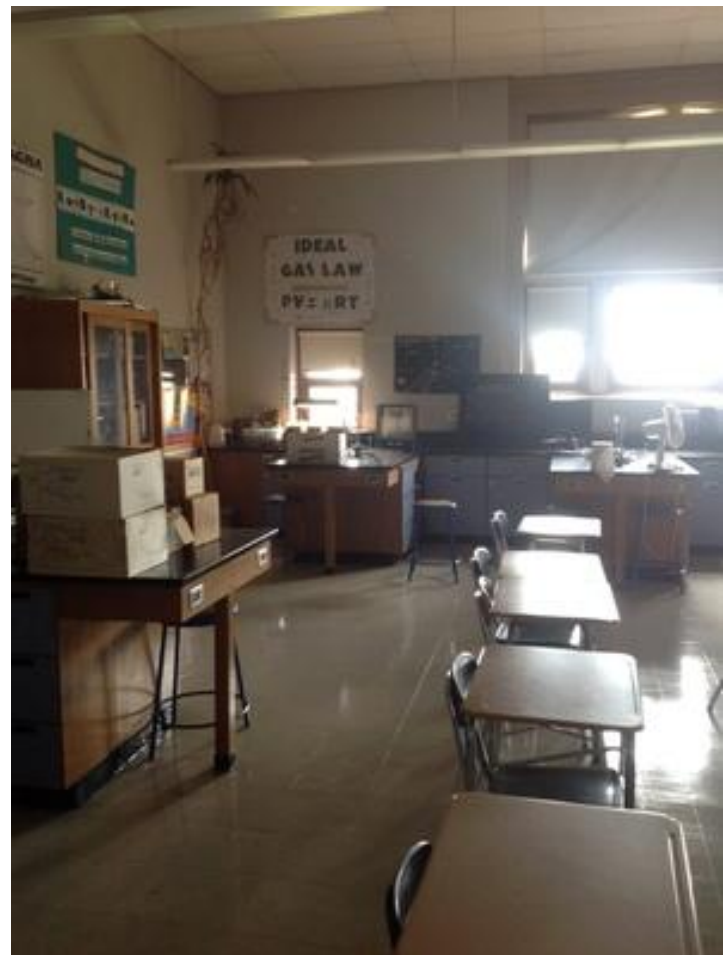
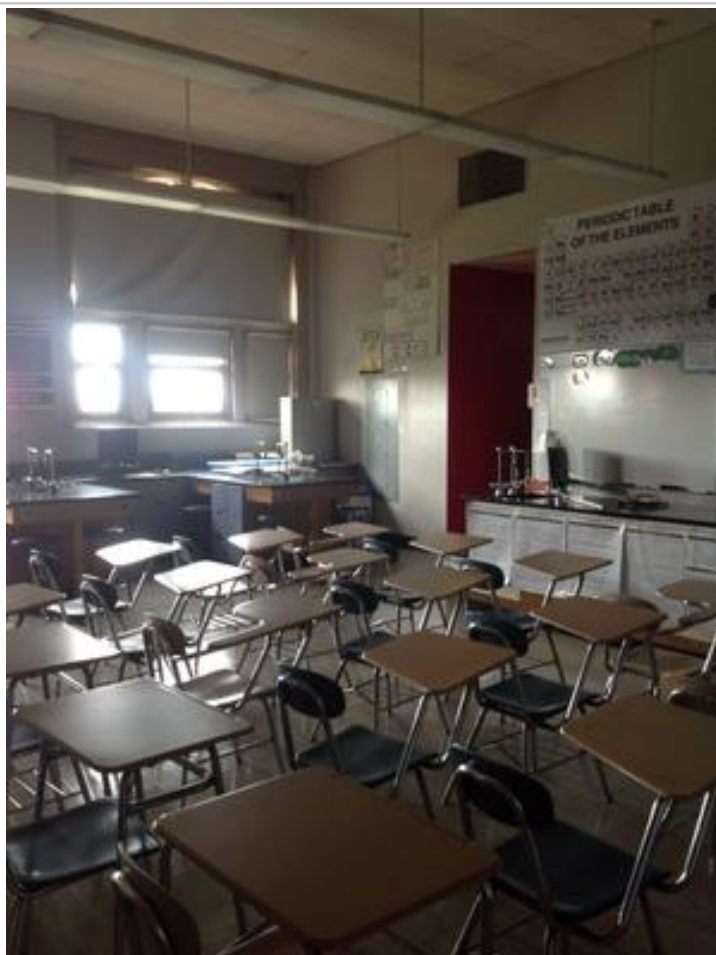
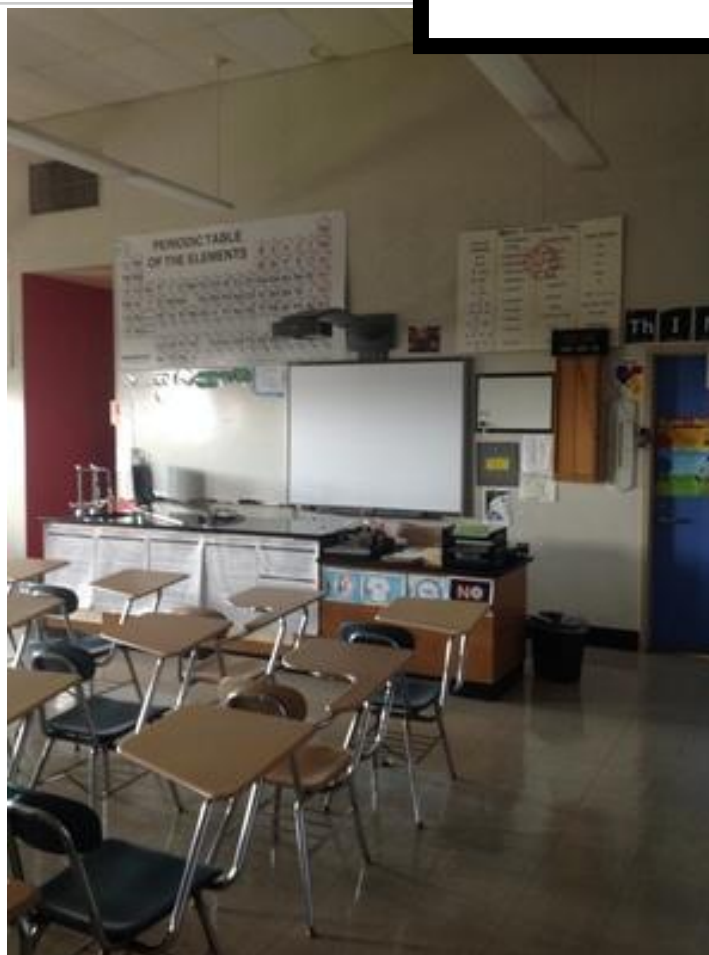
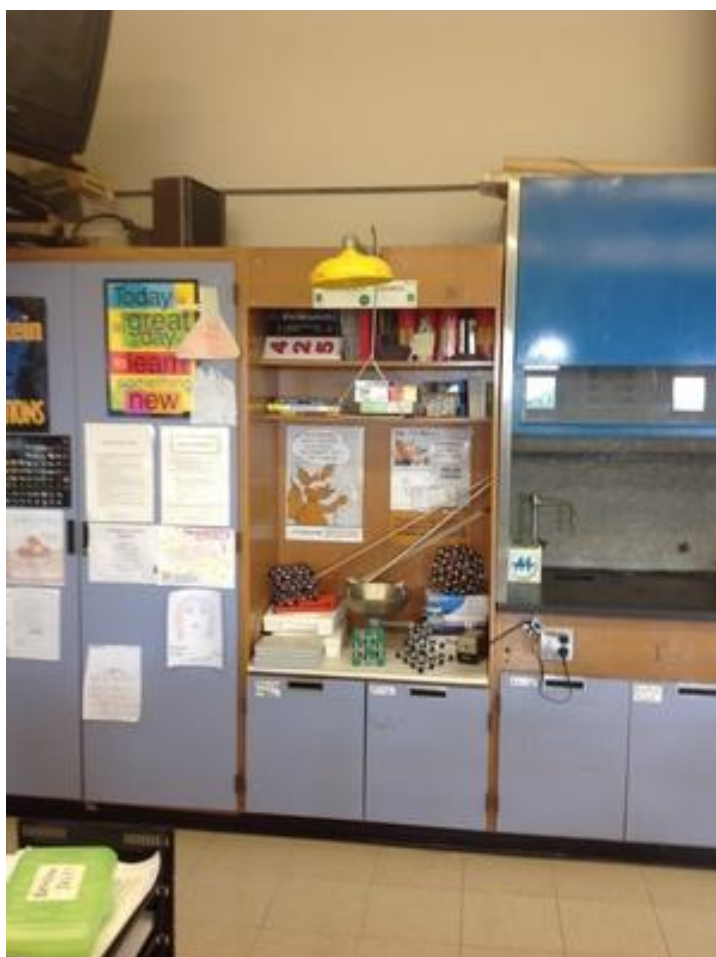
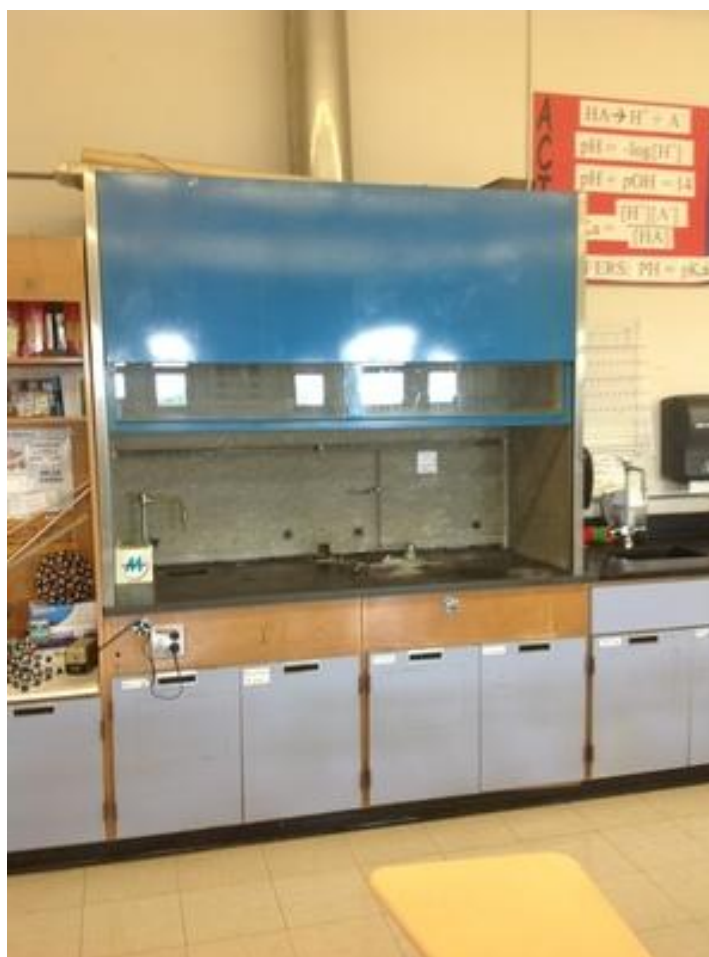
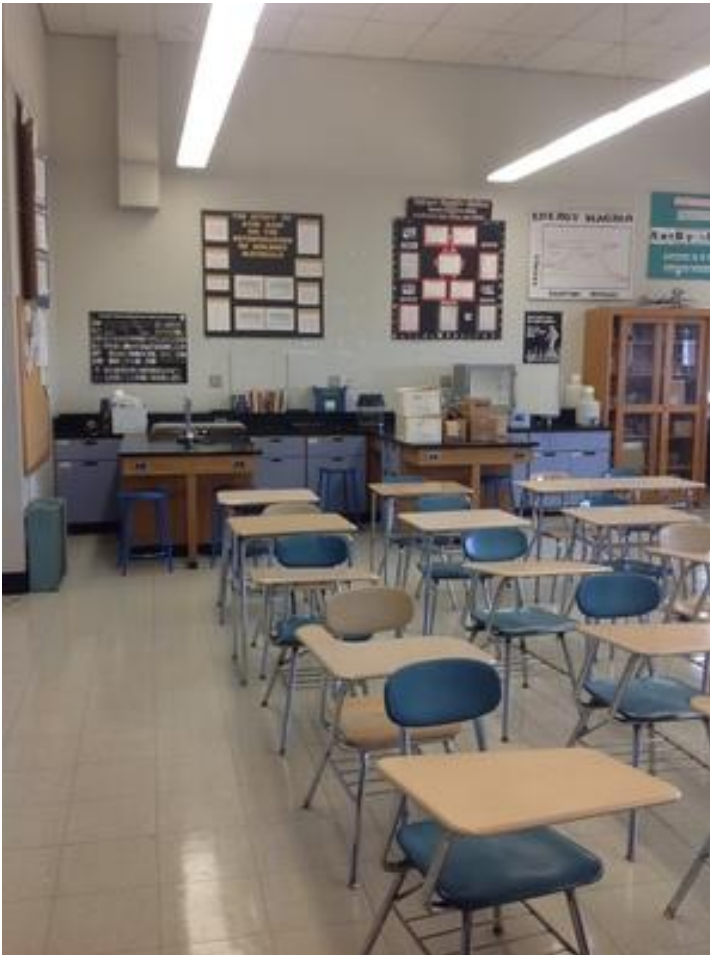
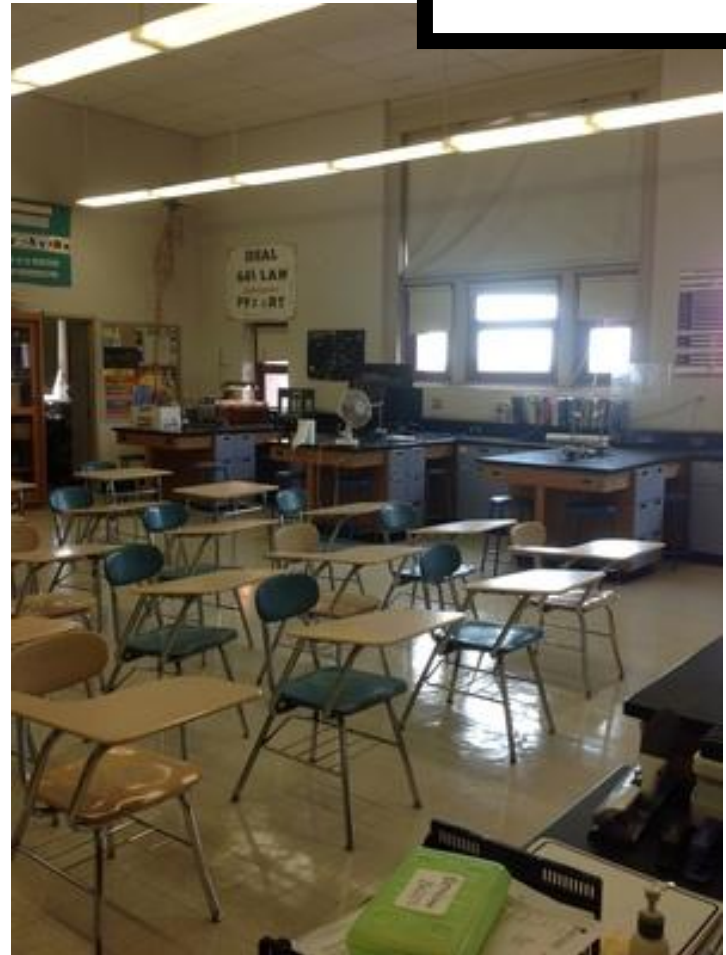
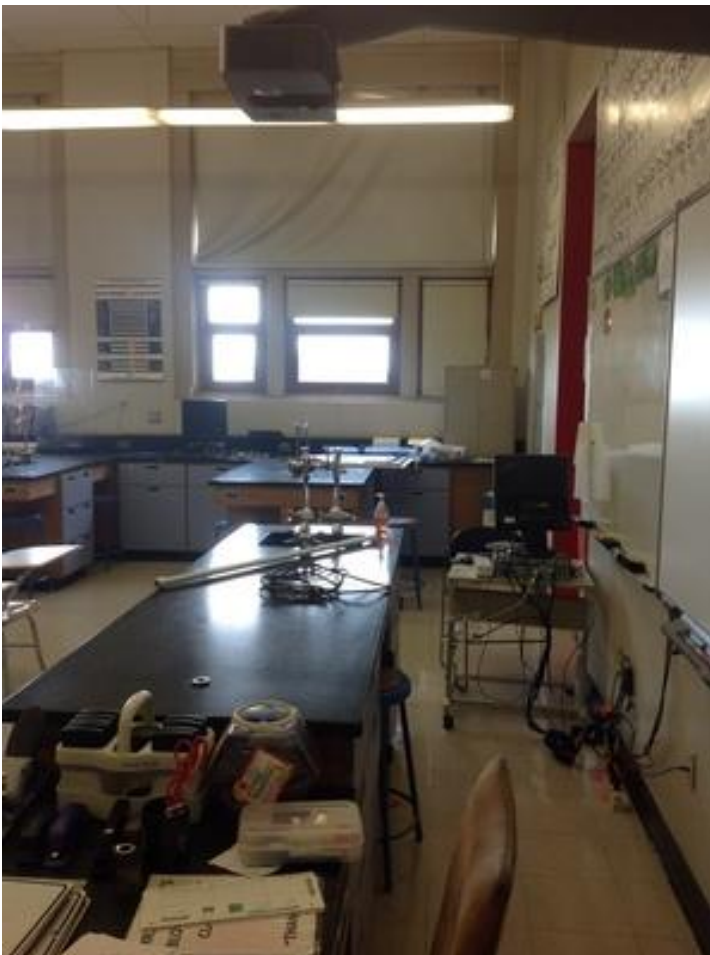
Attached Images for ID KJ-00044

VCT flooring in fair condition. Paint is chipping on walls. 2x4 ACT ceiling in fair condition. Surface mounted equipment and wiring is haphazard. Shades are in poor condition. Millwork in poor condition. Unit heater in poor condition. Some windows have lost their seal. Classroom has smartboard.

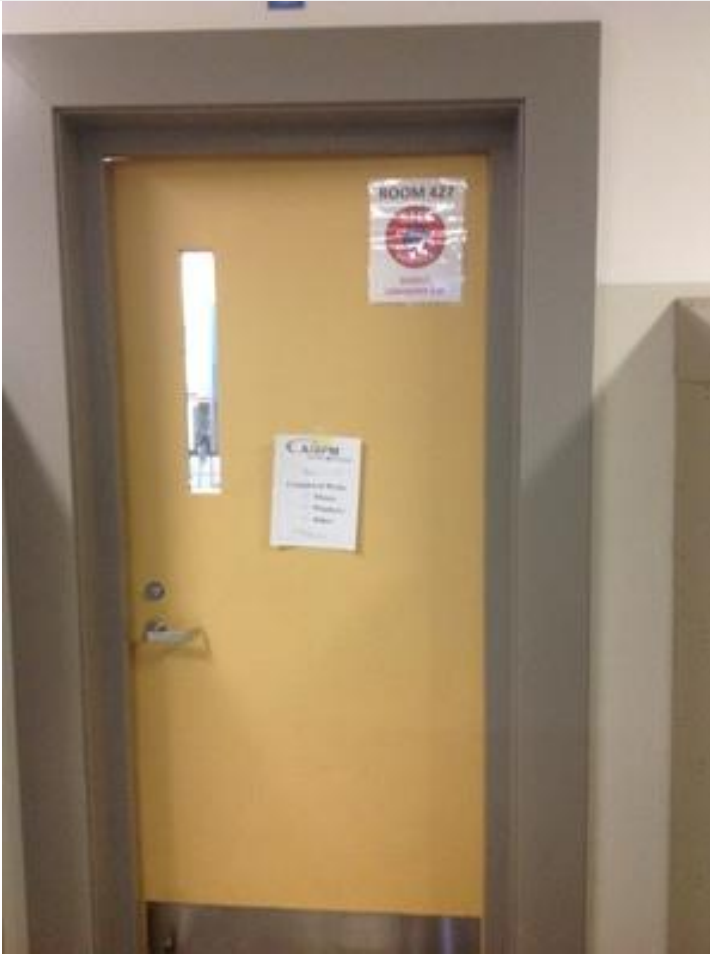
Attached Images for ID KJ-00046

Wood flooring in good condition but creaky. Paint is chipping on walls and ceiling. Light fixtures missing covers in some locations. Surface mounted equipment and wiring is haphazard. Millwork in poor condition.

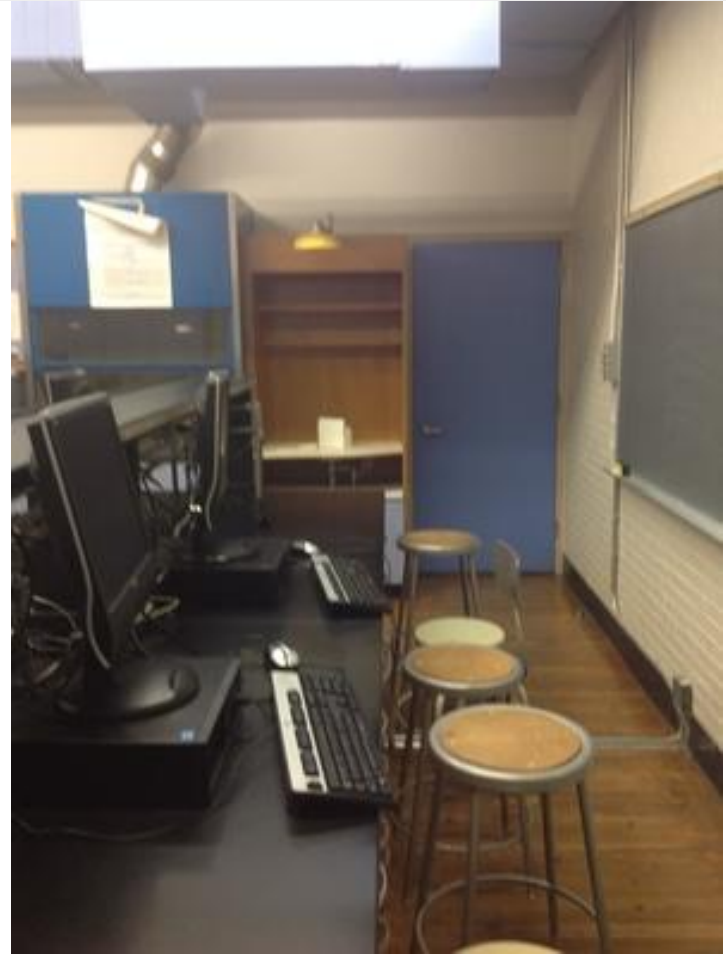
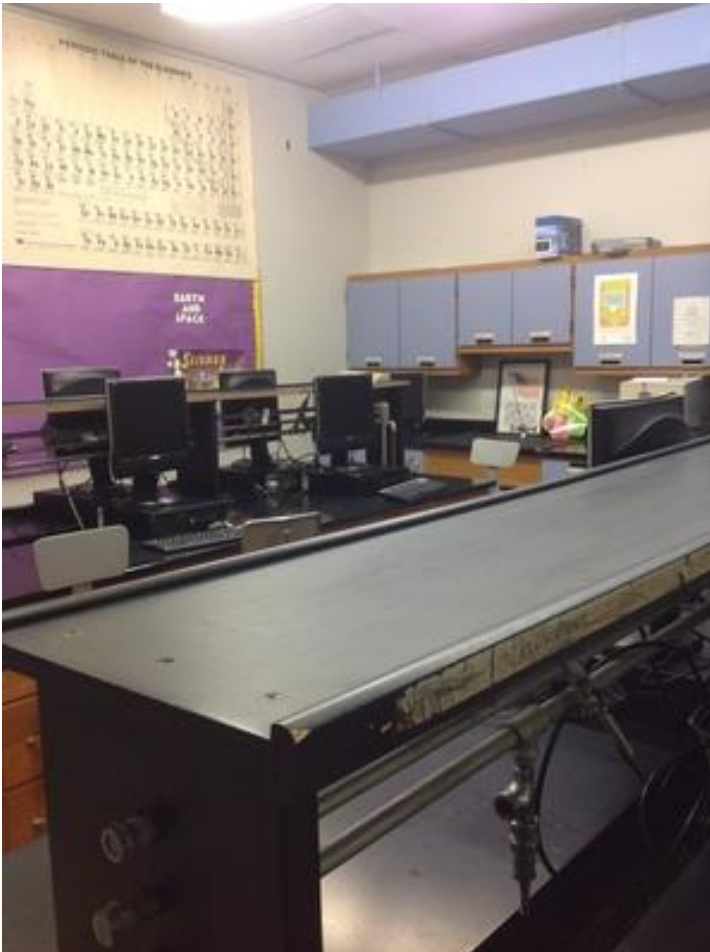
Ceiling has water damage. Wood flooring in good condition but creaky. Paint is chipping on walls and ceiling. Surface mounted equipment and wiring is haphazard. Shades are in poor condition. Millwork in poor condition. Unit heater in poor condition. Some windows have lost their seal. Classroom has smartboard.

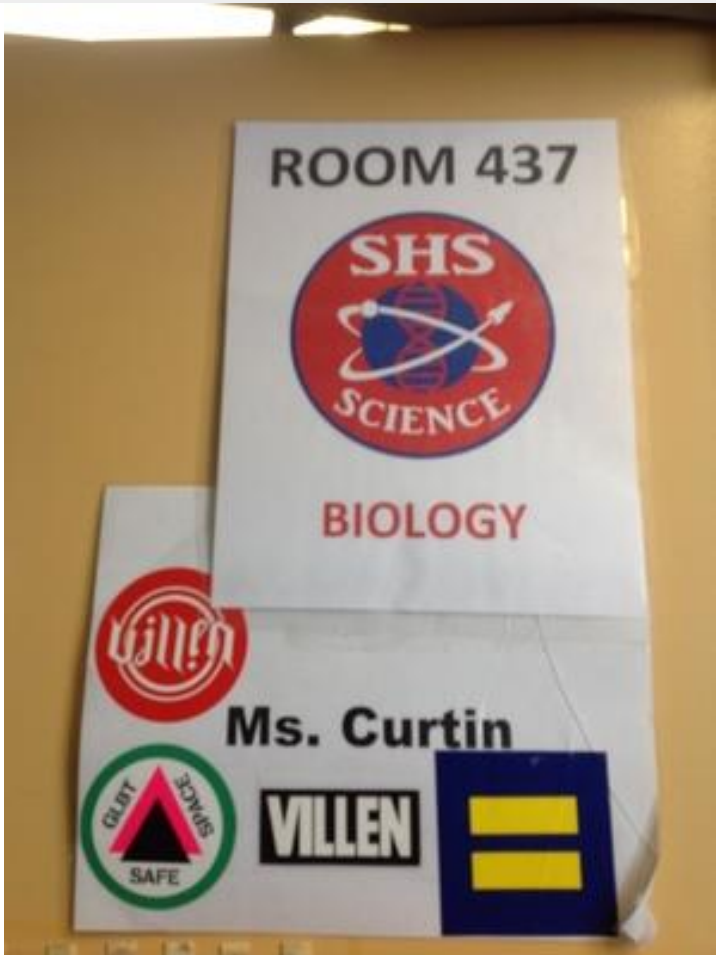
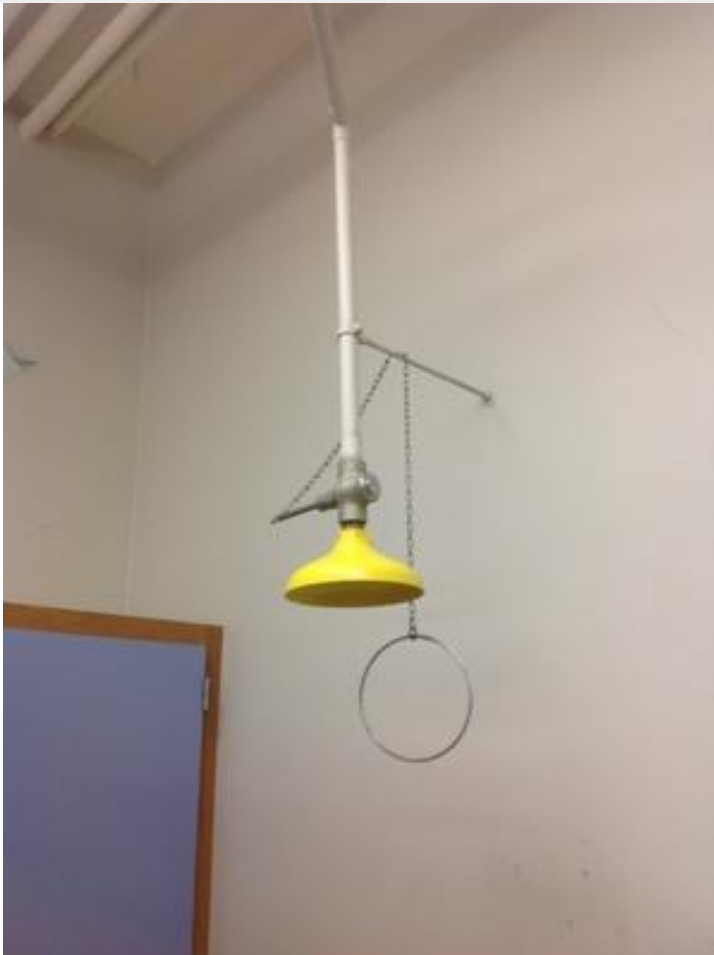
Attached Images for ID KJ-00048

Wood flooring in good condition but creaky. Paint is chipping on walls and ceiling. Light fixtures missing covers in some locations. 2x4 ACT in fair condition. Surface mounted equipment and wiring is haphazard. Shades are in poor condition. Millwork in poor condition - significant warping of countertops. Unit heater in poor condition. Some windows have lost their seal. Classroom has smartboard.

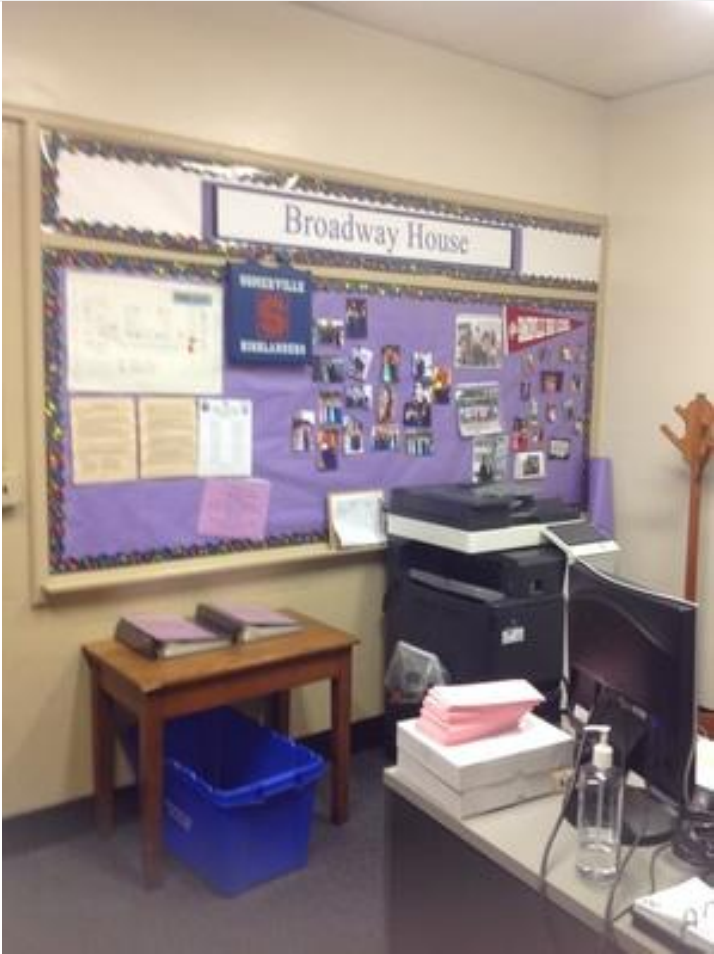
Attached Images for ID KJ-00053

Description
Office in fair condition. VCT flooring in fair condition. Door swing into corridor is a code violation. Paint is chipping/peeling on walls and ceiling. Shades are in poor condtion. Unit heater in poor condtion.

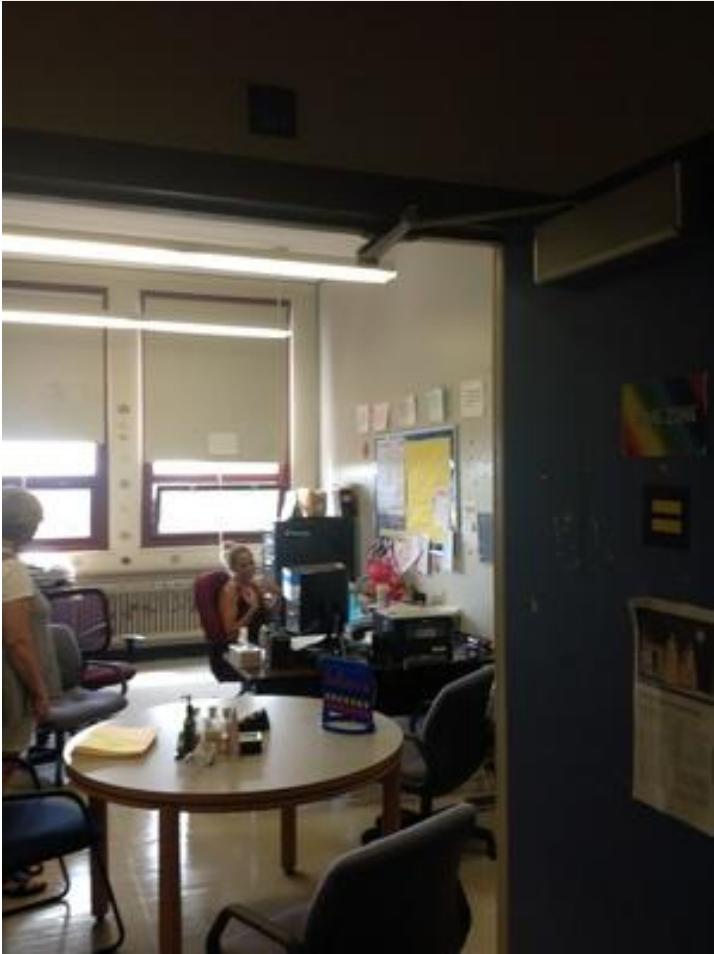
Attached Images for ID KJ-00054

| Description Teacher planning 458 in fair condition. VCT in fair condition. Paint is peeling/chipping. | | | |

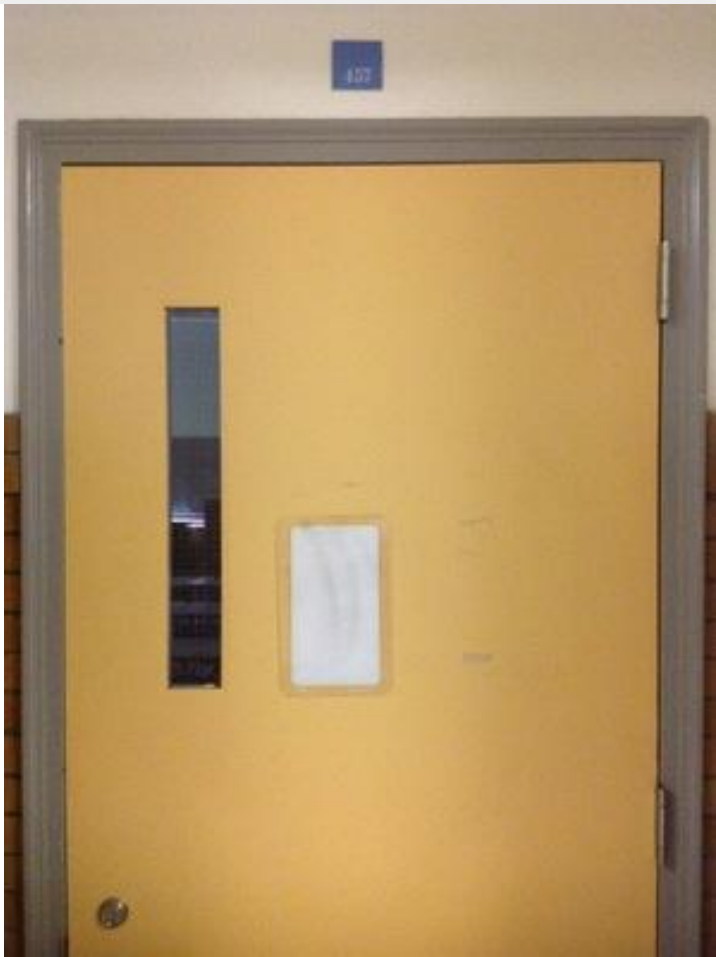
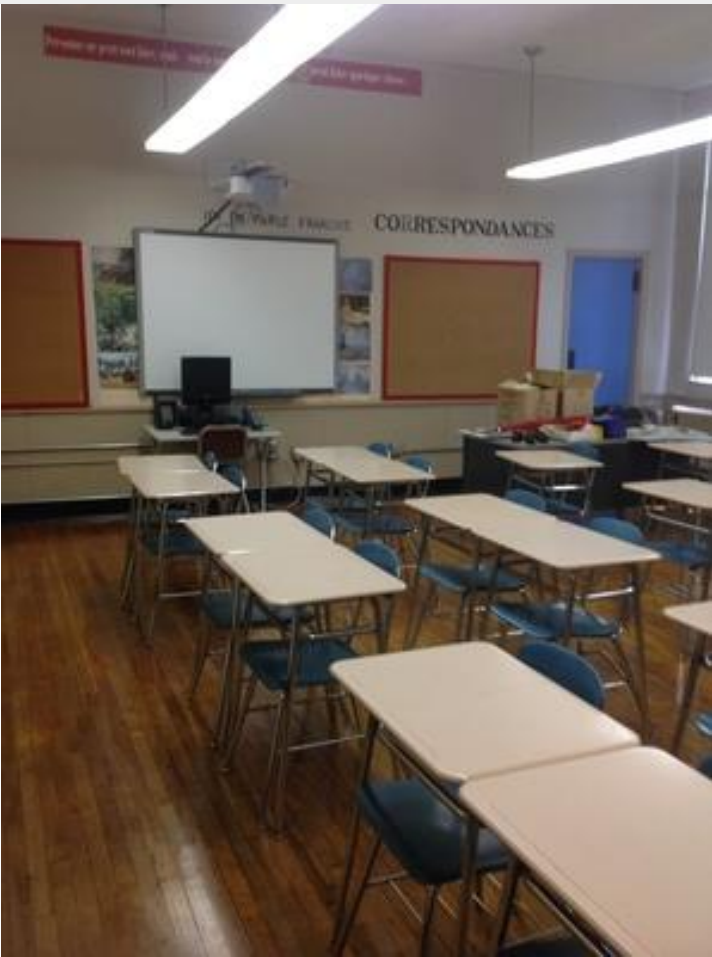
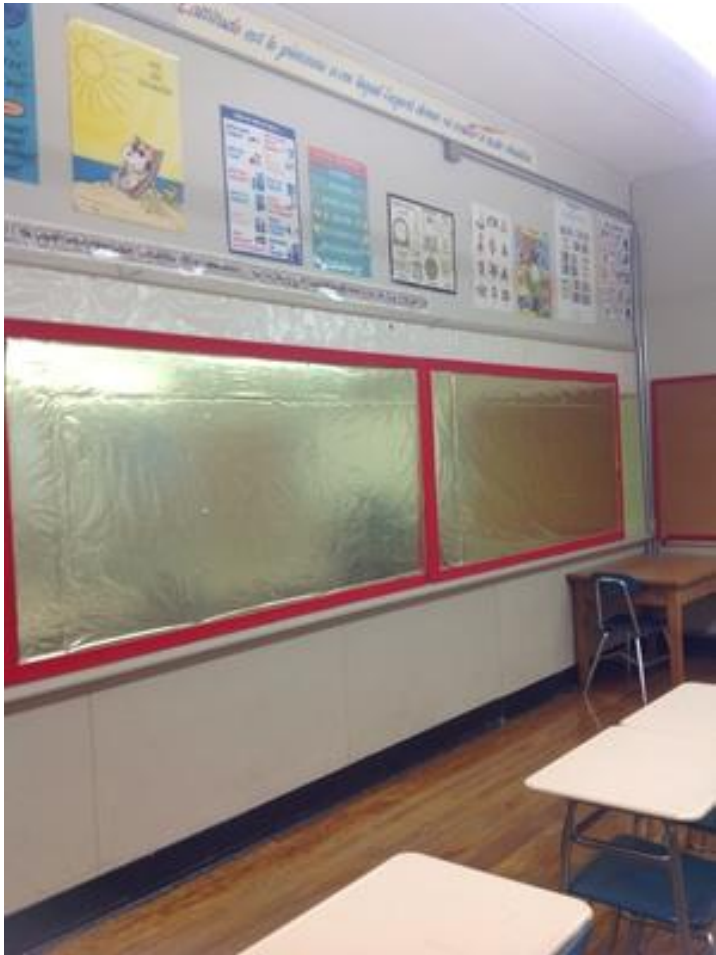
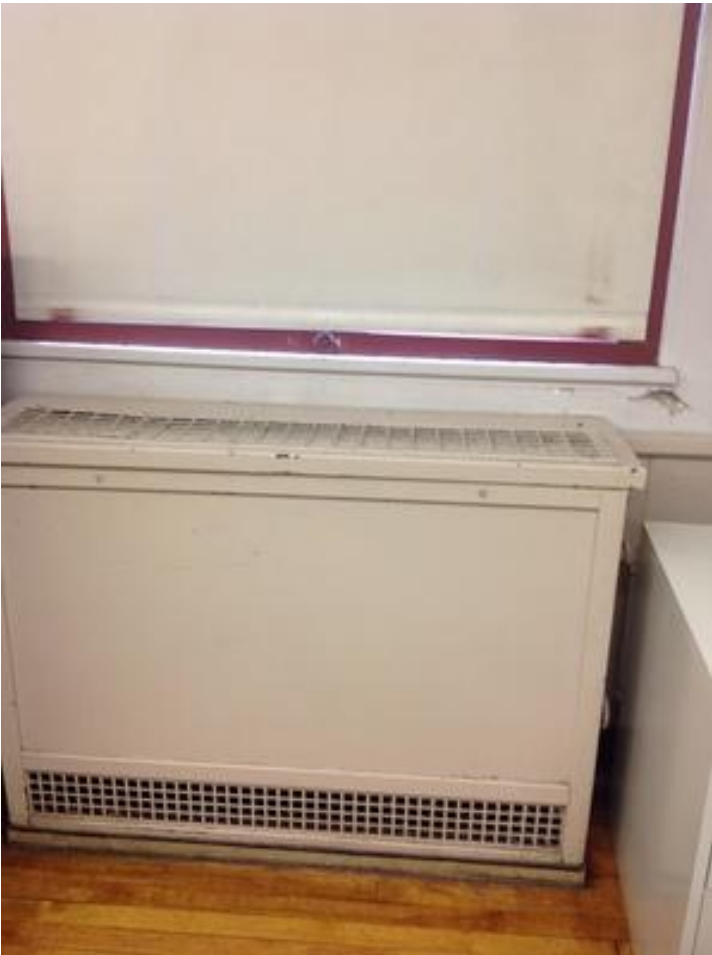
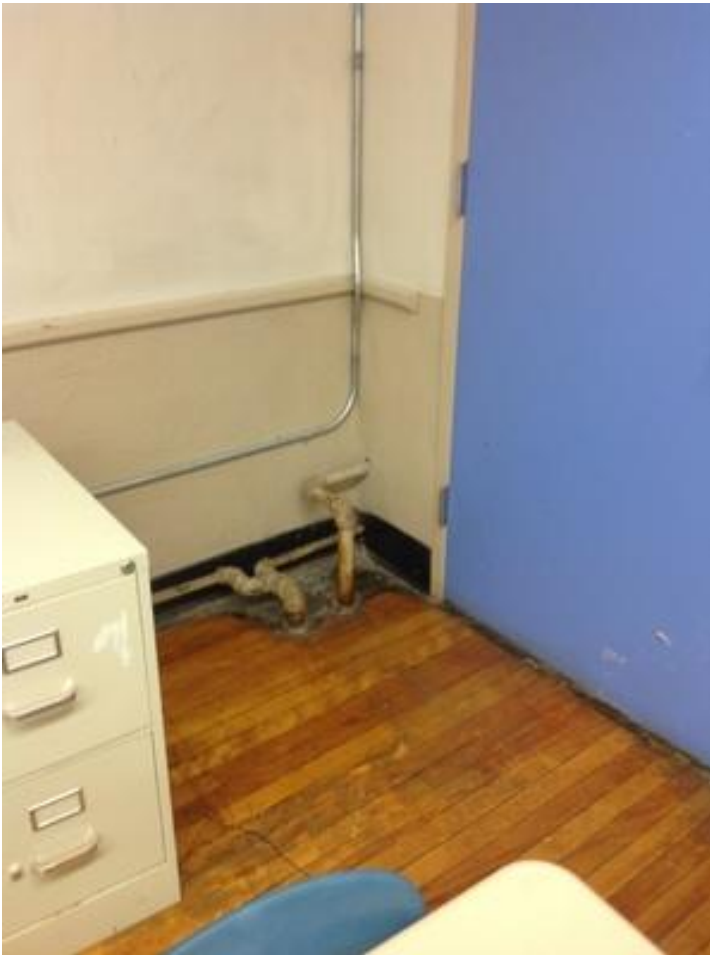
Attached Images for ID KJ-00057

Wood flooring in good condition but creaky. Paint is chipping on walls and ceiling. Light fixtures missing covers in some locations. 10'x20' area of 12"x12" VCT on ceiling. Surface mounted equipment and wiring is haphazard. Shades are in poor condition. Millwork in poor condition. Unit heater in poor condition. Some windows have lost their seal. Classroom has smartboard.

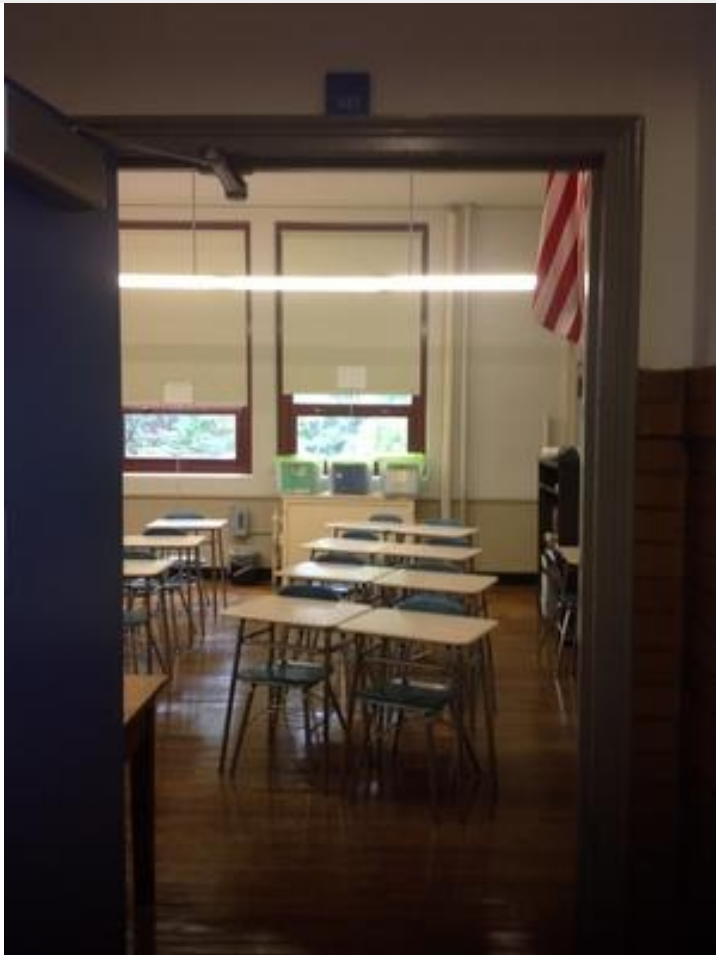
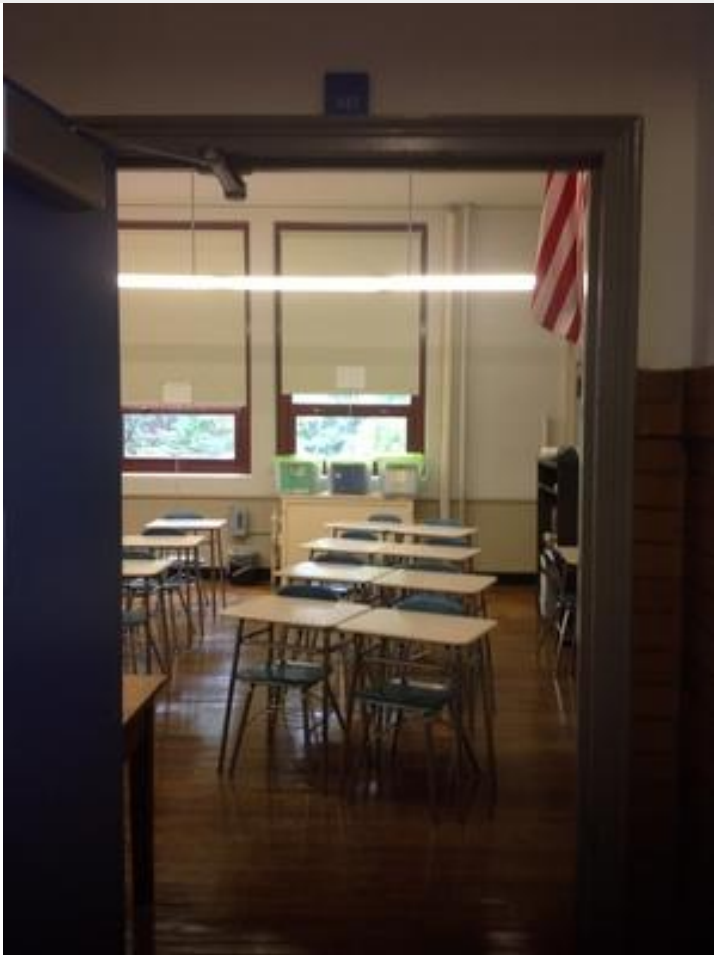
Attached Images for ID KJ-00066

Description
Wood flooring in good condition but creaky. Paint is chipping on walls and ceiling. Light fixtures missing covers in some locations. 10'x20' area of 12"x12" VCT on ceiling. Surface mounted equipment and wiring is haphazard. Shades are in poor condition. Millwork in poor condition. Unit heater in poor condition. Some windows have lost their seal. Classroom has smartboard. Movable dividing partition does not function and creates poor acoustic environment.

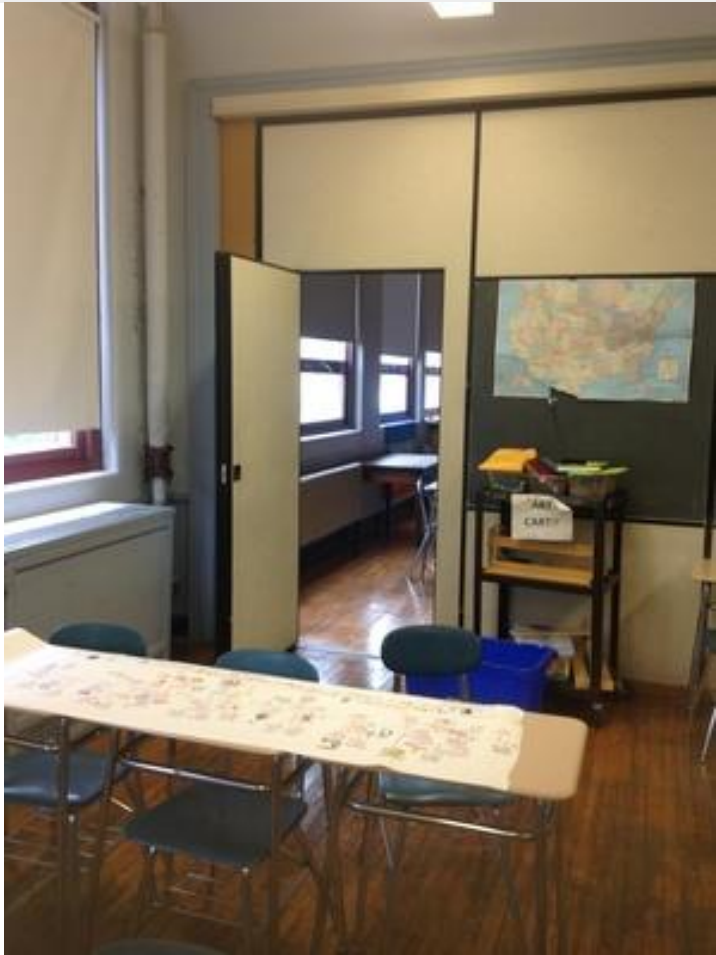
Attached Images for ID KJ-00067

| Description Wood flooring in good condition but creaky. Paint is chipping on walls and ceiling. Light fixtures missing covers in some locations. 10'x20' area of 12"x12" VCT on ceiling. Surface mounted equipment and wiring is haphazard. Shades are in poor condition. Millwork in poor condition. Unit heater in poor condition. Some windows have lost their seal. Classroom has smartboard. Movable dividing partition does not function and creates poor acoustic environment. | | | |

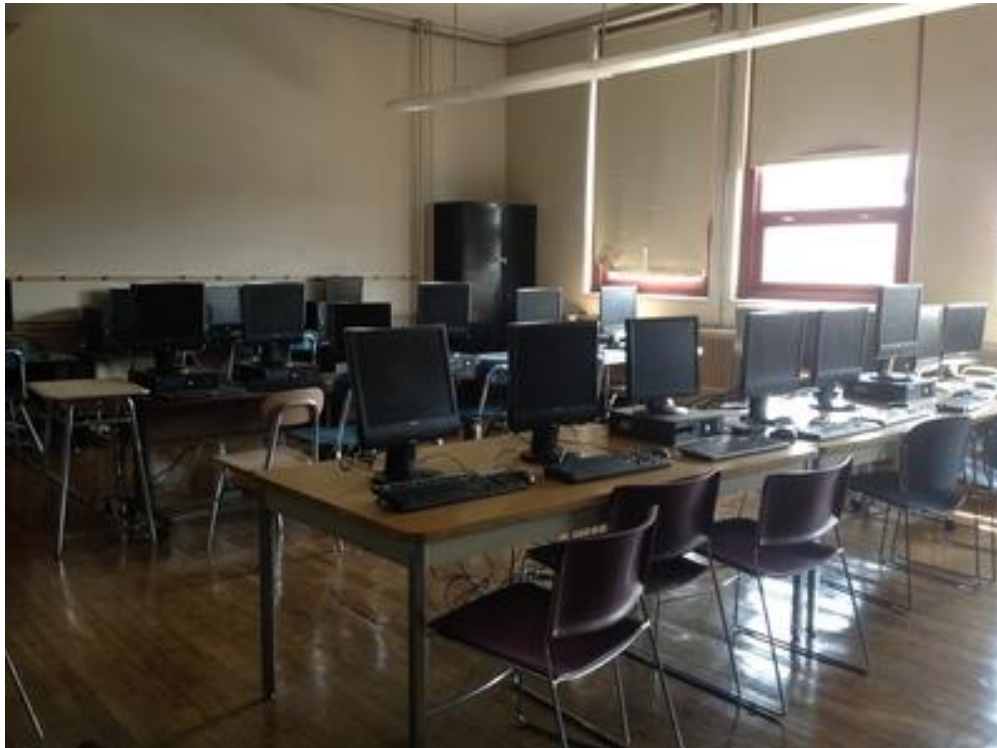
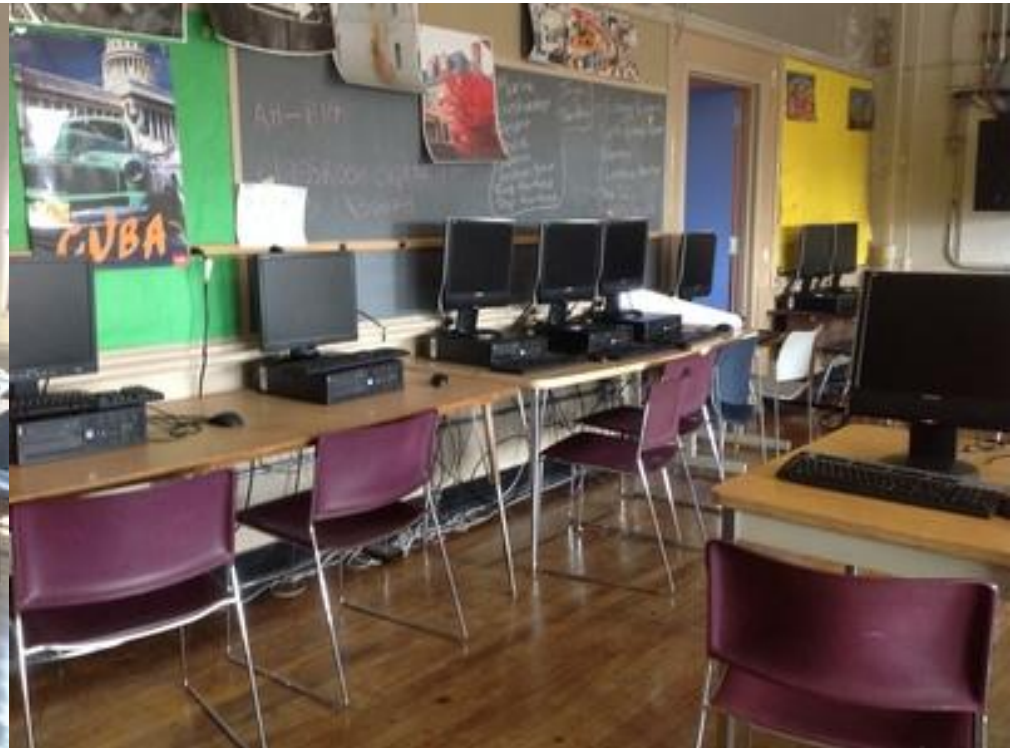
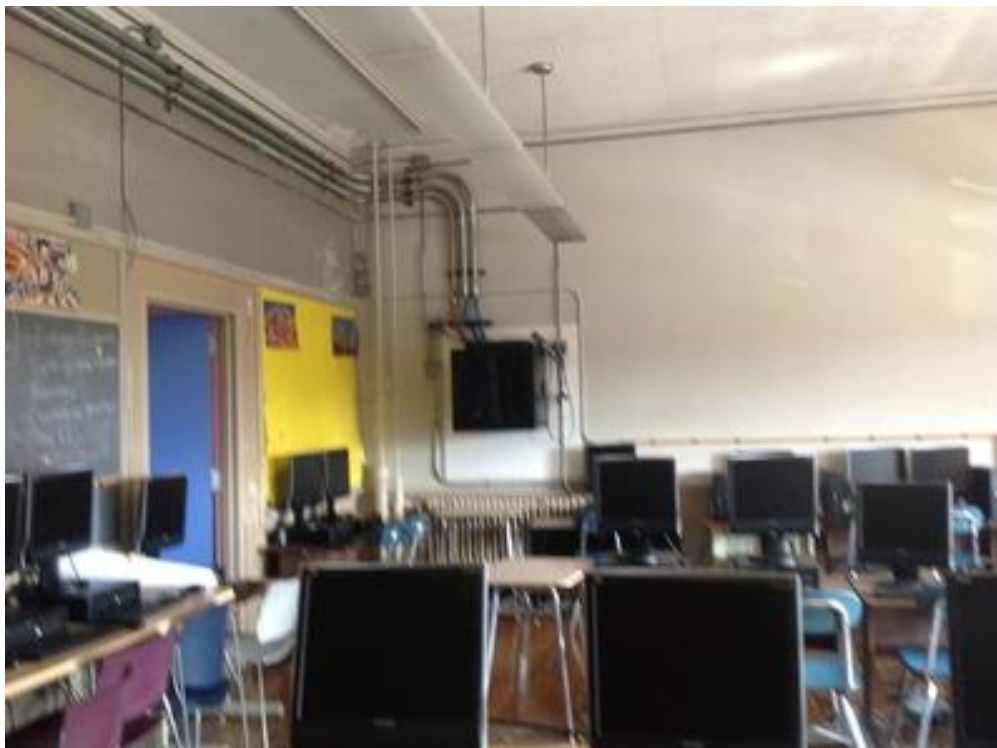
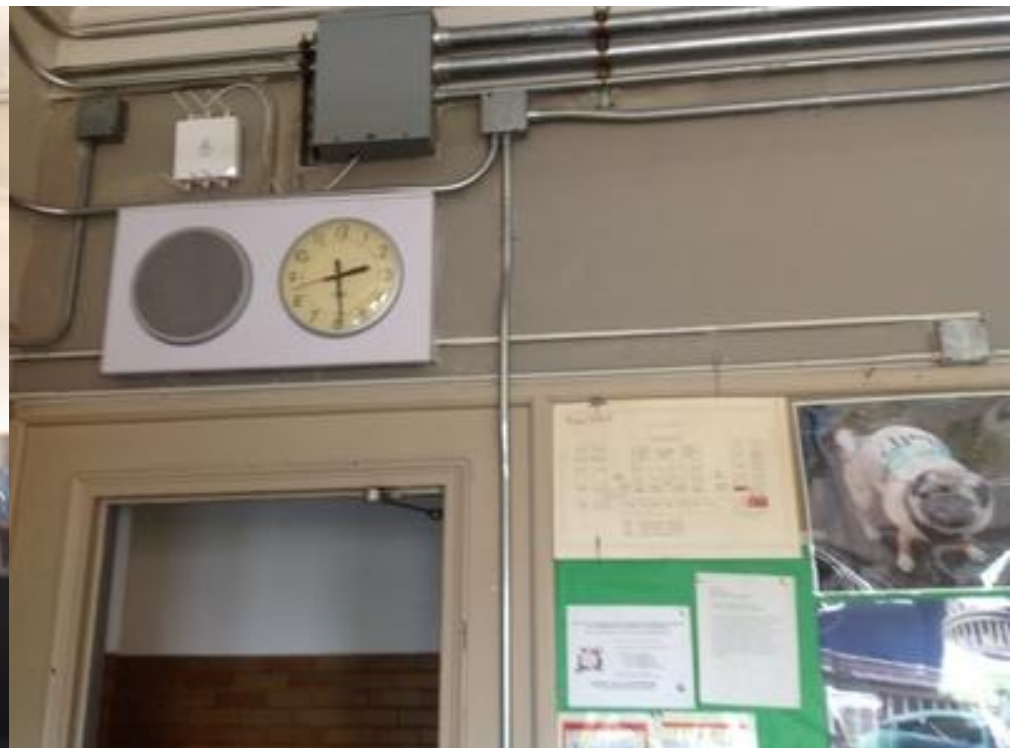
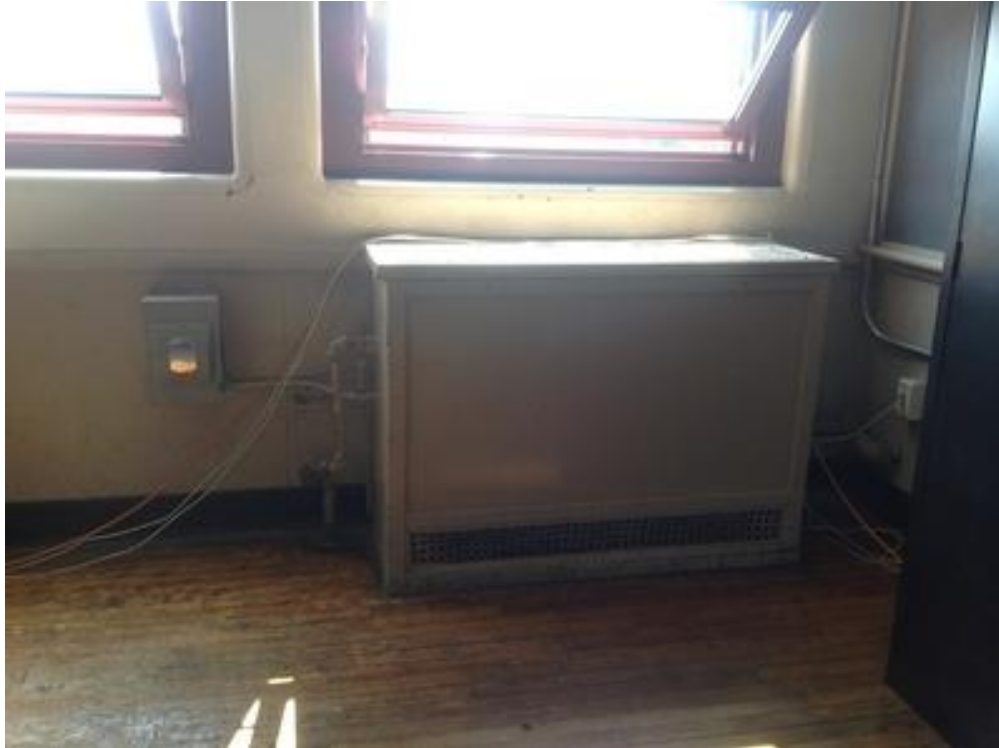
Description
Computer classroom. Wood flooring in good condition but creaky. Paint is chipping on walls and ceiling. Surface mounted equipment and wiring is haphazard and creates tripping hazard. Shades are in poor condition. Millwork in poor condition. Unit heater in poor condition. Some windows have lost their seal. Classroom has smartboard.

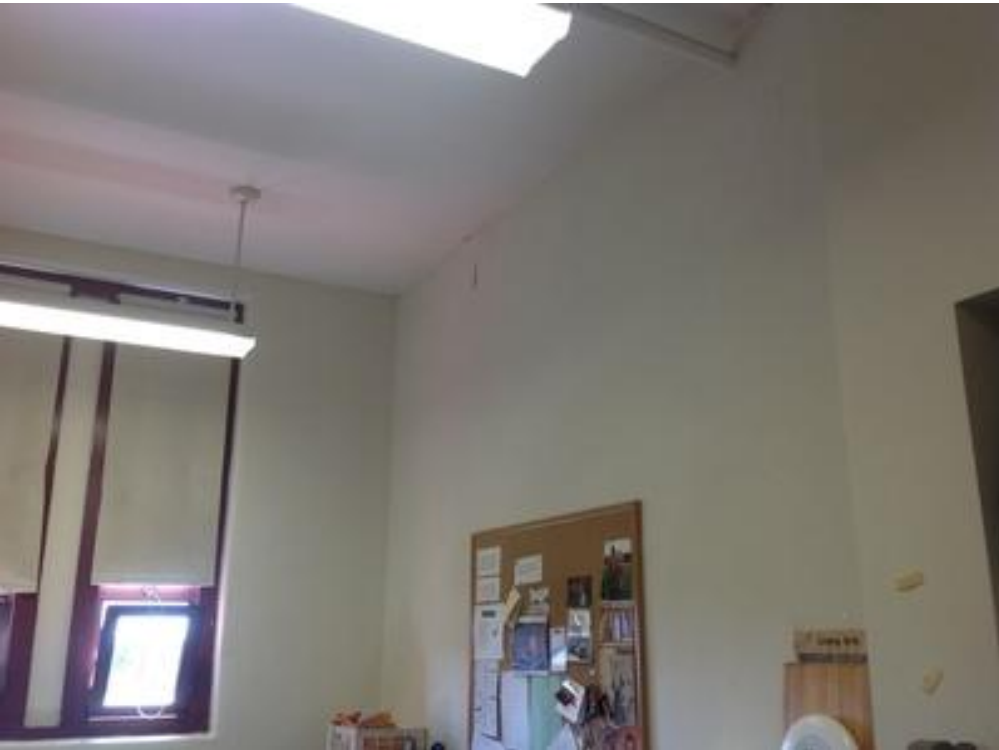
| Attached Images for ID KJ-00074 | | | |

| Description Paint is chipping on walls and ceiling. Surface mounted equipment and wiring is haphazard. Shades are in poor condition. Millwork in poor condition. Unit heater in poor condition. Some windows have lost their seal. | | | |
