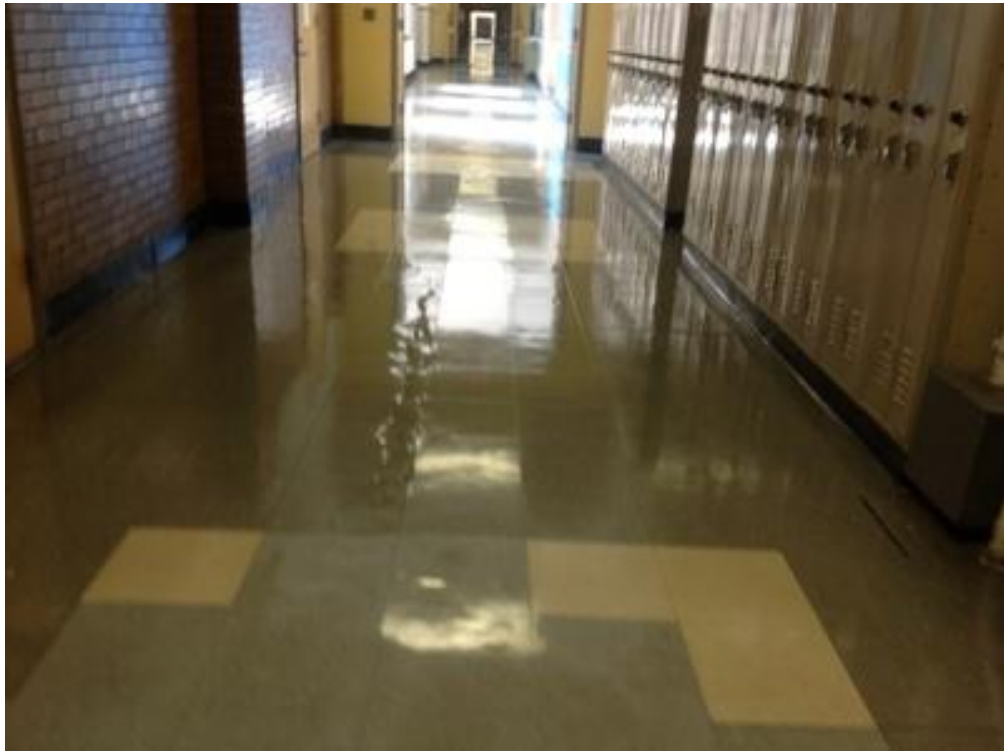
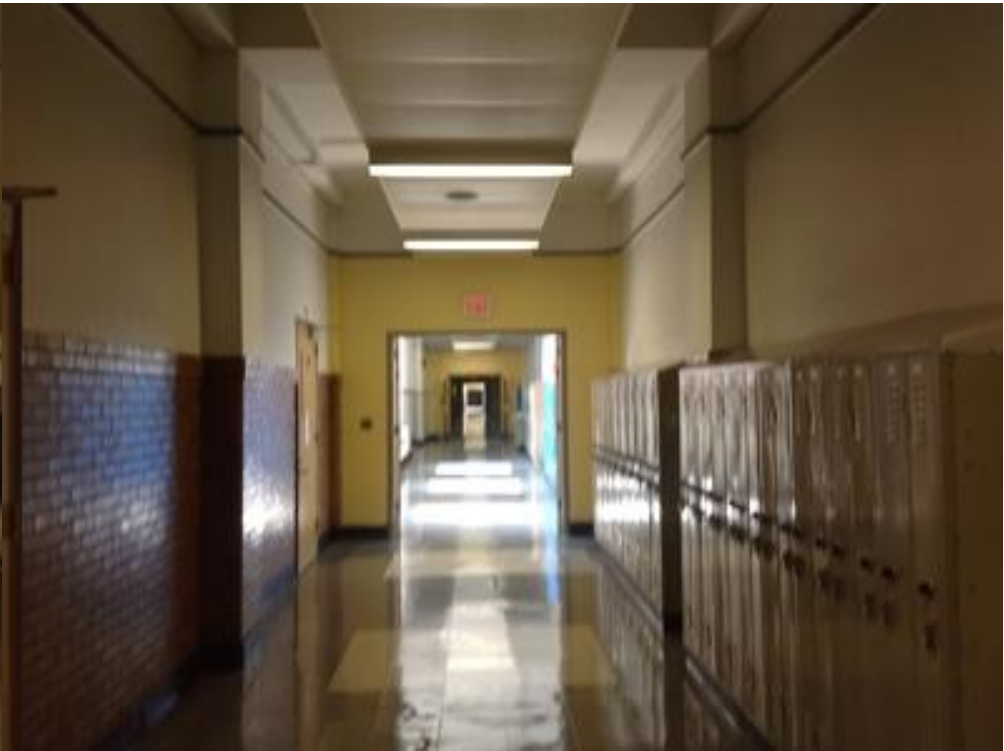
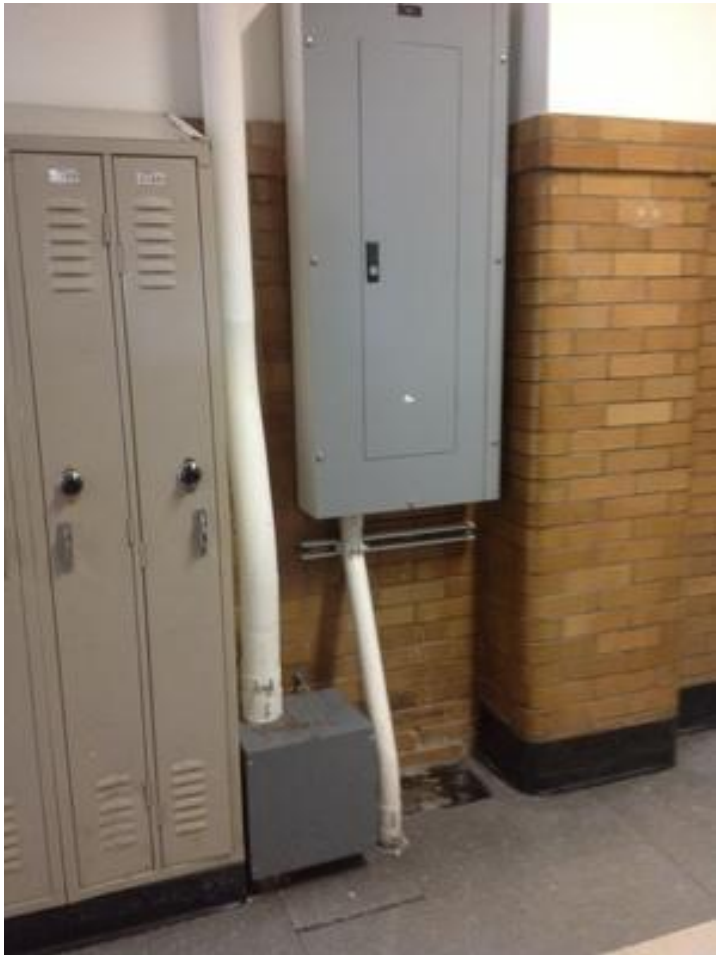
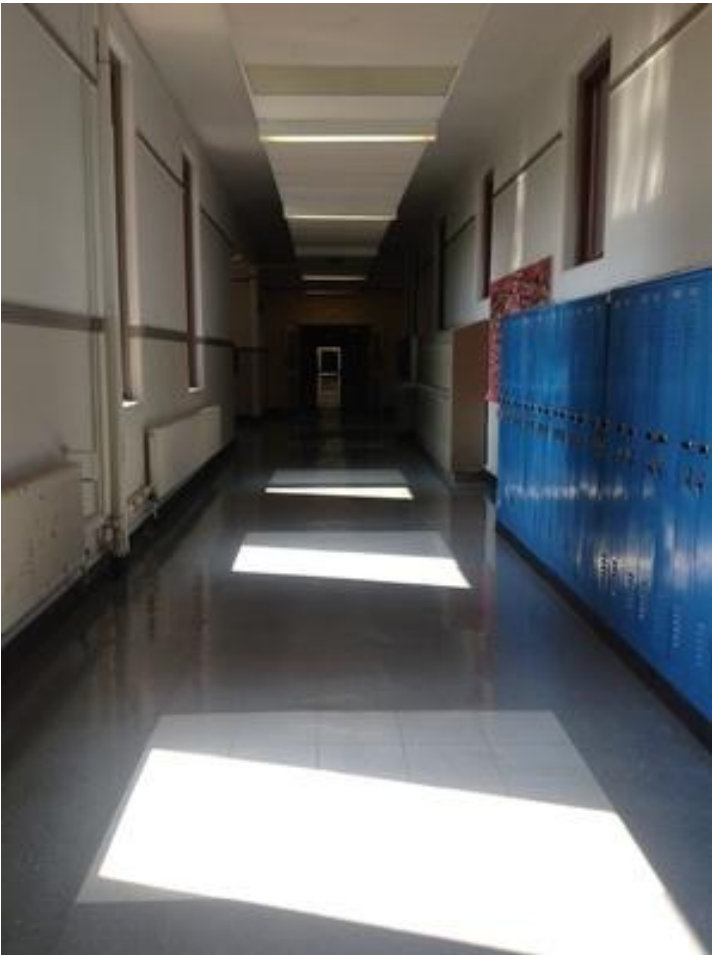
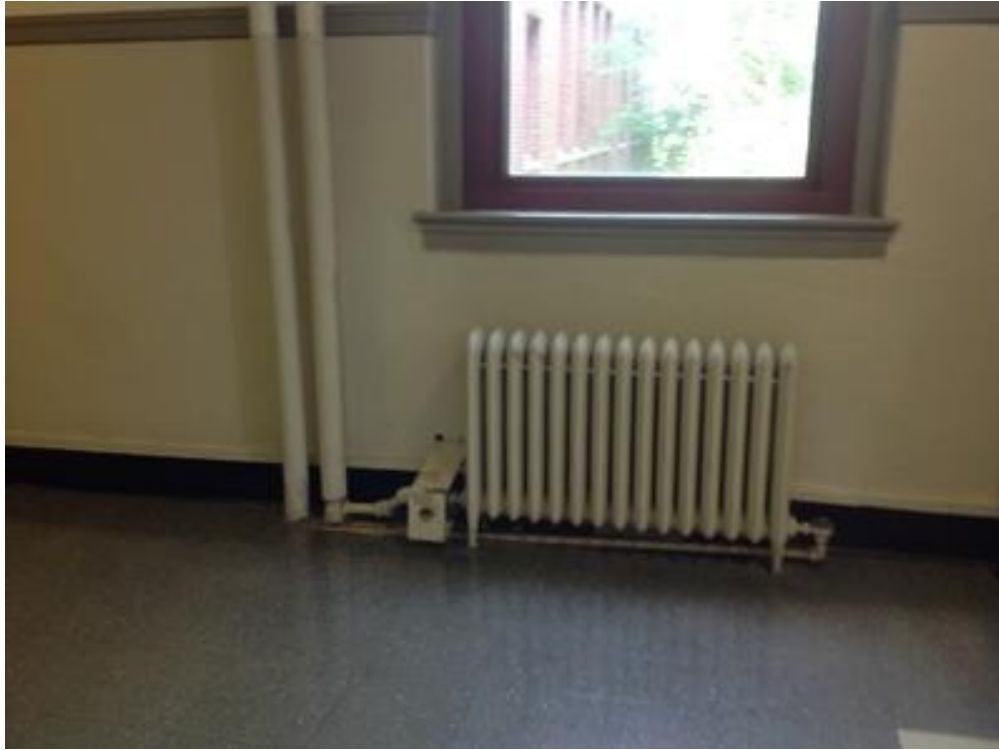
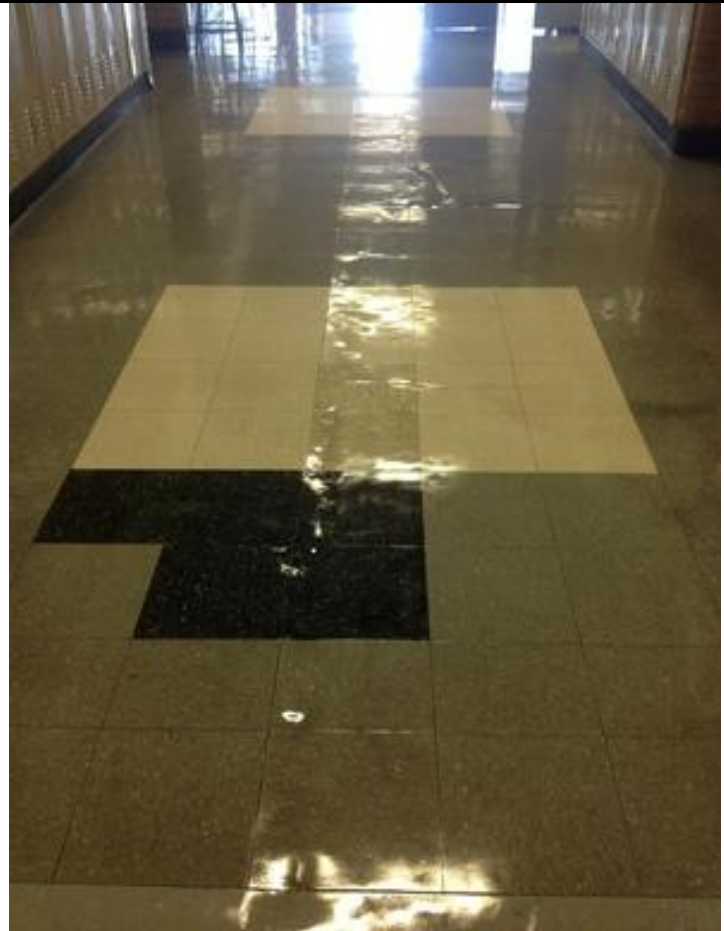
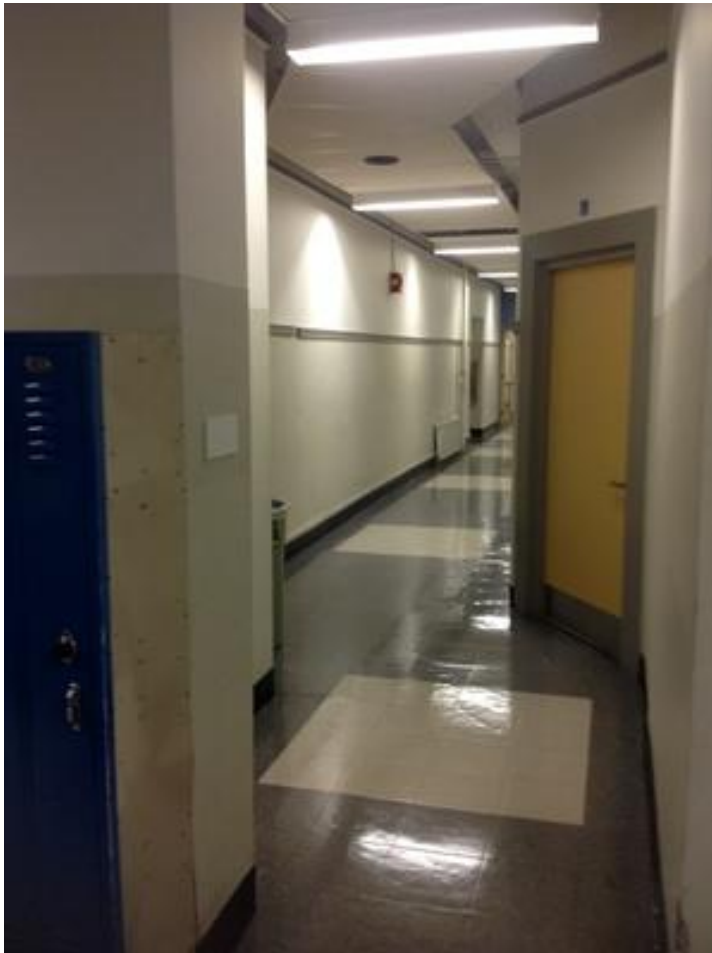
Entire Building- Corridors

Description
Typical - Corridors are in fair to poor condition. Warping has caused an uneven surface. Windows are scratched, vandalized, and some have lost seals. Paint on plaster is dented and chipping and cracking. Exposed piping and wiring is haphazard and in some cases can be a tripping hazard. Piping insulation is in poor condition. Some drinking fountains are not ADA compliant.
