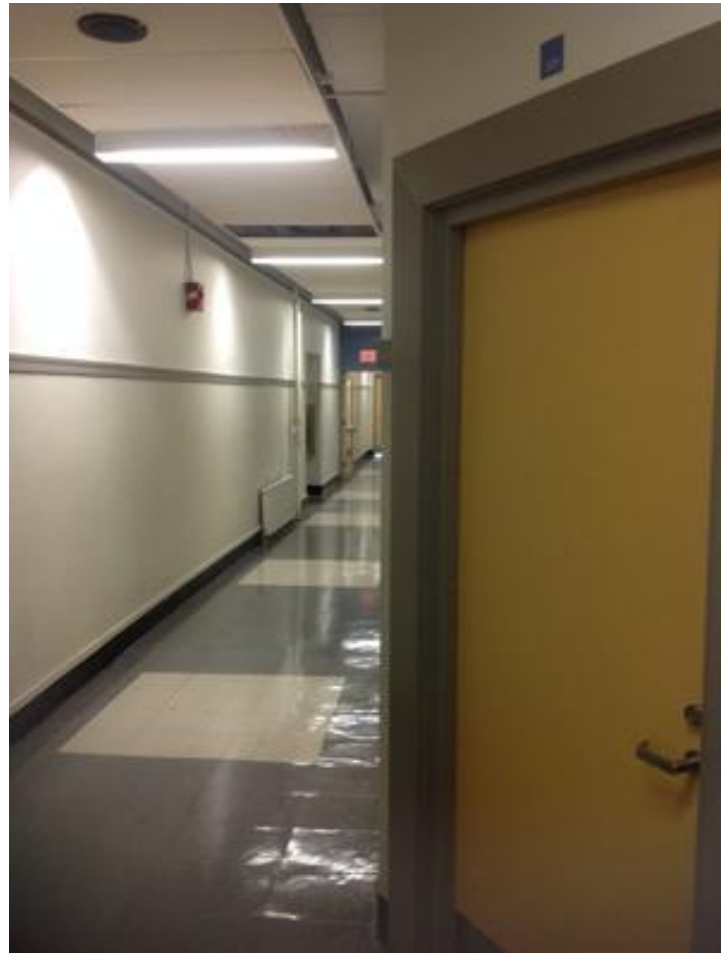
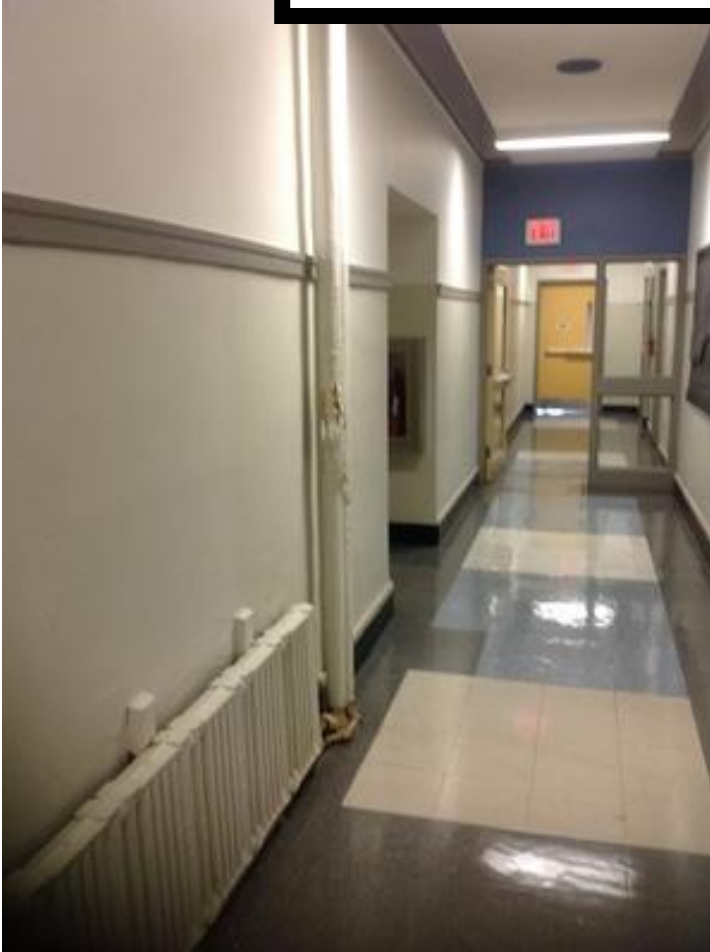
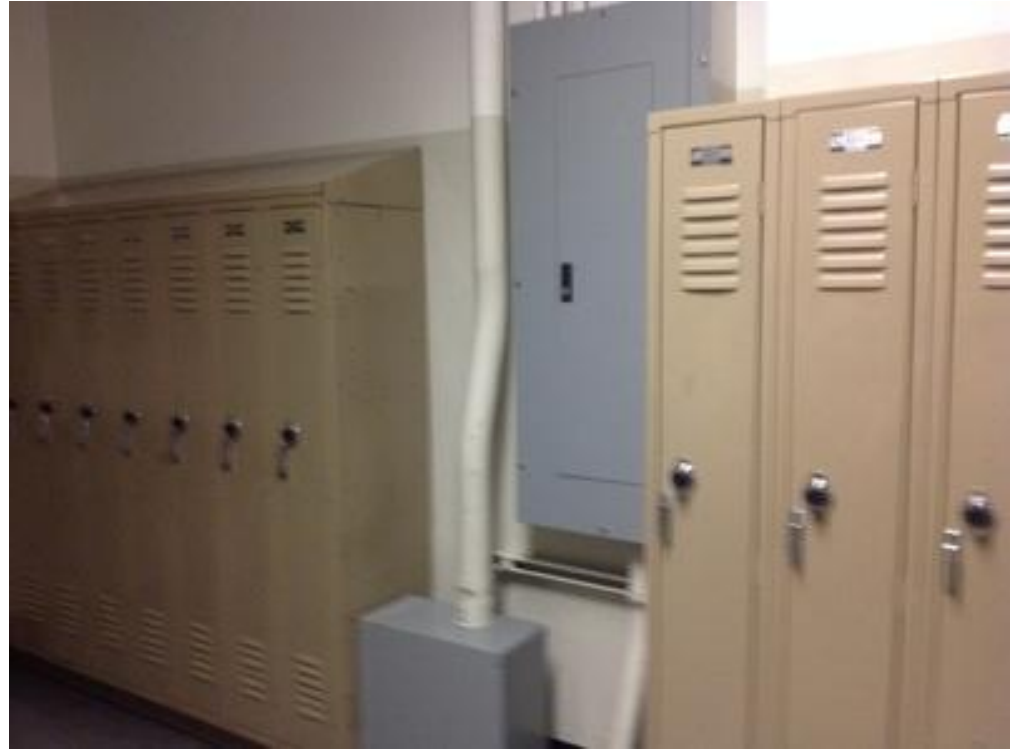
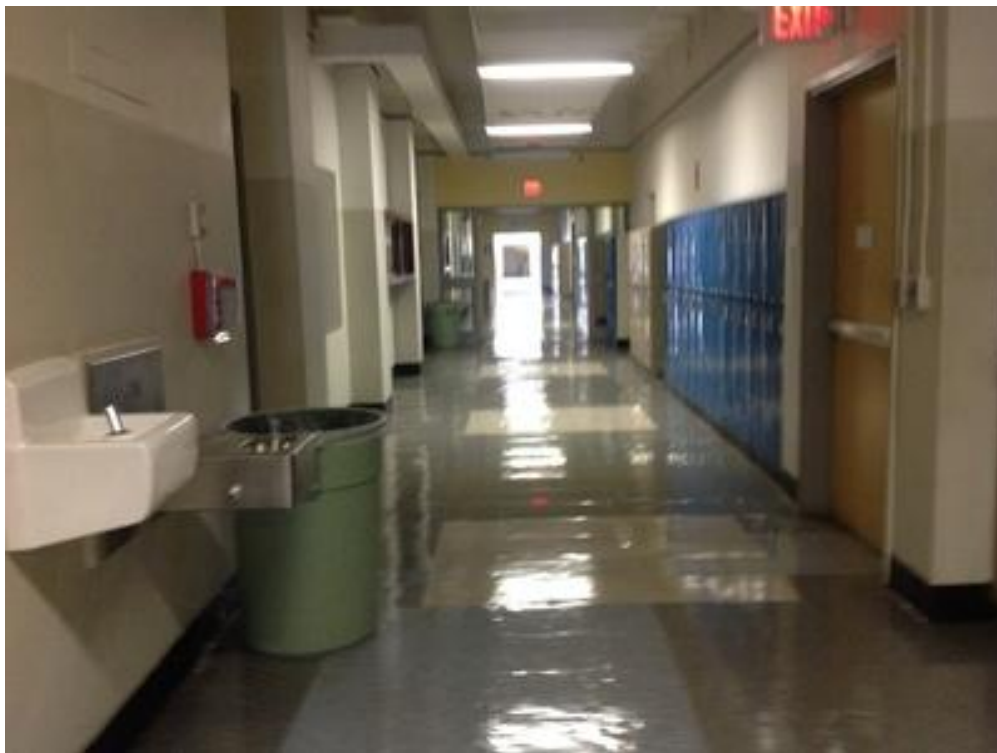
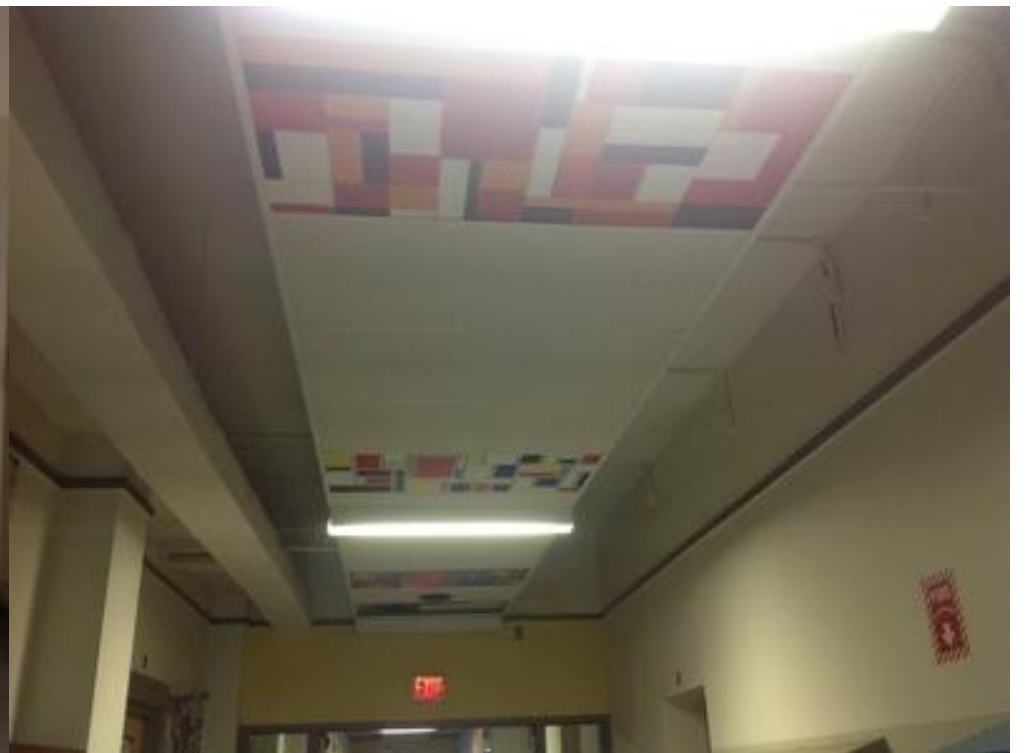
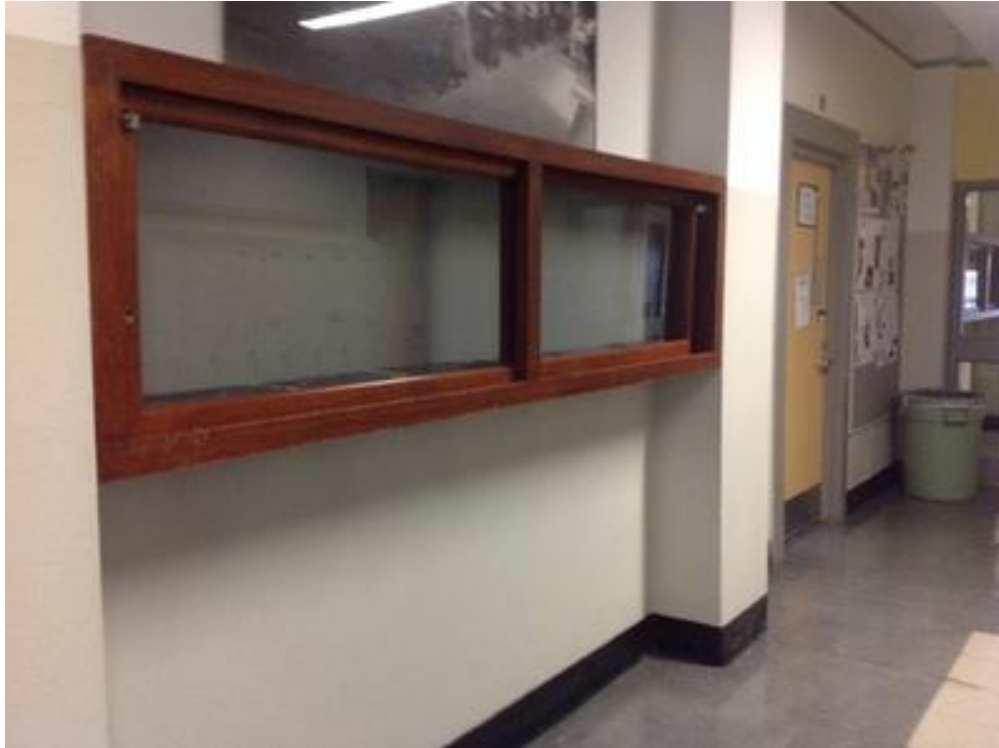
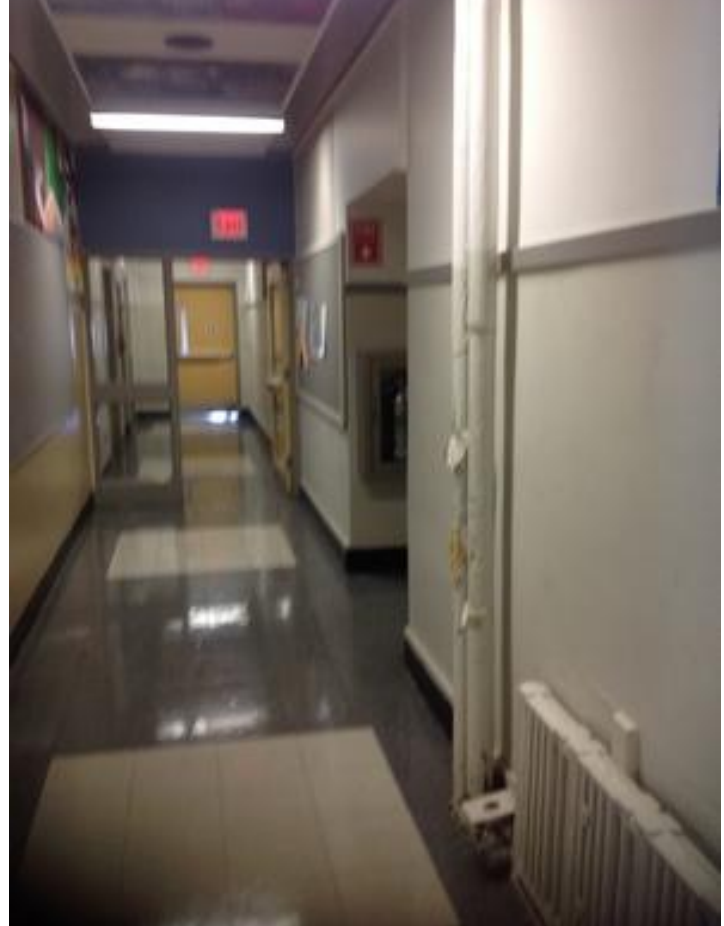
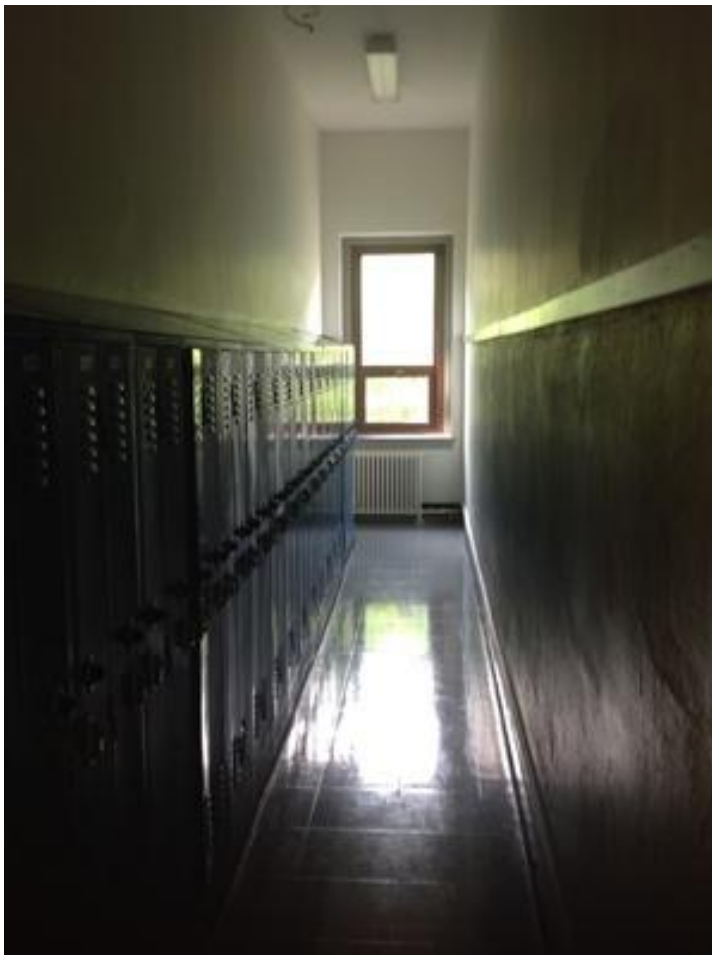
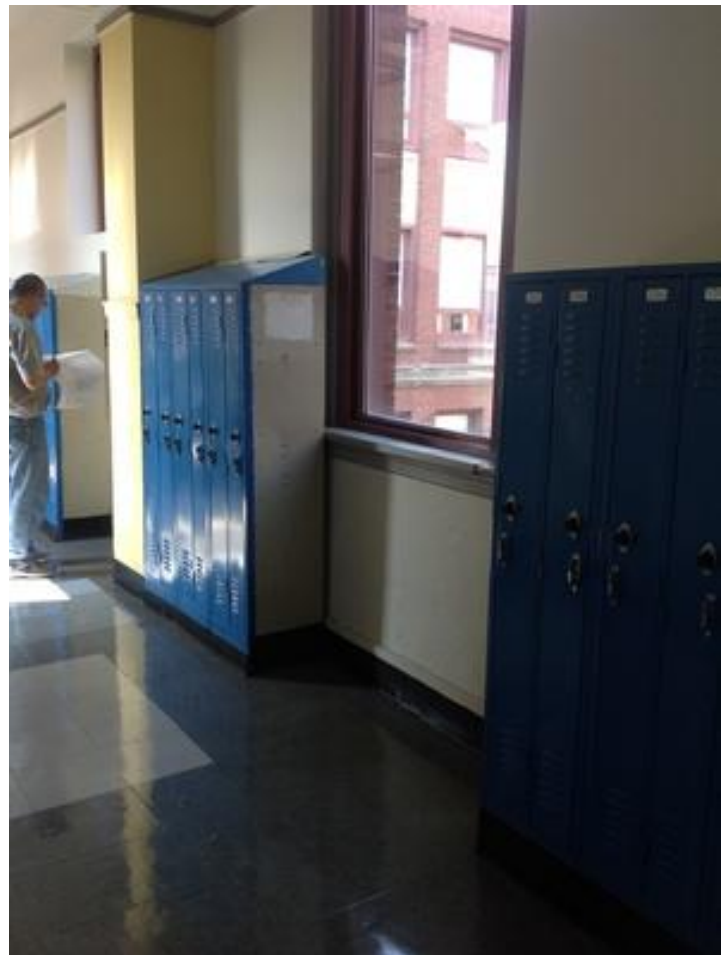
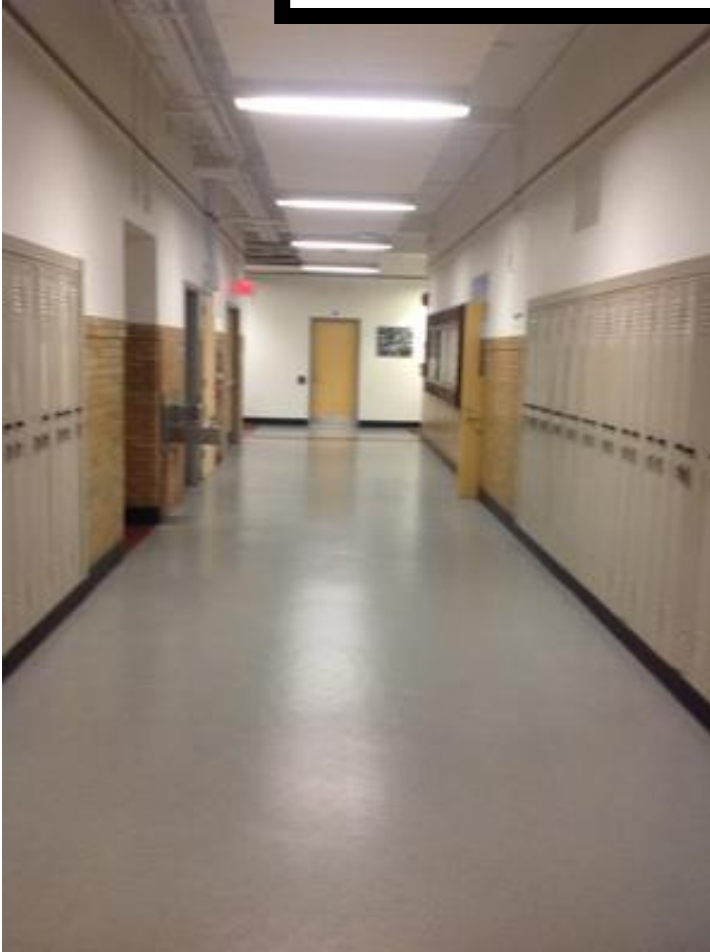
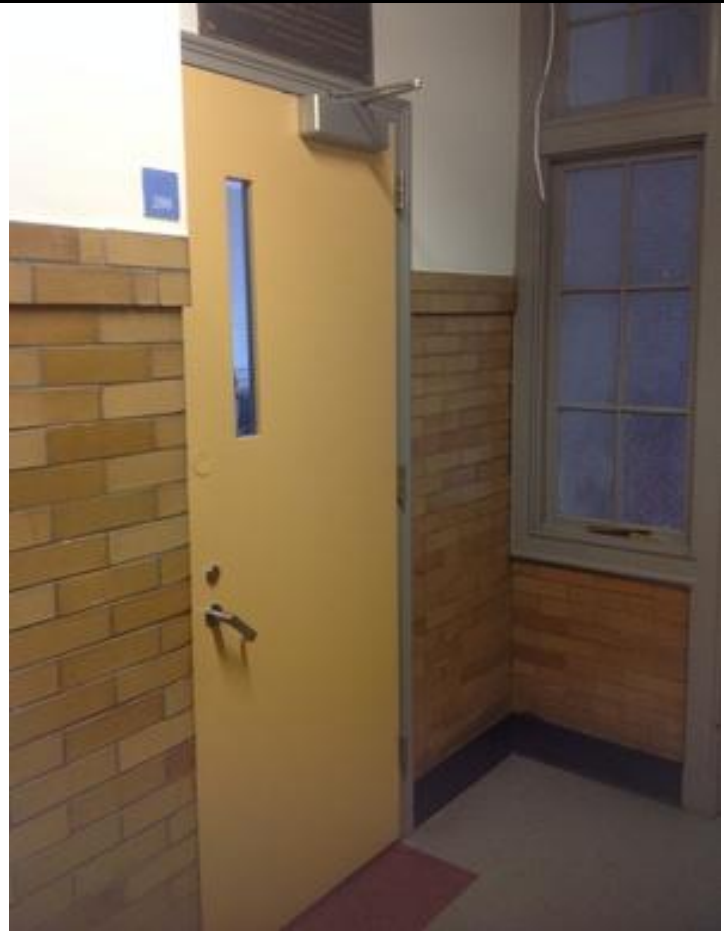
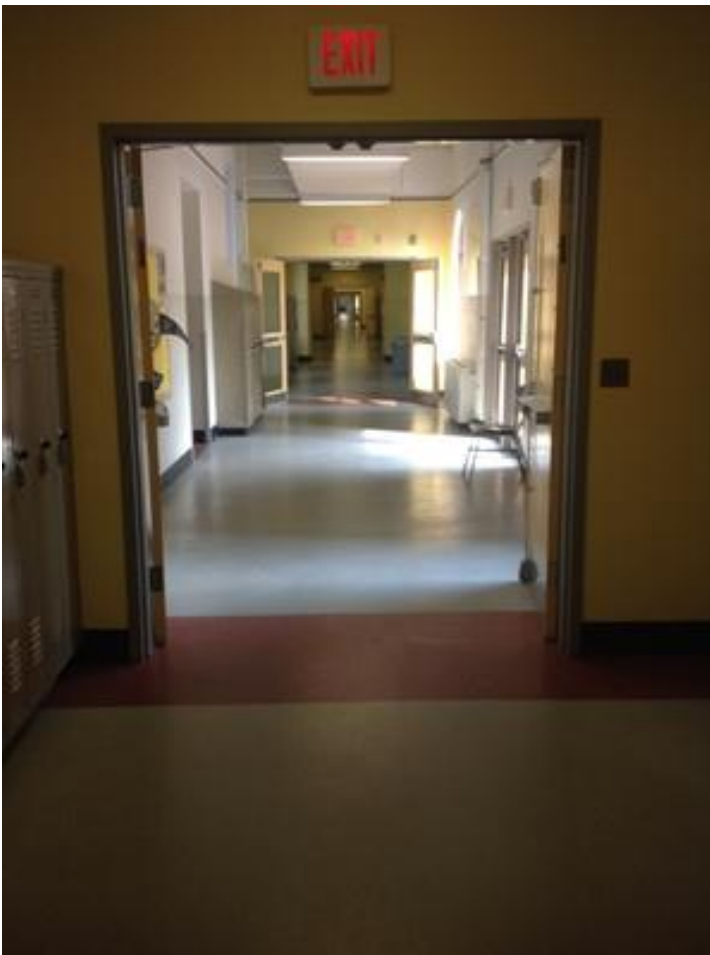
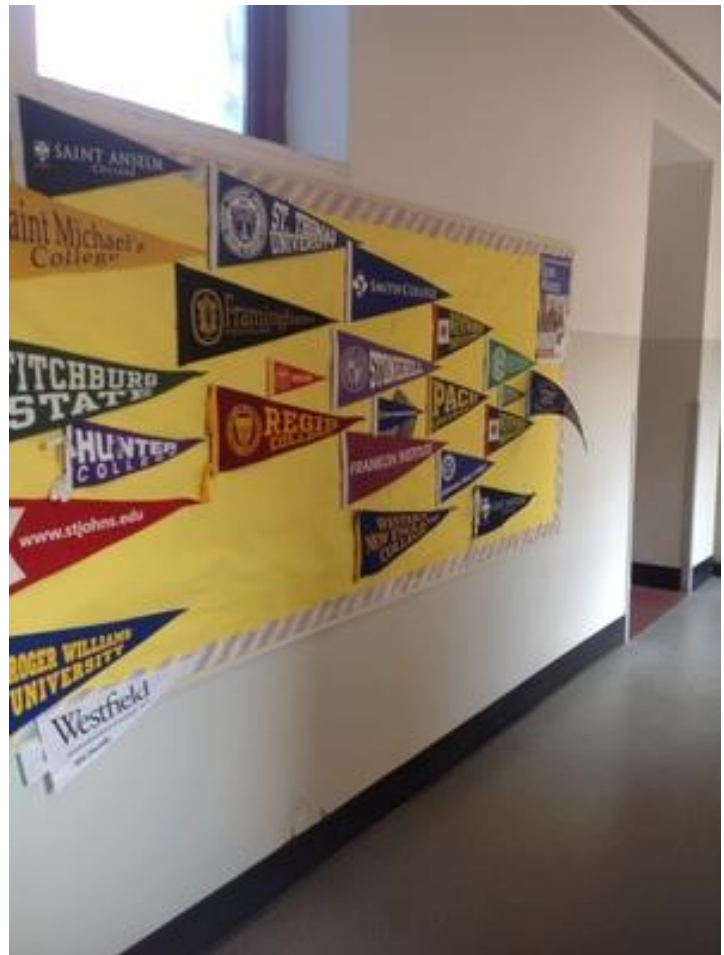
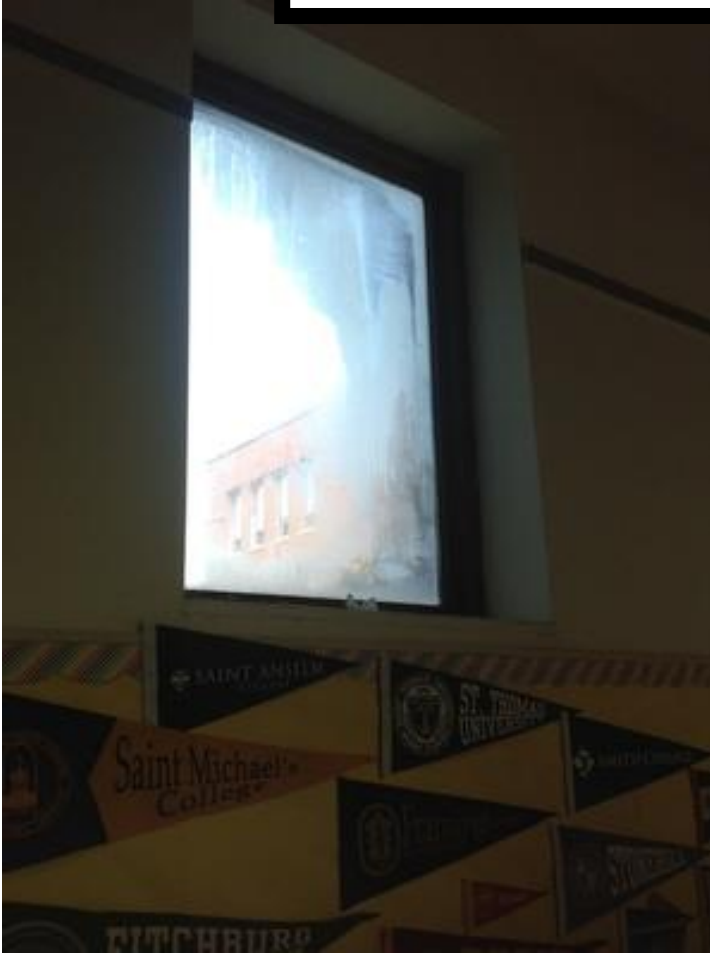
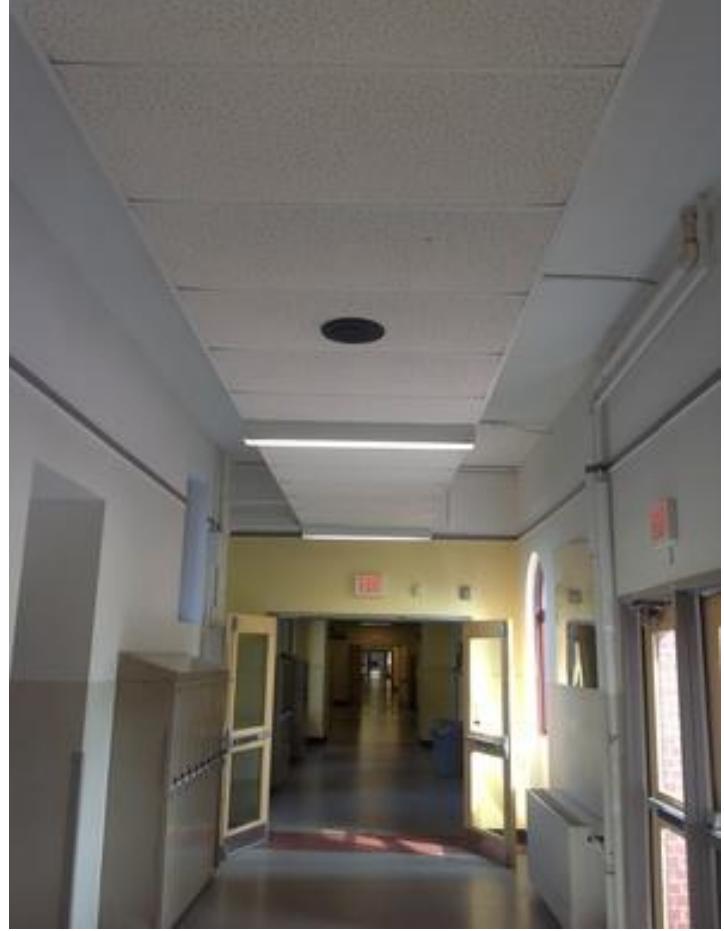
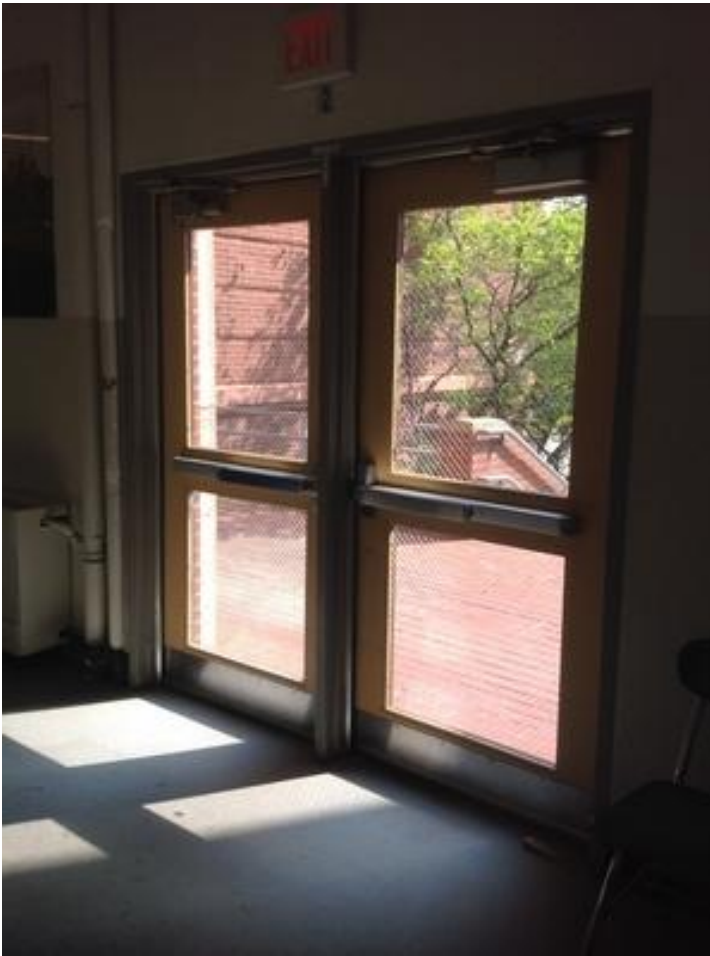
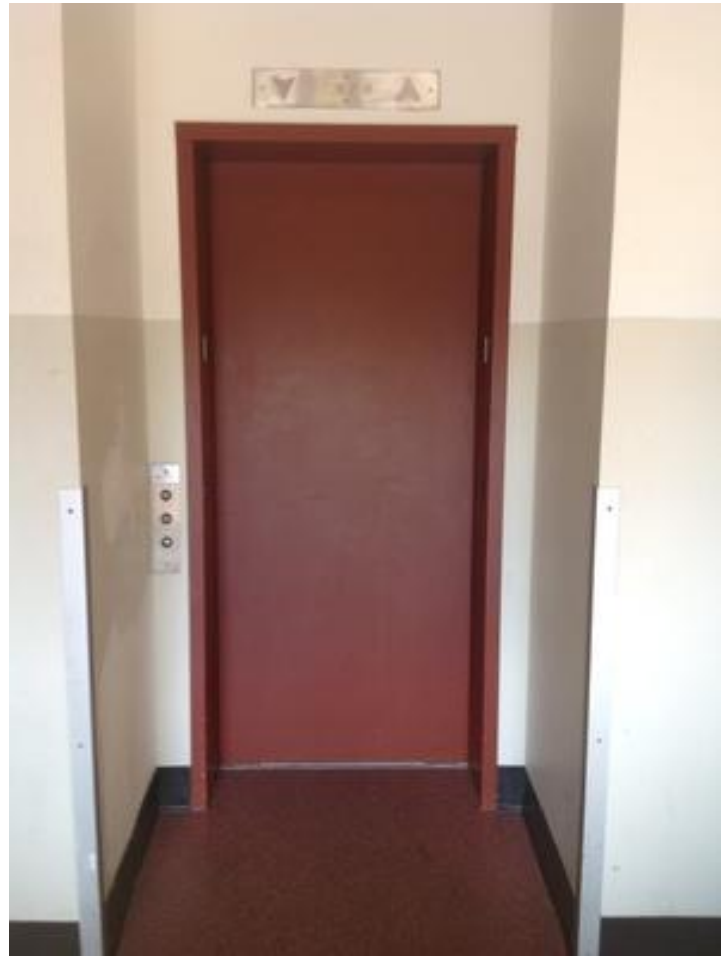
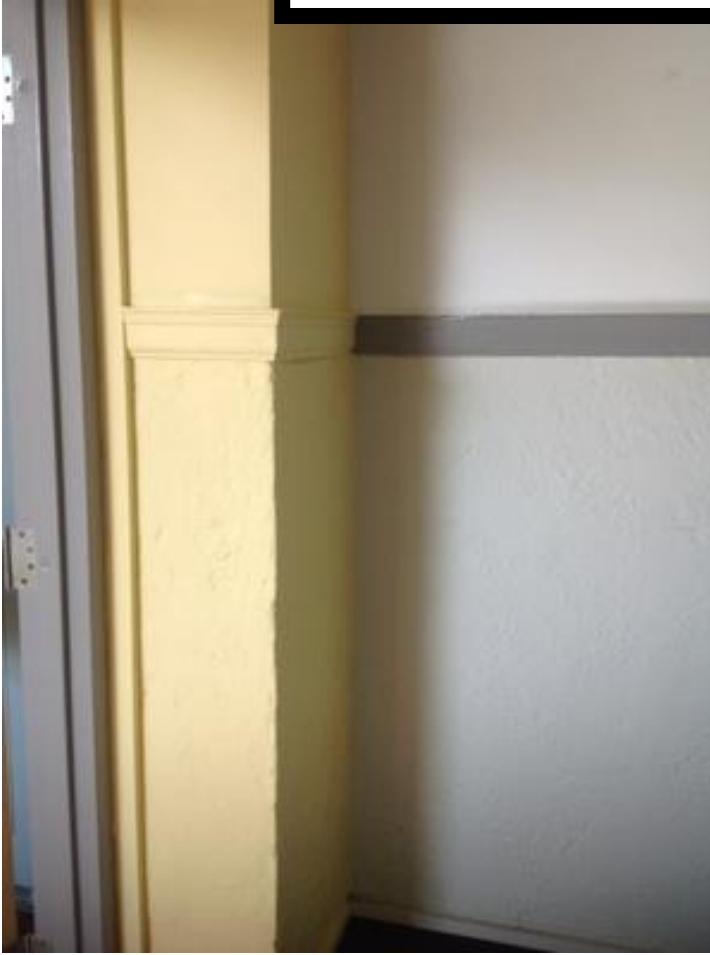
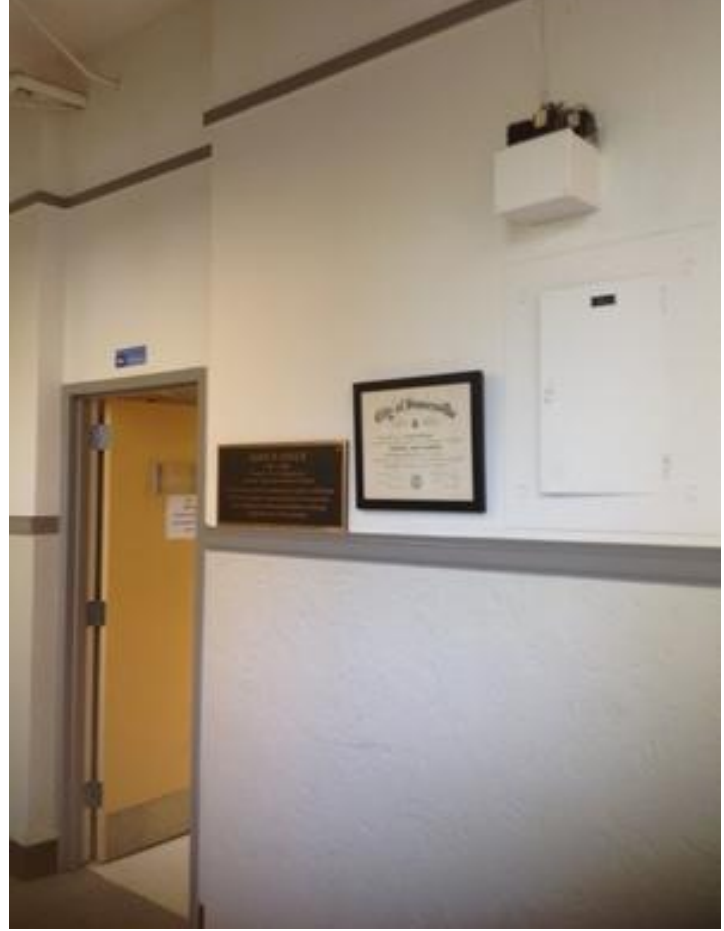
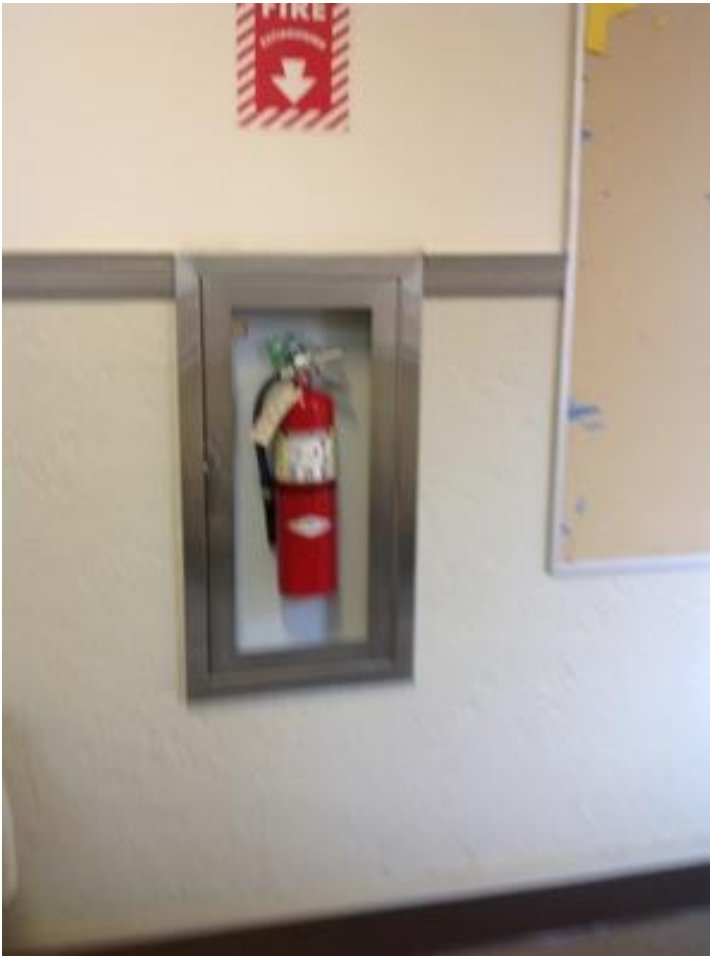
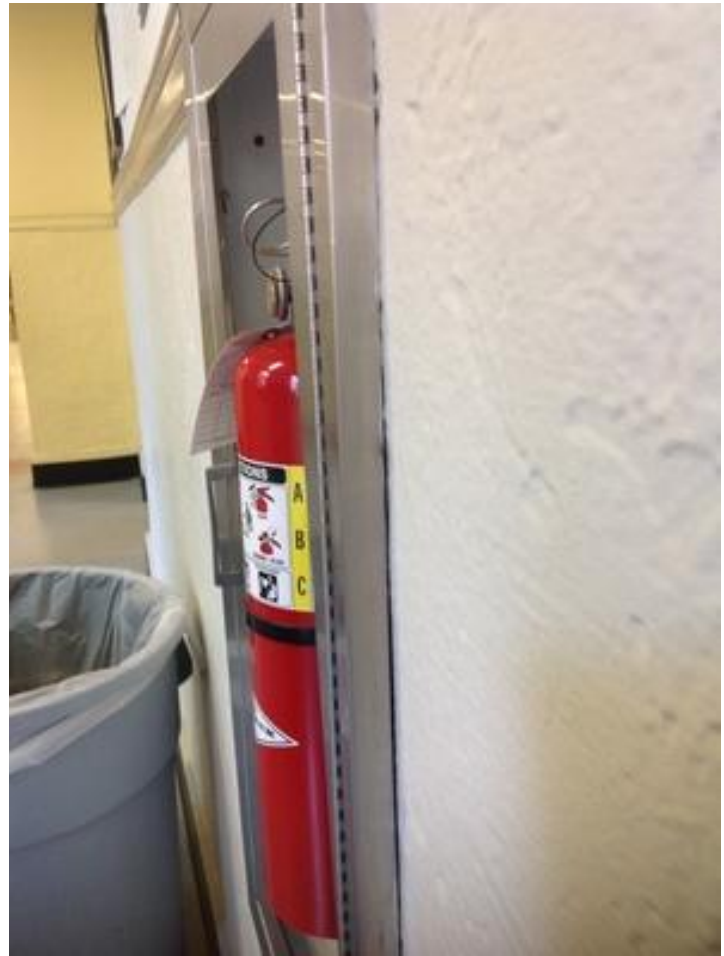
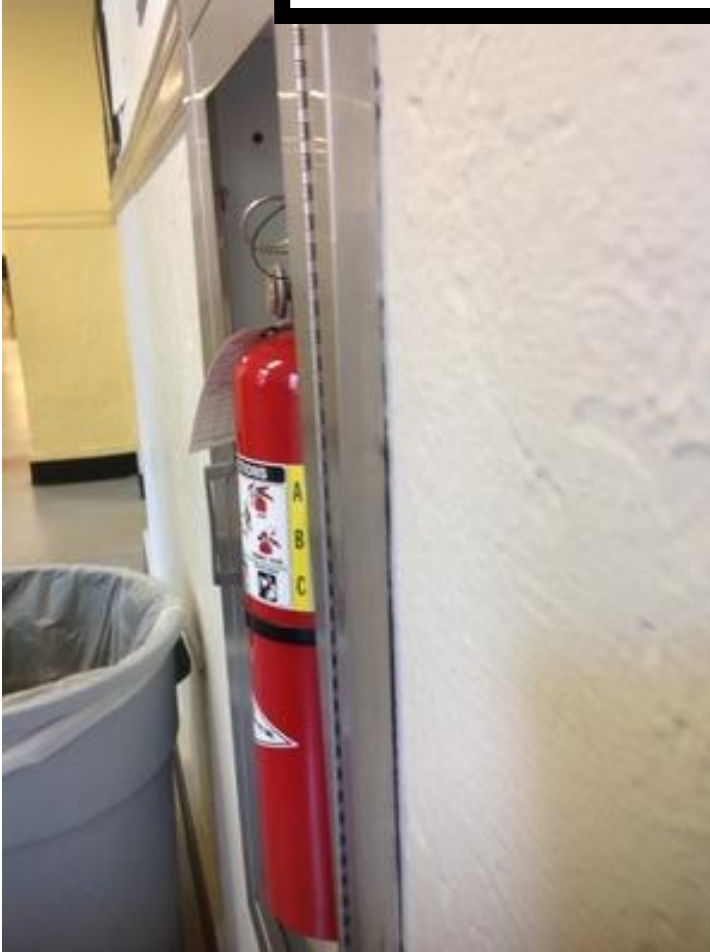
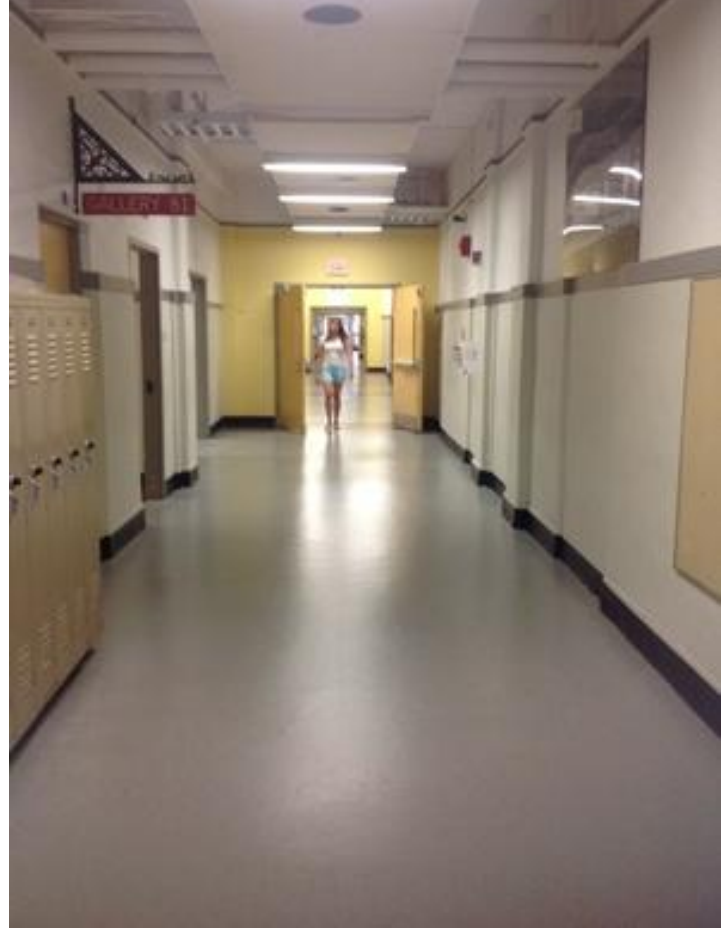
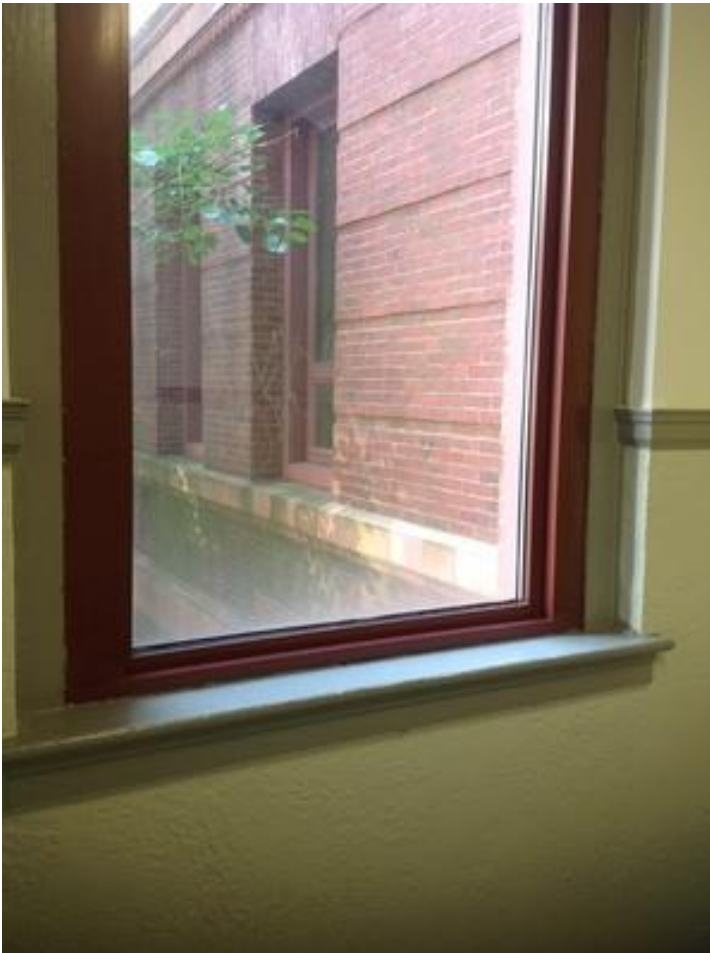
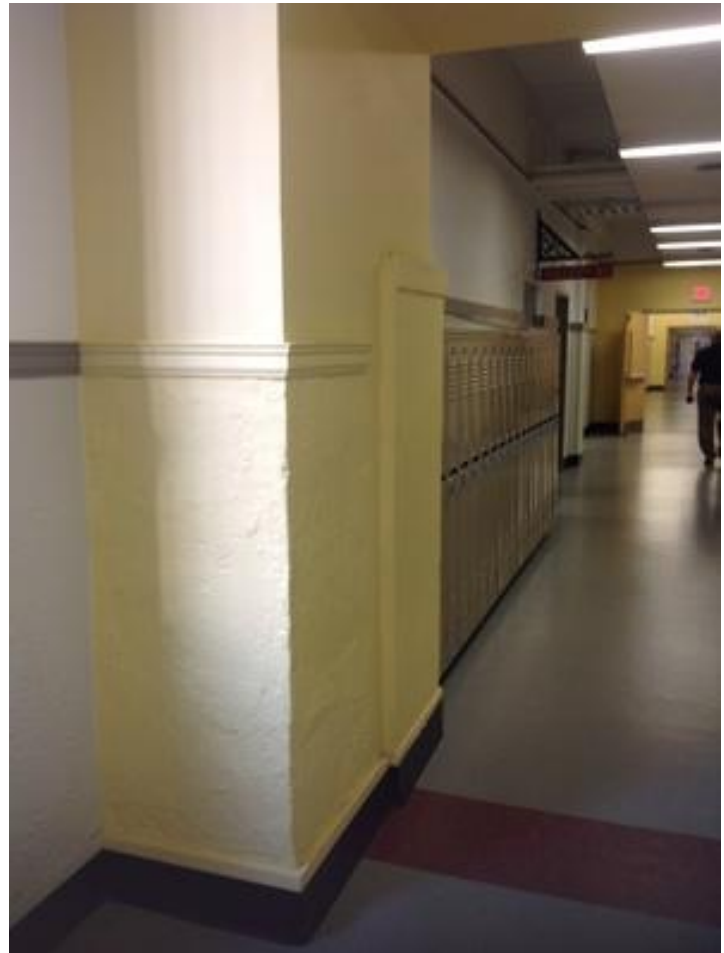
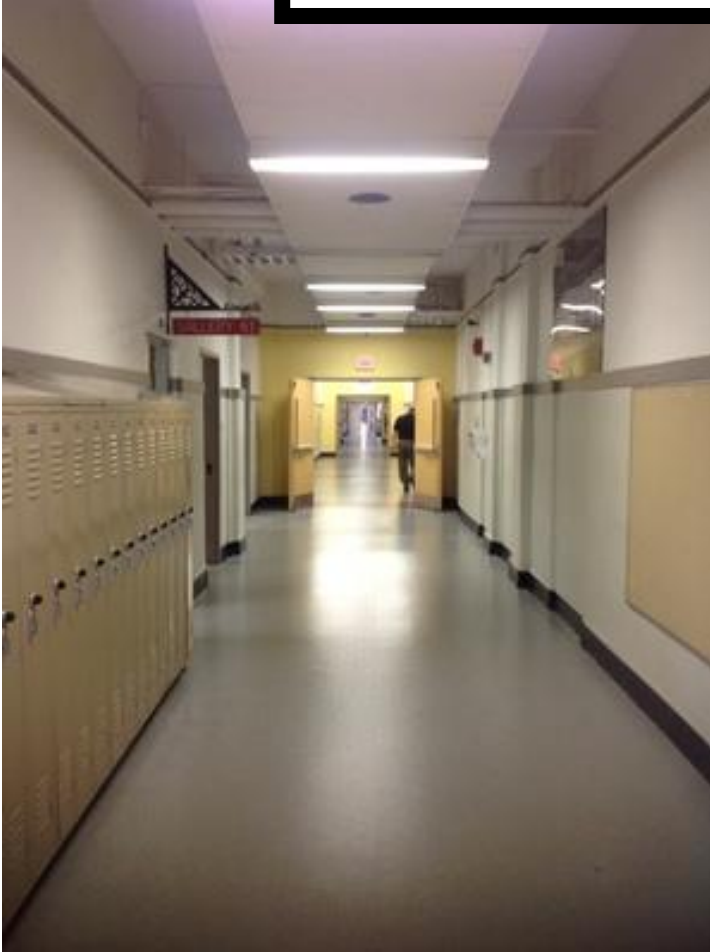
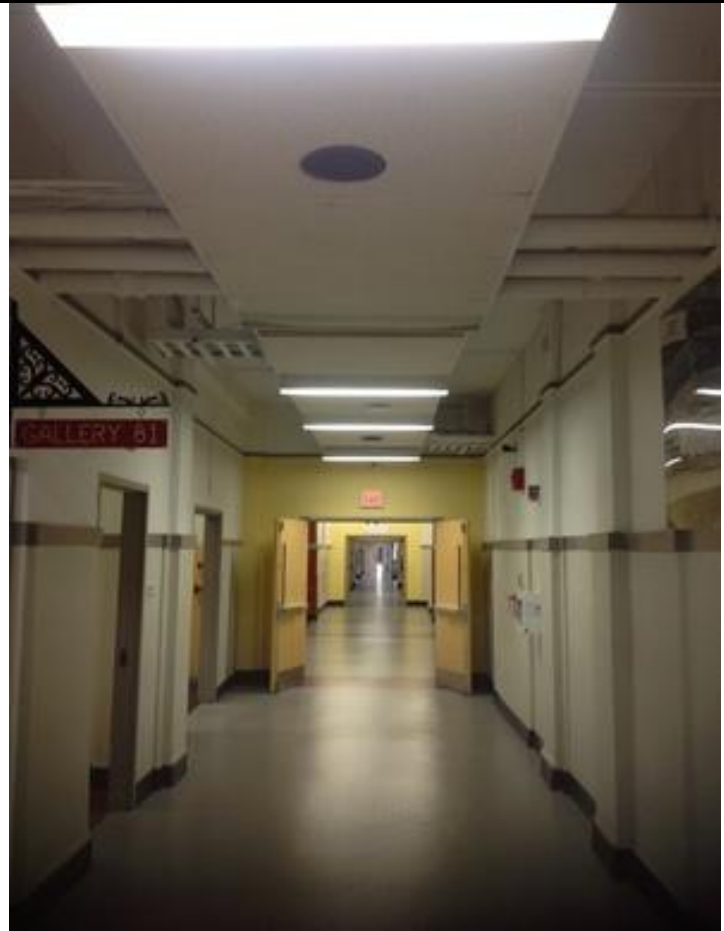
Entire Building- Corridors

Description
Typical - Corridors are in fair to poor condition. Warping has caused an uneven surface. Windows are scratched, vandalized, and some have lost seals. Paint on plaster is dented and chipping and cracking. Exposed piping and wiring is haphazard and in some cases can be a tripping hazard. Piping insulation is in poor condition. Some drinking fountains are not ADA compliant.
