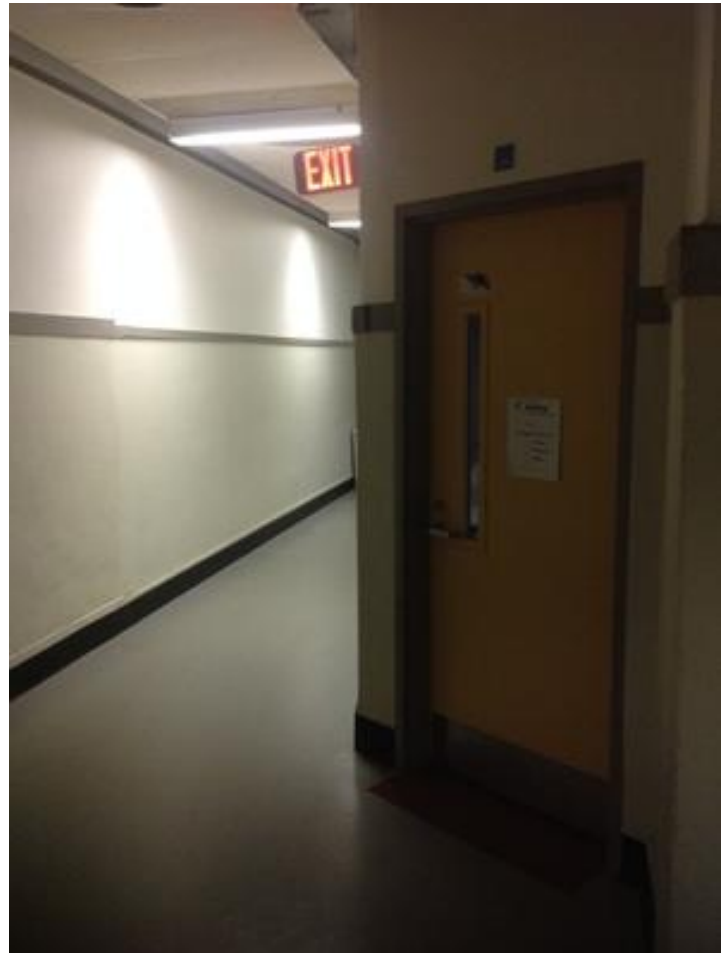
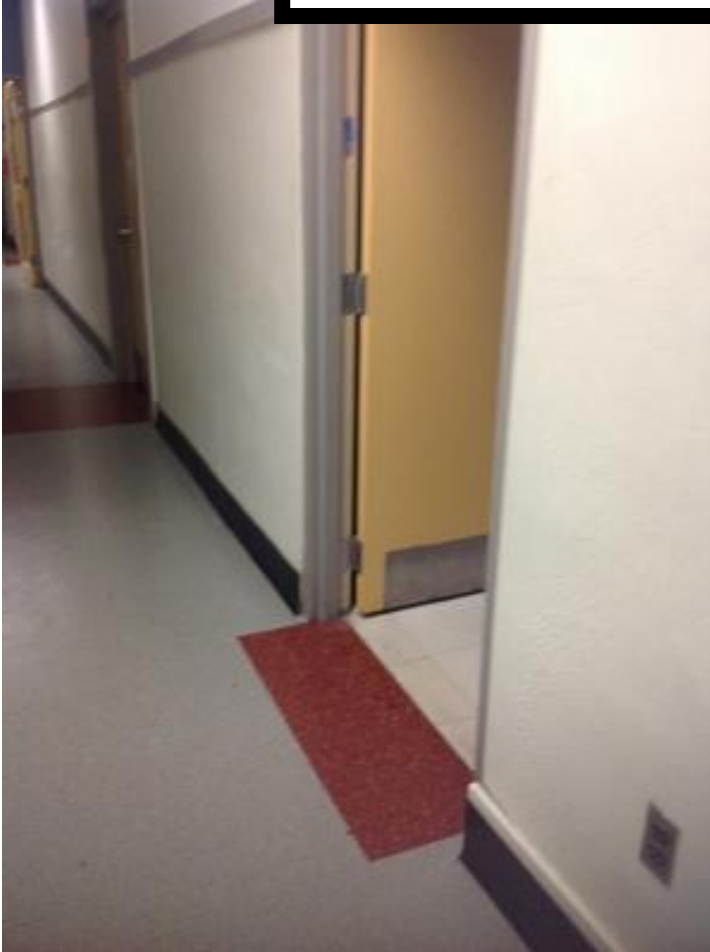
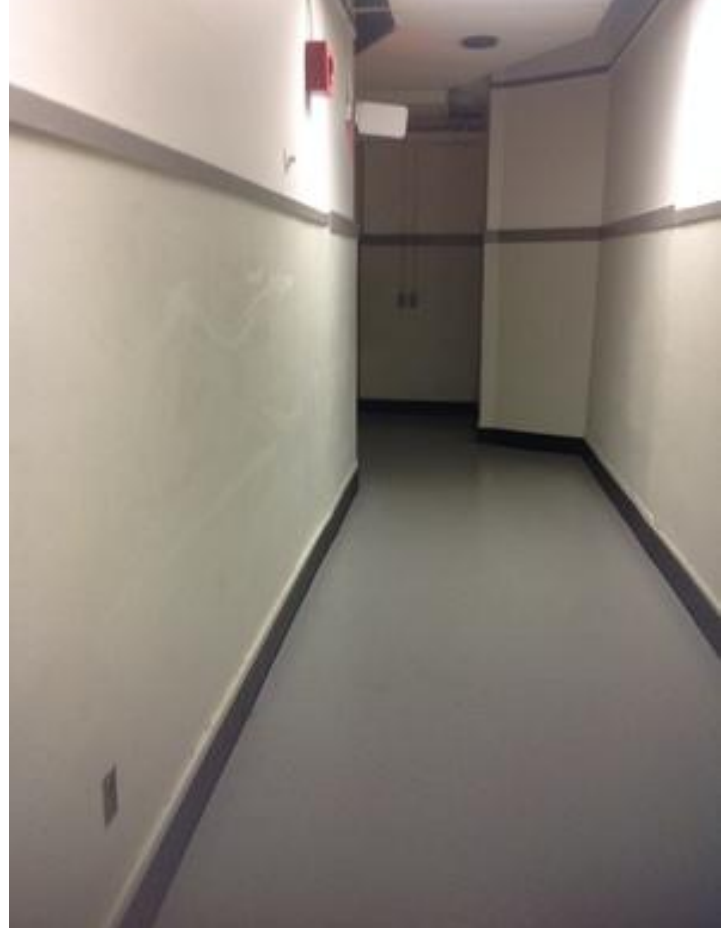
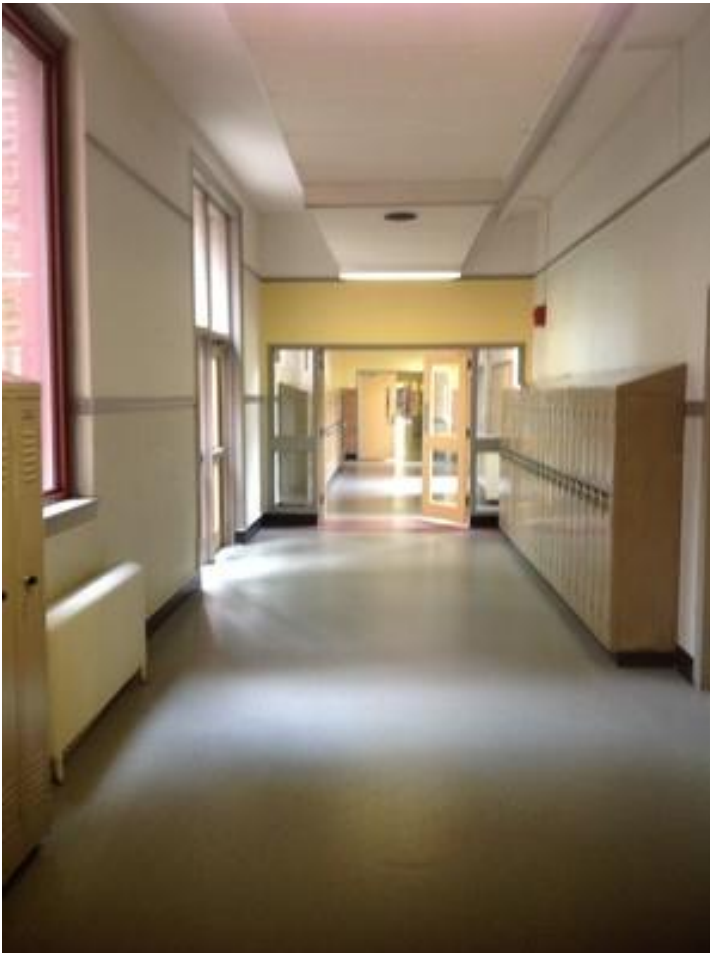
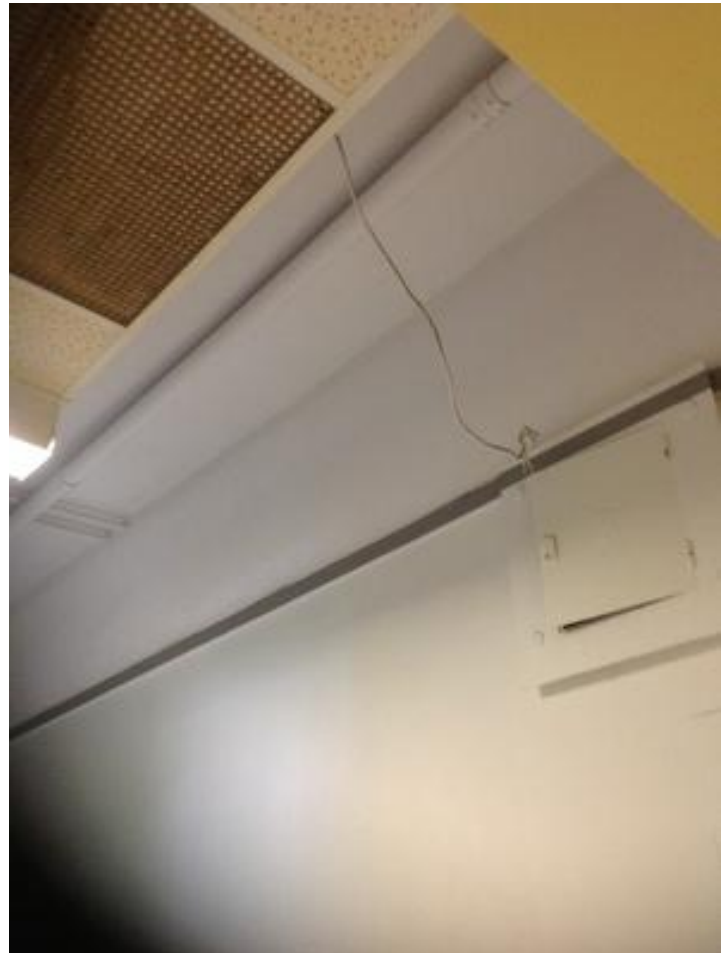
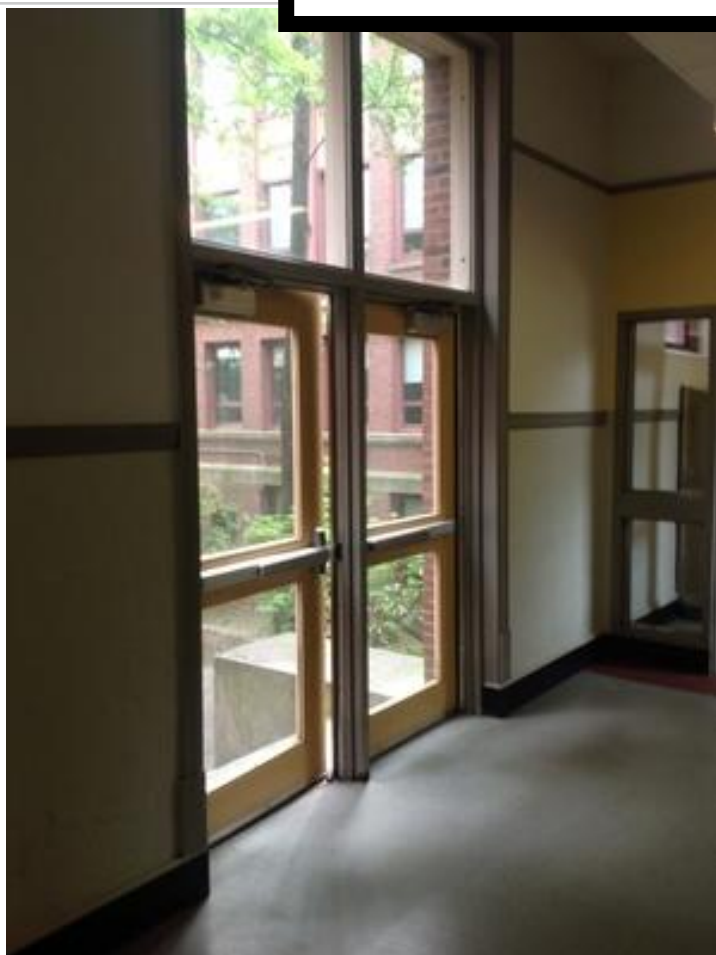
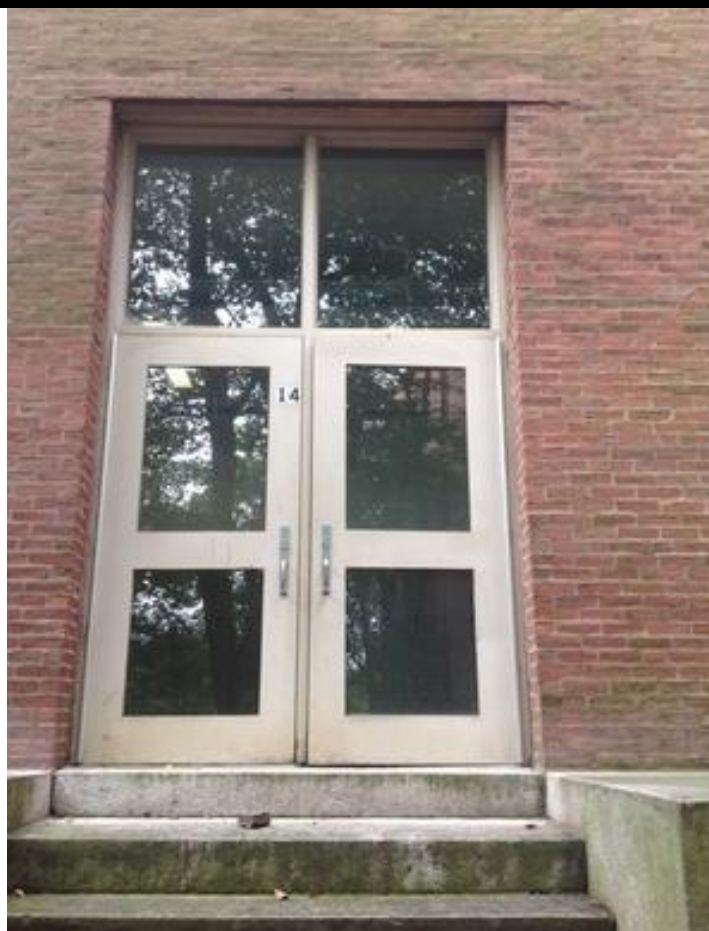
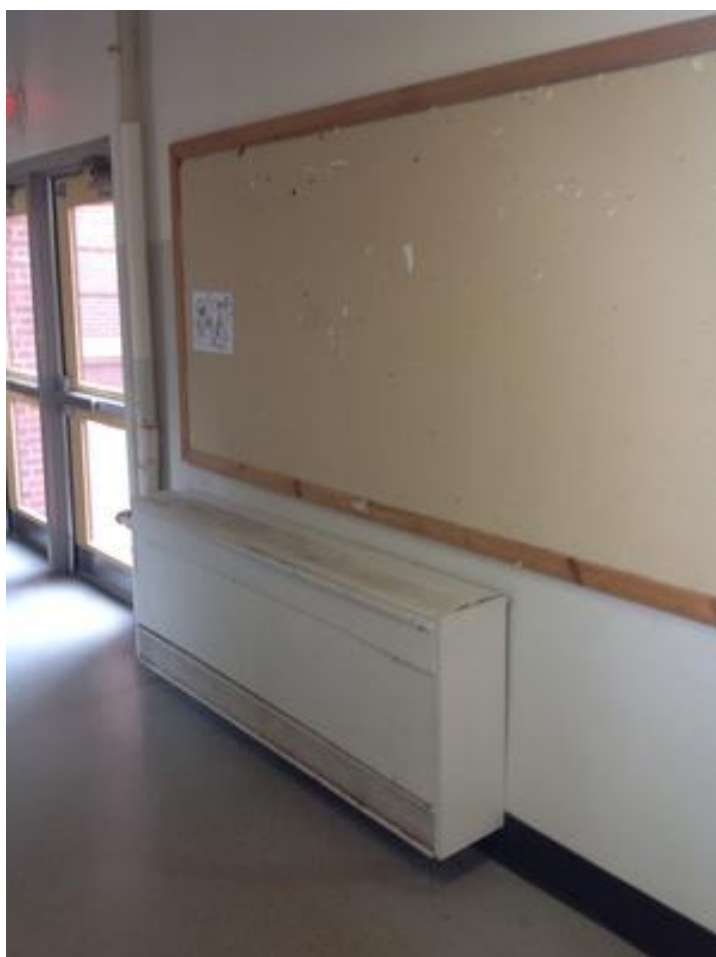
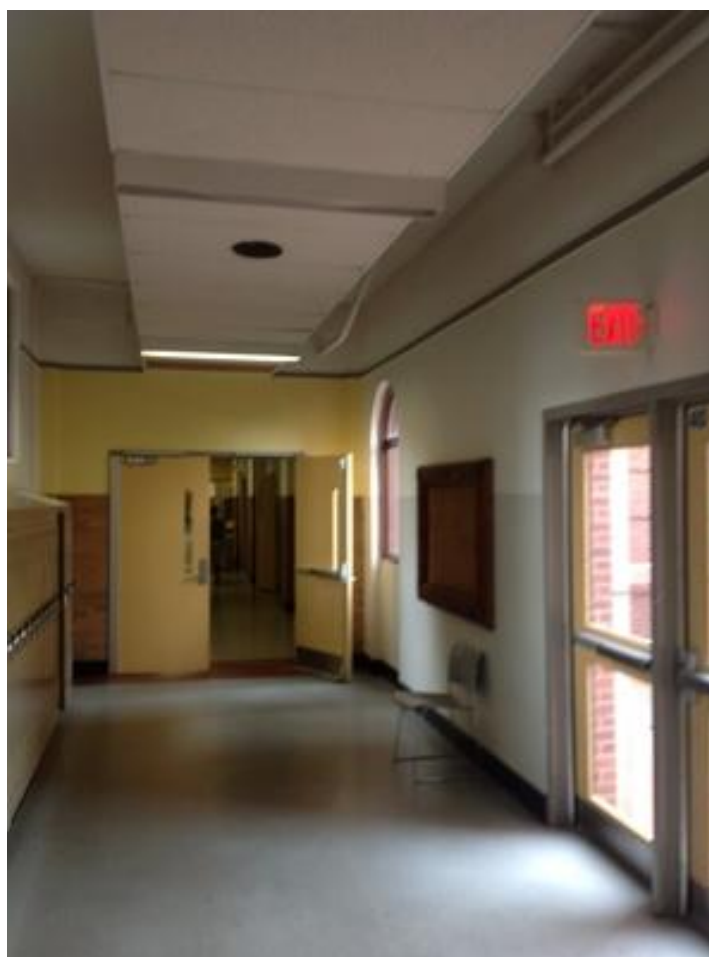
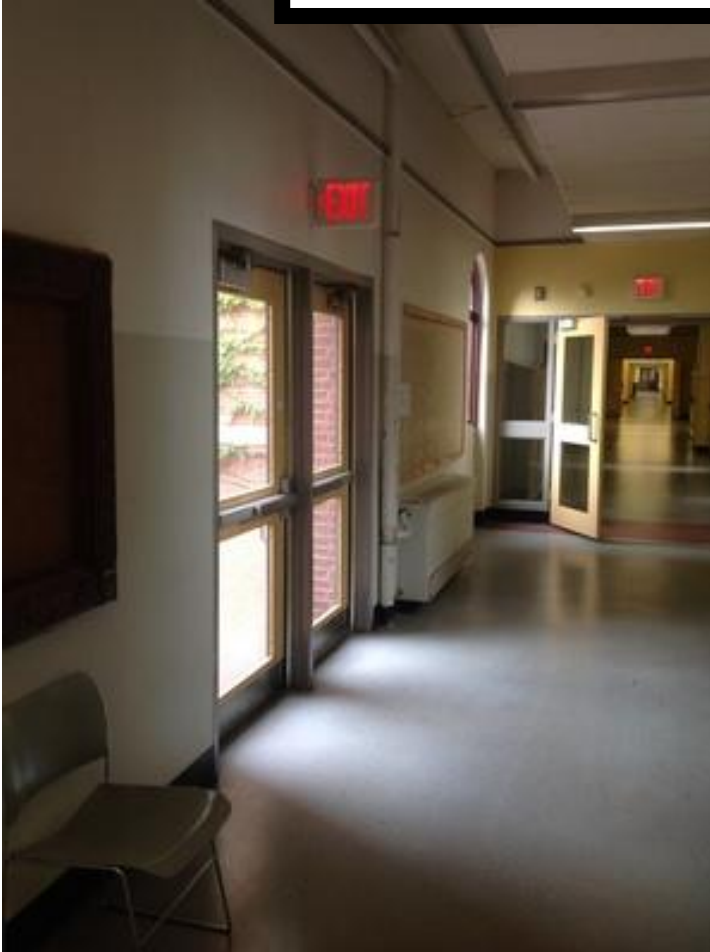
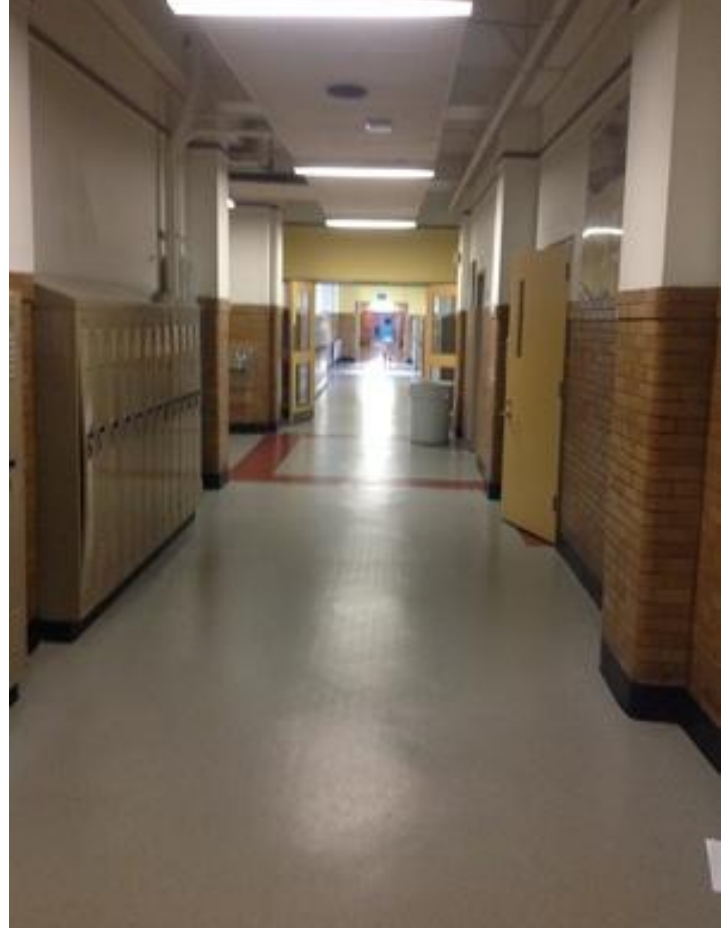
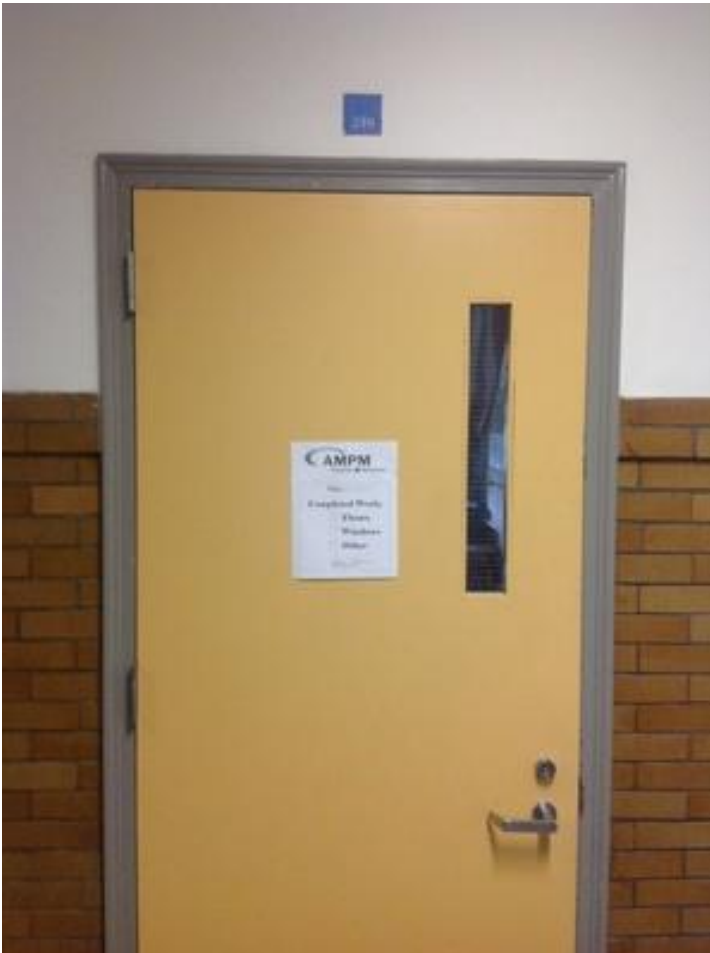
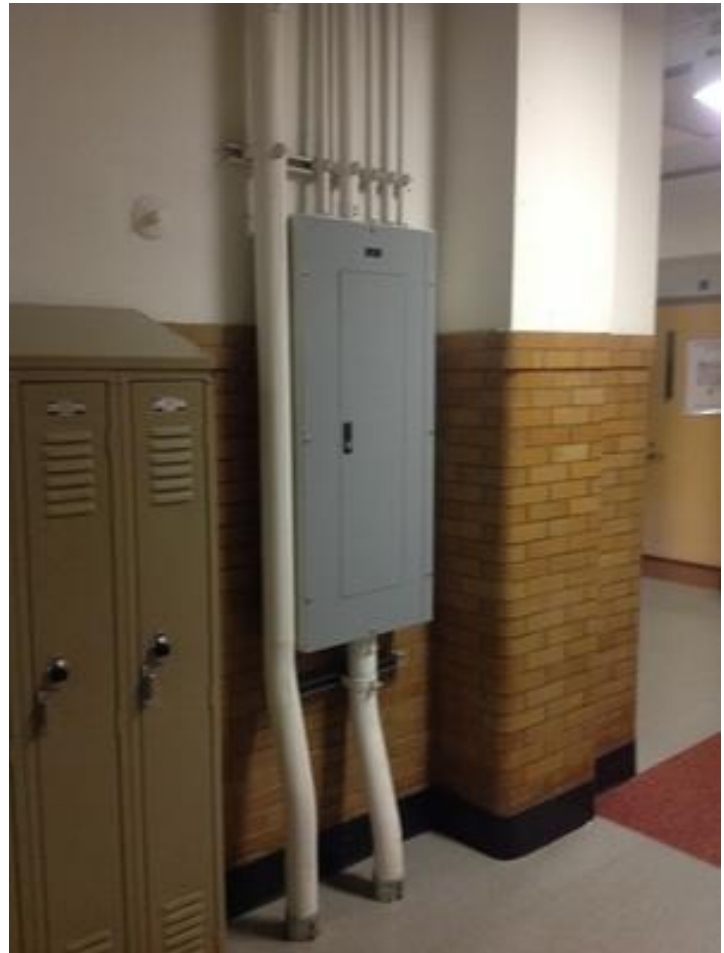
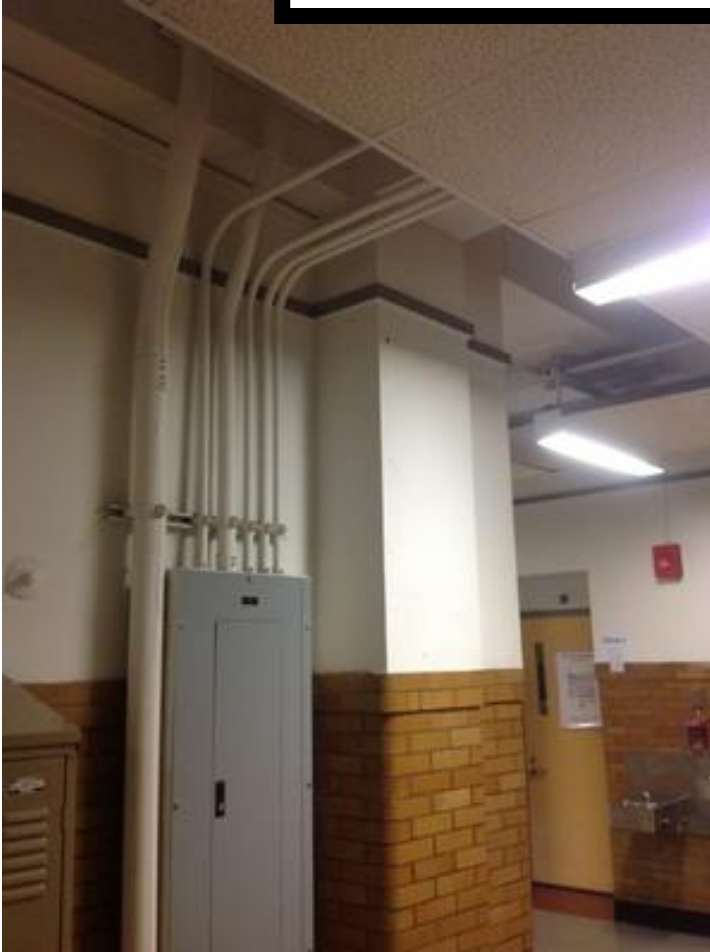
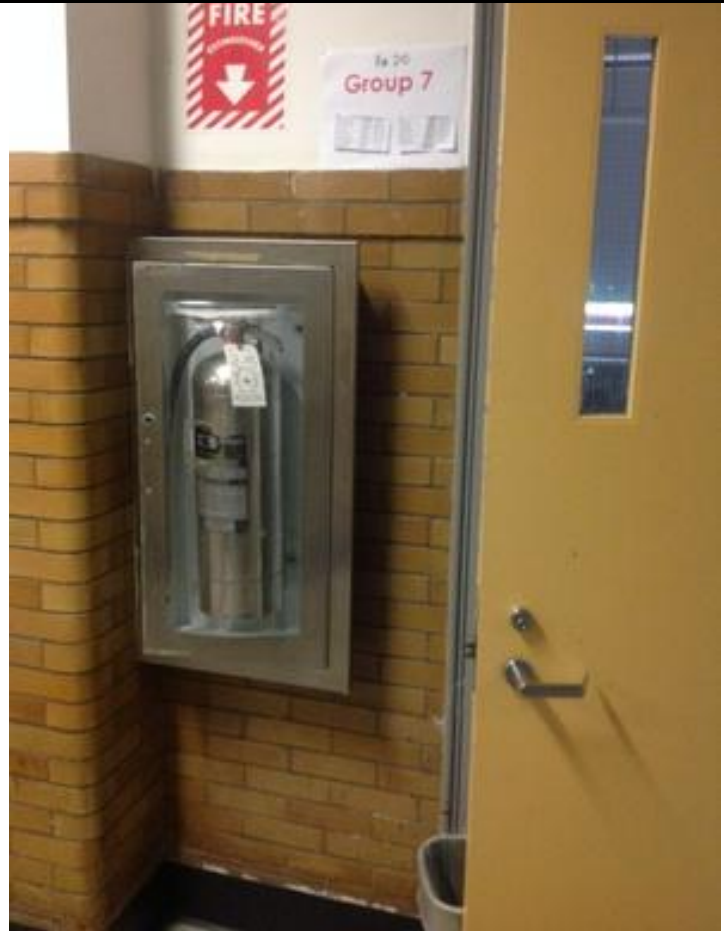
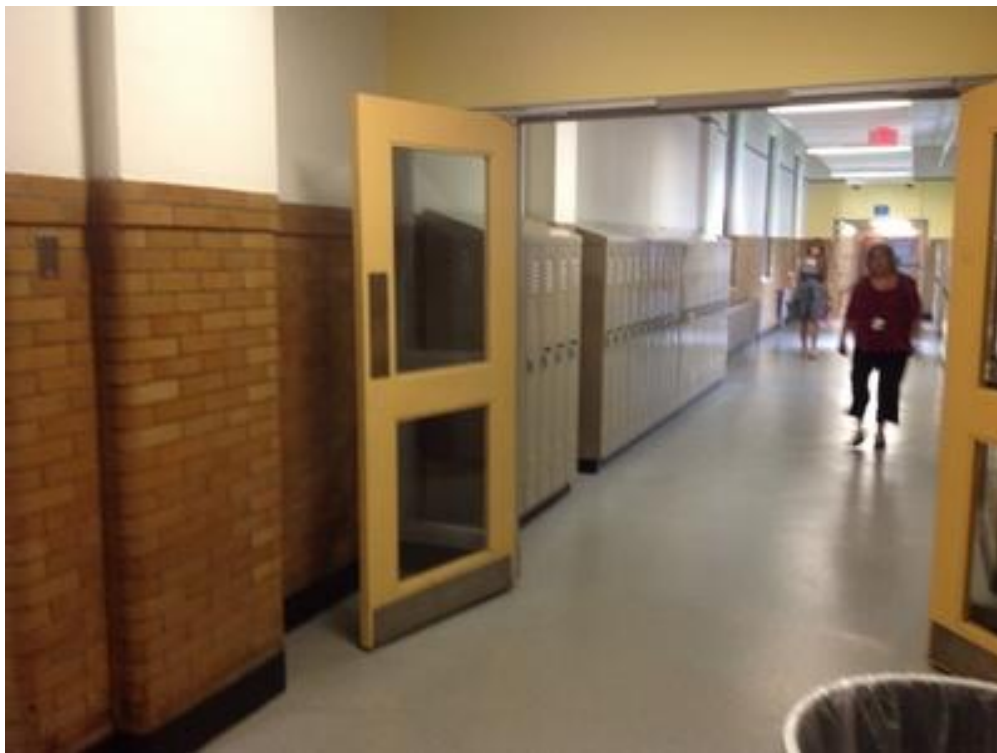
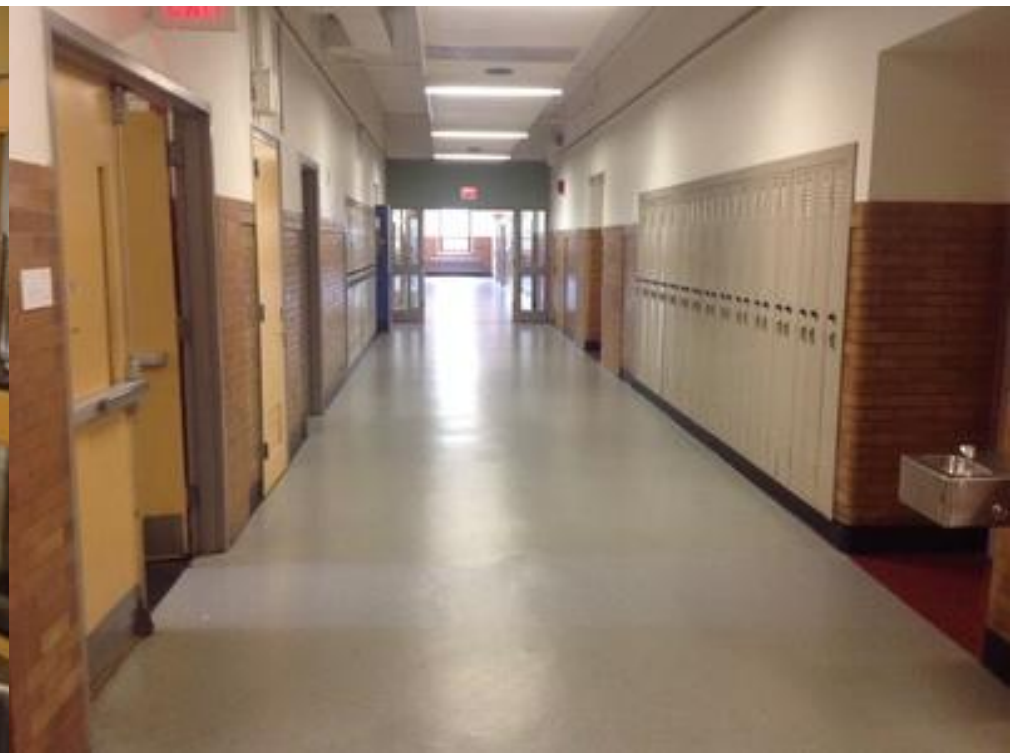
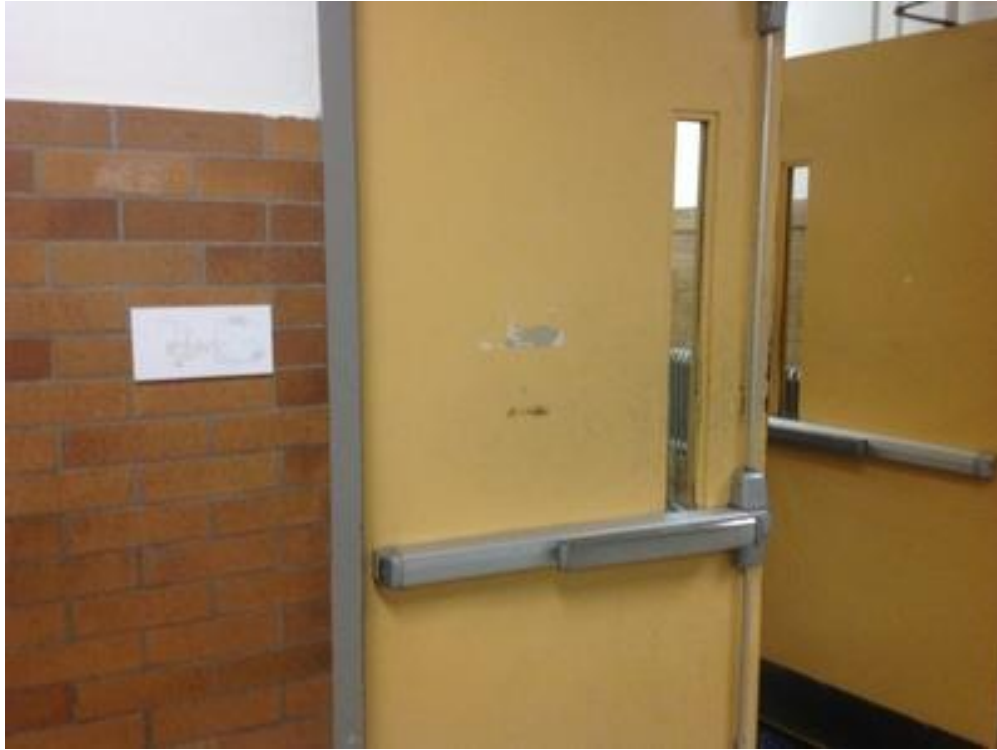
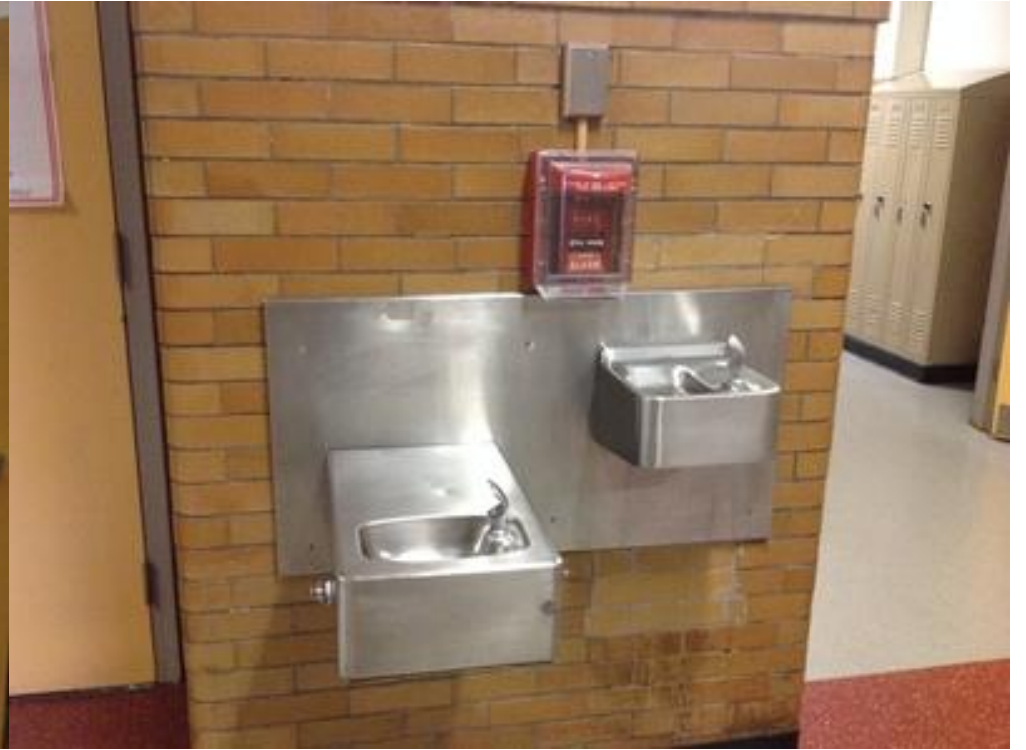
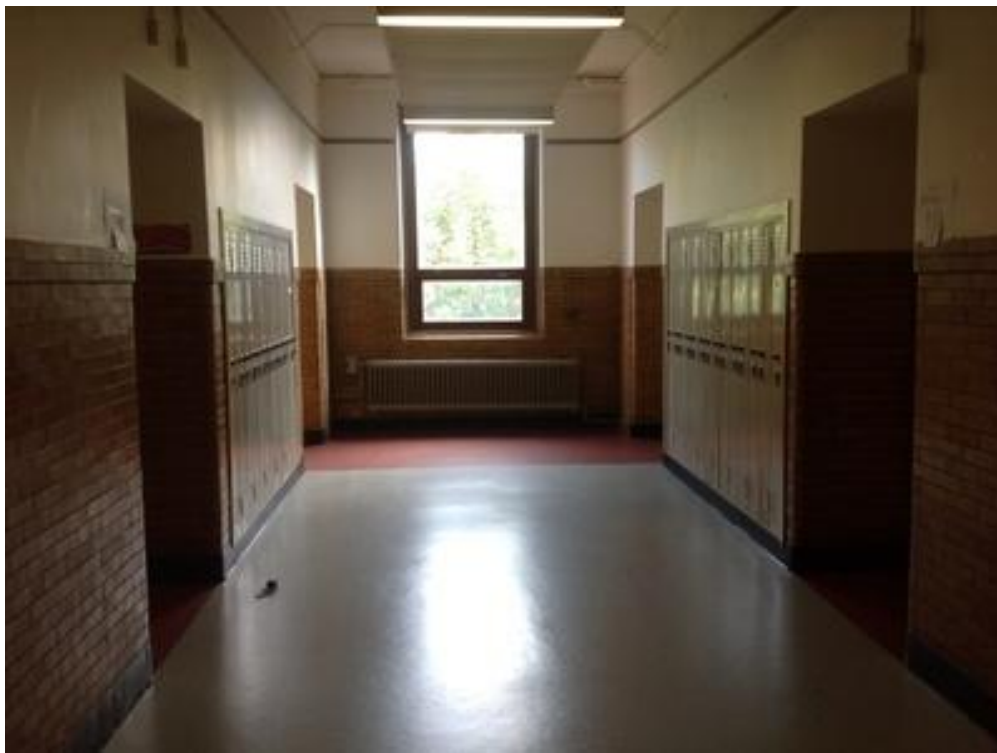
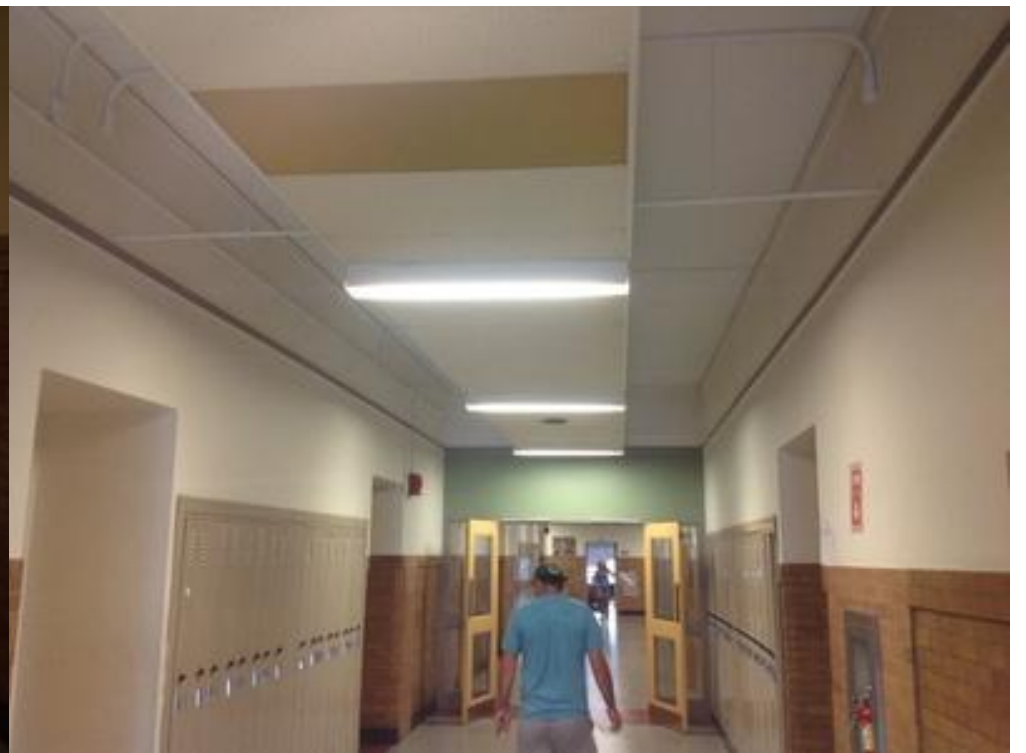
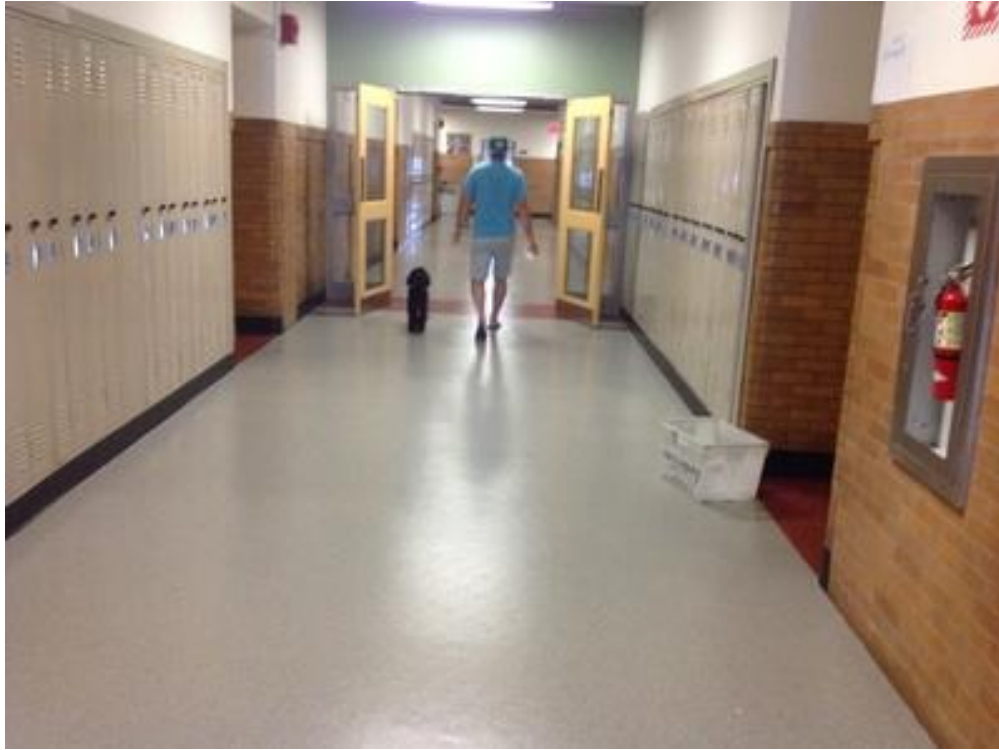
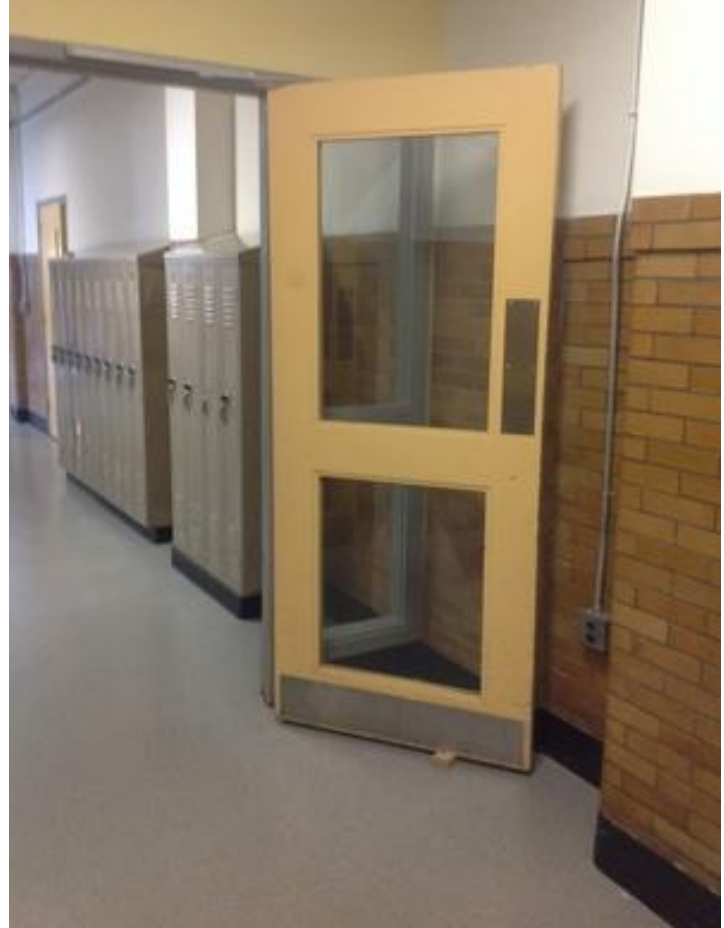
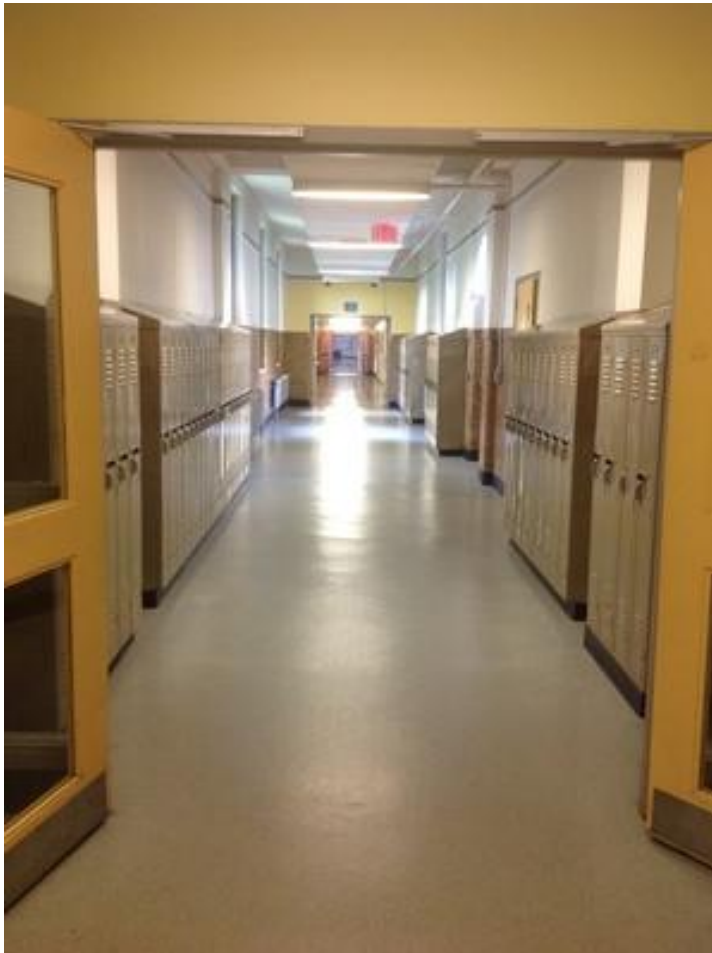
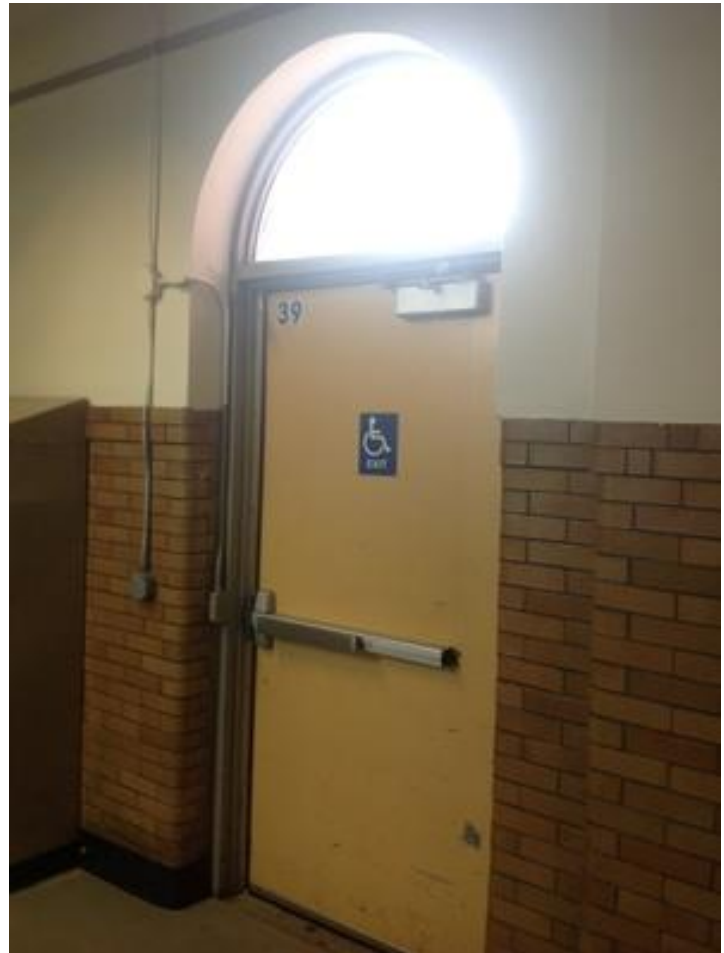
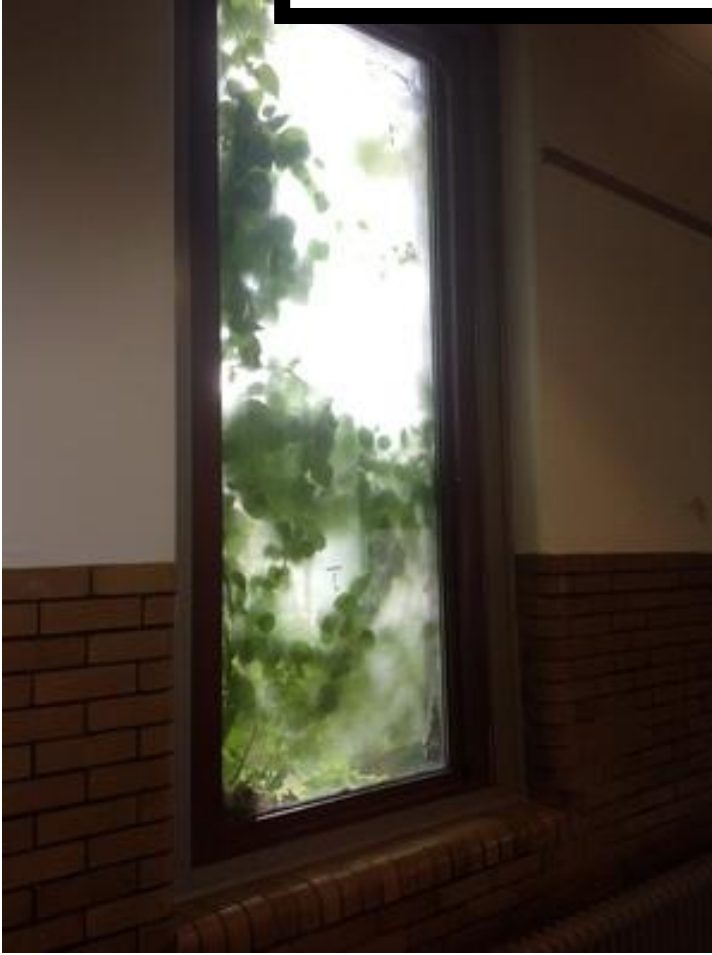
Entire Building- Corridors

Description
Typical - Corridors are in fair to poor condition. Warping has caused an uneven surface. Windows are scratched, vandalized, and some have lost seals. Paint on plaster is dented and chipping and cracking. Exposed piping and wiring is haphazard and in some cases can be a tripping hazard. Piping insulation is in poor condition. Some drinking fountains are not ADA compliant.

| Condition | Fair | | |

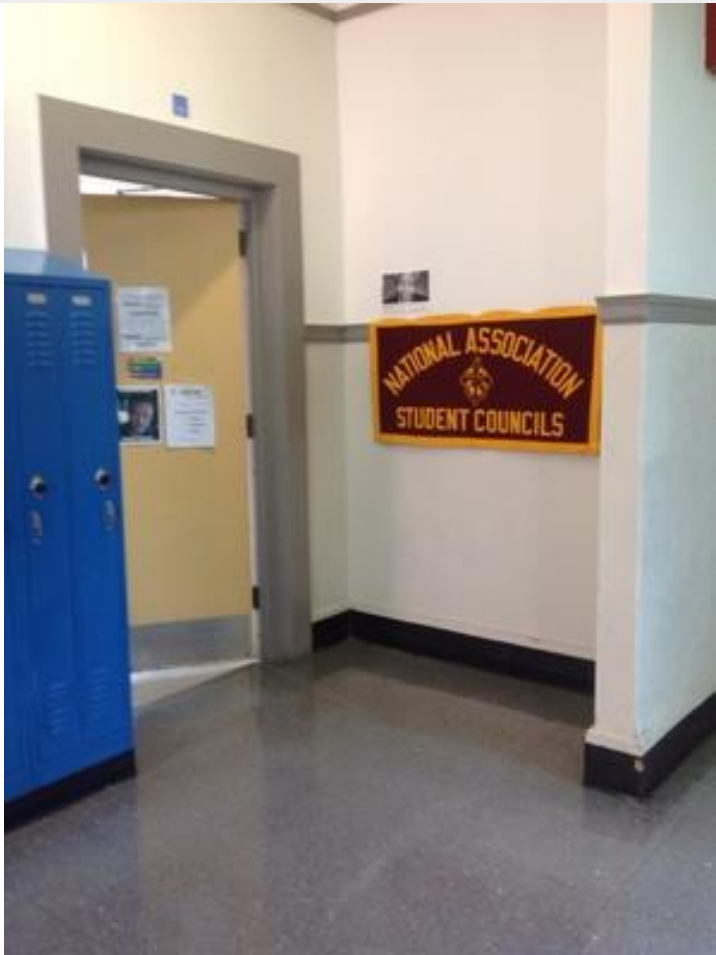
IMG_0431.JPG

| Description VCT flooring in fair condition but has some warping-typical. Paint is chipping on walls and ceiling. 2x4 ACT and grid centered in corridor exposes piping/wires. Surface mounted equipment and wiring is haphazard. Shades are in poor condition. Millwork in poor condition. Unit heater in poor condition. Some windows have lost their seal. Classroom has smartboard. | | | |

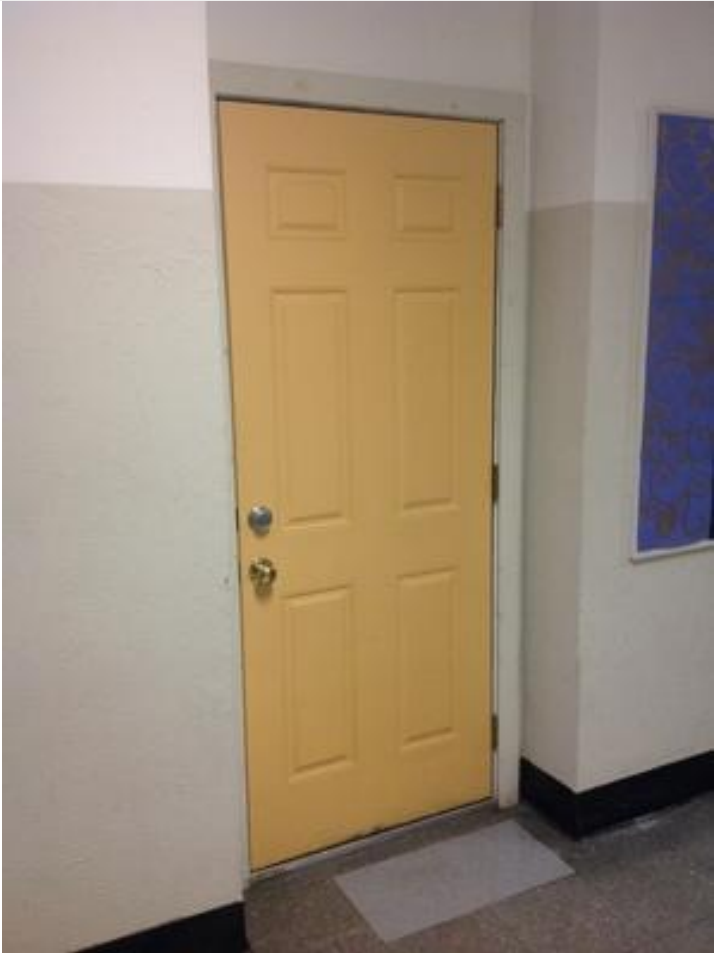
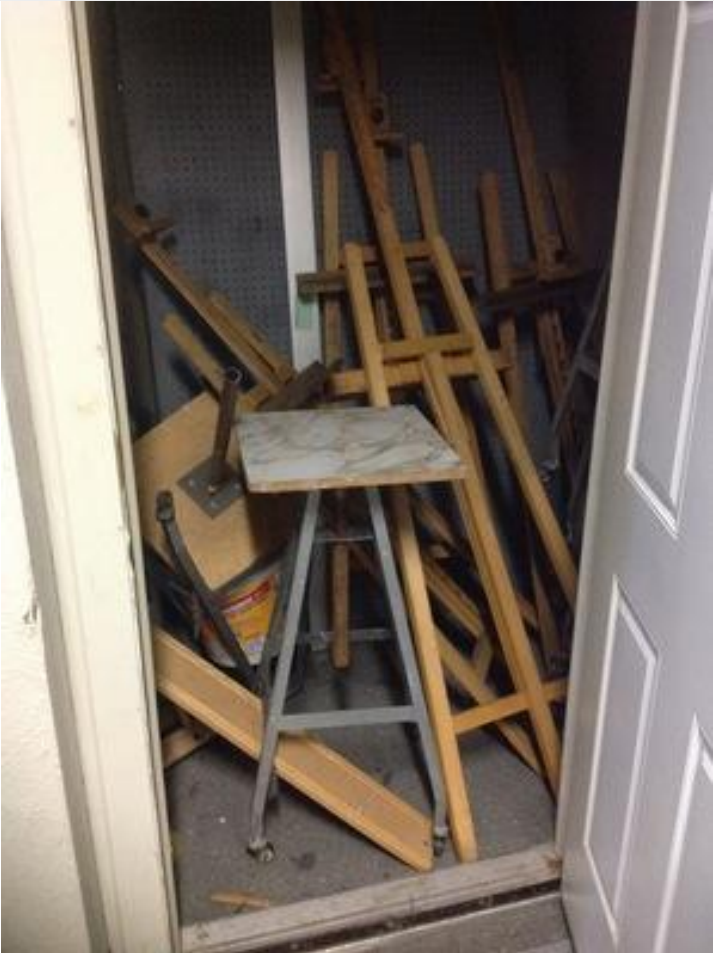
| Description Corridor replacement doors not code compliant. Threshold too high and knob handles. | | | |
