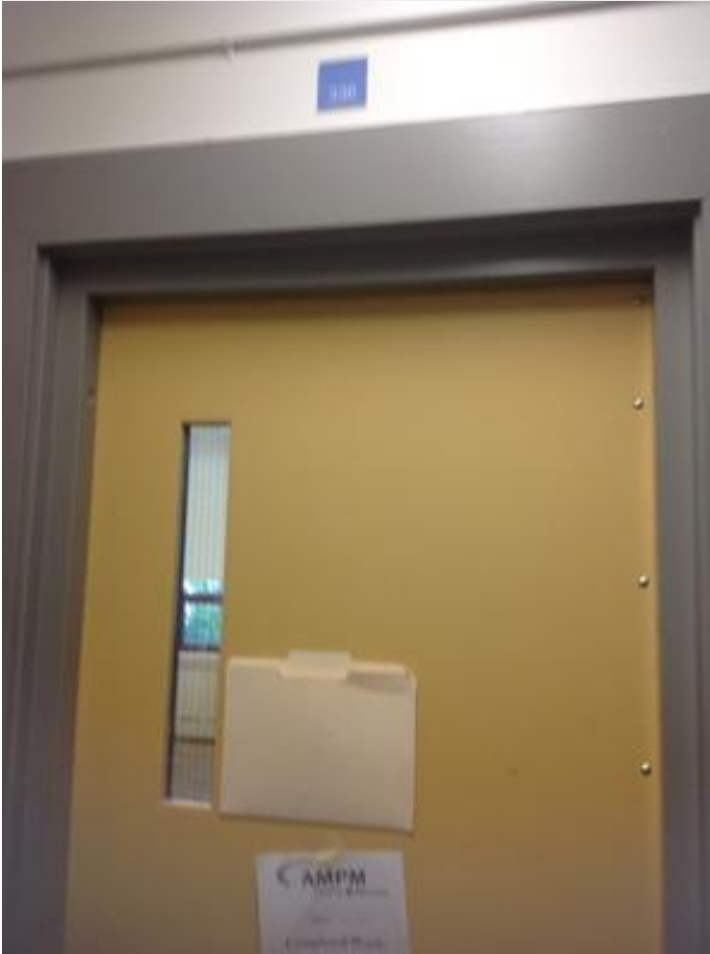
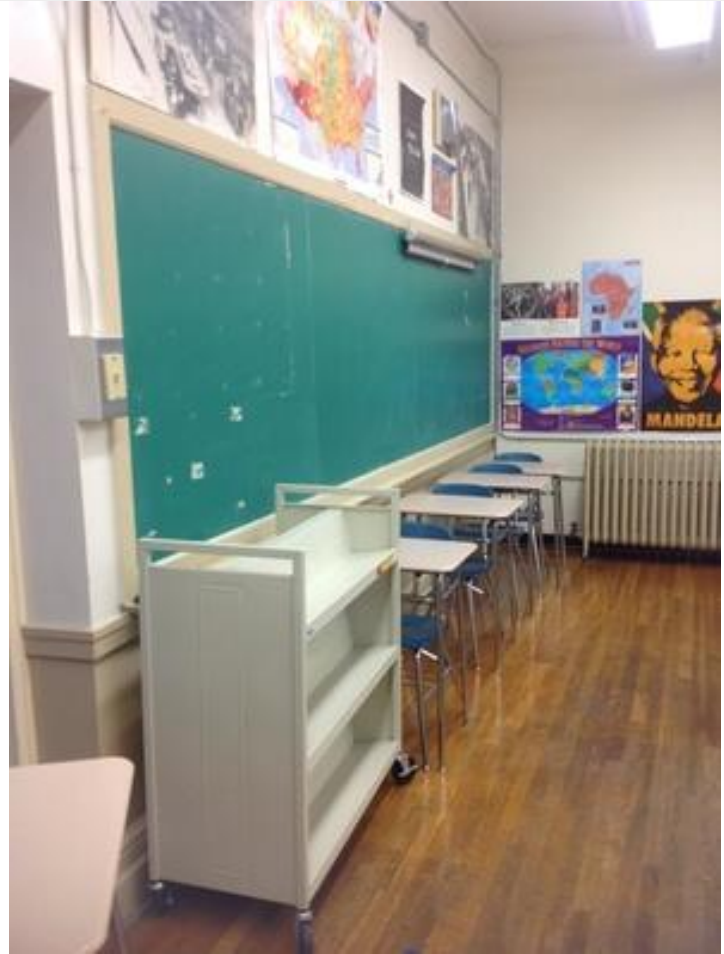
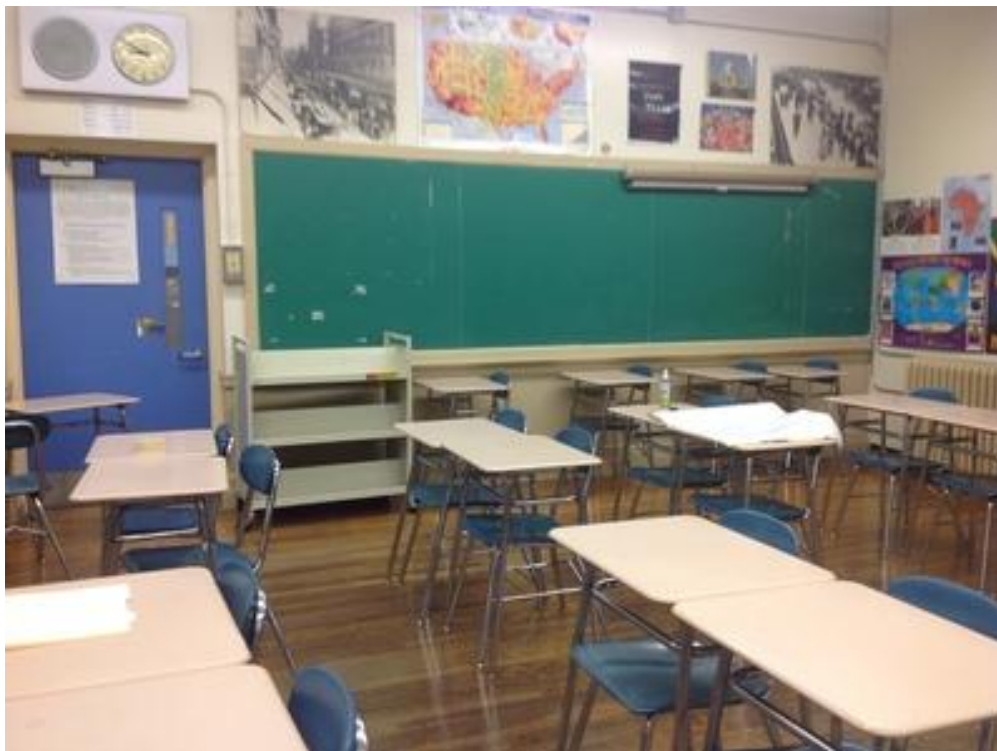
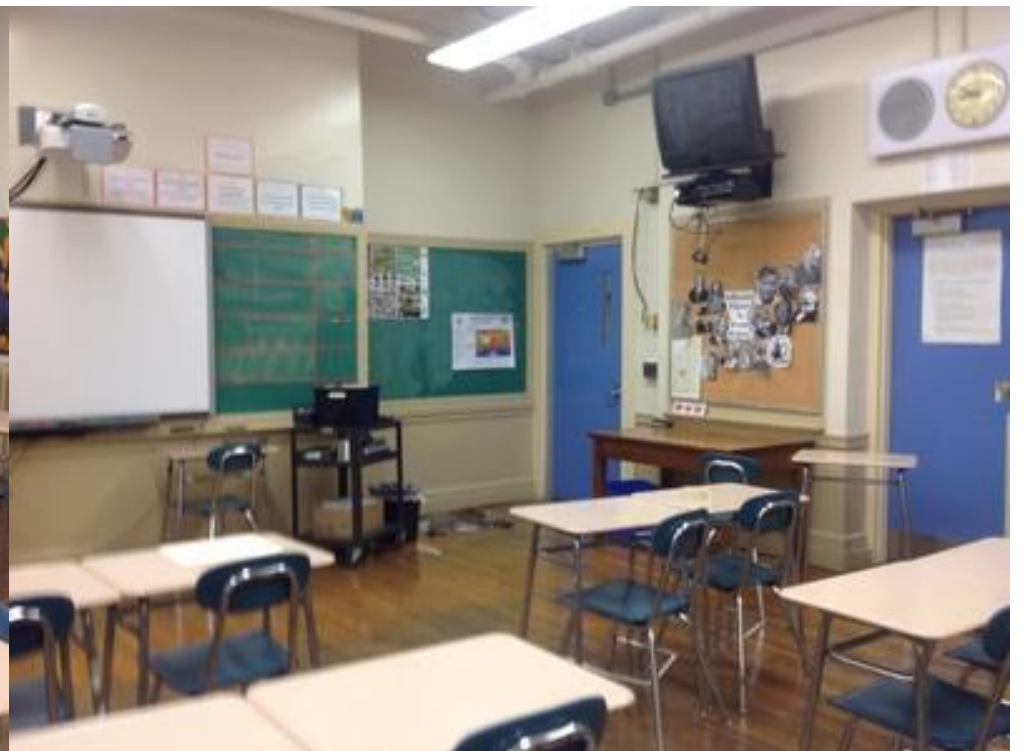
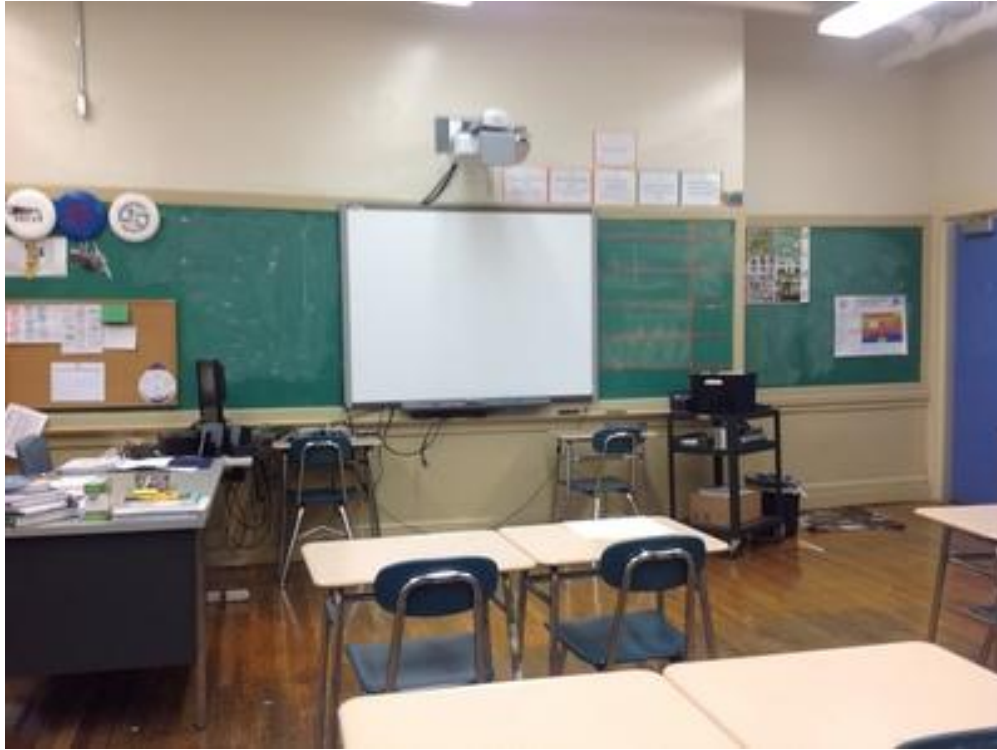
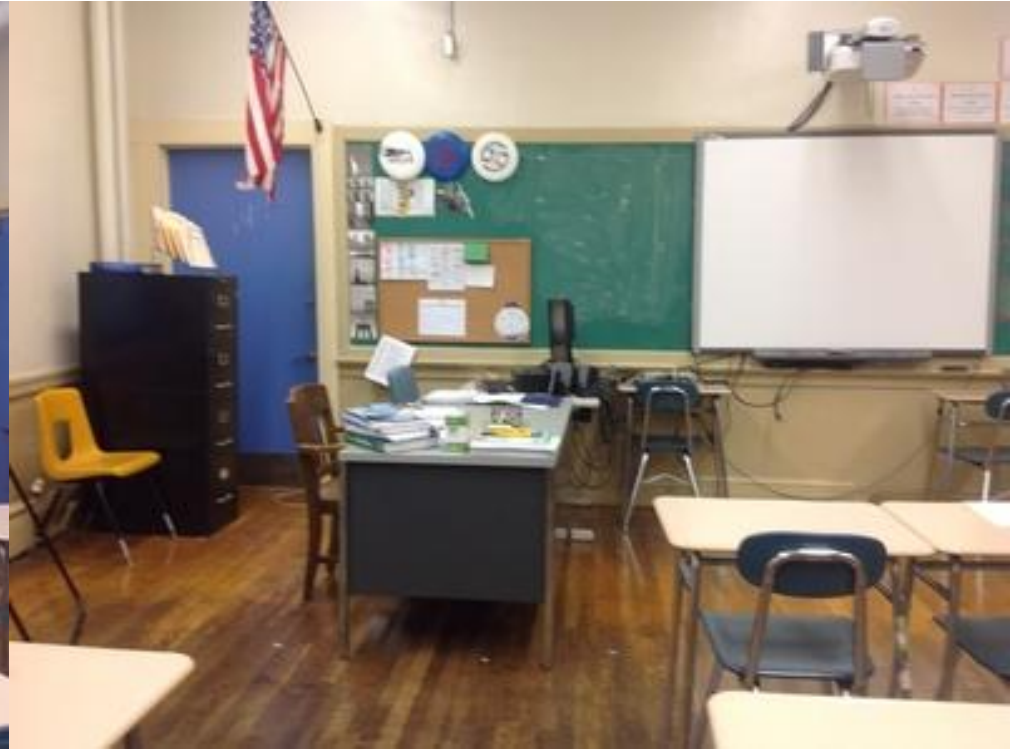
Description
Wood flooring in good condition but creaky. Paint is chipping on walls and ceiling. Light fixtures missing covers in some locations. 10'x20' area of 12"x12" VCT on ceiling. Surface mounted equipment and wiring is haphazard. Shades are in poor condition. Millwork in poor condition. Unit heater in poor condition. Some windows have lost their seal. Classroom has smartboard. Blackboards are beyond usable life.

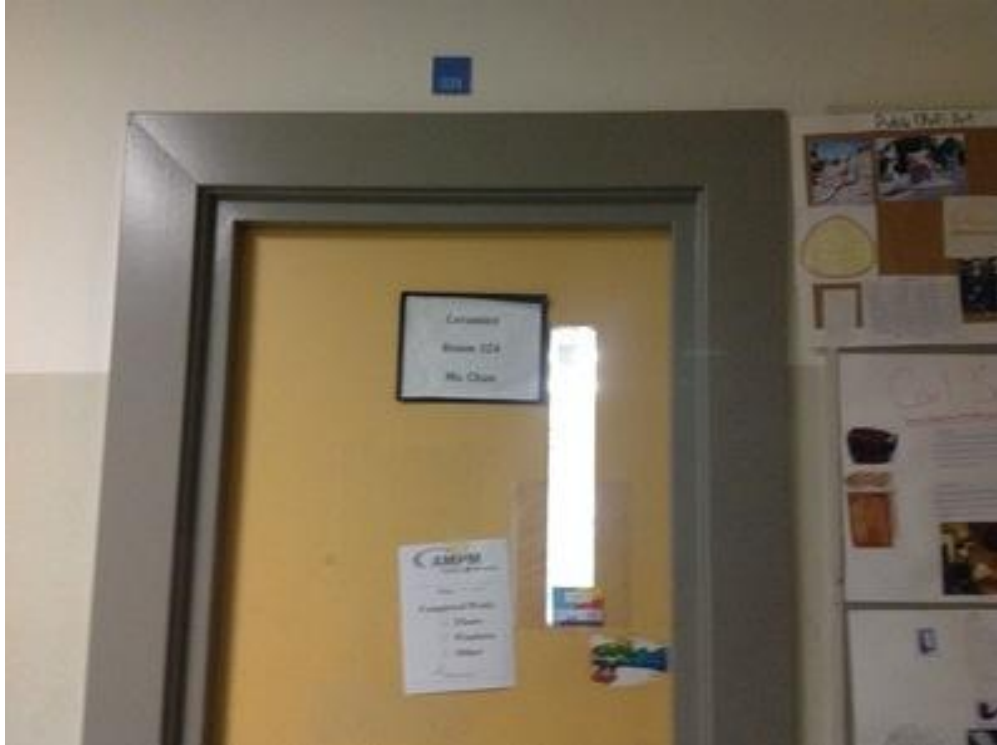
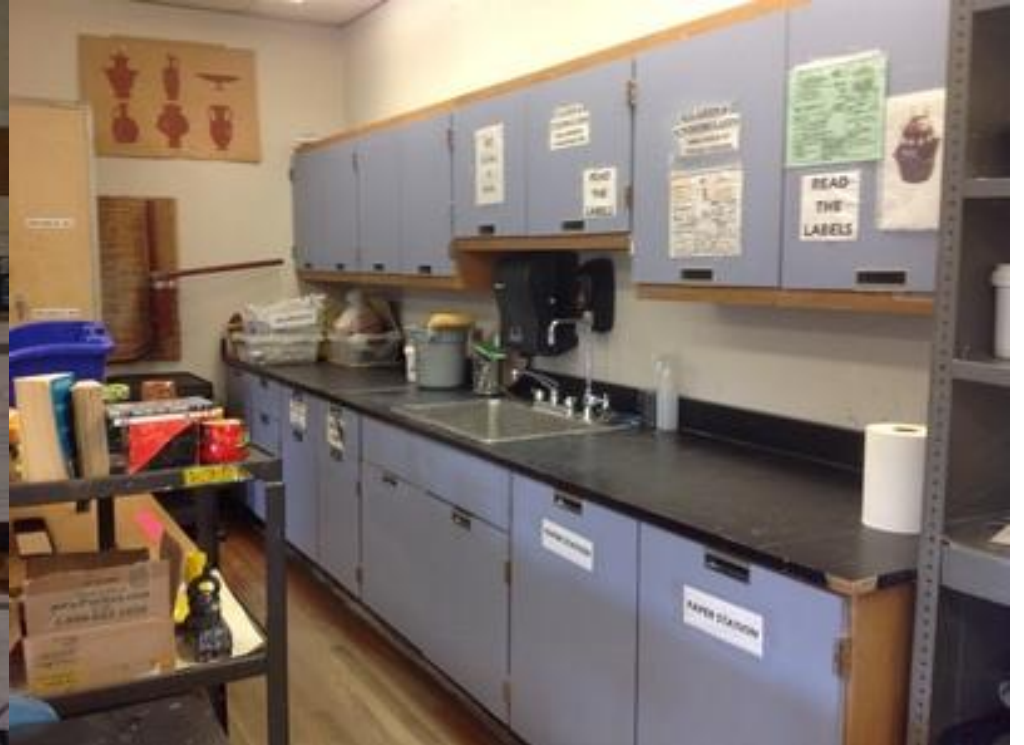
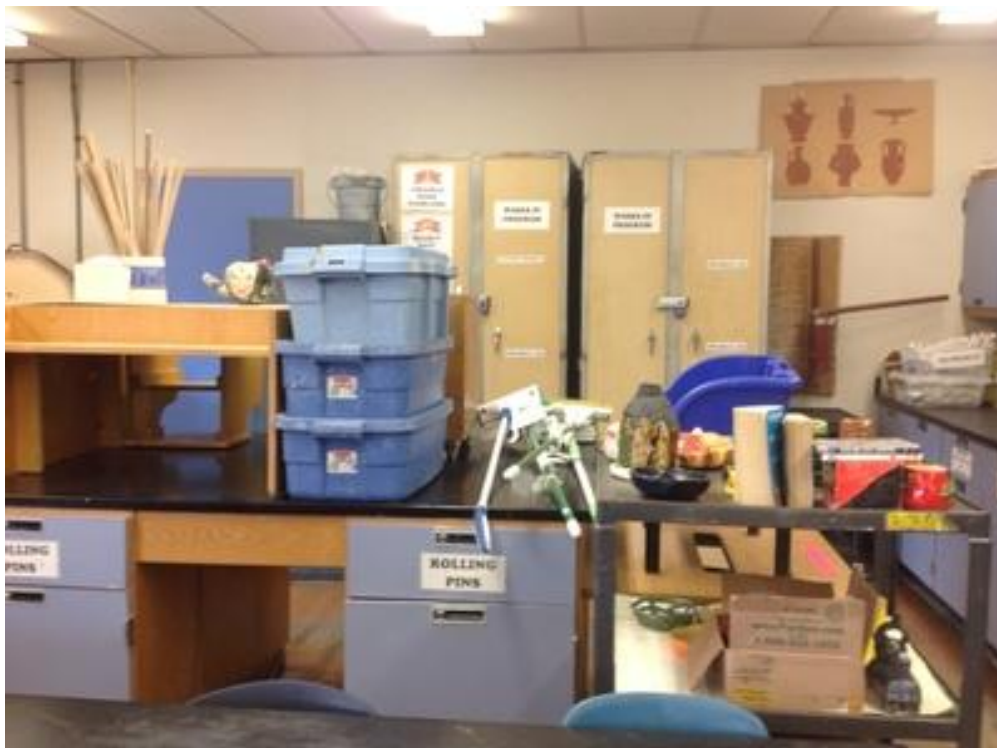
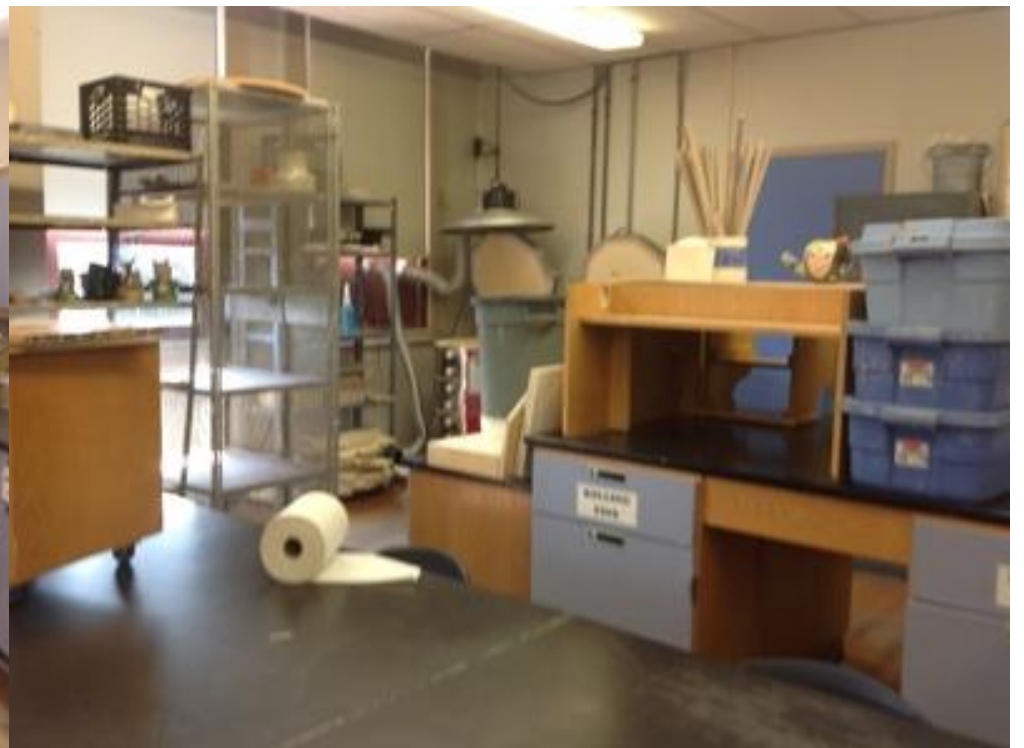
Description
Wood flooring in good condition but creaky. Paint is chipping on walls and ceiling. Light fixtures missing covers in some locations. Surface mounted equipment and wiring is haphazard. Shades are in poor condition. Millwork in poor condition. Unit heater in poor condition. Some windows have lost their seal. Classroom very congested with storage and materials. Sinks not ADA compliant. Venting for kilns does not appear to be code compliant.

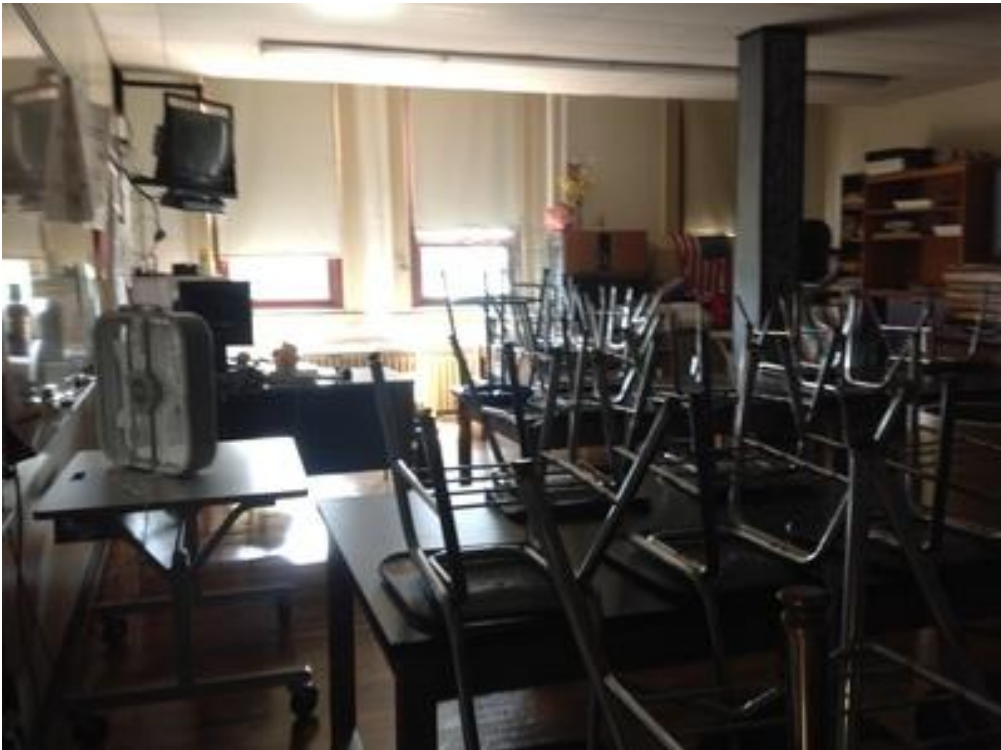
IMG_0477.JPG

Wood flooring in good condition but creaky. Paint is chipping on walls and ceiling. Light fixtures missing covers in some locations. 10'x20' area of 12"x12" VCT on ceiling. Surface mounted equipment and wiring is haphazard. Shades are in poor condition. Millwork in poor condition. Unit heater in poor condition. Some windows have lost their seal. Room is very cluttered making it difficult to move and possible creating accessibility issues. Sinks not accesible

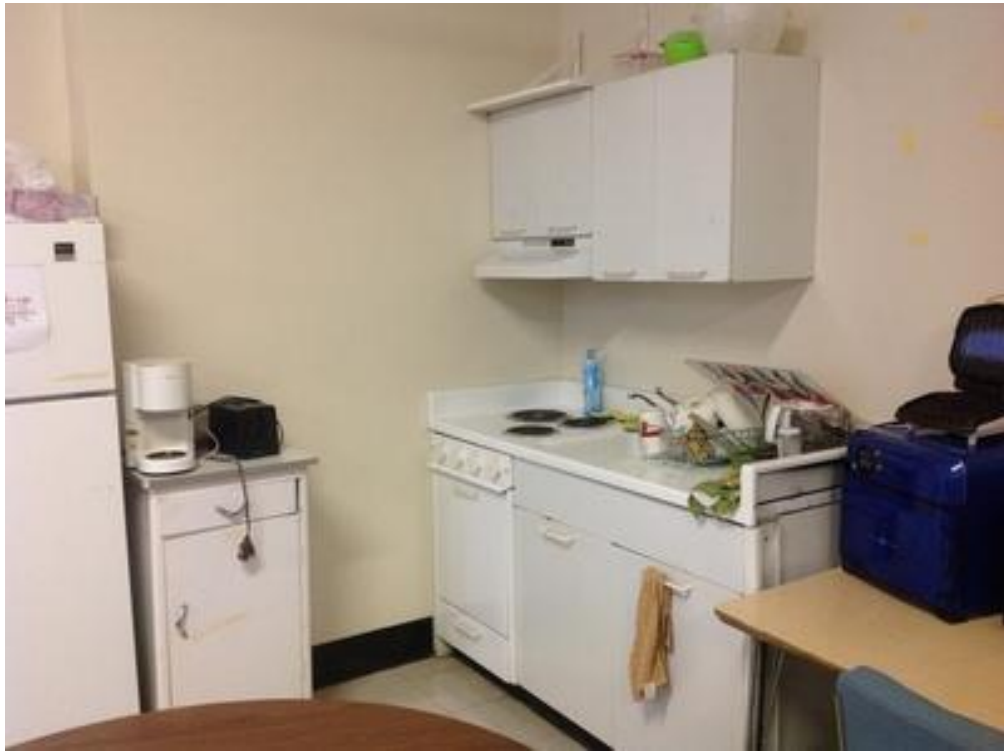
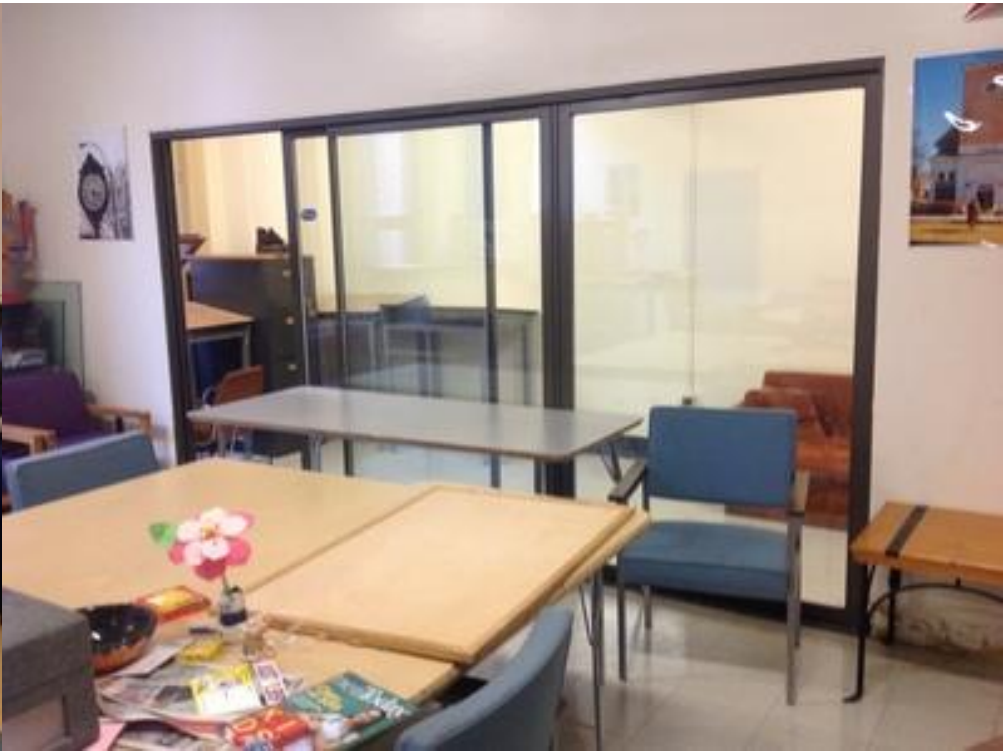
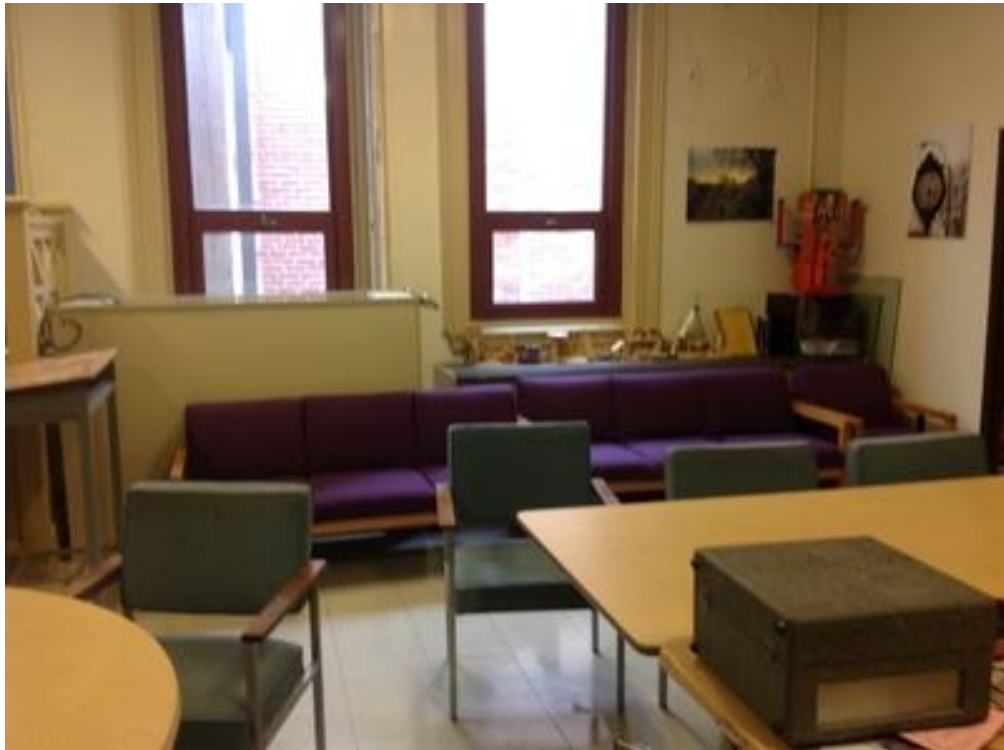
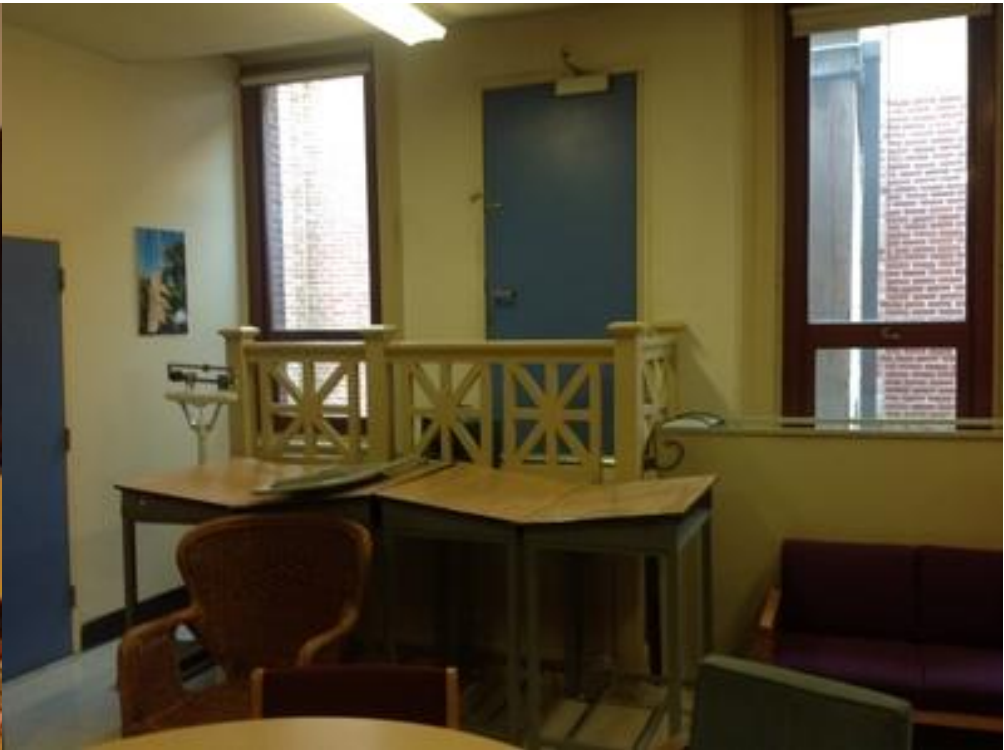
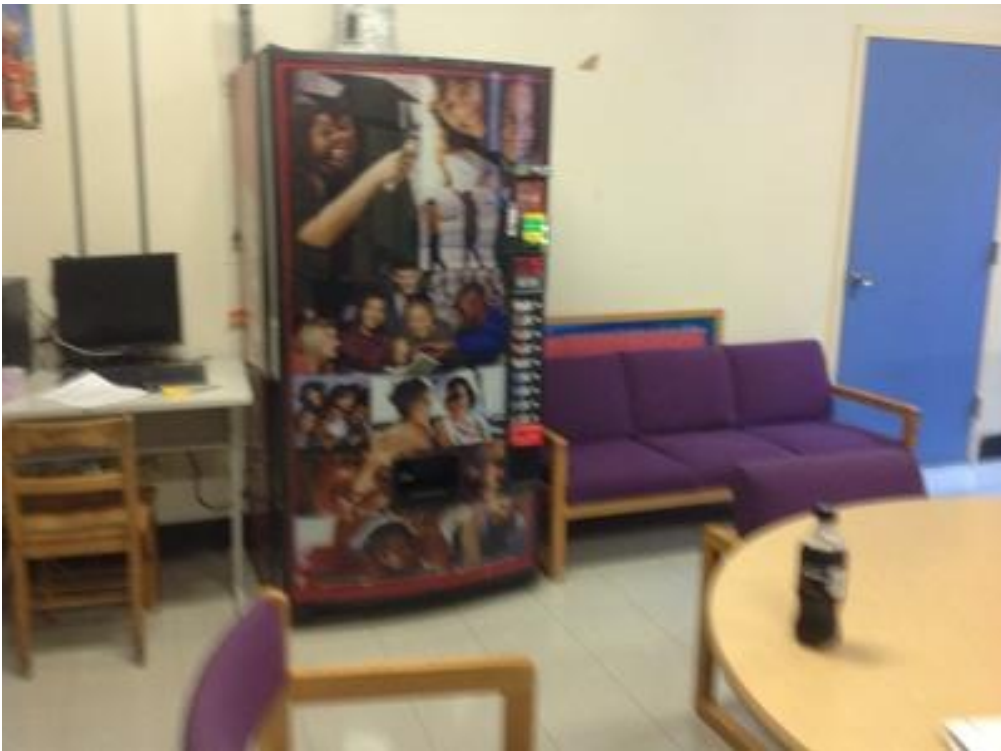
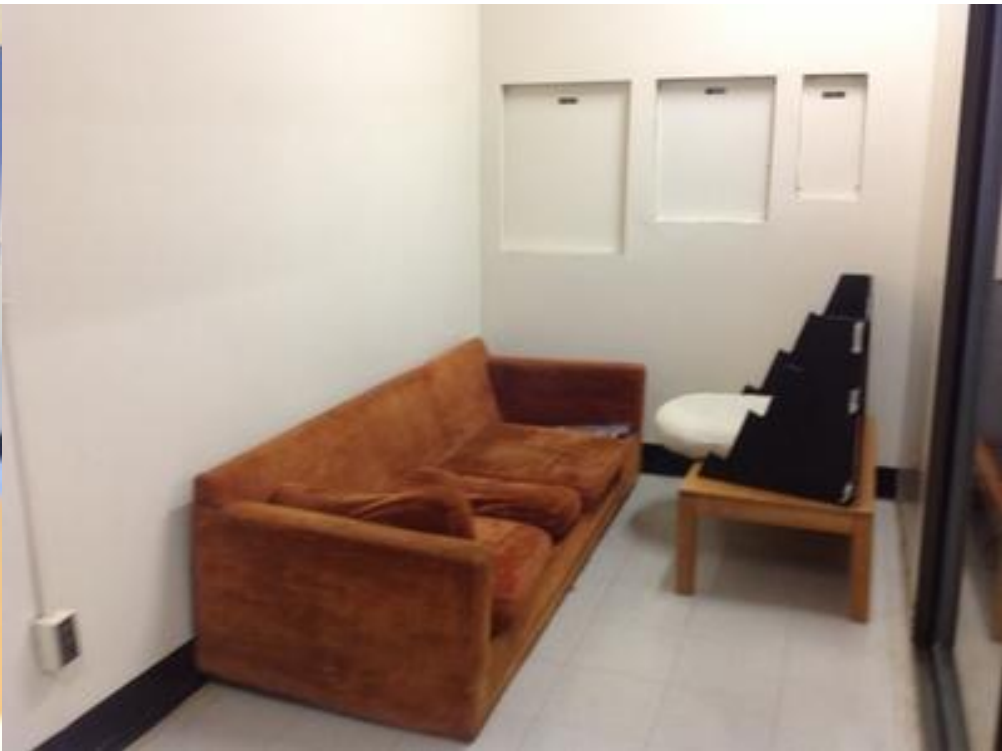
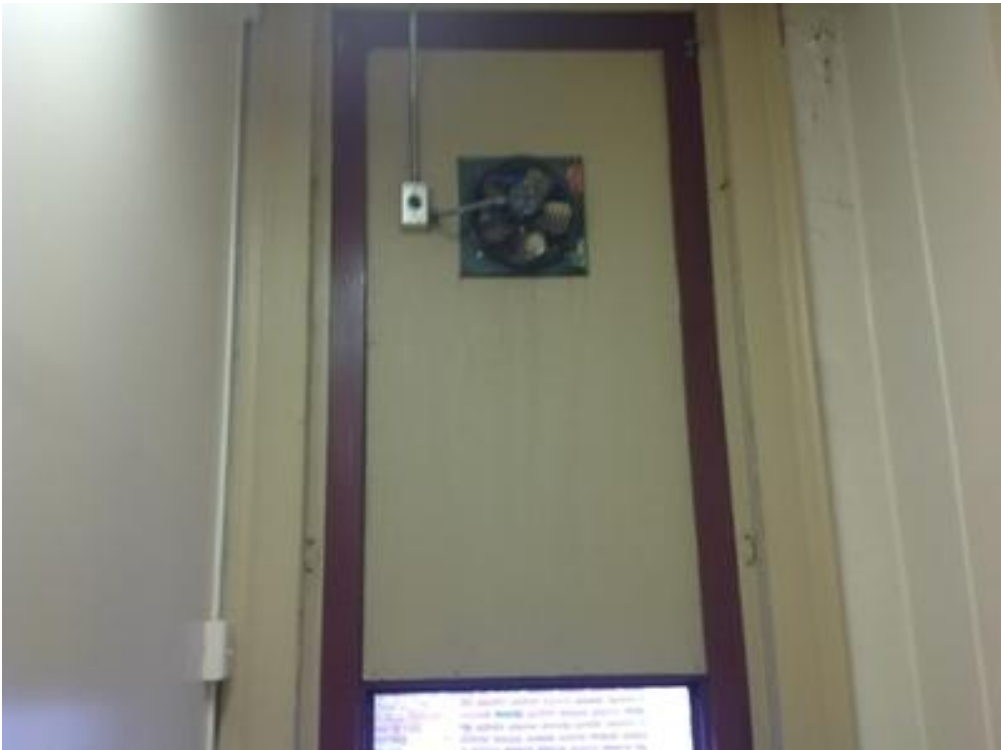
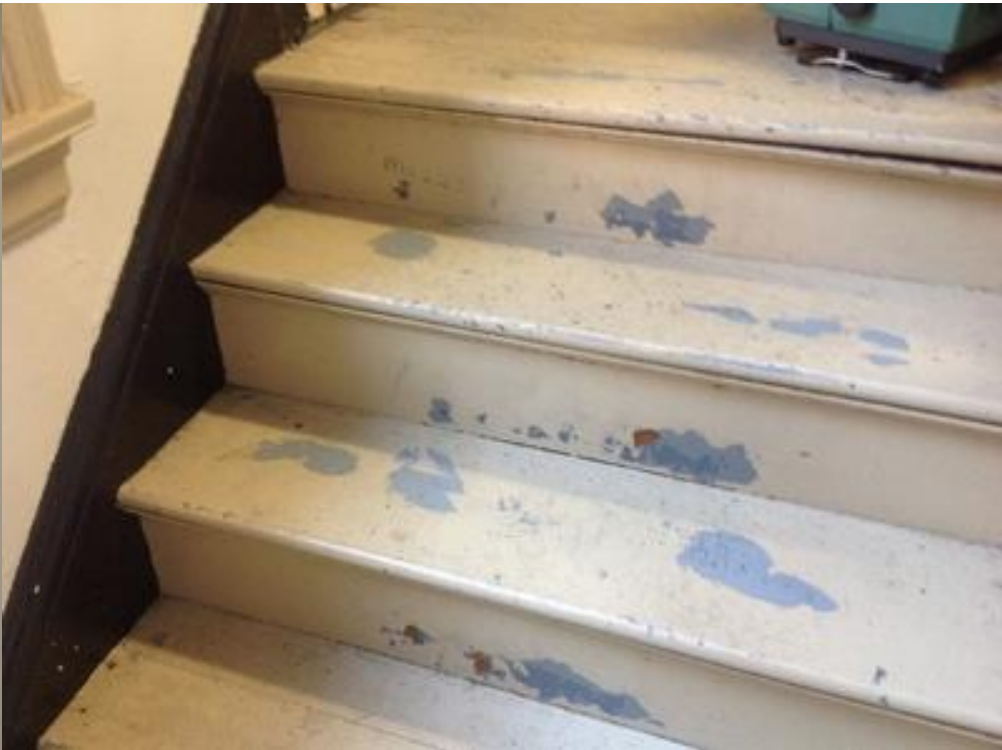
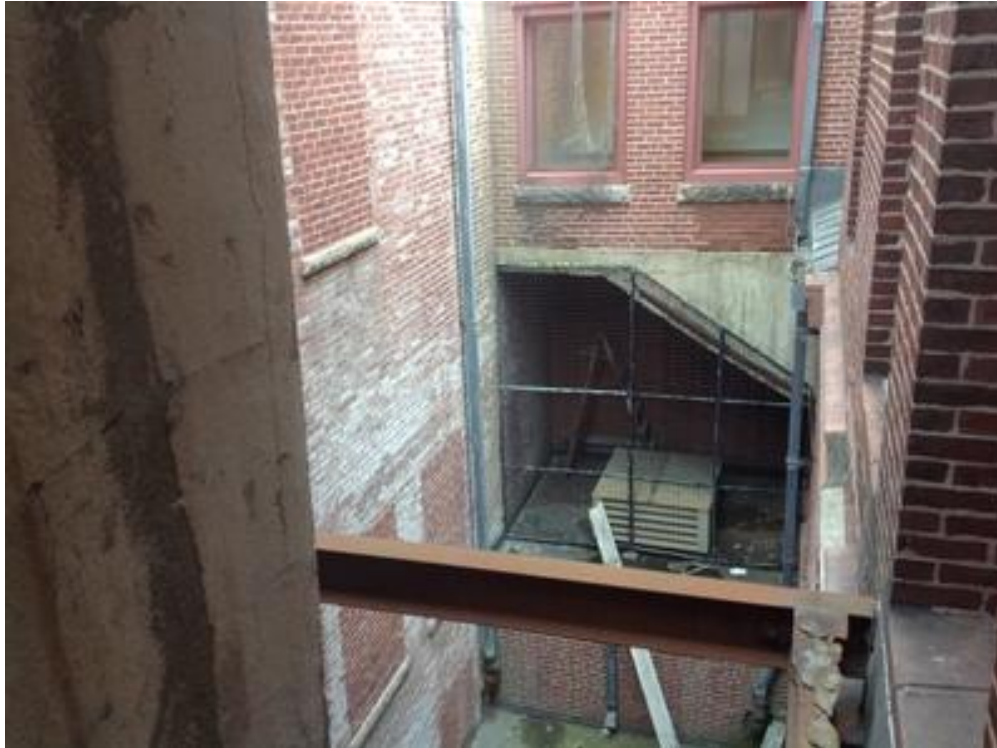
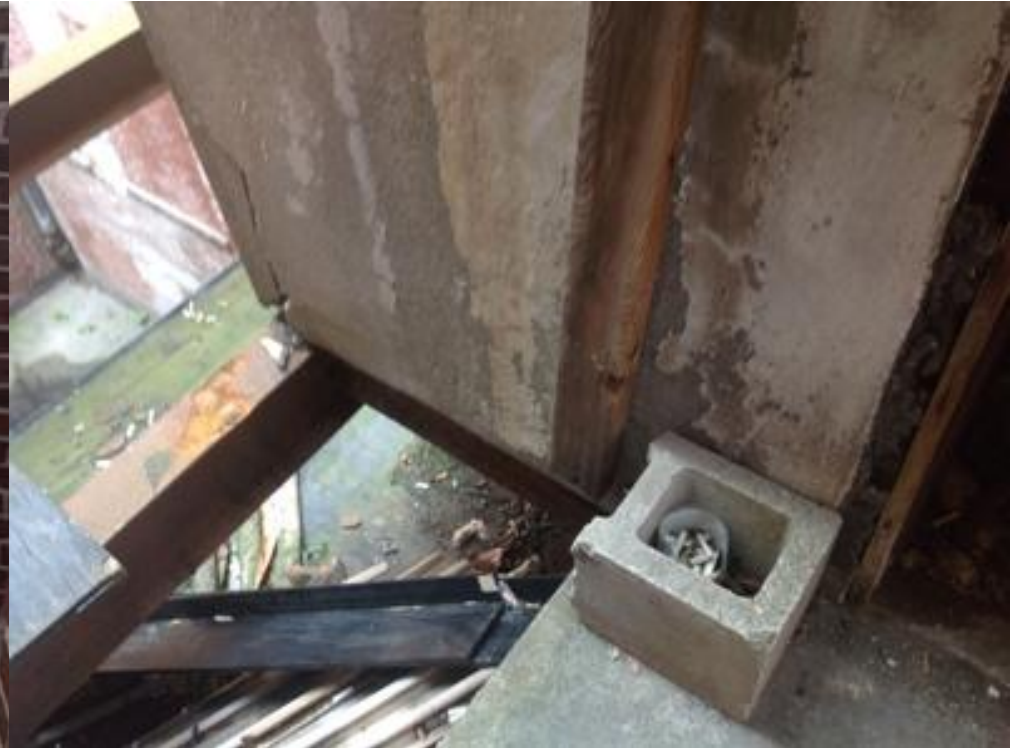
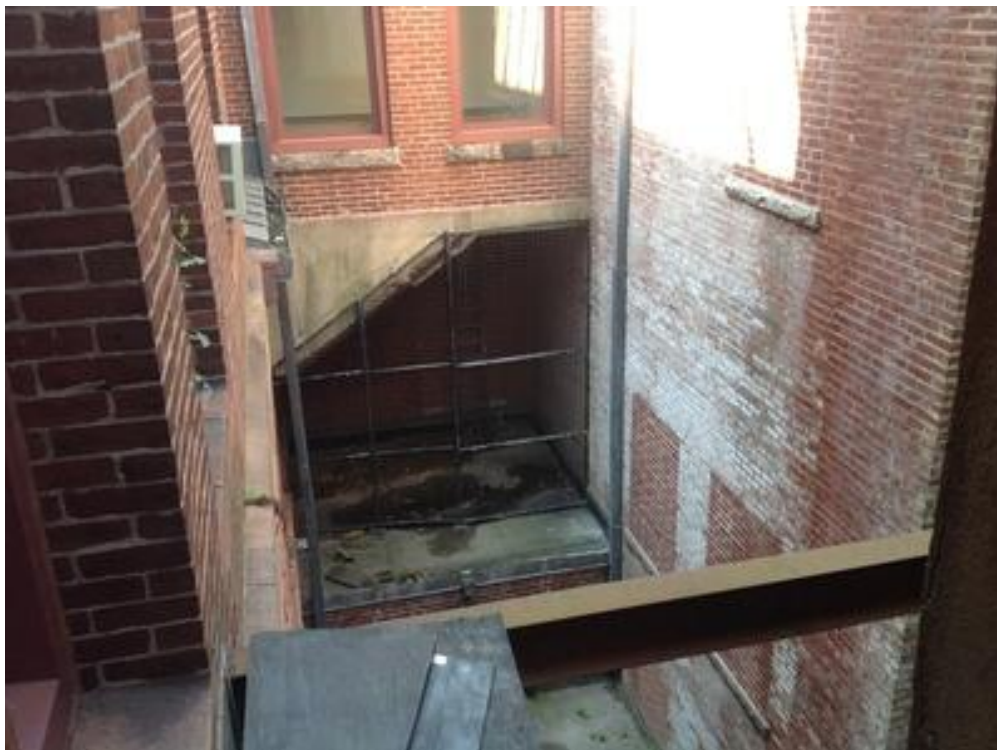
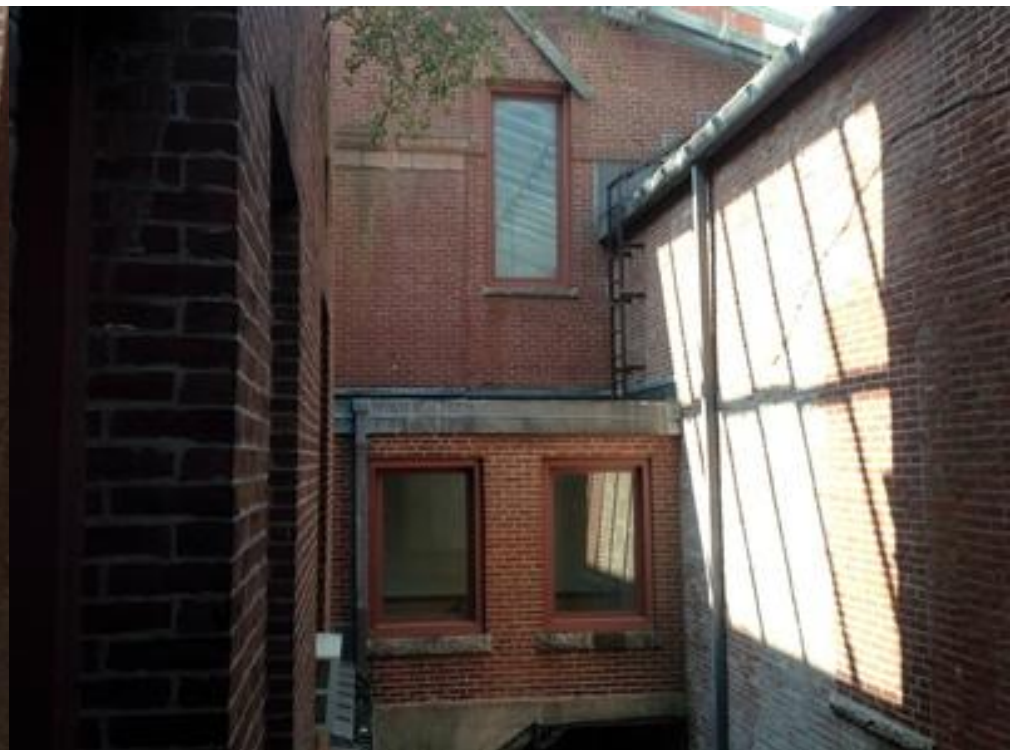
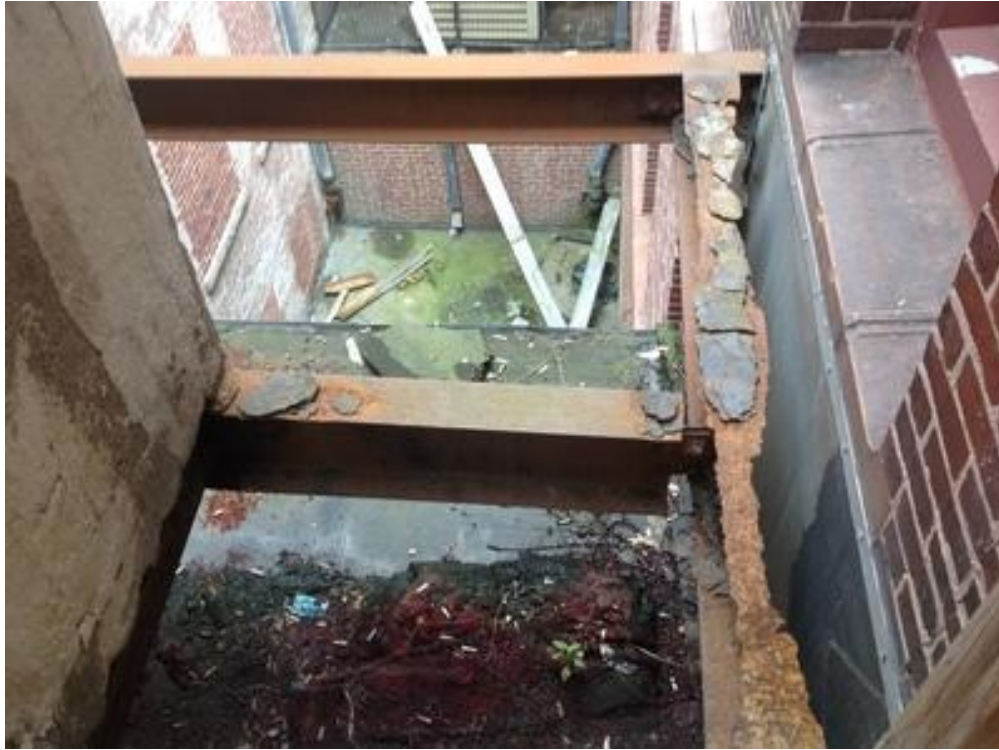
VCT flooring in fair condition but has some warping-typical. Paint is chipping on walls and ceiling. Kitchenette is not accessible. Sliding doors create entry to side room. A door to the light well creates an access point to a platform which is showing structural damage. Access to this space should be restricted.

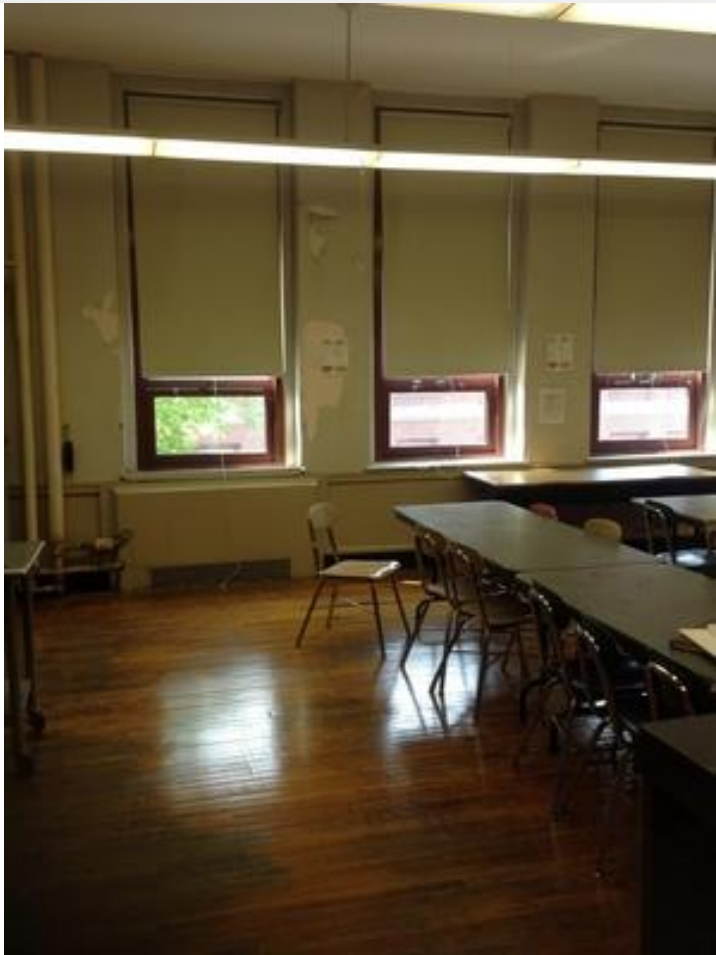
IMG_0498.JPG

Wood flooring in good condition but creaky. Paint is chipping on walls and ceiling. Light fixtures missing covers in some locations. Surface mounted equipment and wiring is haphazard. Shades are in poor condition. Millwork in poor condition. Unit heater in poor condition. Some windows have lost their seal. Classroom has smartboard and many printers. Graphic design classroom. Sink not accessible.

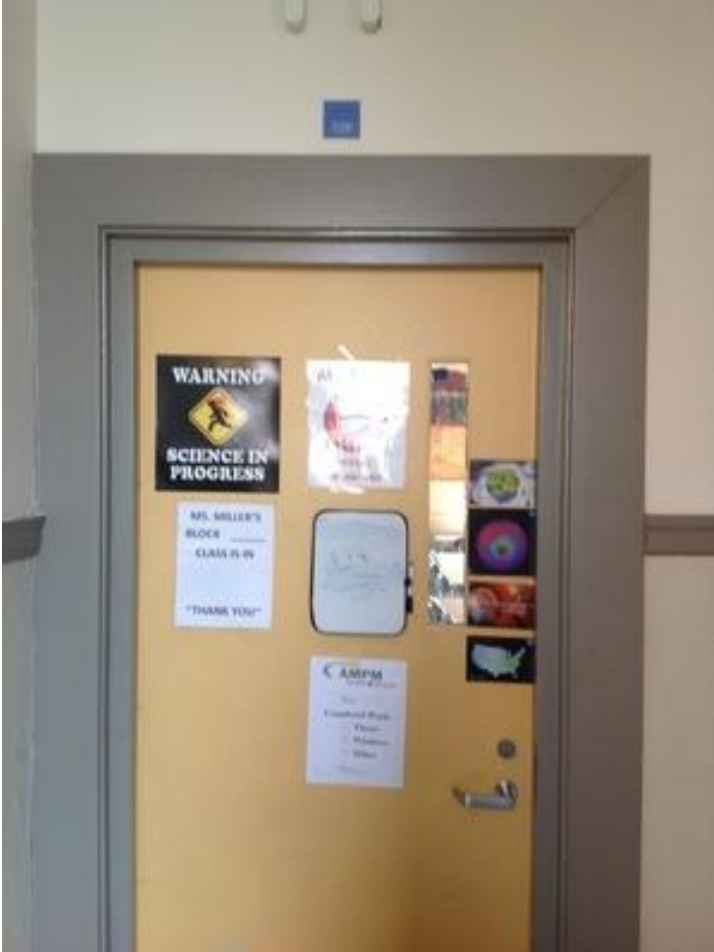
IMG_0507.JPG

Wood flooring in good condition but creaky. Paint is chipping on walls and ceiling. 2x4 ACT and grid centered in corridor exposes piping/wires. Surface mounted equipment and wiring is haphazard. Shades are in poor condition. Millwork in poor condition. Unit heater in poor condition. Some windows have lost their seal. Classroom has smartboard.

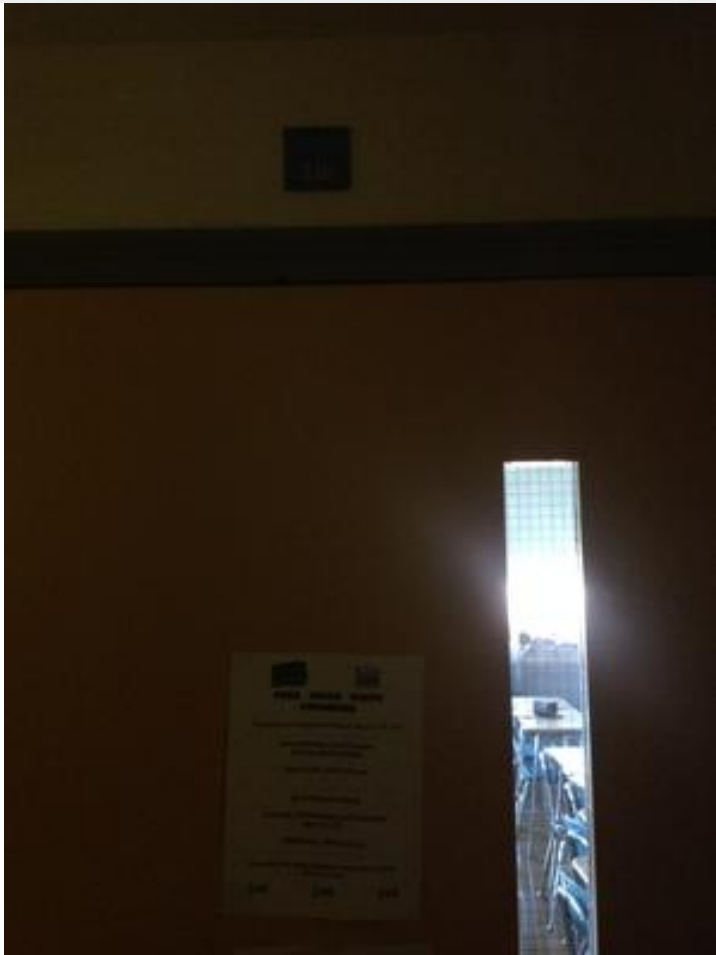
IMG_0518.JPG

Description
Wood flooring in good condition but creaky. Paint is chipping on walls and ceiling. Light fixtures missing covers in some locations. 10'x20' area of 12"x12" VCT on ceiling. Surface mounted equipment and wiring is haphazard. Shades are in poor condition. Millwork in poor condition. Unit heater in poor condition. Some windows have lost their seal. Classroom has smartboard.

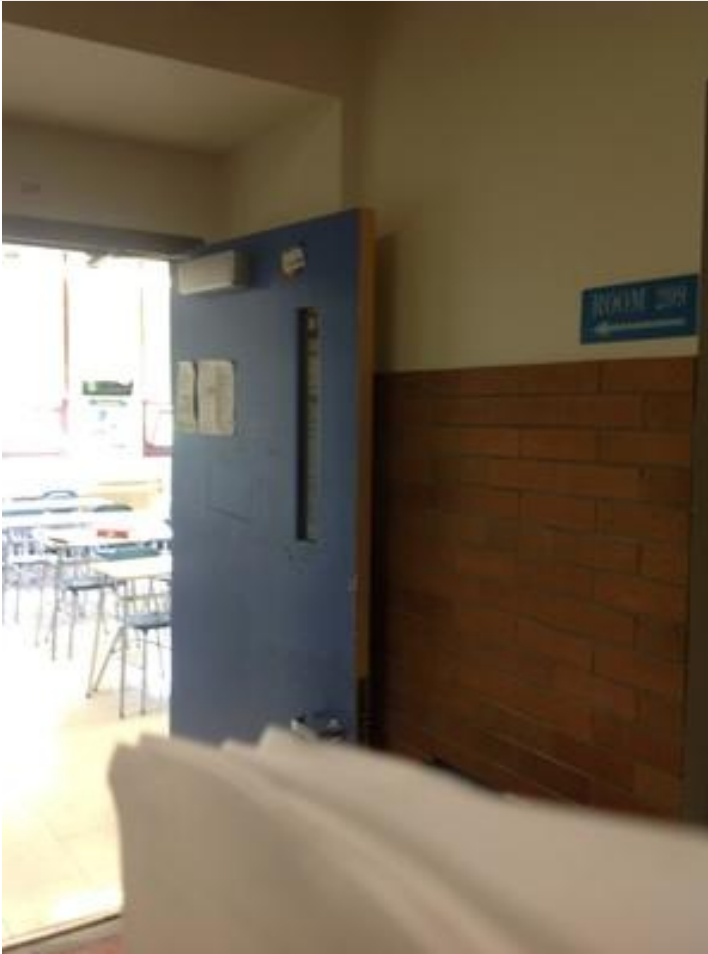
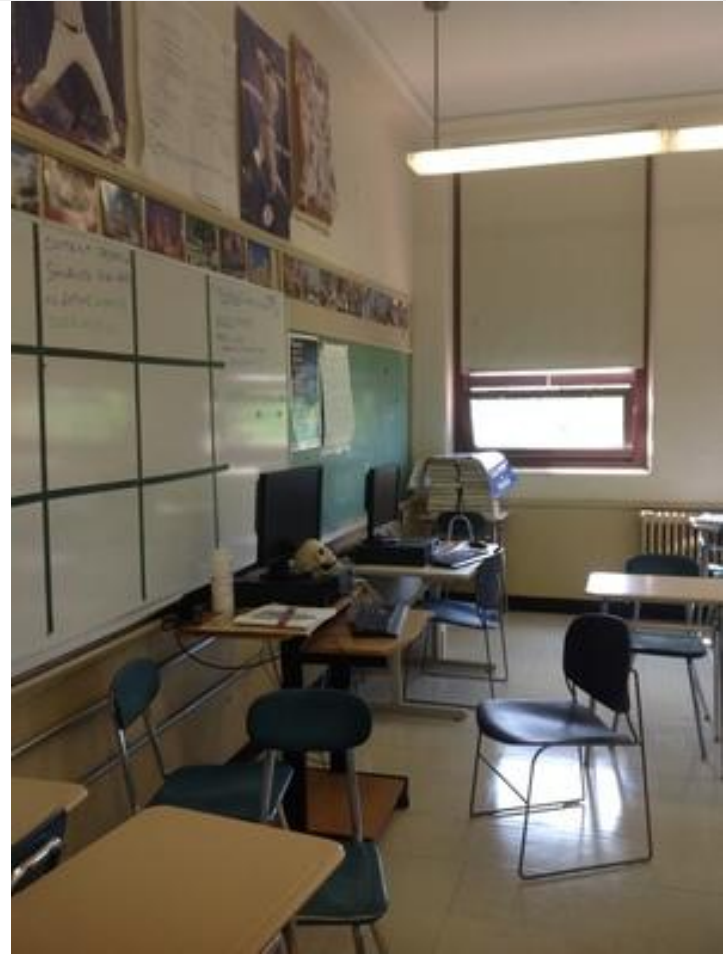
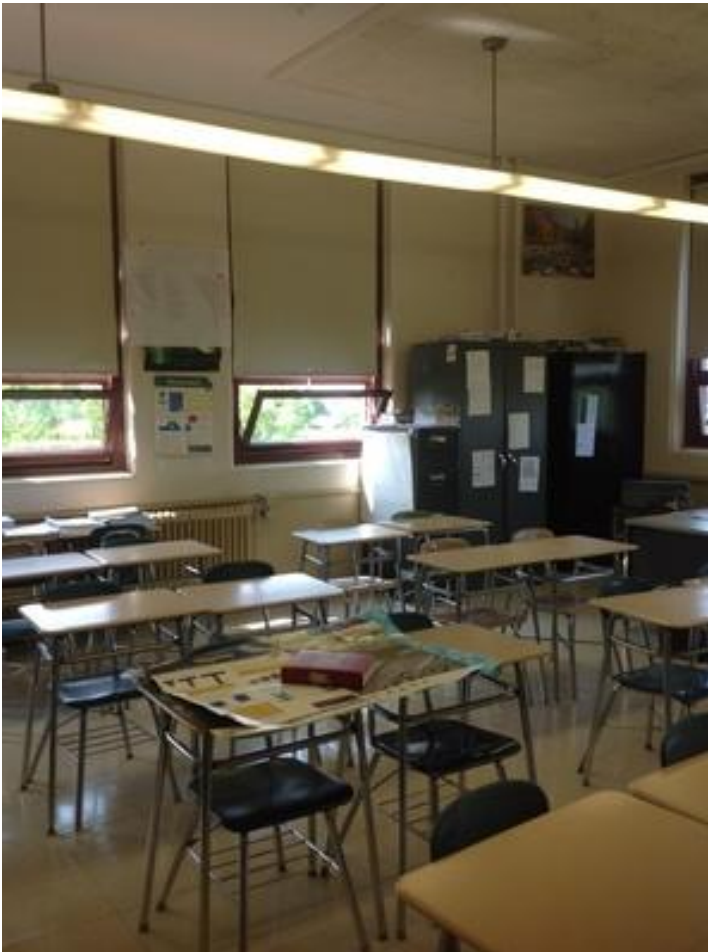
Description
VCT flooring in fair condition. Paint is chipping on walls and ceiling. Light fixtures missing covers in some locations. 10'x20' area of 12"x12" VCT on ceiling. Surface mounted equipment and wiring is haphazard. Shades are in poor condition. Millwork in poor condition. Unit heater in poor condition. Some windows have lost seals. Classroom has smartboard.
