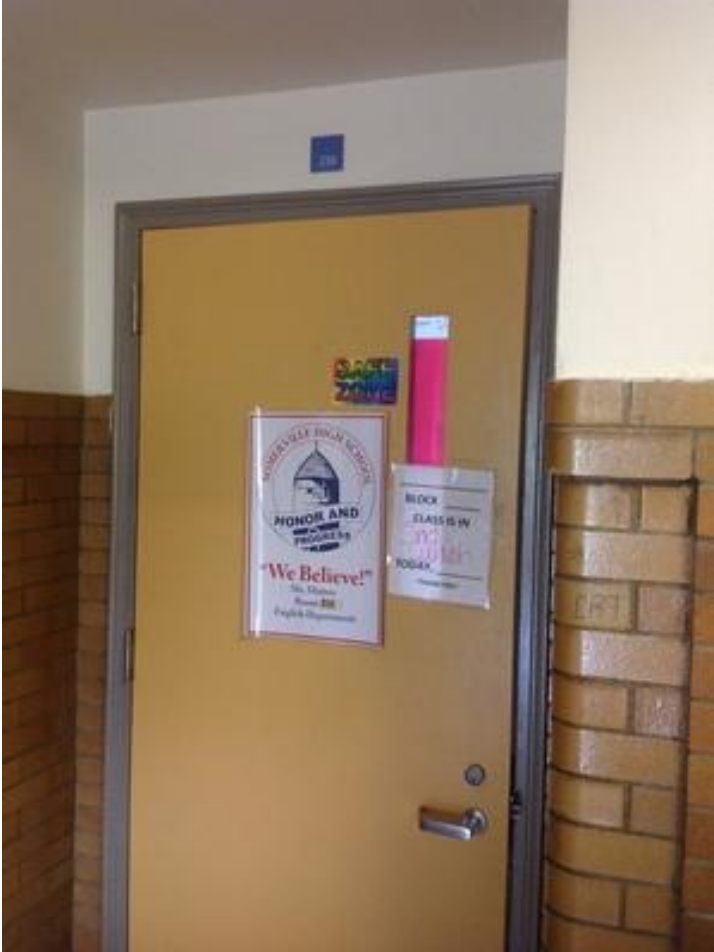
IMG_0540.JPG

VCT flooring in fair condition but has some warping-typical. Paint is chipping on walls and ceiling. Light fixtures missing covers in some locations. 10'x20' area of 12"x12" VCT on ceiling. Surface mounted equipment and wiring is haphazard. Shades are in poor condition. Millwork in poor condition. Unit heater in poor condition. Some windows have lost seals. Classroom has smartboard.

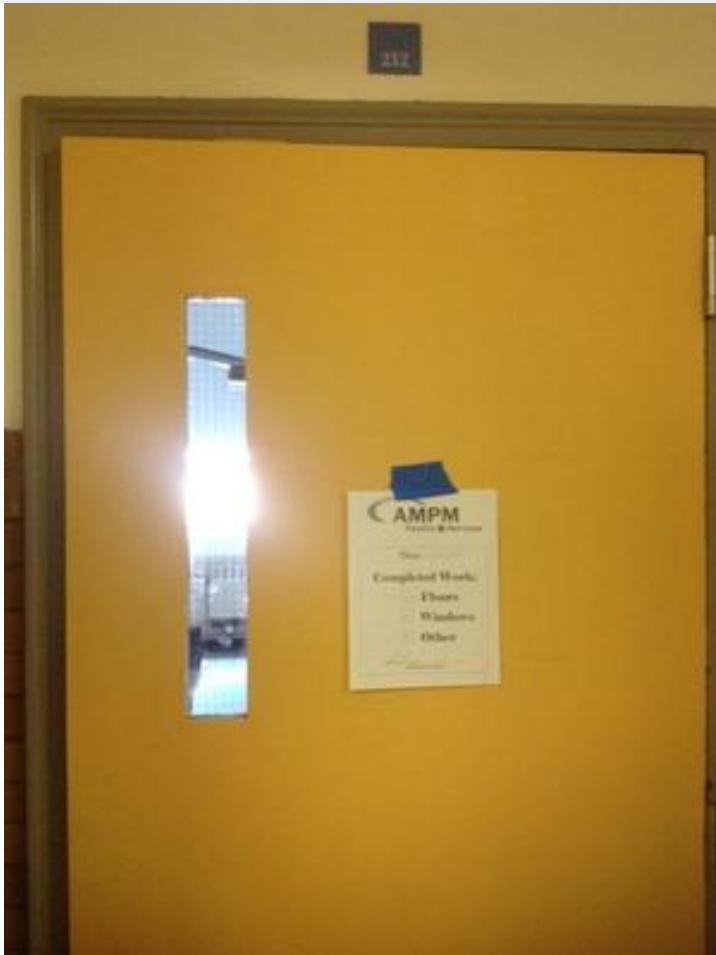
IMG_0546.JPG

Description
VCT flooring in fair condition but has some warping-typical. Paint is chipping on walls and ceiling. Light fixtures missing covers in some locations. 10'x20' area of 12"x12" VCT on ceiling. Surface mounted equipment and wiring is haphazard. Shades are in poor condition. Millwork in poor condition. Unit heater in poor condition. Some windows have lost seals. Classroom has smartboard.

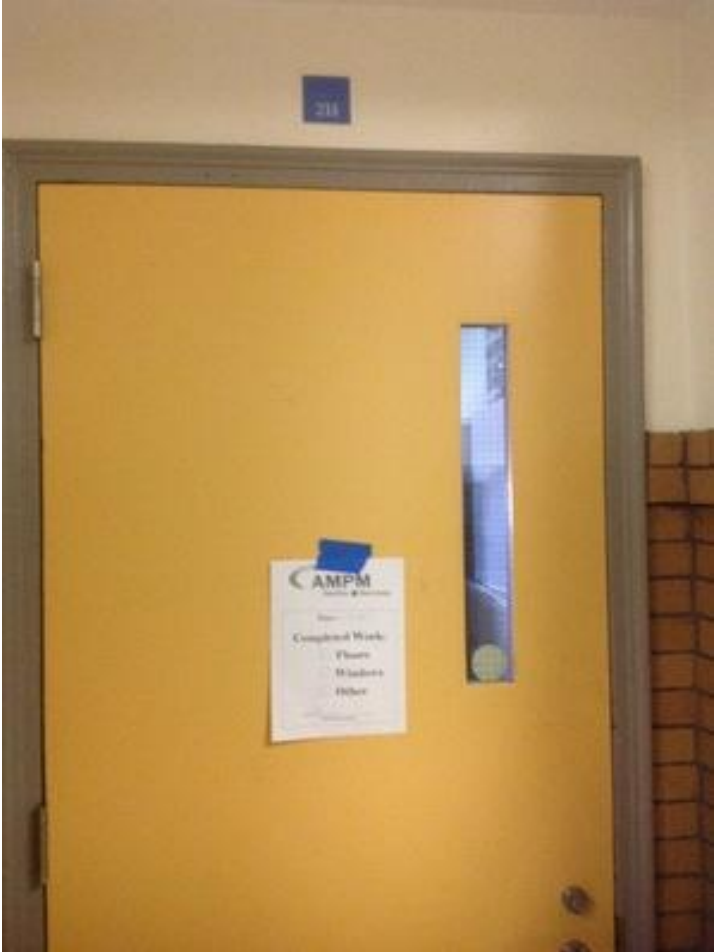
IMG_0551_1.JPG

VCT flooring in fair condition but has some warping-typical. Paint is chipping on walls and ceiling. Light fixtures missing covers in some locations. 10'x20' area of 12"x12" VCT on ceiling. Surface mounted equipment and wiring is haphazard. Shades are in poor condition. Millwork in poor condition. Unit heater in poor condition. Some windows have lost seals. Classroom has smartboard.

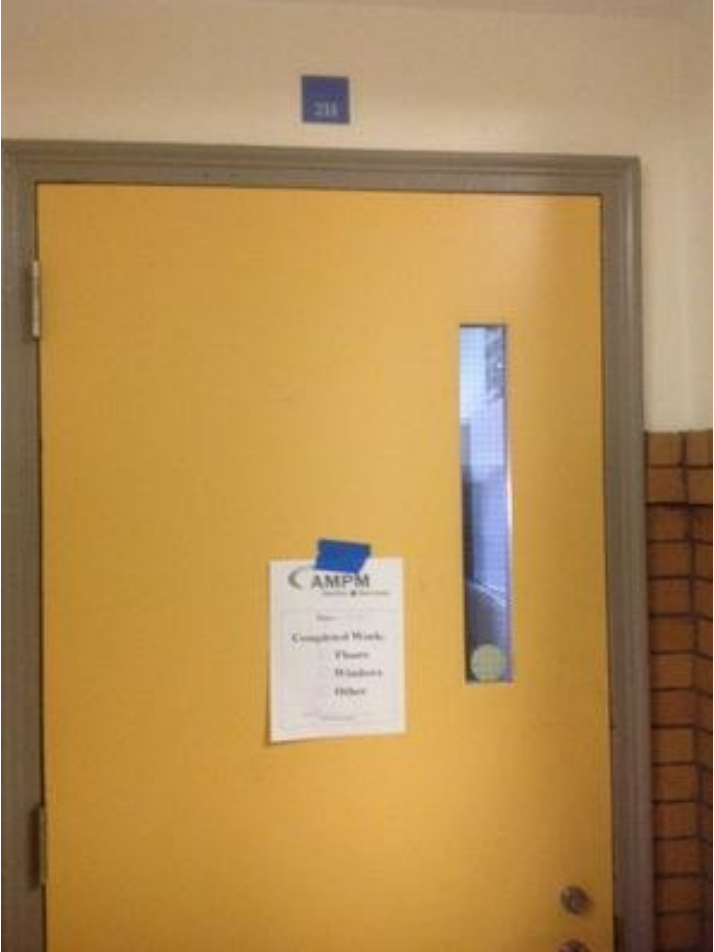
IMG_0551.JPG

Description
VCT flooring in fair condition but has some warping-typical. Paint is chipping on walls and ceiling. Light fixtures missing covers in some locations. 10'x20' area of 12"x12" VCT on ceiling. Surface mounted equipment and wiring is haphazard. Shades are in poor condition. Millwork in poor condition. Unit heater in poor condition. Some windows have lost seals. Classroom has smartboard. Class has second zone for computer area. Electrical drops in center of room.

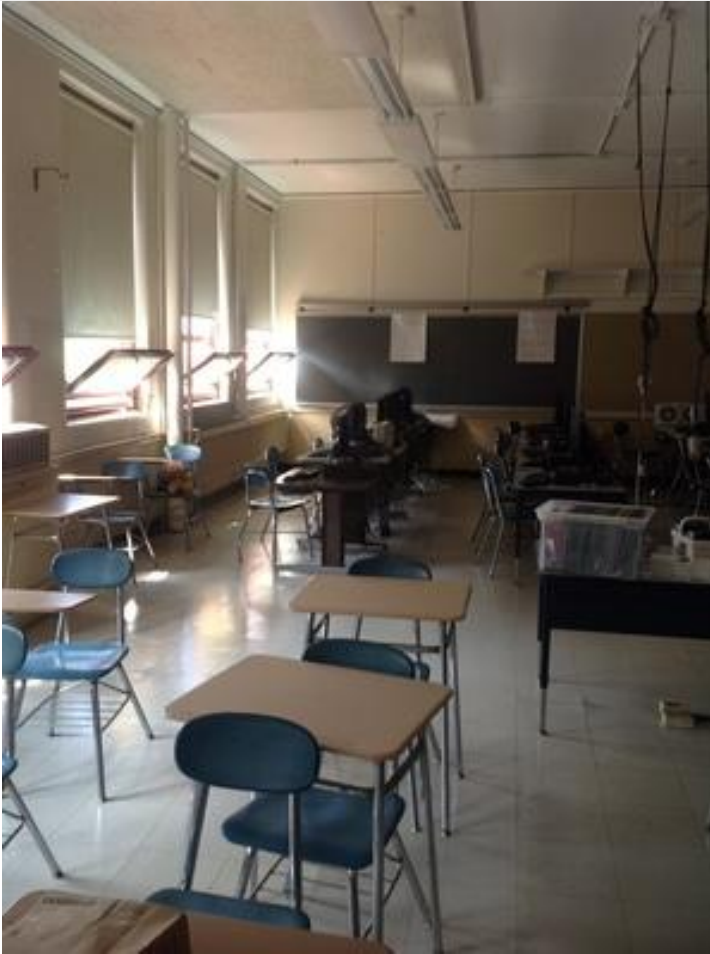
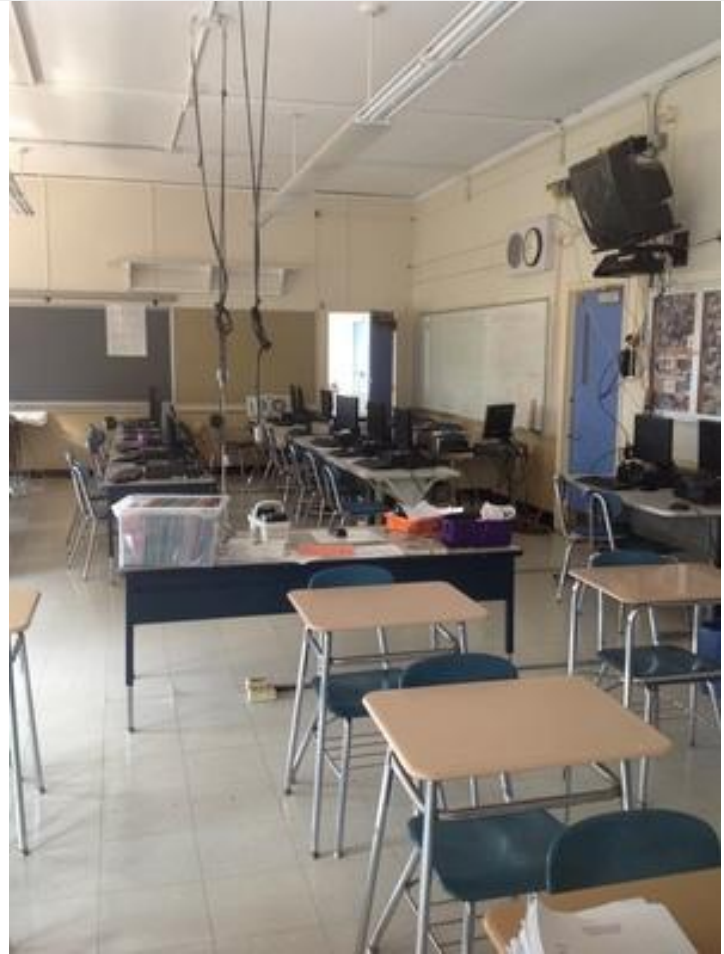
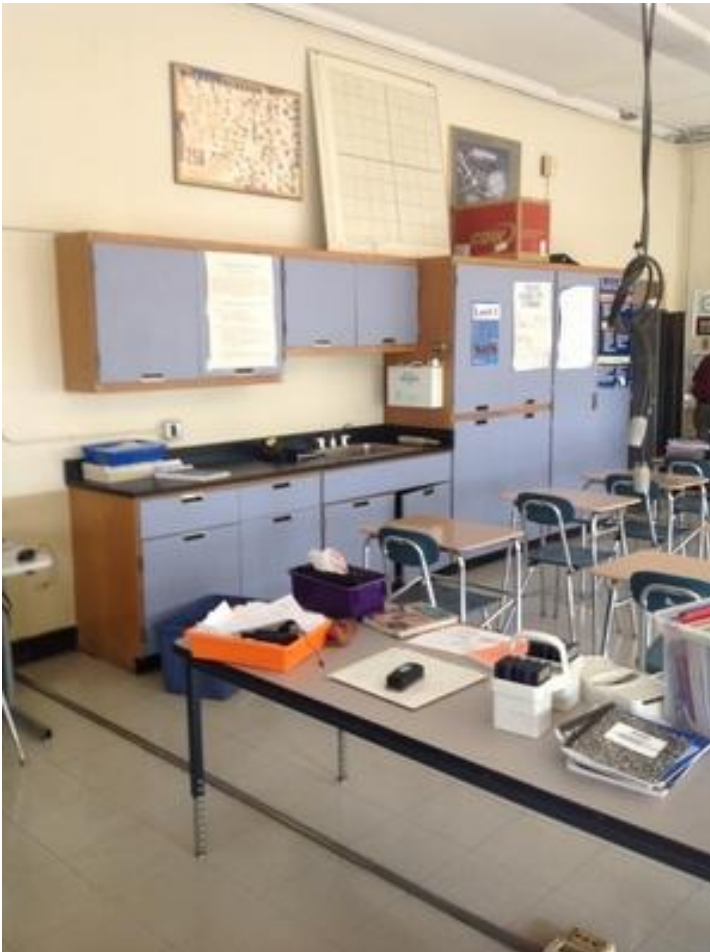
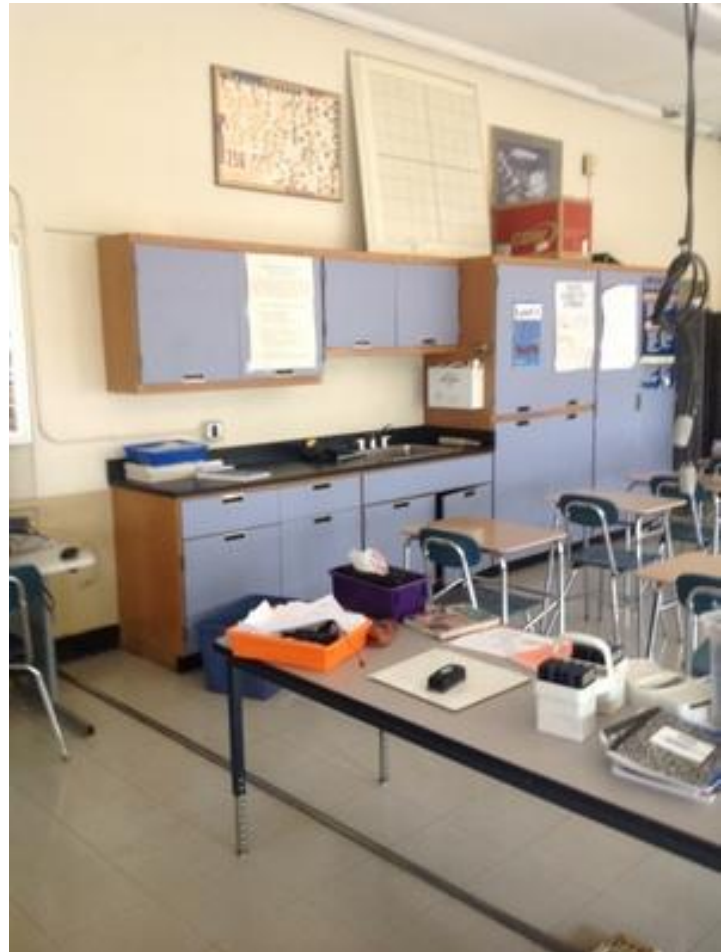
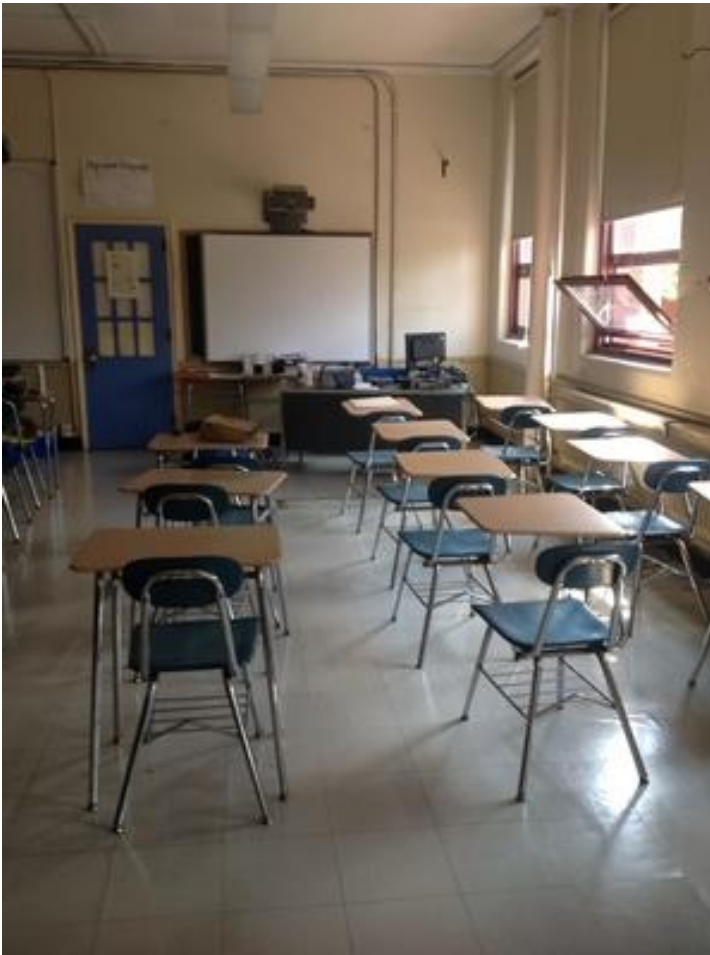
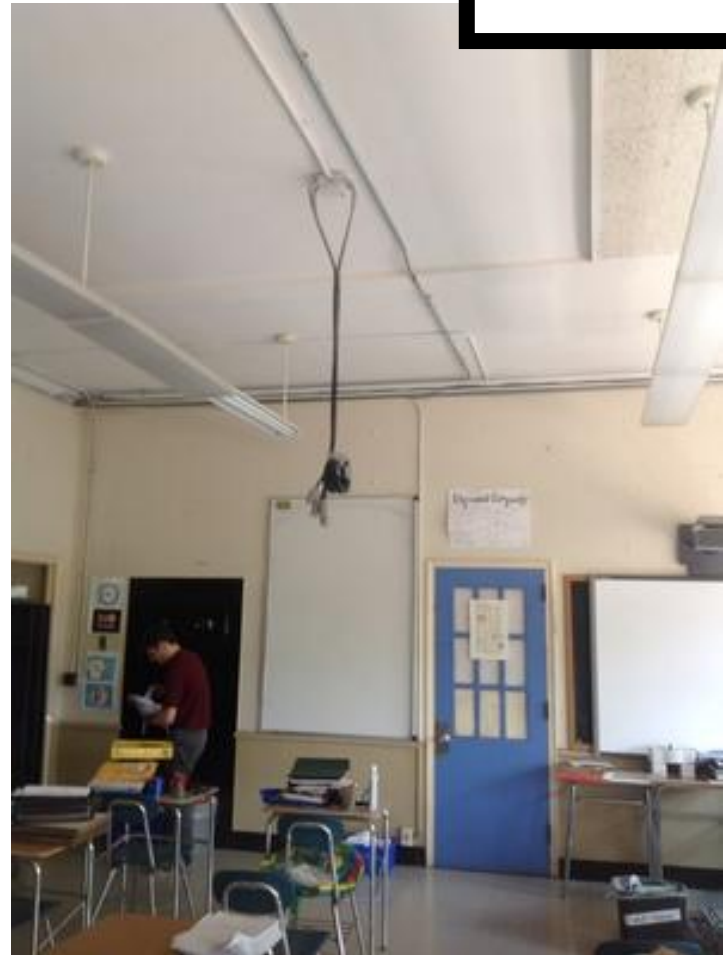
Attached Images for ID KU-00090

Description
Typical - Office area in fair condition. 2x4 ACT in poor condition with warping and dirty near some air supply vents. VCT in fair condition. Wire mesh glazing used at entry doors. Shades in poor condition. Walls have been constructed to subdivide space and have poor acoustic quality. New door hardware is not ADA compliant.

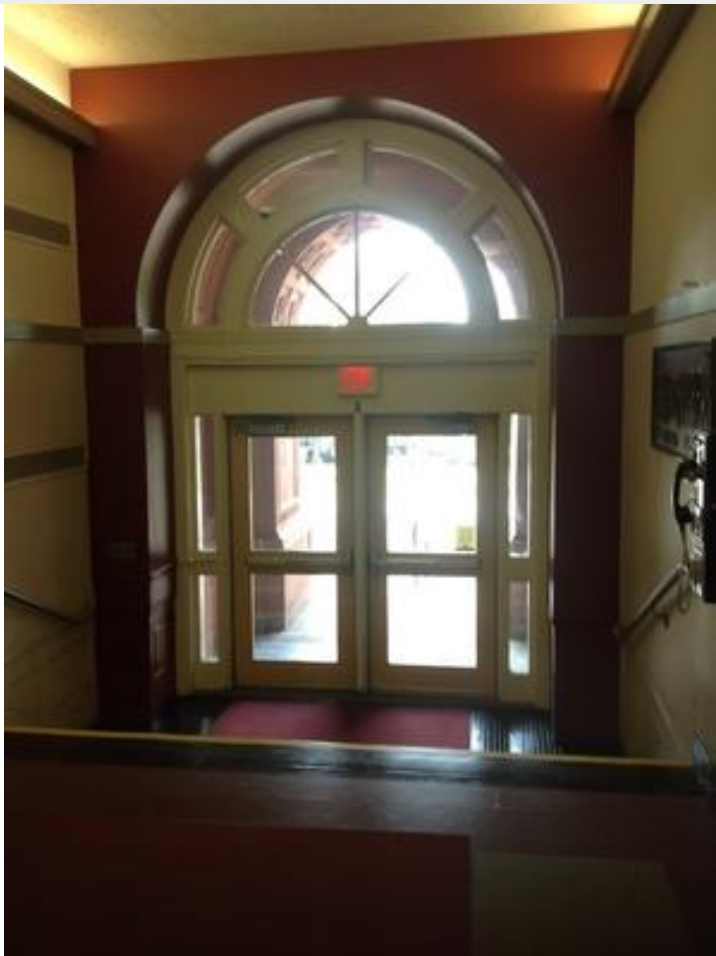
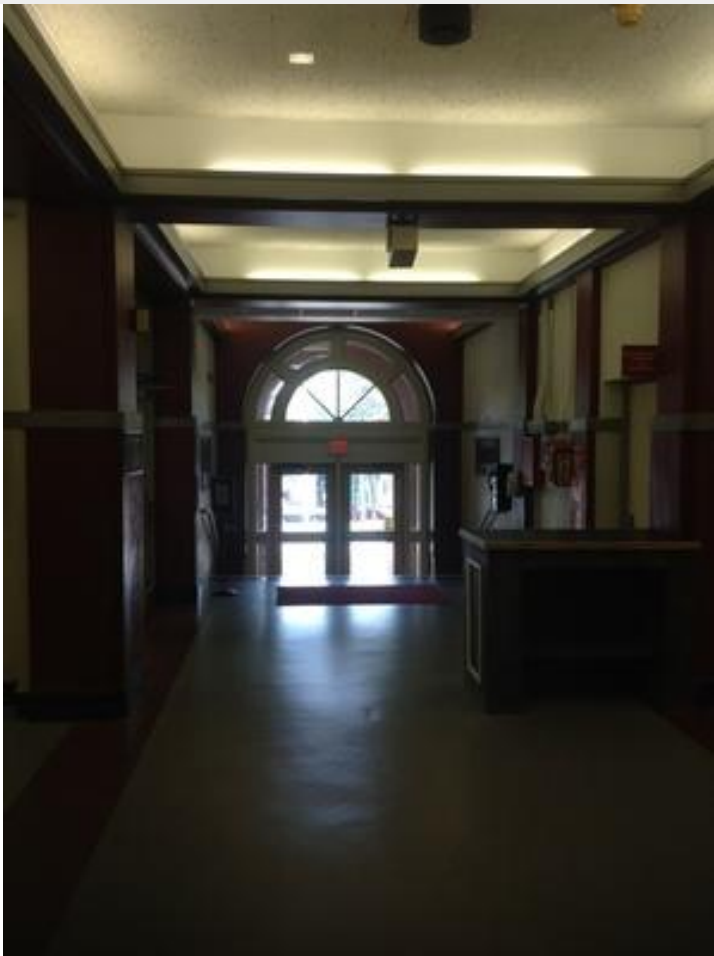
Attached Images for ID KU-00092

| Description Entry door in fair condition. Main entry not ADA compliant - no ramp provided. | | | |

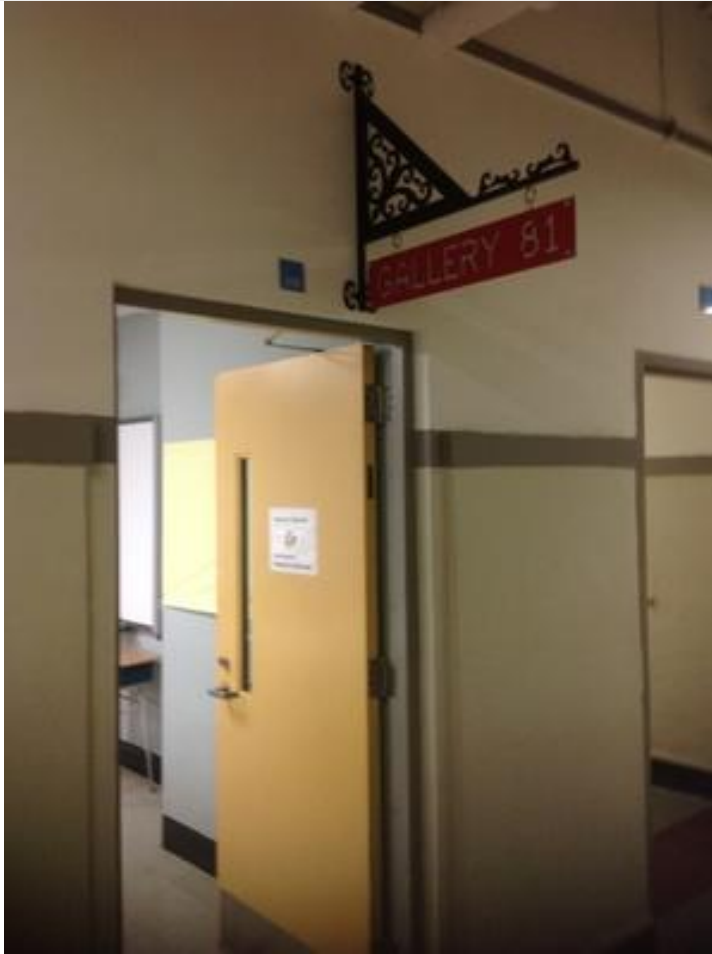
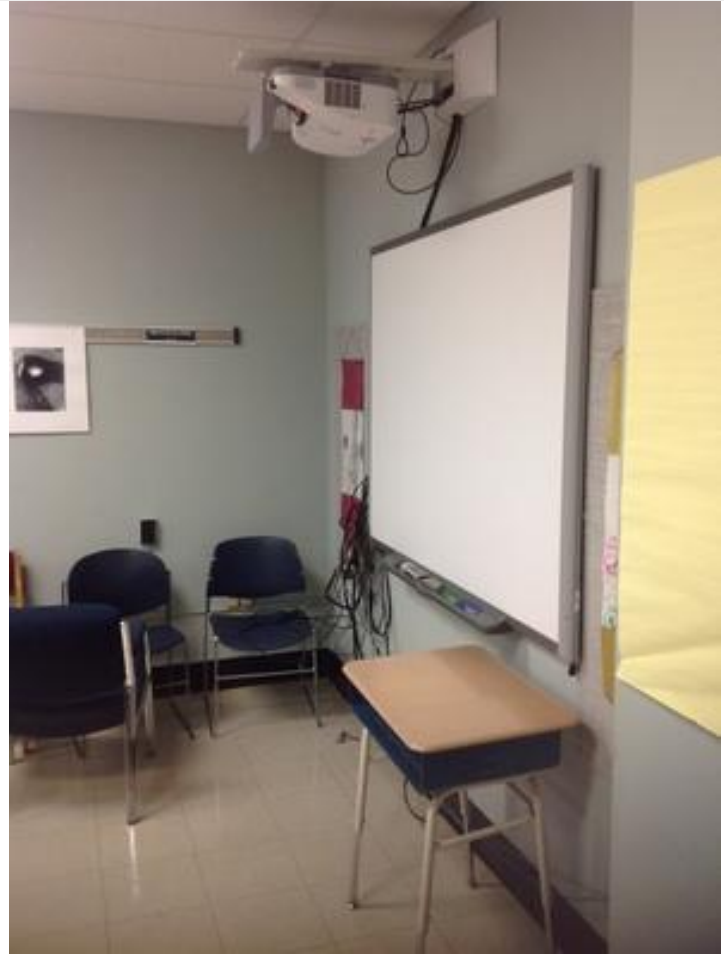
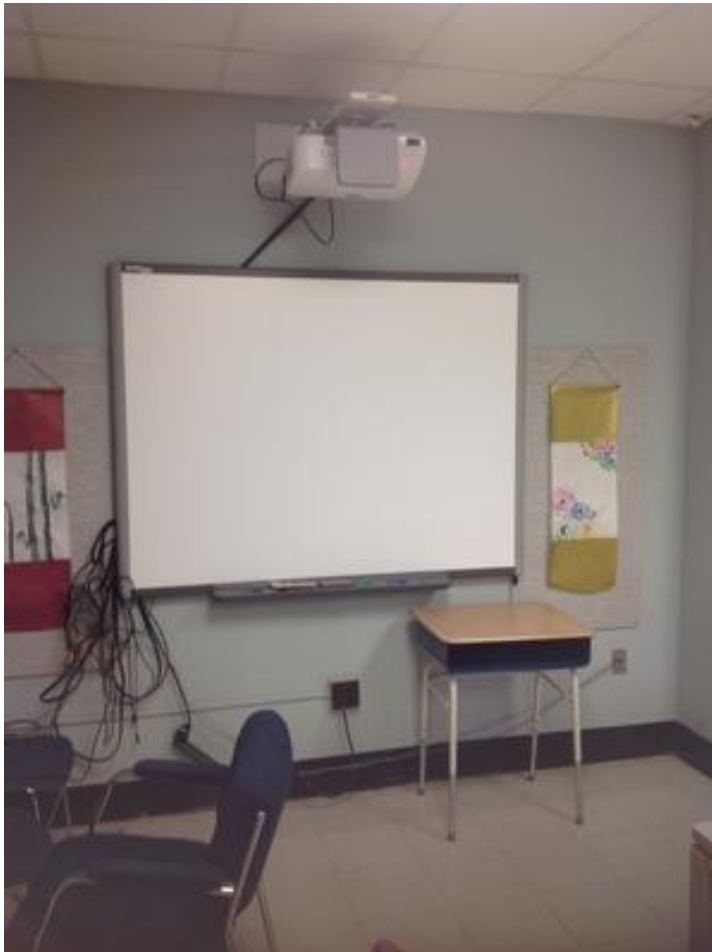
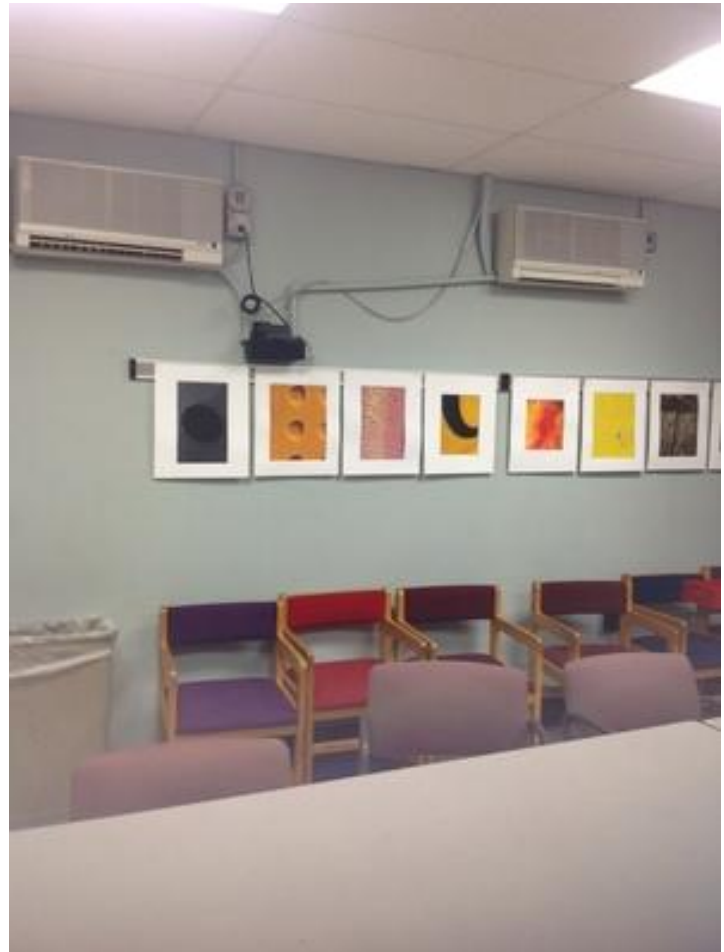
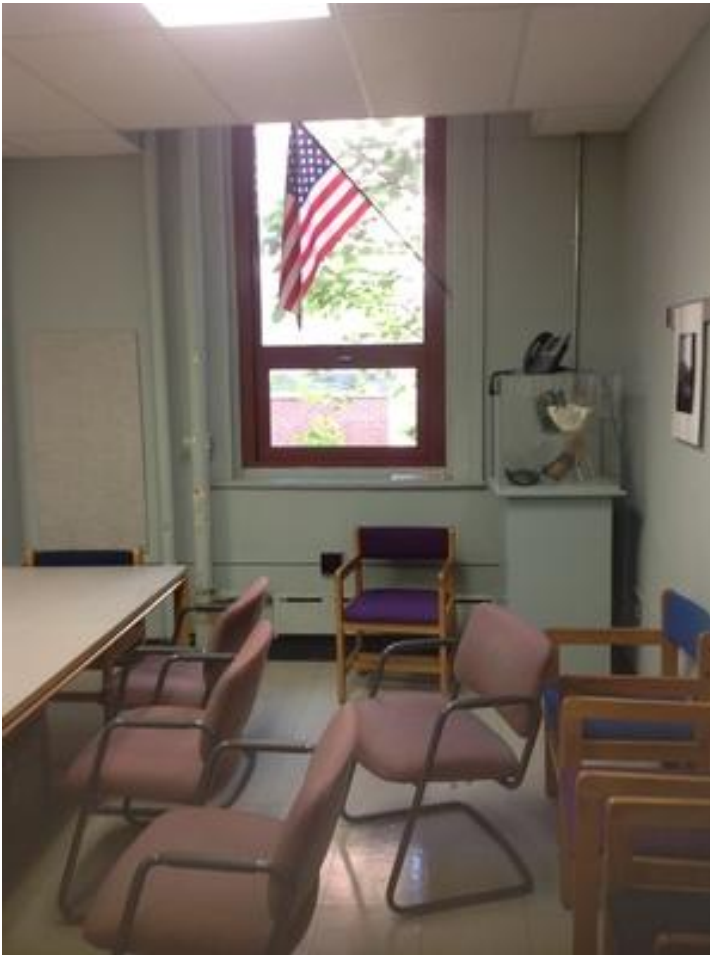
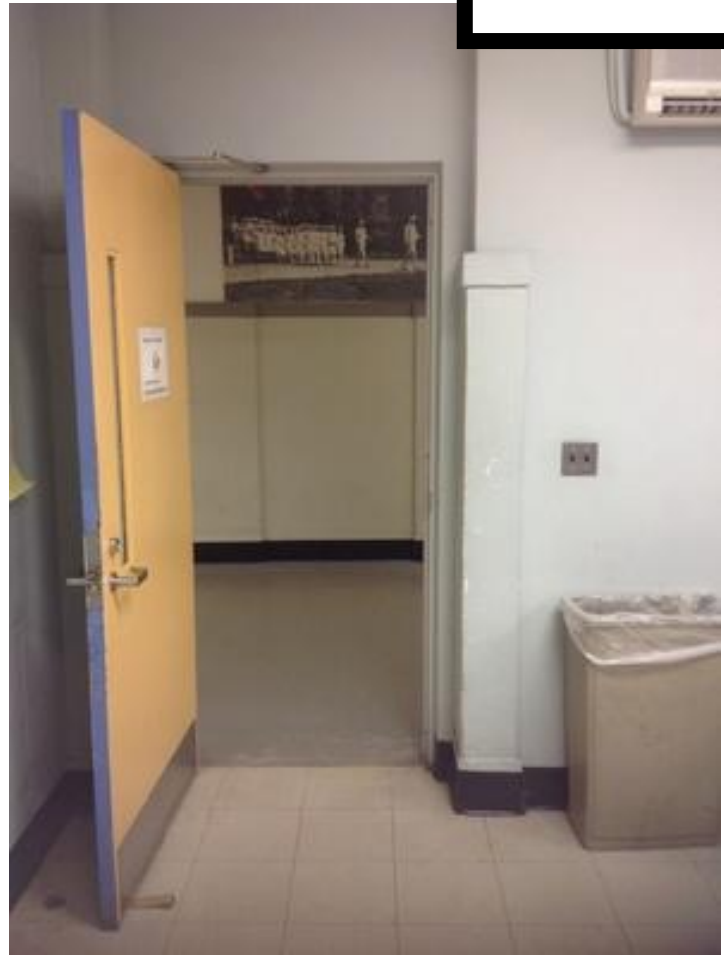
Attached Images for ID KU-00093

AC units are noisy. Wiring and piping for AC units, smartboard, and heating systems are haphazard and distracting from room program as a gallery space. ACT ceiling is in fair condition. VCT flooring is in fair condition.

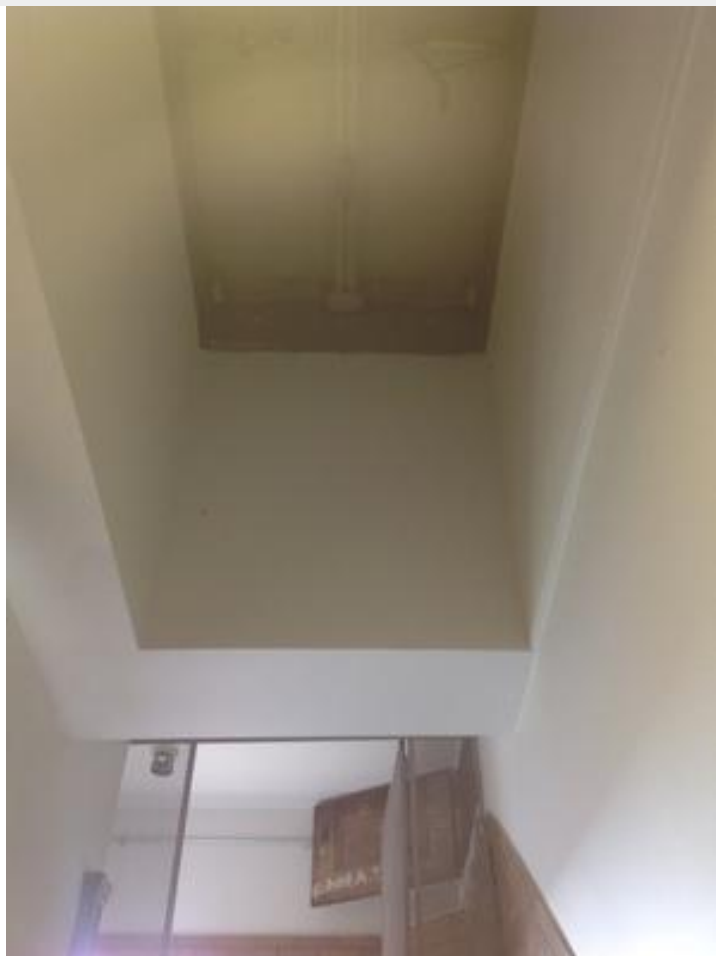
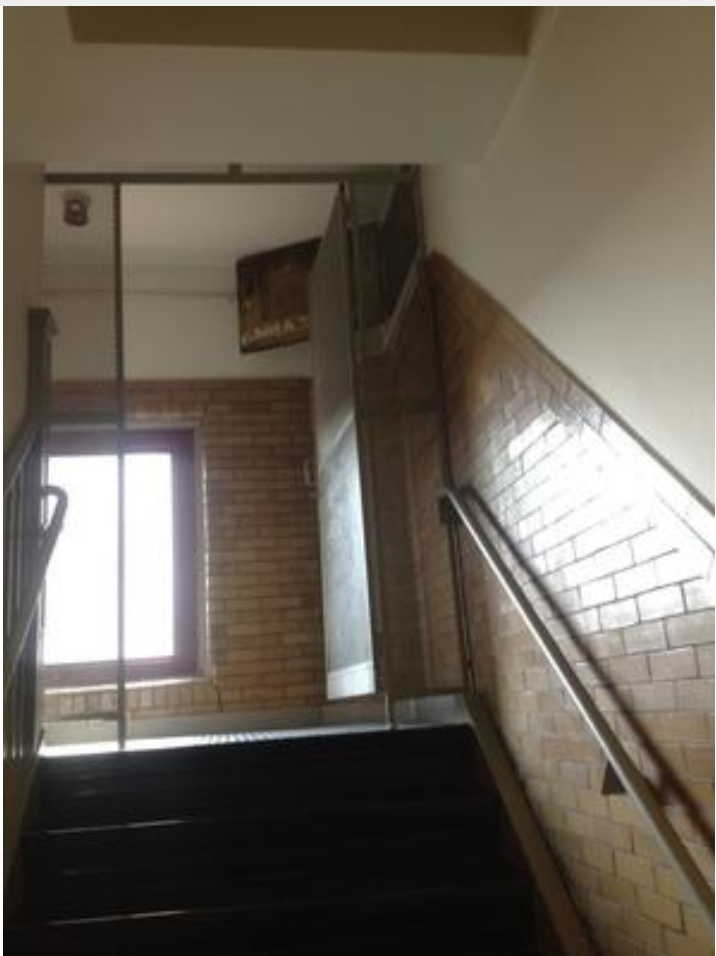
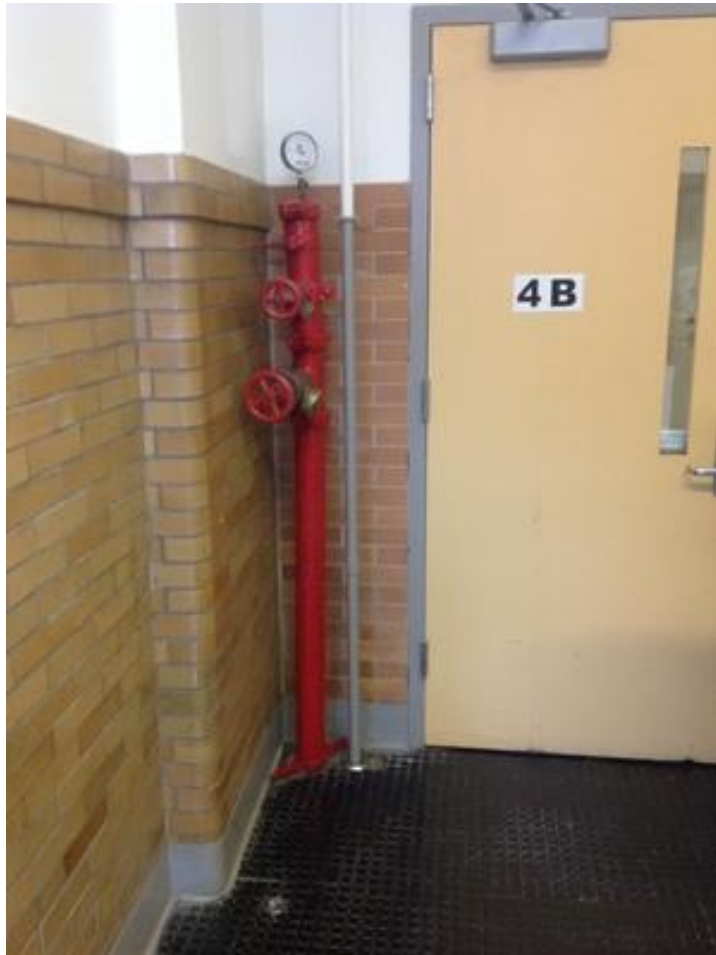
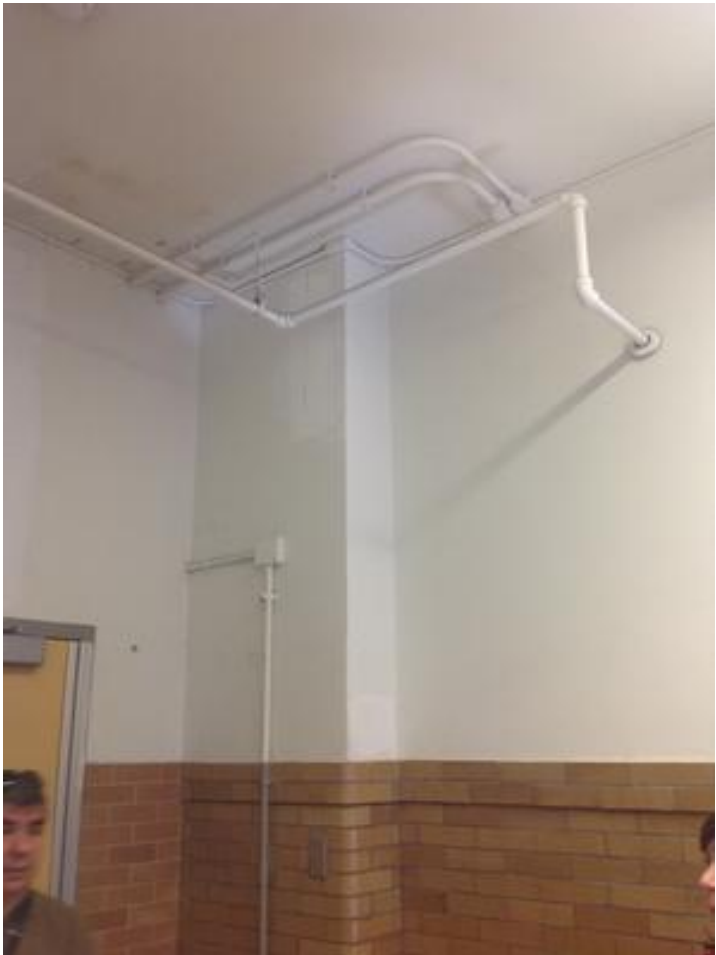
Entire Building- Stairs

Description
Typical - Stairs are in fair condition. Handrails and guard rails do not meet code in most stairs.
