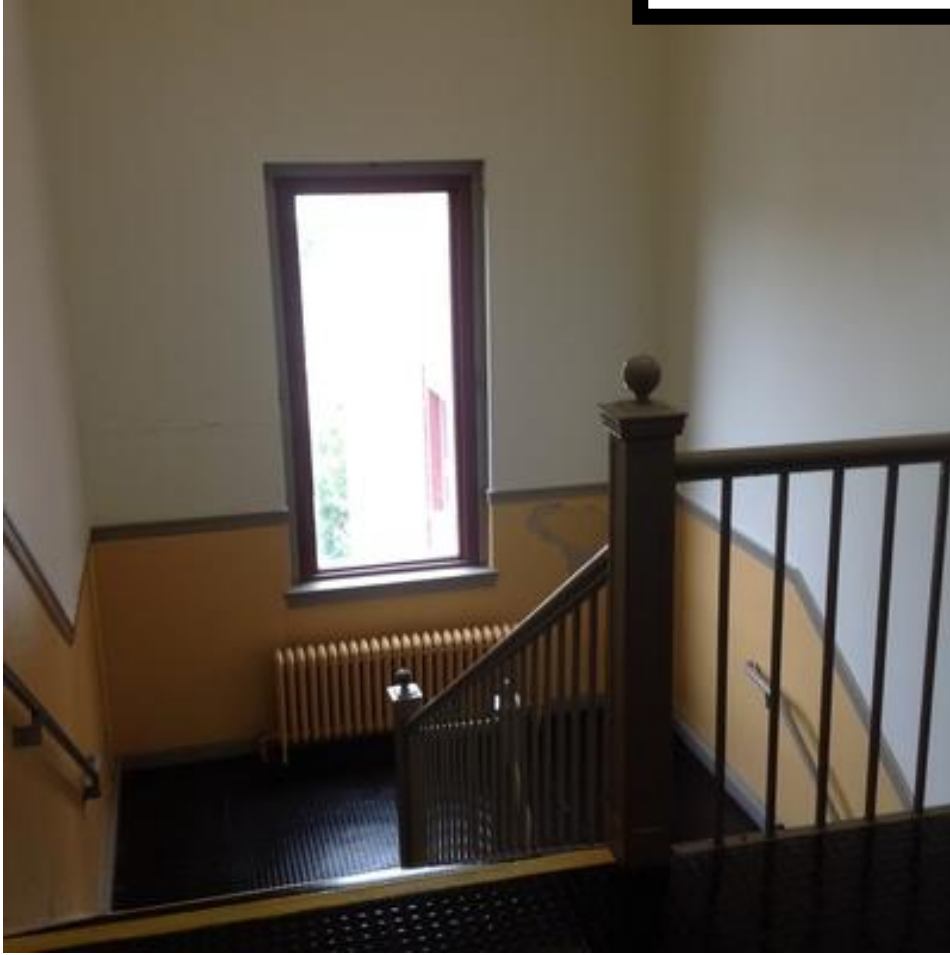
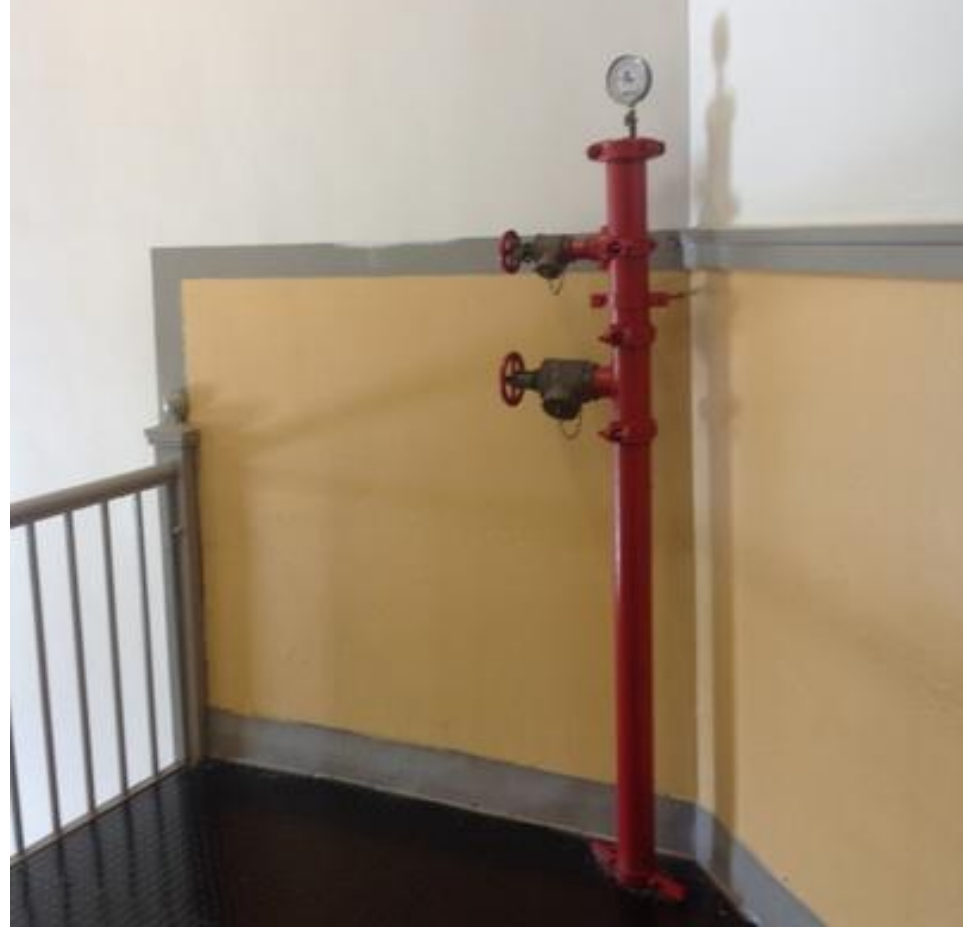
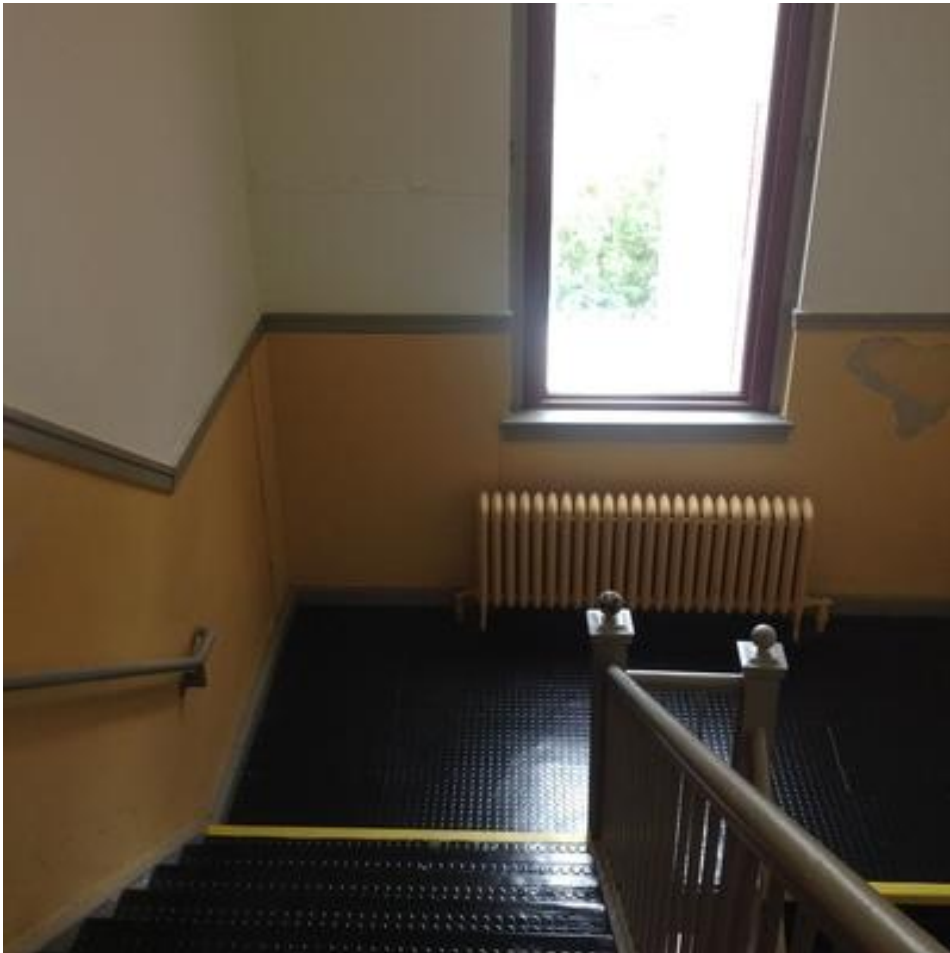
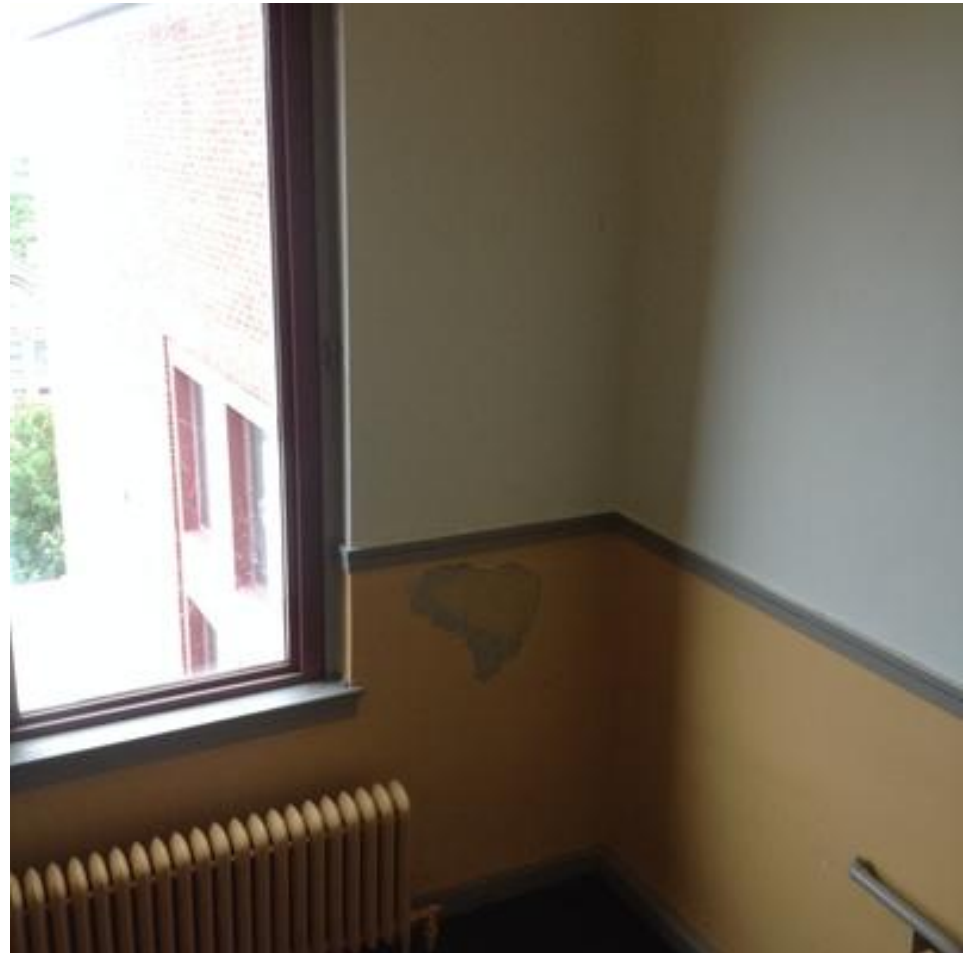
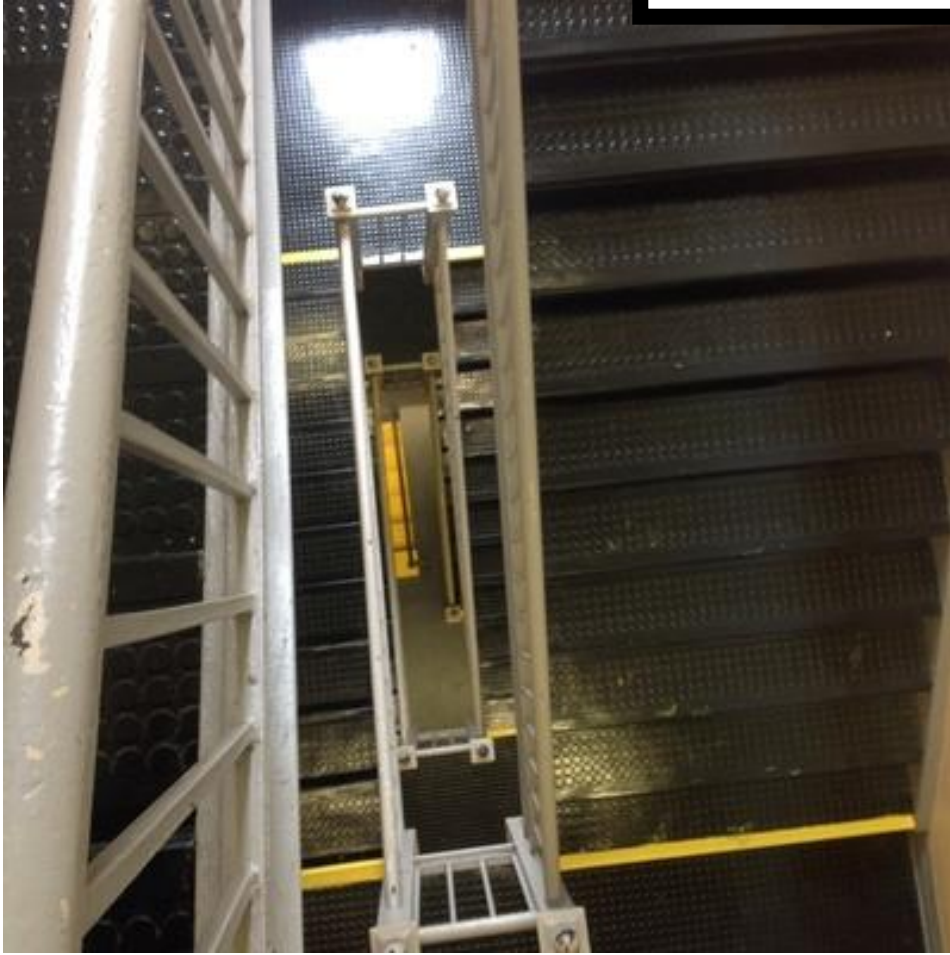
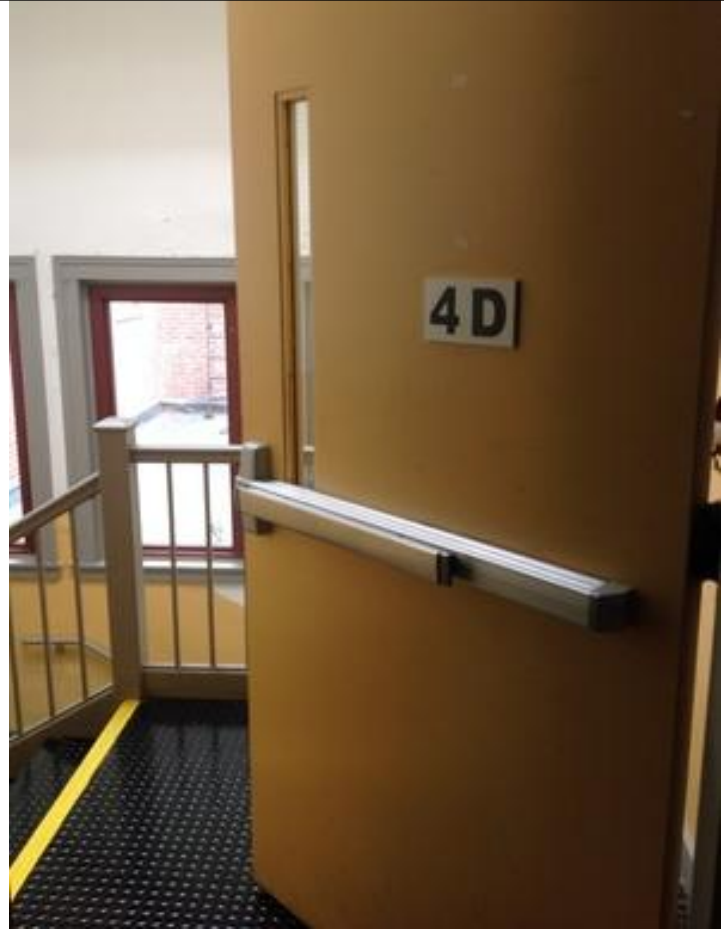
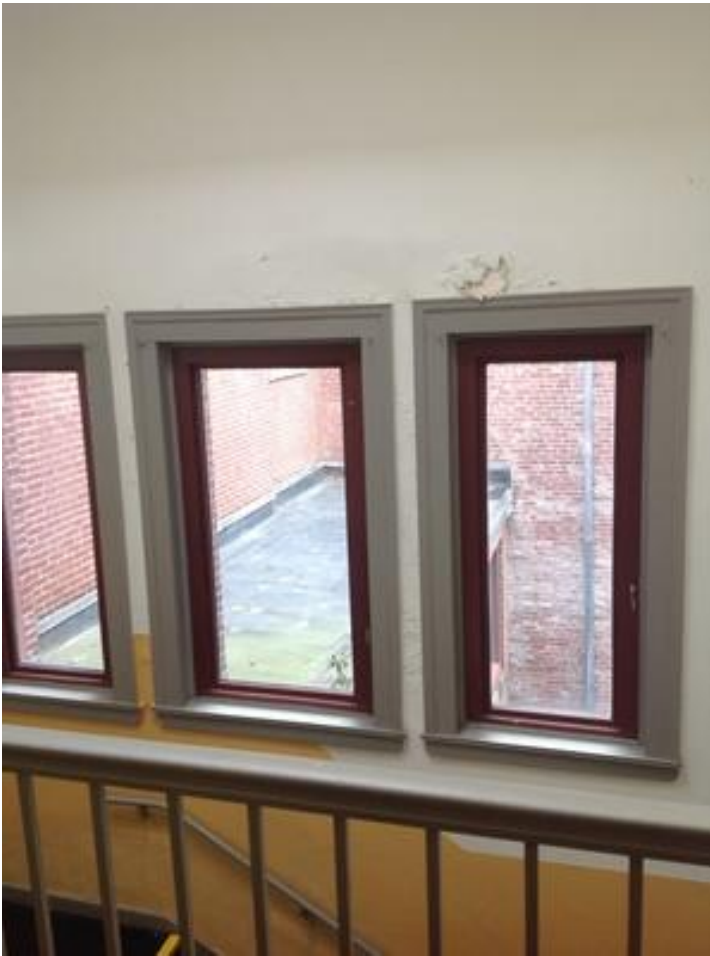
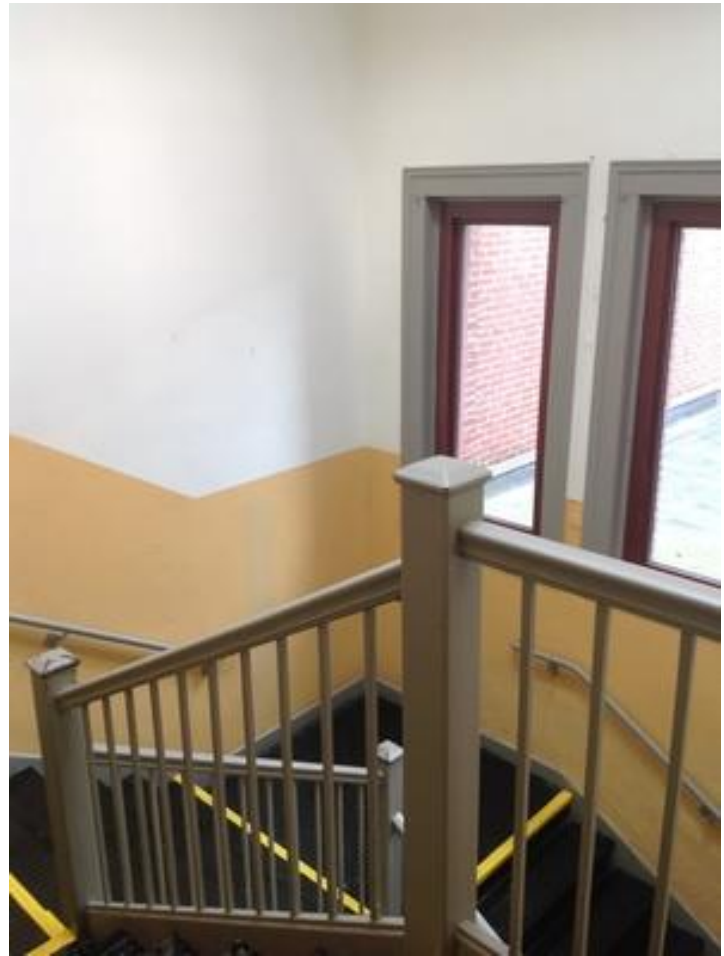
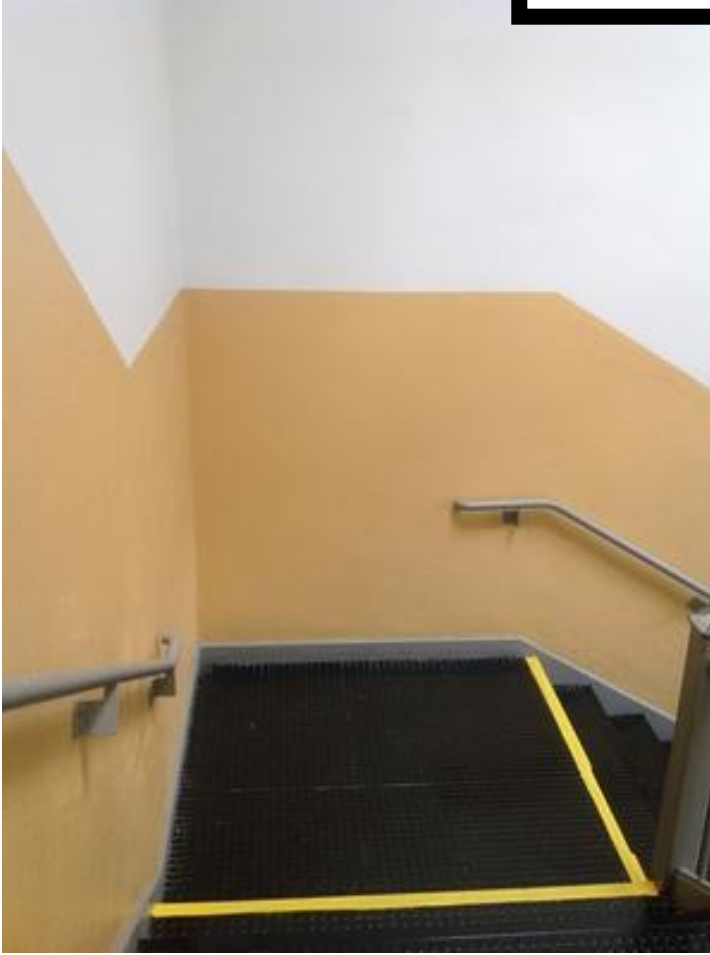
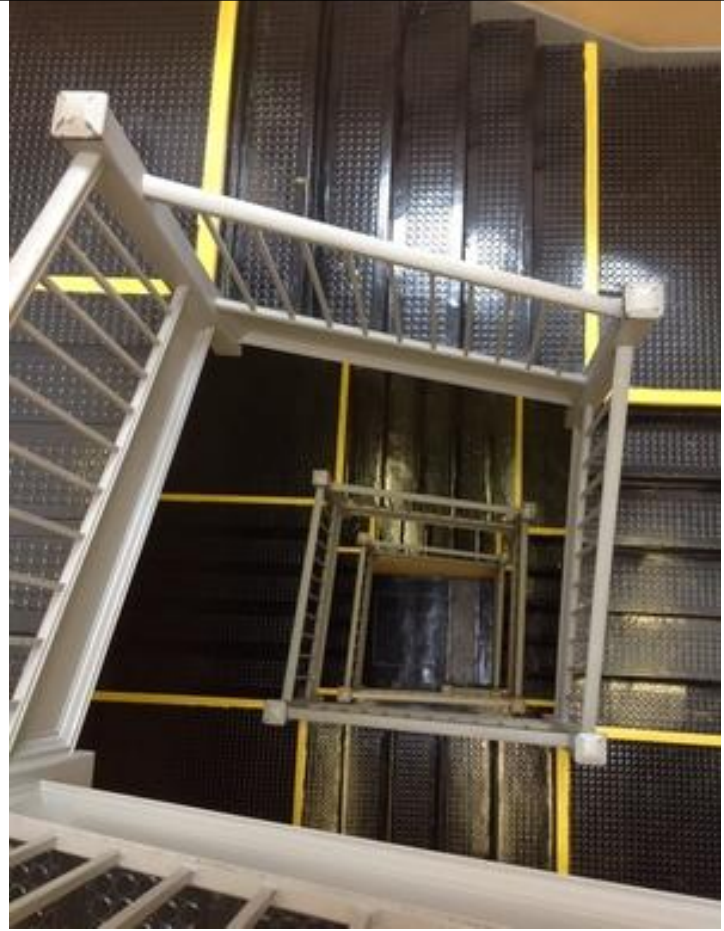
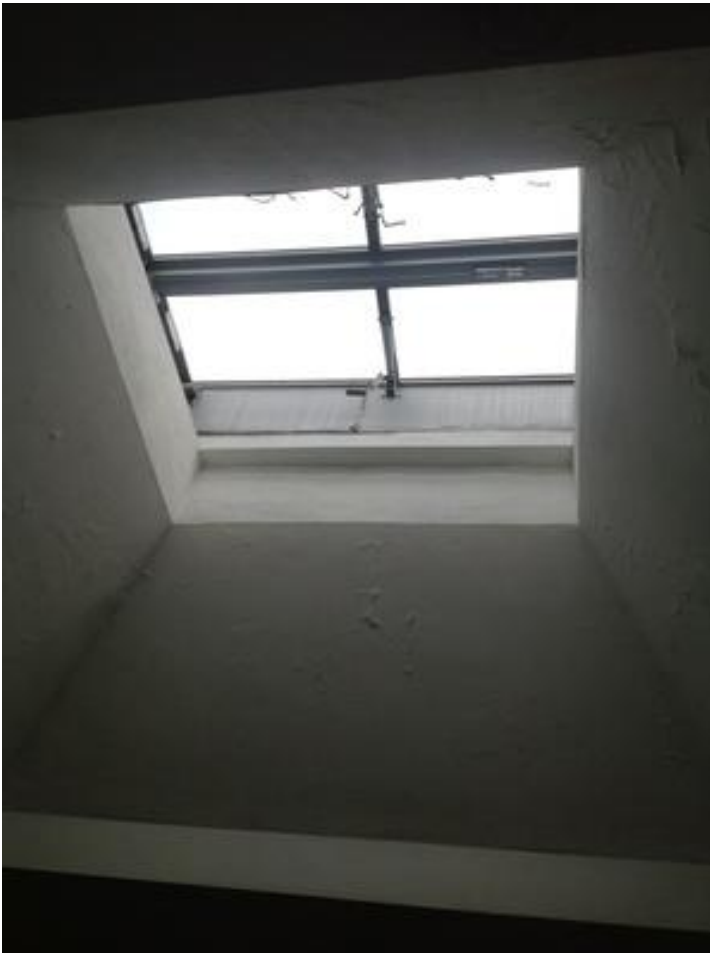
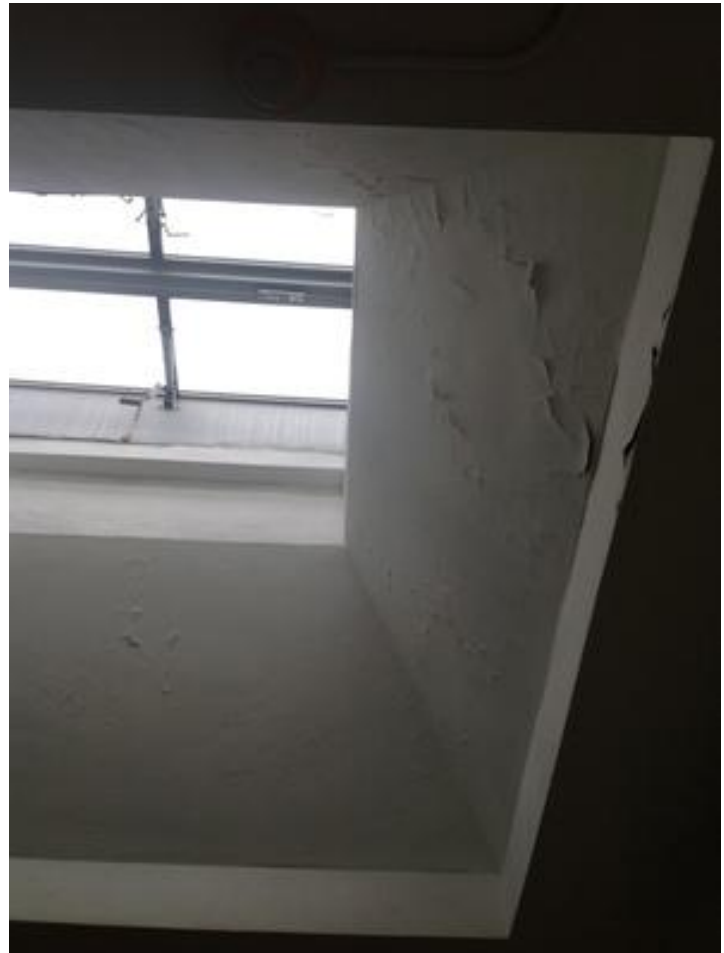
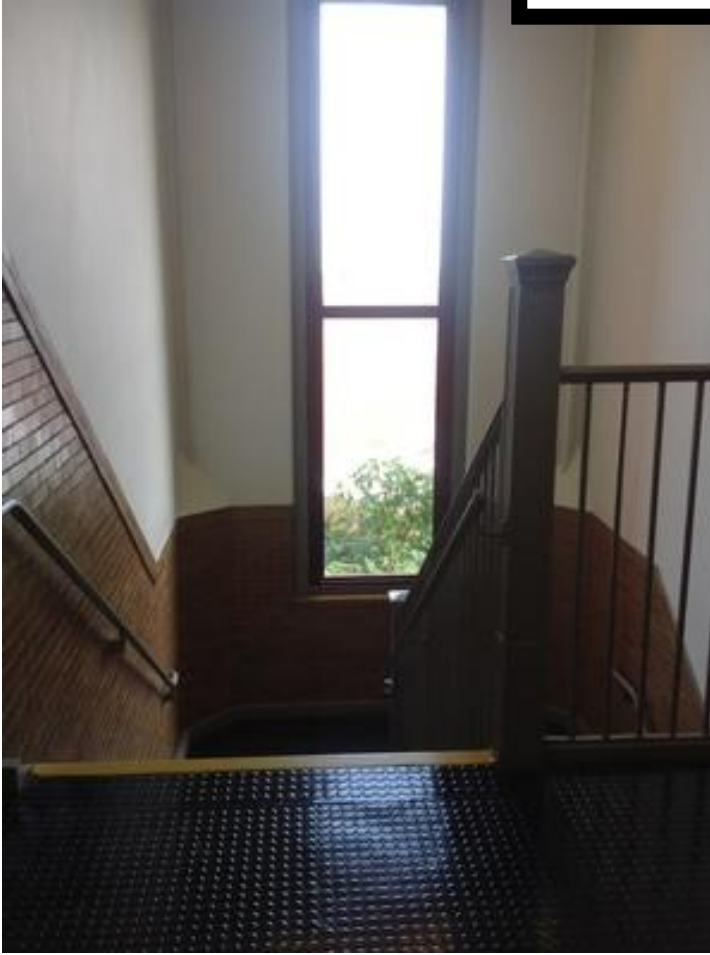
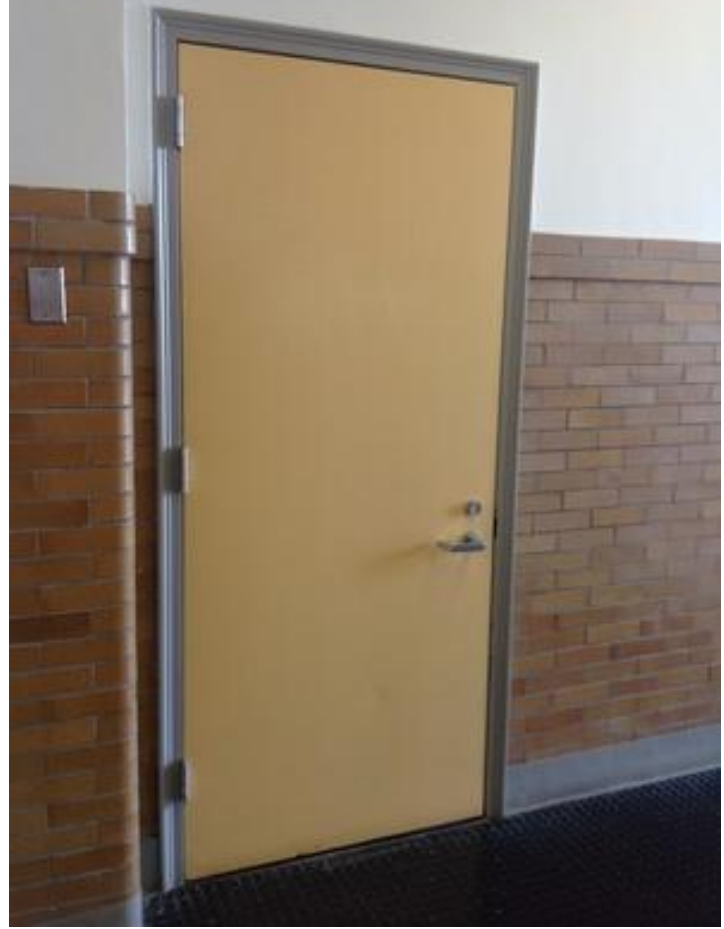
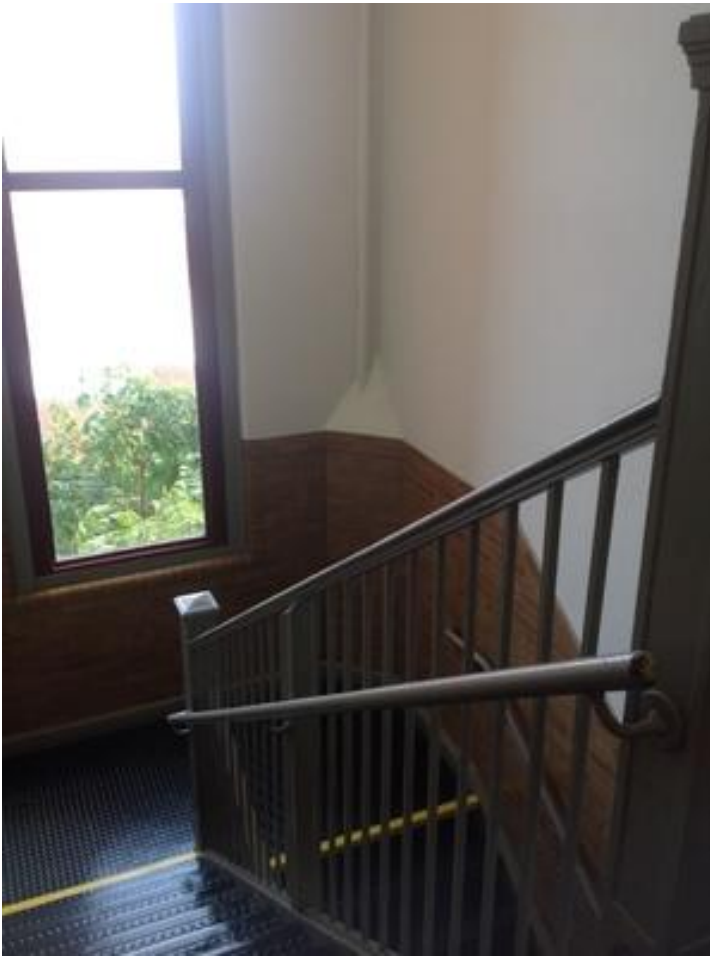
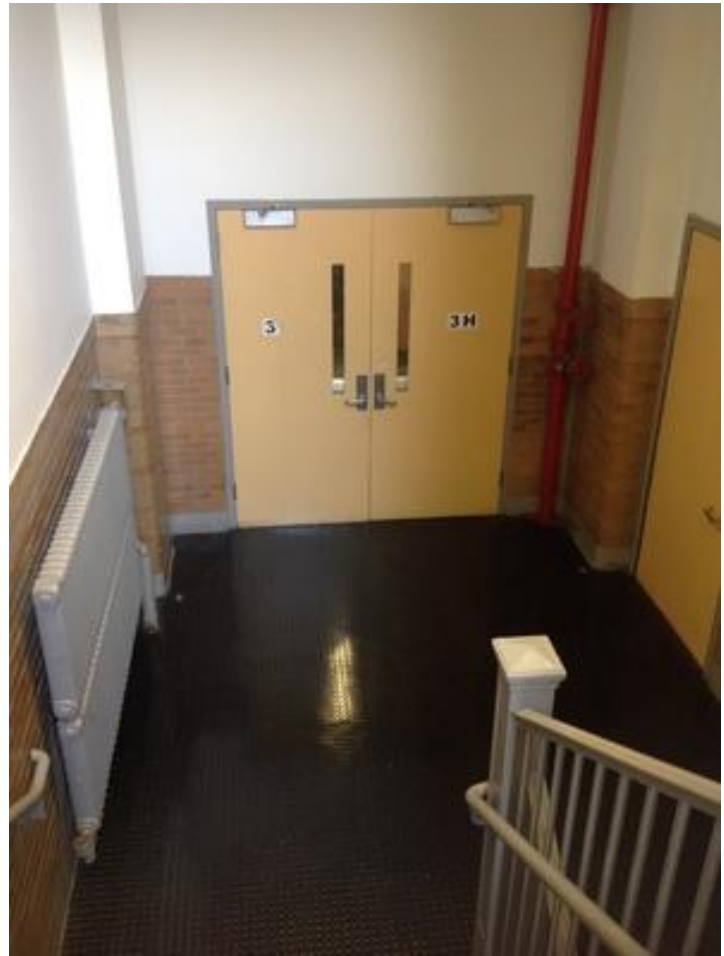
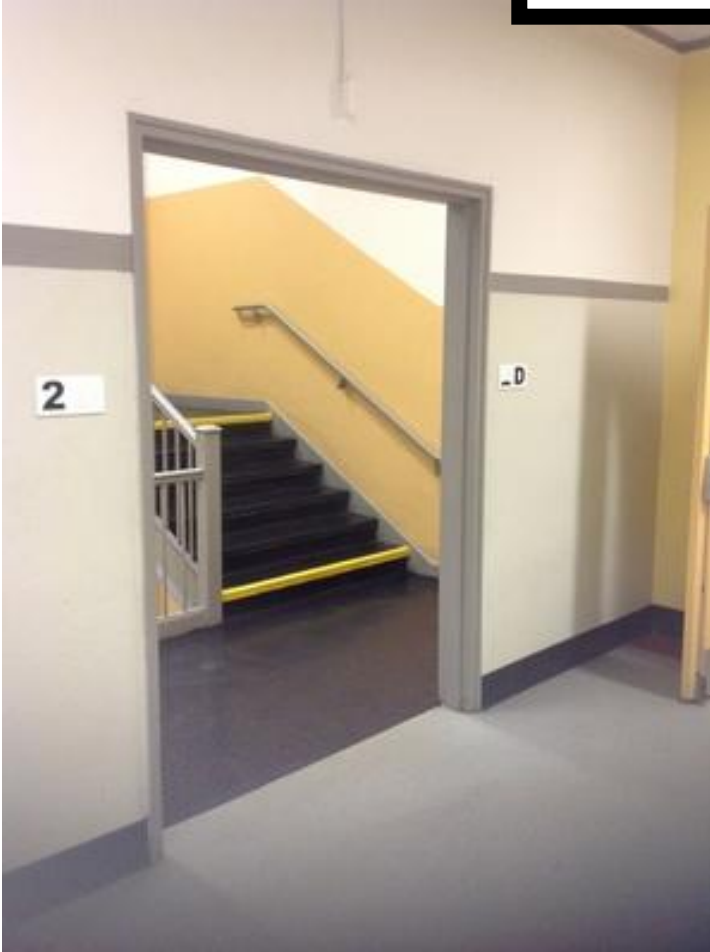
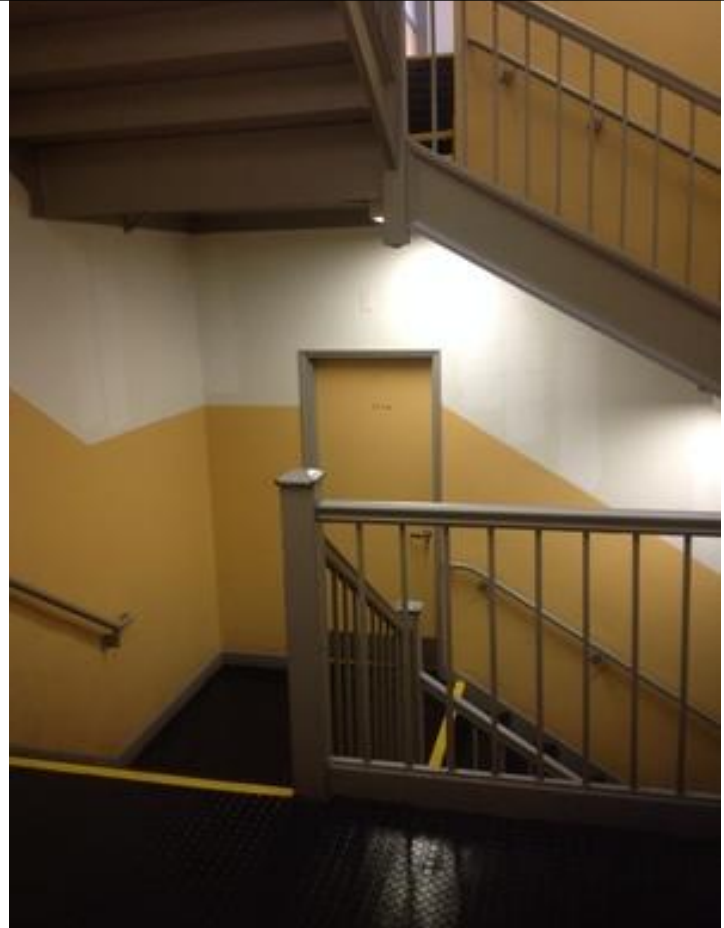
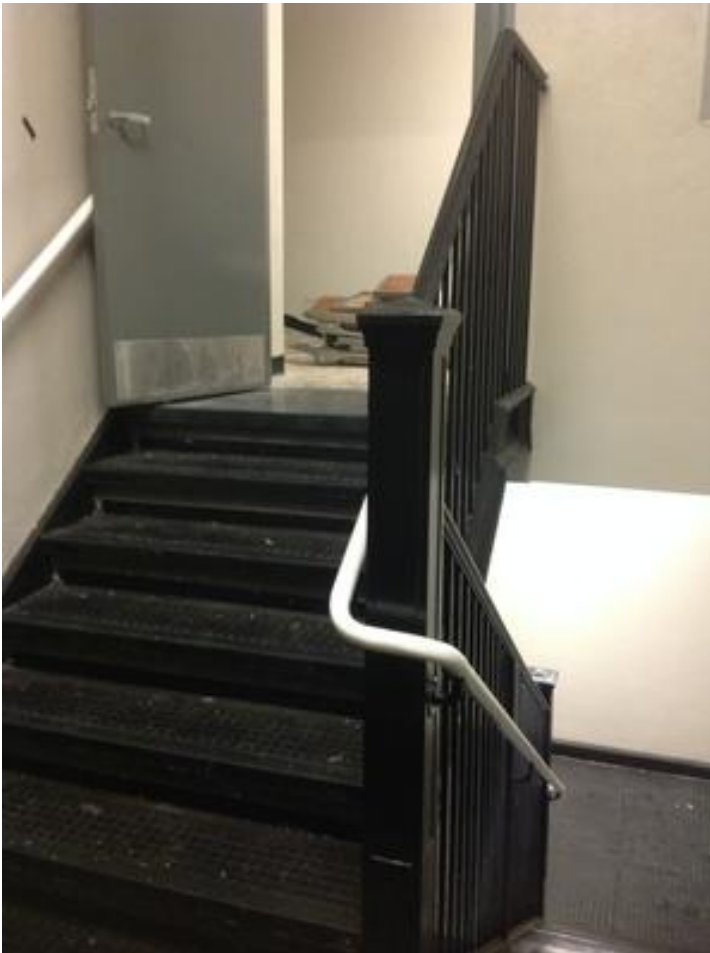
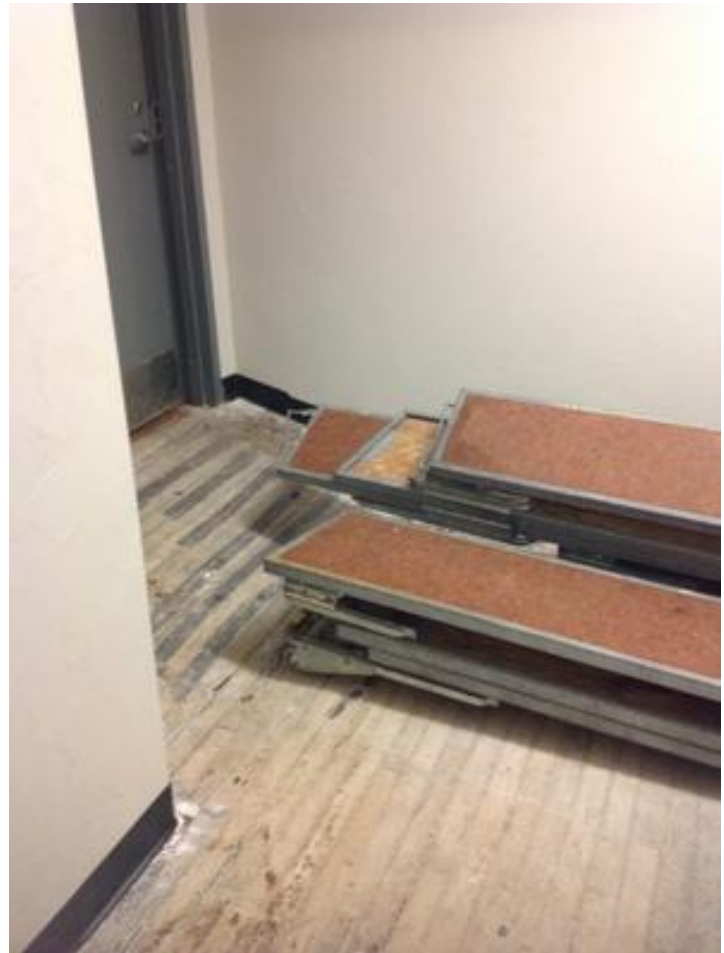
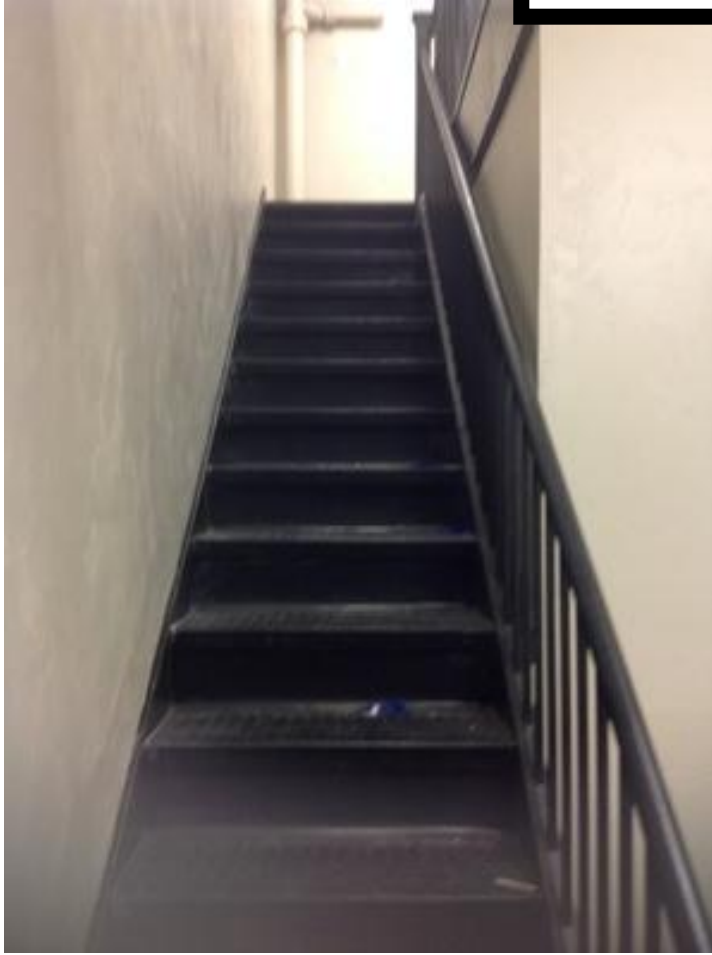
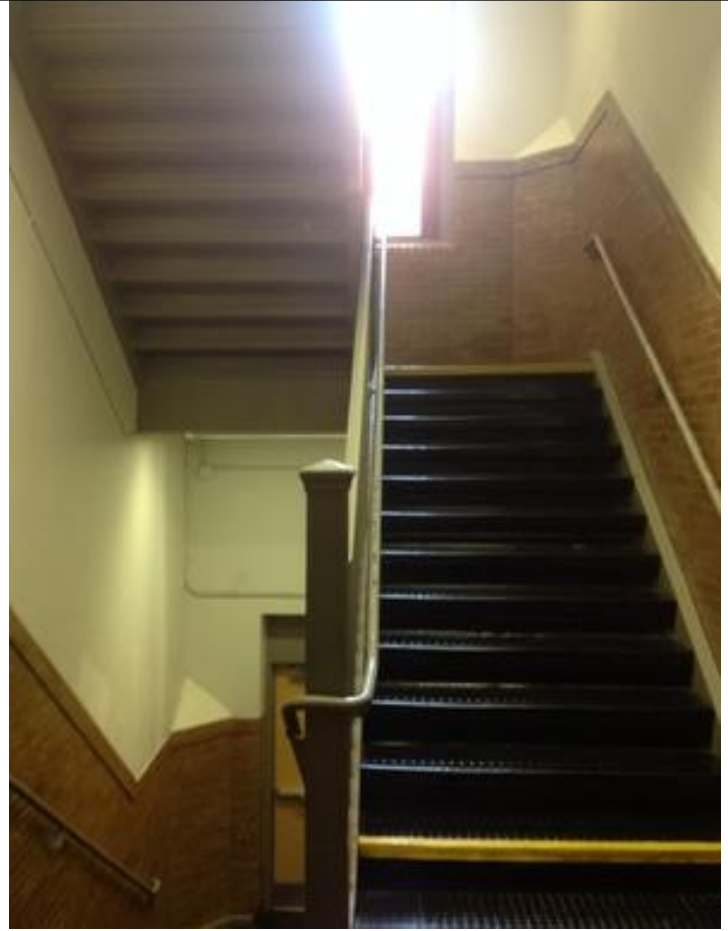
Entire Building- Stairs

Description
Typical - Stairs are in fair condition. Handrails and guard rails do not meet code in most stairs.
