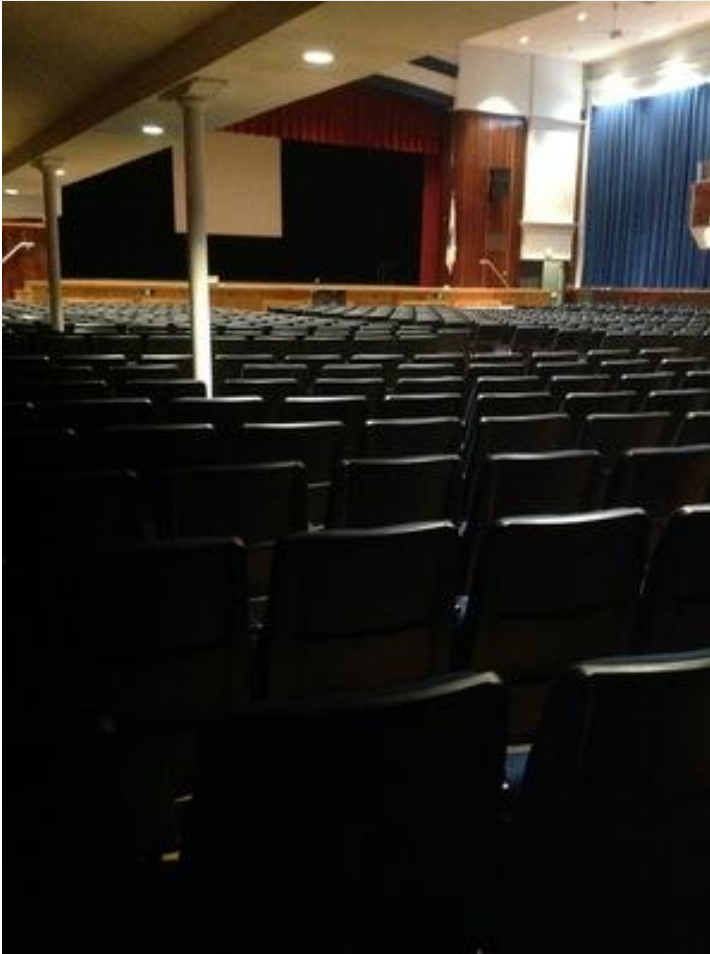
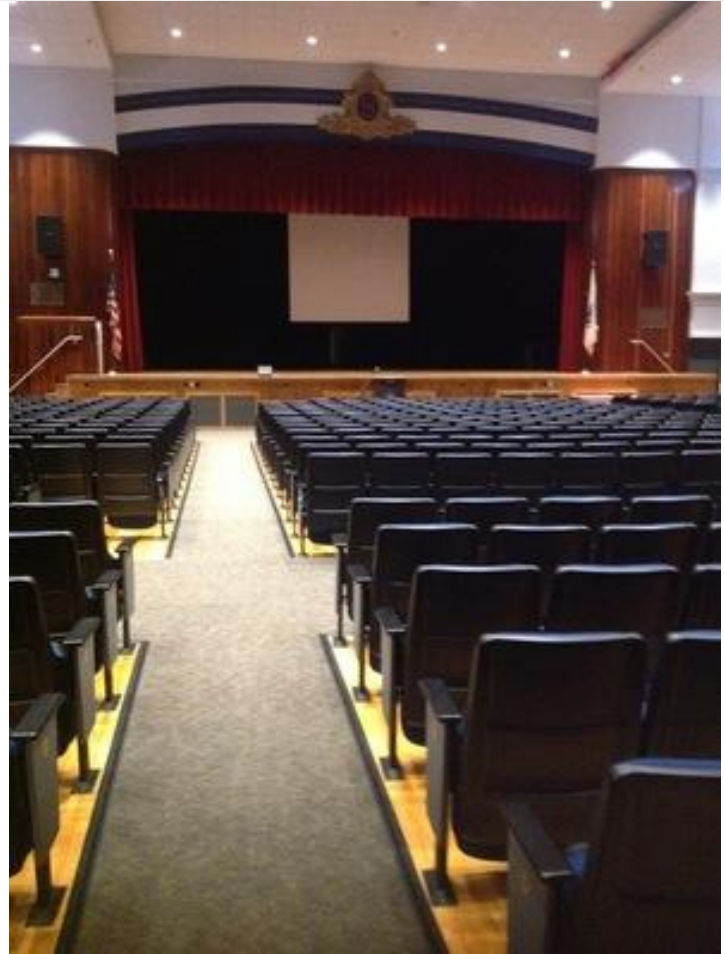
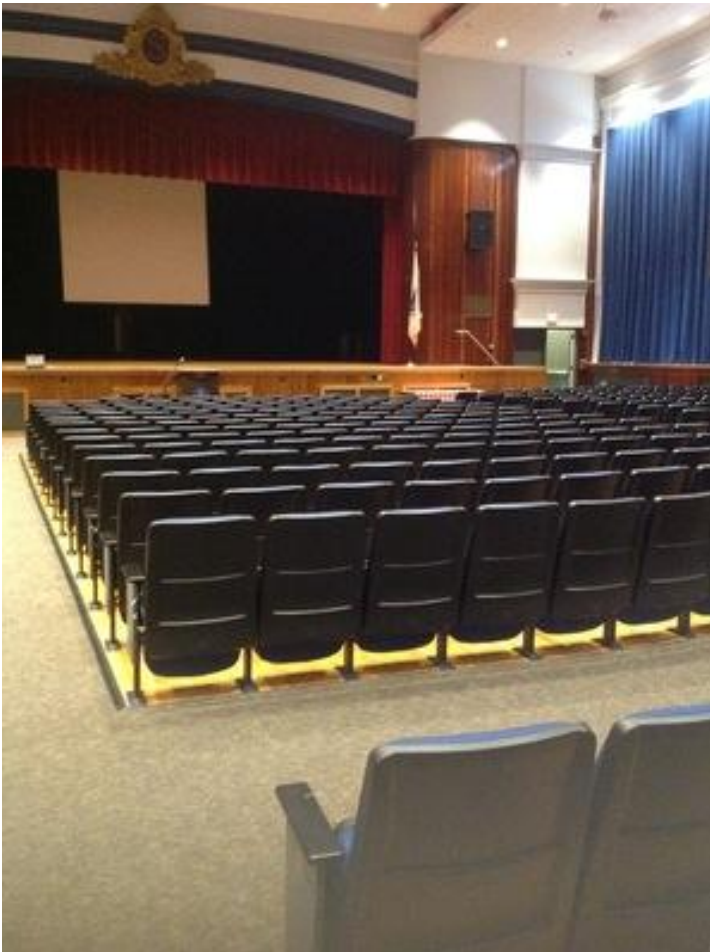
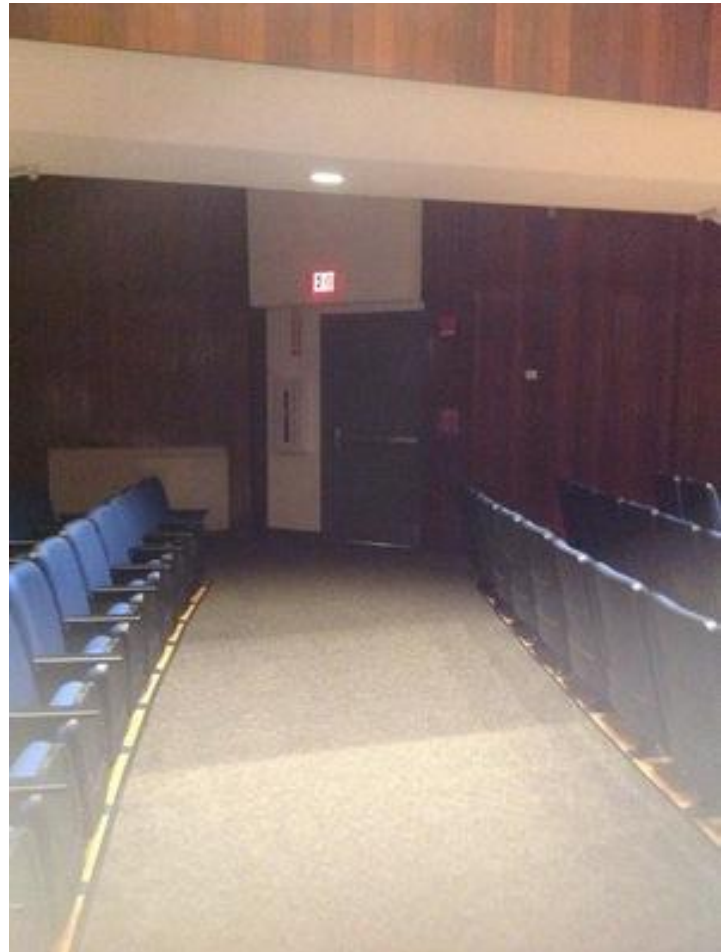
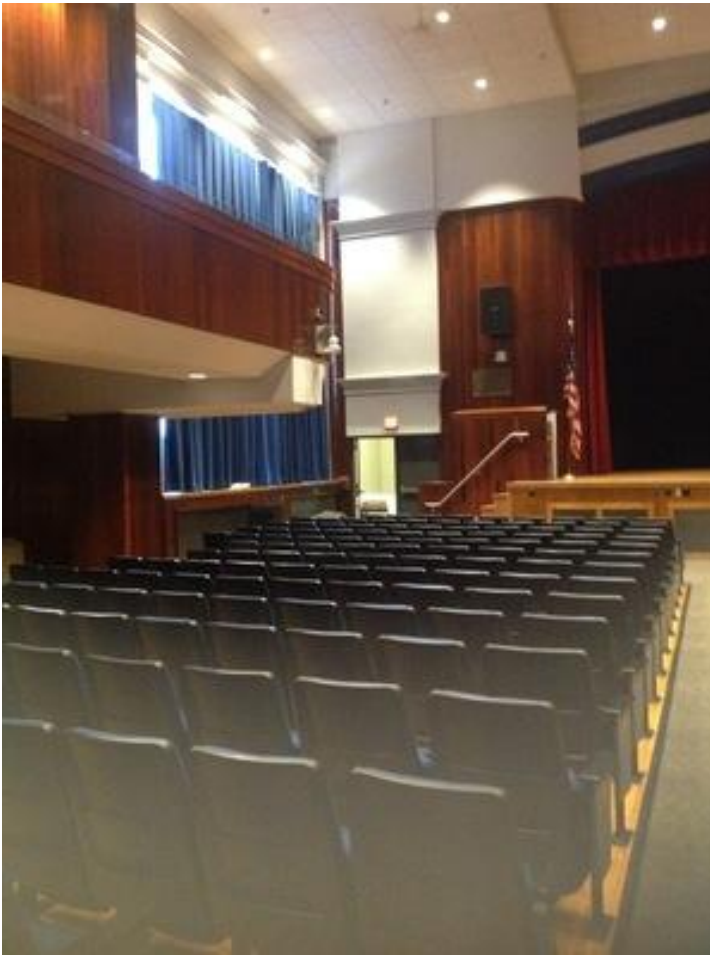
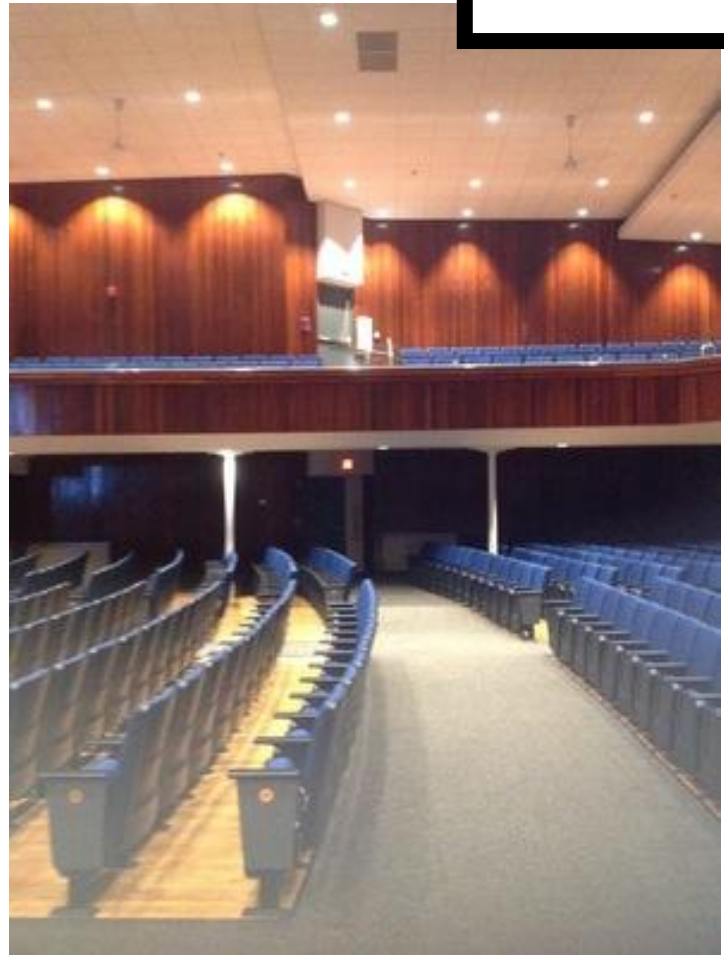
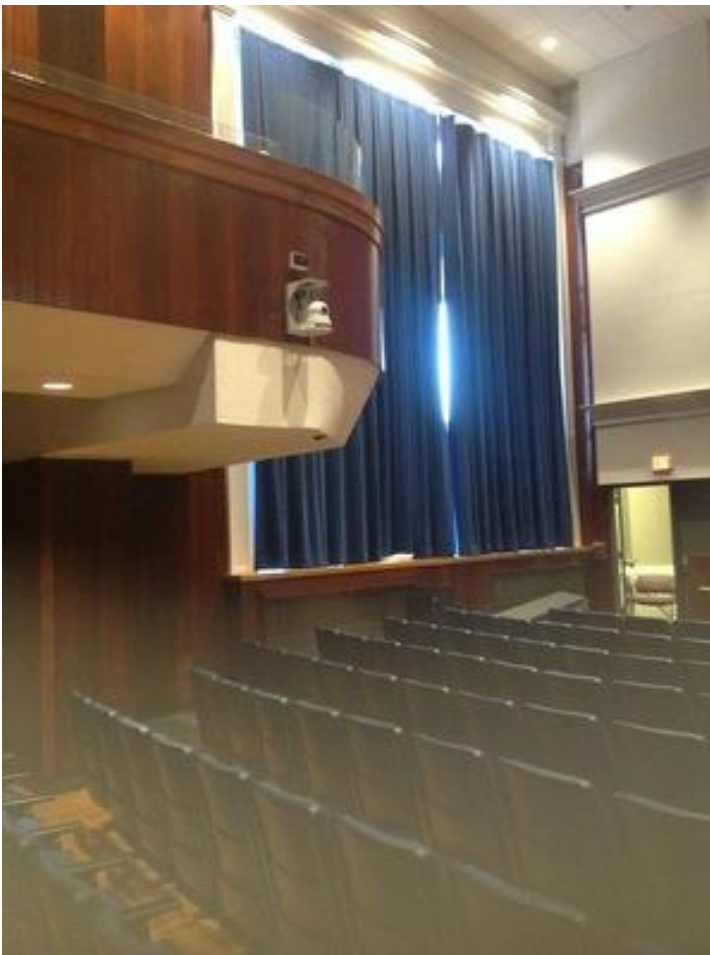
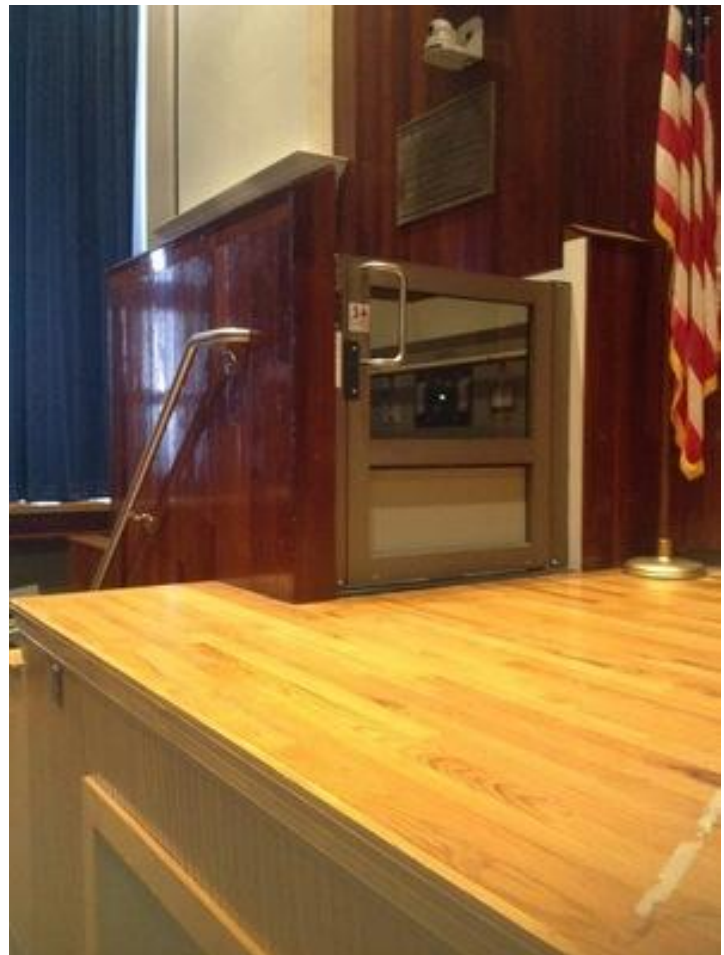
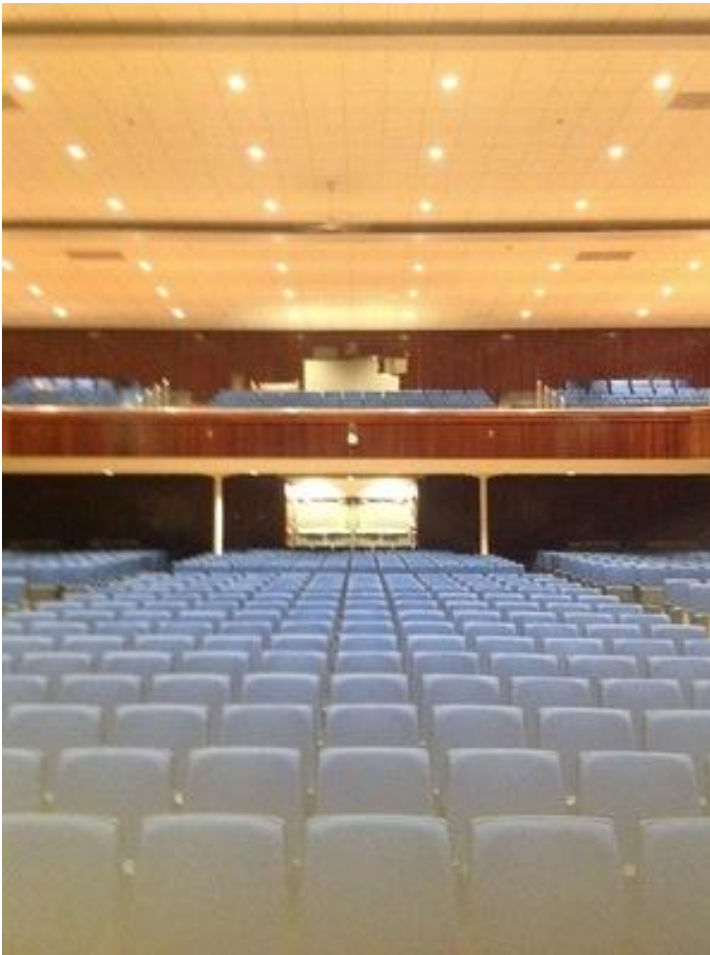
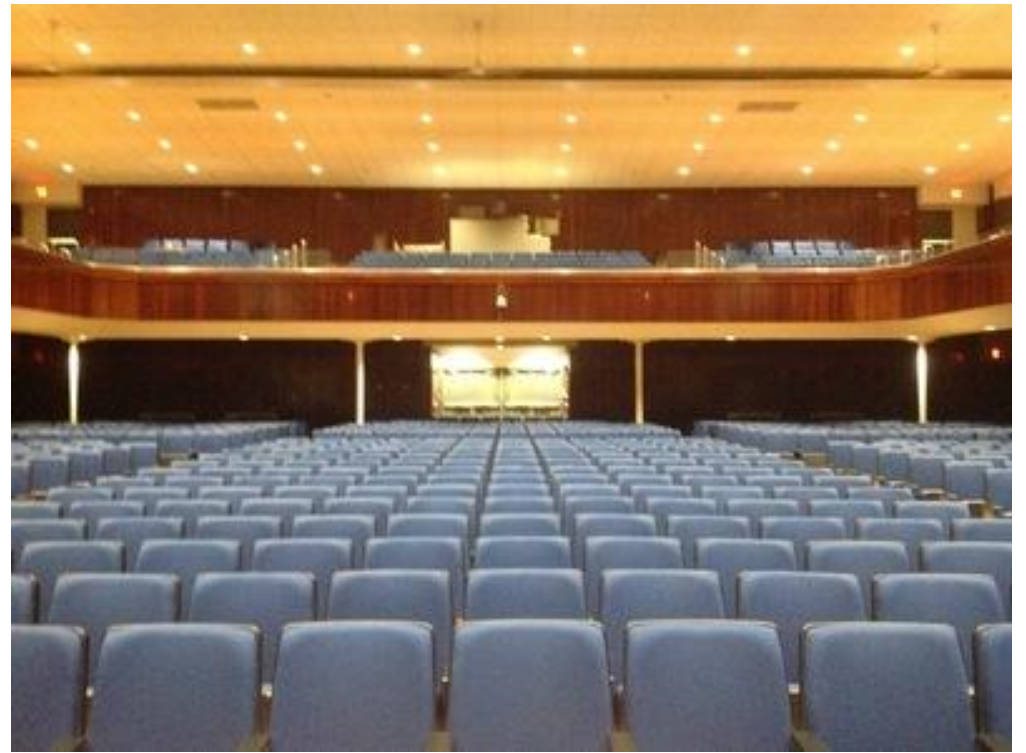
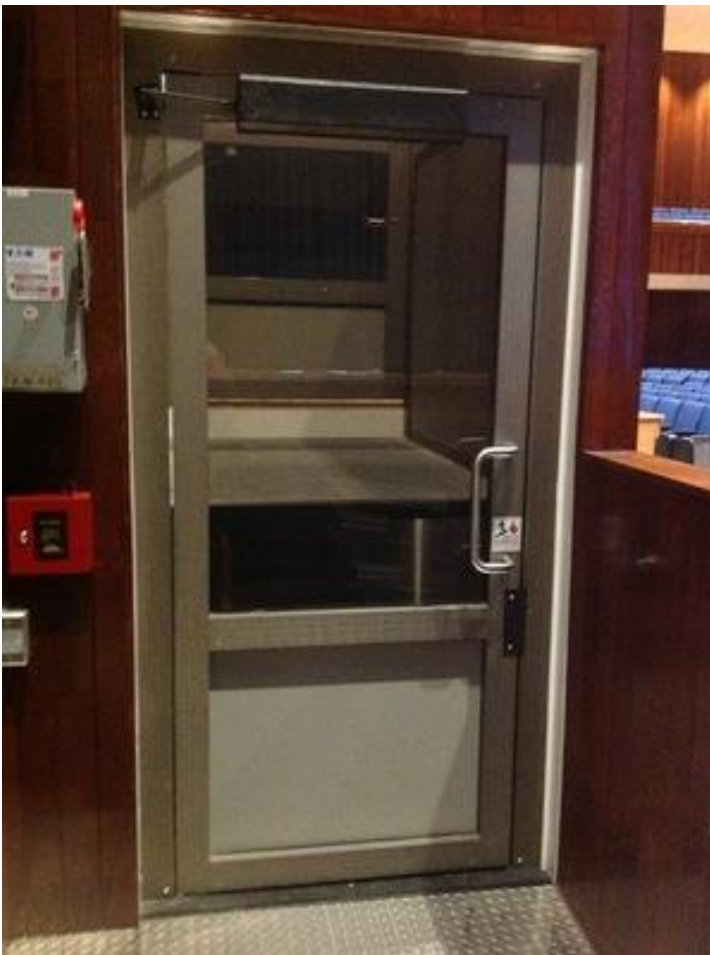
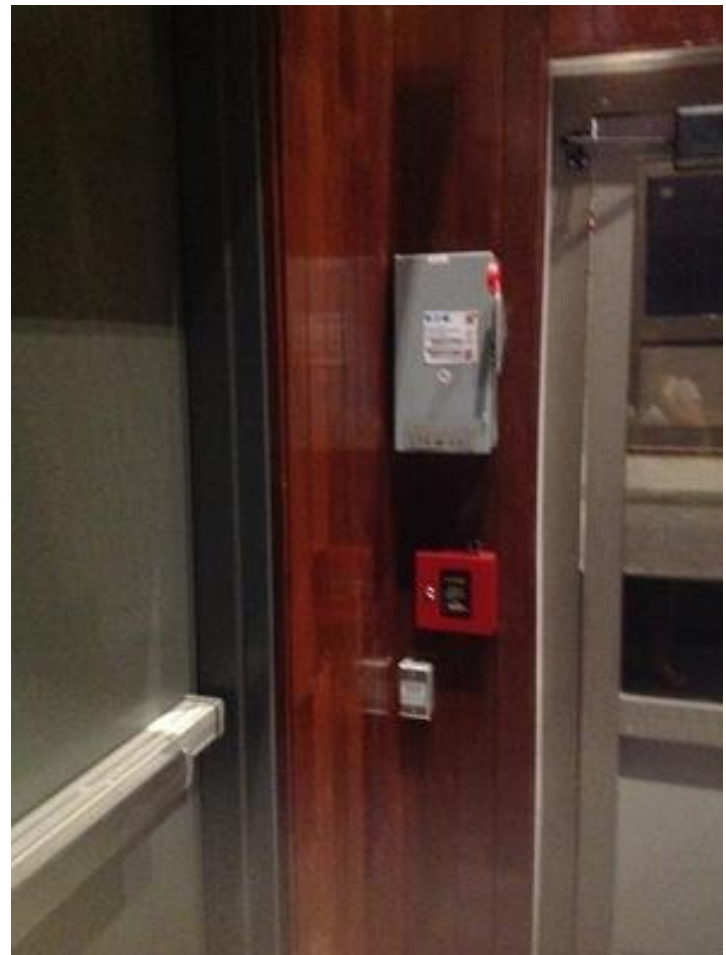
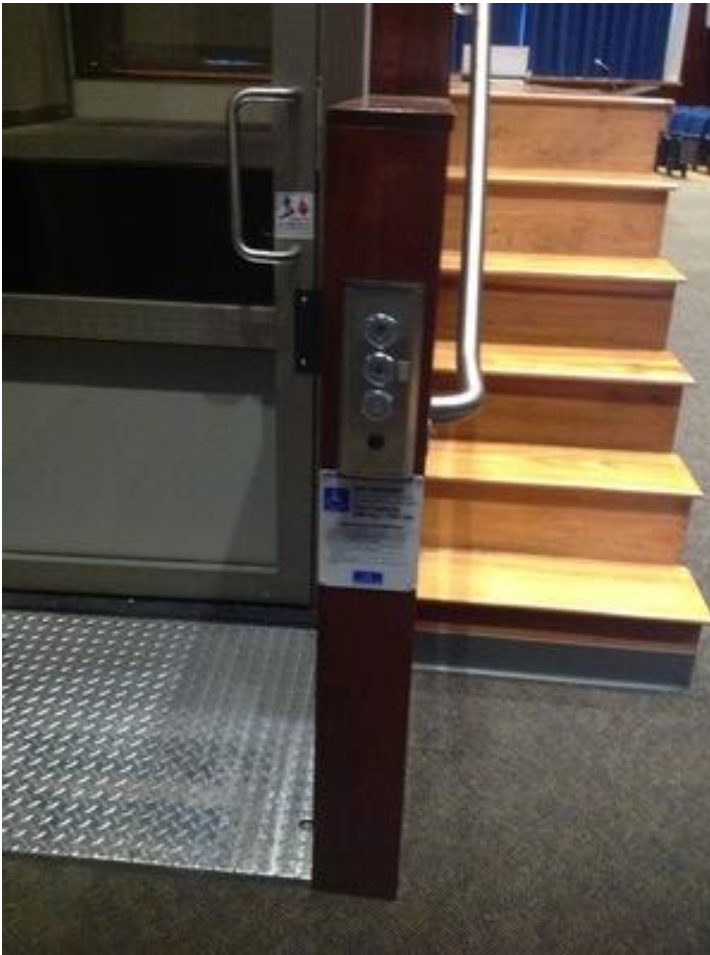
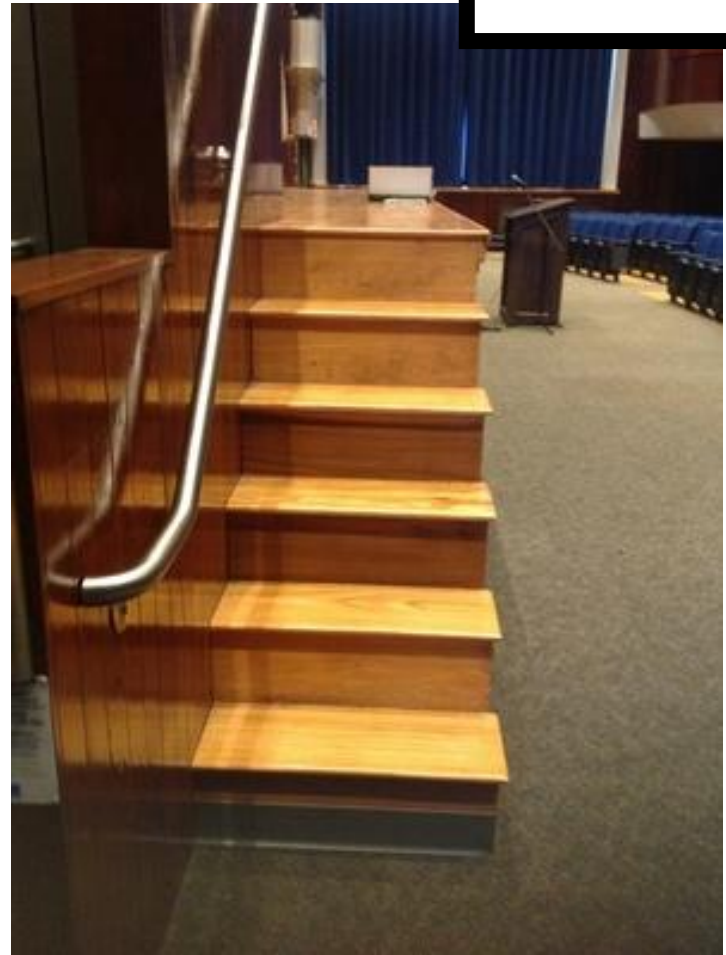
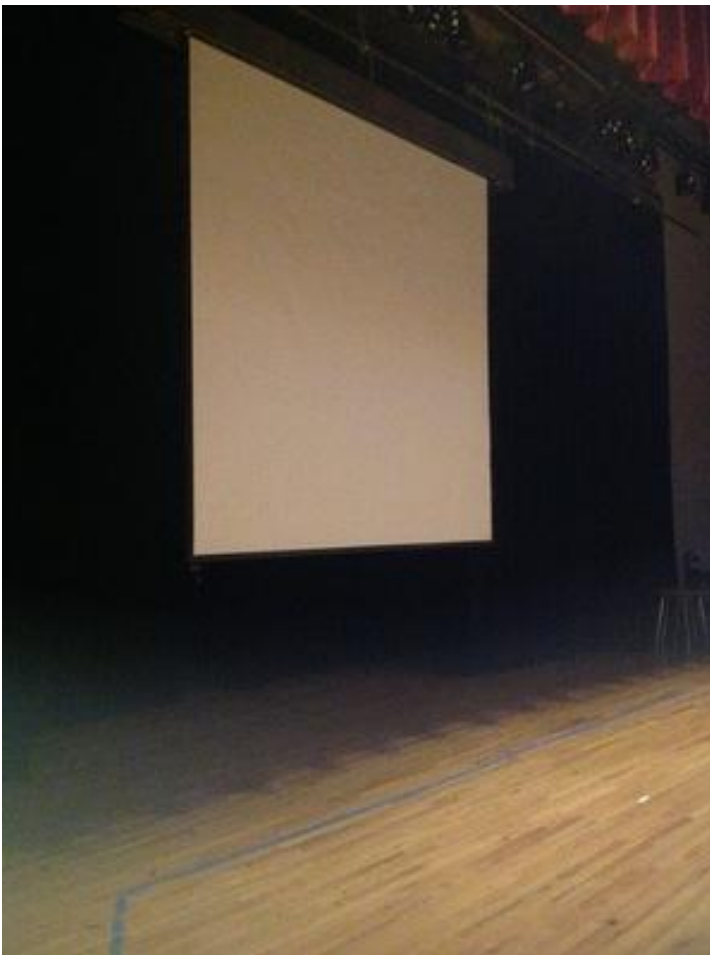
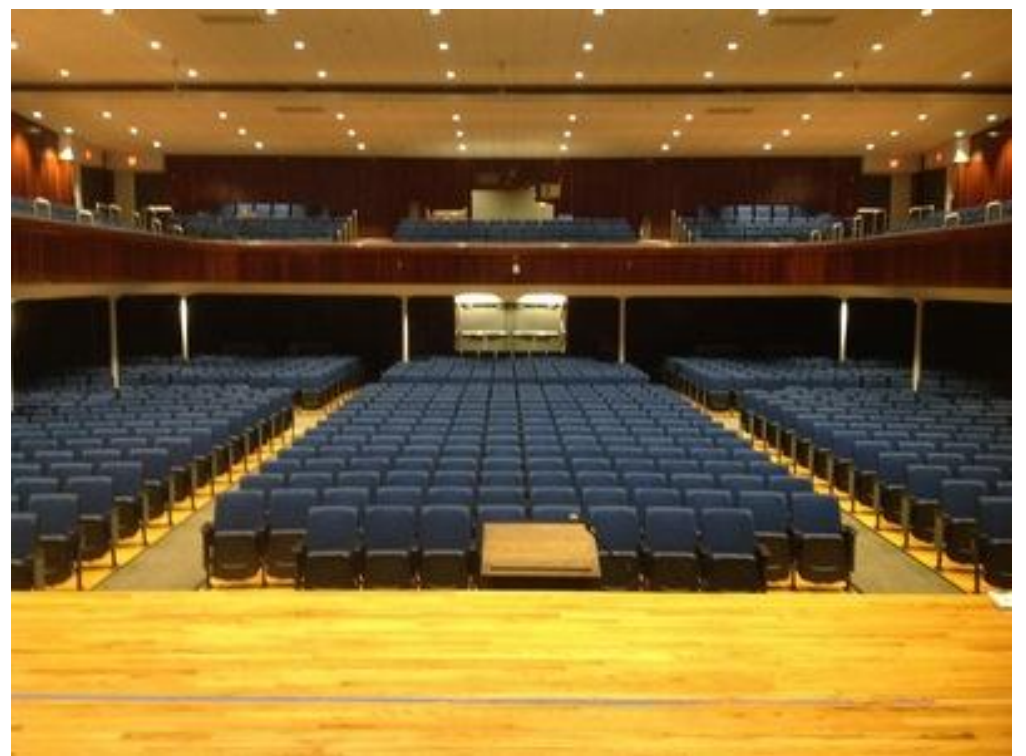
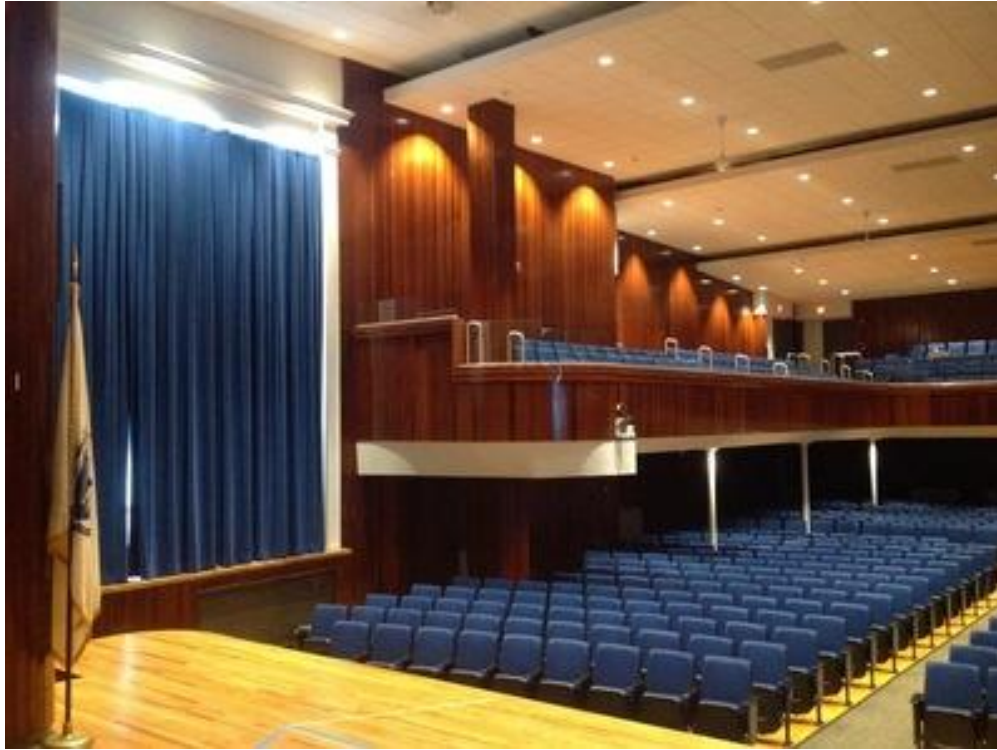
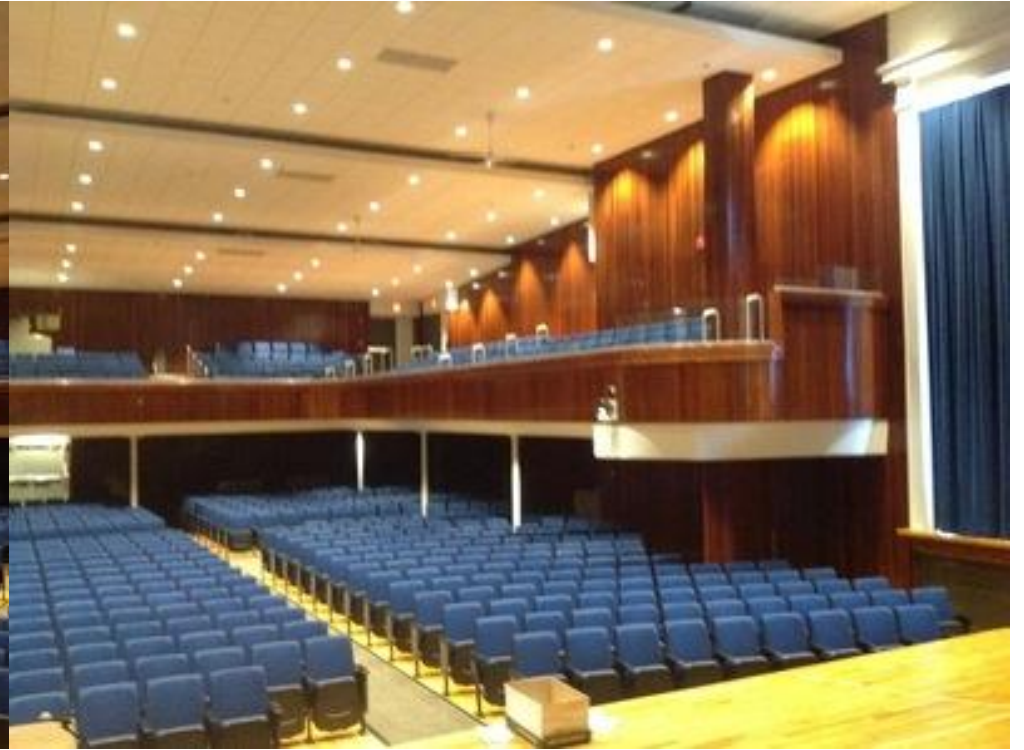
Attached Images for ID KU-00095

| Description Auditorium is excellent condition. It was recently renovated and meets current building code. | | | |

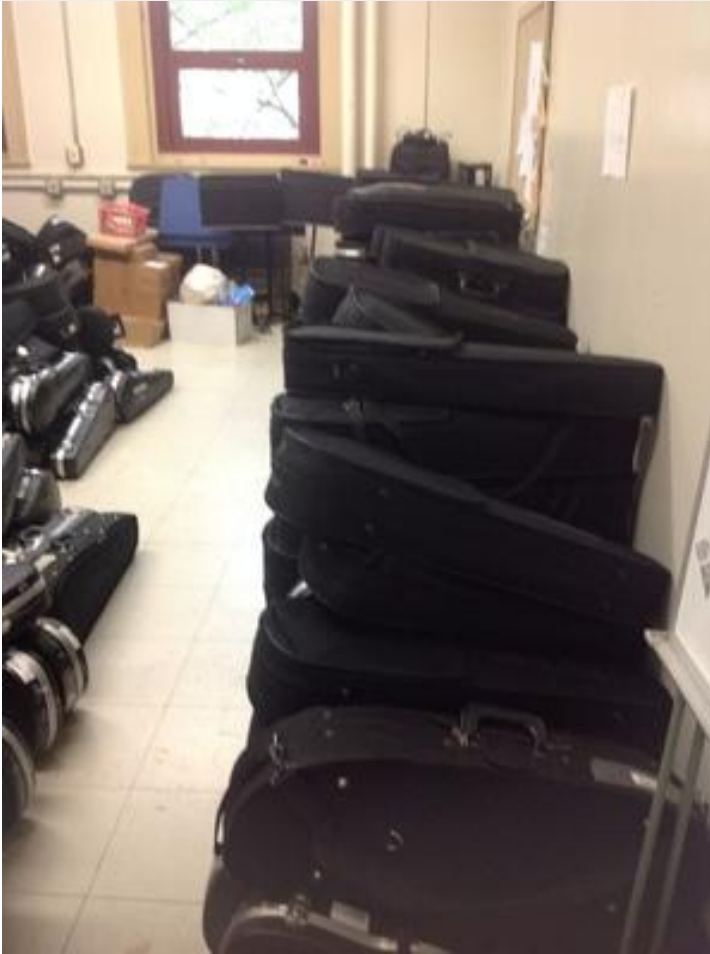
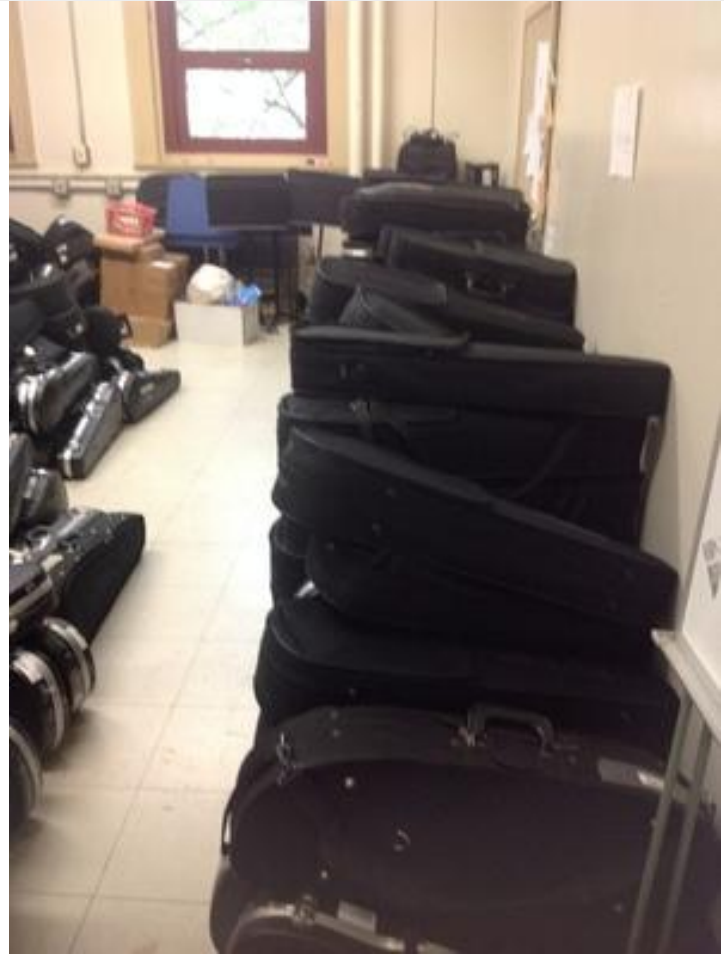
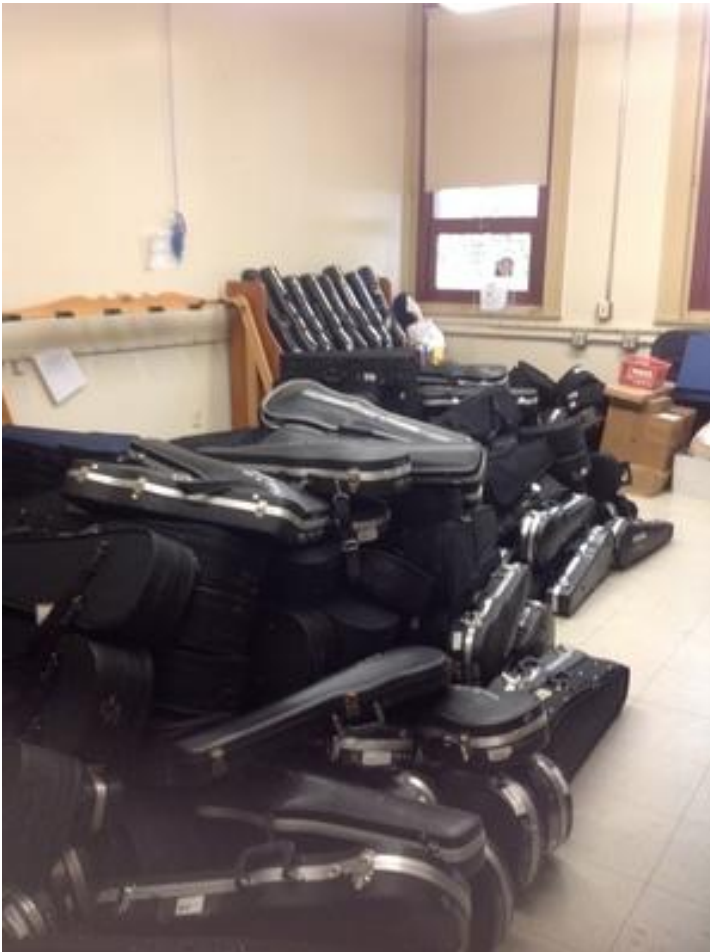
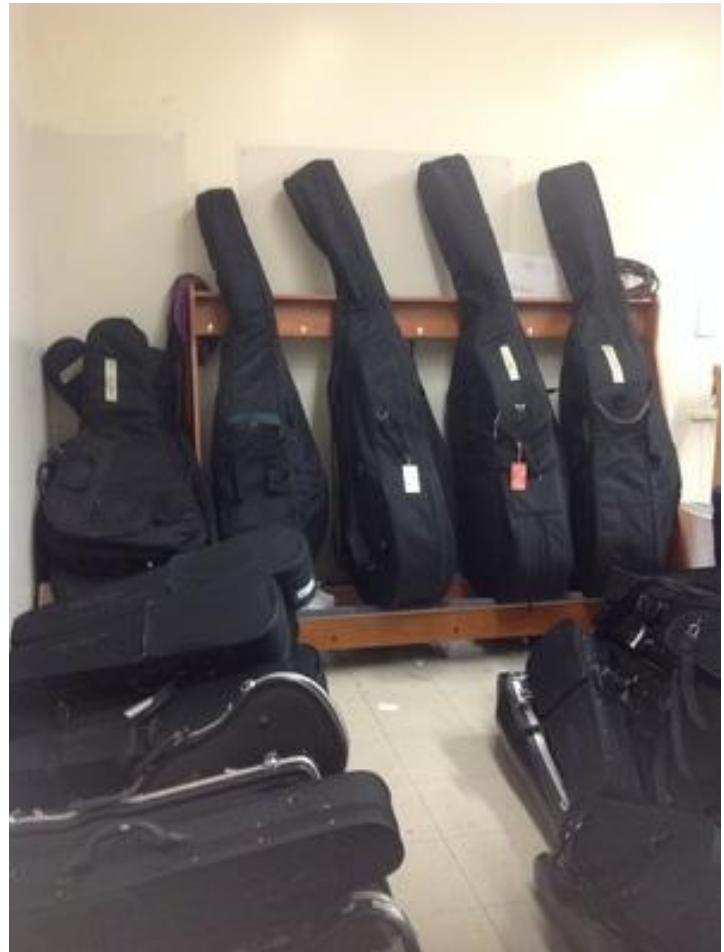
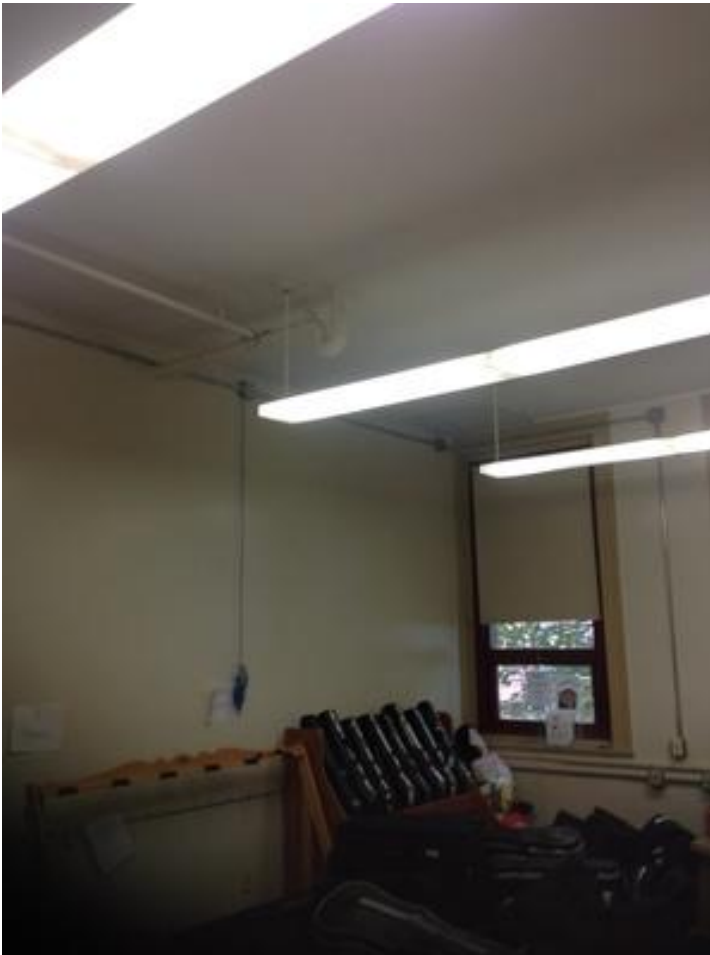
Attached Images for ID KU-00097

Description
Carpet and VCT are in very poor condition. Permanent risers are creaky and in poor condition. Shades are in poor condition. Millwork in poor condition. Unit heater in poor condition. Some windows have lost their seal. Classroom has smartboard.

| Condition | Poor | | |

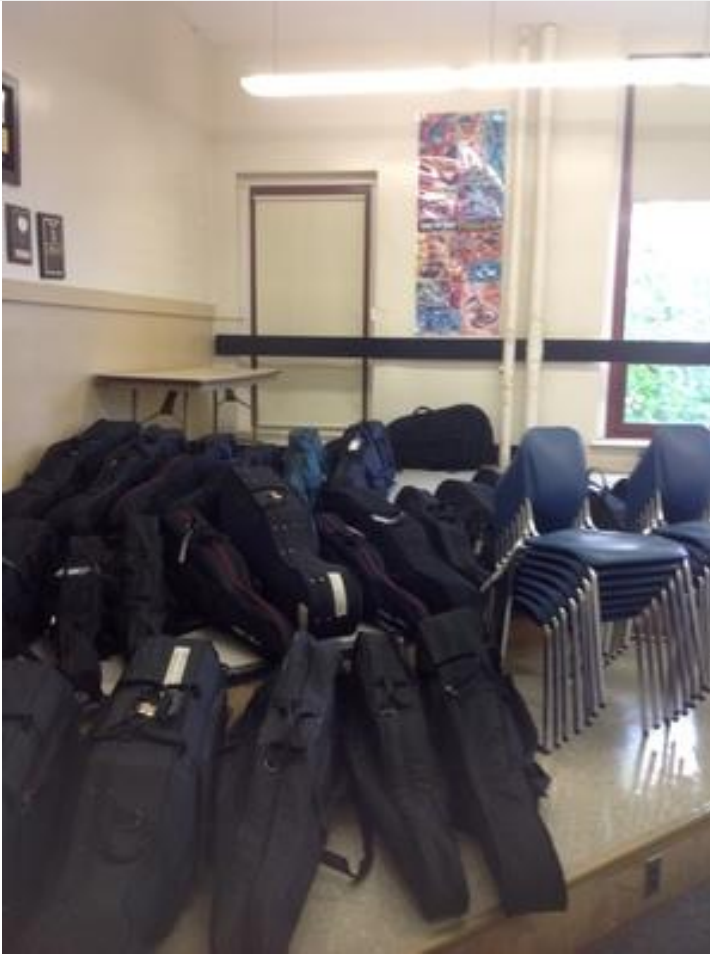
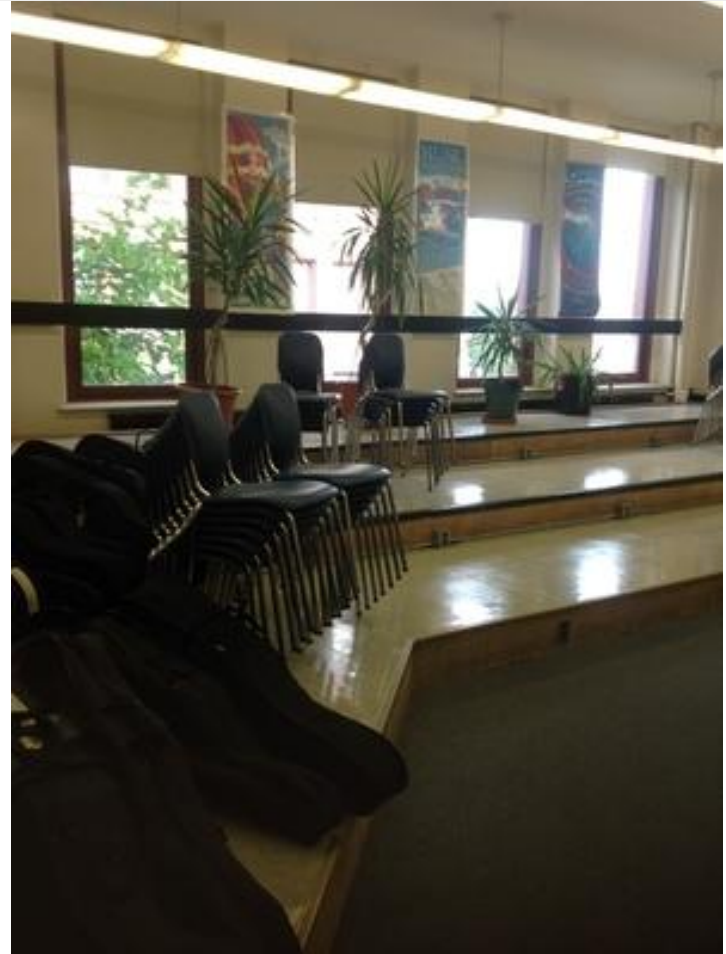
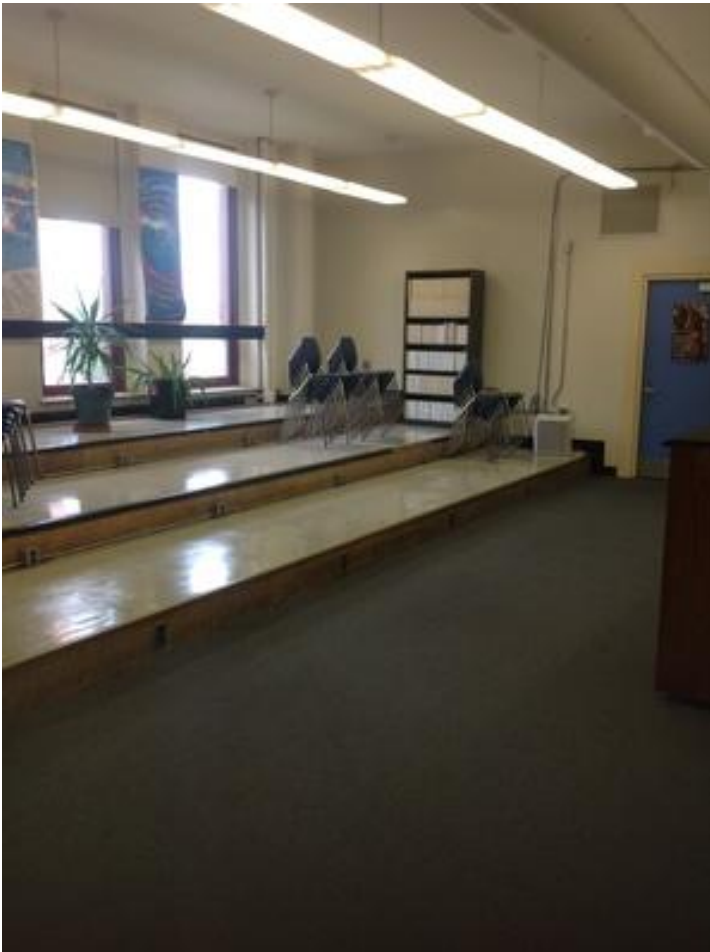
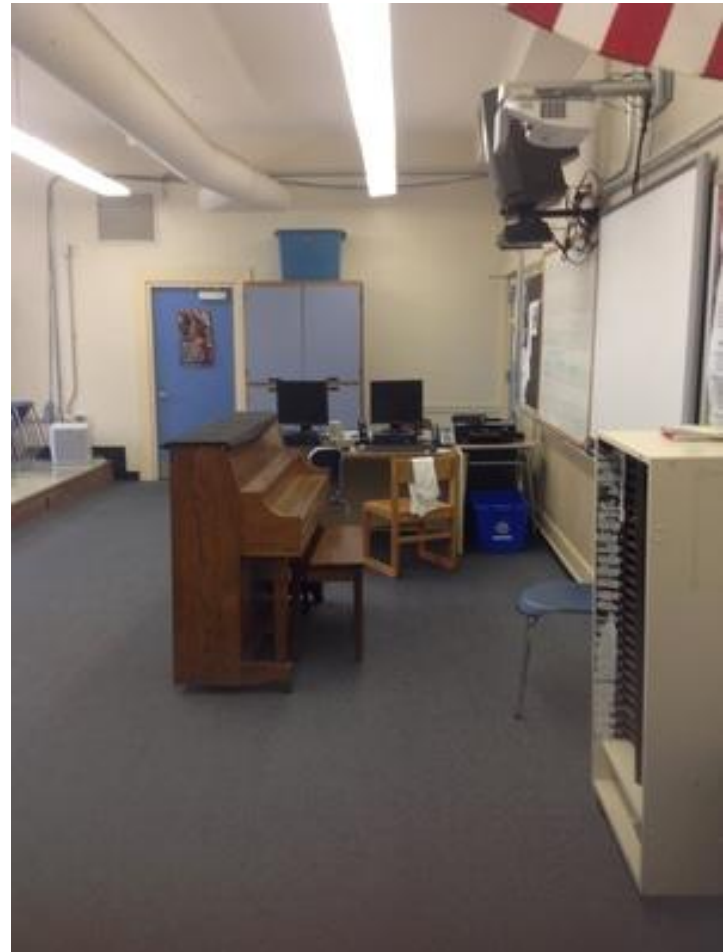
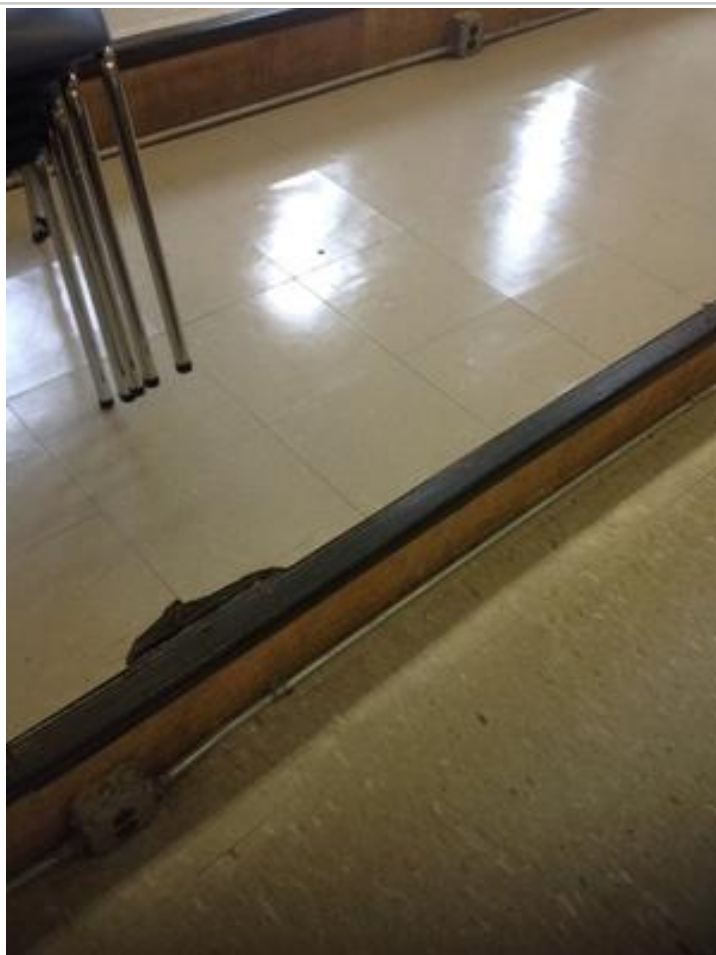
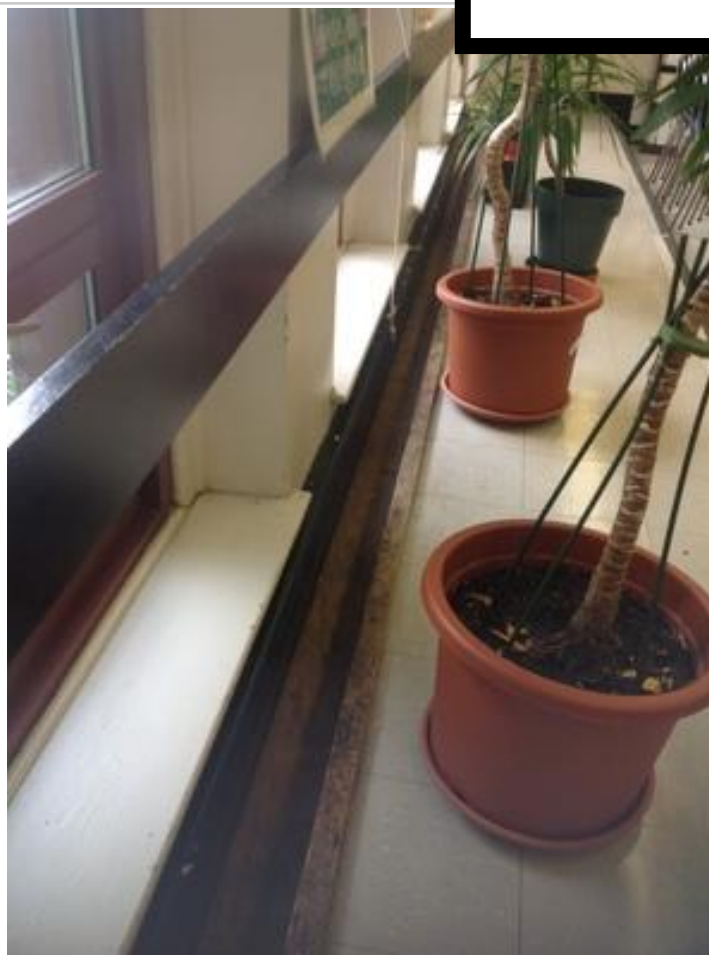
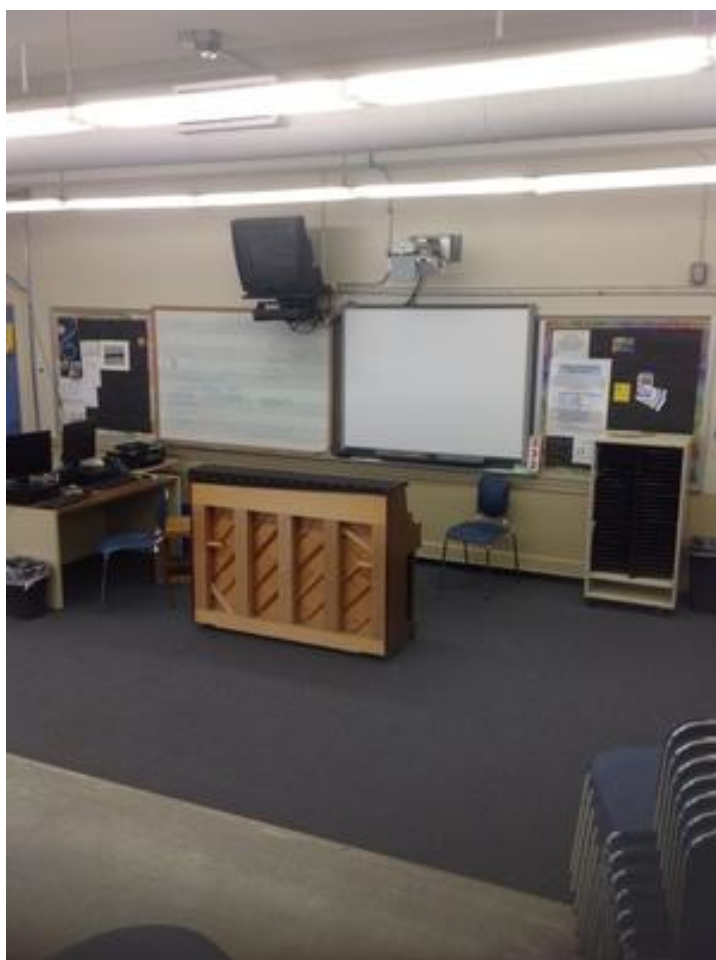
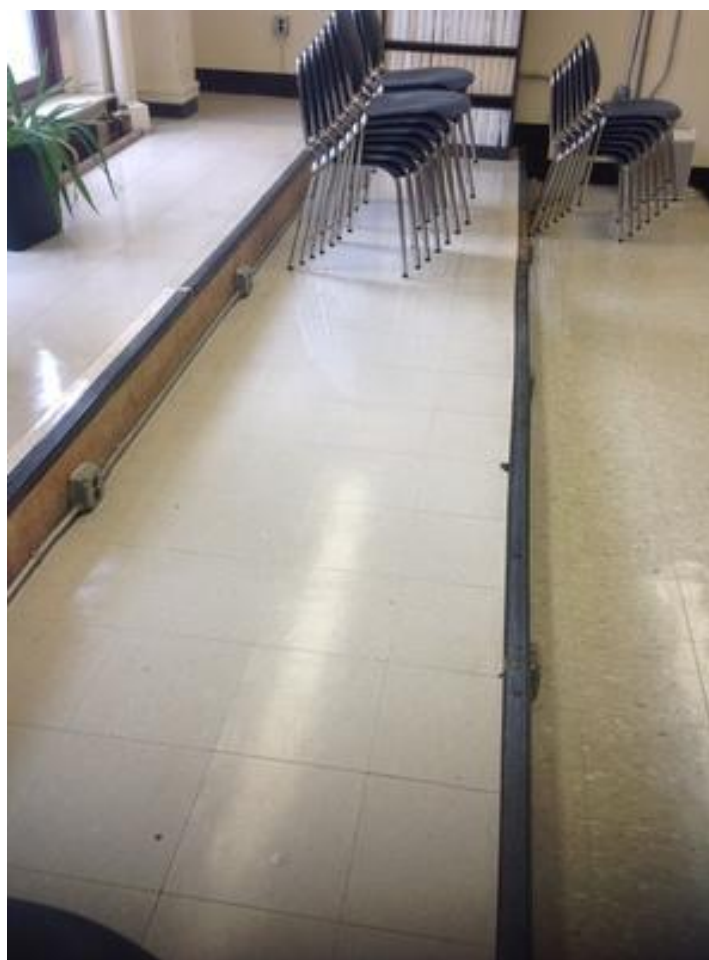
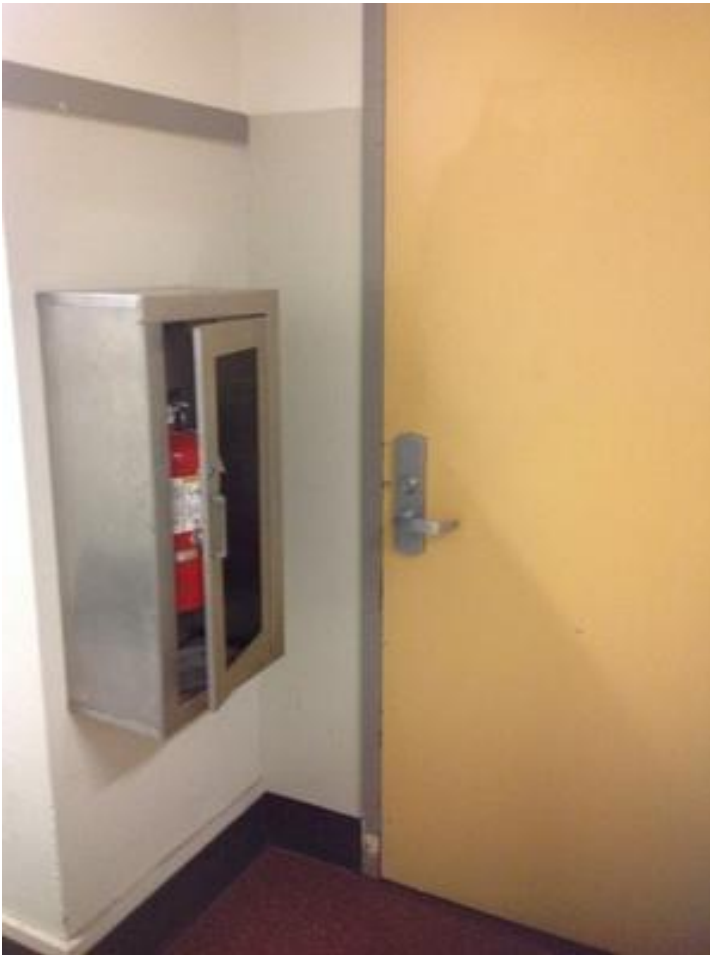
Attached Images for ID KU-00098

Carpet and VCT are in very poor condition. Permanent risers are creaky and in poor condition. Shades are in poor condition. Millwork in poor condition. Unit heater in poor condition. Some windows have lost their seal. Classroom has smartboard.

| Condition | Poor | | |
