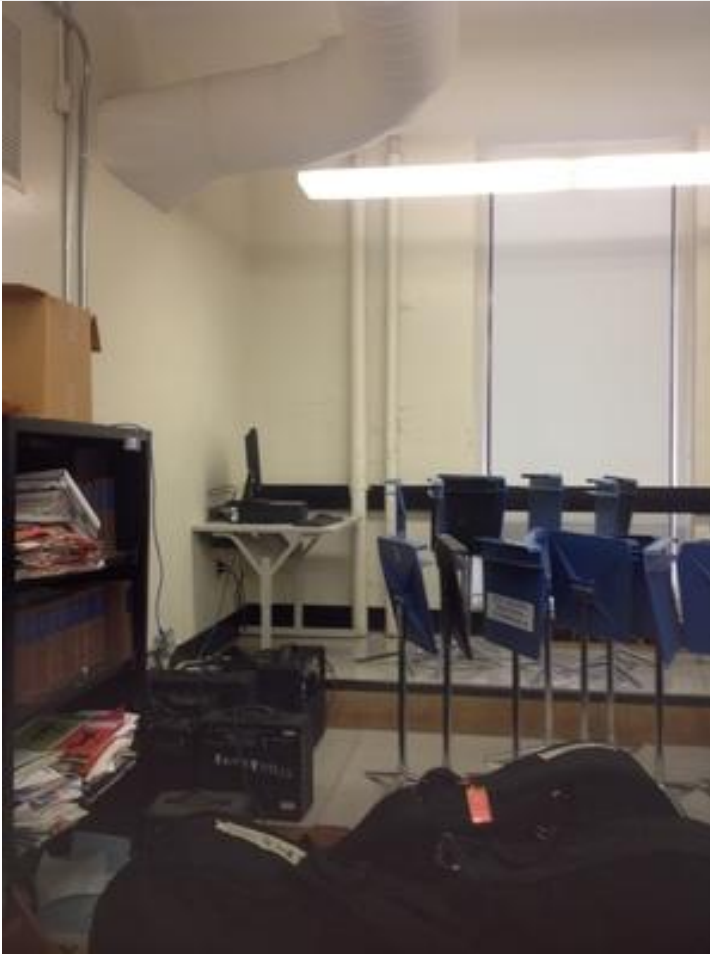
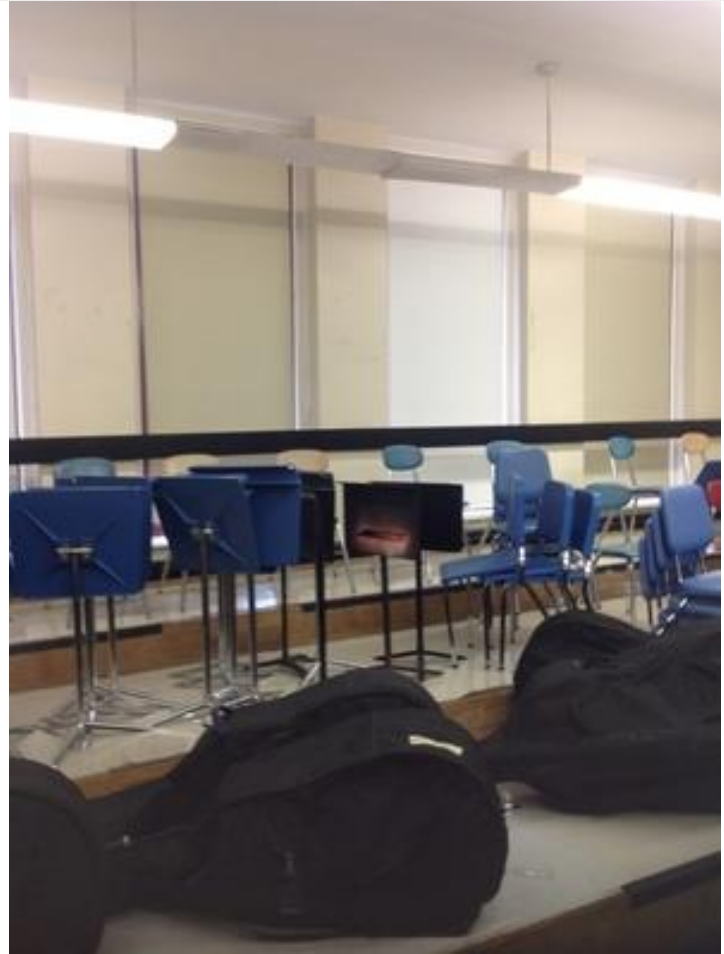
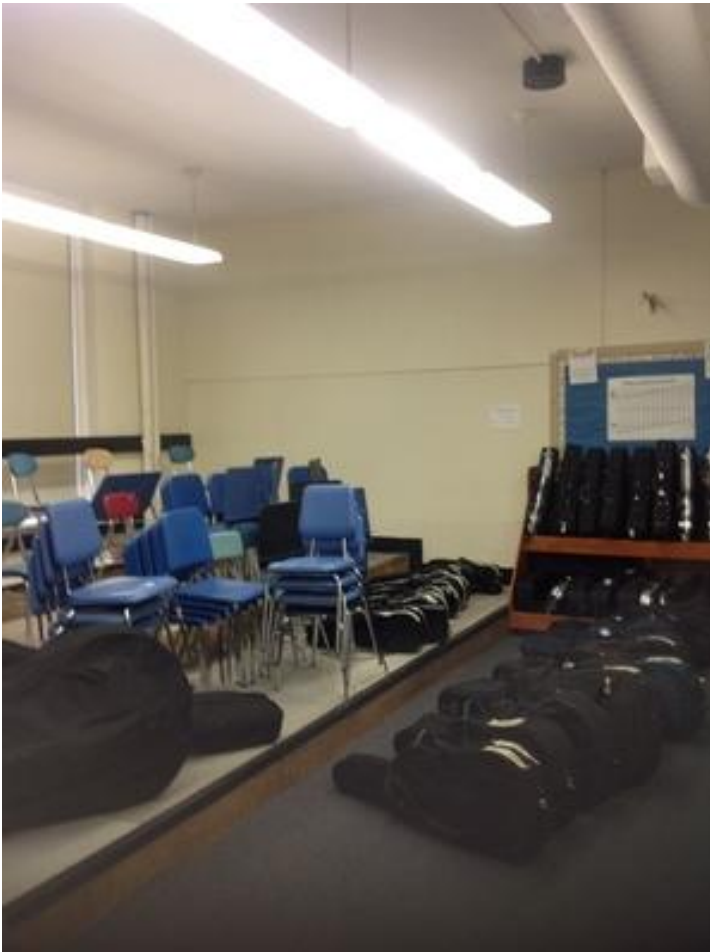
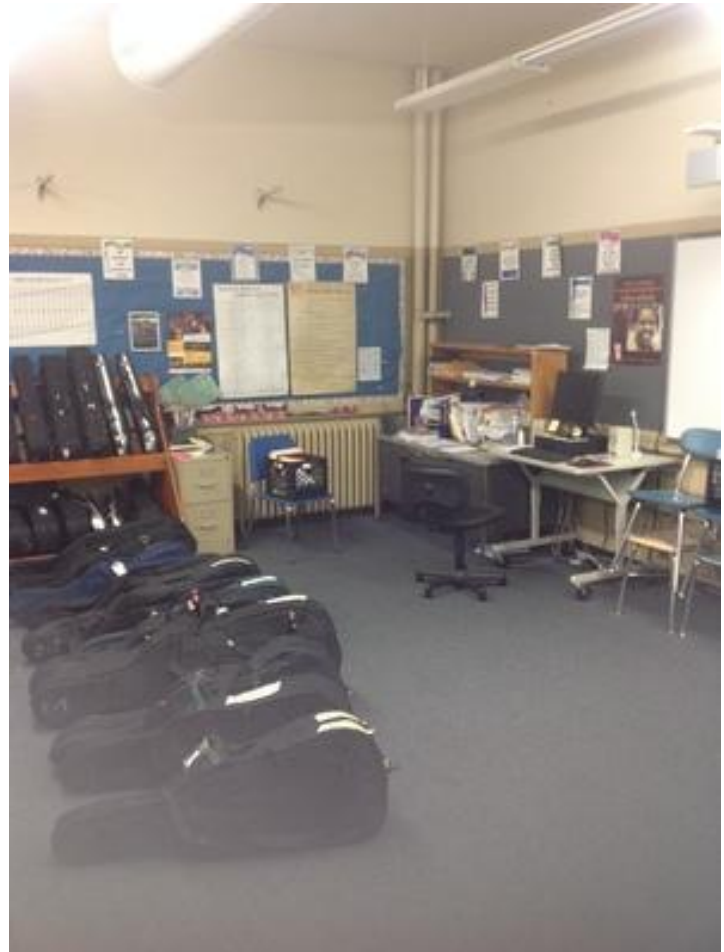
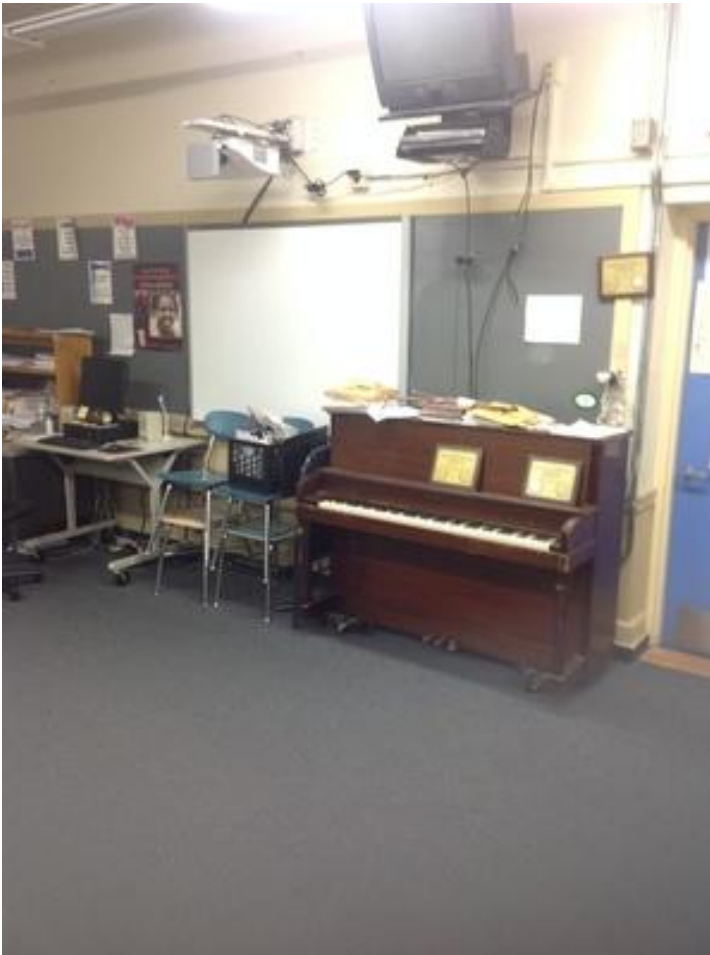
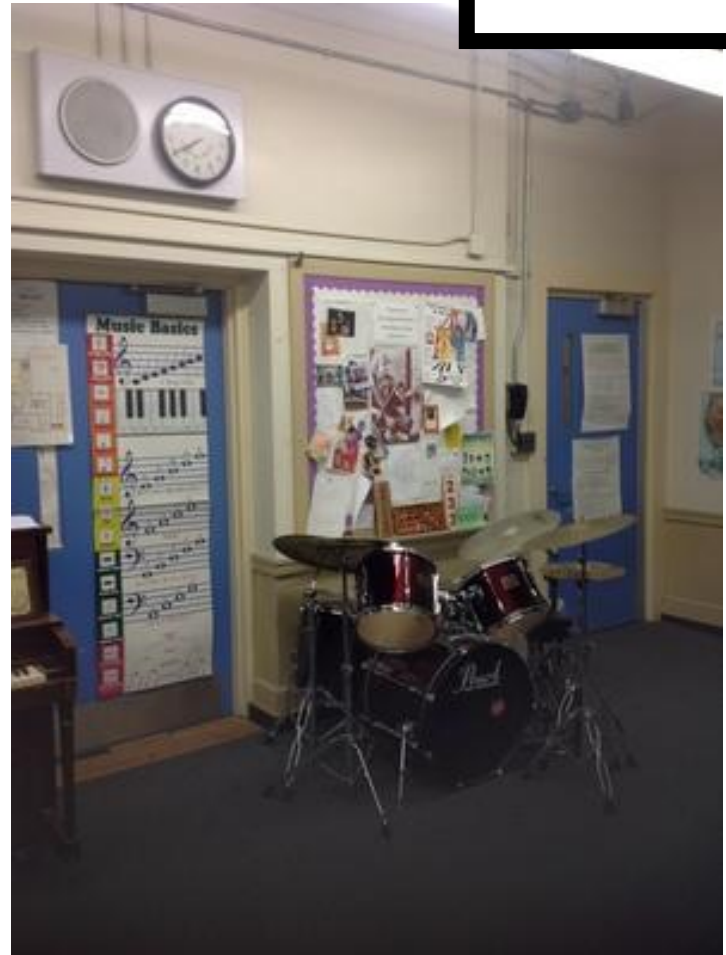
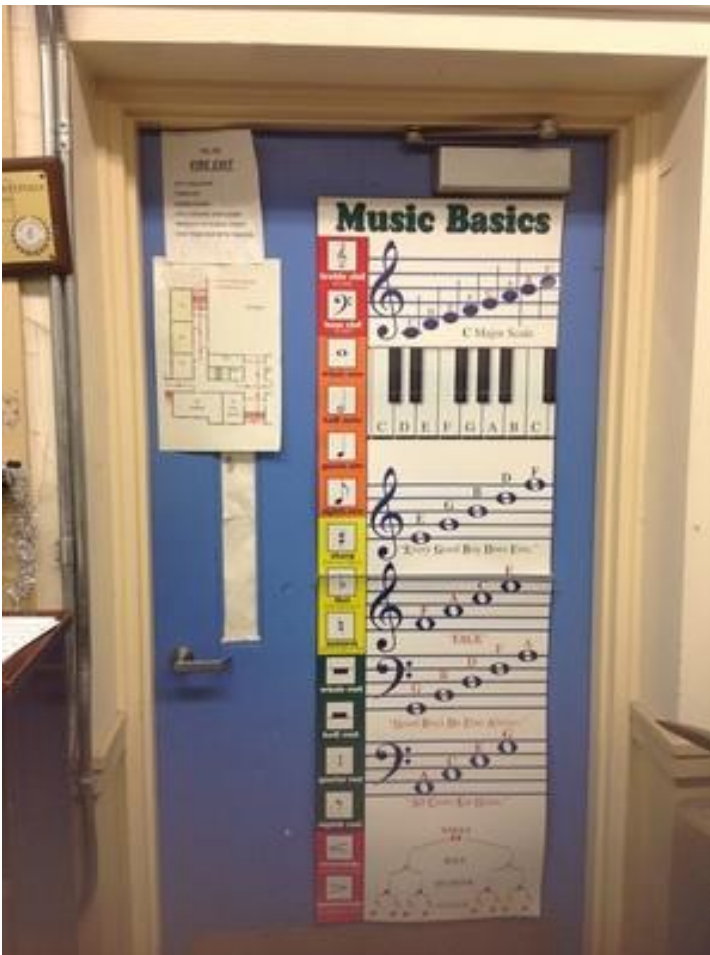
Attached Images for ID KU-00099

Description
VCT flooring in fair condition but has some warping-typical. Paint is chipping on walls and ceiling. Light fixtures missing covers in some locations. Portions of plaster ceiling have adhered acoustical treatment. Surface mounted equipment and wiring is haphazard. Shades are in poor condition. Millwork in poor condition. Unit heater in poor condition. Some windows have lost seals. Classroom has smartboard.

| Condition | Fair | | |

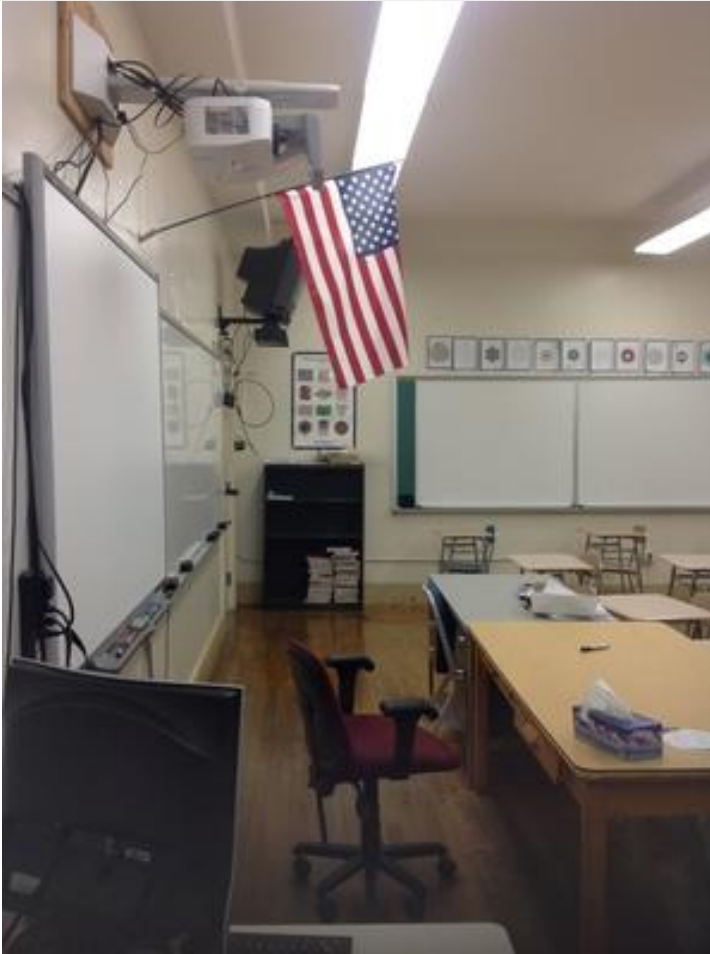
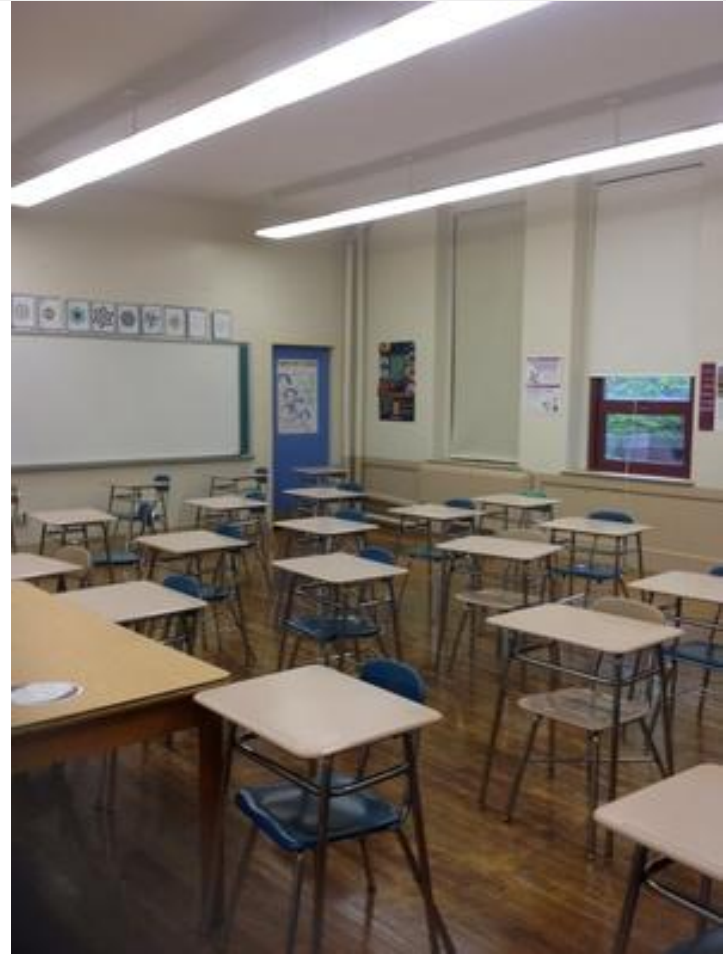
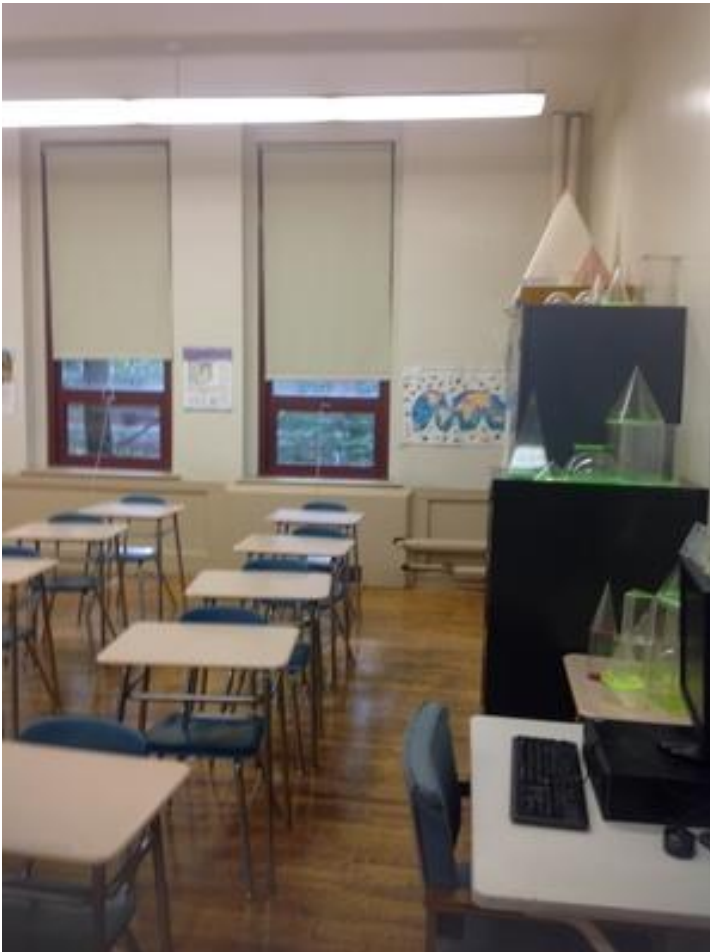
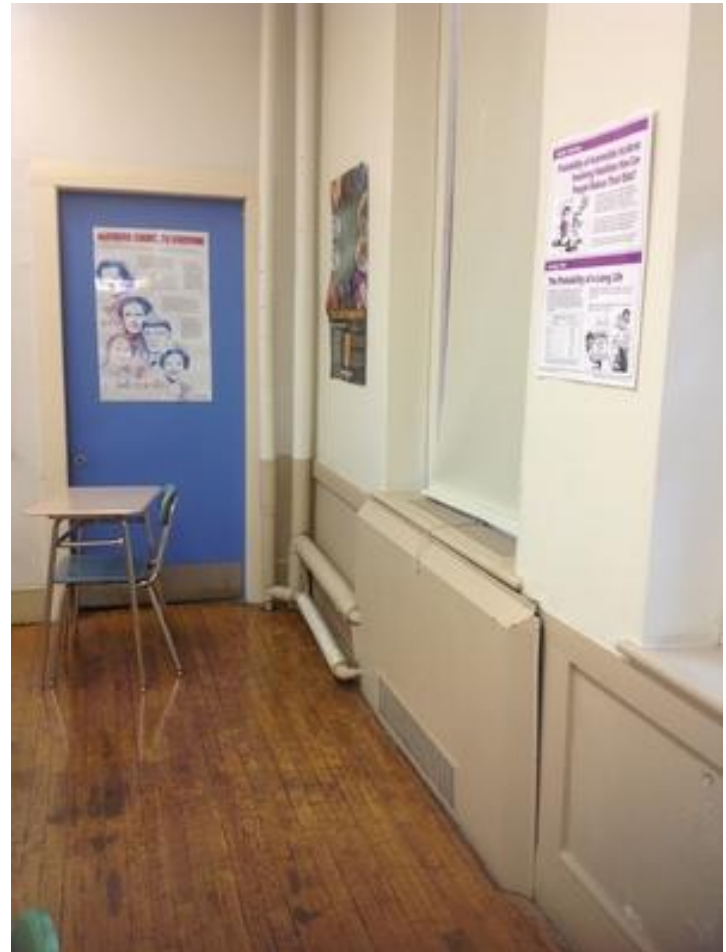
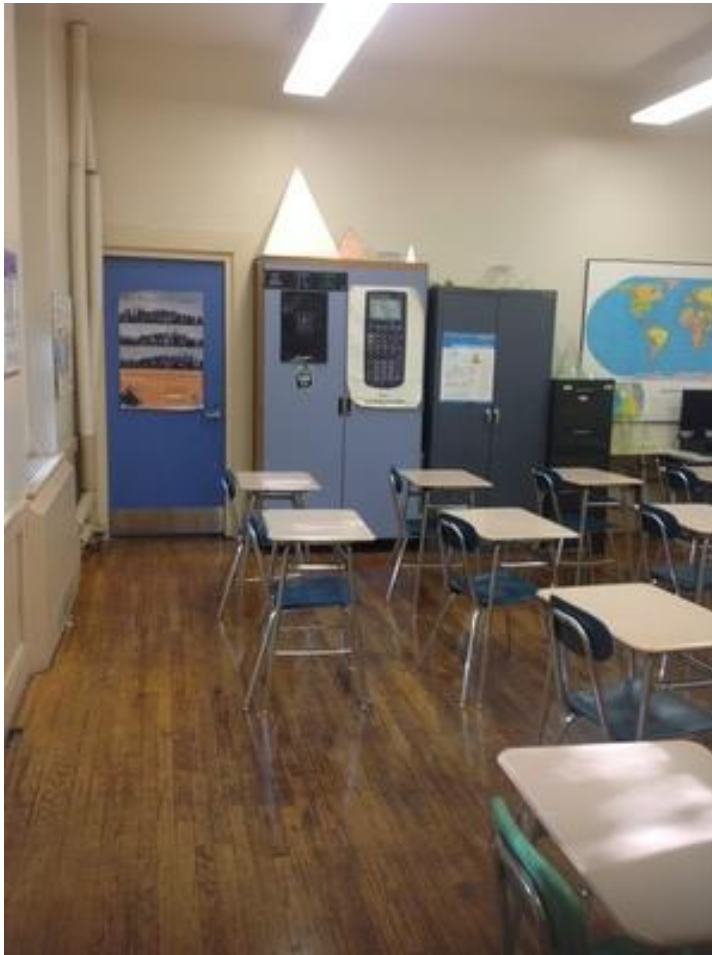
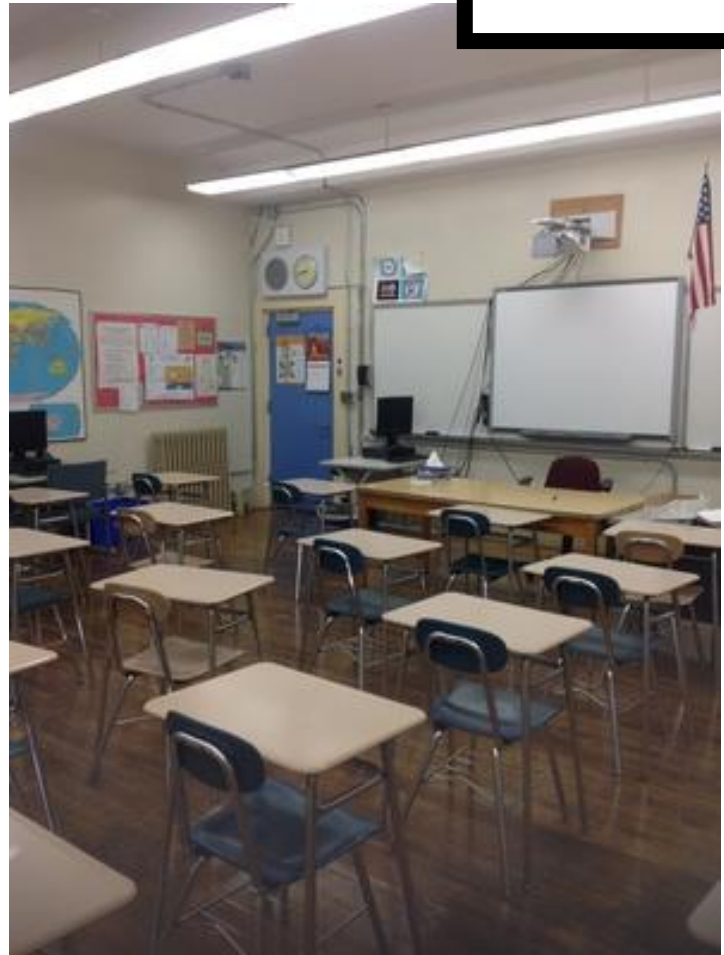
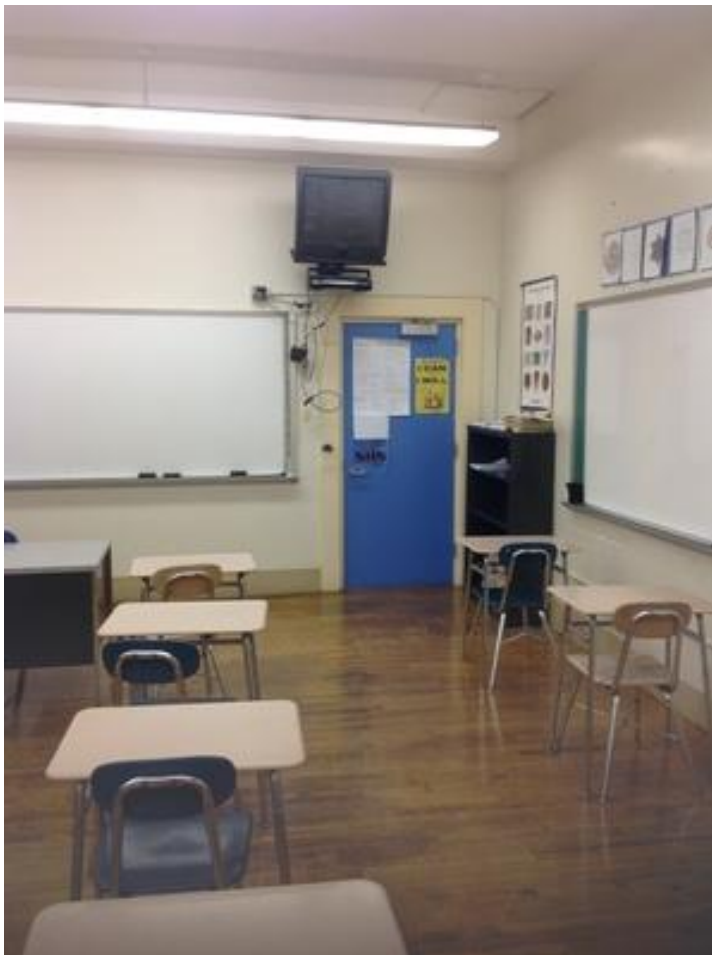
Attached Images for ID KU-00101

Description
Wood flooring in good condition but creaky. Paint is chipping on walls and ceiling. Surface mounted equipment and wiring is haphazard. Shades are in poor condition. Millwork in poor condition. Unit heater in poor condition. Some windows have lost their seal. Classroom has smartboard.

| Condition | Fair | | |

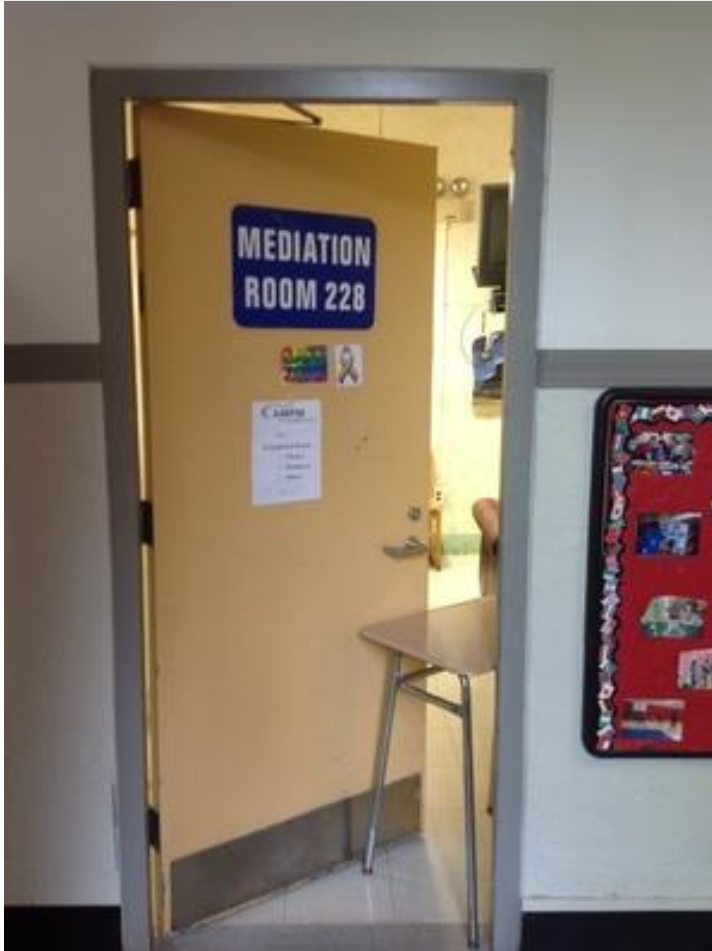
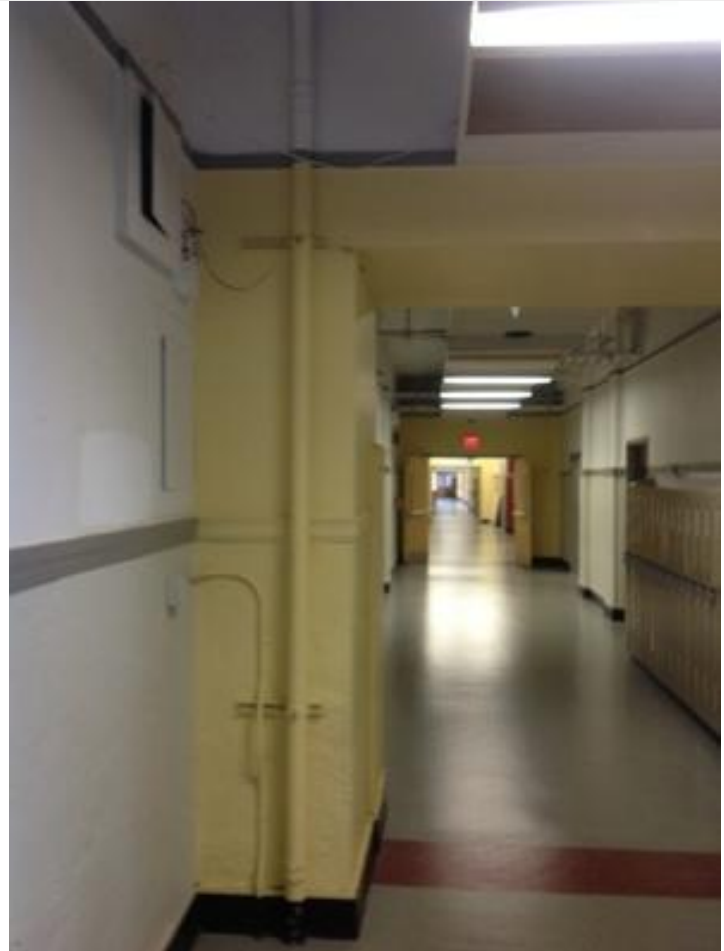
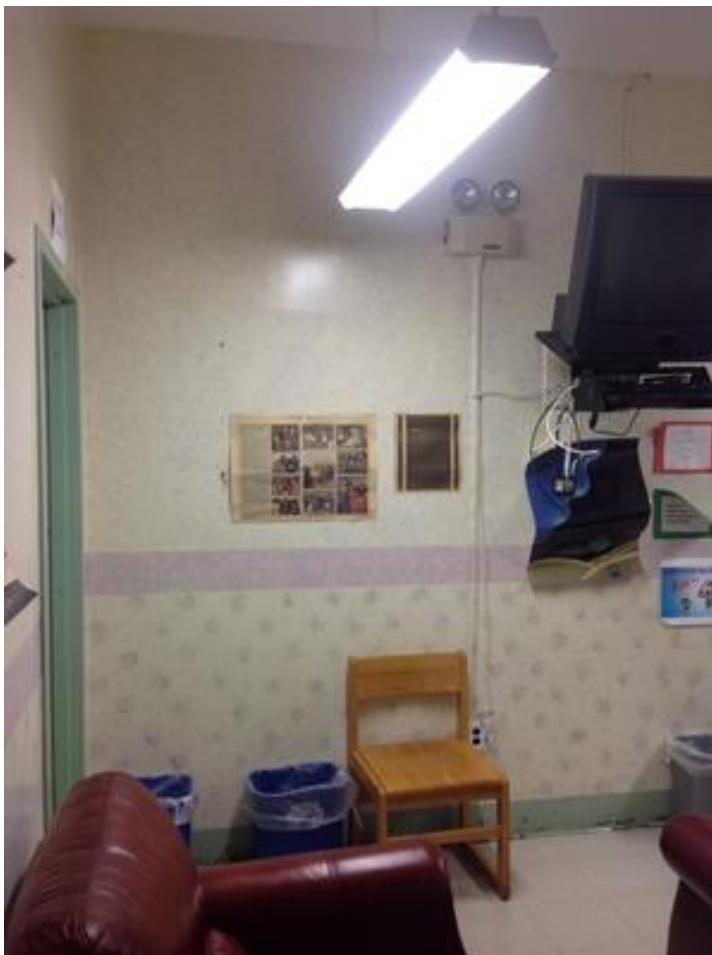
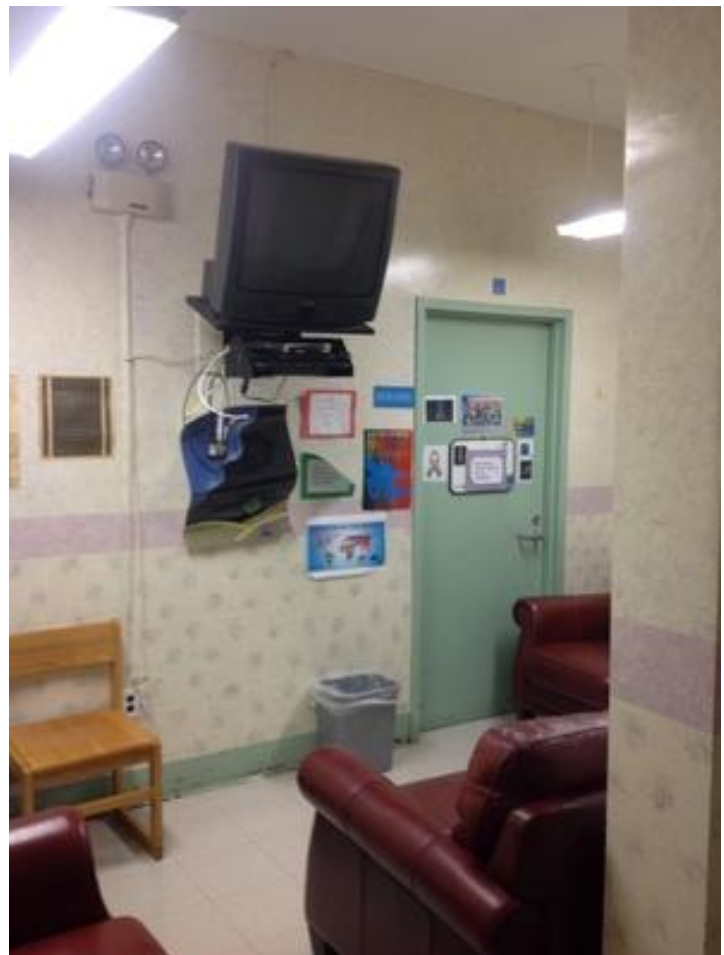
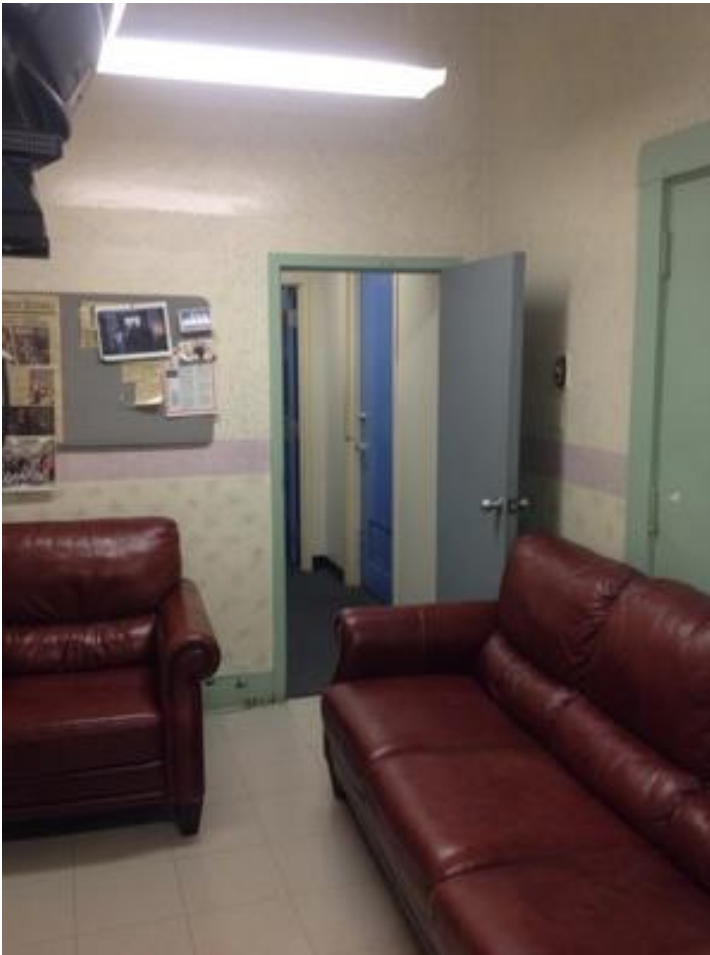
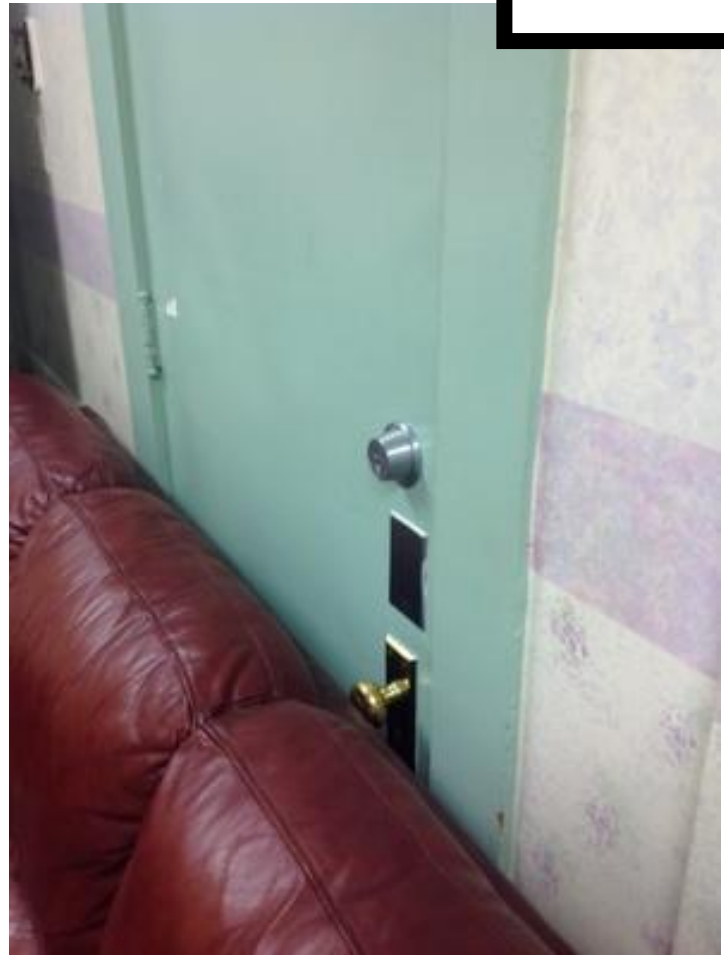
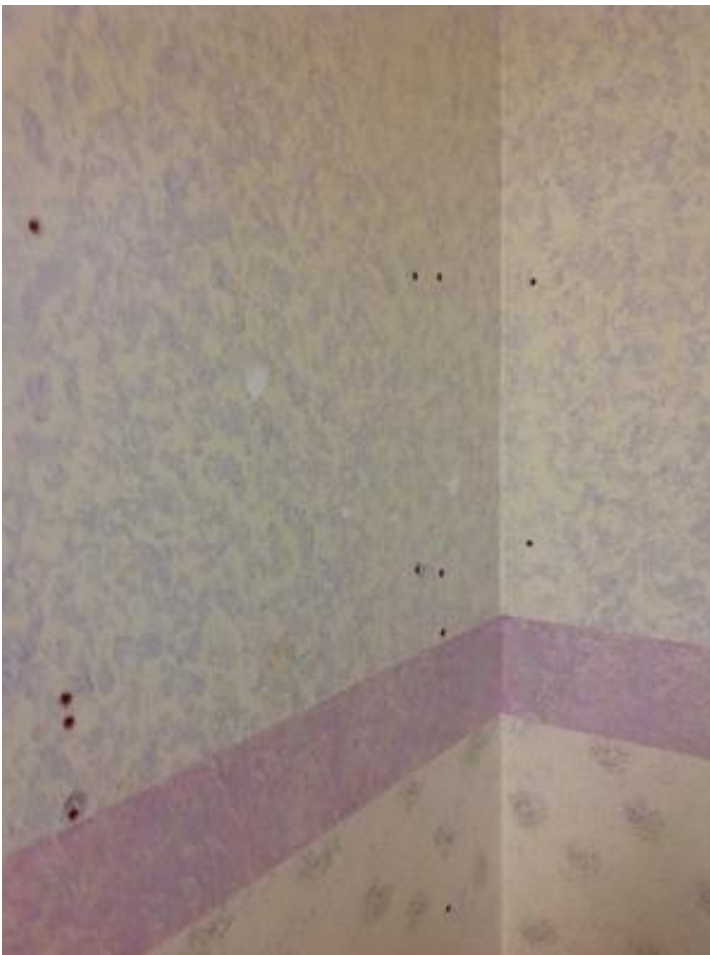
Attached Images for ID KU-00103

Description
VCT flooring in fair condition but has some warping-typical. Wall paper is in poor condition. Surface mounted equipment and wiring is haphazard. Doors hardware not ADA compliant. Furniture blocks access to doors.

| Condition | Poor | | |

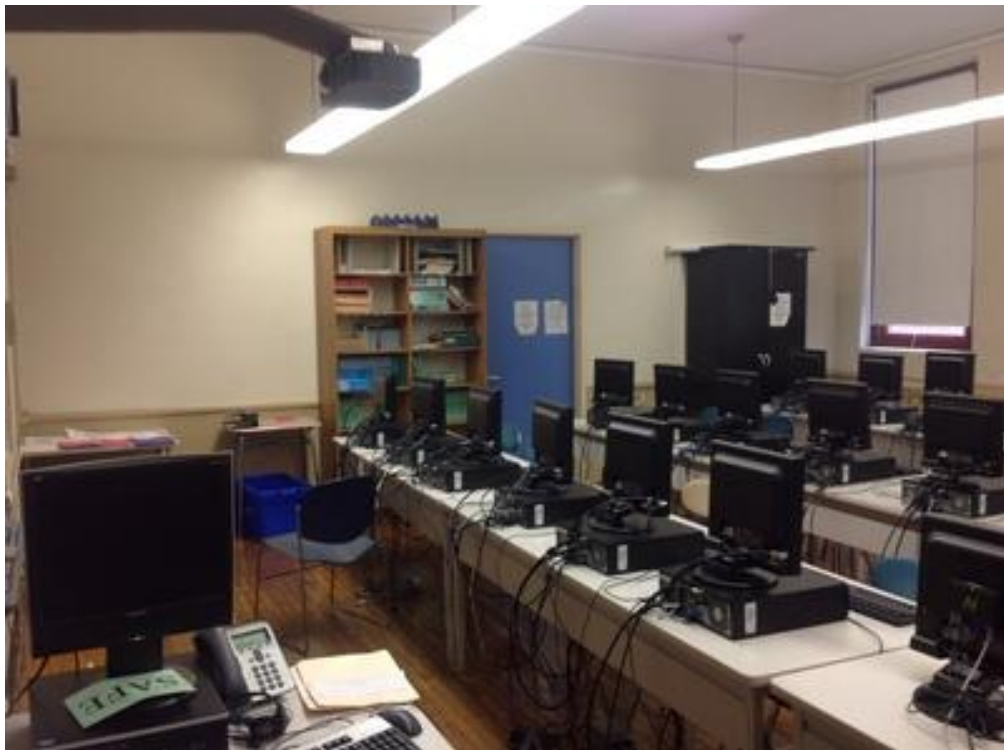
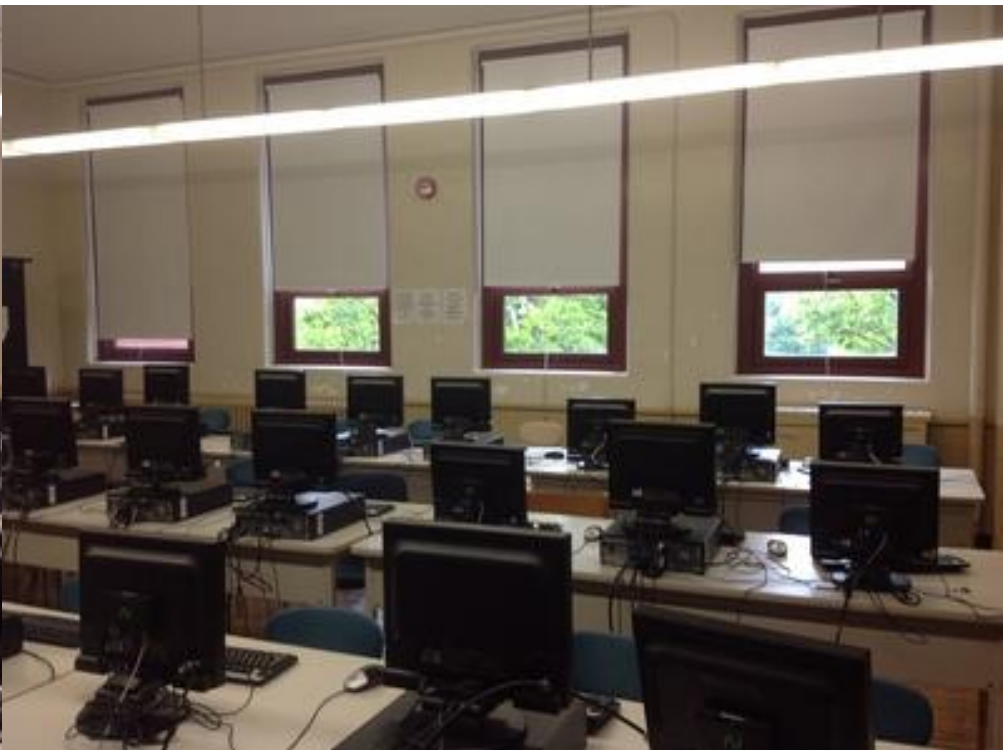
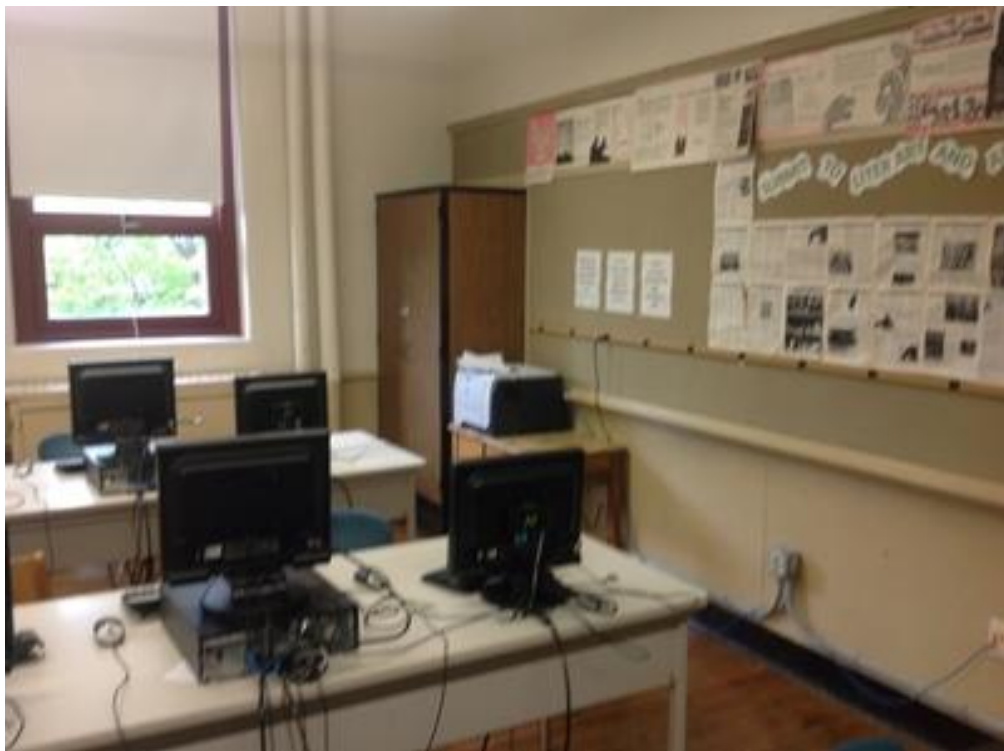
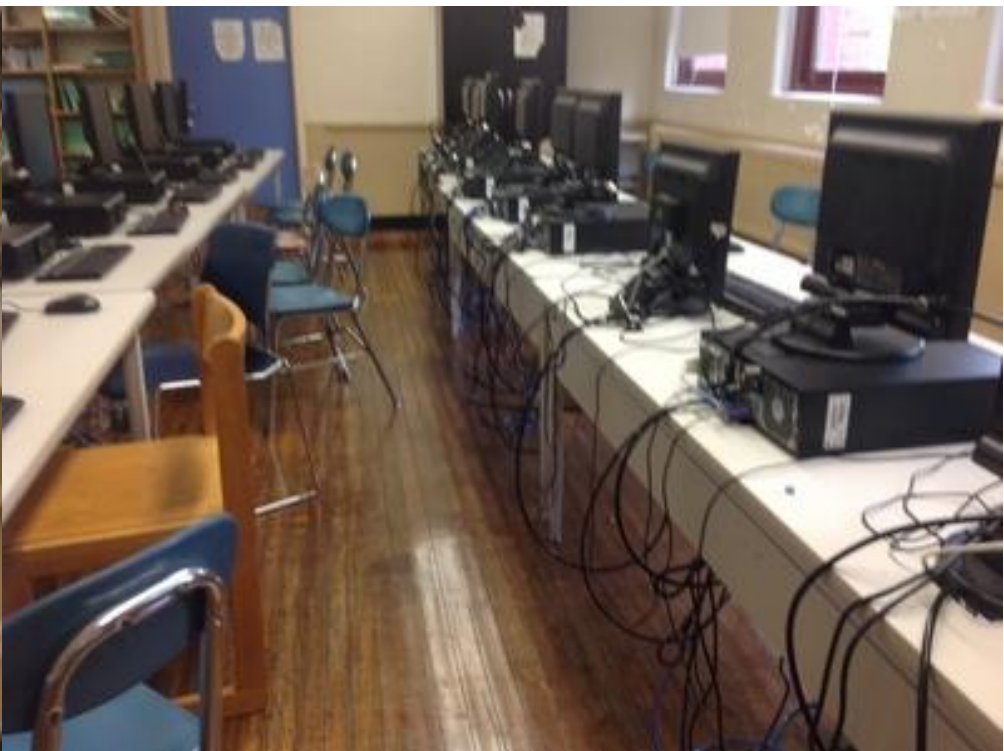
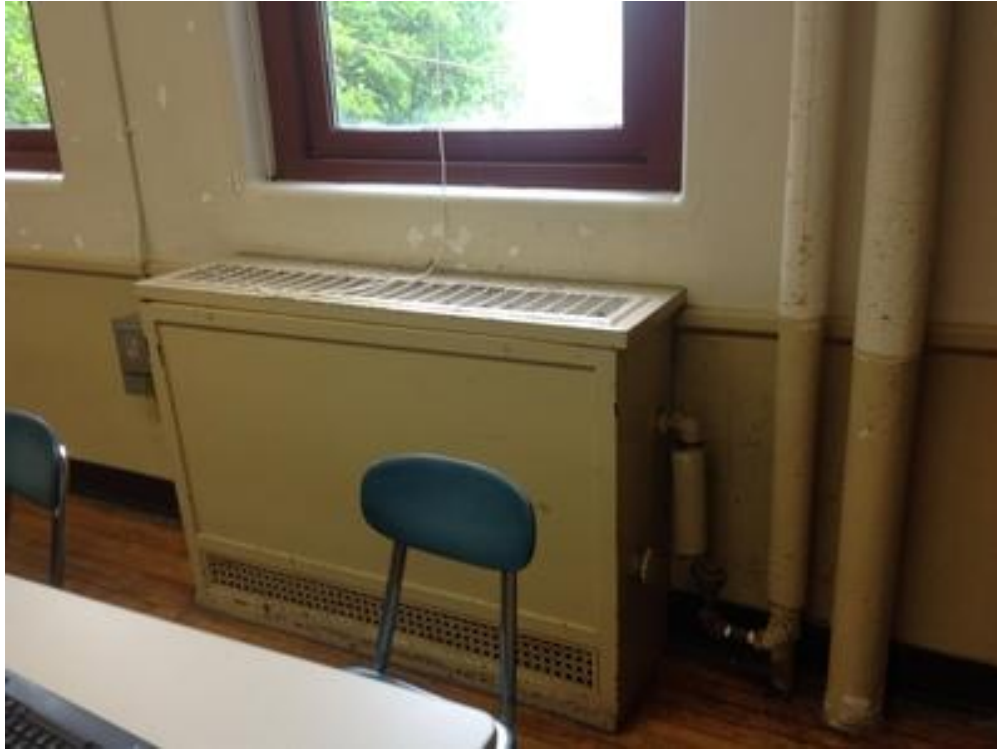
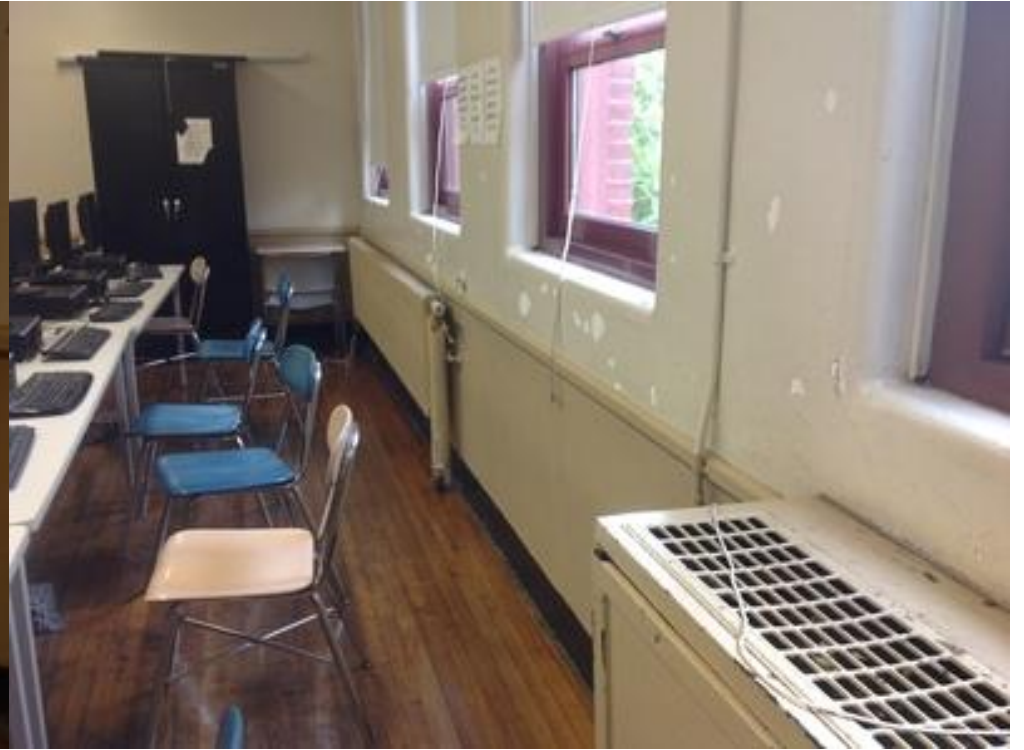
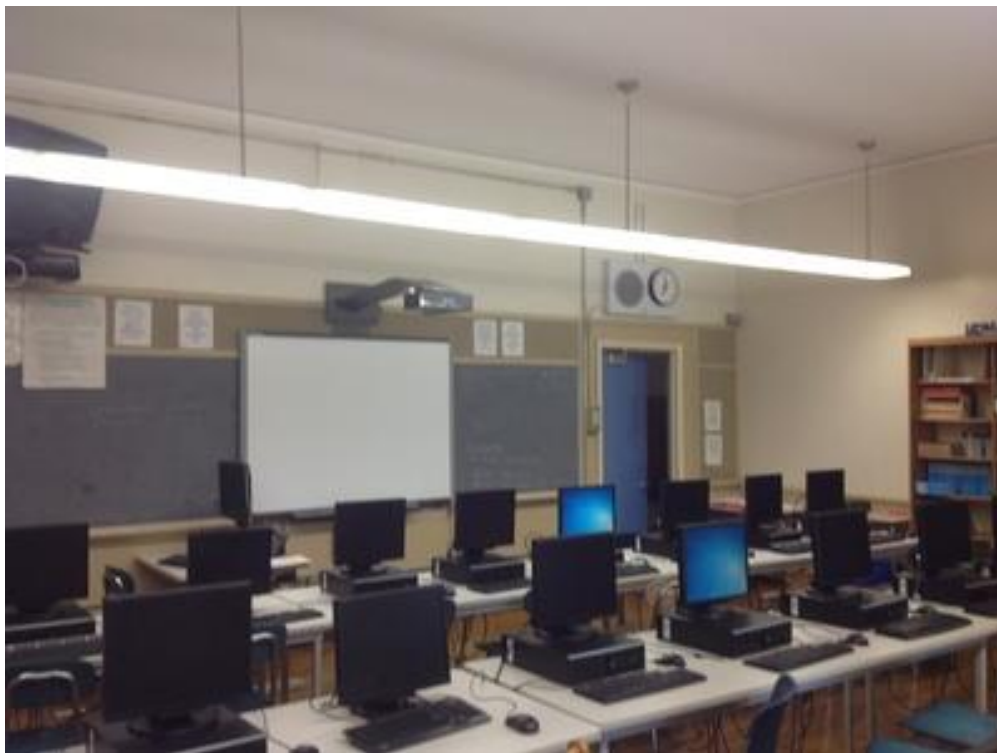
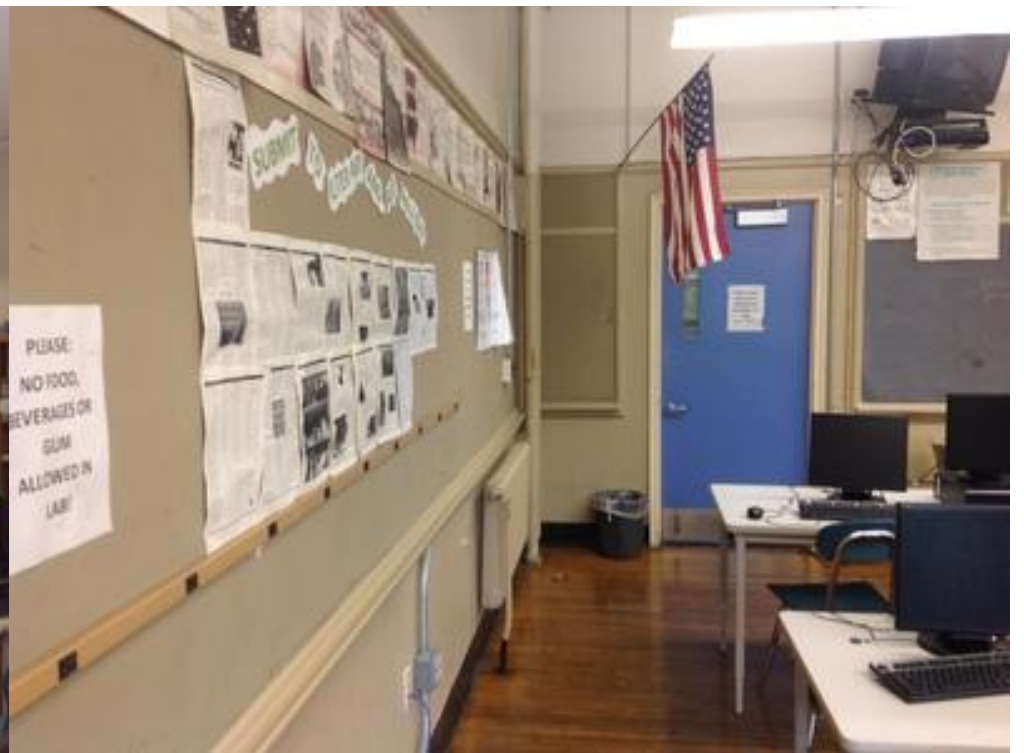
Description
Wood flooring in good condition but creaky. Paint is chipping on walls and ceiling. Surface mounted equipment and wiring is haphazard. Shades are in poor condition. Millwork in poor condition. Unit heater in poor condition. Some windows have lost their seal. Classroom has smartboard.

| Condition | Fair | | |

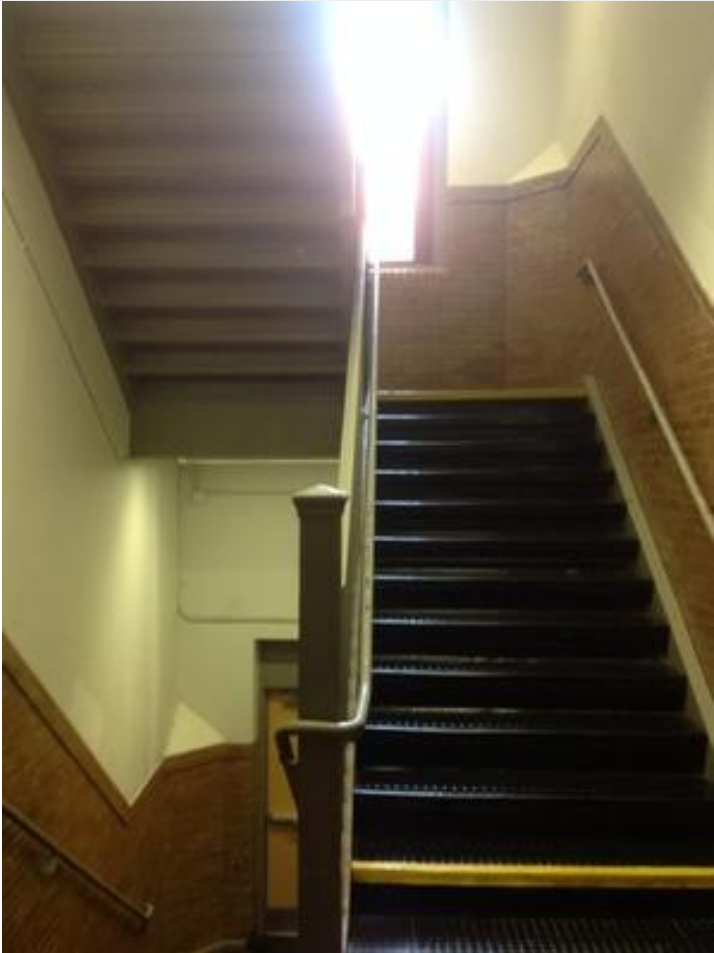
Attached Images for ID KU-00105

| Description Stair is in fair condition | | | |

| Condition | Fair | | |
