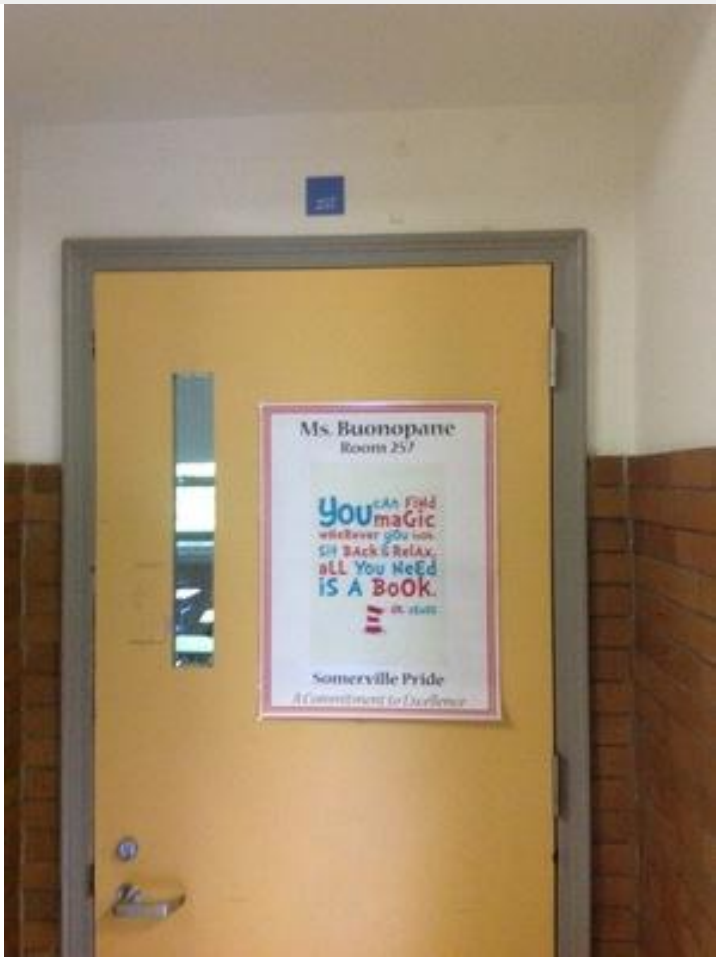
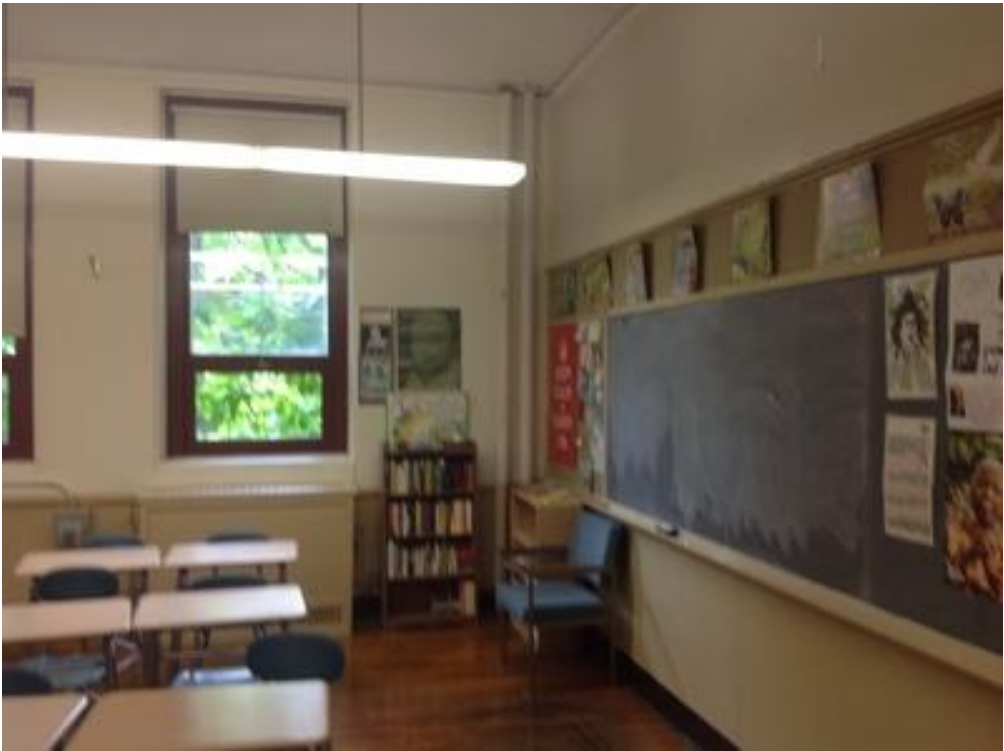
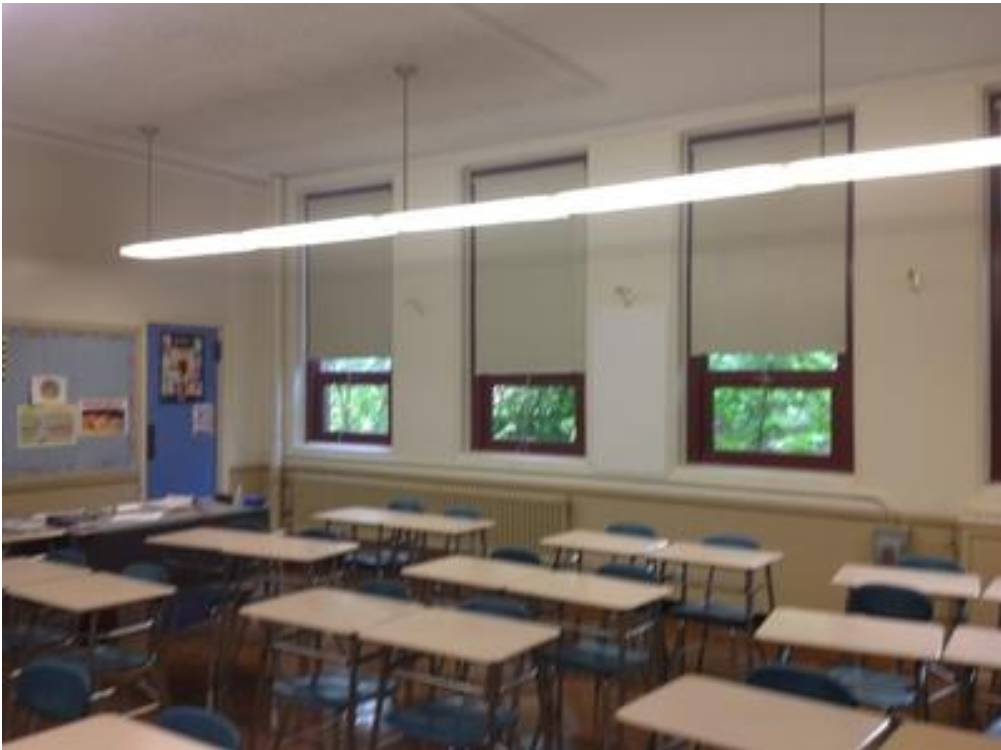
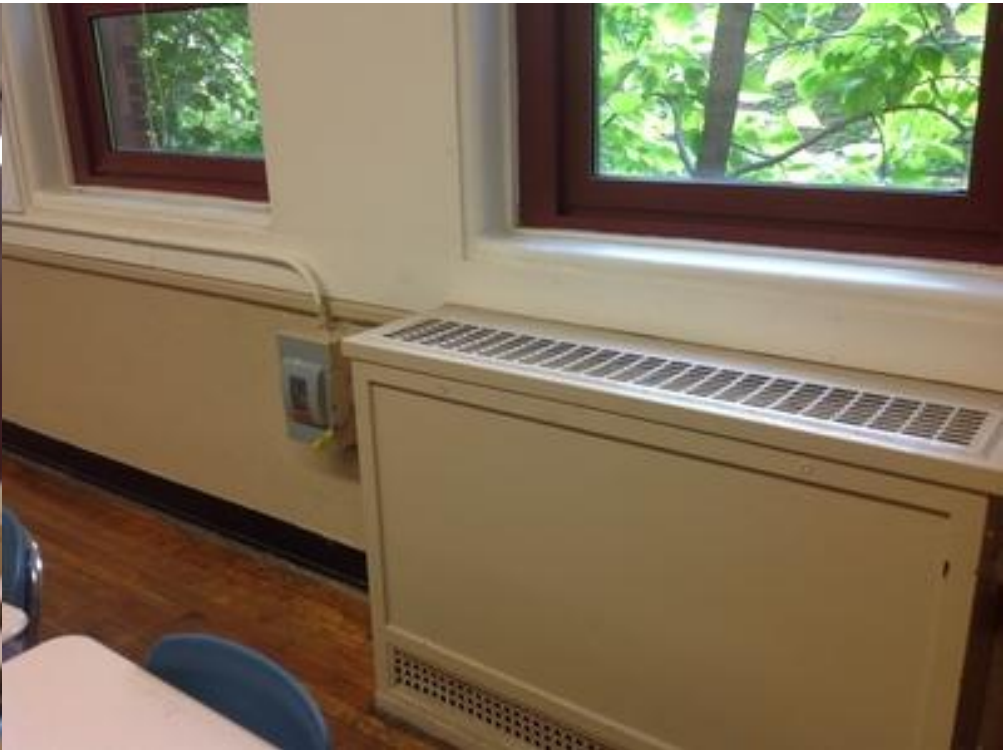
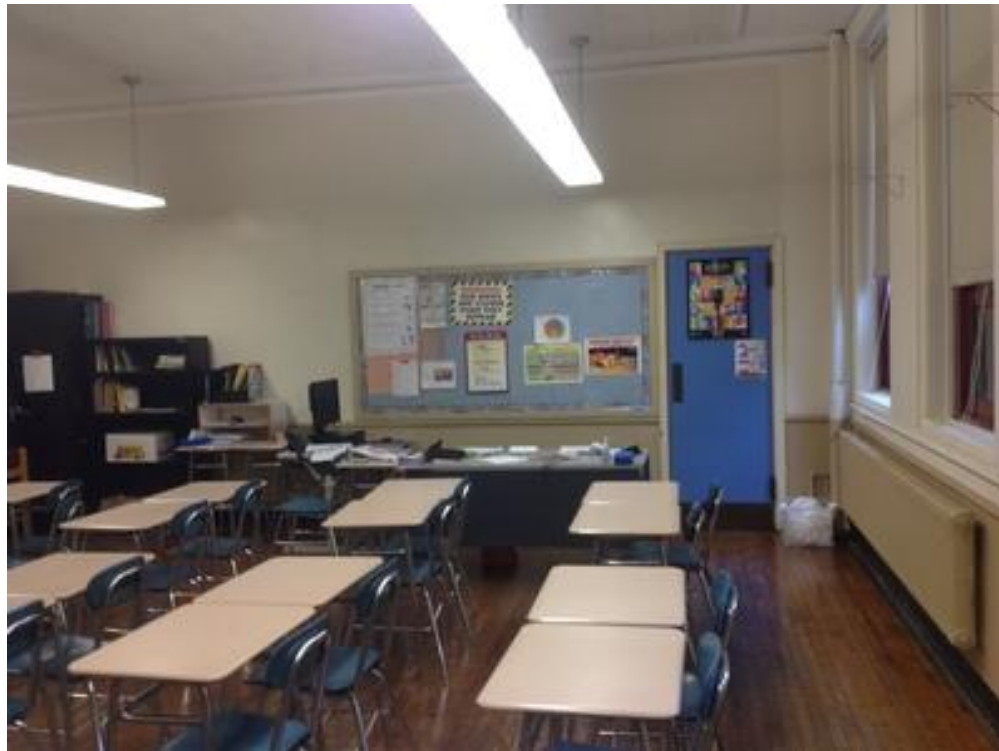
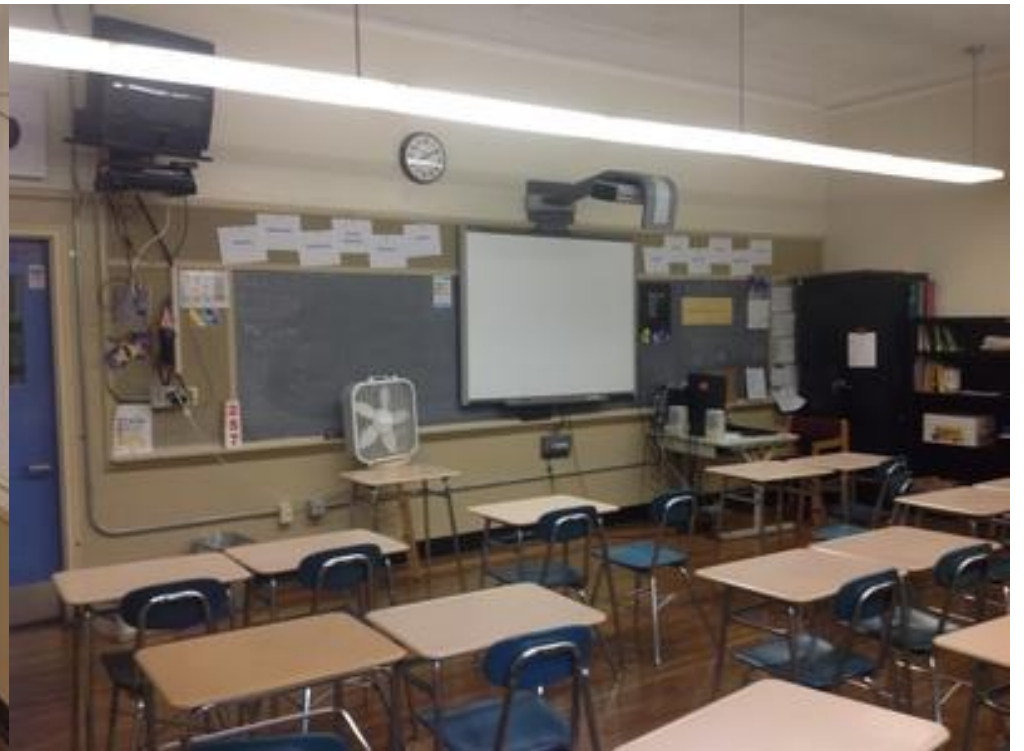
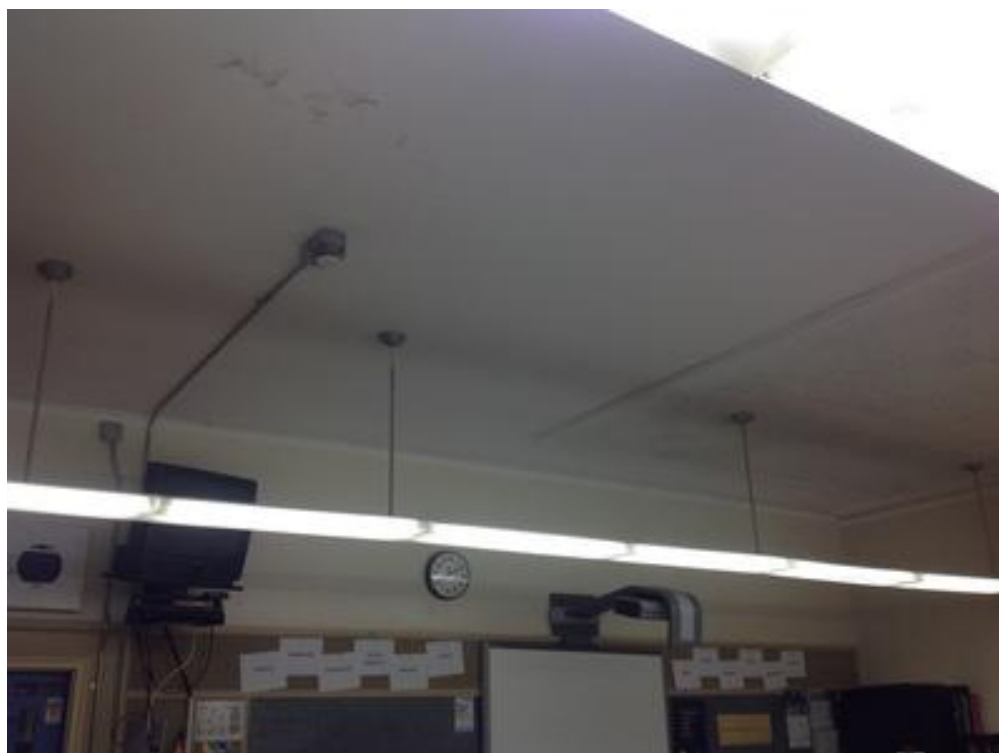
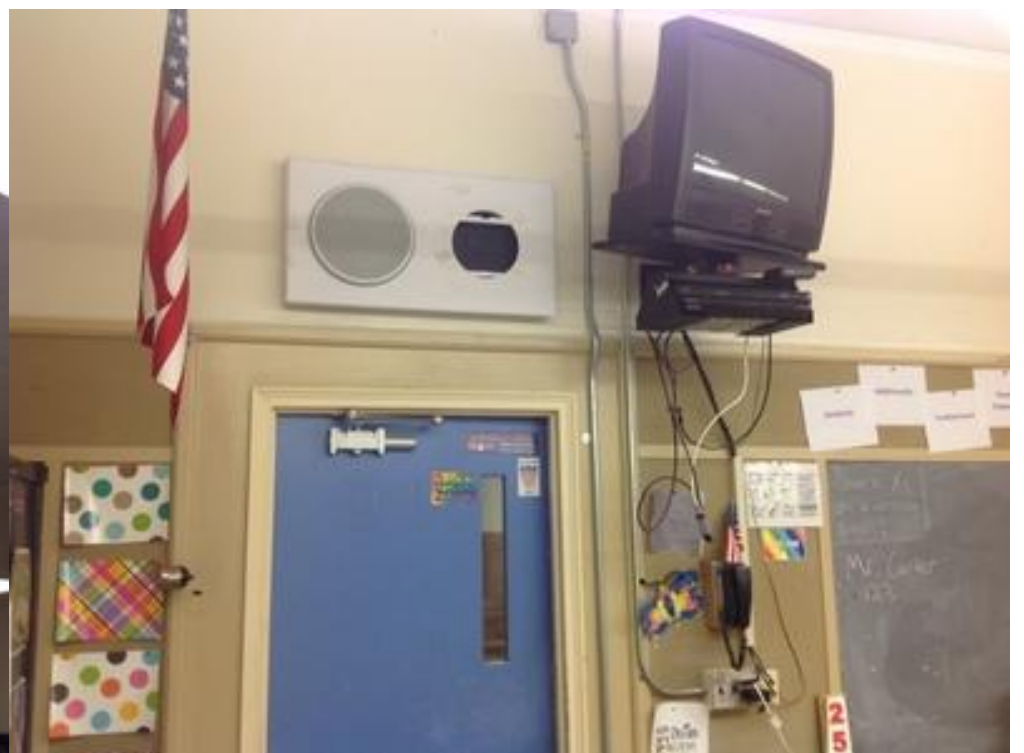
Attached Images for ID KU-00106

Description
Wood flooring in good condition but creaky. Paint is chipping on walls and ceiling. Surface mounted equipment and wiring is haphazard. Shades are in poor condition. Millwork in poor condition. Unit heater in poor condition. Some windows have lost their seal. Classroom has smartboard.

| Condition | Fair | | |

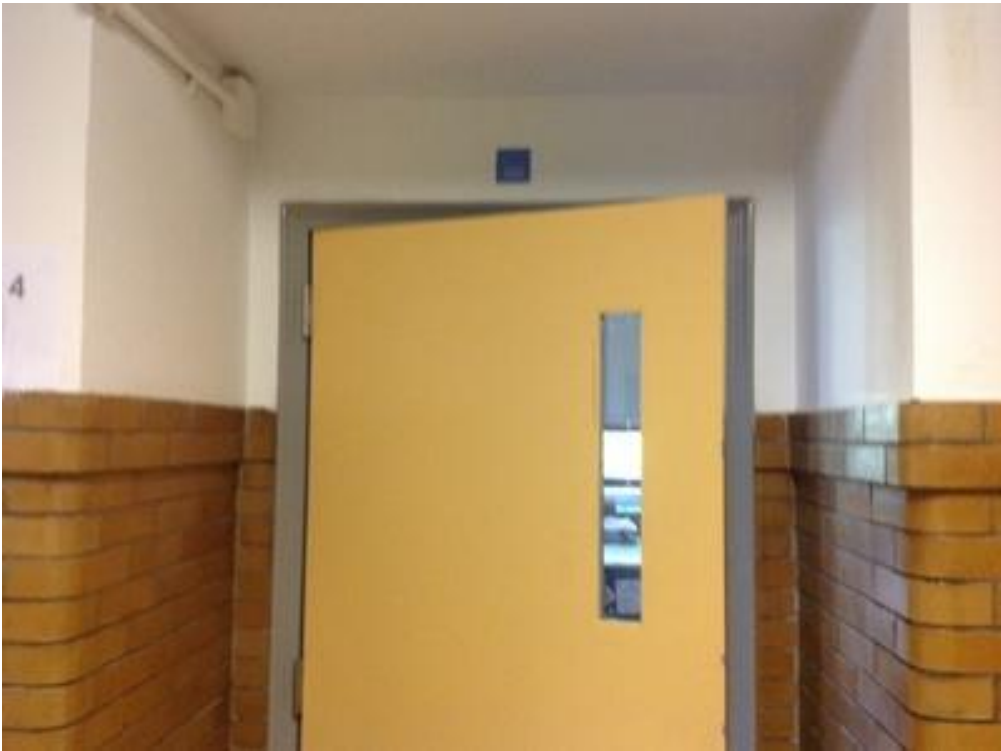
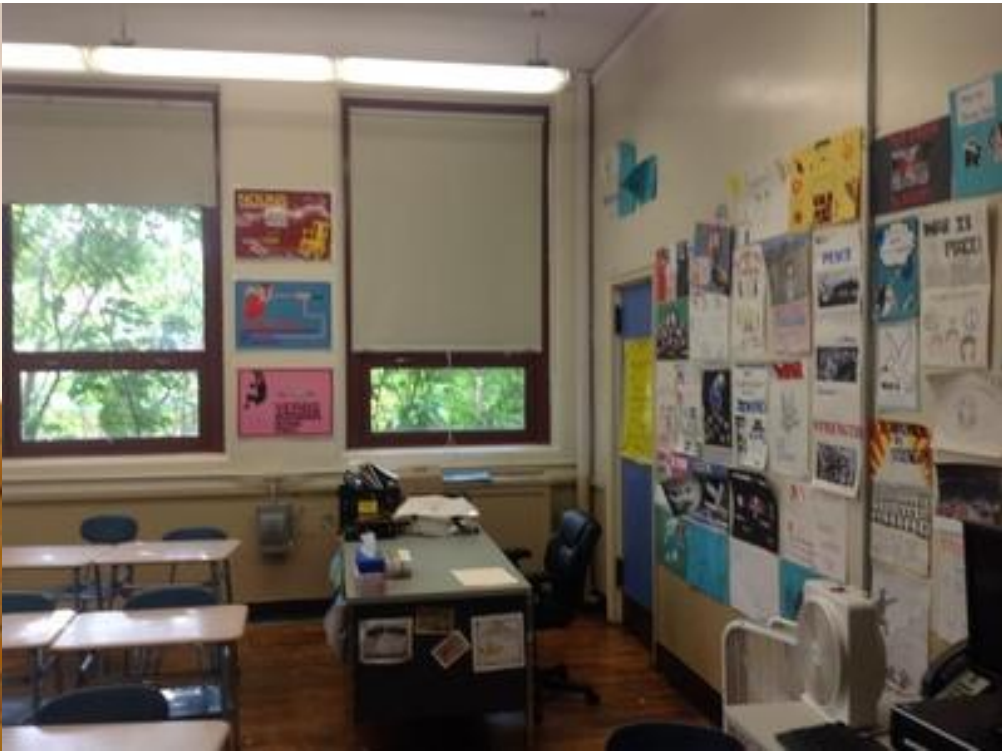
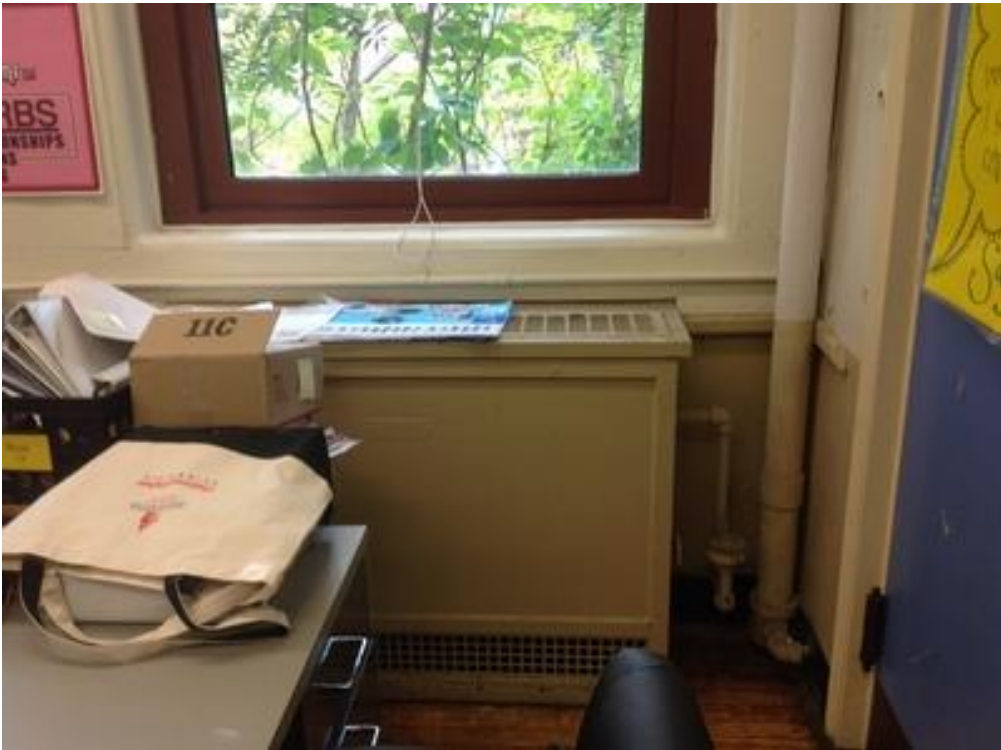
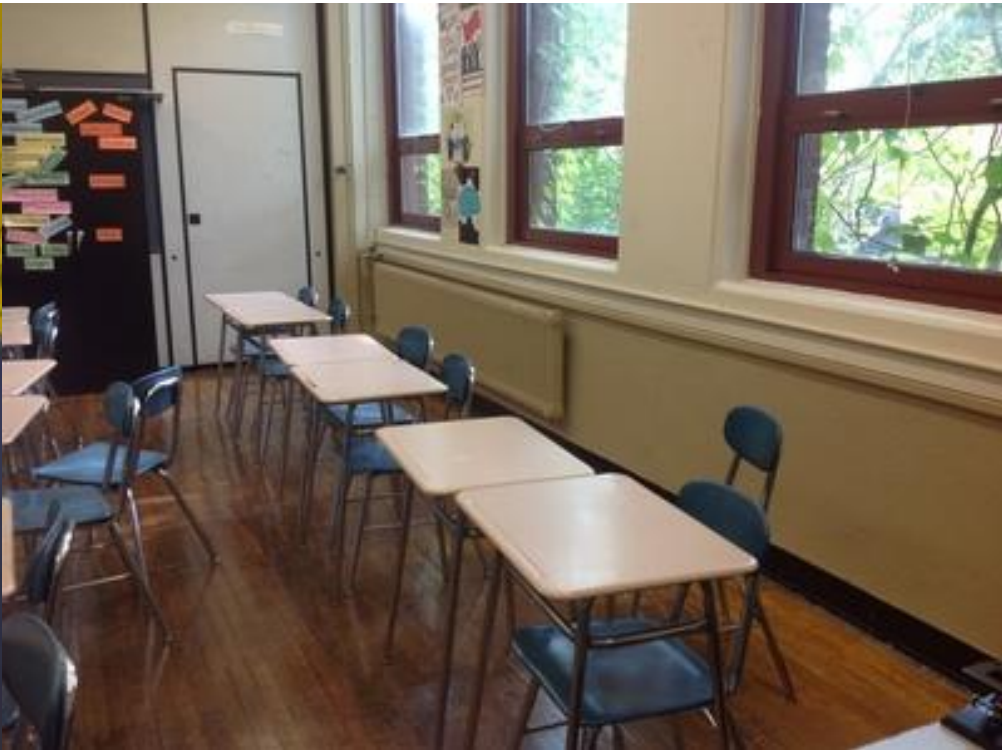
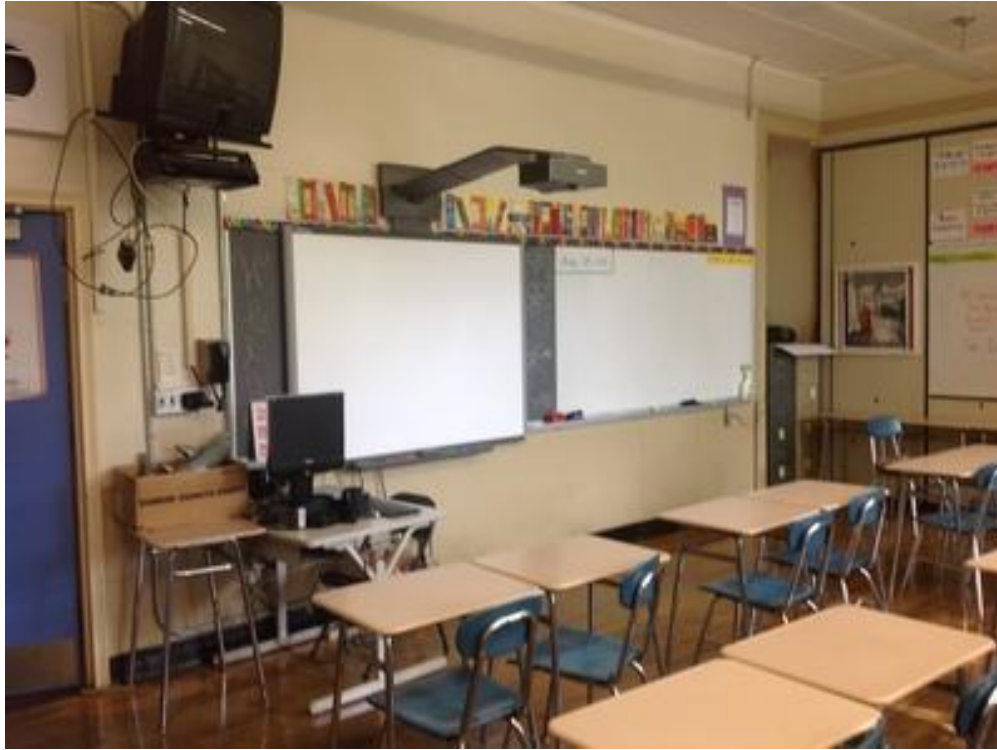
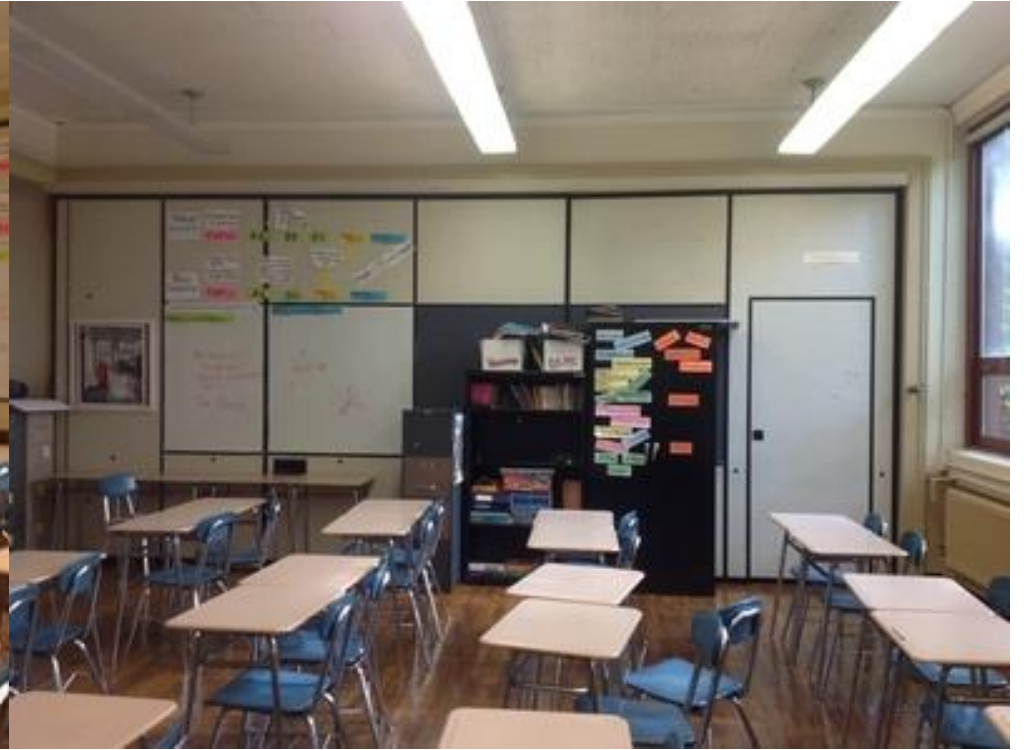
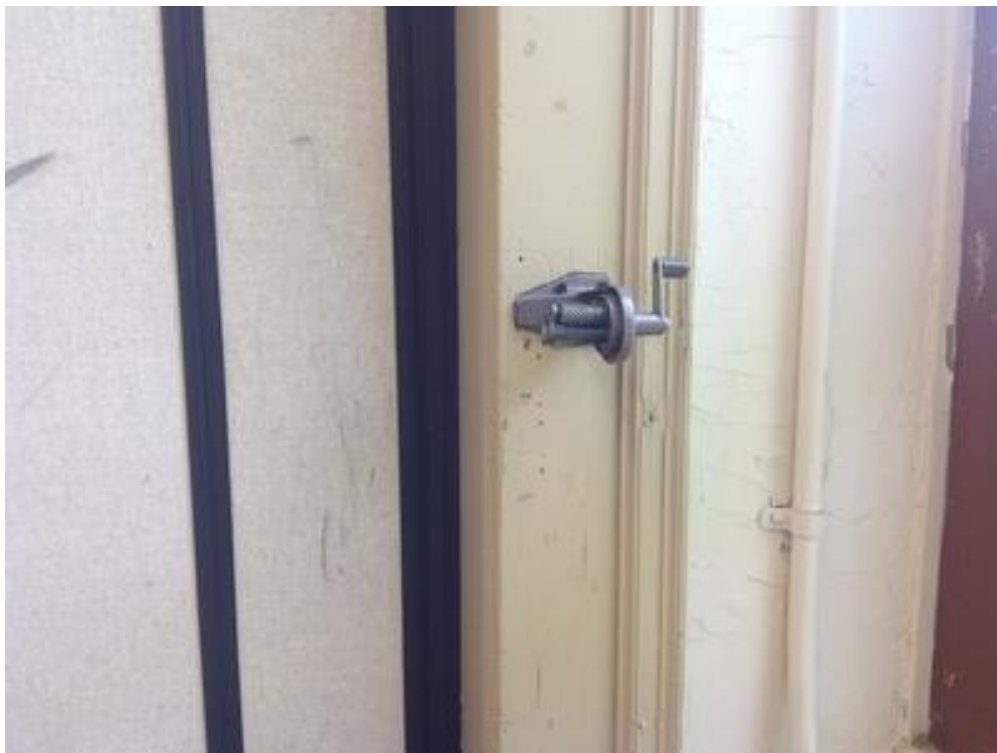
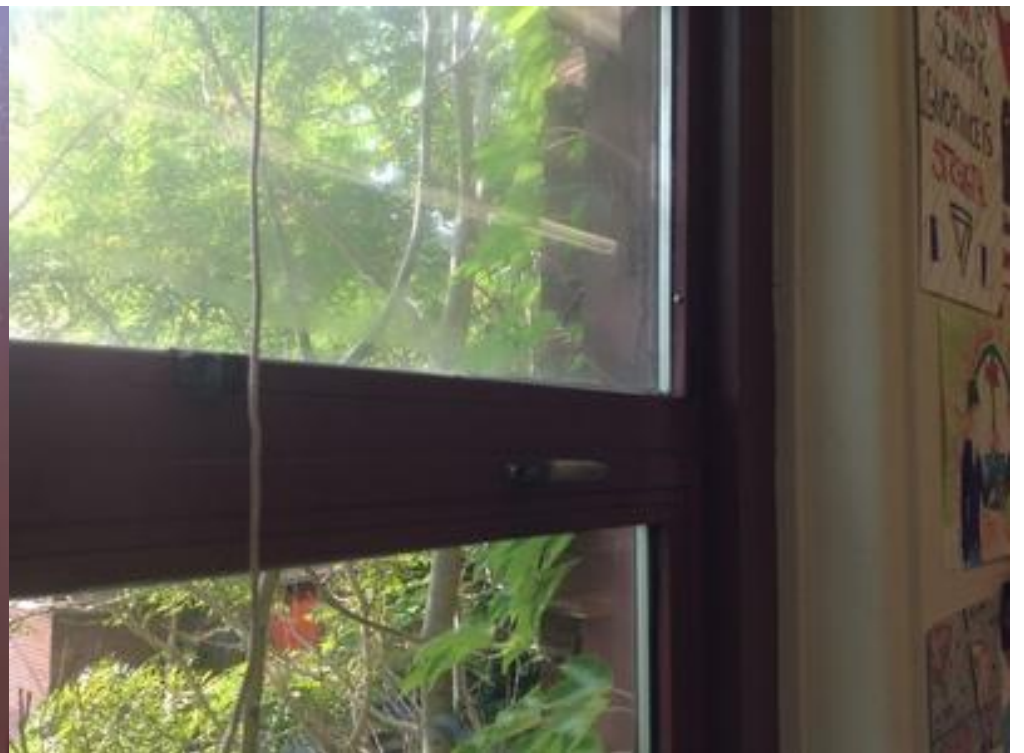
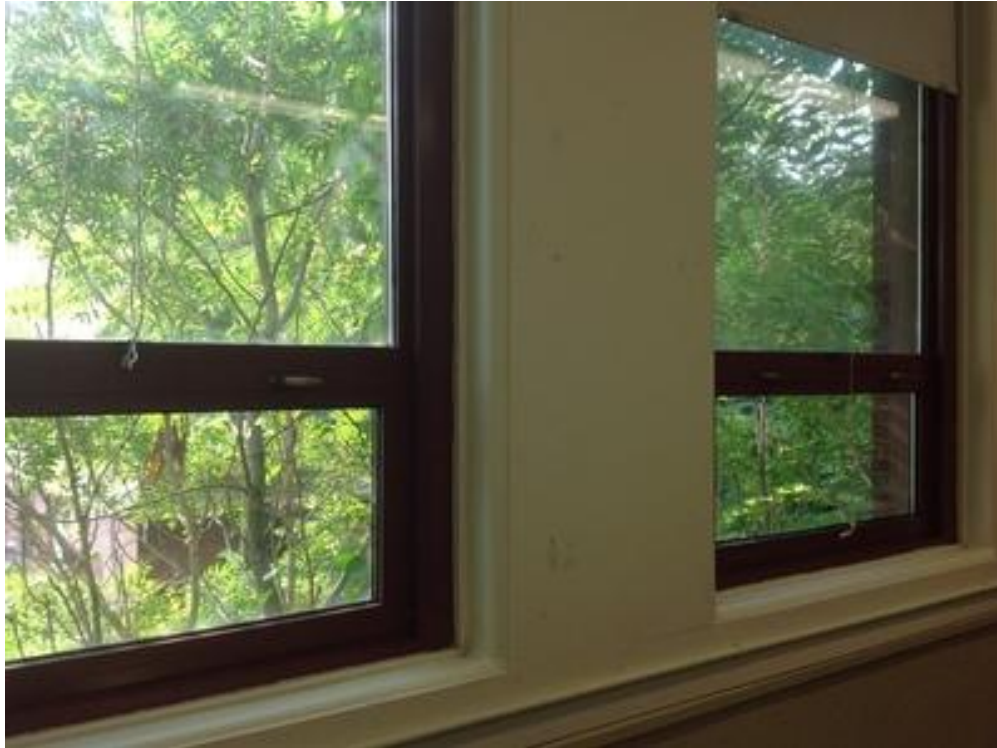
Description
Wood flooring in good condition but creaky. Paint is chipping on walls and ceiling. Surface mounted equipment and wiring is haphazard. Shades are in poor condition. Millwork in poor condition. Unit heater in poor condition. Some windows have lost their seal. Classroom has smartboard. Movable dividing partition does not function and creates poor acoustic environment.

| Condition | Poor | | |

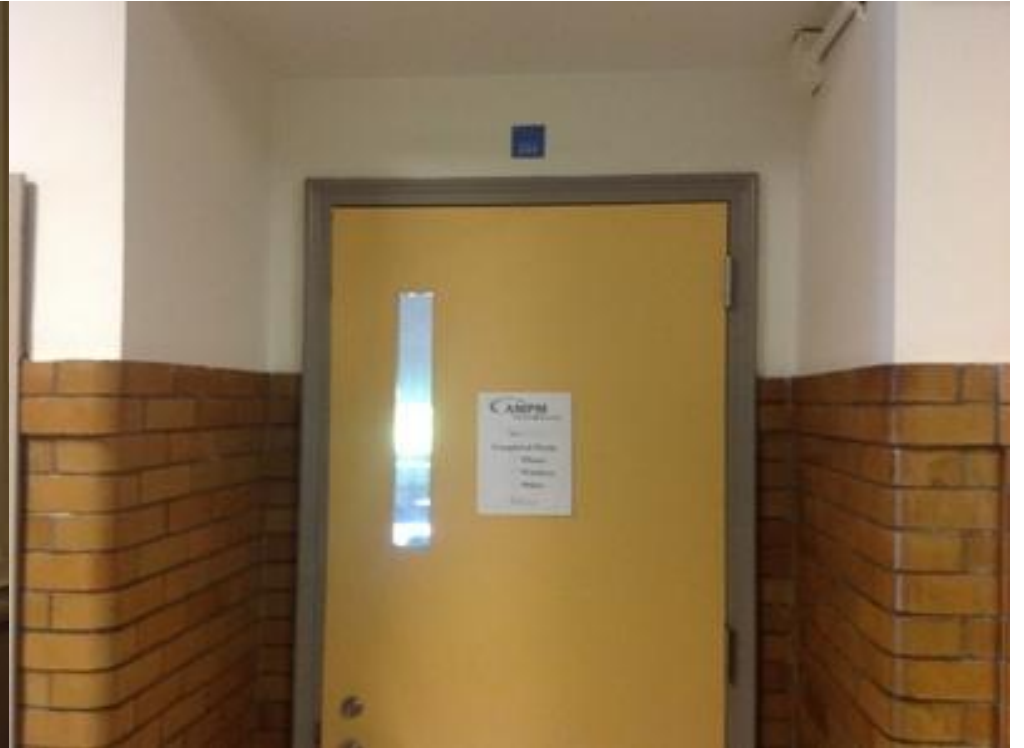
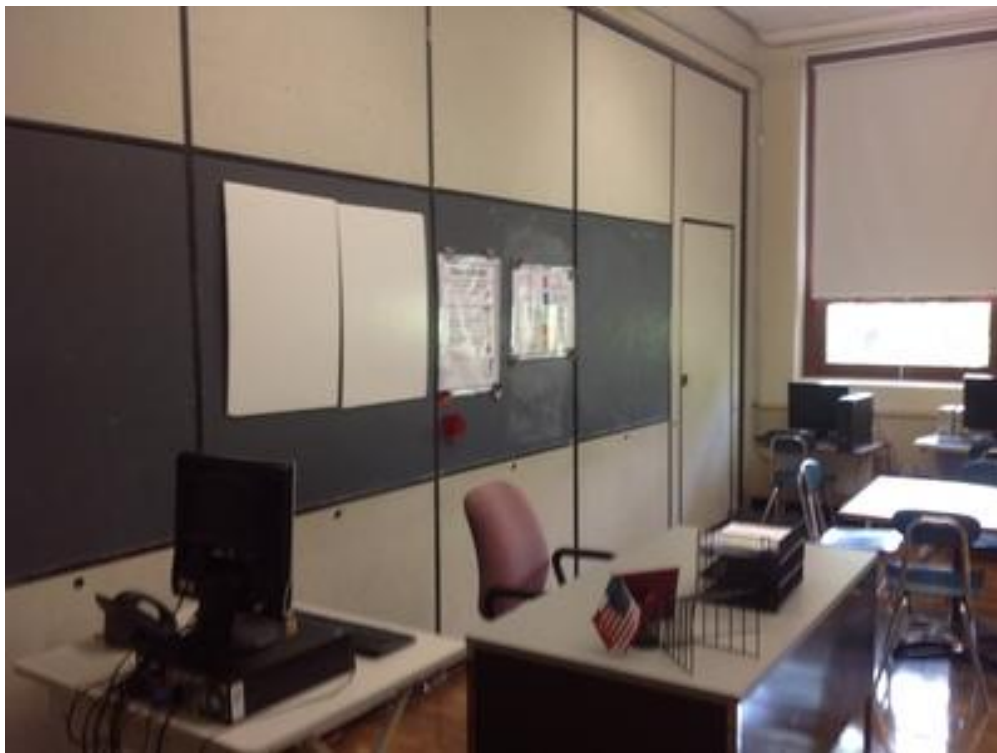
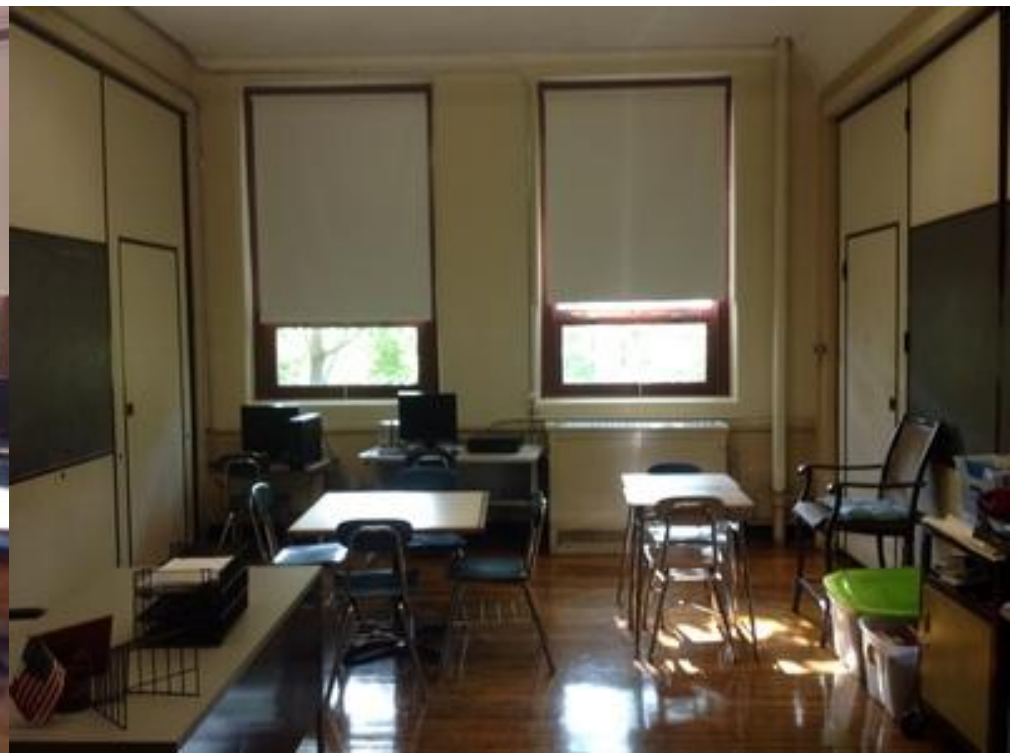
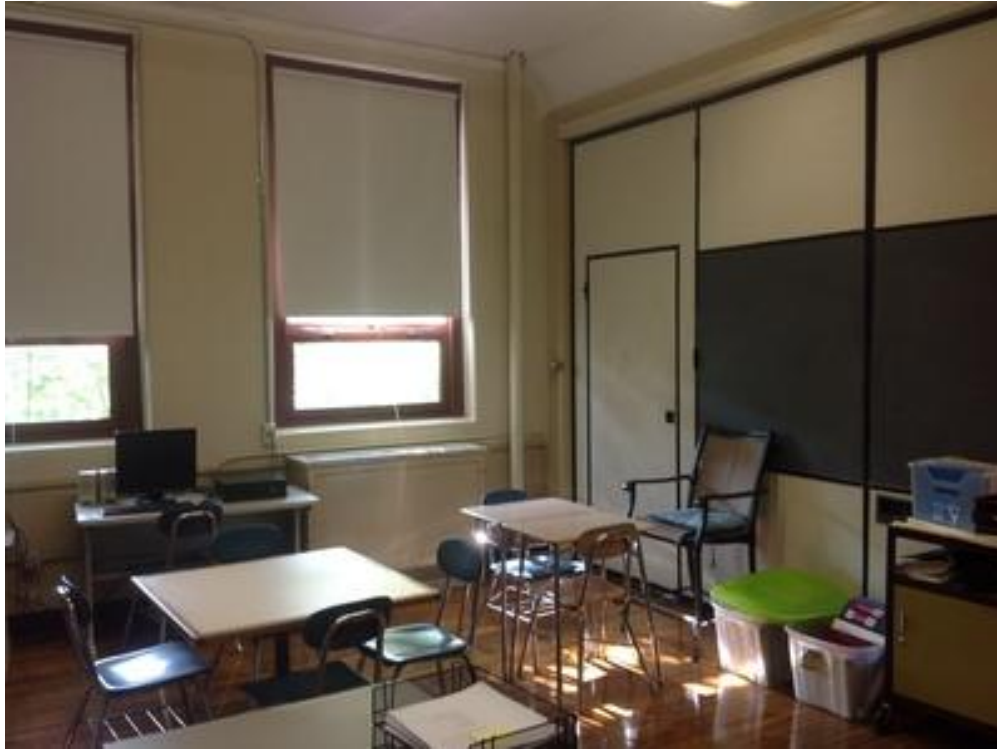
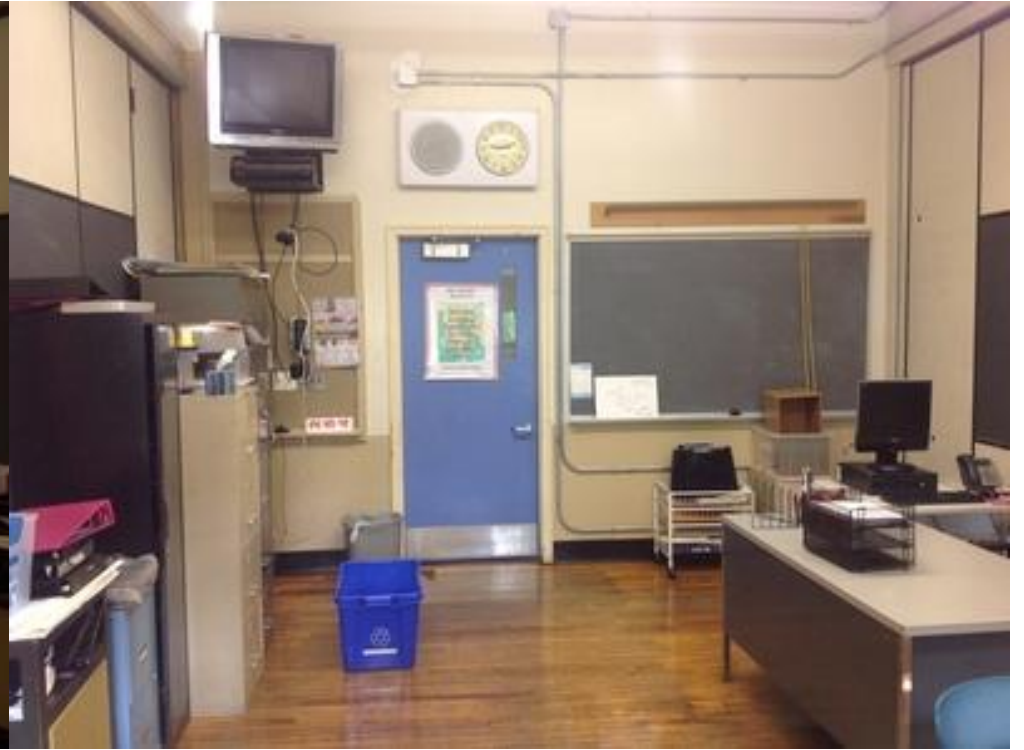
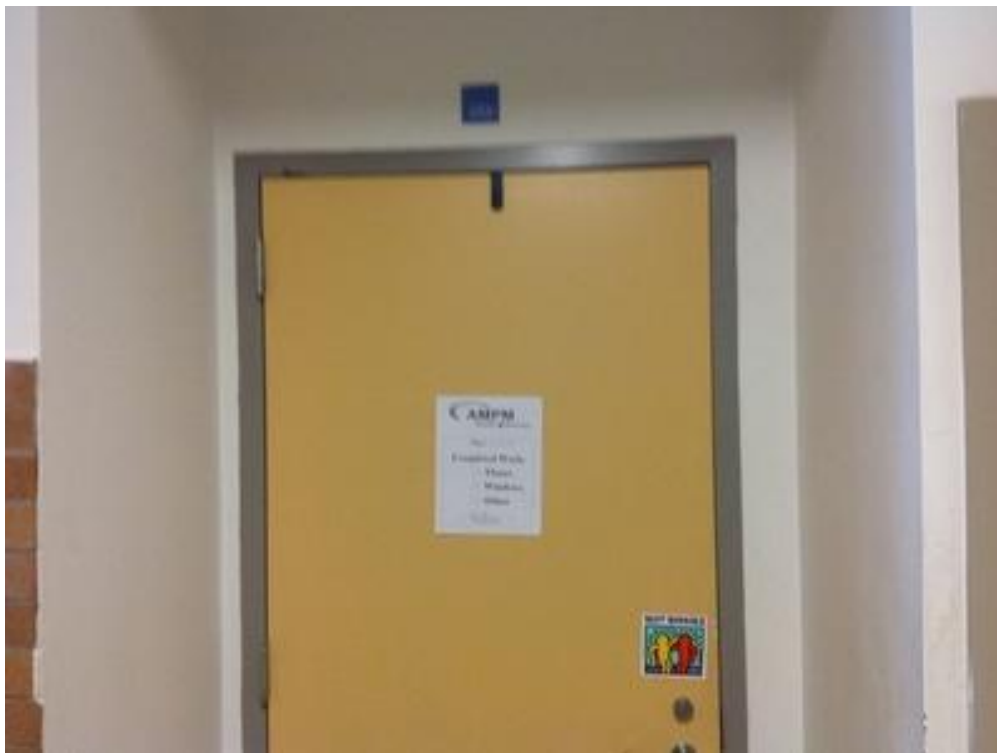
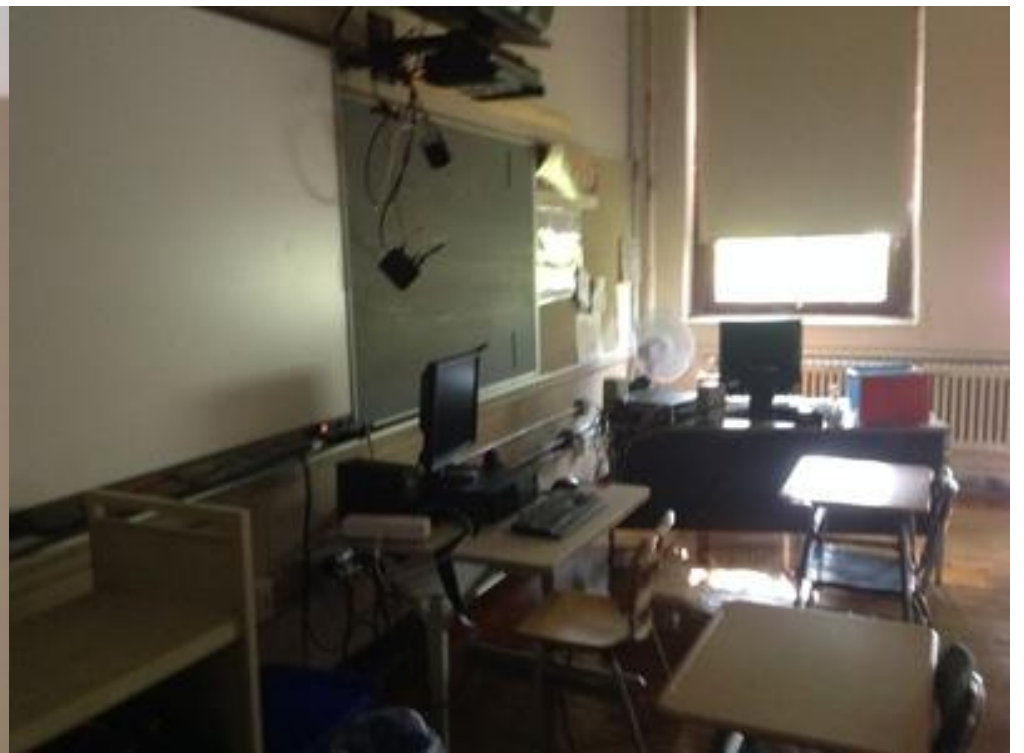
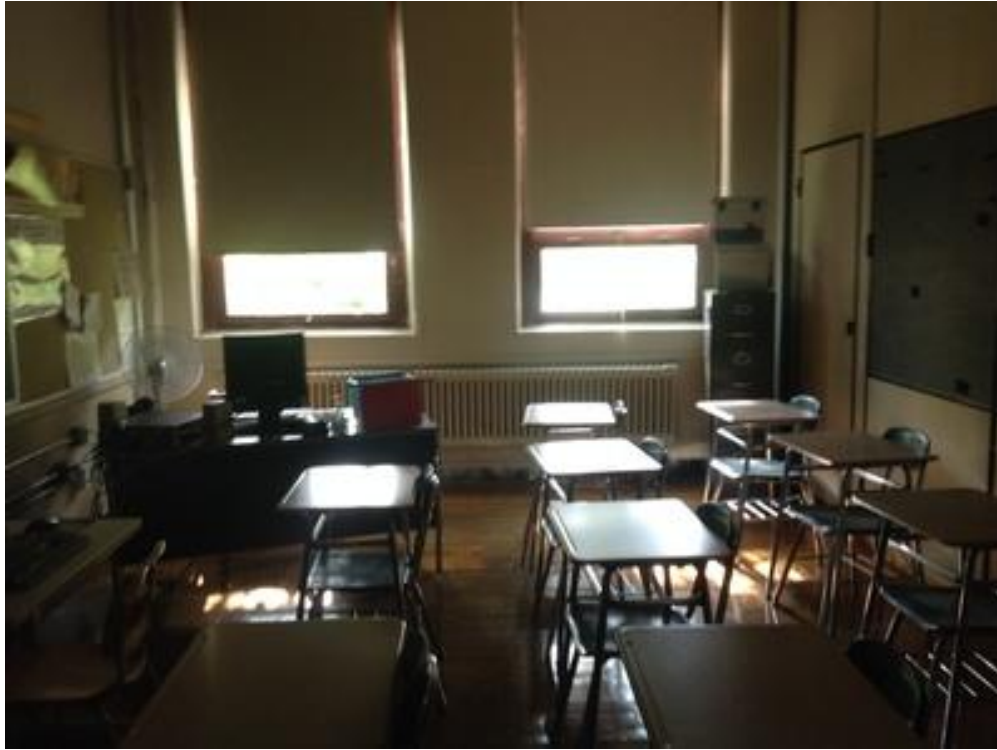
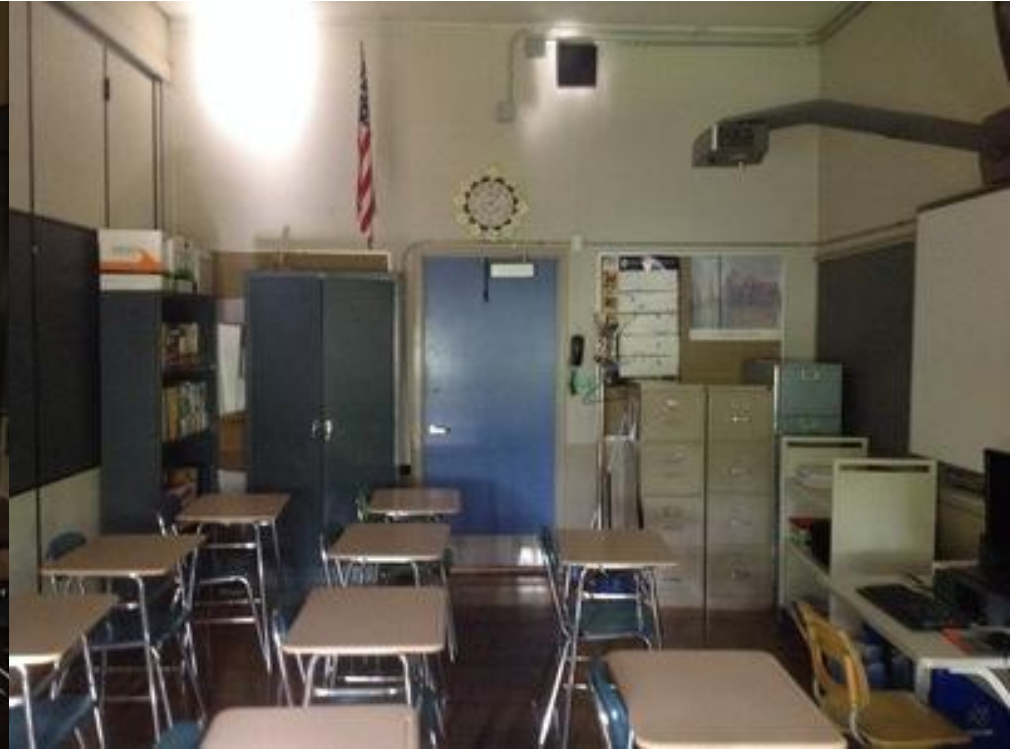
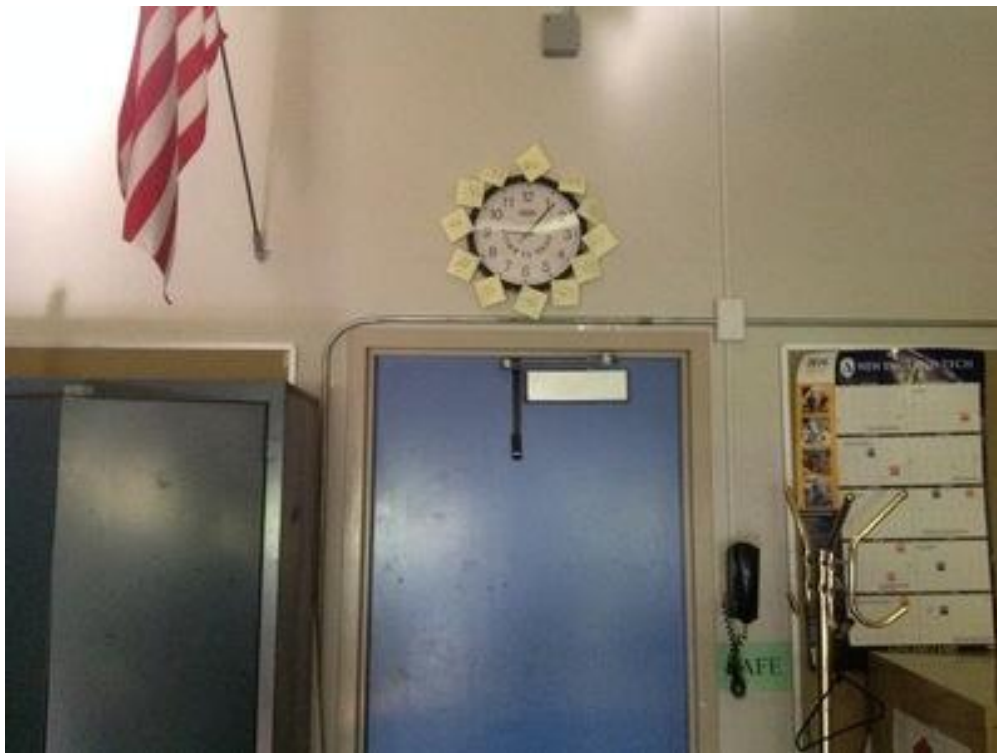
Description
Wood flooring in good condition but creaky. Paint is chipping on walls and ceiling. 10'x20' area of 12"x12" VCT on ceiling. Surface mounted equipment and wiring is haphazard. Shades are in poor condition. Millwork in poor condition. Unit heater in poor condition. Some windows have lost their seal. Classroom has smartboard.
