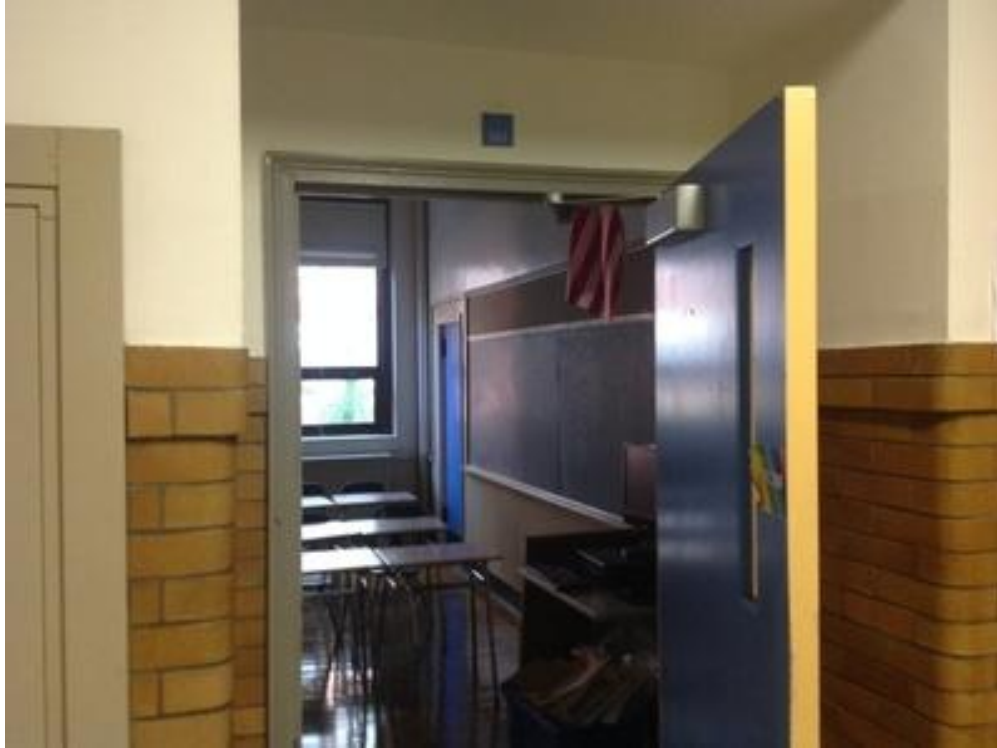
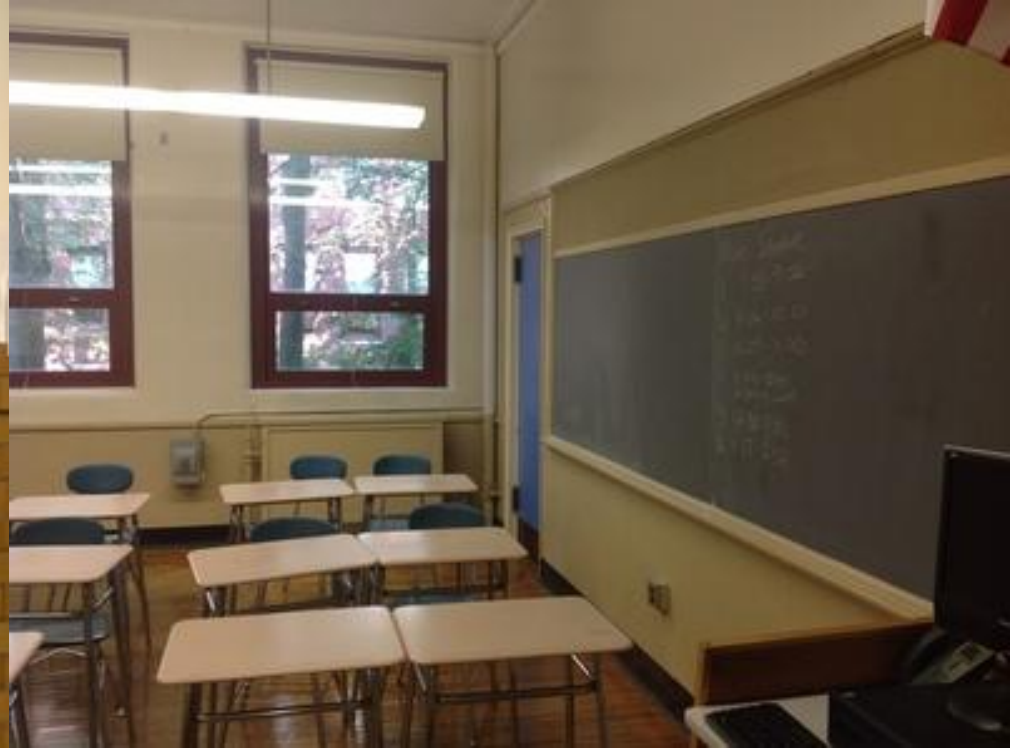
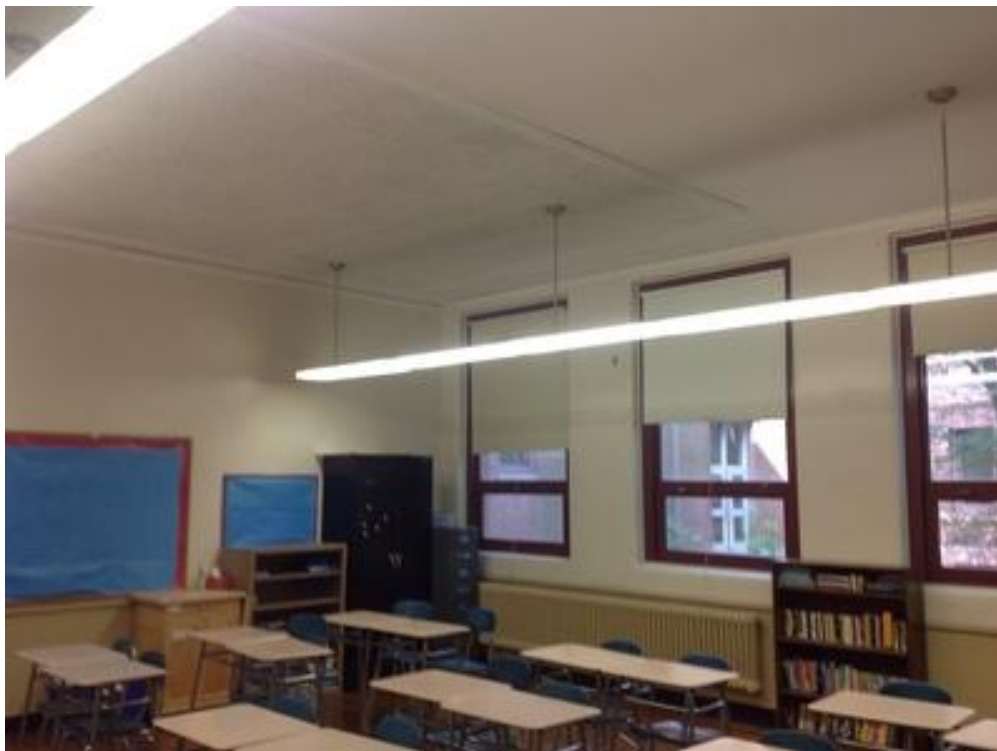
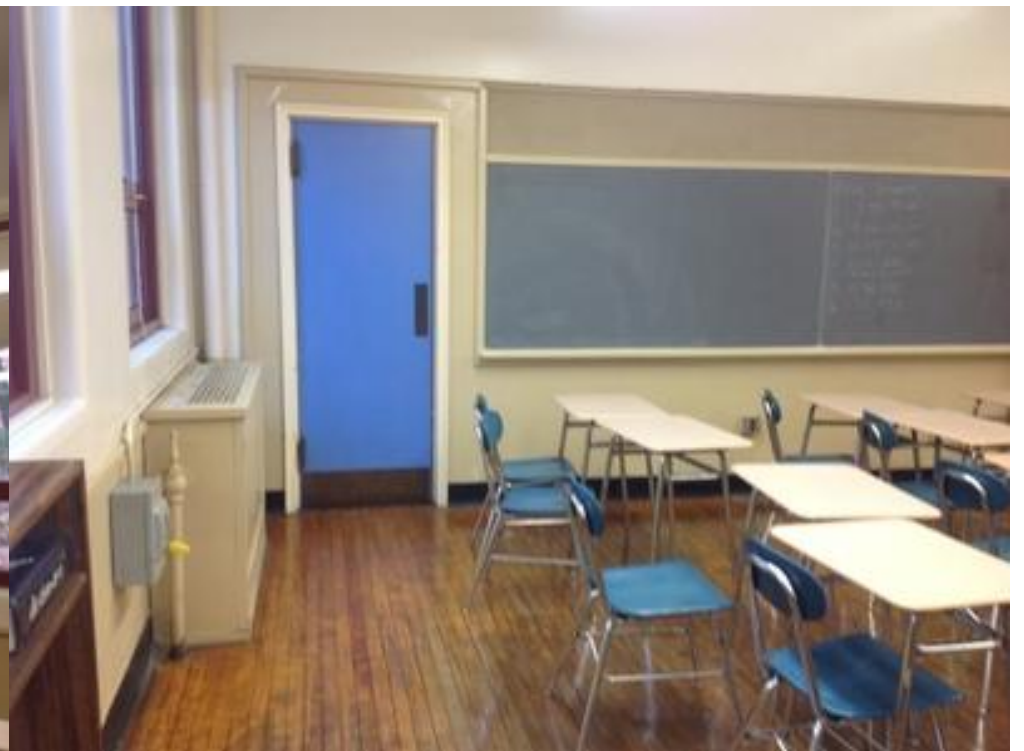
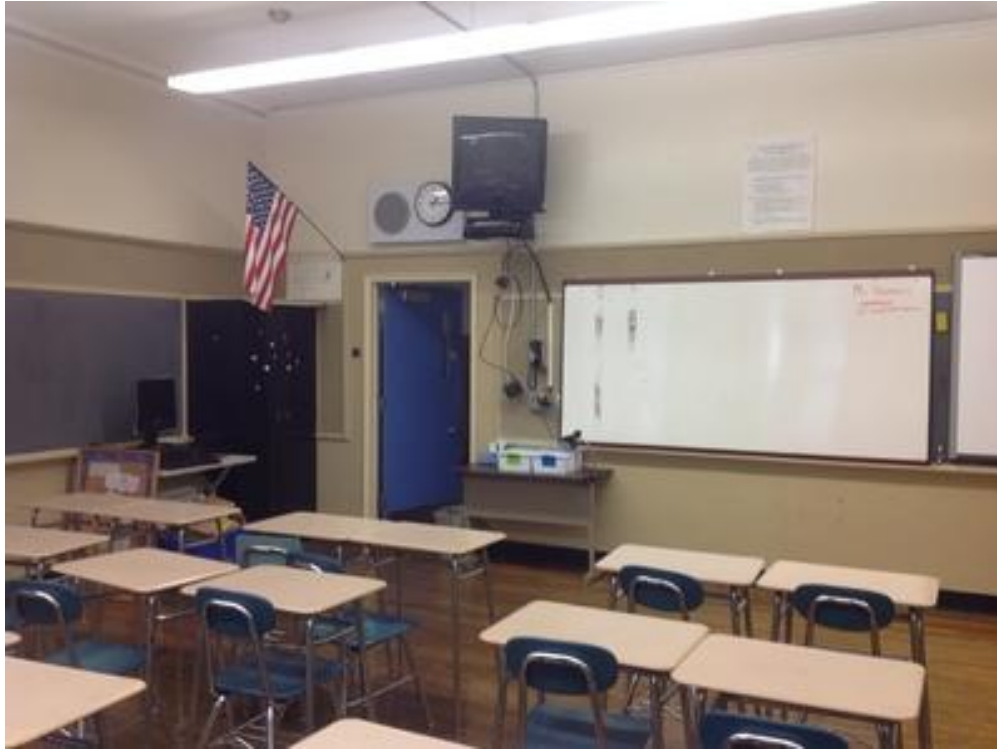
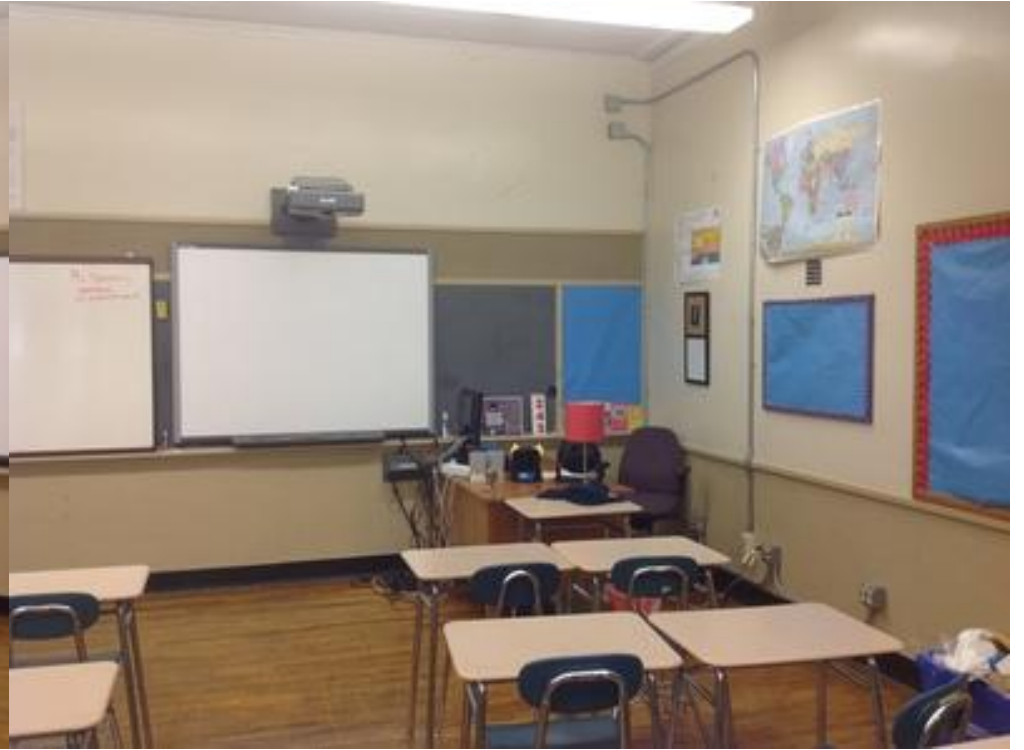
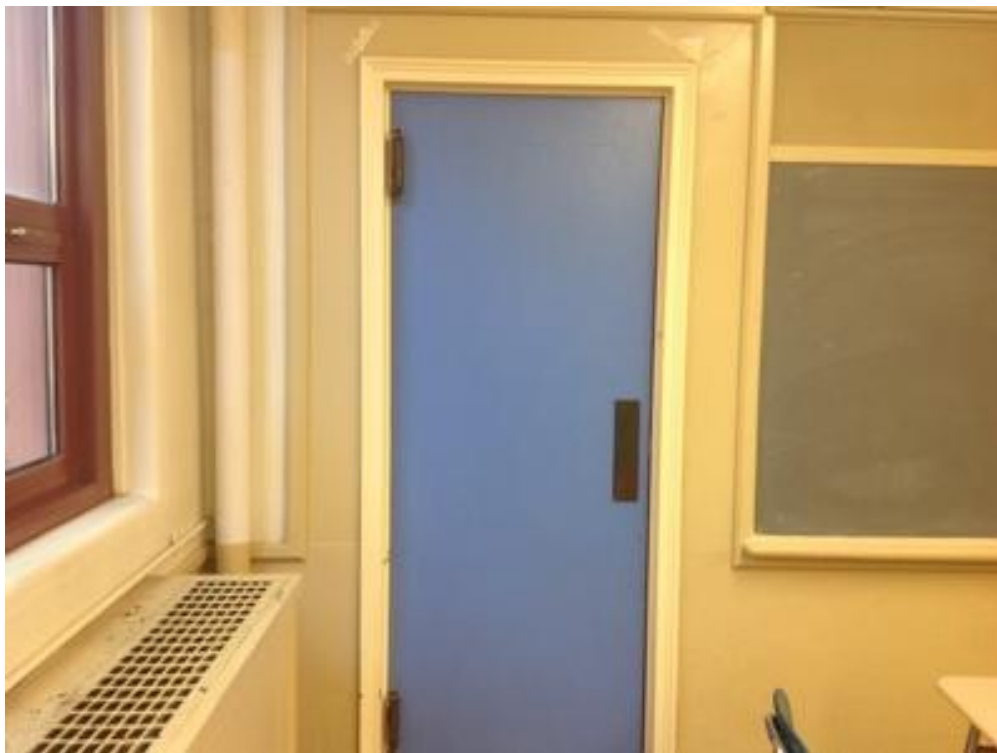
Description
Wood flooring in good condition but creaky. Paint is chipping on walls and ceiling. Light fixtures missing covers in some locations. 10'x20' area of 12"x12" VCT on ceiling. Surface mounted equipment and wiring is haphazard. Shades are in poor condition. Millwork in poor condition. Unit heater in poor condition. Some windows have lost their seal. Classroom has smartboard.

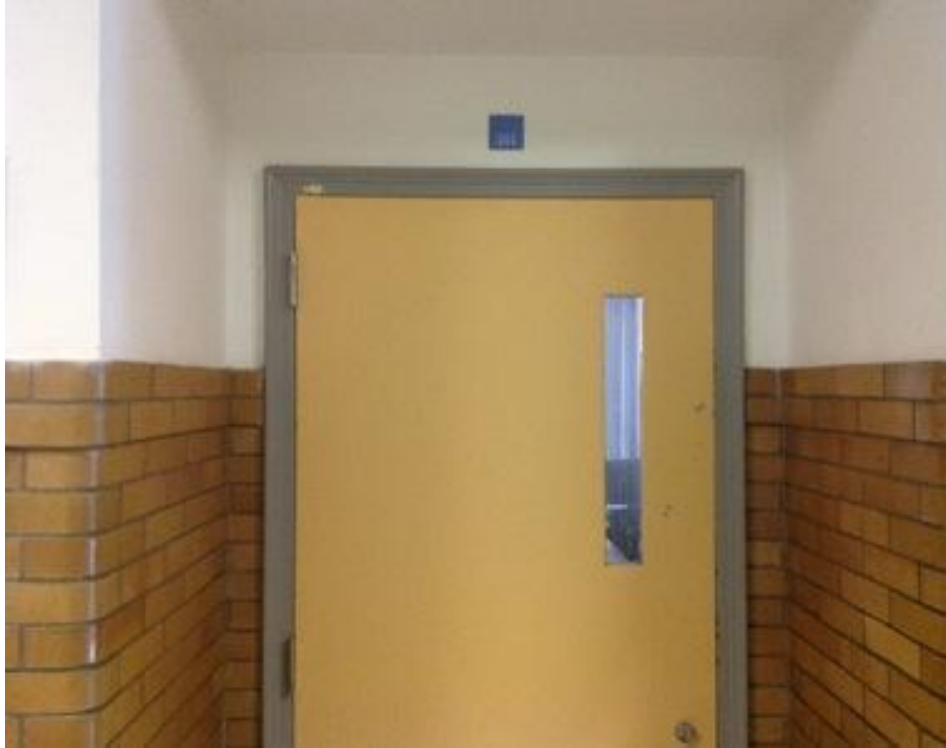
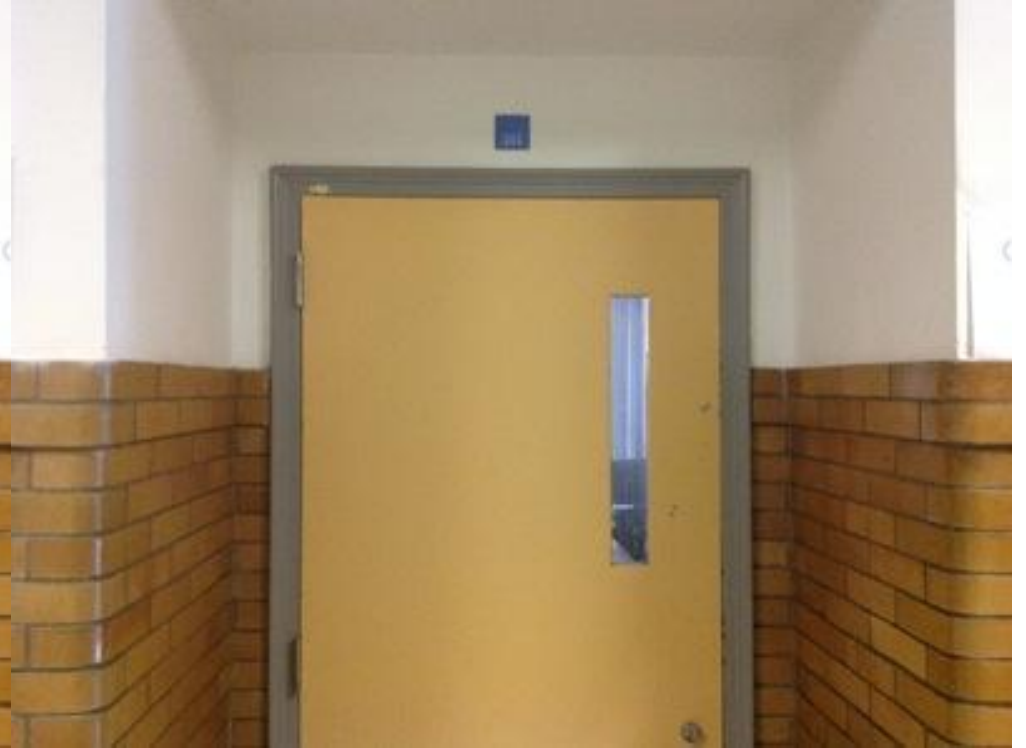
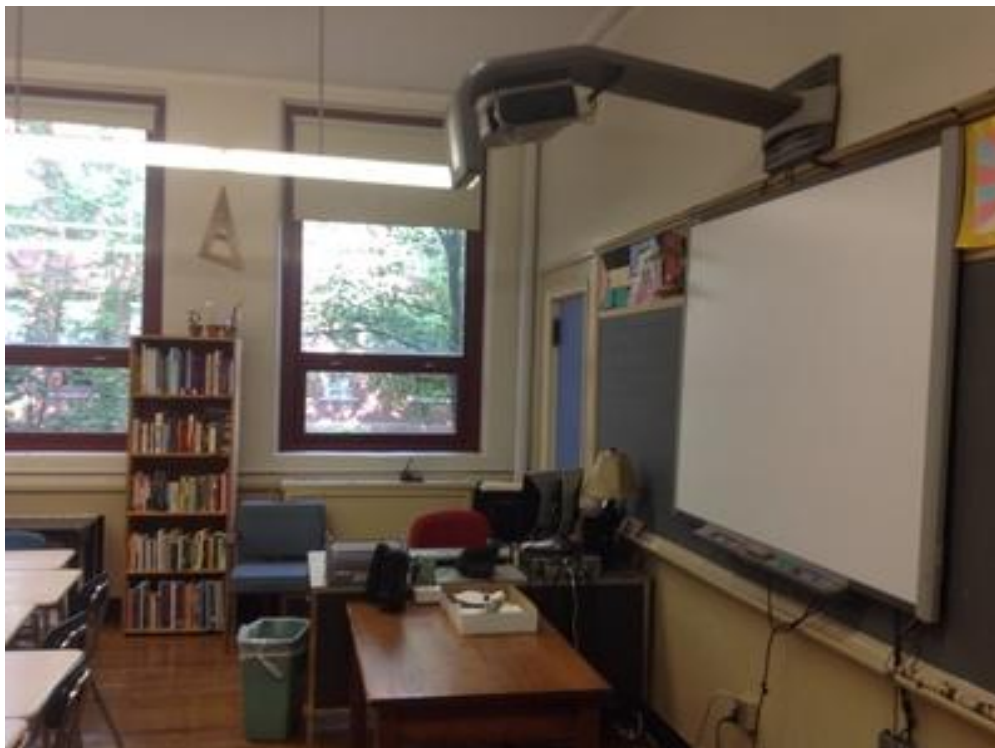
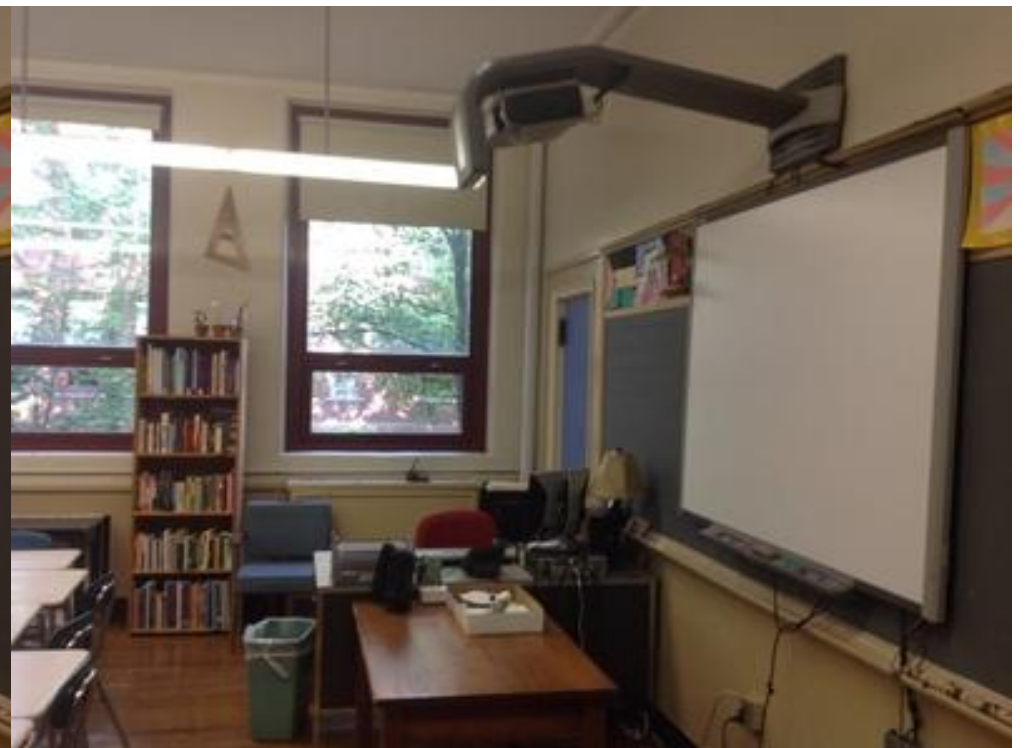
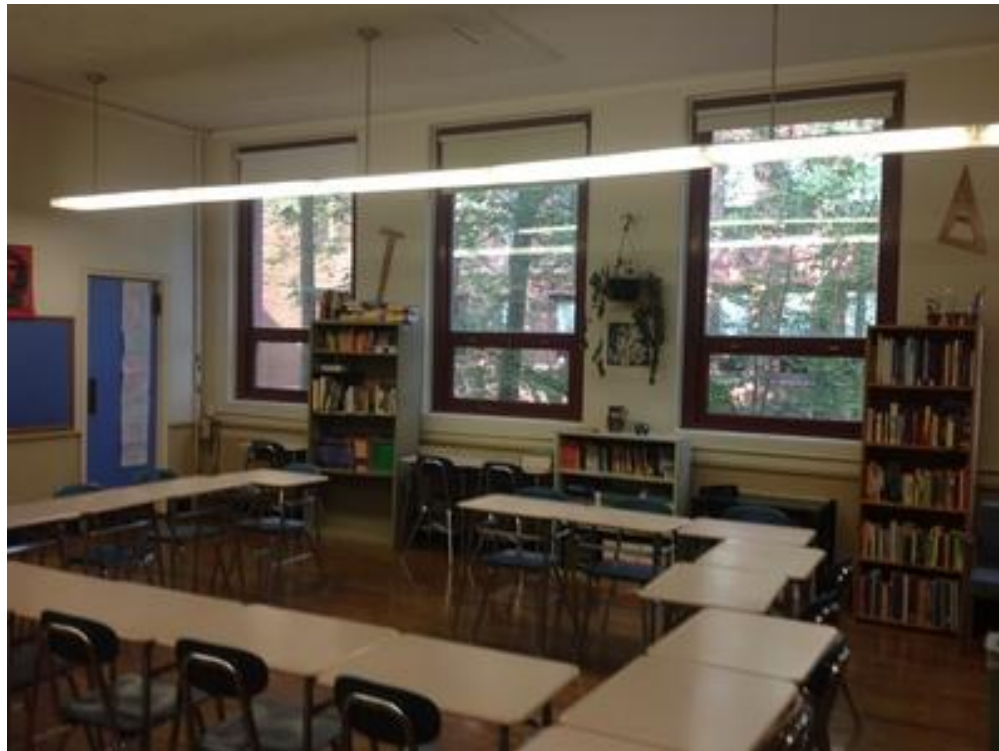
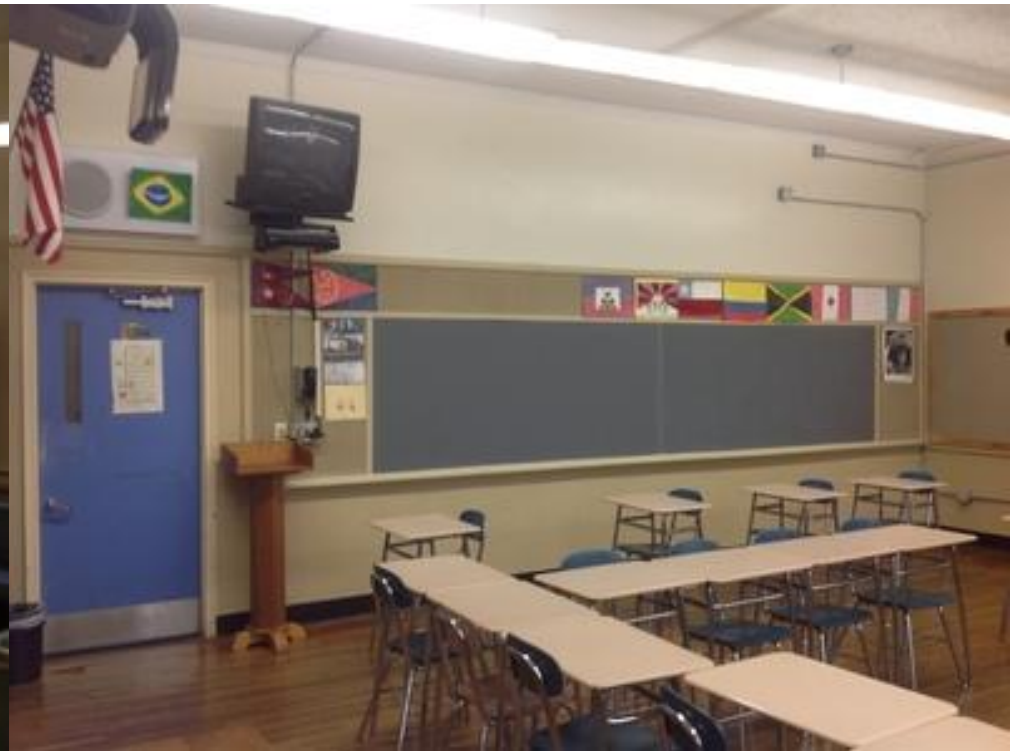
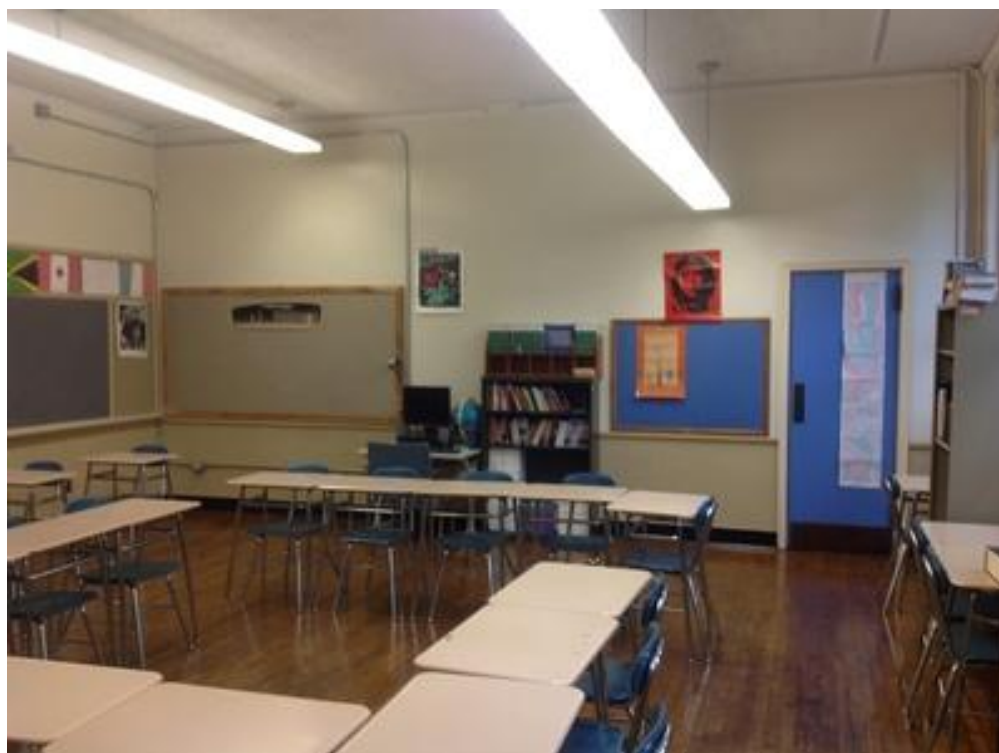
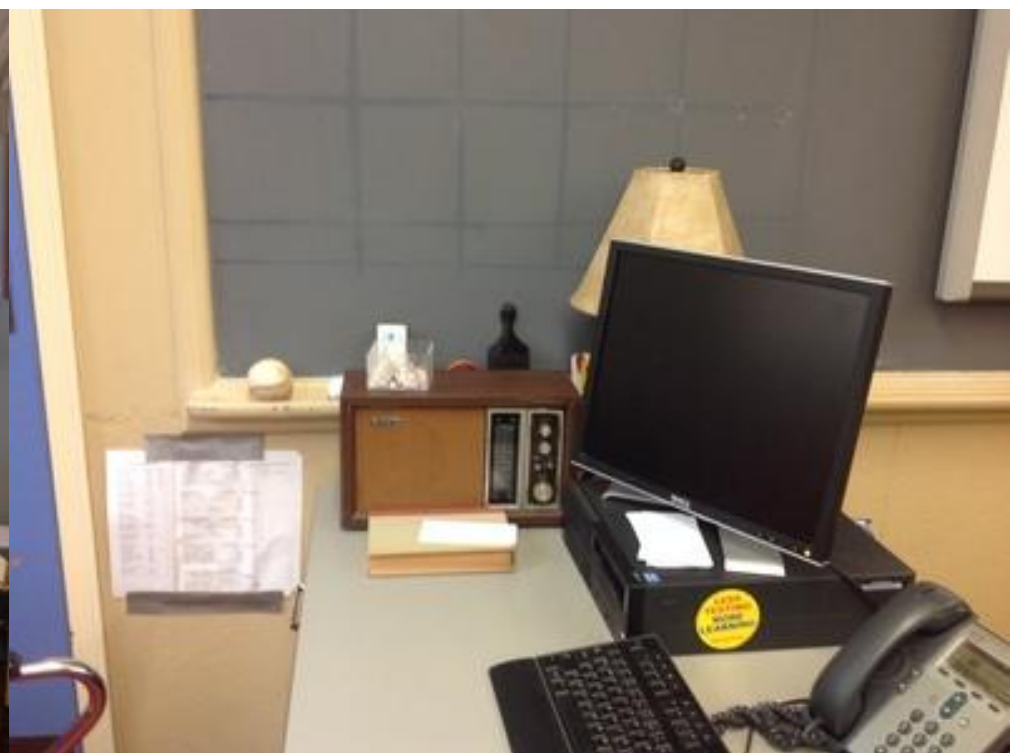
Wood flooring in good condition but creaky. Paint is chipping on walls and ceiling. Surface mounted equipment and wiring is haphazard. Shades are in poor condition. Millwork in poor condition. Unit heater in poor condition. Some windows have lost their seal. Classroom has smartboard.

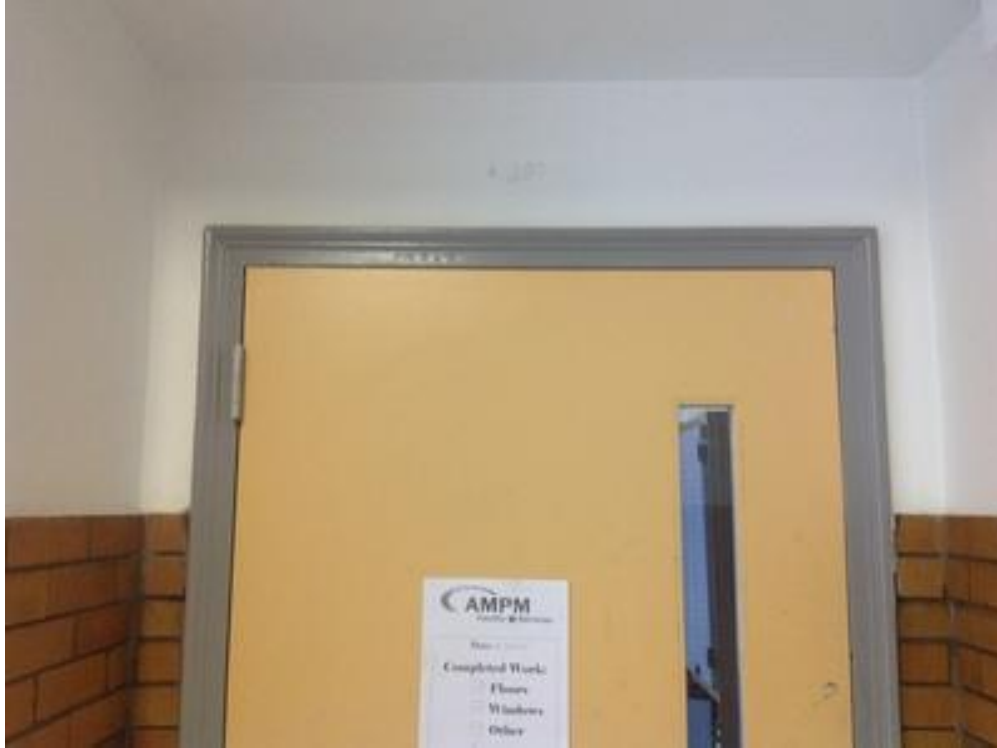
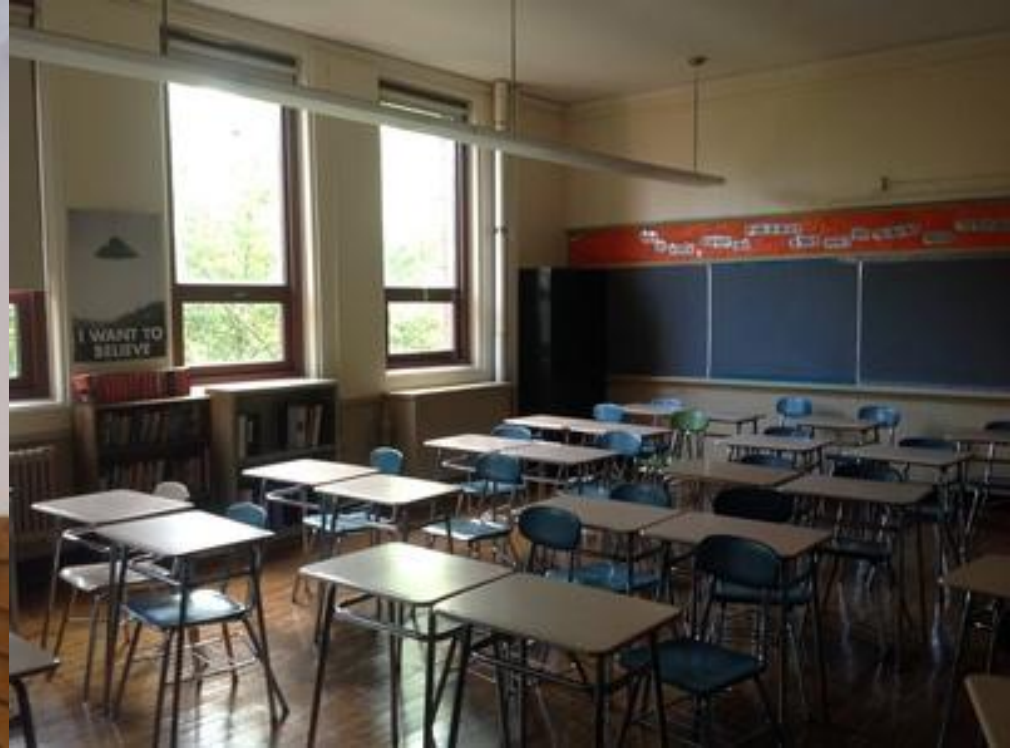
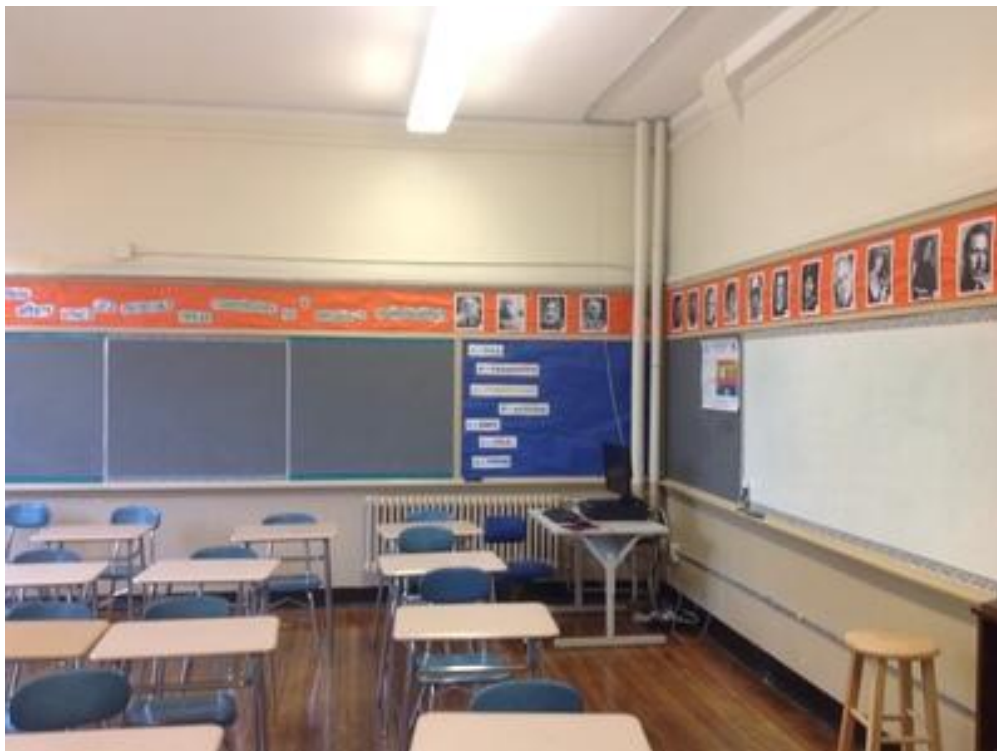
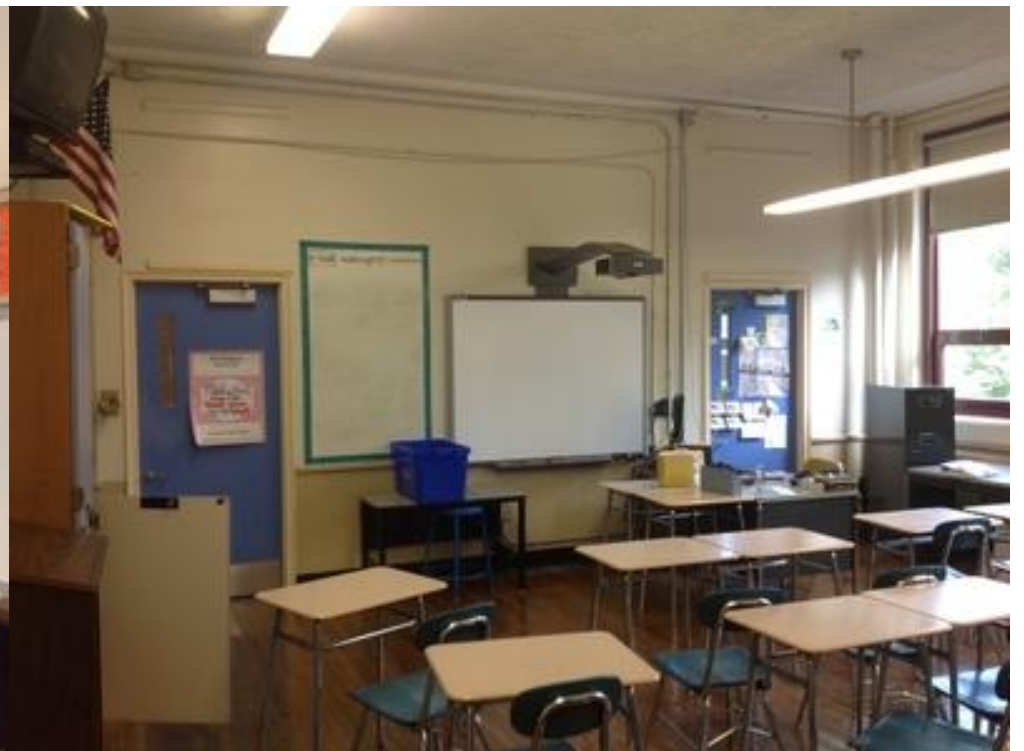
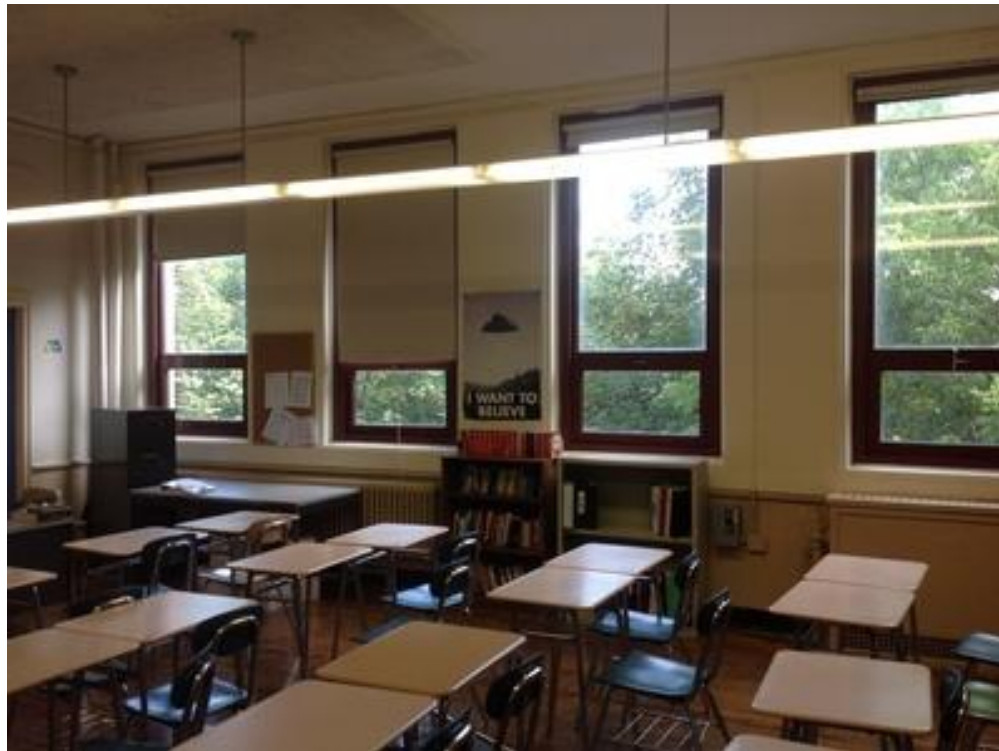
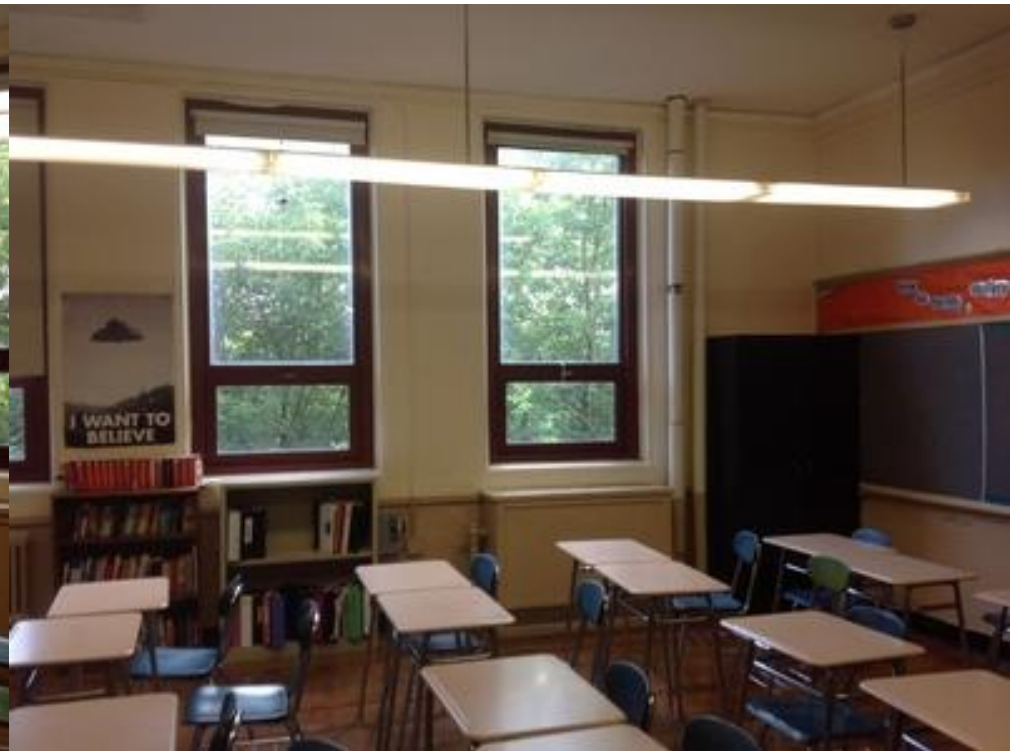
Wood flooring in good condition but creaky. Paint is chipping on walls and ceiling. Surface mounted equipment and wiring is haphazard. Shades are in poor condition. Millwork in poor condition. Unit heater in poor condition. Some windows have lost their seal. Classroom has smartboard.

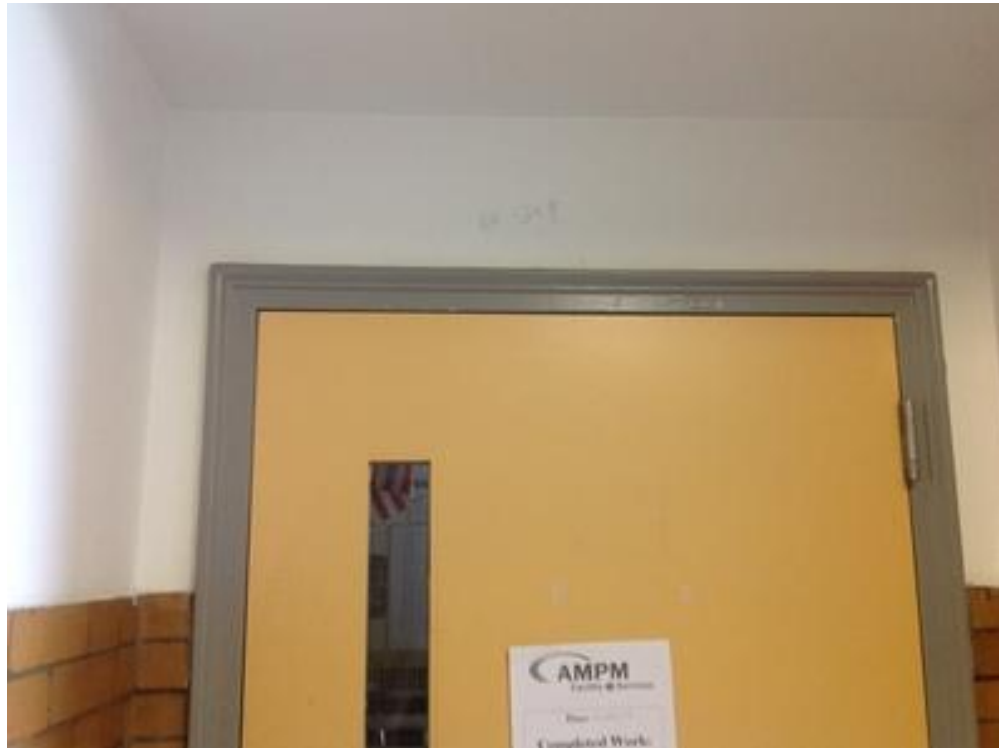
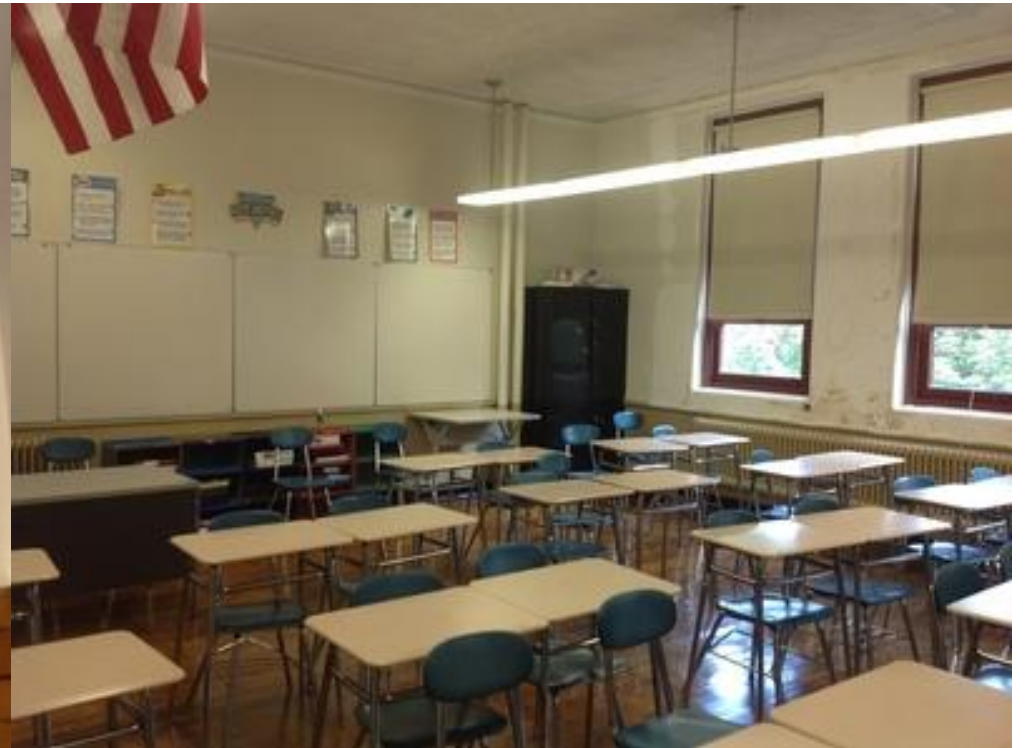
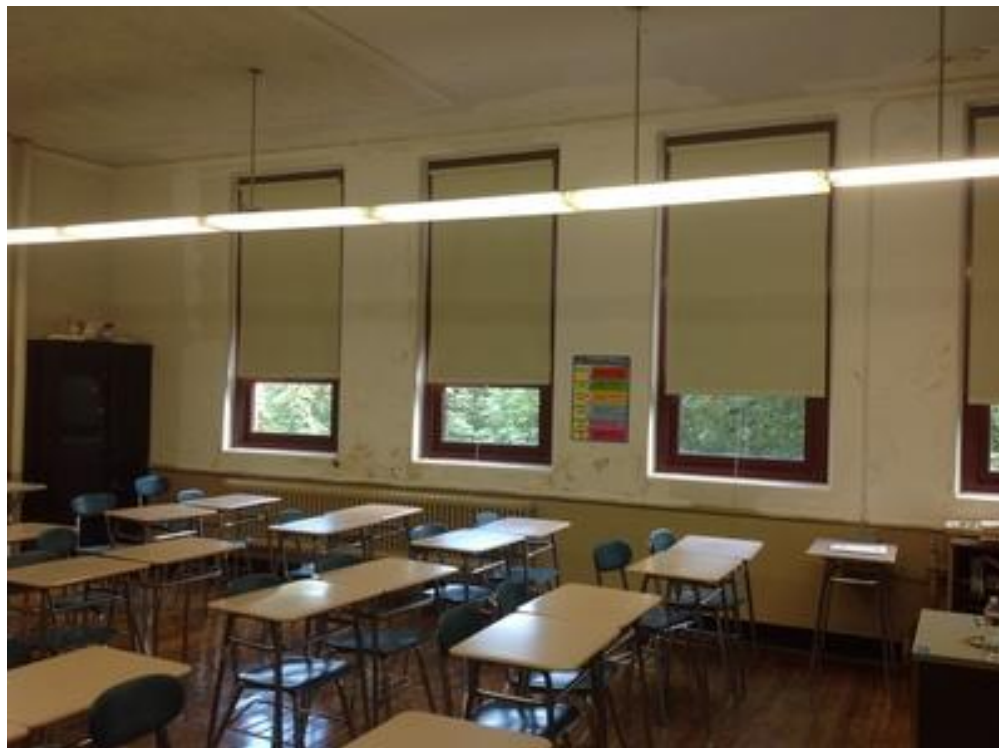
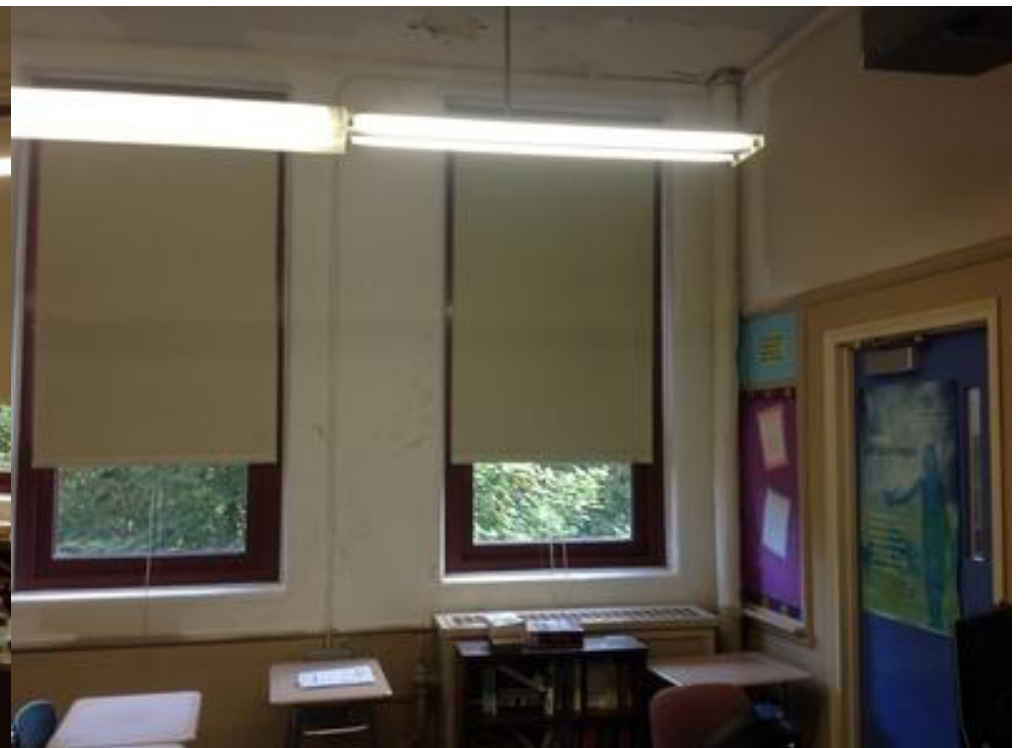
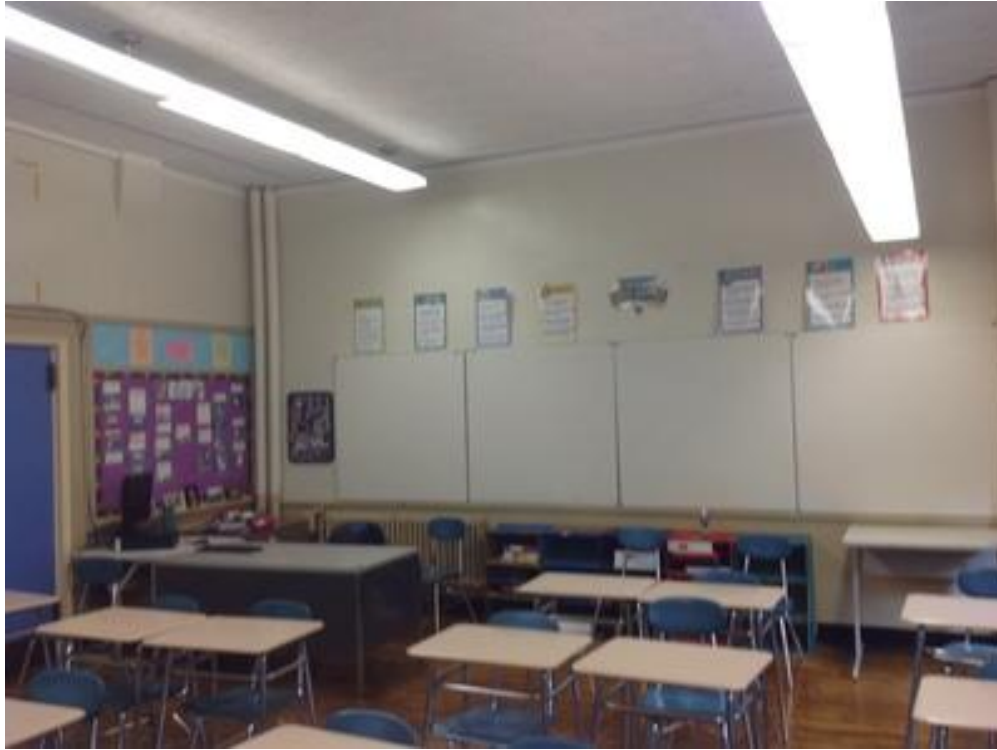
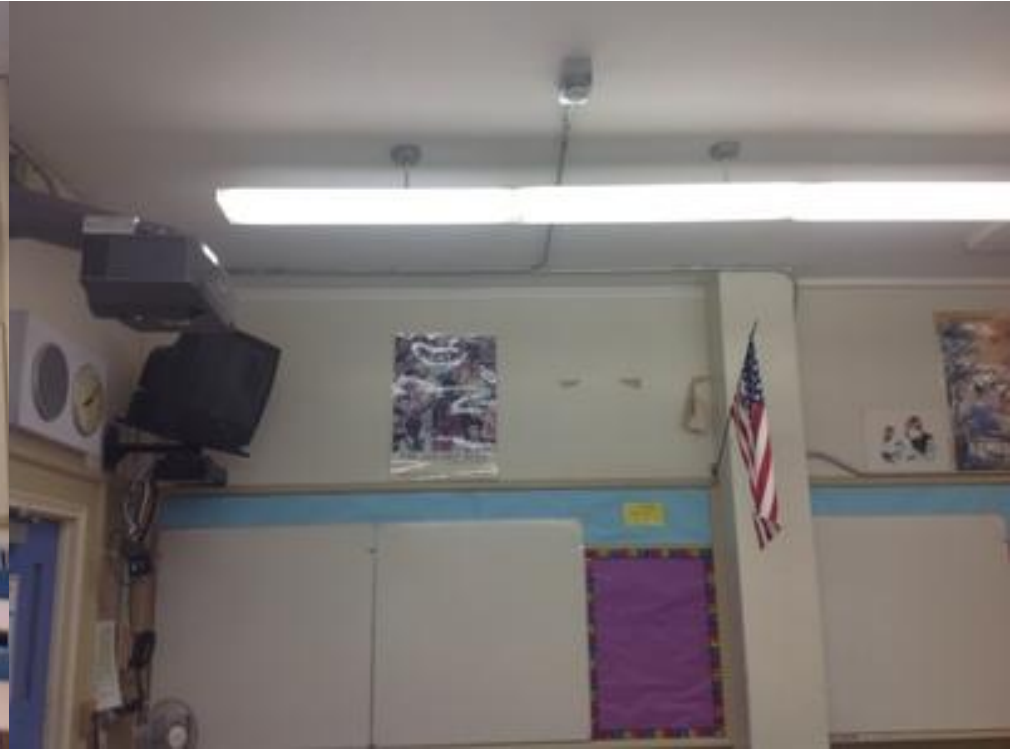
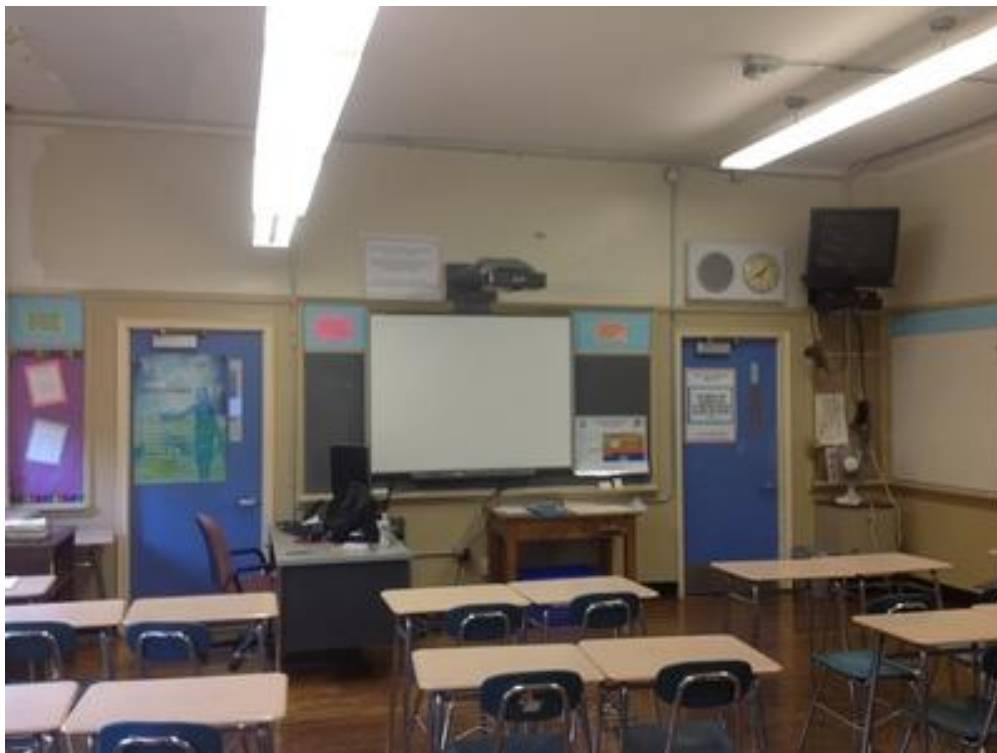
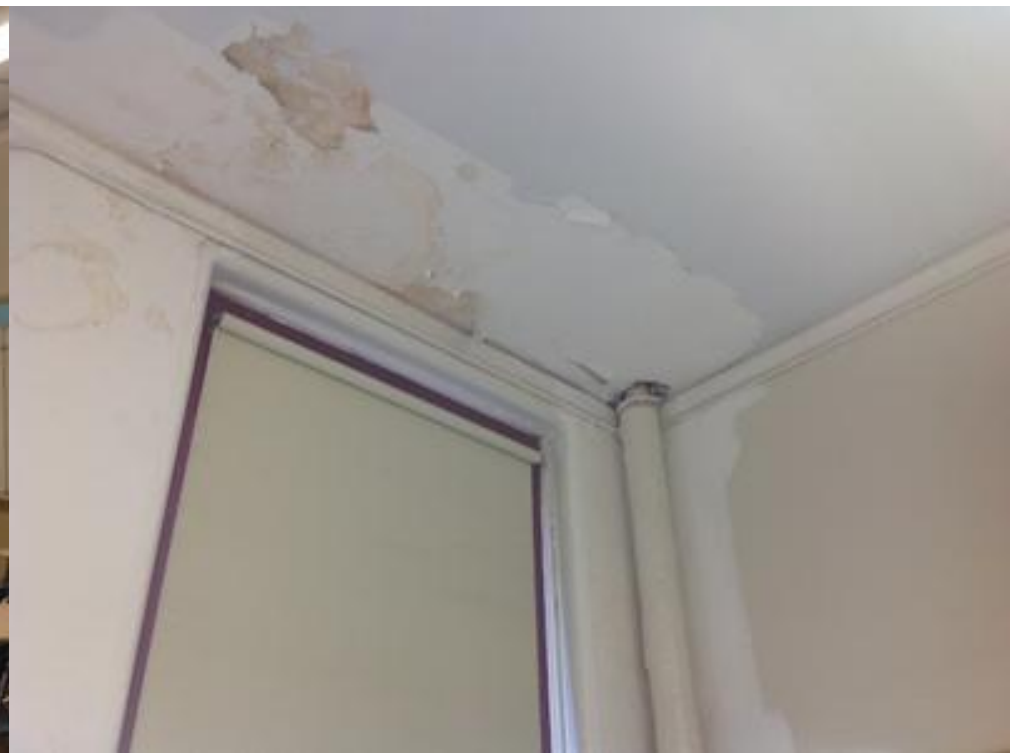
Description
Wood flooring in good condition but creaky. Paint is chipping on walls and ceiling. Surface mounted equipment and wiring is haphazard. Shades are in poor condition. Millwork in poor condition. Unit heater in poor condition. Some windows have lost their seal. Classroom has smartboard.
