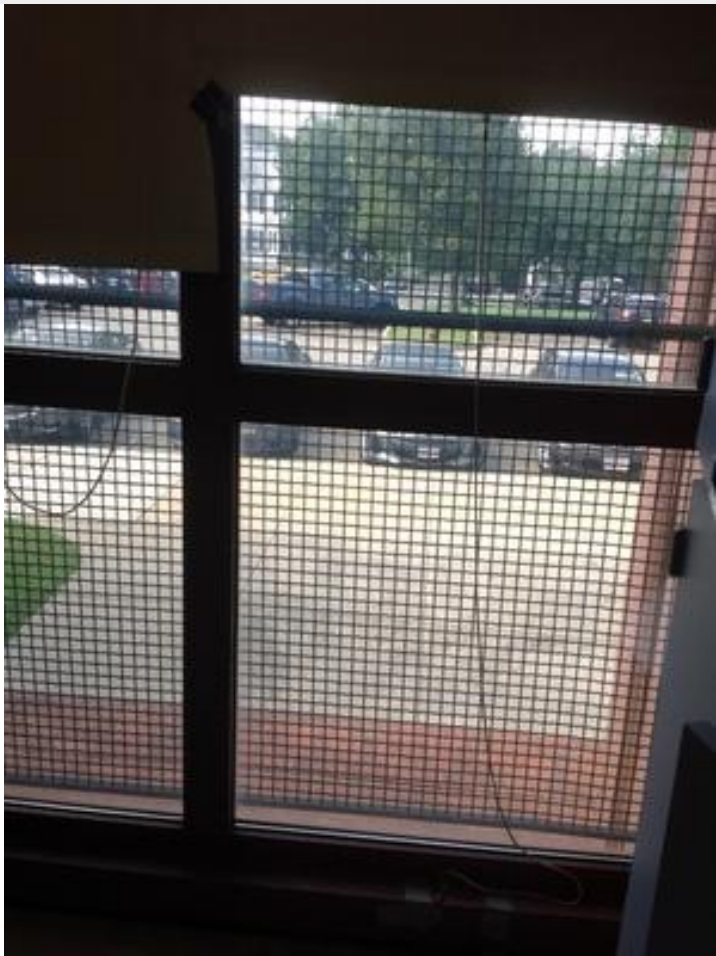
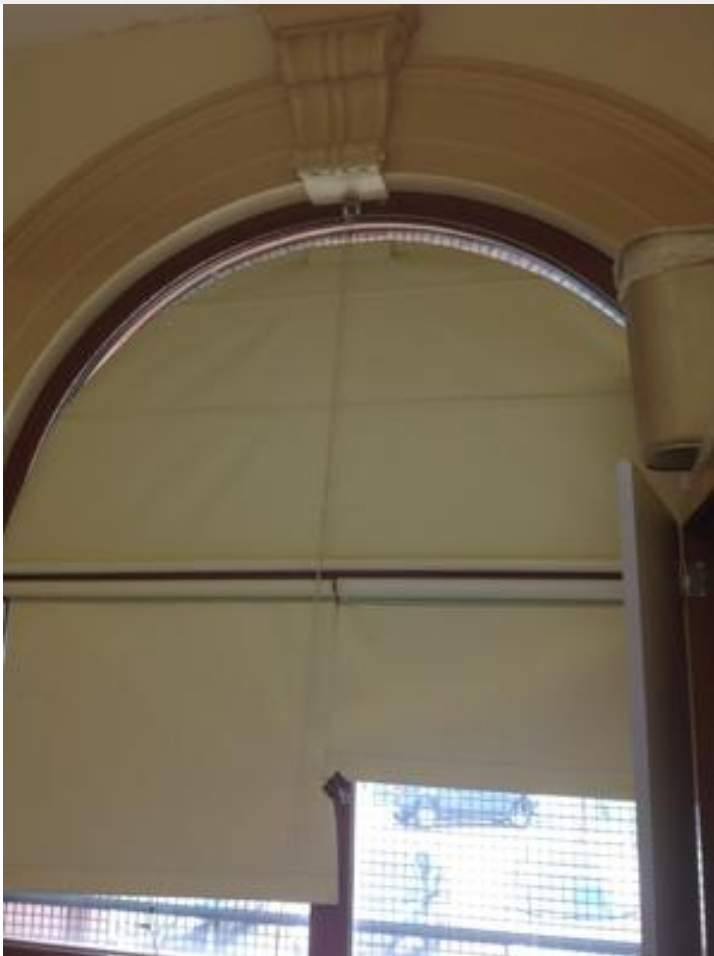
Teacher resource room in fair condition. Wood flooring in good condition but creaky. Paint is chipping on walls and ceiling. Surface mounted equipment and wiring is haphazard. Shades are in poor condition. Unit heater in poor condition. Some windows have lost their seal.

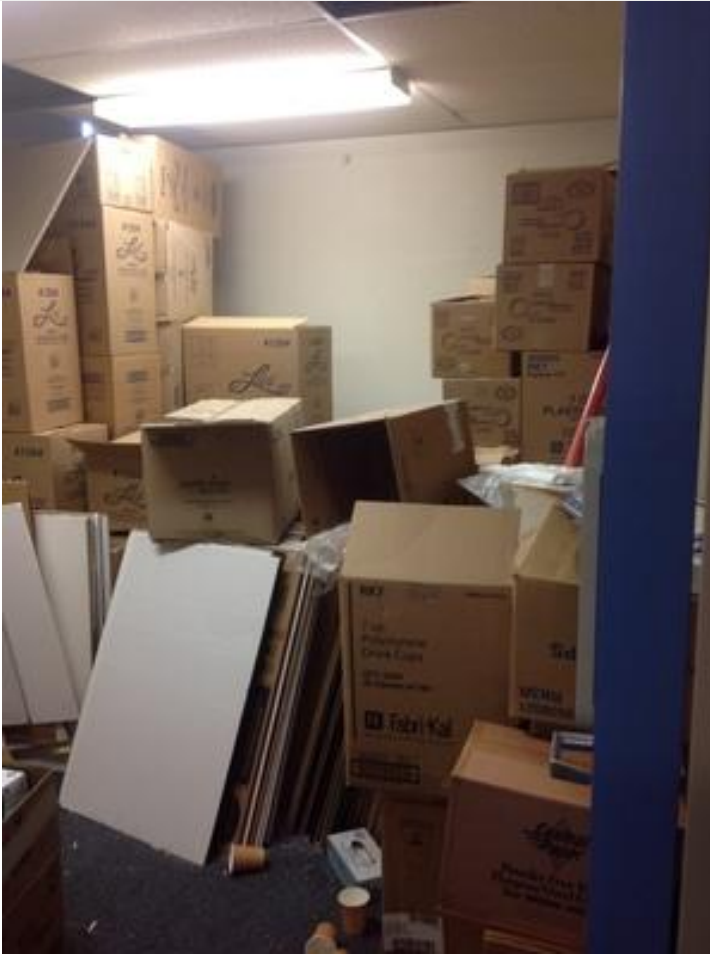
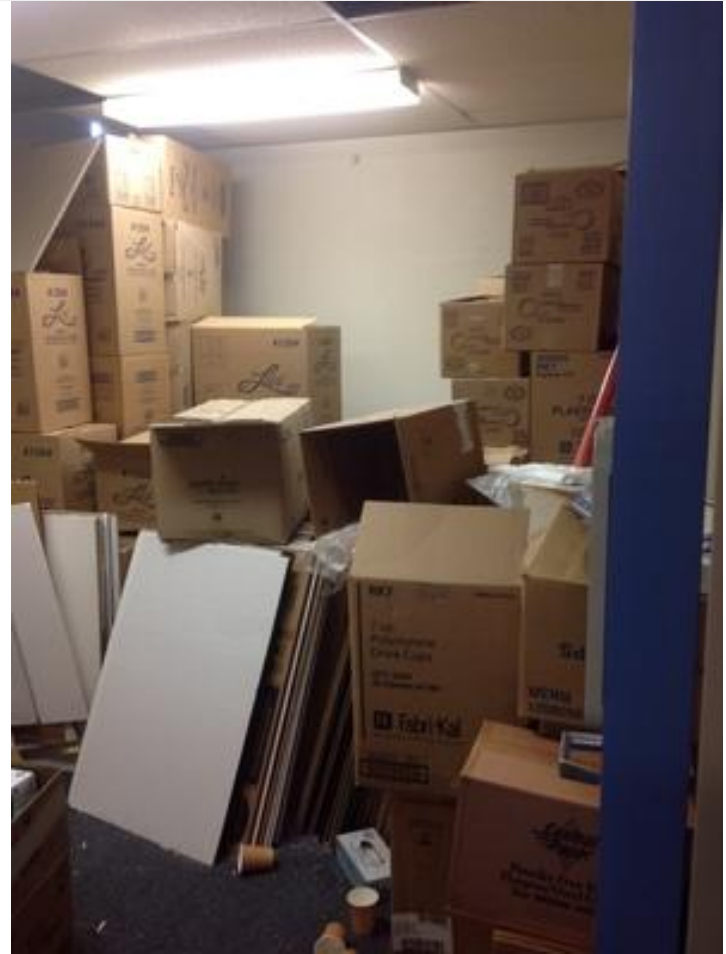
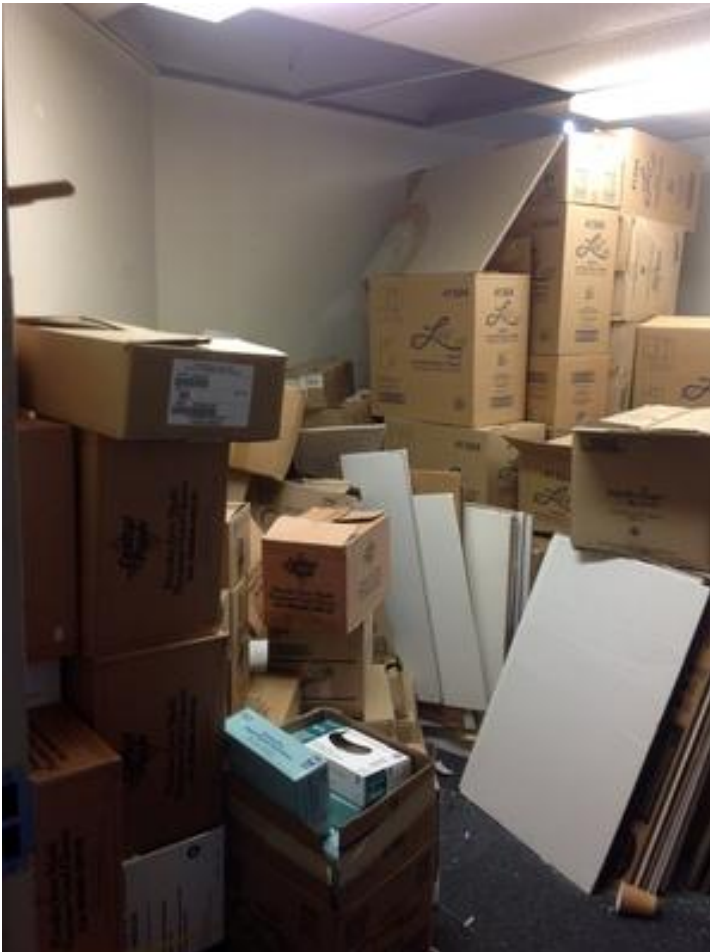
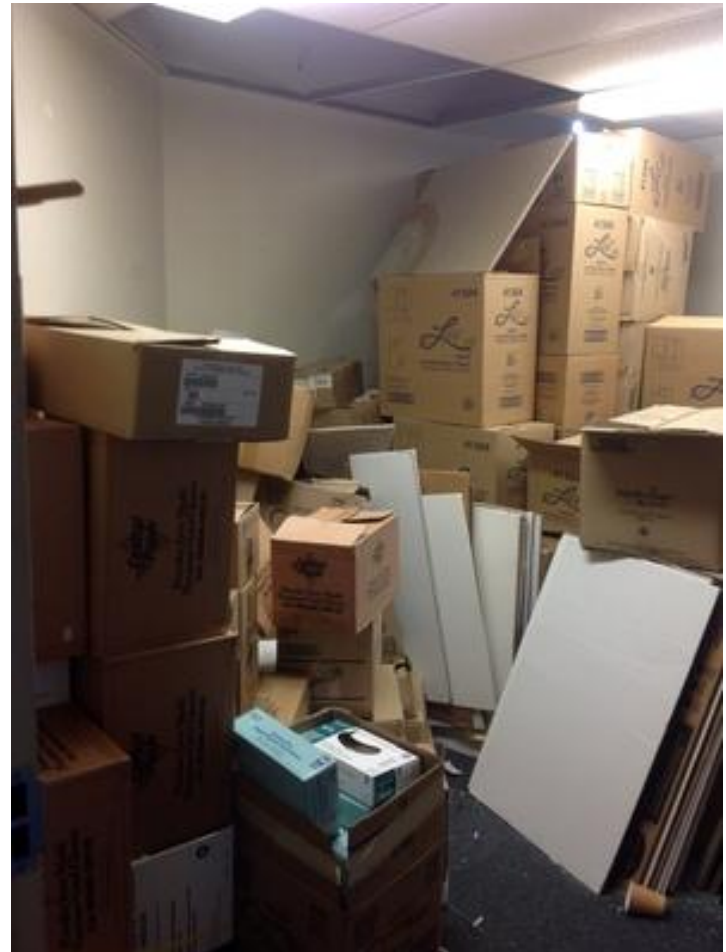
Significant water damage to ceiling tiles. Some are missing or have been removed. At windows, wall creates niche that is filled with debris and dirt. Window cannot open fully. Shades are in poor condition. Carpet in fair condition.

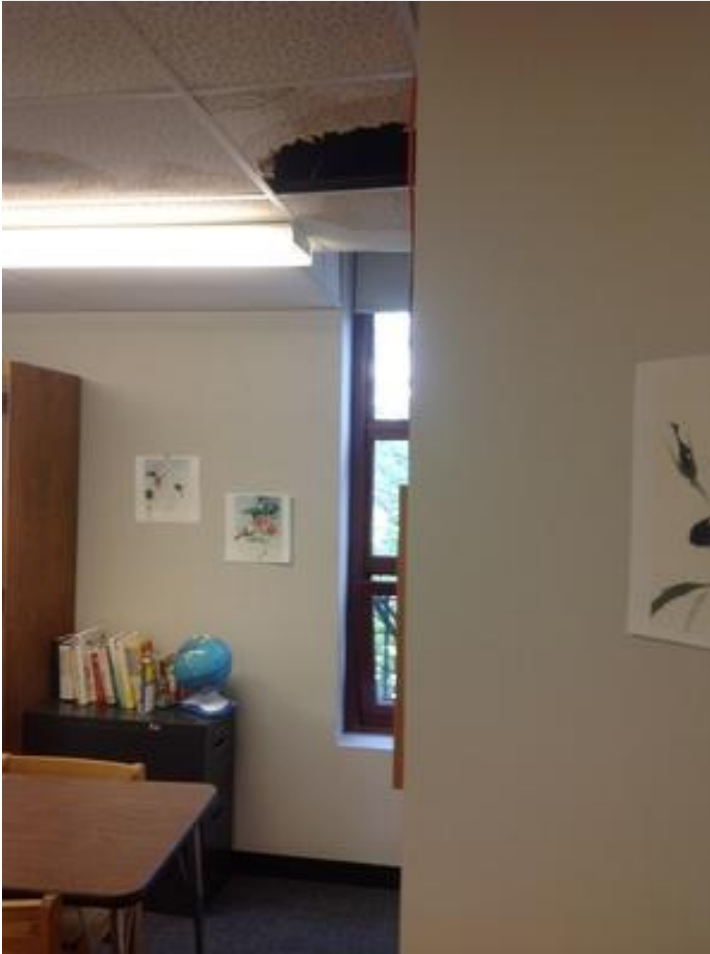
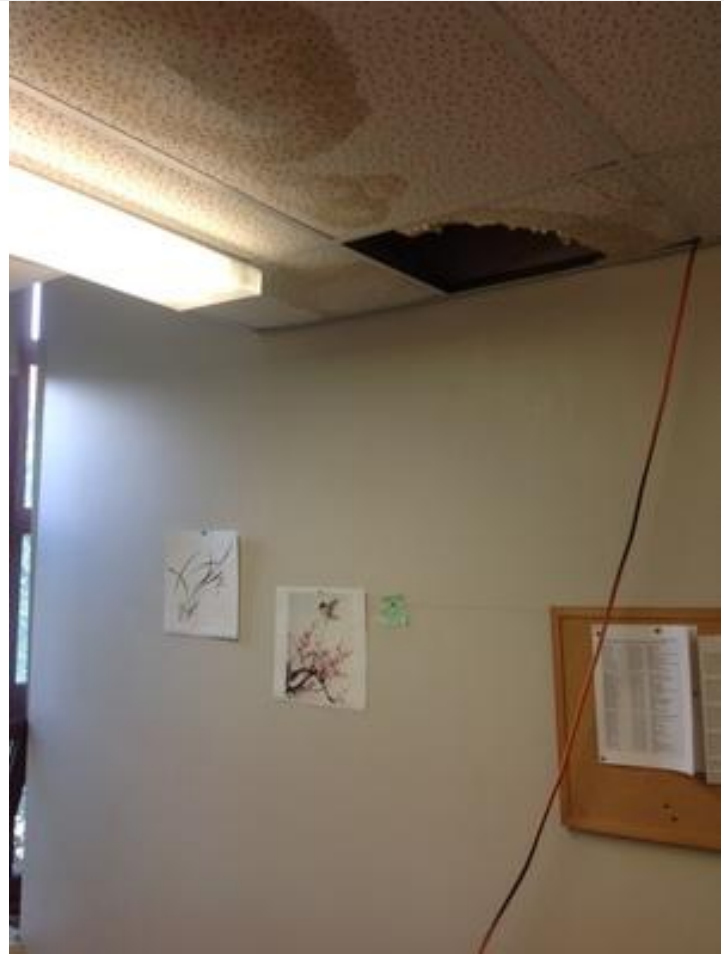
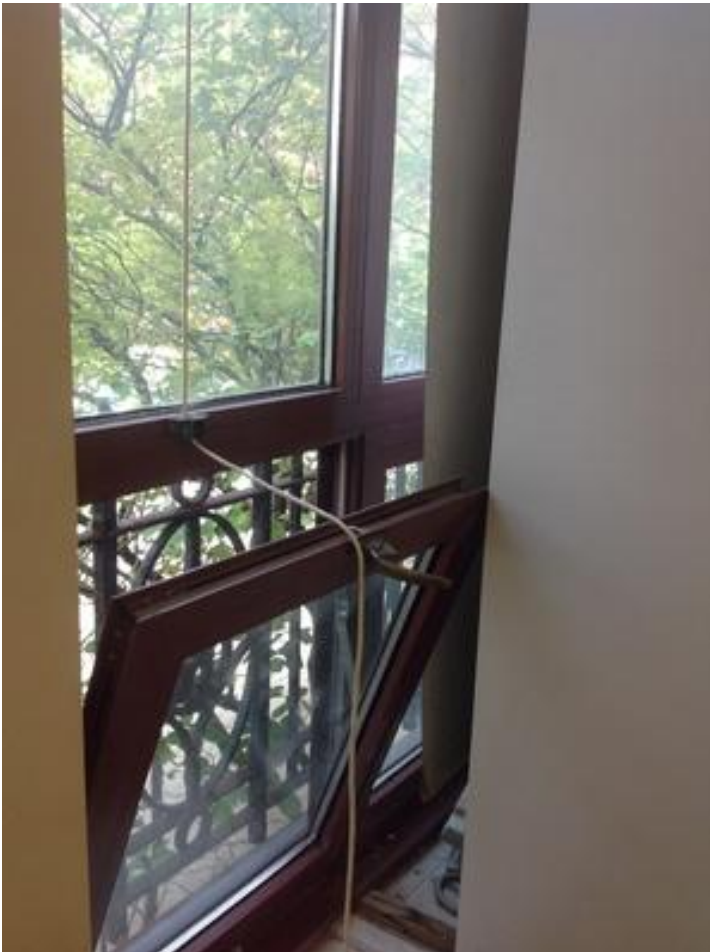
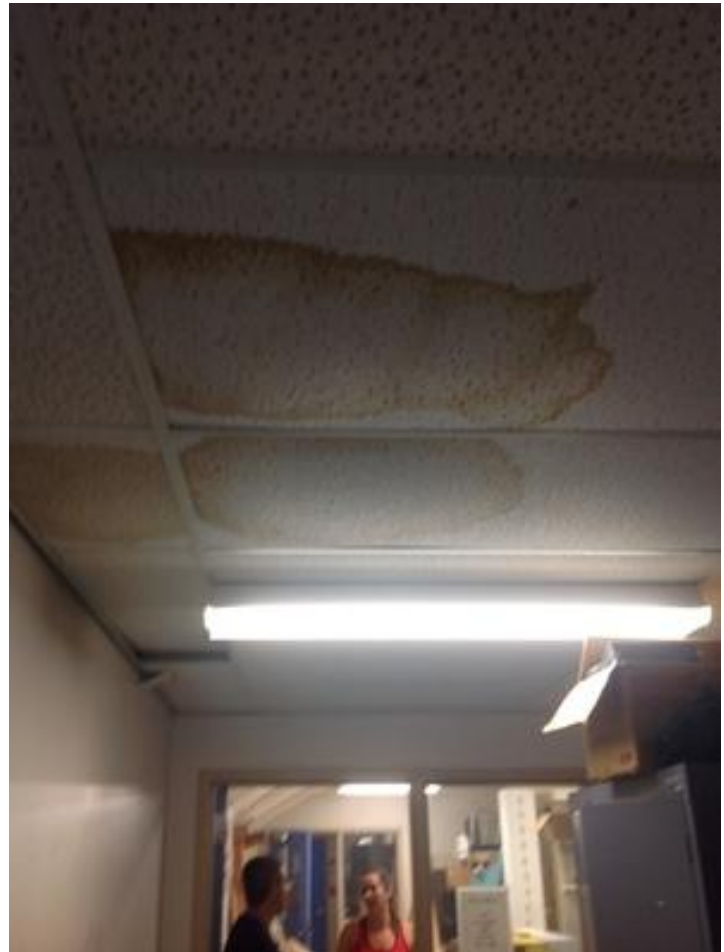
Millwork in very poor condition. Significant water damage to ceiling tiles. Some are missing or have been removed. VCT Flooring in poor condition. Sink is not accessible. Space is used as scenery storage for auditorium and drama. Inadequate space creates accessibility and egress concerns. Materials block exits. Piping is missing insulation in some locations.

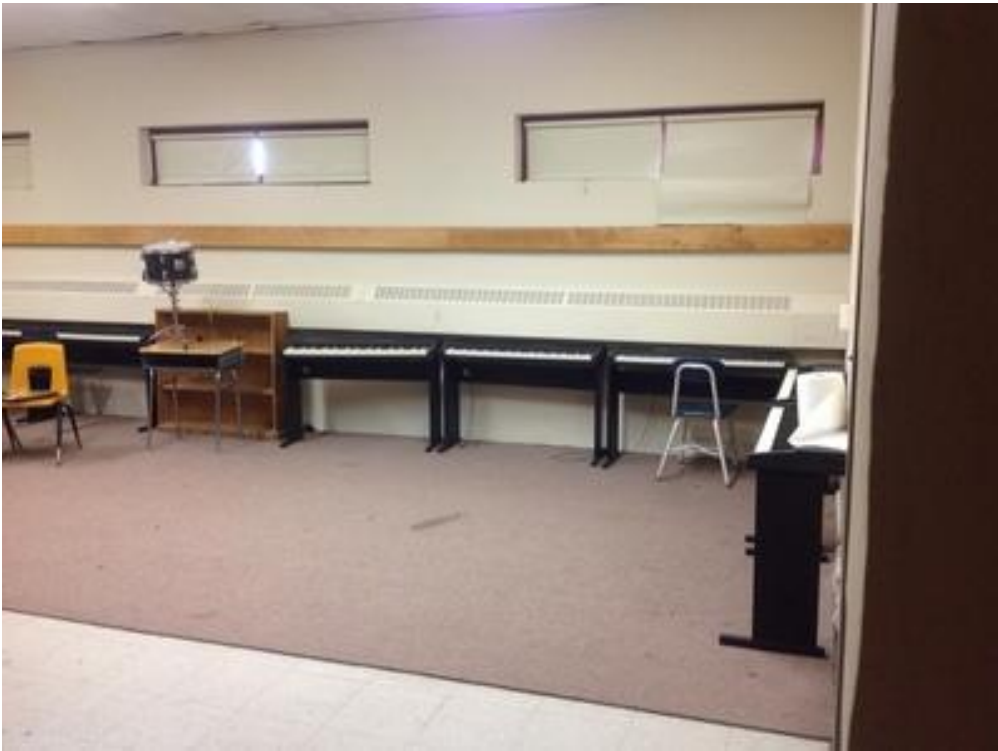
Entry to media center space is not accessible. Space appears to be abandoned and unused. Initially served as gymnasium. Rubber flooring in poor condition. Painted GWB is peeling. Unit ventilator in poor condition. No handrails.

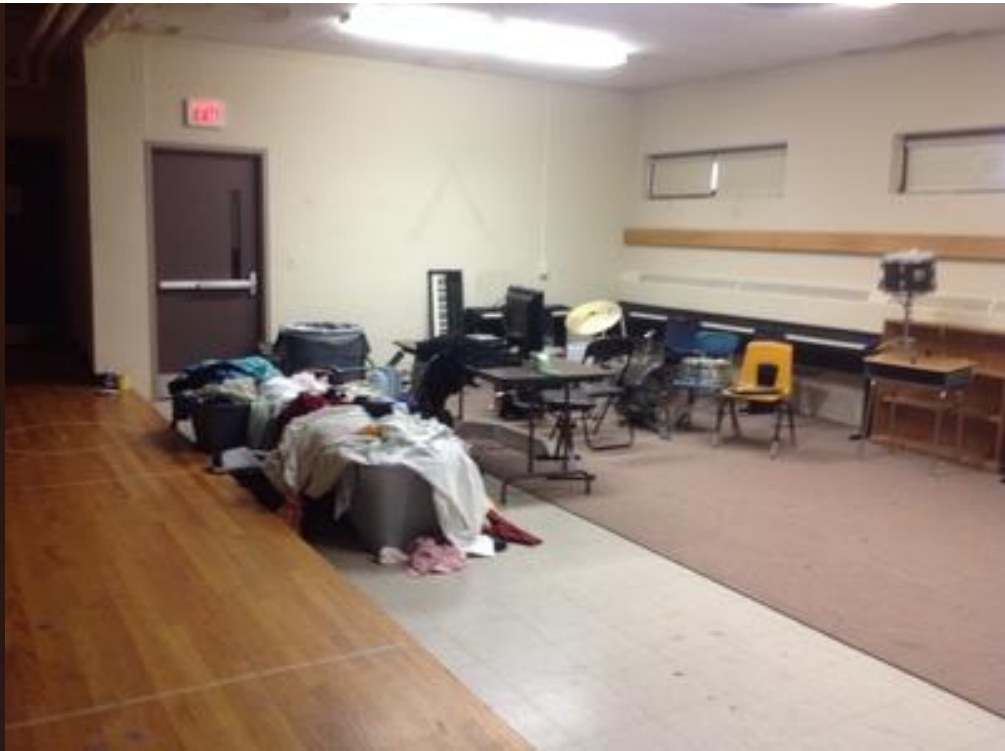
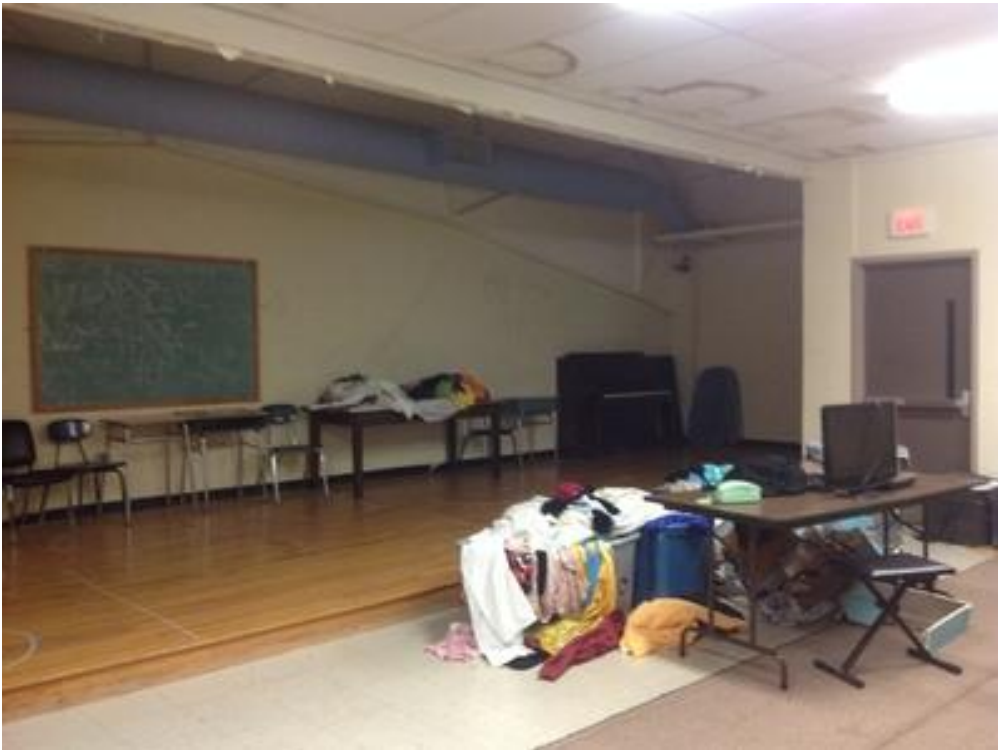
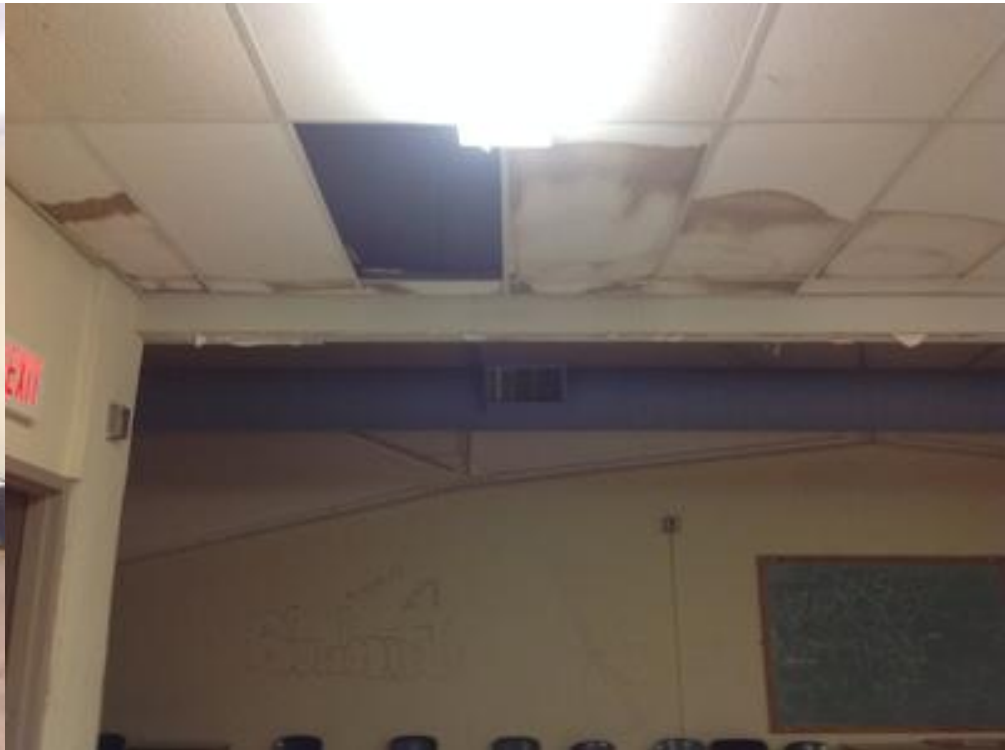
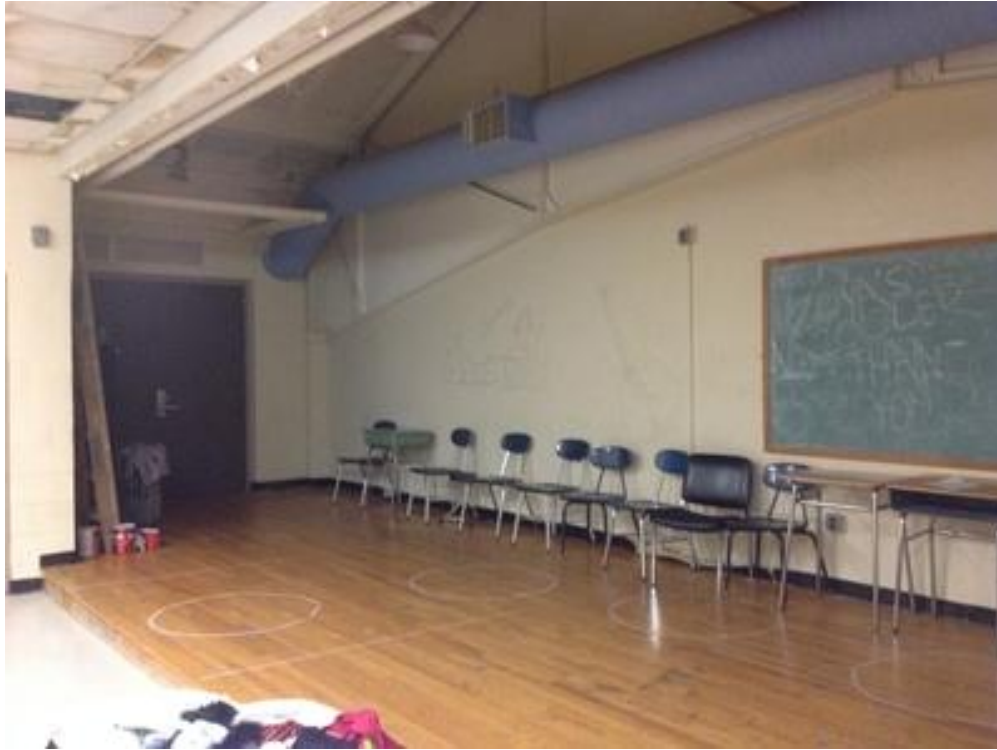
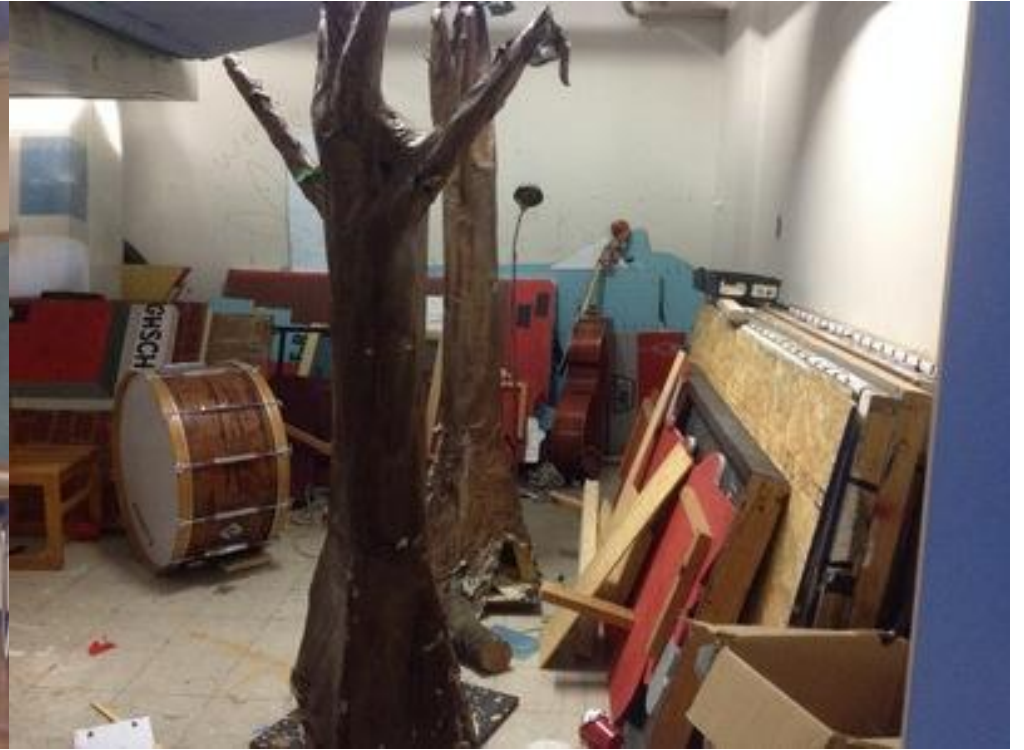
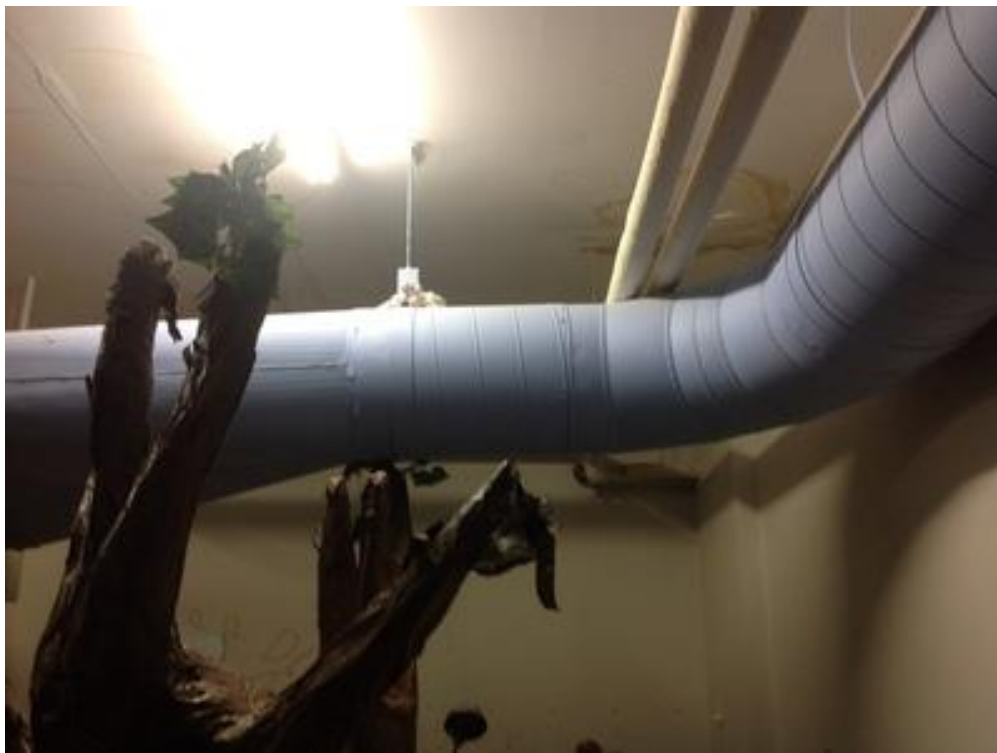
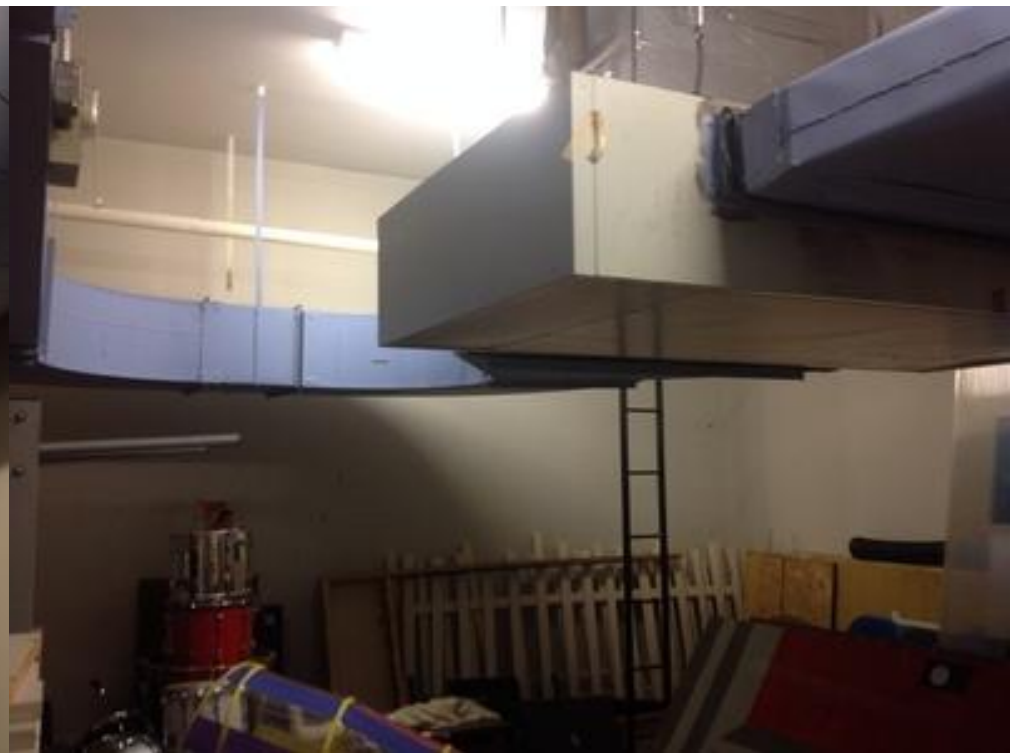
Space appears unused. Ceiling shows significant water infiltration damage from room leak. VCT and carpet flooring is in very poor condition. Accessibility to space is not possible. Space is littered with clutter and debris.

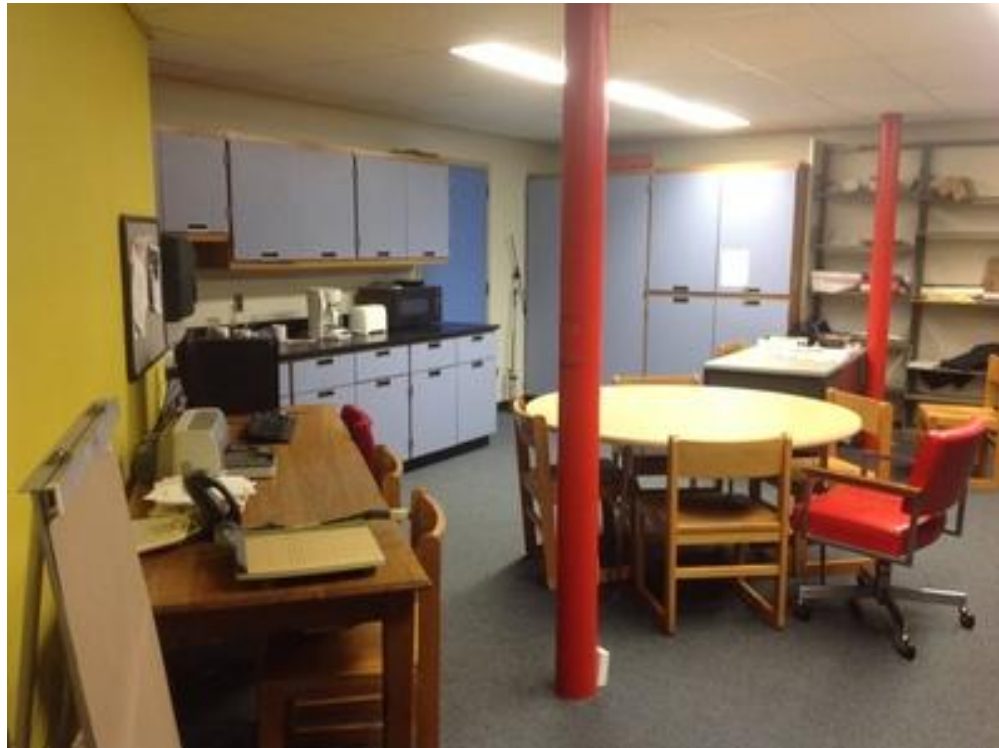
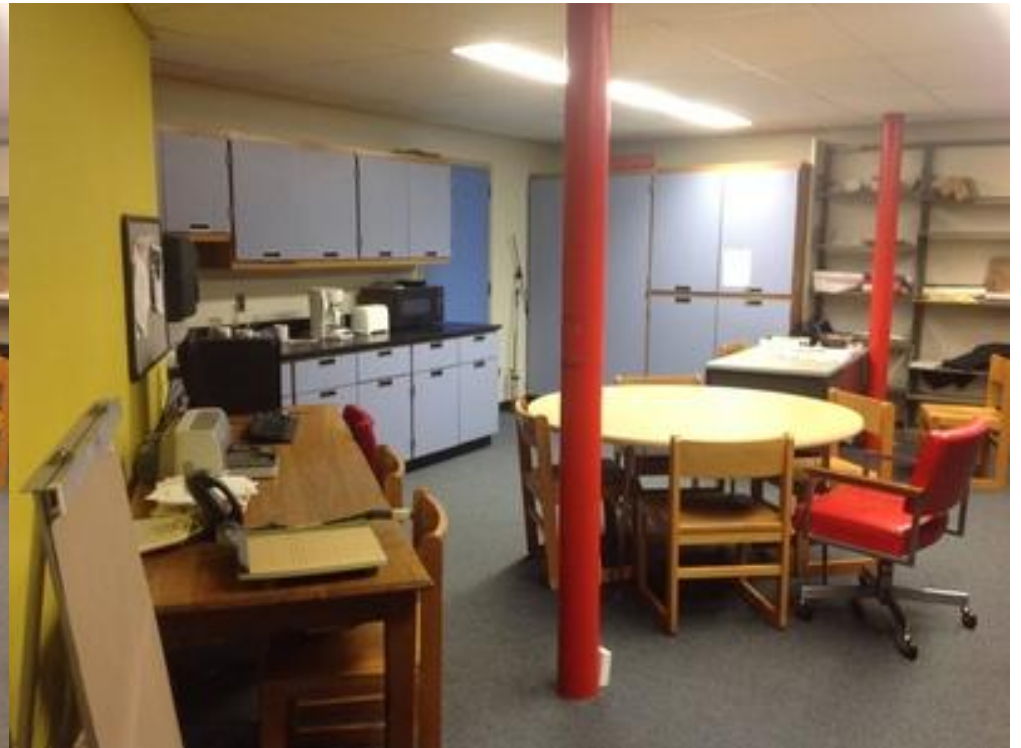
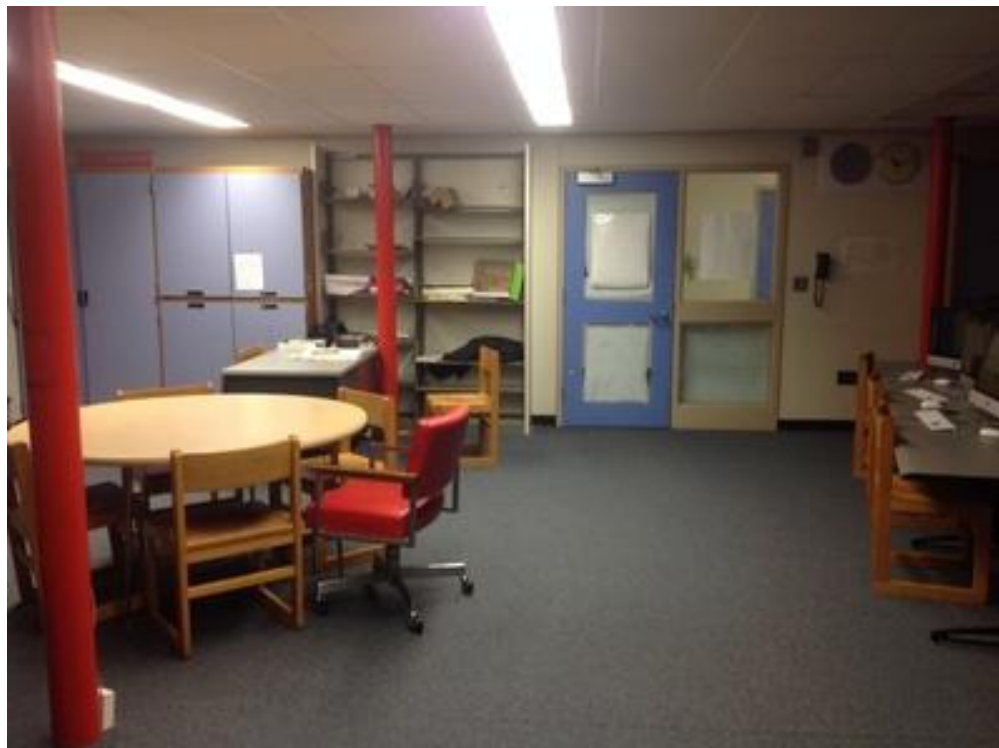
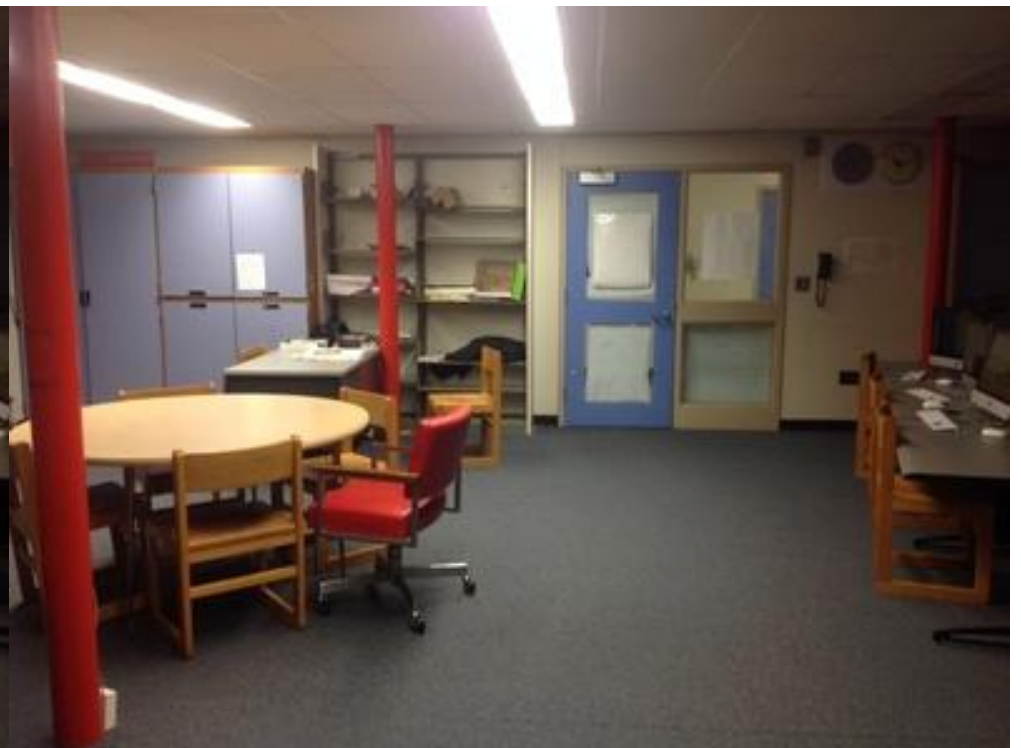
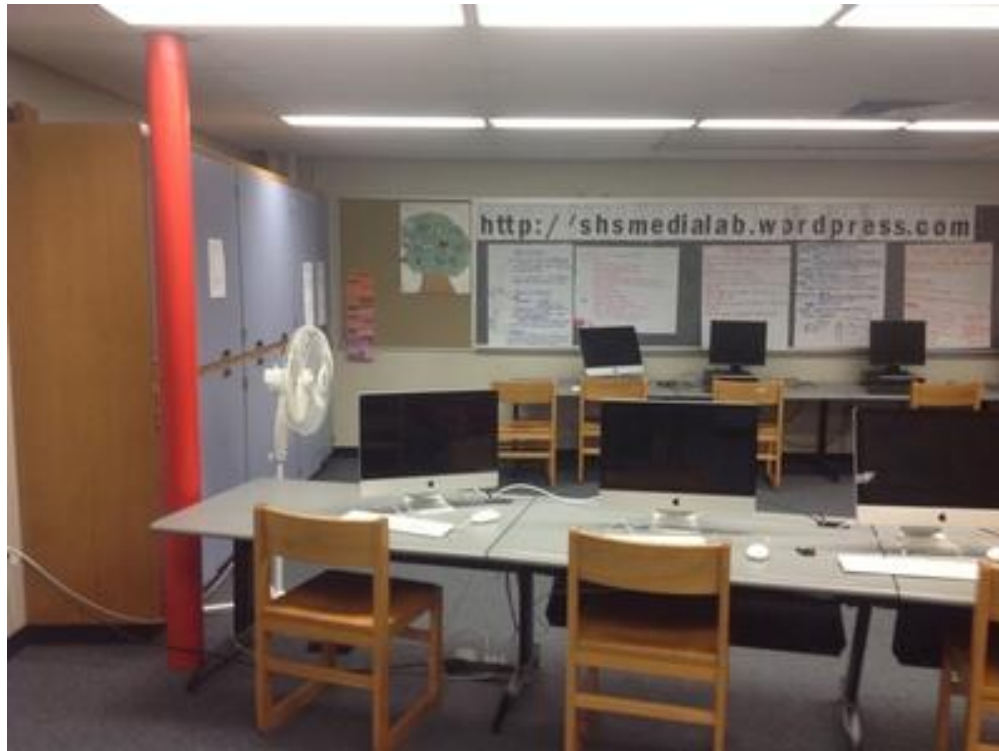
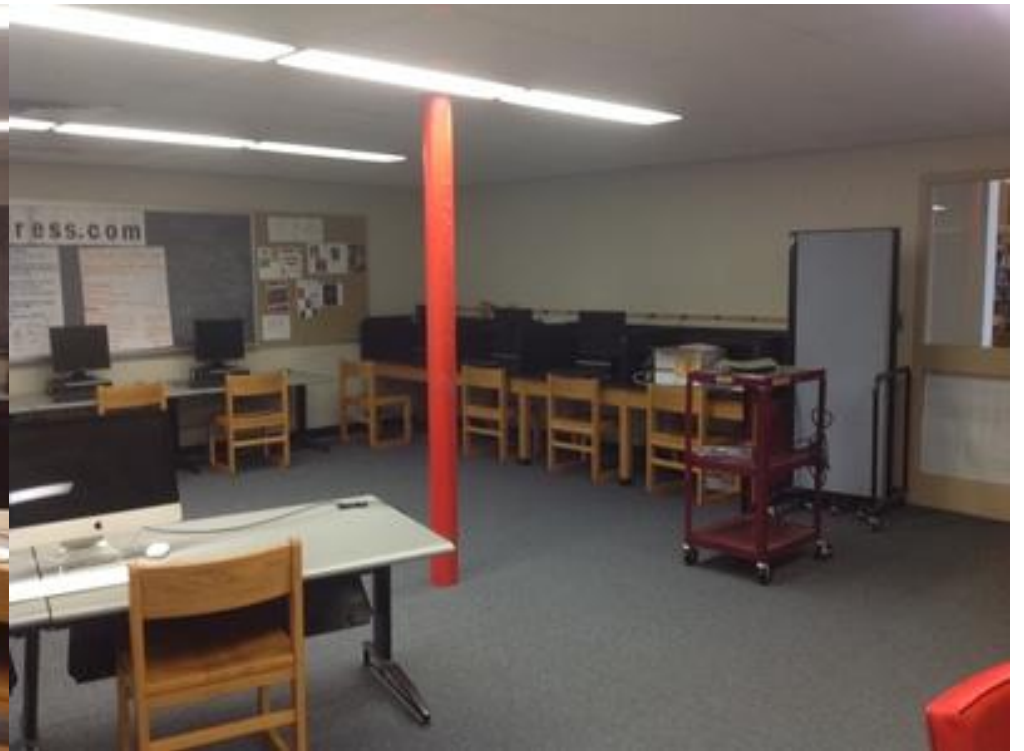
| Media lab in fair condition. Carpet in fair condition. ACT ceiling in fair condition. Millwork in poor condition. | | | |
