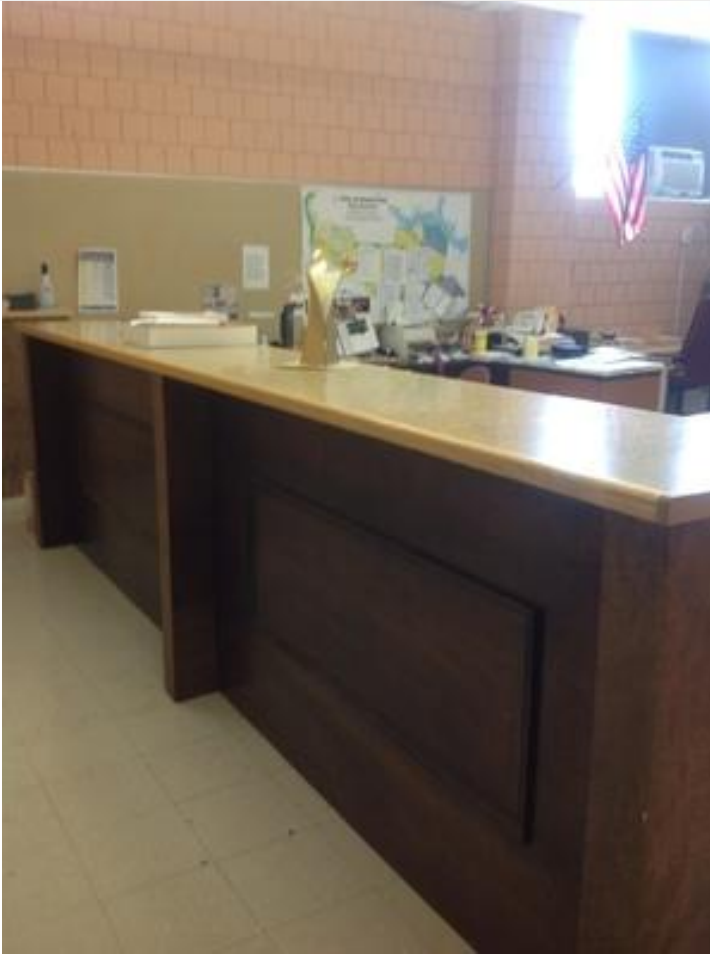
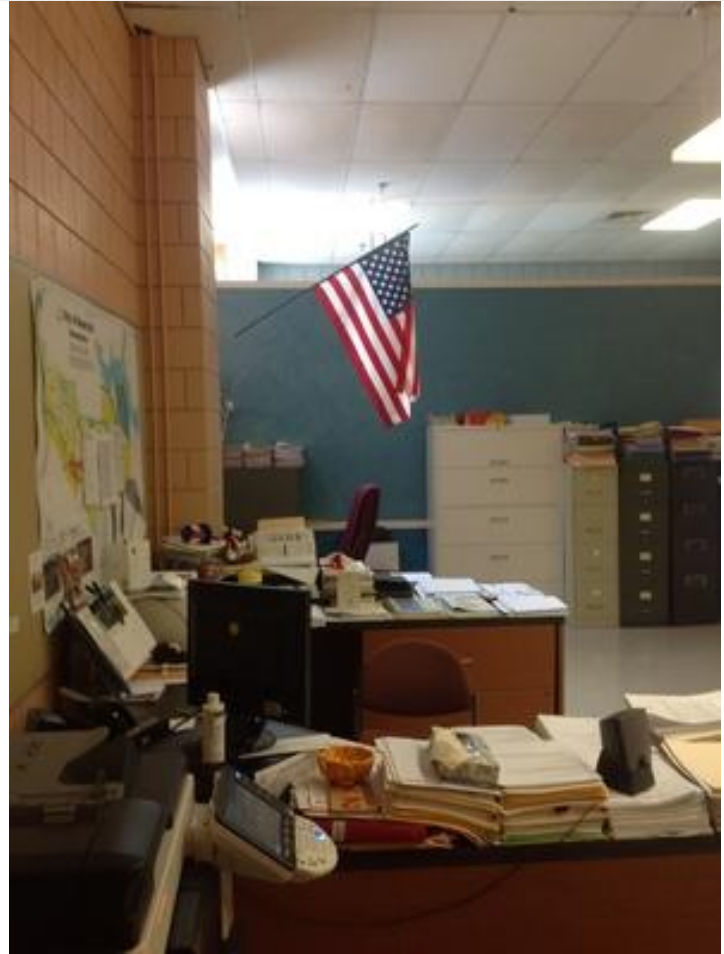
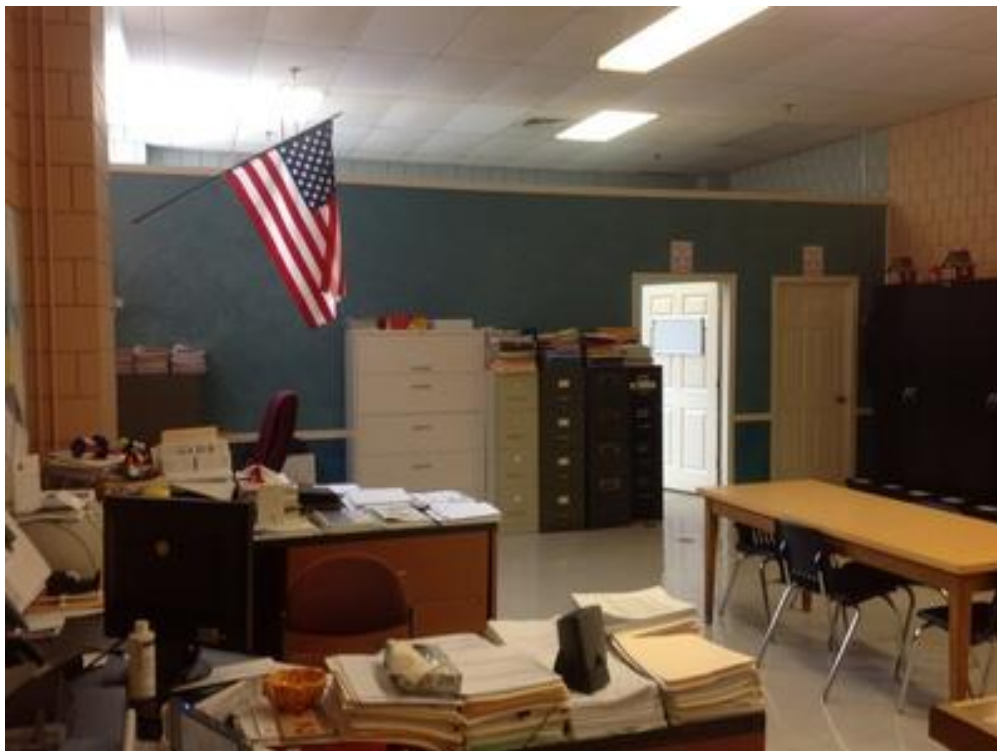
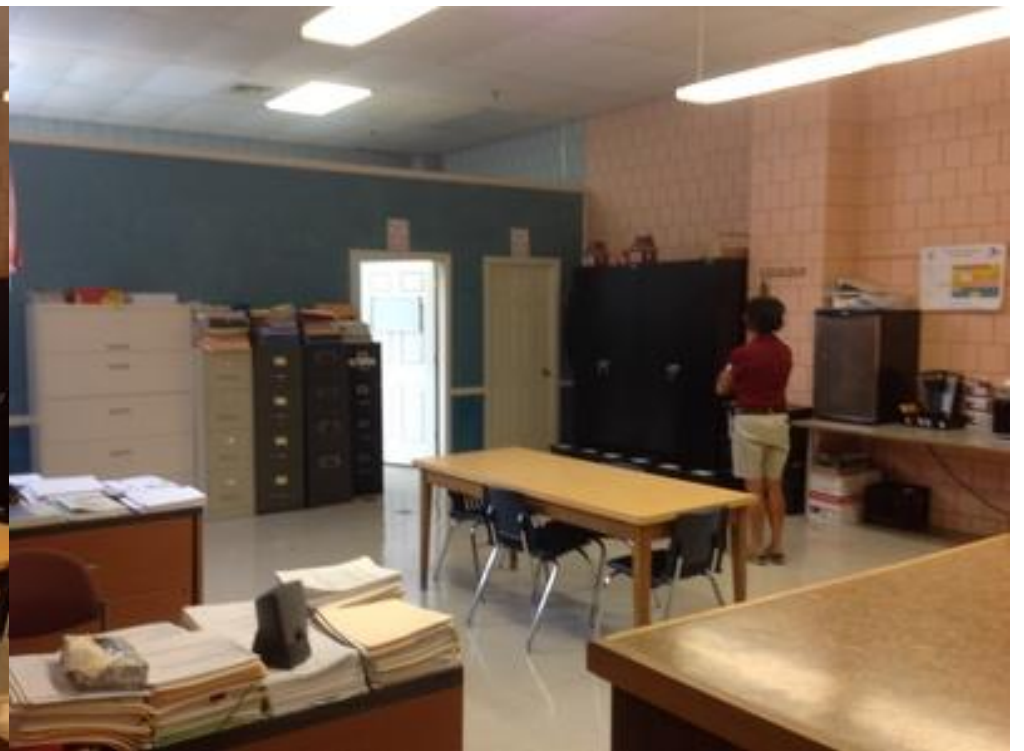
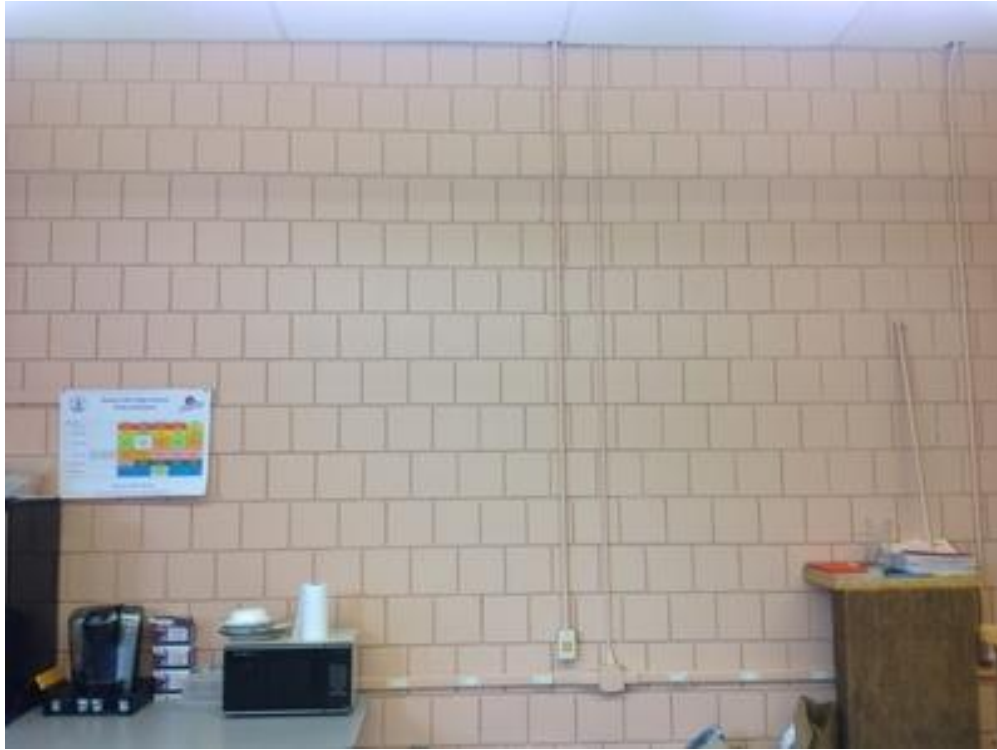
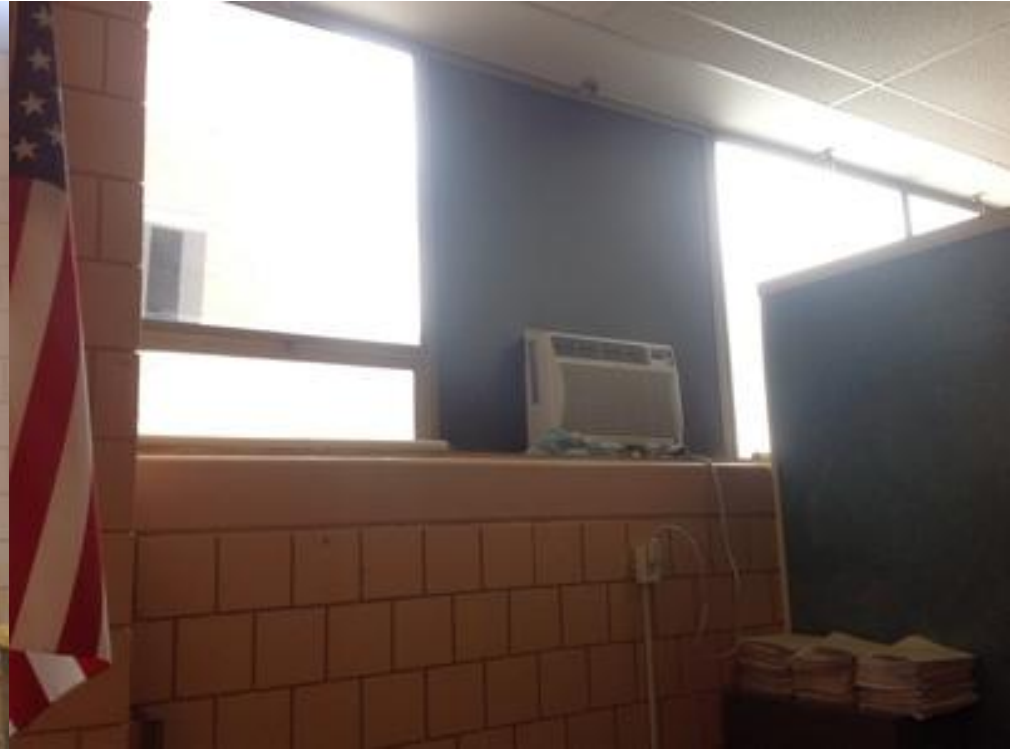
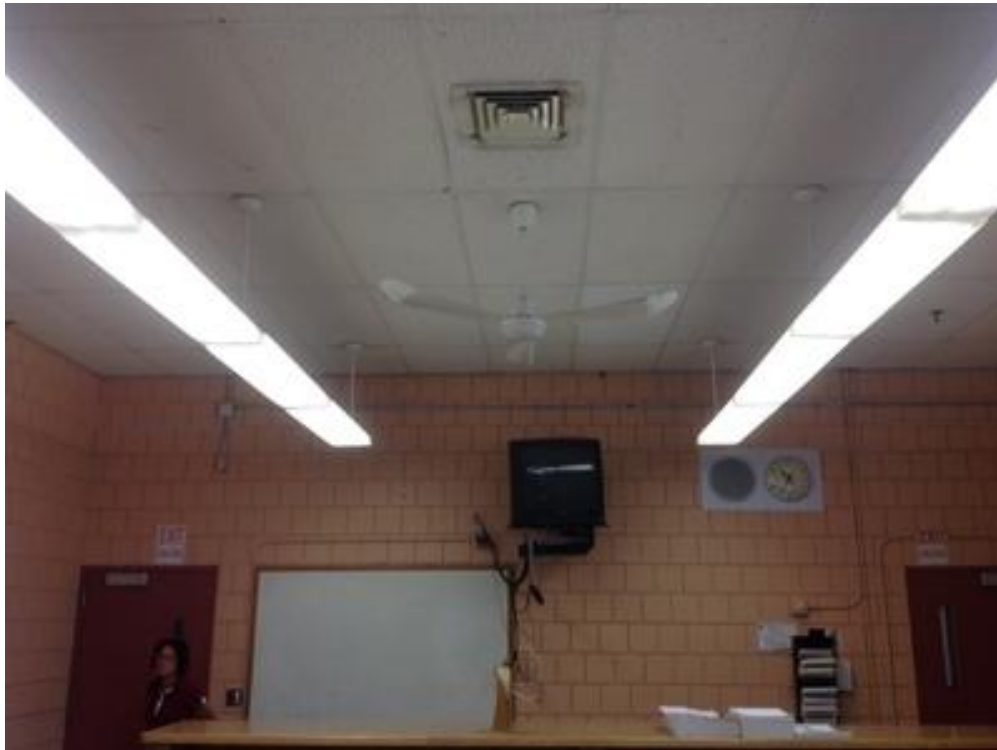
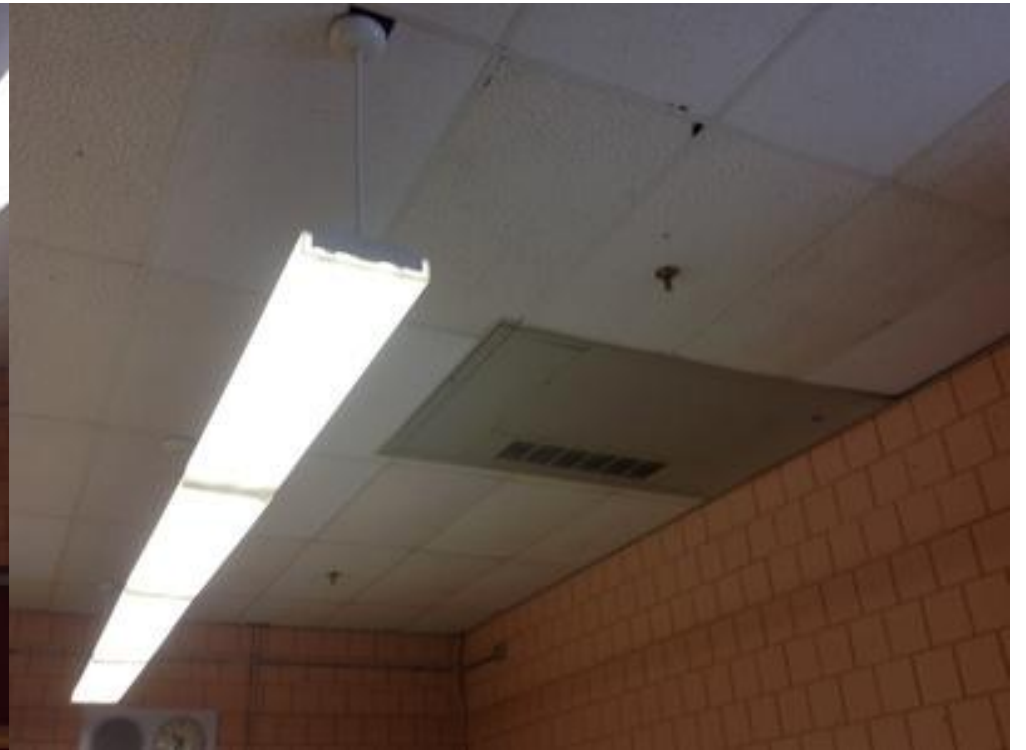
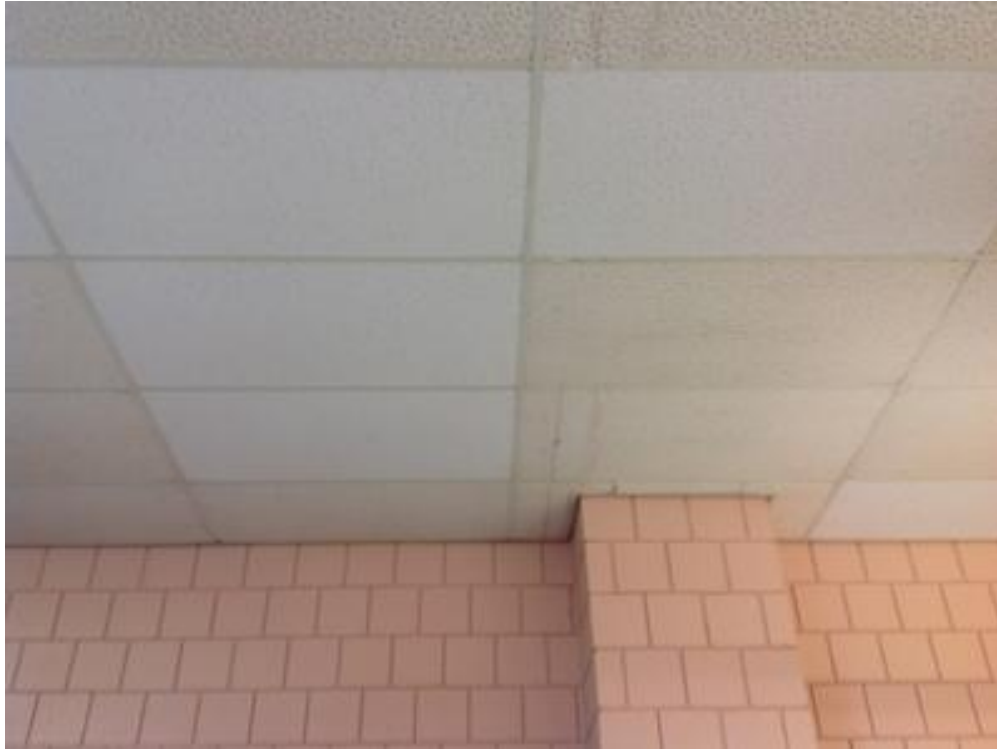
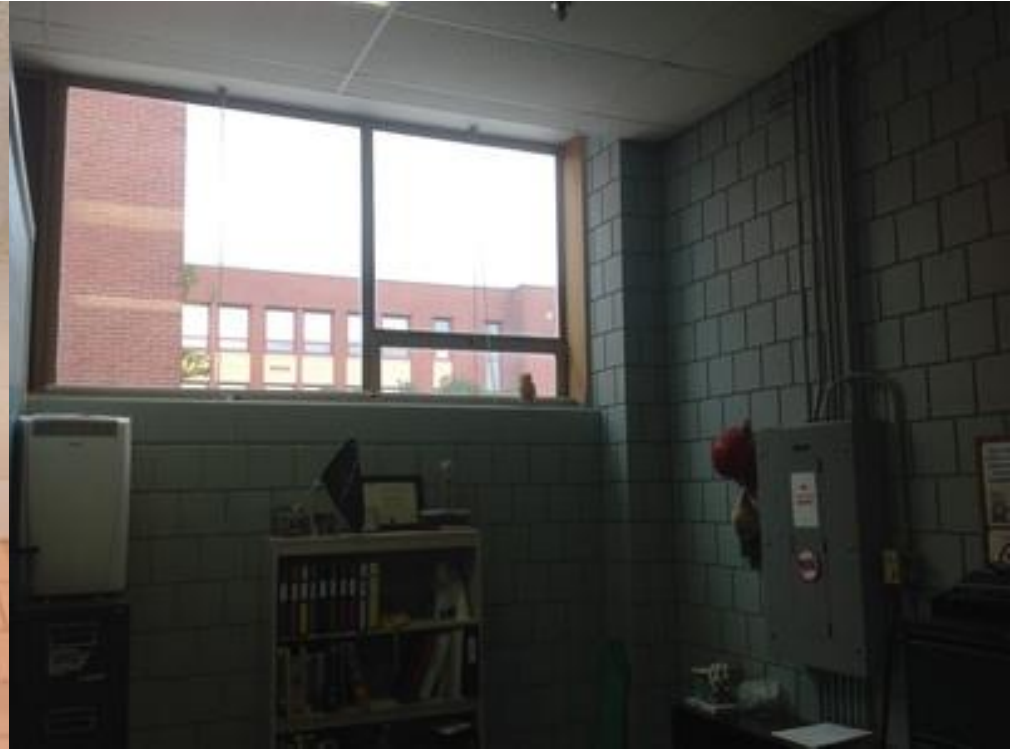
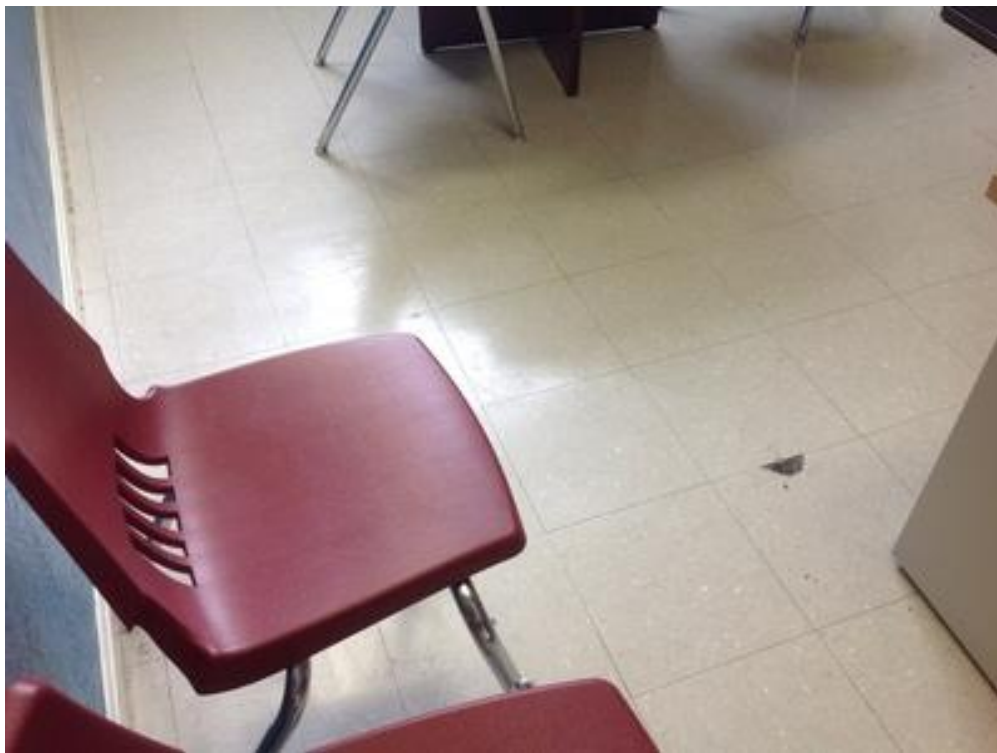
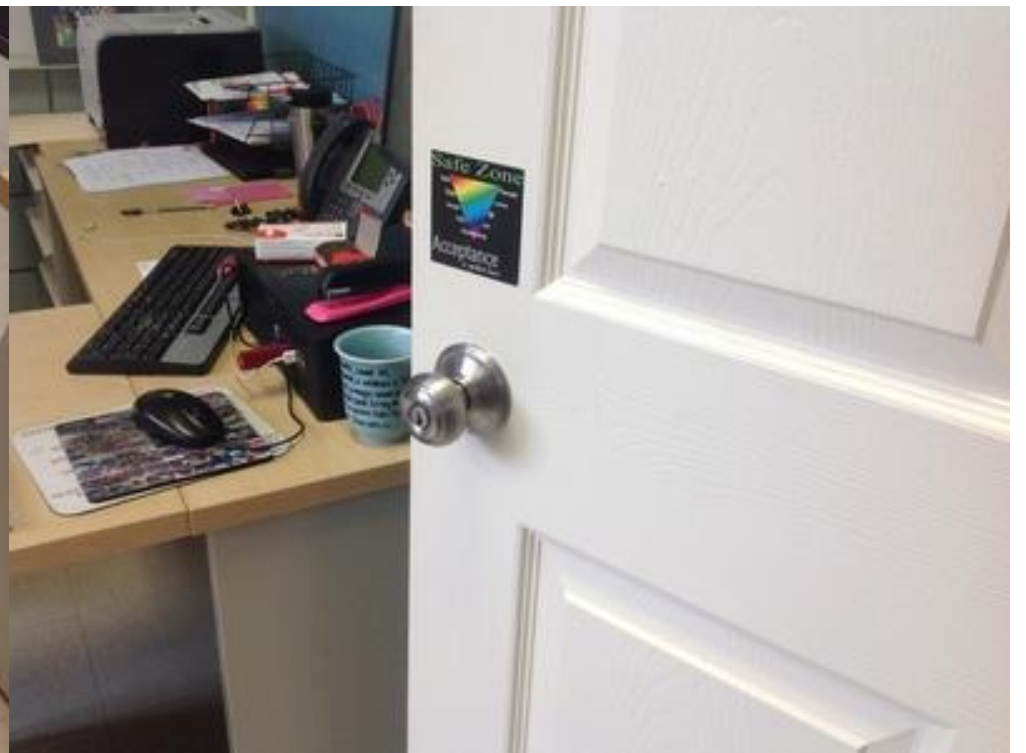
Attached Images for ID KU-00123

Space serves as office for vocations. Desk is not accessible. Door hardware is not accessible. Flooring is in fair condition. CMU walls are in fair condition. ACT ceiling is in poor condition. Mismatching, broken, and sagging ceiling tiles. Unit air conditioner sealed by a towel.

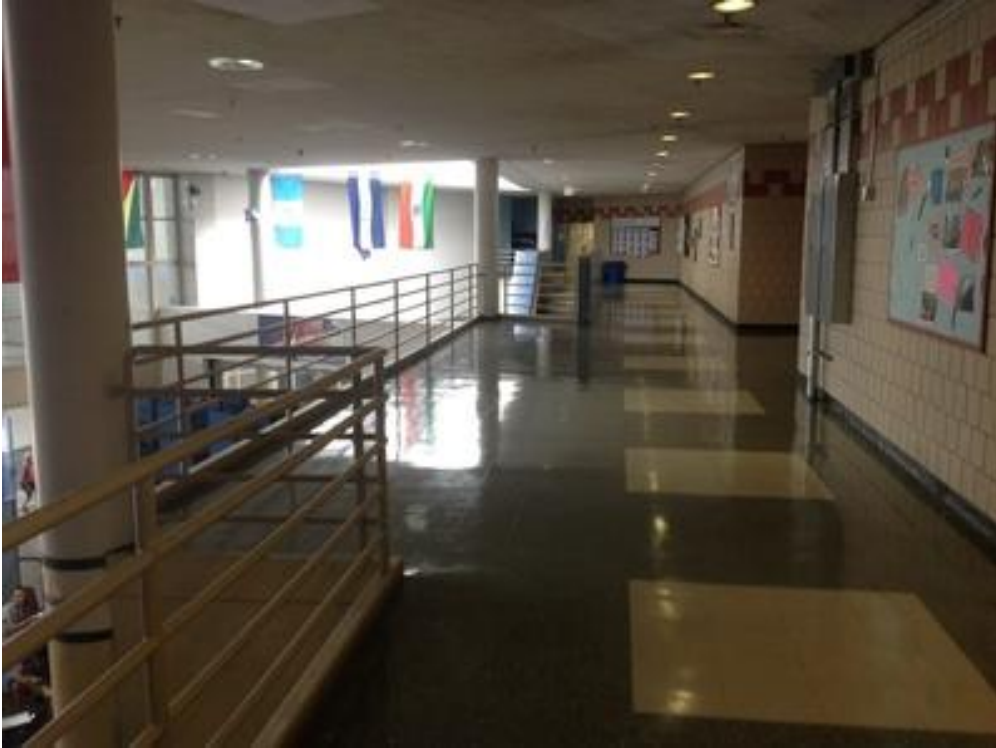
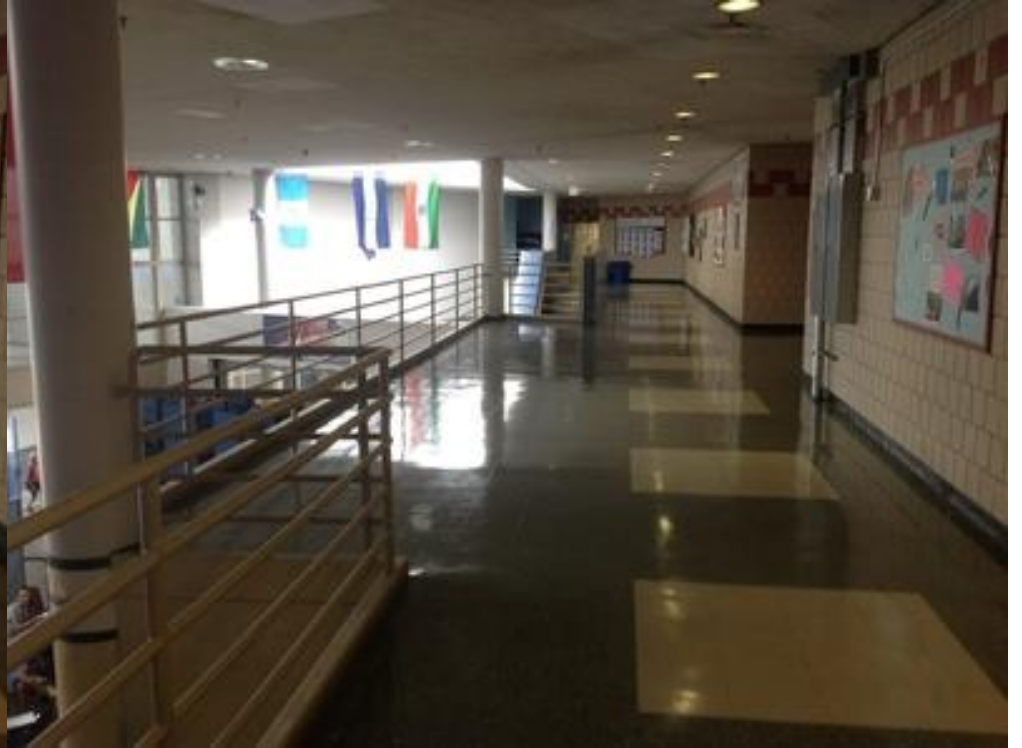
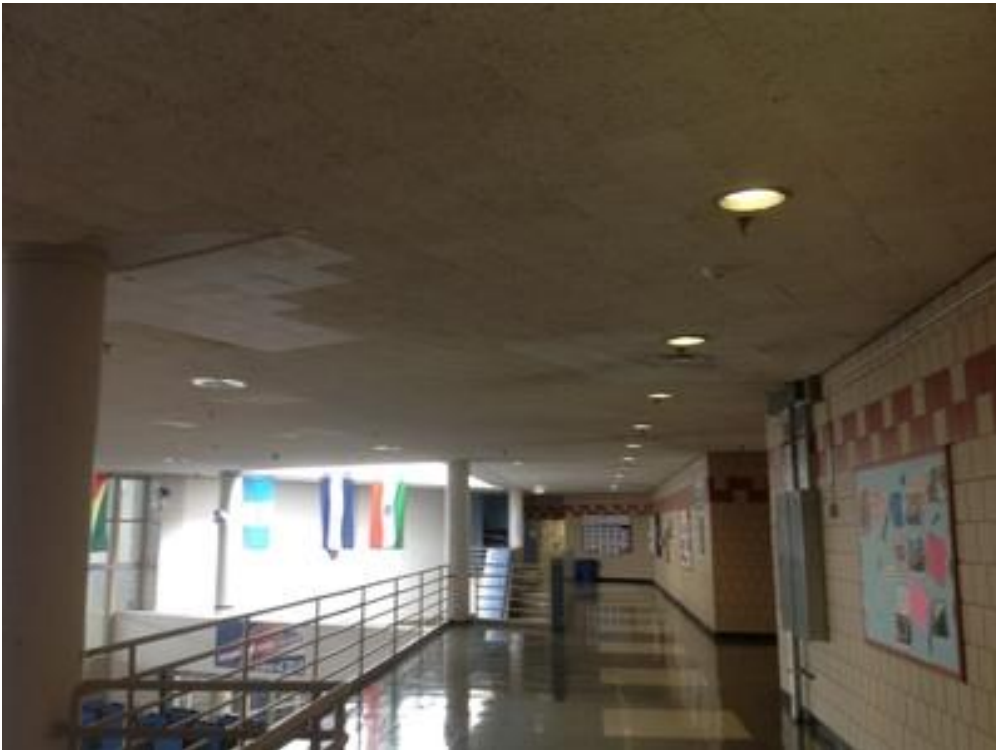
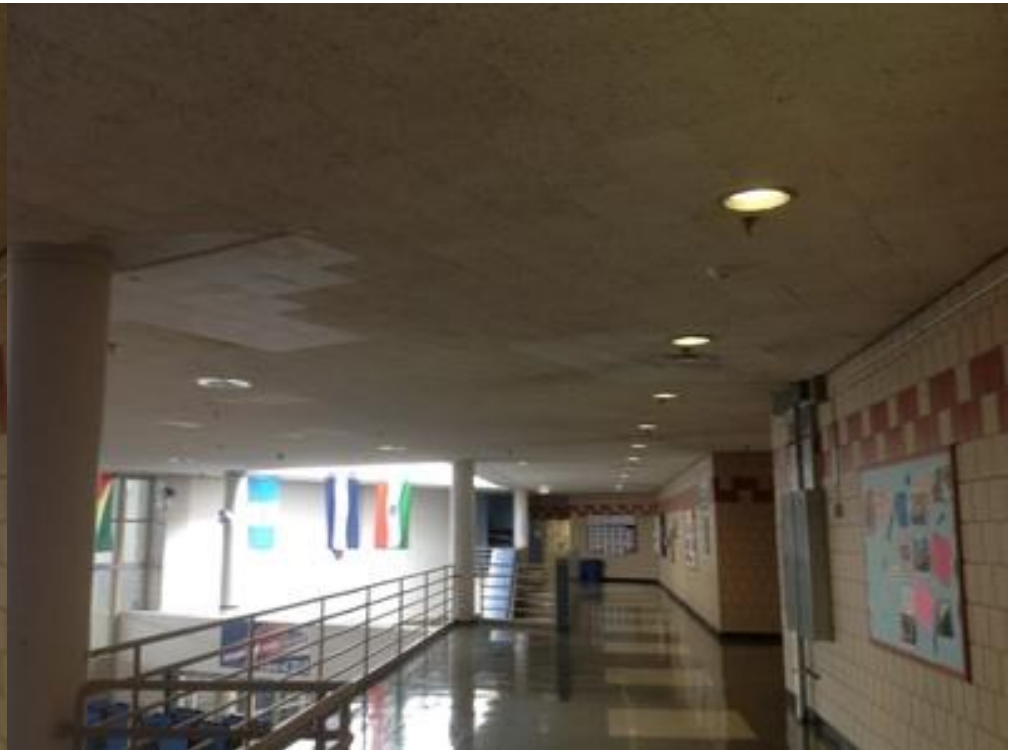
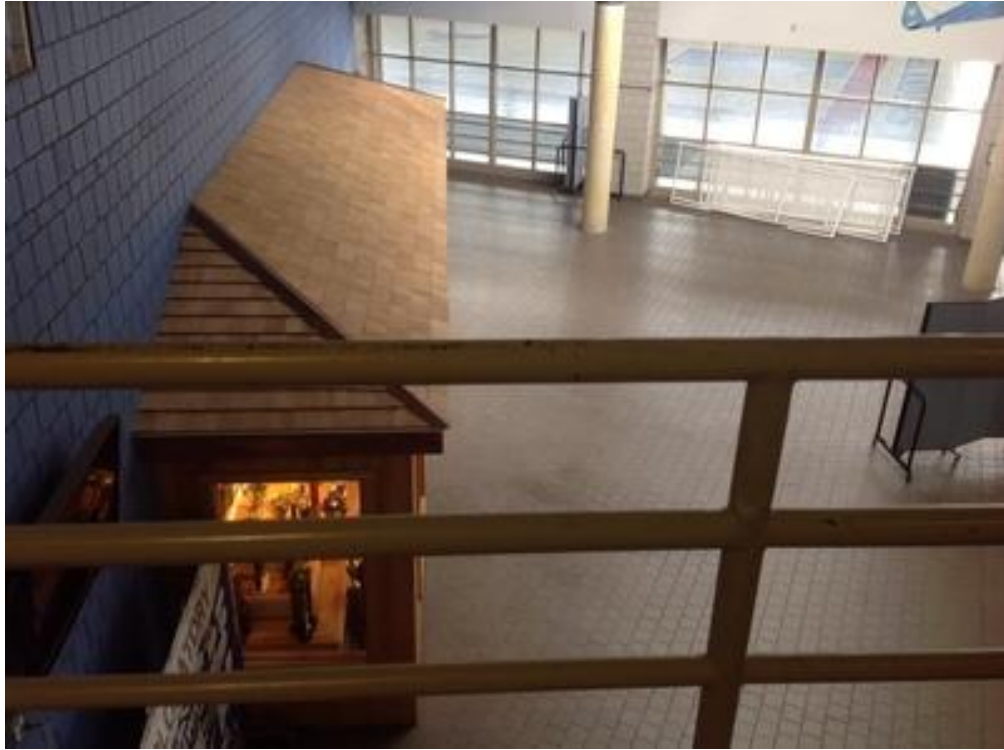
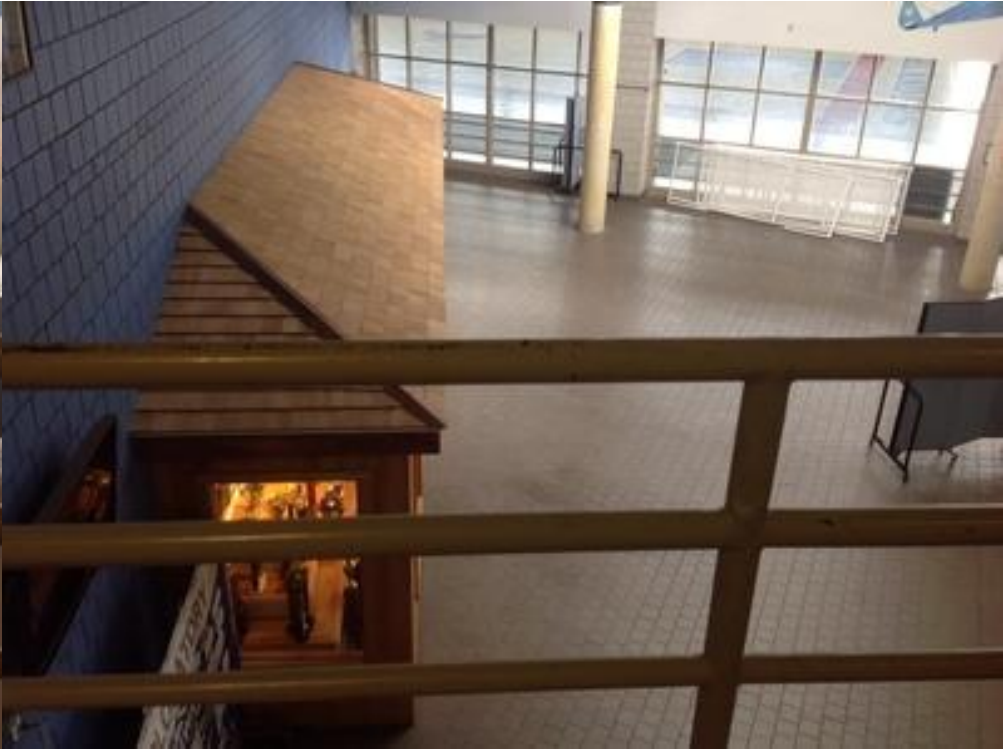
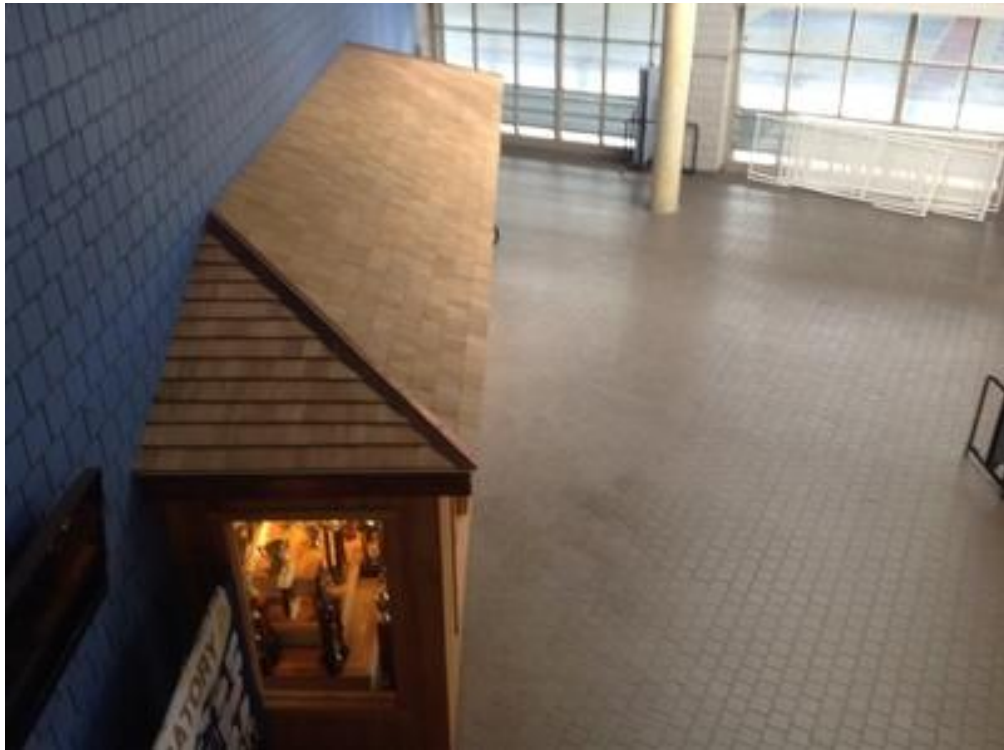
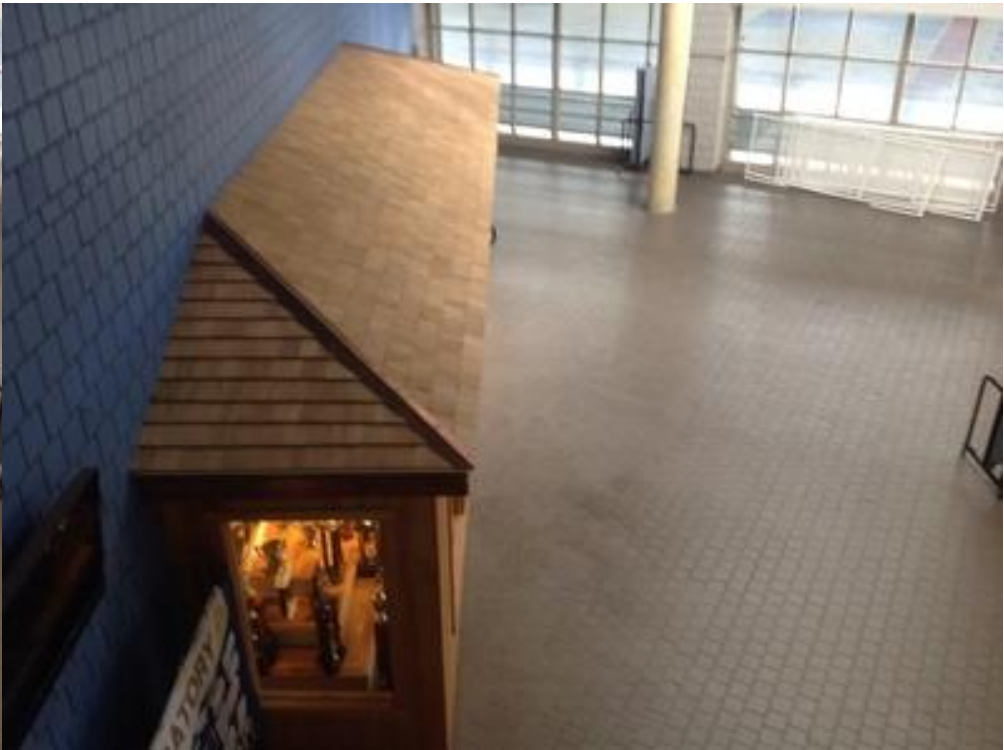
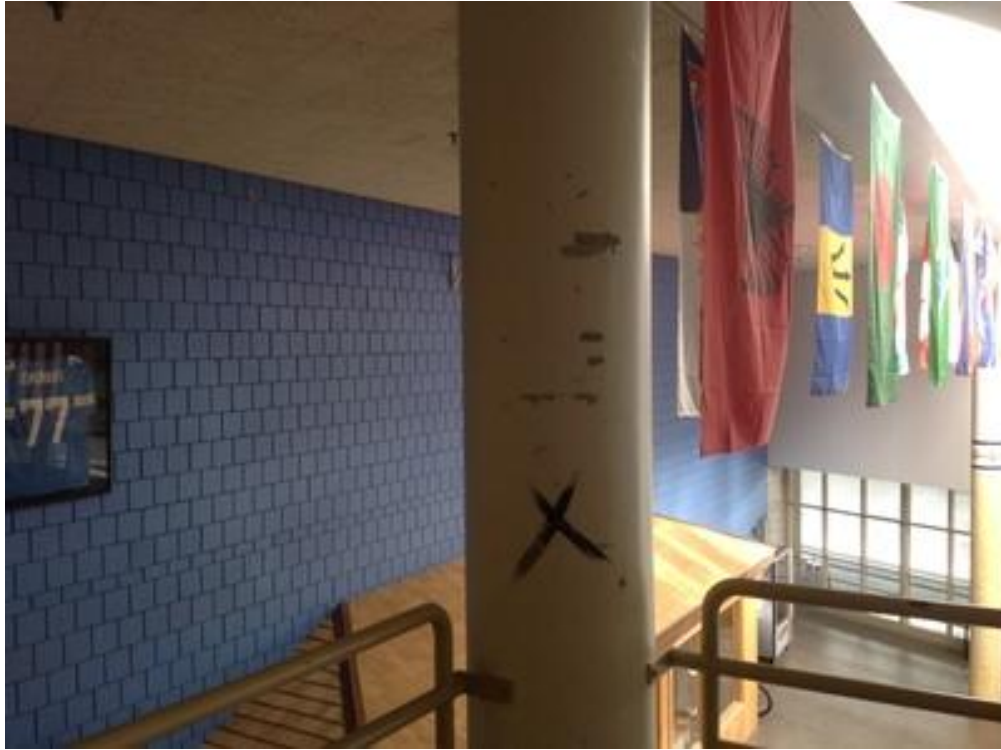
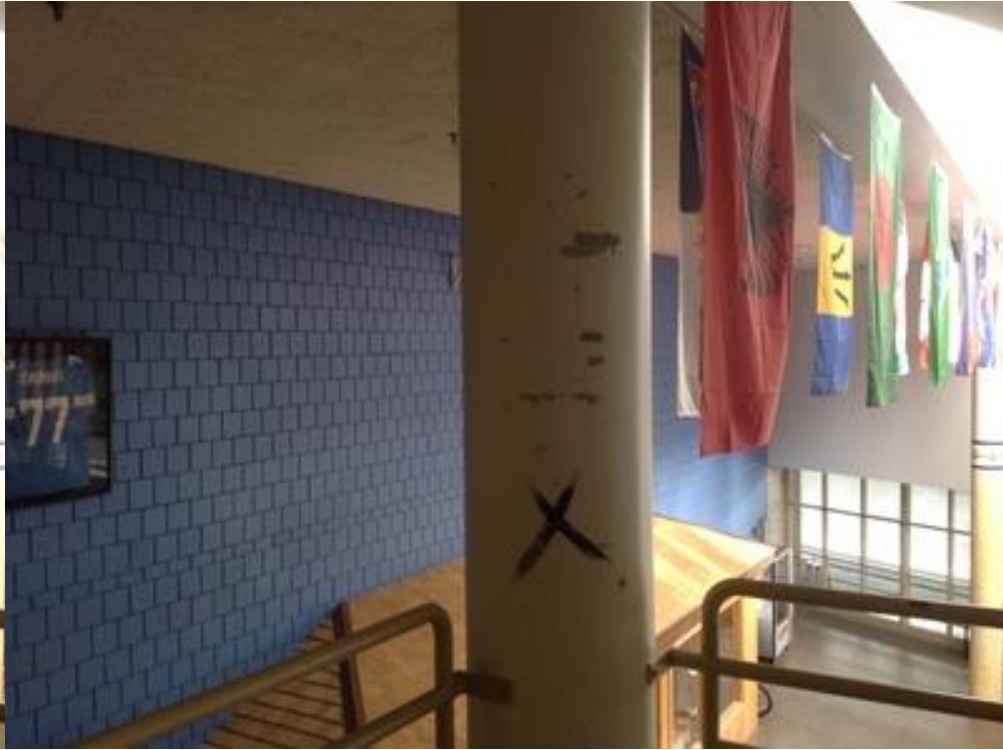
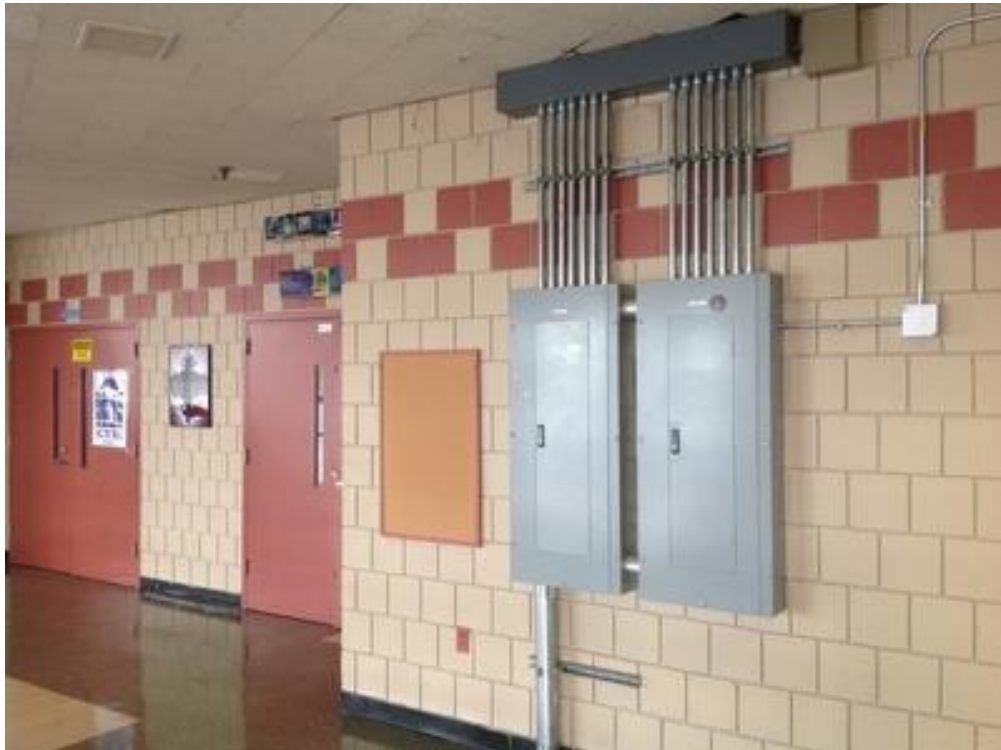
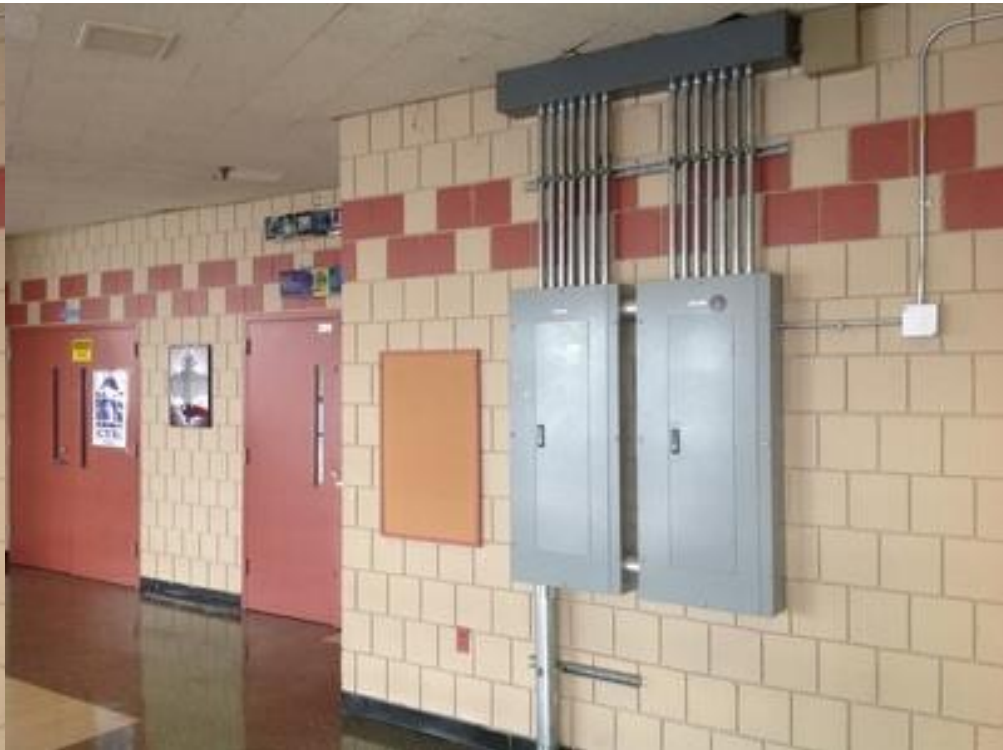
Building E- Corridors

Description
Typical - Corridors are in fair condition. Flooring is in good condition. Surface mounted equipment is haphazard. GWB walls and column covers have some minor scuffs and dent damage. ACT ceiling in poor condition. Tiles are stained, mismatched, and damaged.
