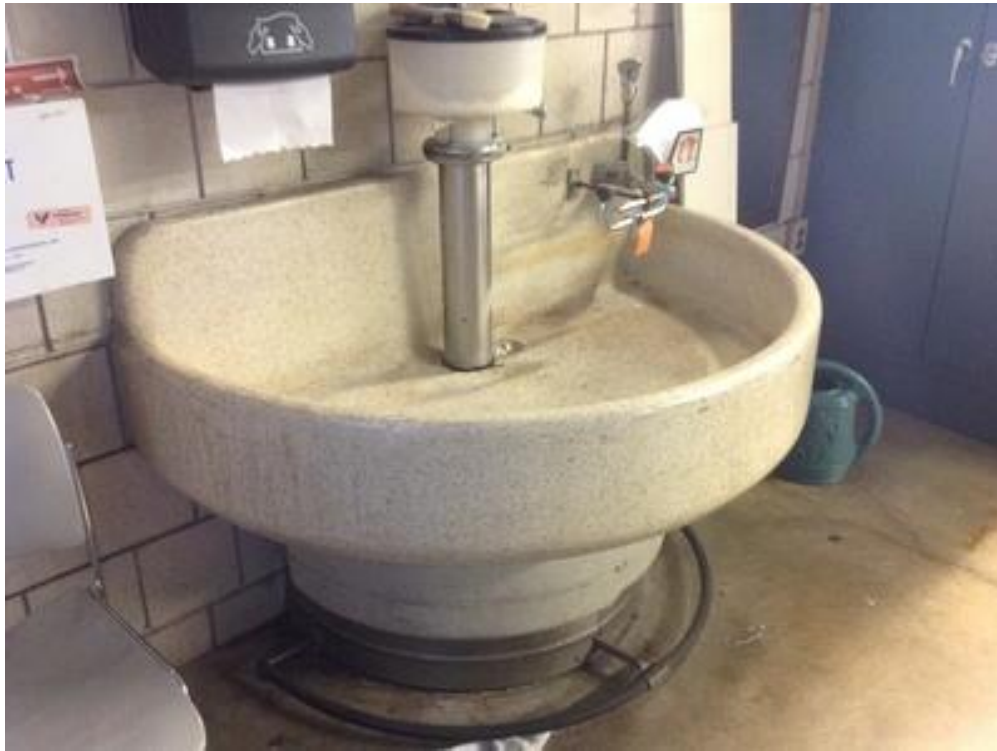
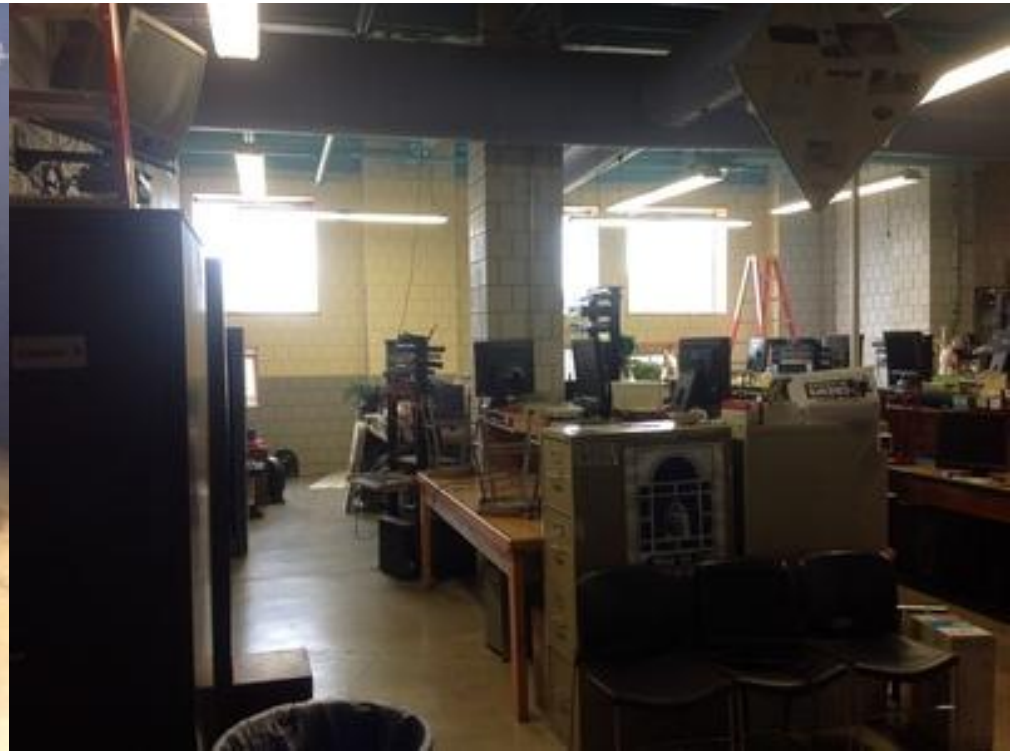
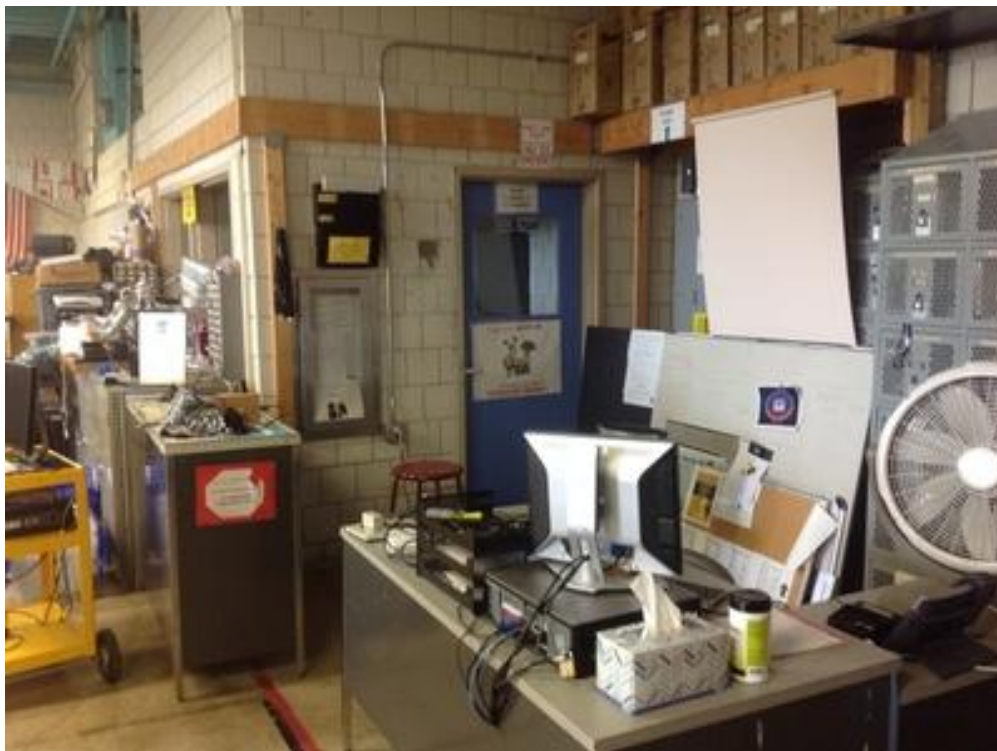
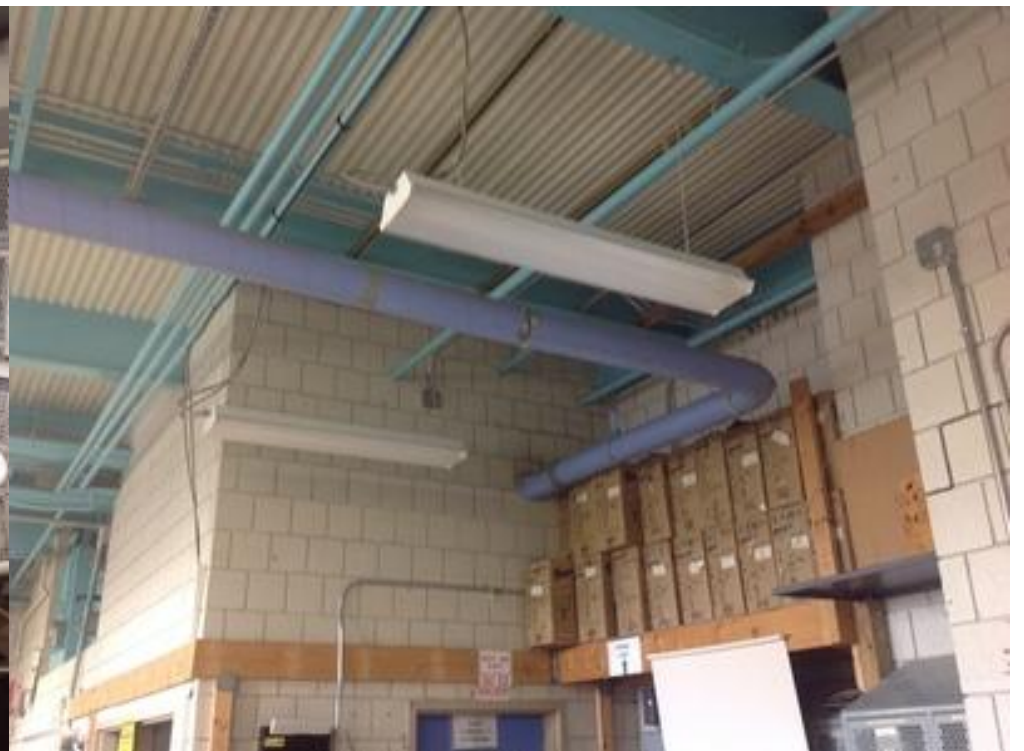
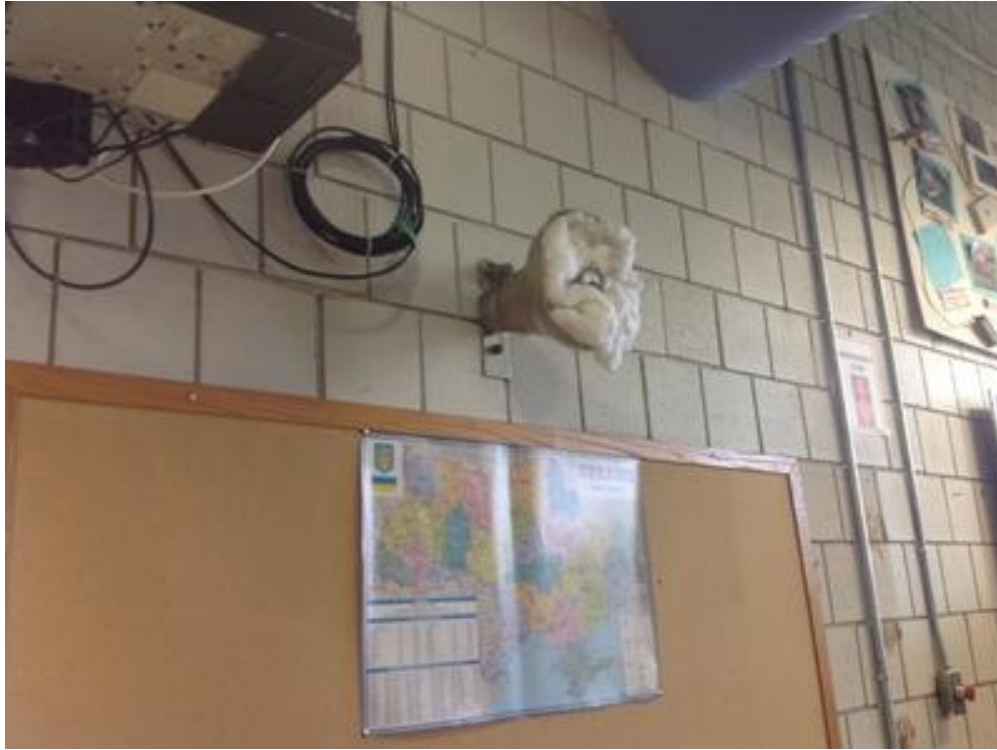
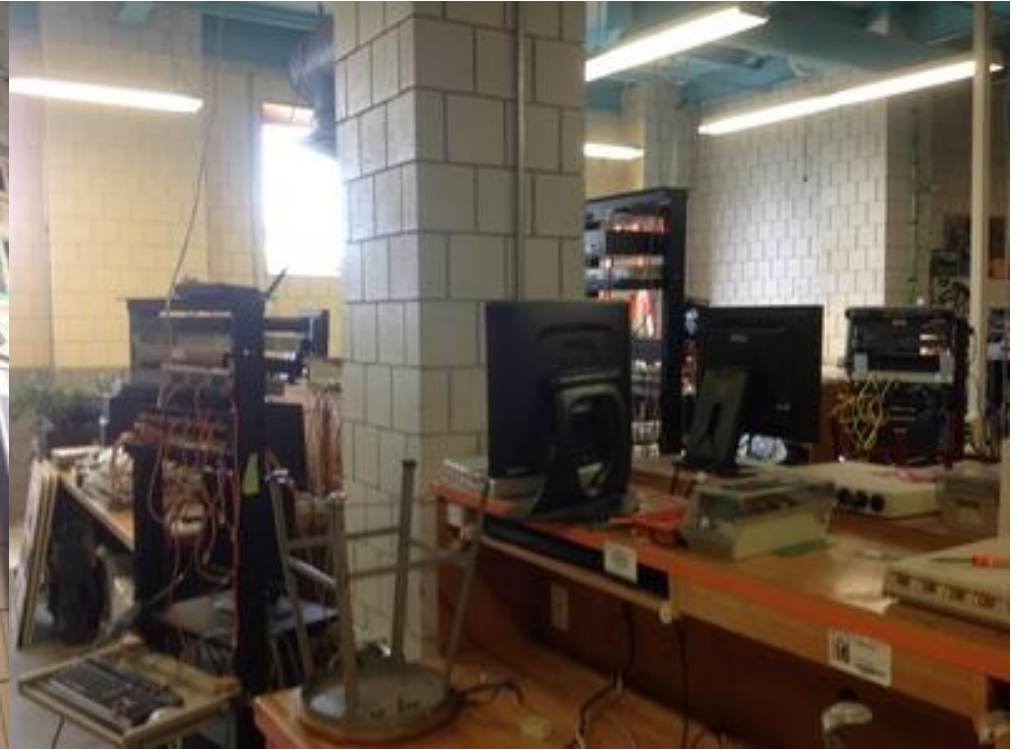
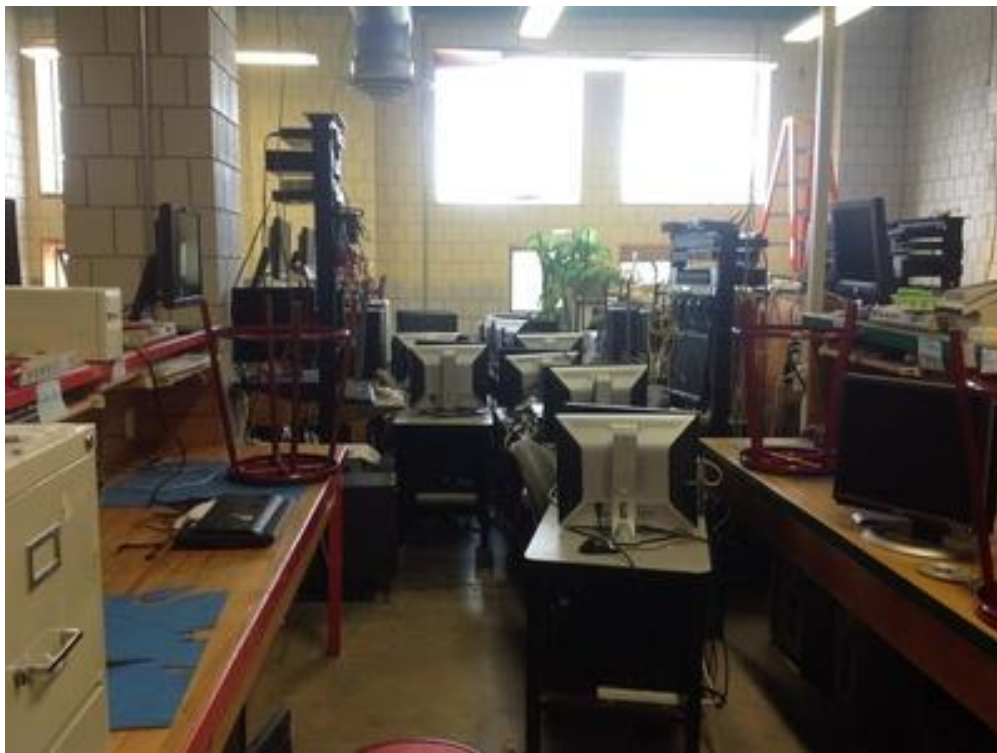
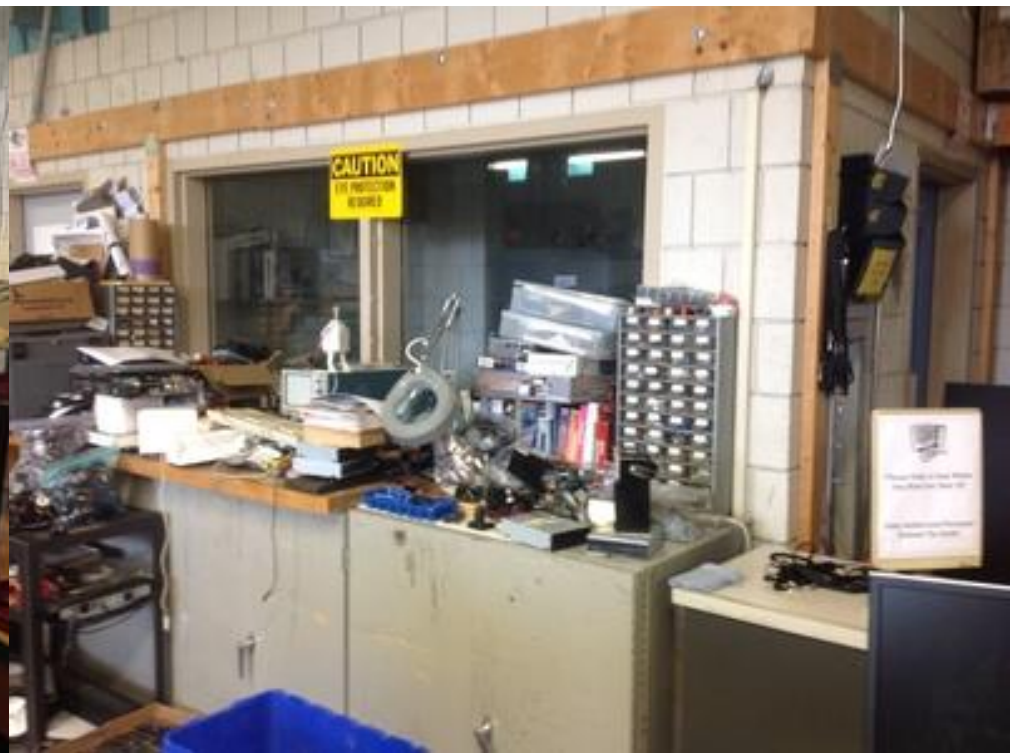
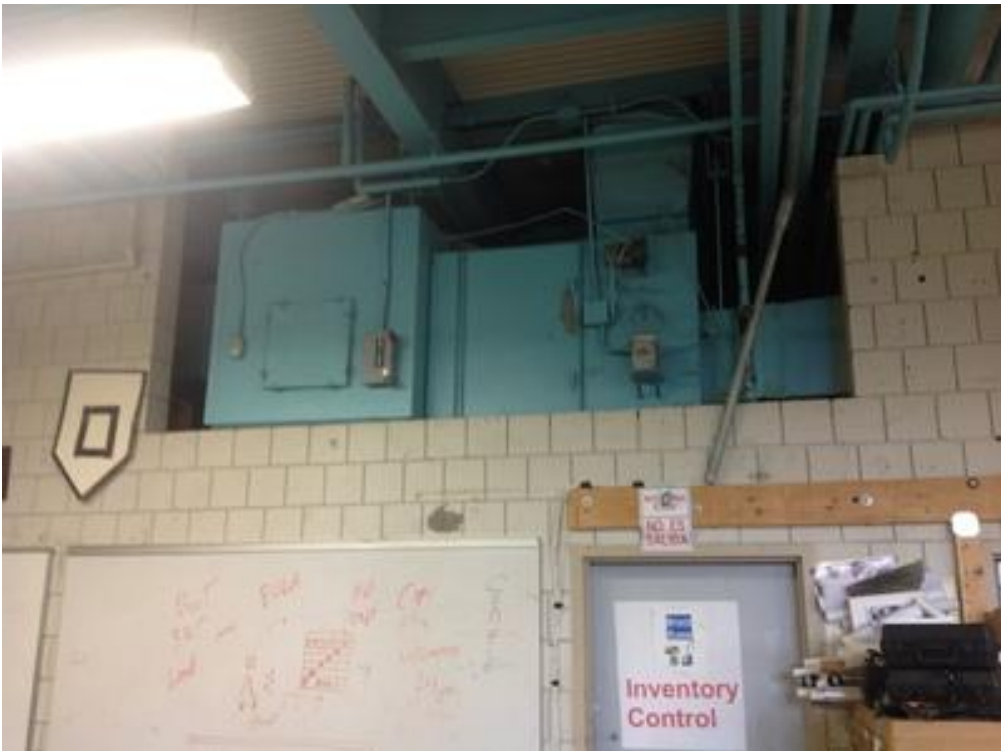
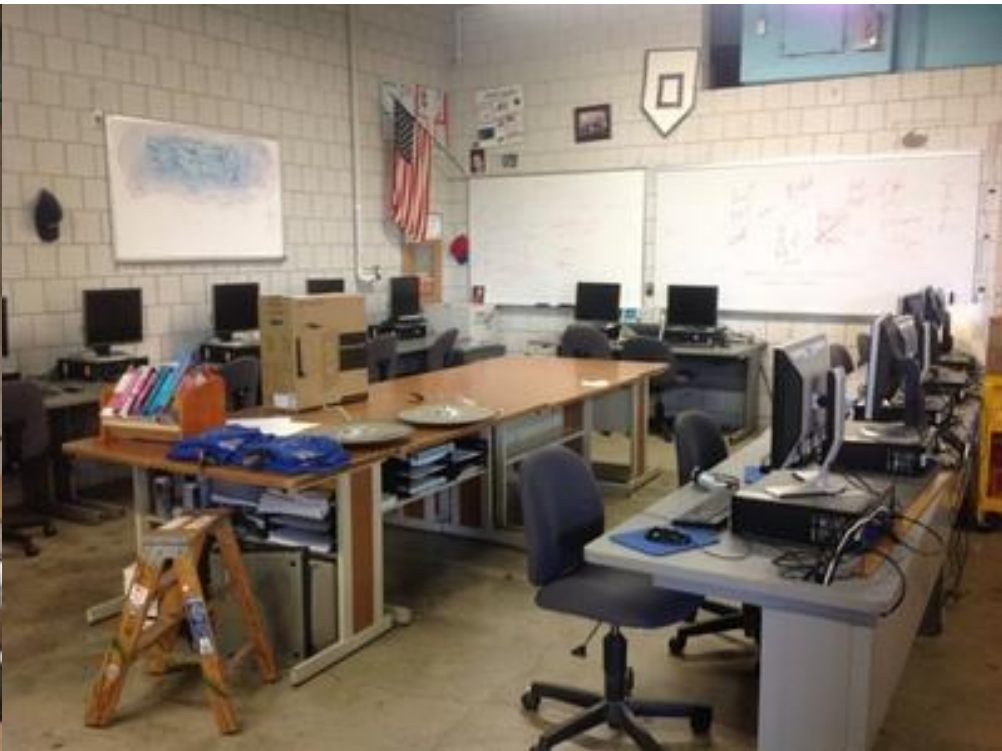
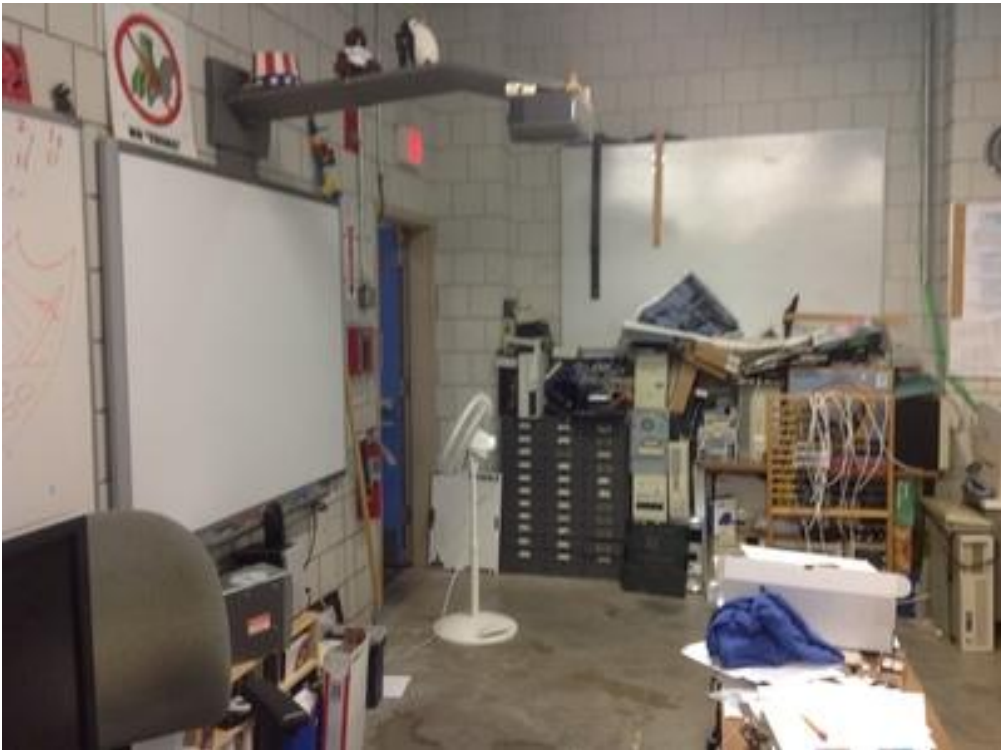
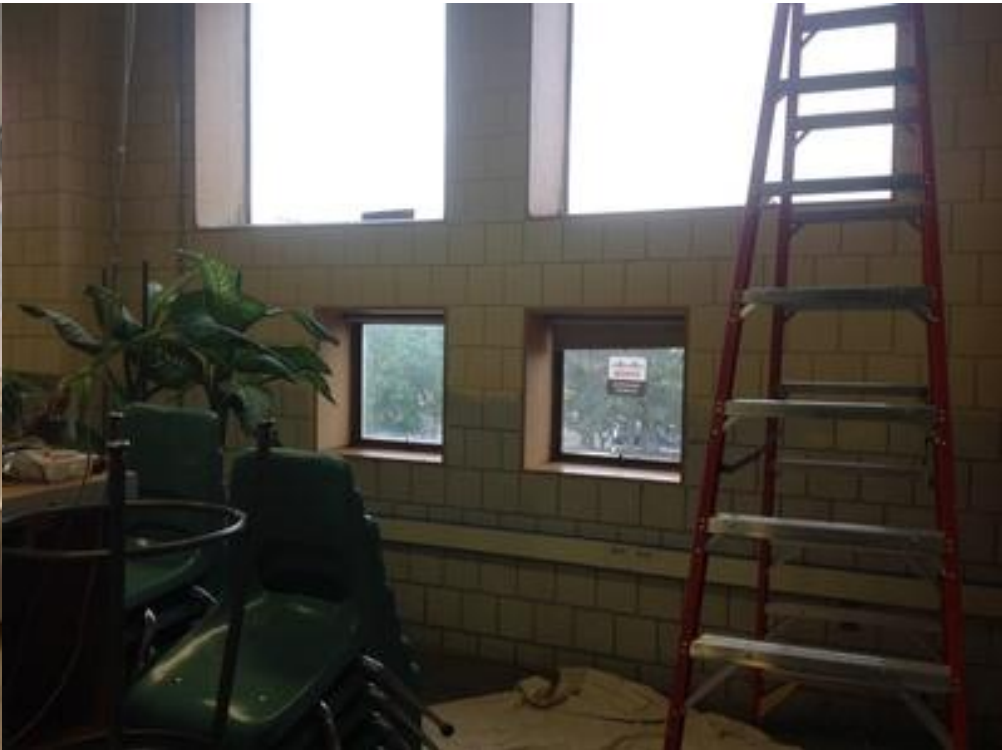
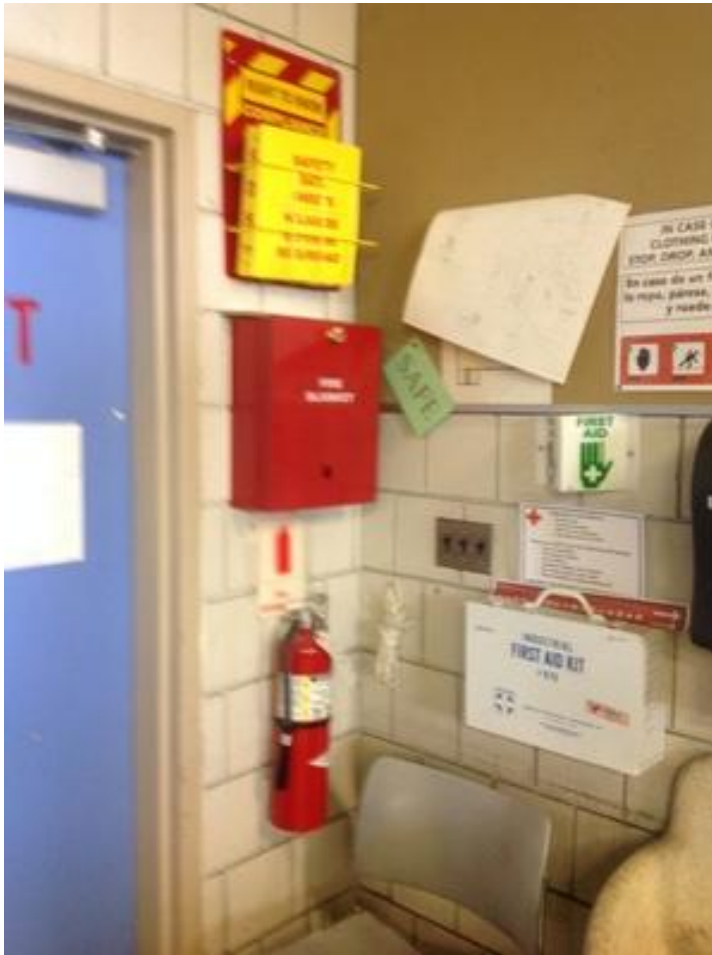
Description
Computer Repair Lab in fair condition. CMU walls in fair condition. Painted structure about is exposed. Space is cluttered with items and debris. Classroom area in fair condition. Storage cabinets in poor condition. Drinking fountains not ADA compliant.

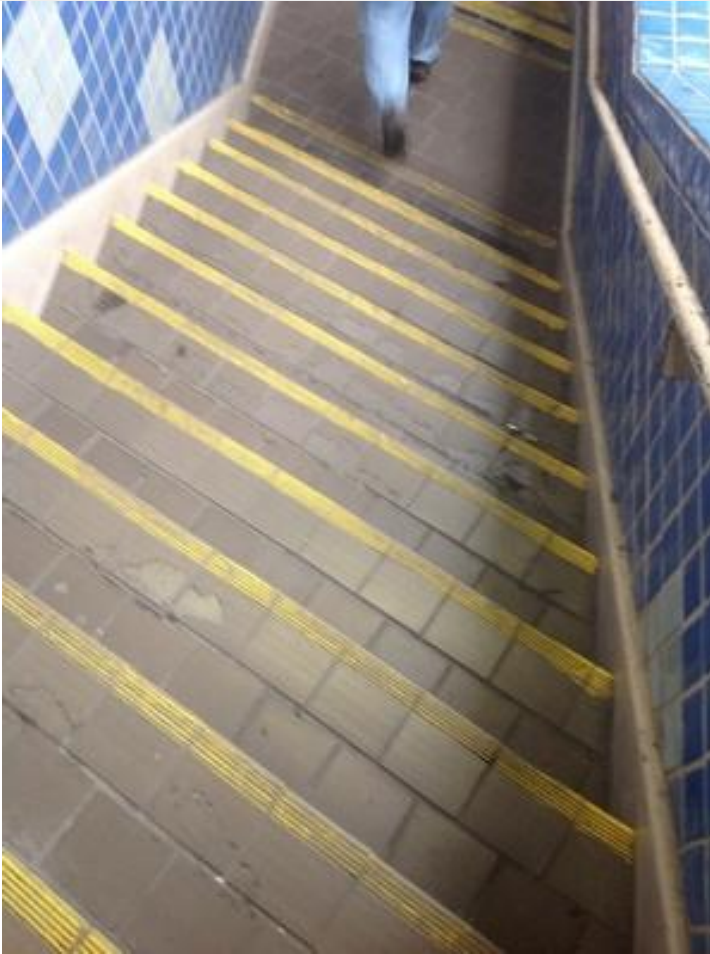
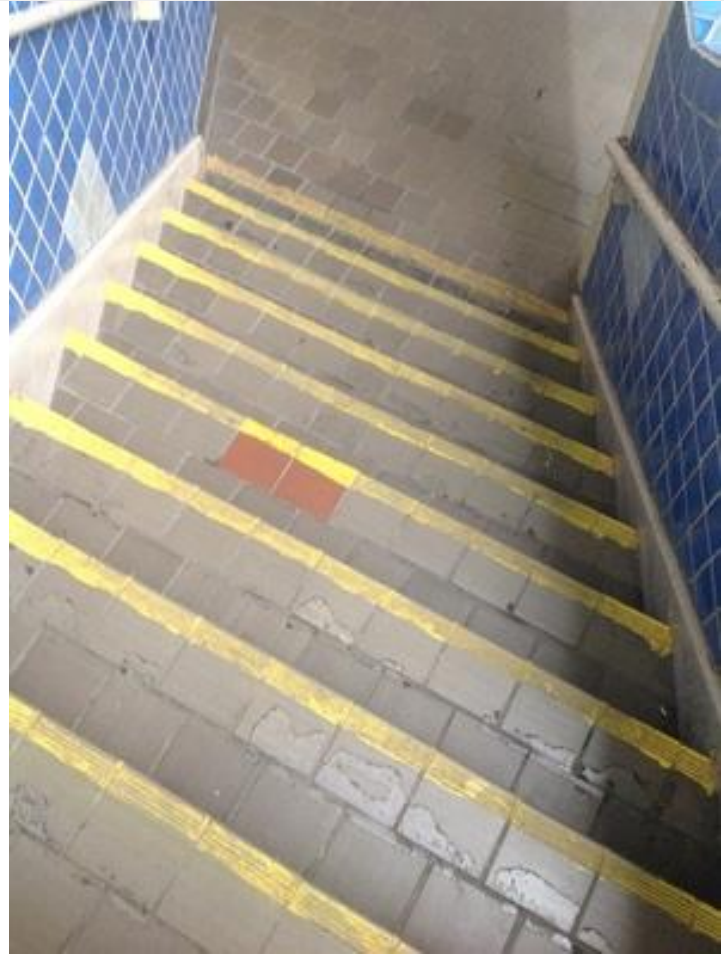
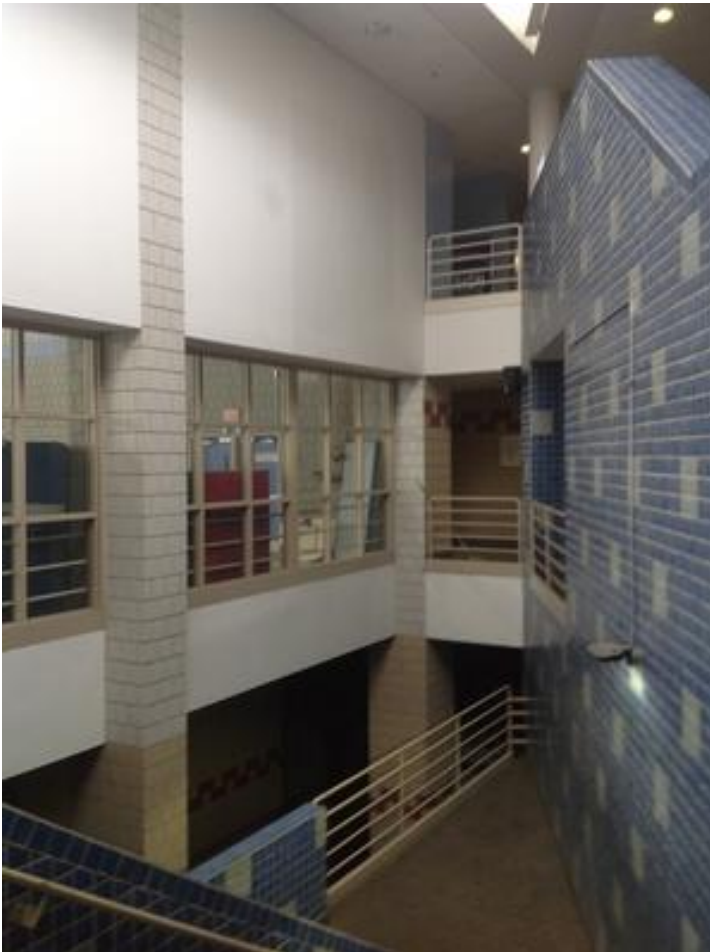
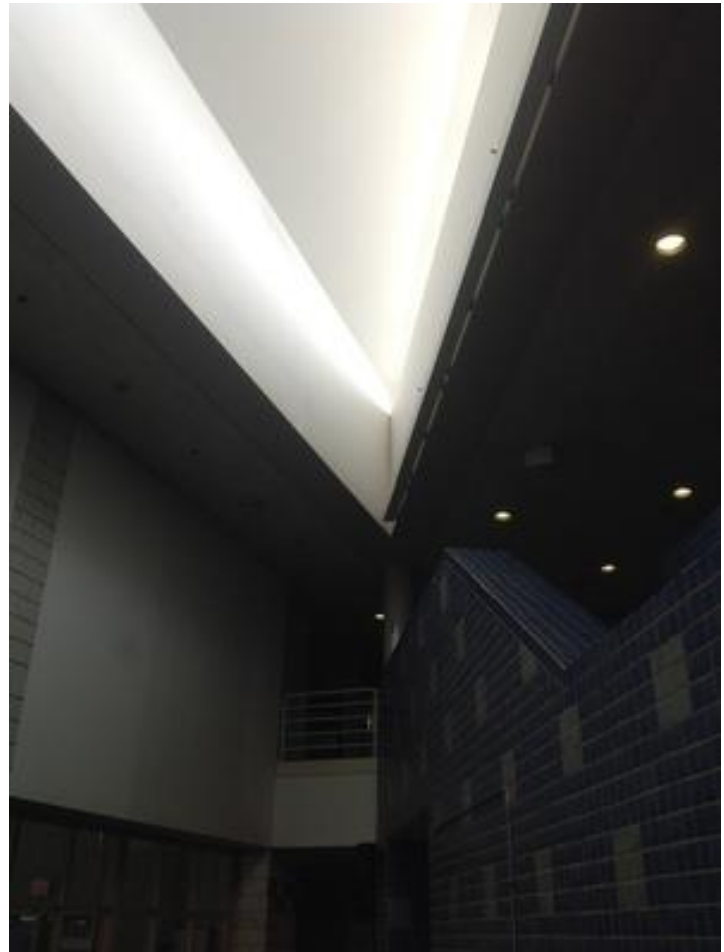
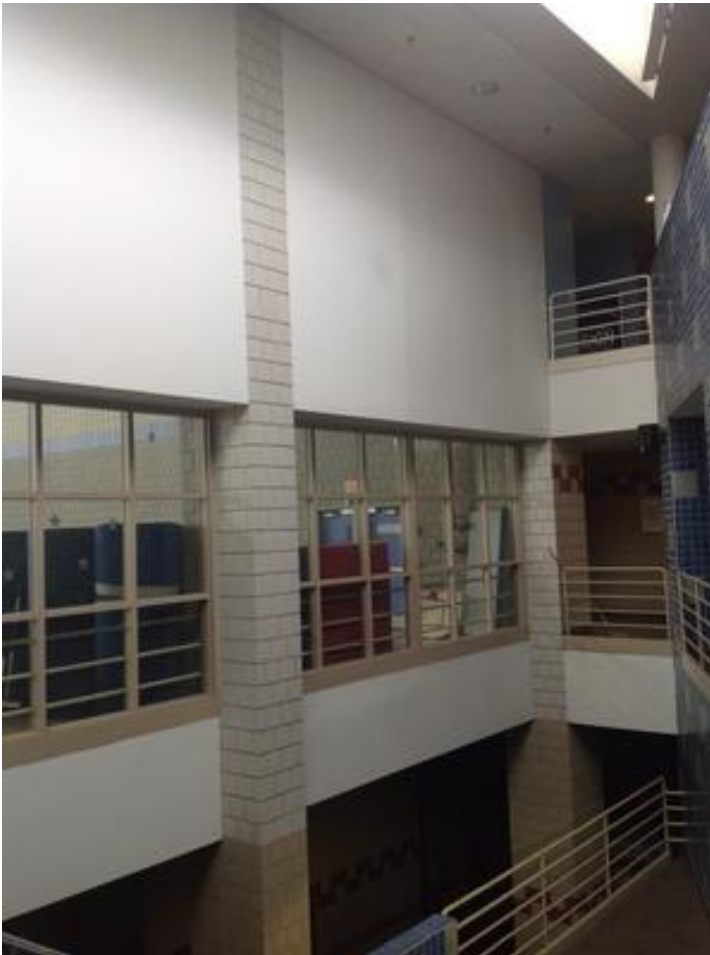
Attached Images for ID KU-00126

Stairs are in poor condition. Significant wear on tiles. Nosing strips are significantly deteriorated. Some patching has occurred with mismatching tiles. Stair angled orientation is awkward and may not be compliant with current ADA standards.

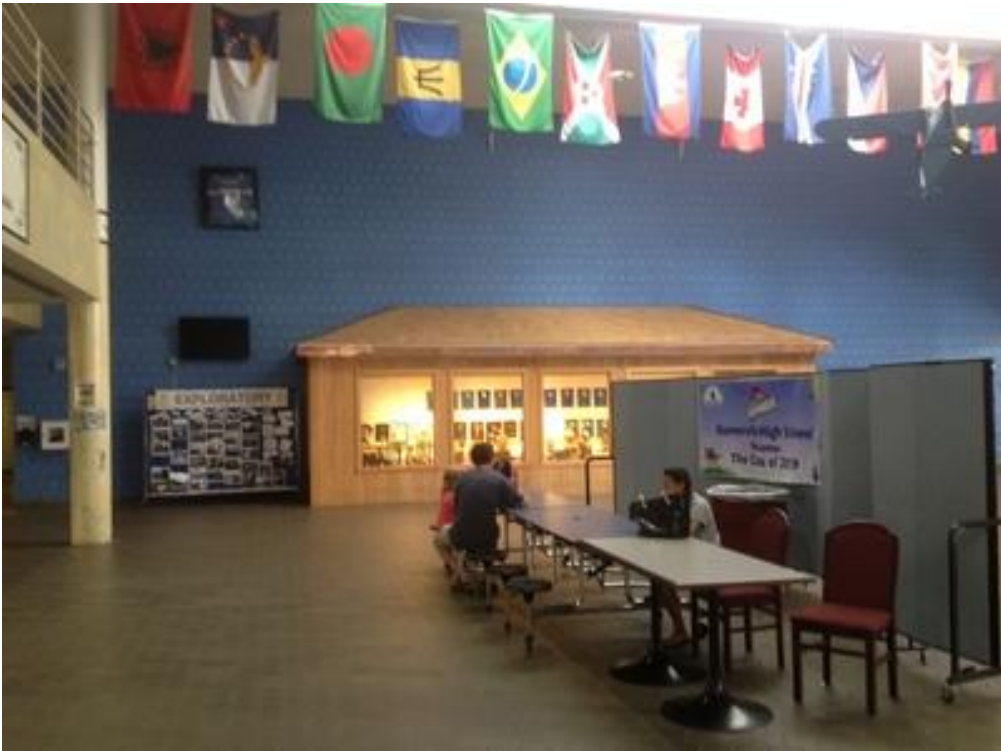
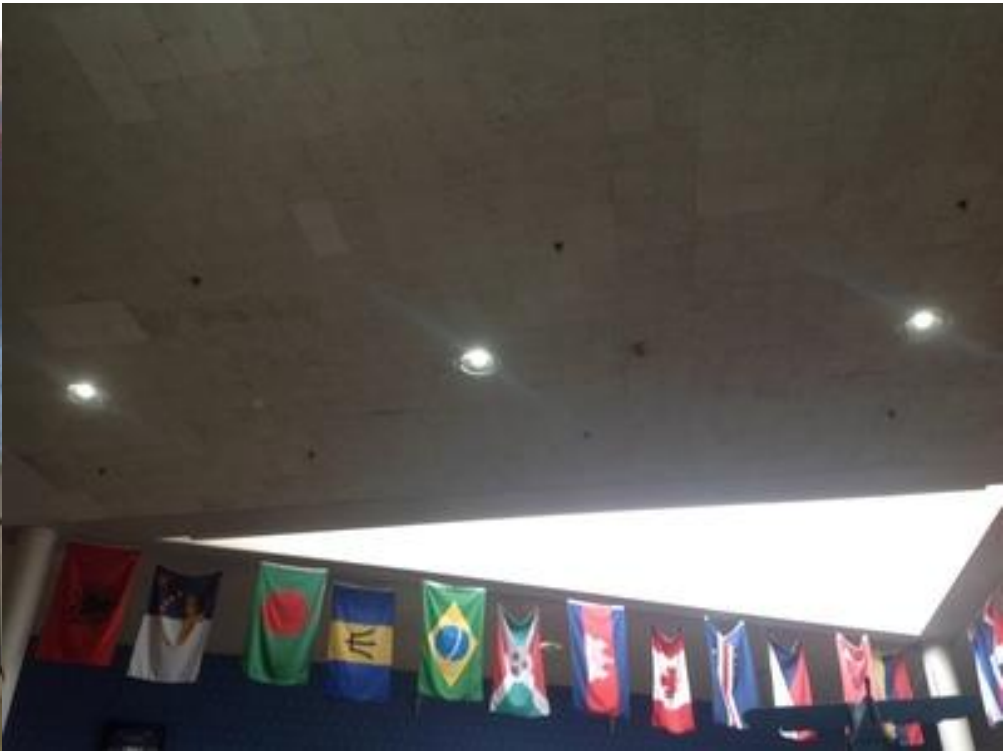
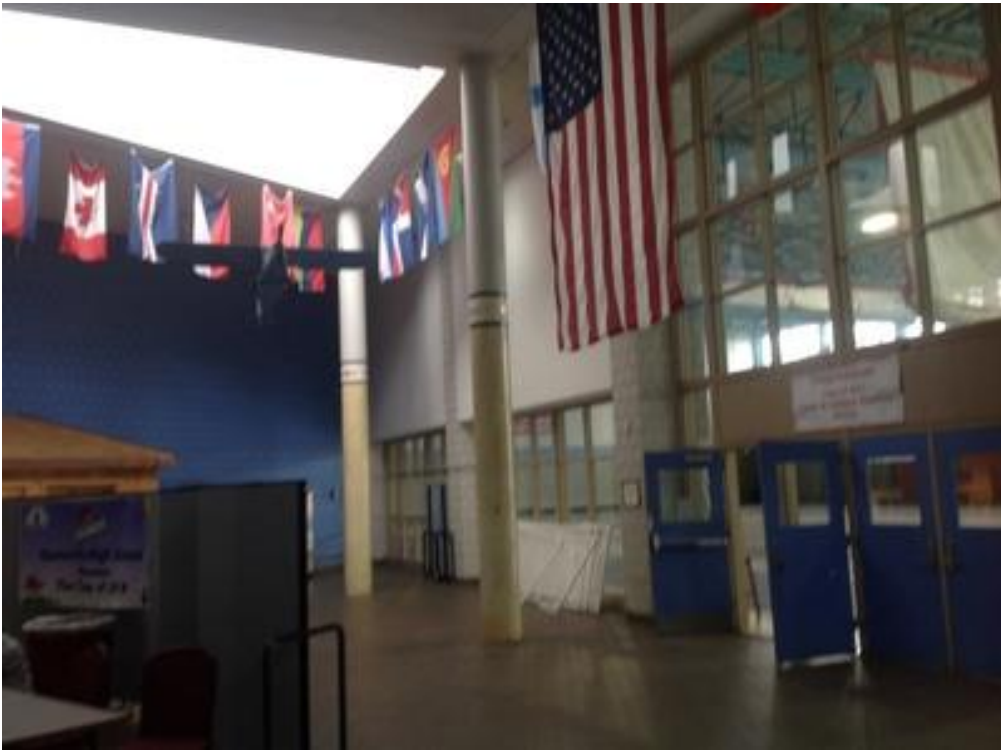
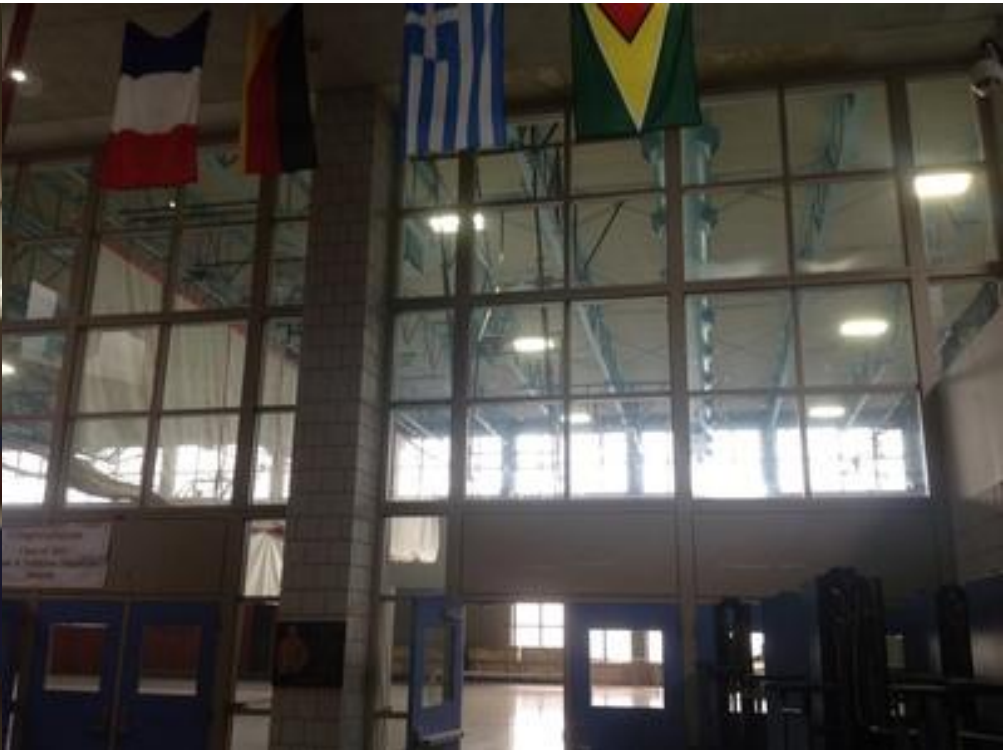
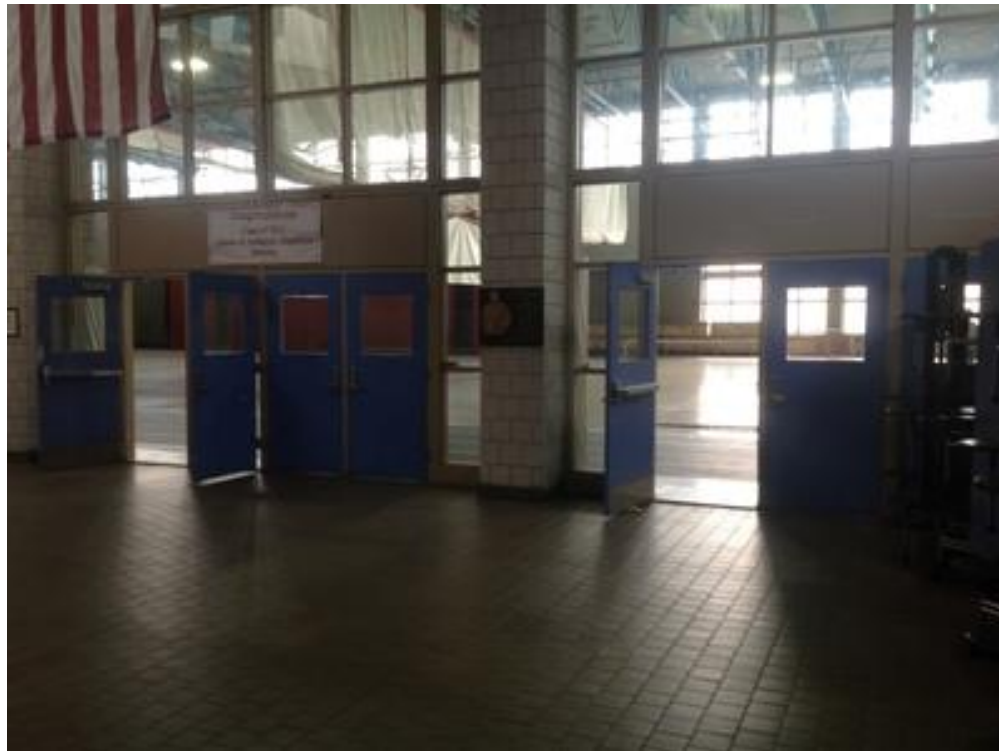
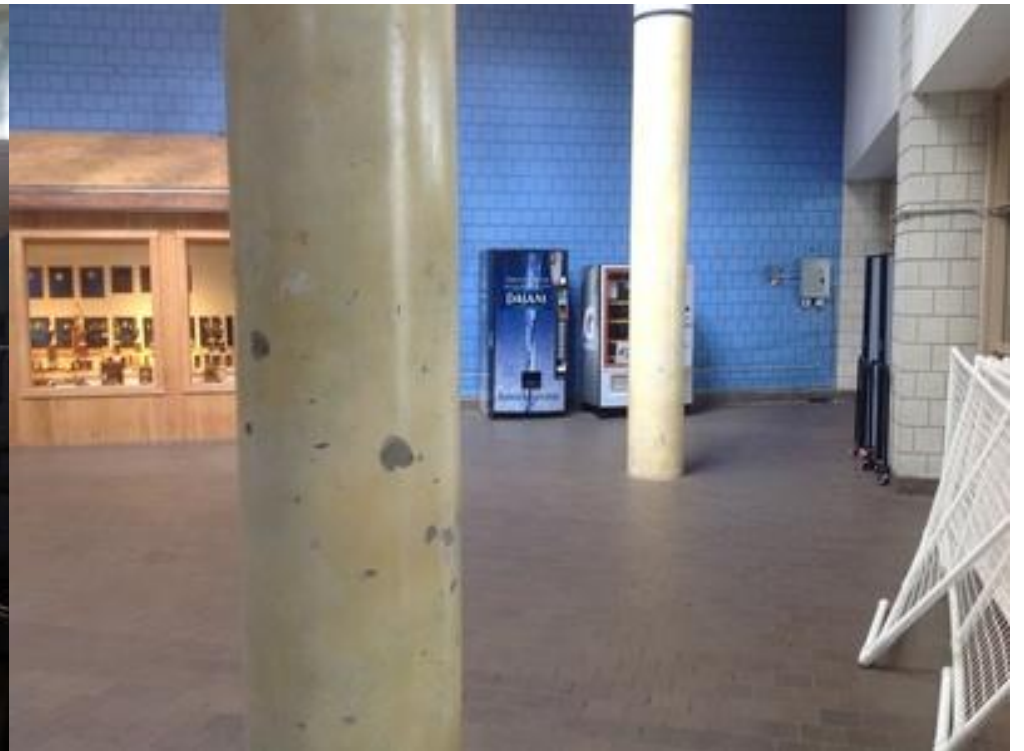
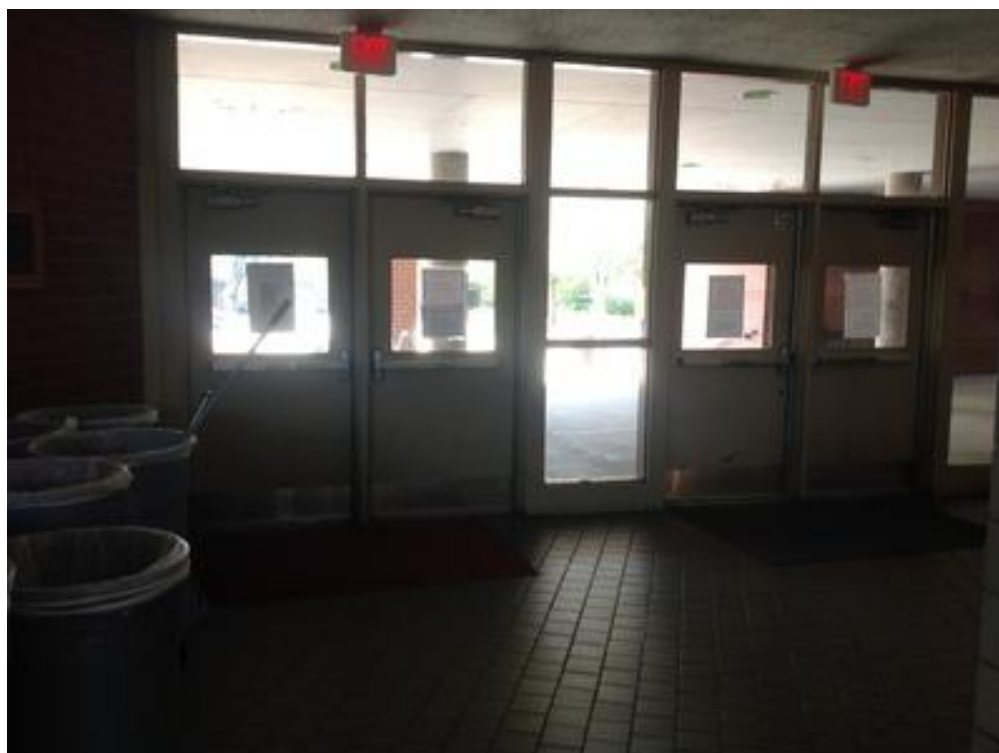
Attached Images for ID KU-00127

CT flooring is in fair condition. ACT ceiling is in poor condition. Tiles are mismatched, broken, and stained. Column covers show significant wear. Storefront is in fair condition.

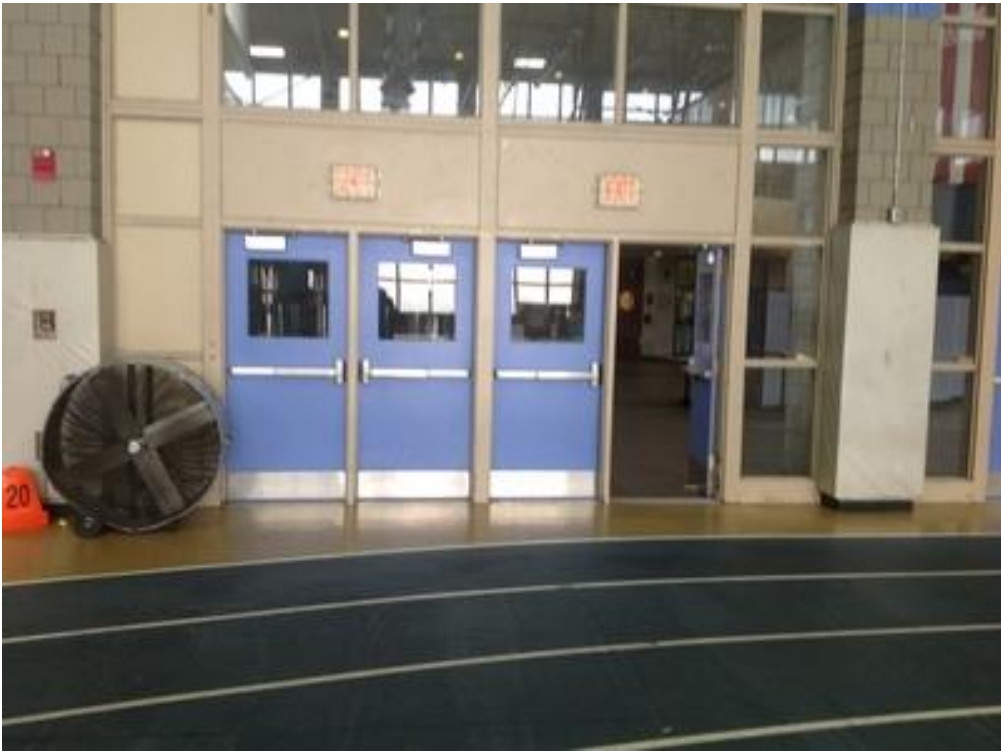
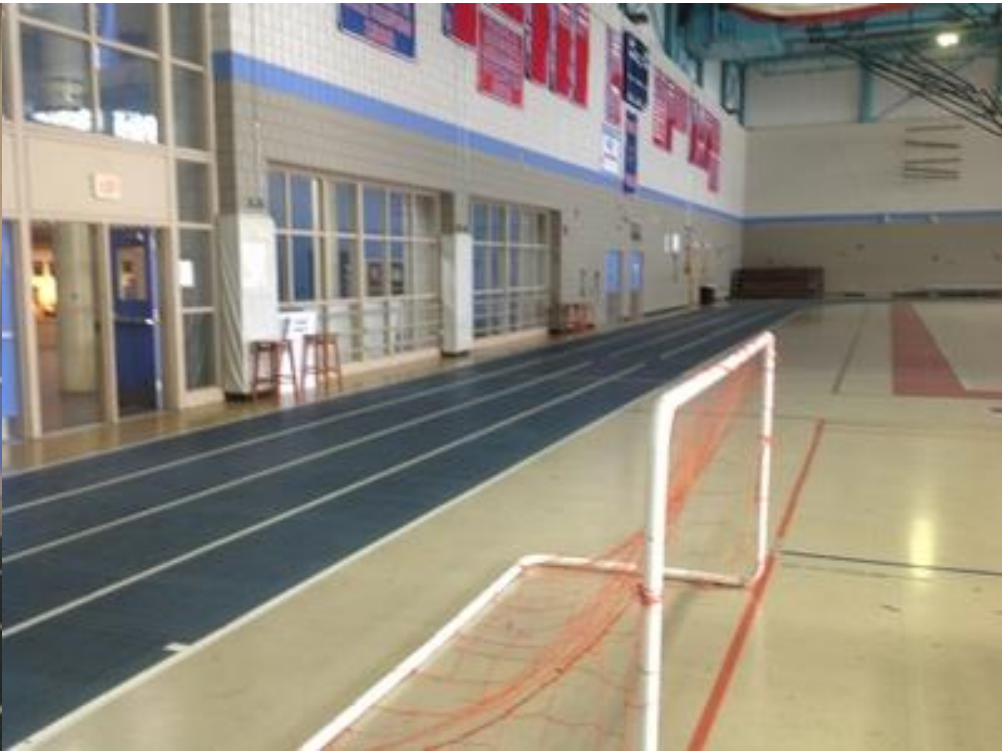
Description
Gymnasium is in fair condition. Storefront has dings and dents throughout. Glazing is wire mesh. CMU block walls are in fair condition. Flooring is in poor condition. Painted structure exposed above.
