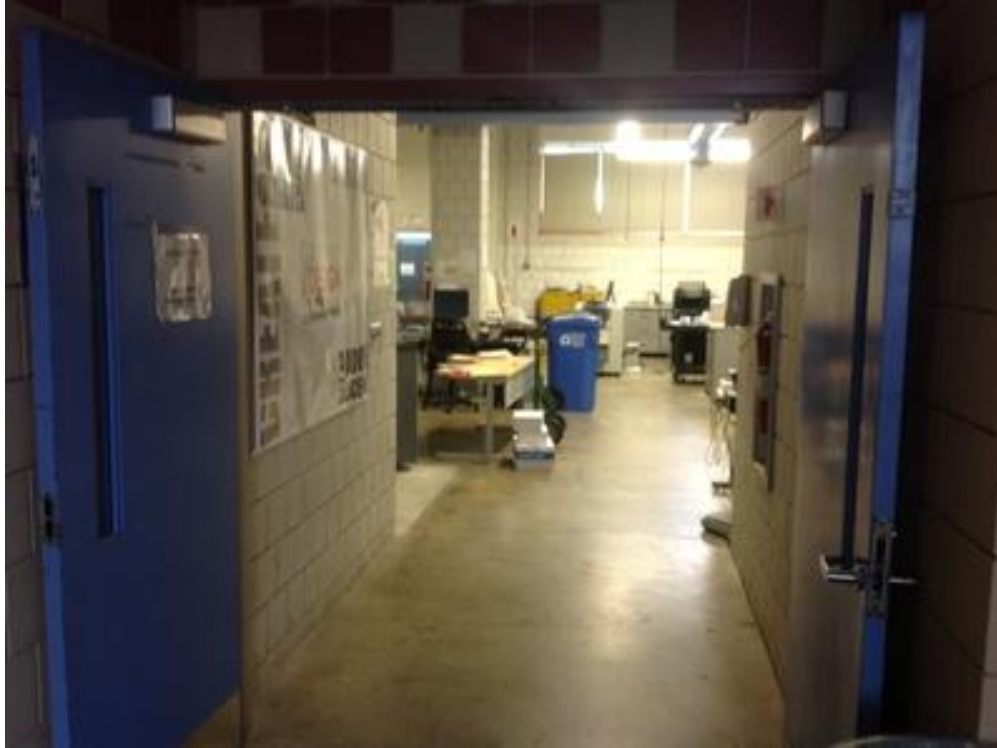
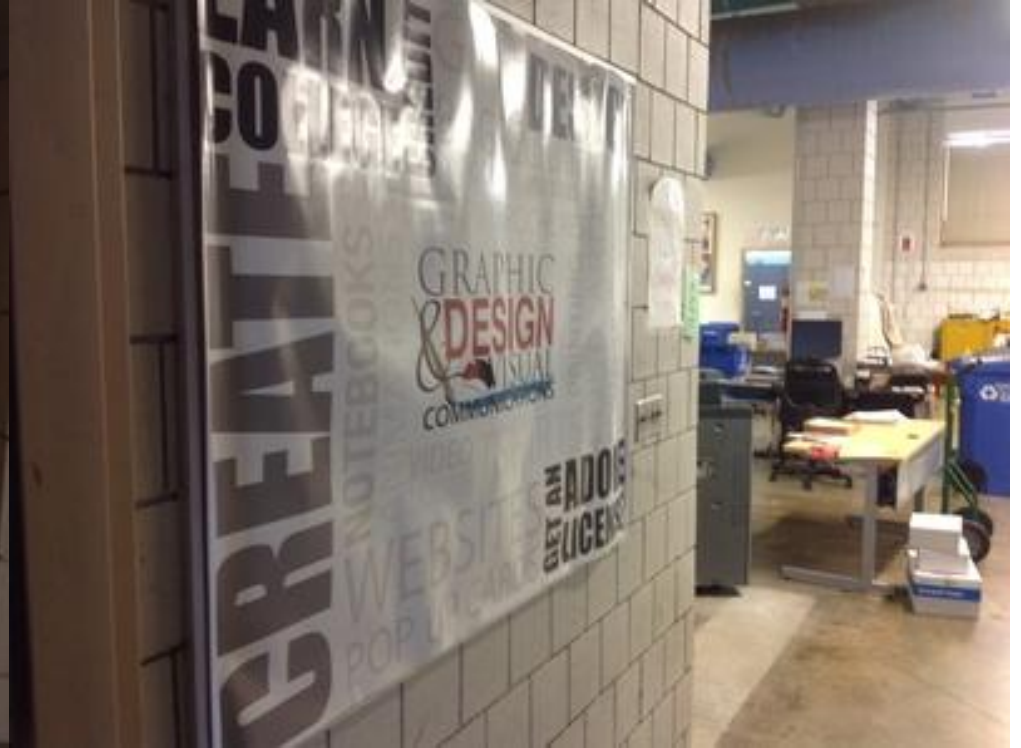
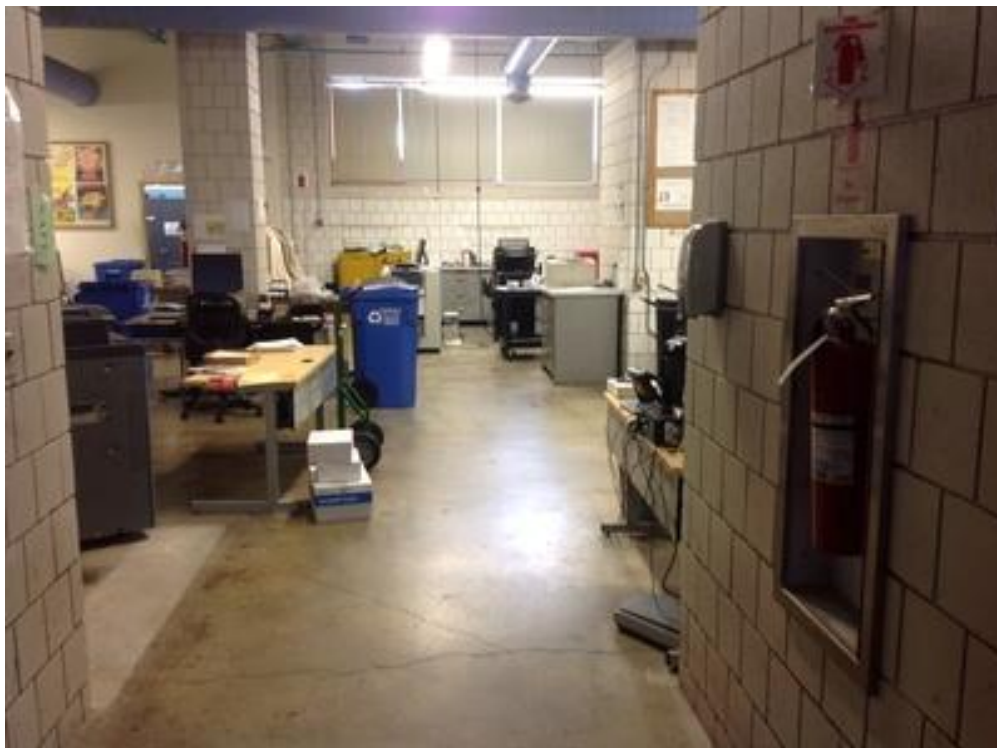
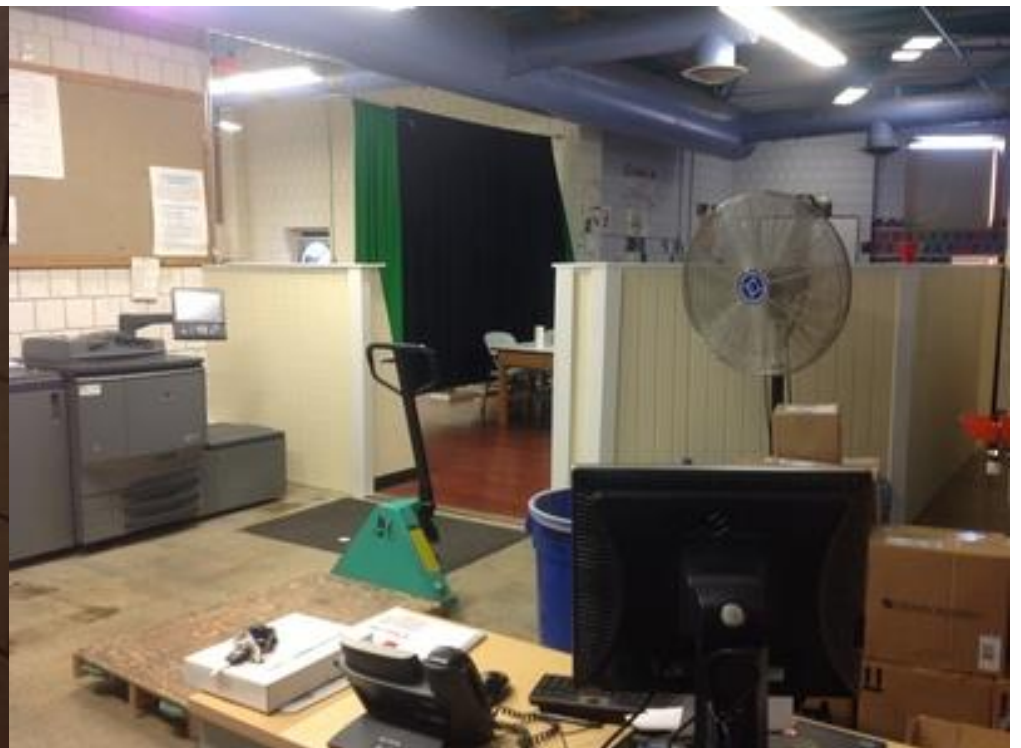
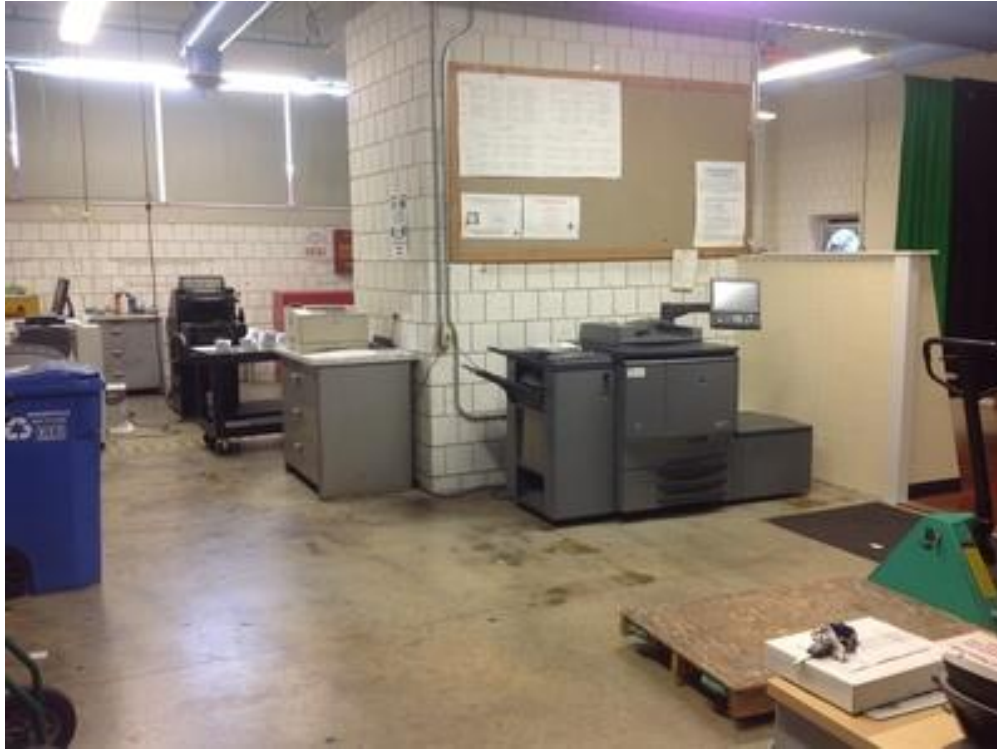
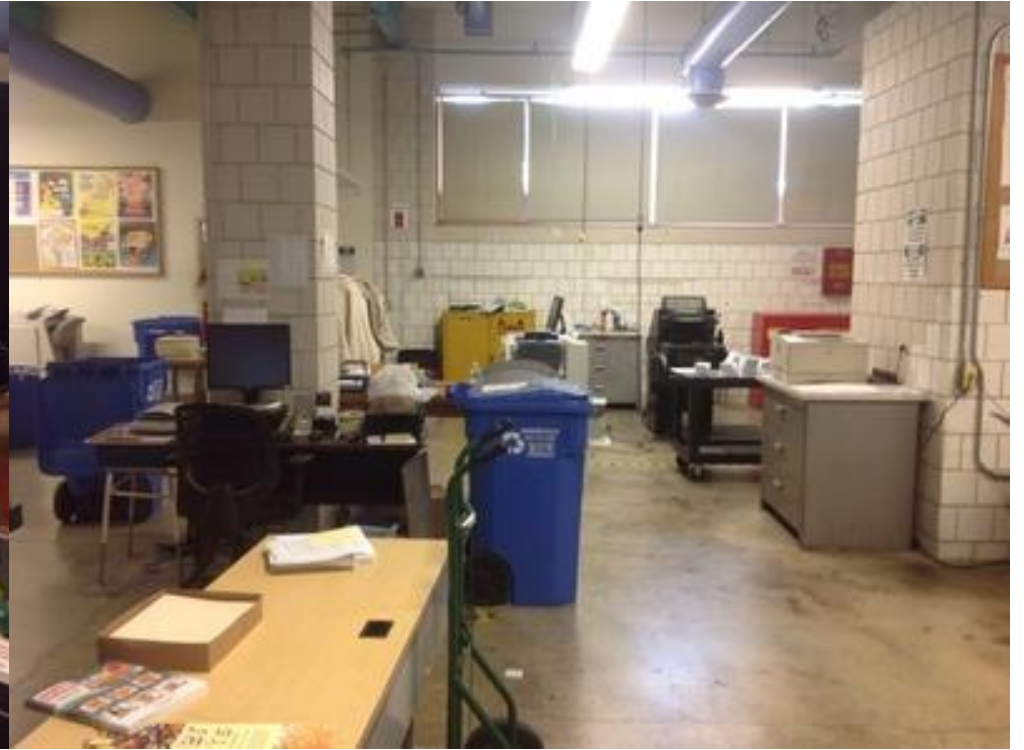
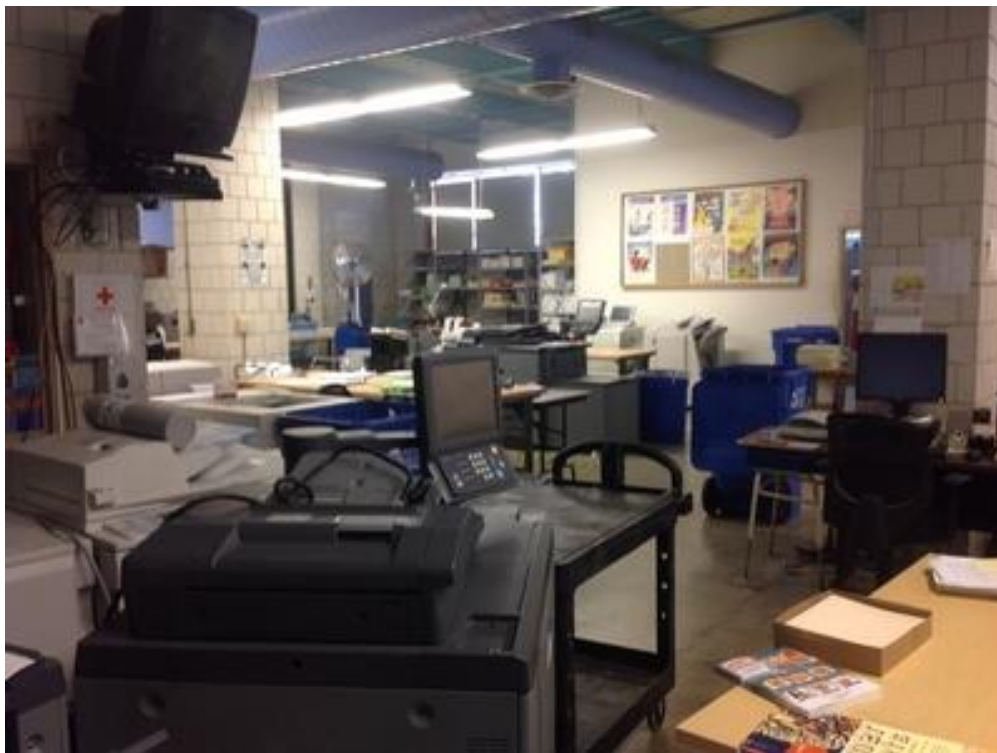
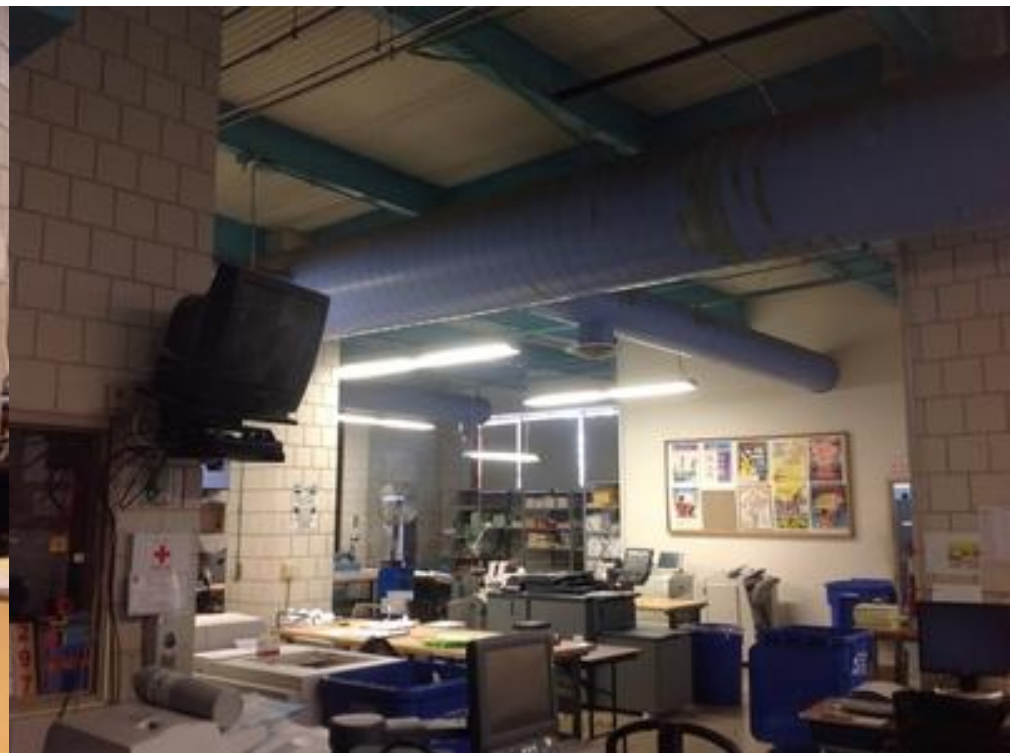
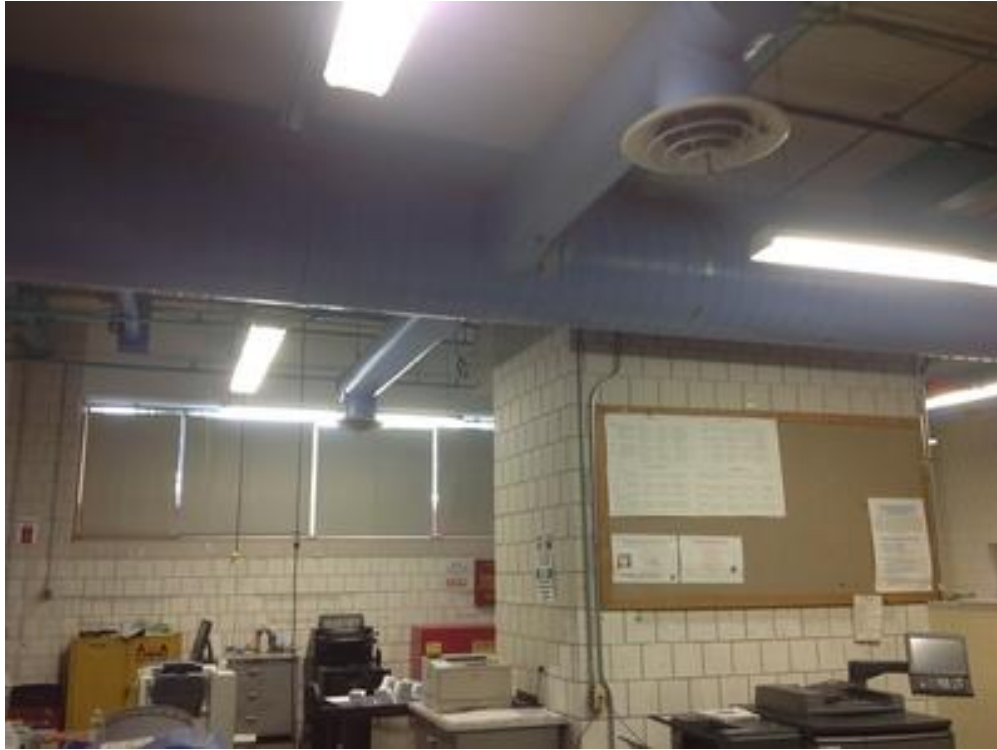
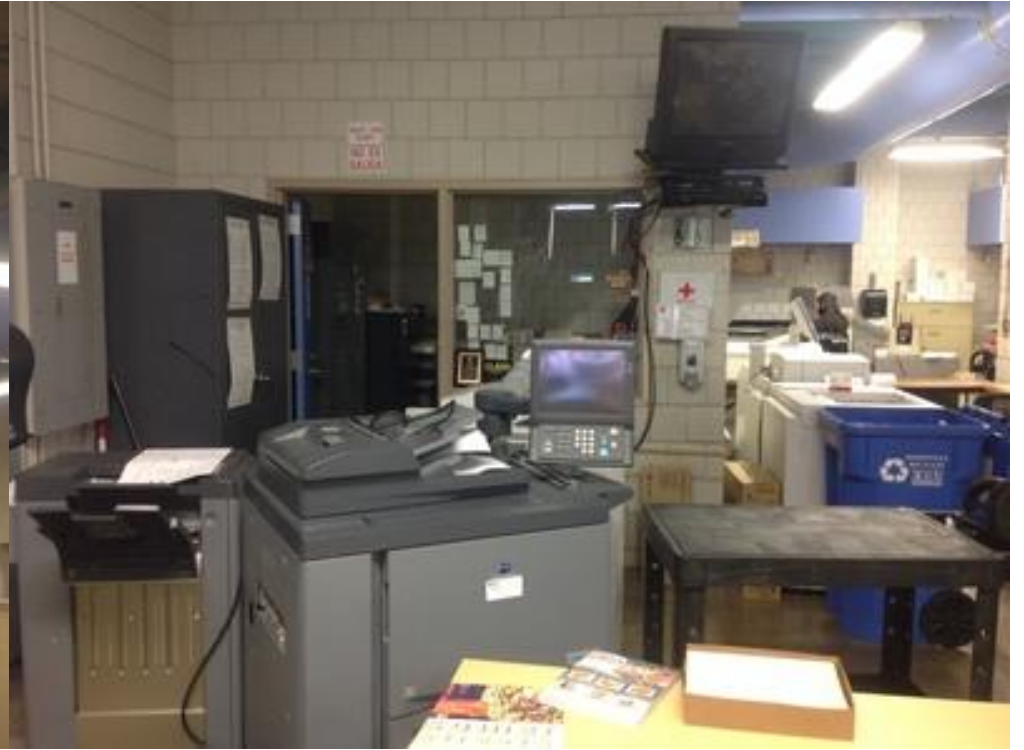
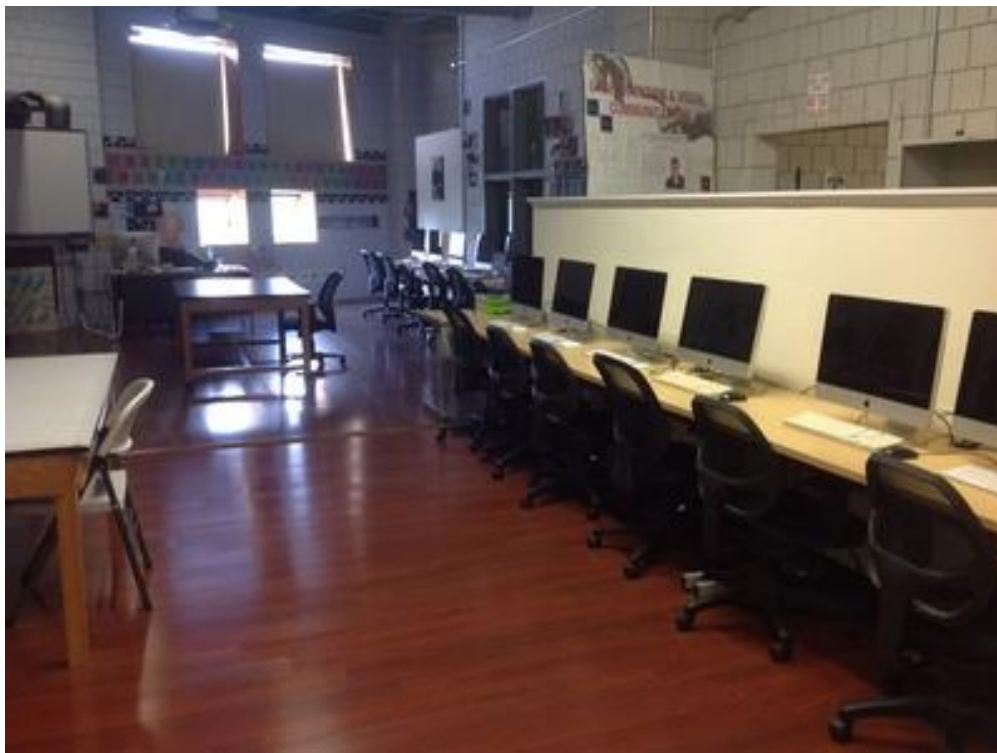
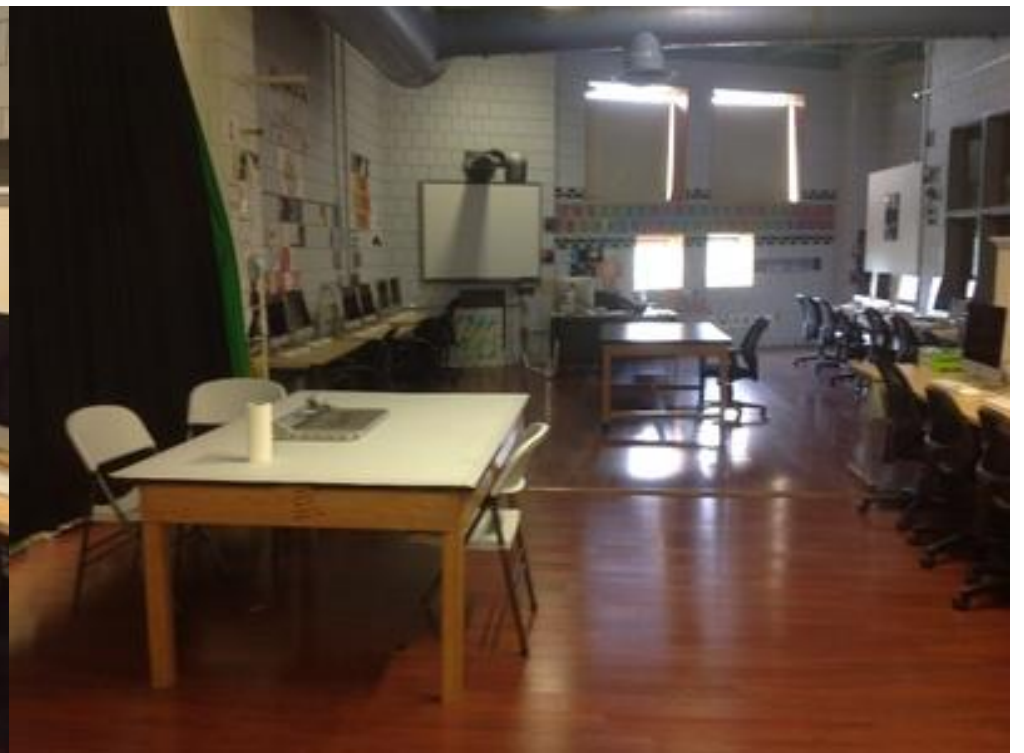
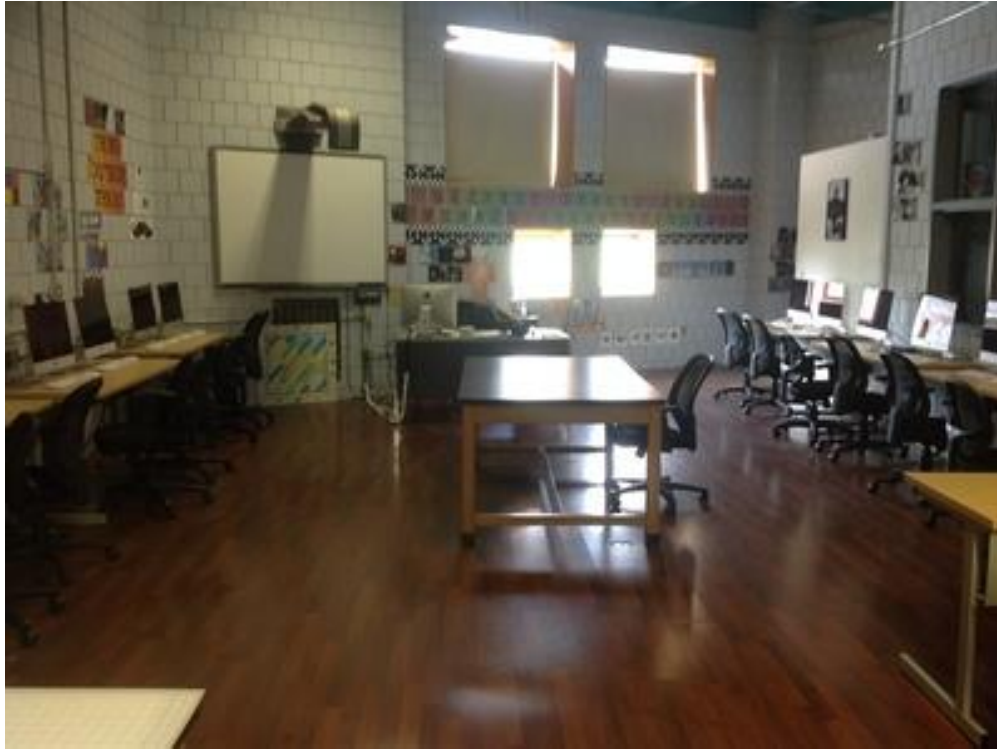
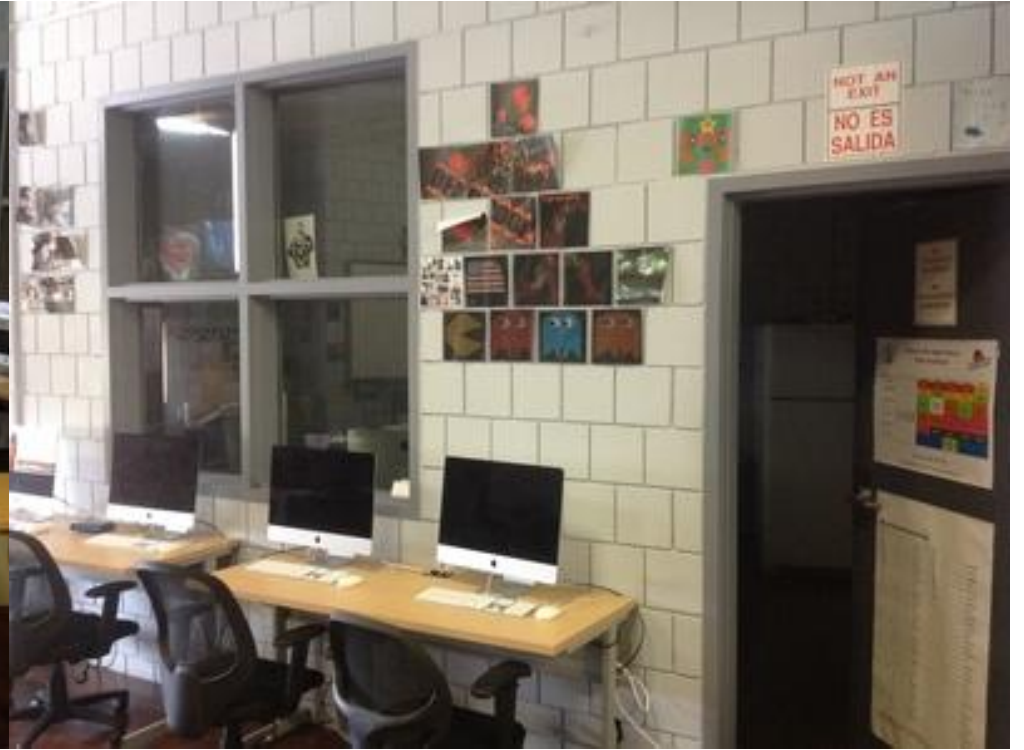
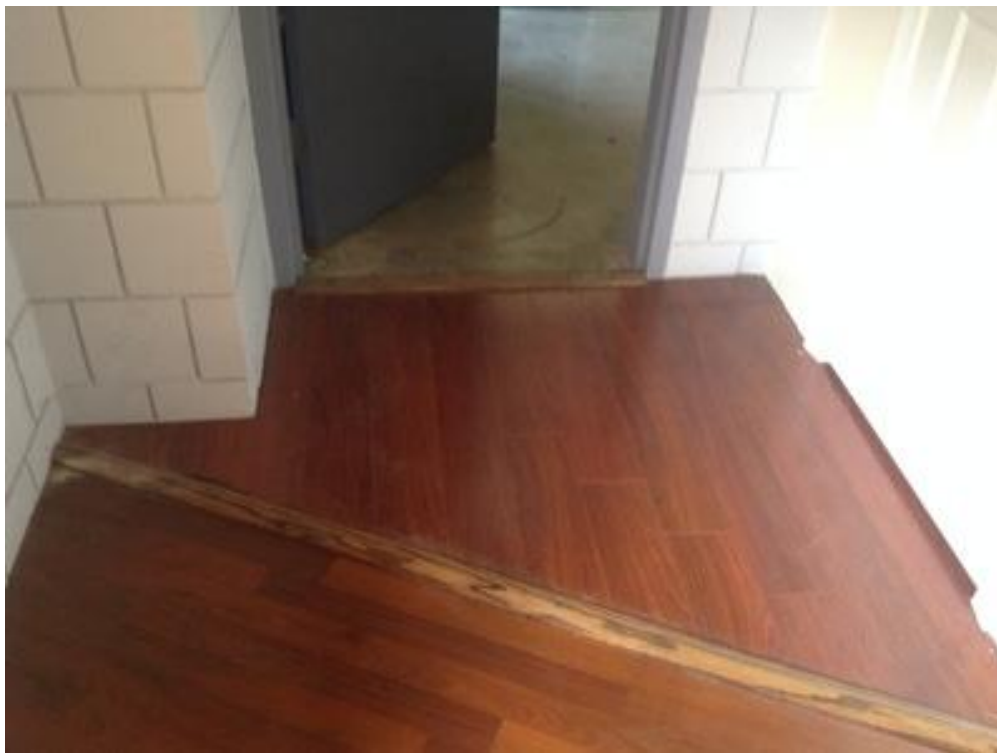
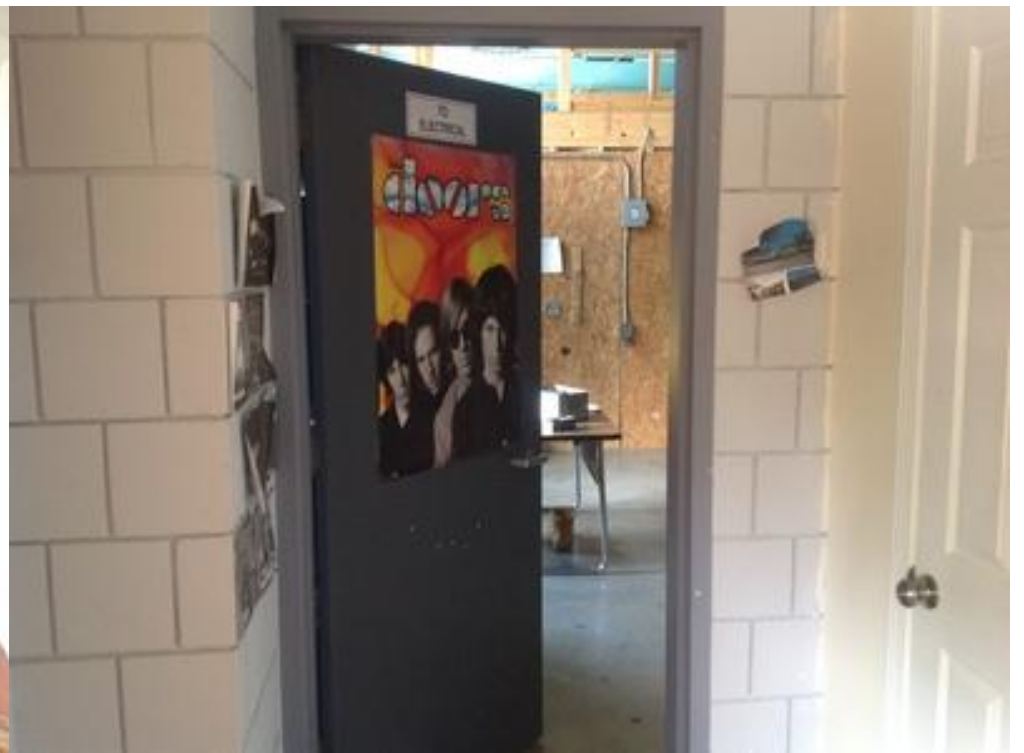
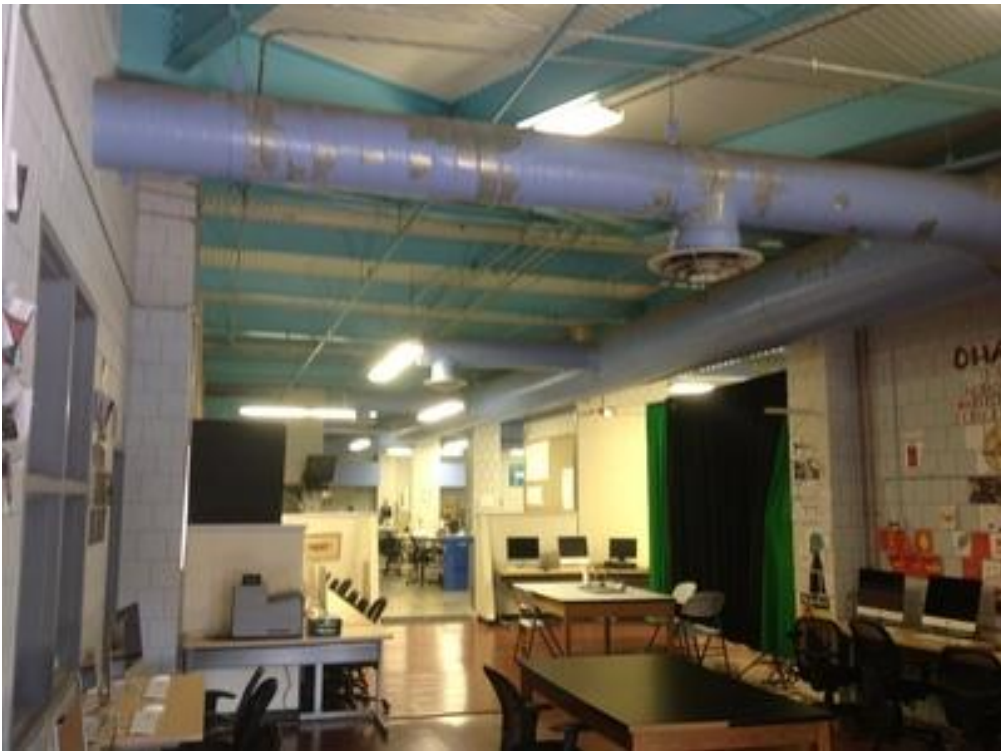
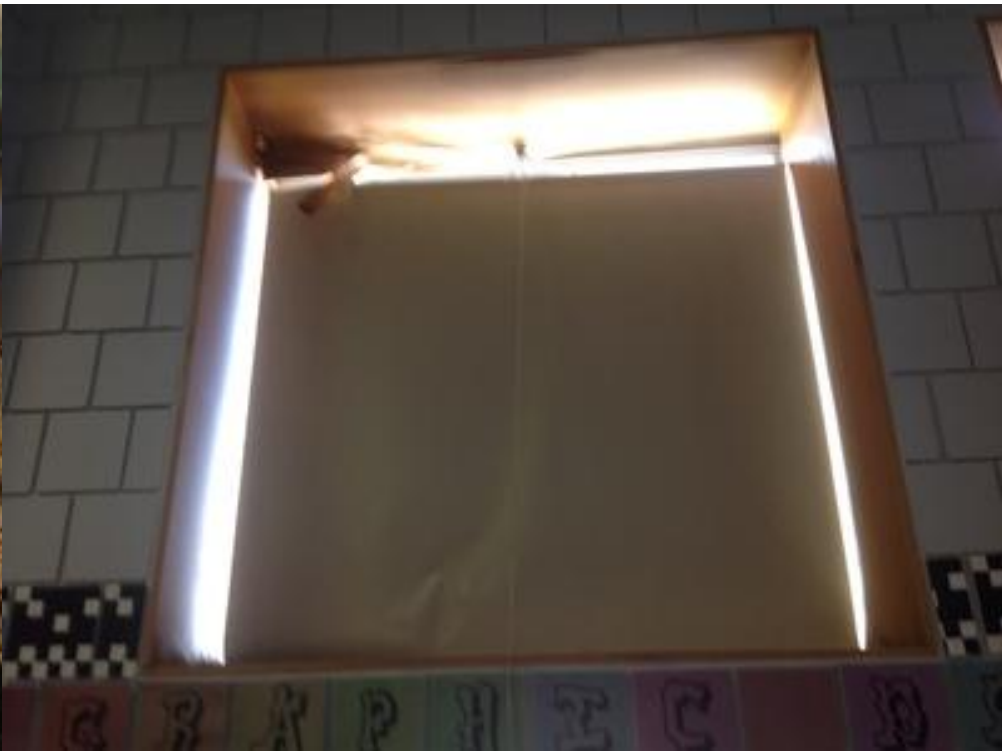
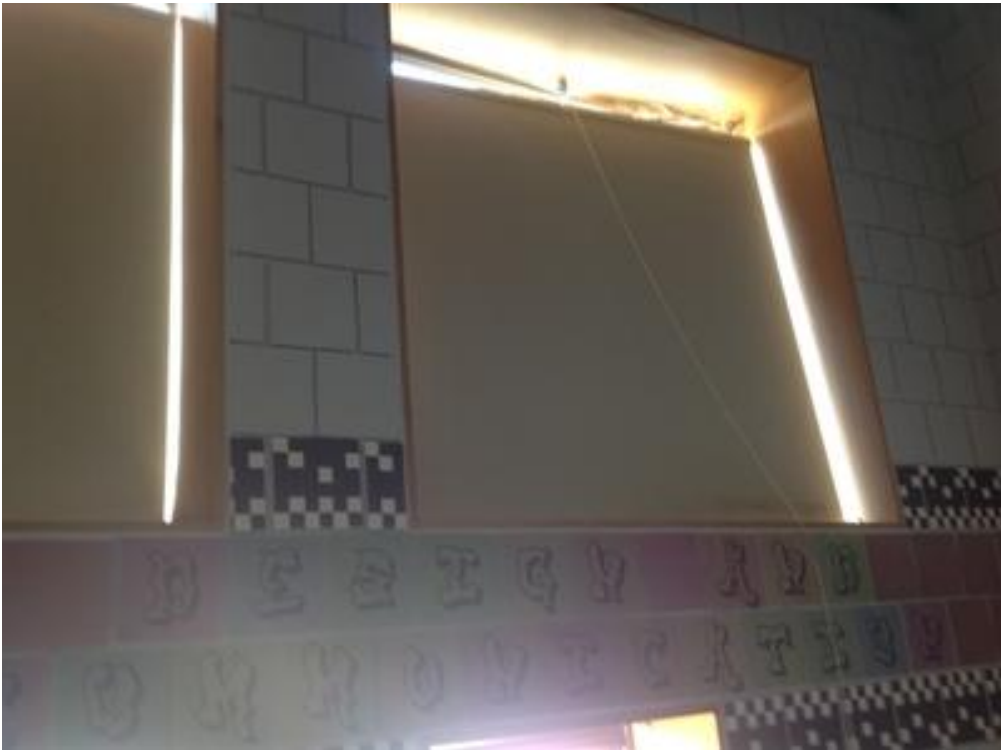
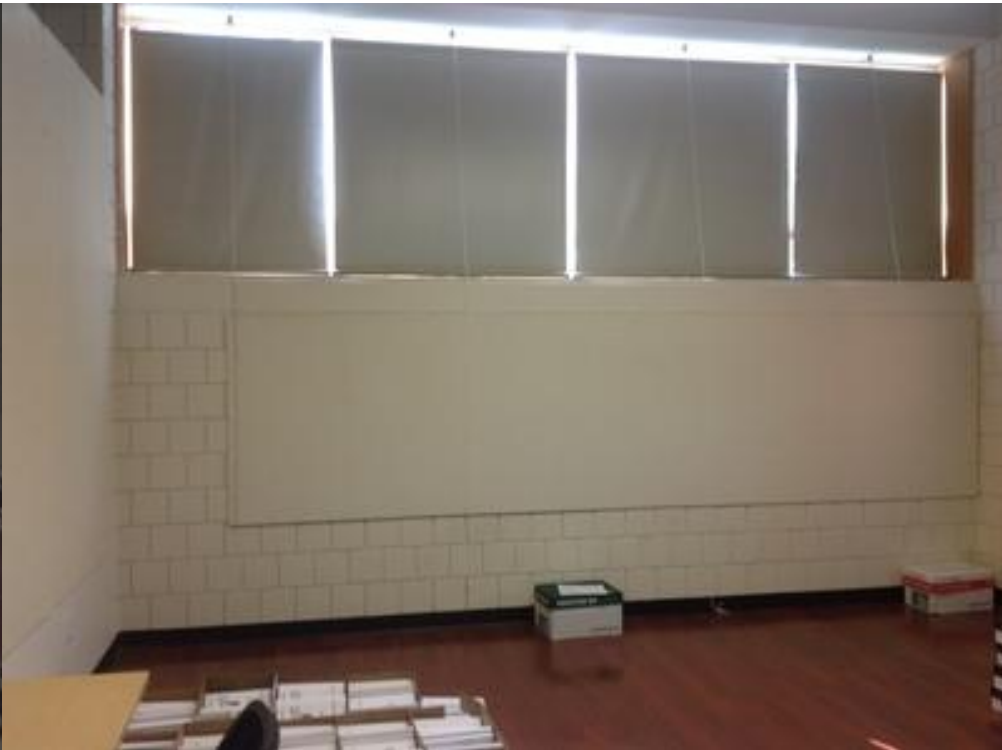
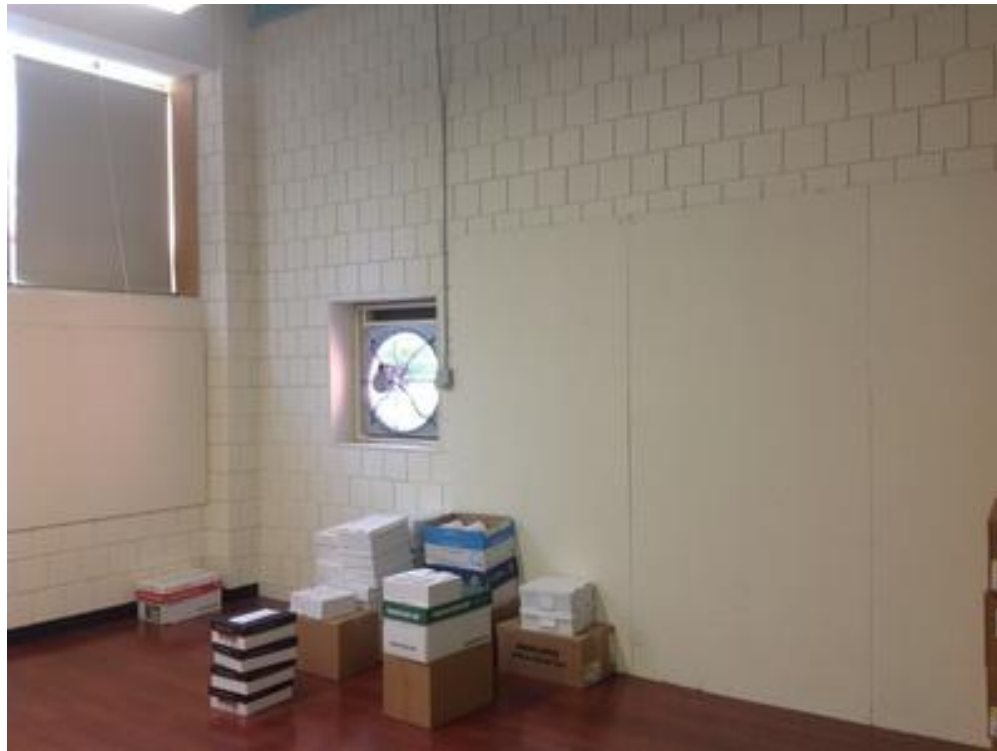
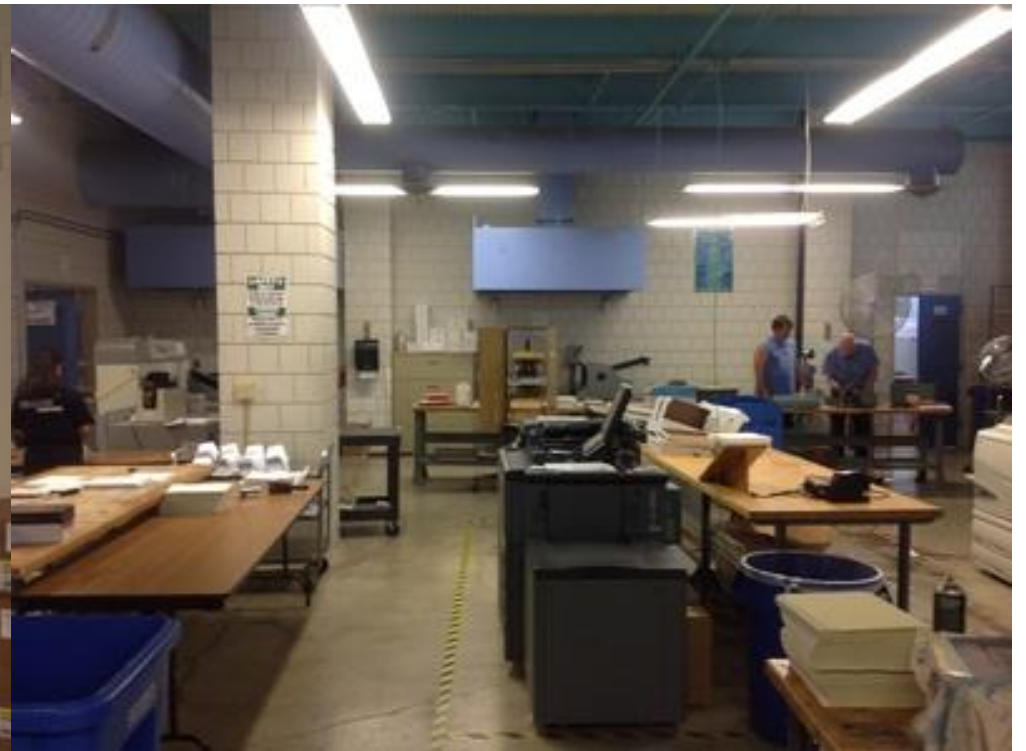
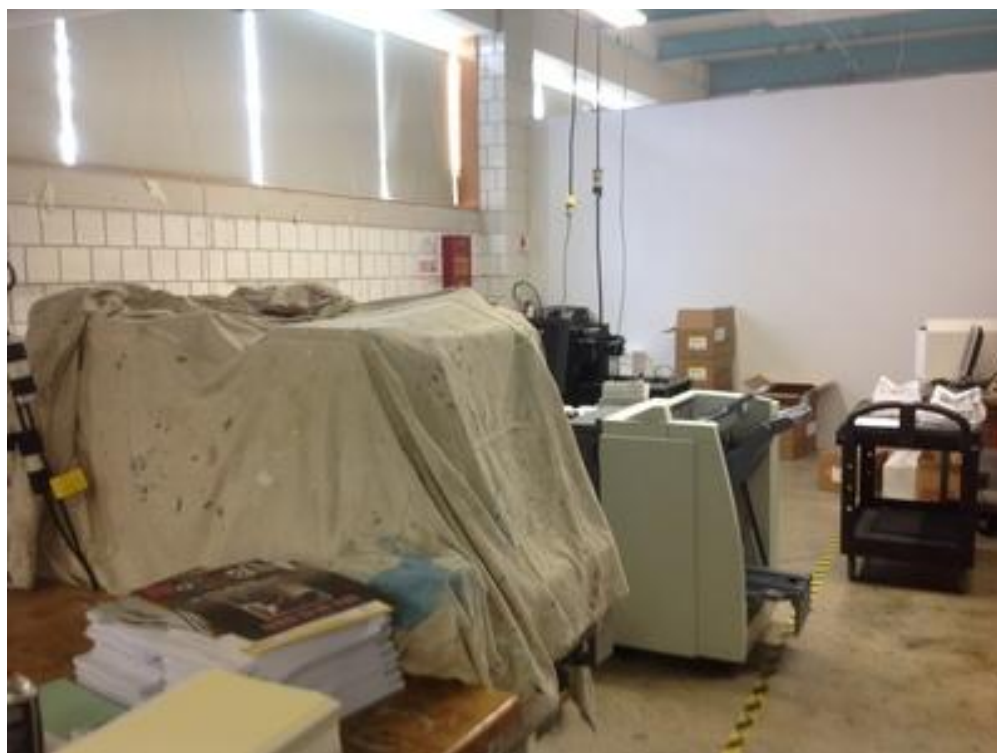
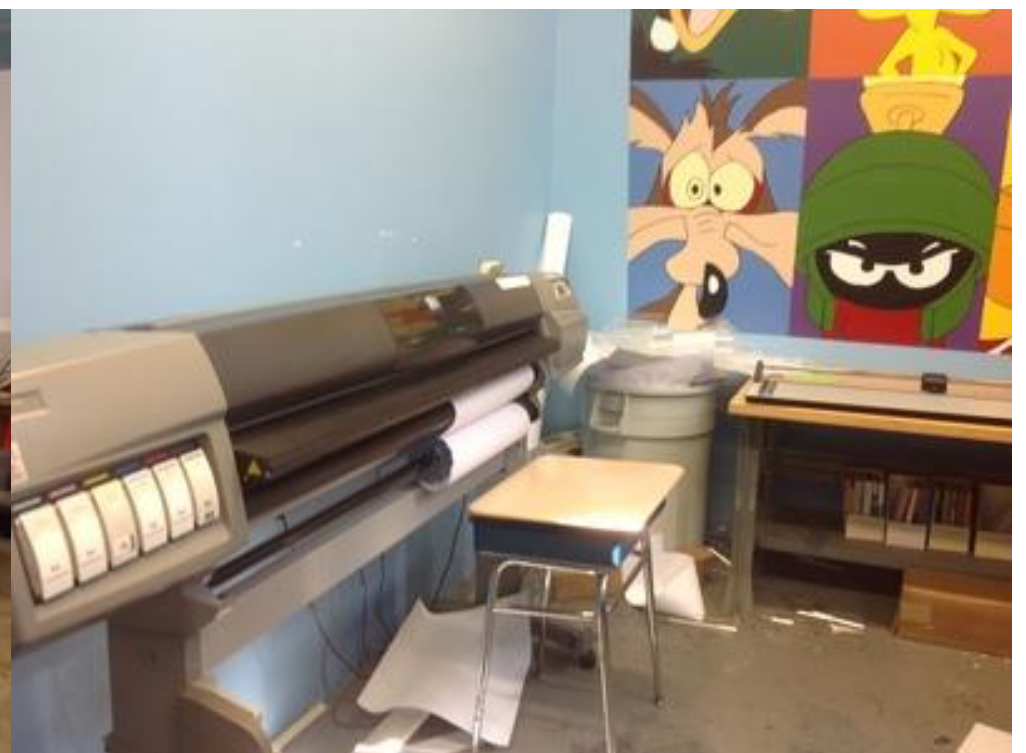
Graphic arts shop is comprised of several different zones including a classroom area that has been recently renovated. Classroom area finishes are in excellent condition. Millwork is in poor condition. Portions of ceilings of adjacent offices show significant water damage to GWB.

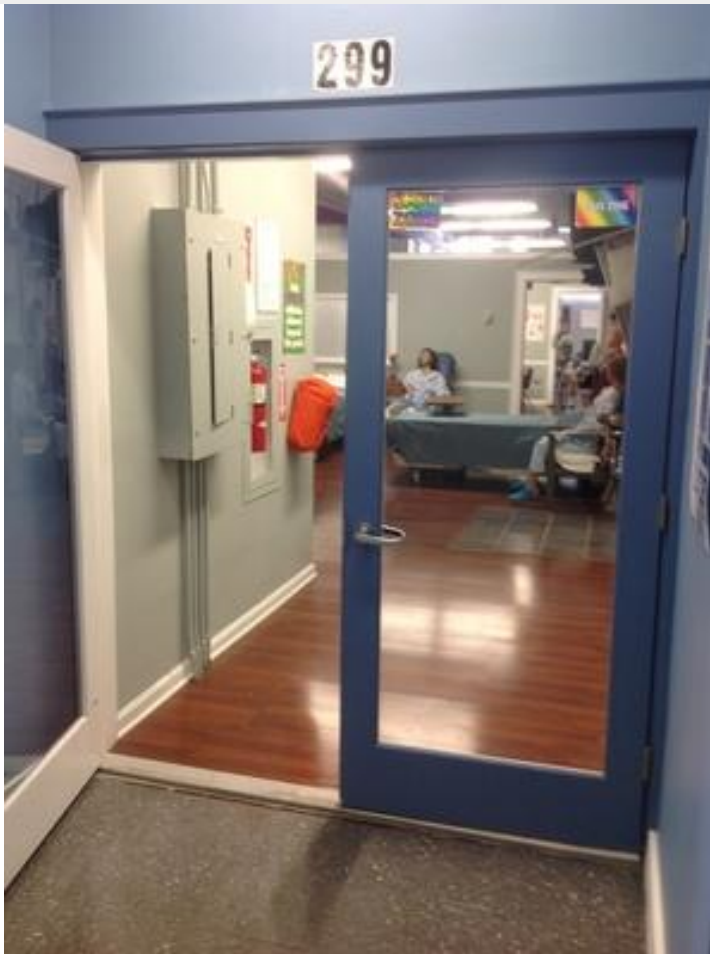
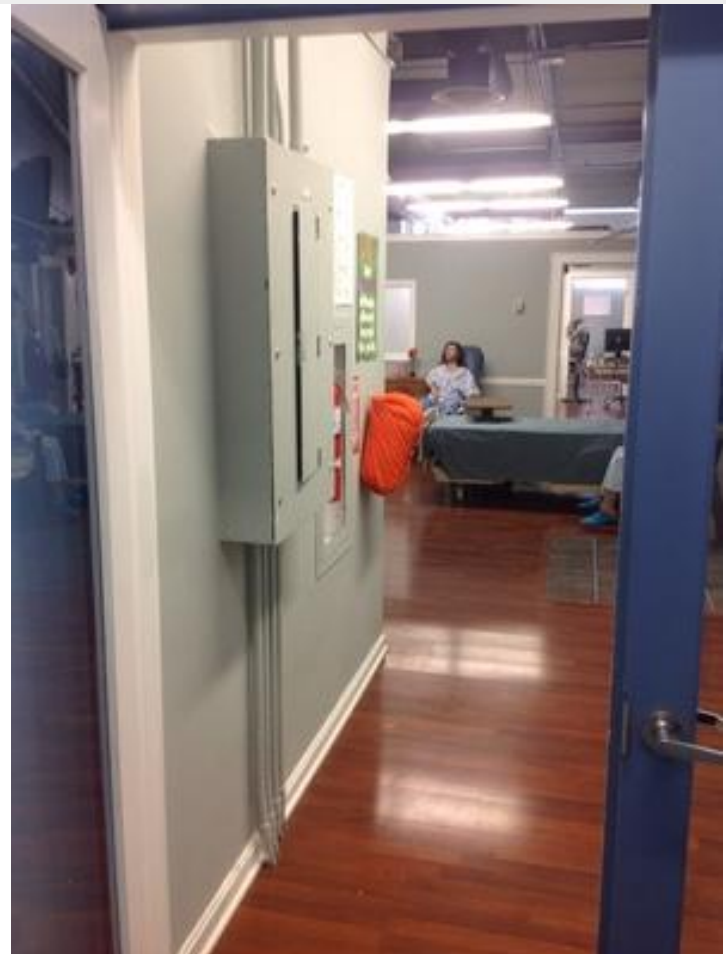
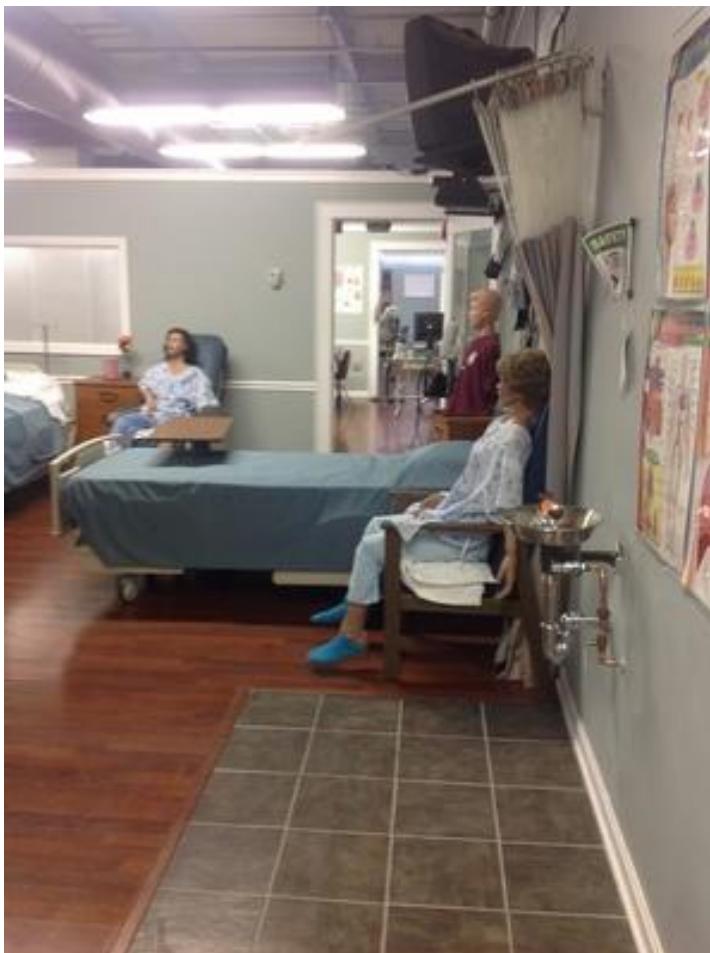
Attached Images for ID KU-00130

Health Careers is a newly renovated CTE program occupying 3 major teaching spaces, 2 offices, linen supply, and laundry areas. The finishes are in like-new condition. The millwork is in excellent condition and ADA compliant.
