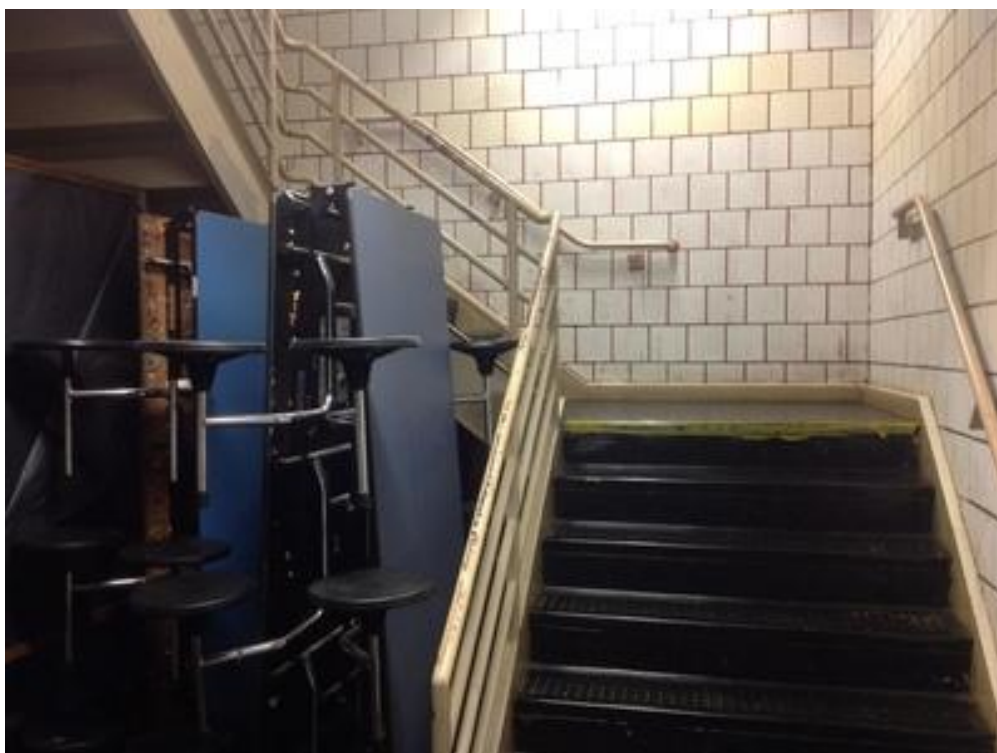
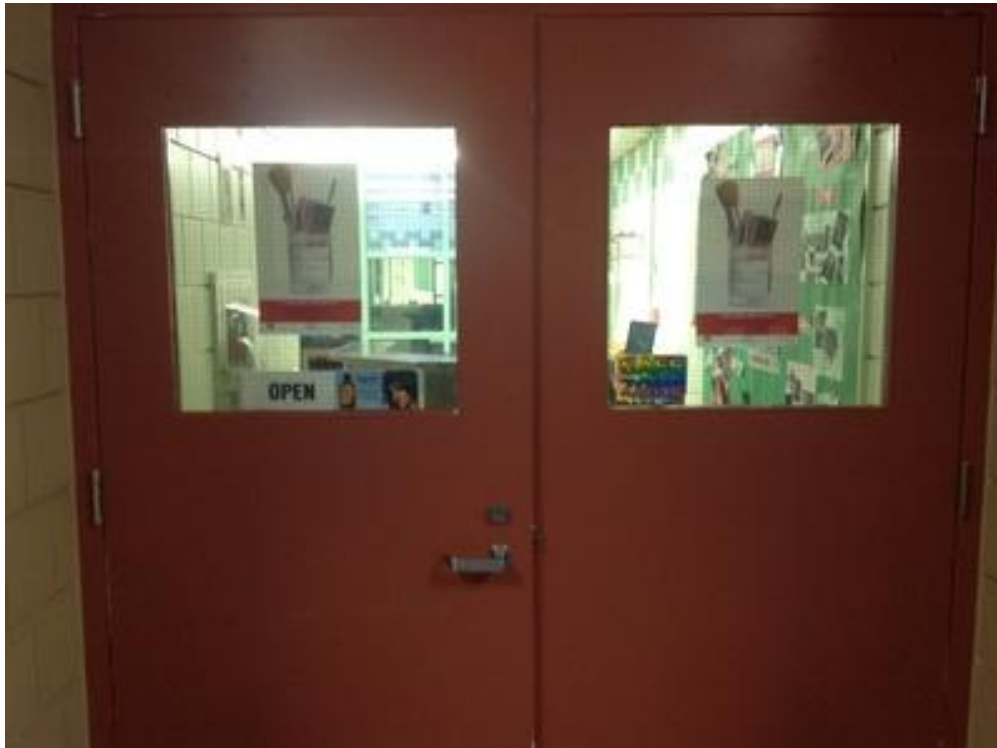
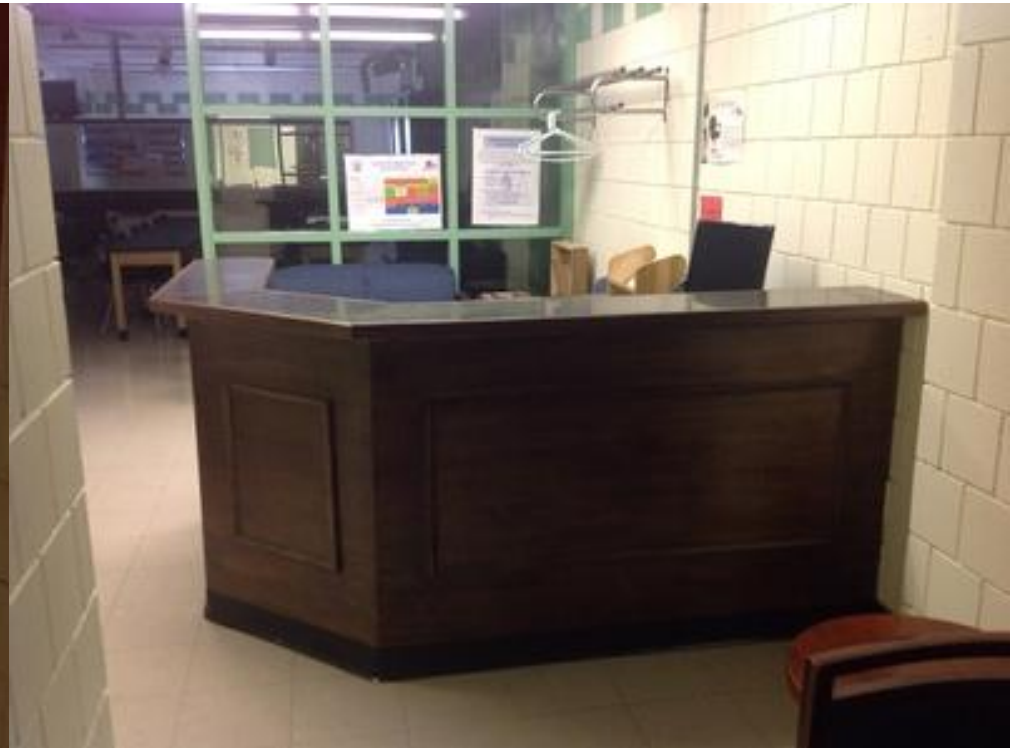
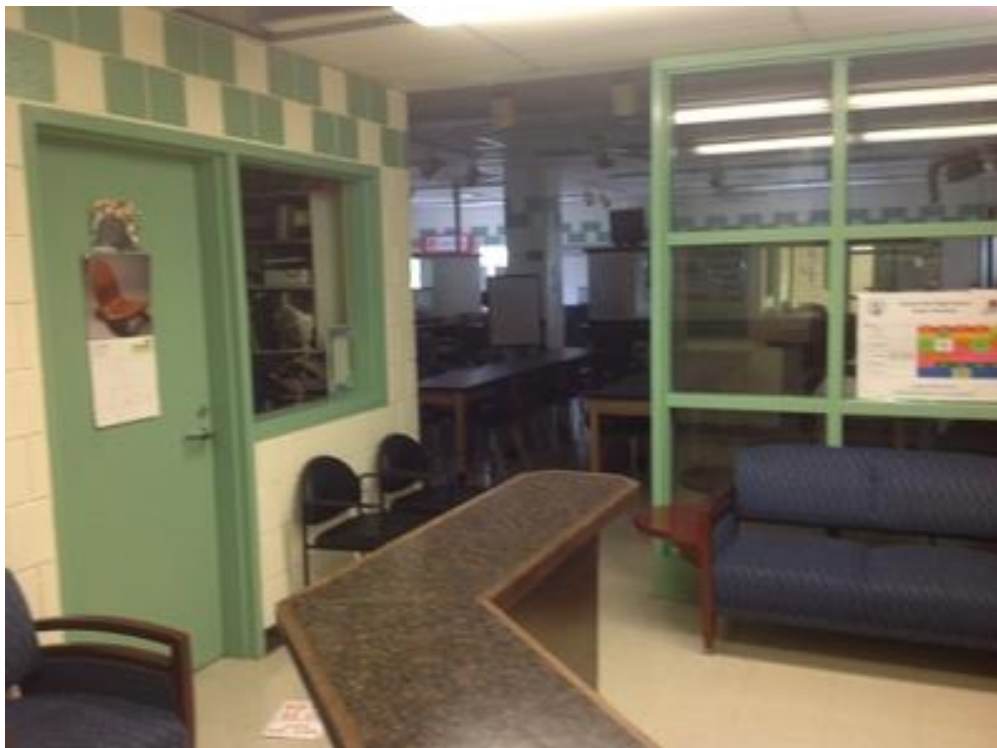
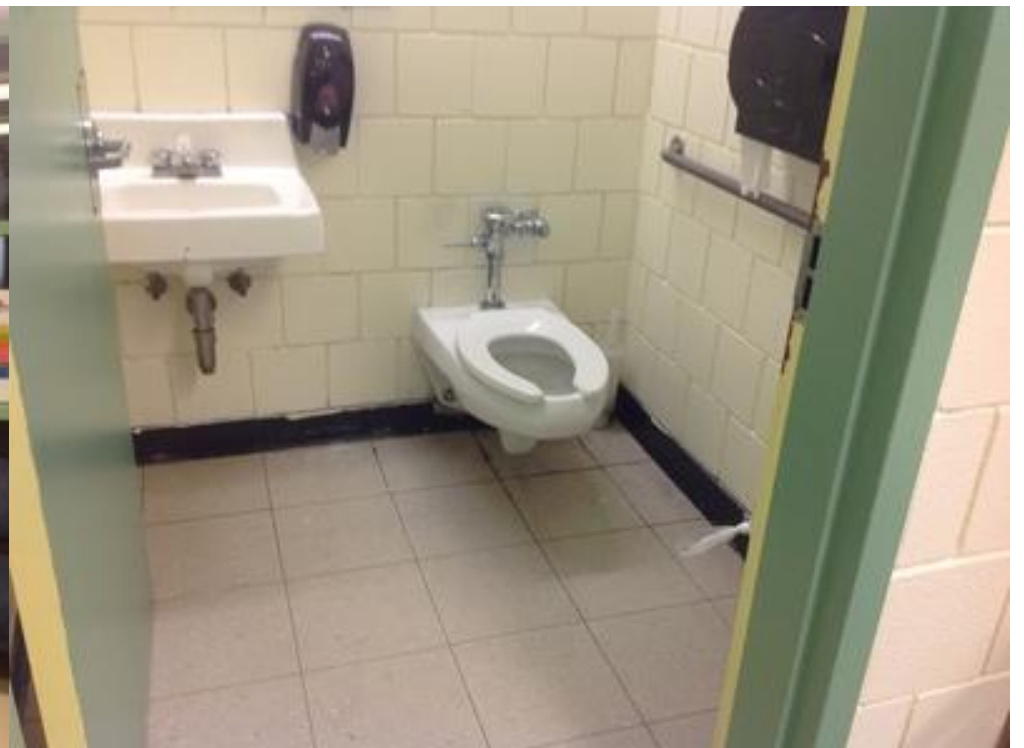
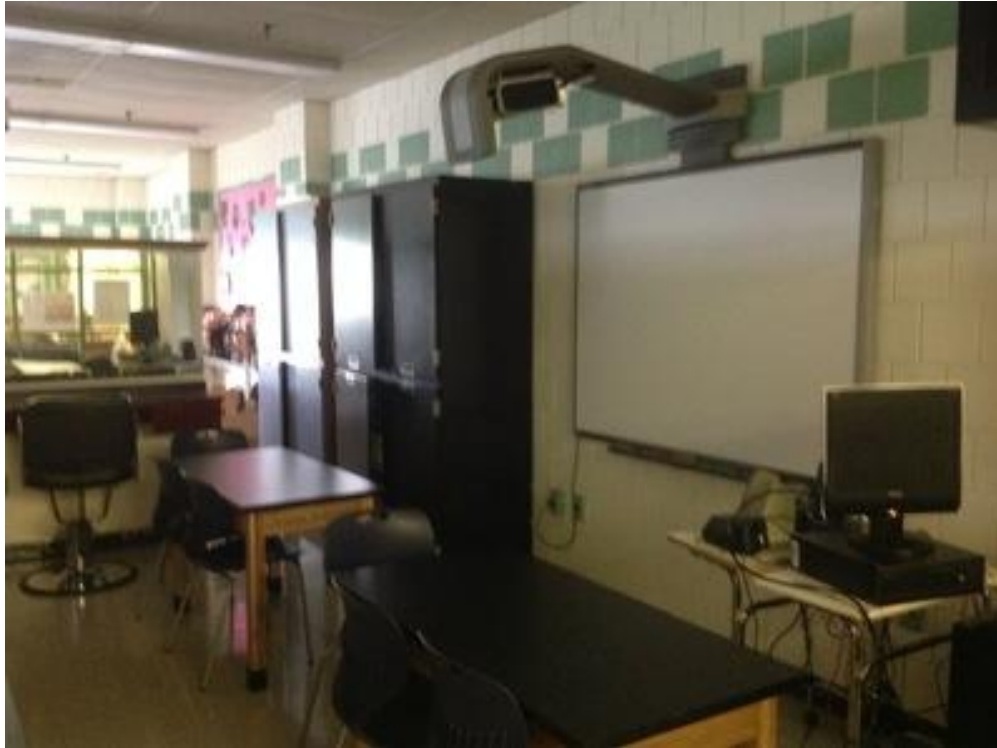
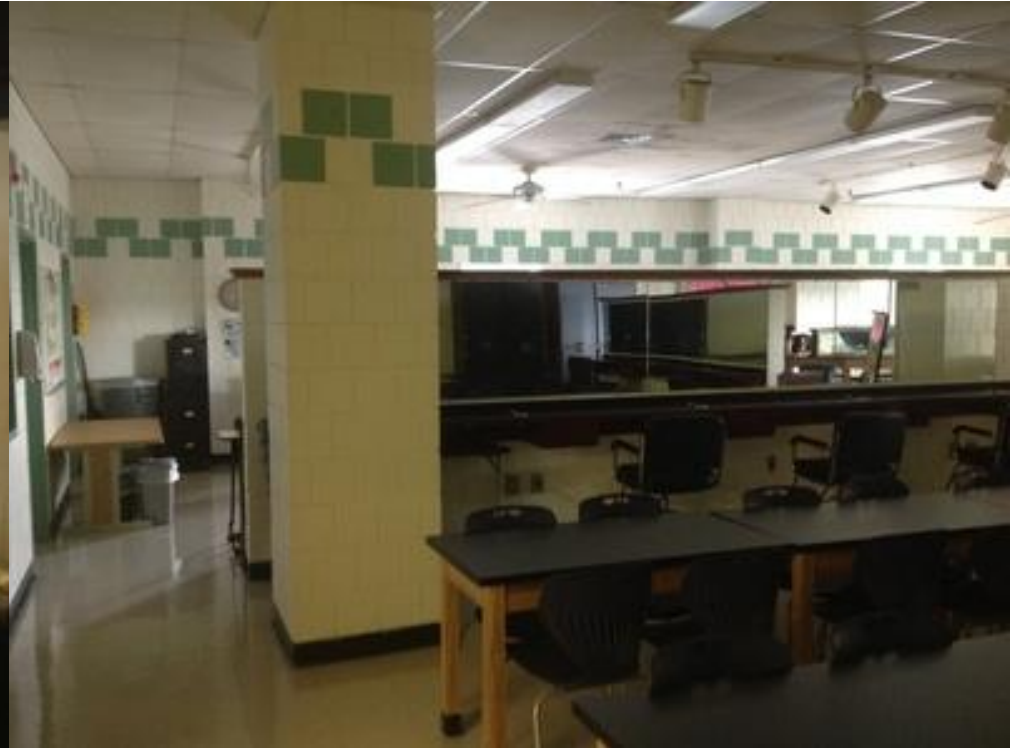
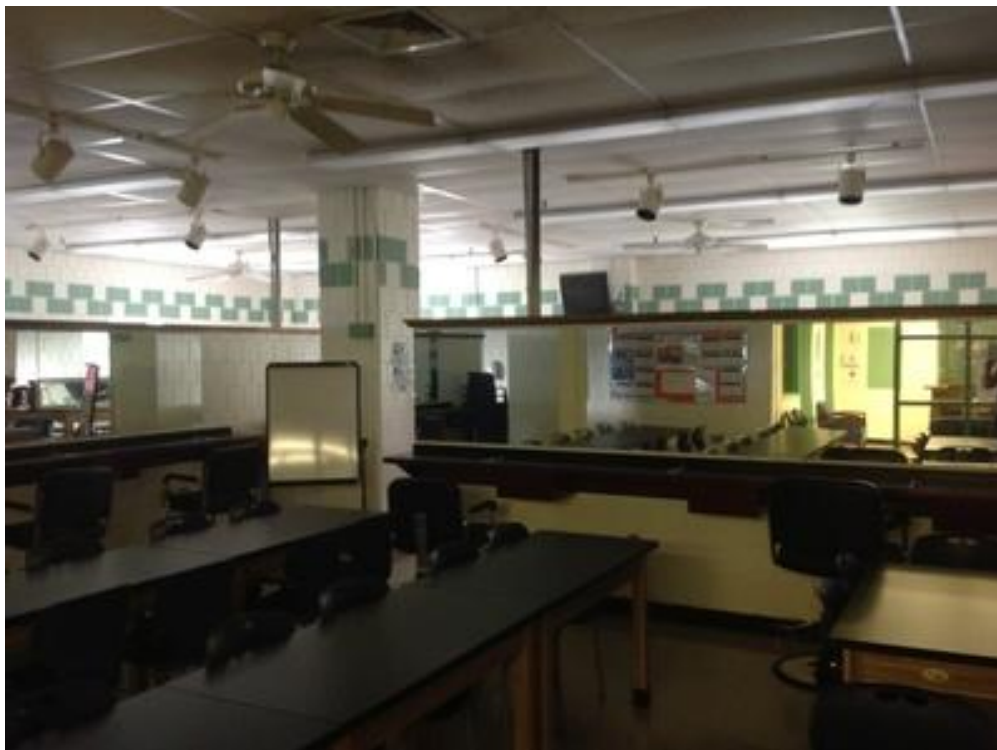
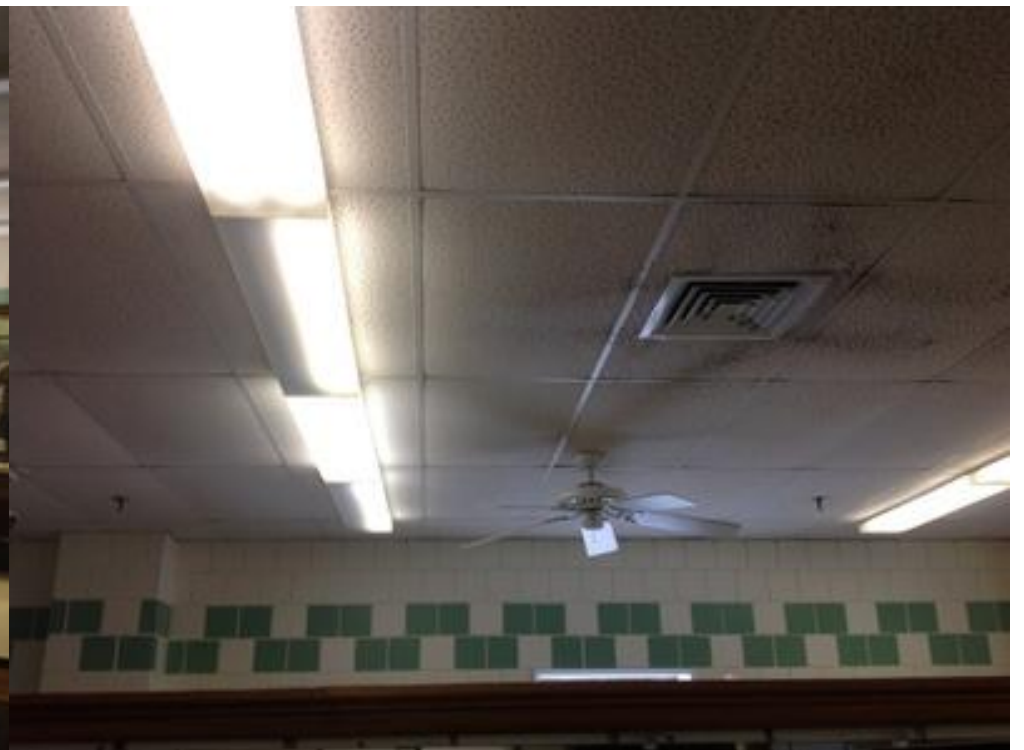
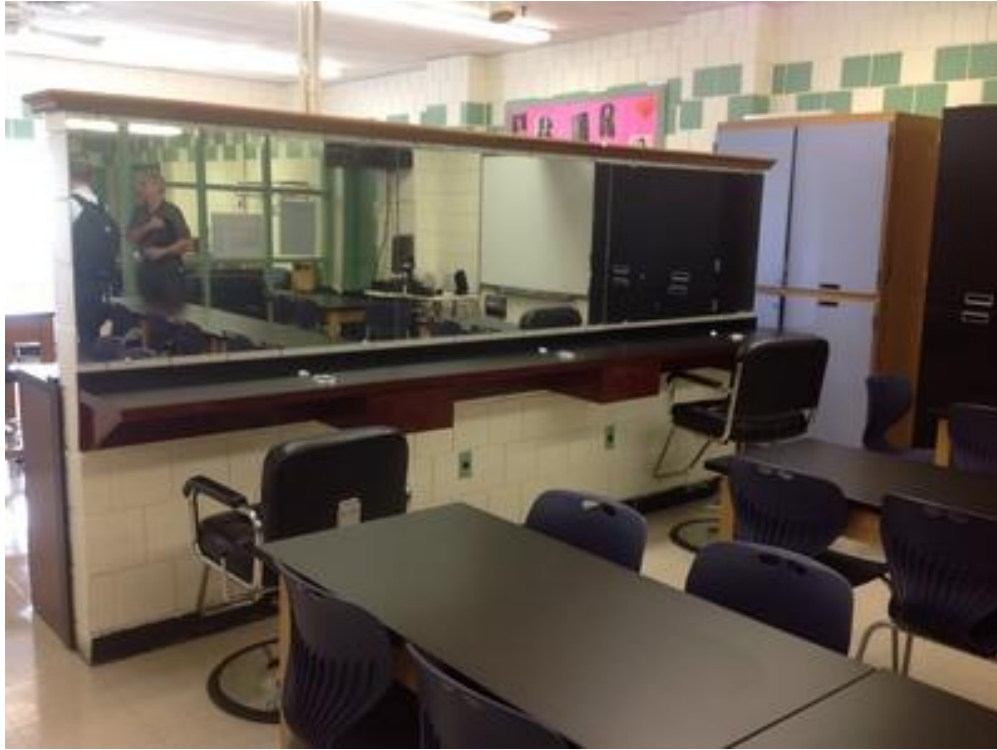
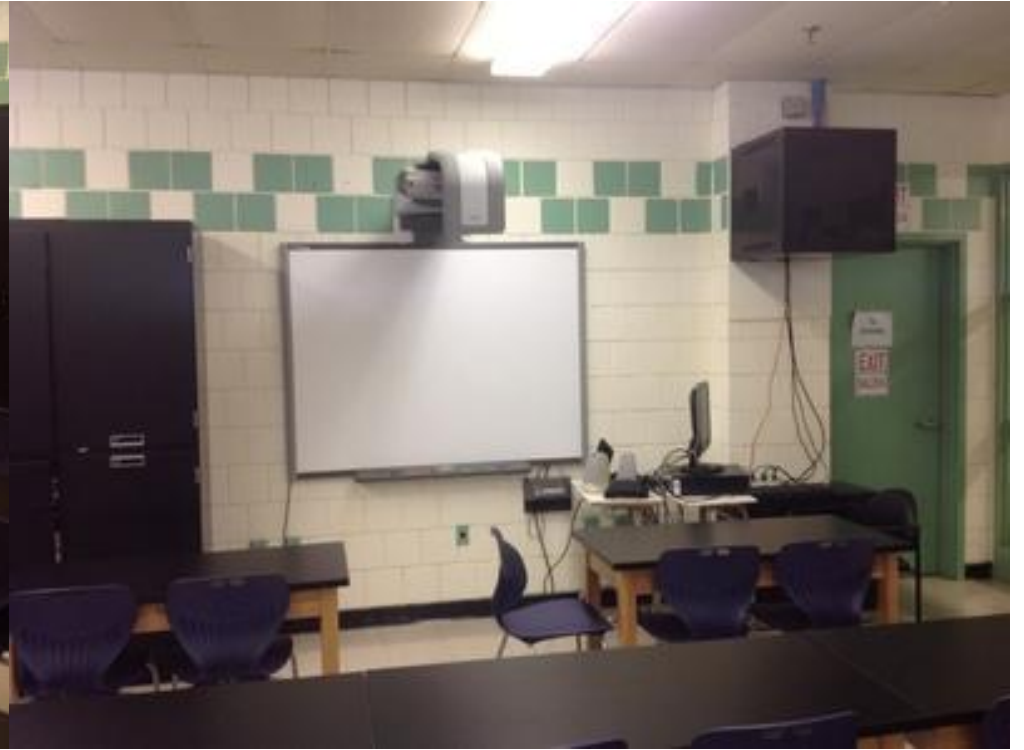
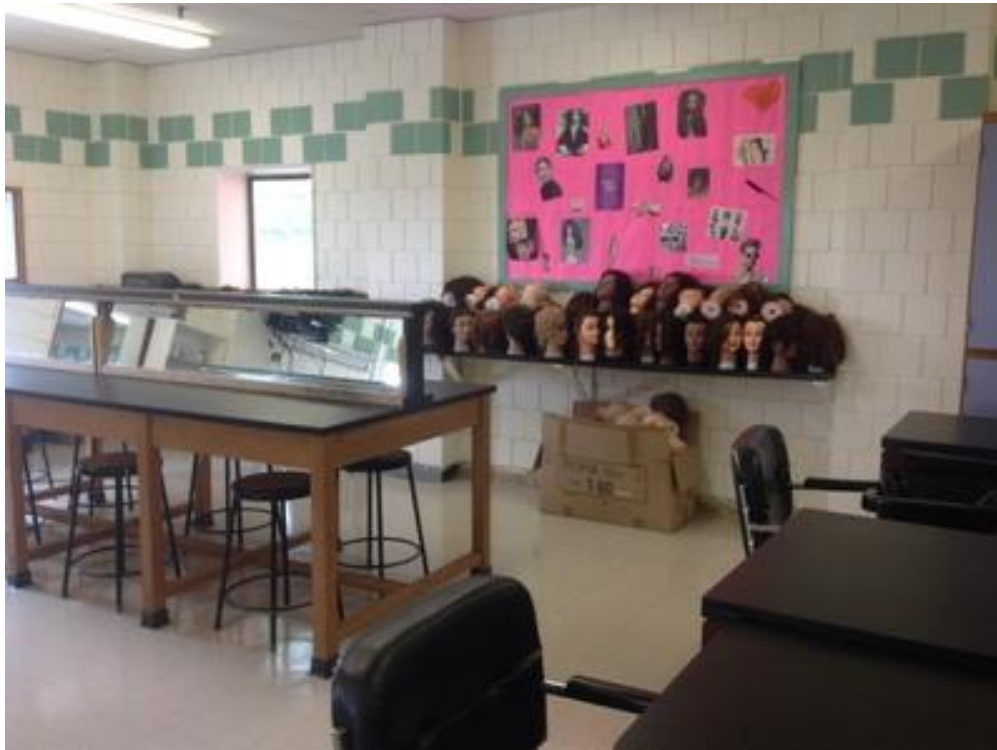
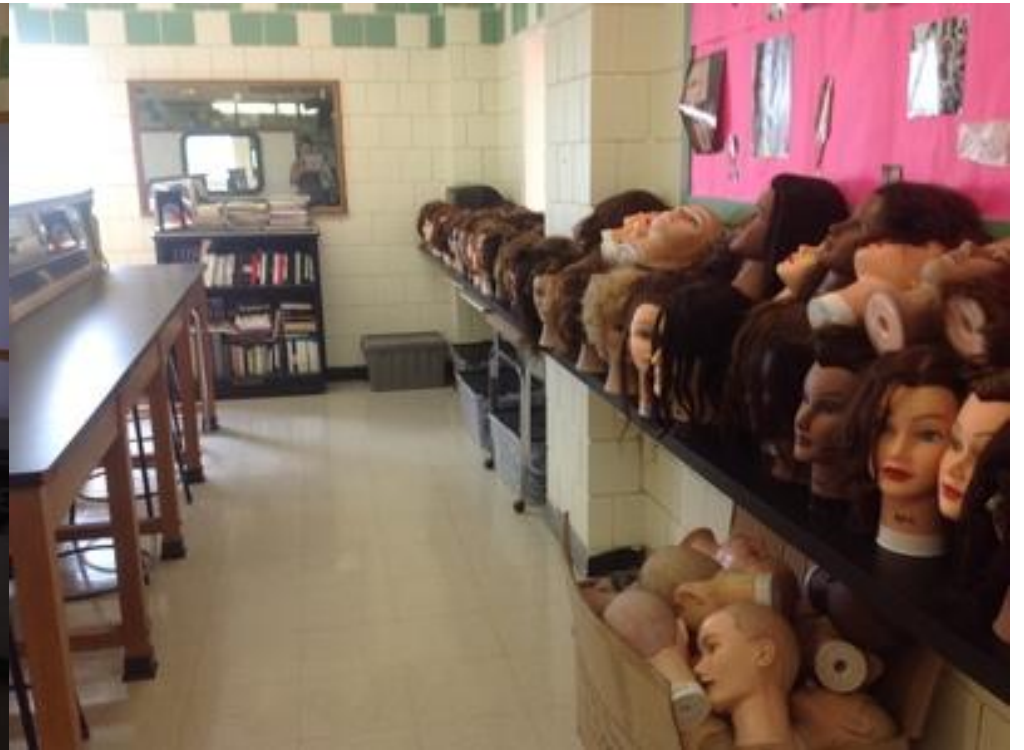
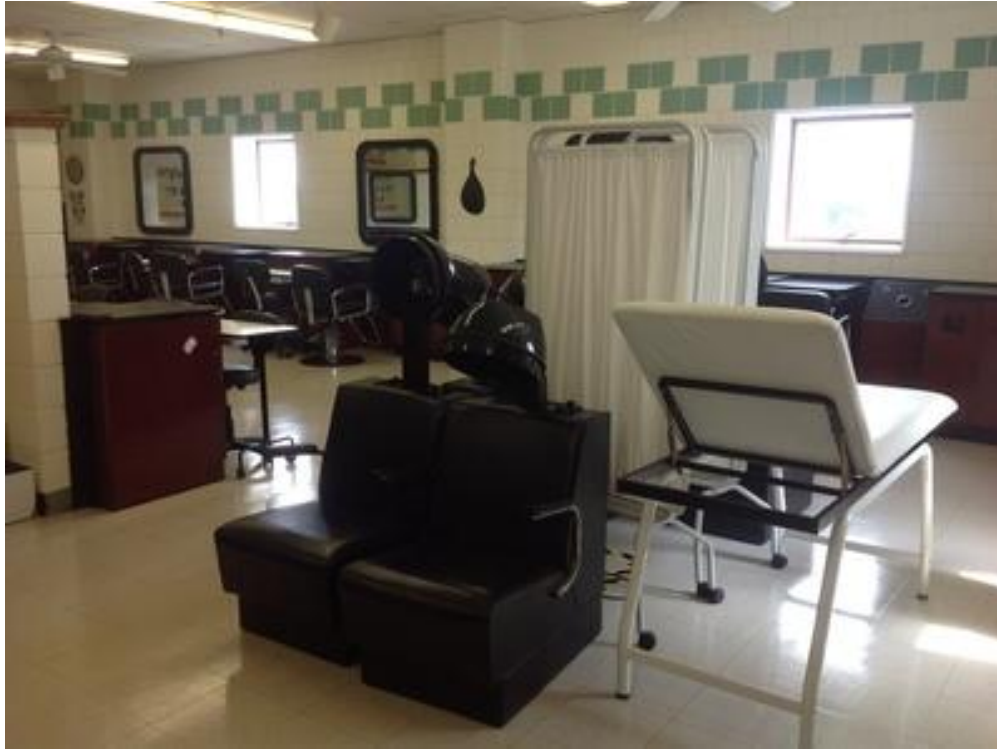
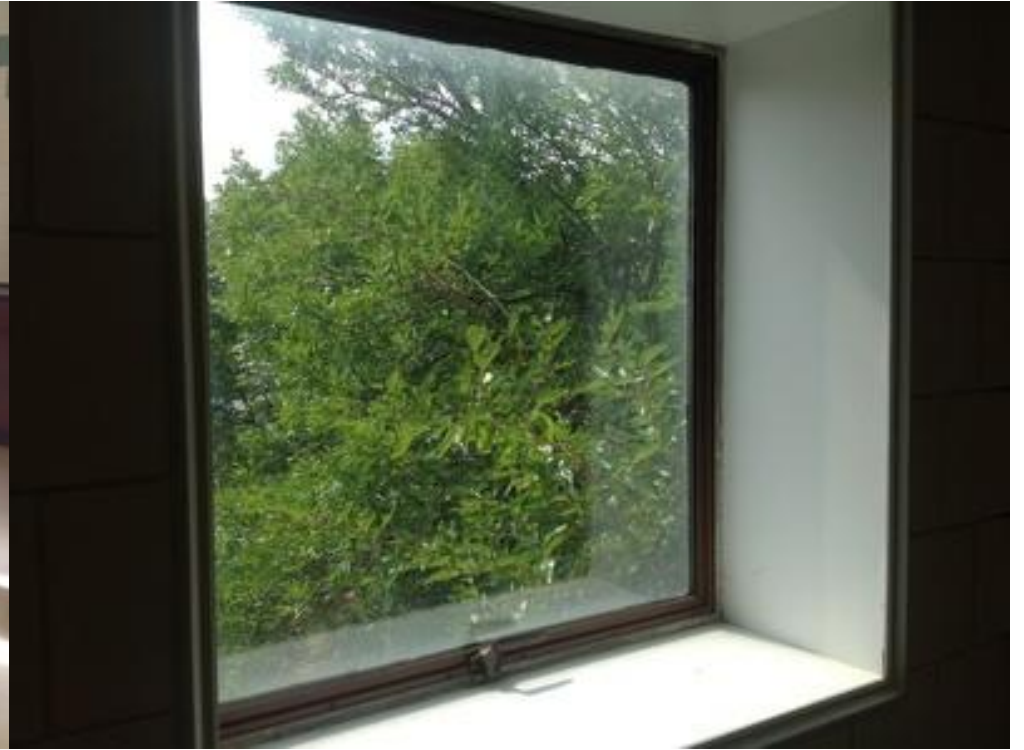
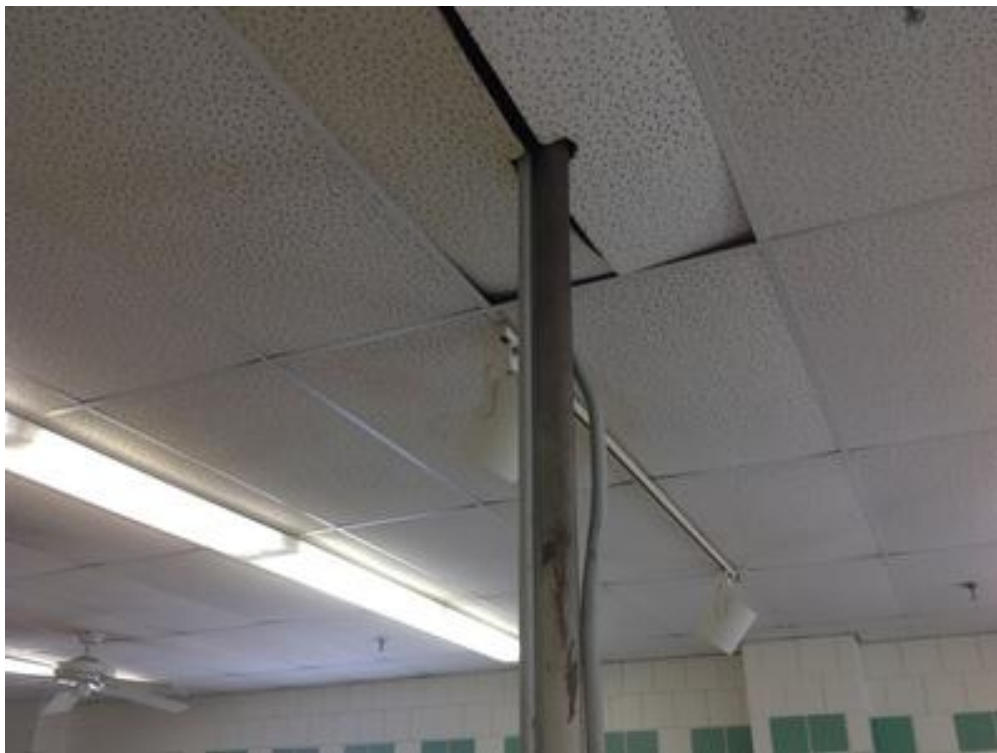
Description
Cosmetology suite is in fair condition. CMU walls are in good condition. VCT flooring is in good condition. ACT ceiling in poor condition - dirty, broken, and bowed tiles. Strip and track lighting is in poor condition. Windows are in poor condition and have lost seals in some locations.
