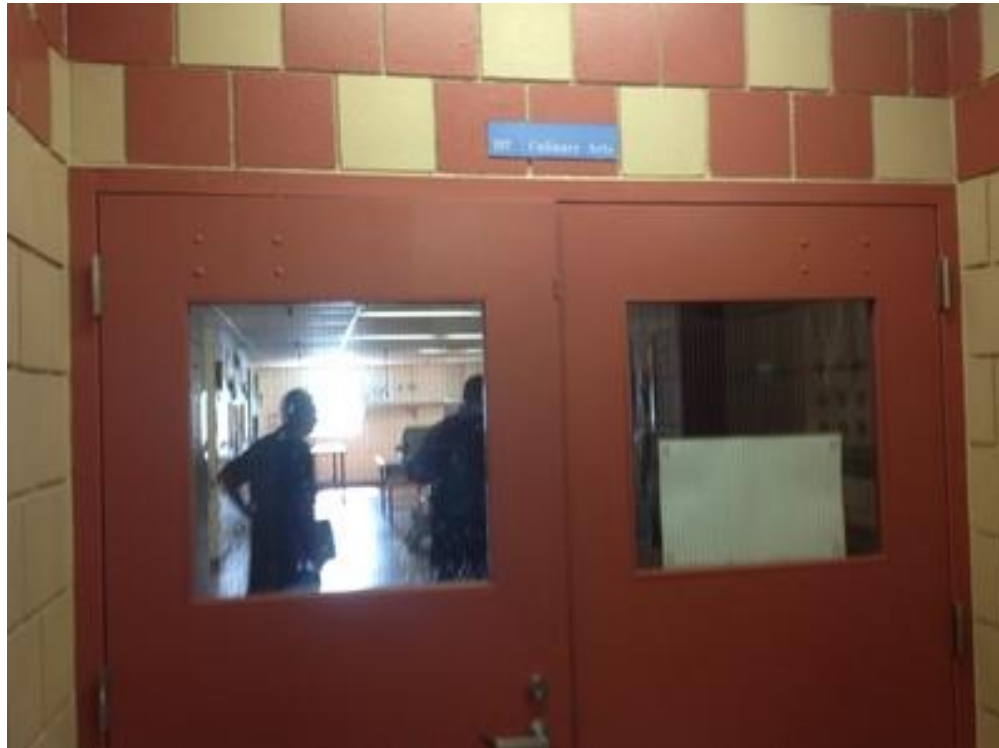
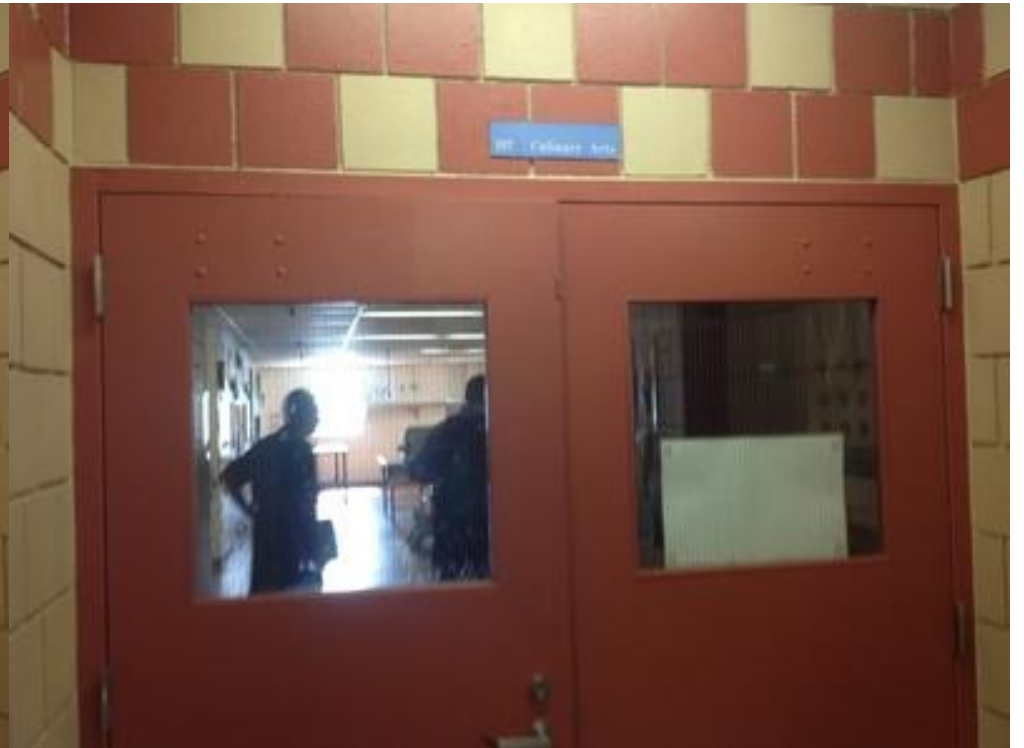
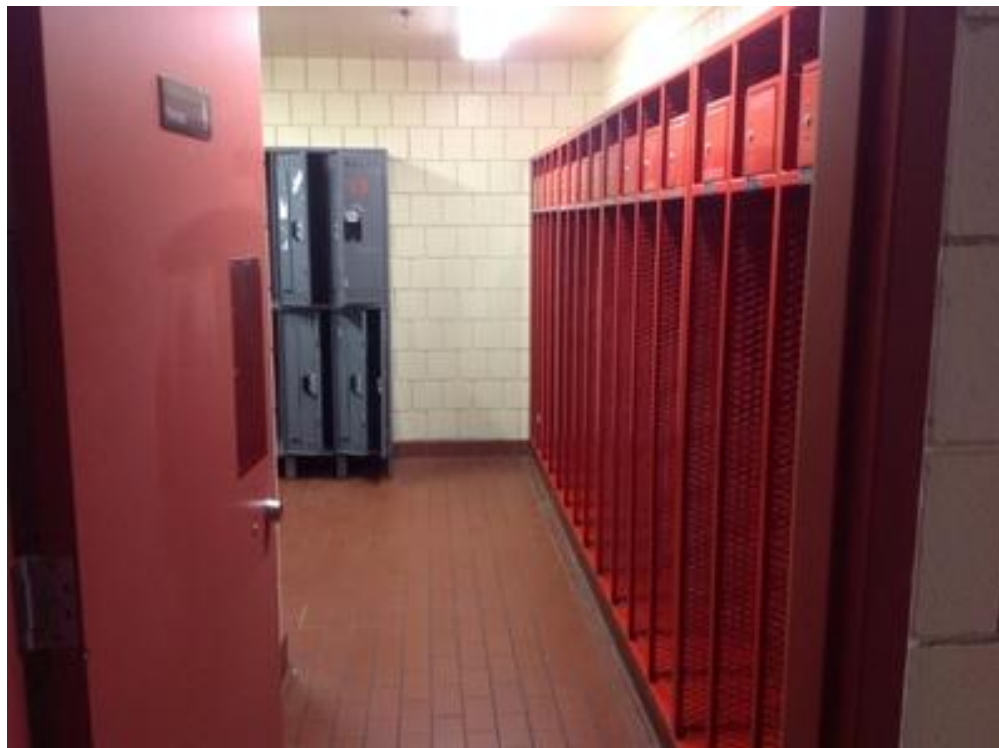
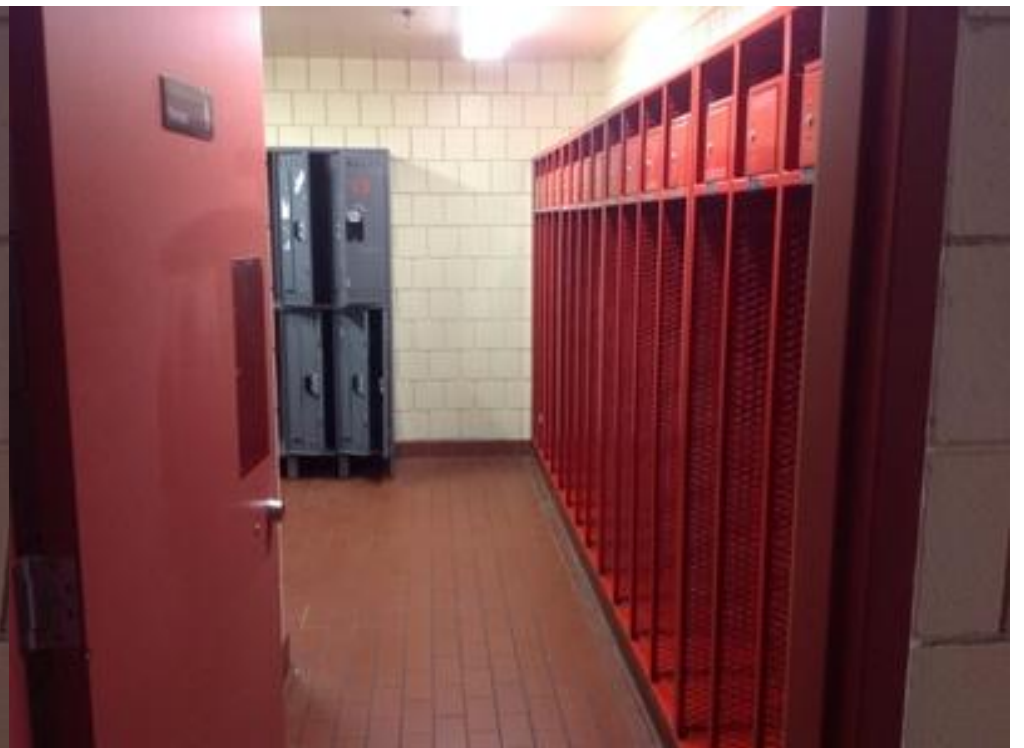
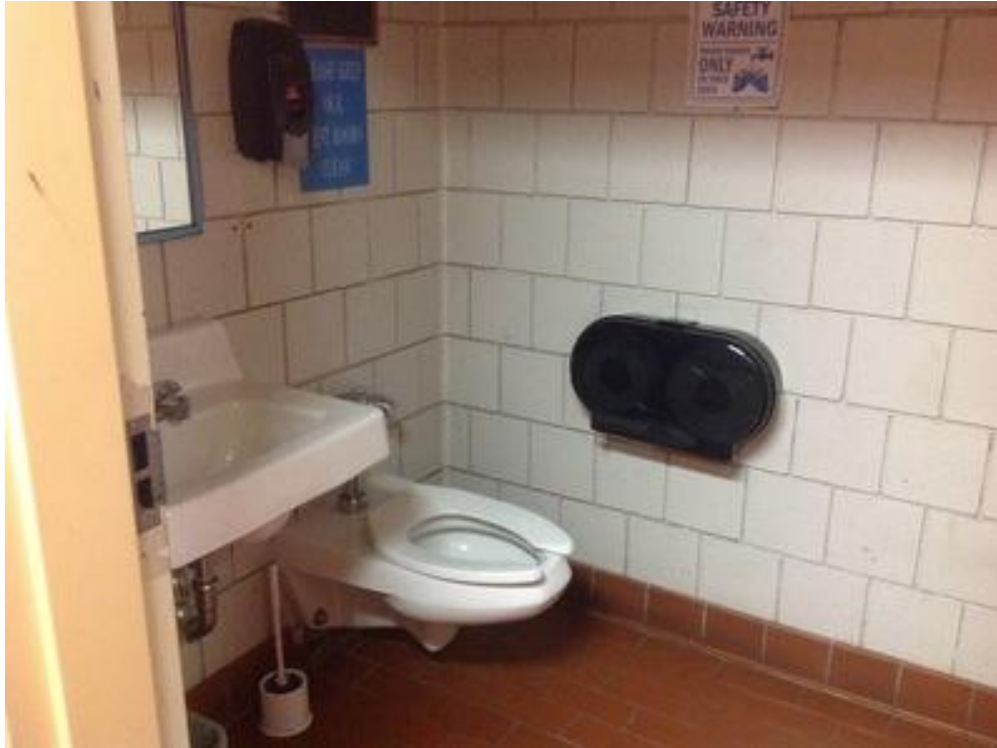
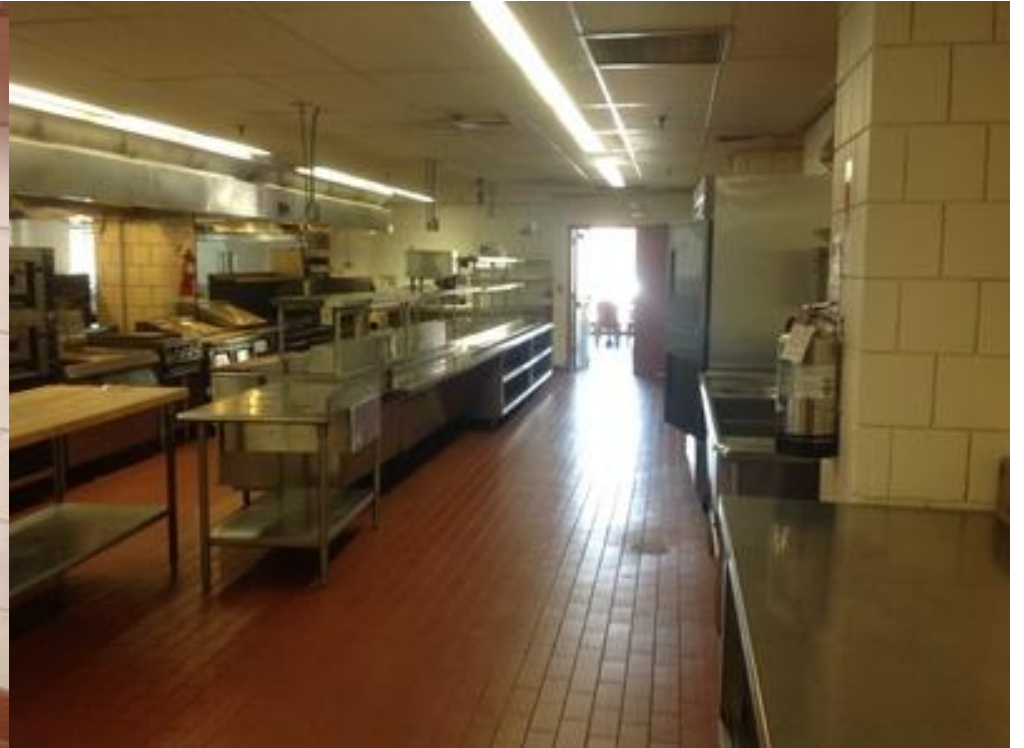
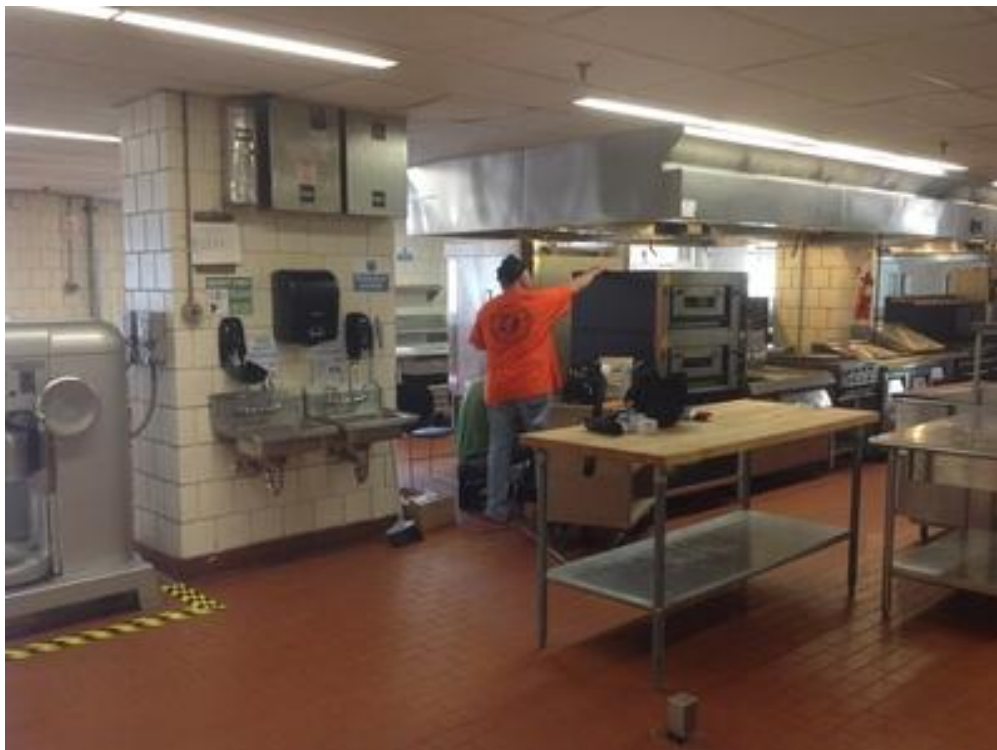
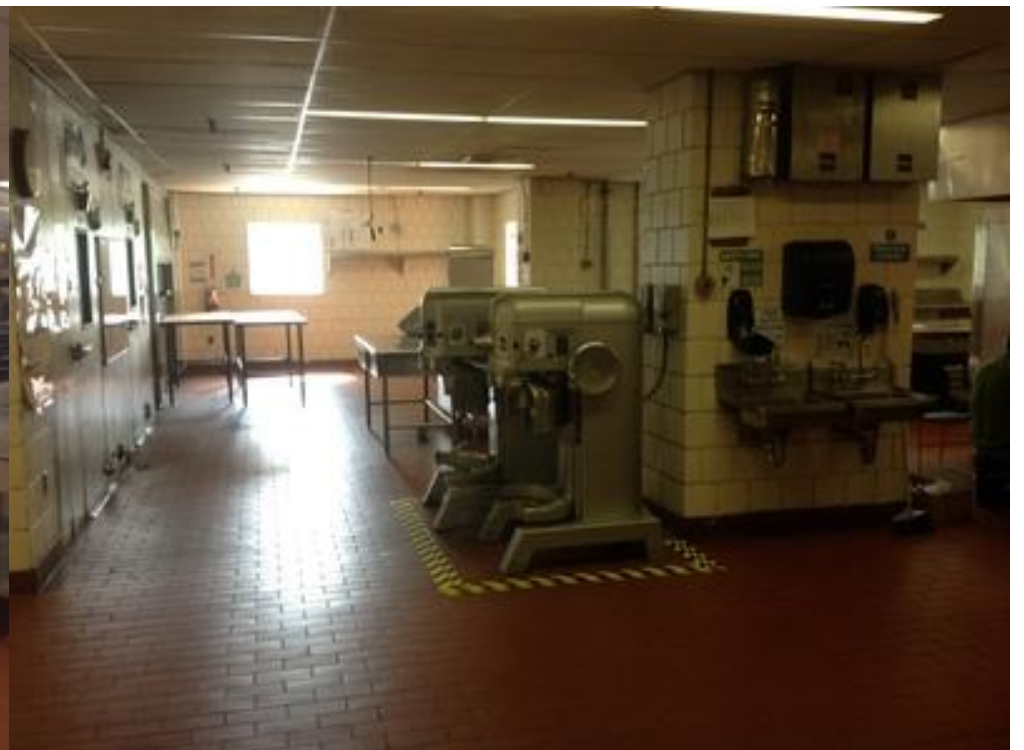
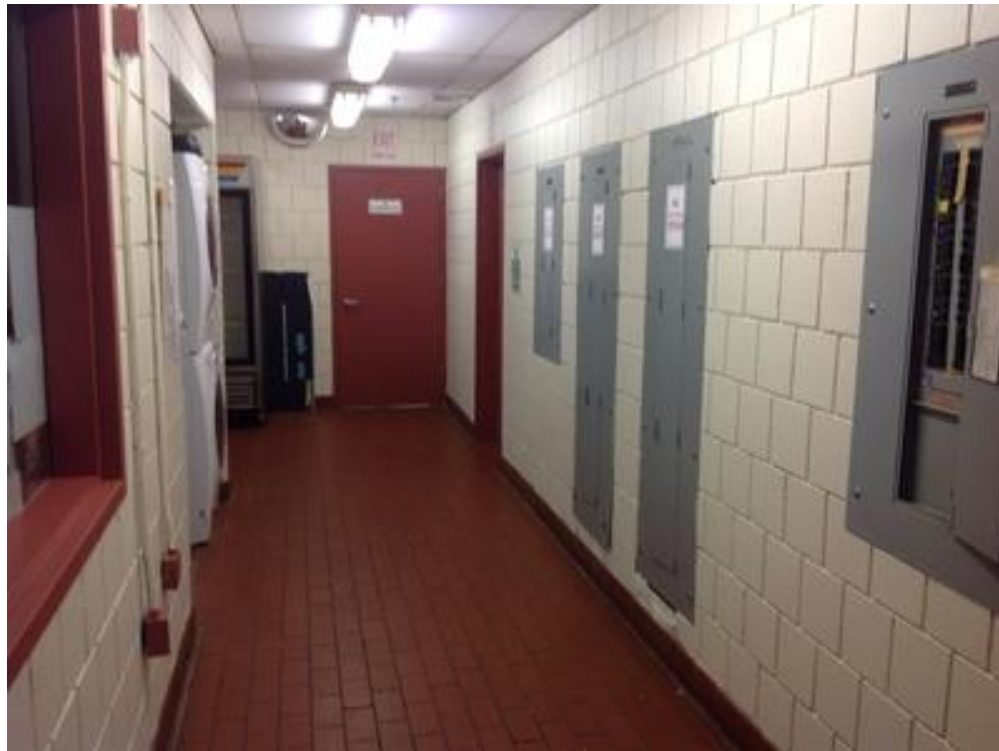
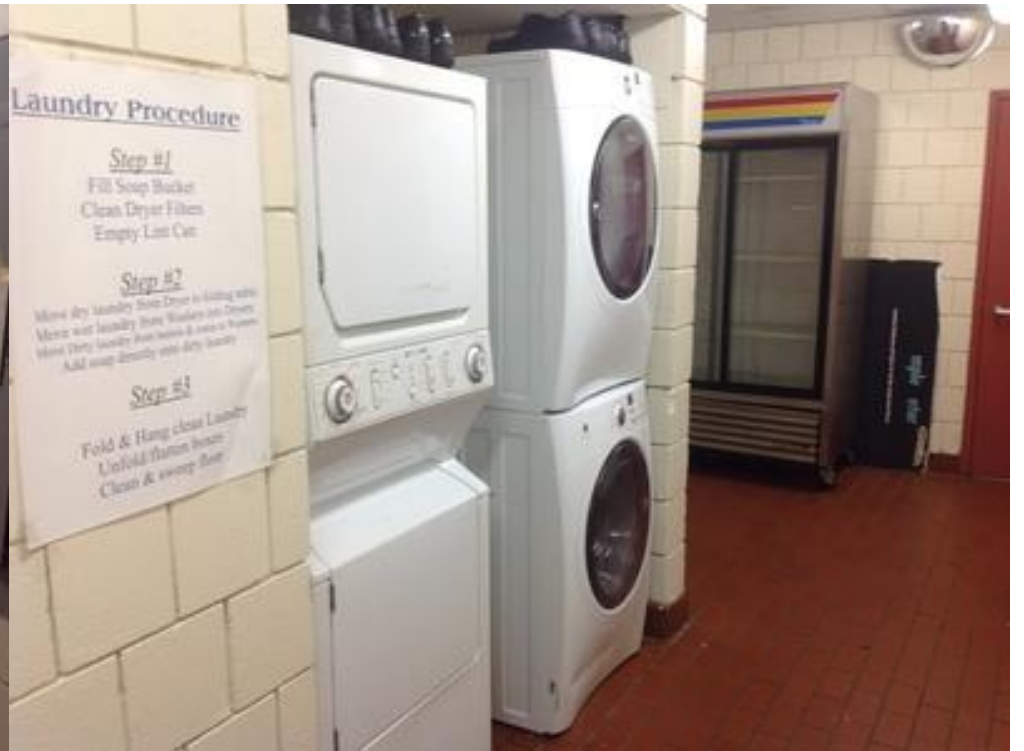
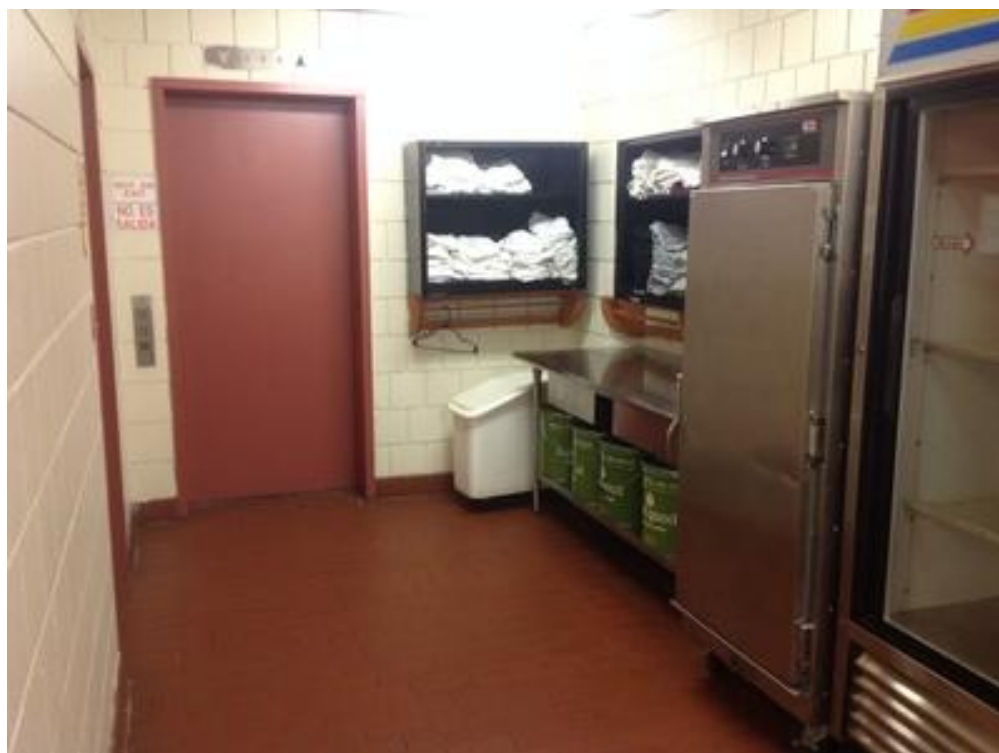
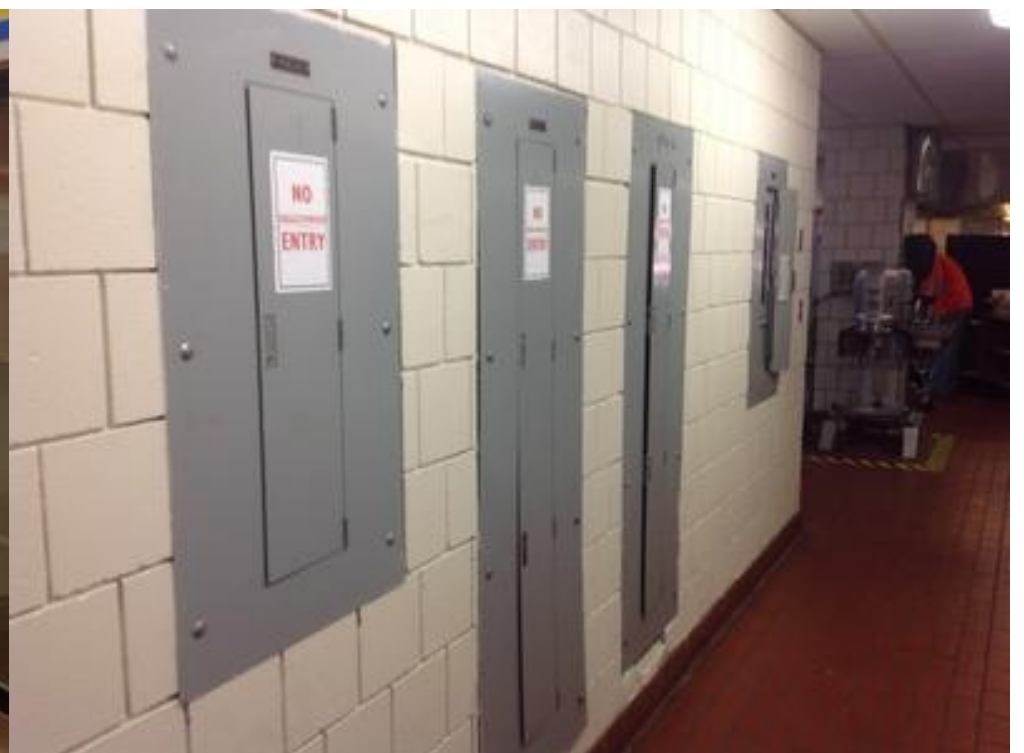
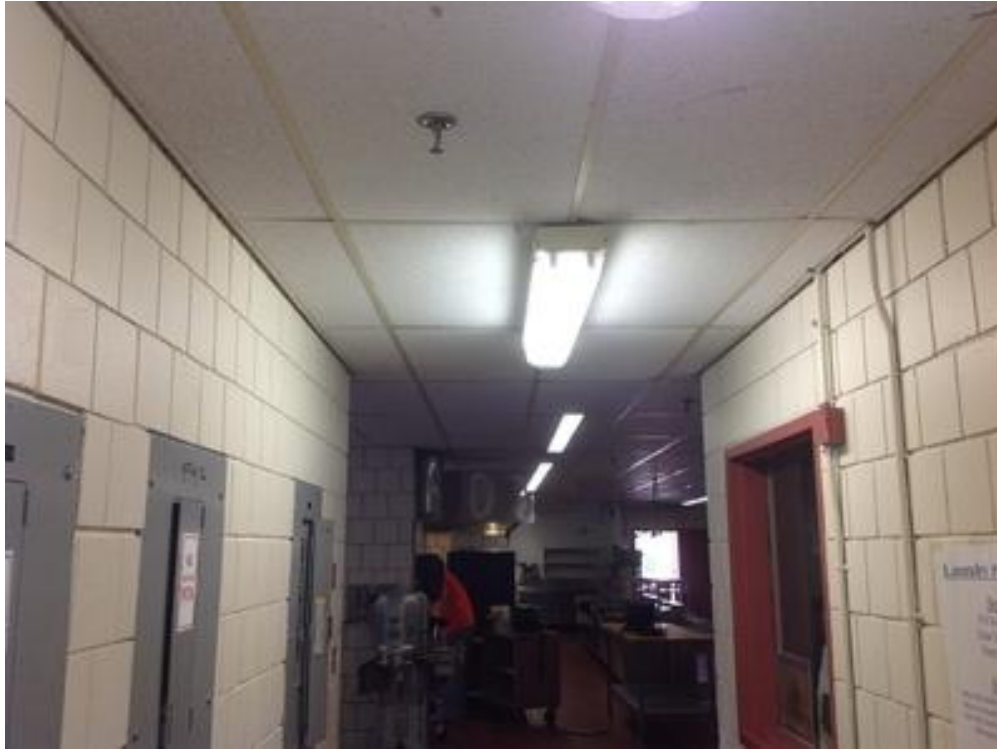
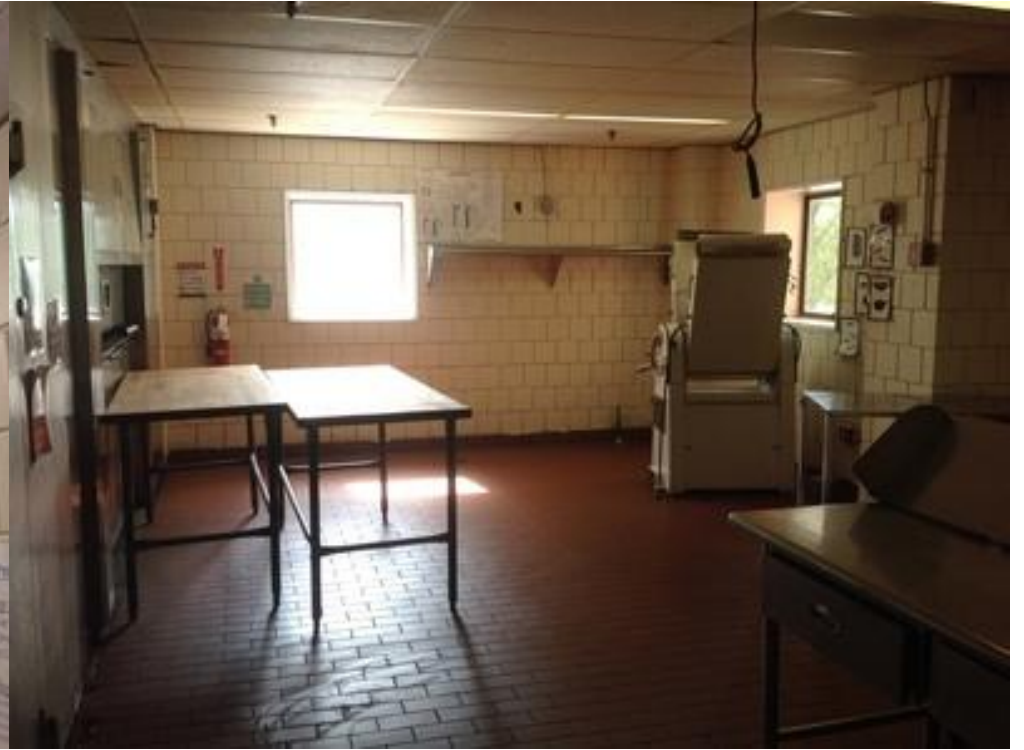
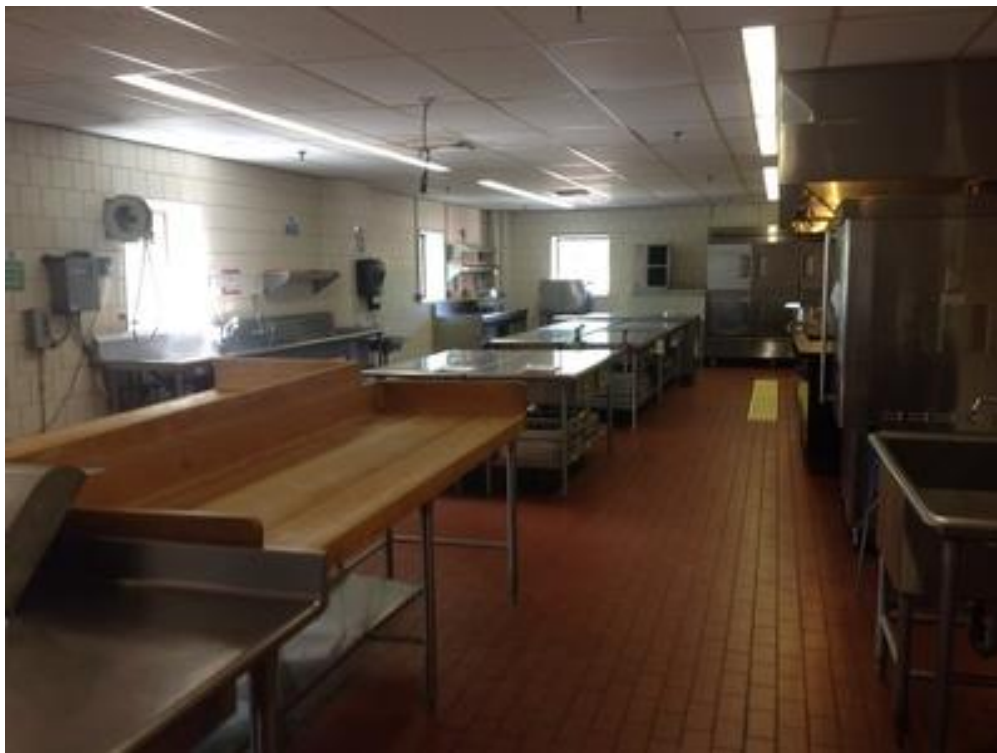
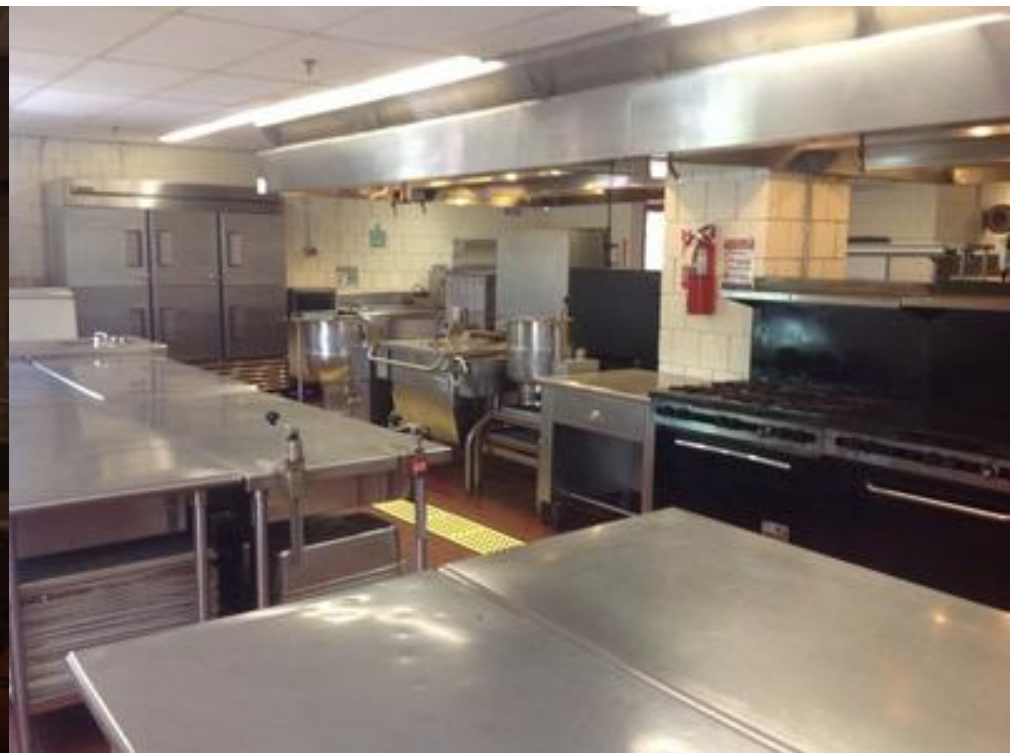
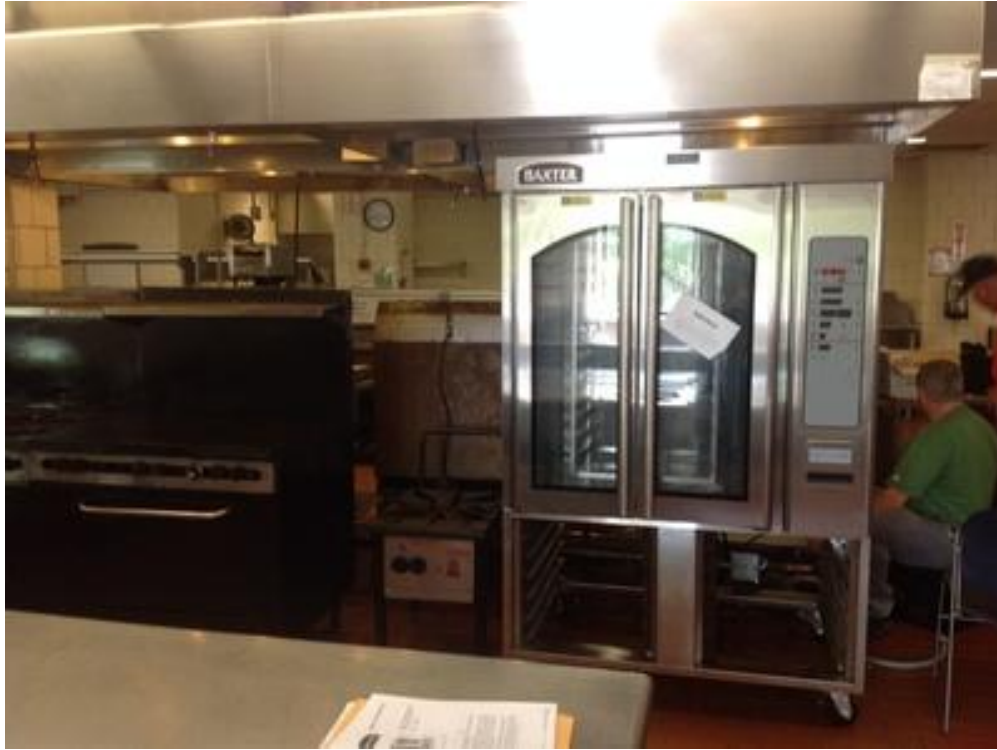
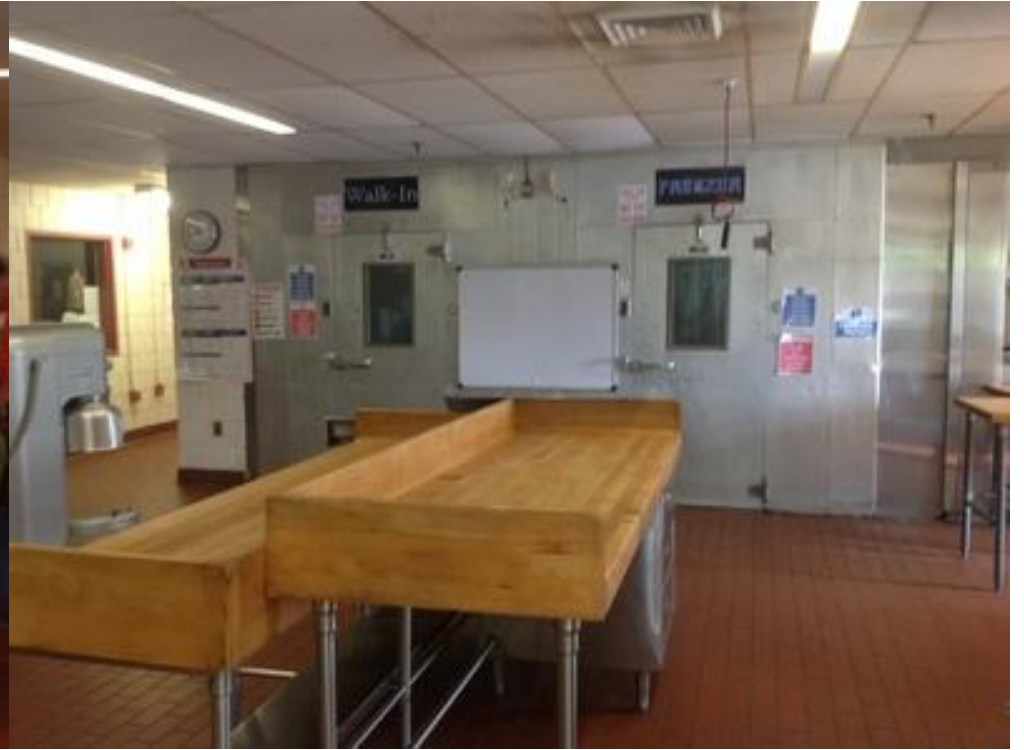
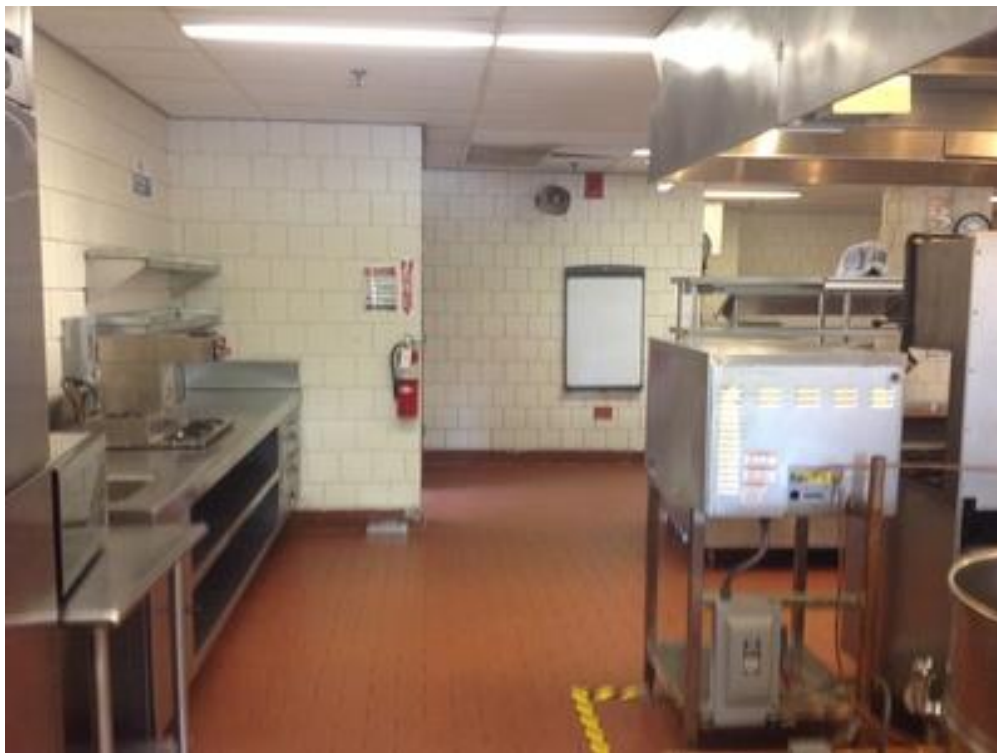
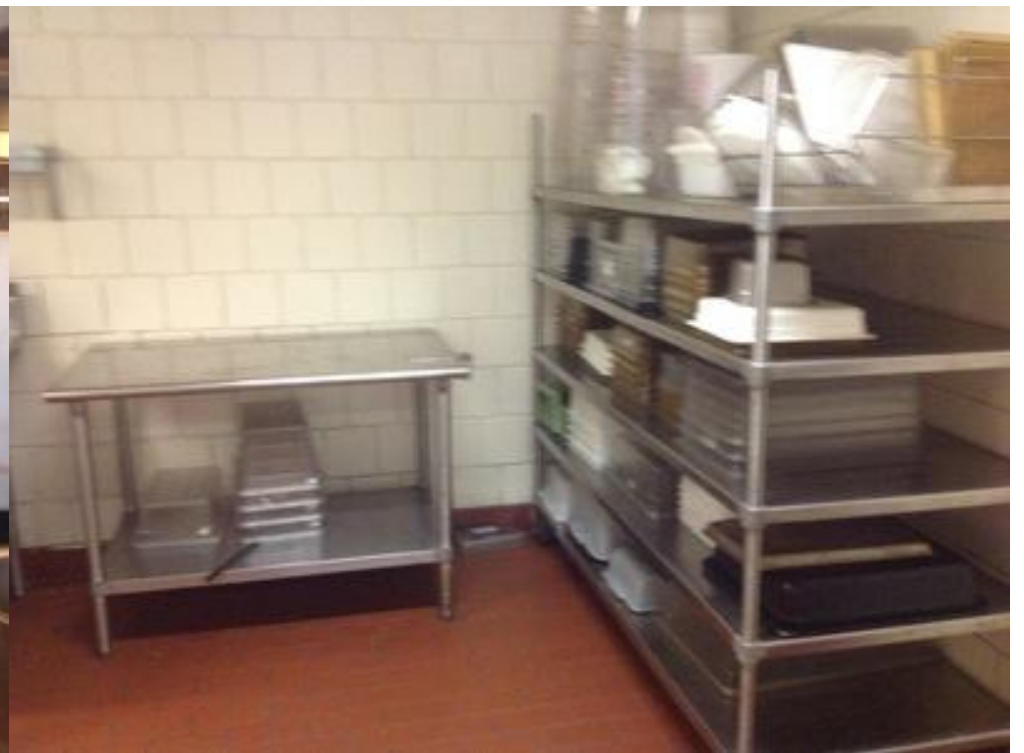
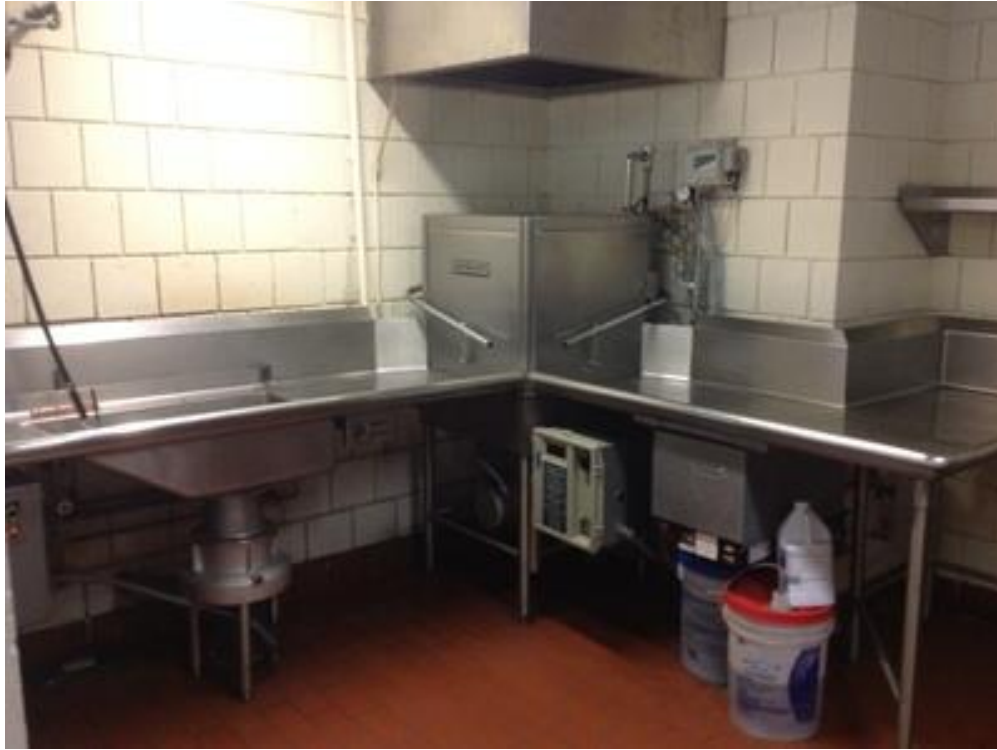
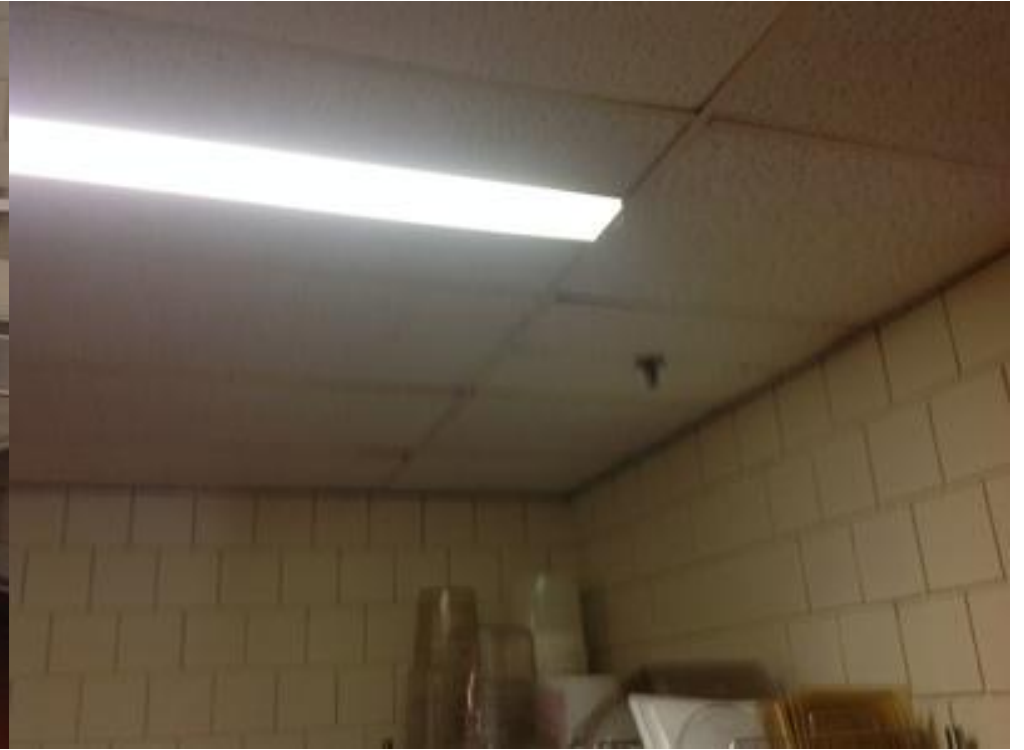
Description
Culinary CTE program area in fair condition. CMU walls are in fair condition. CT flooring is in fair condition. ACT ceiling is in poor condition - dirty, broken, and bowed tiles. Some windows are in poor condition and have lost seals.

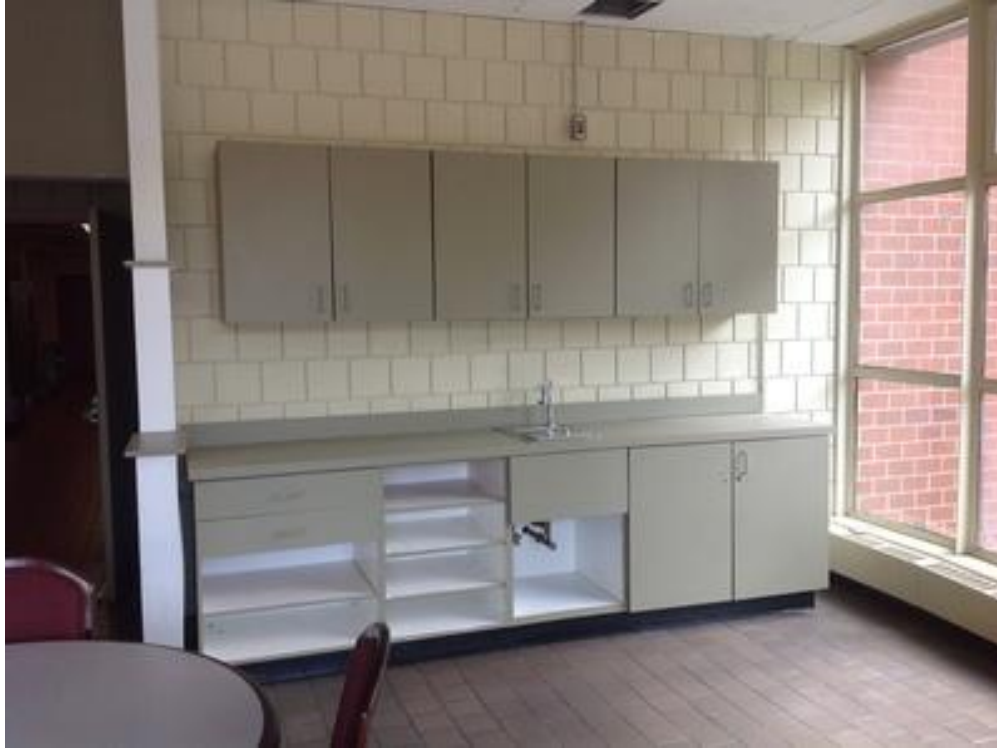
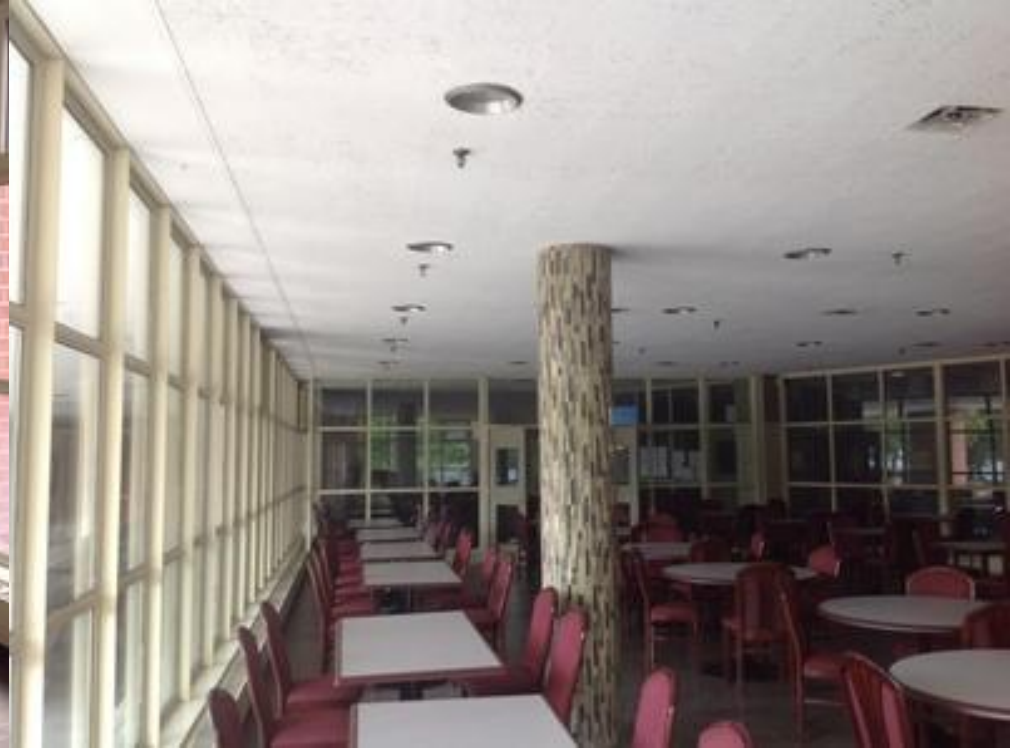
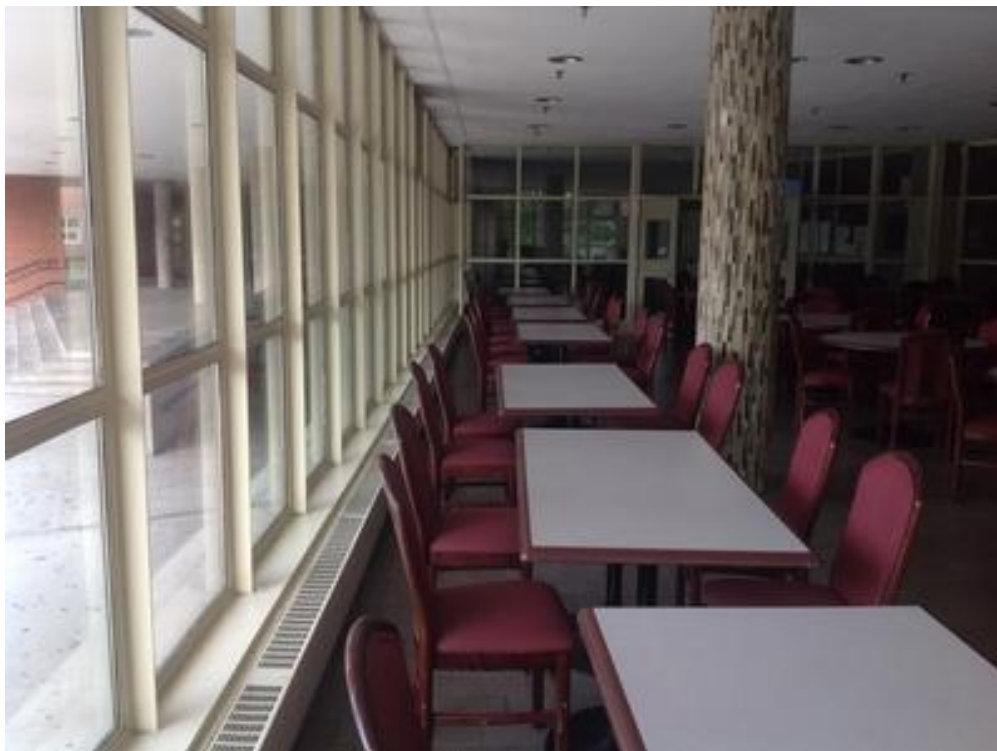
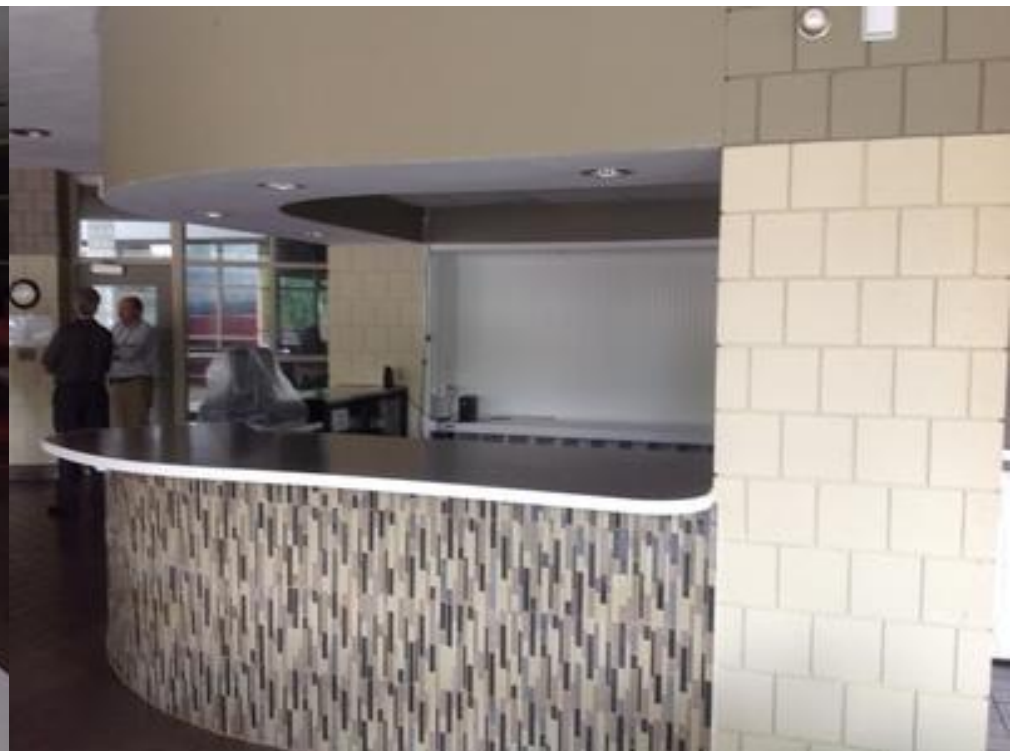
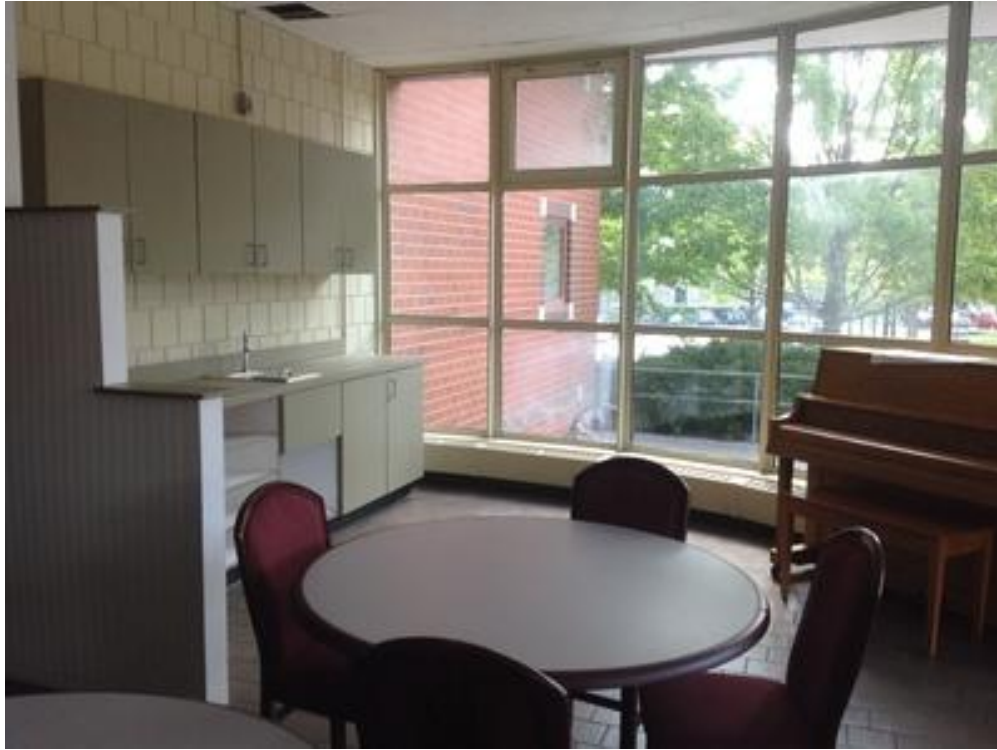
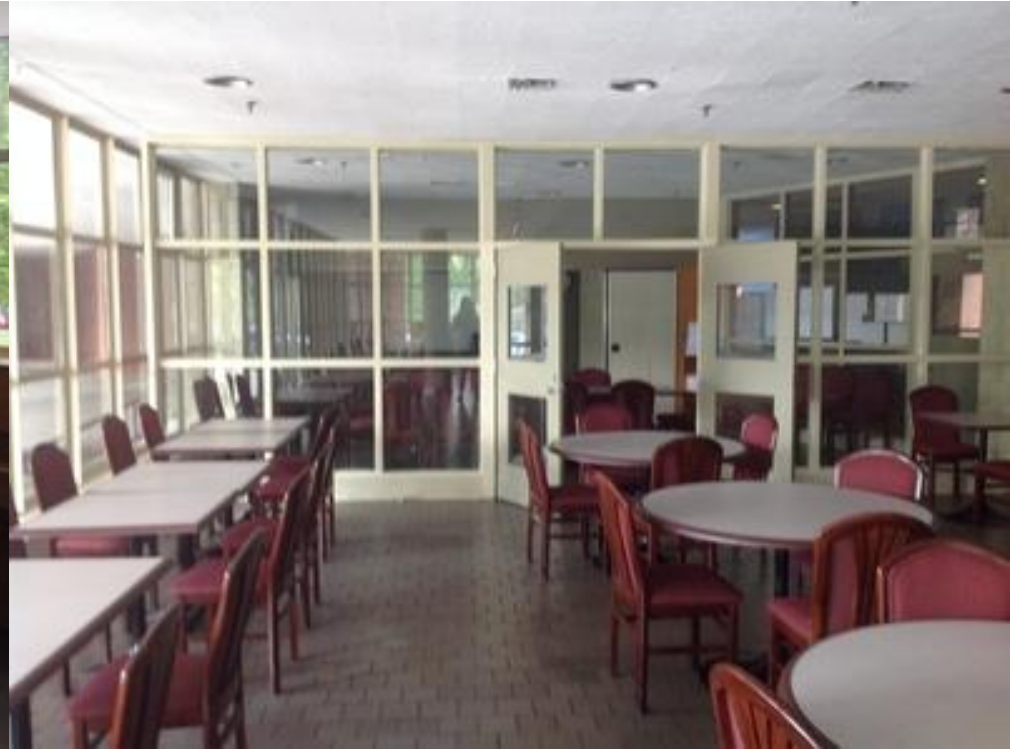
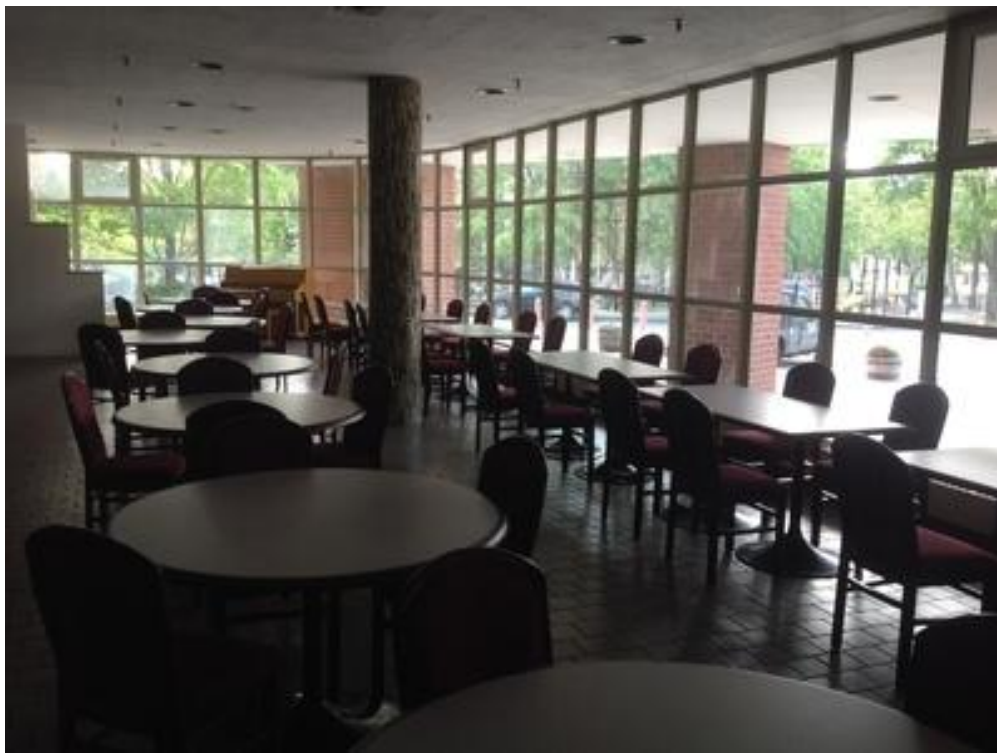
Dining room is in fair condition. CT is in fair condition. ACT is in poor condition. Storeefront in fair condition. Bar area and column have been recently updated with tile finish. Millwork is in fair condition.
