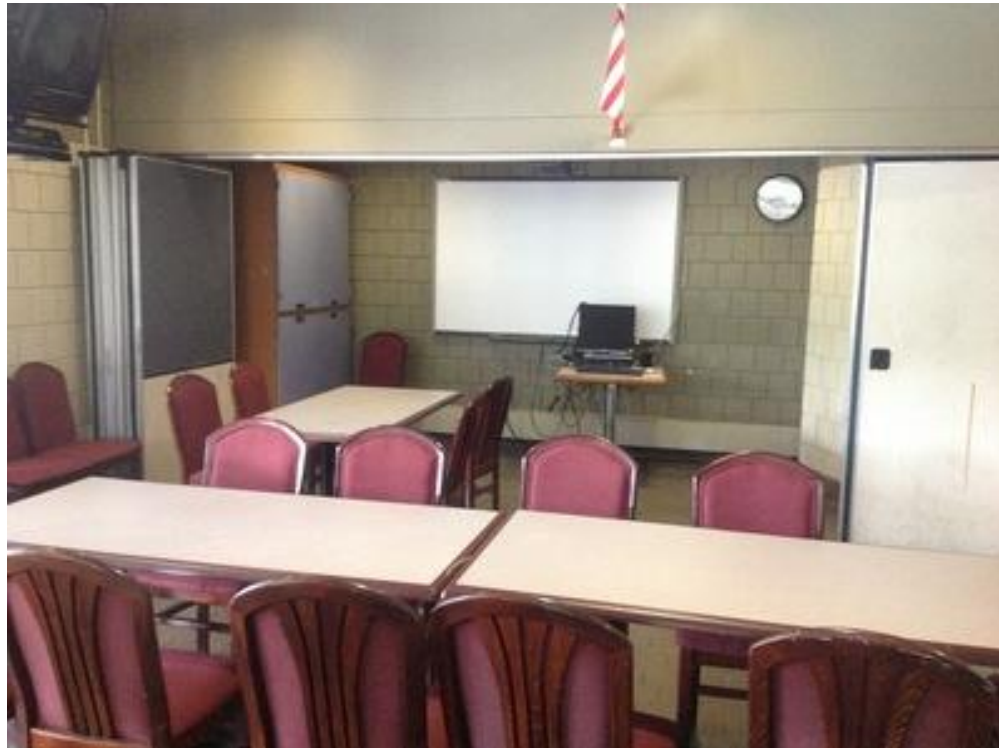
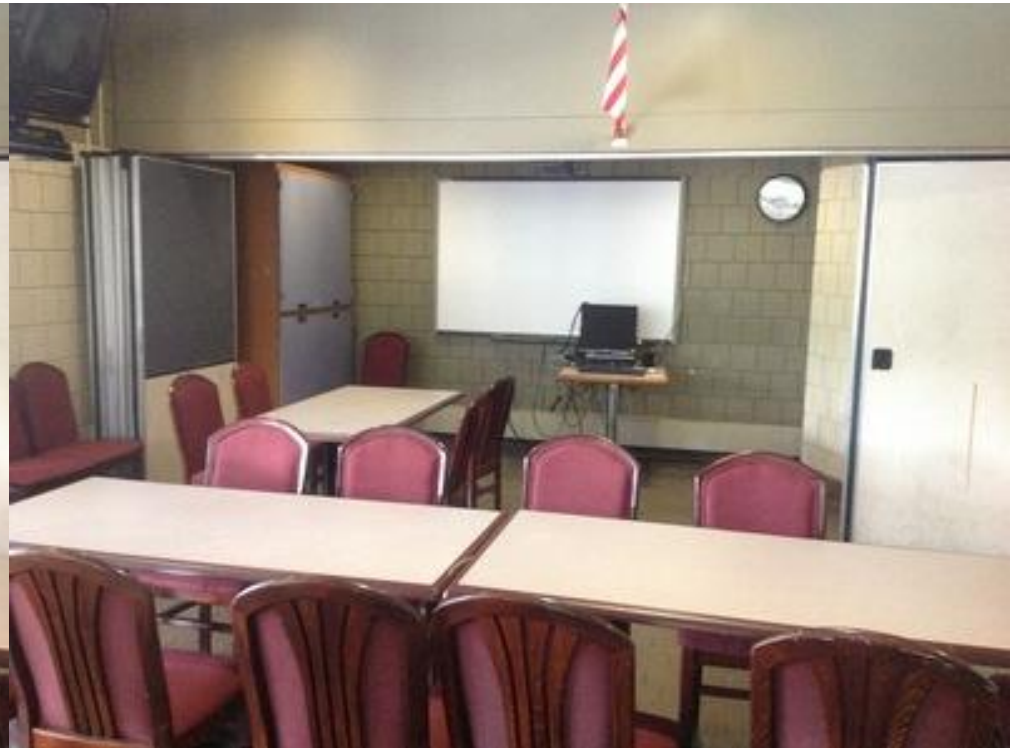
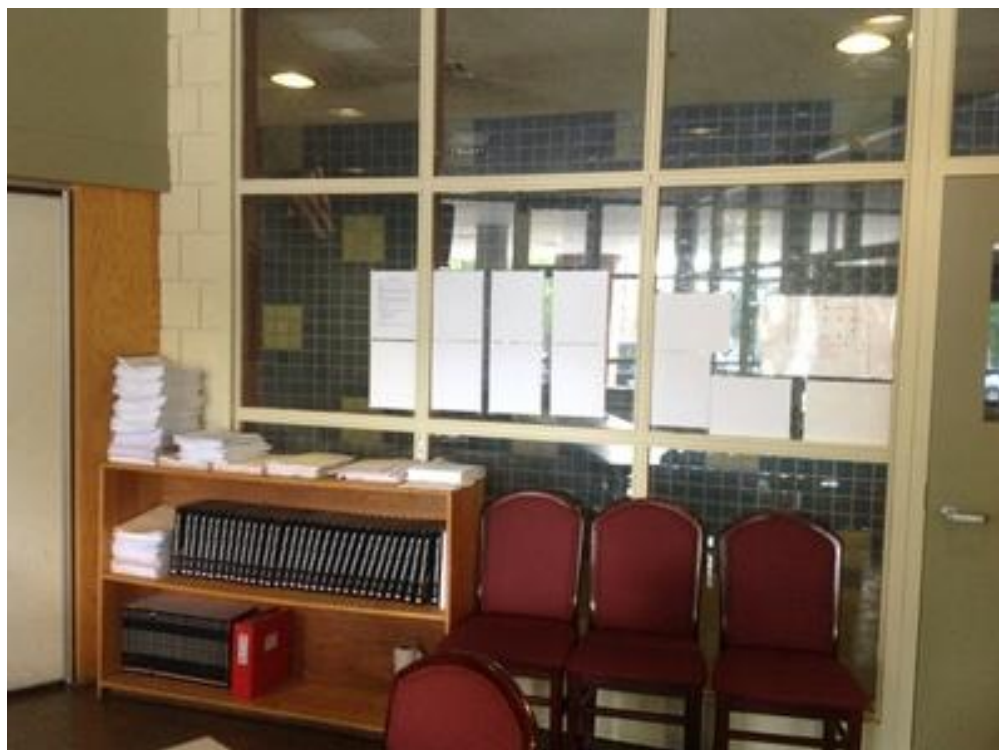
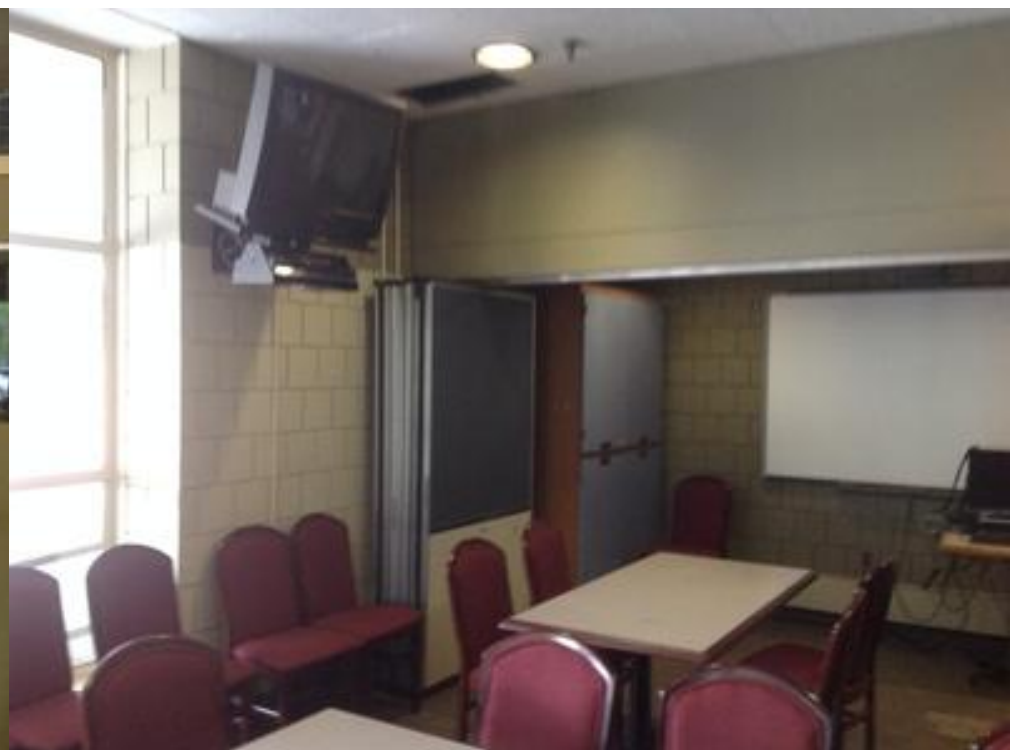
Classroom in fair condition. Folding partition is in poor condition and appears unused. Smartboard.

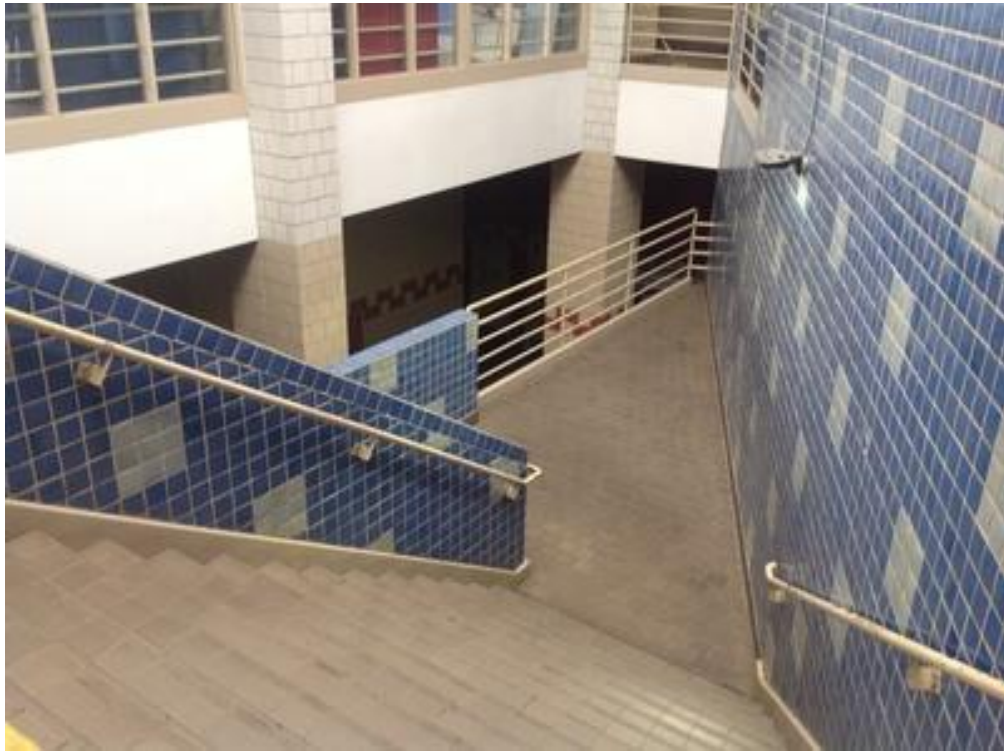
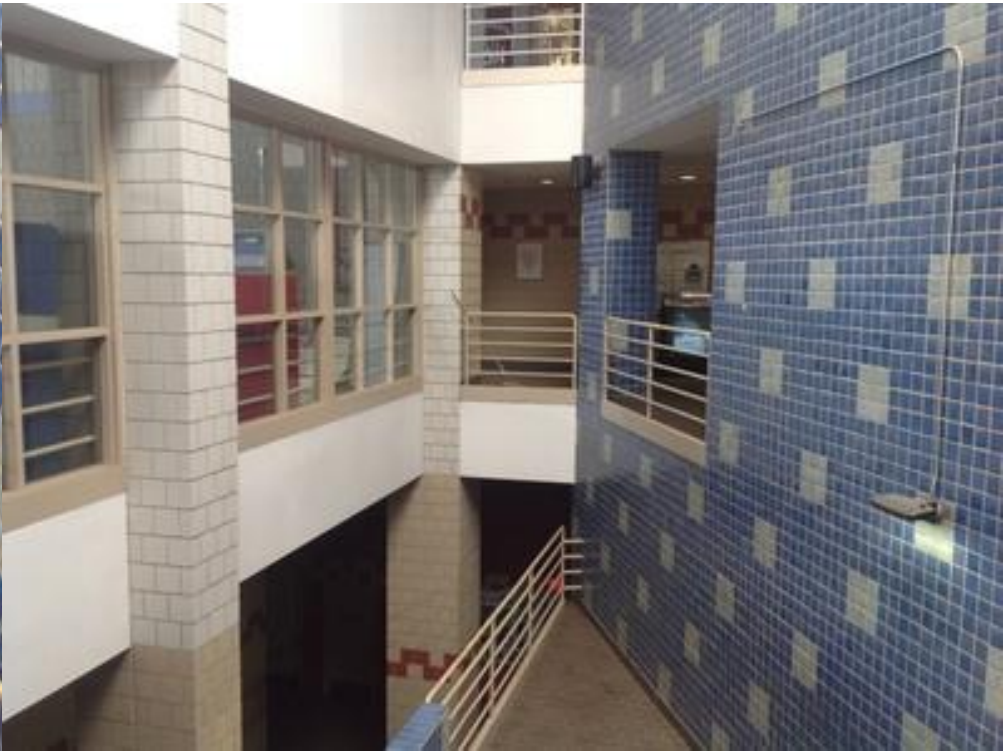
Attached Images for ID KU-00137

| <div>Description</div> <div>Stair is in fair condition. Some tiles show sign of wear over time. Handrails are in poor condition and have many paint chips and dings.</div> | | | |

| Condition | Fair | | |

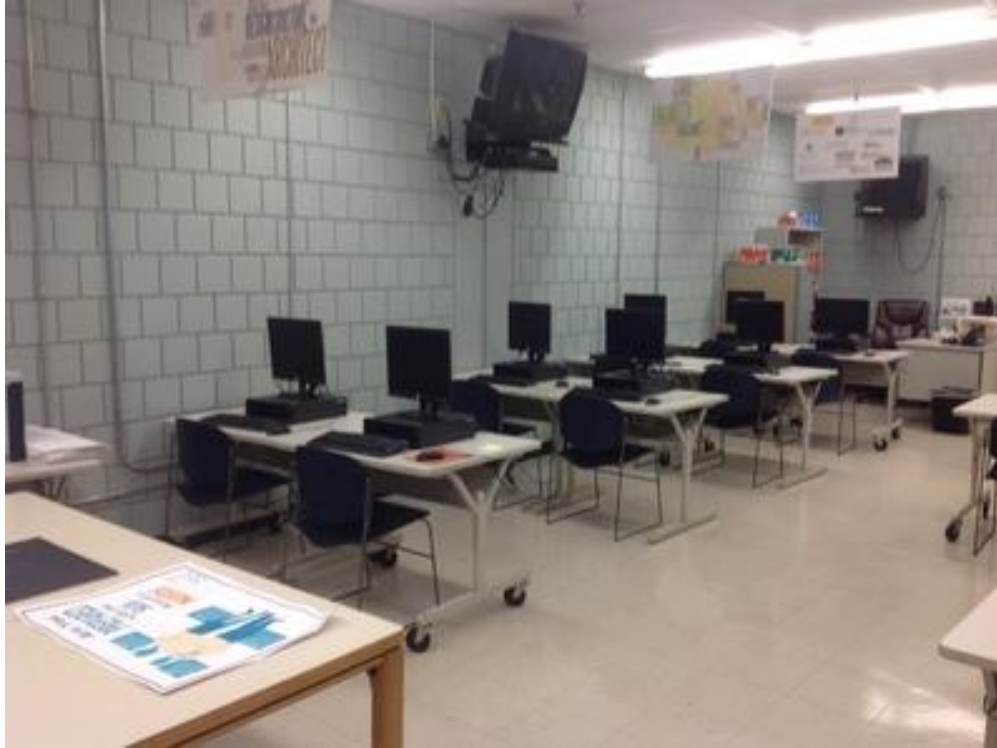
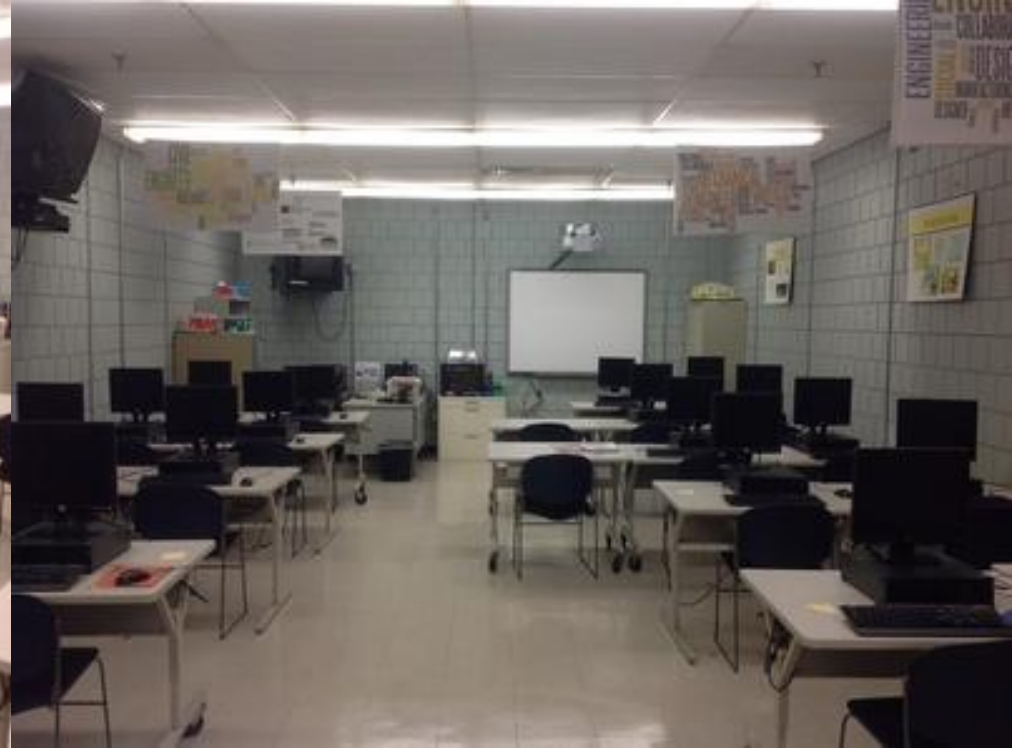
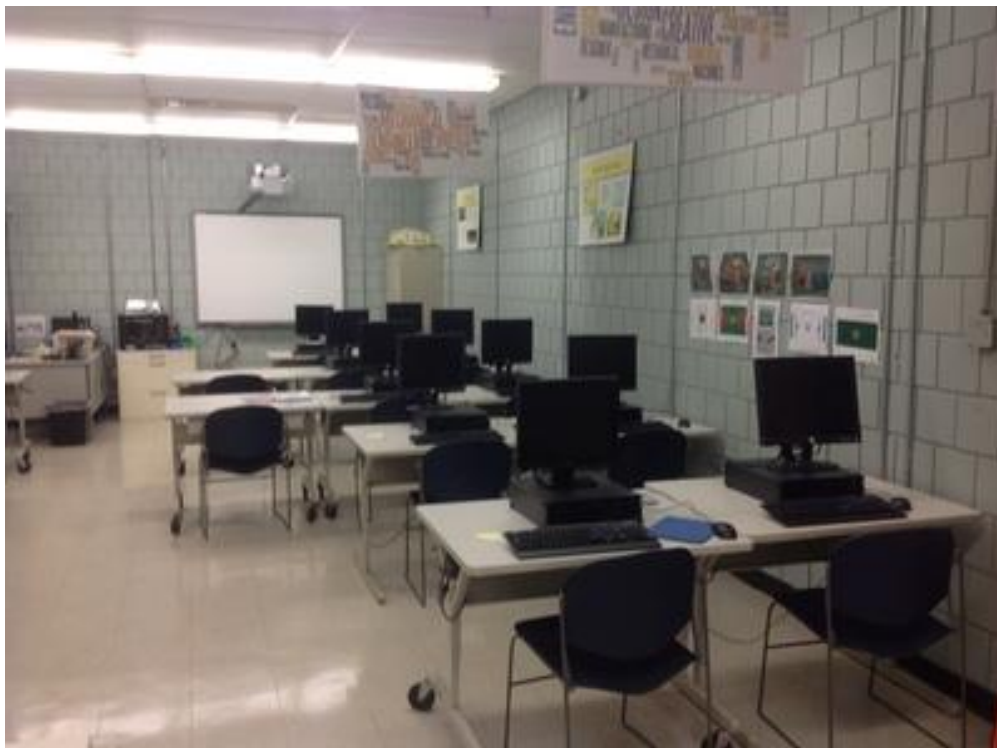
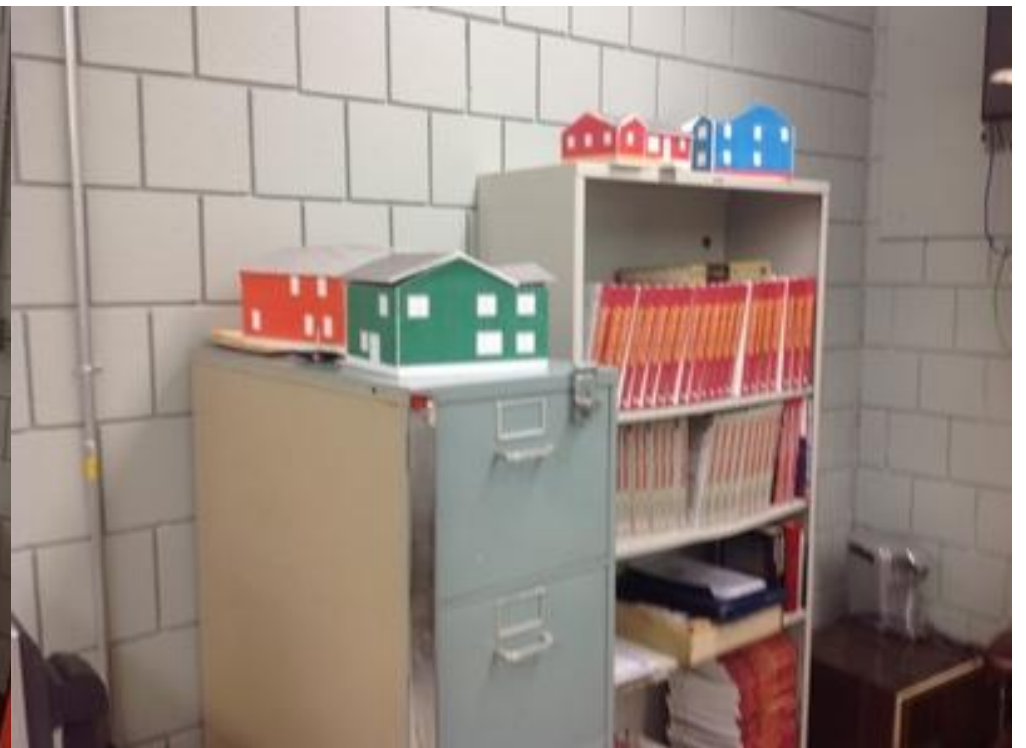
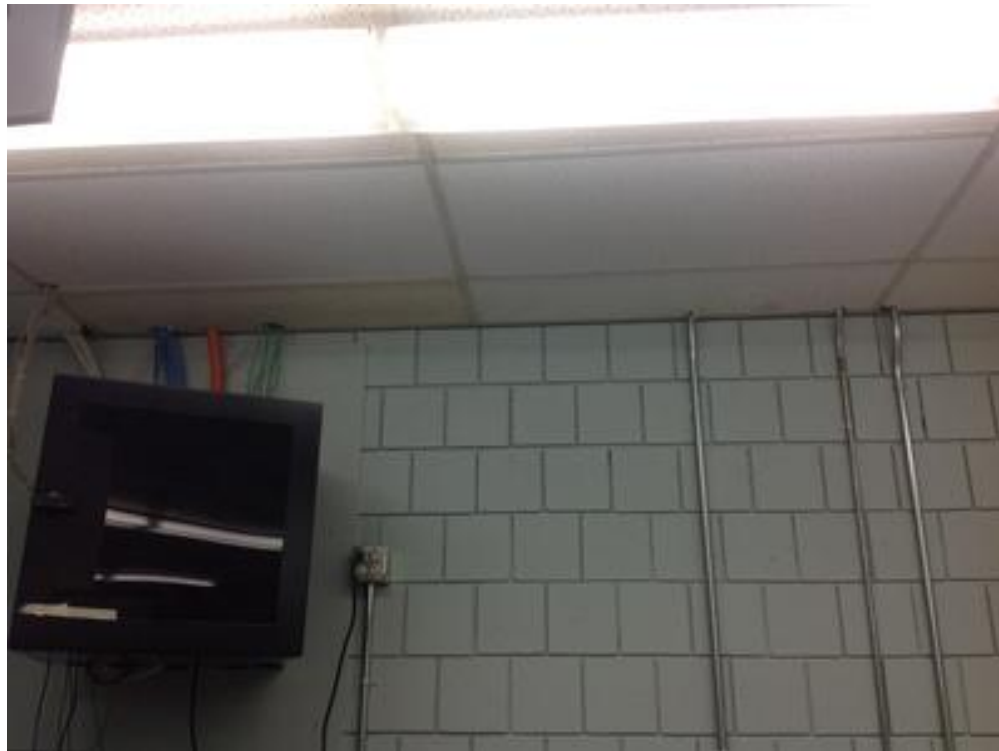
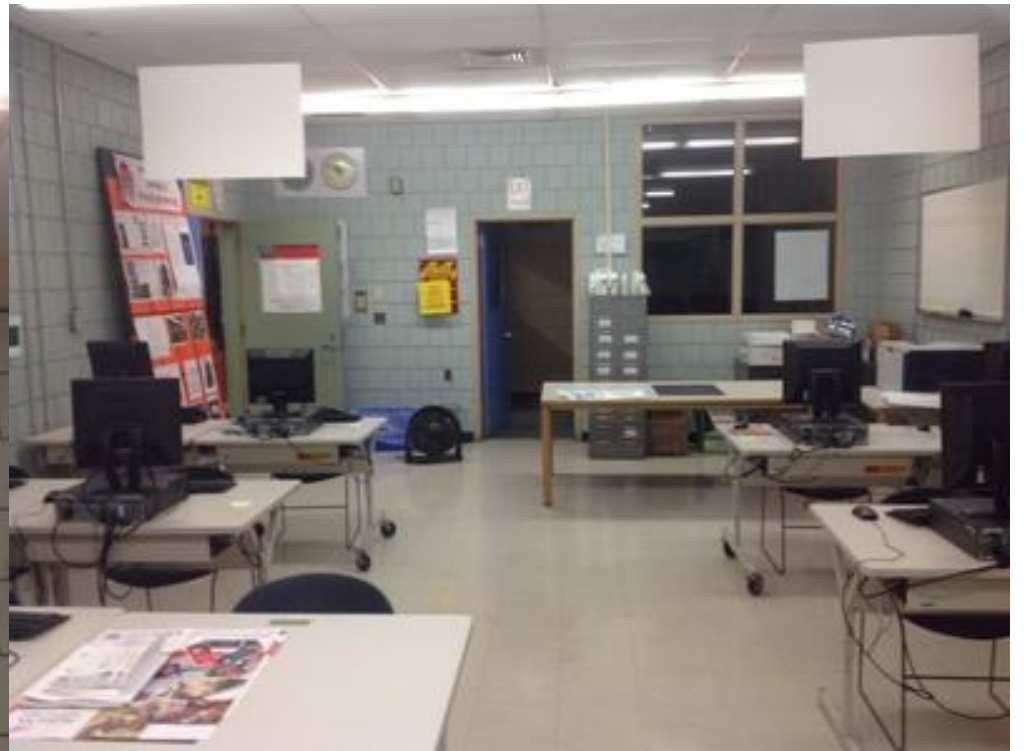
Engineering CR in good condition. VCT Flooring in good condition. CMU walls in good condition. Lighting in fair condition. ACT ceiling in poor condition.

| Condition | Fair | | |

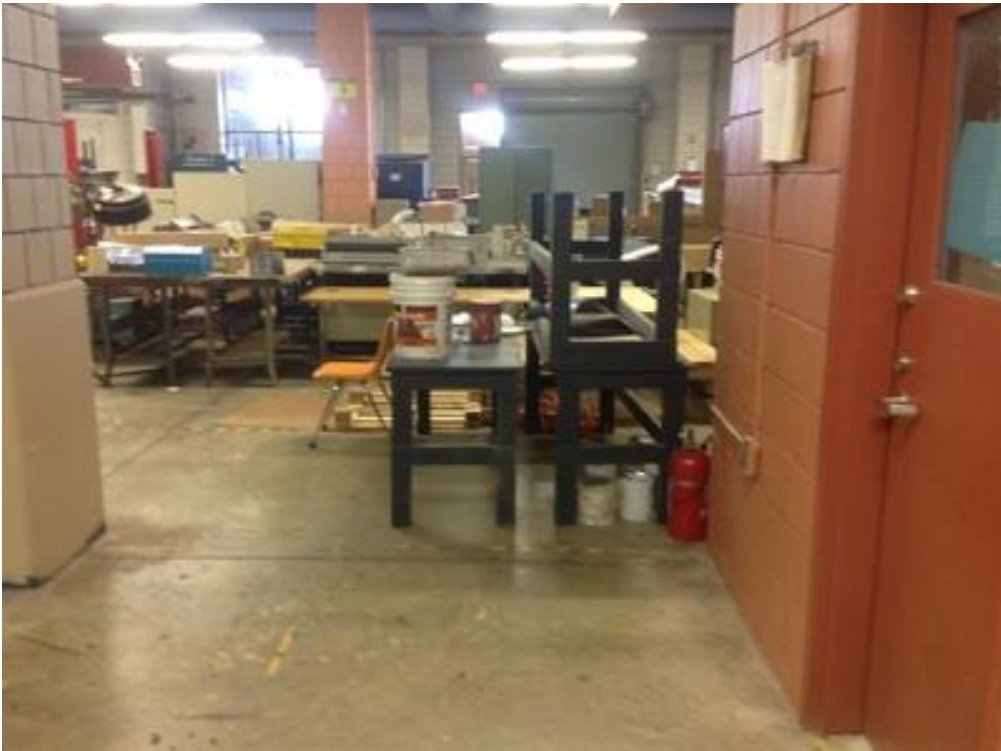
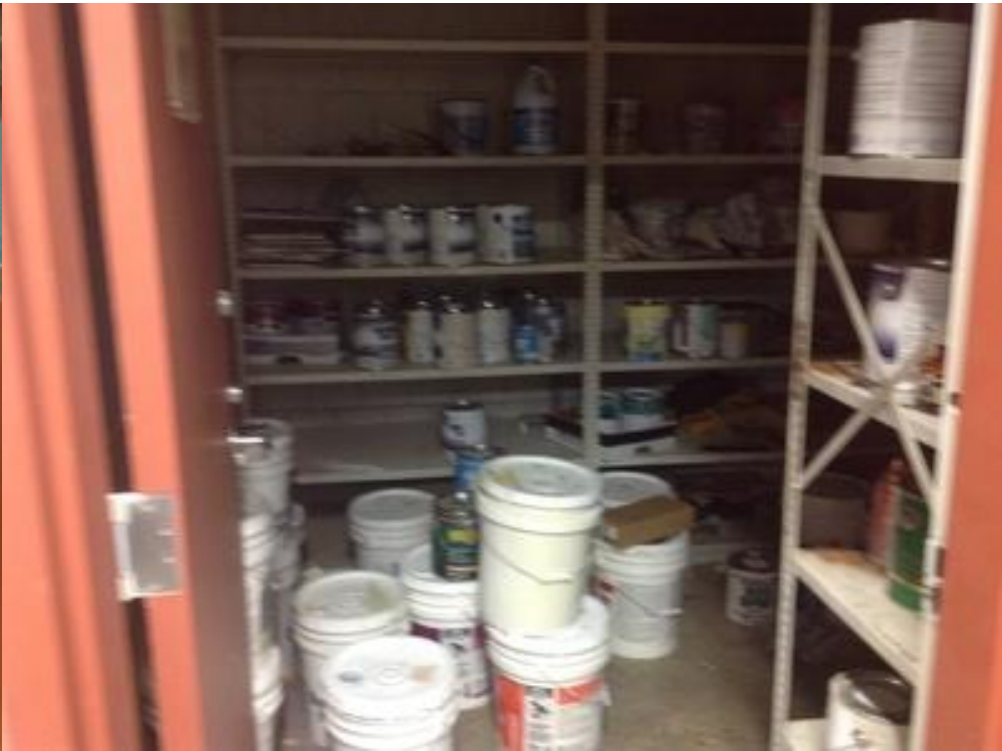
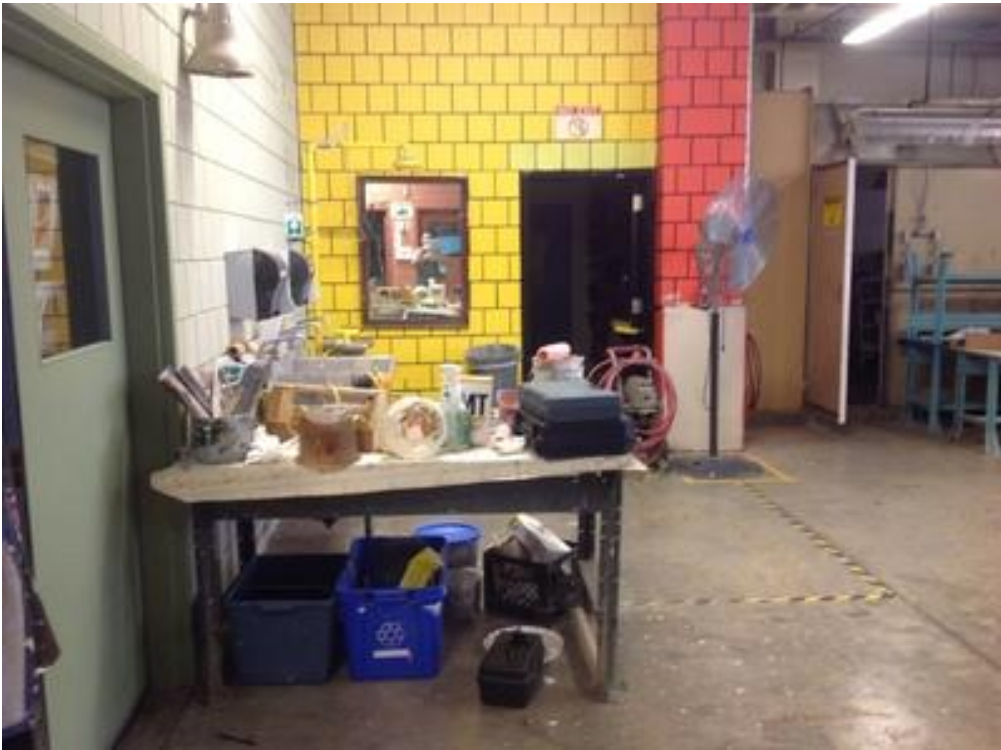
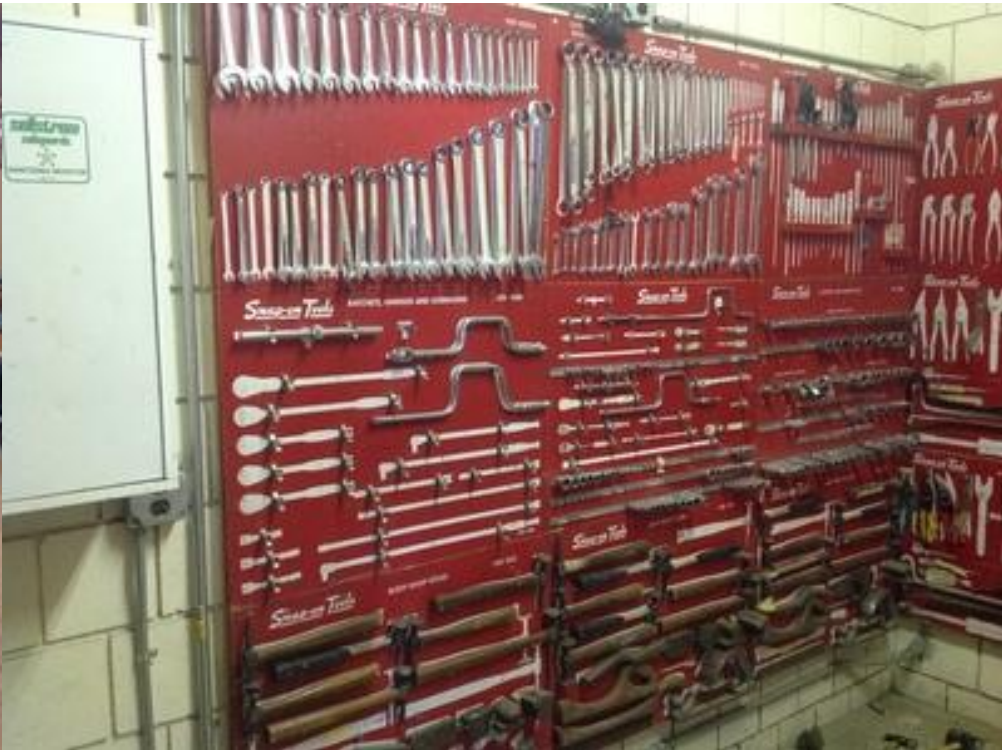
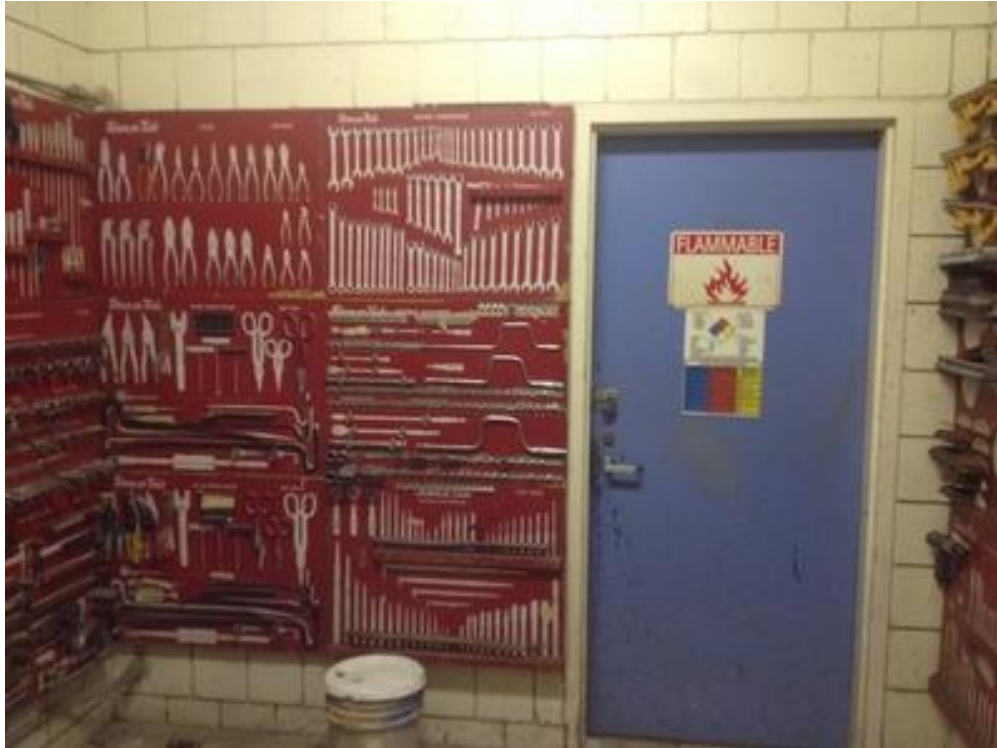
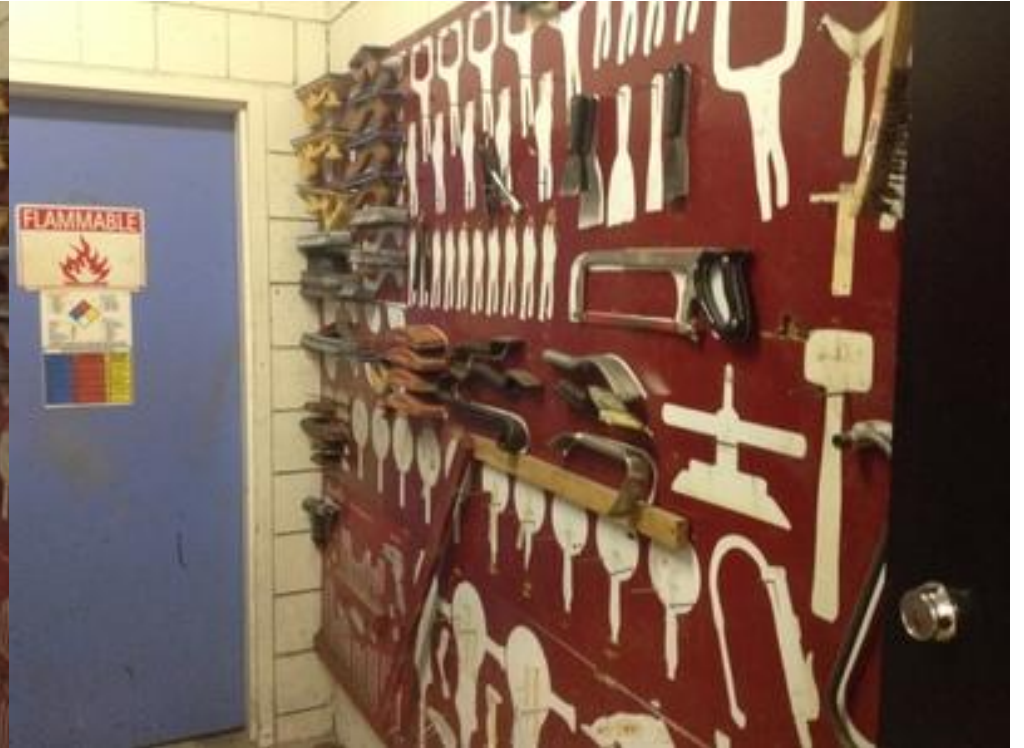
Auto Body Shop is in fair condition. Sealed concrete floors are in fair condition. CMU block walls in fair condition. Windows are in fair condition but some have lost their seals. Millwork in poor condition. Painted structure and ductwork above.

| Condition | Fair | | |

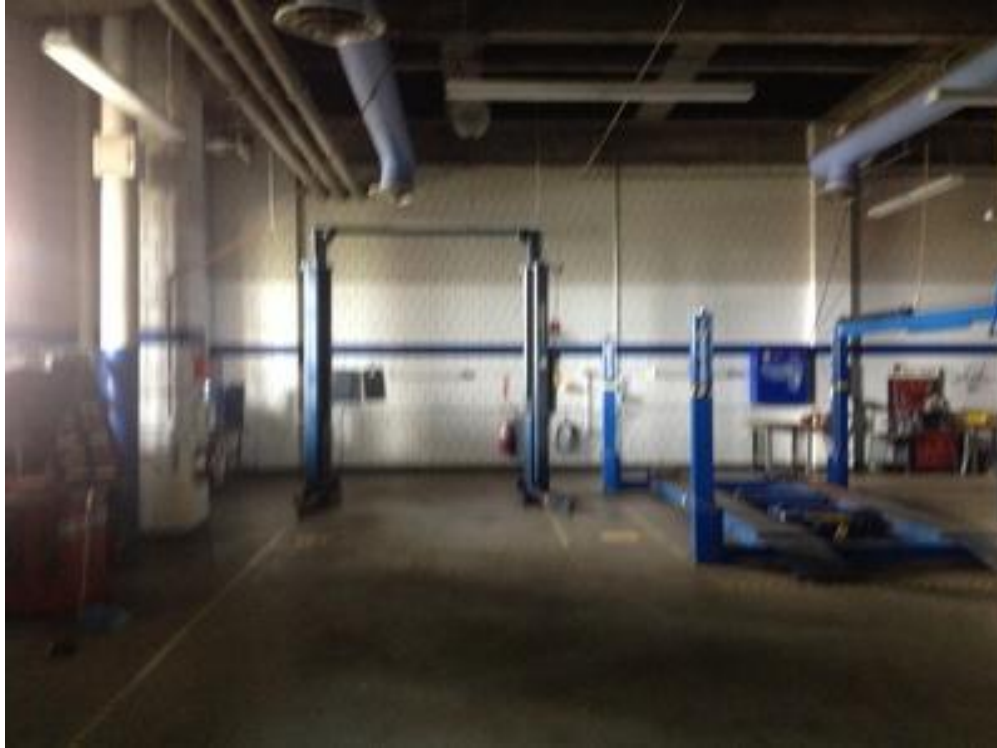
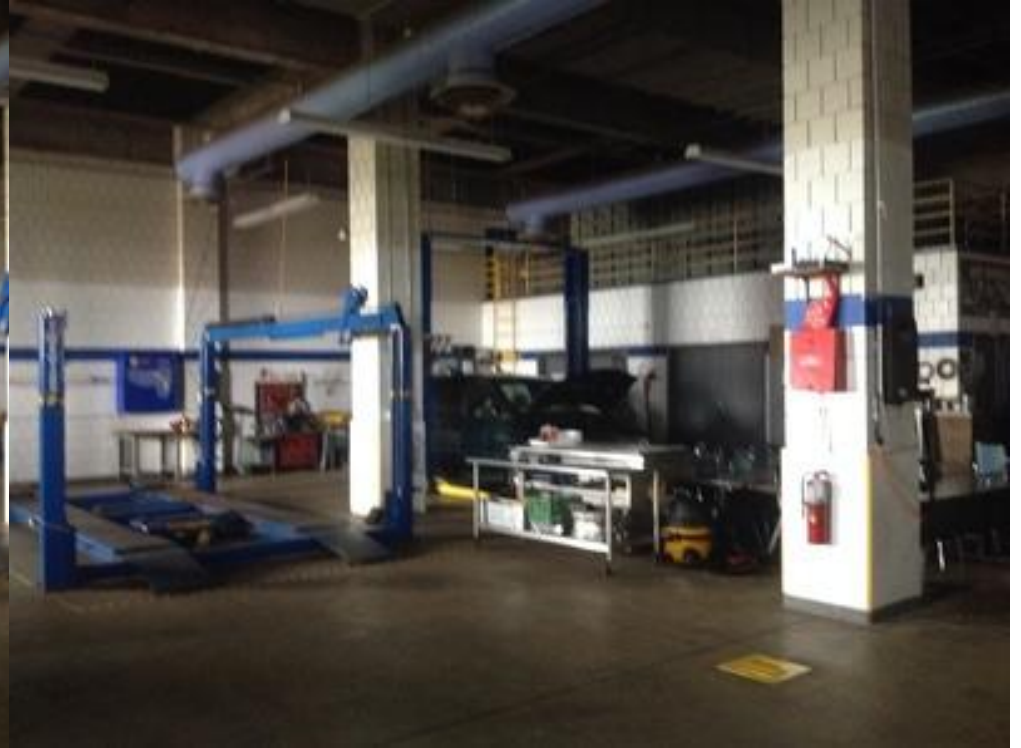
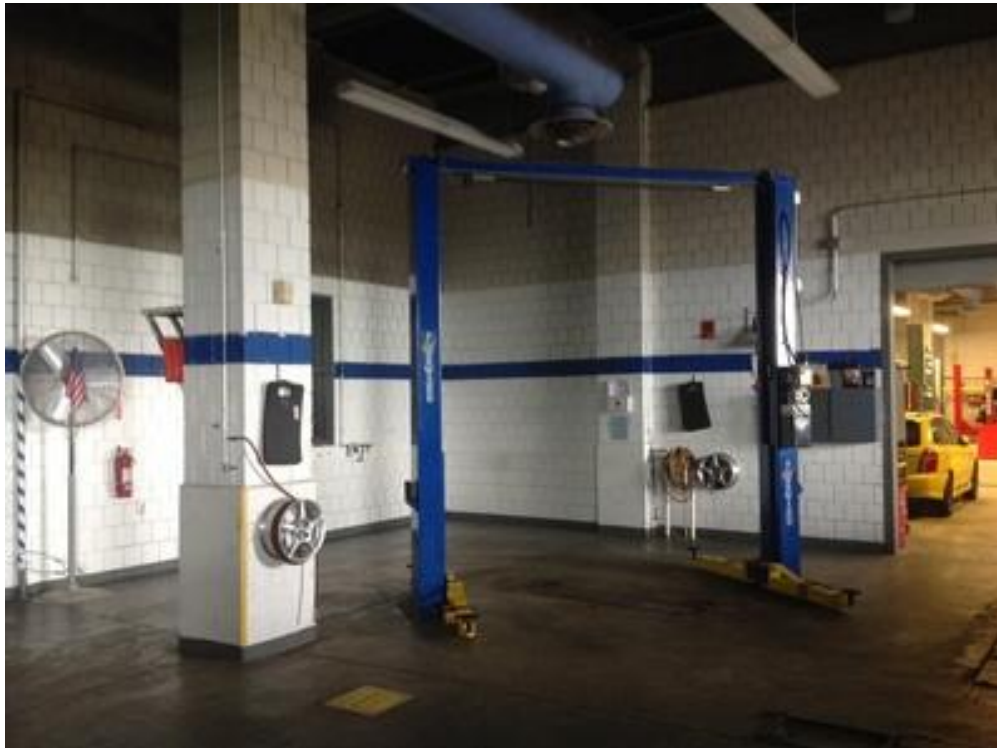
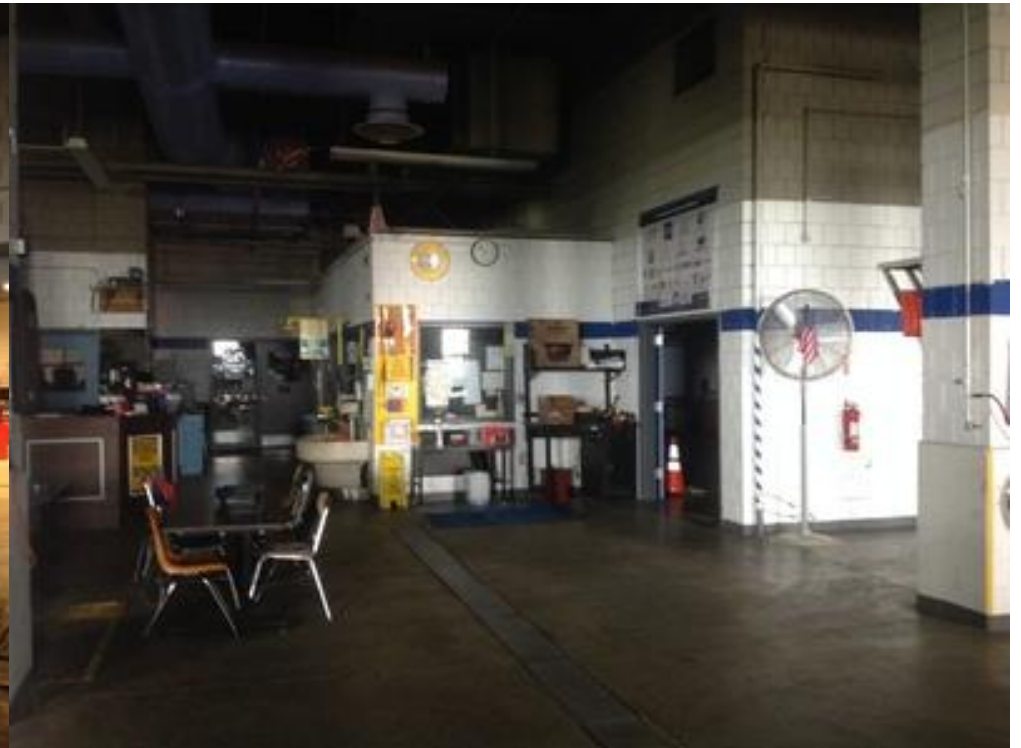
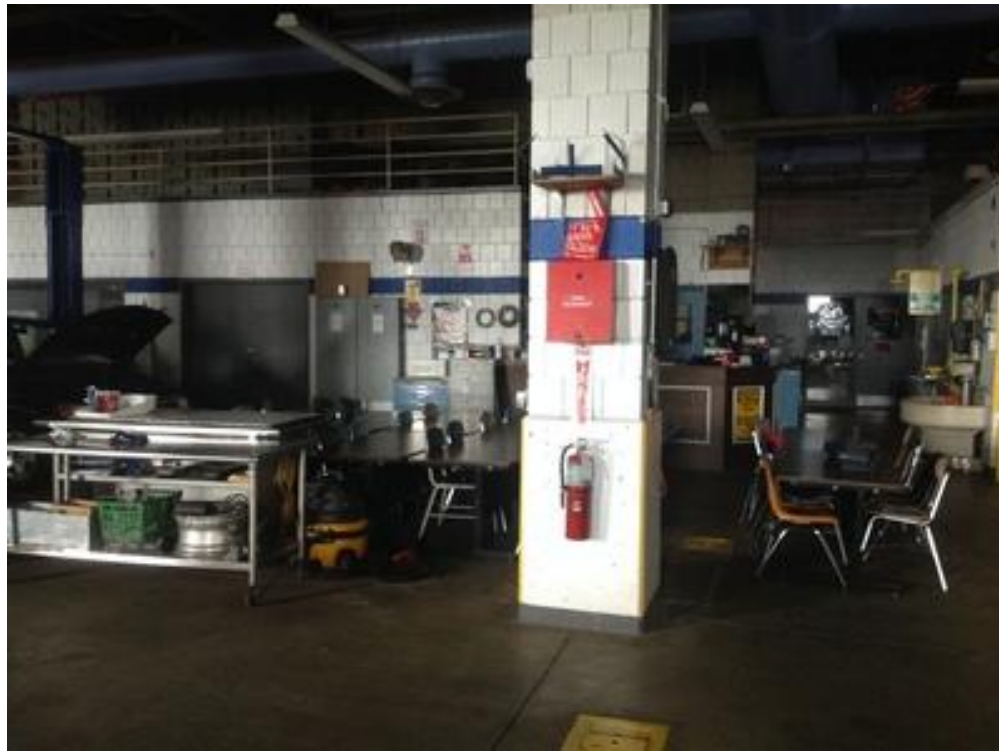
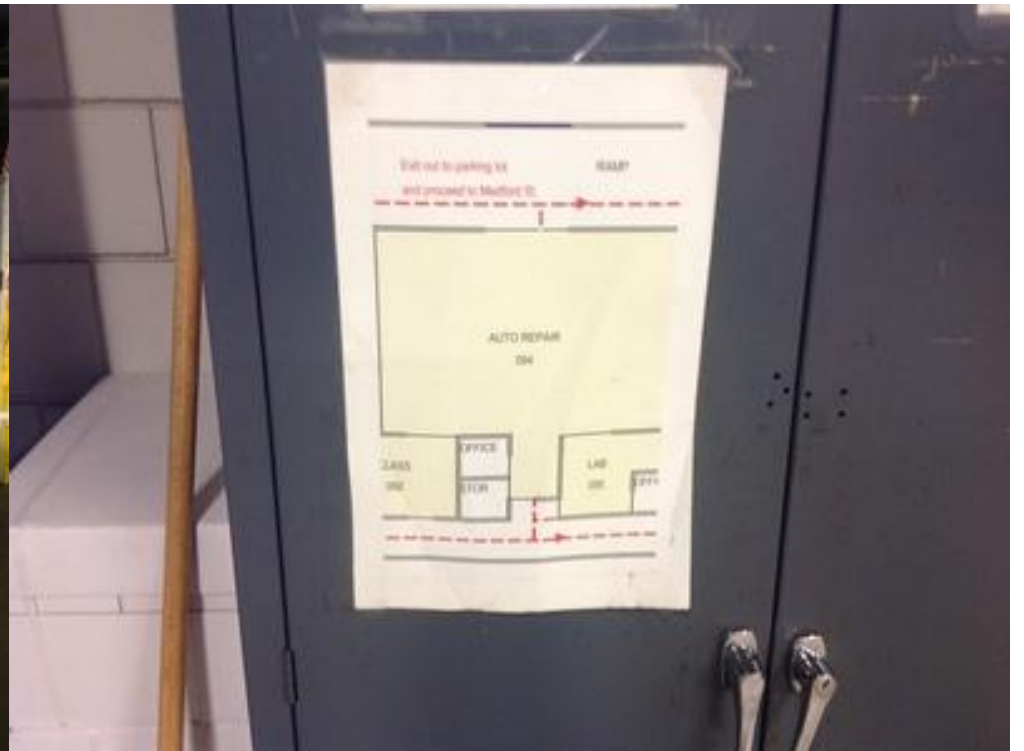
Somerville HS>VOCATIONAL WING>SHOP LEVEL>AUTO REPAIR SHOP 460

Auto Repair Shop is in fair condition. Sealed concrete floors are in fair condition. CMU block walls in fair condition. Windows are in fair condition but some have lost their seals. Millwork in poor condition. Painted structure and ductwork above.

| Condition | Fair | | |

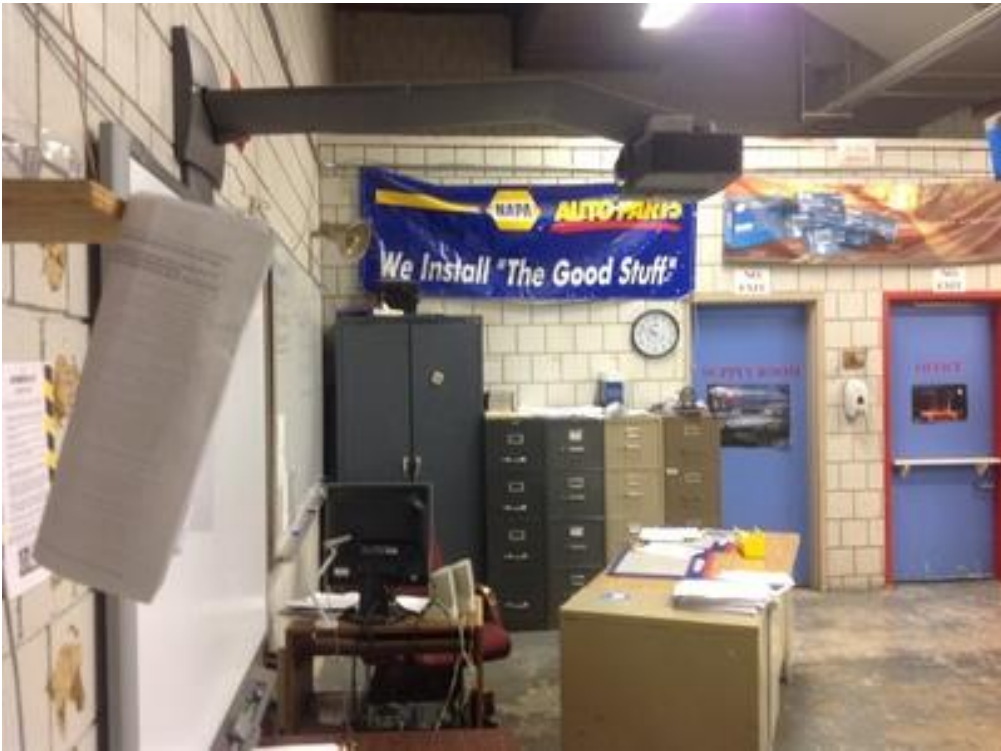
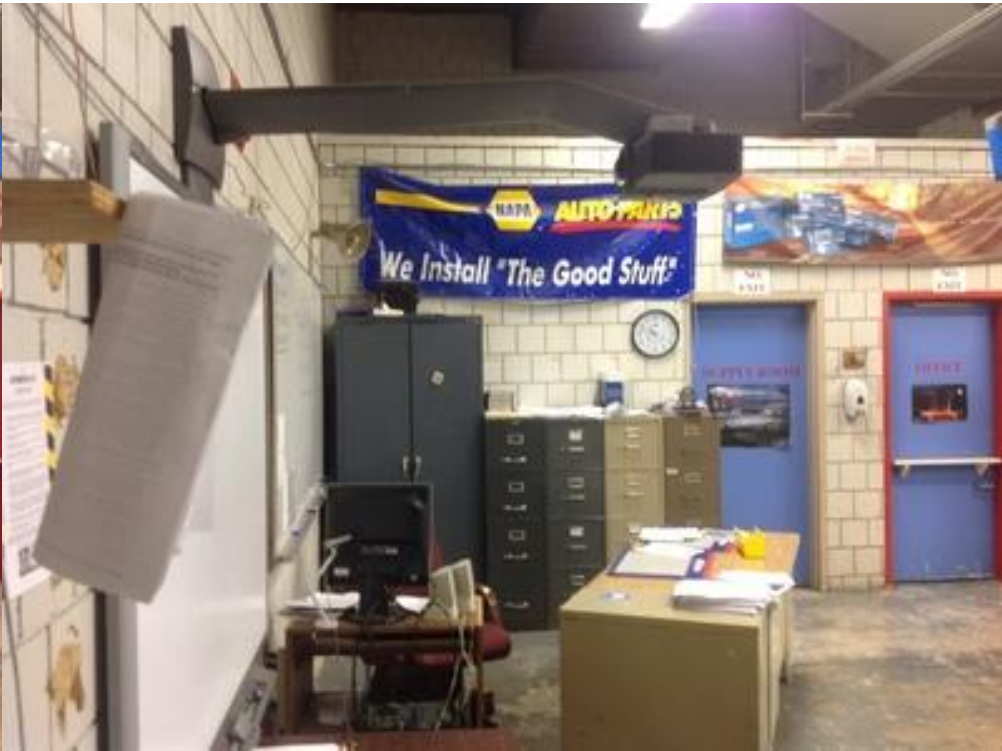
Attached Images for ID KU-00141

CTE Small engine repair classroom is in fair condition. Sealed concrete floors are in fair condition. CMU block walls in fair condition. Windows are in fair condition but some have lost their seals. Millwork in poor condition. Painted structure and ductwork above.

| Condition | Fair | | |

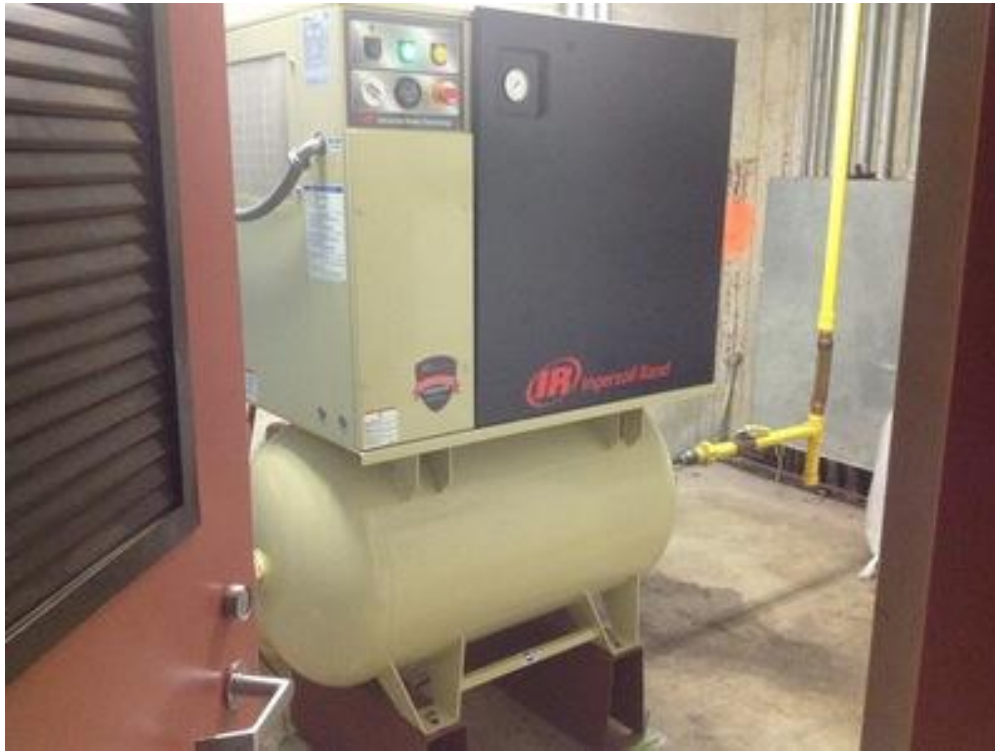
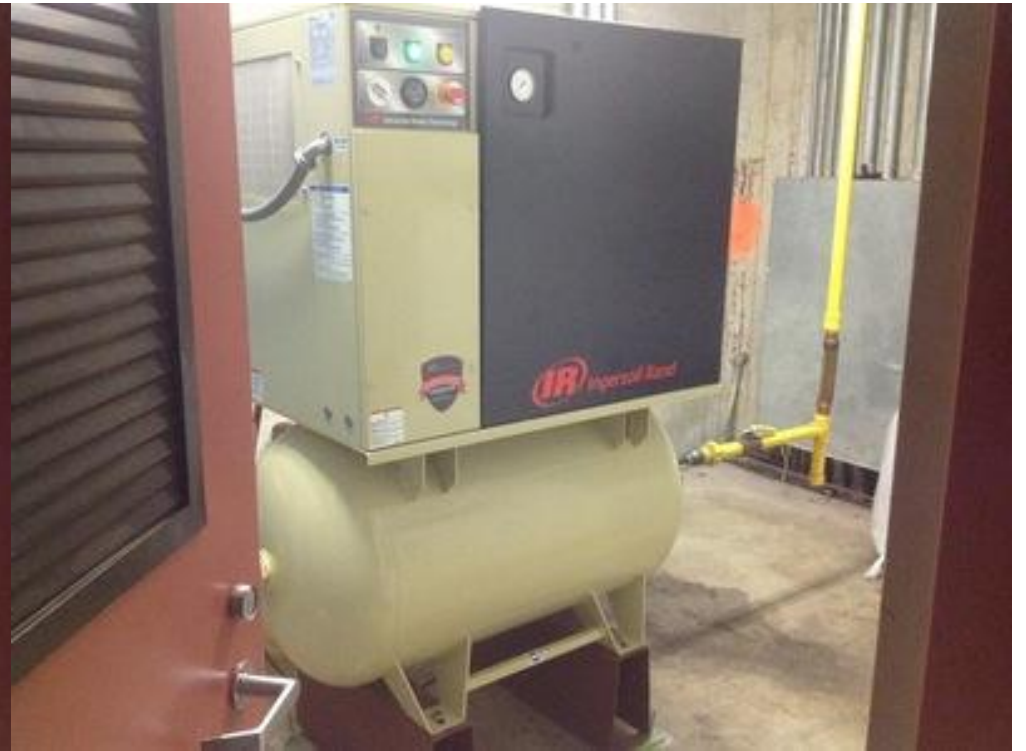
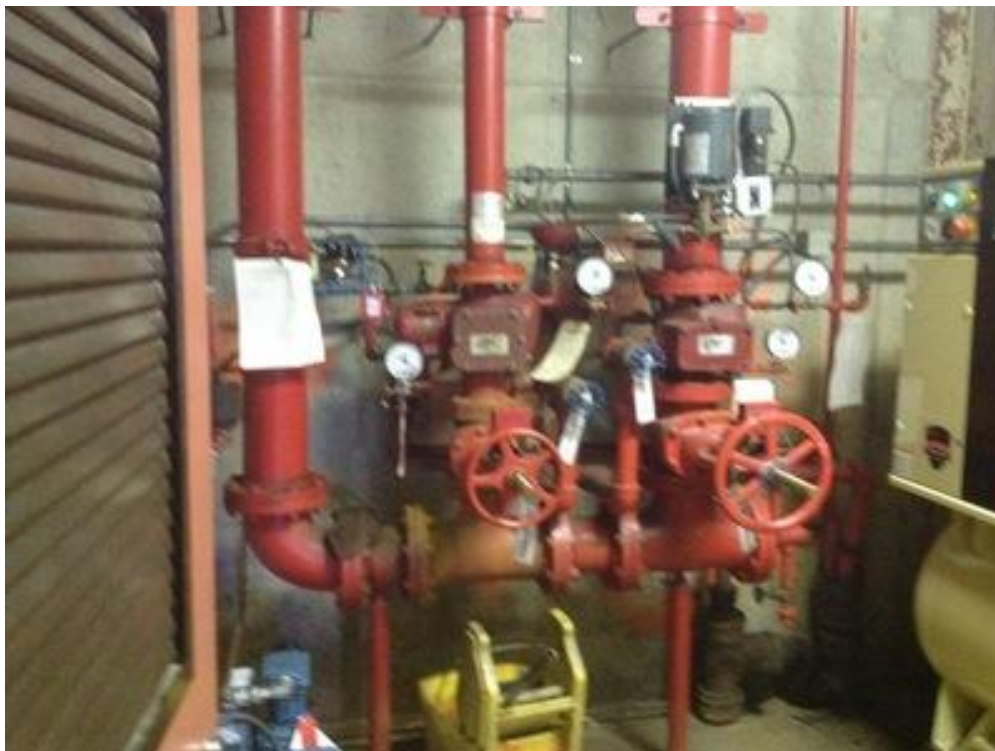
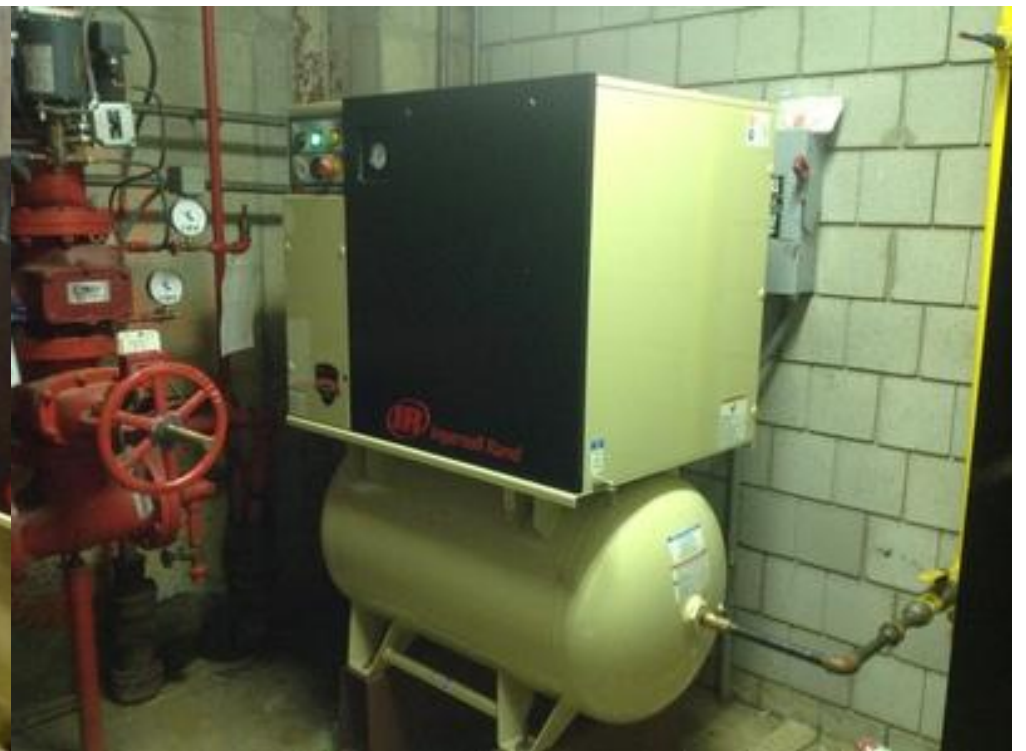
| Description Machine room in fair condition. | | | |
