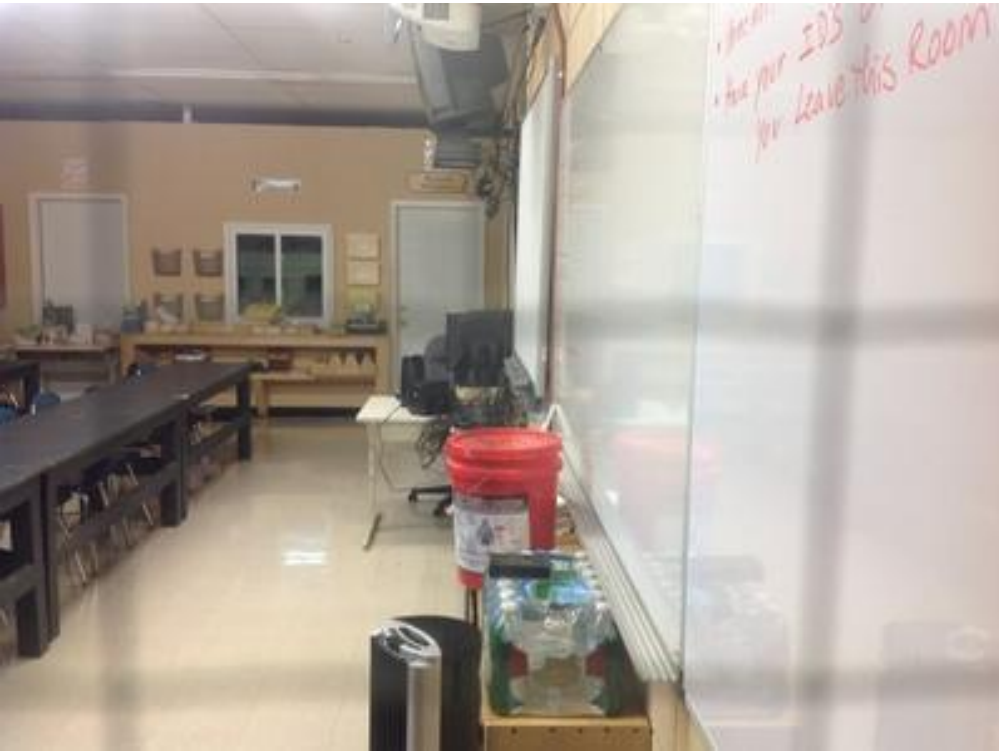
IMG_1218.JPG

| Description Classroom is in fair condition. VCT is in good condition. ACT is in fair to poor condition. | | | |

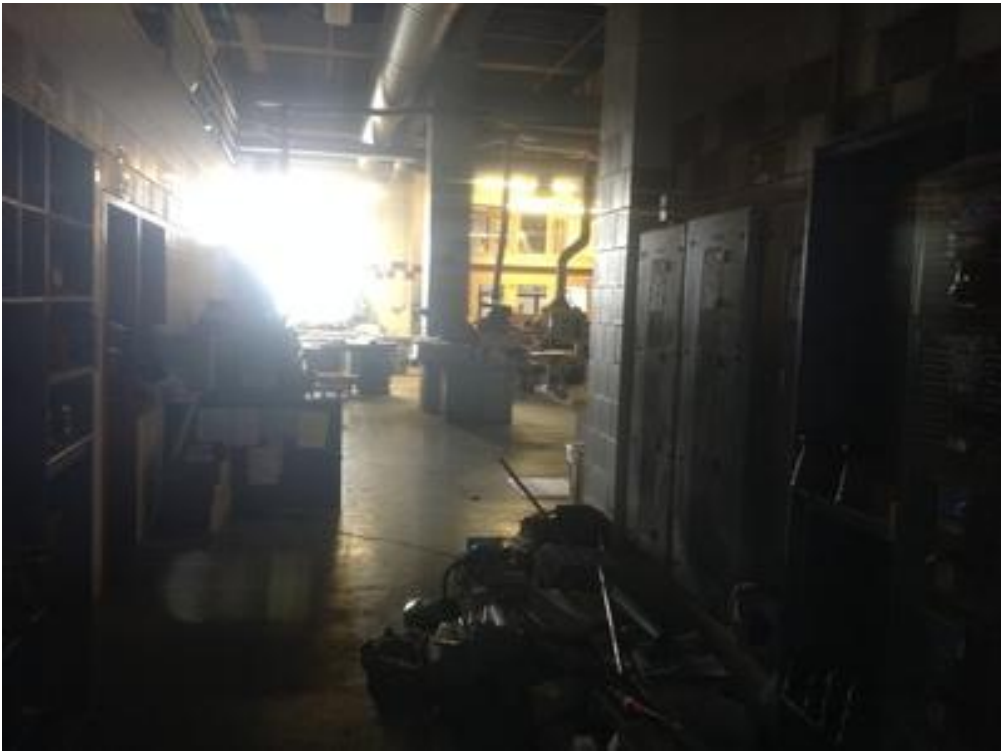
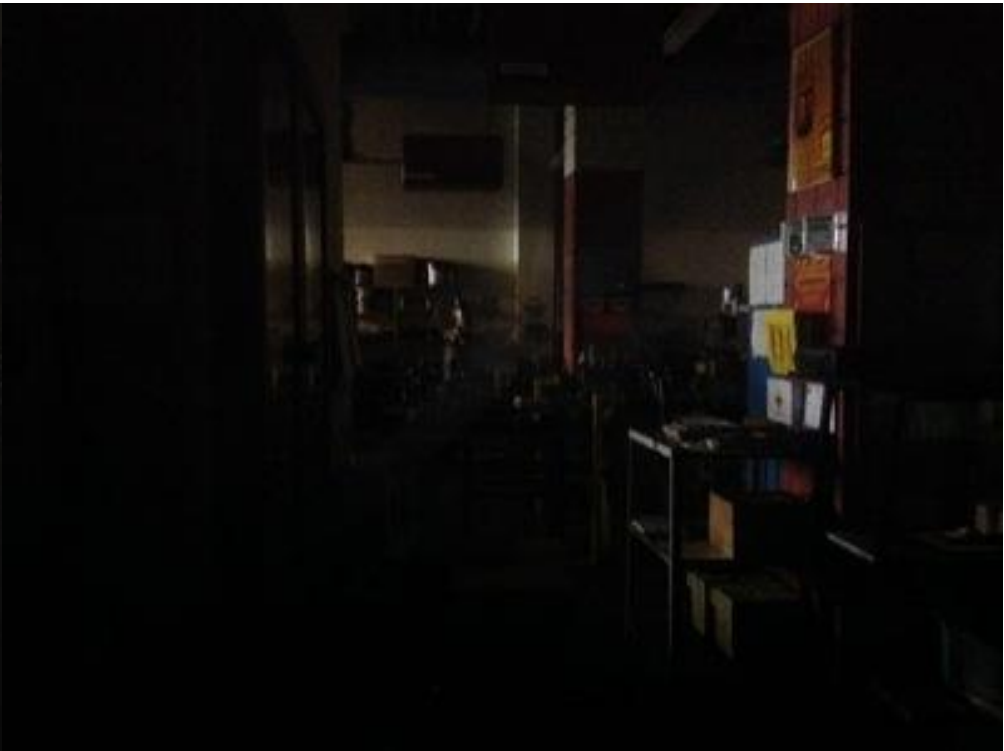
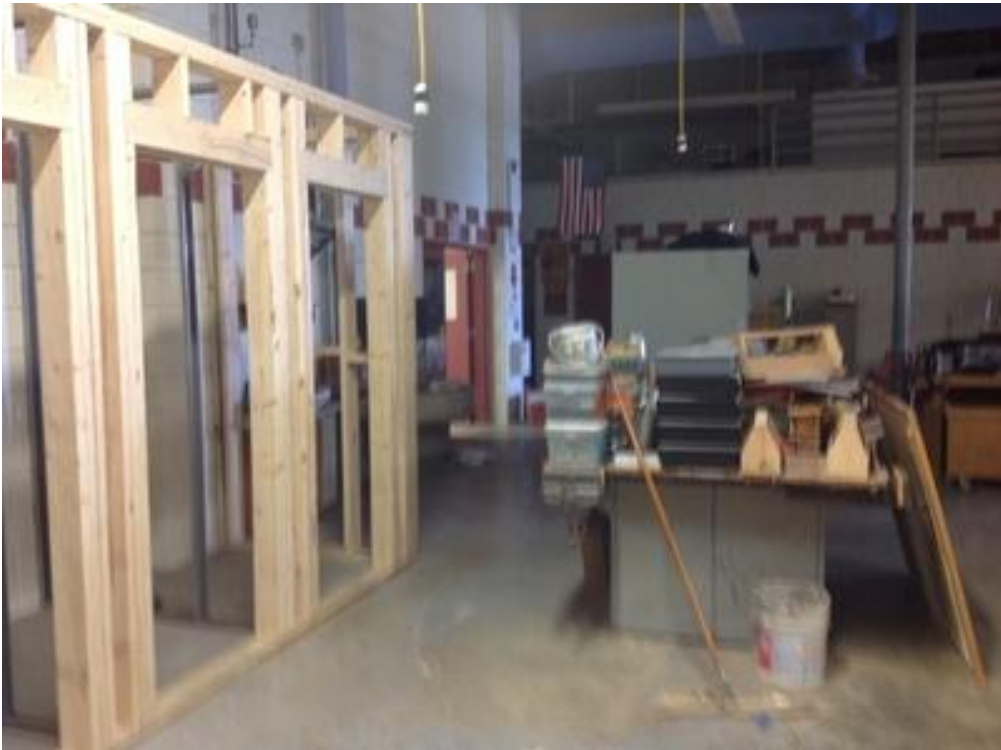
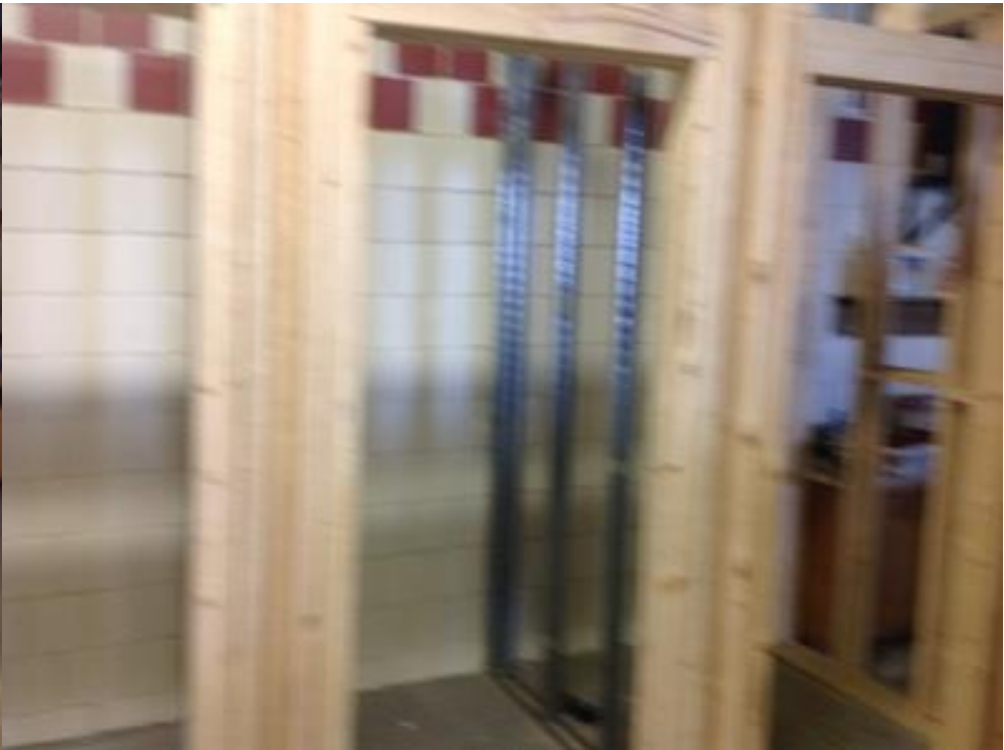
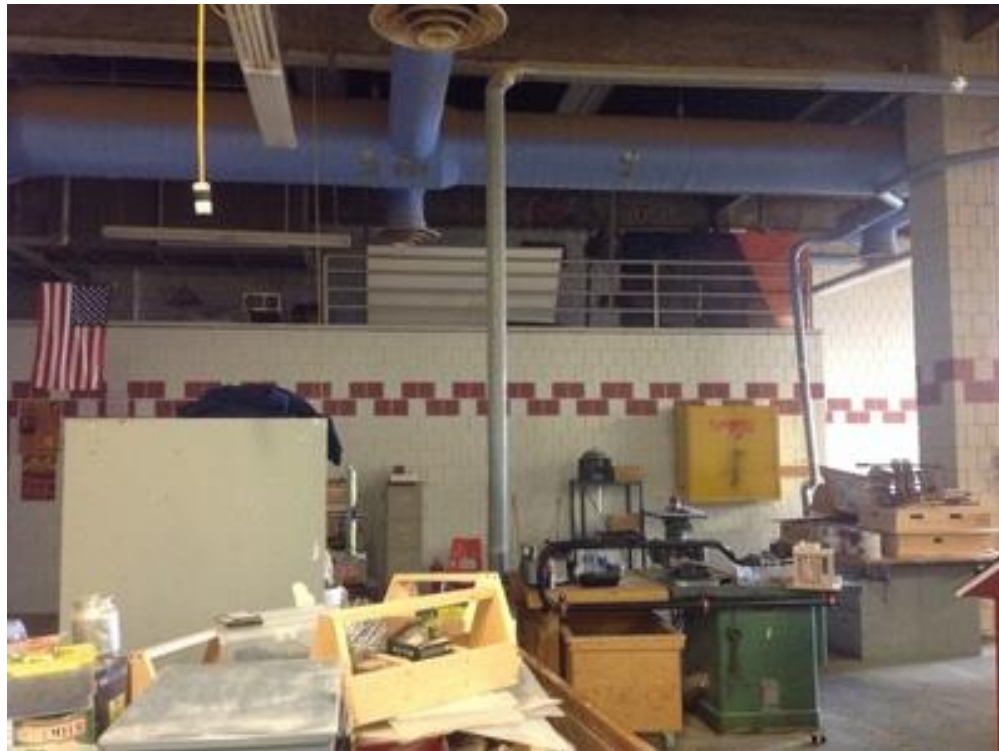
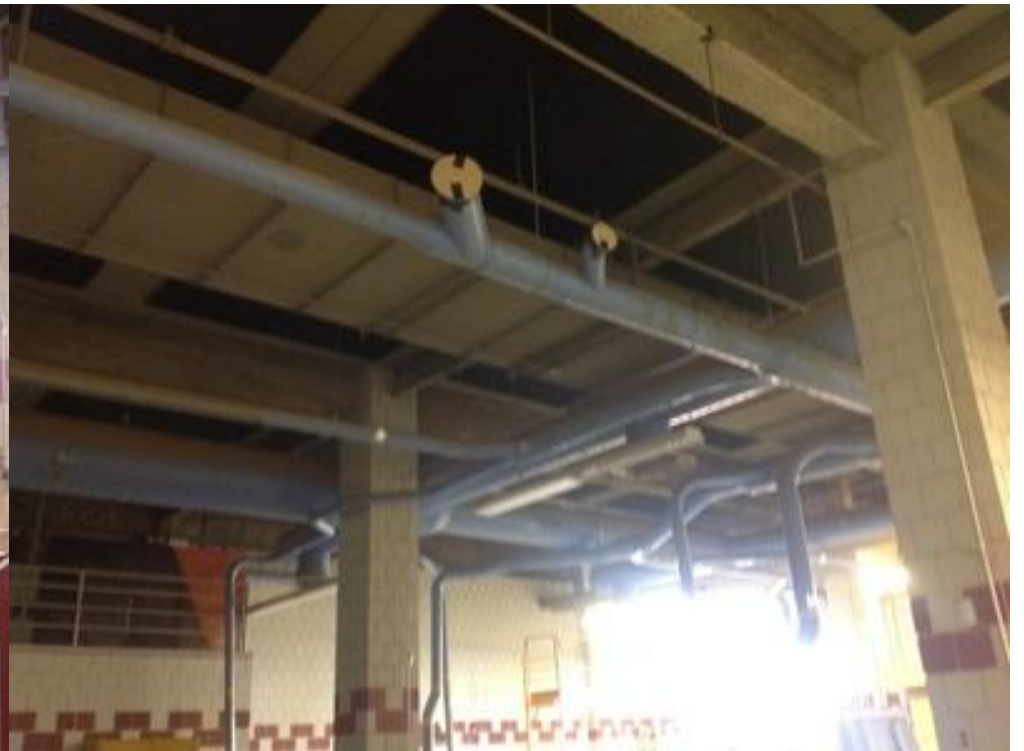
Carpentry shop is in fair condition. Sealed concrete floors are in fair condition. CMU block walls in fair condition. Windows are in fair condition but some have lost their seals. Millwork in poor condition. Painted structure and ductwork above.

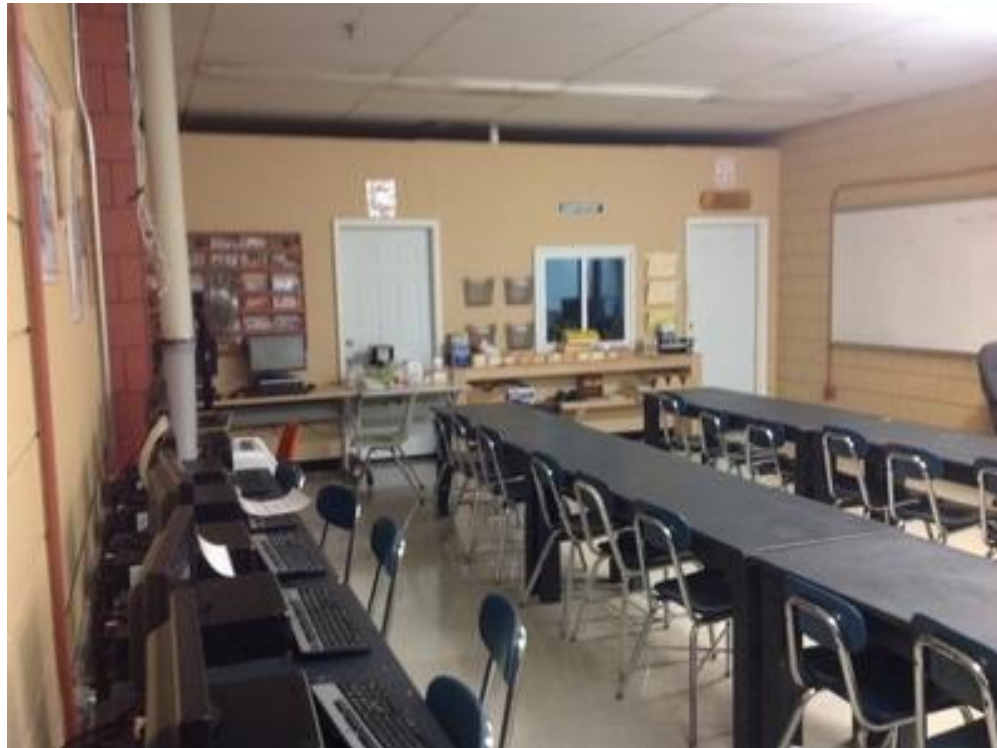
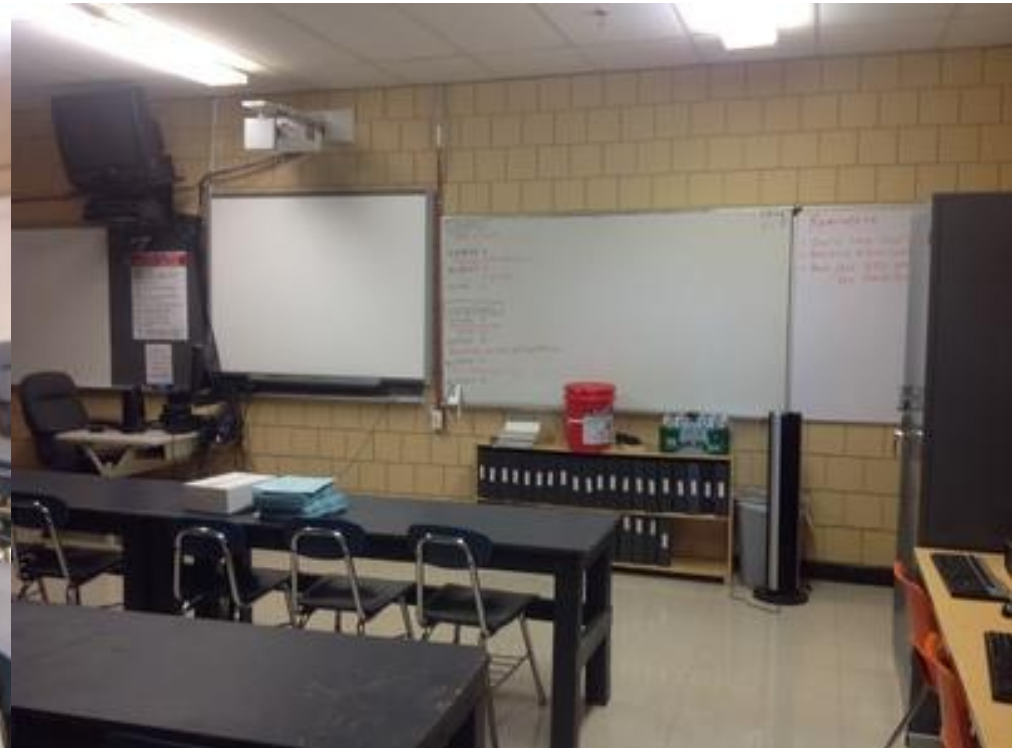
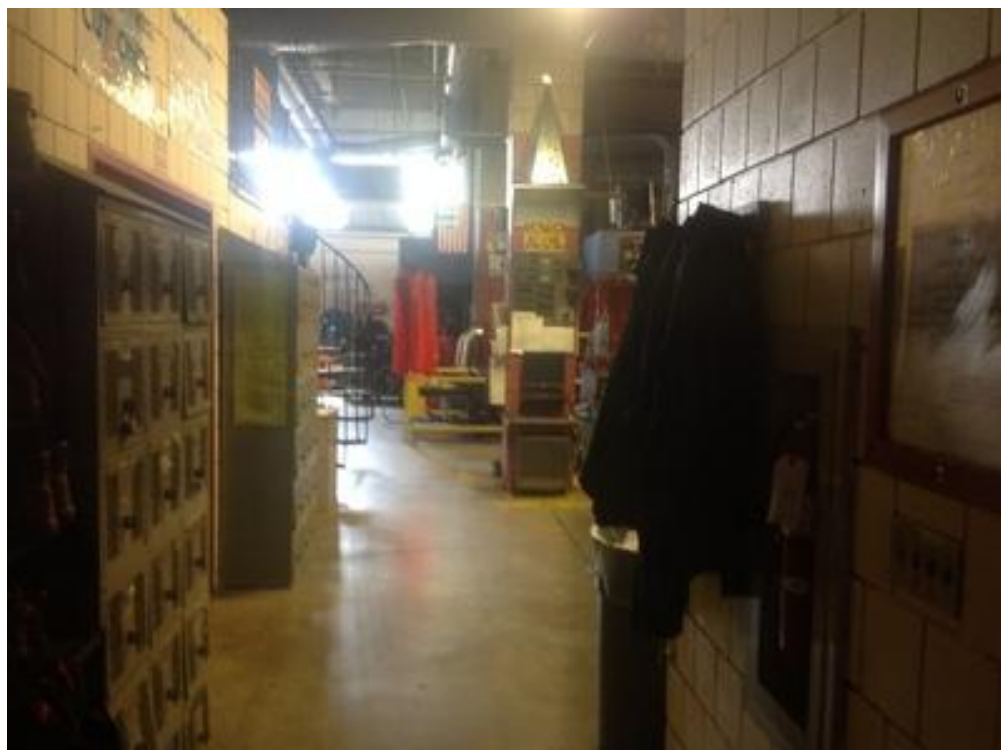
| Classroom is in fair condition. VCT is in good condition. ACT is in fair to poor condition. | | | |

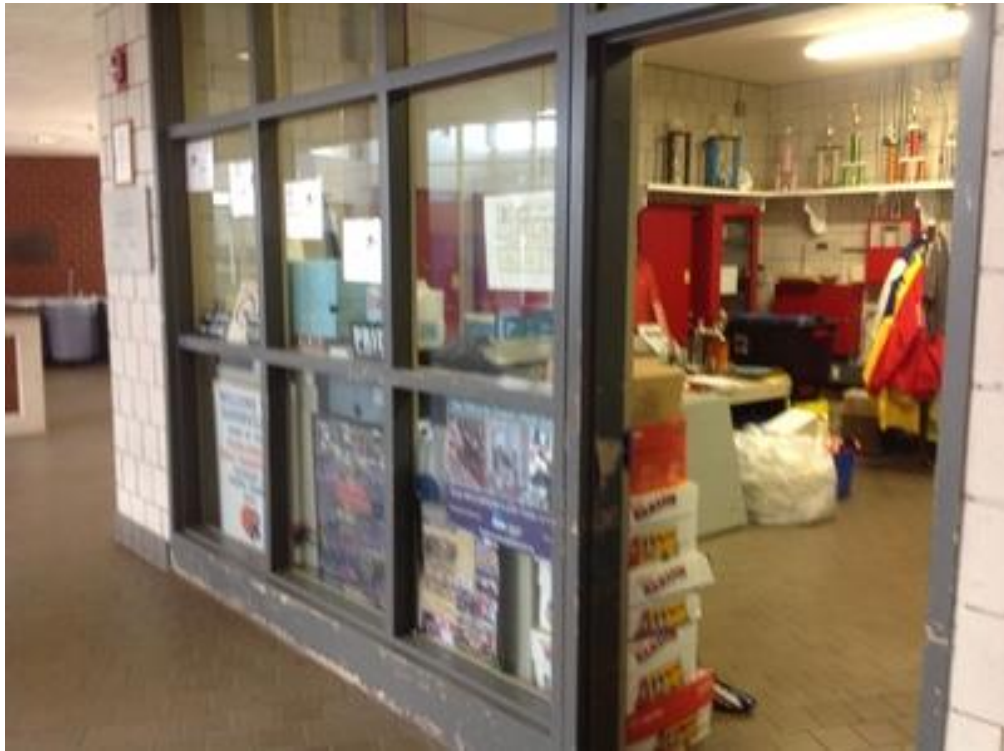
IMG_1242.JPG

| Description Coach's/AD office. Storefront is damaged with dings and missing paint. | | | |

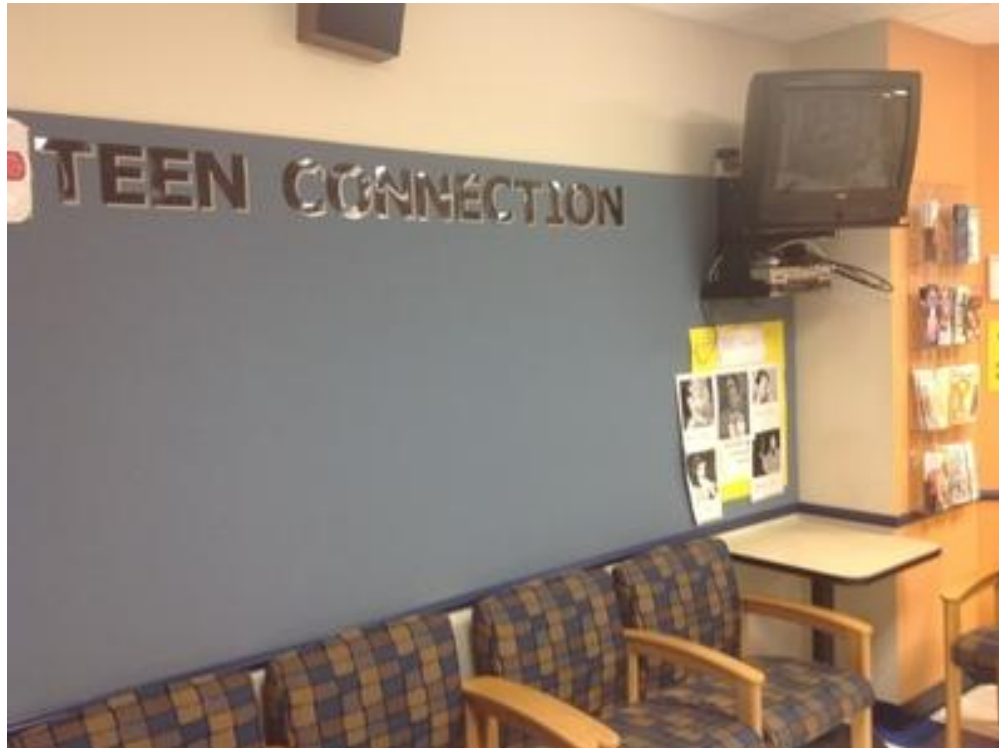
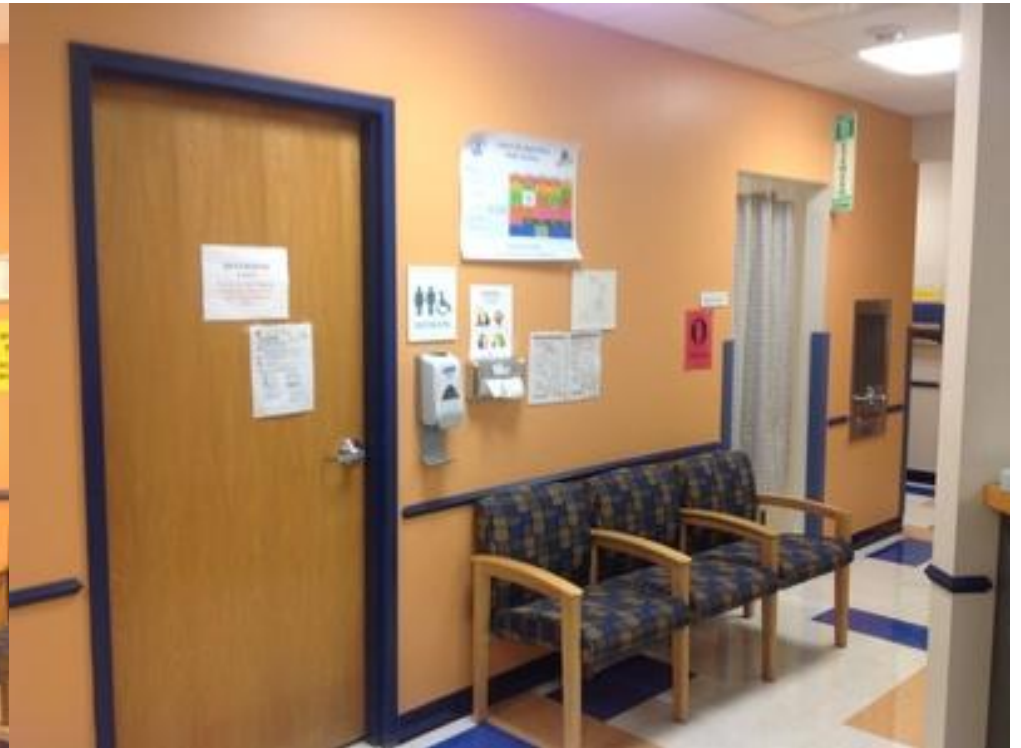
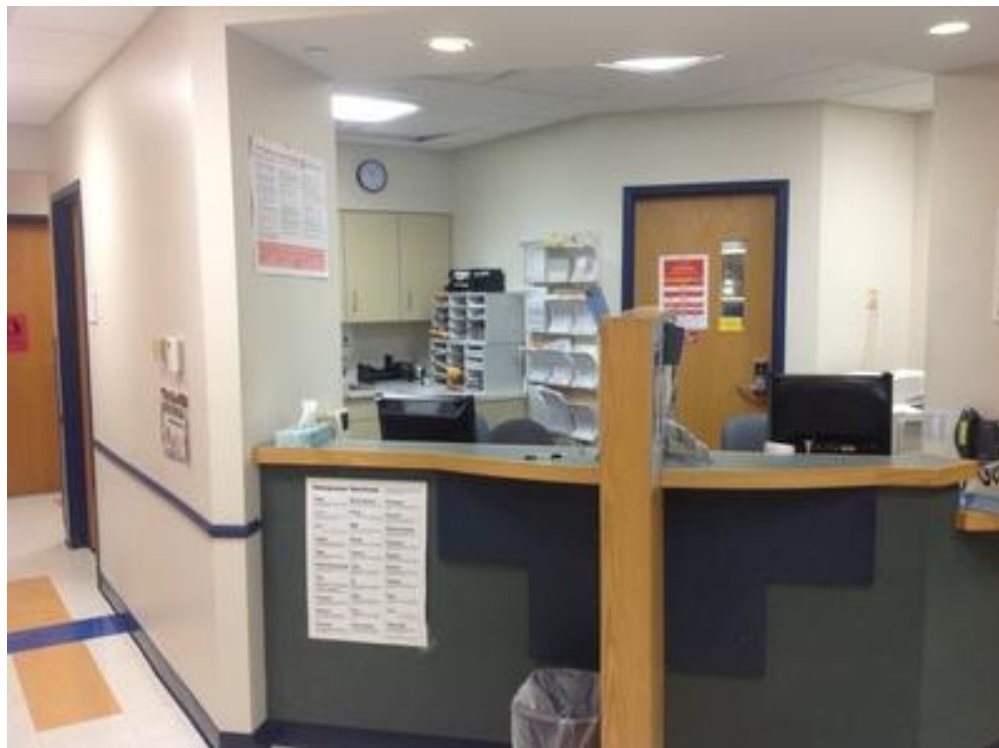
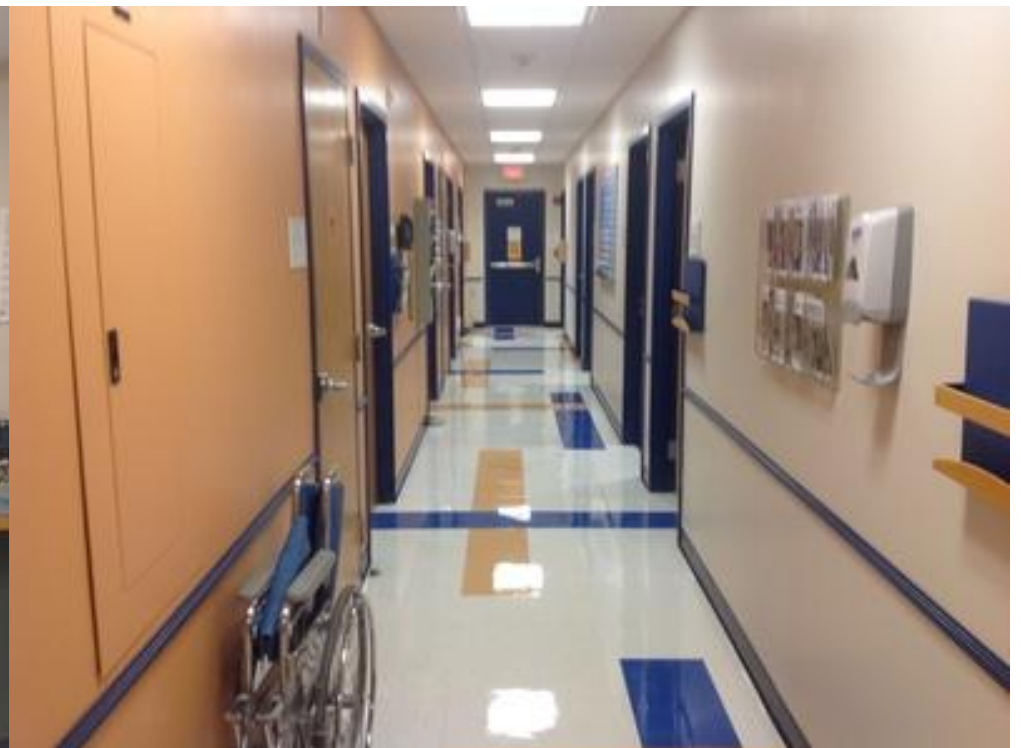
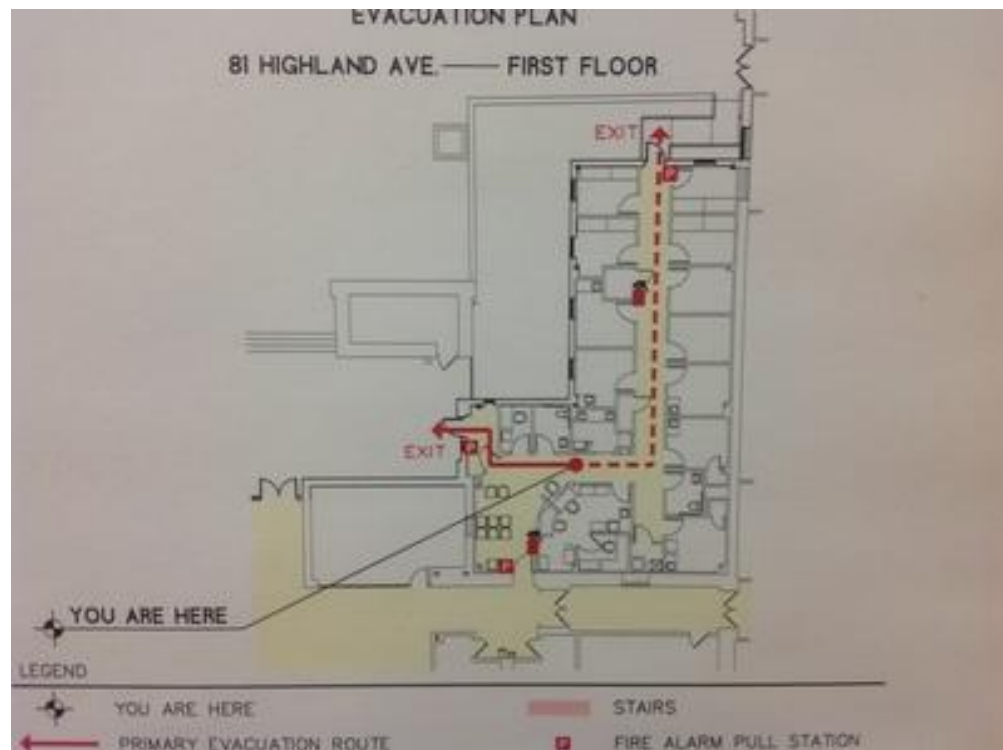
| Description Health center is in good condition. | | | |

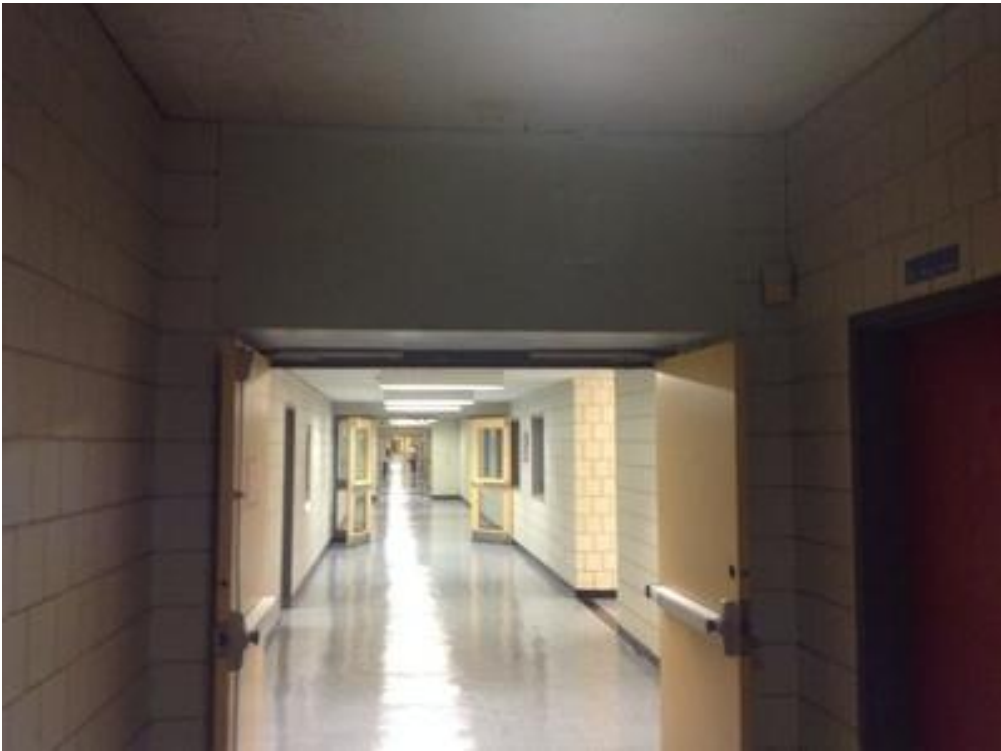
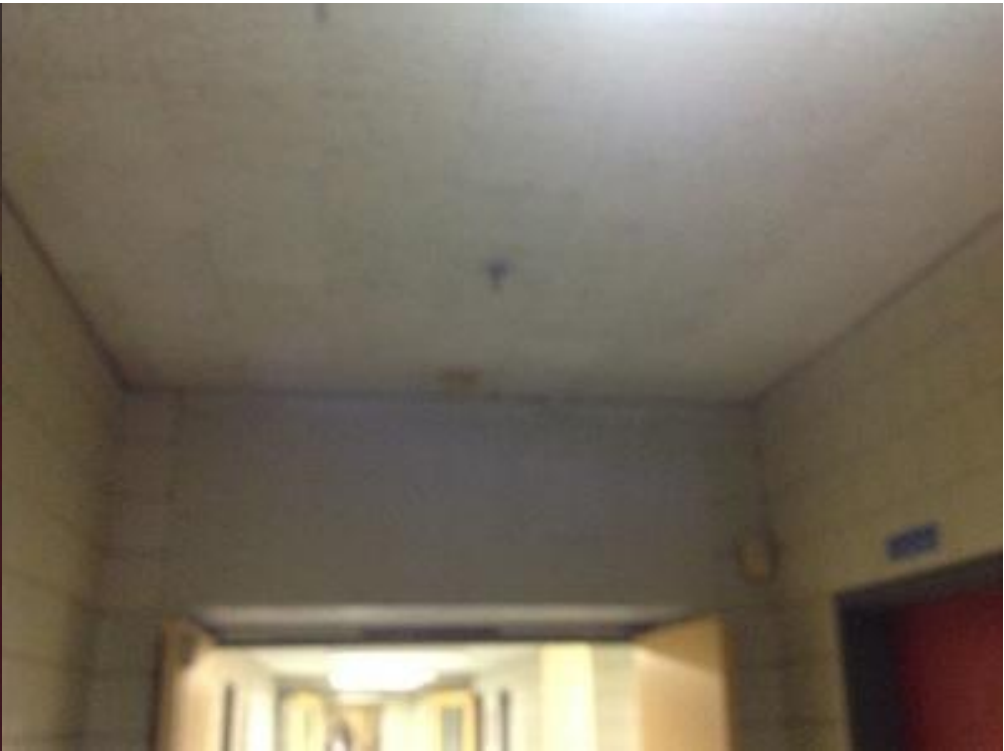
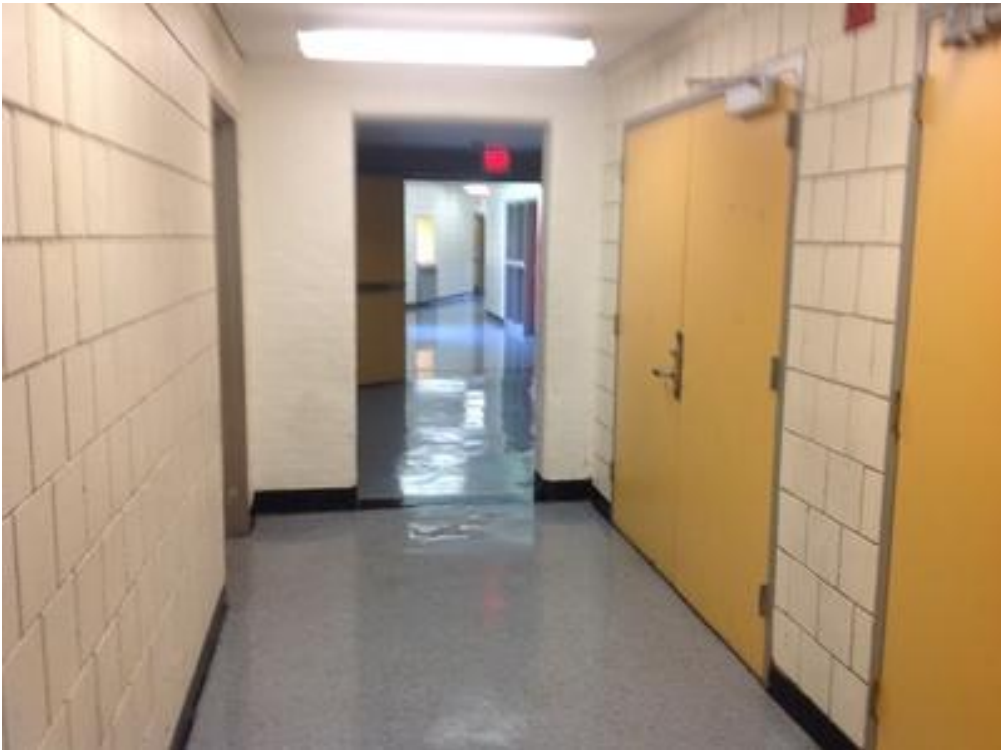
Description
Typical - Corridors are in poor to fair condition. Flooring tiles are uneven and have become wavy over time. Ceiling is partial ACT in poor condition. Where ceiling is full ACT, tiles are mismatched, bowed, broken. Grid is in poor condtion. Exposed piping and wiring is haphazard. Flooring has been infilled with mismatching VCT in some locations.

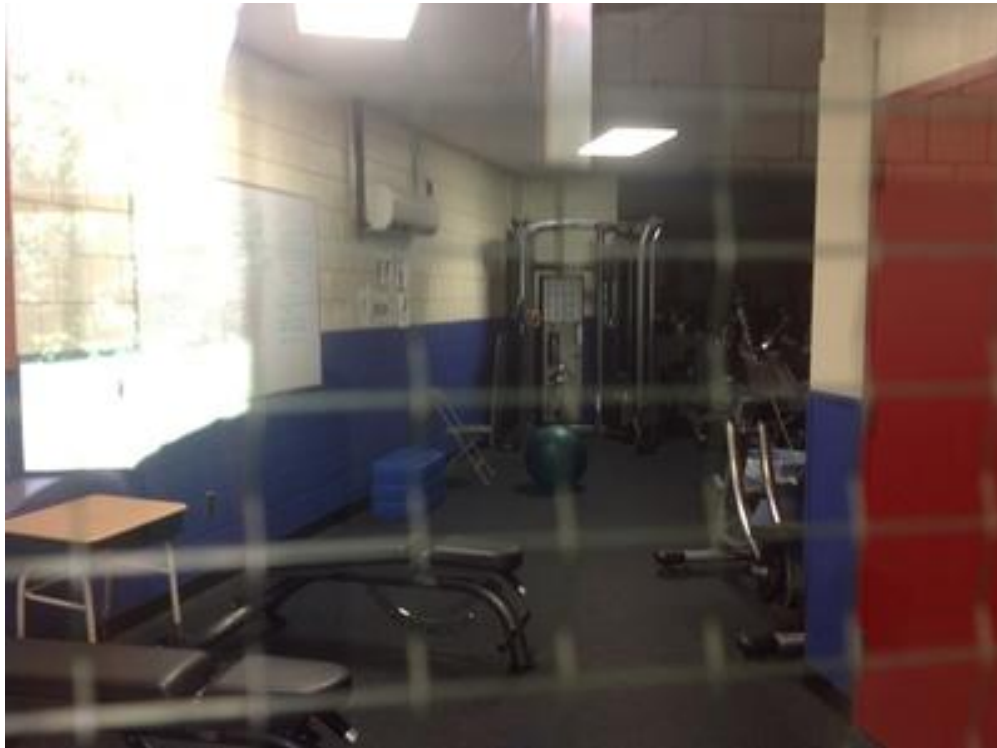
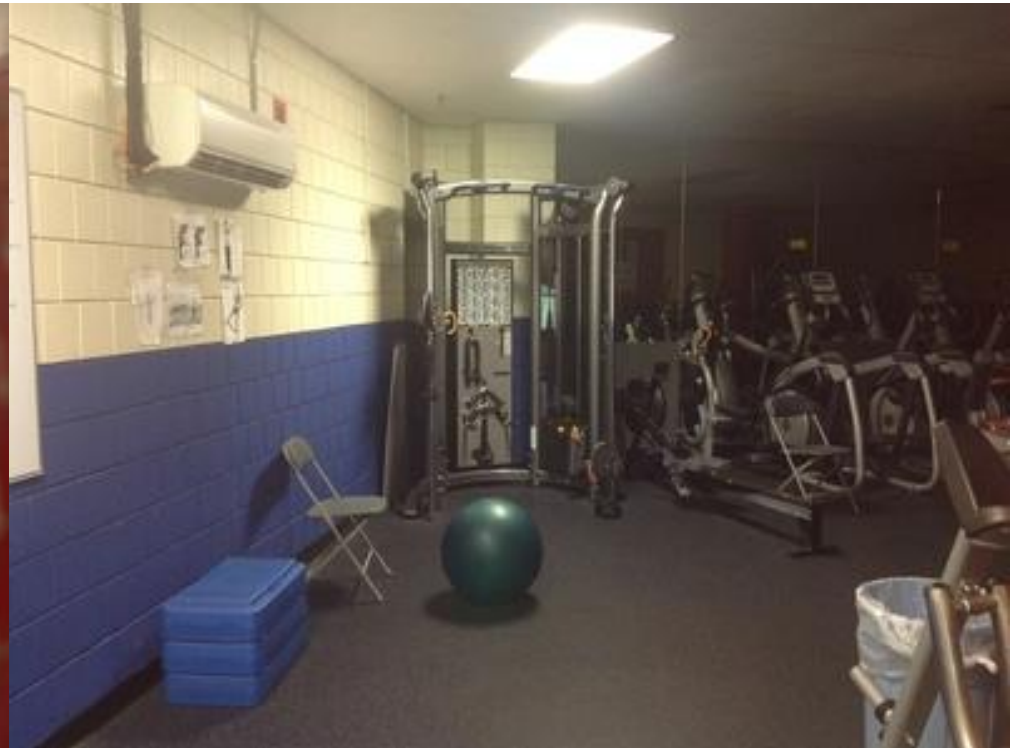
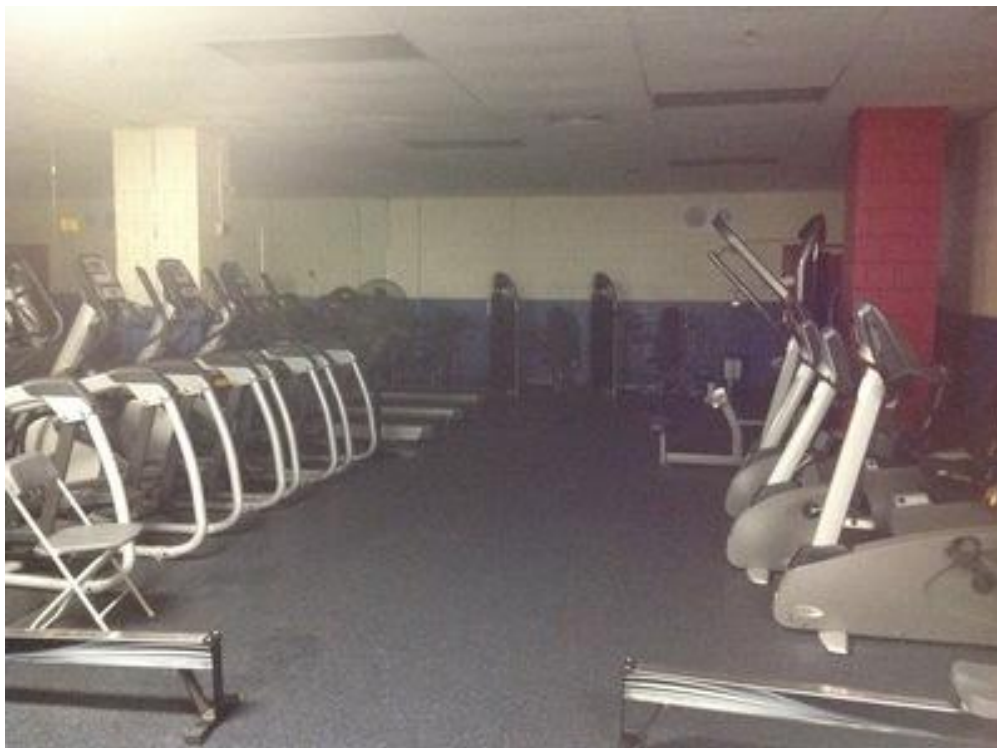
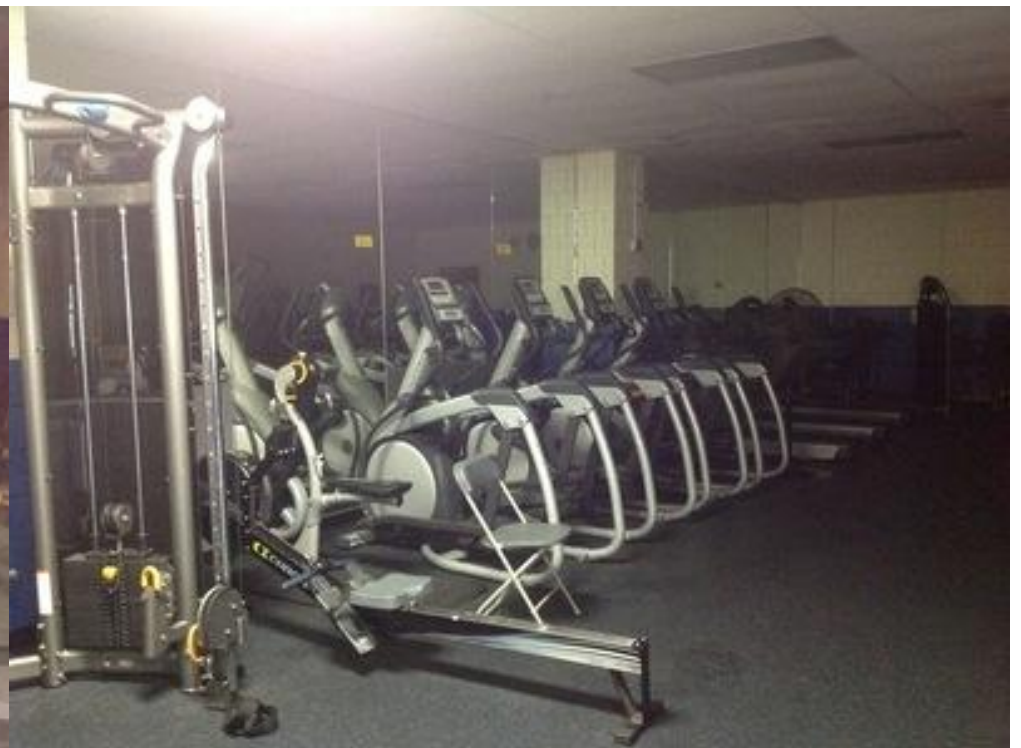
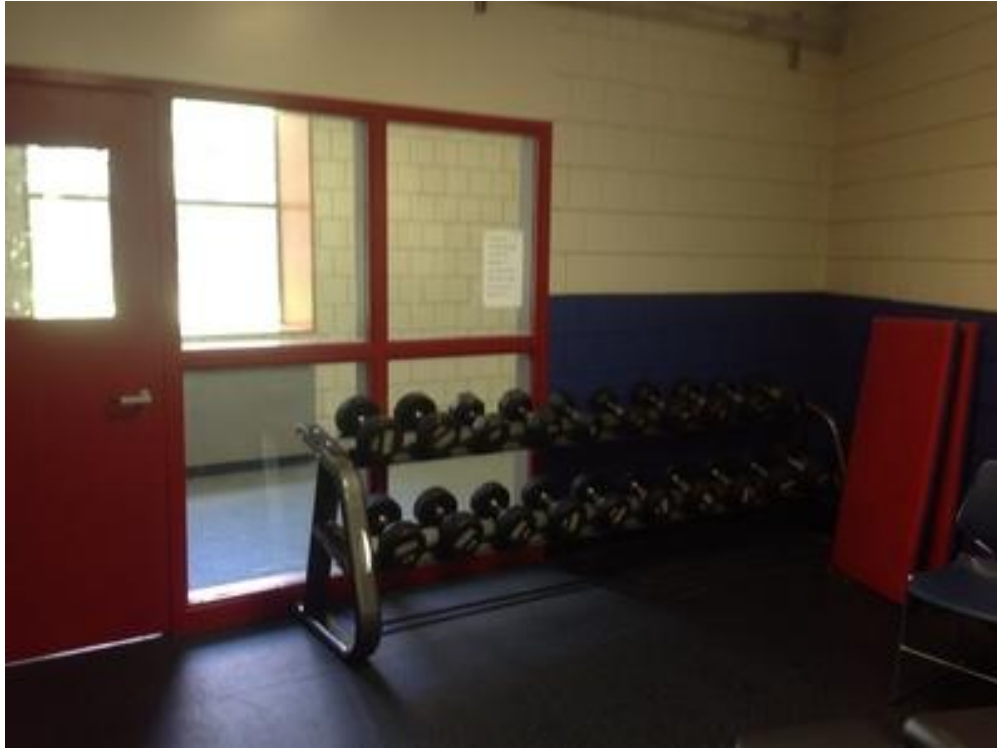
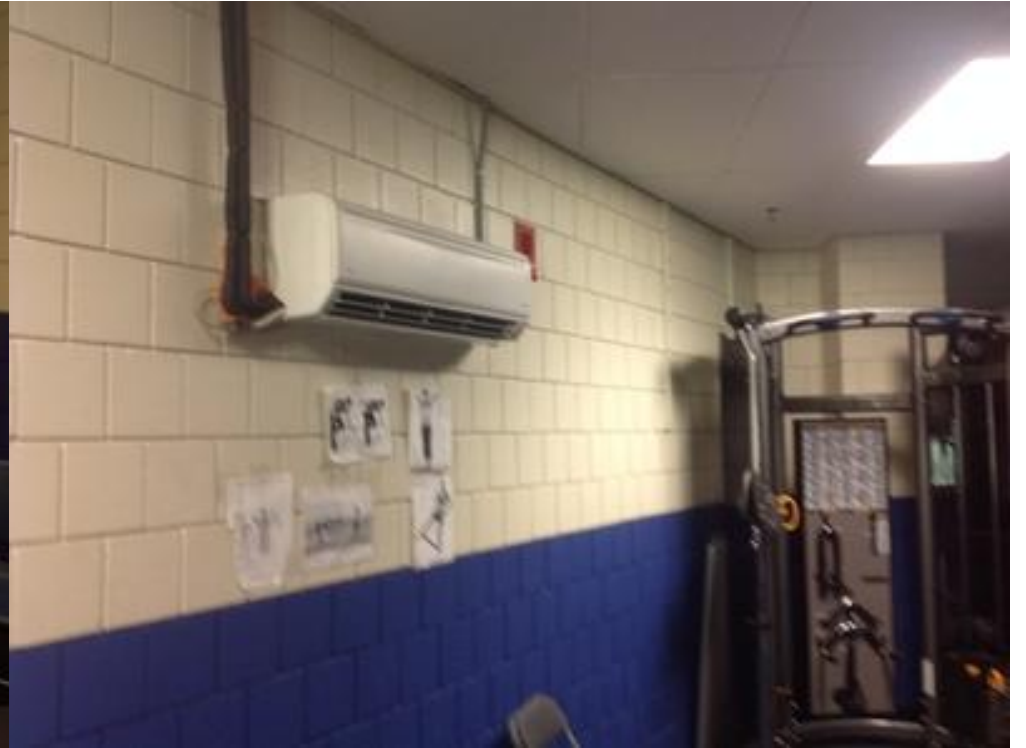
| Description Weight room is in fair condition. Rubber flooring is in fair condition. CMU walls are in fair condition. | | | |

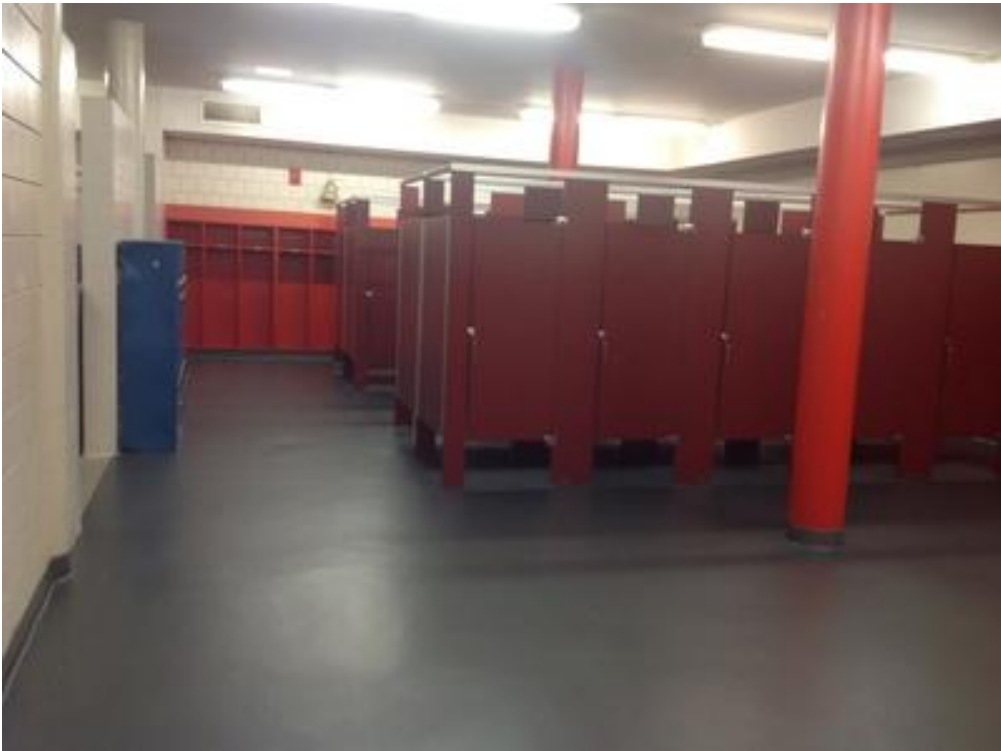
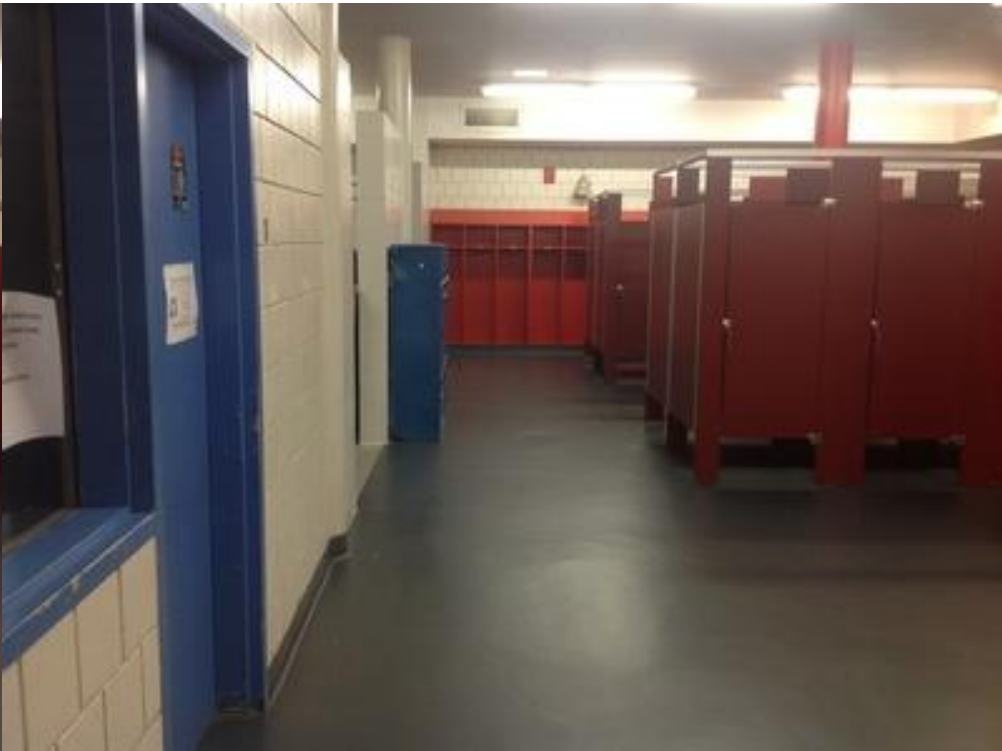
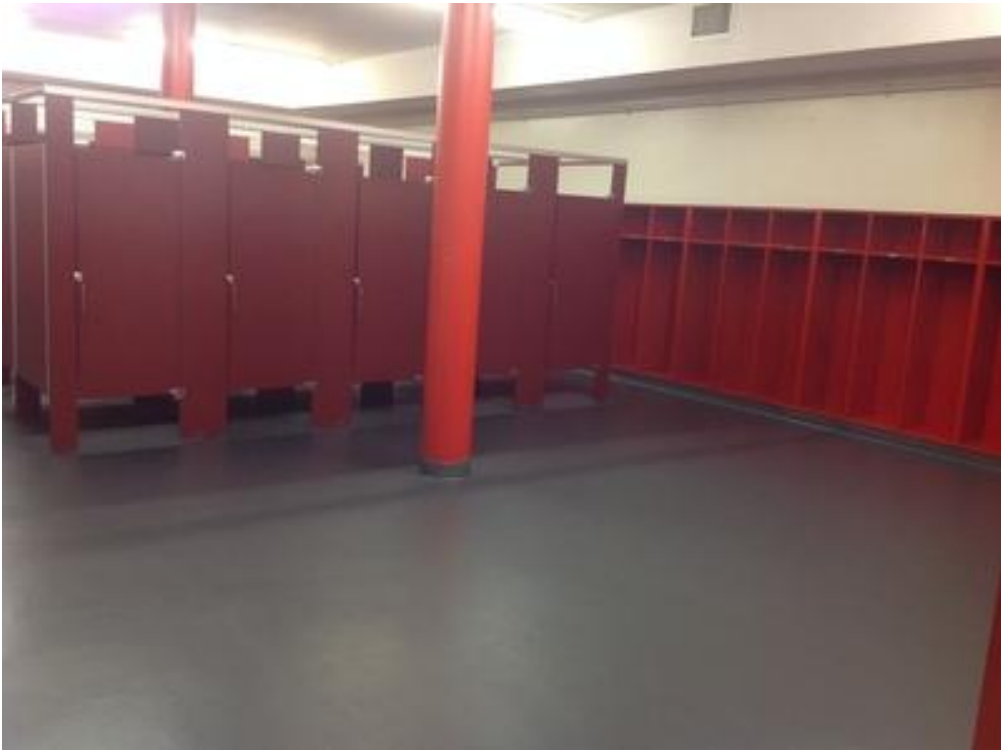
Attached Images for ID KU-00151

Locker rooms in fair to good condition. CMU walls in fair condition. Flooring is in good condition. Privacy panels and lockers in good condition. Shower areas were not confirmed.
