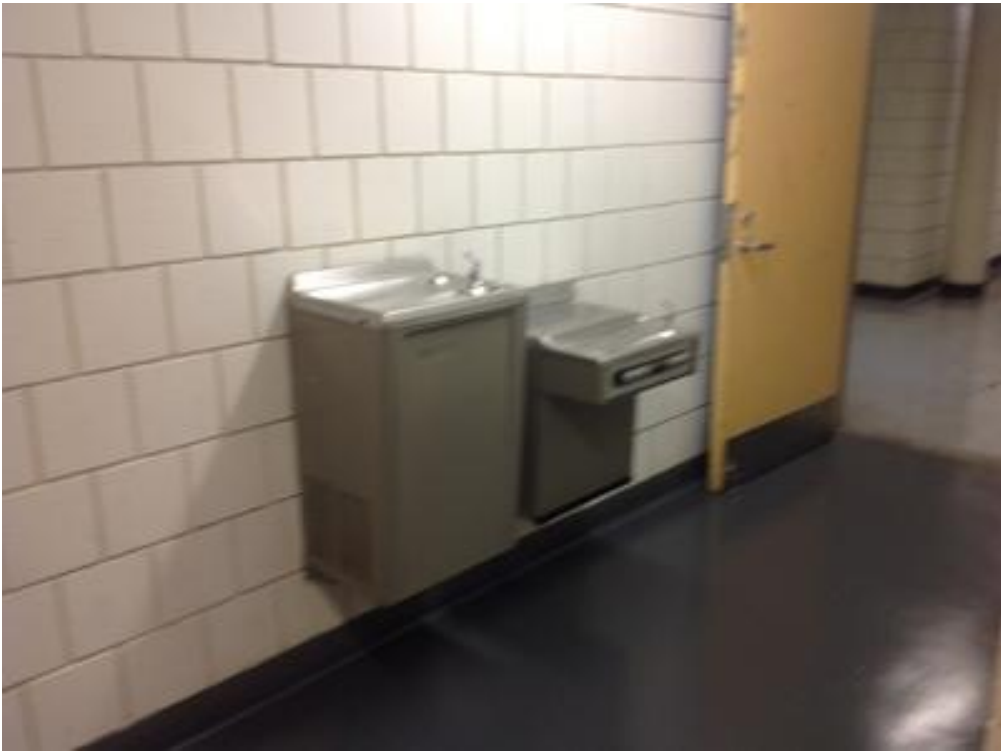
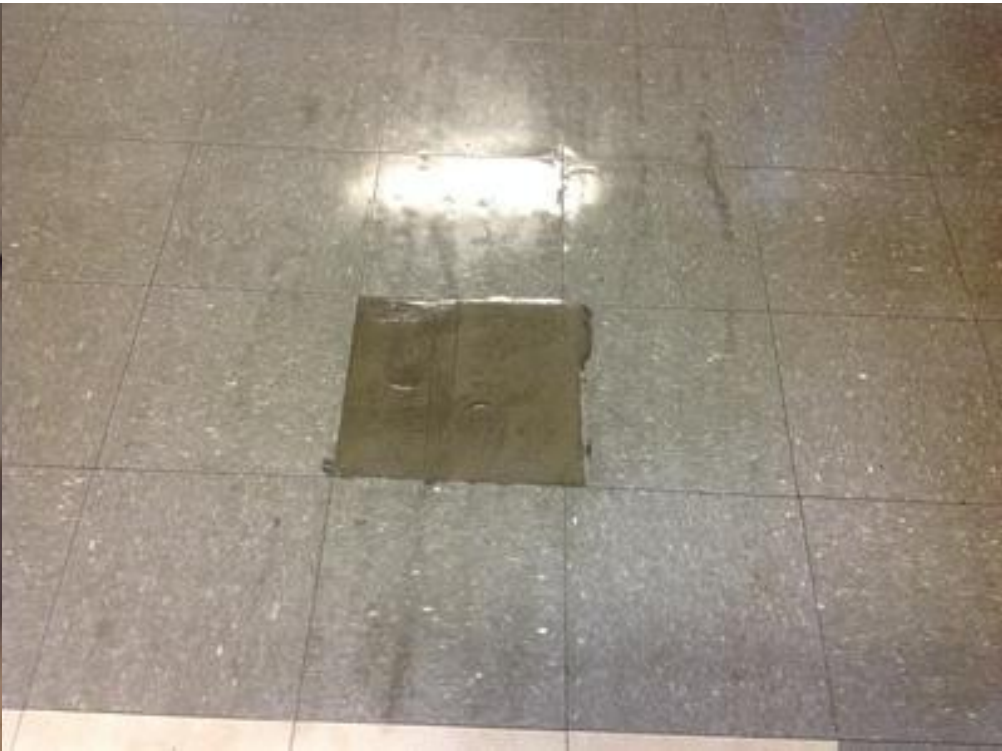
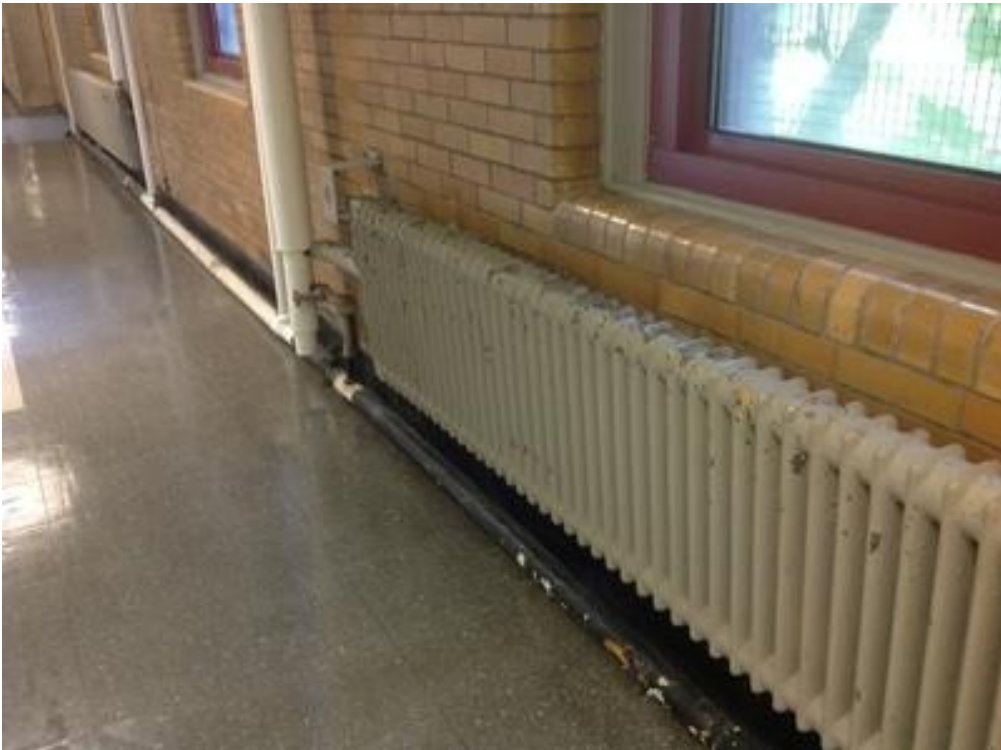
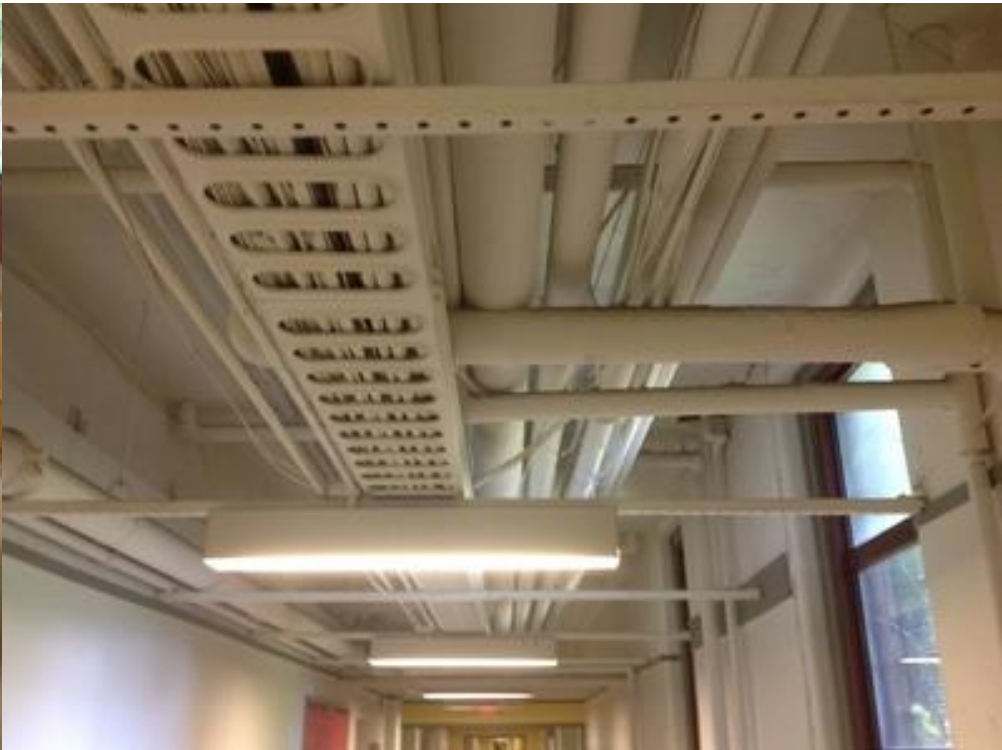
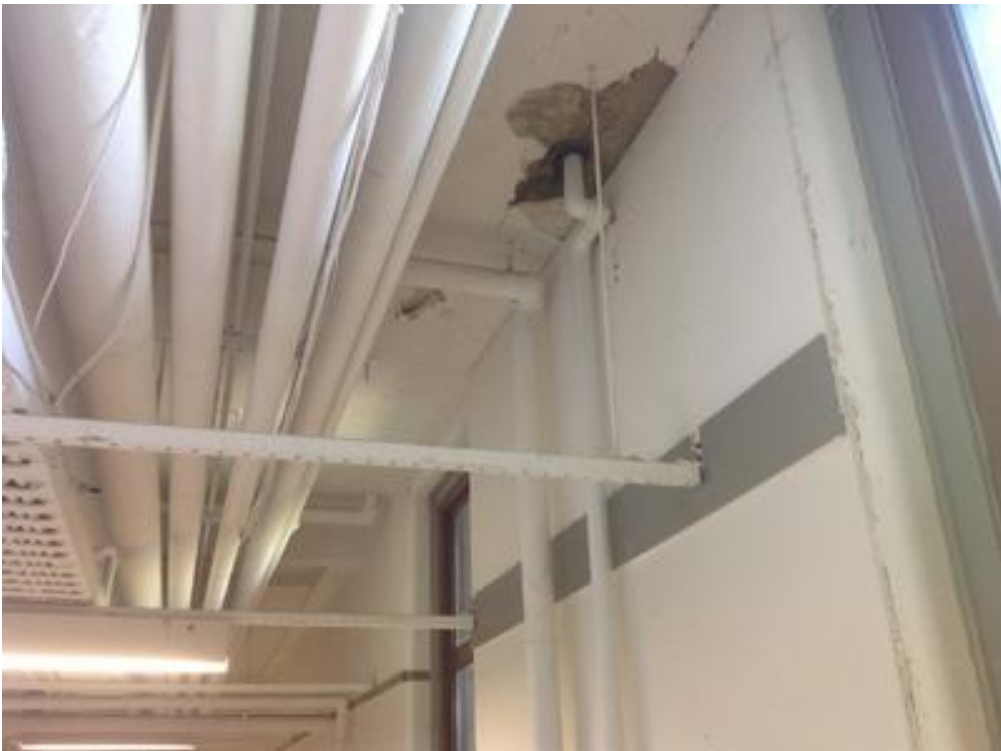
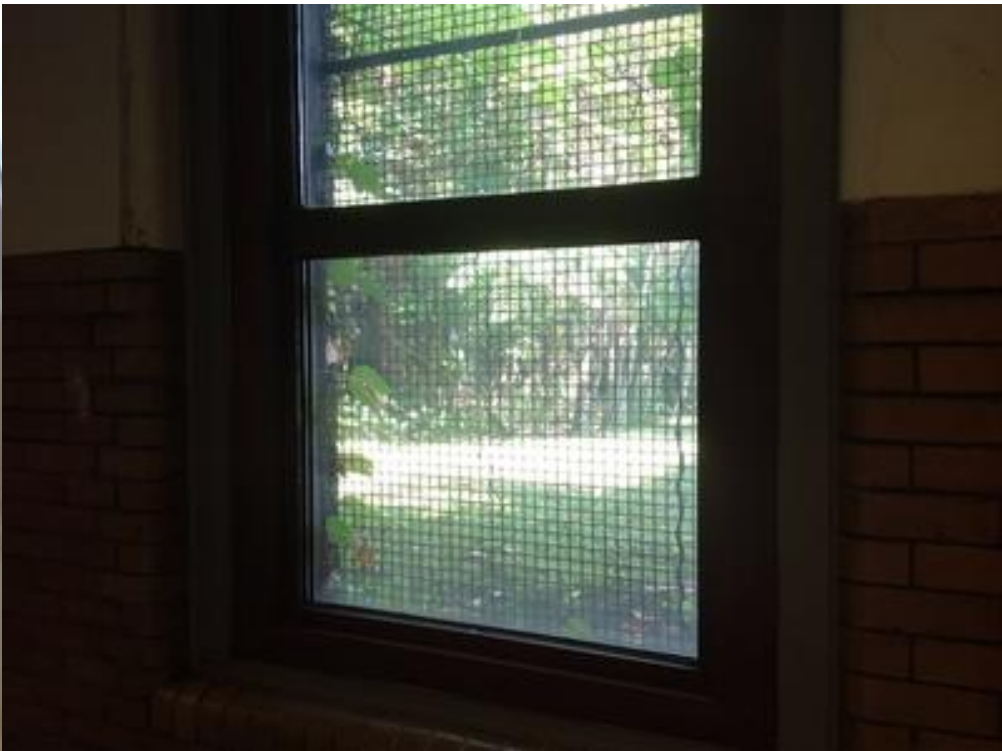
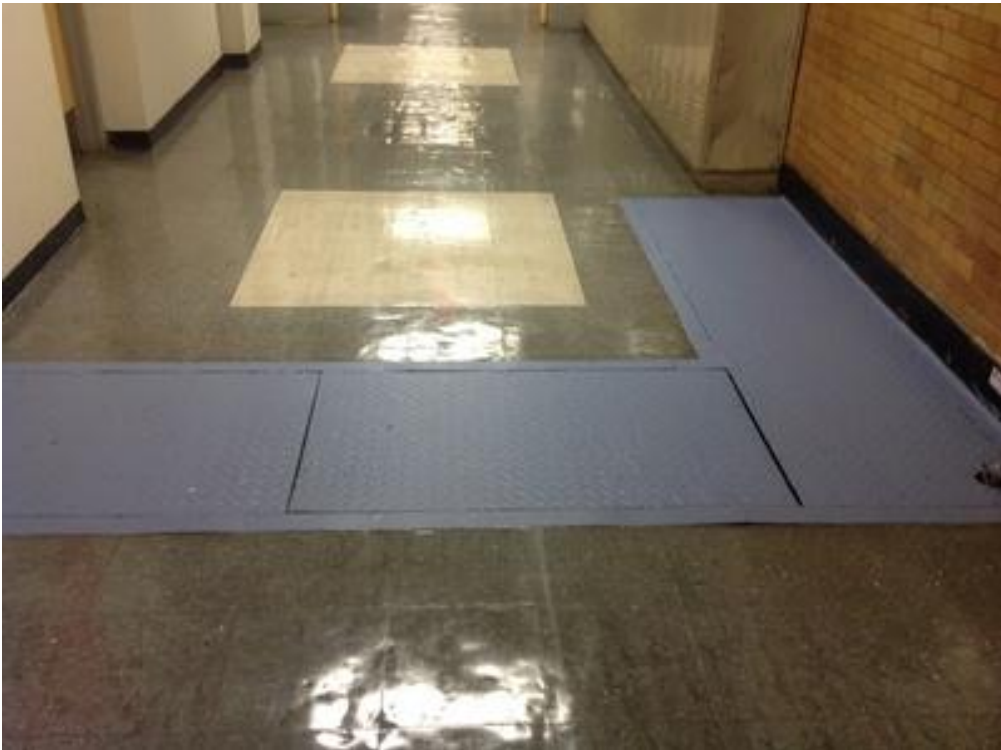
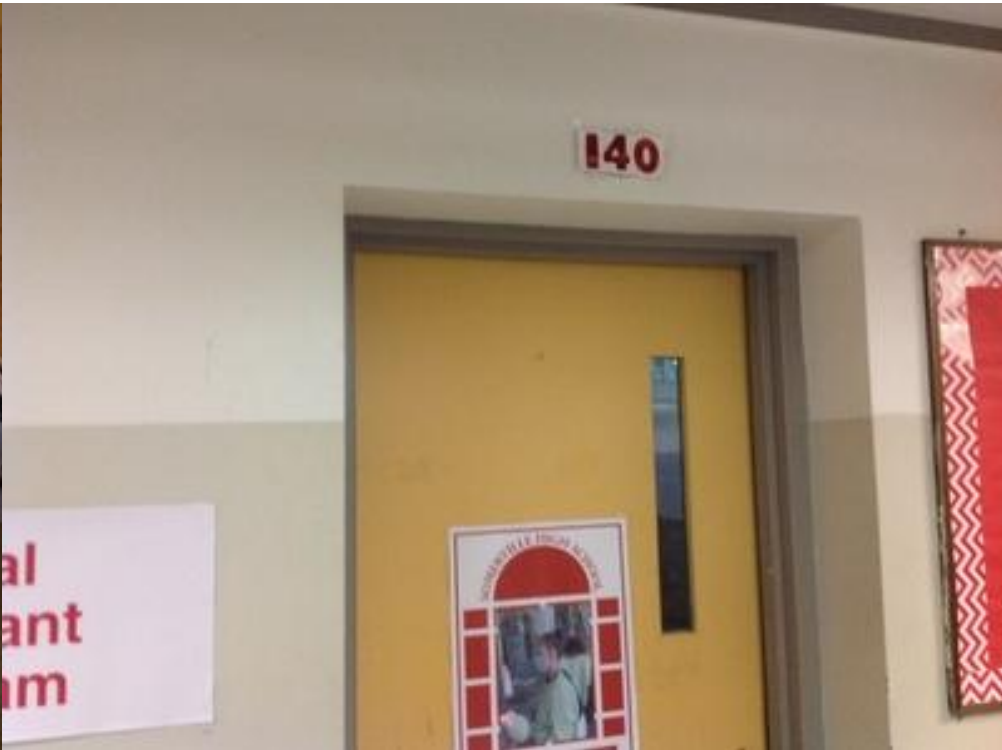
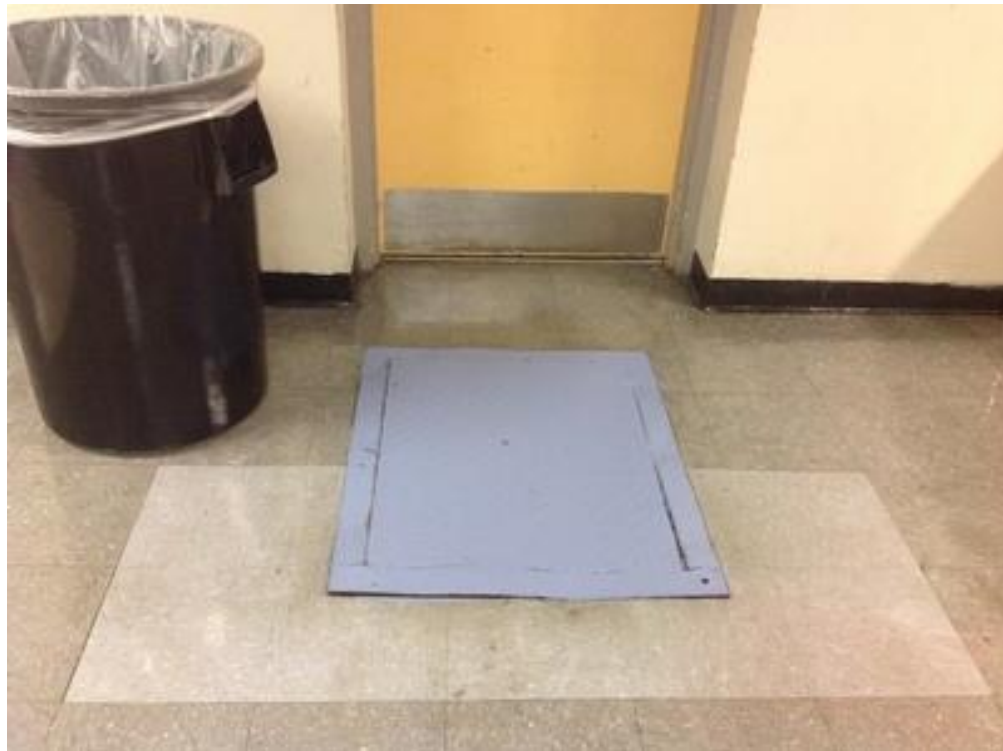
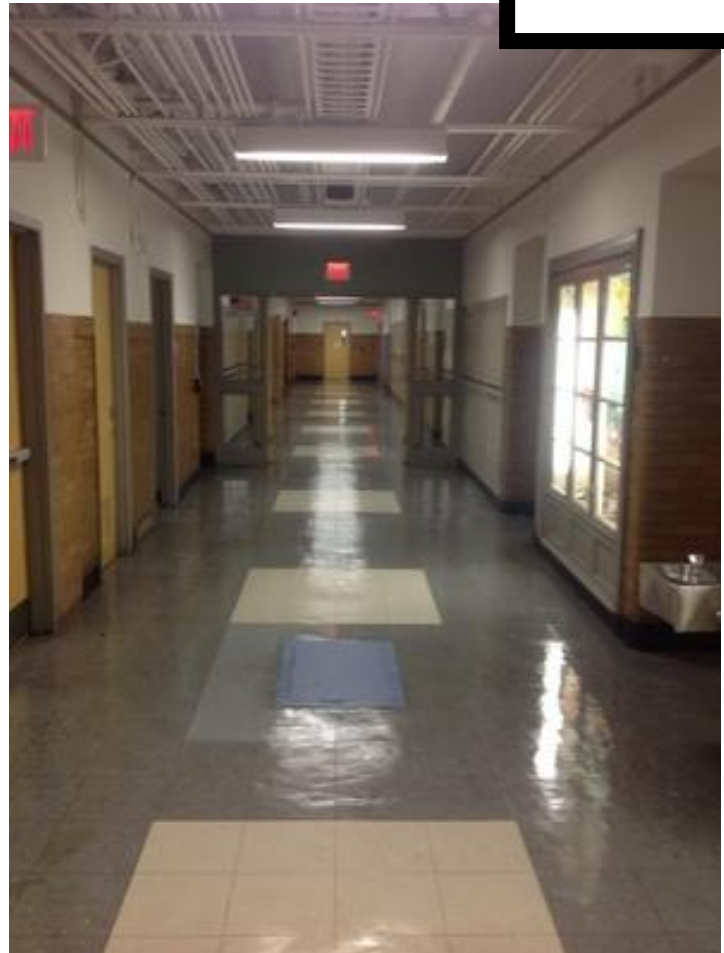
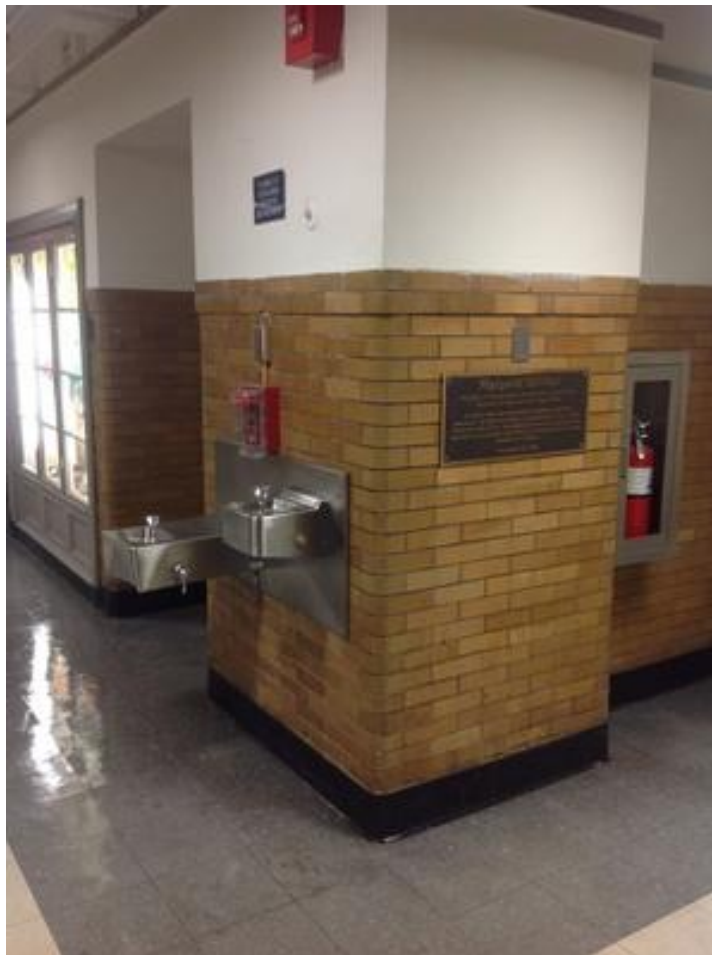
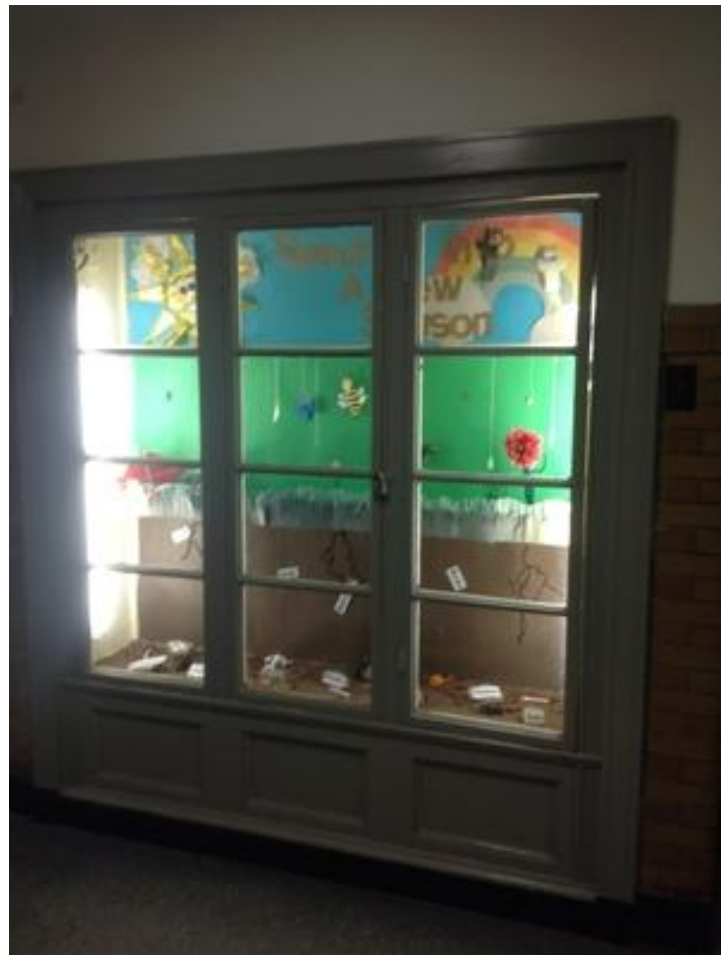
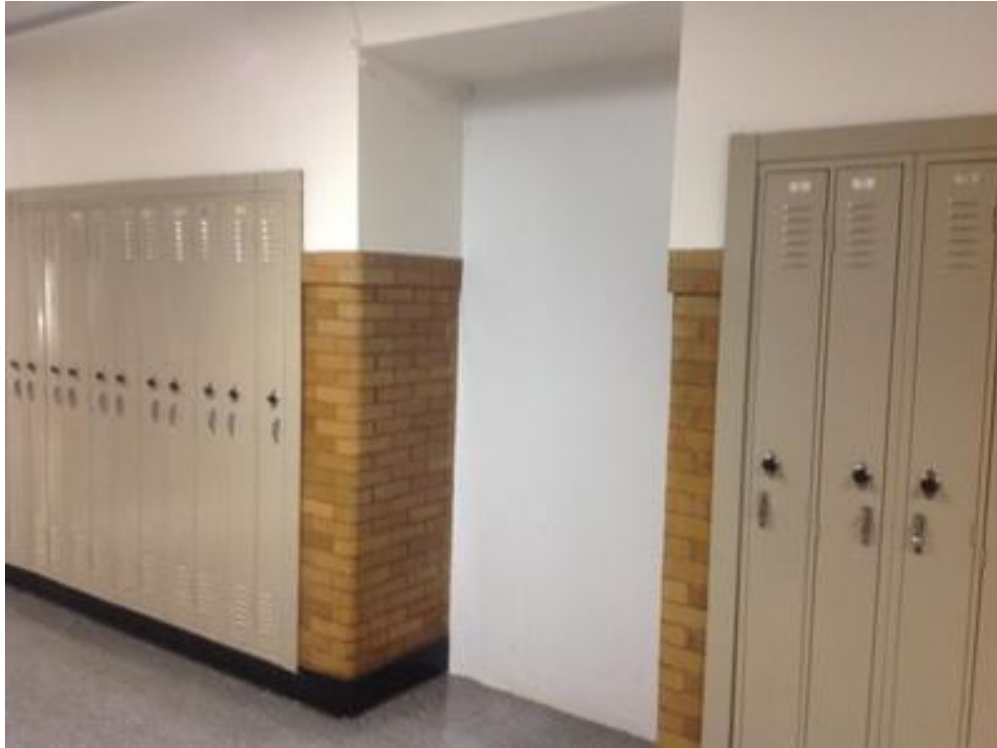
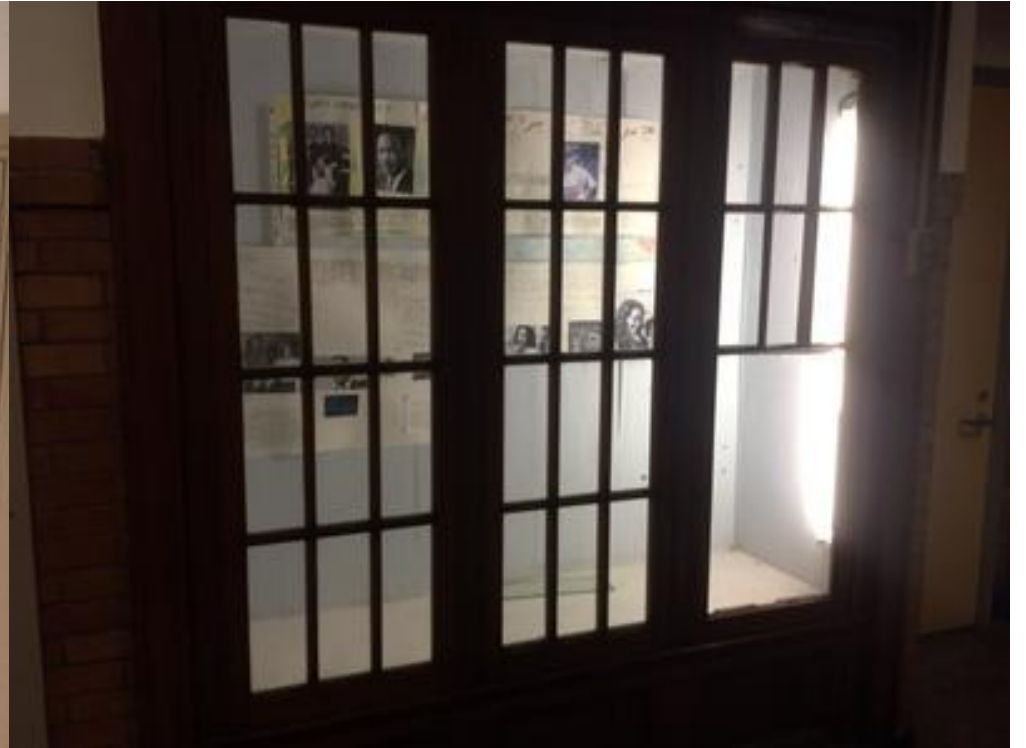
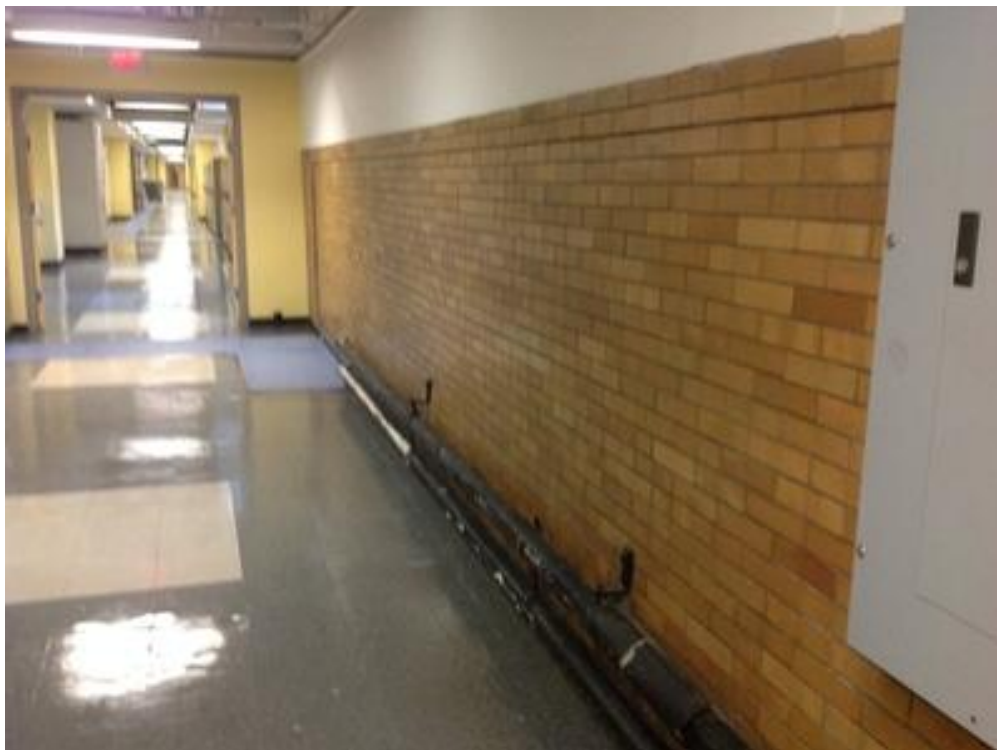
Typical - Corridors are in poor condition. Piping and HVAC equipment on walls is in poor condition. Windows have lost their seals. Metal mesh on exterior windows create ladder for excessive plant growth blocks that blocks views.

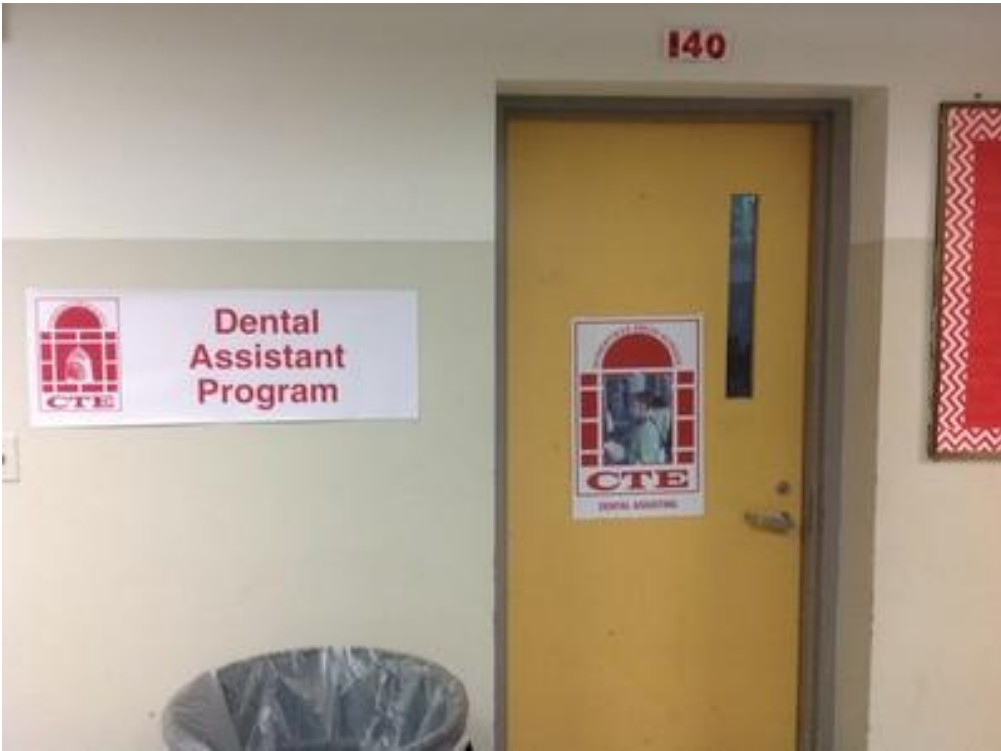
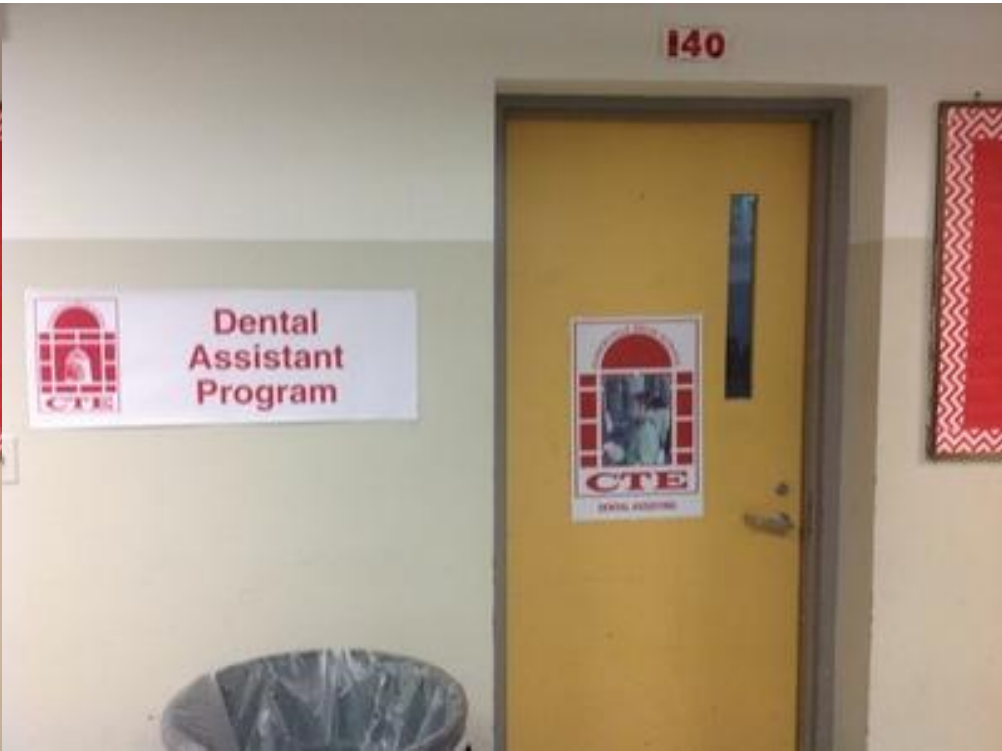
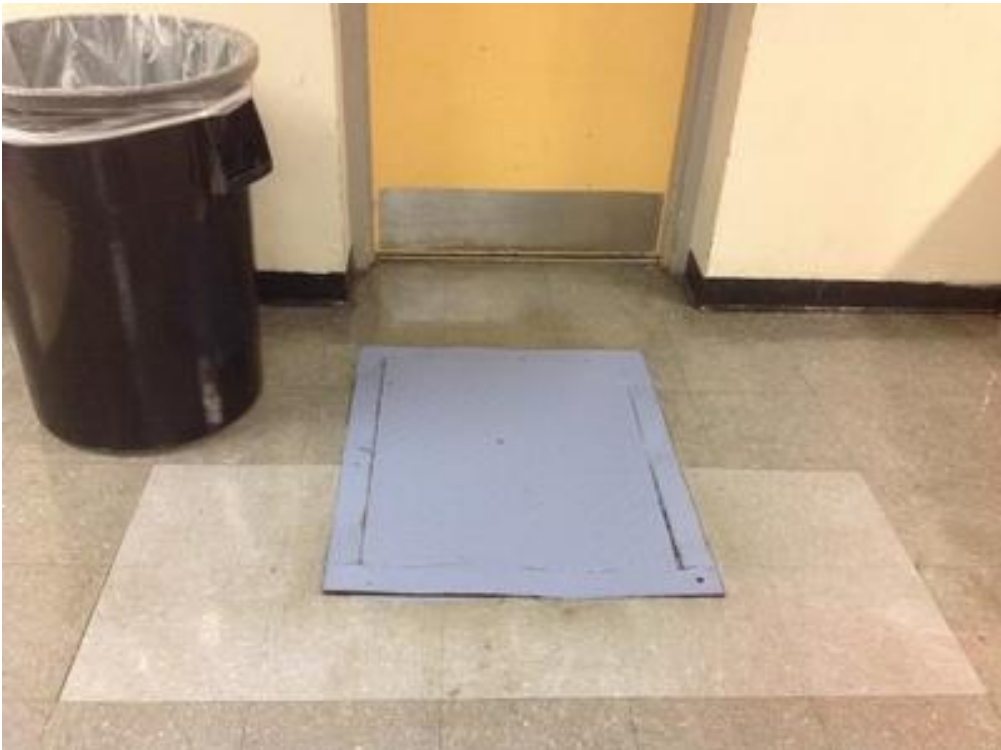
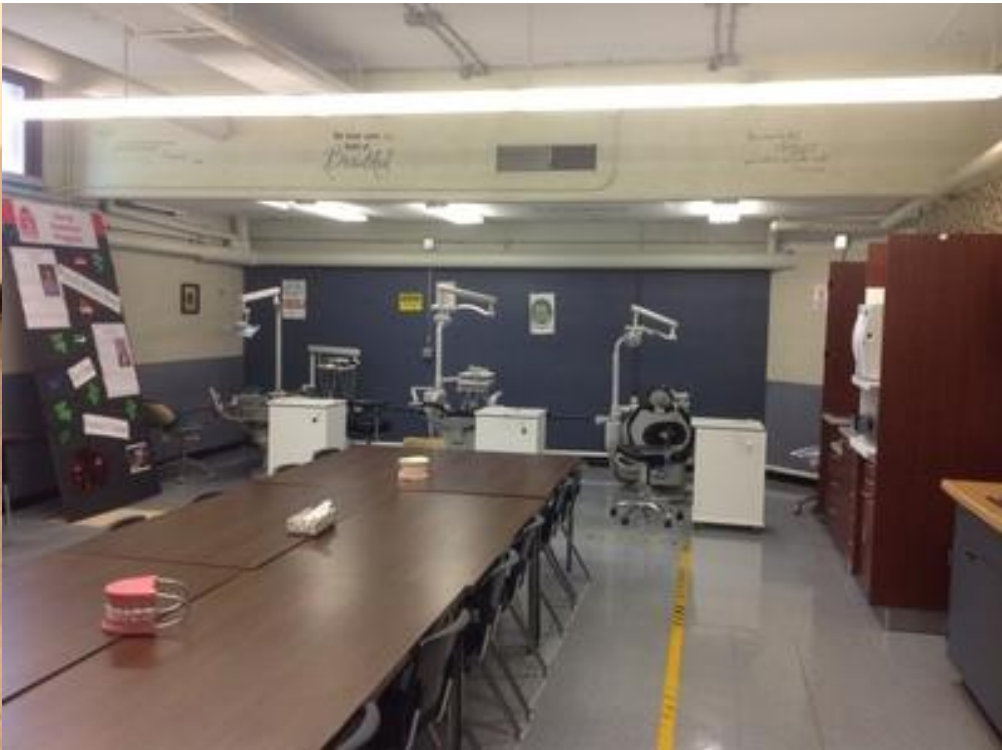
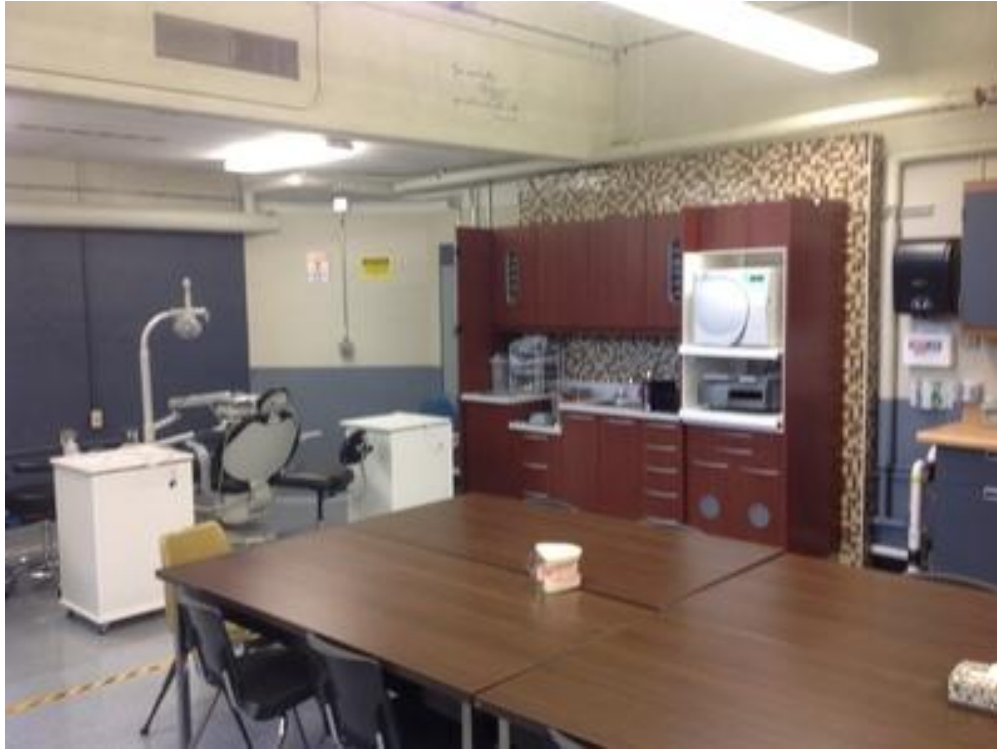
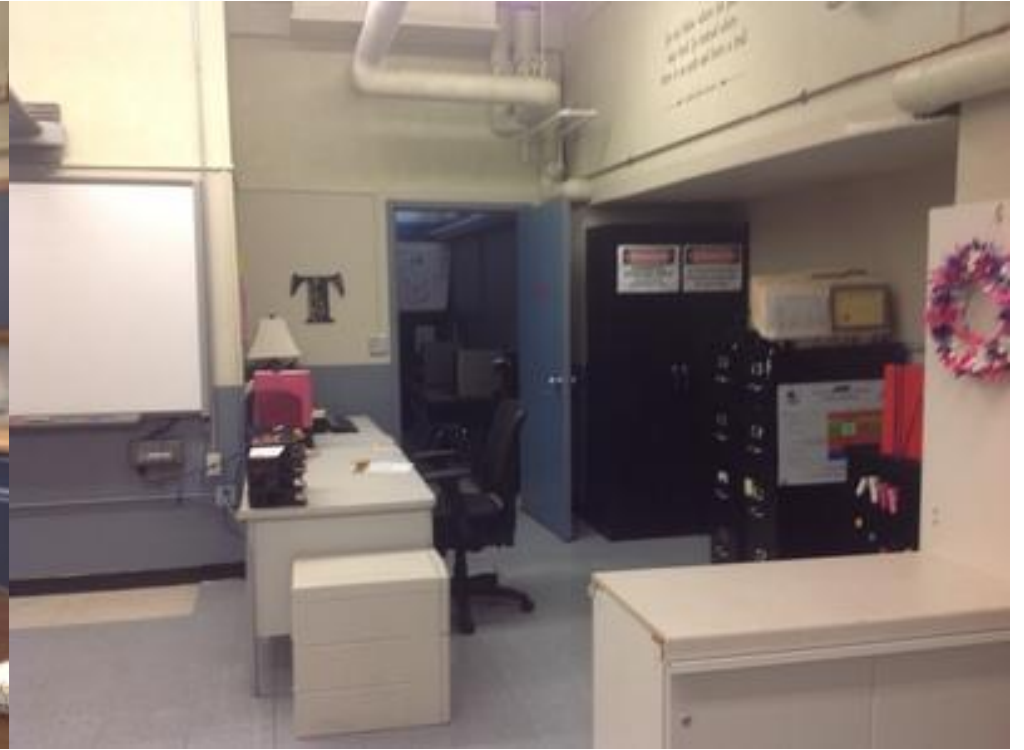
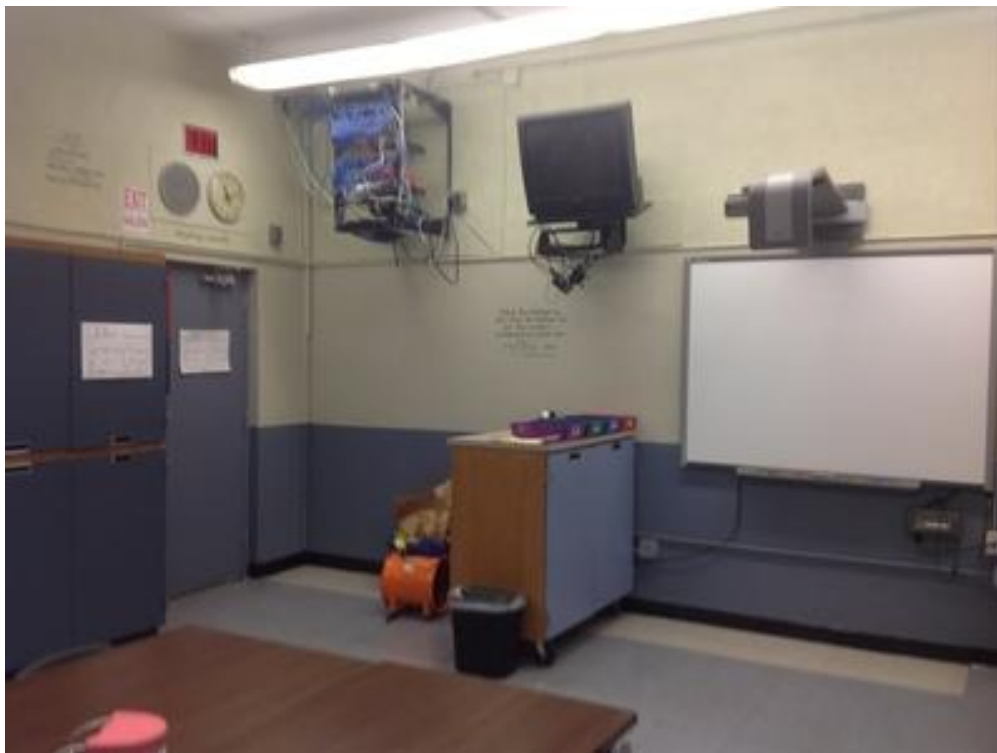
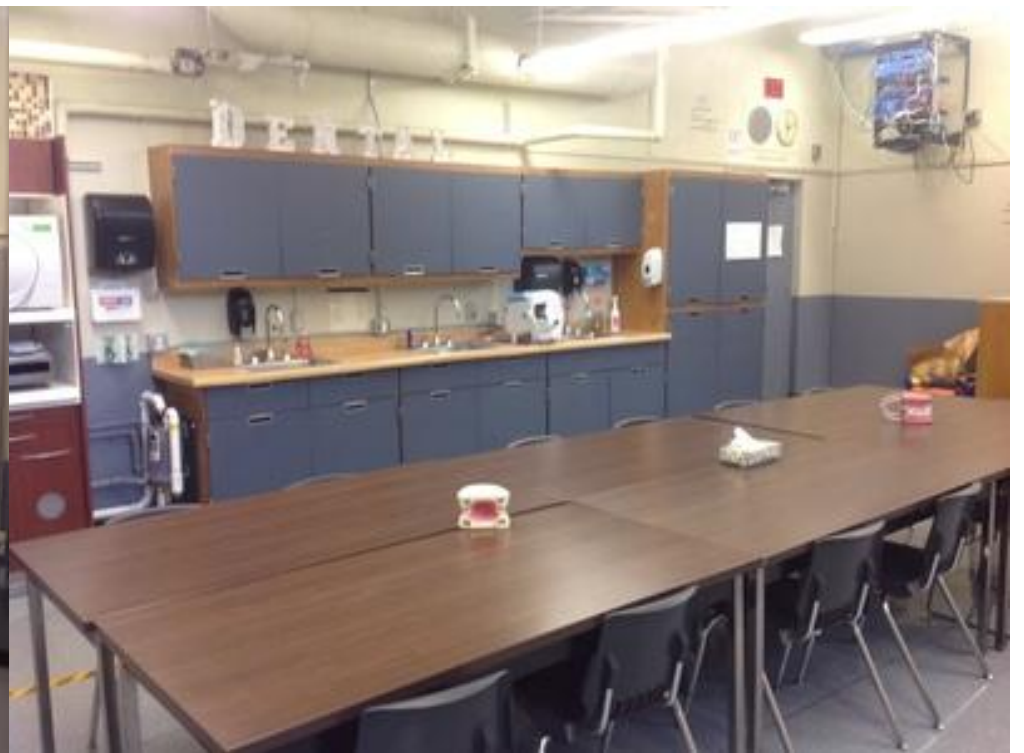
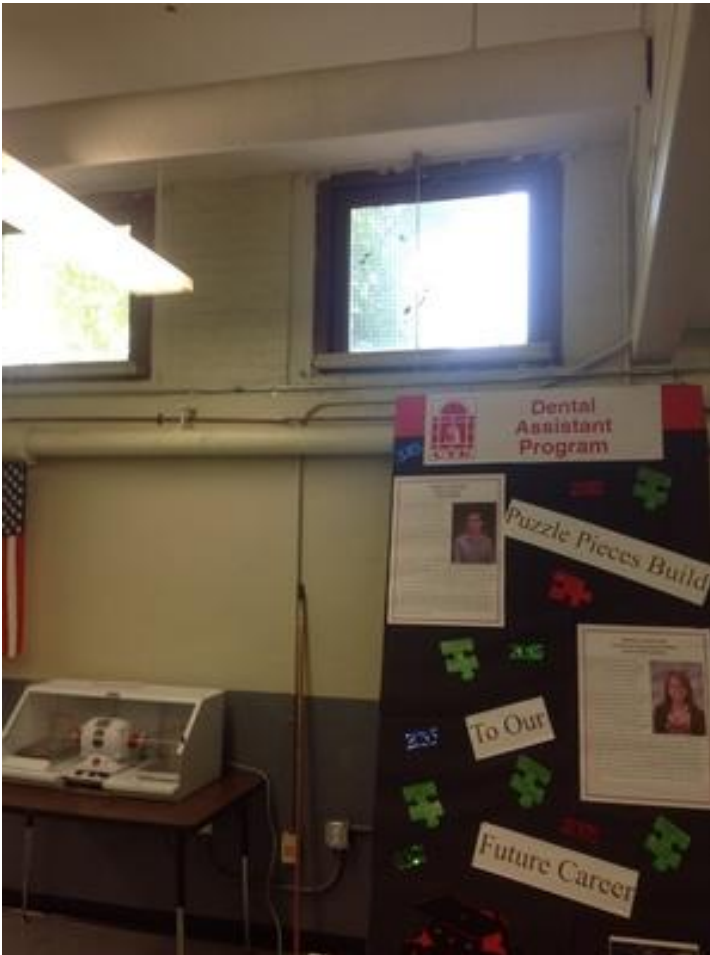
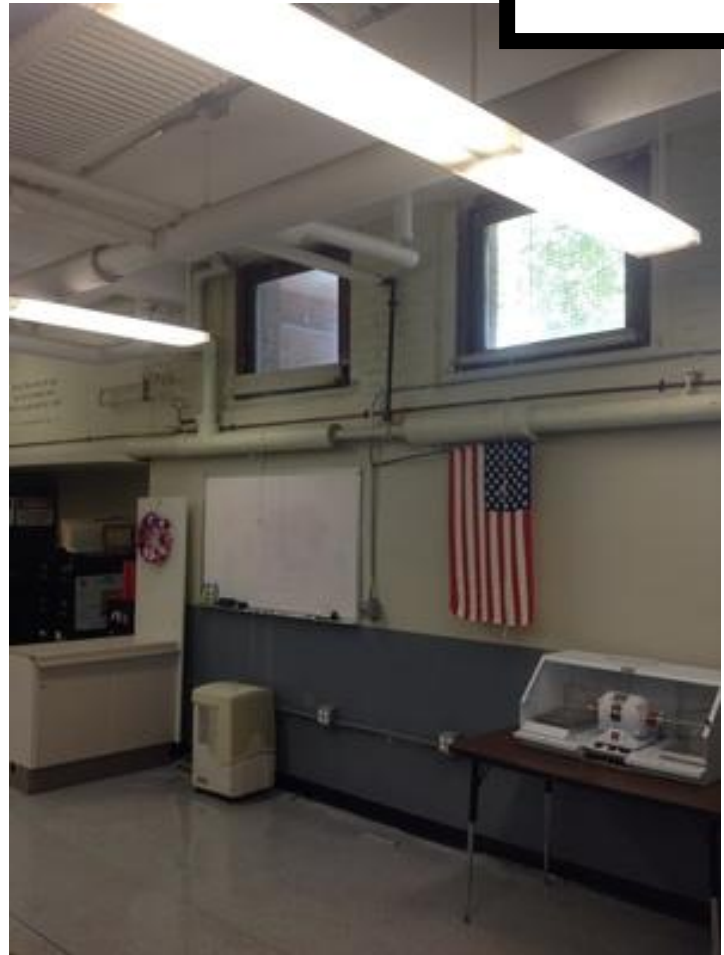
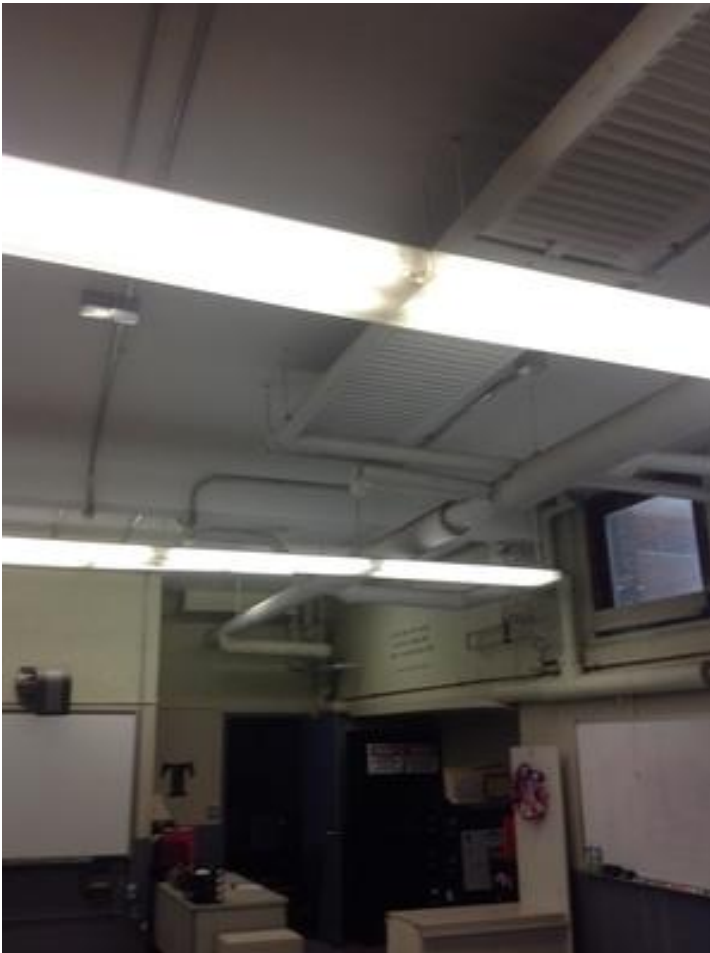
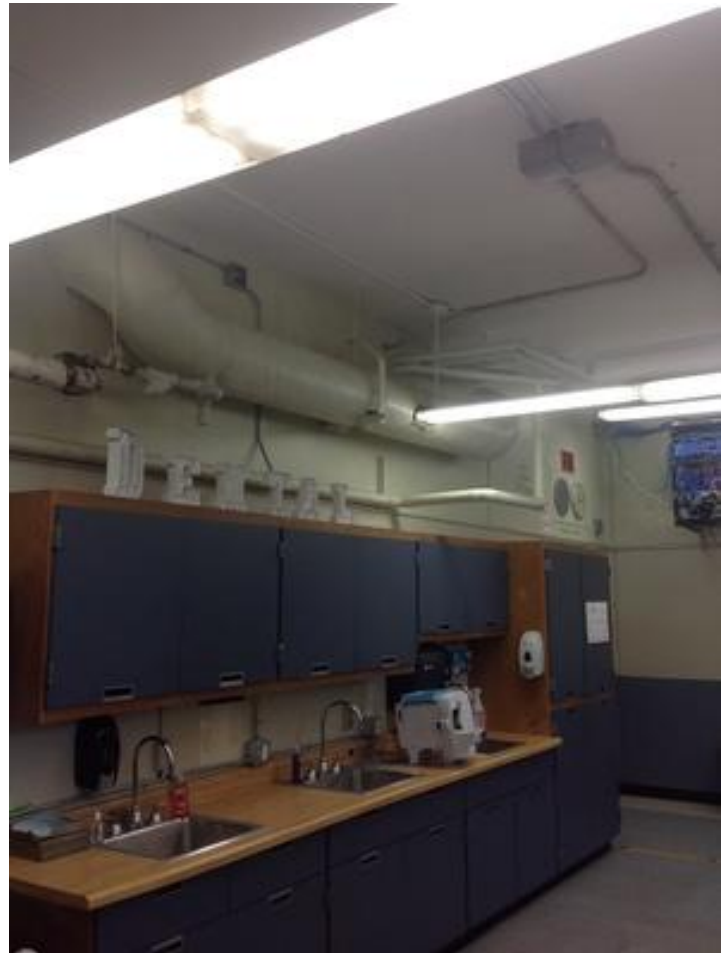
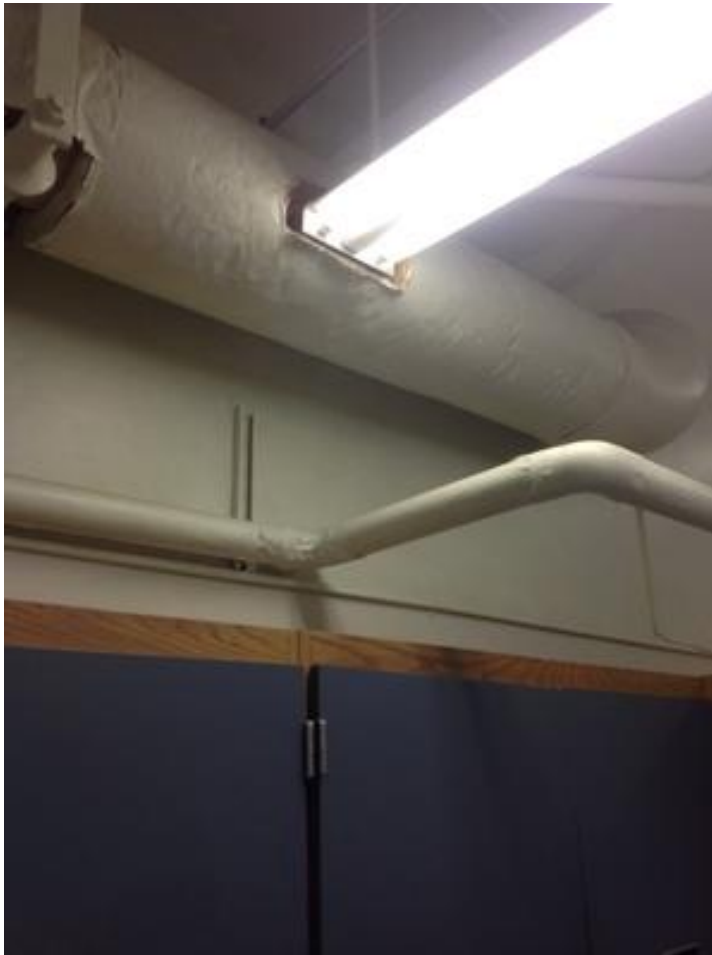
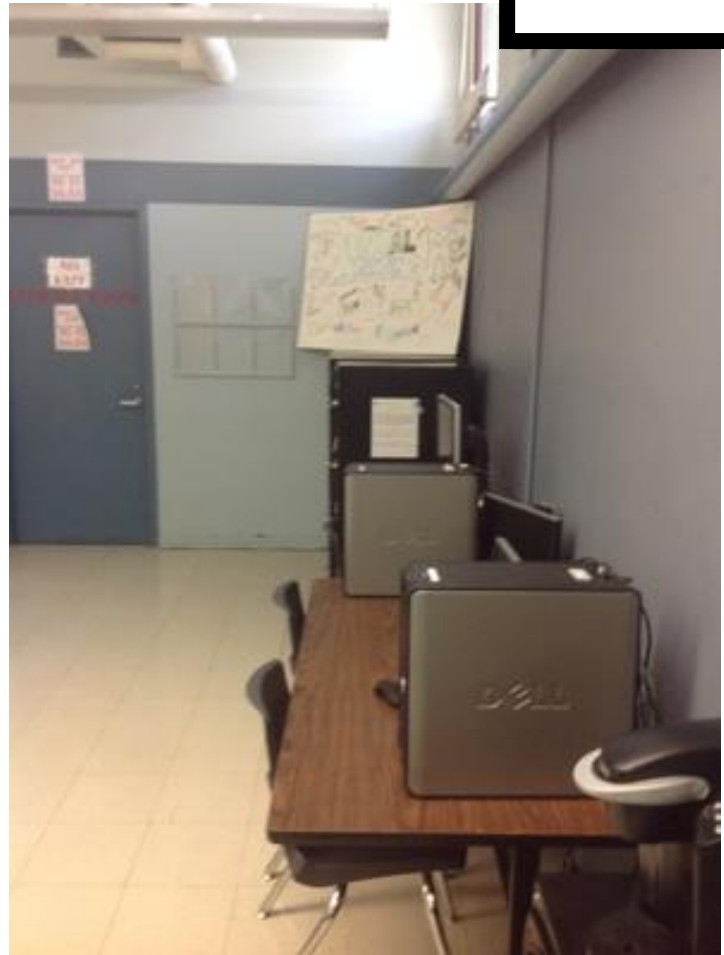
Attached Images for ID KU-00154

Description
Dental Assistant CTE program in fair condition. Flooring is in fair condition. Piping and wiring is haphazard and surface mounted. Millwork is in poor condition. Windows are in poor condition Exterior metal mesh on windows creates ladder for plant growth. Some of the clerestory windows have lost their seals. Lighting is in poor condition. Some ductwork and piping is rusty.
