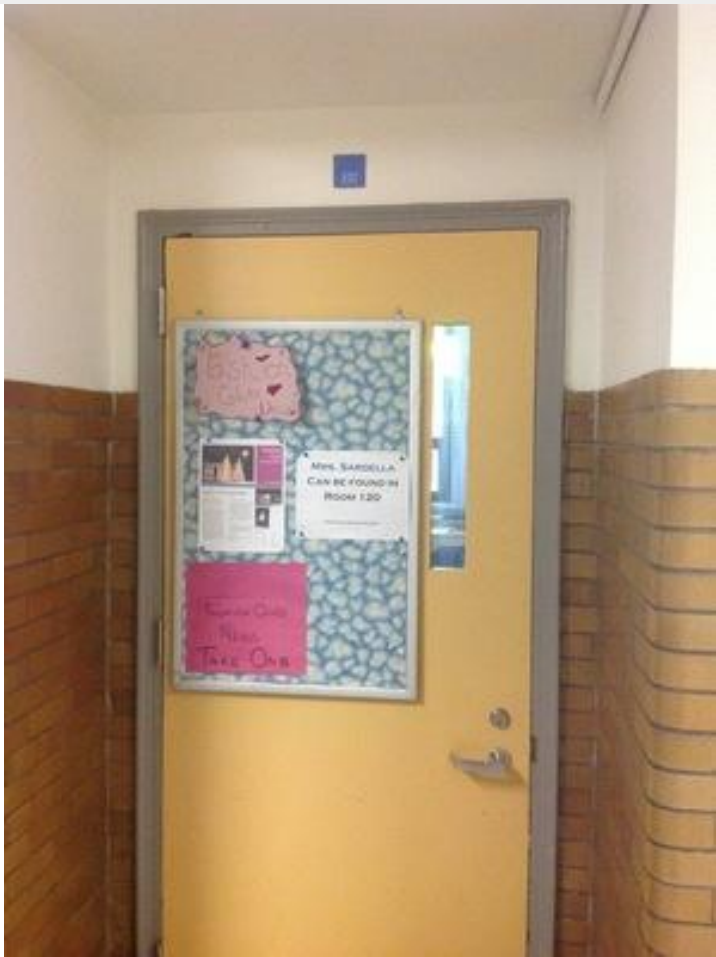
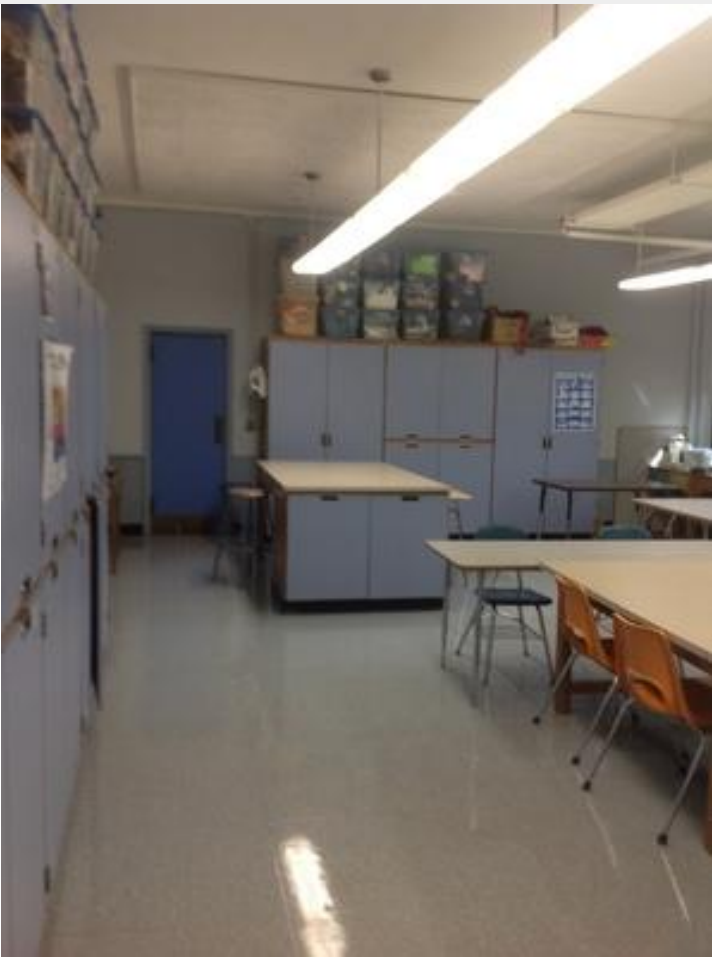
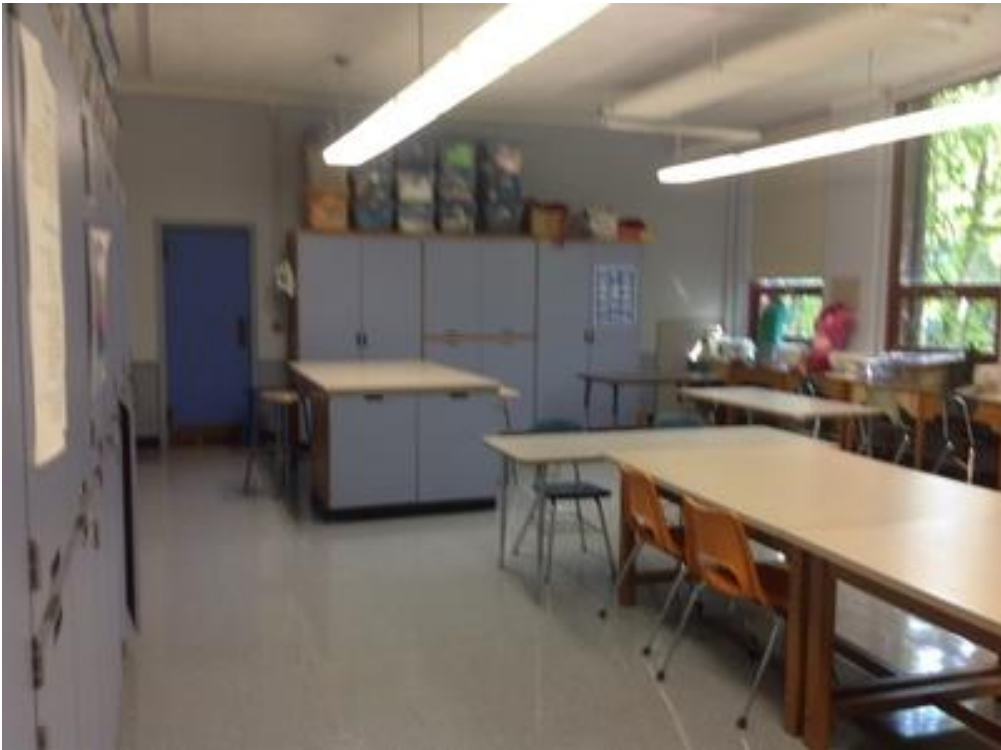
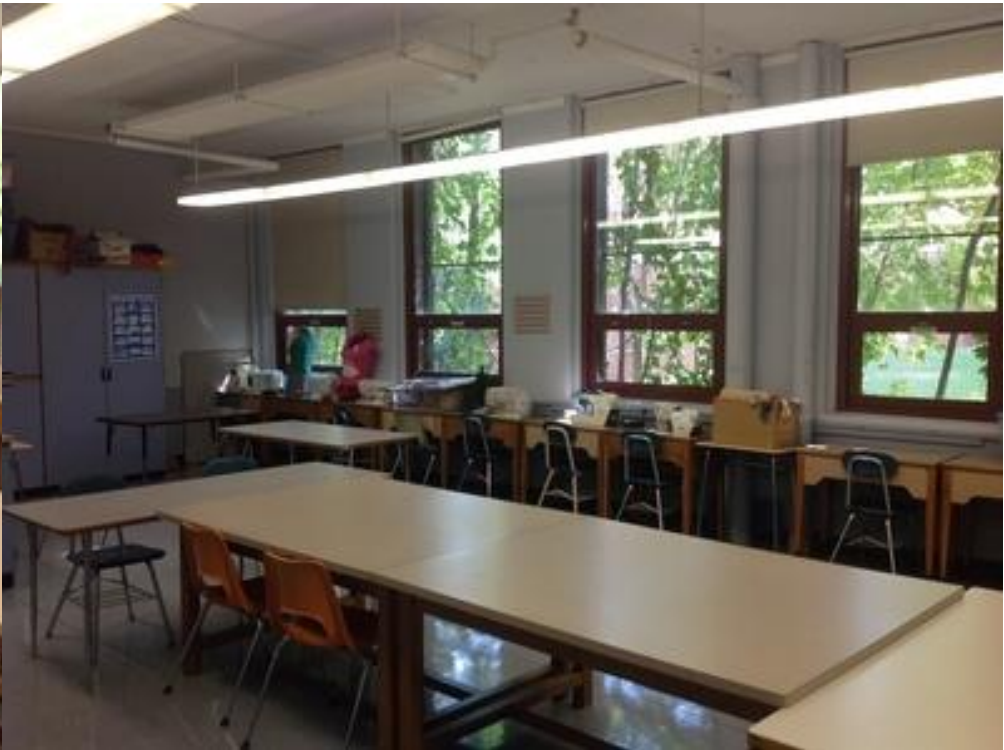
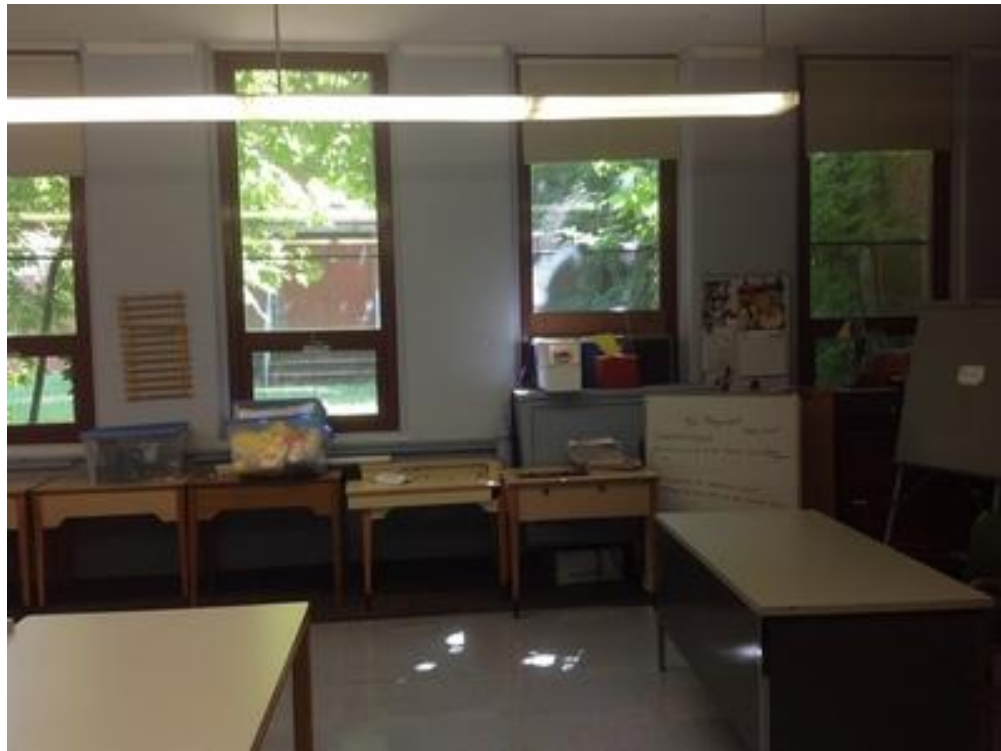
Attached Images for ID KU-00155

Description
Fashion/Clothing classroom is in fair condition. VCT flooring is in fair condition. At perimeter, steam pipe access grill is in poor condition. Piping and wiring is haphazard and surface mounted. Millwork is in poor condition. Windows are in poor condition Exterior metal mesh on windows creates ladder for plant growth. Some of the windows have lost their seals. Lighting is in poor condition. Some ductwork and piping is rusty and piping insulation has gouges.

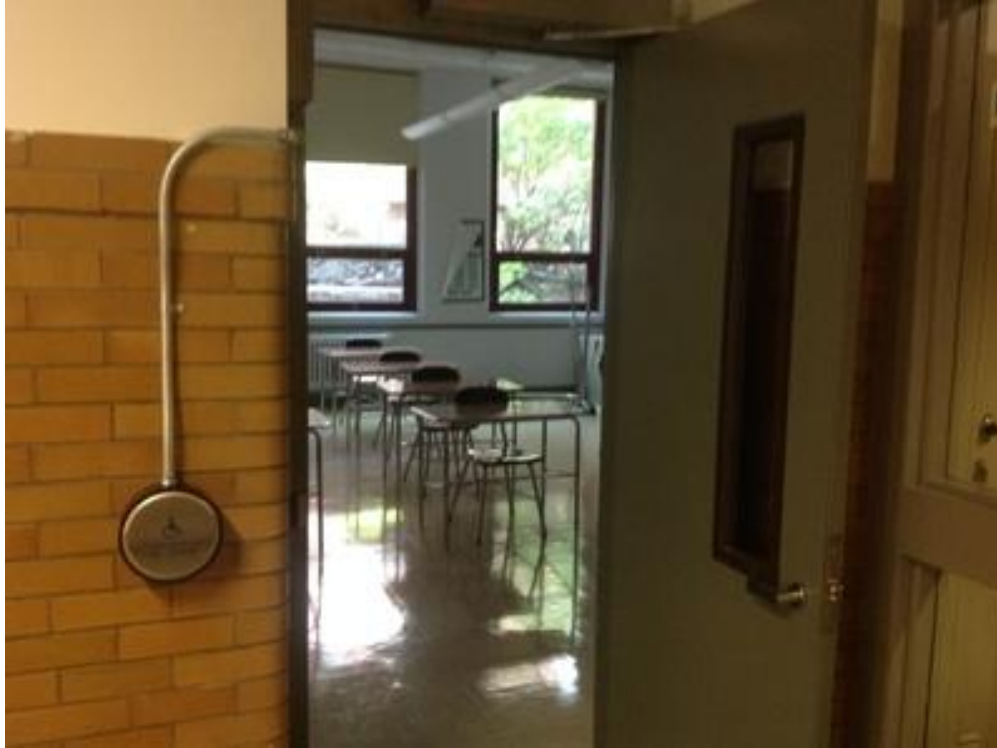
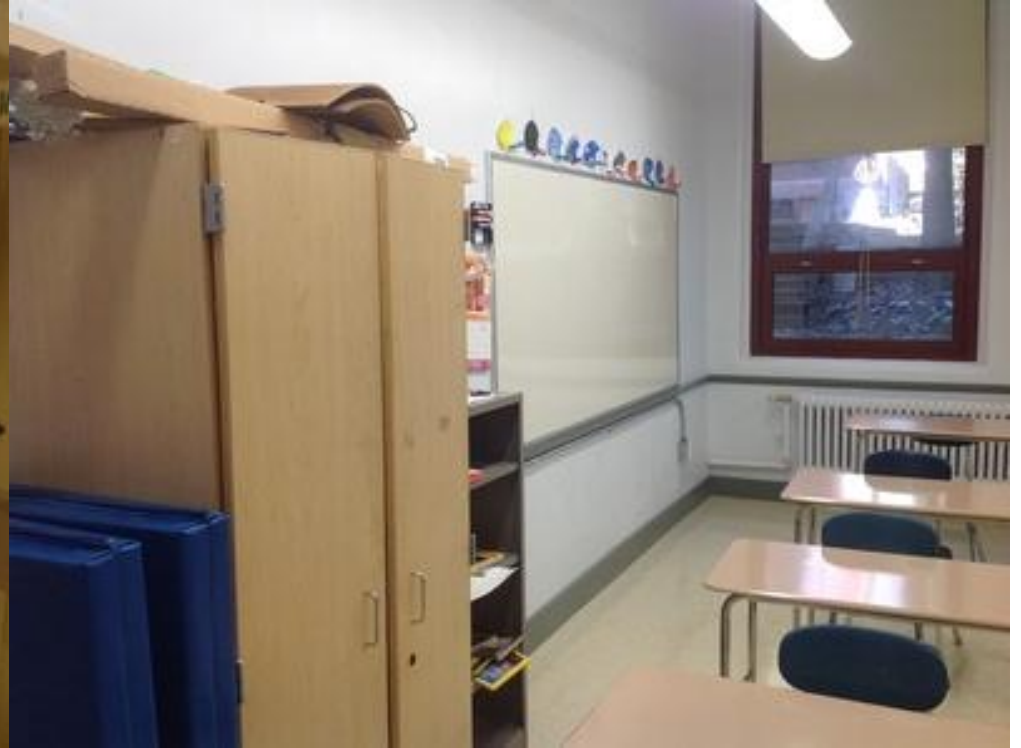
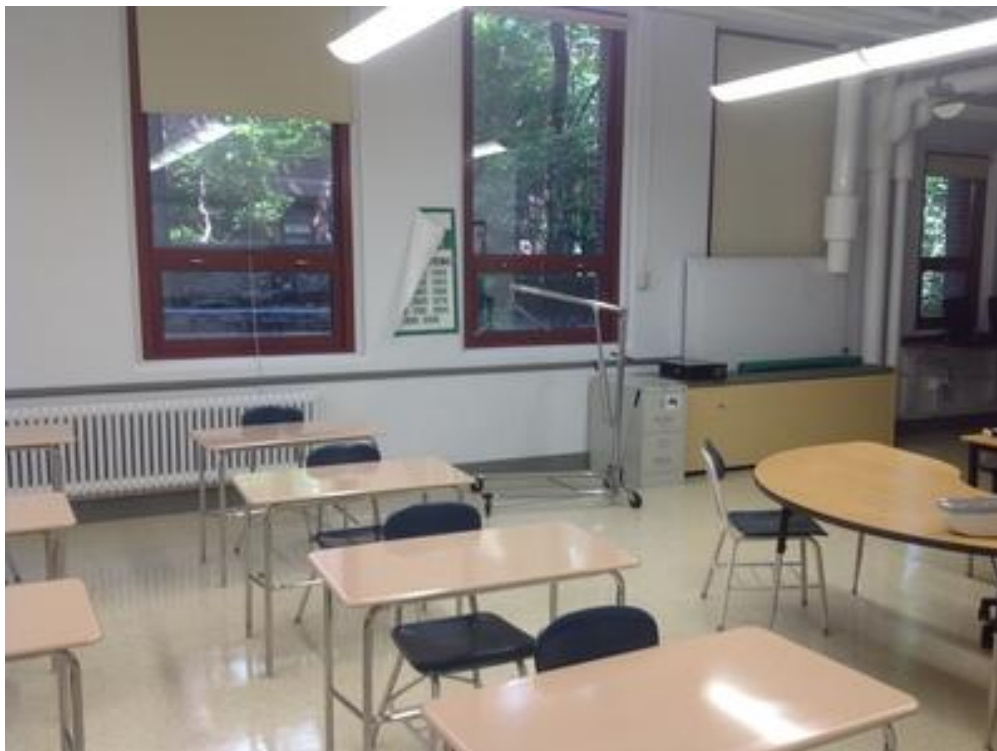
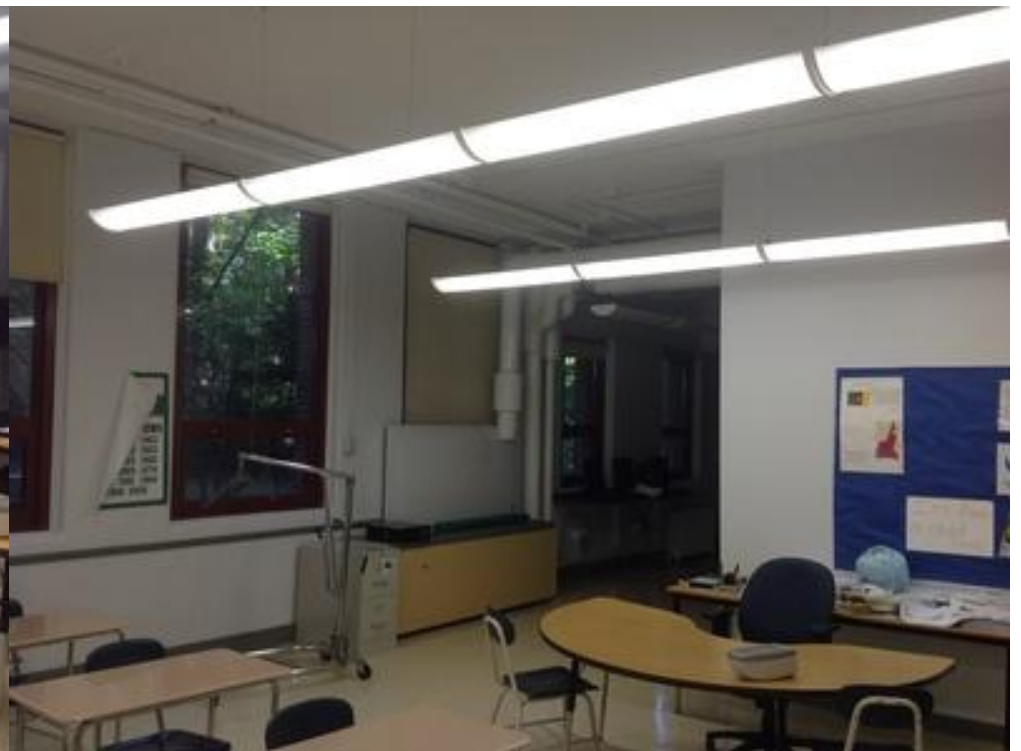
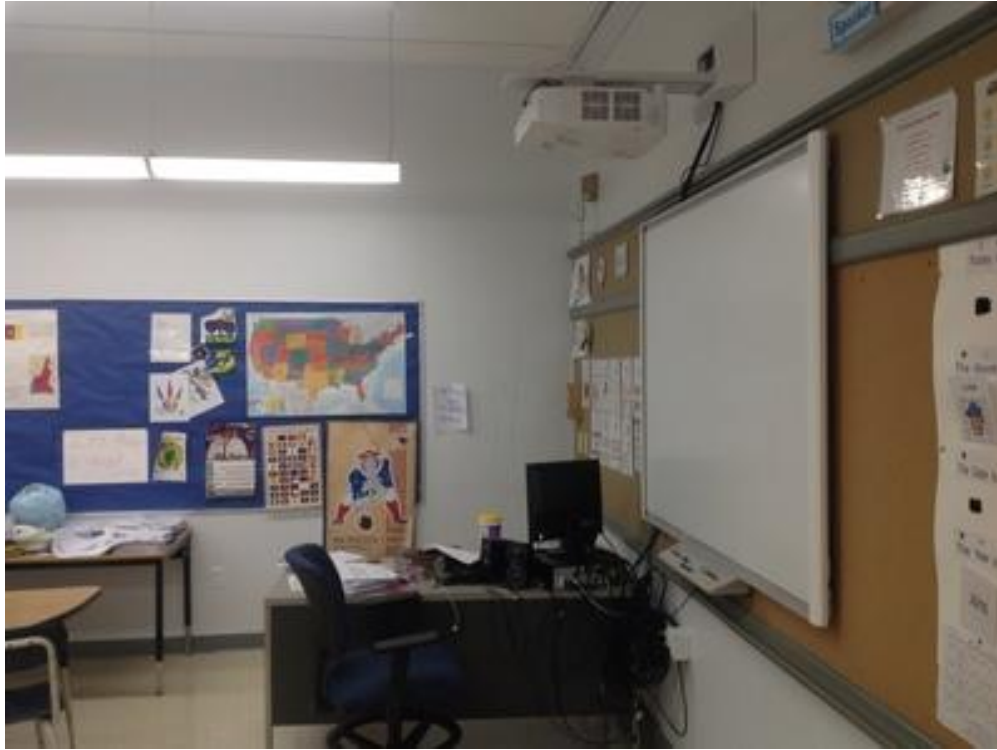
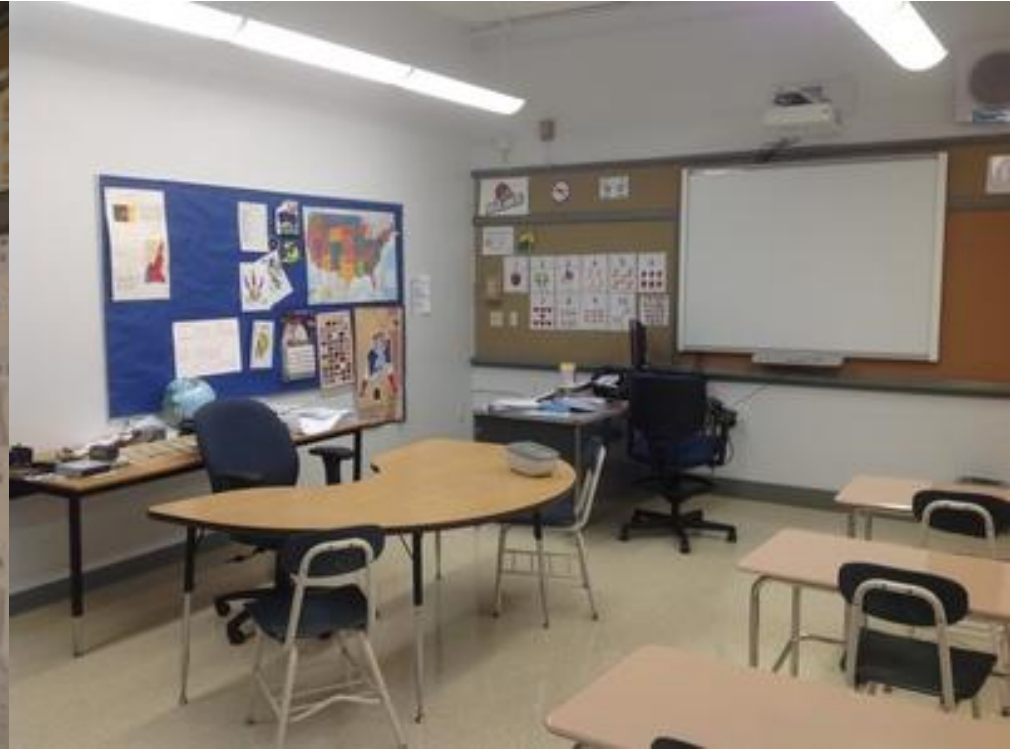
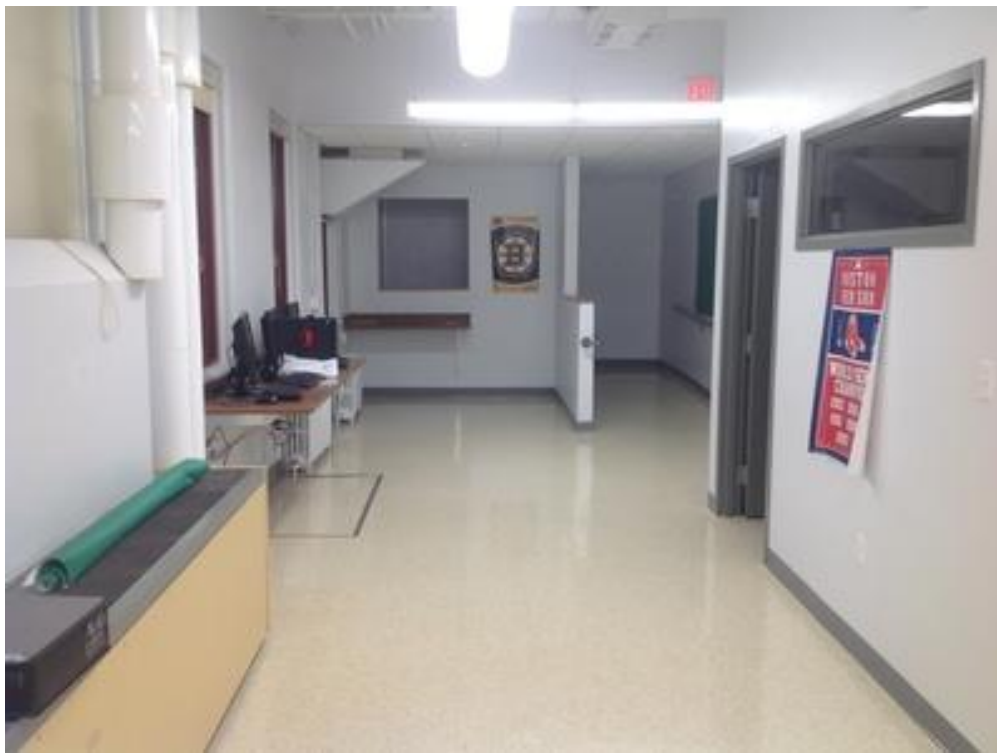
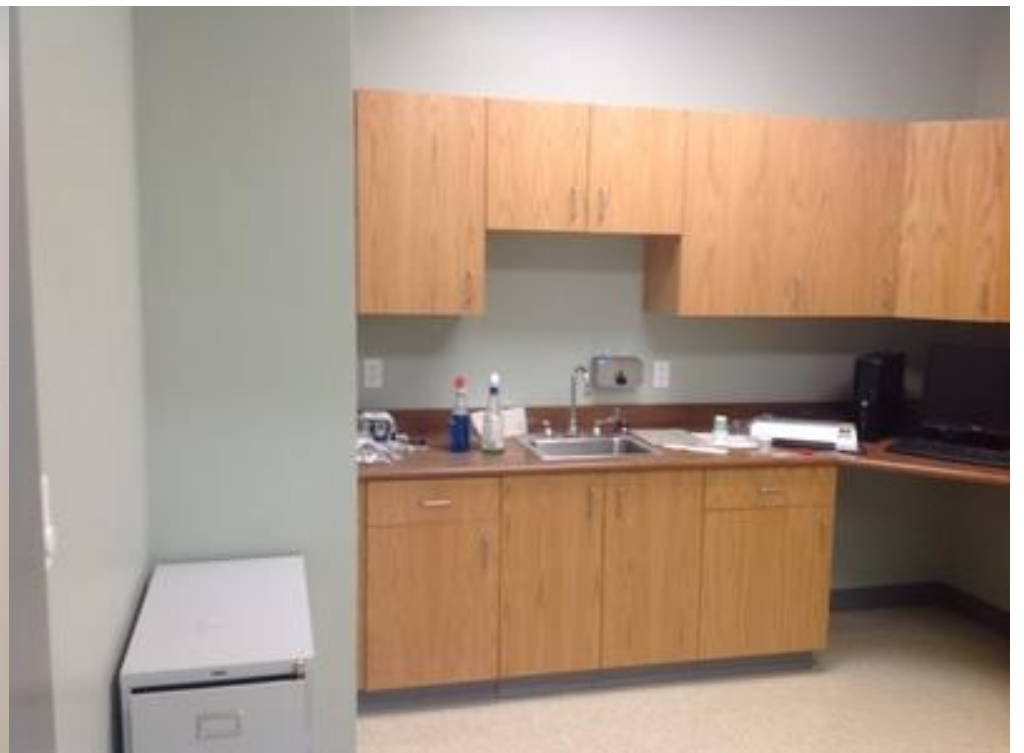
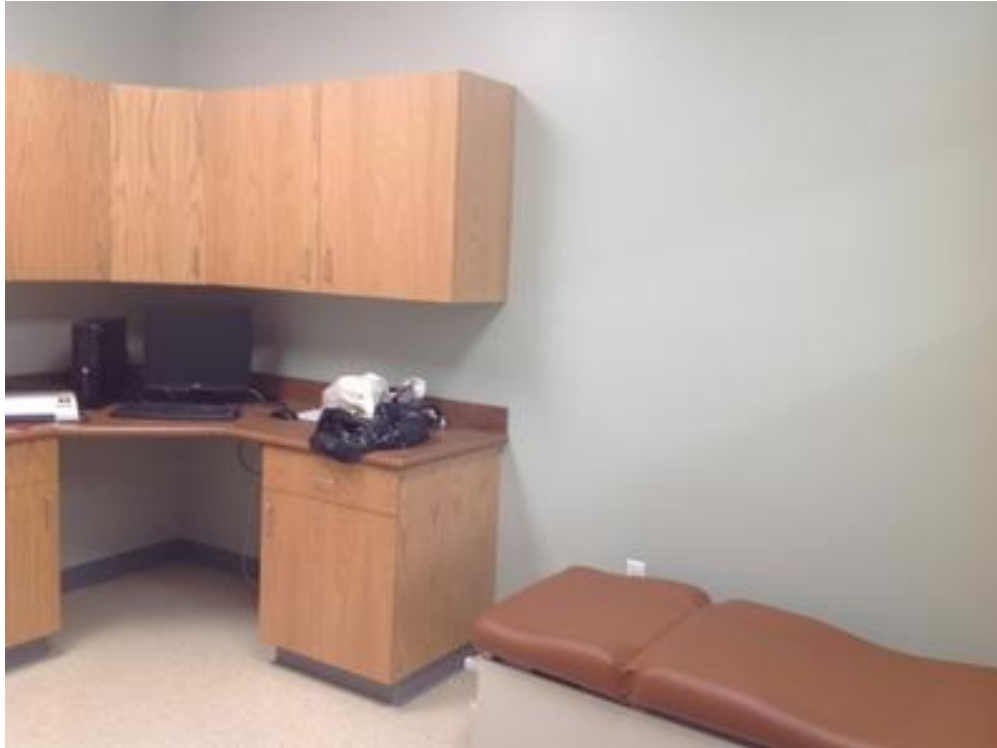
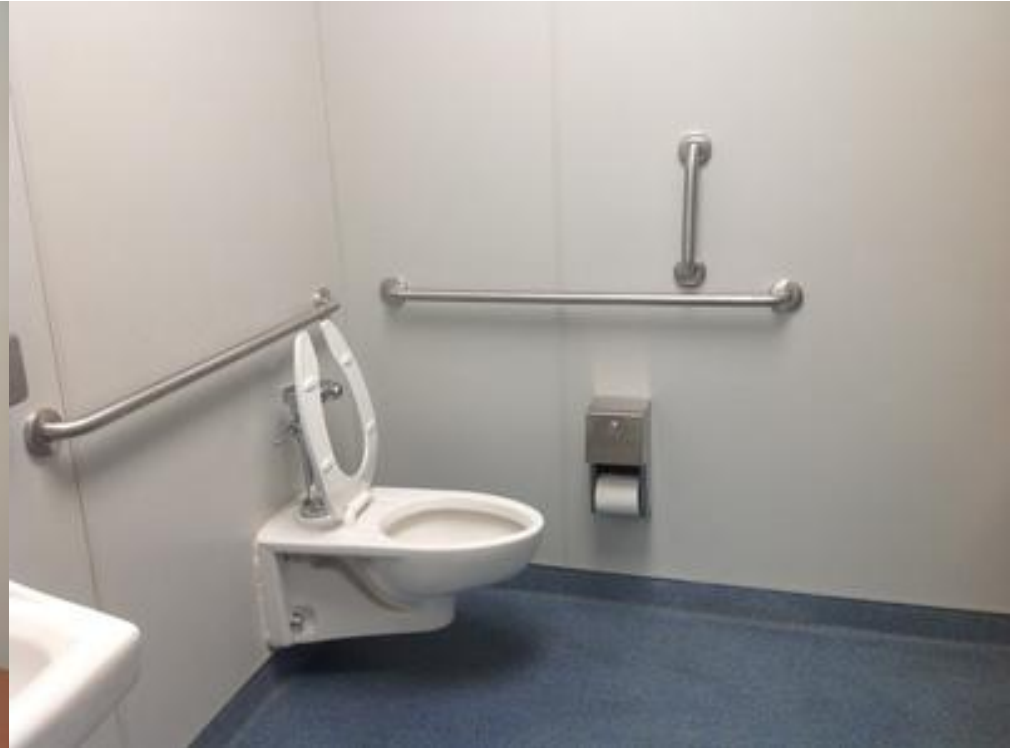
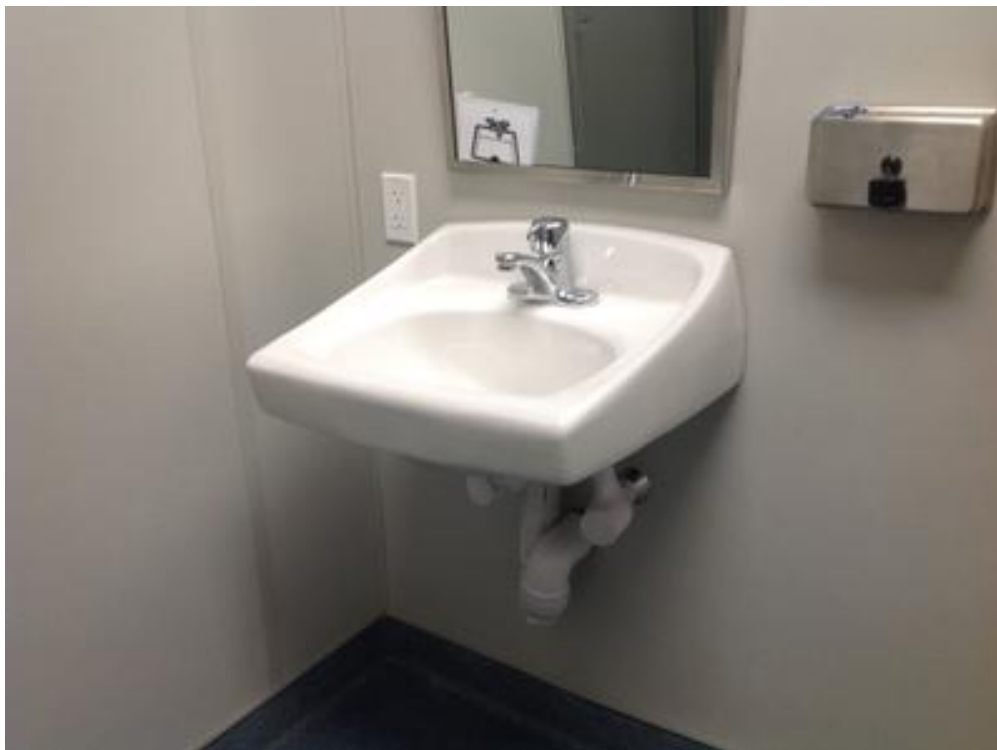
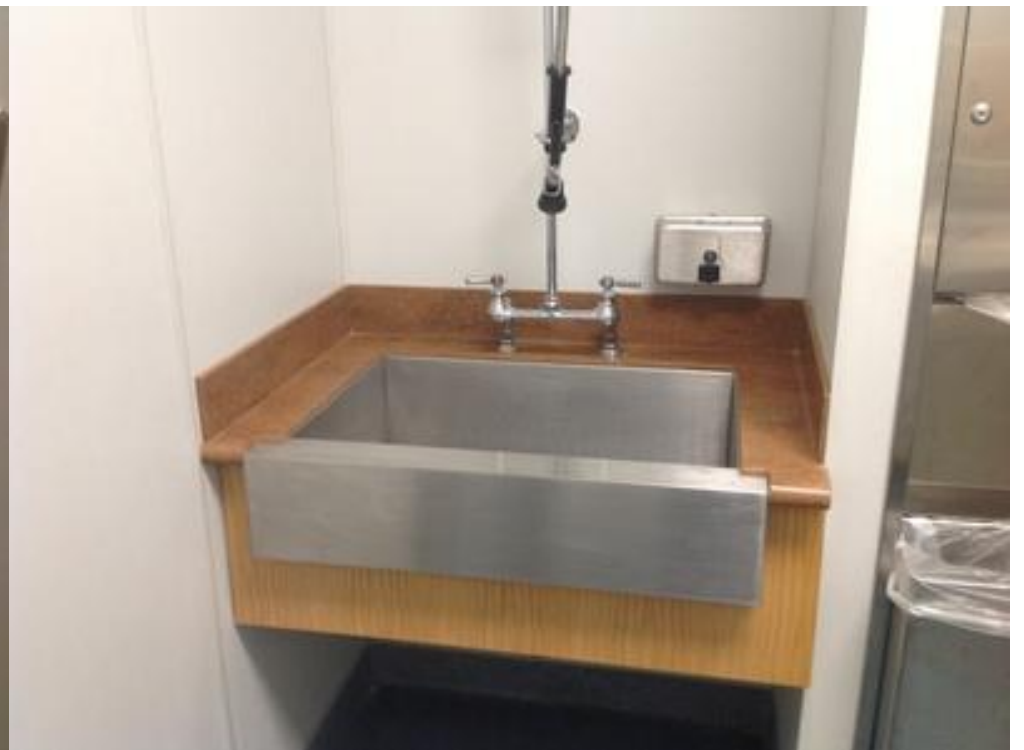
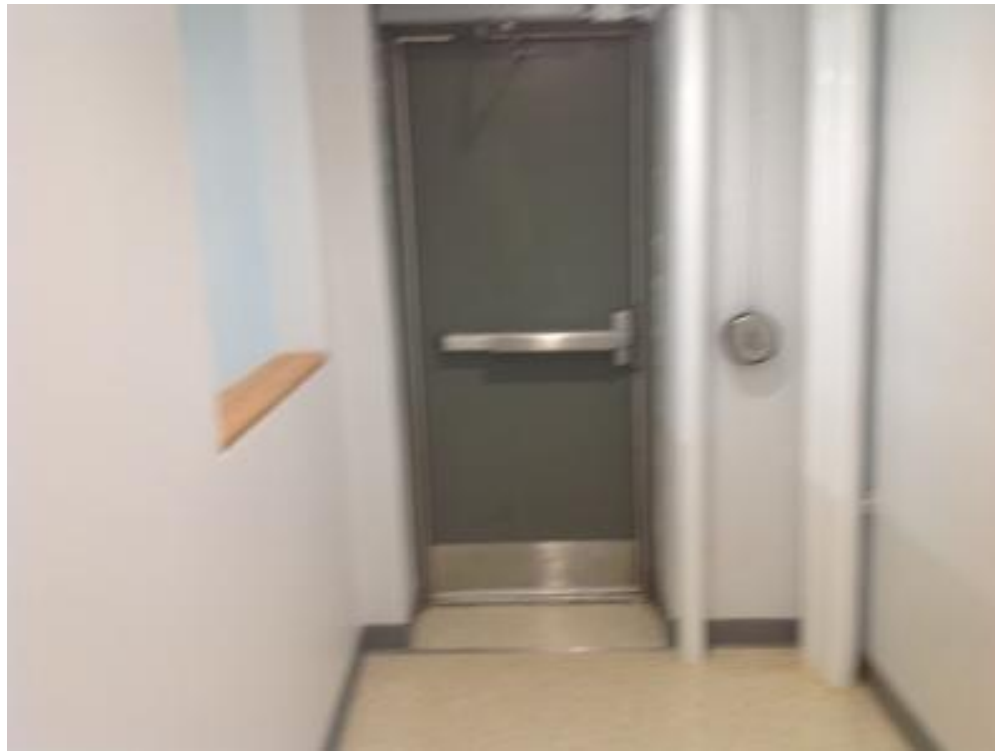
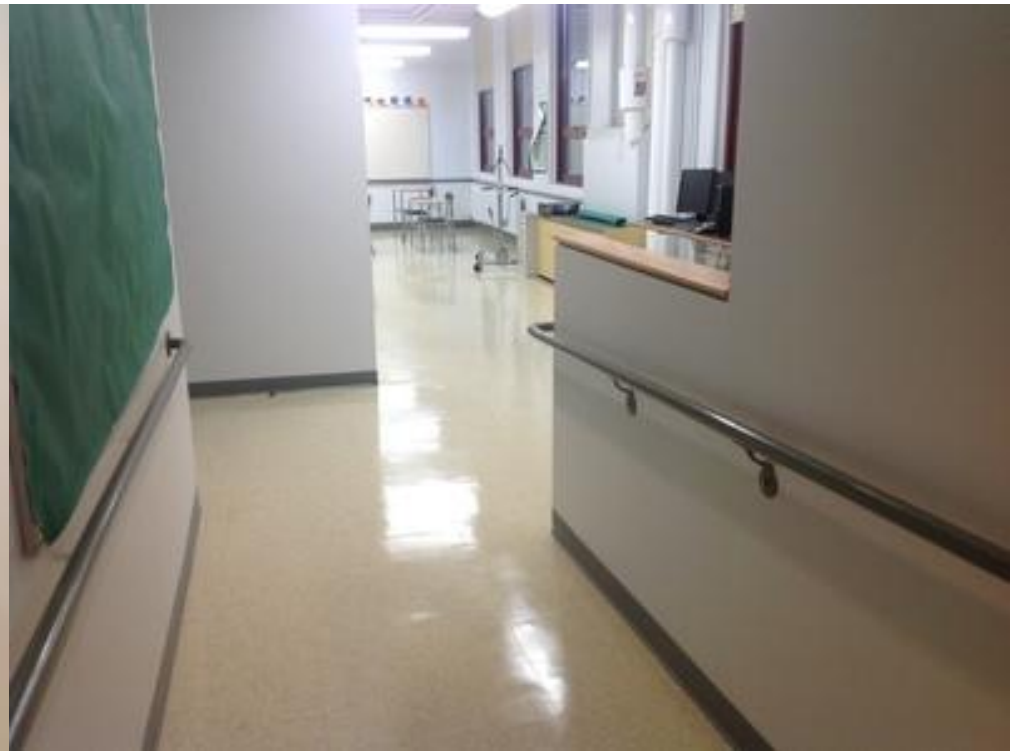
Description
Special Education suite is in new condition. Space has undergone renovation. Flooring, lighting, and millwork are new. Walls have been painted. Ramp has been included with access to courtyard in rear of building. ADA compliant kitchenette and restroom are included. Pushplate door hardware allows compliant access to room and exterior space.
