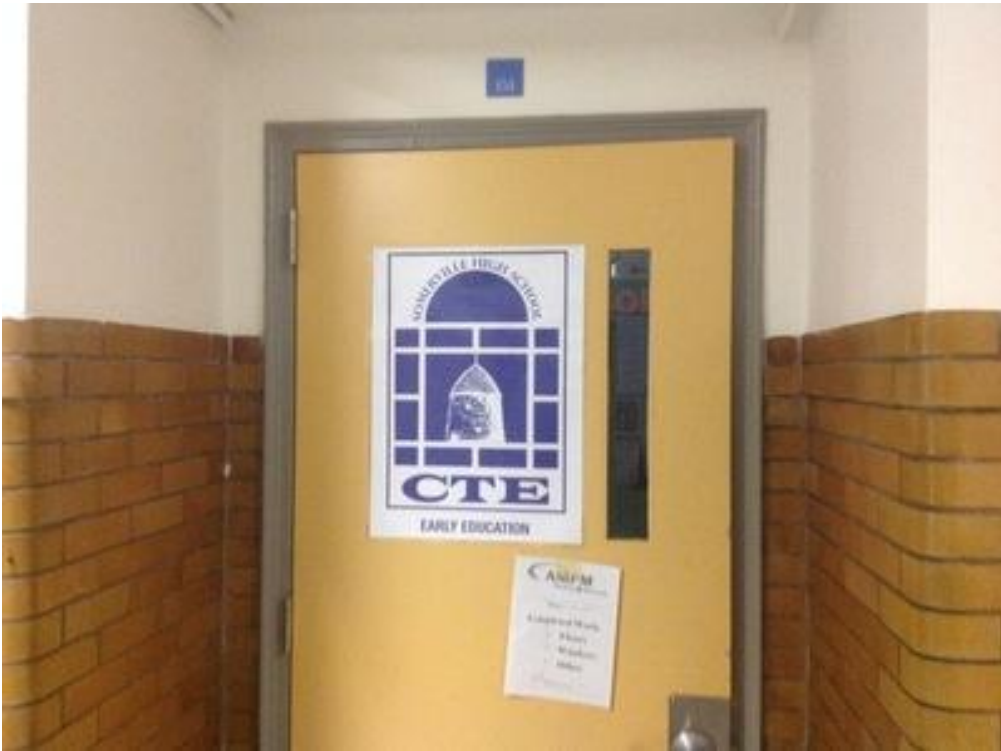
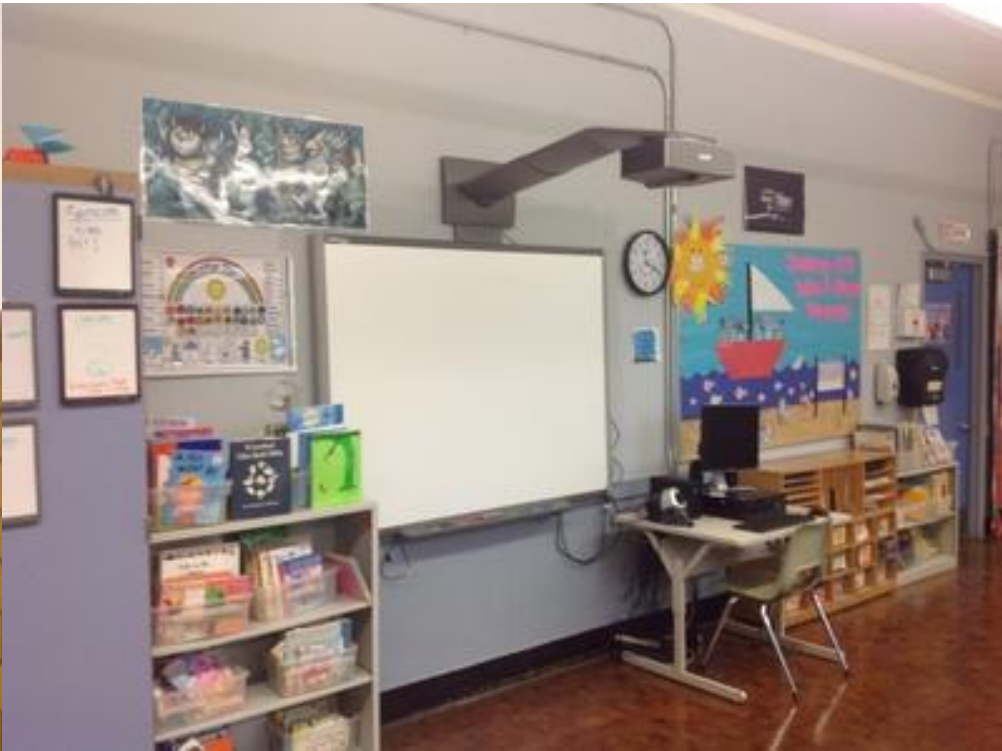
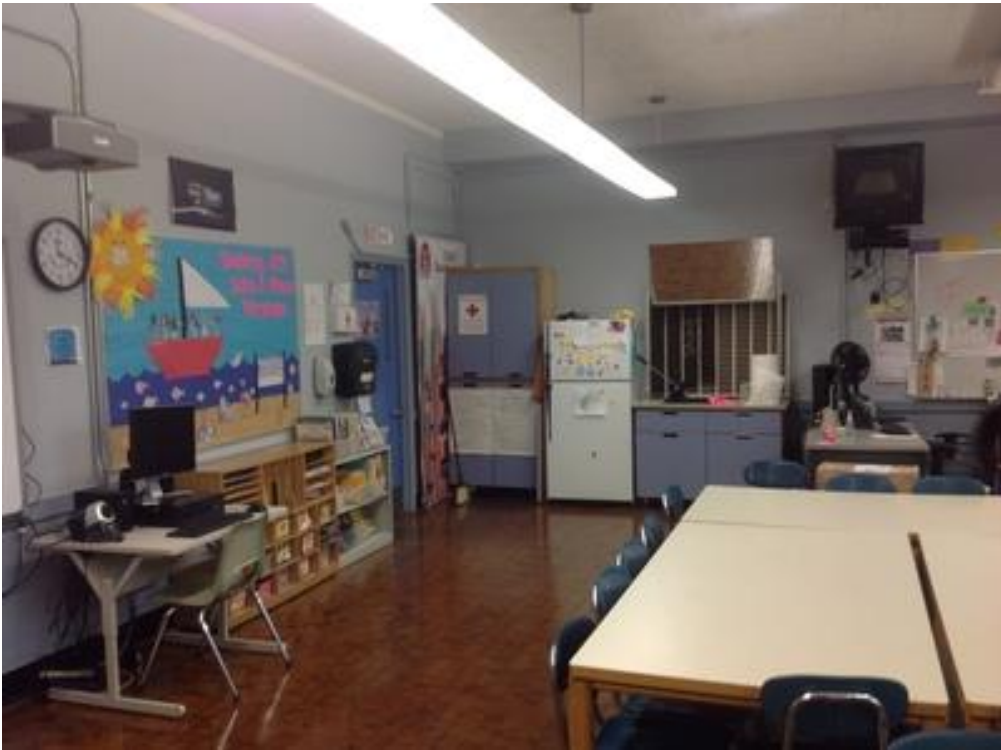
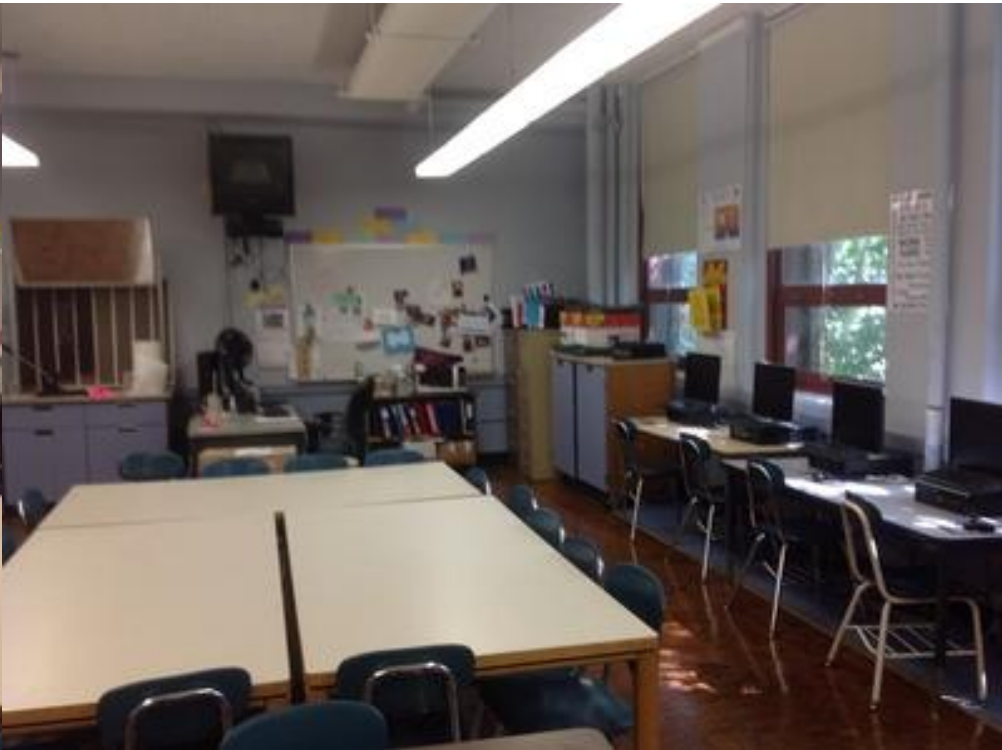
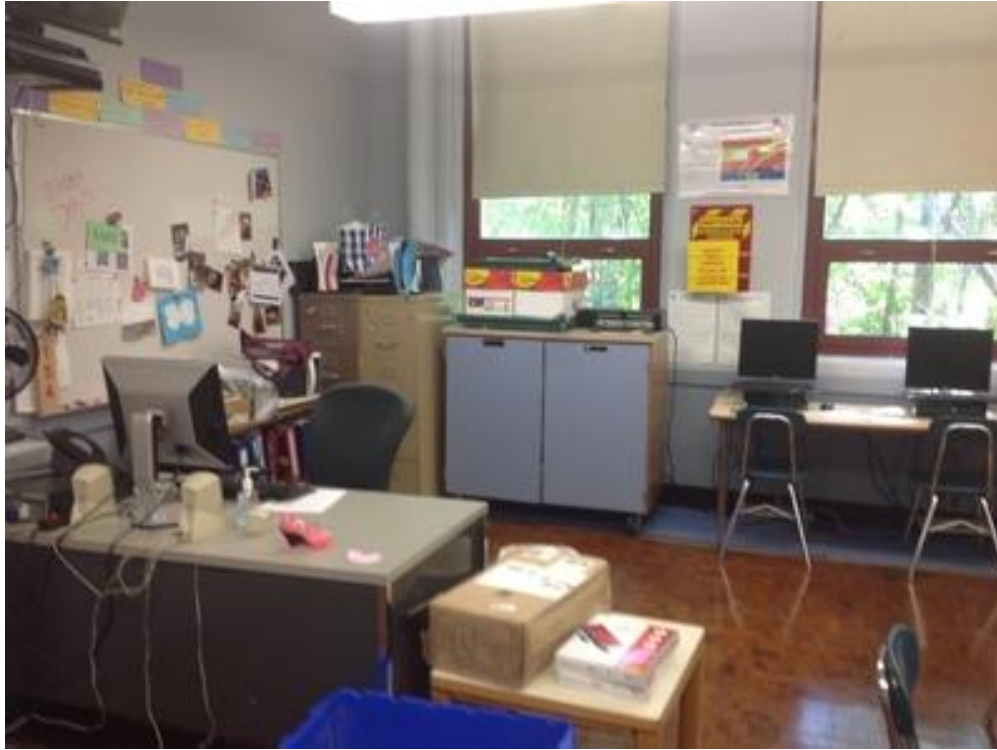
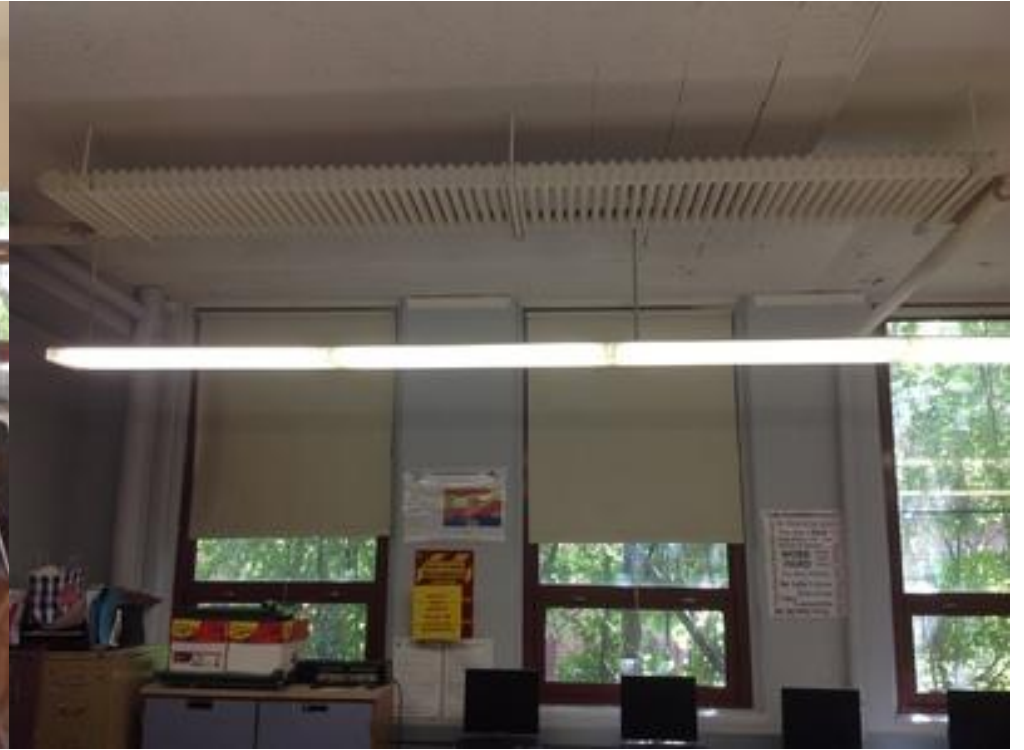
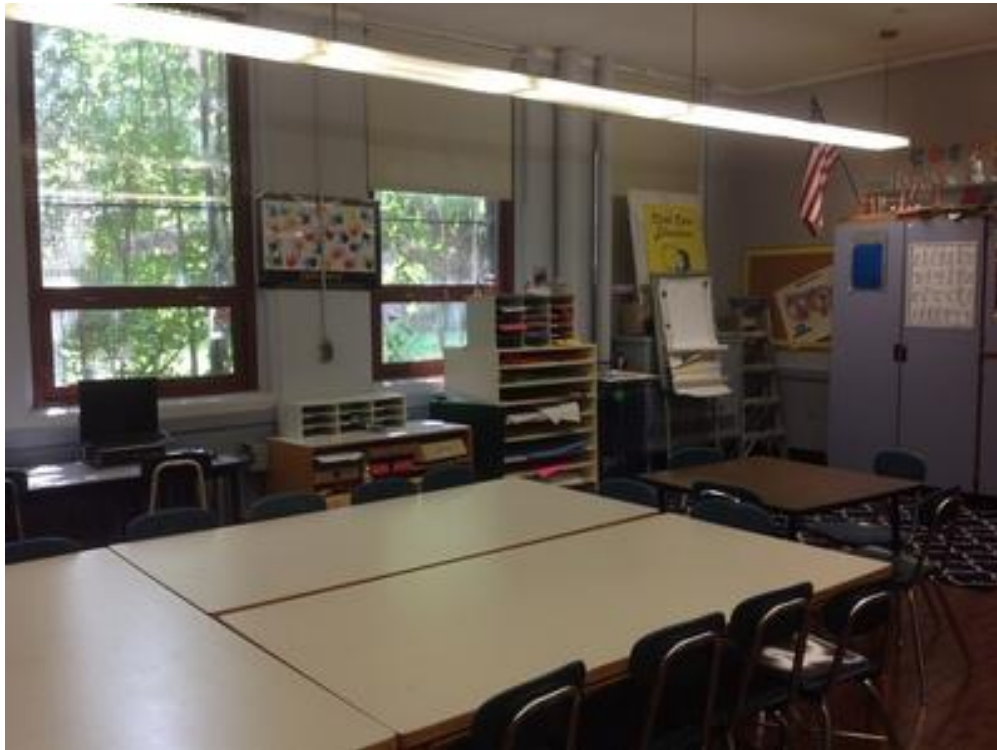
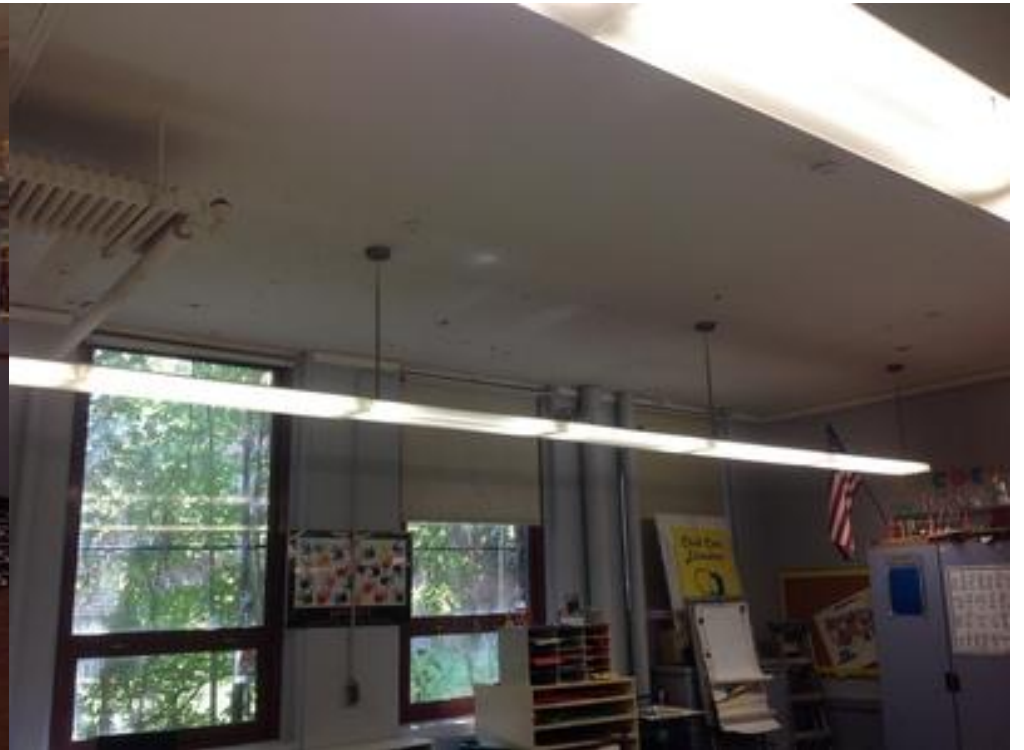
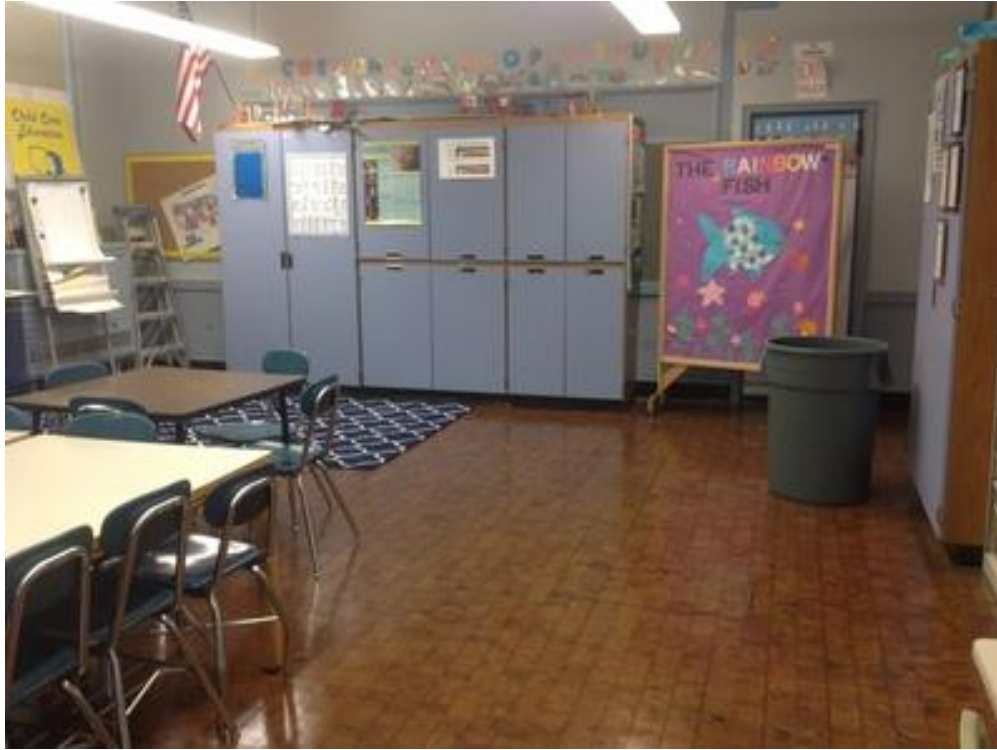
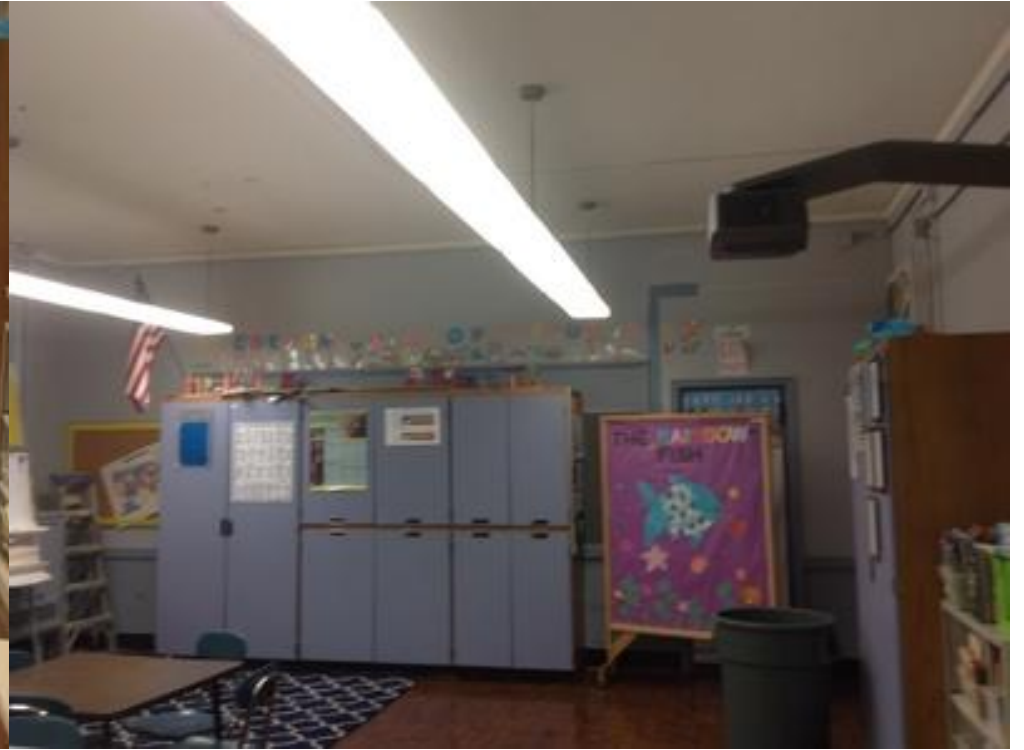
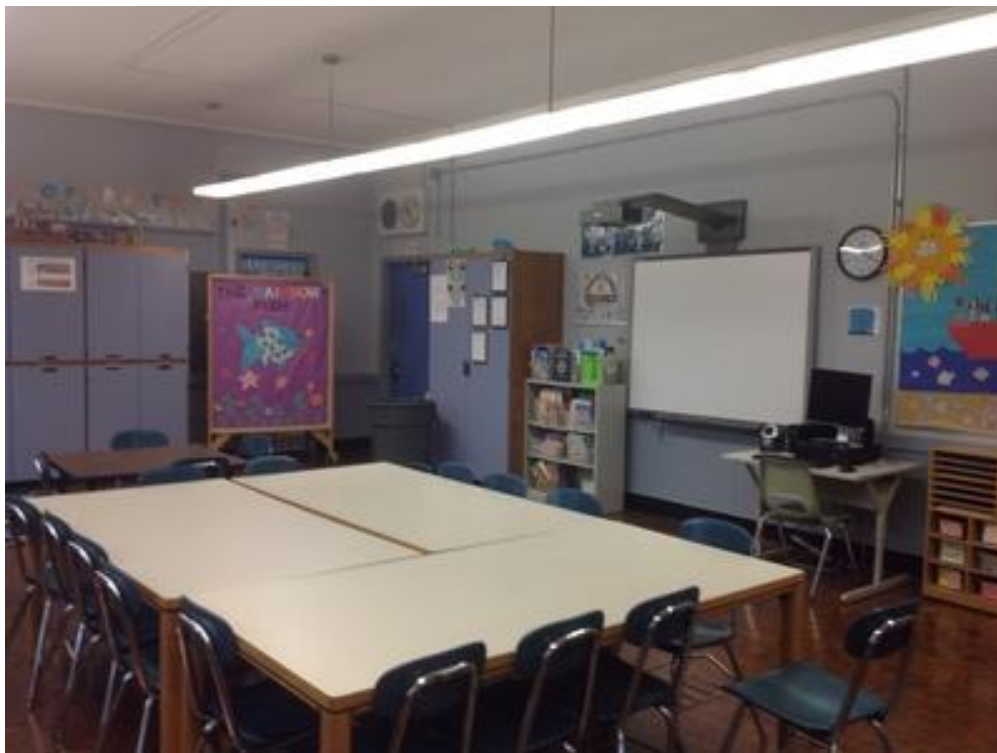
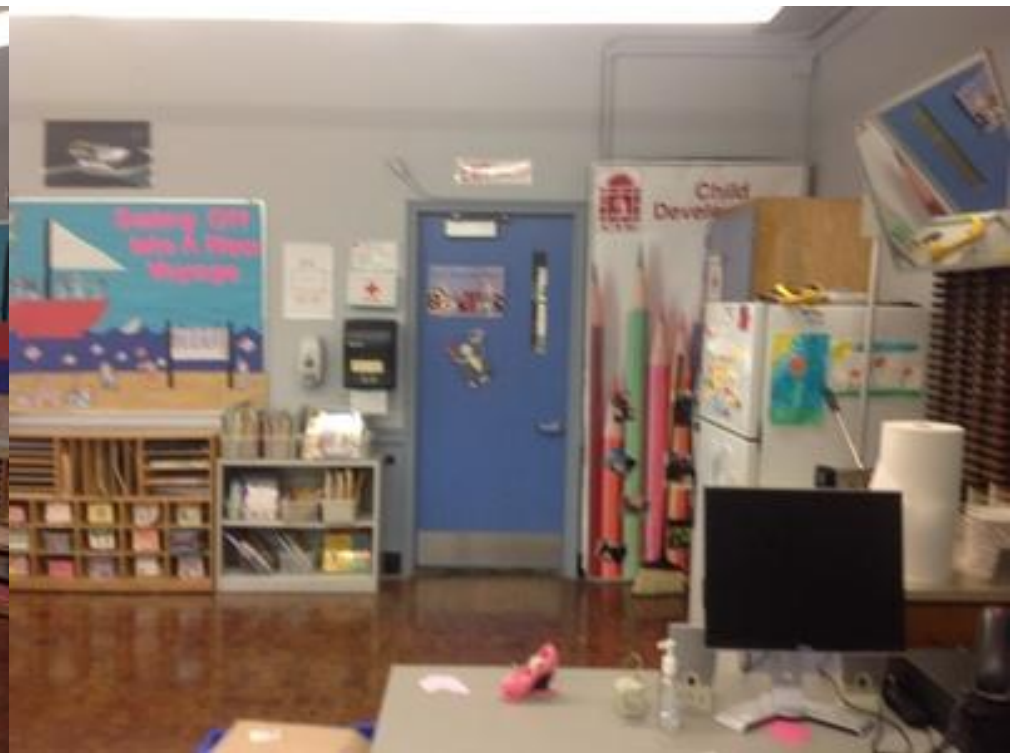
Description
Child Development CTE program classroom is in fair condition. Wood parquet flooring is in good condition. At perimeter, steam pipe access grill is in poor condition. Piping and wiring is haphazard and surface mounted. Millwork is in poor condition. Windows are in poor condition Exterior metal mesh on windows creates ladder for plant growth. Some of the windows have lost their seals. Lighting is in poor condition. Some ductwork and piping is rusty and piping insulation has gouges.

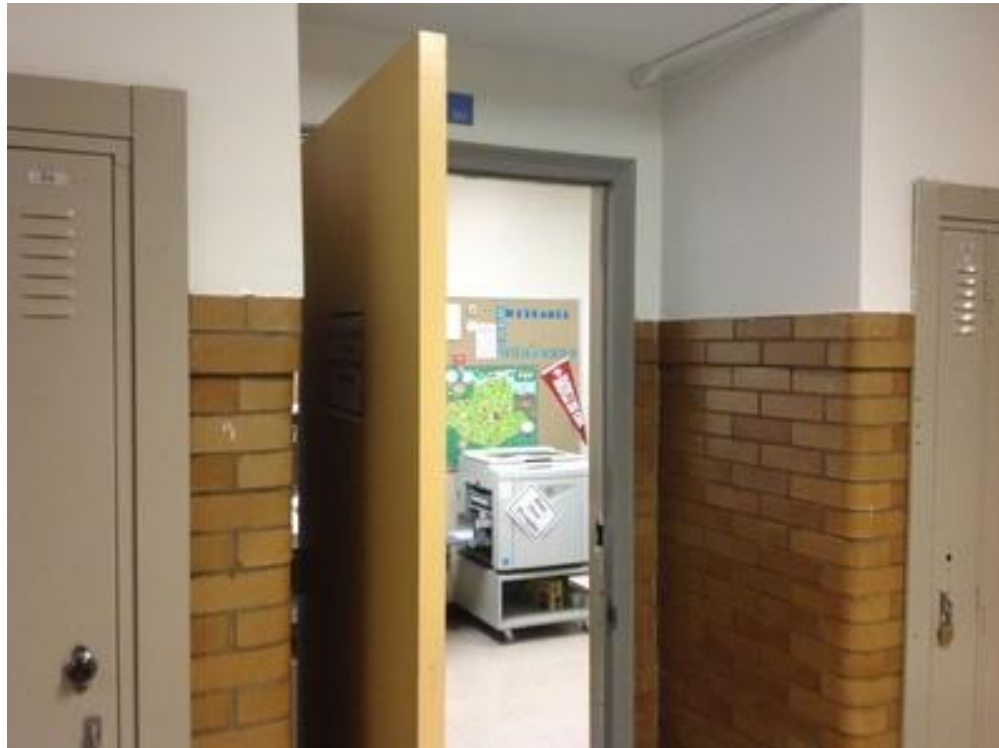
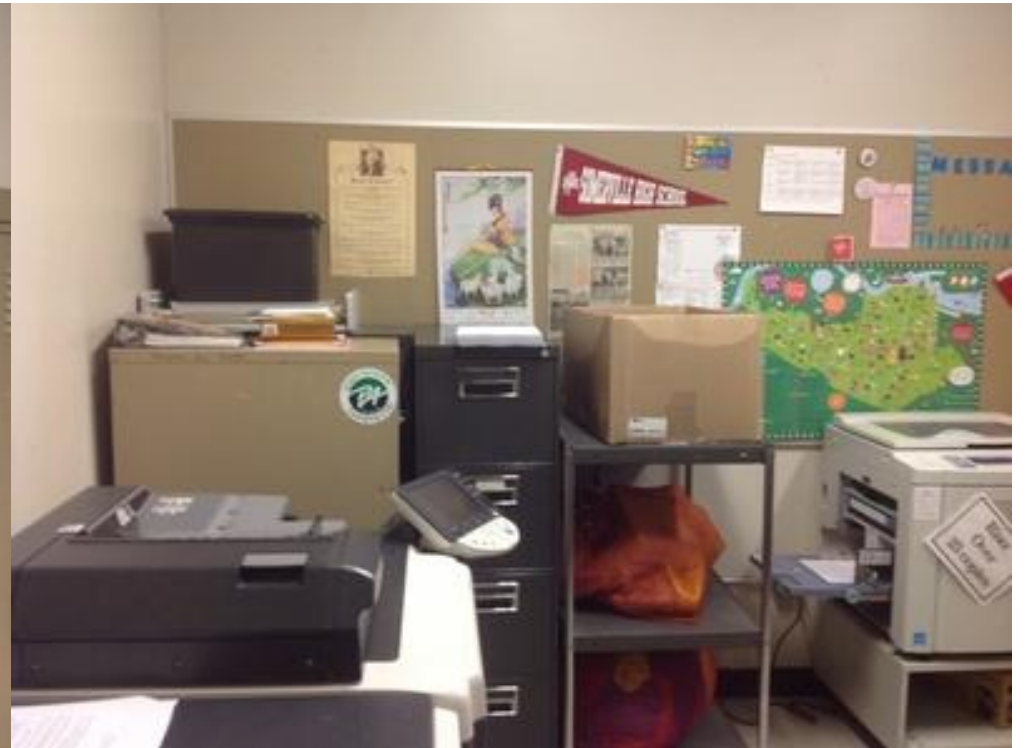
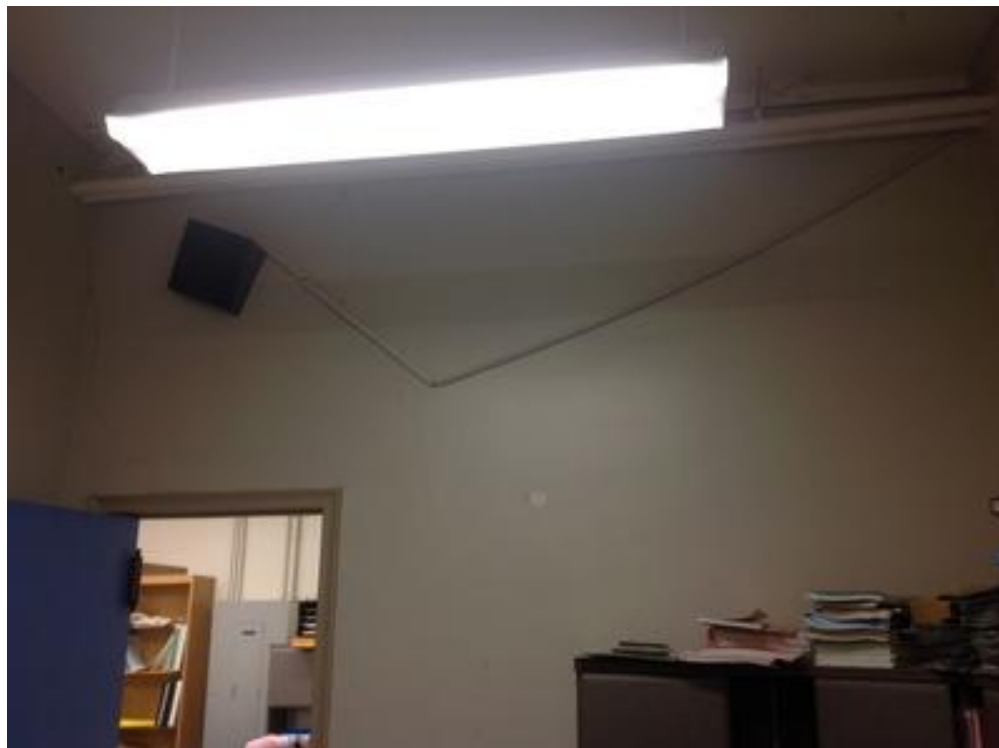
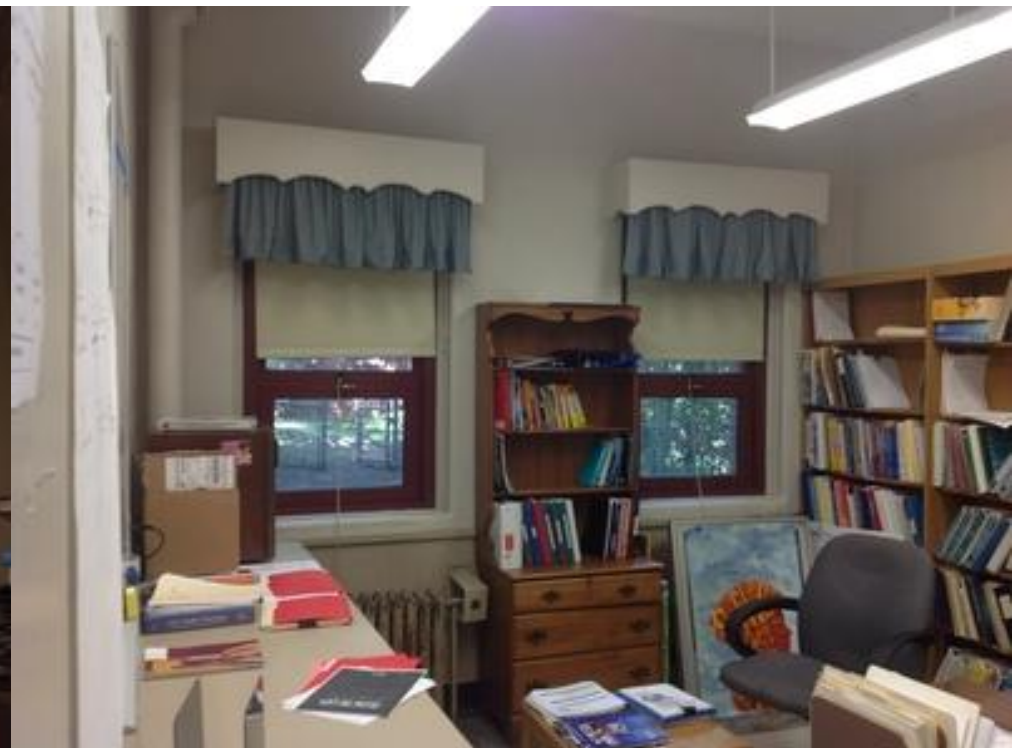
| Description PE office is in fair condition. Entry is not accessible. Space is very cluttered. Heating unit in poor condition. | | | |

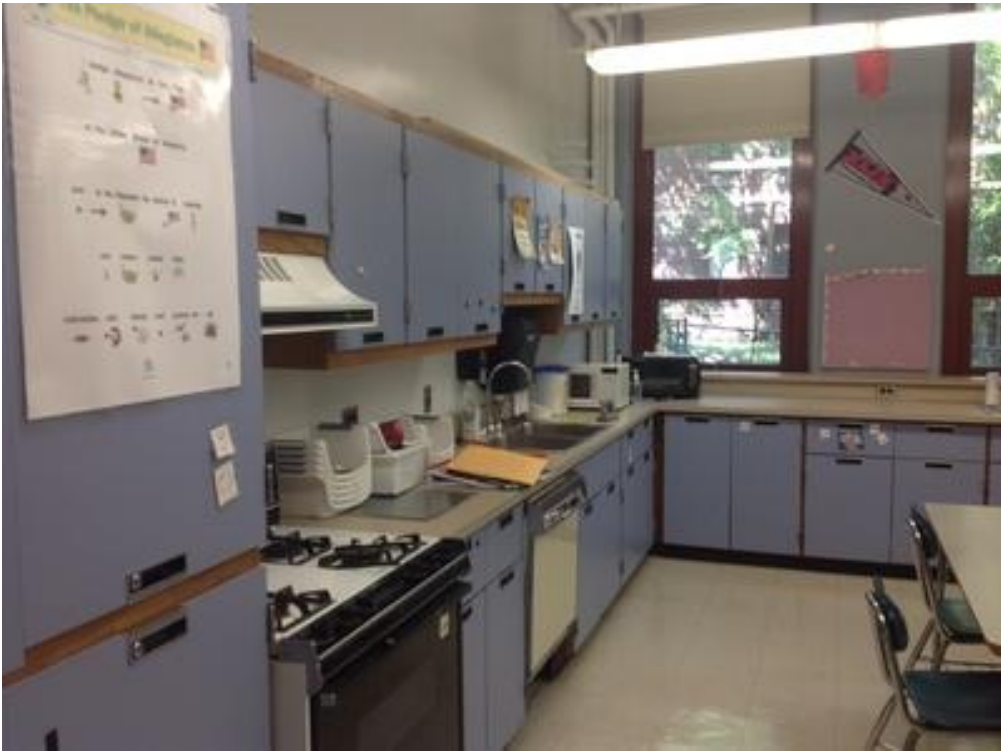
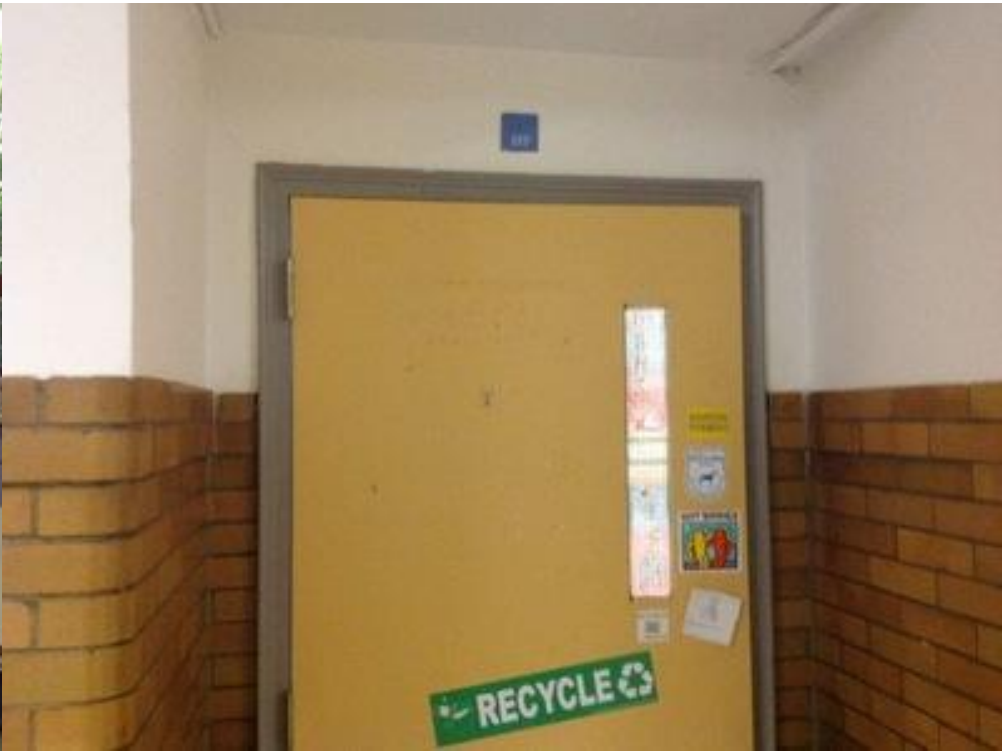
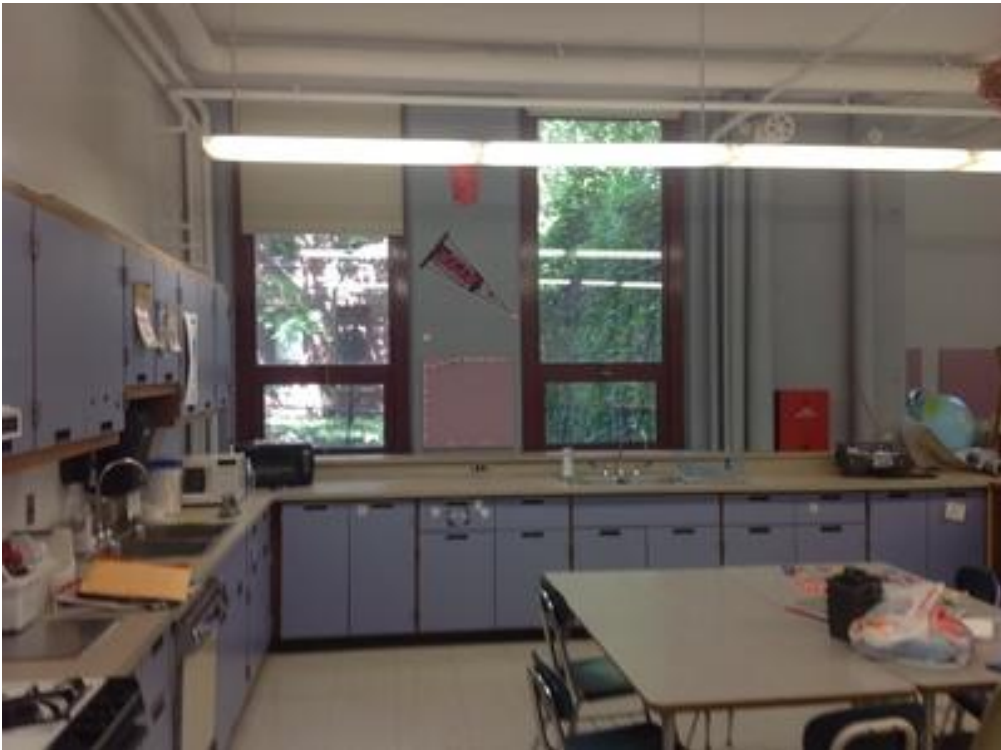
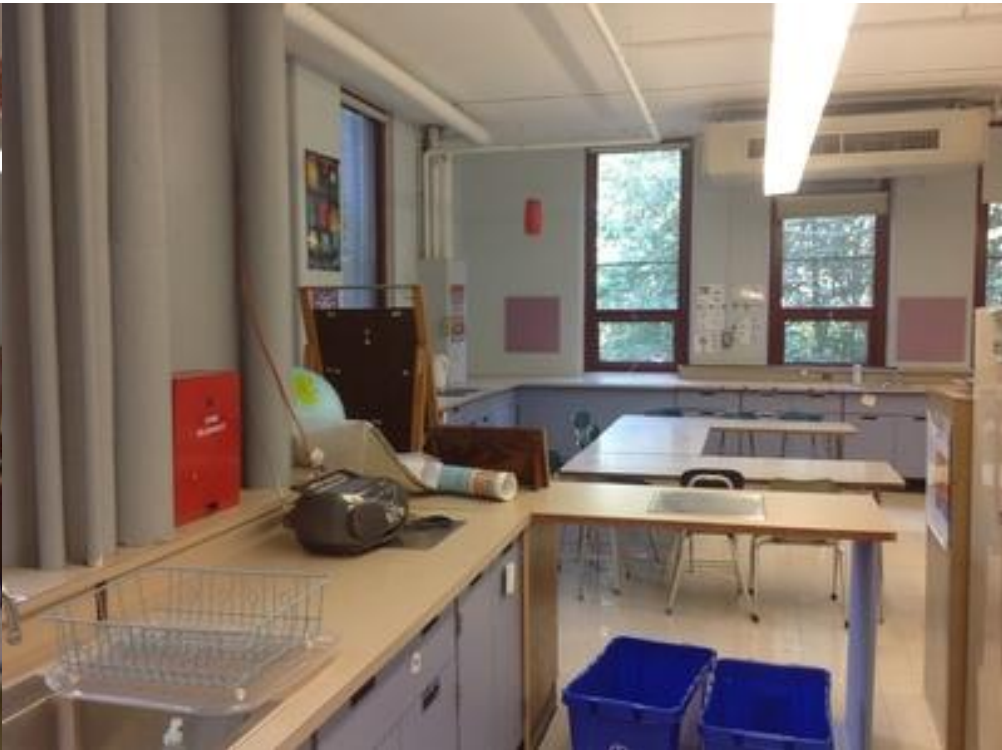
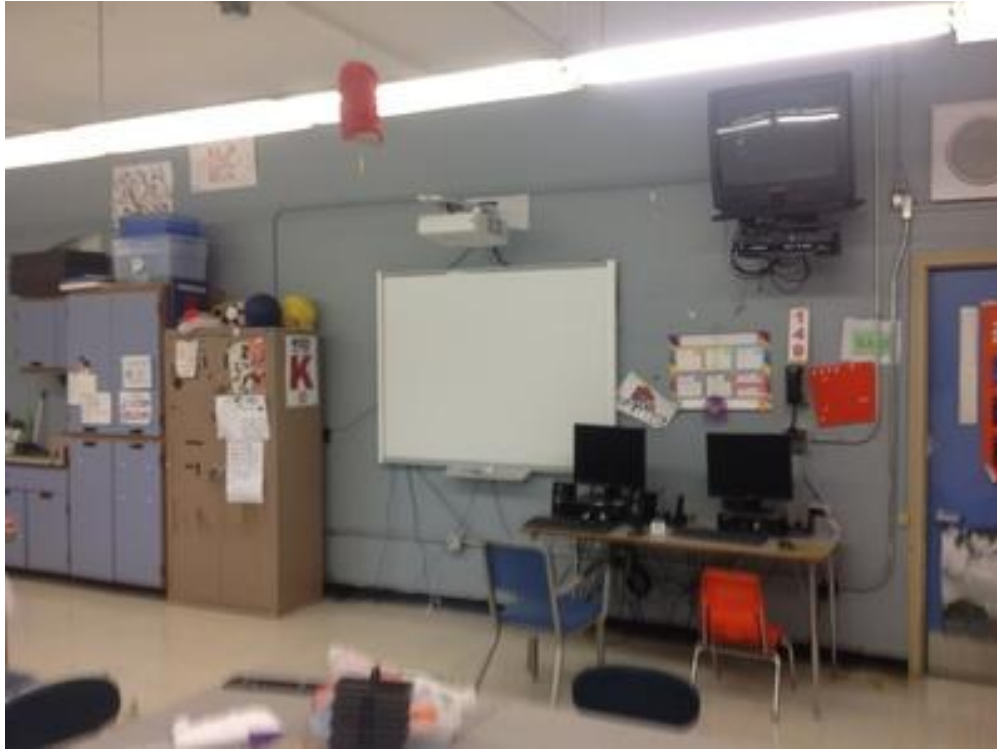
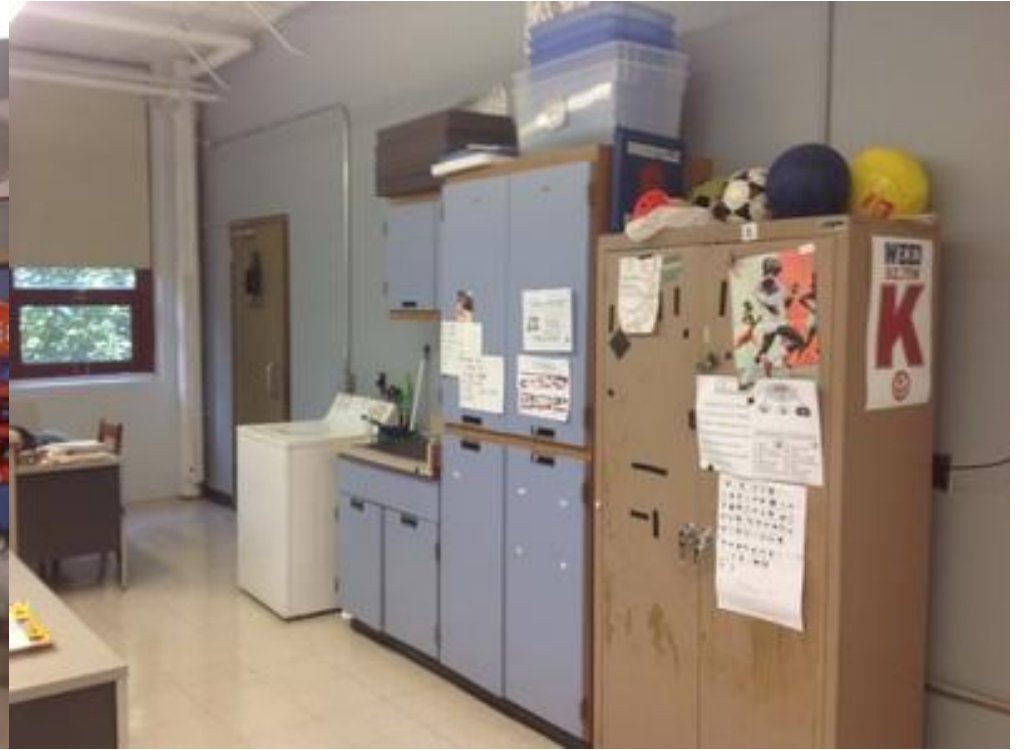
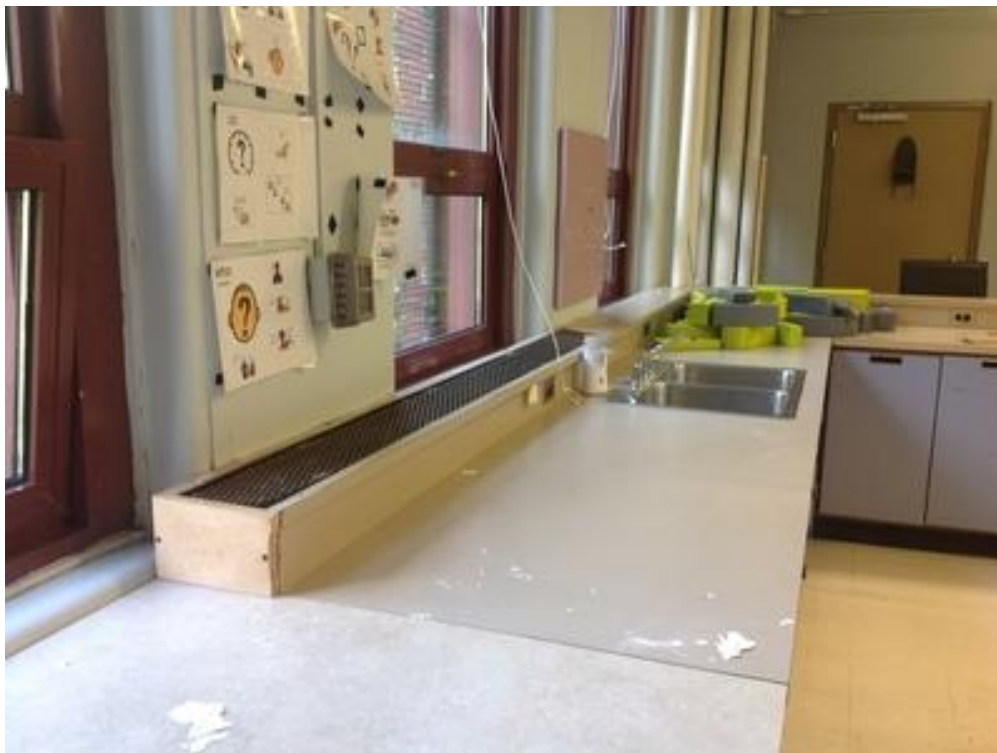
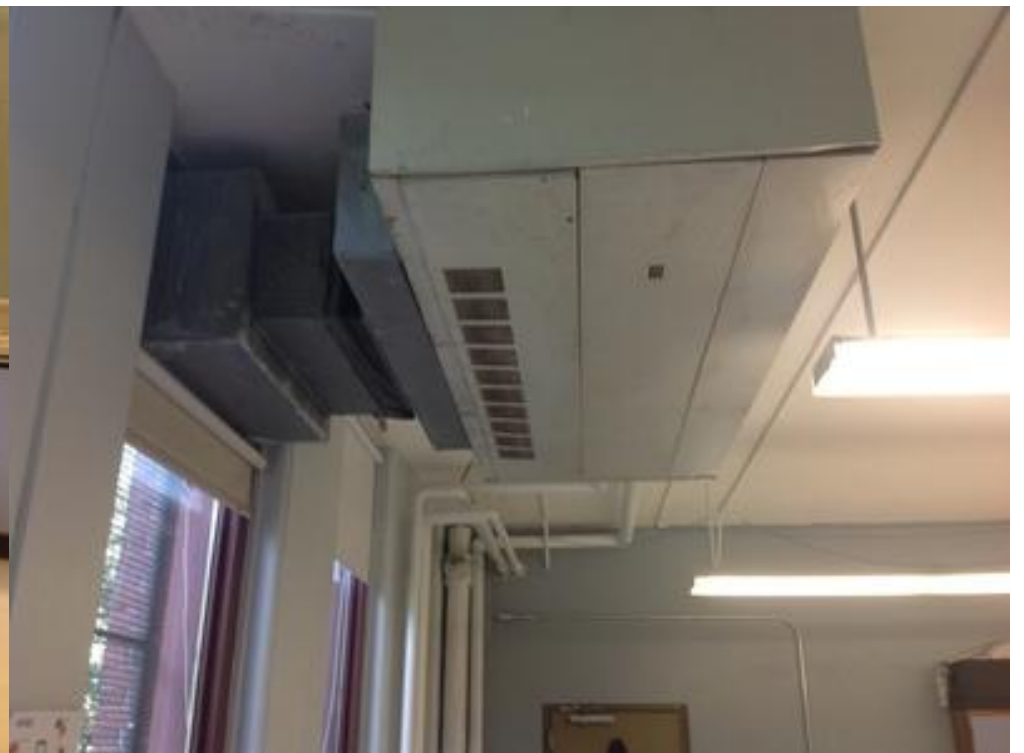
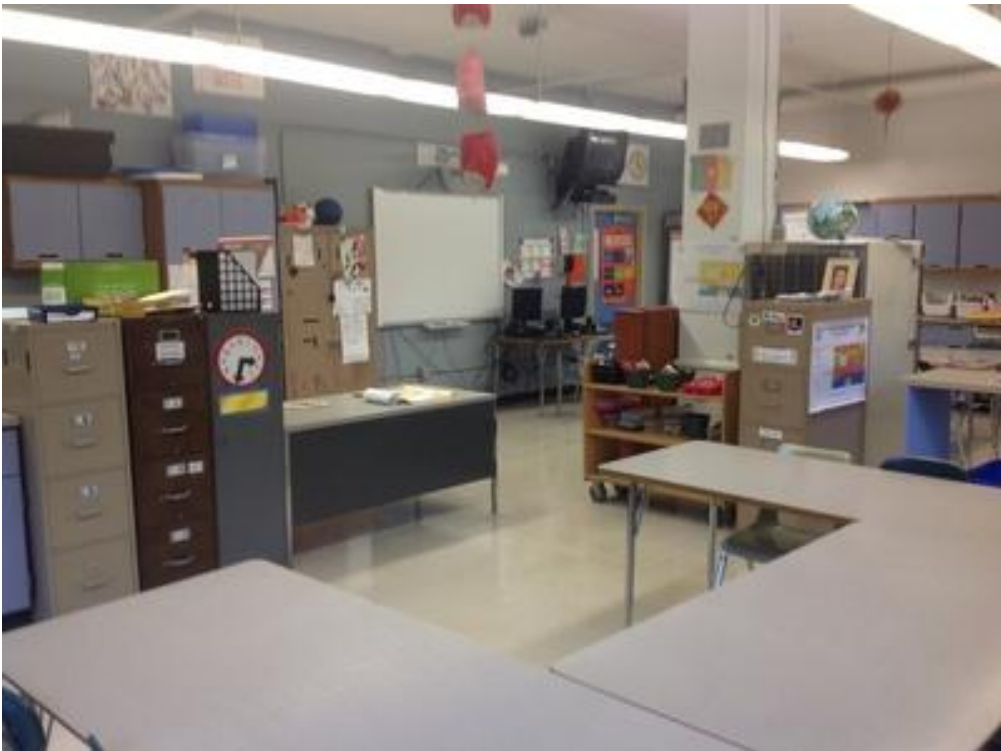
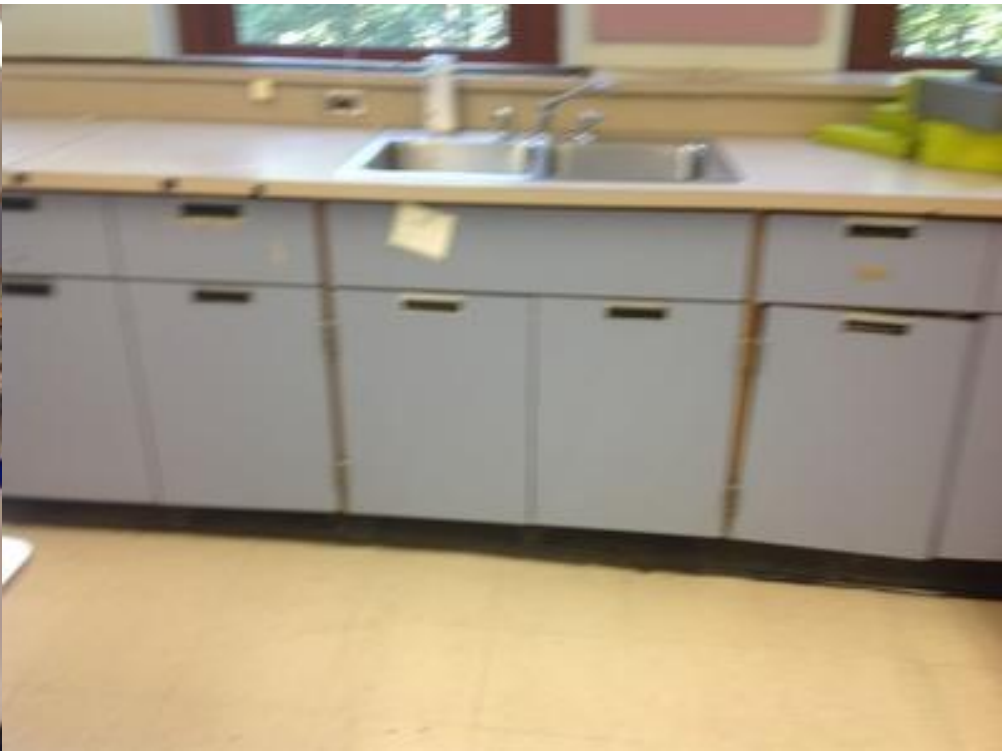
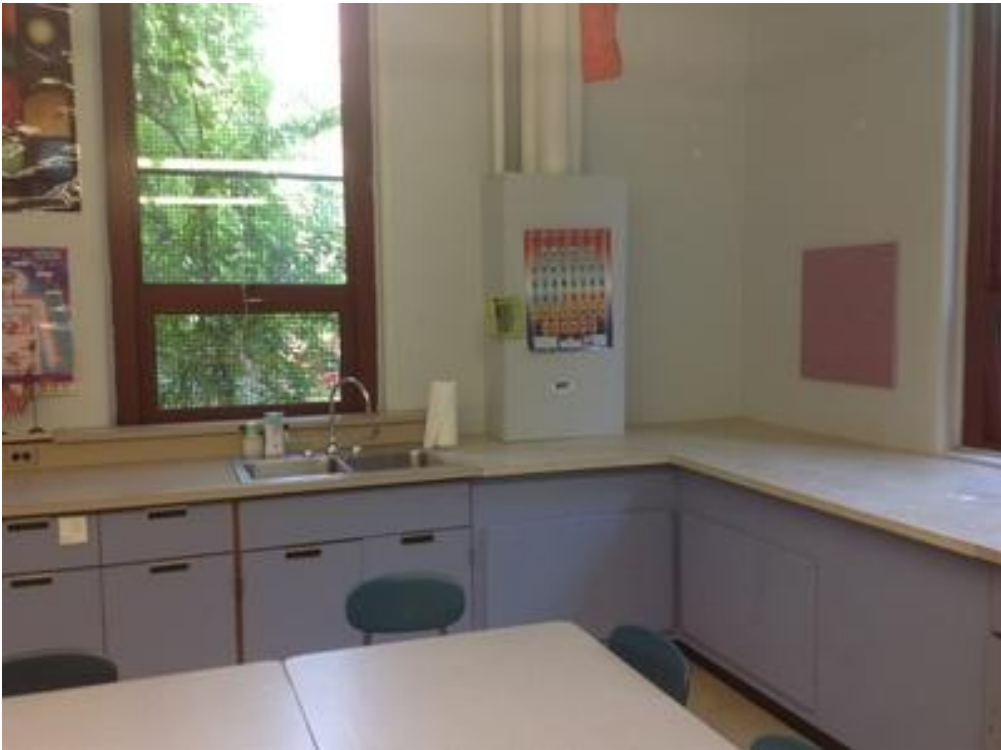
Cooking classroom is in fair condition. VCT flooring is in fair condition. At perimeter, steam pipe access grill is in poor condition. Piping and wiring is haphazard and surface mounted. Millwork is in poor condition. Windows are in poor condition Exterior metal mesh on windows creates ladder for plant growth. Some of the windows have lost their seals. Lighting is in poor condition. Some ductwork and piping is rusty and piping insulation has gouges.

| Condition | Poor | | |

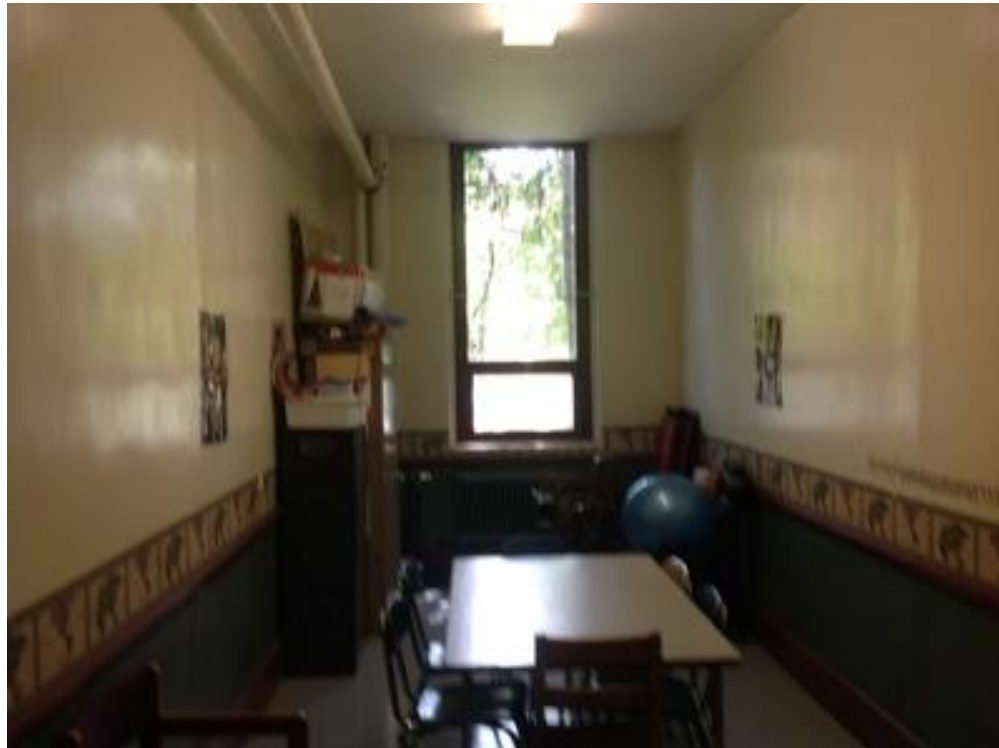
IMG_1353.JPG

Description
Office is in fair condition. VCT flooring is in fair condition. Piping and wiring is haphazard and surface mounted. Windows are in poor condition Exterior metal mesh on windows creates ladder for plant growth. Windows have lost their seals. Lighting is in poor condition. Some ductwork and piping is rusty and piping insulation has gouges. Wallpaper and molding in poor condition.

| Condition | Poor | | |
