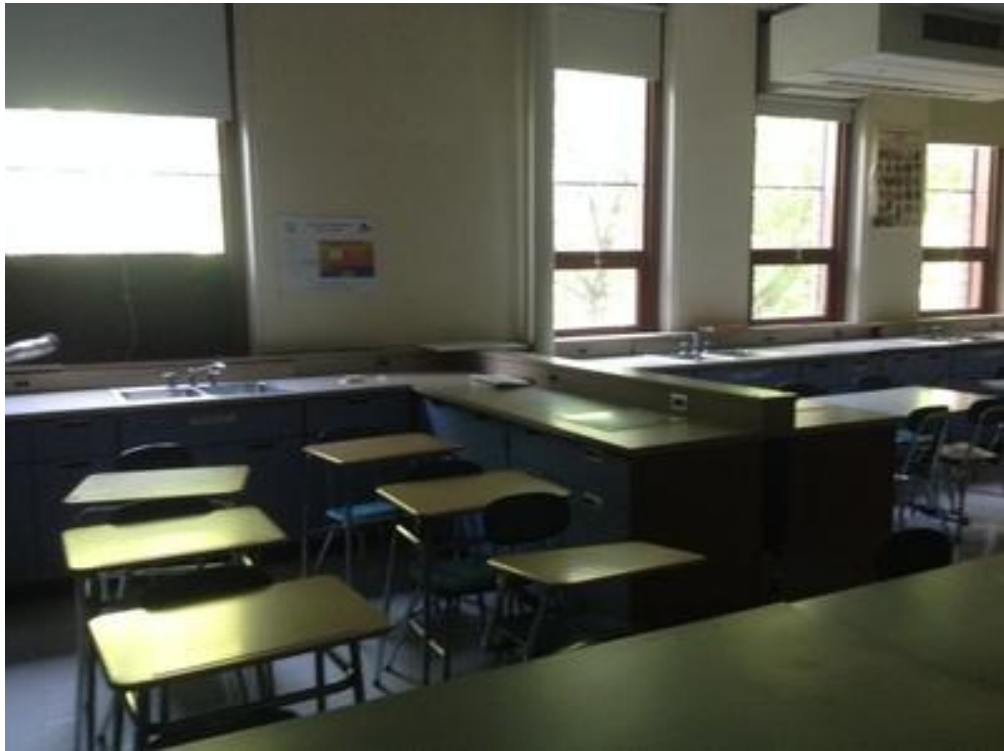
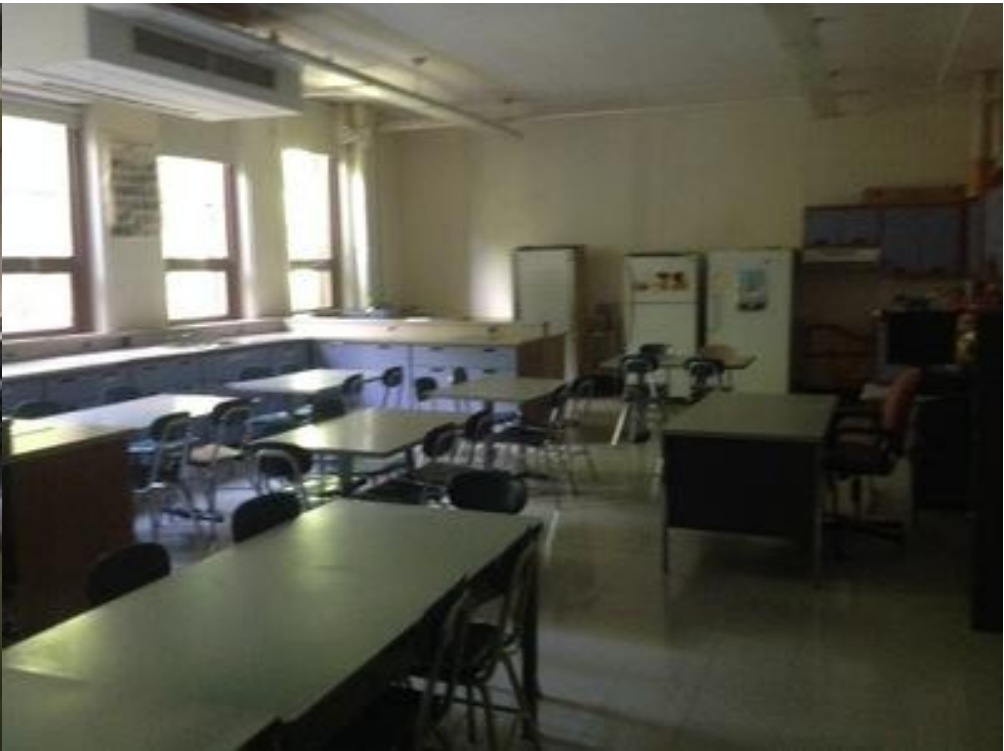
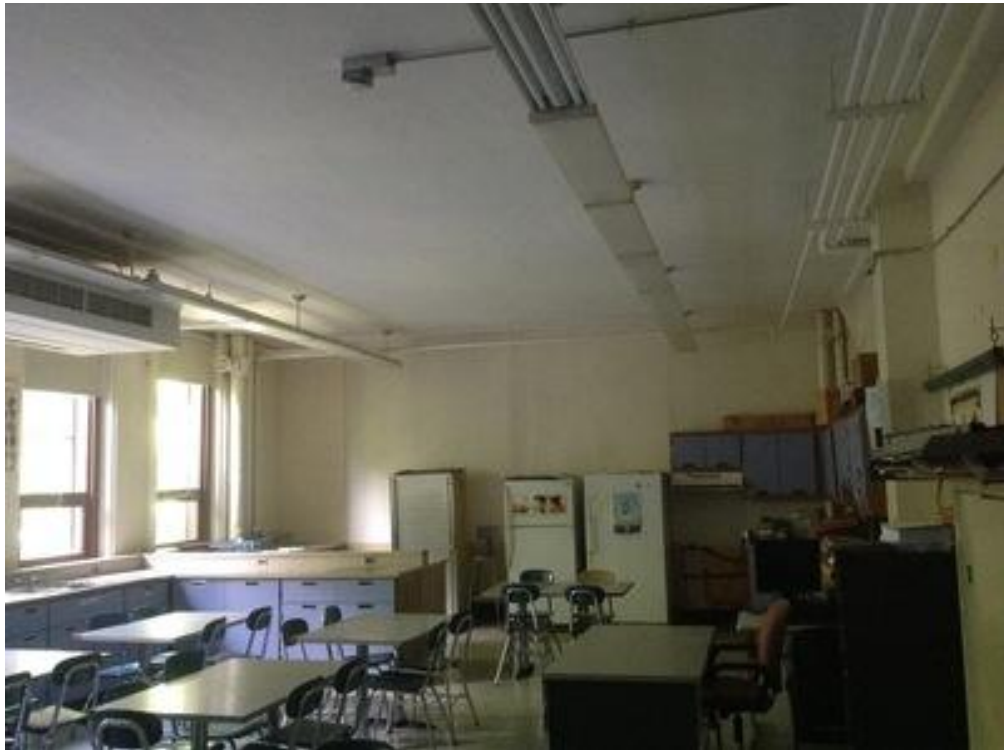
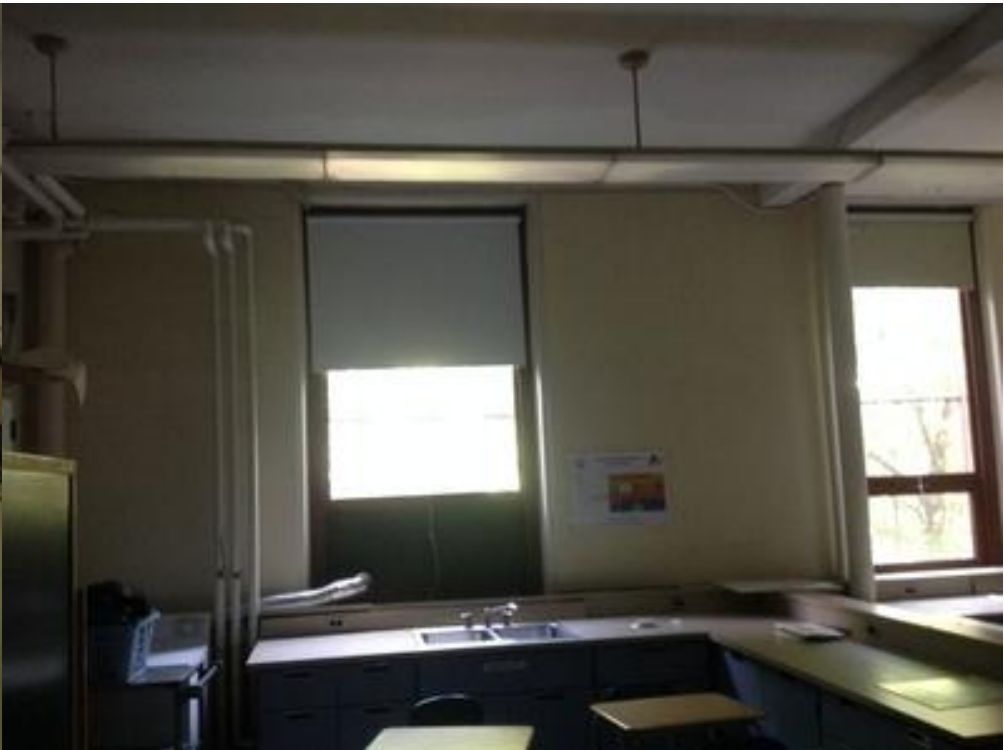
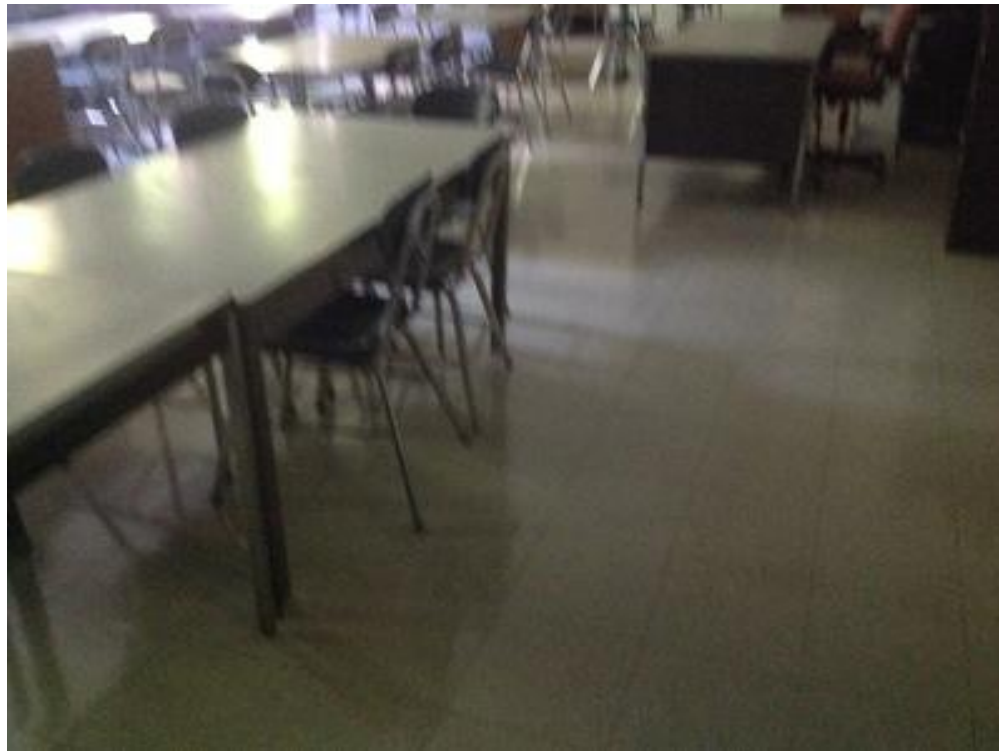
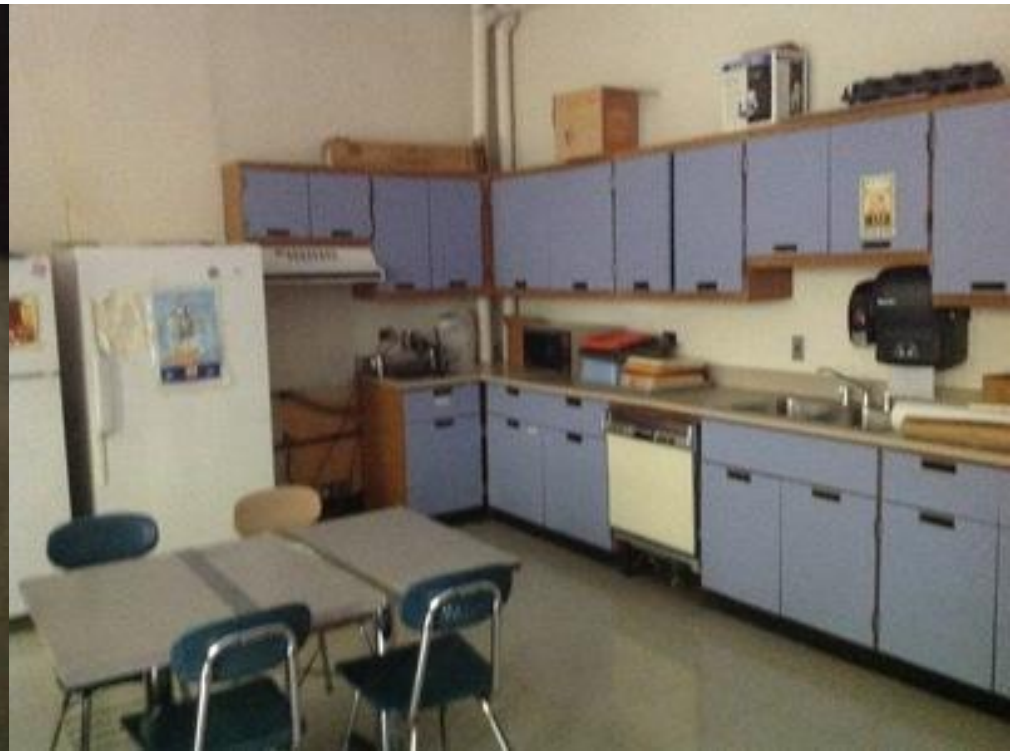
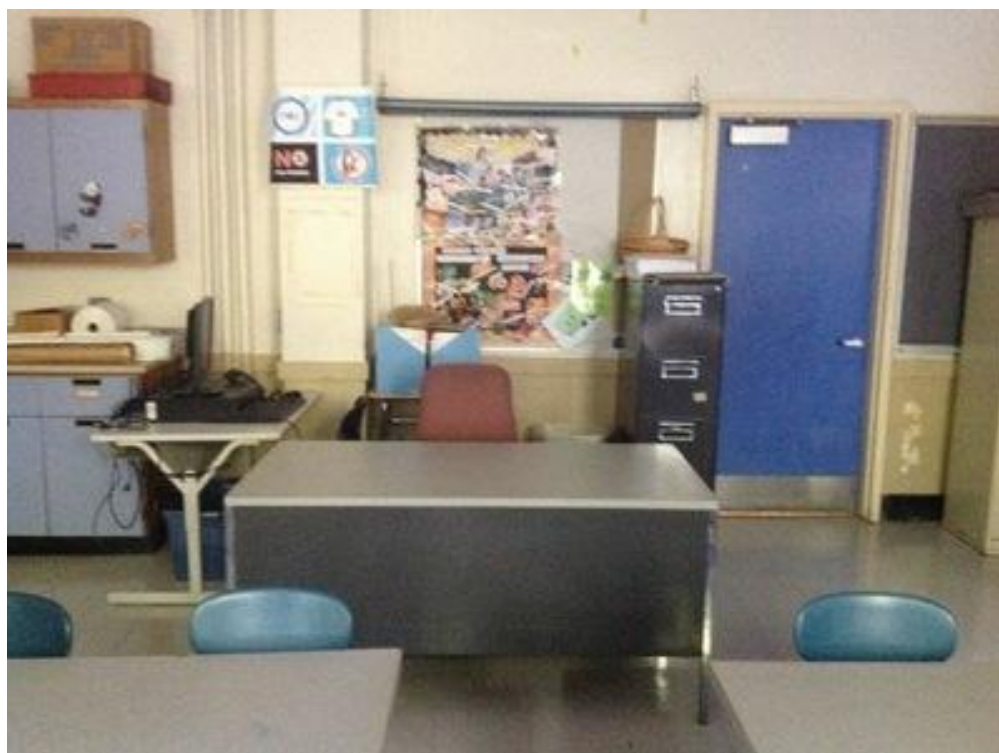
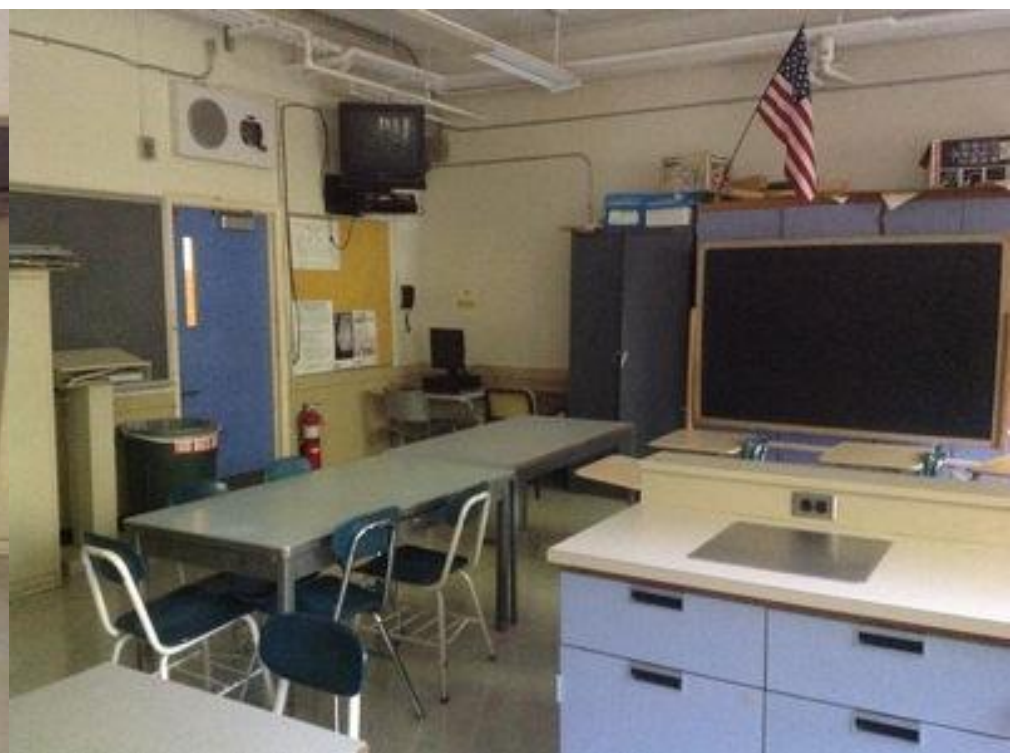
Description
Cooking classroom is in fair condition. VCT flooring is in fair condition. At perimeter, steam pipe access grill is in poor condition. Piping and wiring is haphazard and surface mounted. Millwork is in poor condition. Windows are in poor condition Exterior metal mesh on windows creates ladder for plant growth. Some of the windows have lost their seals. Lighting is in poor condition and some fixtures are missing covers. Some ductwork and piping is rusty and piping insulation has gouges.

| Condition | Fair | | |

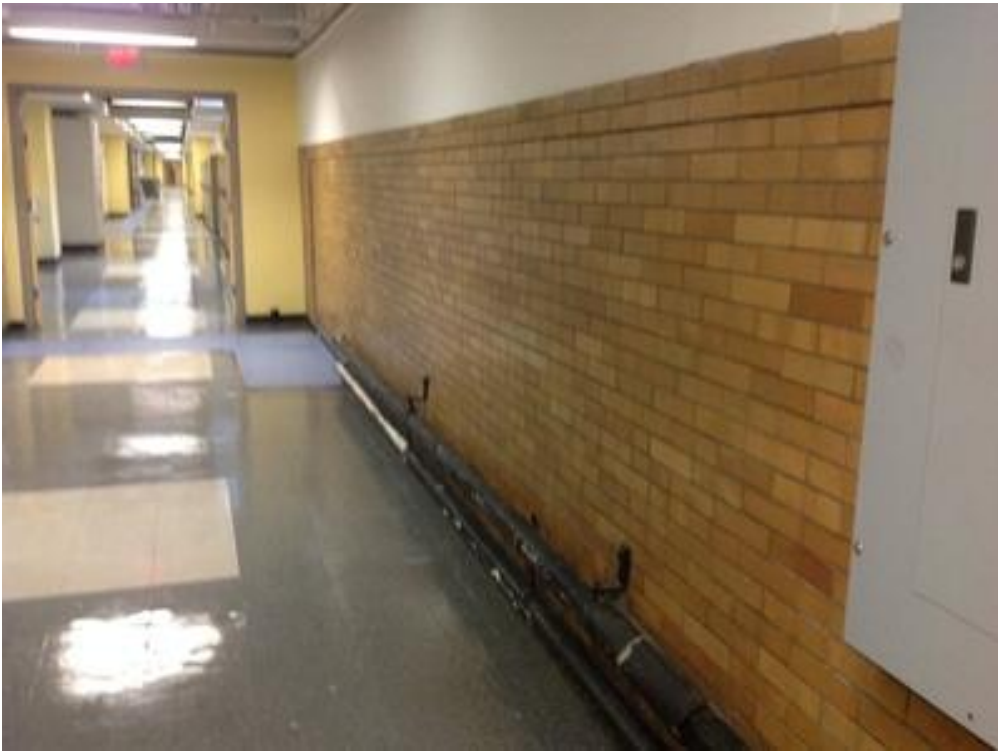
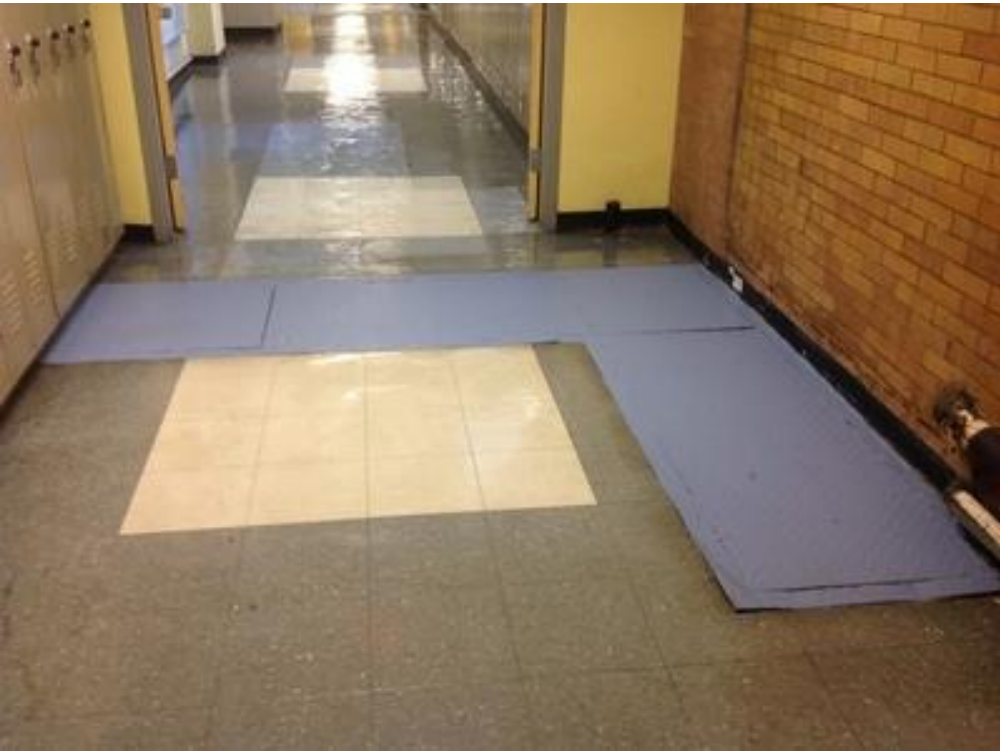
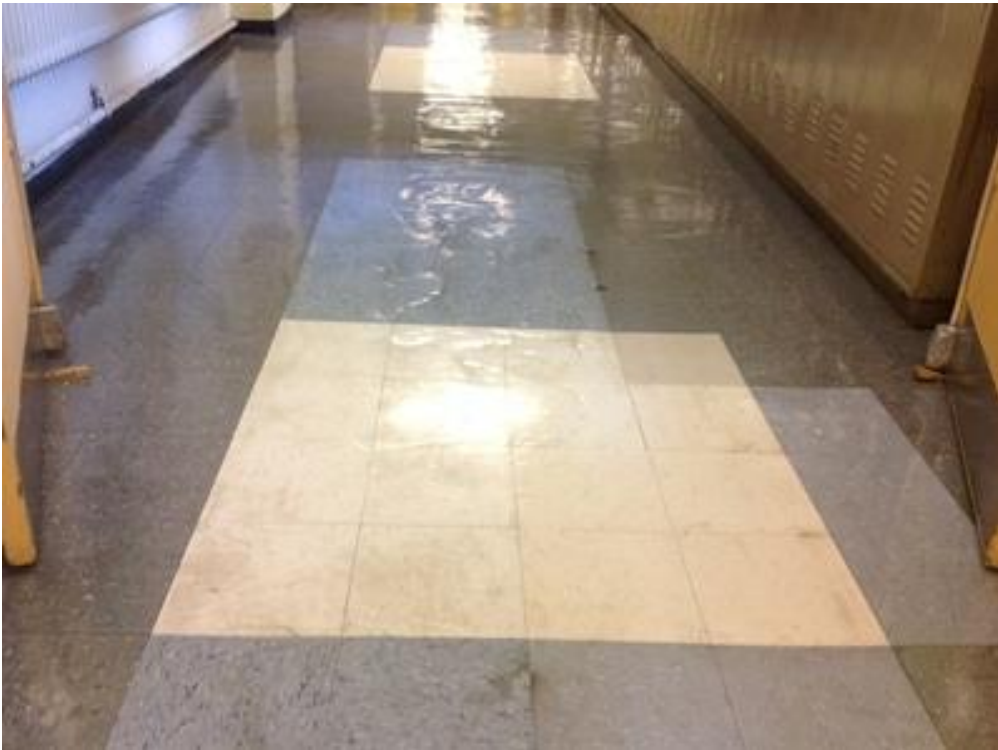
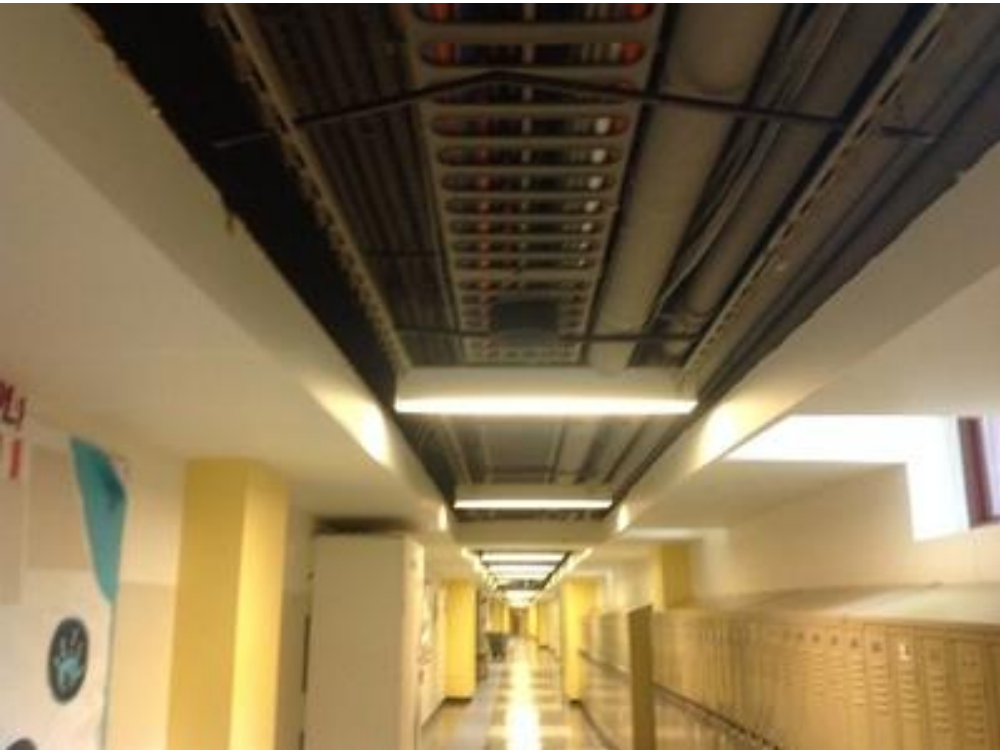
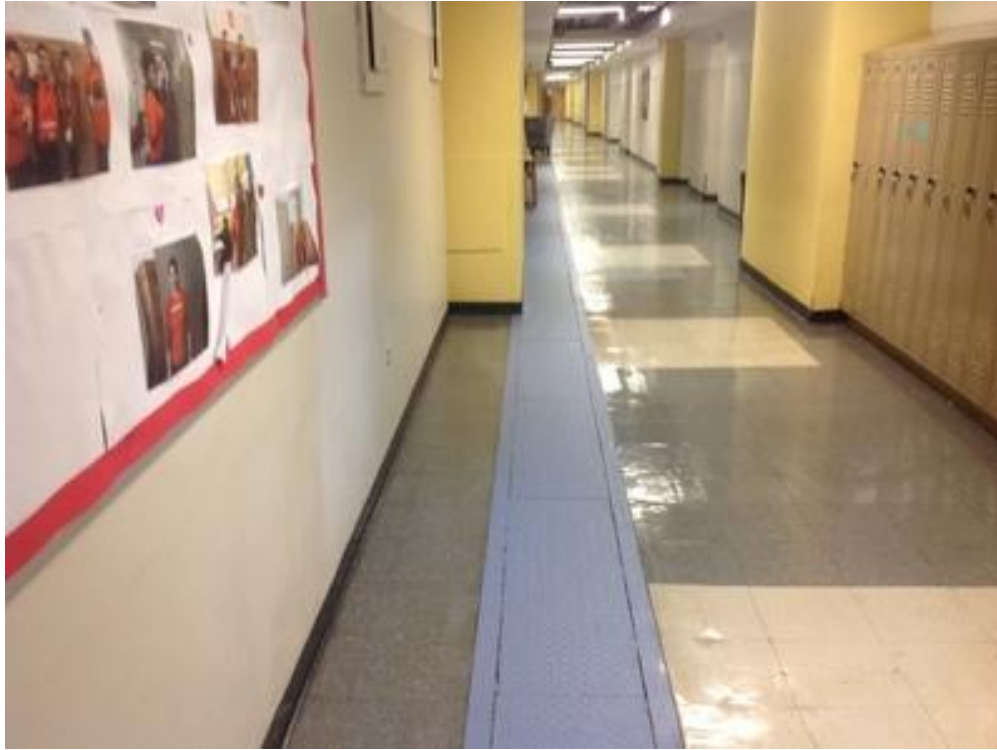
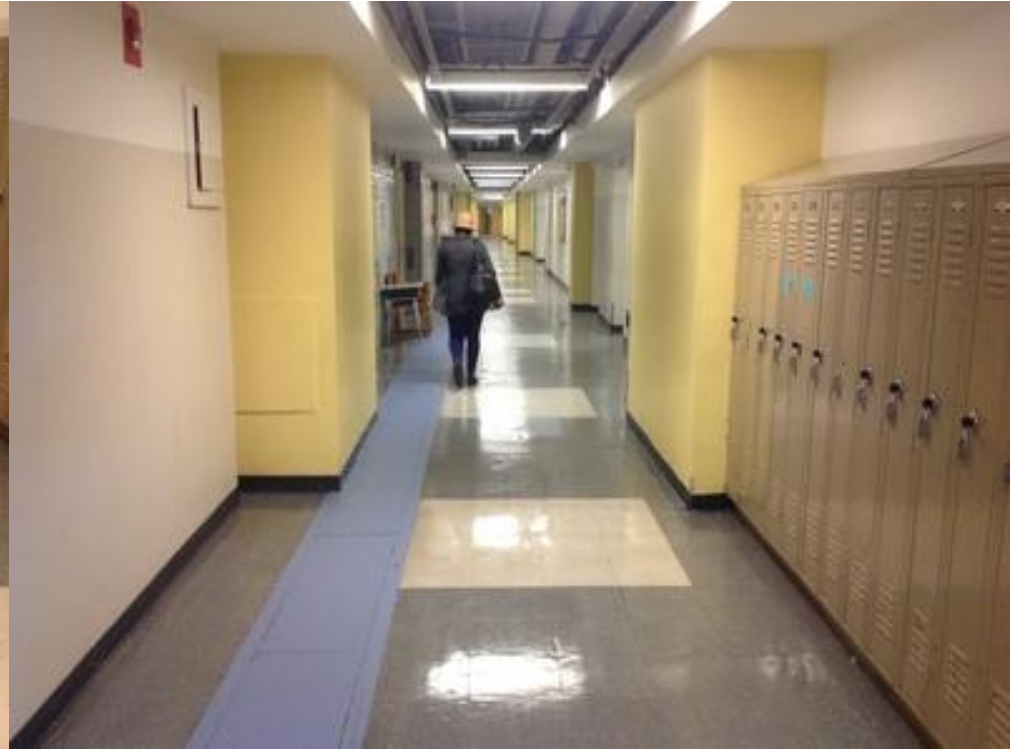
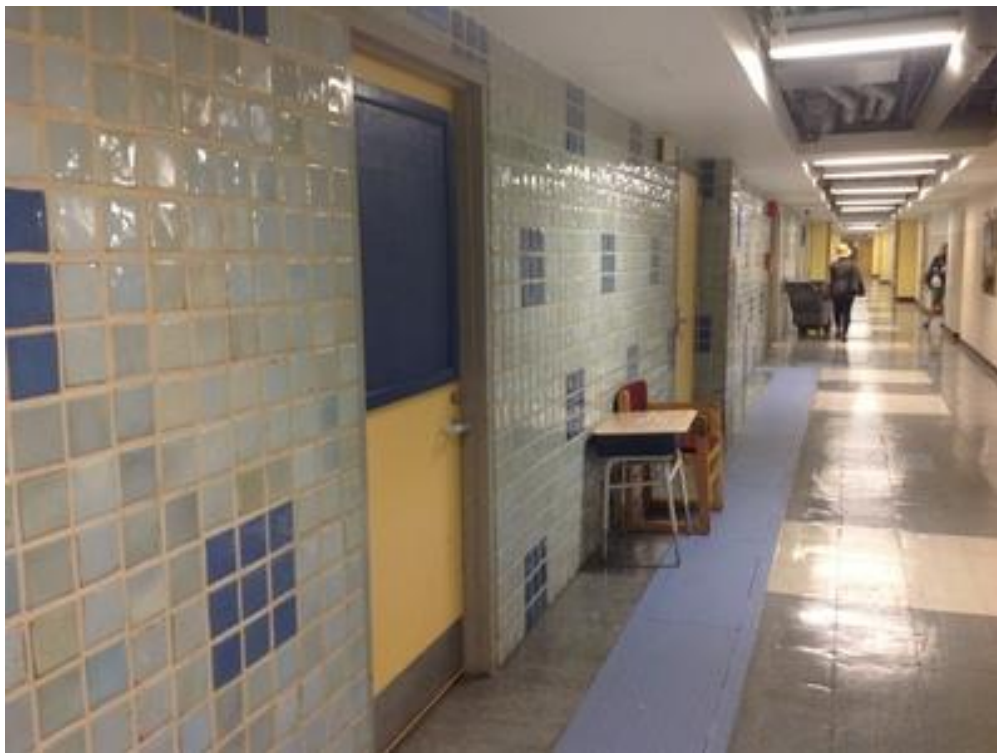
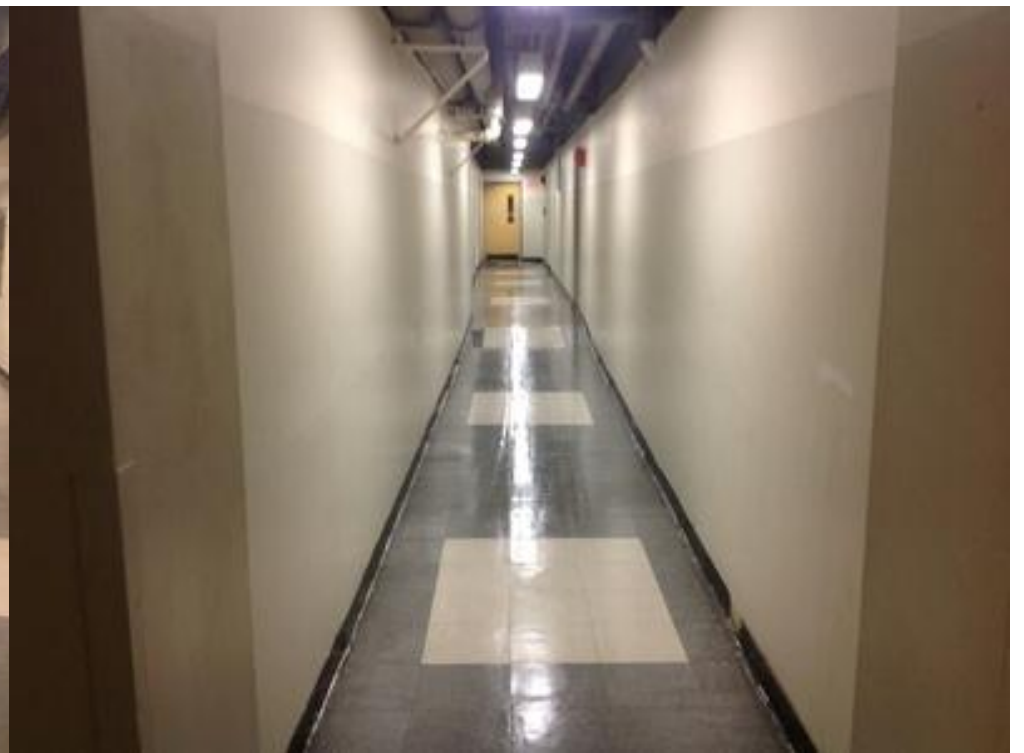
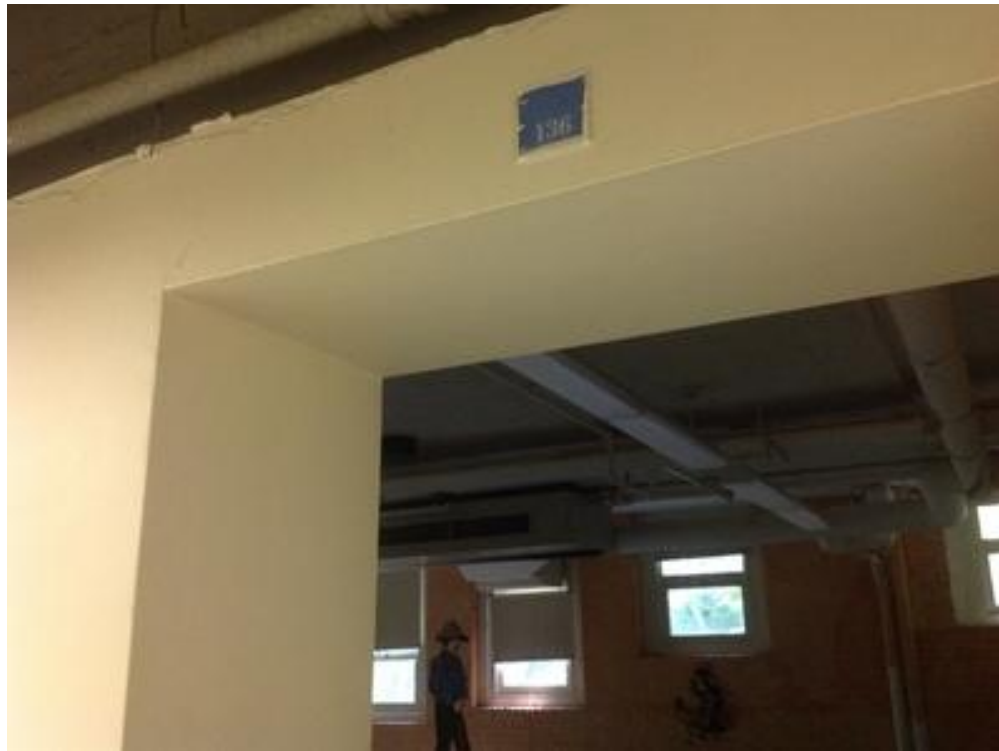
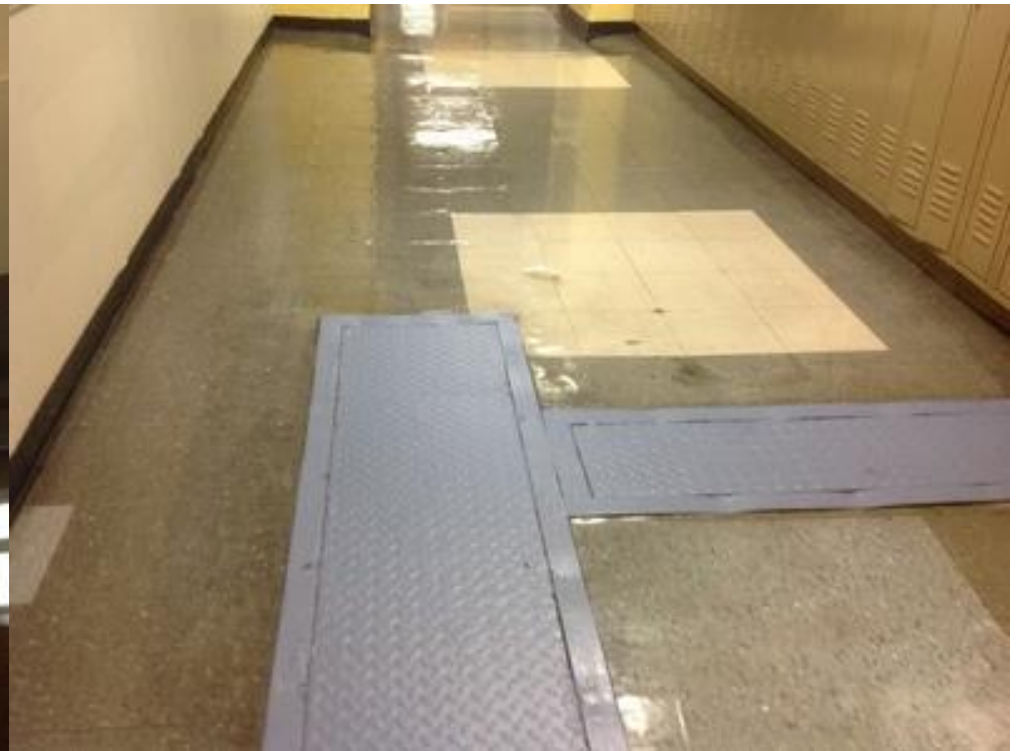
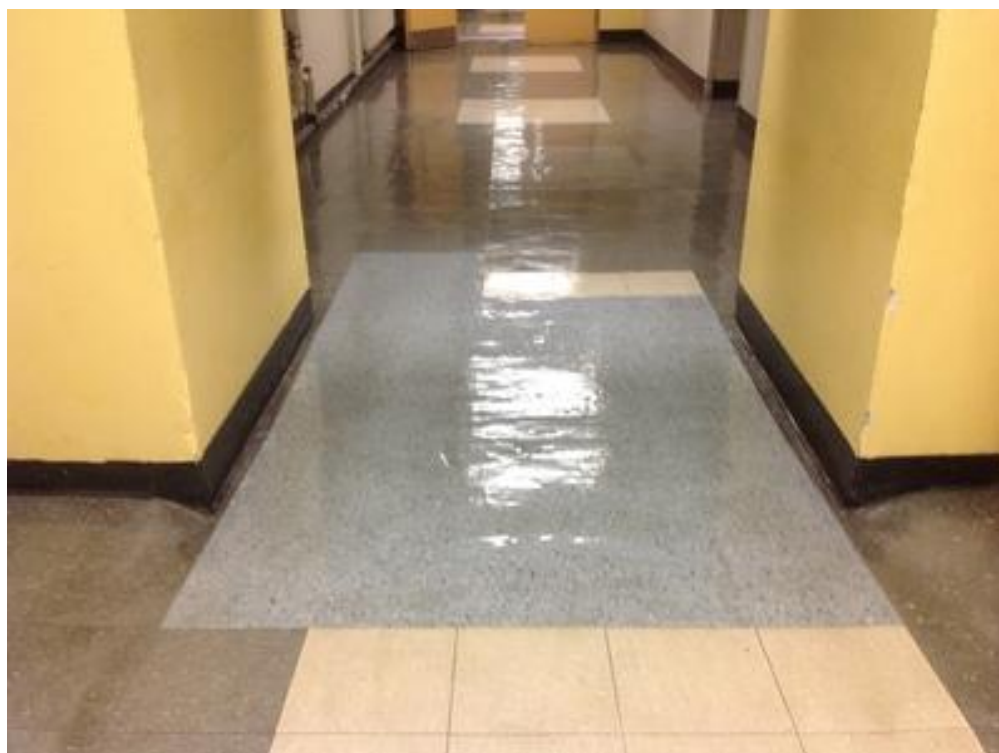
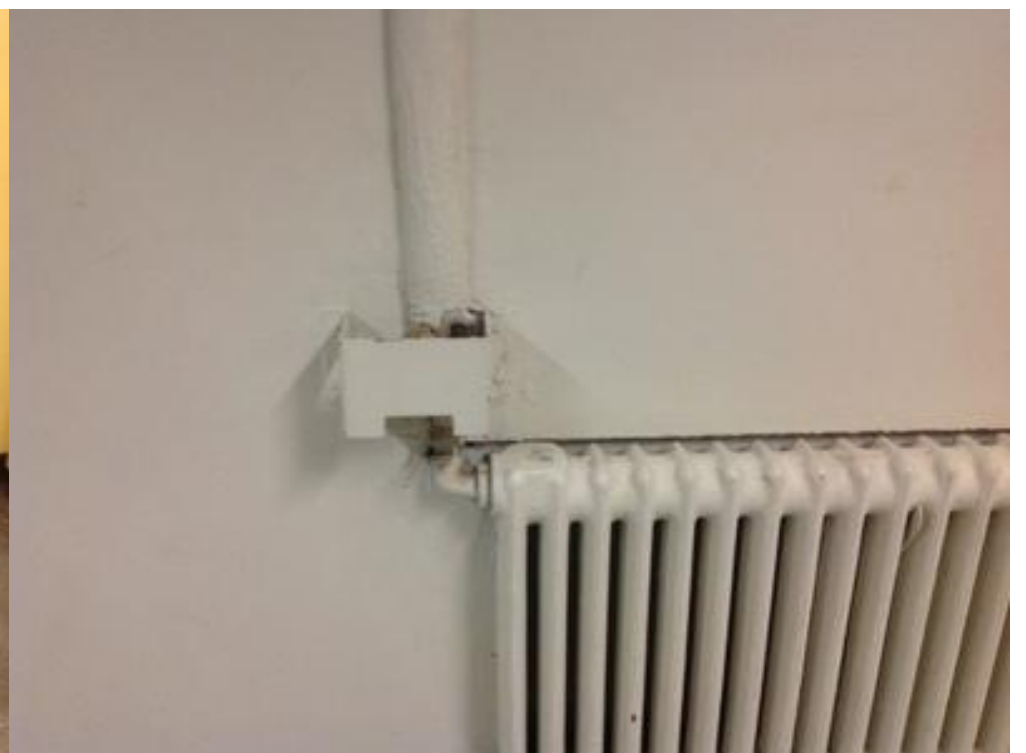
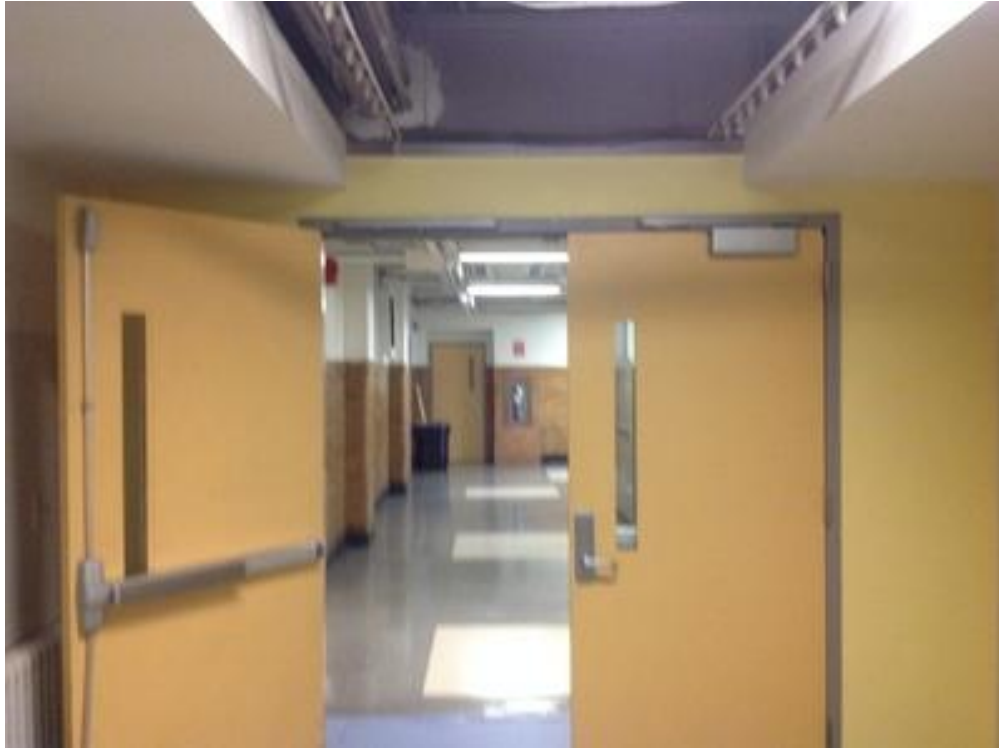
Description
Typical - Corridors are in poor condition. Piping and HVAC equipment on walls is in poor condition. Windows have lost their seals. Metal mesh on exterior windows create ladder for excessive plant growth blocks that blocks views. VCT flooring has been patched and mismatched. Steam pipe access grates are unaligned and create a tripping hazard.

| Condition | Poor | | |

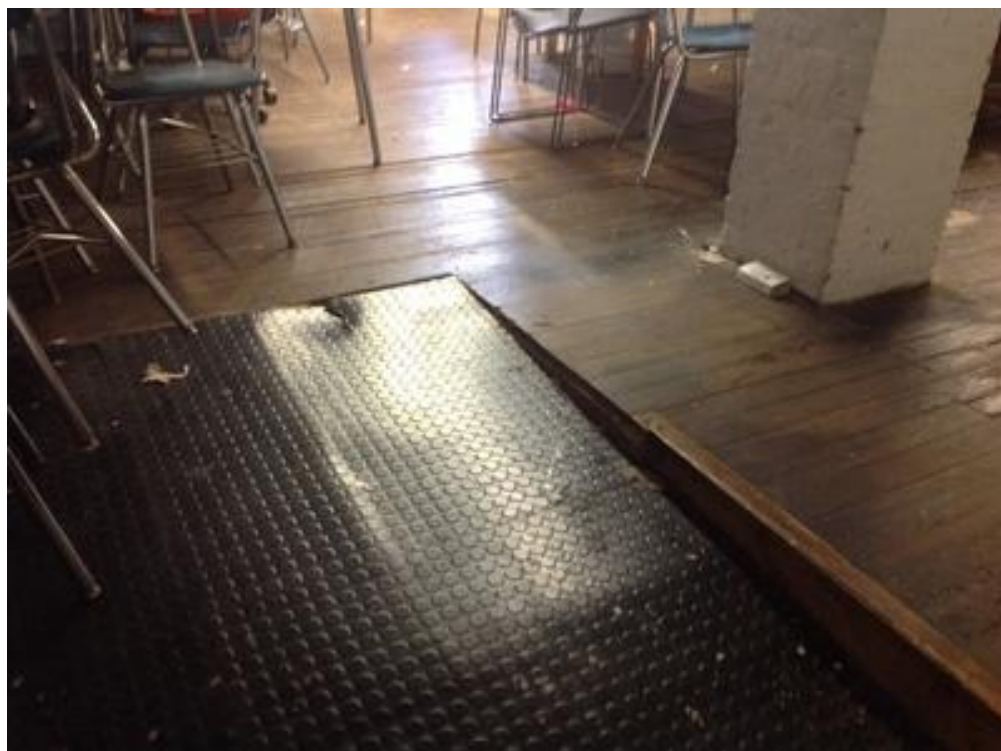
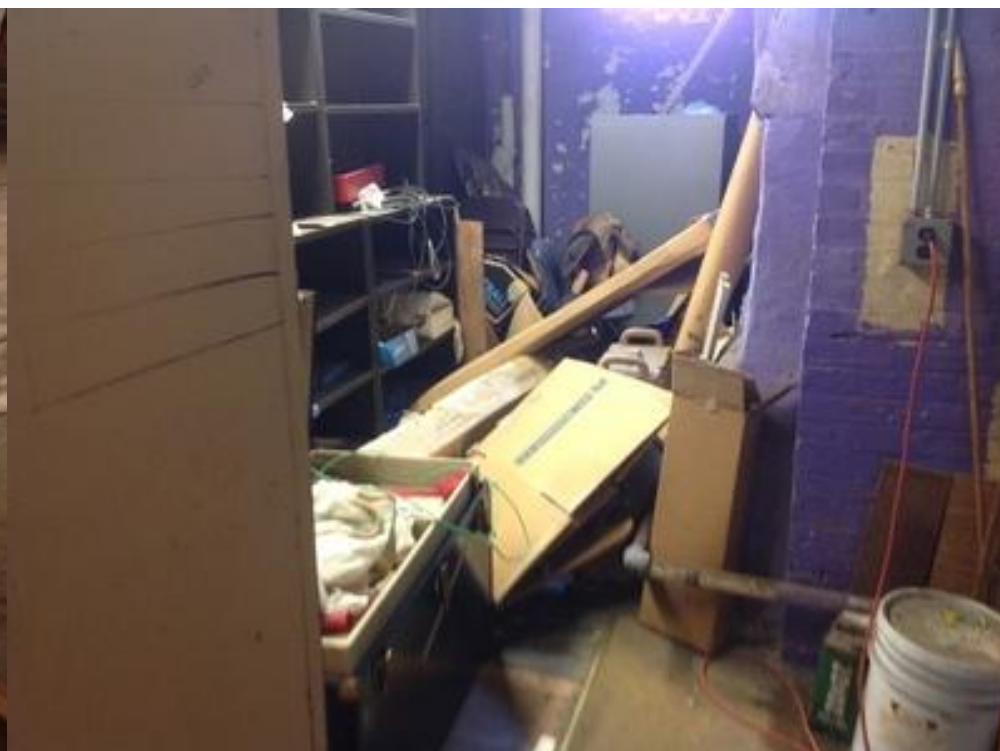
| Description Custodial and storage room in poor condition. | | | |

| Condition | Poor | | |
