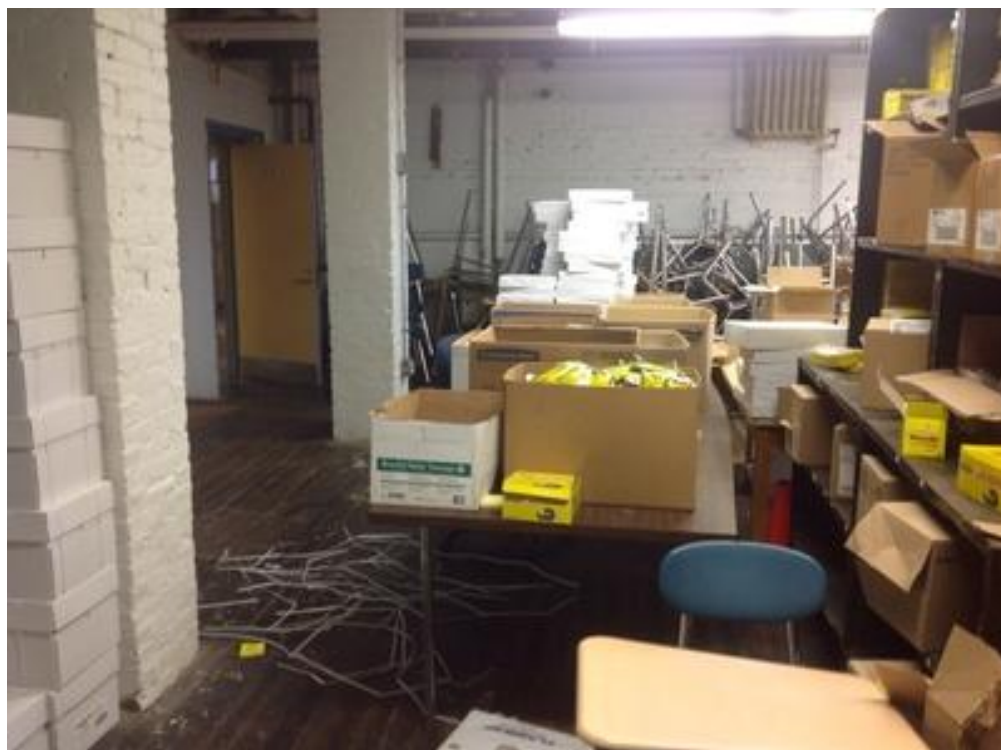
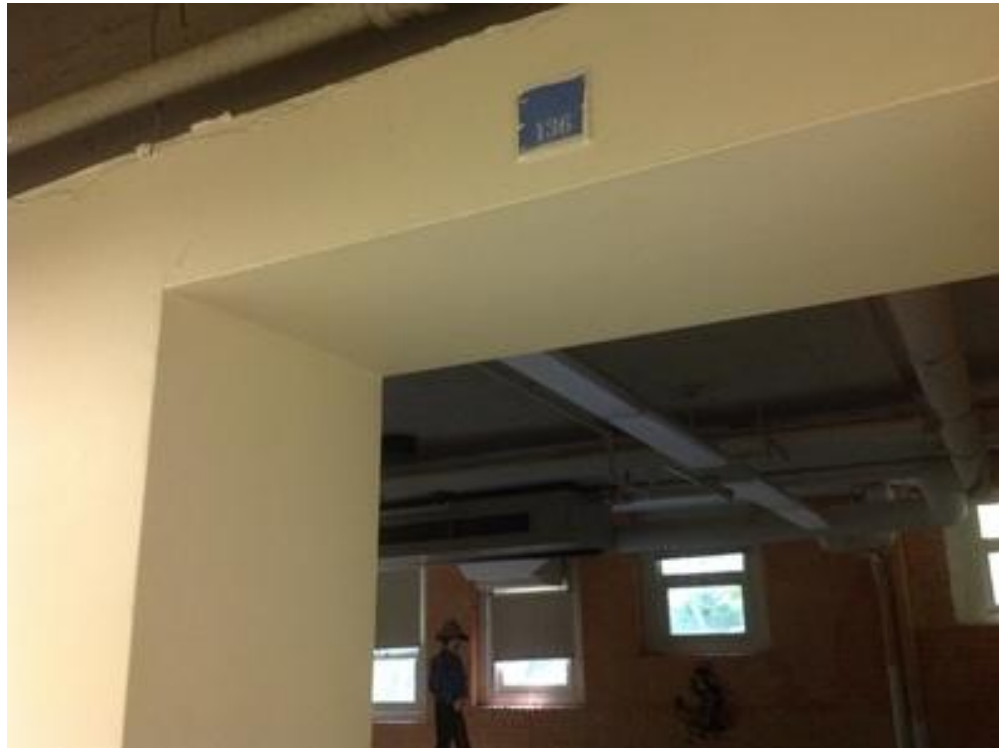
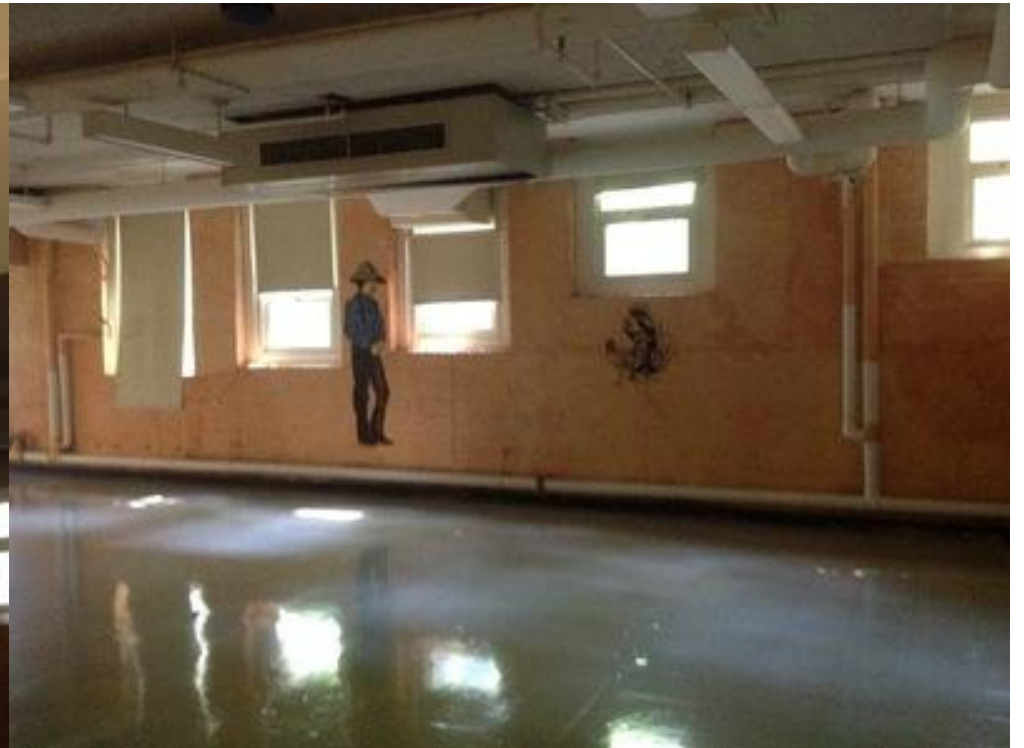
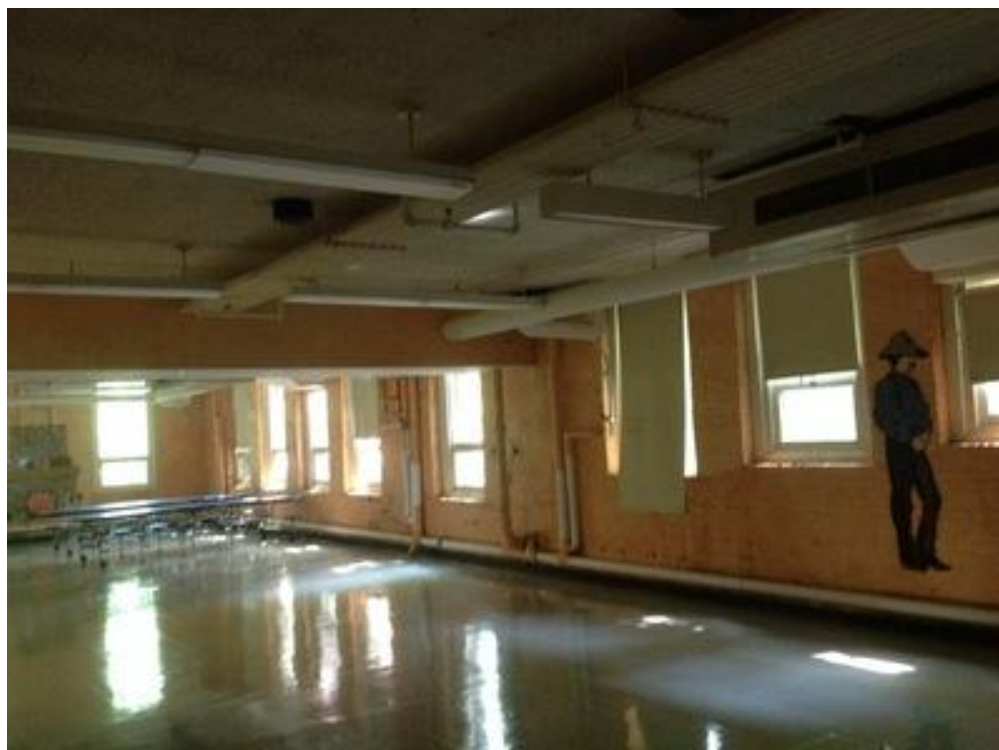
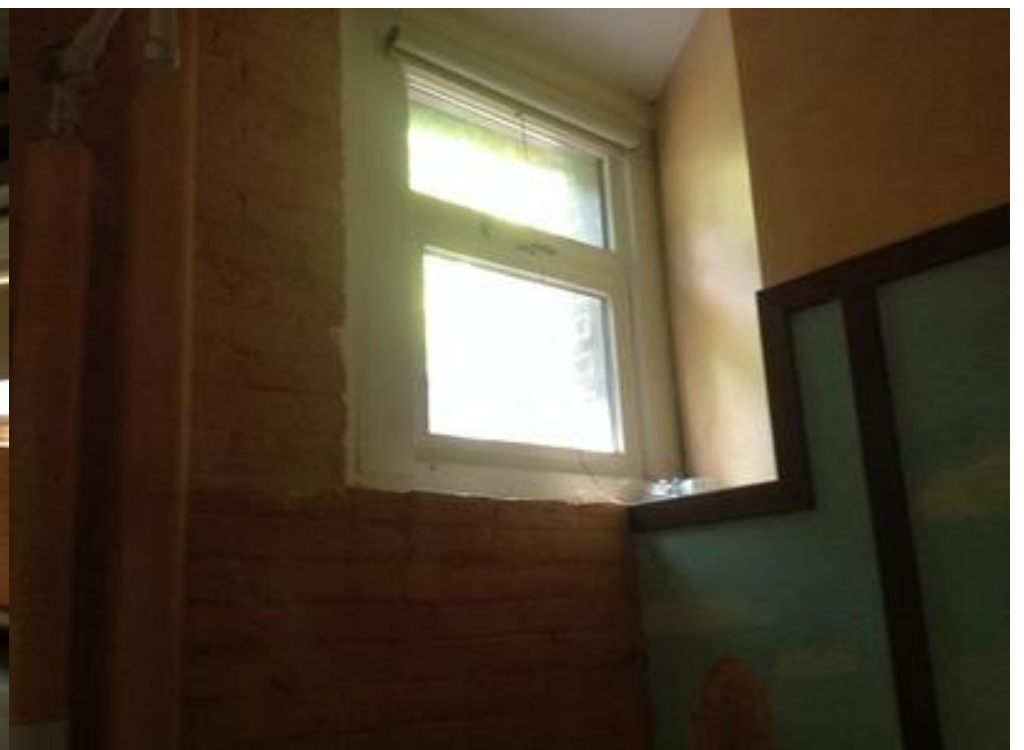
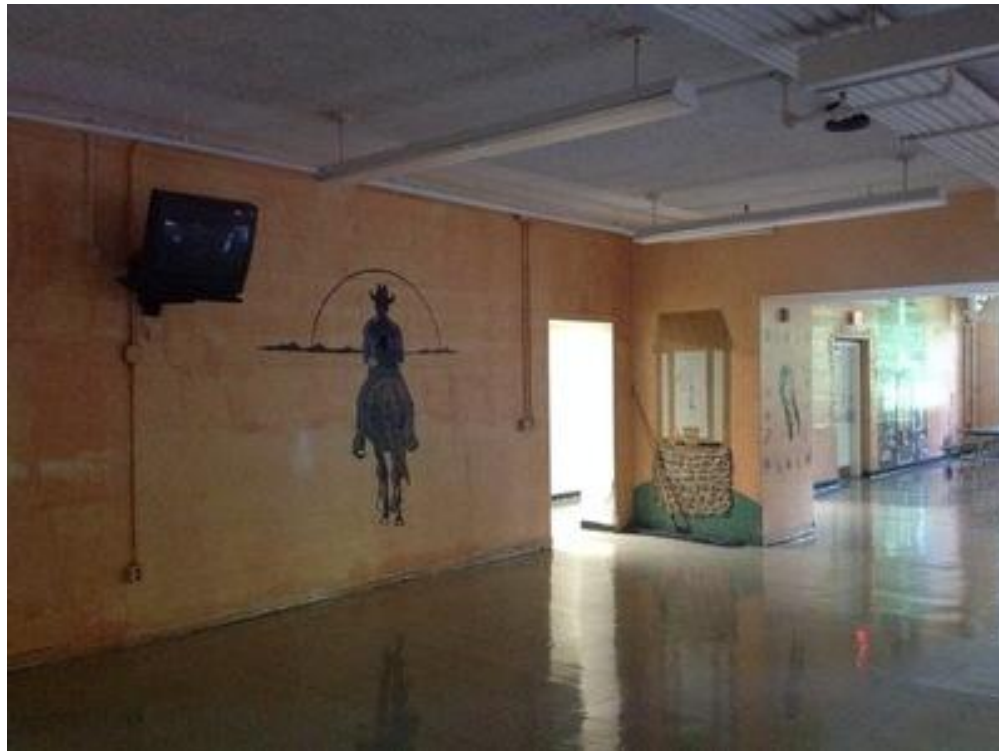
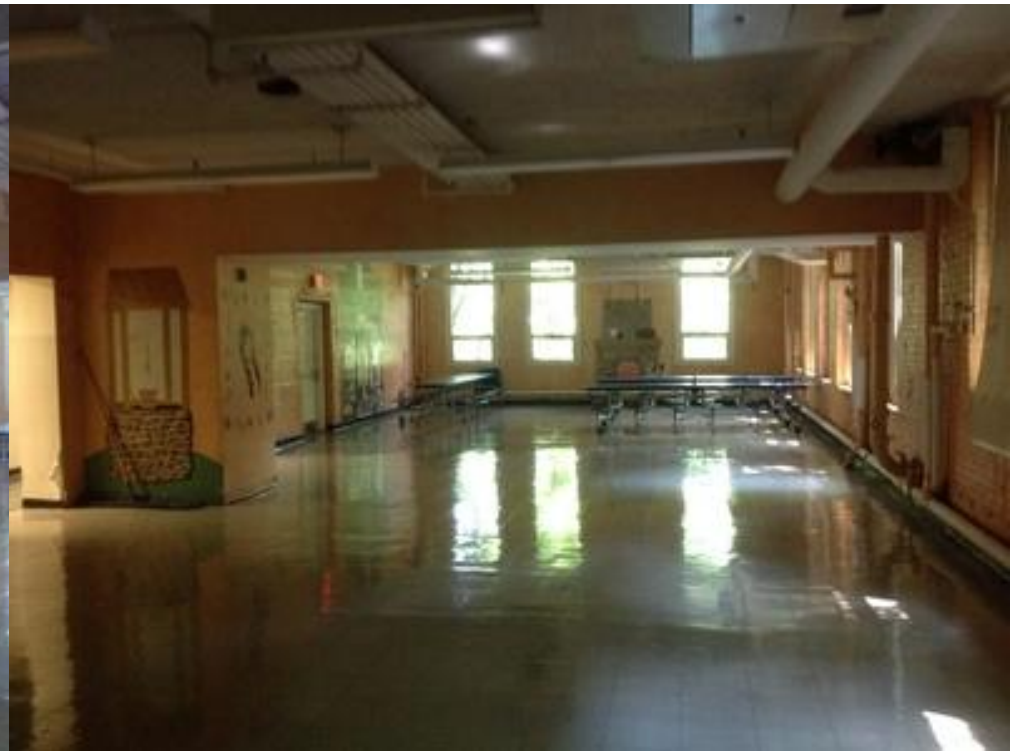
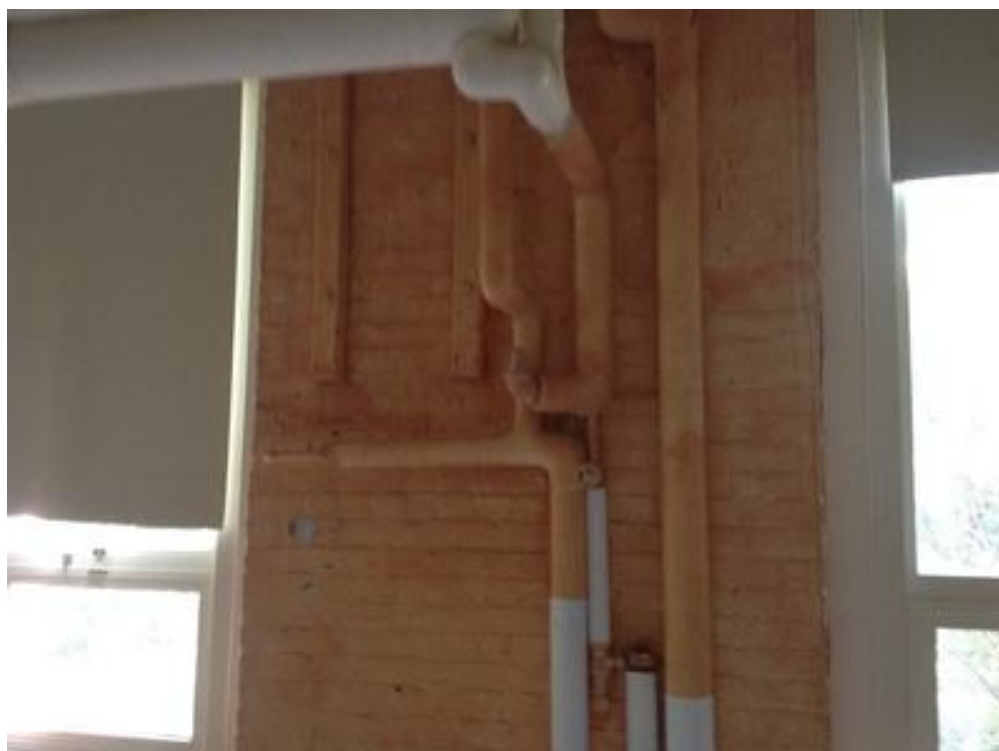
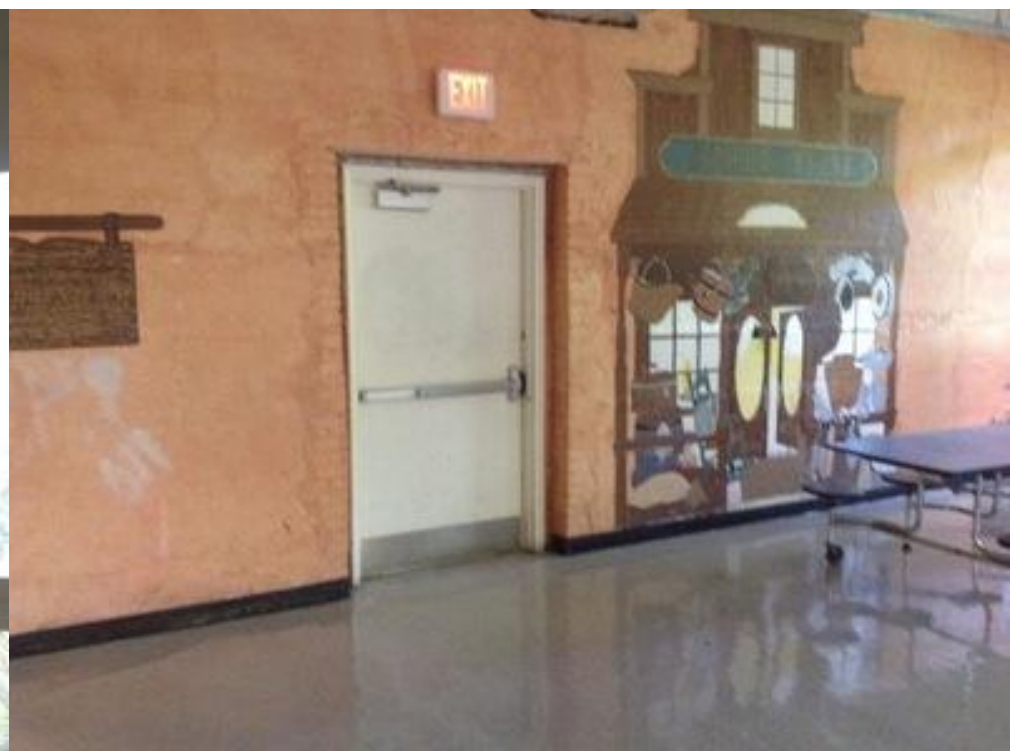
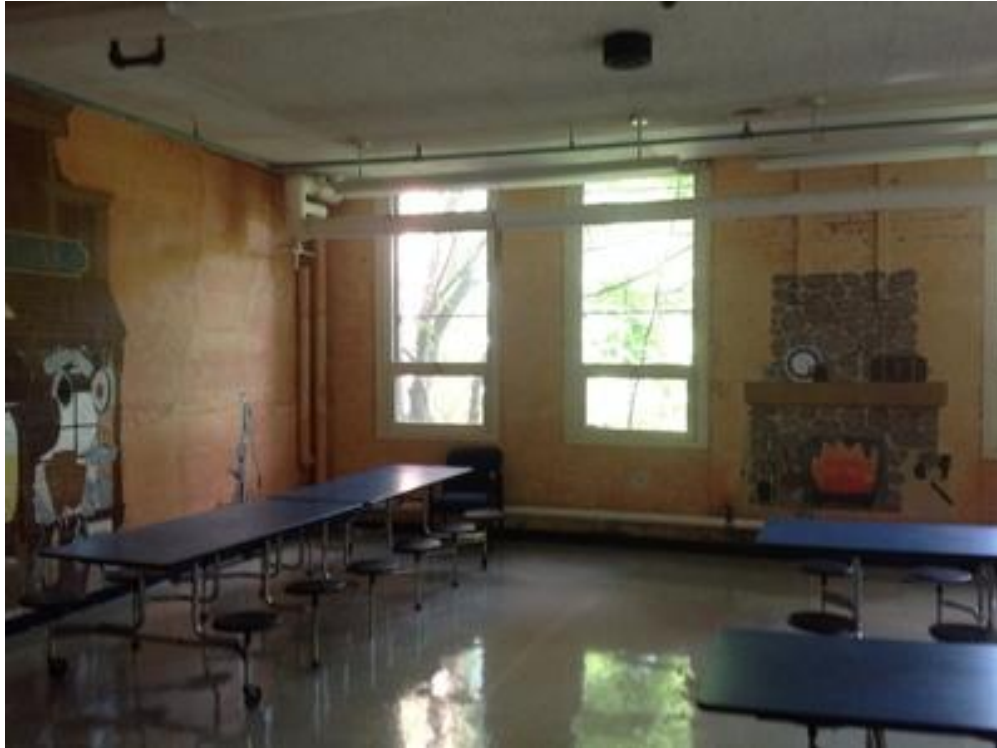
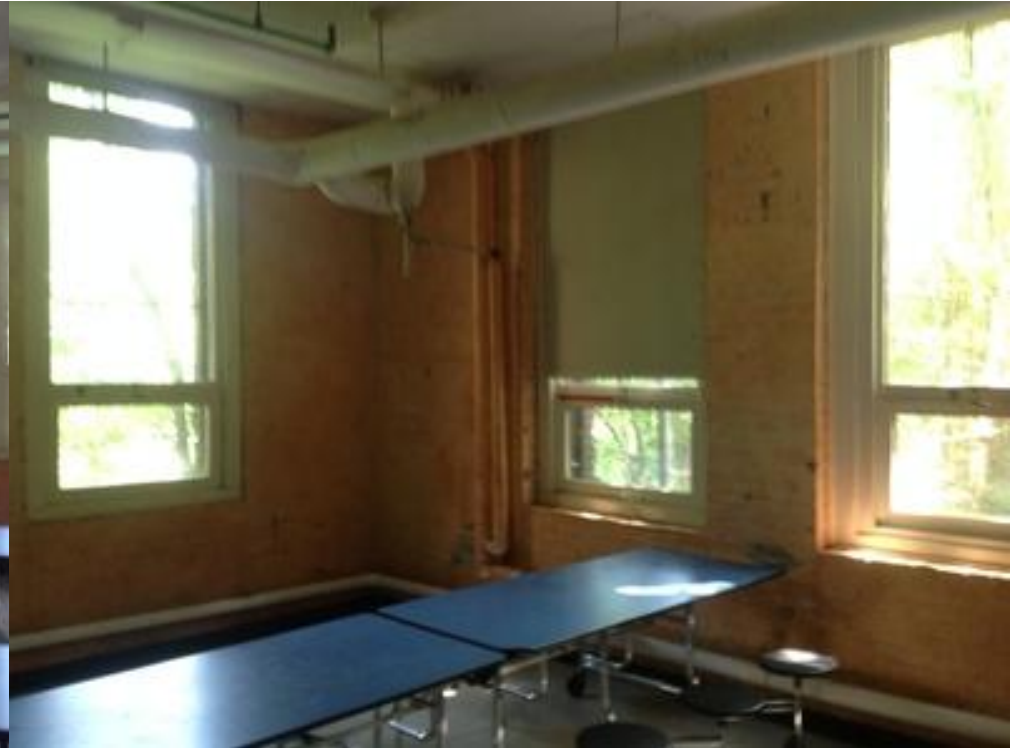
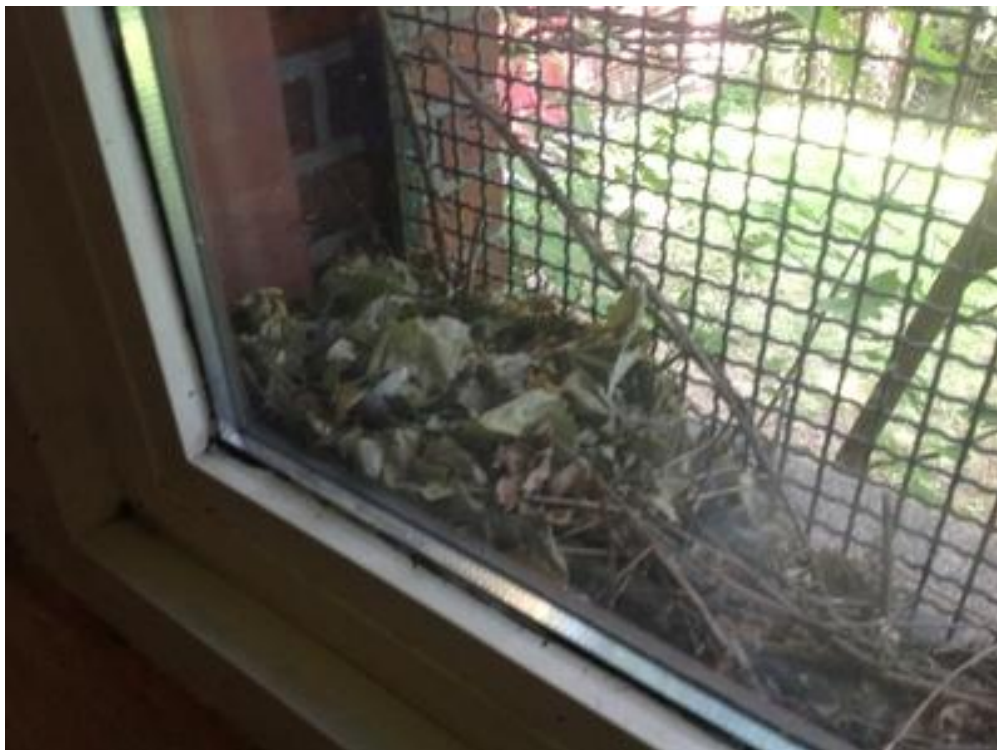
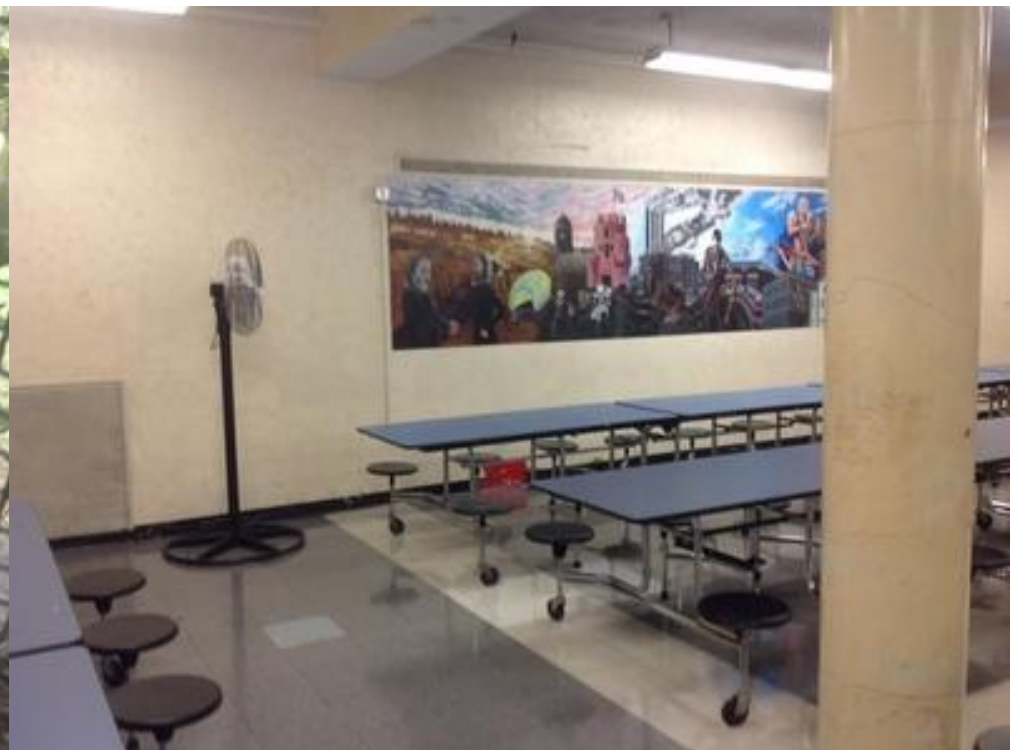
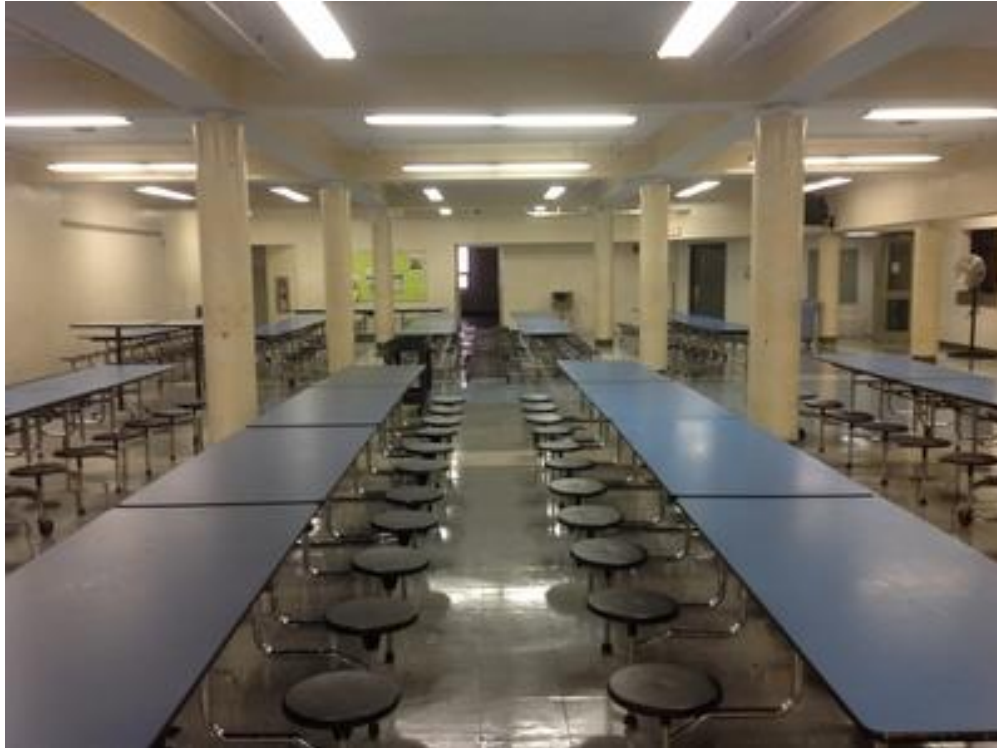
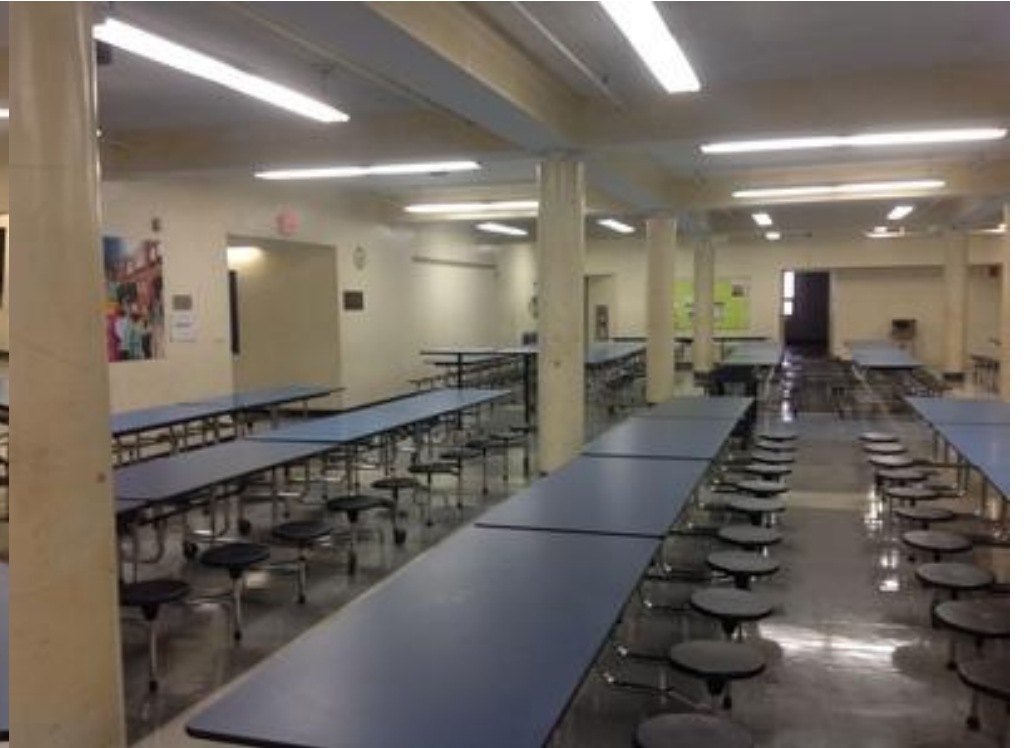
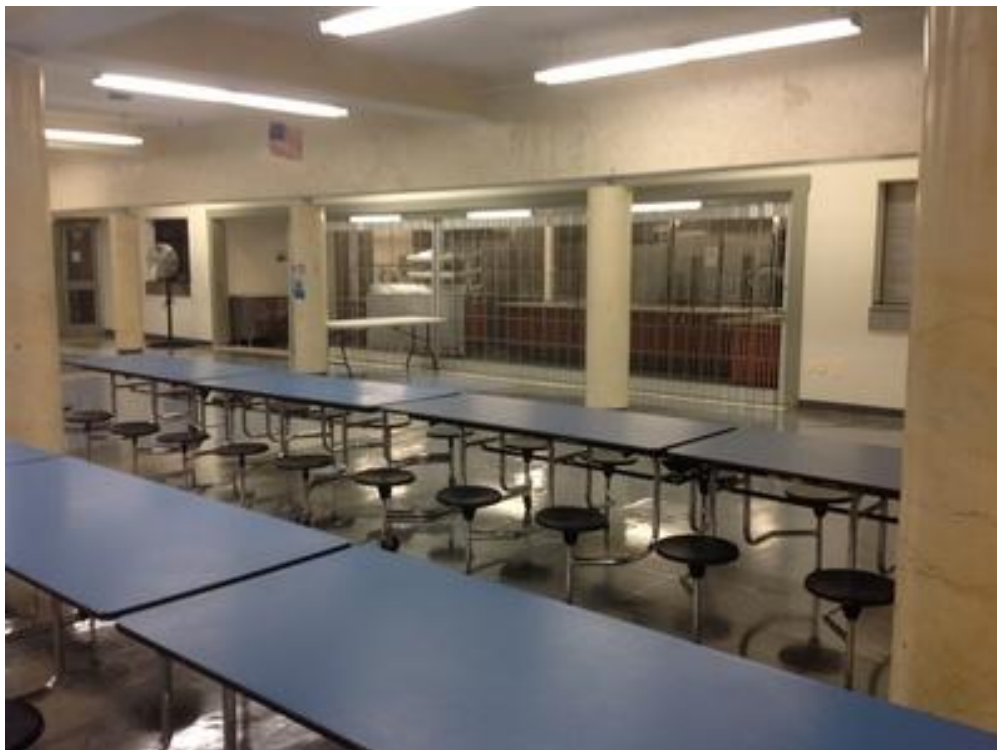
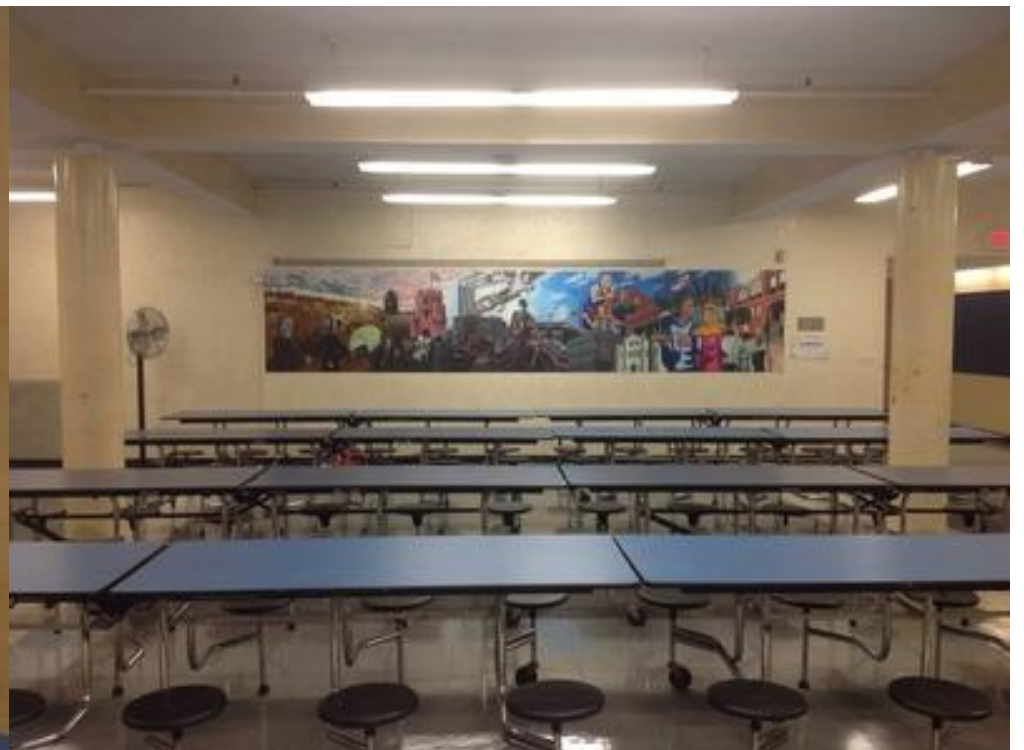
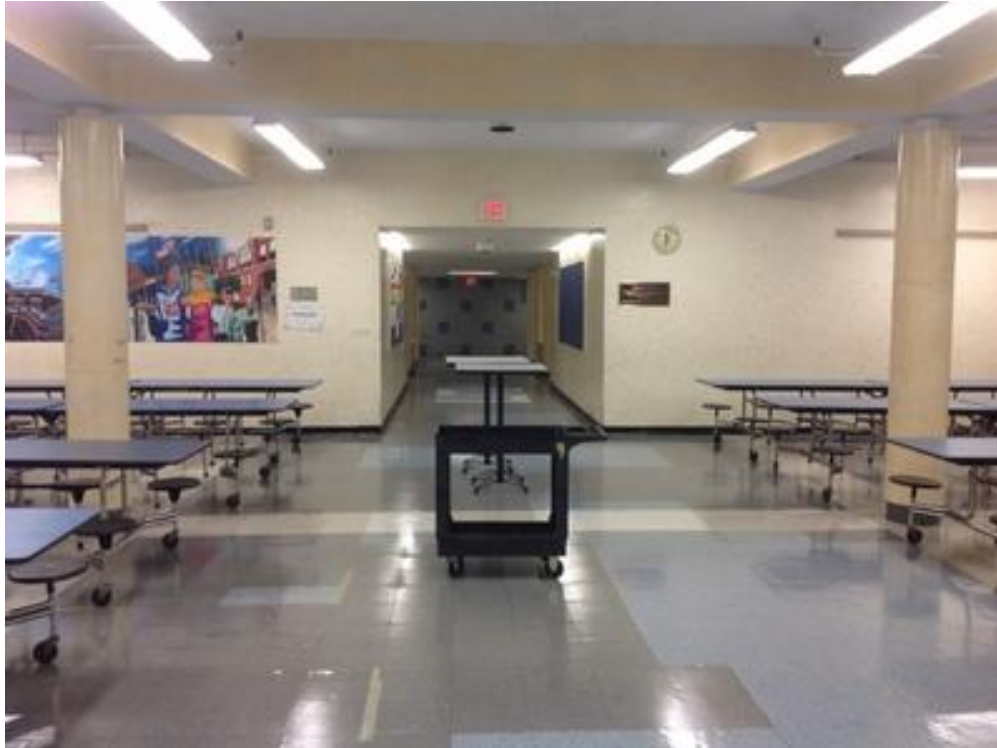
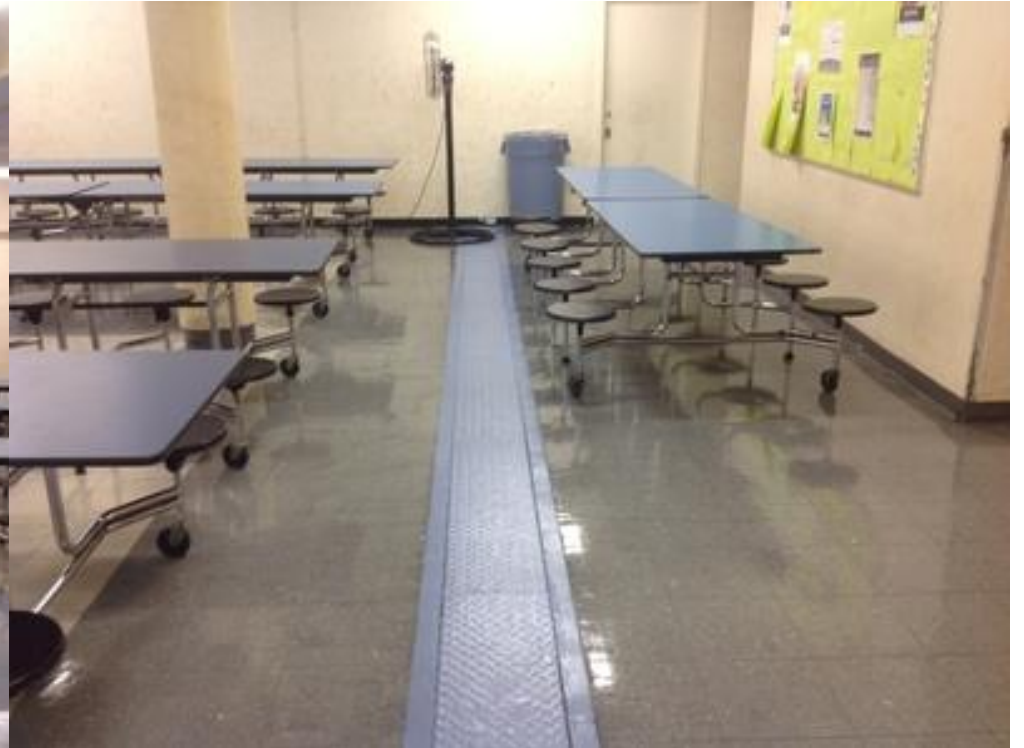
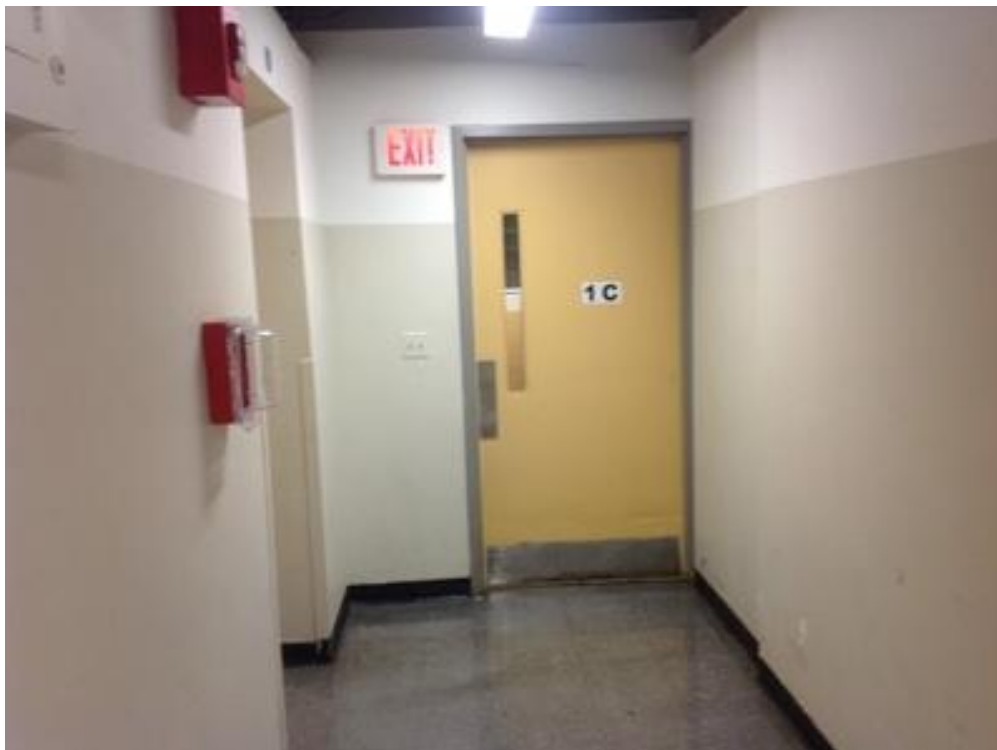
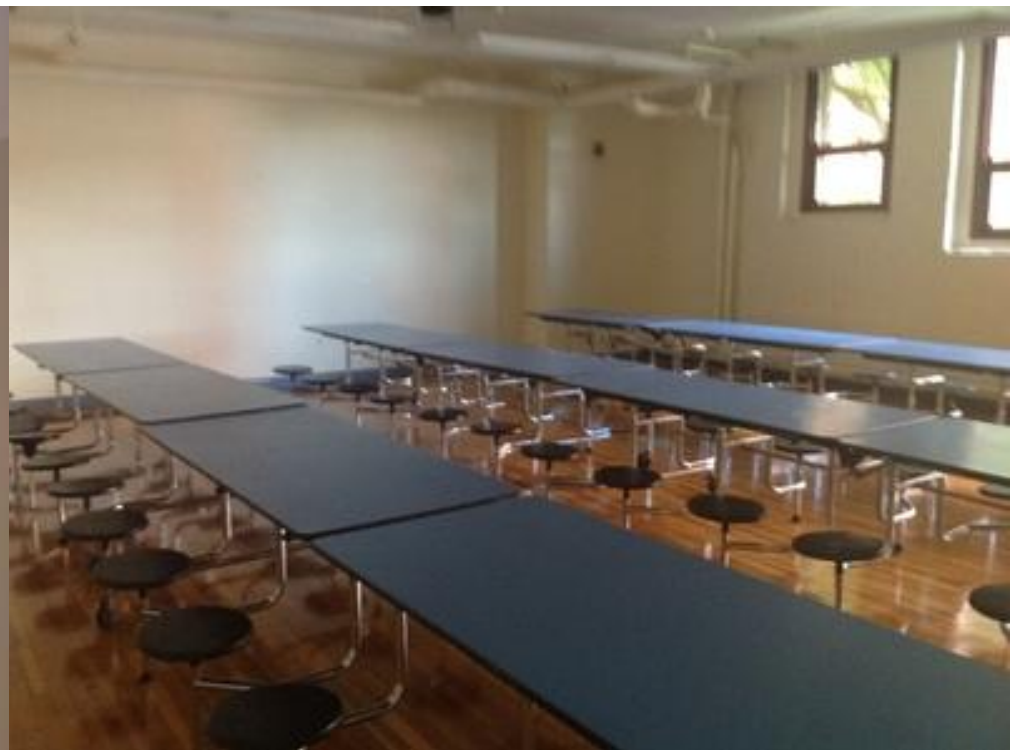
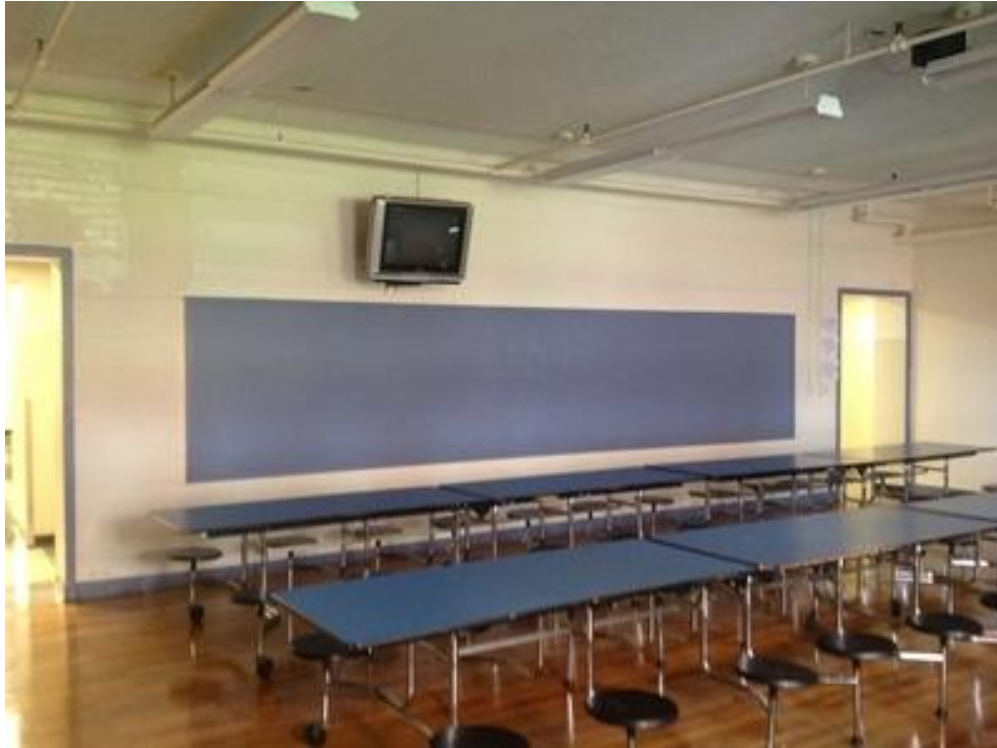
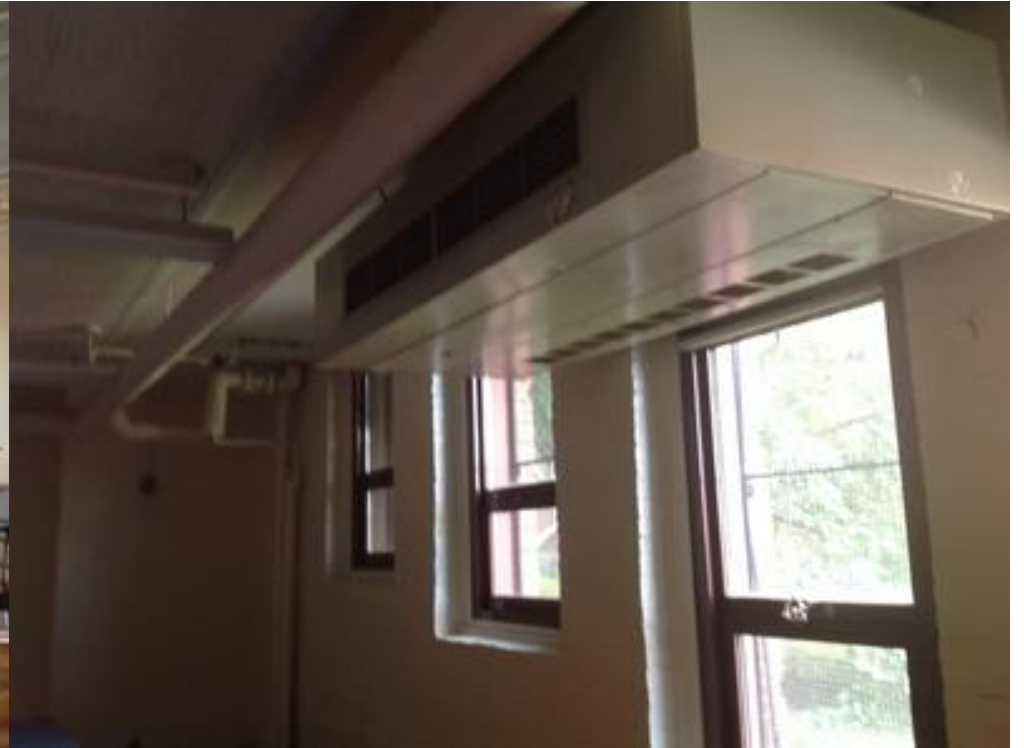
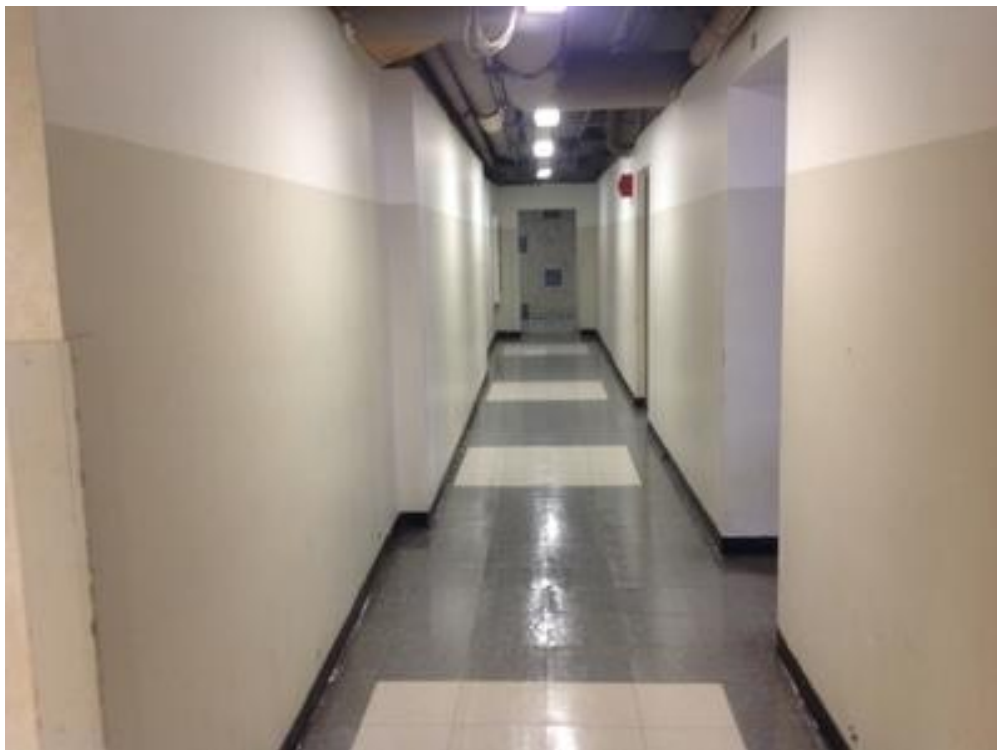
Description
Cafeteria is in fair condition. Main cafeteria and side eating areas have poor natural light. Murals on walls are in poor condition. VCT flooring is in fair condition. Walls have chipping and peeling paint. Exposed piping is unsightly.

| Condition | Fair | | |
