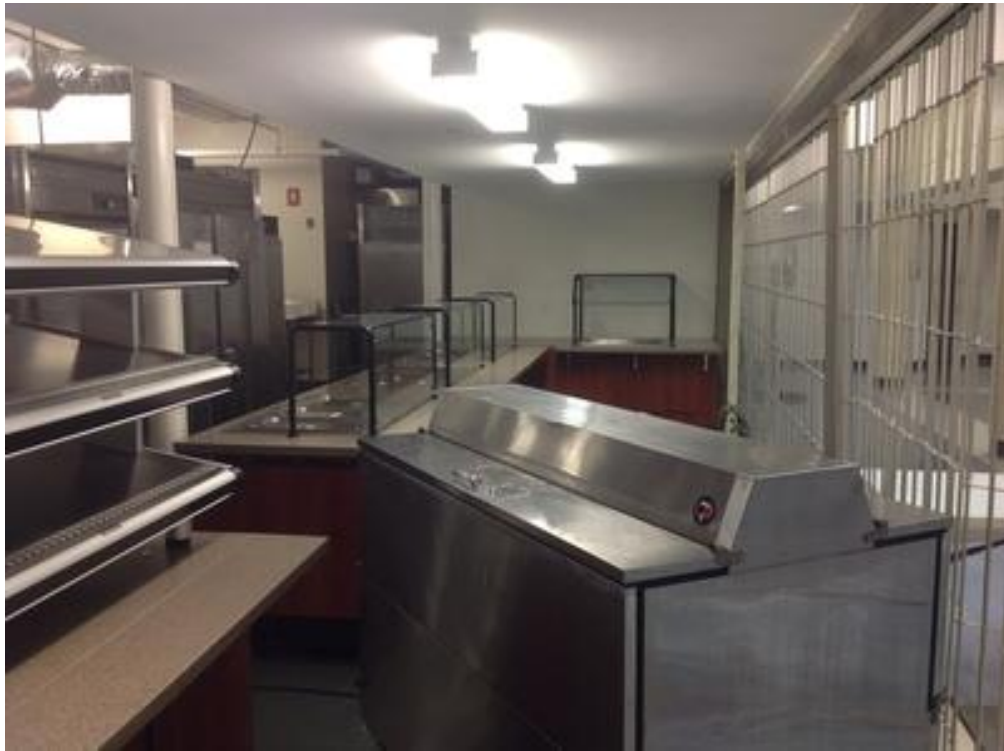
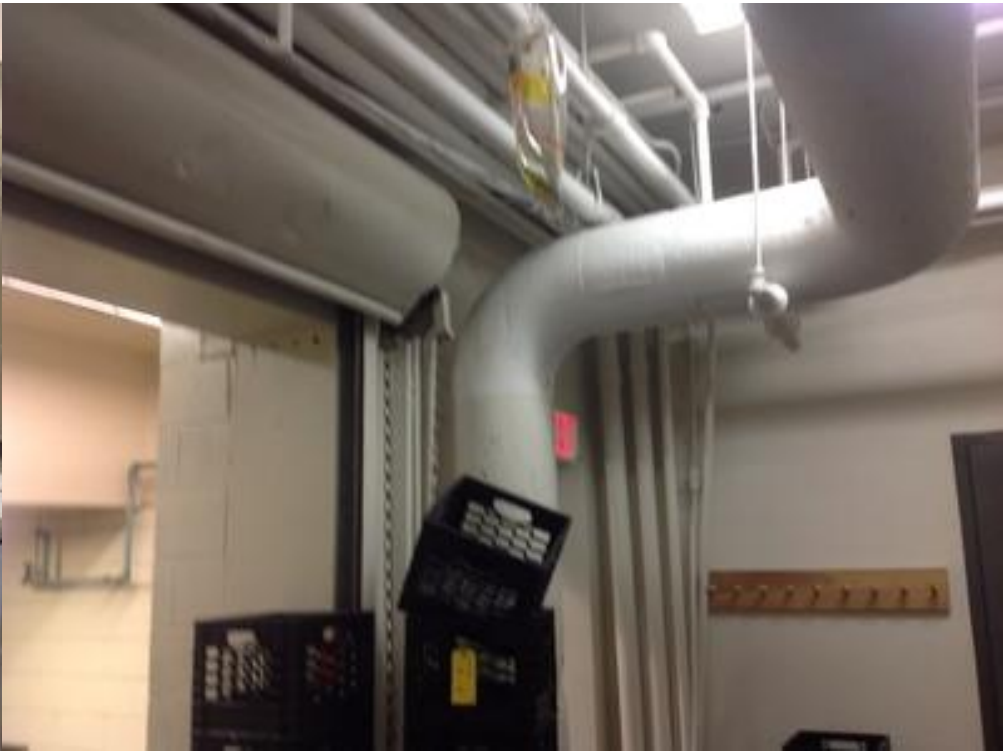
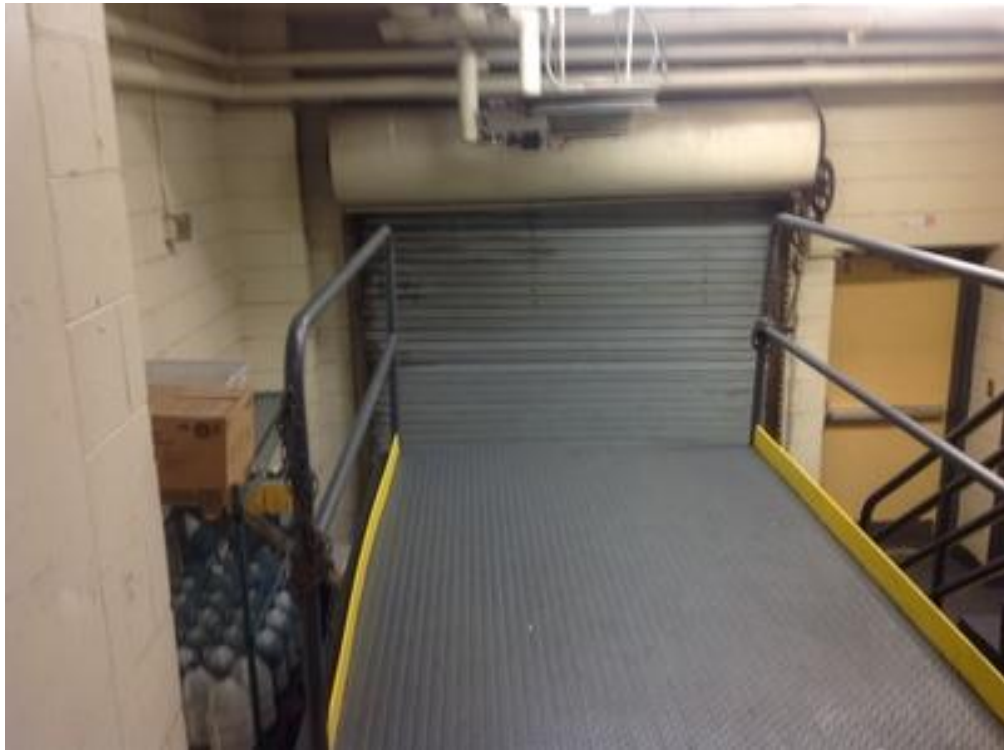
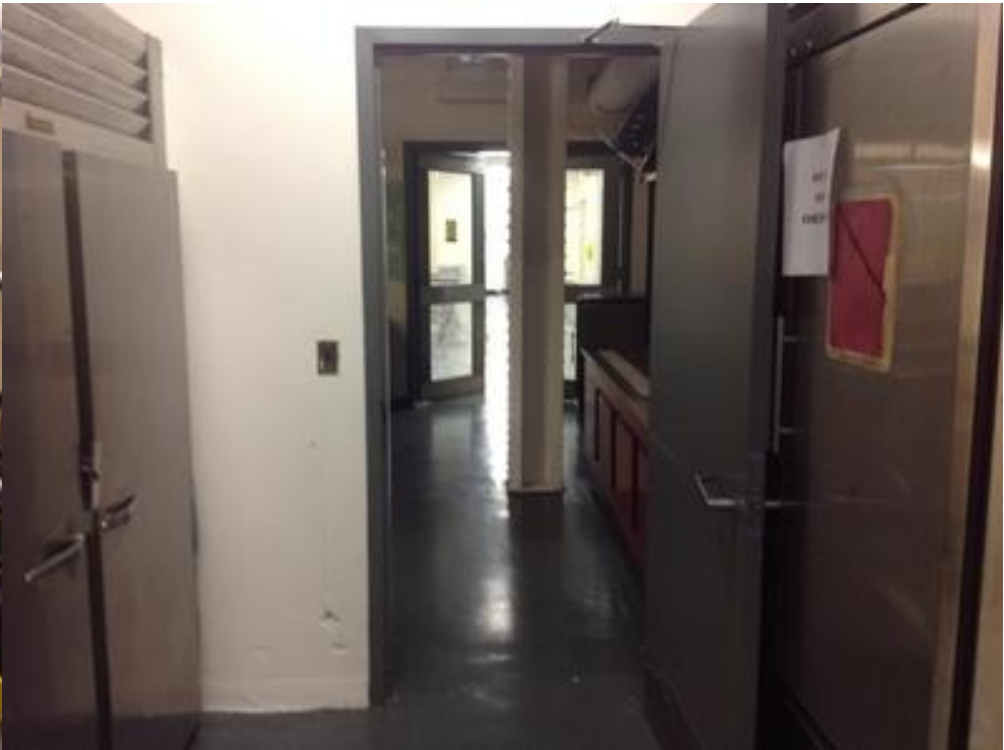
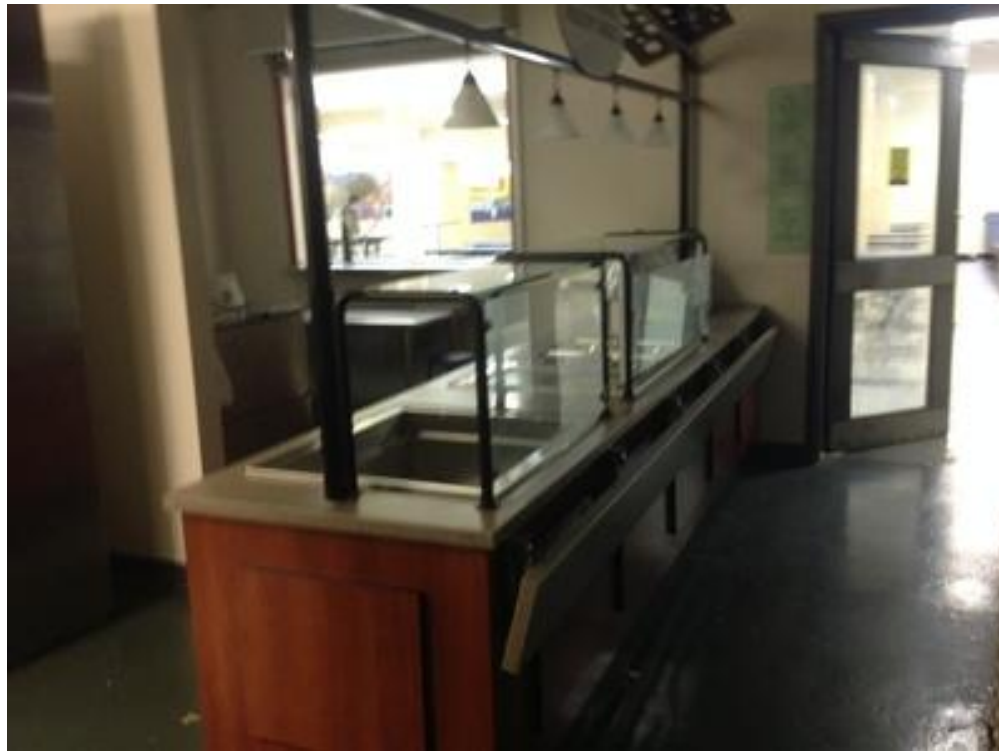
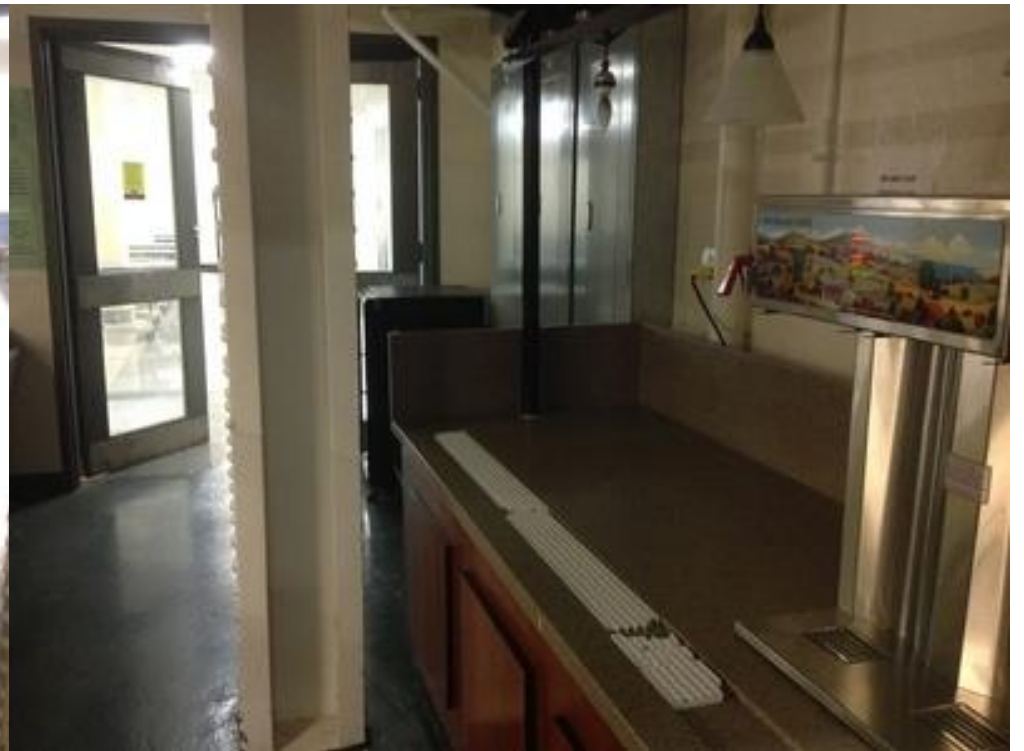
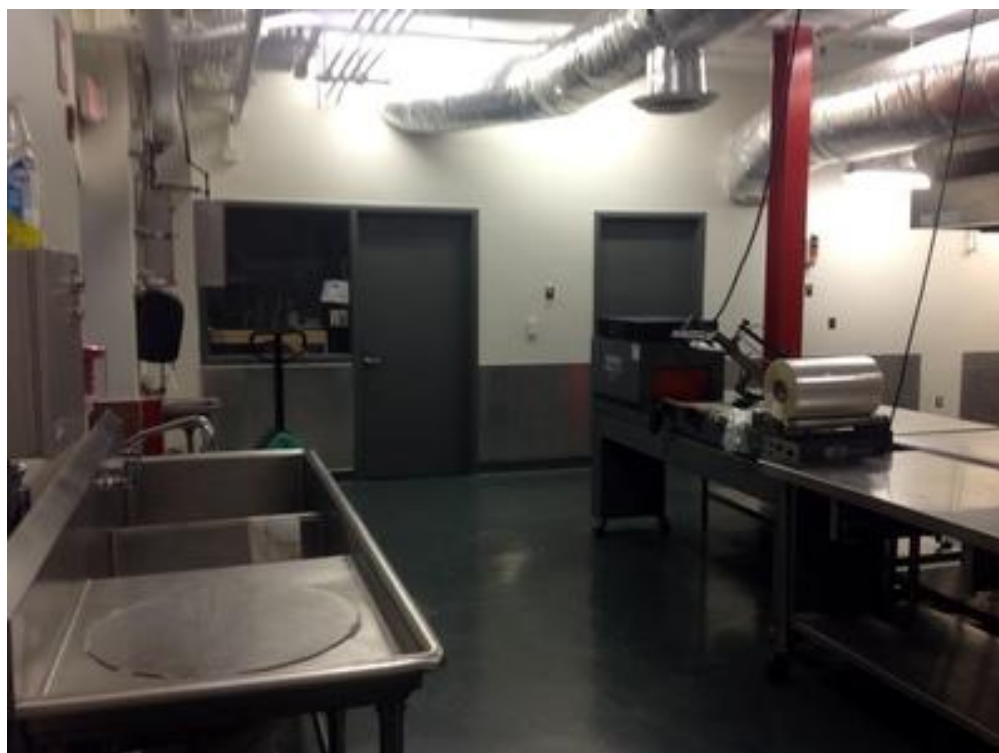
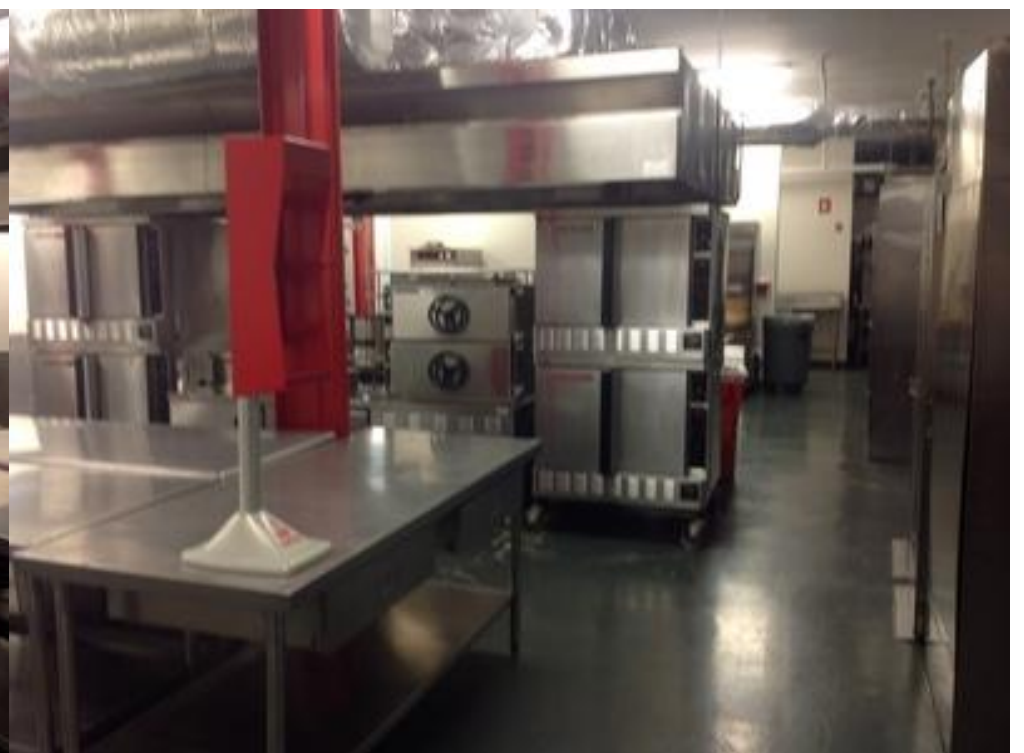
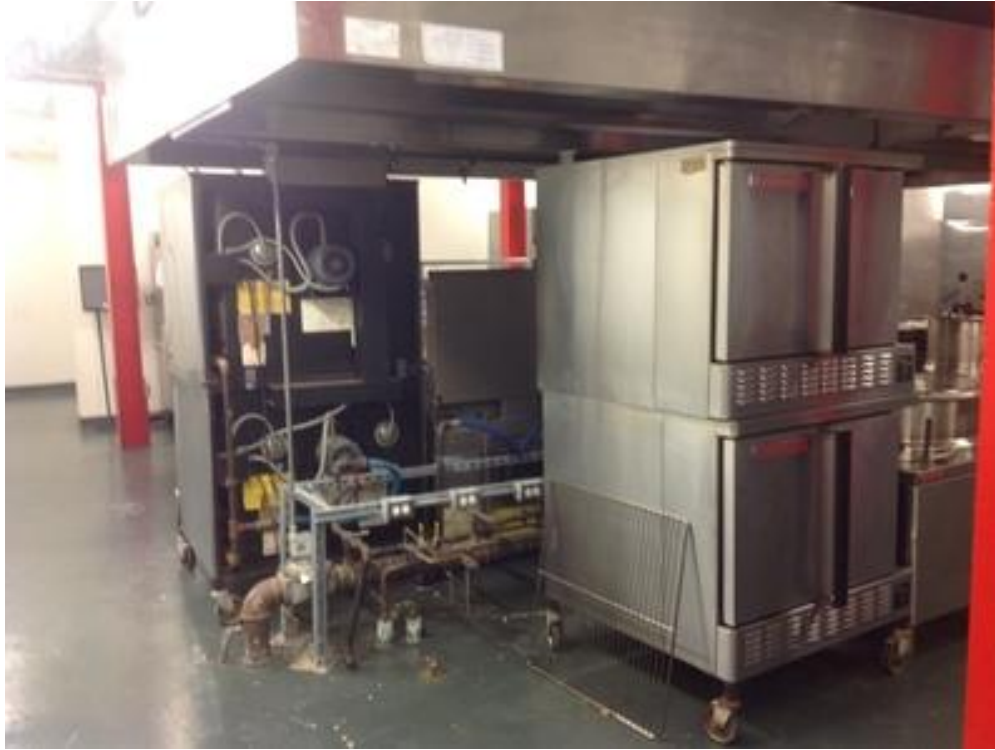
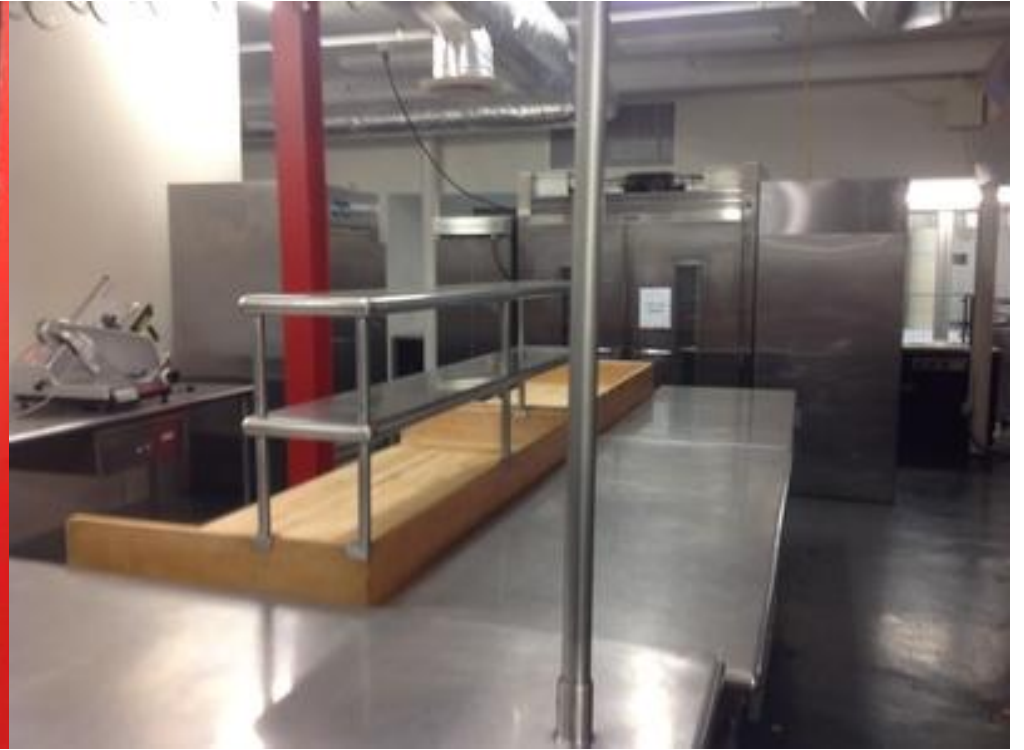
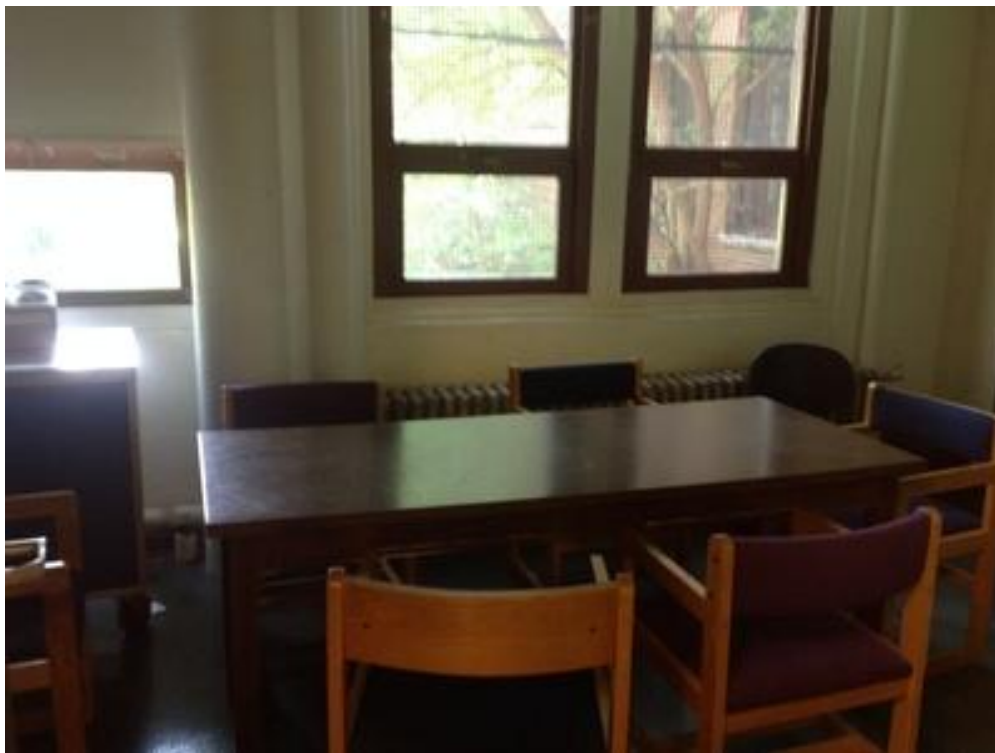
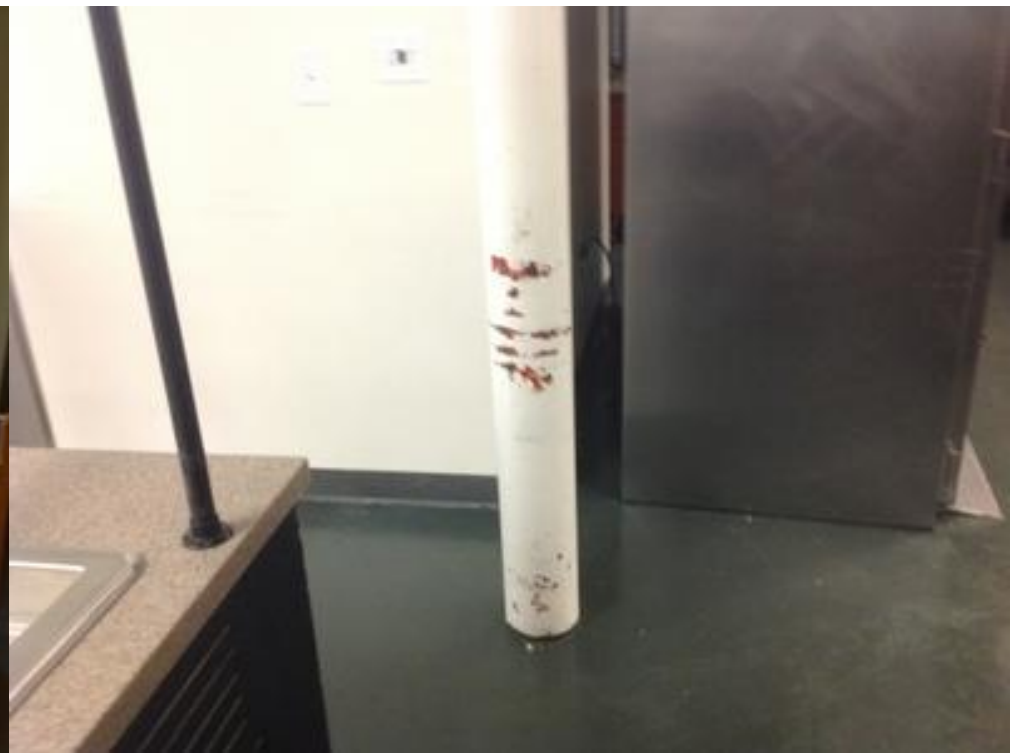
| Description Kitchen is in good condition. | | | |

| Condition | Good | | |

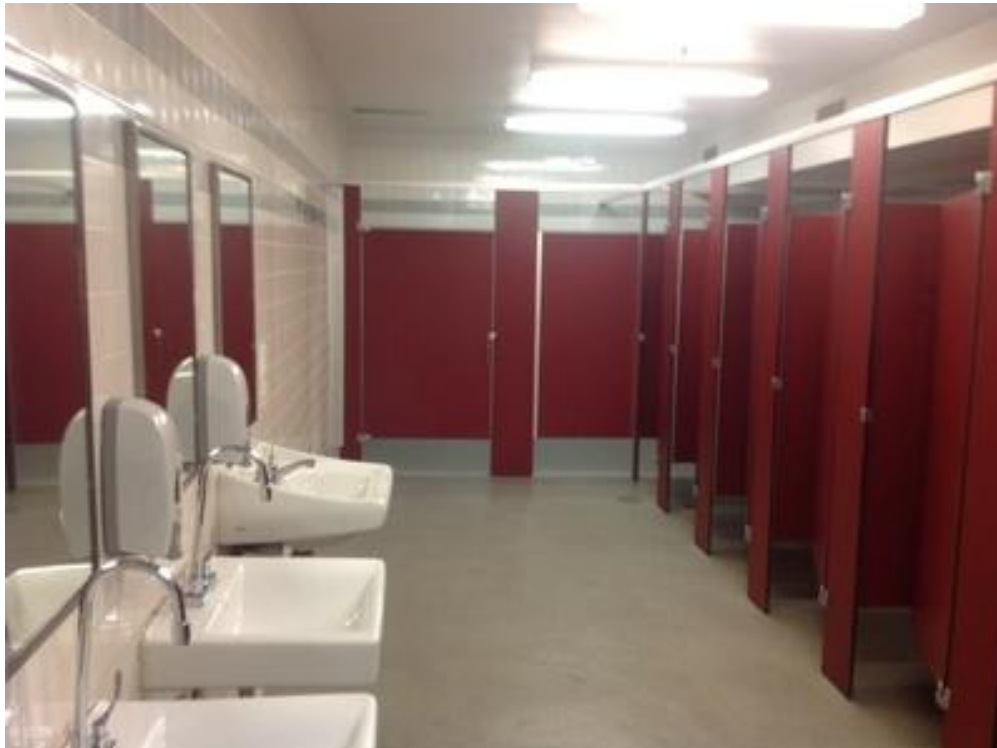
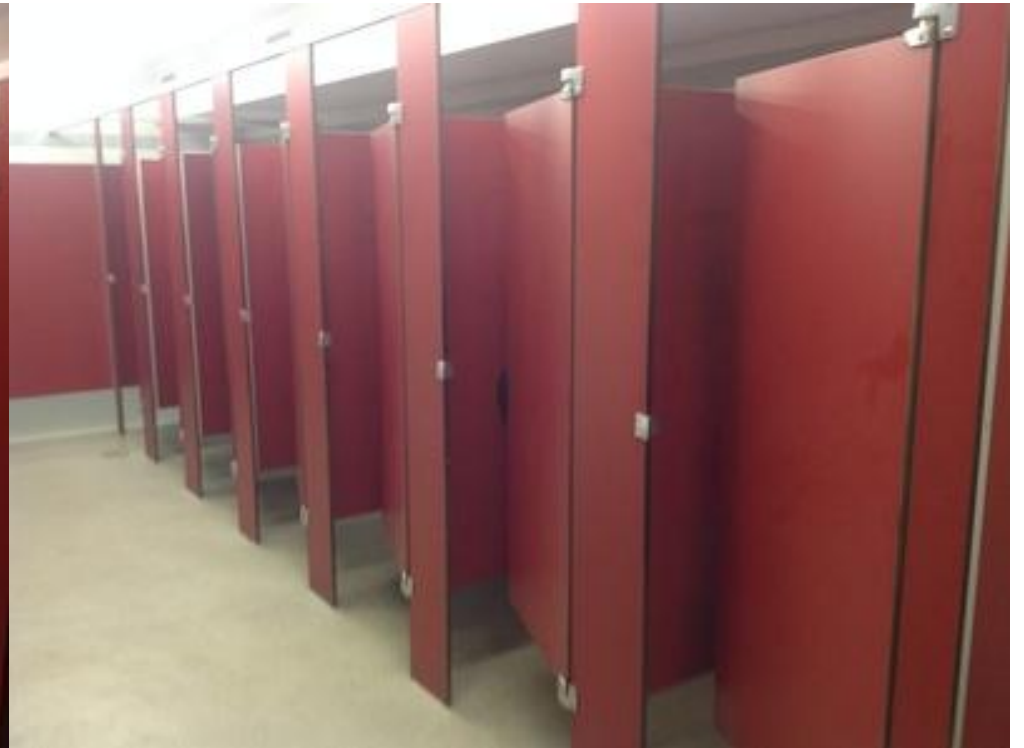
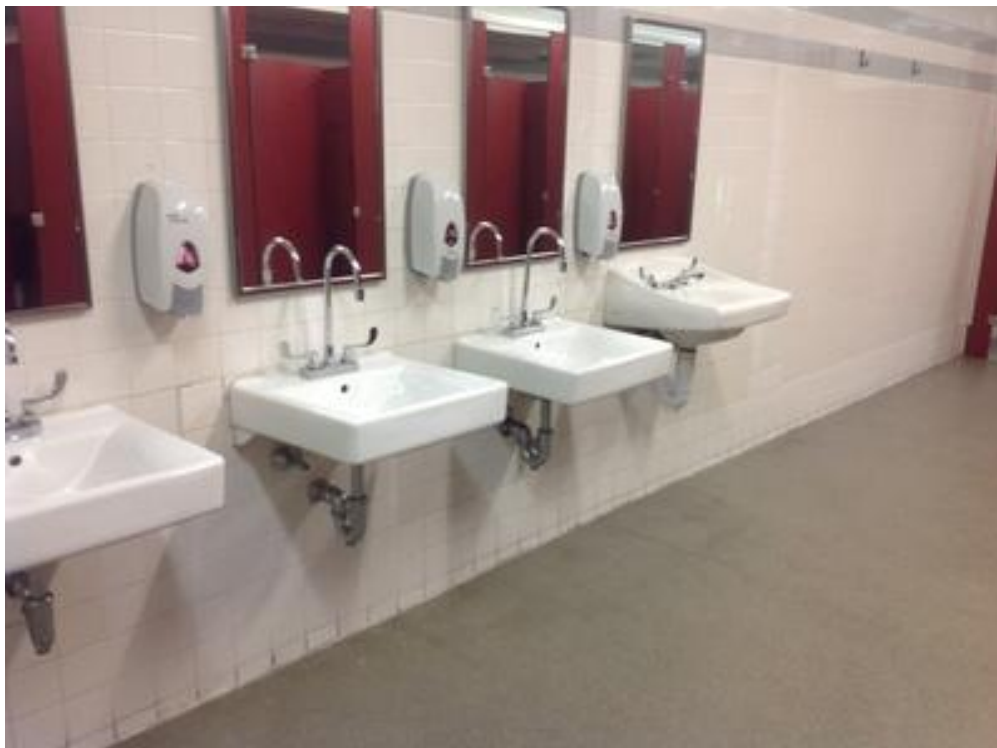
Restrooms are in good condition.

| Condition | Good | |

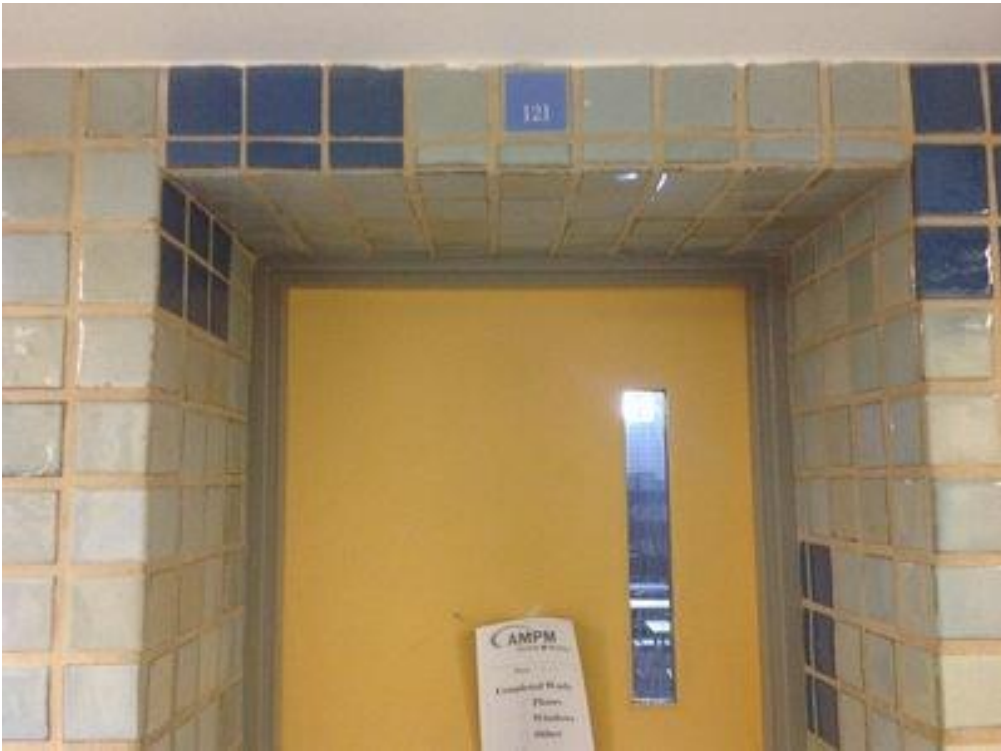
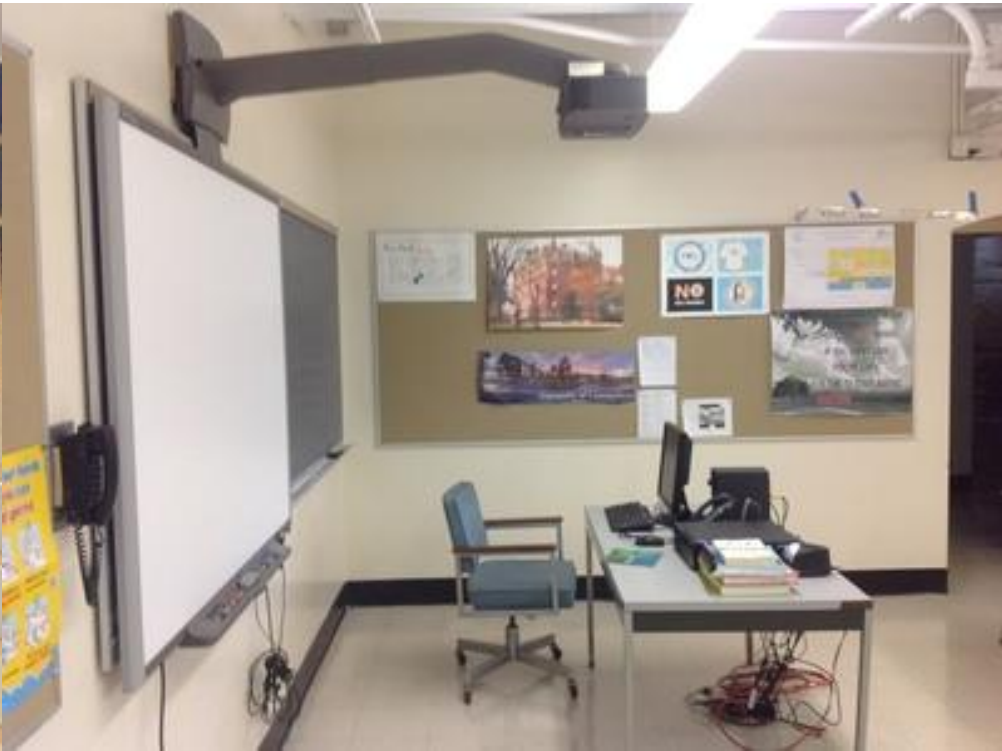
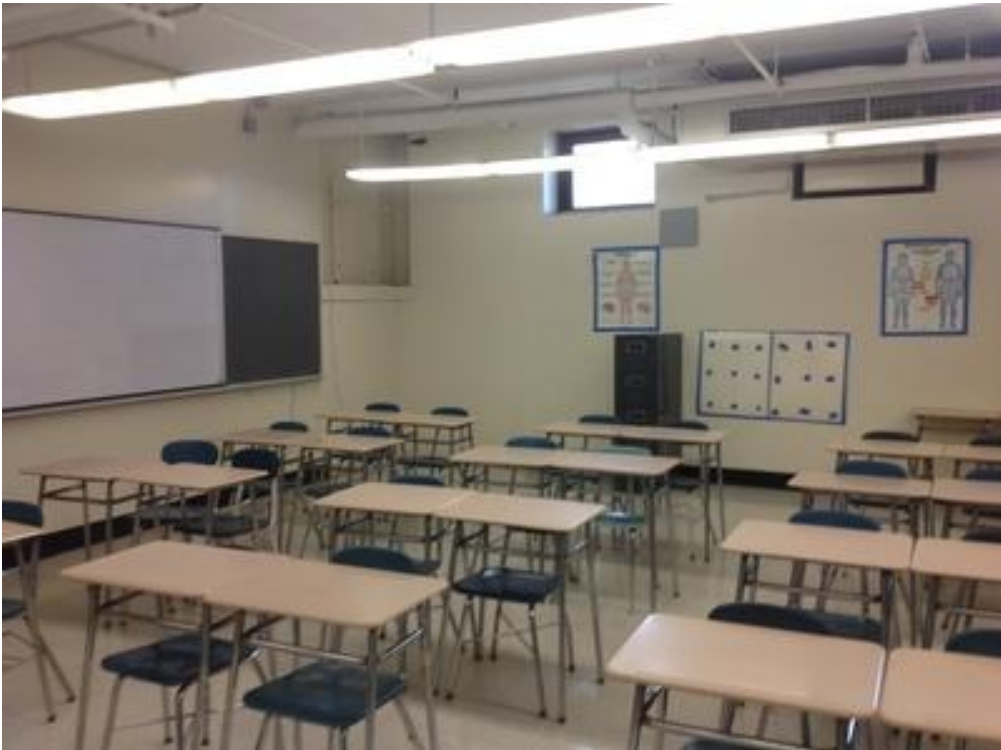
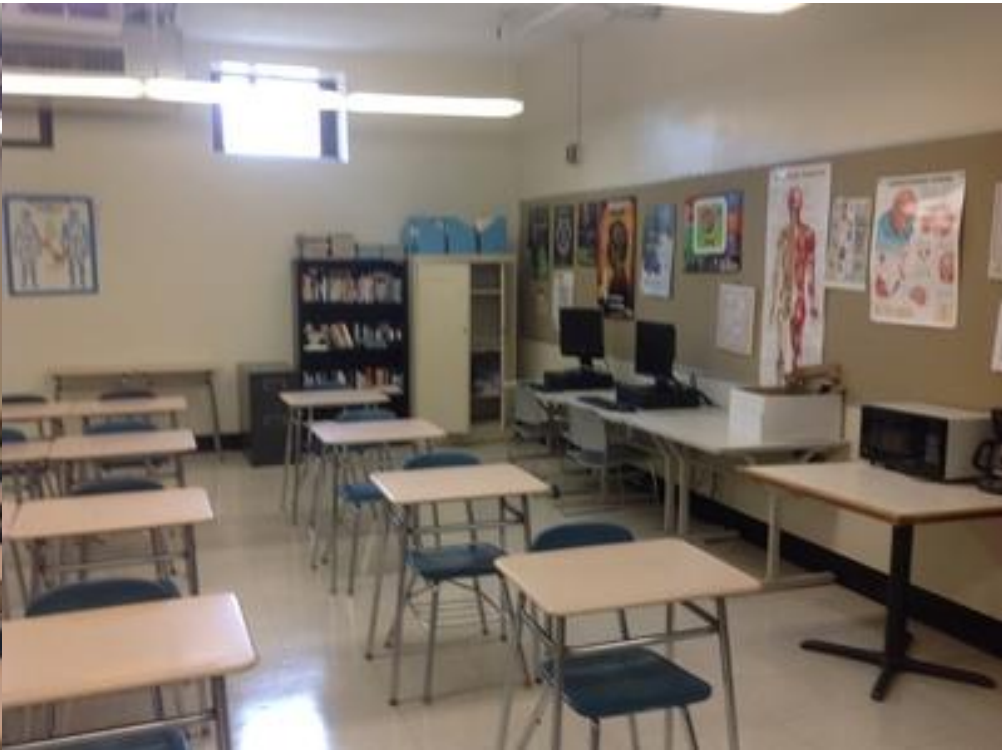
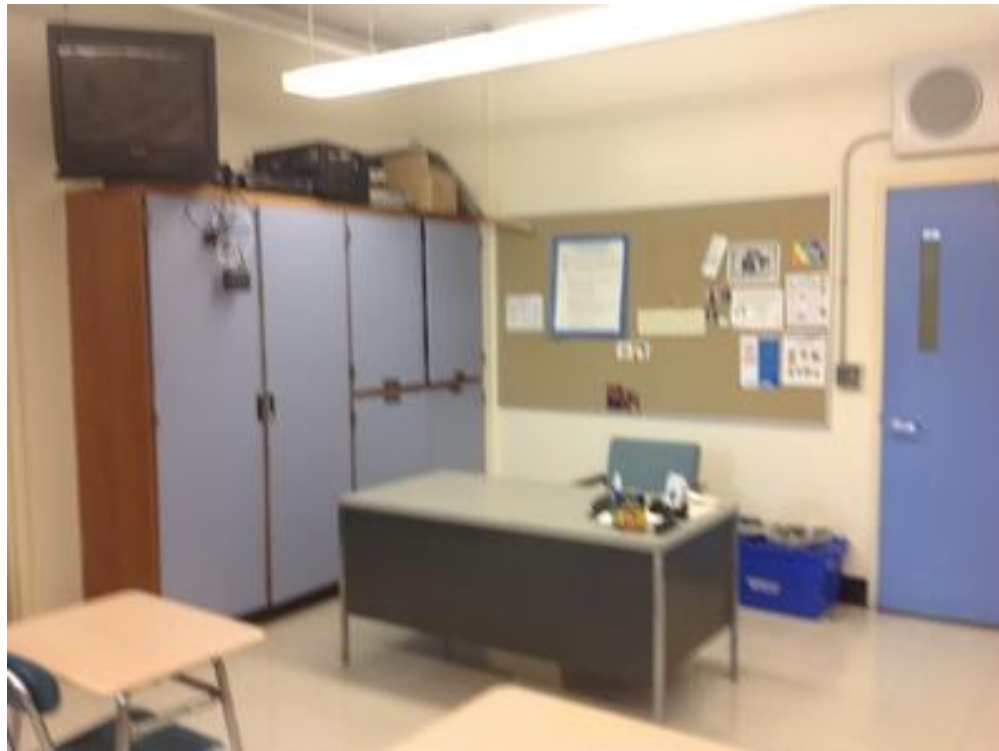
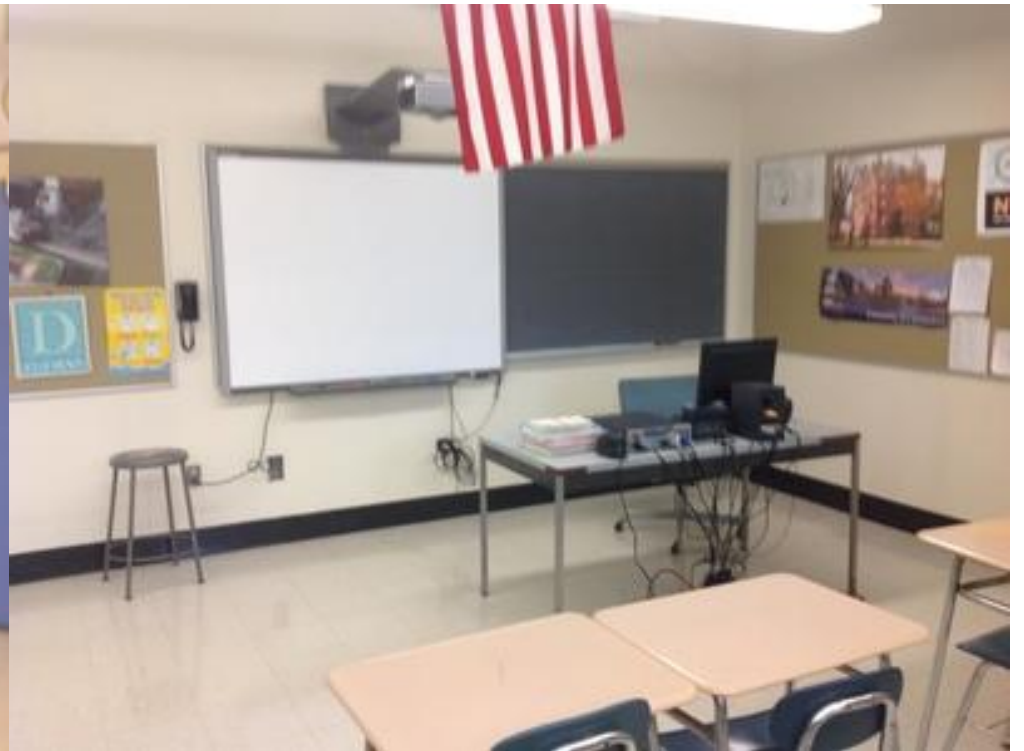
Description
Health classroom in fair condition. VCT Flooring is in fair condition. Piping and wiring is haphazard and surface mounted. Millwork is in poor condition. Some of the clerestory windows have lost their seals. Lighting is in poor condition. Some ductwork and piping is rusty.

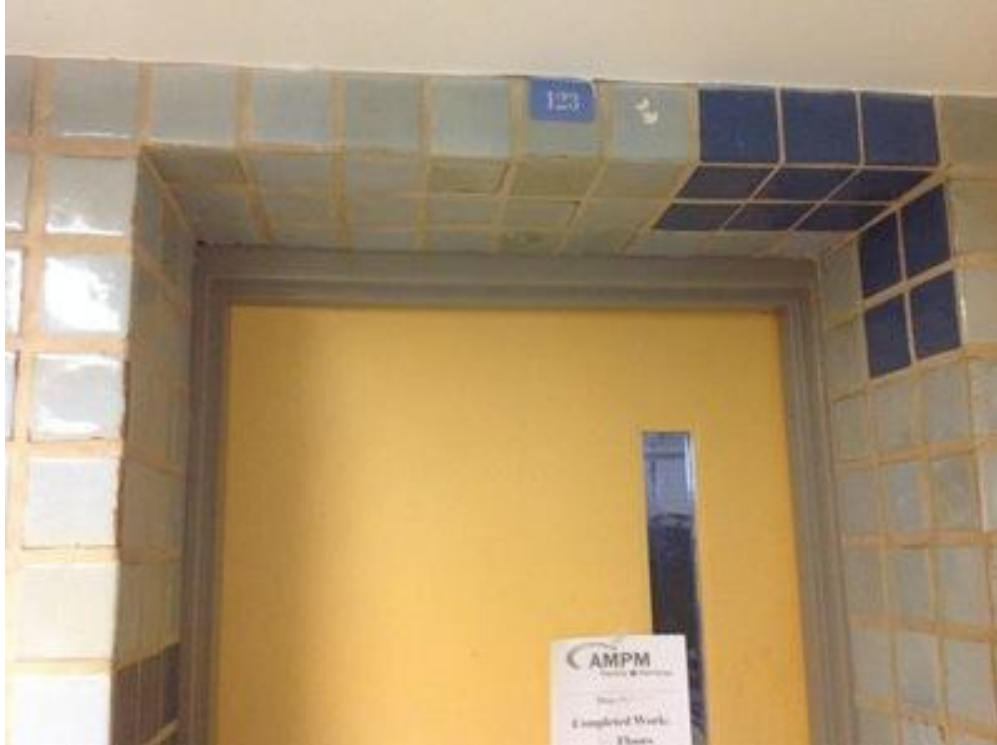
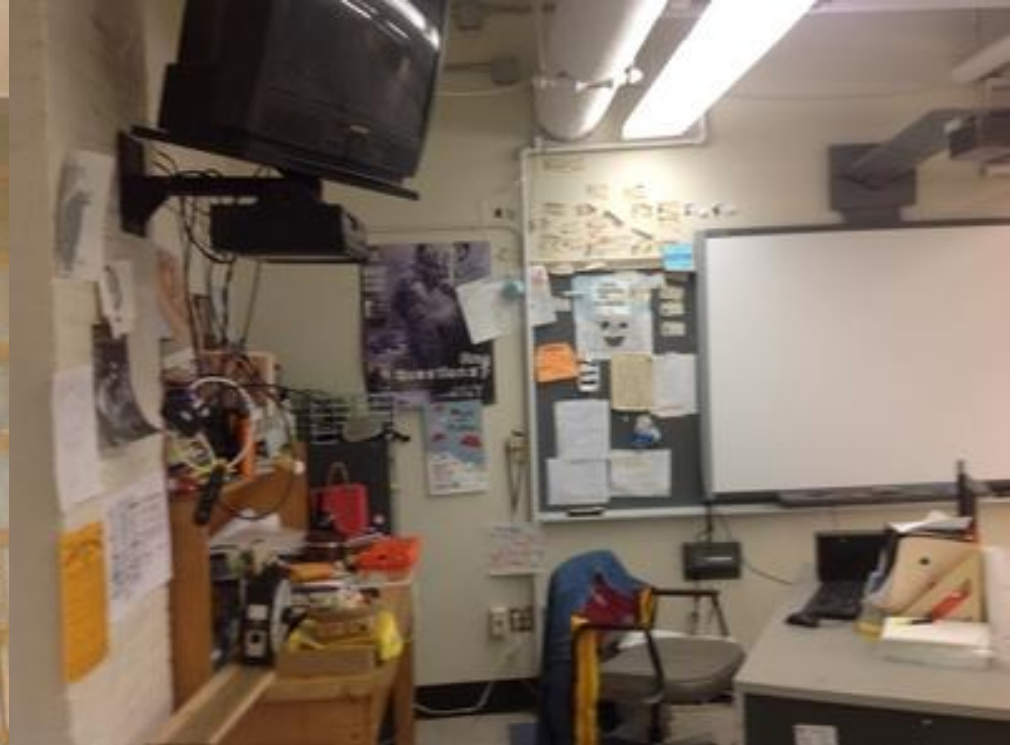
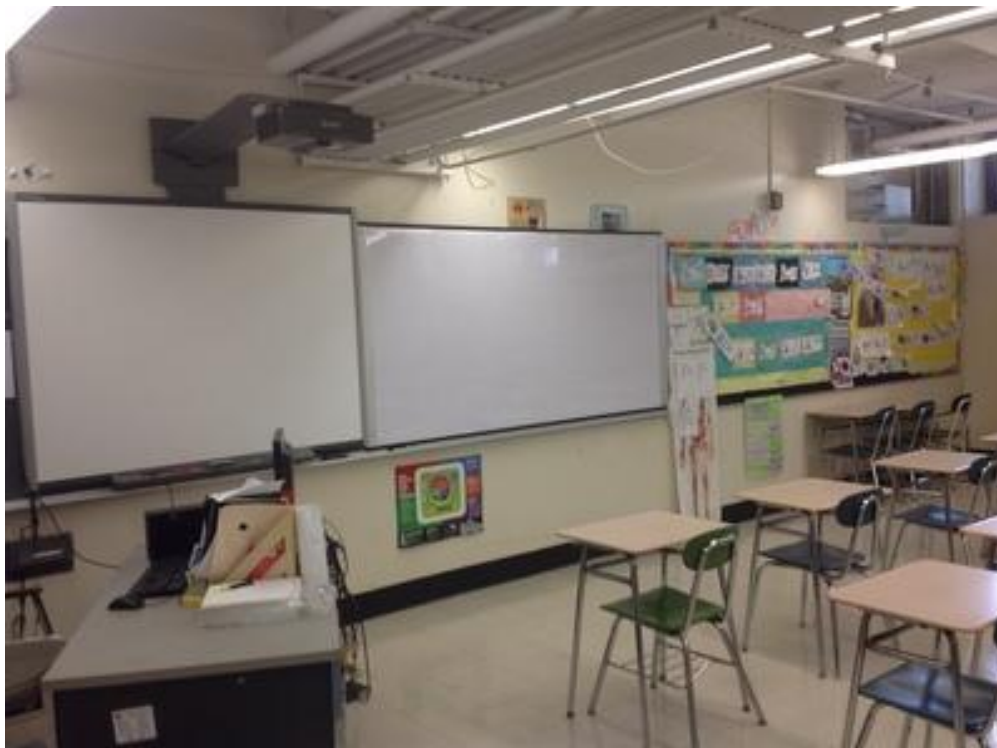
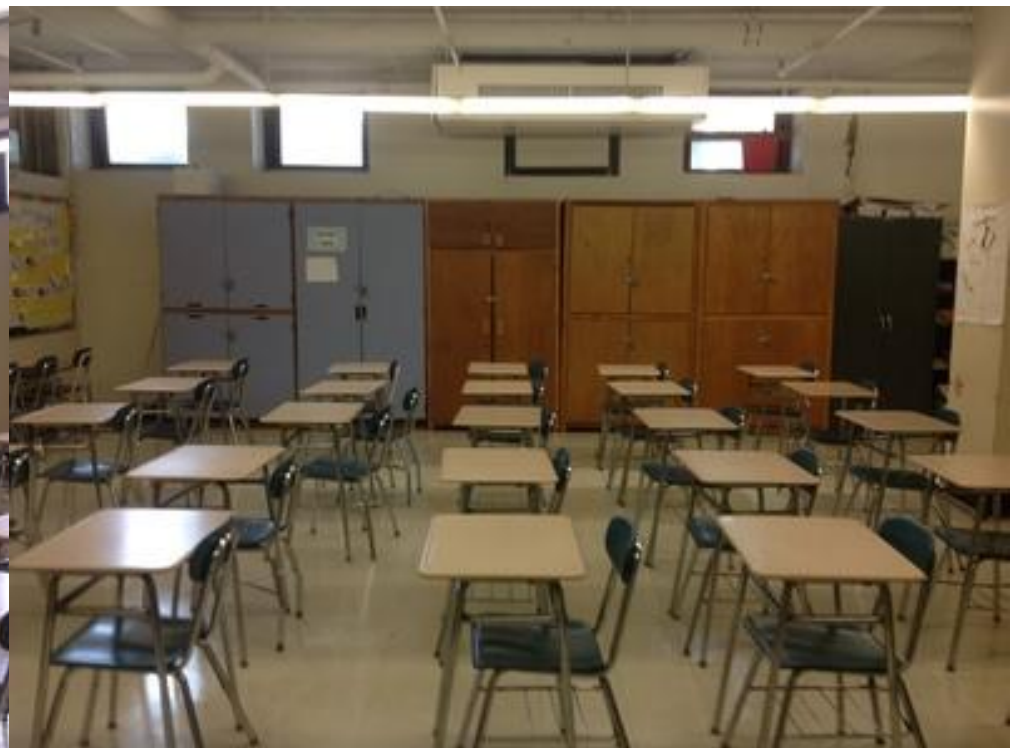
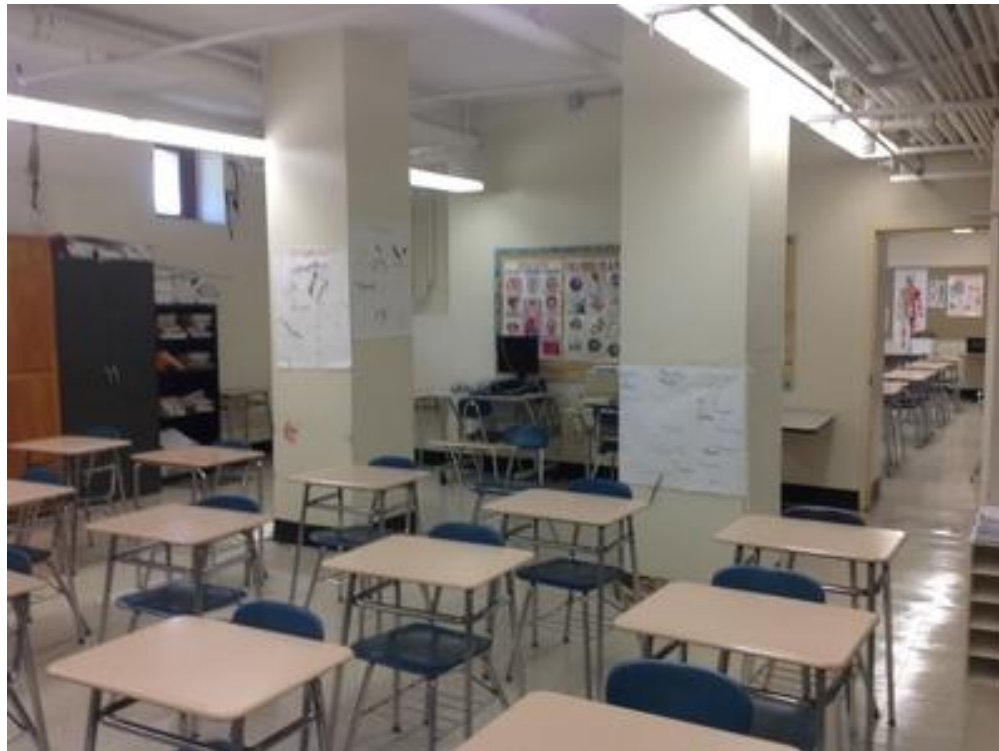
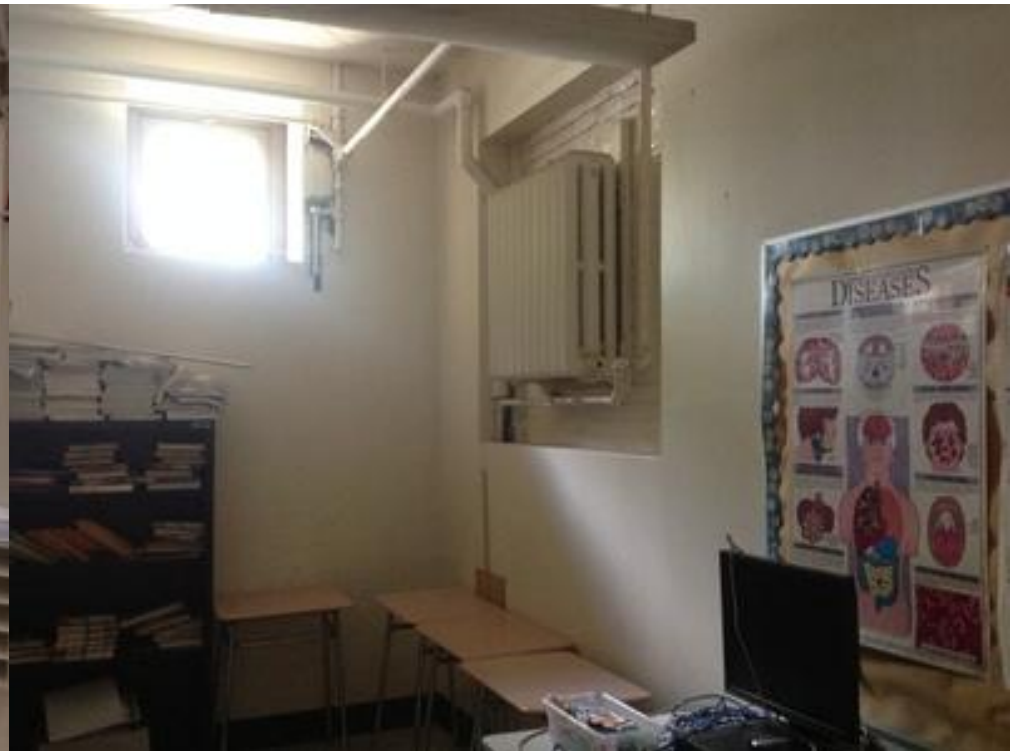
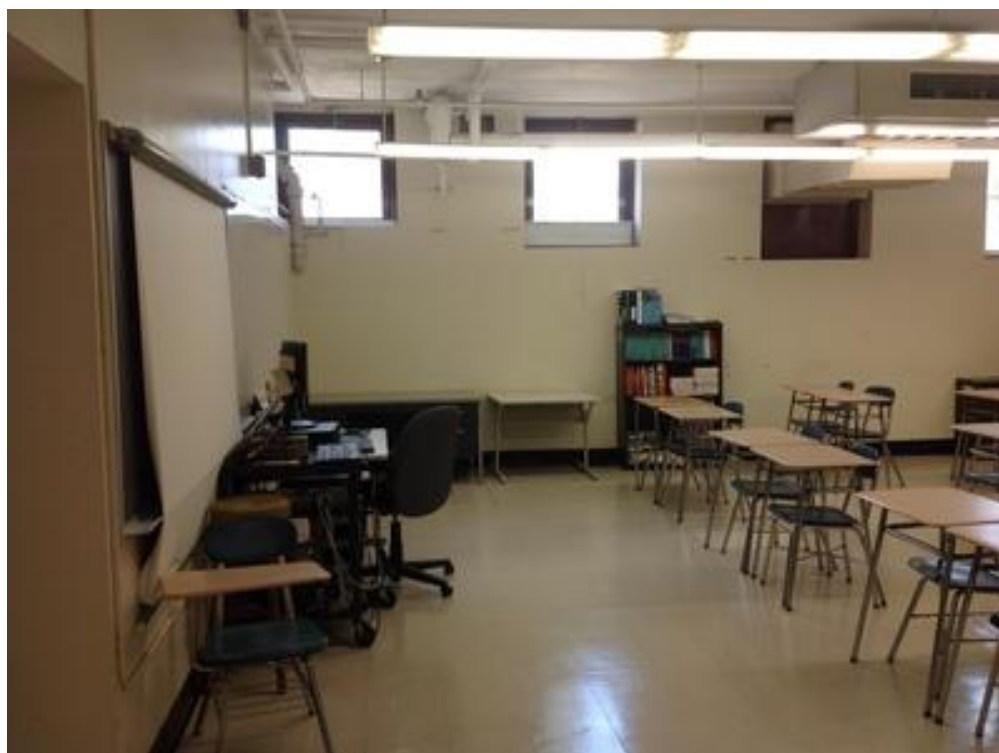
Health classroom in fair condition. VCT Flooring is in fair condition. Piping and wiring is haphazard and surface mounted. Millwork is in poor condition. Some of the clerestory windows have lost their seals. Lighting is in poor condition. Some ductwork and piping is rusty.
