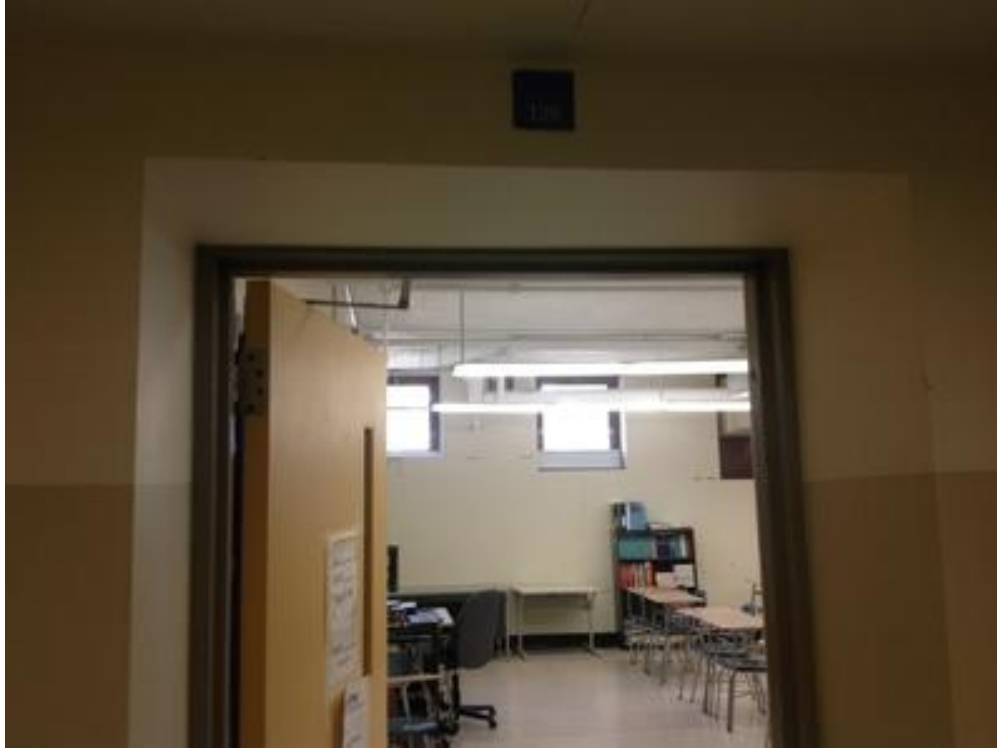
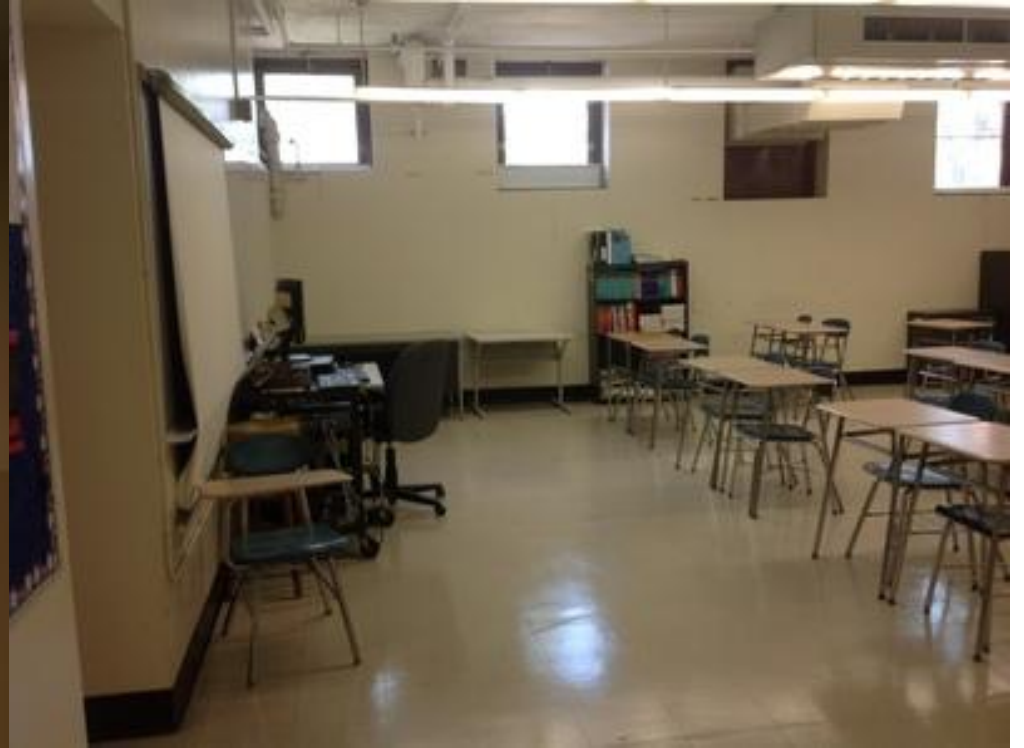
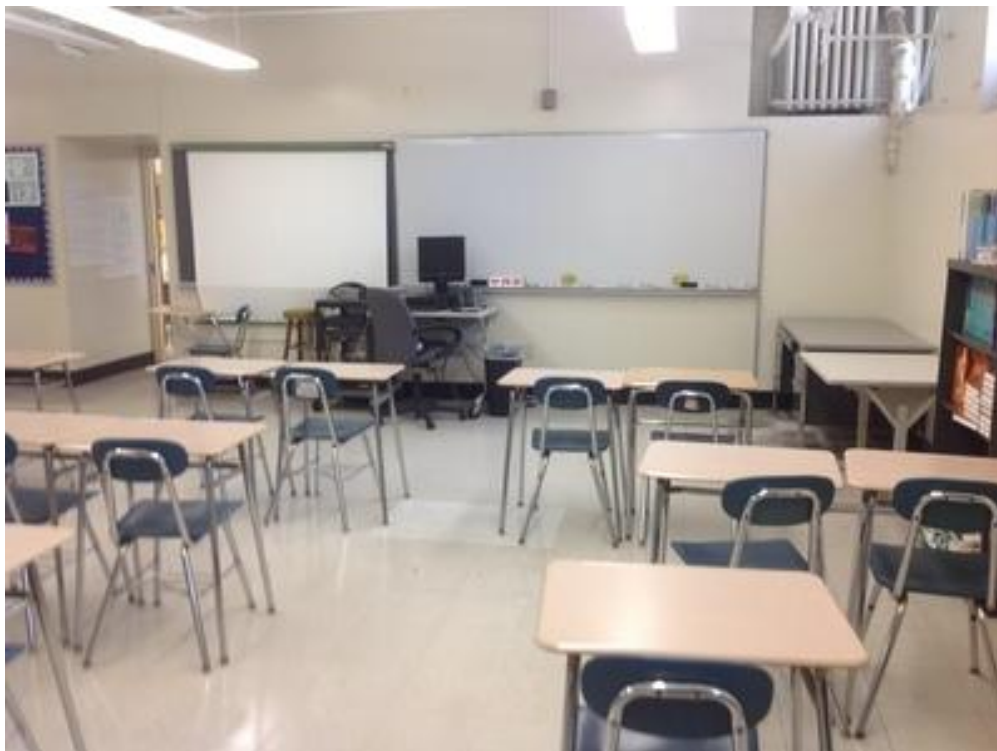
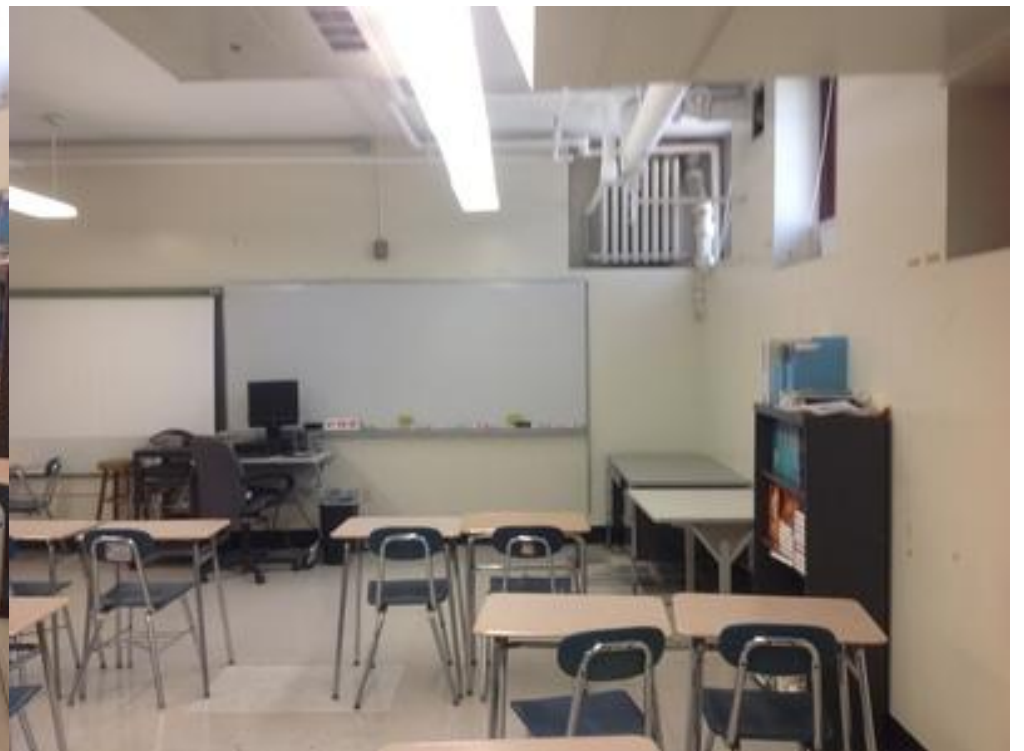
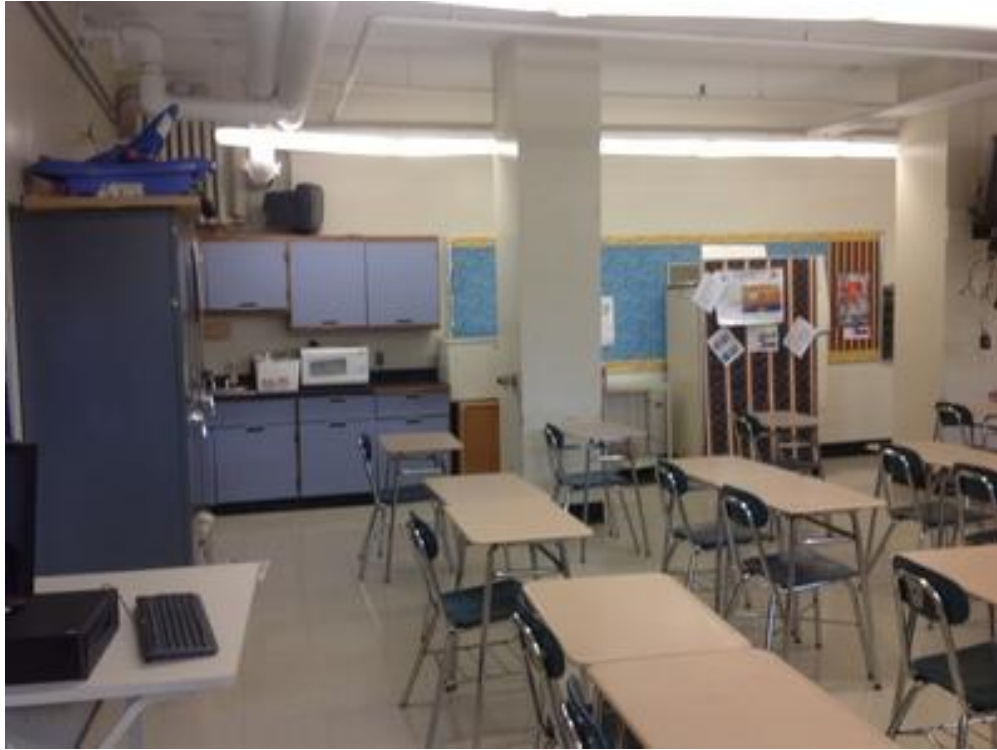
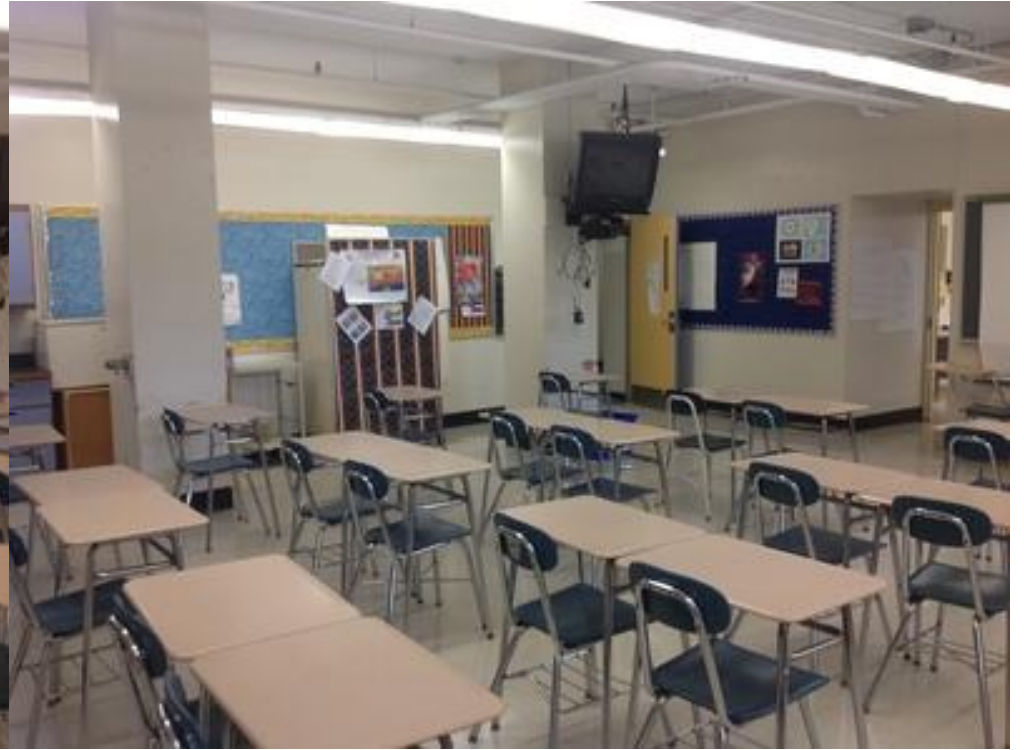
Health classroom in fair condition. VCT Flooring is in fair condition. Piping and wiring is haphazard and surface mounted. Millwork is in poor condition. Some of the clerestory windows have lost their seals. Lighting is in poor condition. Some ductwork and piping is rusty.

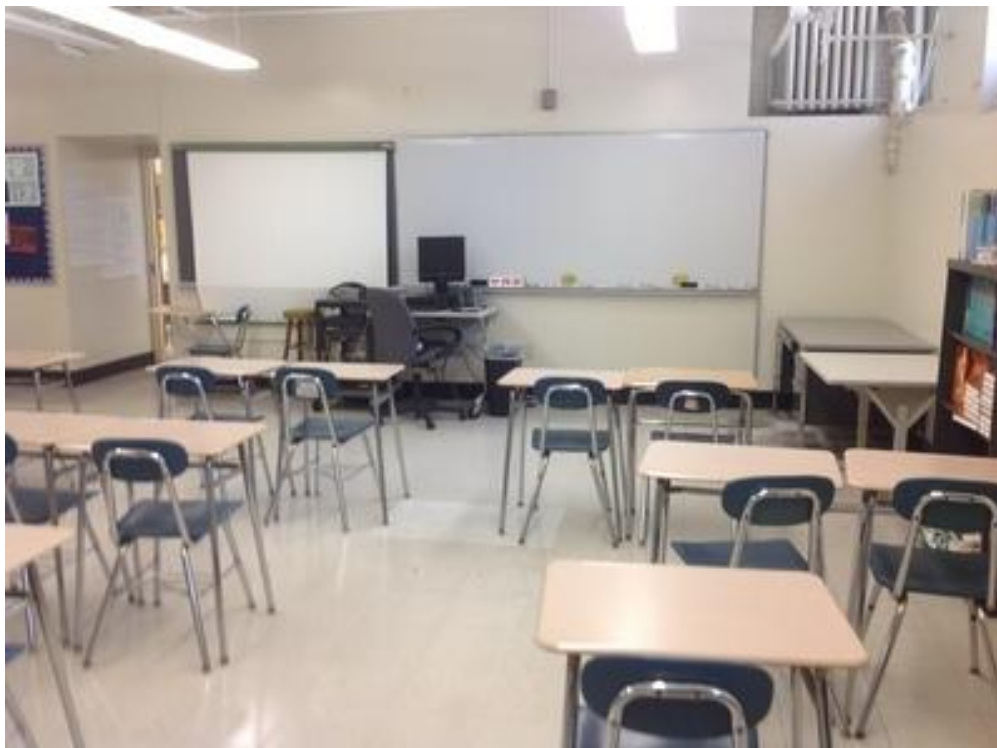
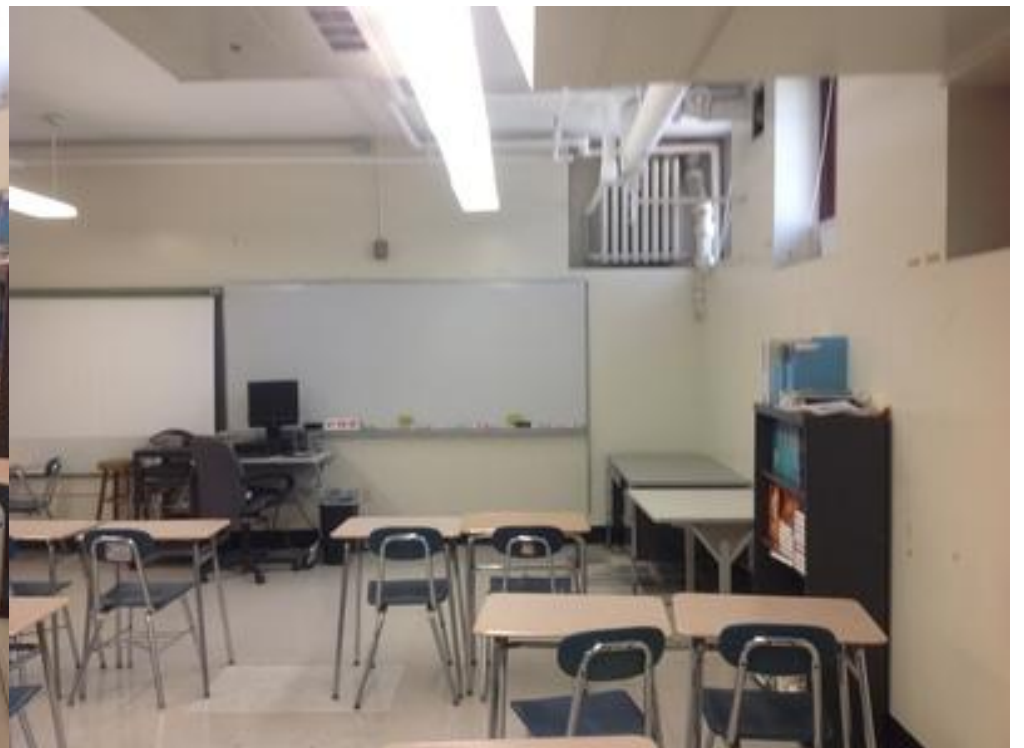
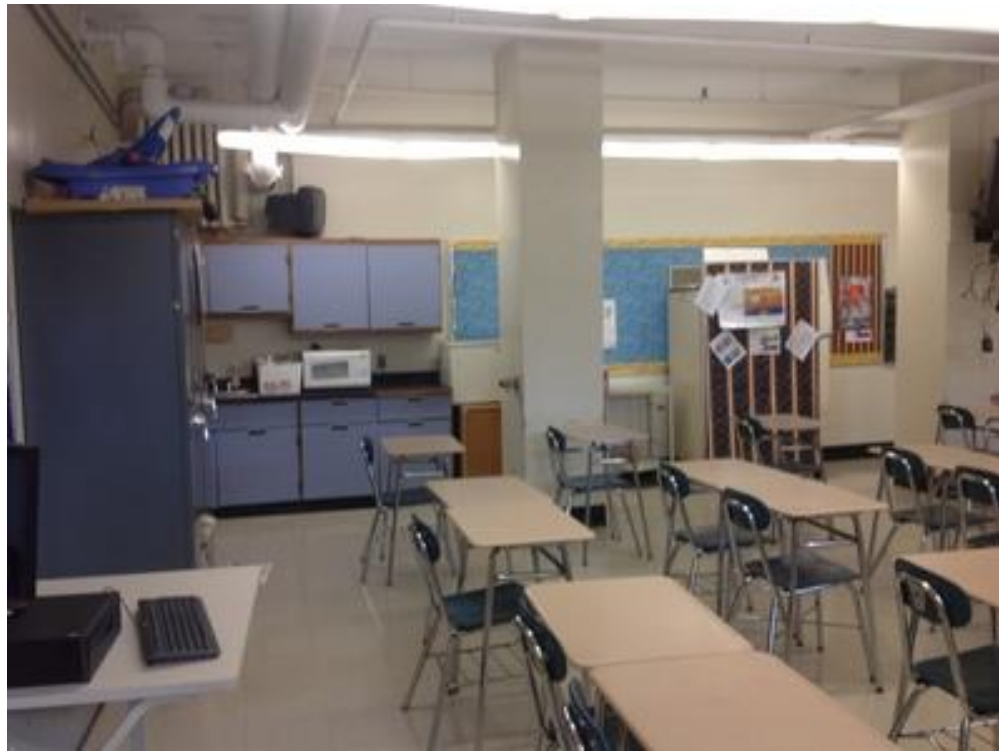
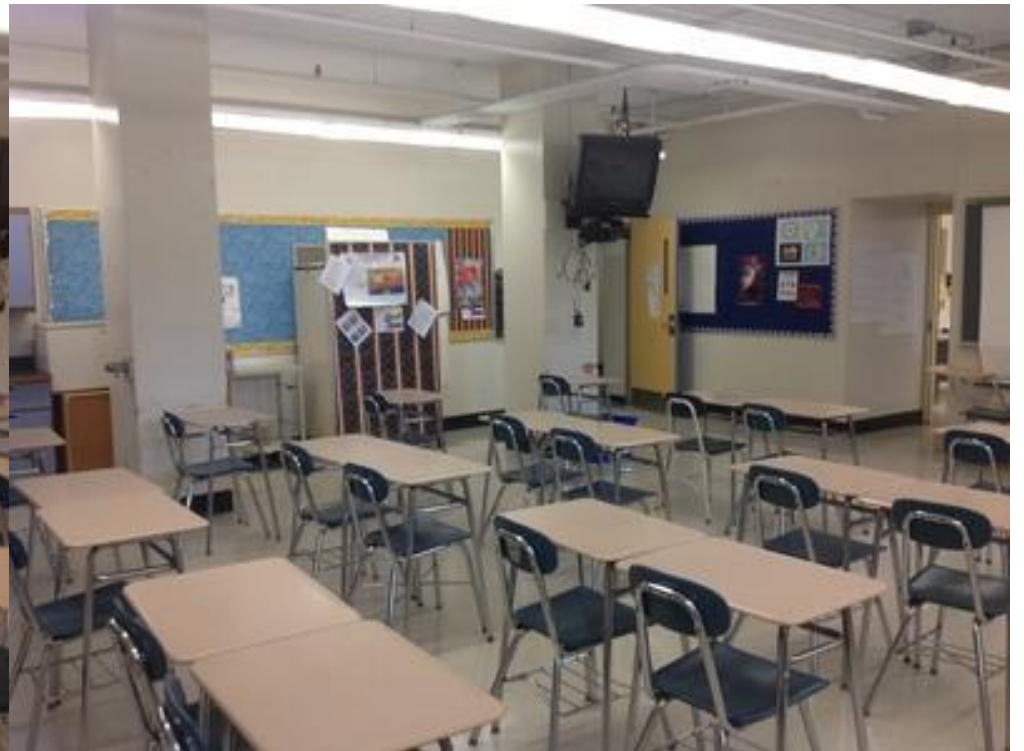
Description
IT space is in fair condition. VCT Flooring is in fair condition. Piping and wiring is haphazard and surface mounted. Millwork is in poor condition. ACT ceiling in poor conditionSome of the clerestory windows have lost their seals. Lighting is in poor condition. Some ductwork and piping is rusty.

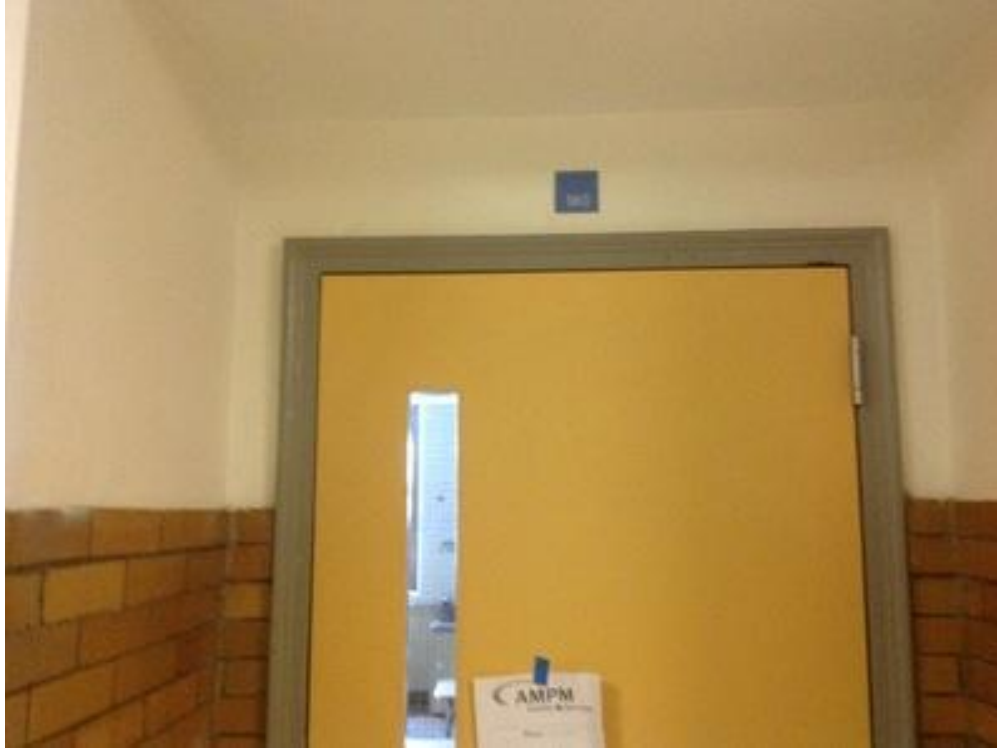
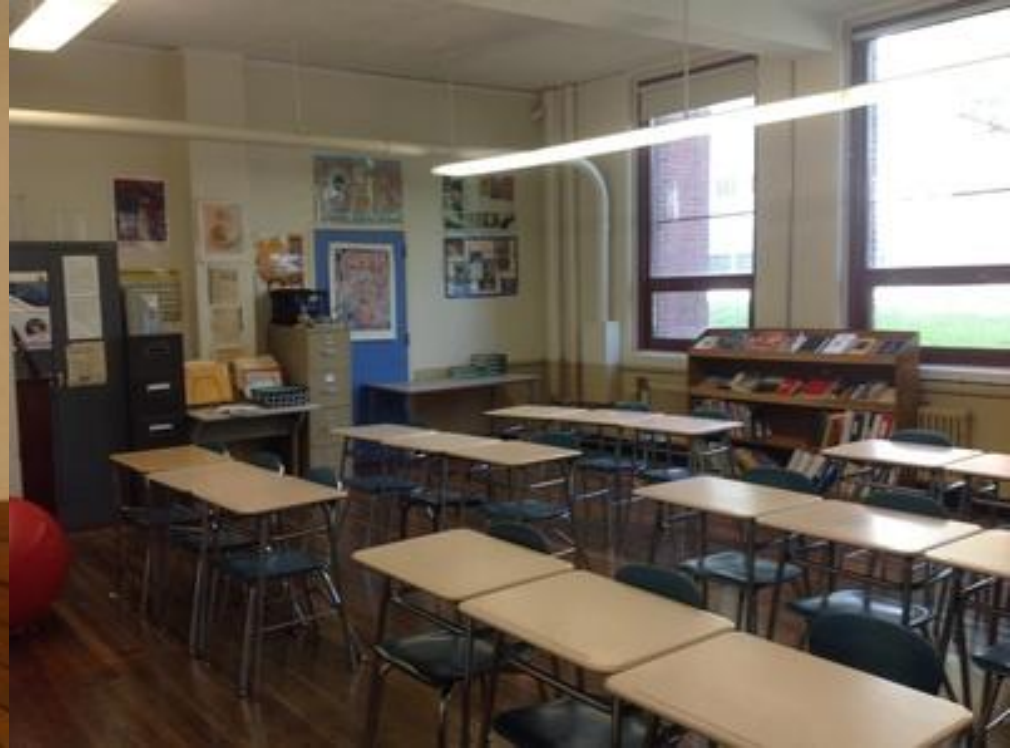
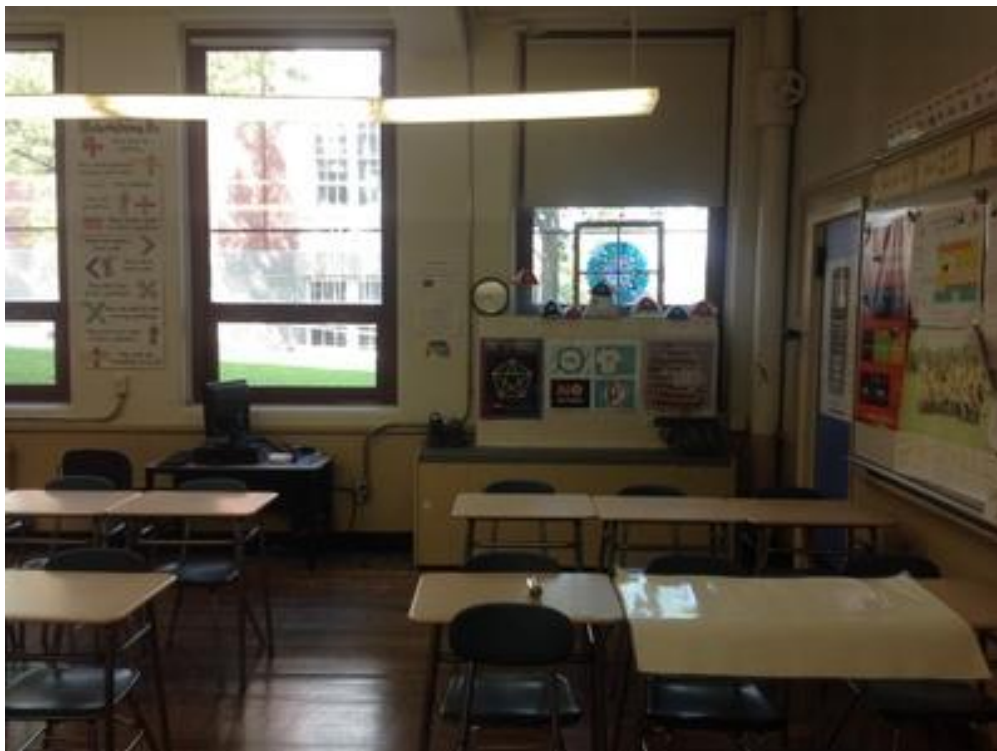
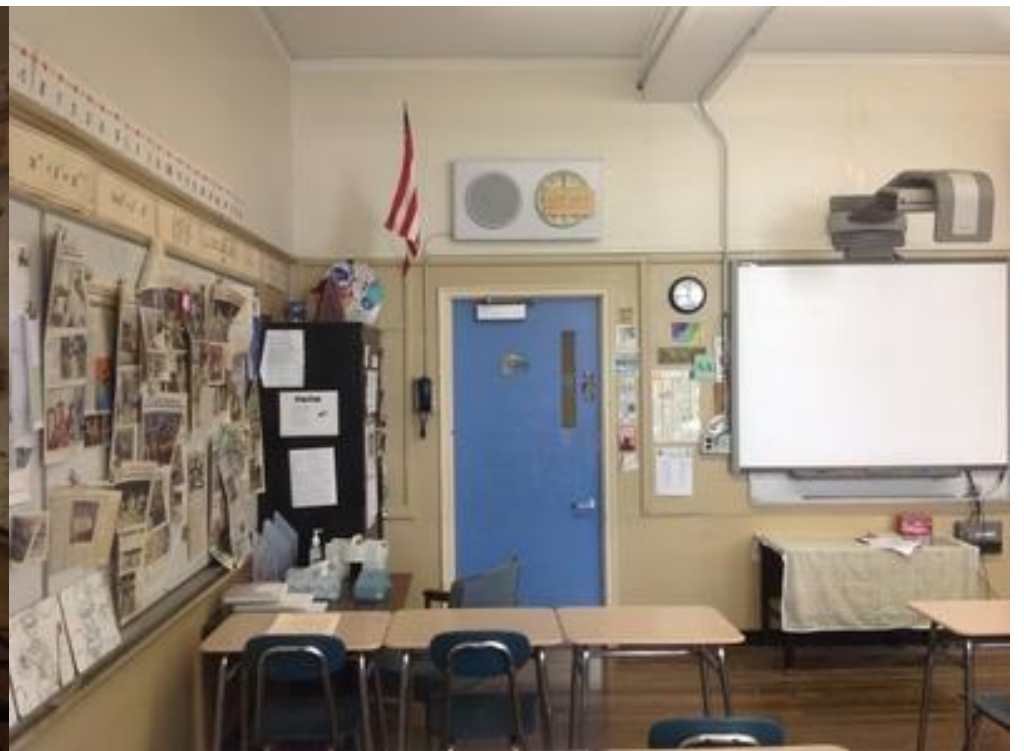
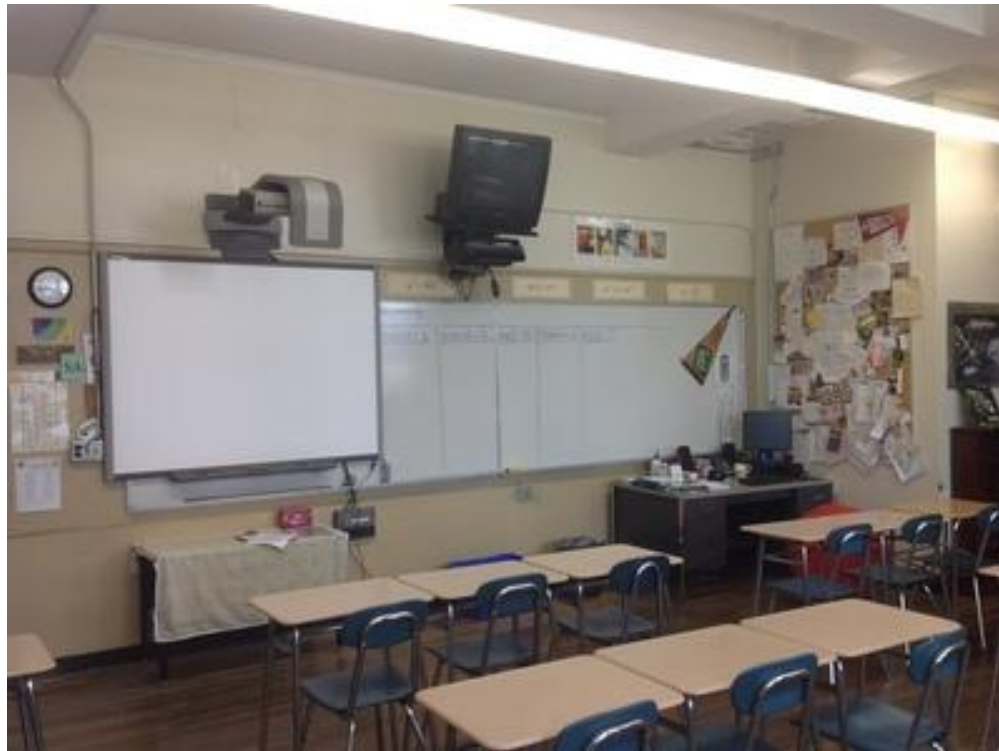
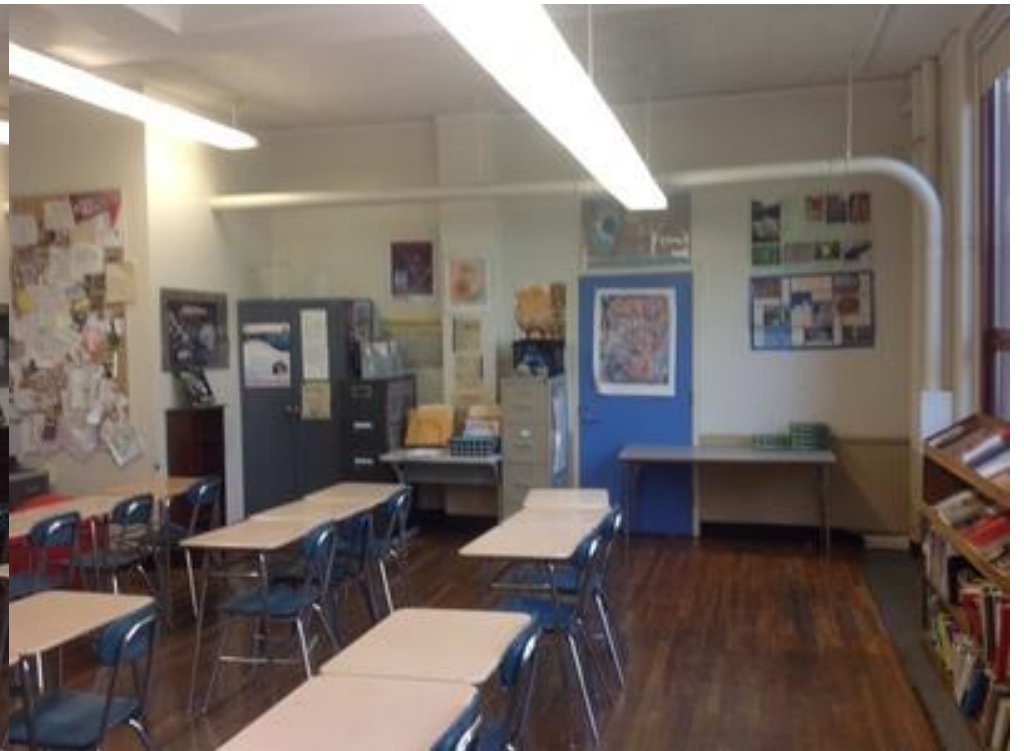
Description
Wood flooring in good condition but creaky. Paint is chipping on walls and ceiling. Light fixtures missing covers in some locations. 10'x20' area of 12"x12" VCT on ceiling. Surface mounted equipment and wiring is haphazard. Shades are in poor condition. Millwork in poor condition. Unit heater in poor condition. Some windows have lost their seal. Classroom has smartboard.
