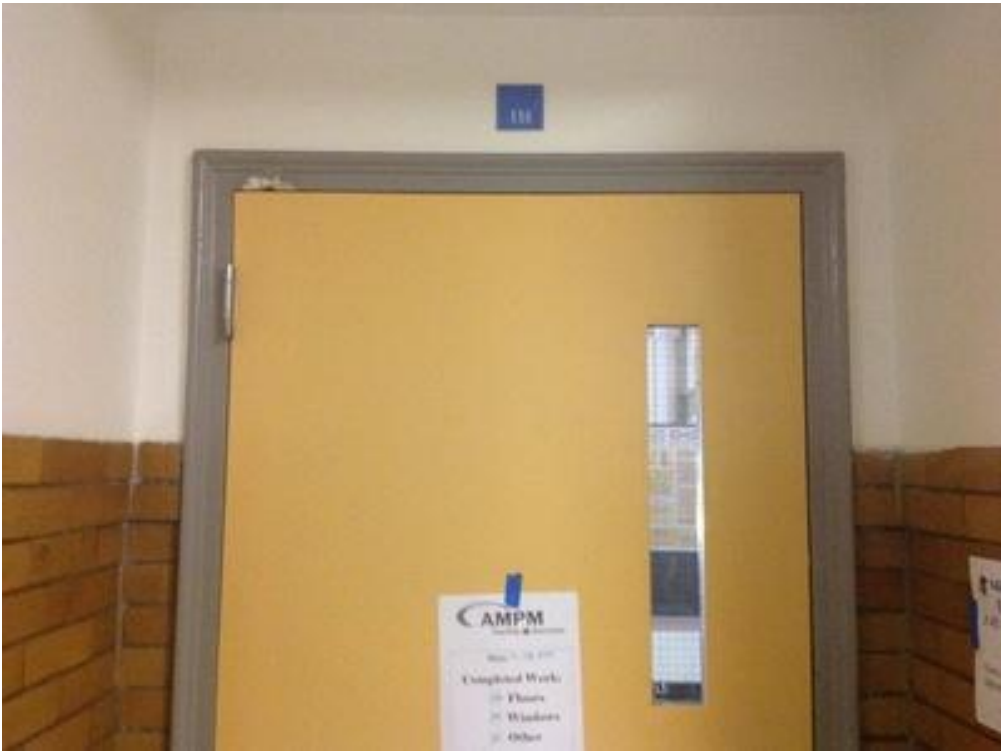
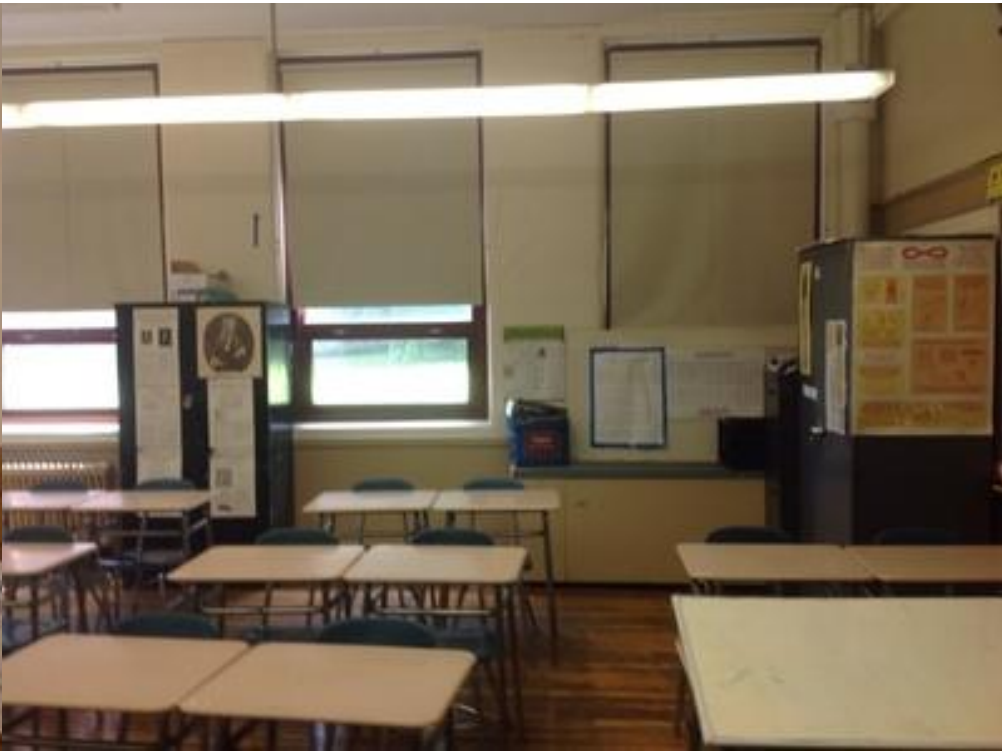
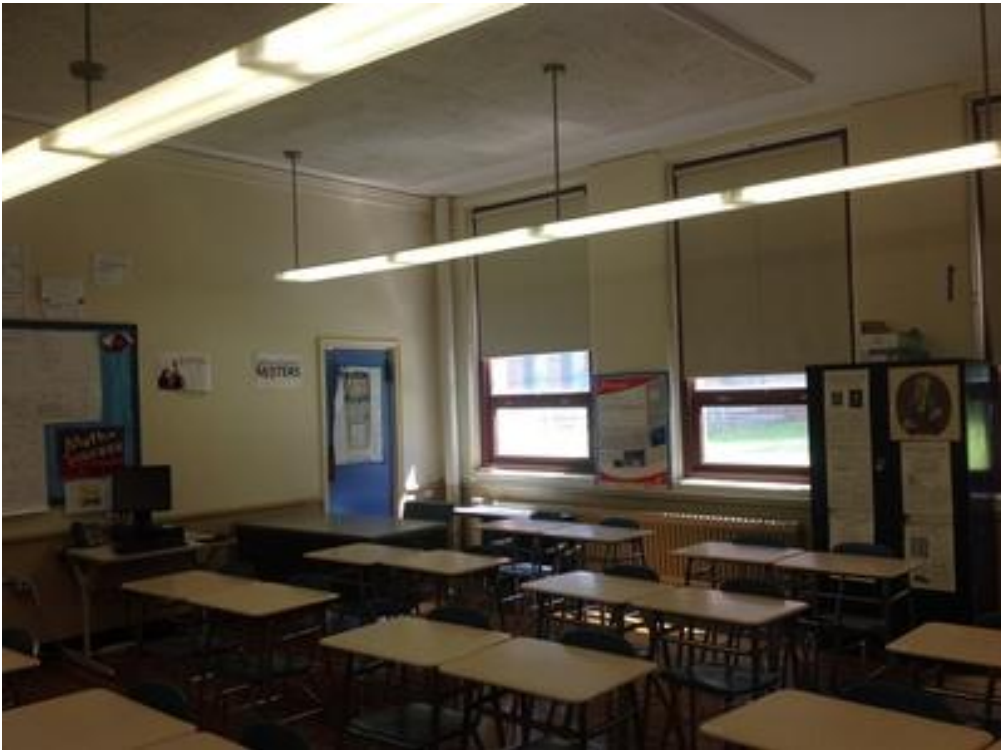
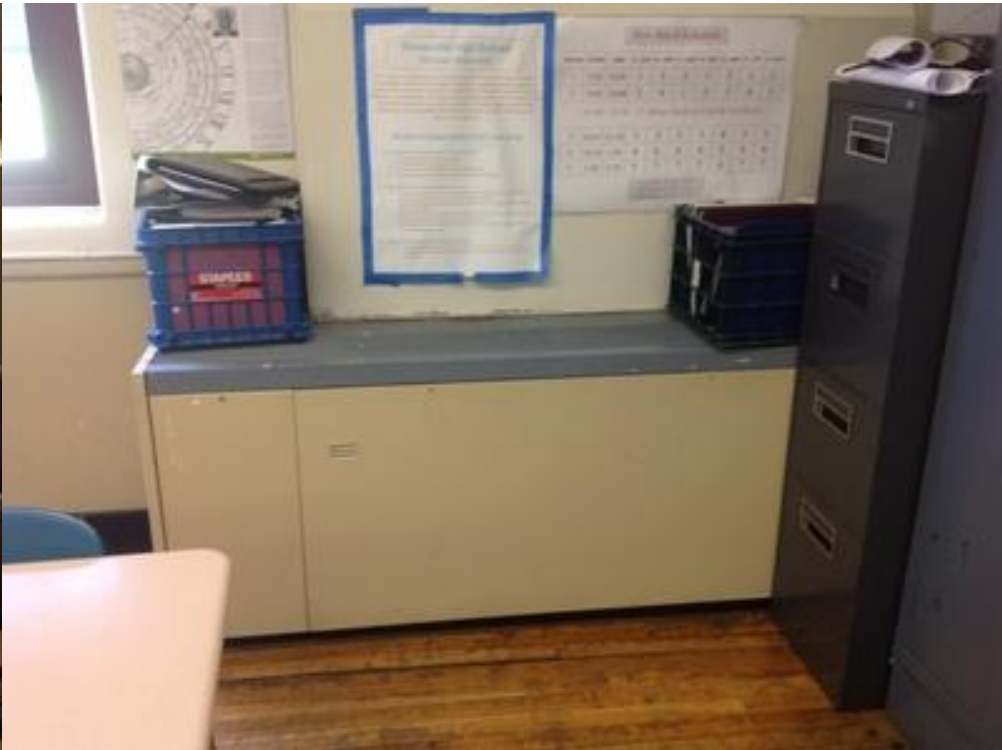
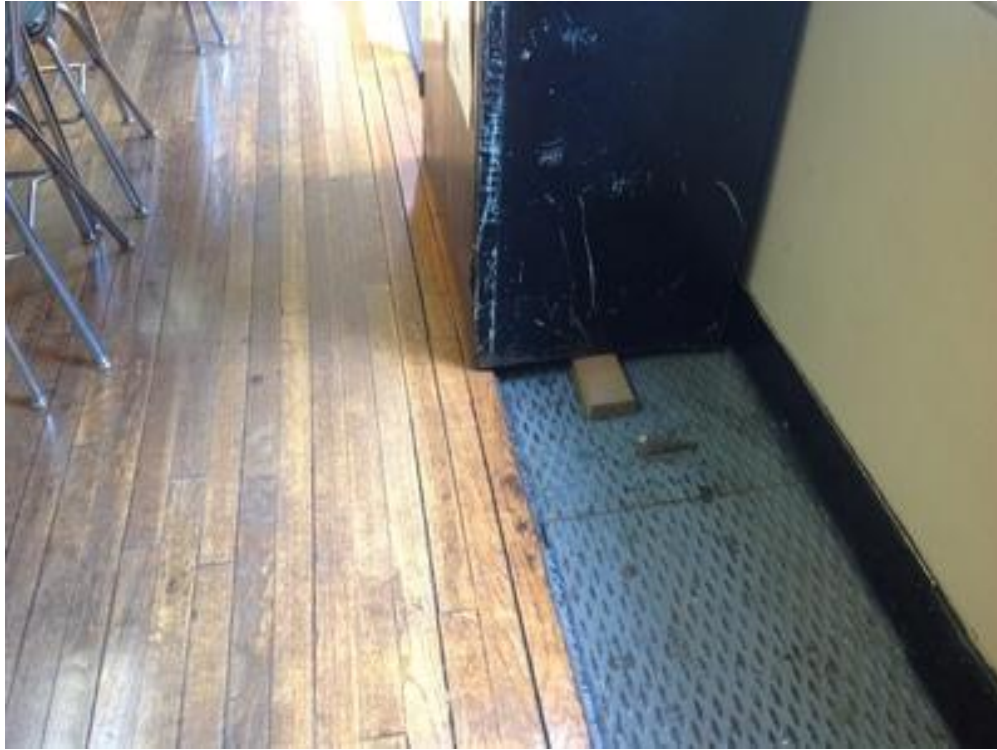
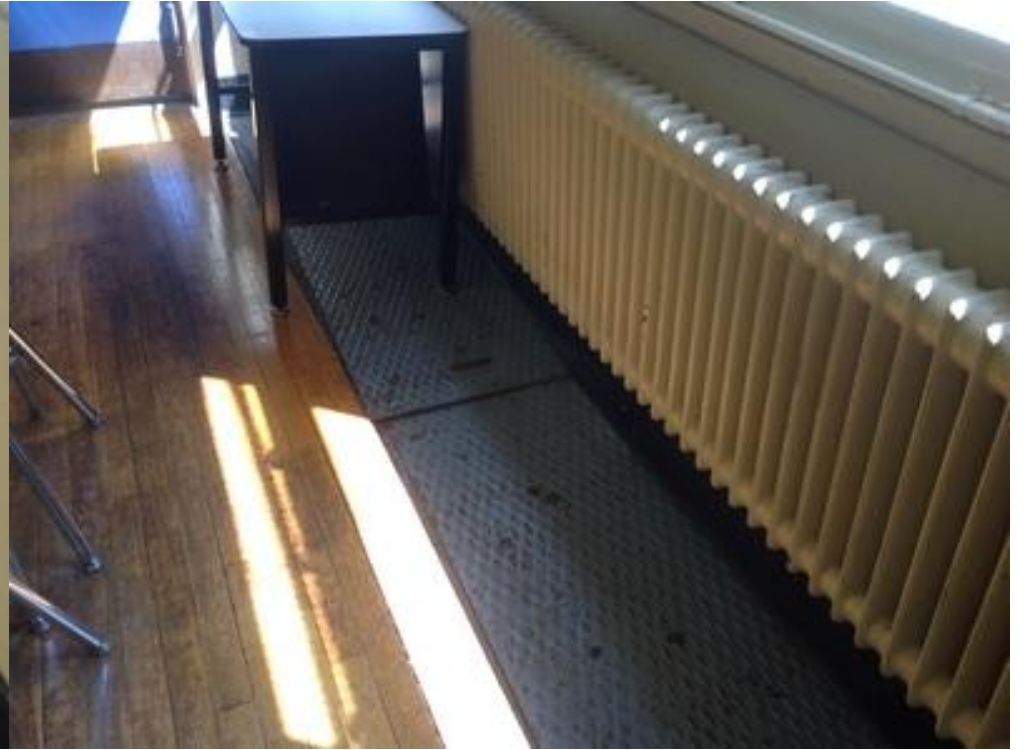
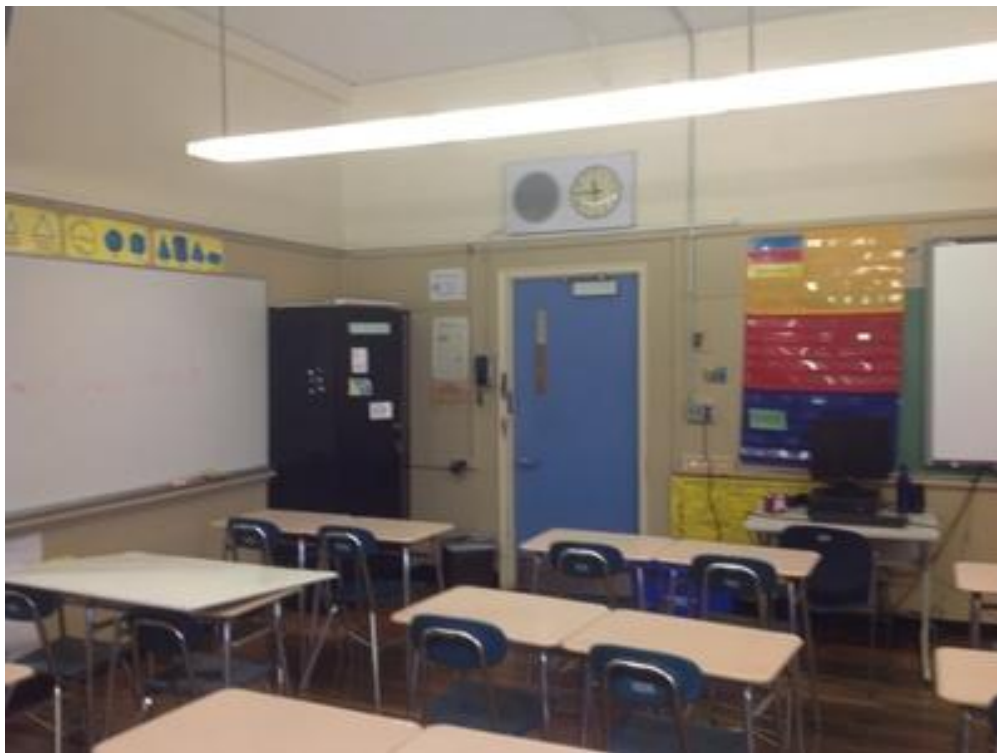
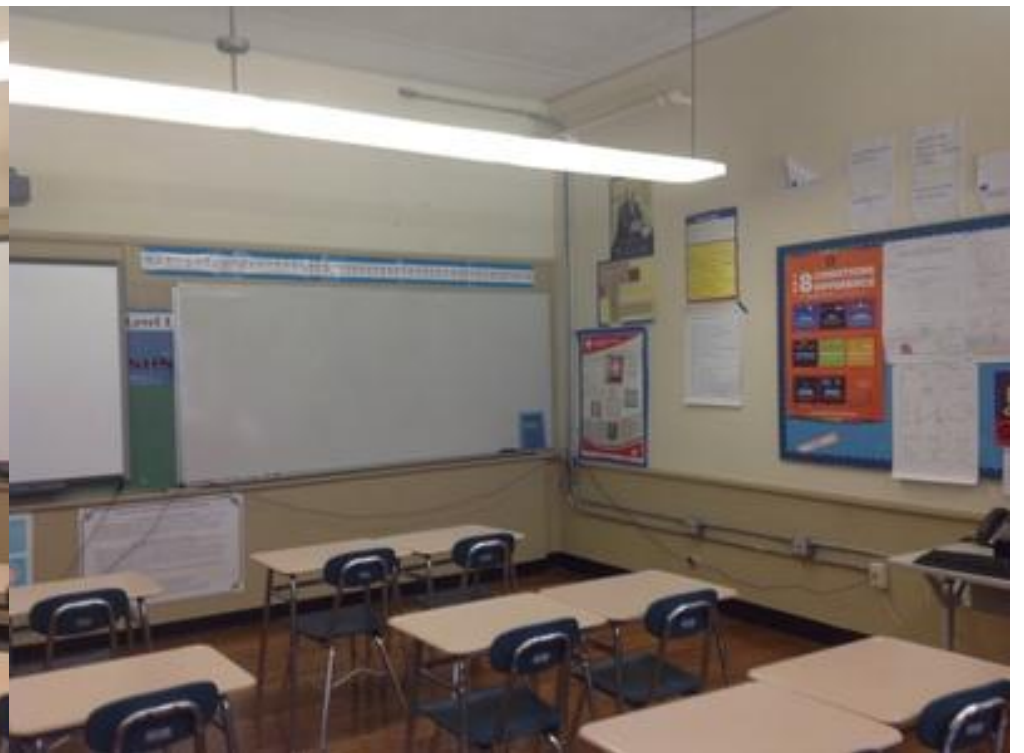
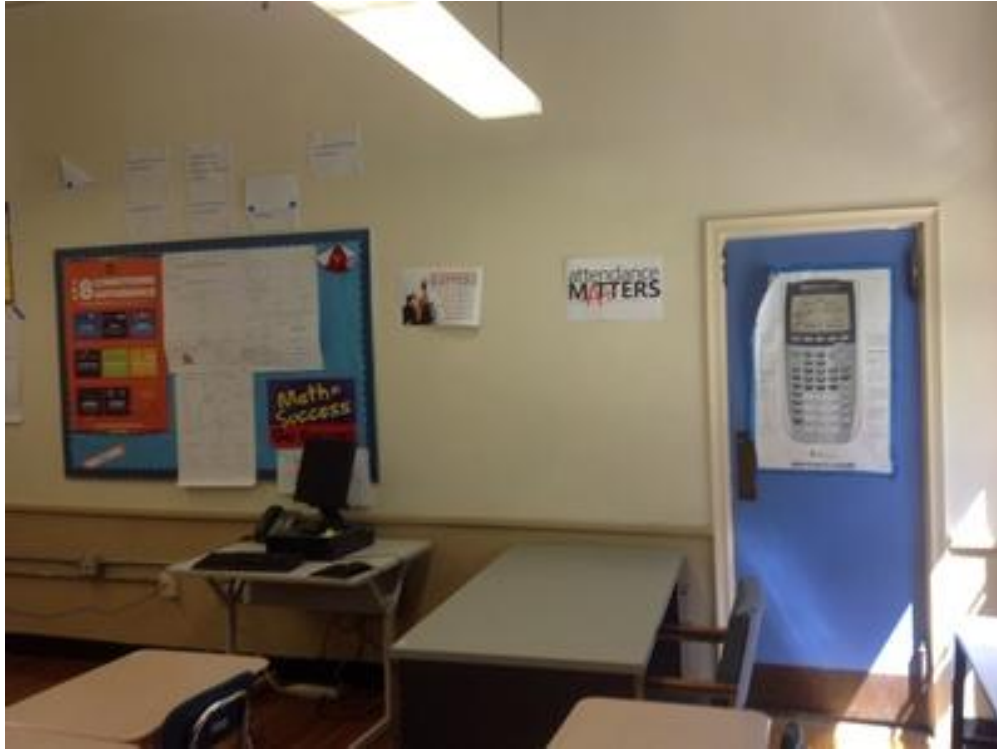
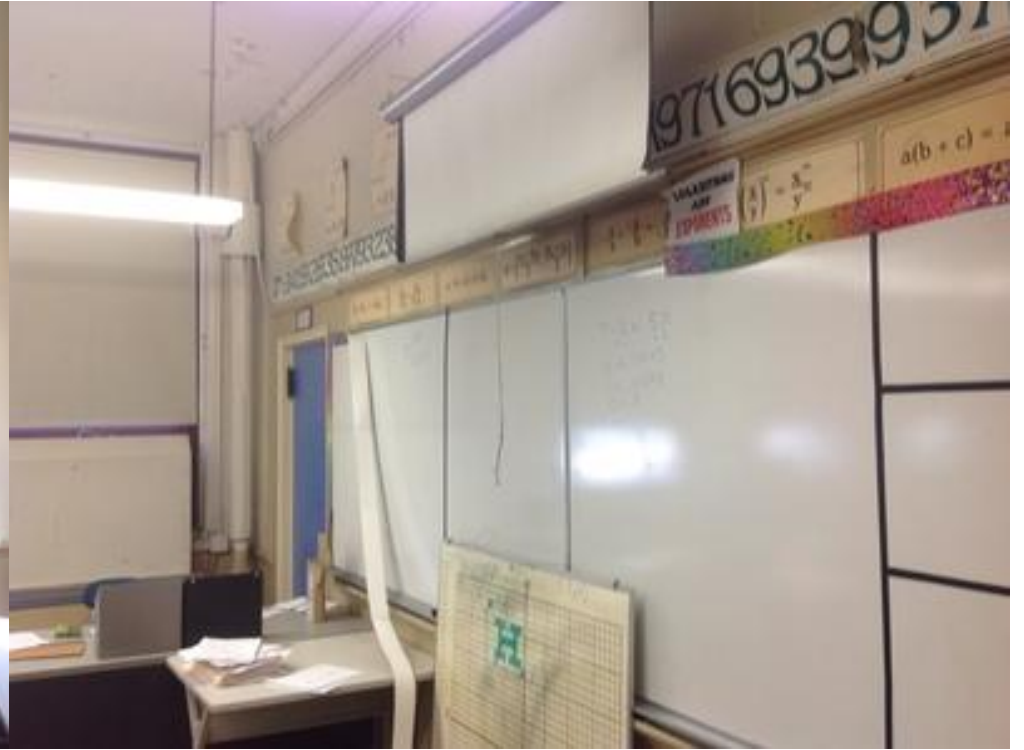
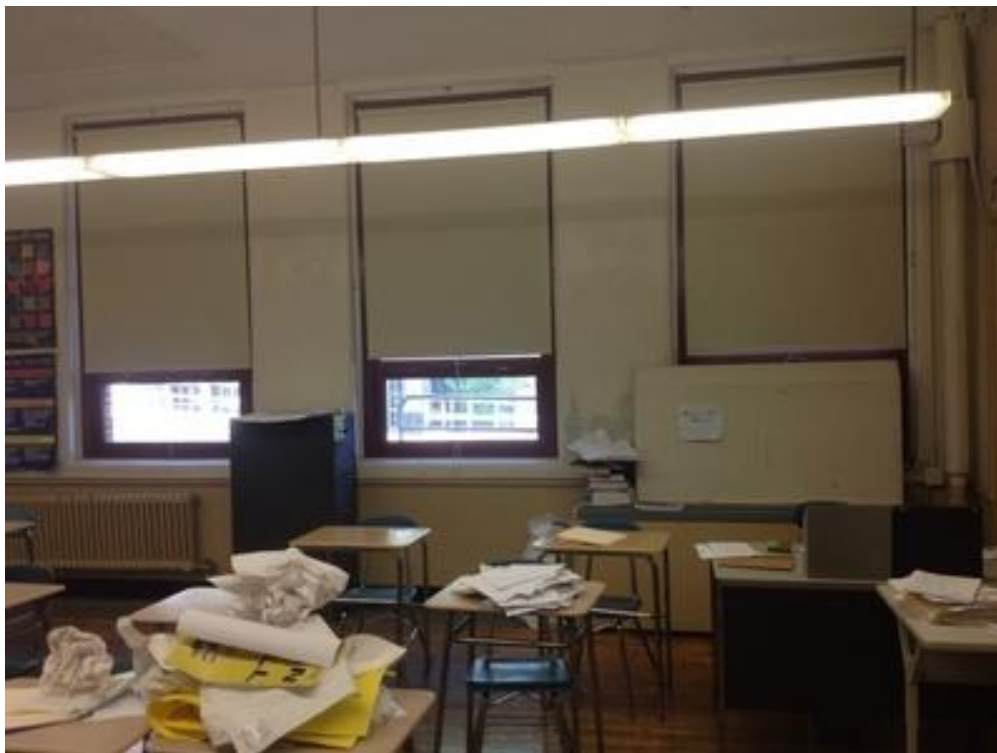
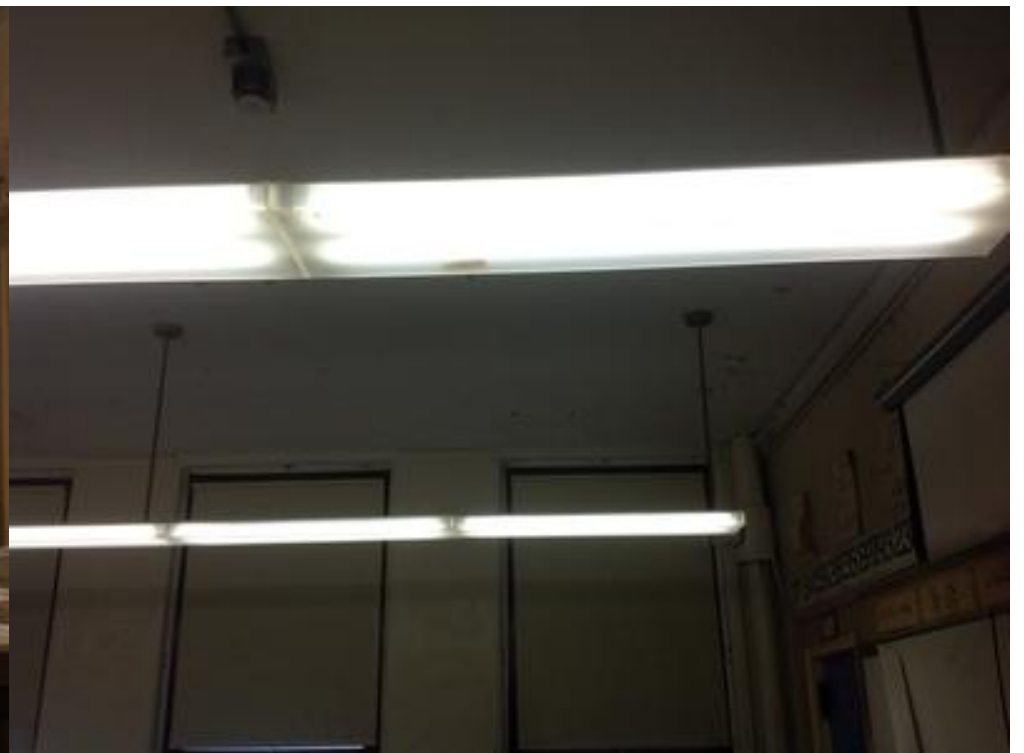
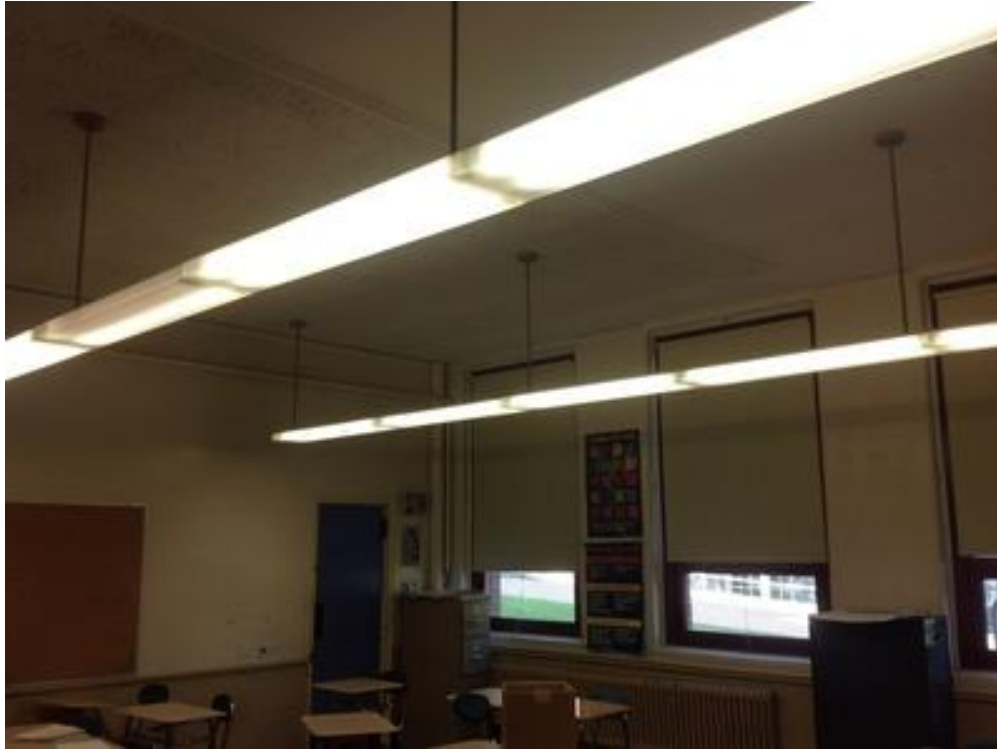
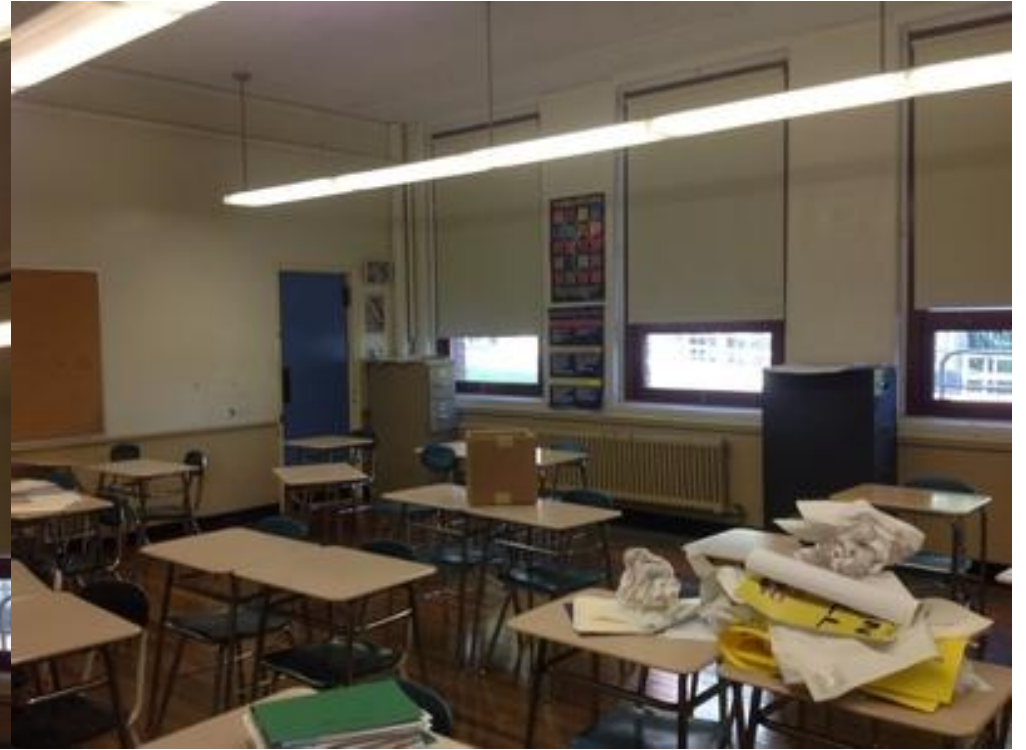
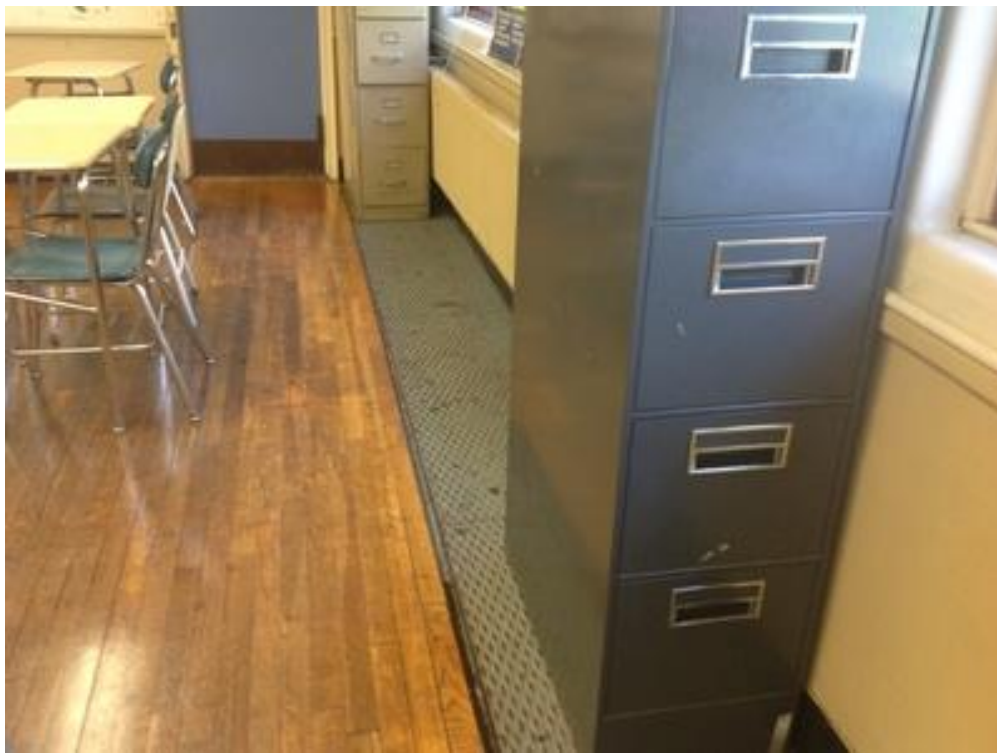
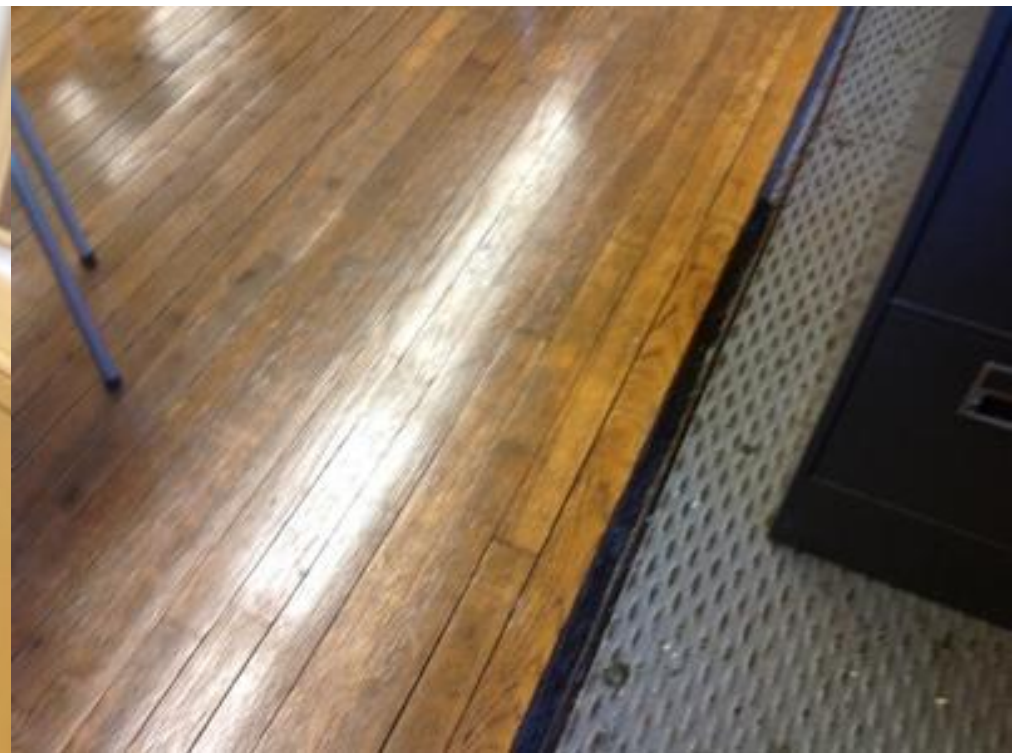
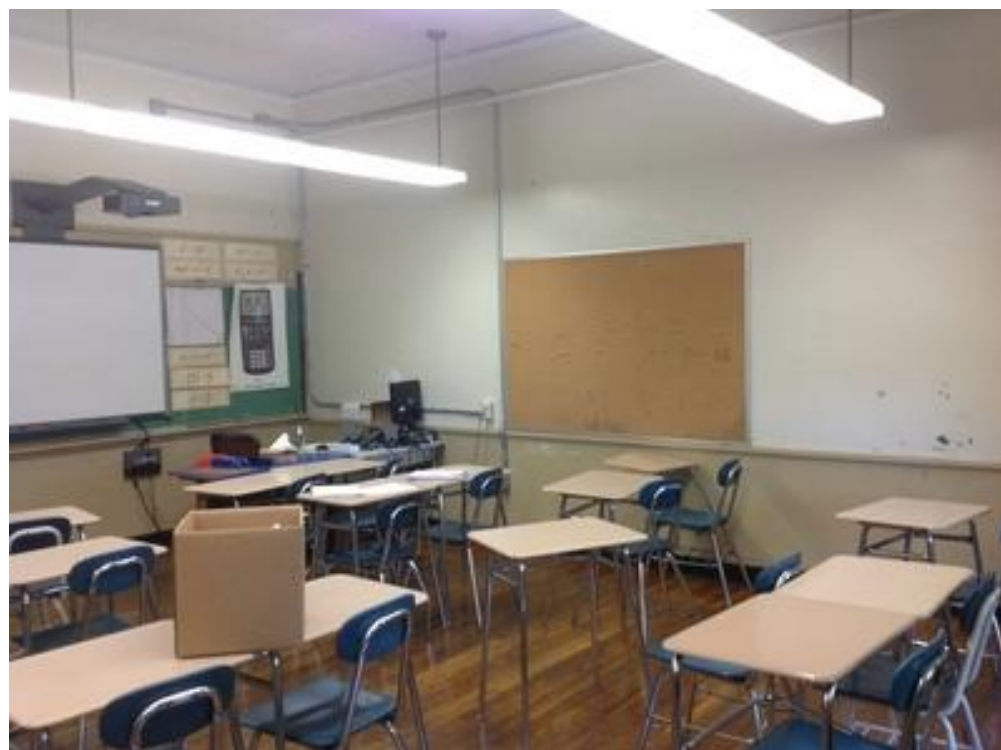
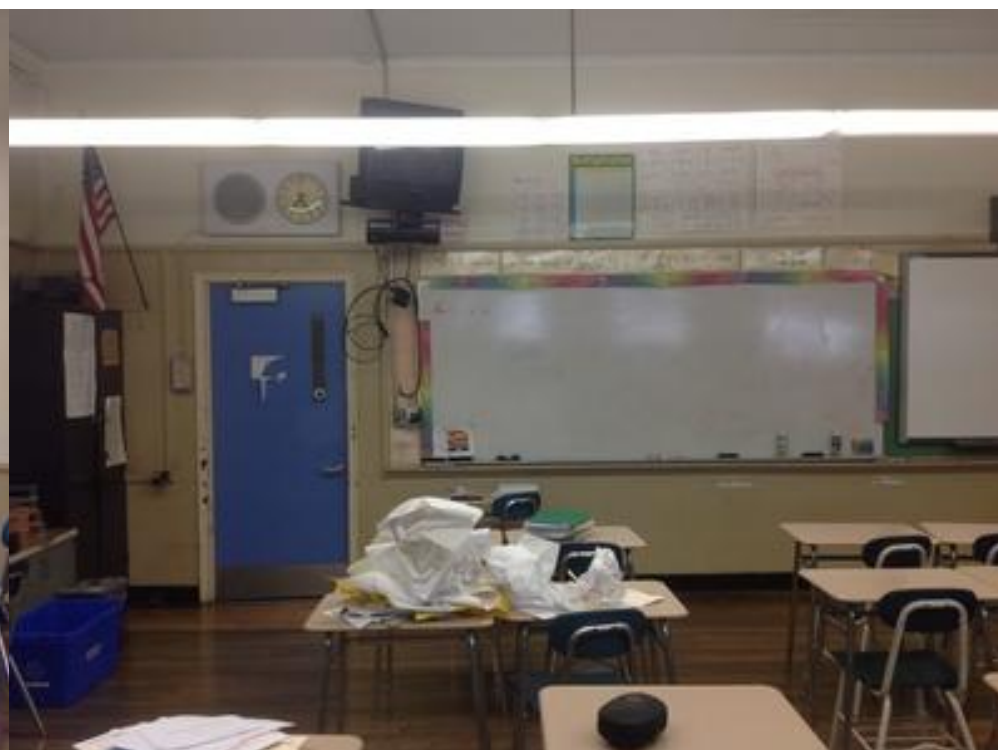
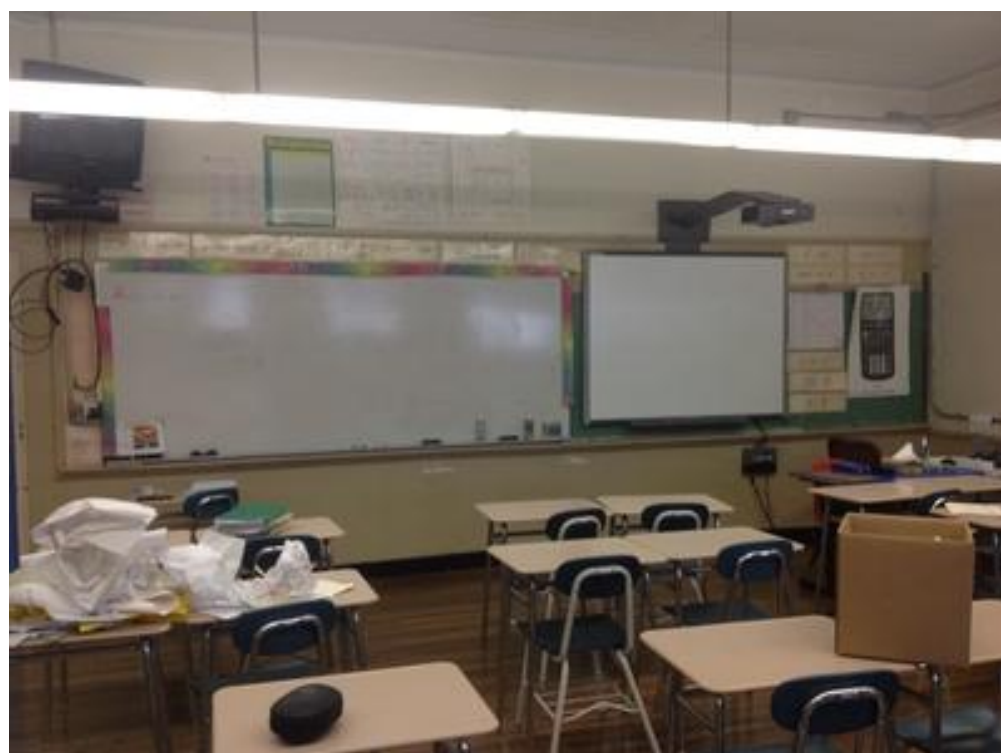
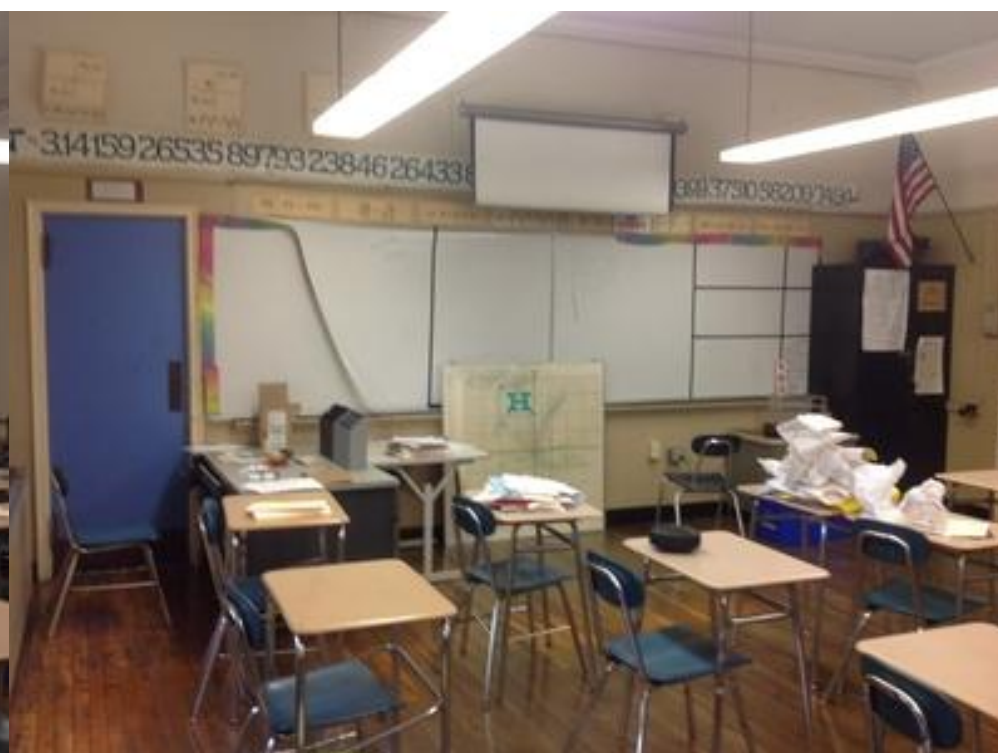
Description
Wood flooring in good condition but creaky. Paint is chipping on walls and ceiling. Light fixtures missing covers in some locations. 10'x20' area of 12"x12" VCT on ceiling. Surface mounted equipment and wiring is haphazard. Shades are in poor condition. Millwork in poor condition. Unit heater in poor condition. Some windows have lost their seal. Classroom has smartboard.

| Condition | Fair | | |

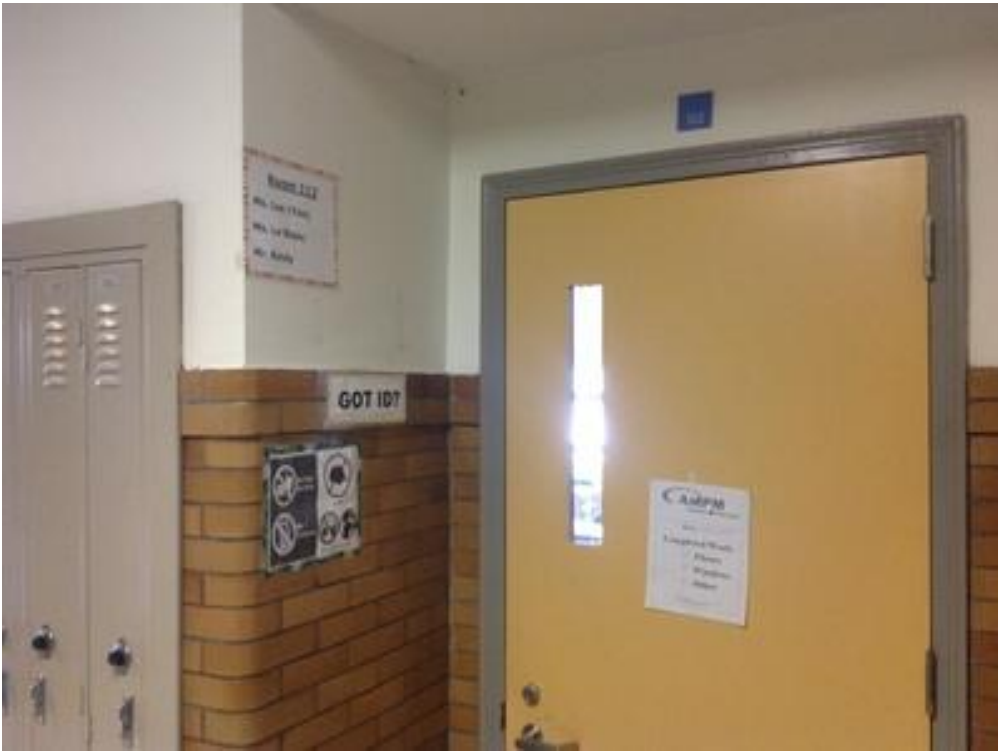
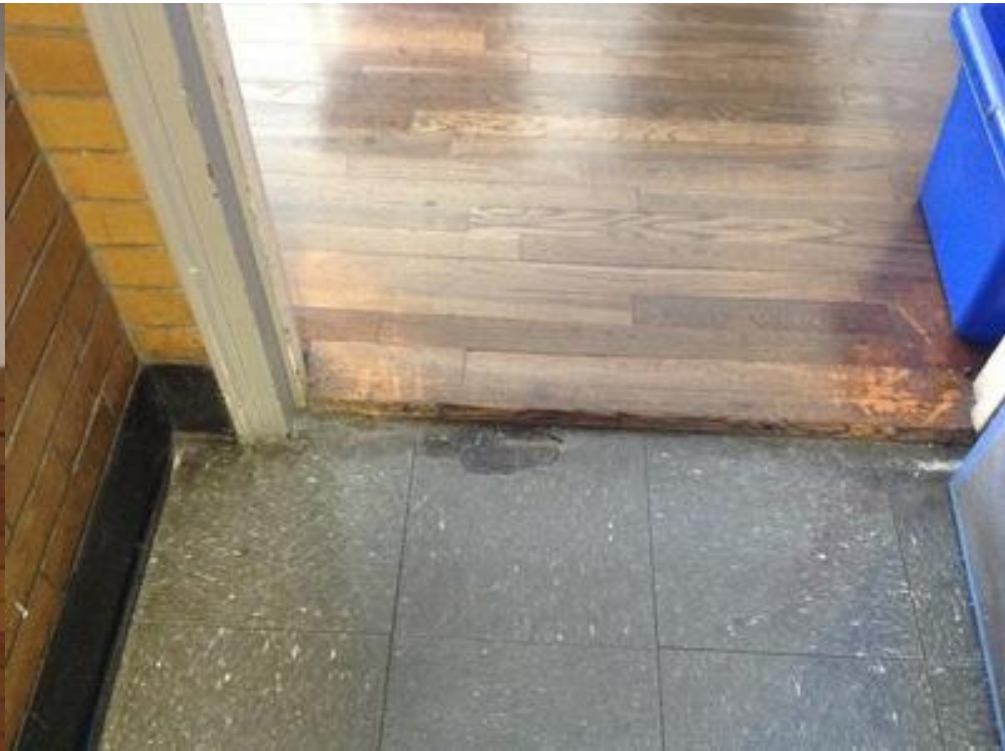
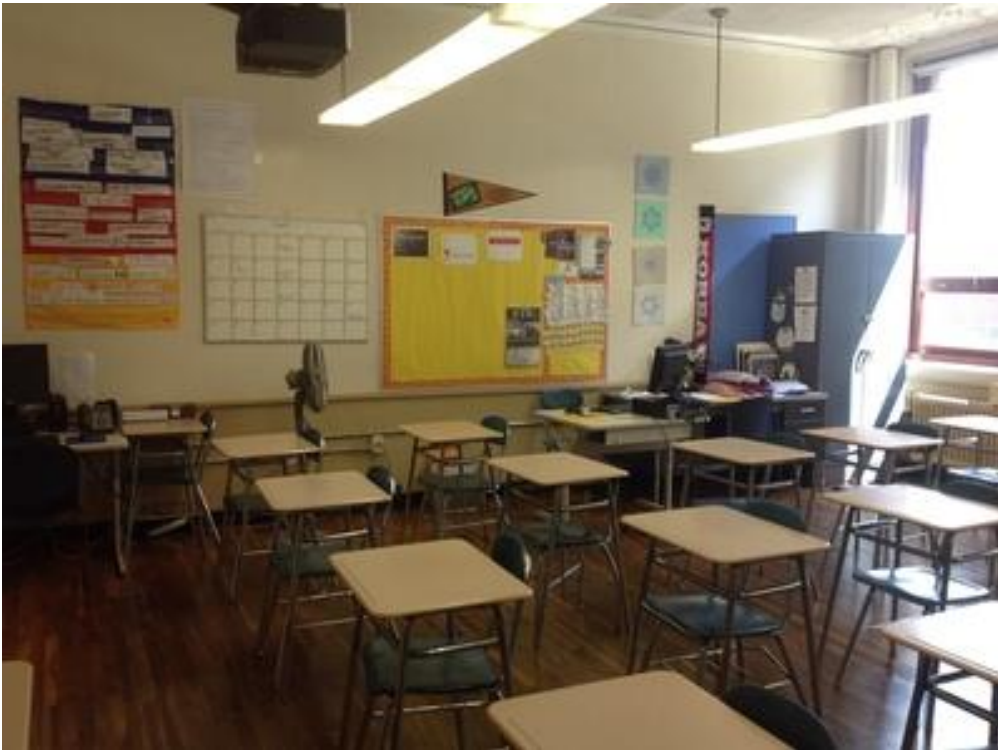
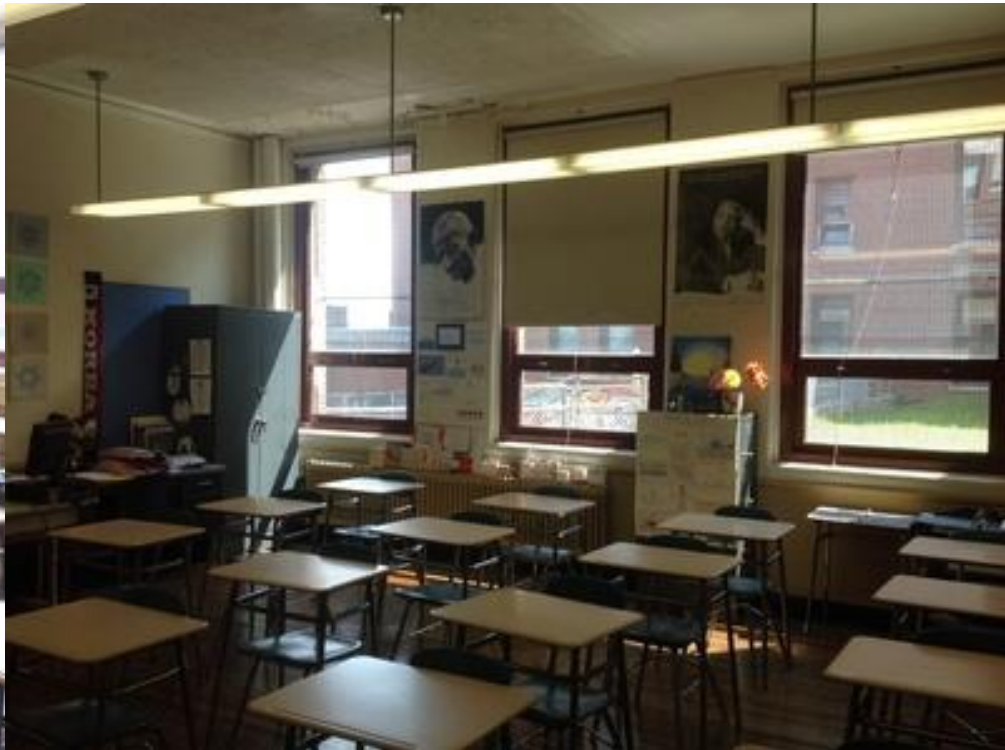
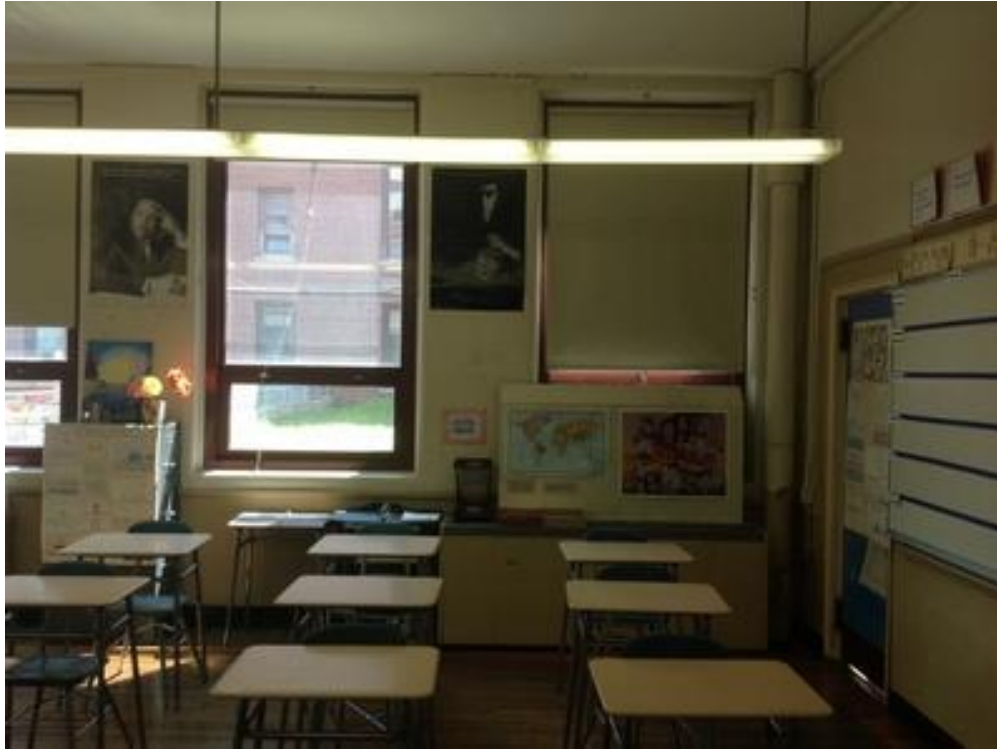
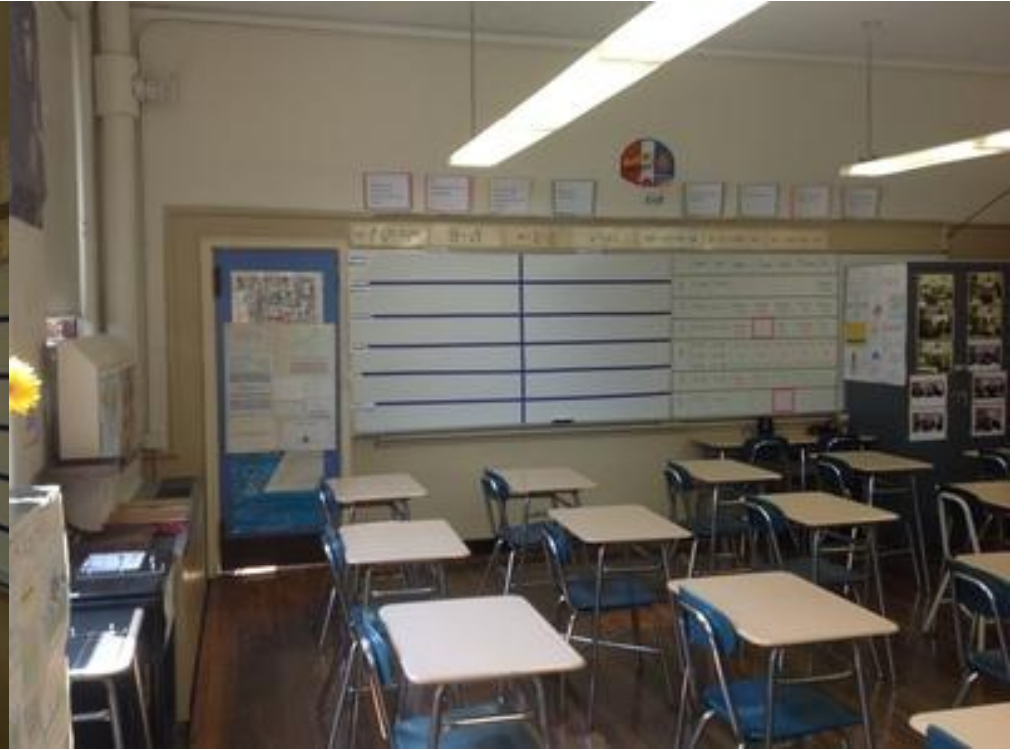
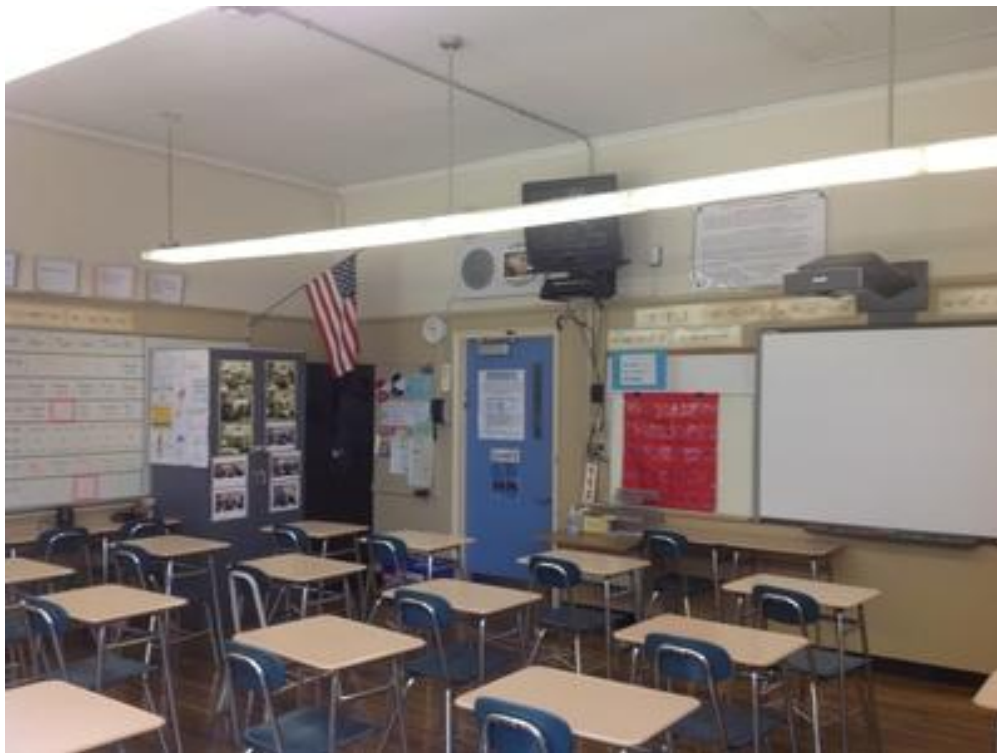
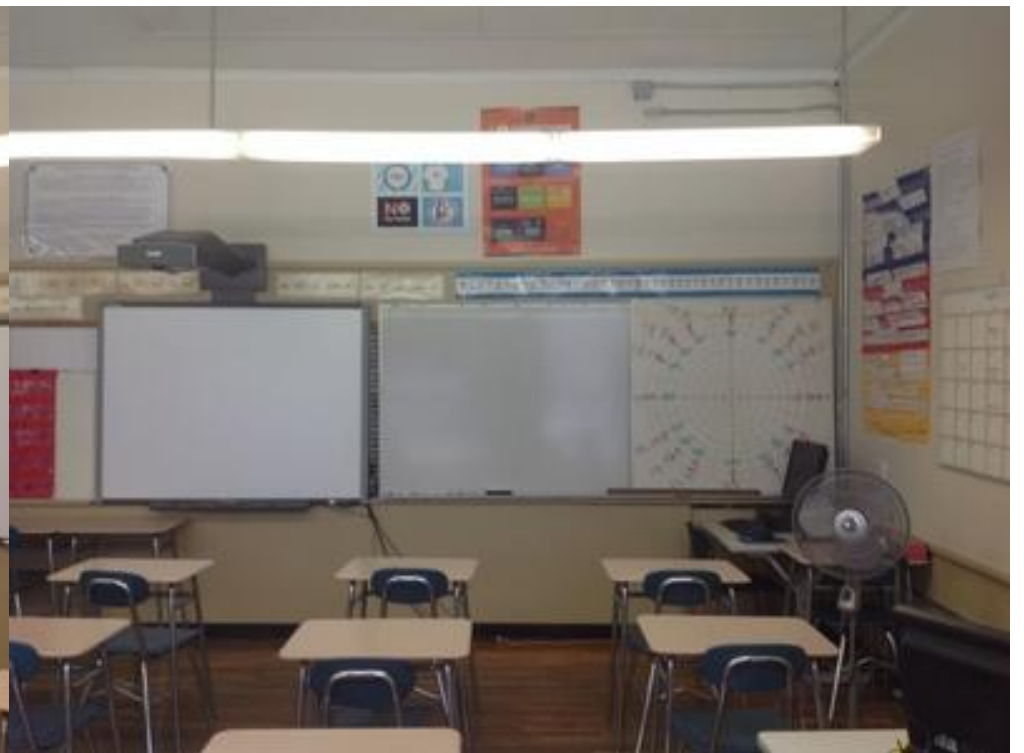
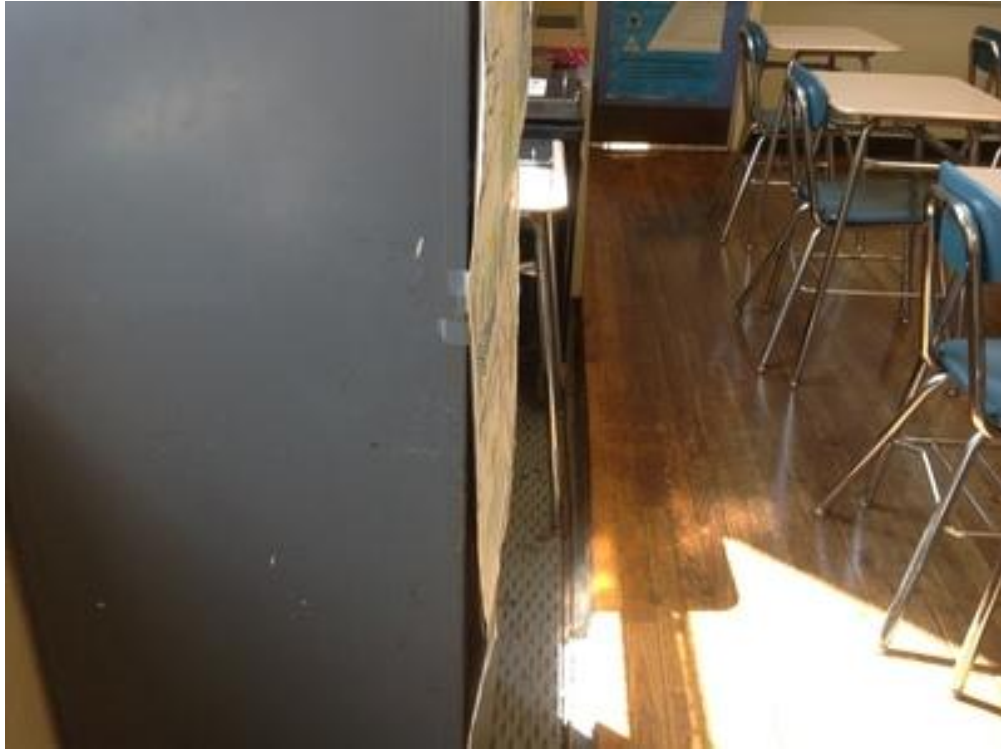
Description
Wood flooring in good condition but creaky. Paint is chipping on walls and ceiling. Light fixtures missing covers in some locations. 10'x20' area of 12"x12" VCT on ceiling. Surface mounted equipment and wiring is haphazard. Shades are in poor condition. Millwork in poor condition. Unit heater in poor condition. Some windows have lost their seal. Classroom has smartboard.

| Condition | Fair | | |
