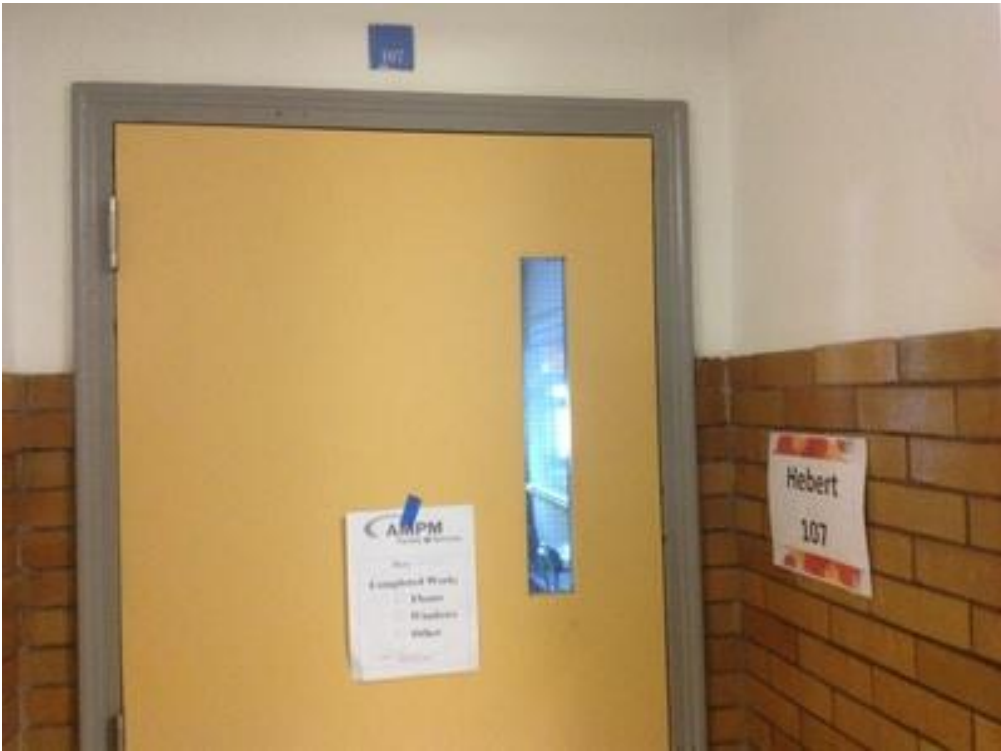
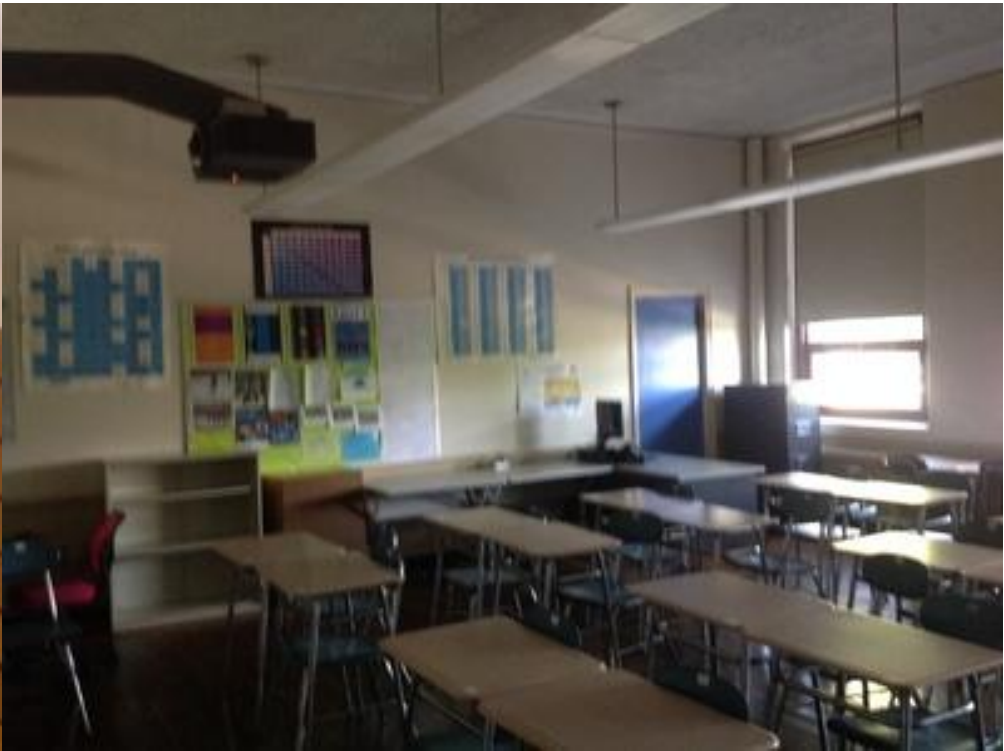
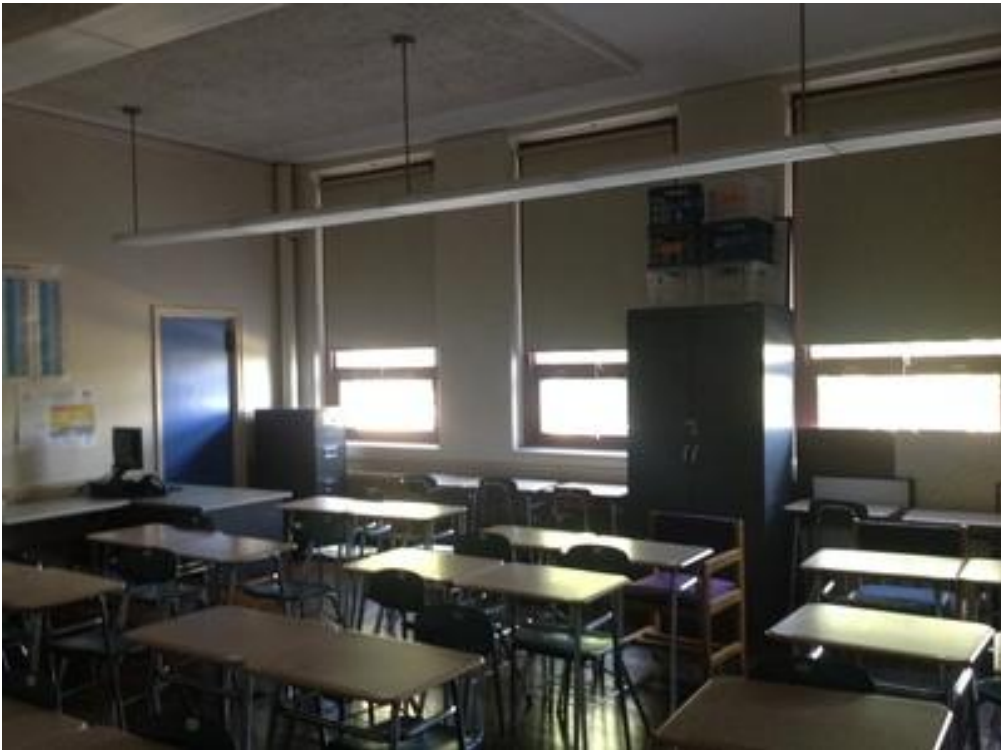
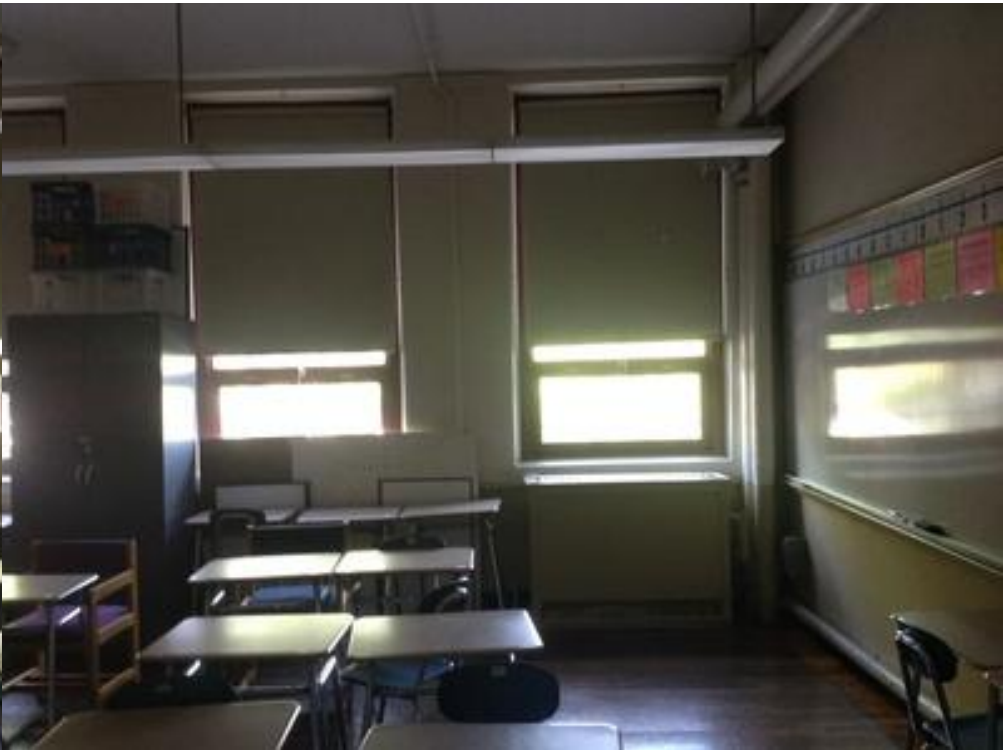
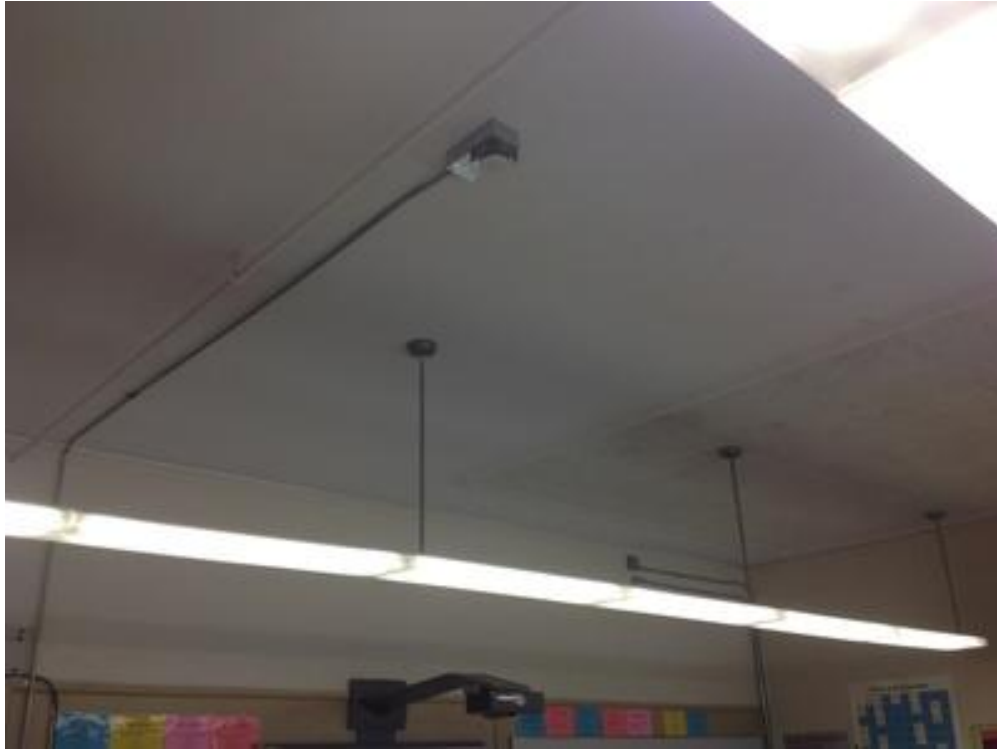
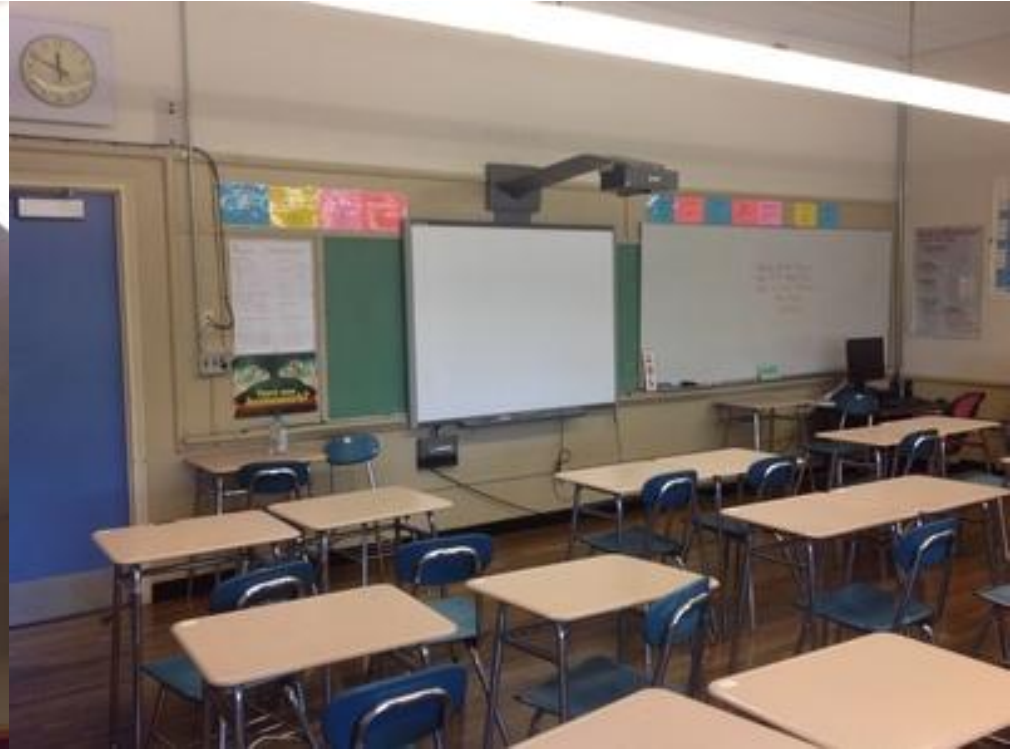
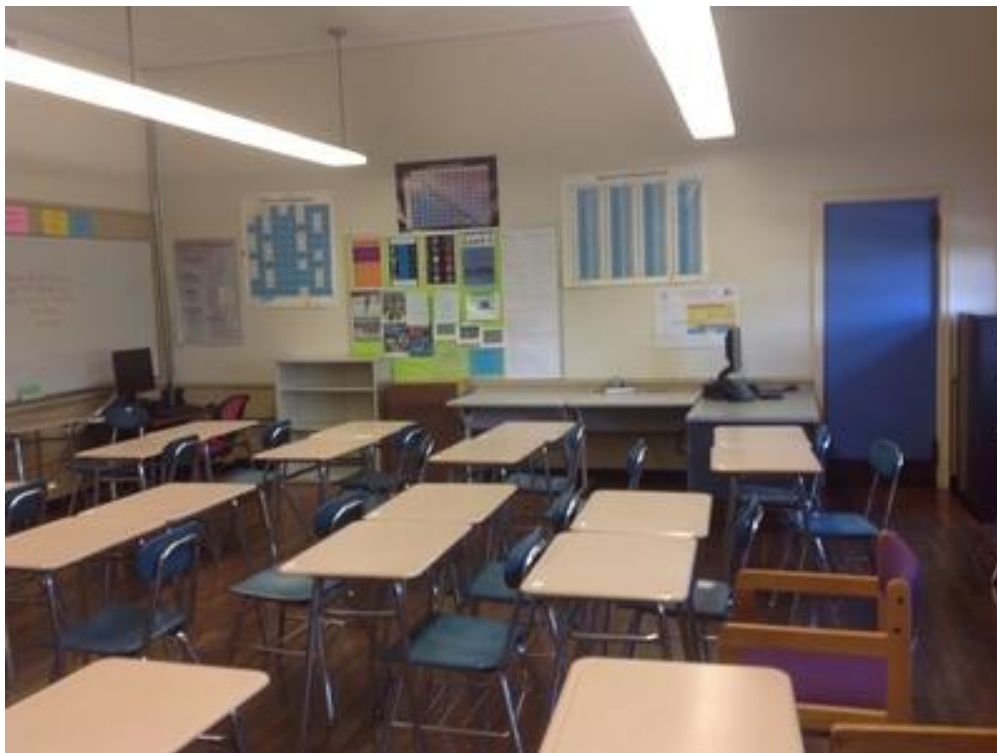
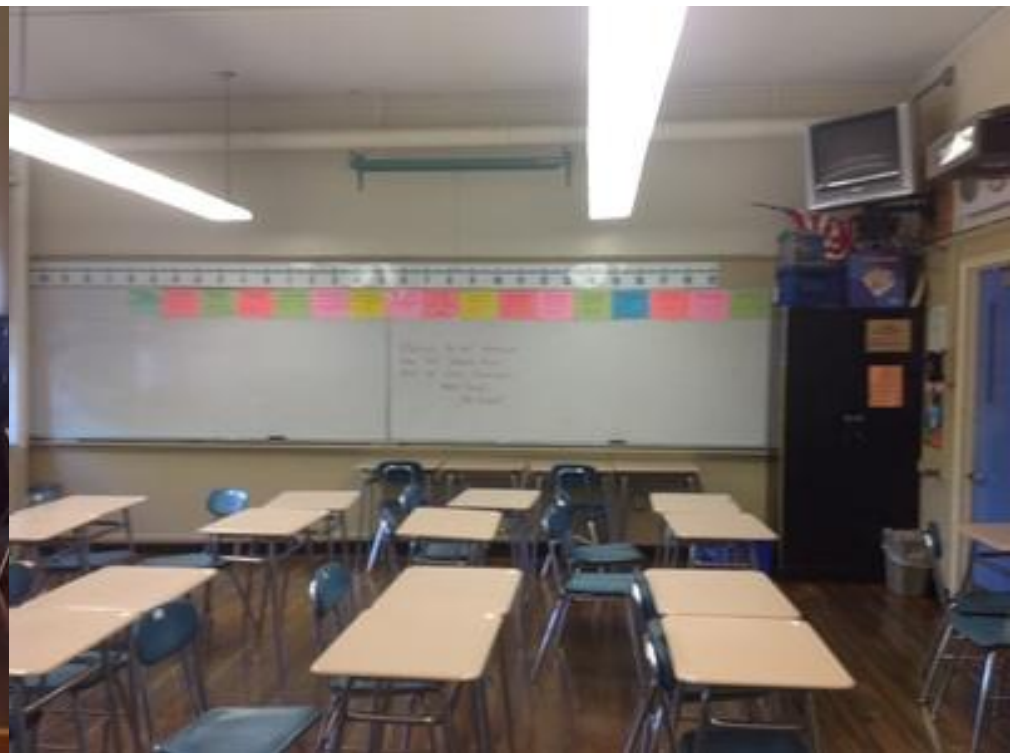
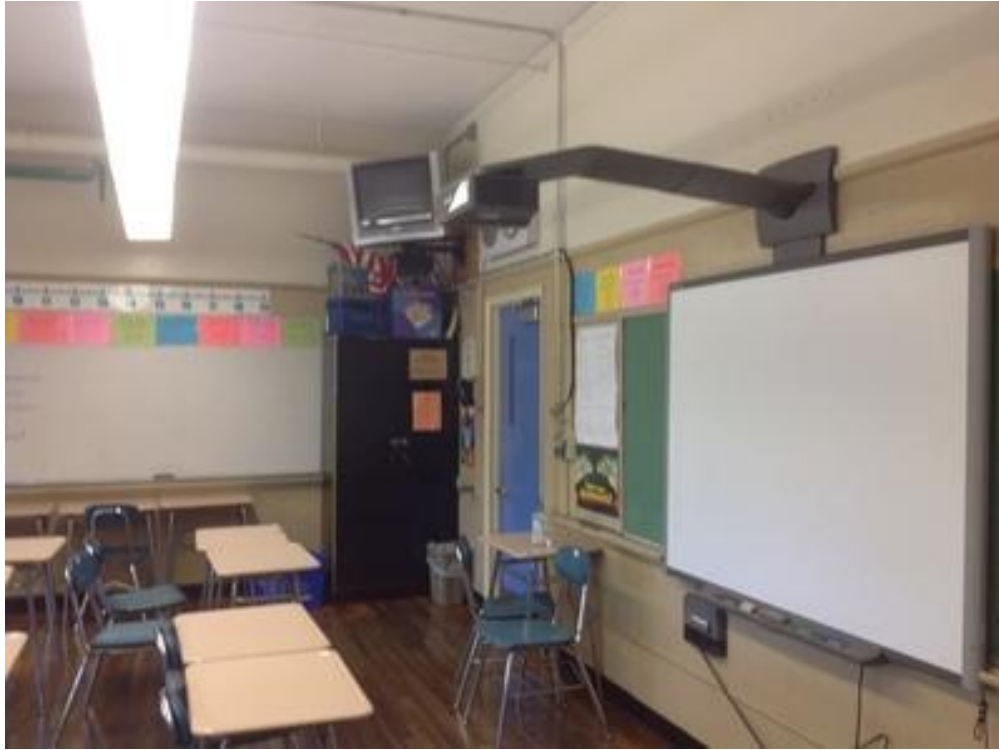
Description
Wood flooring in good condition but creaky. Paint is chipping on walls and ceiling. Light fixtures missing covers in some locations. 10'x20' area of 12"x12" VCT on ceiling. Surface mounted equipment and wiring is haphazard. Shades are in poor condition. Millwork in poor condition. Unit heater in poor condition. Some windows have lost their seal. Classroom has smartboard.

| Condition | Fair | | |

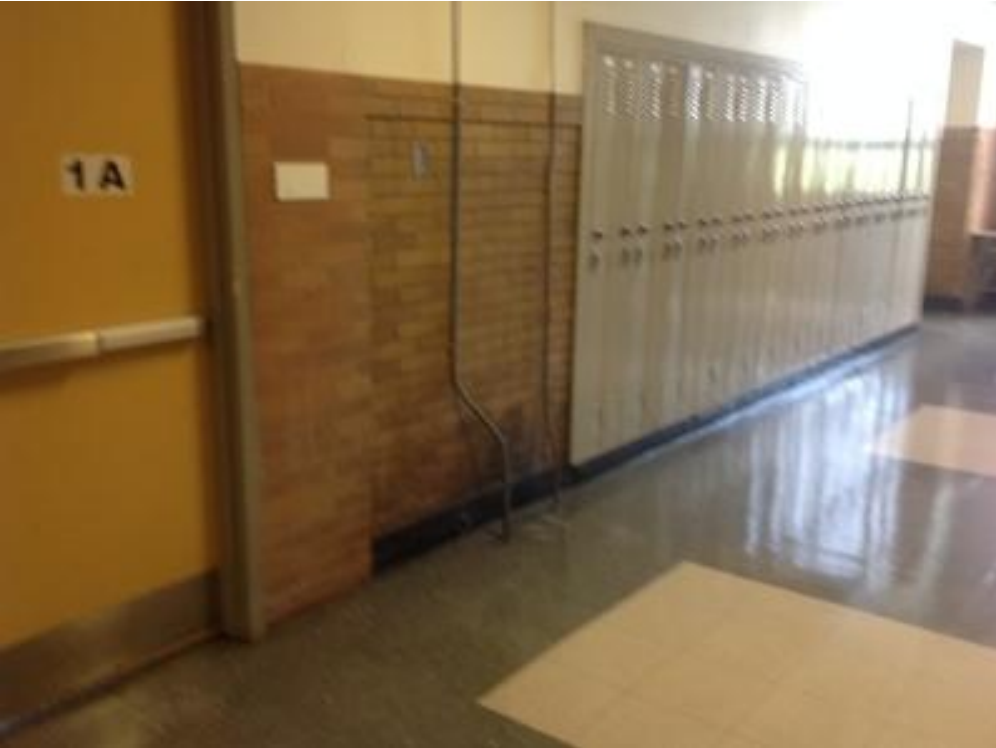
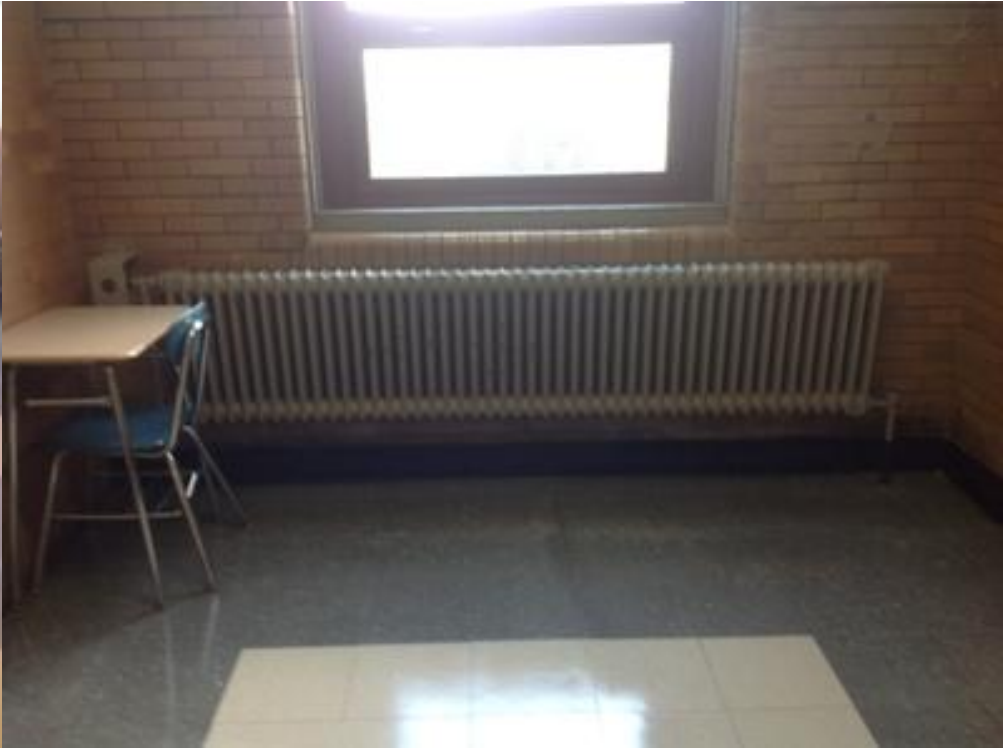
Attached Images for ID KU-00177

Description
Corridors are in poor condition. Flooring has warped in many locations. Unit heaters are in poor condition. Partial ACT ceiling is in fair condition. Exposed piping and ductwork unsightly.

| Condition | Poor | | |
